TID	SC_0799	ACP Segment	AP-1
Stream Name	Pond Hollow	MP	158.91
Survey Date	13-May-2016	Start Time	1100 hrs

Client: Atlantic Coast Pipeline

Project Number: TXG0007

Stream Crossing Plan View and Profile

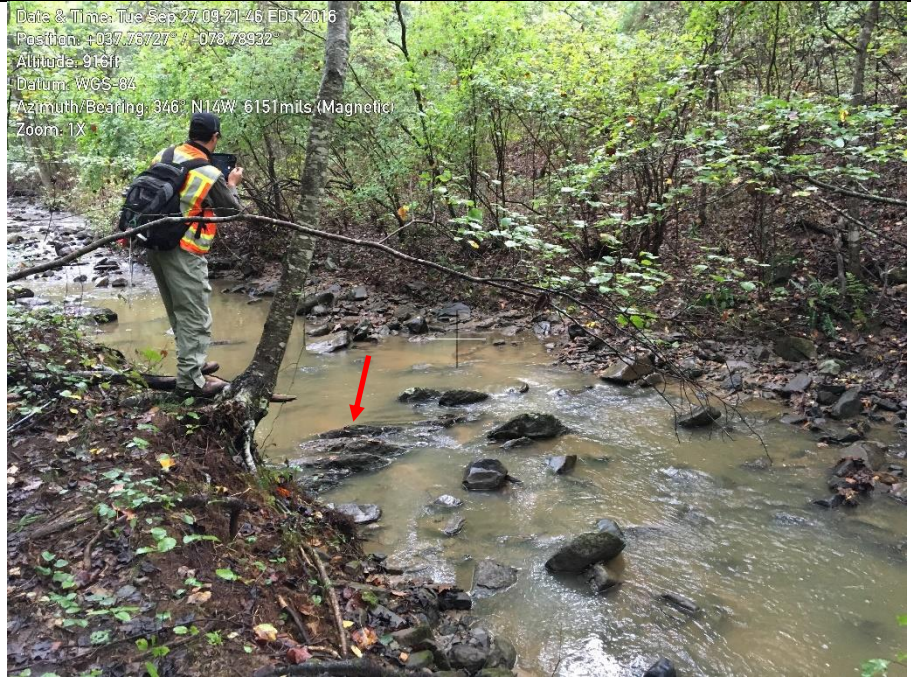
Description: Bedrock identified in stream bed (red arrow). Bedrock was observed upstream and downstream of the crossing.

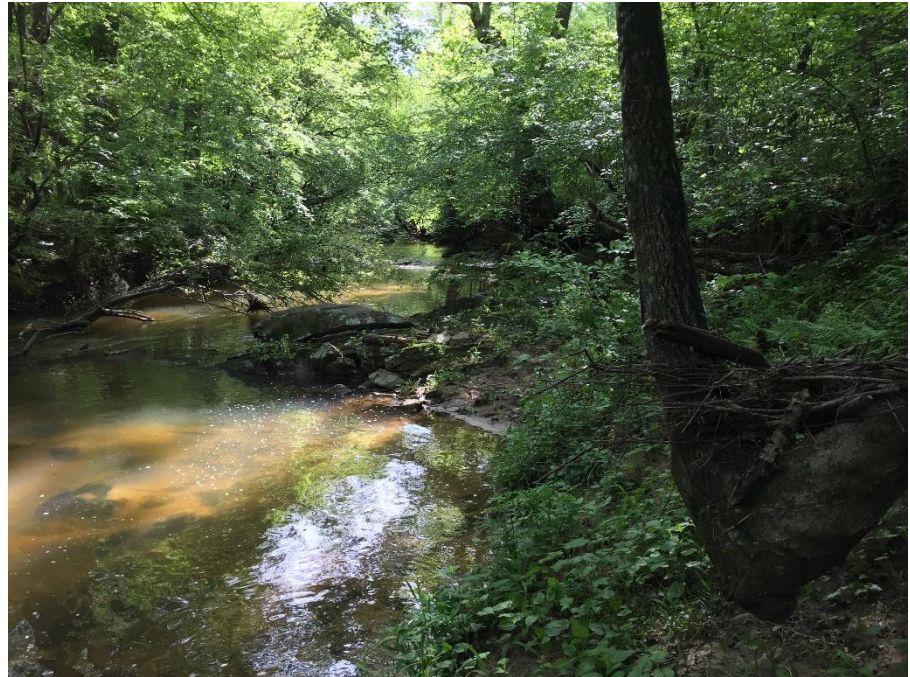
Description: bedrock
outcropping upstream of
crossing. Outside of
bedrock and gravel bars,
bed is loosely
consolidated sand.

Evaluate scour depth for pipeline burial depth. Given lateral migration hazard is moderate due to incised nature of stream, sag bends should be located at least two channel widths outside of left and right banks. If bedrock is encountered shallower than proposed burial depth, burial in bedrock is recommended.
