Stream Crossing Plan View and Profile

Stream Reconnaissance (Based on Thorne, 1998)

Client: Atlantic Coast Pipeline

Subject Site: SC_0398, McElroy Creek at MP 18.55 (TL-635)

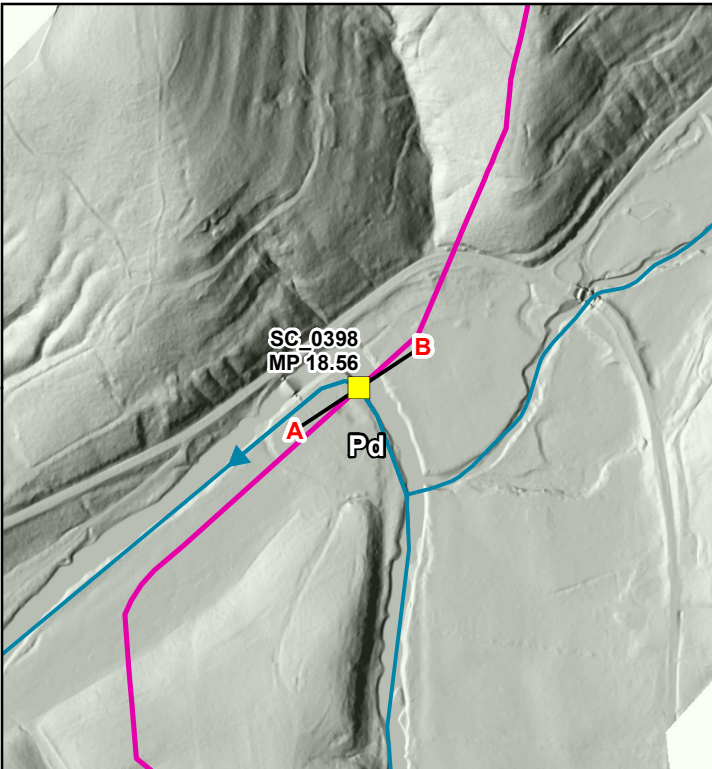
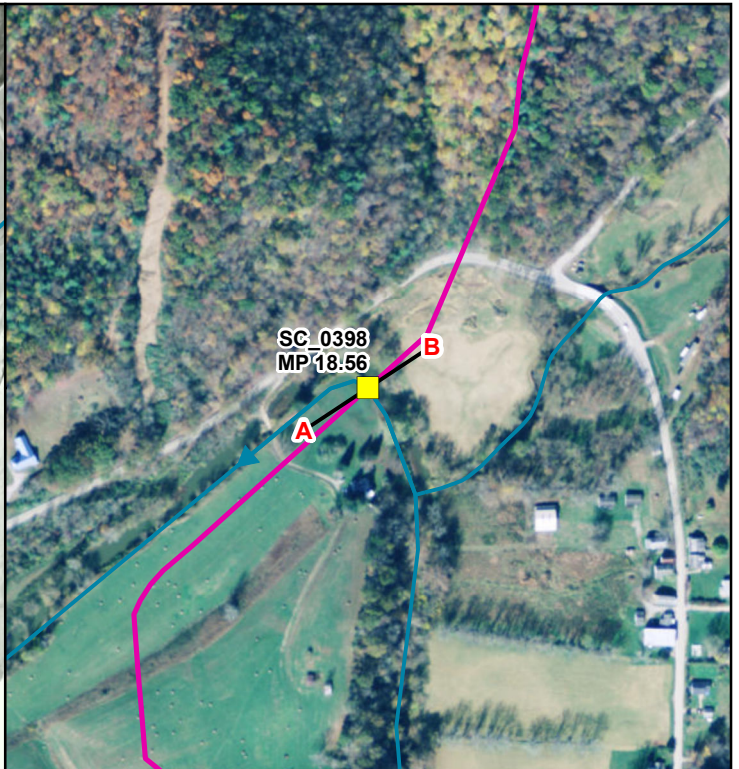
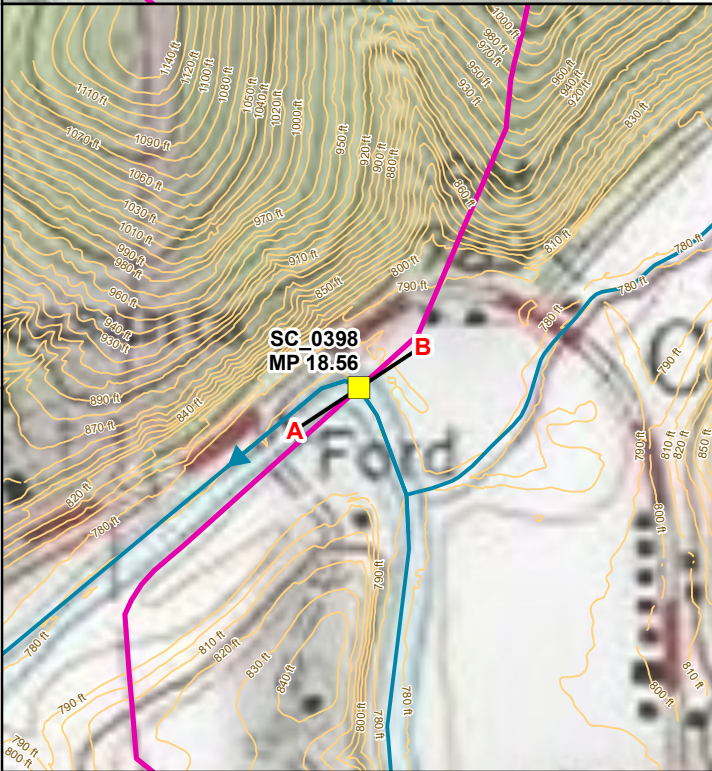
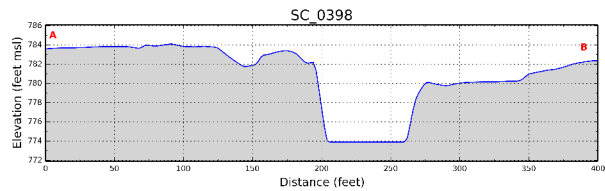
- Survey was conducted from the right bank and creek could not be waded at crossing. Stream was waded downstream of crossing where culverts were installed by landowner to place an access road to property.
- Pipeline crossing is located approximately 90 feet upstream from 90 degree bend against State Highway 23. The opposite side of the road is the toe of a steep slope with rock outcrops.
- No riparian buffer on either bank at location of pipeline crossing. Riparian buffer downstream of crossing.
- Stream bed is predominantly fine grained at crossing, but fine gravel-sized armoring observed approximately 300 feet downstream at culverts.
- Banks are steep and approximately 8 feet high and comprised of fine-grained soils (silt/clay).
- Tributary entering river from right bank.
- Additional information on stream crossing is available on stream reconnaissance form.

Evaluate scour depth for pipeline burial depth as local scour may be significant. Lateral migration towards the left bank is low, but the potential towards the right bank into floodplain is greater. Evaluate local topography to establish setback for sag bends.

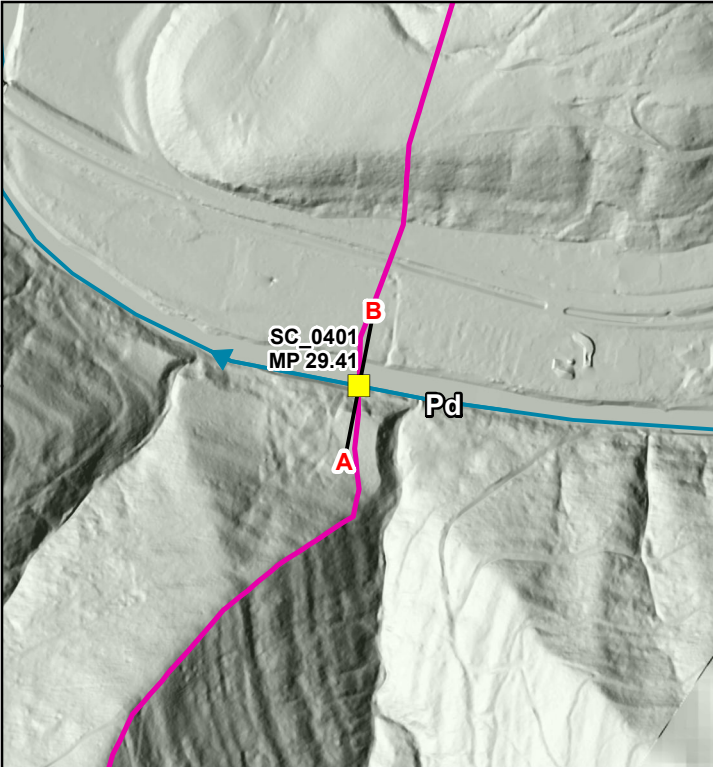
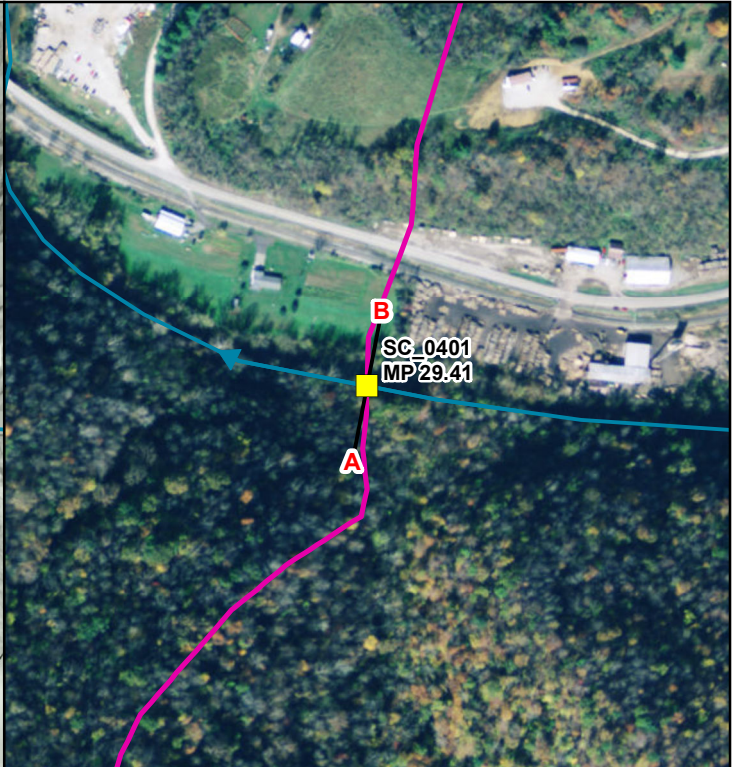
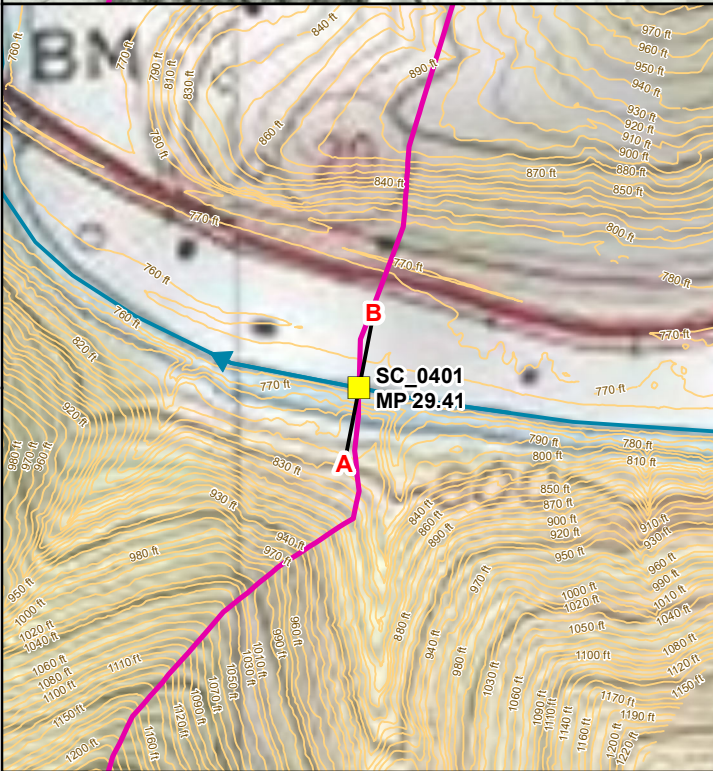
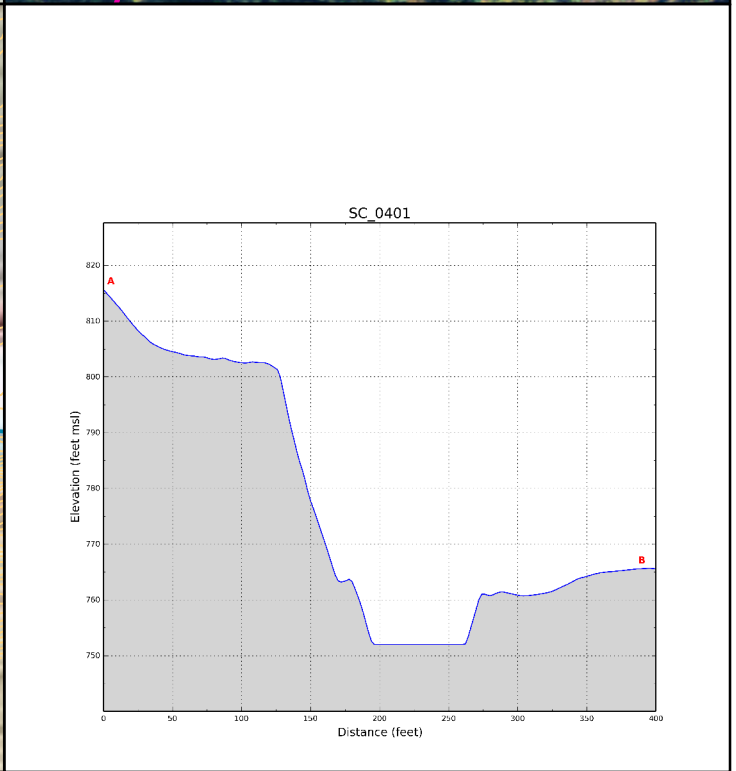
Stream Crossing Plan View and Profile

- Survey was conducted from the right bank and creek could not be waded at crossing.
- Left bank is a natural slope (valley wall) densely forested with deciduous trees.

- Right bank is clayey and next to the stock yard of a wood mill owned by Allegheny Wood Products.
 - Allegheny Wood Products, Mill #11, Outfall #001 entering stream from right bank

- Riparian buffer on the right is thin (less than one stream width) and exhibits falling young trees.
- Stream bed comprises angular and sub-angular boulder and cobble-sized slabs of sandstone and slate.

- Stream has a riffle-pool morphology with pipeline crossing at a riffle with a local scour pool measured at 4 feet deep.
- Two pipes were observed on the left bank at about flood elevation.

- Signs of high flows approximately 5 feet above observed water levels
- Lateral migration towards the left bank is constrained by valley wall.
- Lateral migration to the right is unlikely given active land use as wood mill and State Hwy. 20.

Evaluate scour depth for pipeline burial depth as local scour may be significant. Place right sag bend at standard set back.

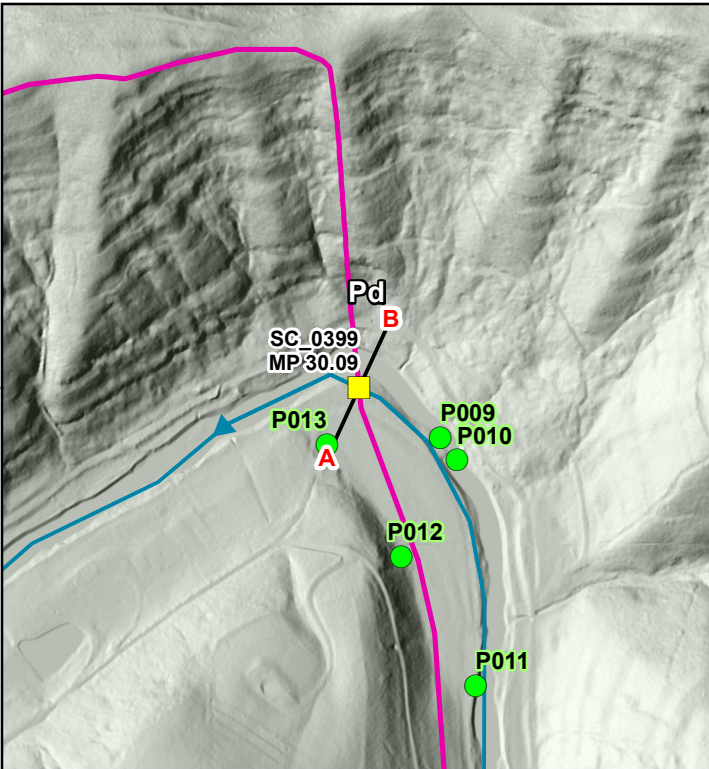
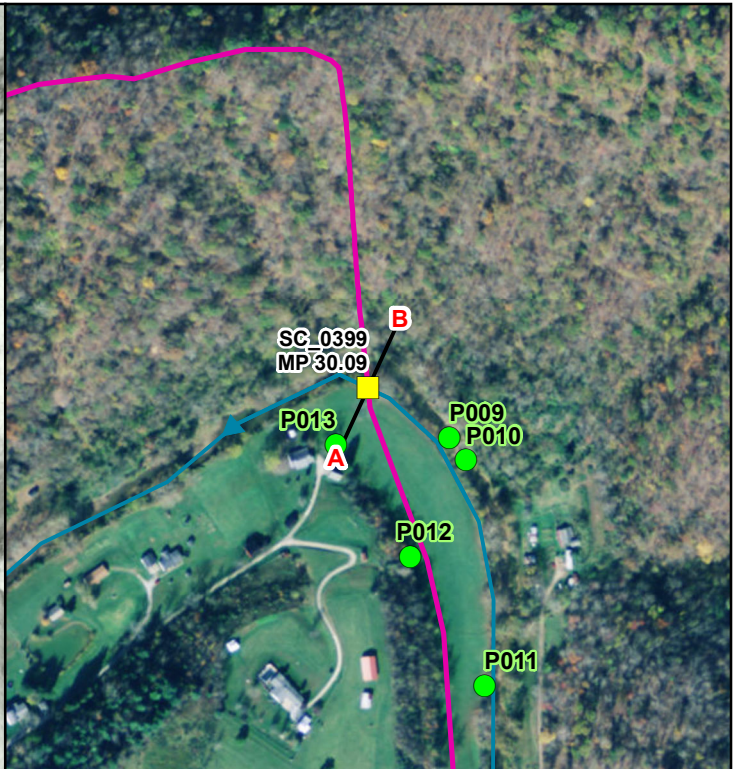
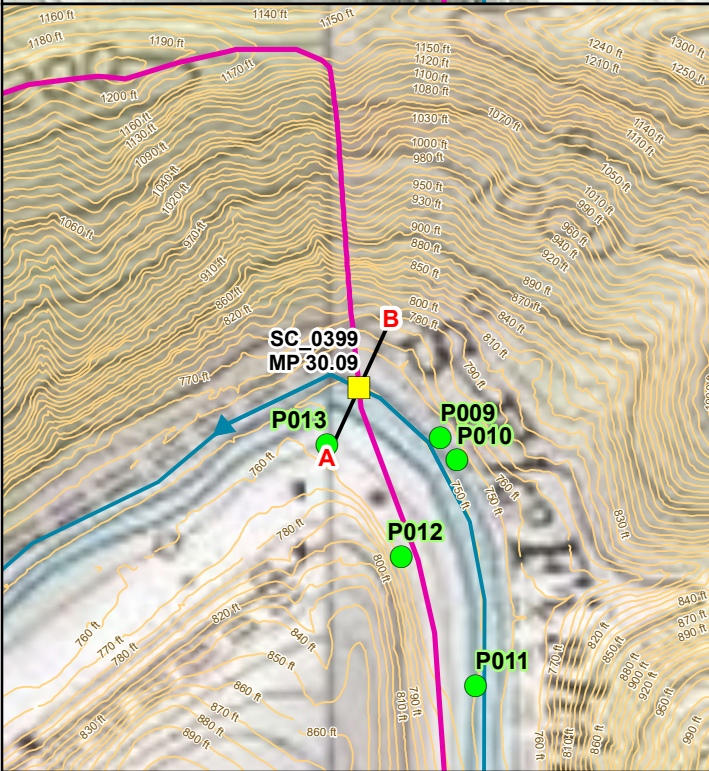
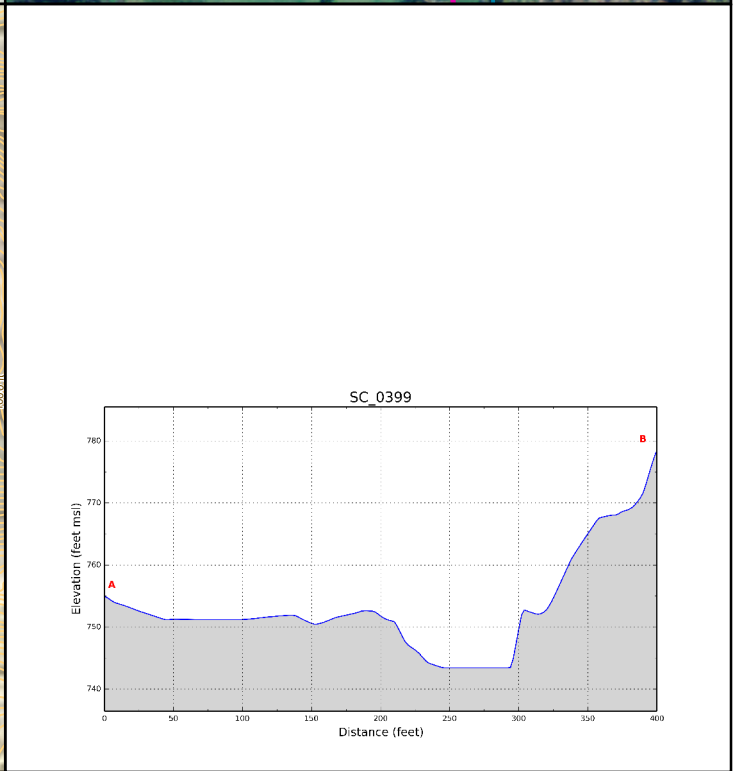
- Stream crossing is at a 90 degree bend against valley wall (right bank).
- Bedrock was observed in stream about 300 yards upstream of crossing, but is expected to be shallow at crossing given the valley wall on left bank.
- Right bank is densely forested with deciduous trees.
- Left bank has a thin riparian buffer (less than one stream width) and is connected to the floodplain pasture.
- Left bank is about 6-feet high and comprised of fine grained soils (clay and silt).
- Conducted Wolman Pebble Count on riffle upstream of crossing where gravel was observed; D₅₀ is 34 mm (coarse gravel).
- Point bar comprising angular and rounded gravel-sized particles at bend where crossing is located.
- Landowner noted historical observations of floods up to near the house on the left bank floodplain.
- Additional information on stream crossing is available on stream reconnaissance form.

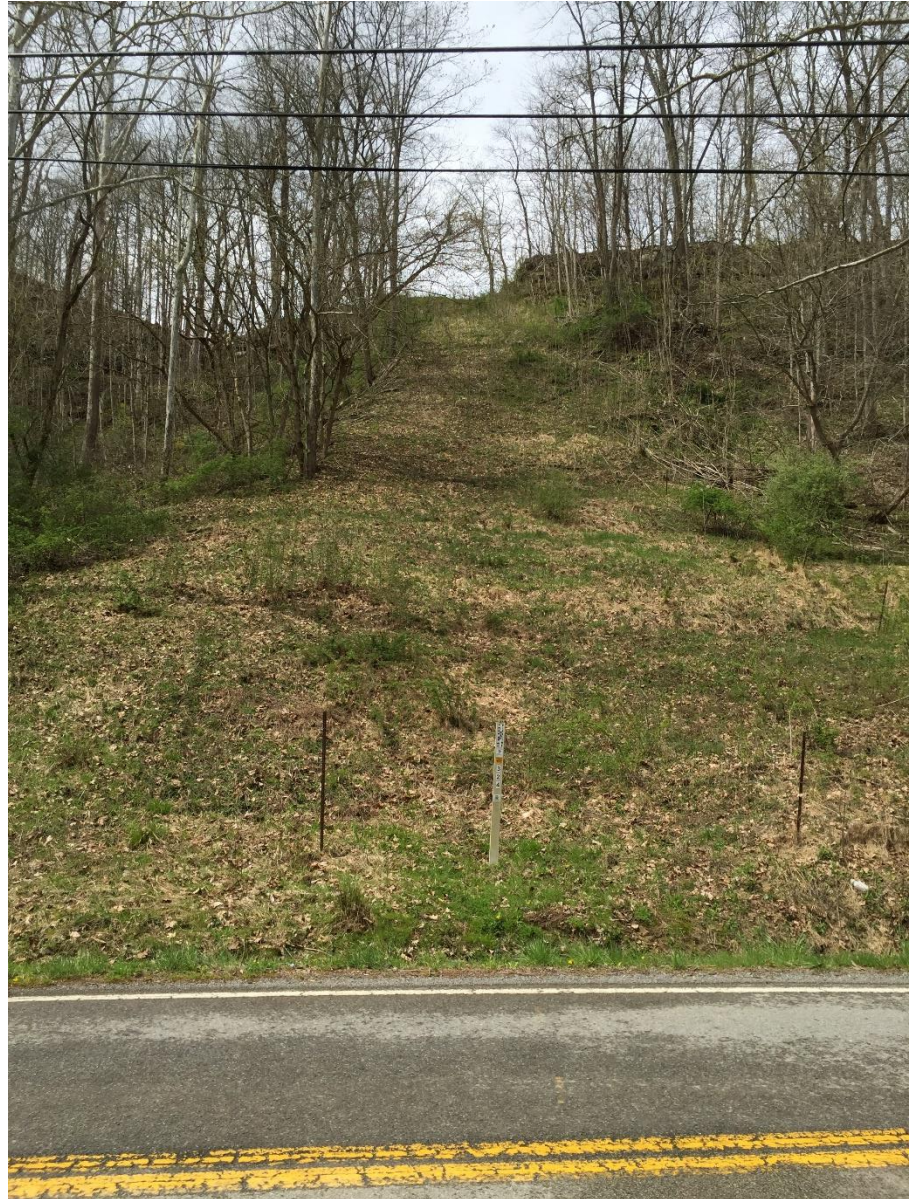
Description: View of
existing gas pipeline right
of way operated by
Dominion.

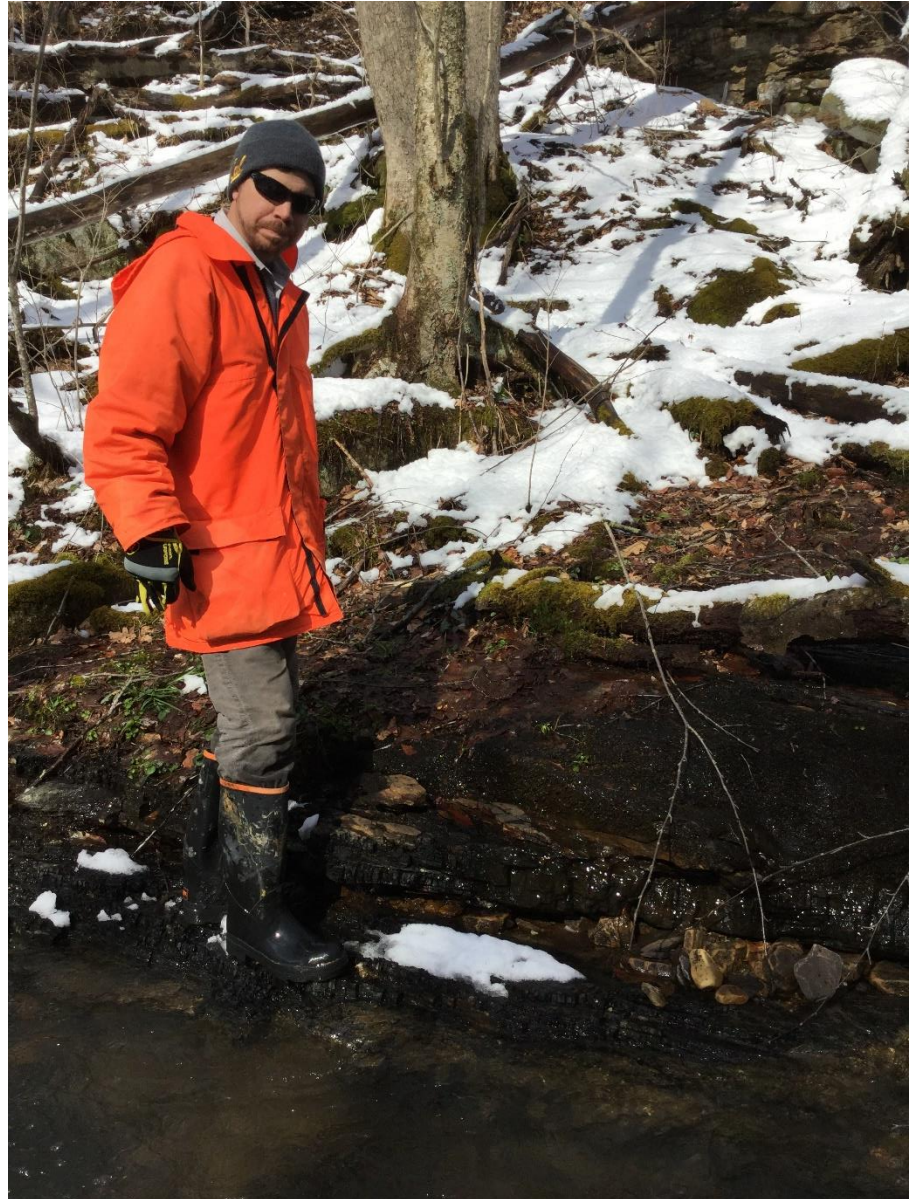
Description: Outcrop on
right bank.

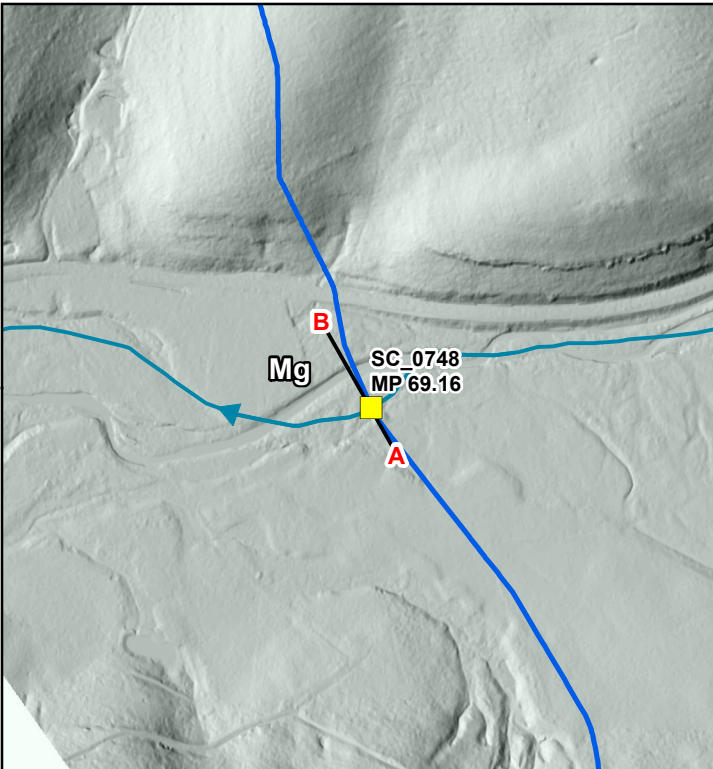
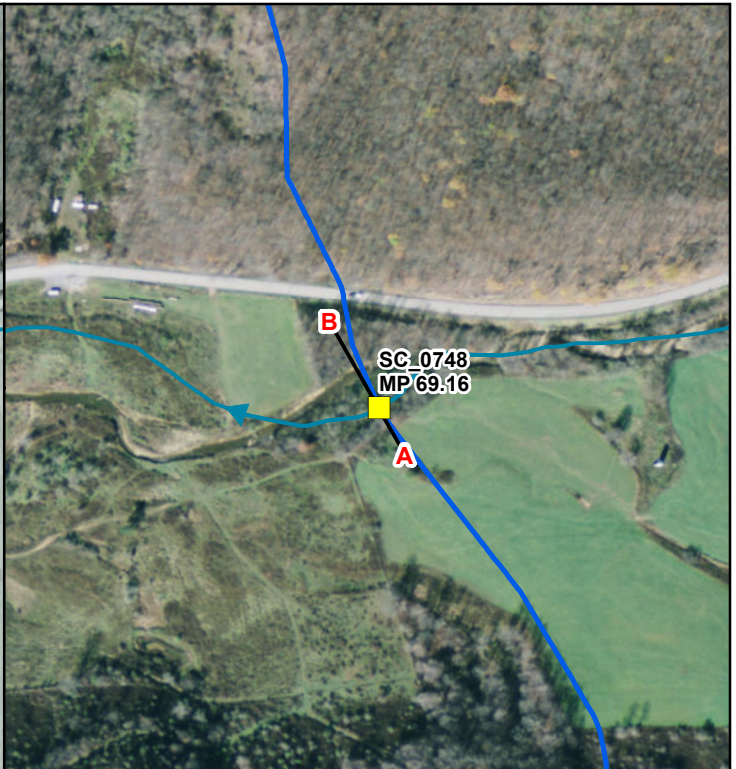
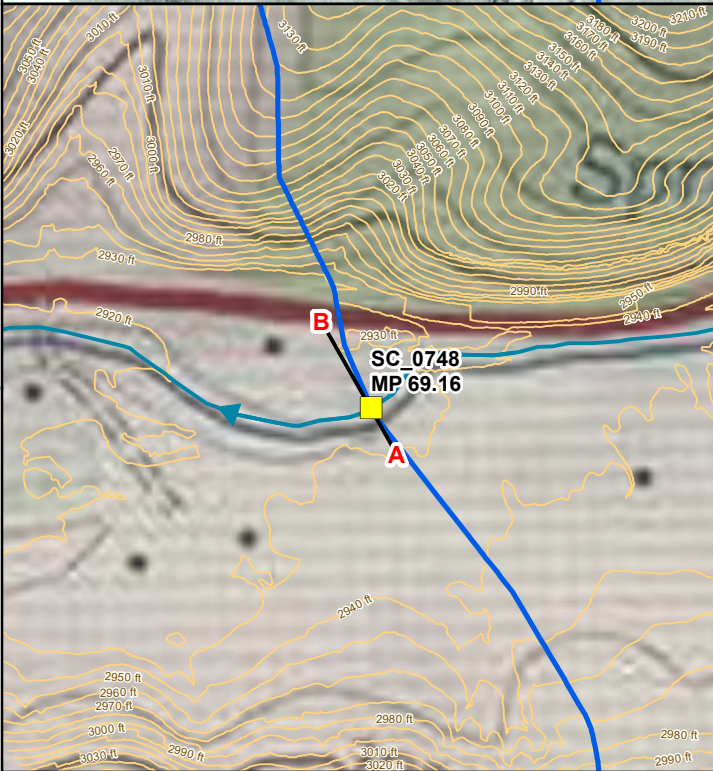
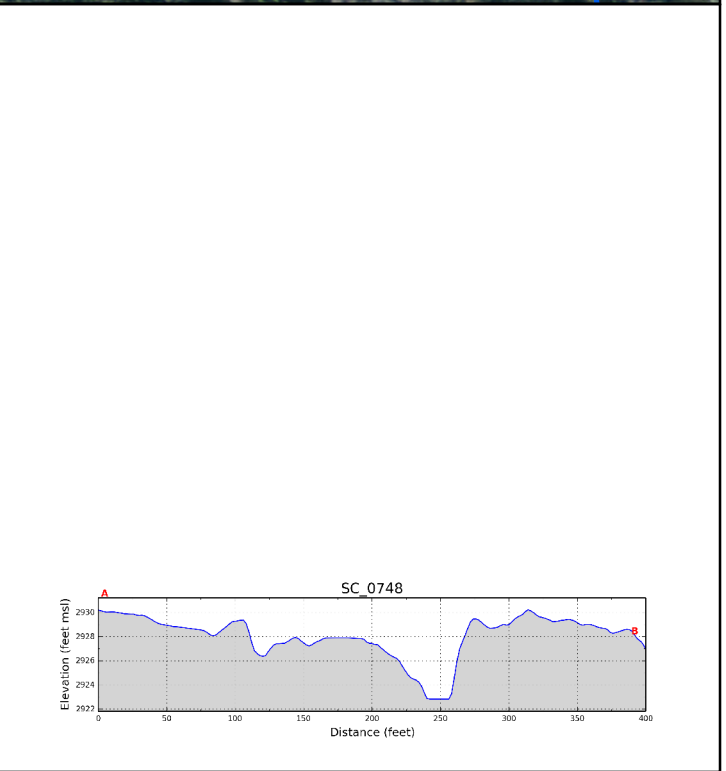
- Stream surveyed from right bank. Wading through stream was not possible.
- Survey conducted while it was snowing and after it had snowed, thus banks were snow covered obscuring our ability to make direct observations bank conditions.

- Minor head cut just upstream of crossing.
- Bed comprised of cobbles and some boulders. Wolman Pebble Count not conducted because of poor weather conditions.

Evaluate scour depth for pipeline burial depth. Lateral migration hazard is most prominent for the right bank due to location of crossing in a broad meander bend. However, the active floodplain is widest to the left bank (five to six river widths wide). While lateral migration rate is likely low for either bank, sag bend should be placed at least two river widths wide from right bank and at least three river widths from the left bank.
