TID	SC_0816	ACP Segment	AP-1
Stream Name	Jackson River	MP	91.47
Survey Date	12-May-2016	Start Time	1105 hrs

PHASE 2 – RAPID STREAM RECONNAISSANCE
Photographic Record

Client: Atlantic Coast Pipeline

Subject Site: SC_0816, Jackson River at MP 91.47 (AP-1)

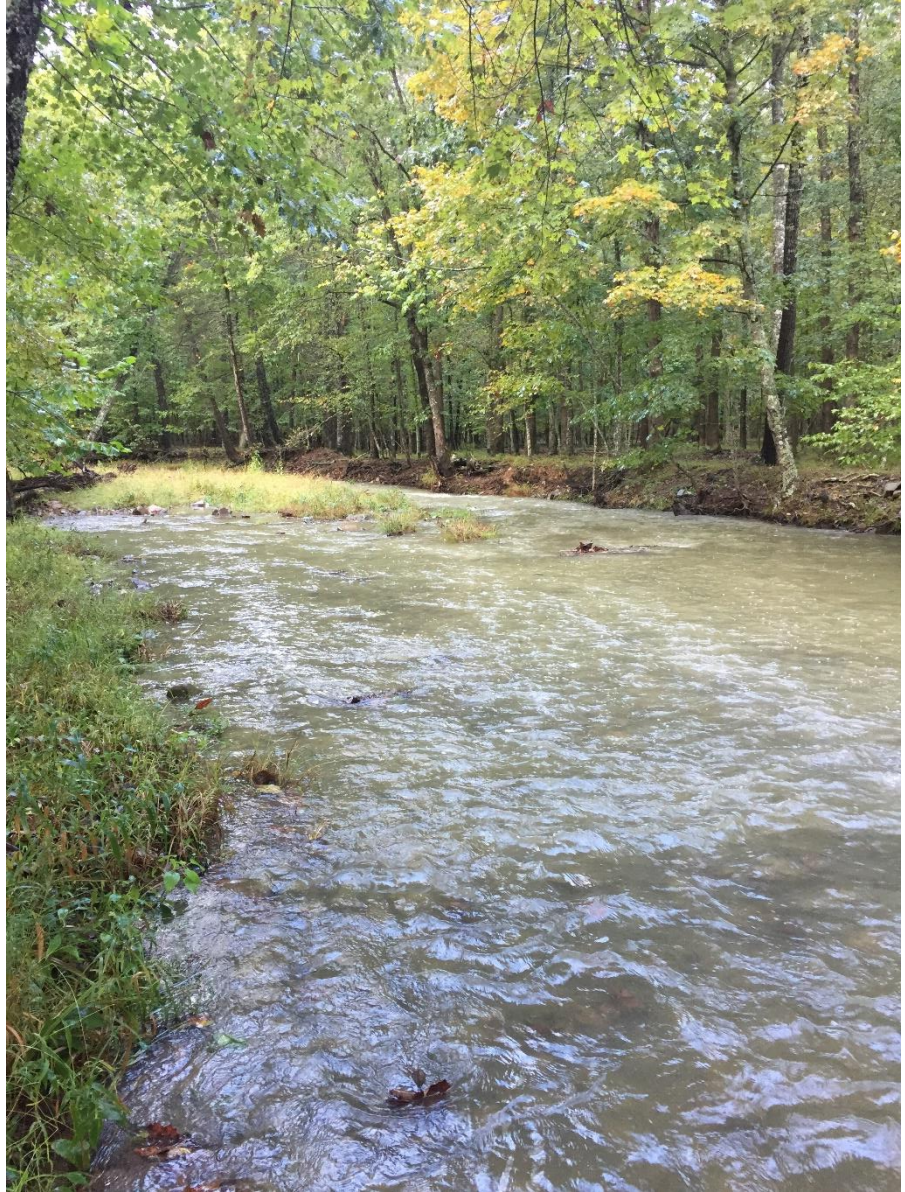
Description: steeper,
eroded banks near
observed head cuts,
downstream of crossing.
Mid channel bar visible
with 1.5-ft high head cuts
on both sides of bar.

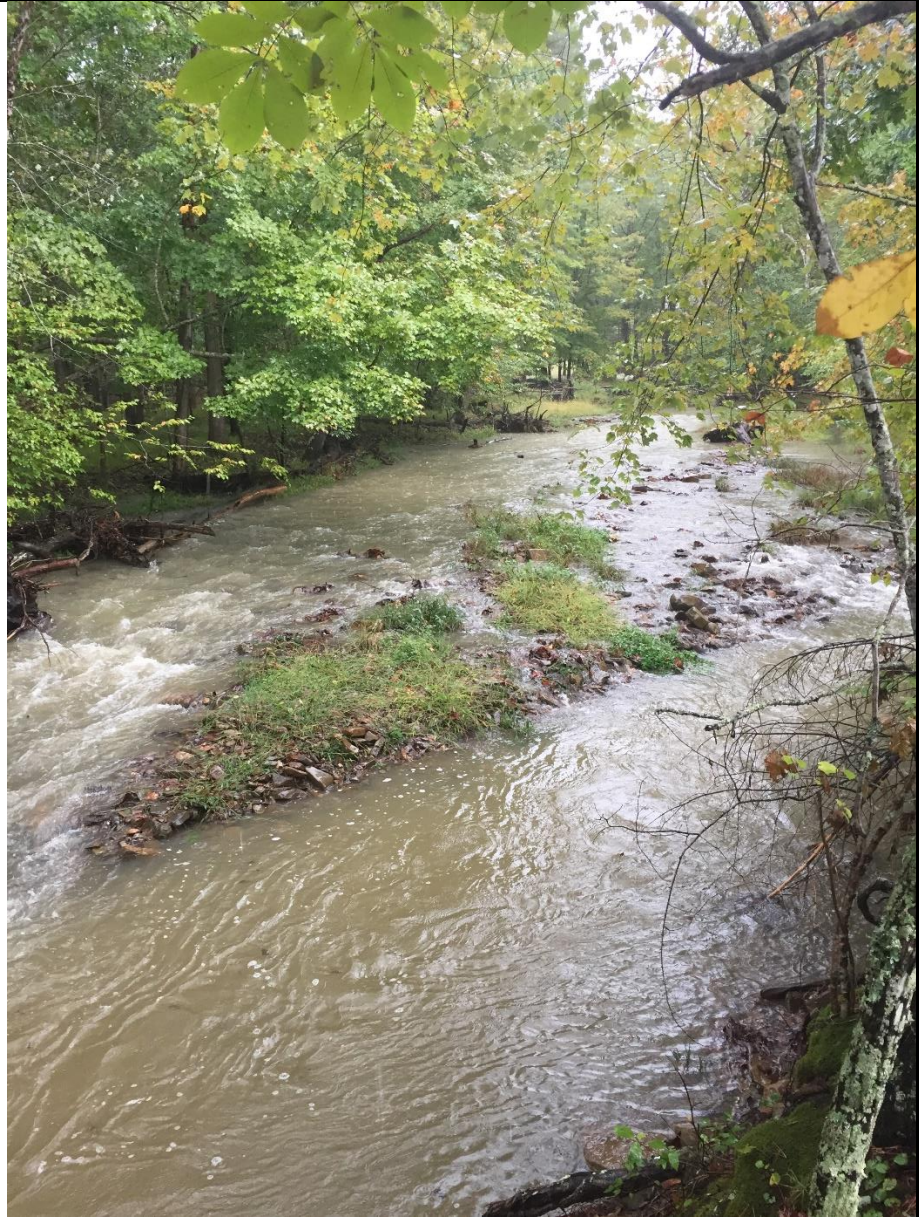
Description: transverse bar with head cuts upstream of crossing. Floodplain remains accessible, predominantly off right bank where it shares the floodplain with White Sulphur Spring Branch (SC_0635).

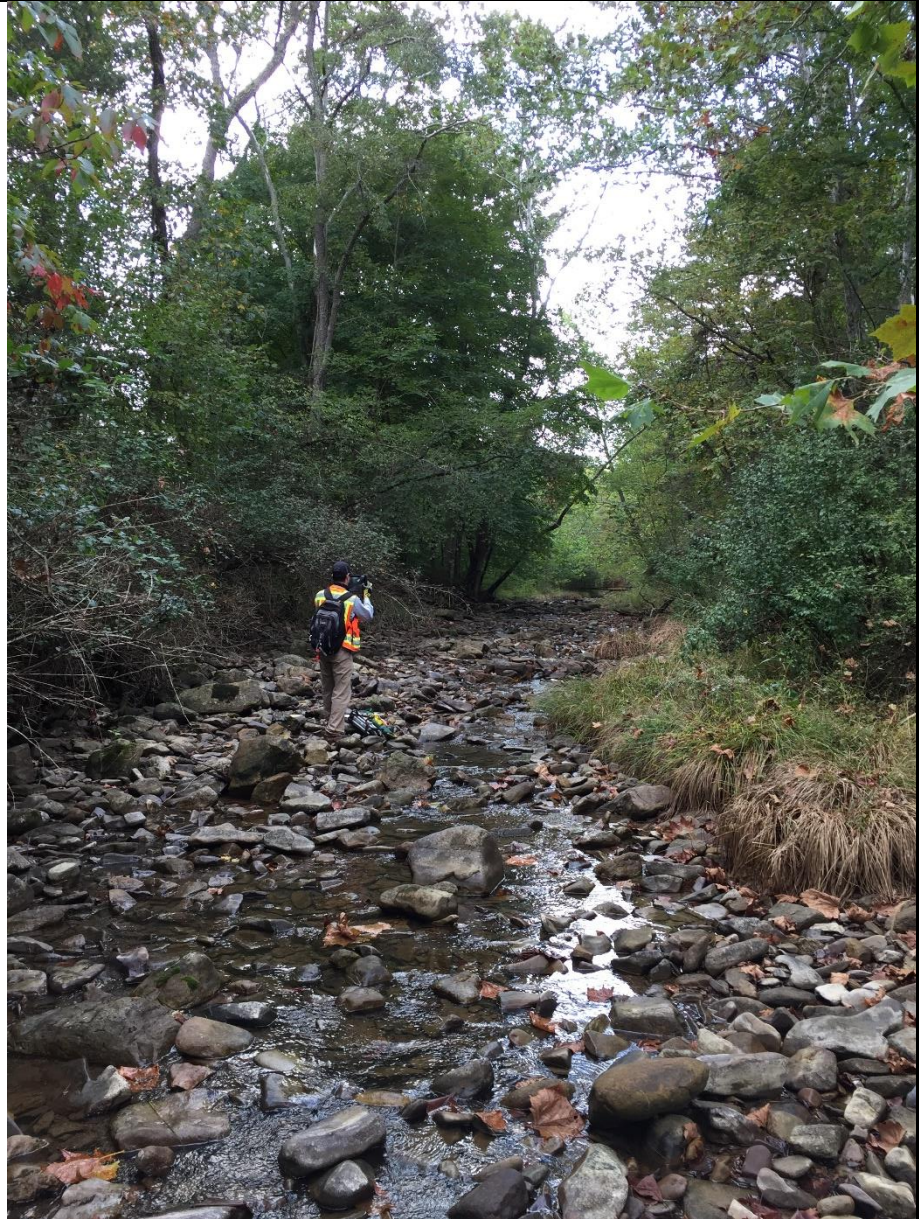
Description: Moderate to shallow bank steepness upstream of crossing. Minor terraced floodplain off left bank. Well established riparian buffer off both banks, extends to road off right bank.

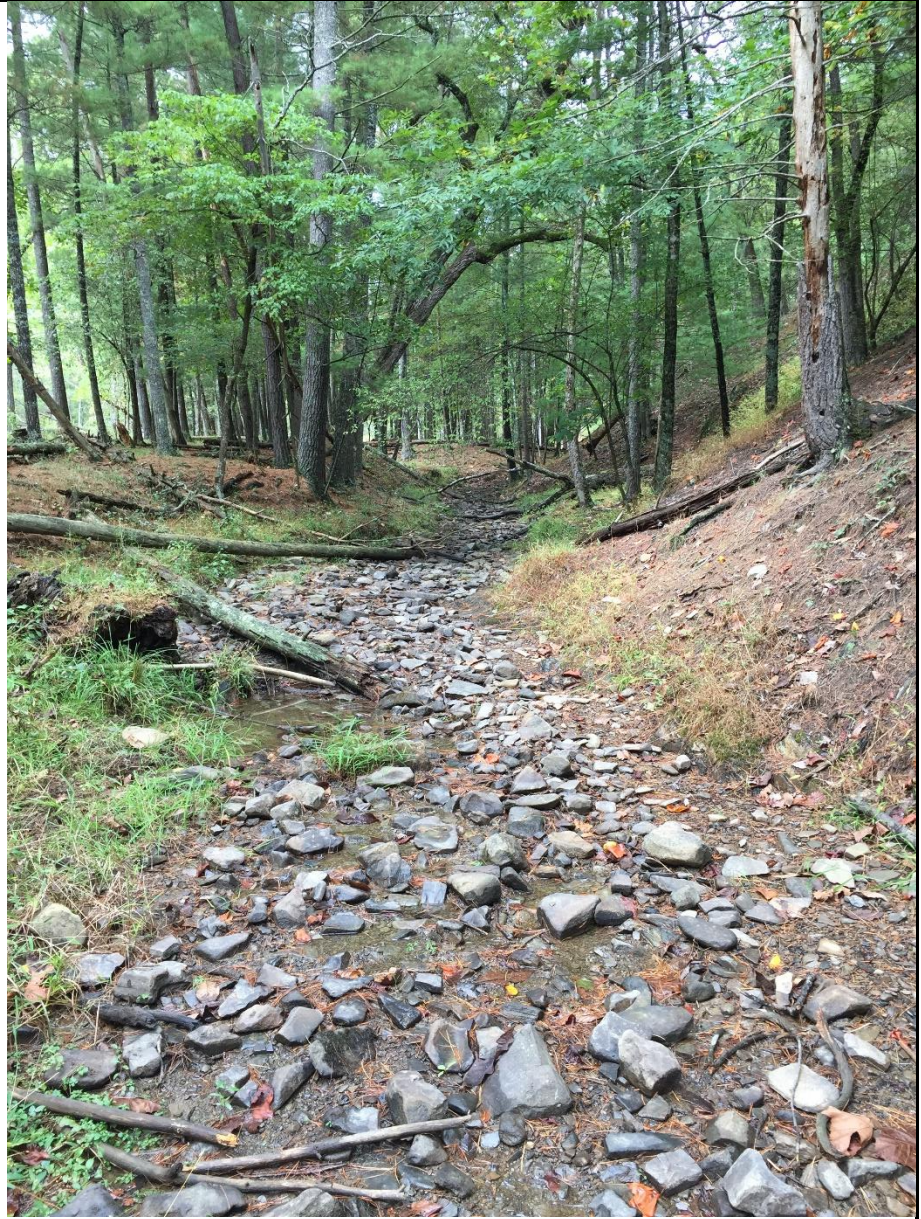
Description: Angular to
sub-angular channel bed.
Riparian buffer 1-5
channel widths off right
bank.

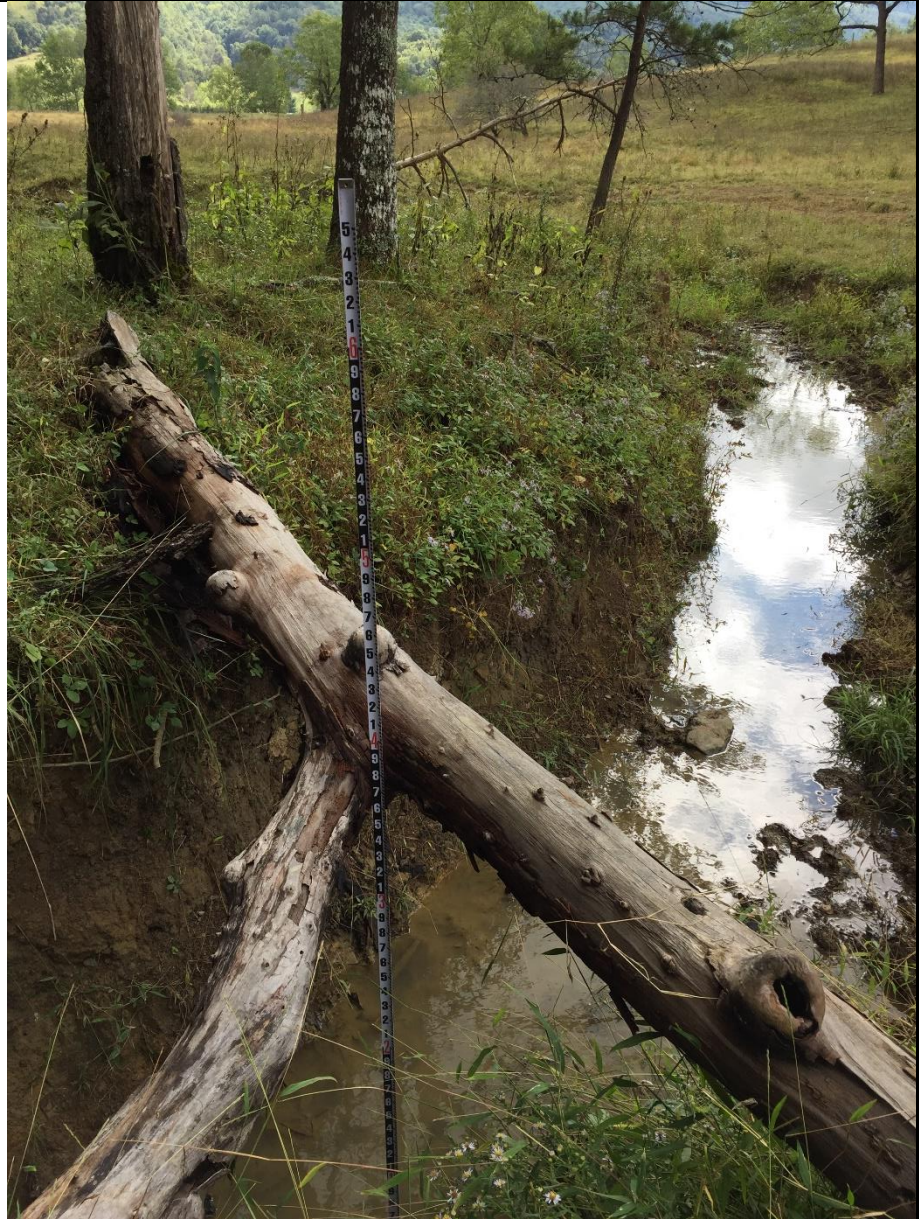
Description: Steep eroded
banks, particularly at
bends, downstream of
crossing.

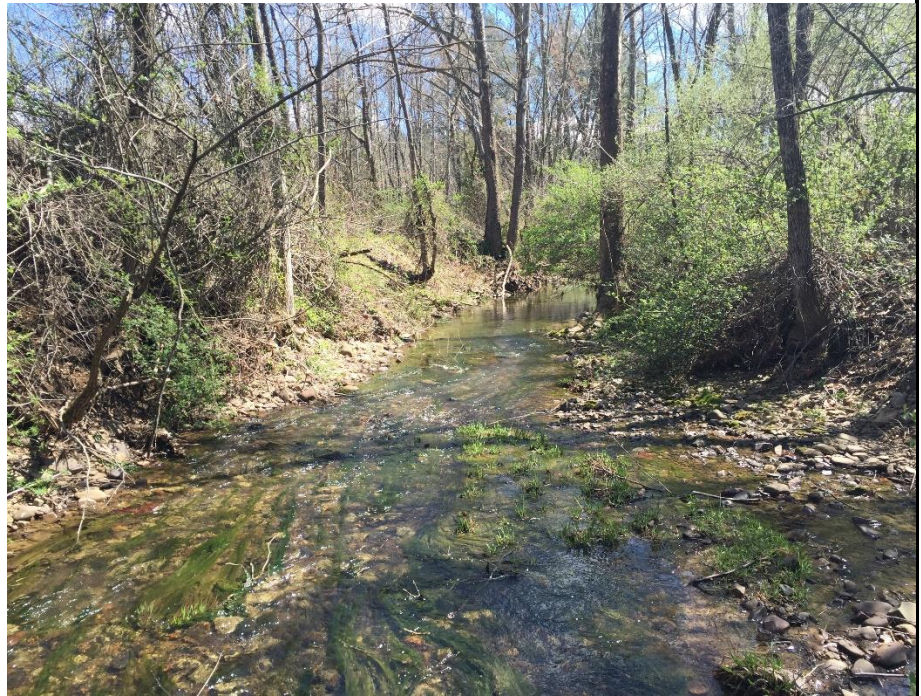
Description: Flow
observed during April
2016 survey, riffle section
visible with quiescent
pools above and below.

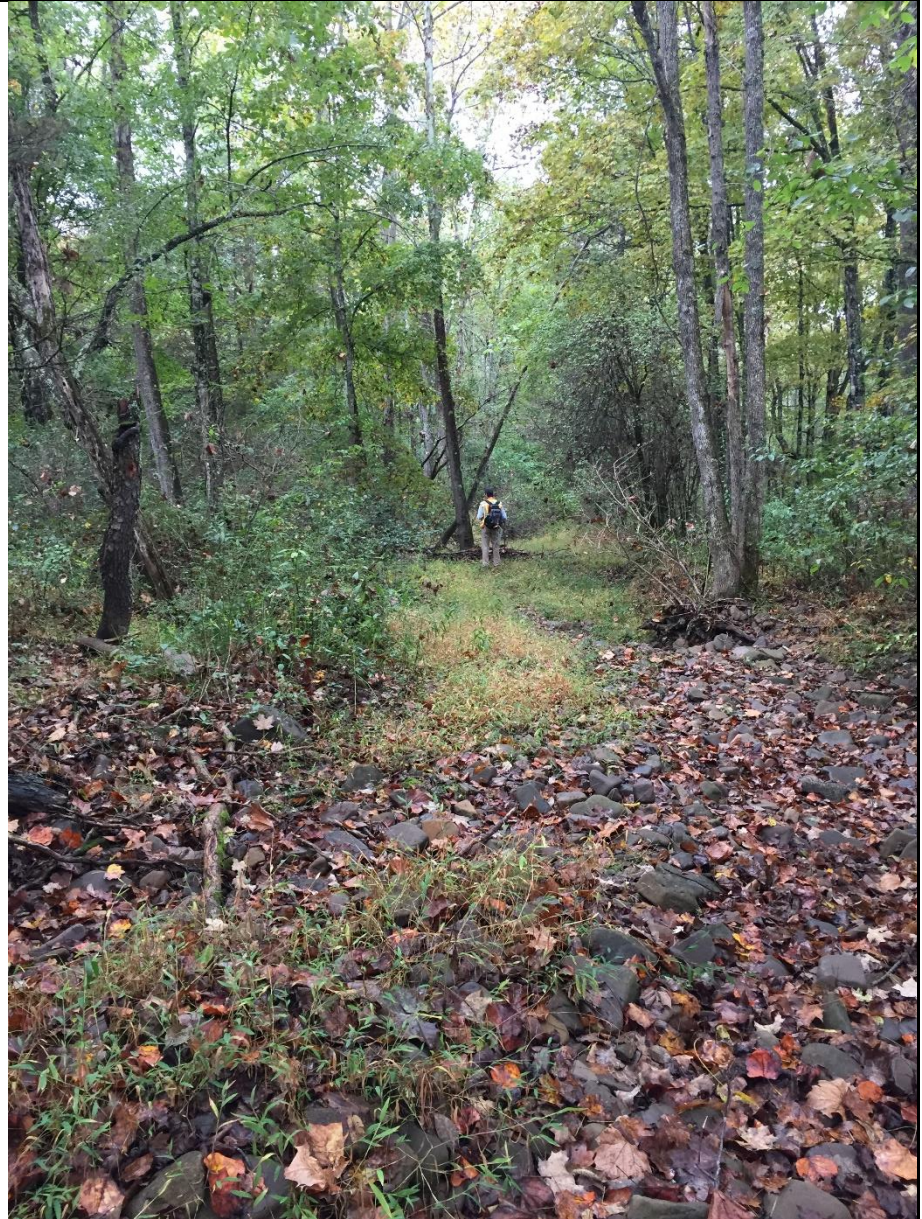
Description: Cobble
channel bottom visible in
sections of steeper local
slope. No significant
signs of vertical or lateral
migration hazards.
