Linear Waterbody Data Sheet

Survey Description			
Project Name: Atlantic Coast Pipeline		Waterbody Name: UNT to Dry Fork	
Waterbody ID: Spoe018		Date: 5/6/2016	
State: West Virginia	County: Pocahontas	Company: NRG	Crew Member Initials: CG, KO
Photos: 1-3			
Tract Number(s): 05-001-E085; Unnamed tract south of 05-001-E085		Nearest Milepost: 67.7	Associated Wetland ID(s): none
Survey Type: <i>(check one)</i> <input type="checkbox"/> Centerline <input type="checkbox"/> Re-Route <input type="checkbox"/> Access Road <input type="checkbox"/> Other:			
Physical Attributes			
Stream Classification: <i>(check one)</i> <input checked="" type="checkbox"/> Ephemeral <input type="checkbox"/> Intermittent <input type="checkbox"/> Perennial			
Waterbody Type: <i>(check one)</i> <input type="checkbox"/> River <input checked="" type="checkbox"/> Stream <input type="checkbox"/> Ditch <input type="checkbox"/> Canal <input type="checkbox"/> Other:

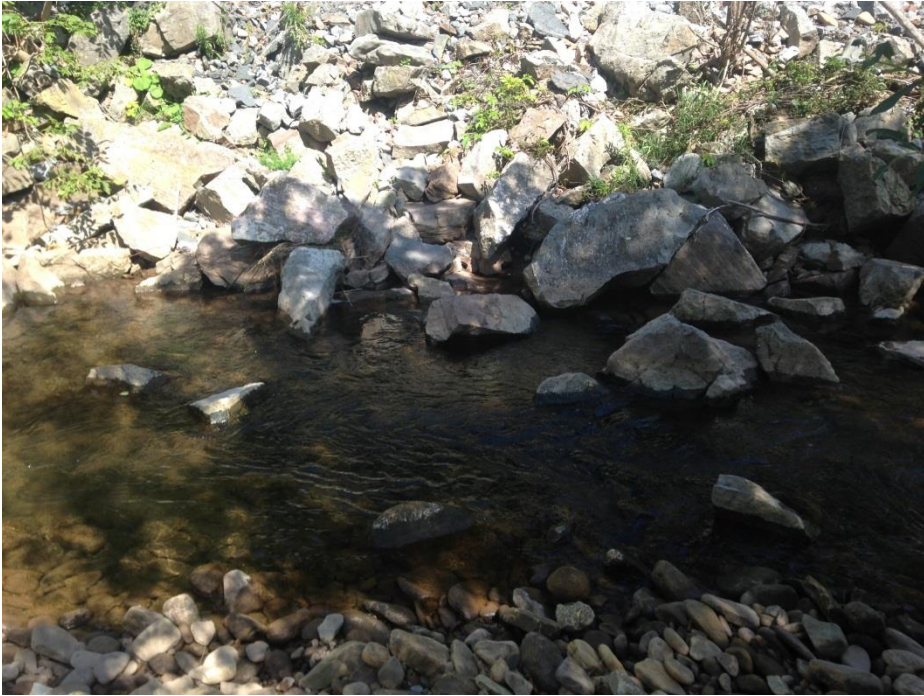
Waterbody spoe046 facing north across

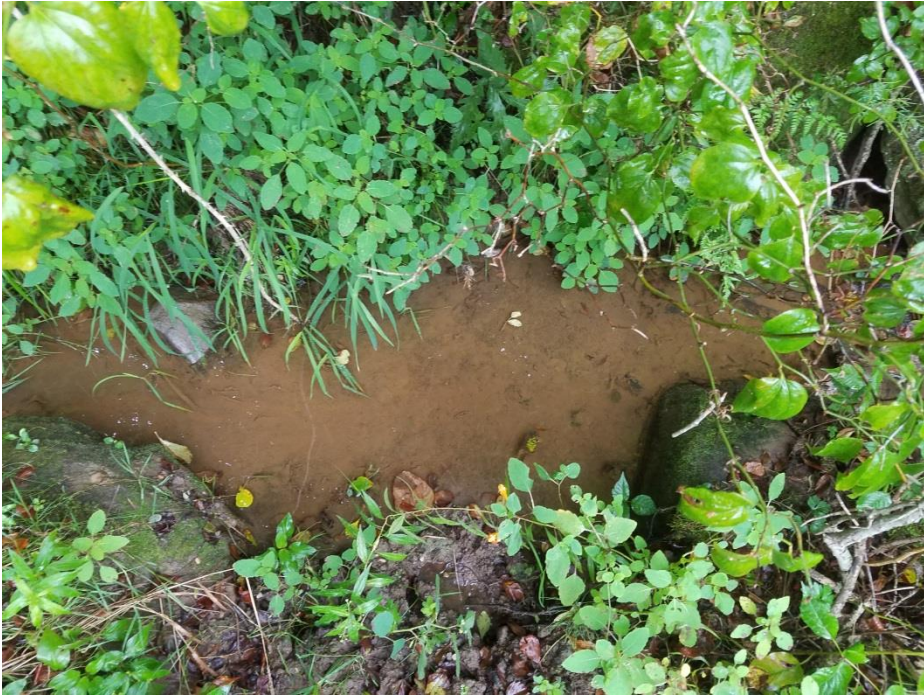
Stream continues out of corridor in both directions; no culvert or bridge present for existing dirt road crossing; flows through PSS wetland wpoa422; stream is extremely trampled by livestock.

Waterbody spoa442 facing west across

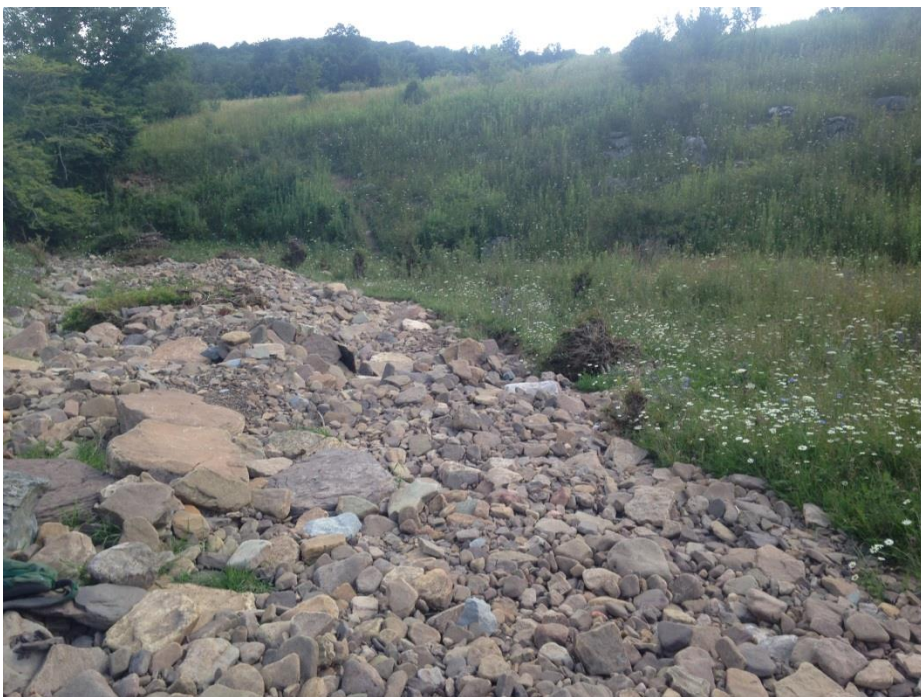
Waterbody spoe045 facing northeast downstream

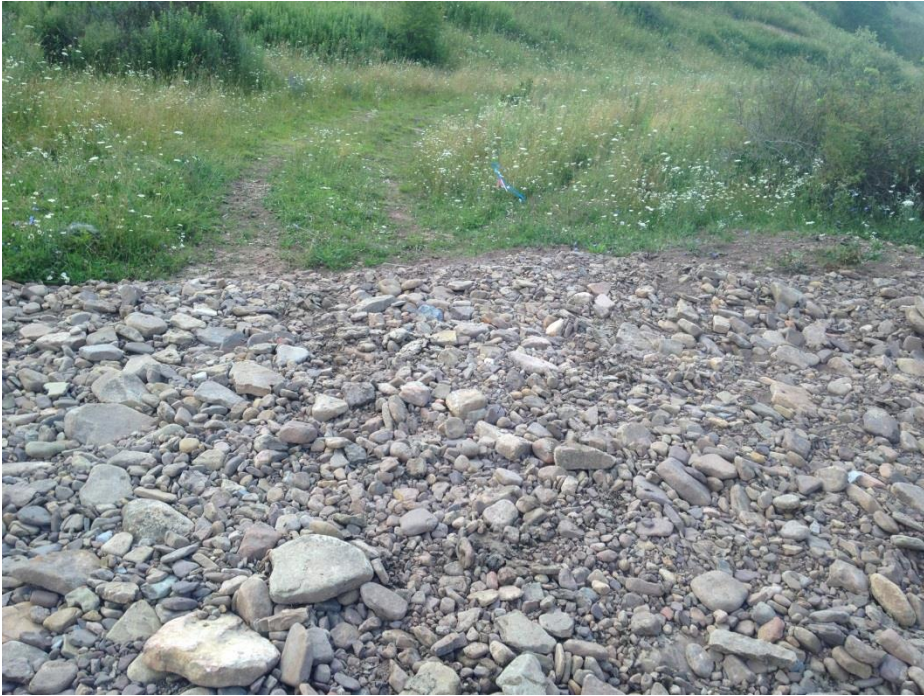
Waterbody spoe045 facing southeast across

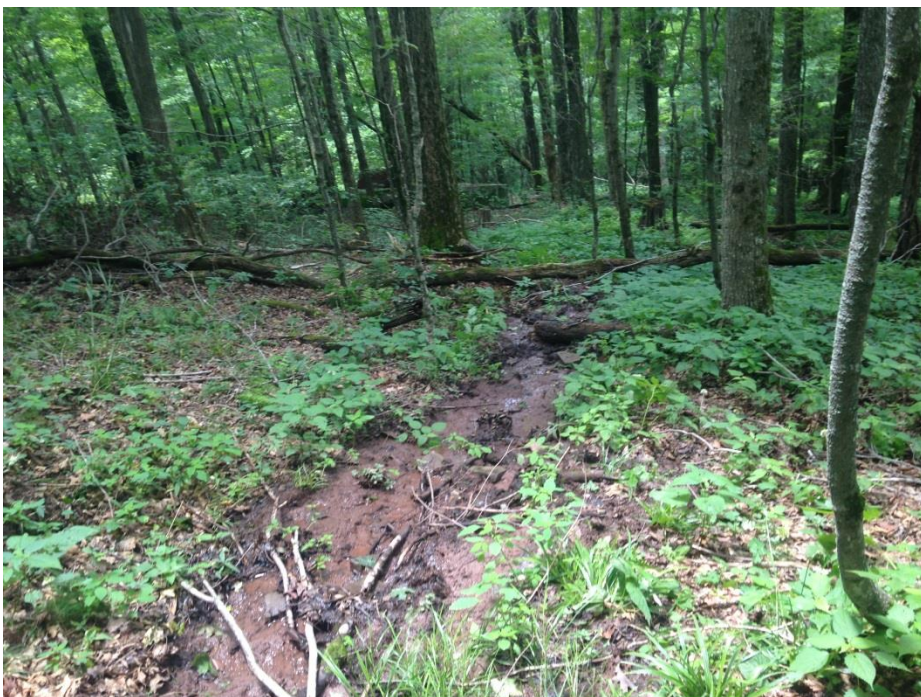
Waterbody spoy004 facing west downstream

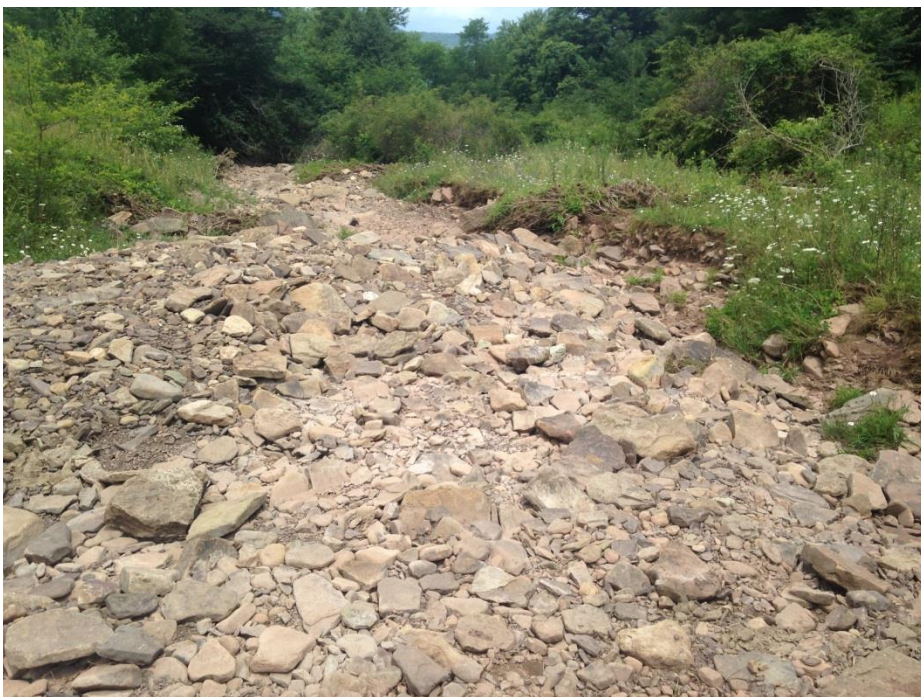
Waterbody spoe044 facing north downstream

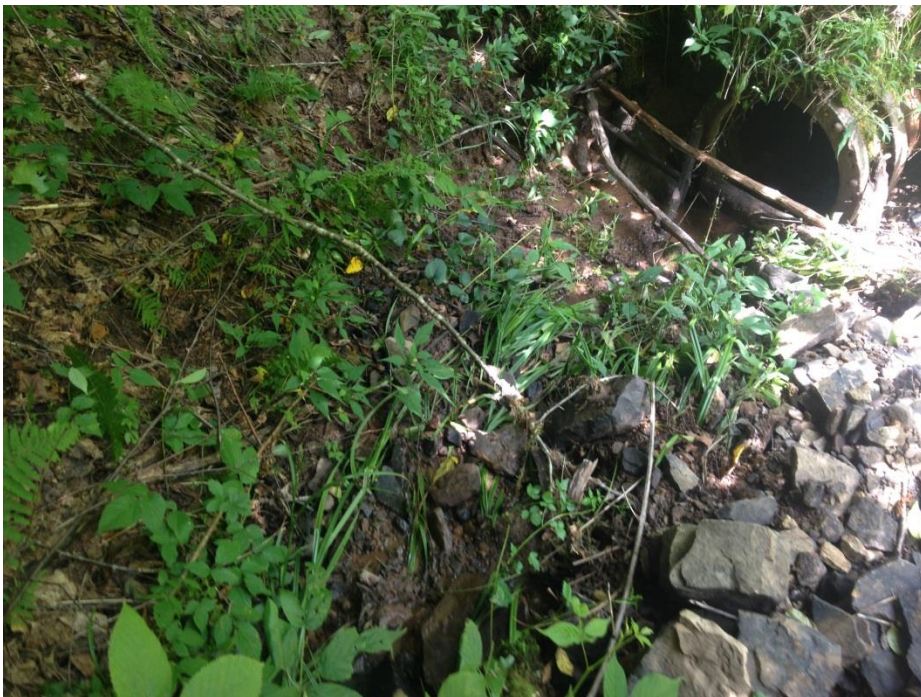
Waterbody spoe043 facing east downstream

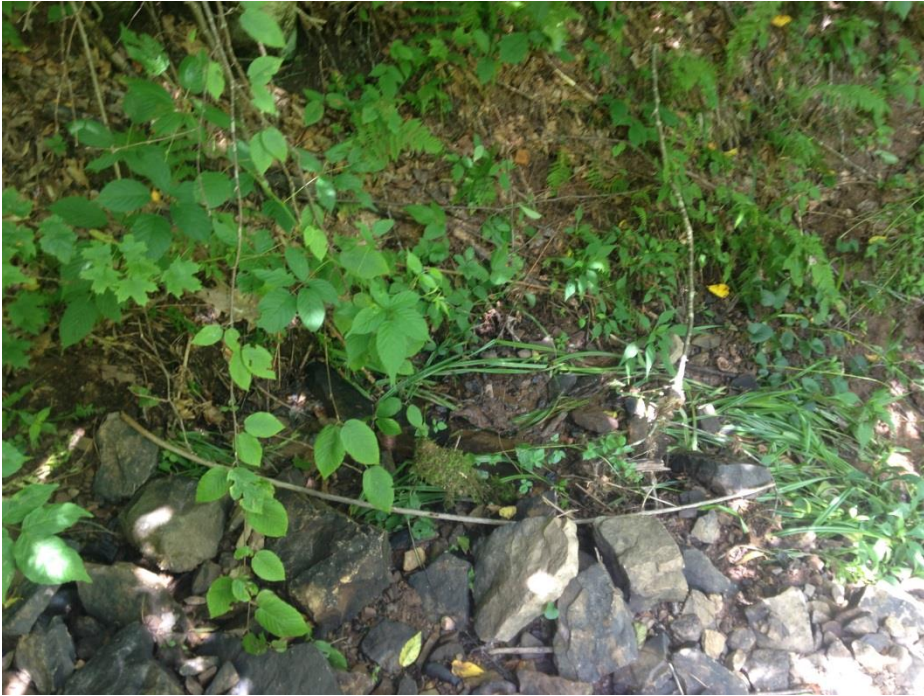
Waterbody spoe043 facing north across

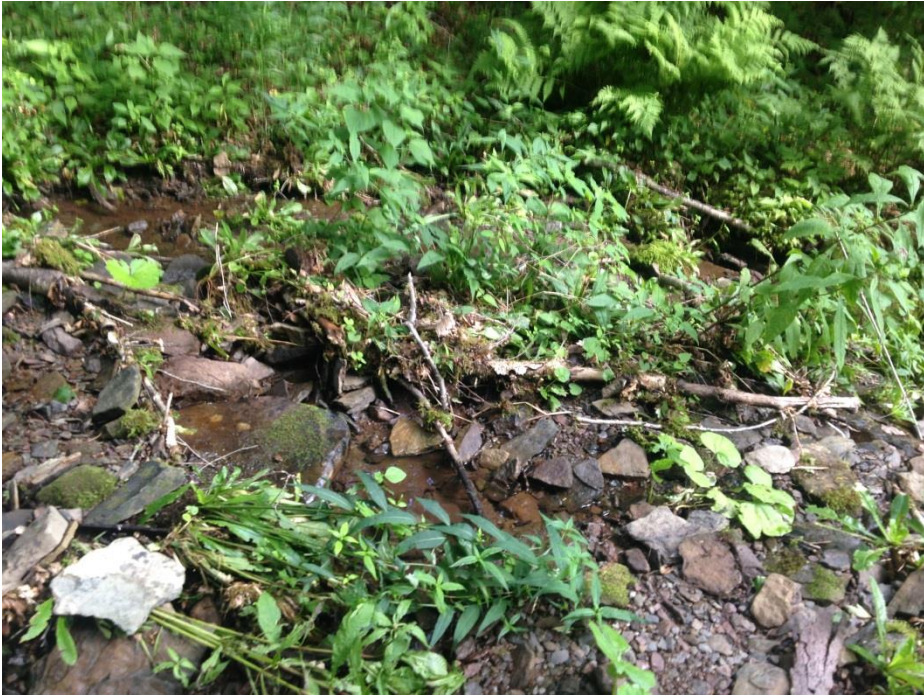
Waterbody spoe040 facing north across

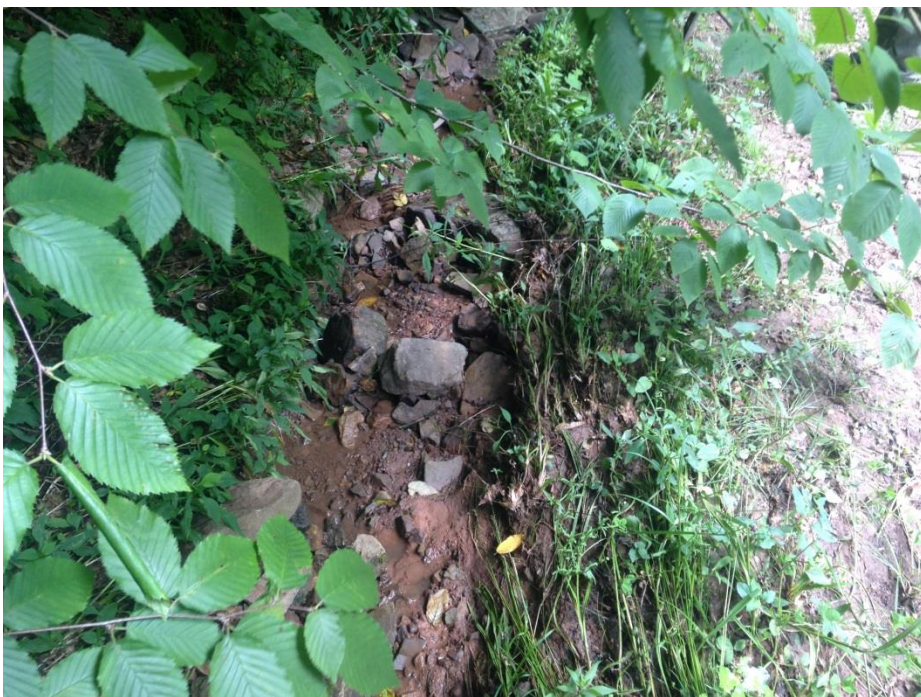
Waterbody spoe041 facing north downstream

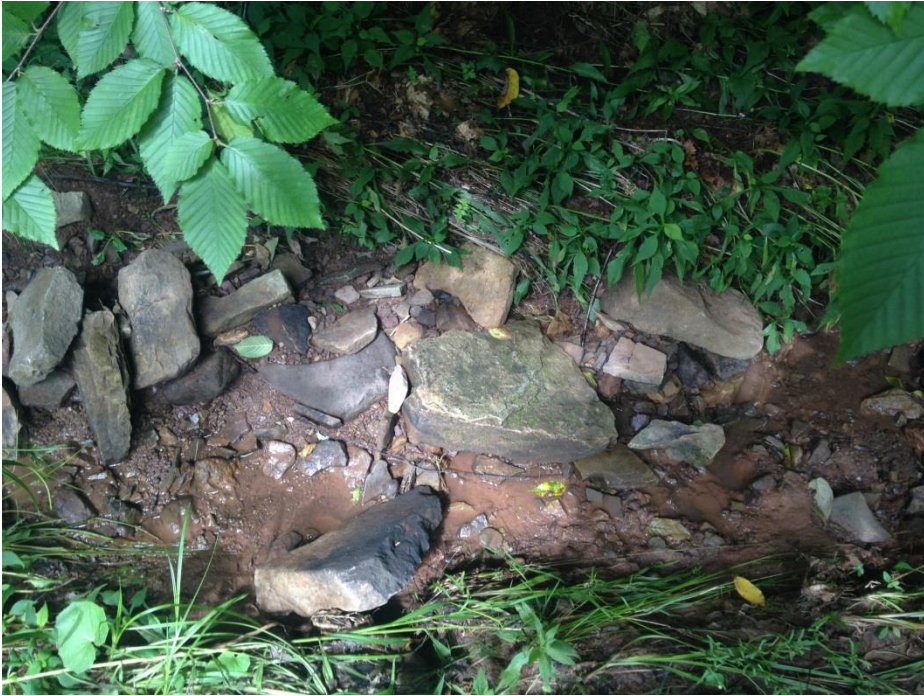
Waterbody spoe041 facing west across

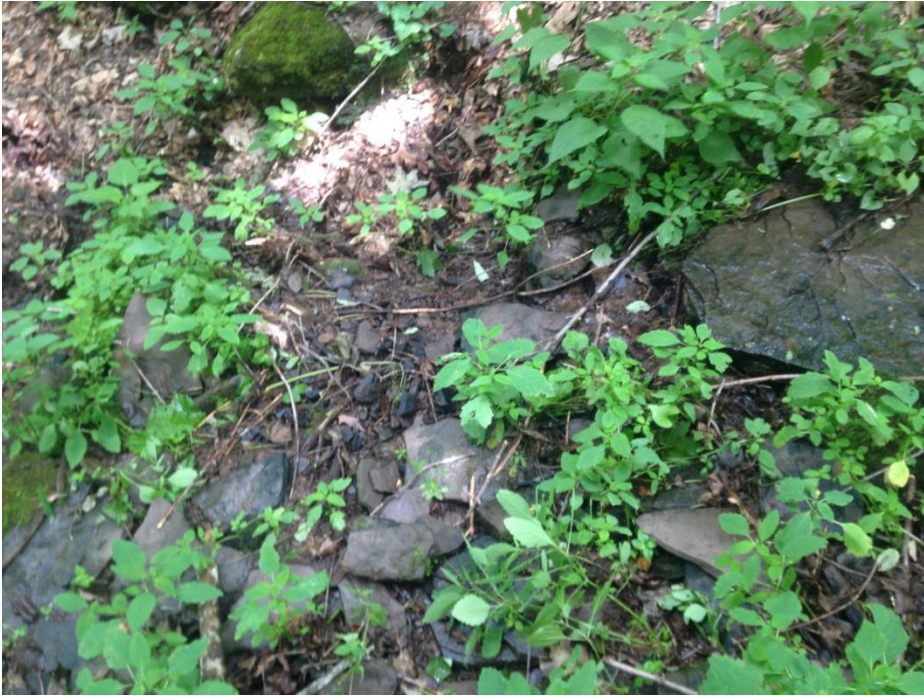
Waterbody spoy003 facing north across

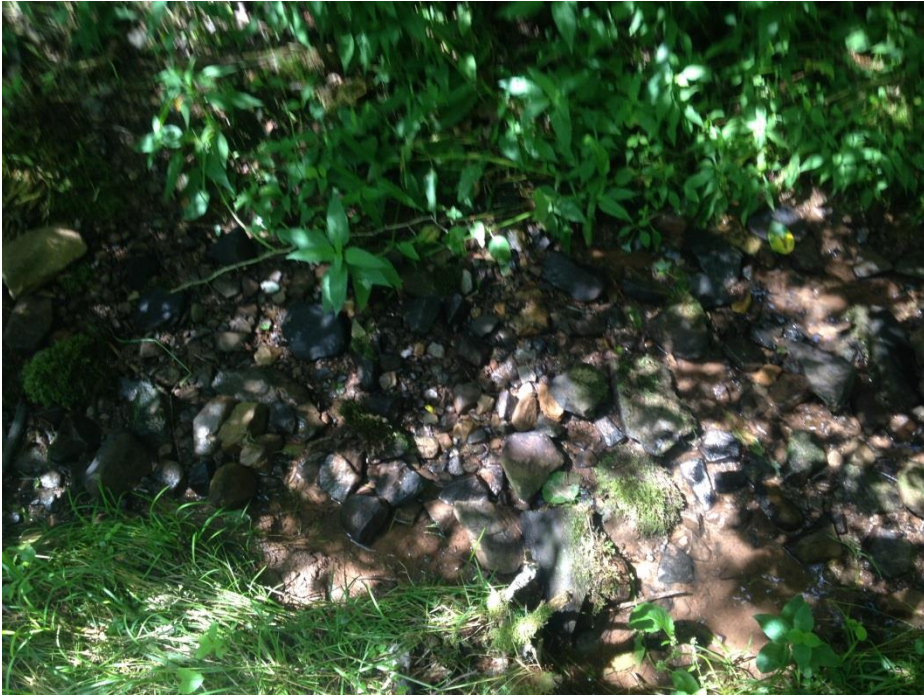
Waterbody spoe039 facing south across

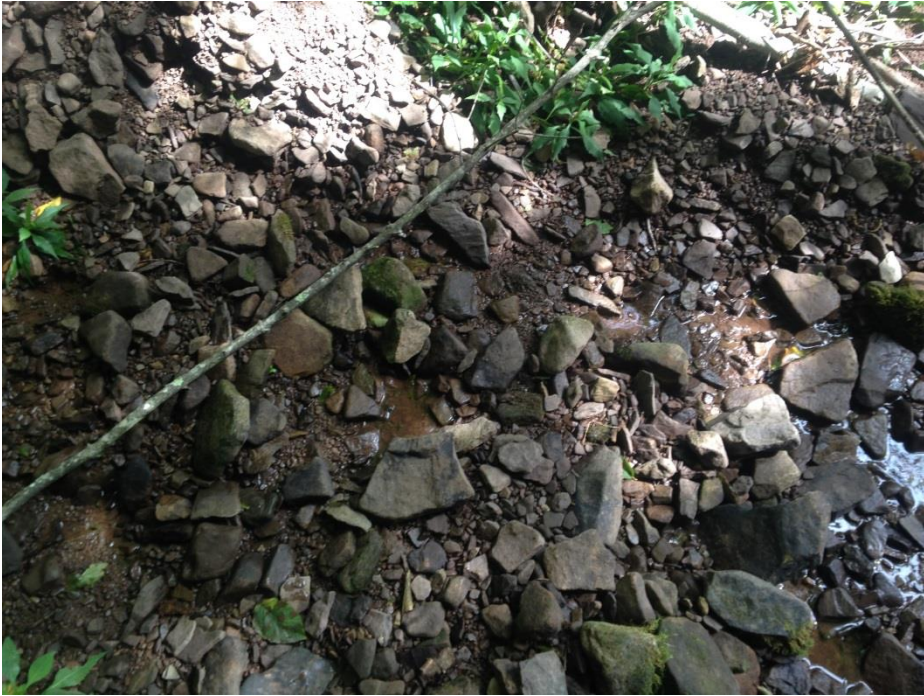
Waterbody spoe038 facing north across

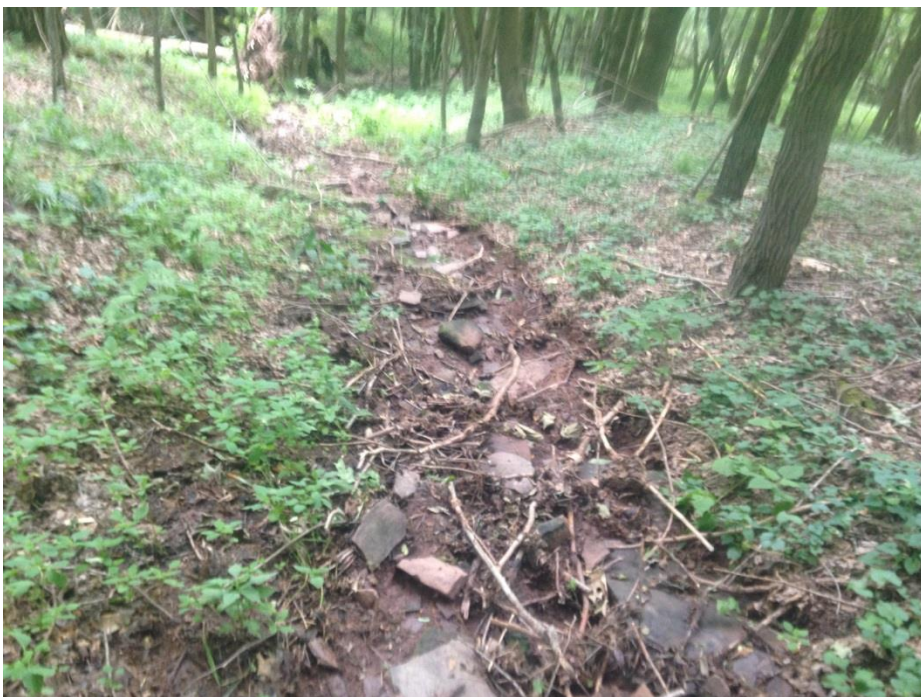
Waterbody spoy002 facing west downstream

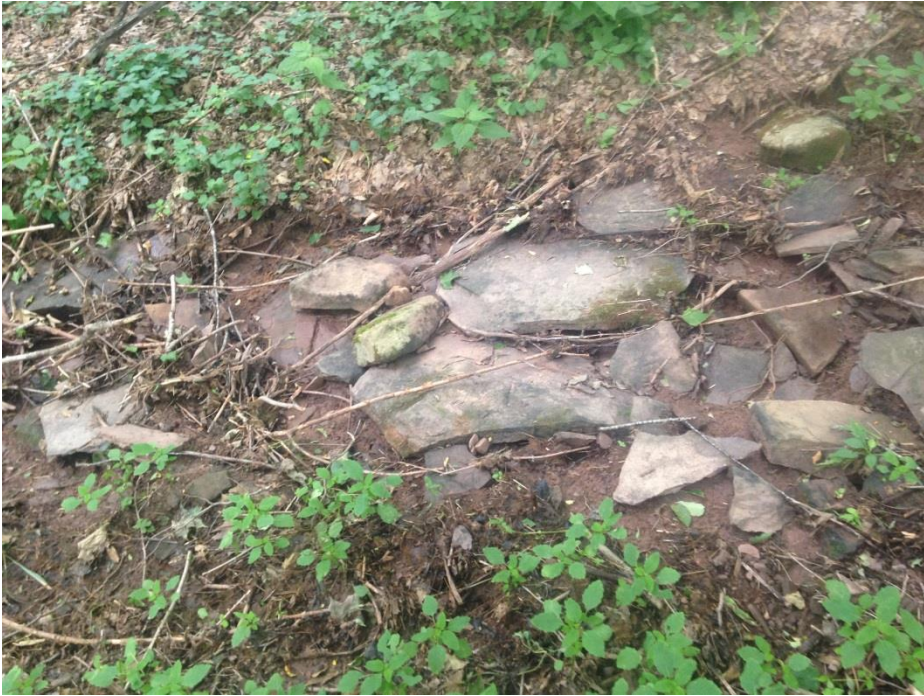
Waterbody spoy002 facing north across

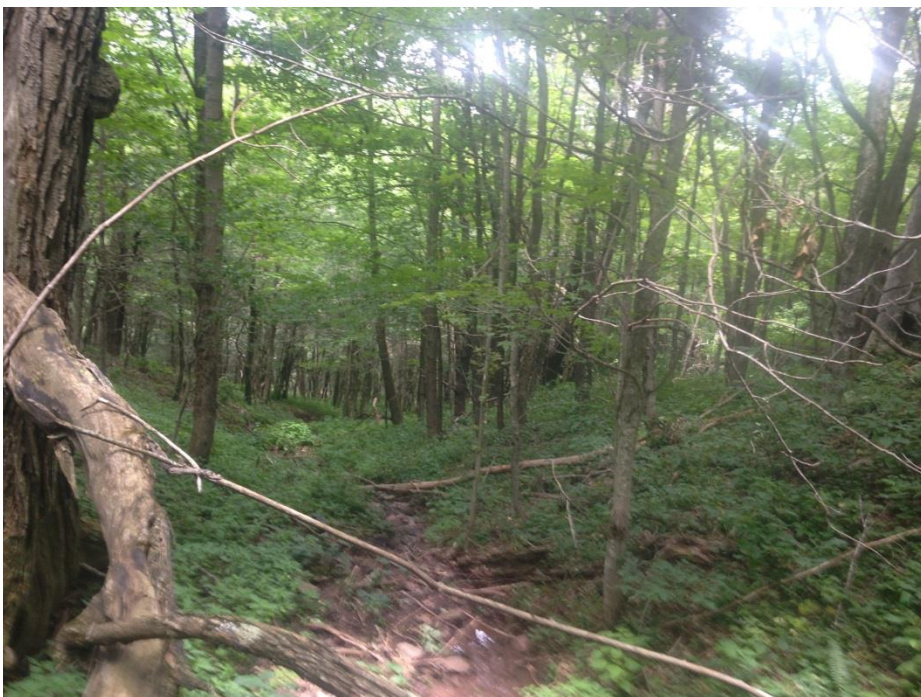
Waterbody spoy001 facing west downstream

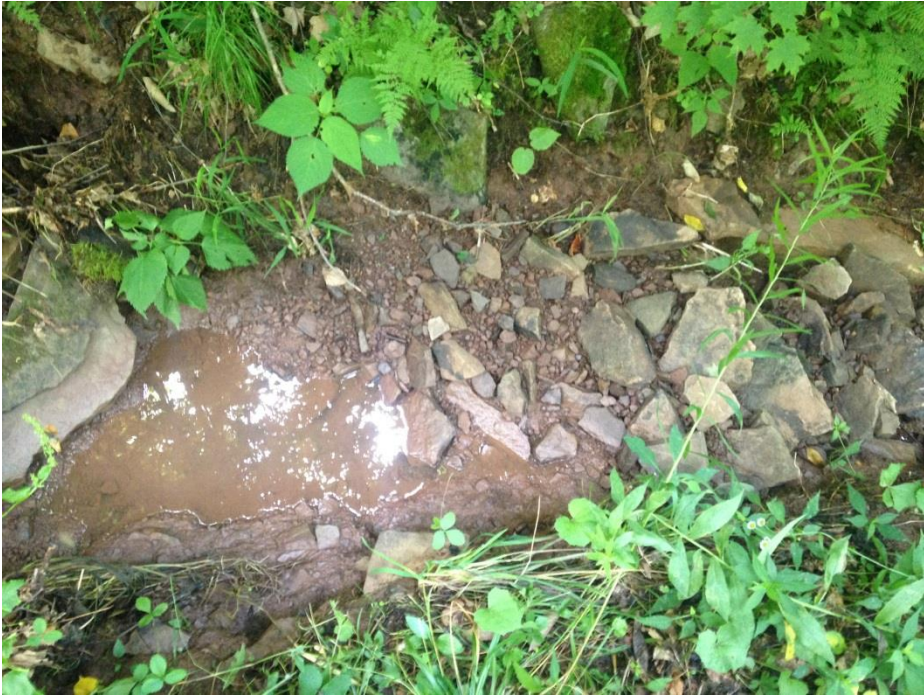
Waterbody spoy006 facing east across

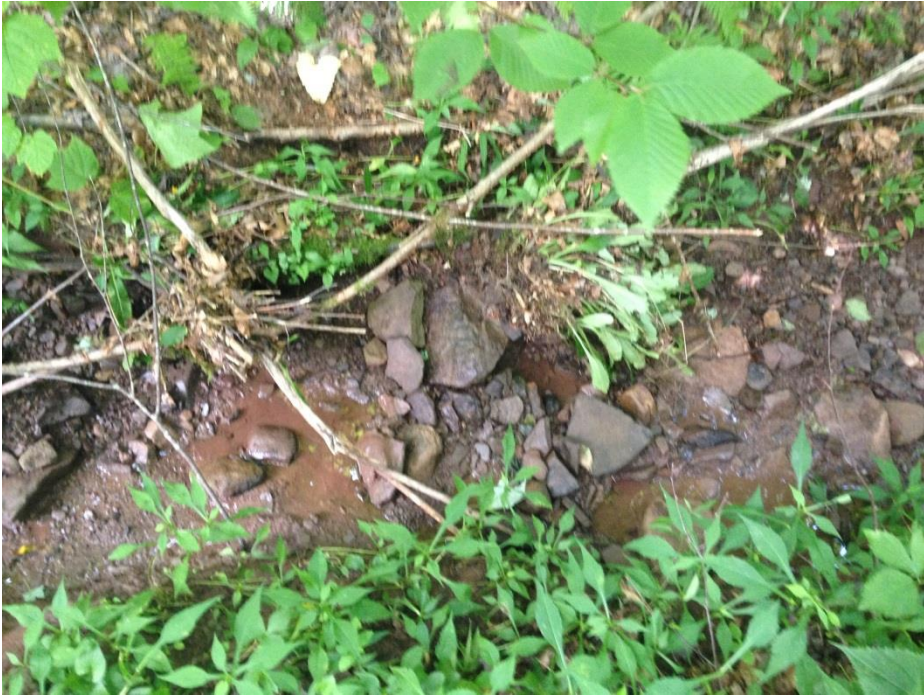
Waterbody spoe036 facing southwest across

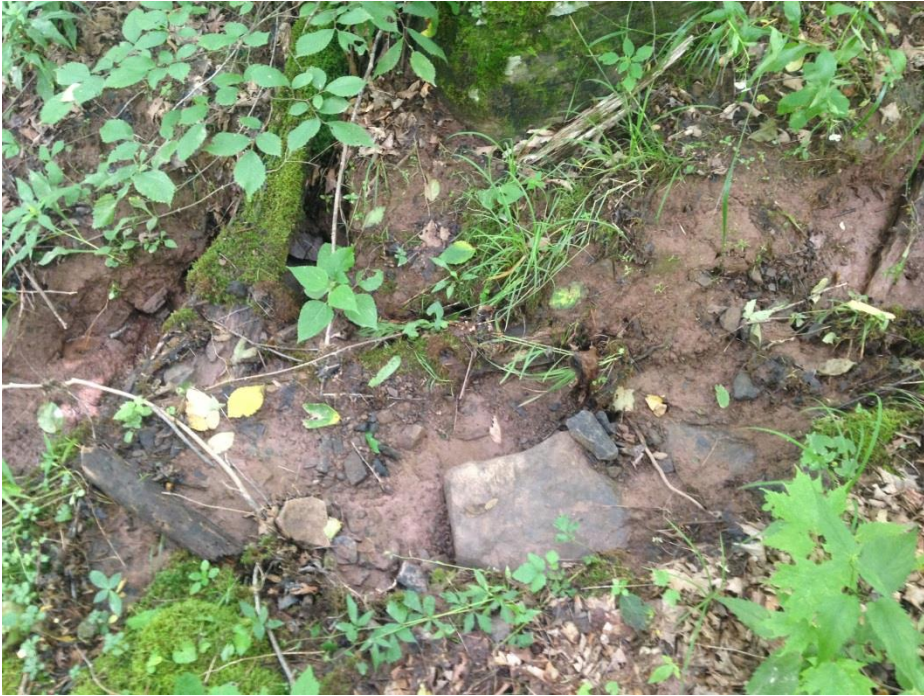
Waterbody spoy007 facing north across

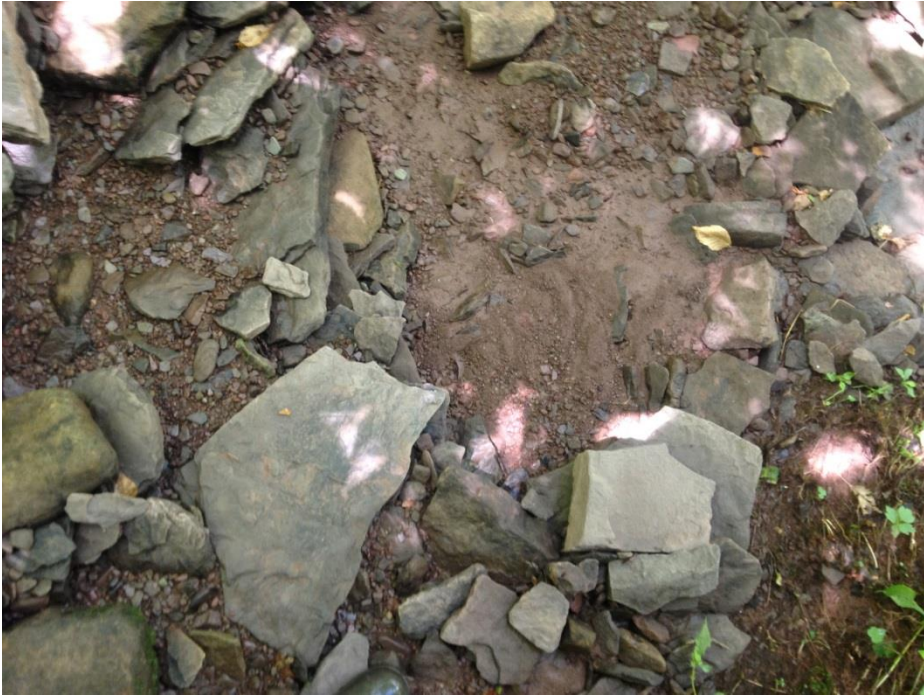
Waterbody spoy011 facing southwest across

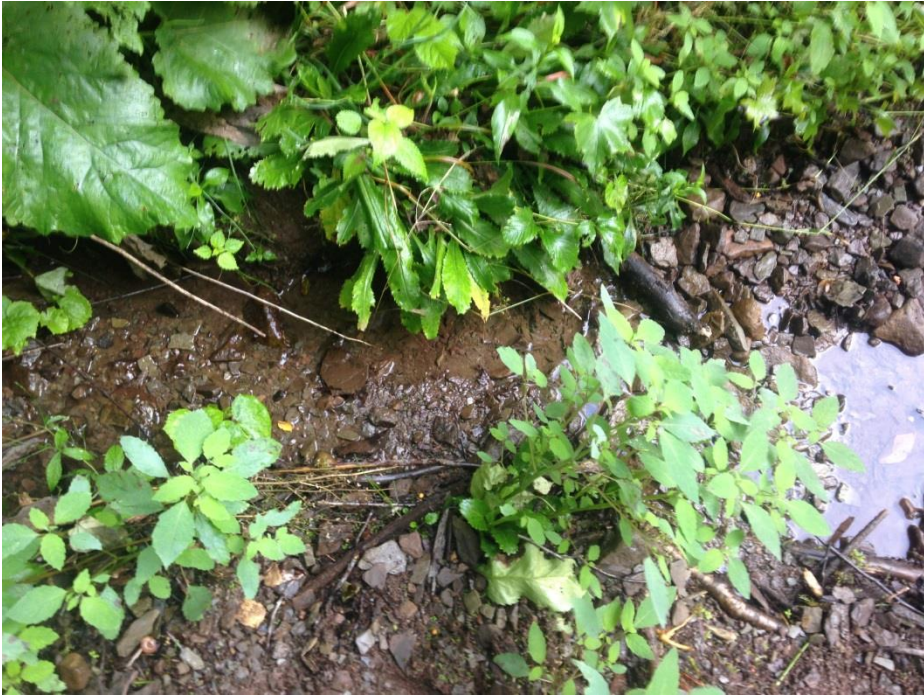
Waterbody spoe034 facing northwest across

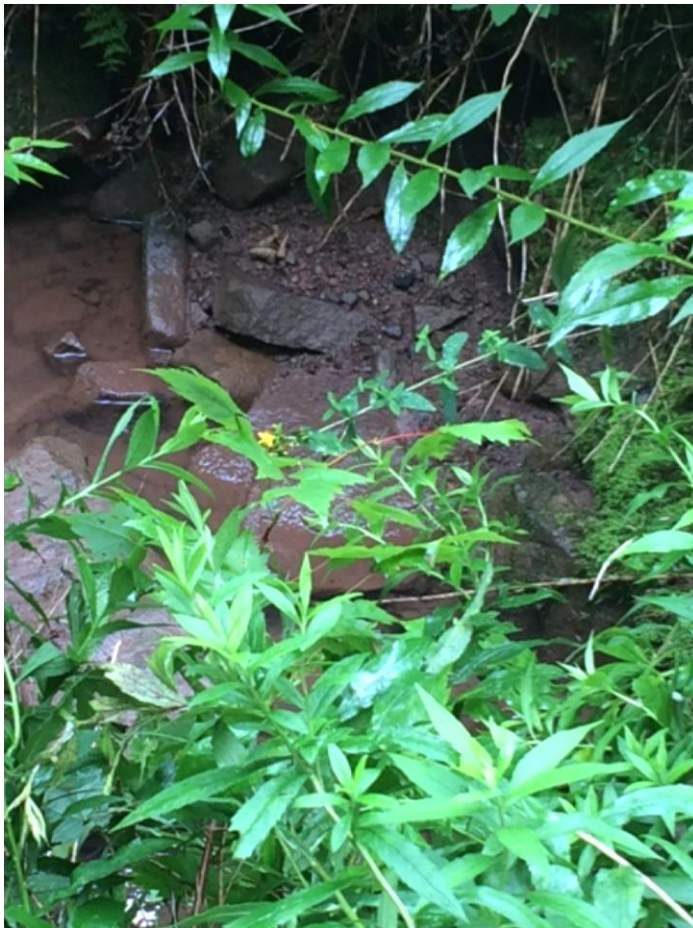
Waterbody SPOE031 facing north across

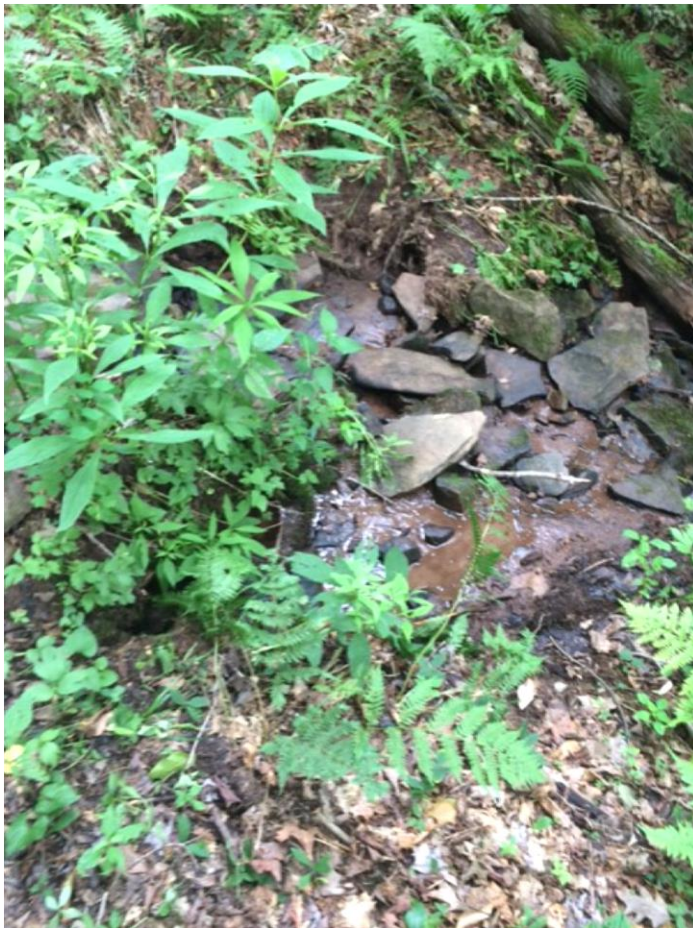
Waterbody SPOE028 facing southeast across

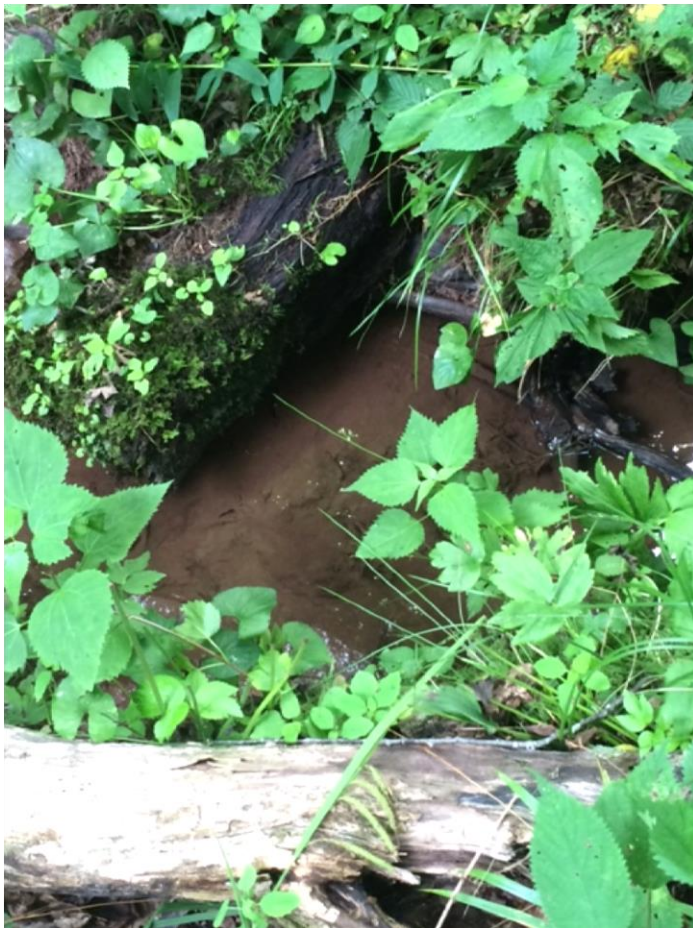
Waterbody SPOE027 facing southeast across

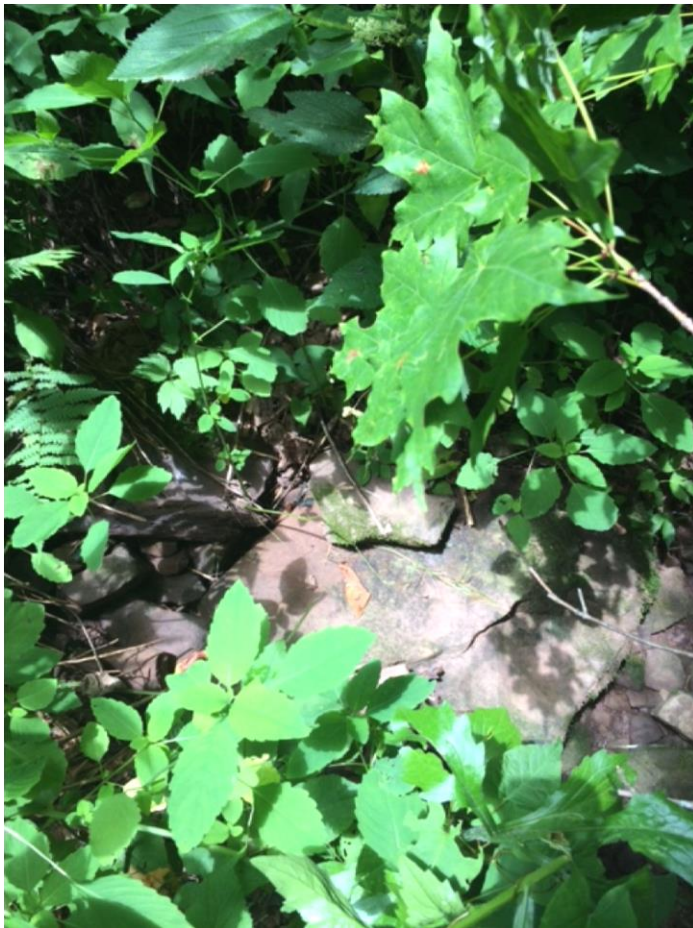
Waterbody SPOE030 facing north across

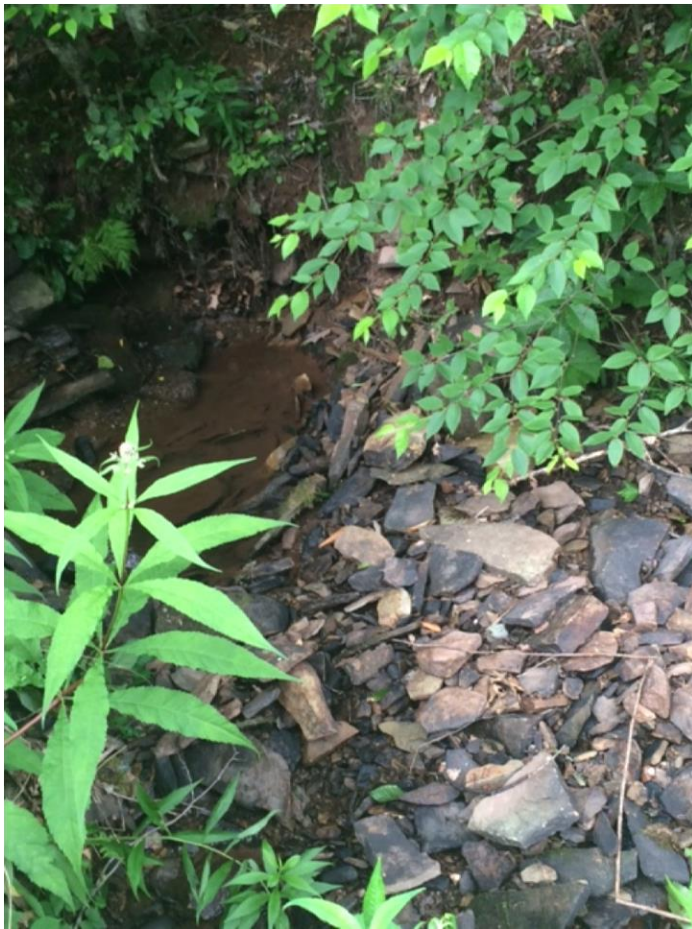
Waterbody SPOE026 facing west across

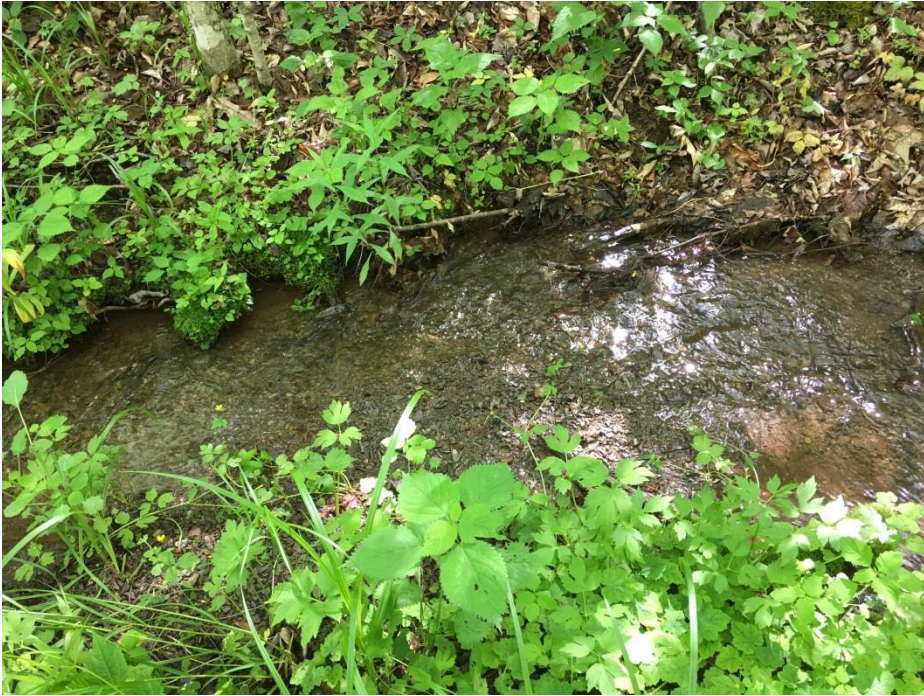
Waterbody SPOA428 facing east across
