Linear Waterbody Data Sheet

Survey Description			
Project Name: Atlantic Coast Pipeline		Waterbody Name: UNT to Slaty Fork	
Waterbody ID: spoa420		Date: 6/1/2016	
State: West Virginia	County: Pocahontas	Company: NRG/ERM	Crew Member Initials: GB, KO
Photos: 4 photos			
Tract Number(s): access road 05-001-C008.AR1		Nearest Milepost: 72.1	Associated Wetland ID(s): none
Survey Type: <i>(check one)</i> <input type="checkbox"/> Centerline <input type="checkbox"/> Re-Route <input checked="" type="checkbox"/> Access Road <input type="checkbox"/> Other:			
Physical Attributes			
Stream Classification: <i>(check one)</i> <input type="checkbox"/> Ephemeral <input checked="" type="checkbox"/> Intermittent <input type="checkbox"/> Perennial			
Waterbody Type: <i>(check one)</i> <input type="checkbox"/> River <input checked="" type="checkbox"/> Stream <input type="checkbox"/> Ditch <input type="checkbox"/> Canal <input type="checkbox"/> Other:

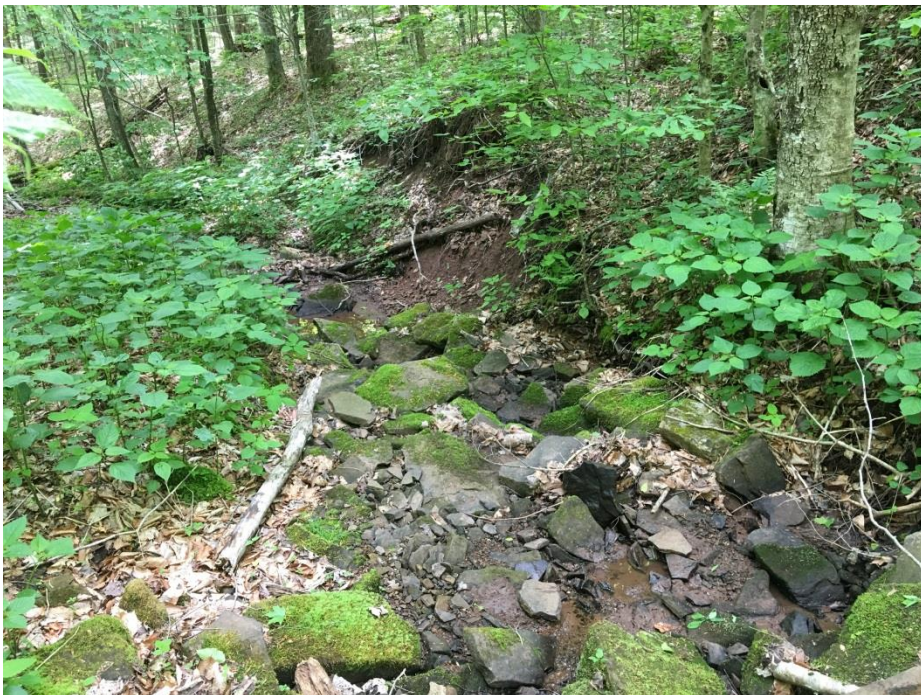
Waterbody spoa420 facing west downstream

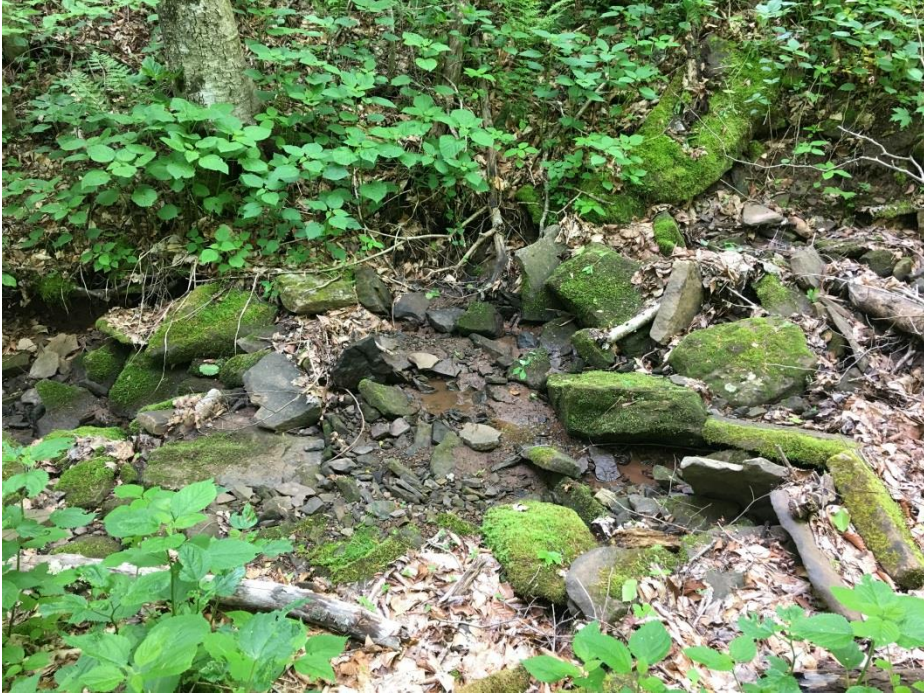
Waterbody spoa420 facing north across

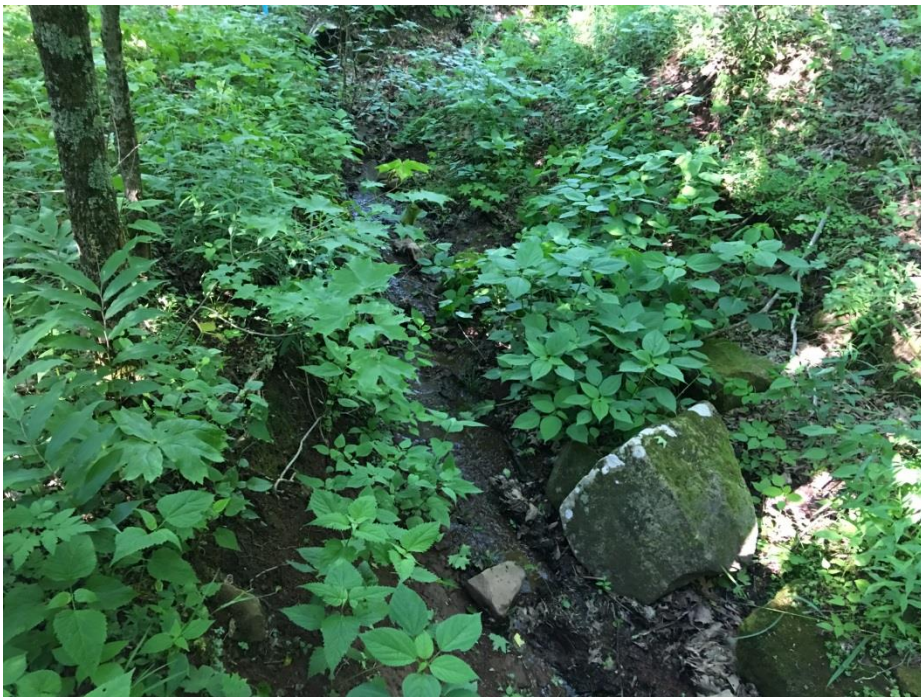
Waterbody SPOA439 facing south downstream

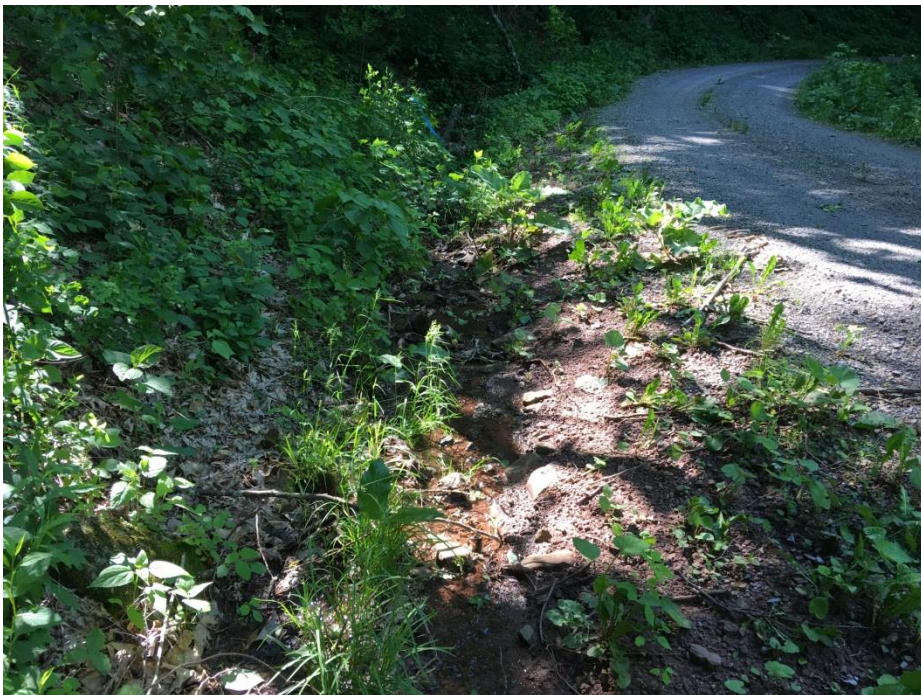
Waterbody SPOA440 facing east downstream

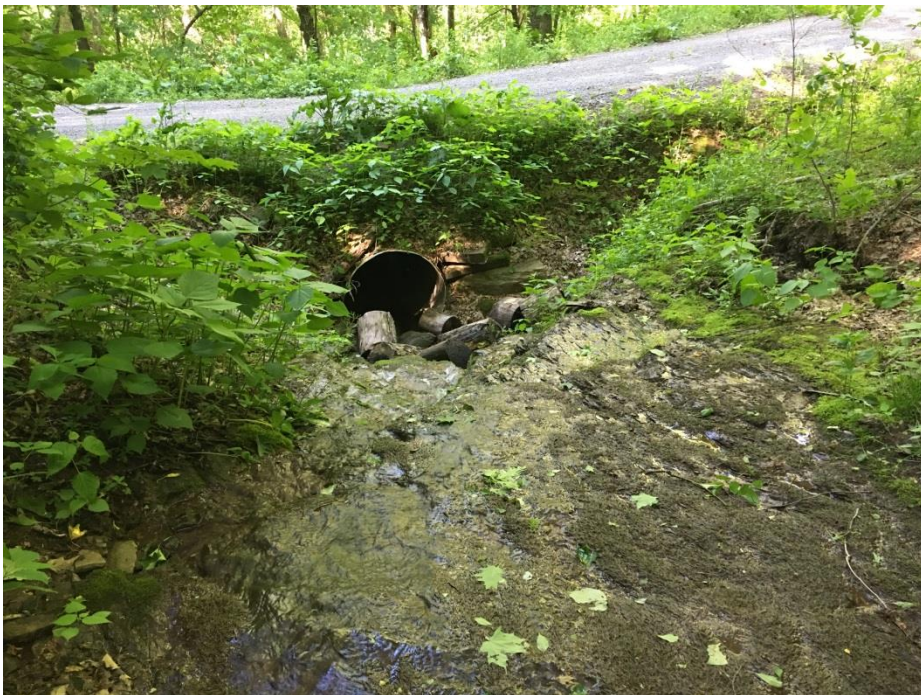
Waterbody SPOA441 facing southwest downstream

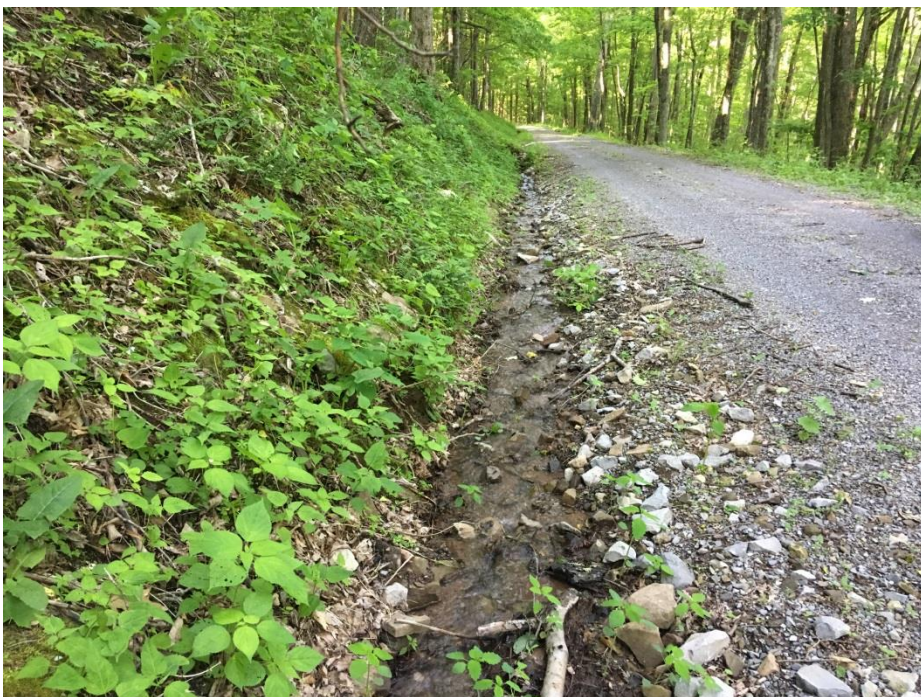
Waterbody SPOA434 facing south downstream

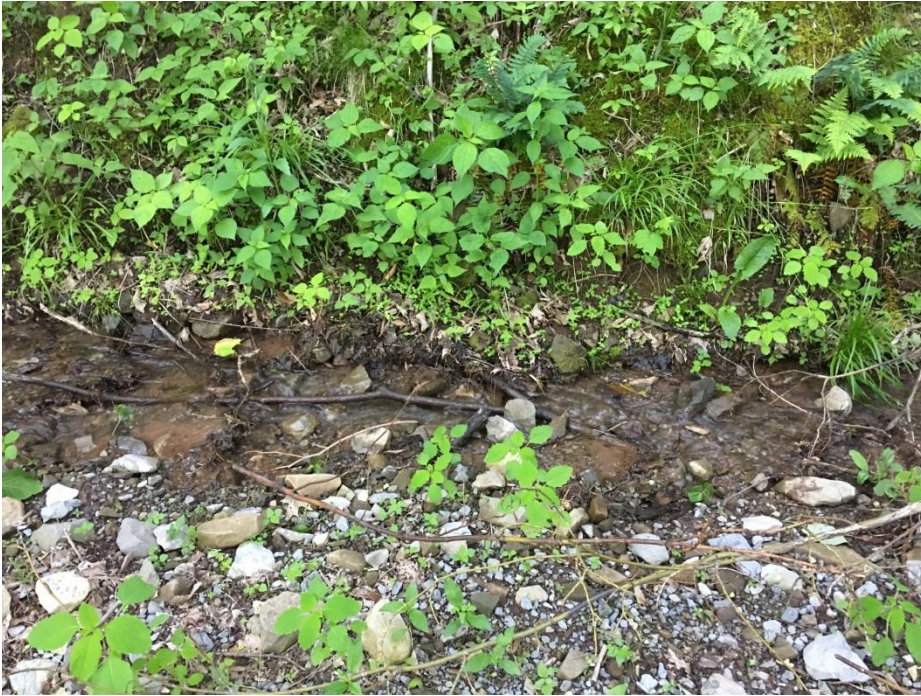
Waterbody SPOA434 facing west across

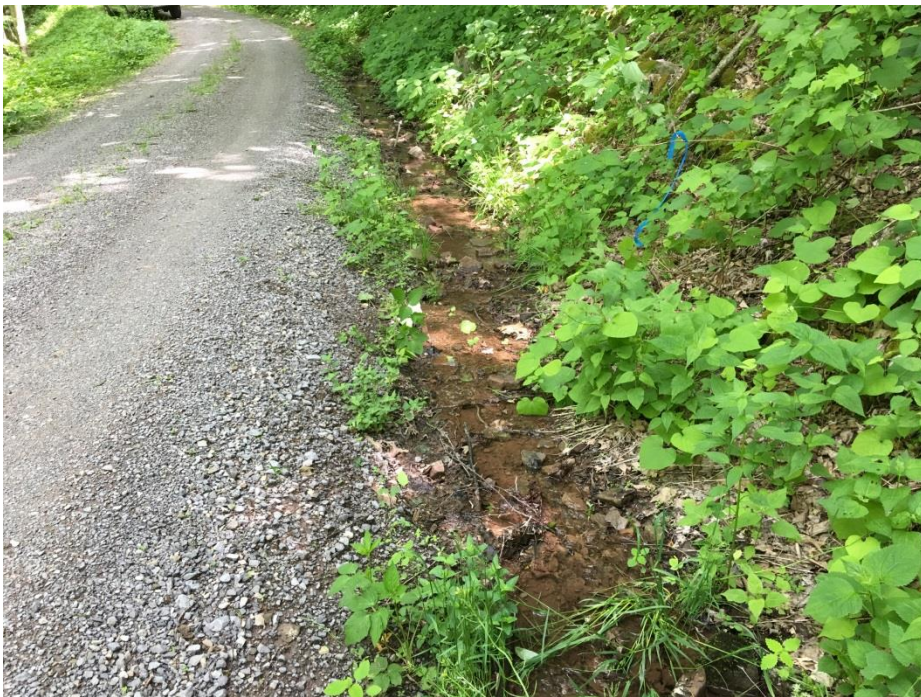
Waterbody SPOA435 facing north downstream

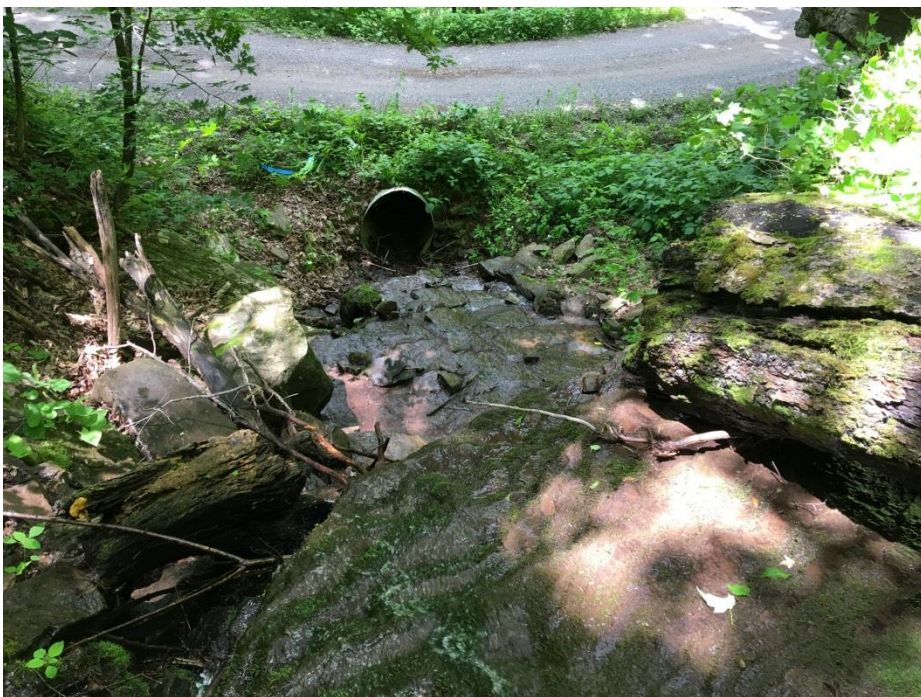
Waterbody SPOA436 facing west downstream

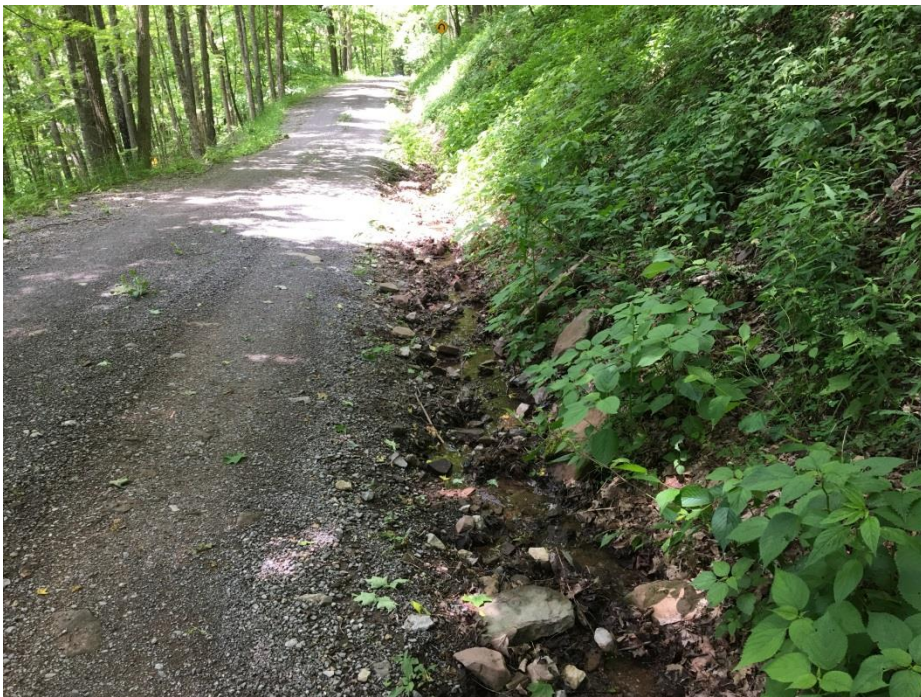
Waterbody SPOA437 facing west downstream

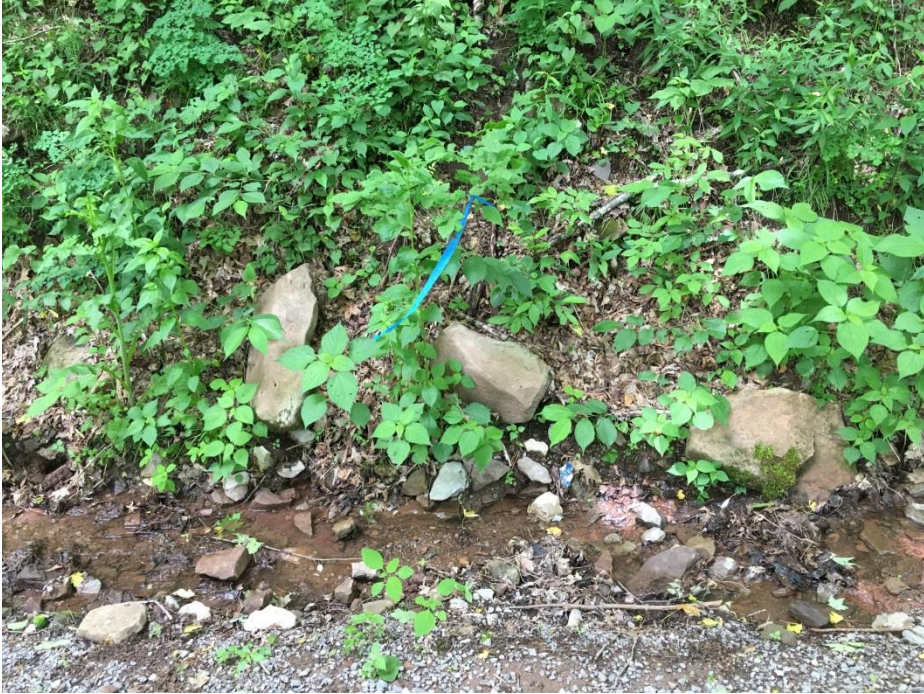
Waterbody SPOA437 facing north across

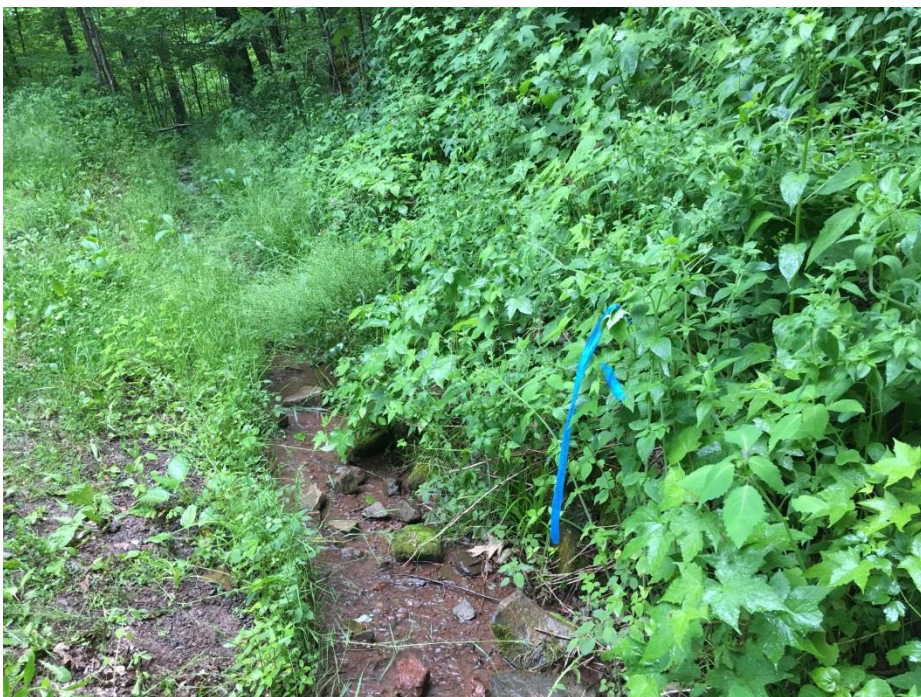
Waterbody SPOA438 facing west downstream

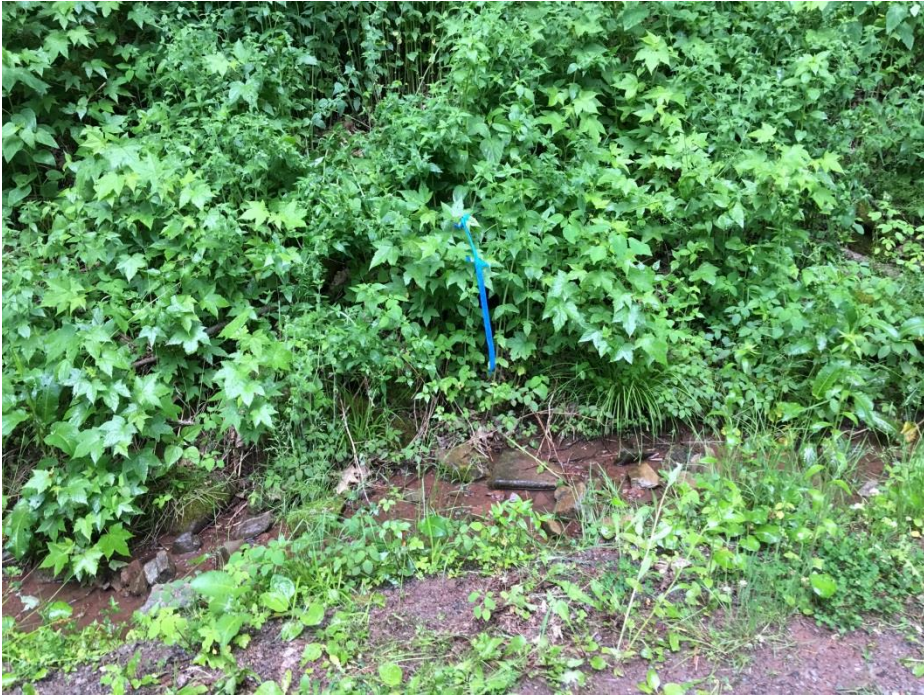
Waterbody SPOA438 facing north across

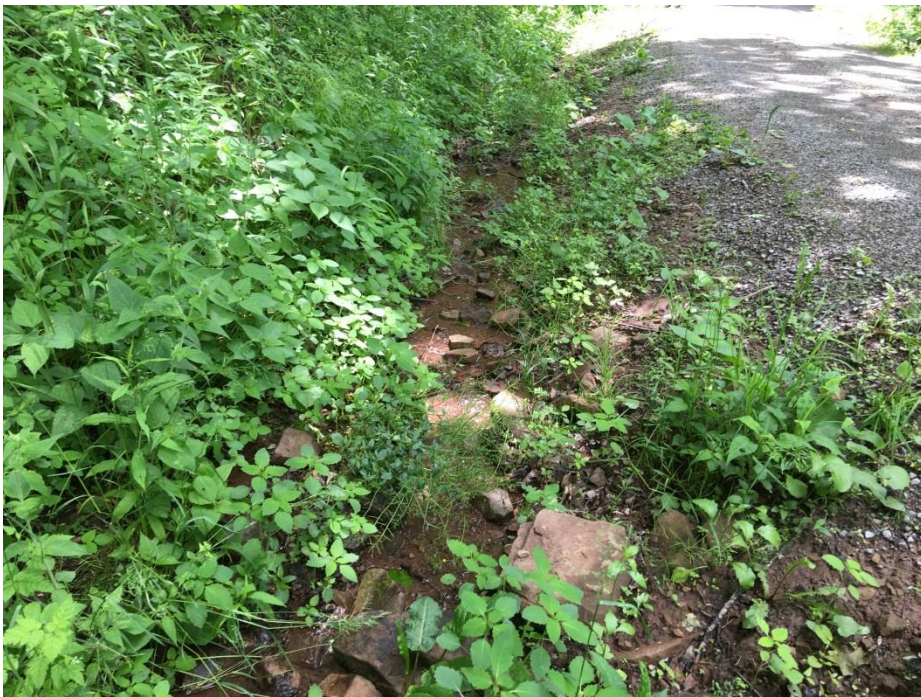
Waterbody SPOA430 facing southeast downstream

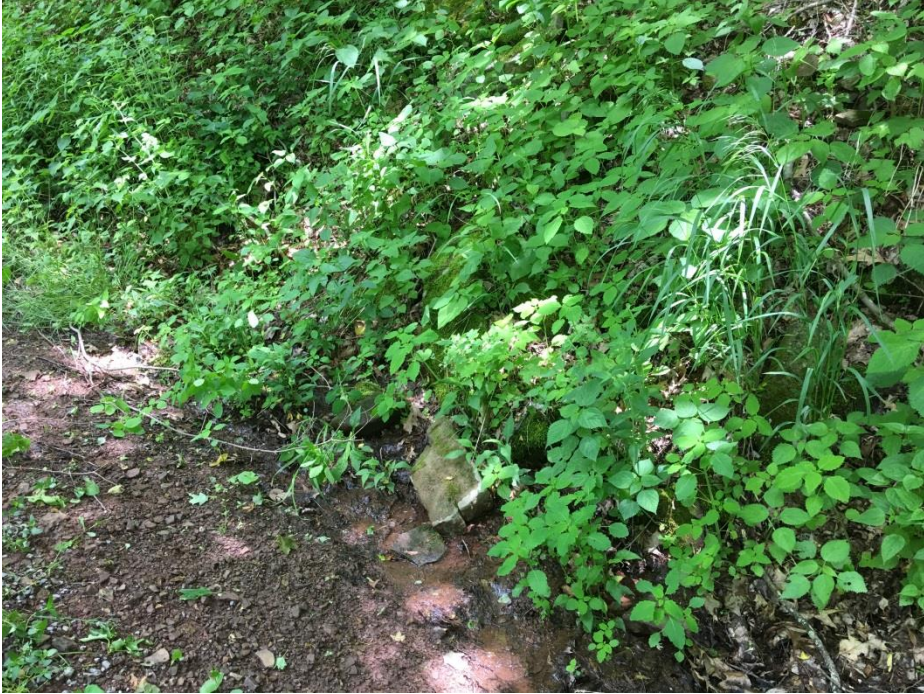
Waterbody SPOA431 facing east across

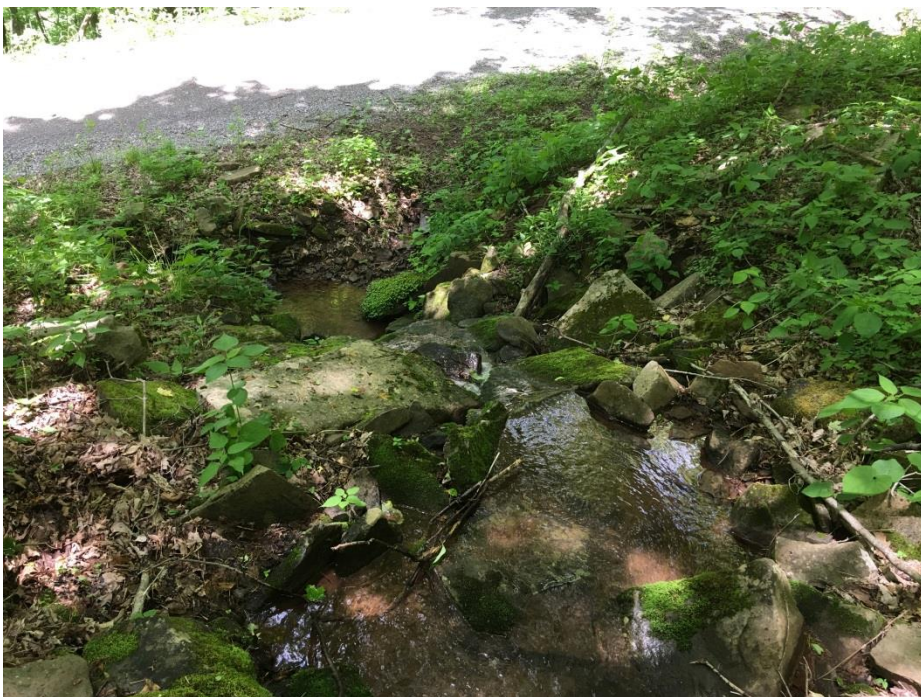
Waterbody SPOA432 facing west downstream

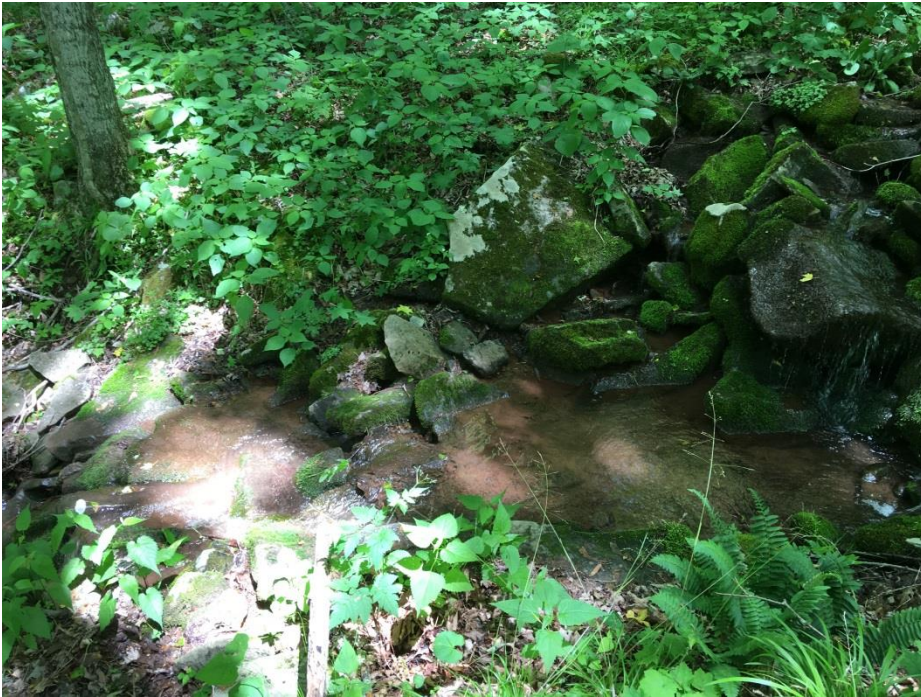
Waterbody SPOA432 facing north across

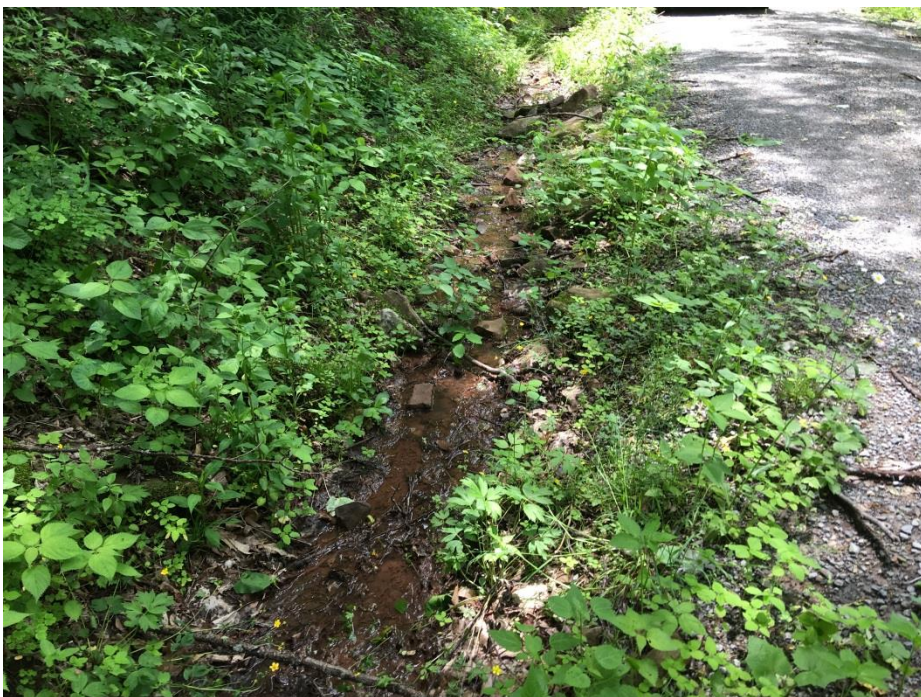
Waterbody SPOA433 facing south downstream

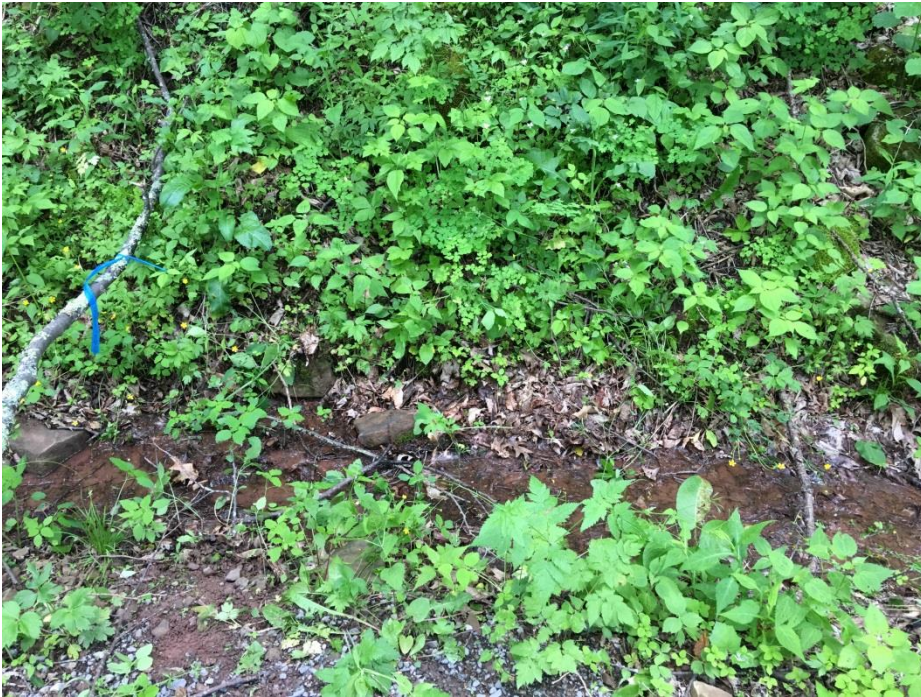
Waterbody SPOA433 facing east across

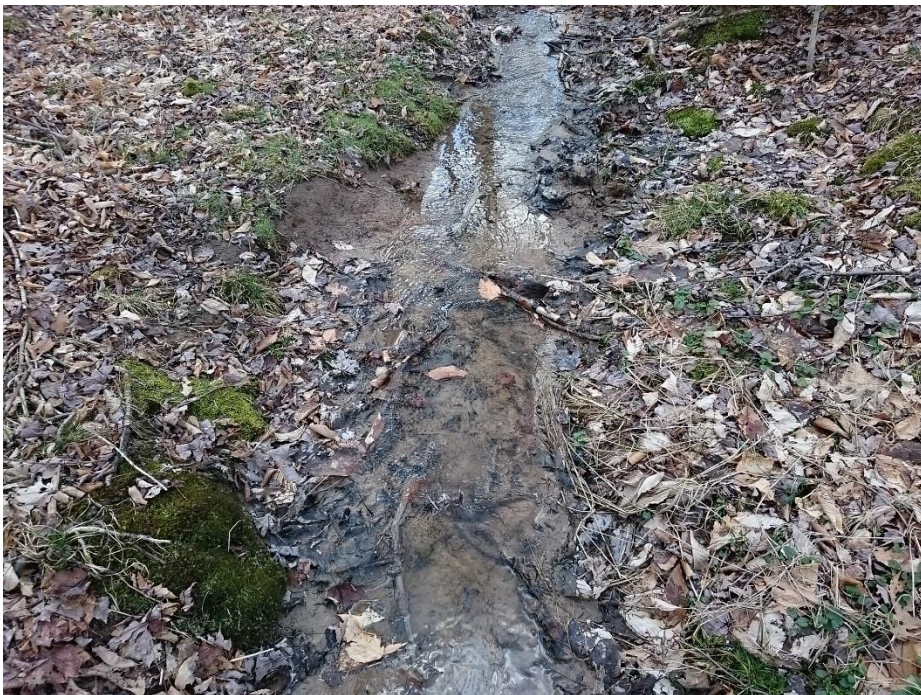
Waterbody SPOC105 facing south downstream

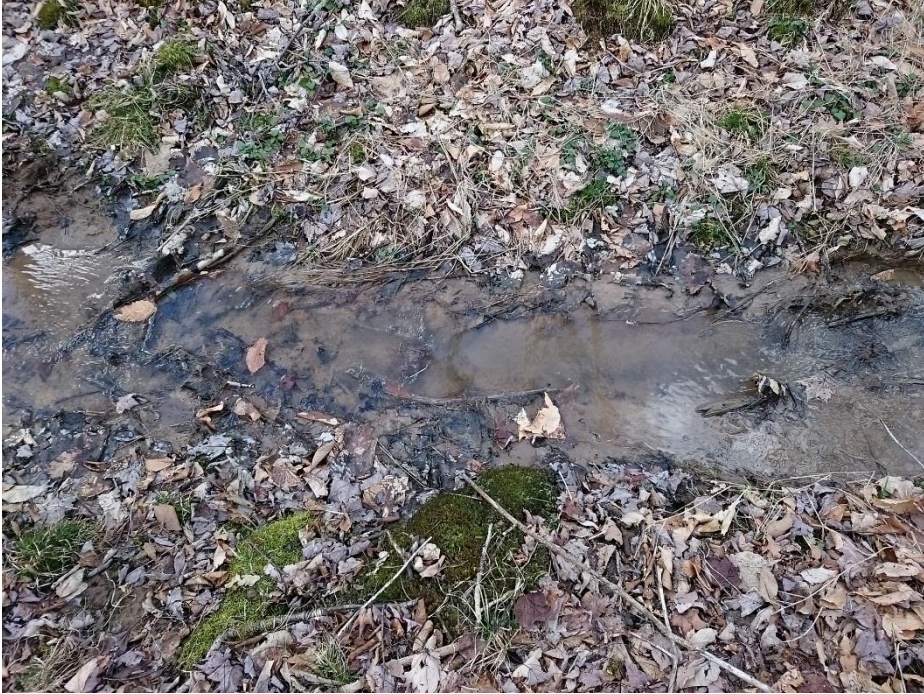
Waterbody SPOC105 facing west across

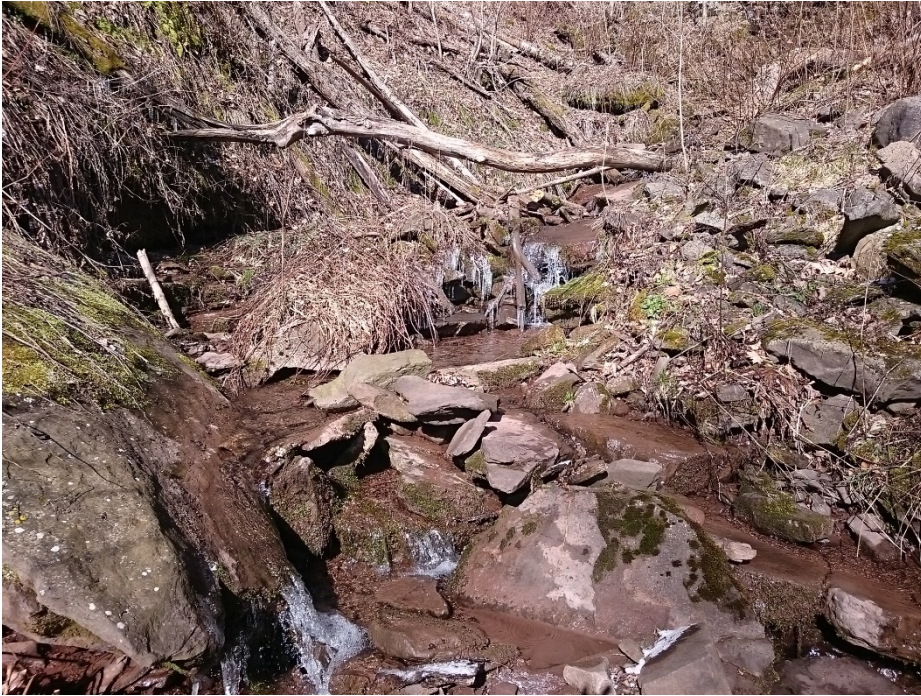
Waterbody SPOC111 facing northwest upstream

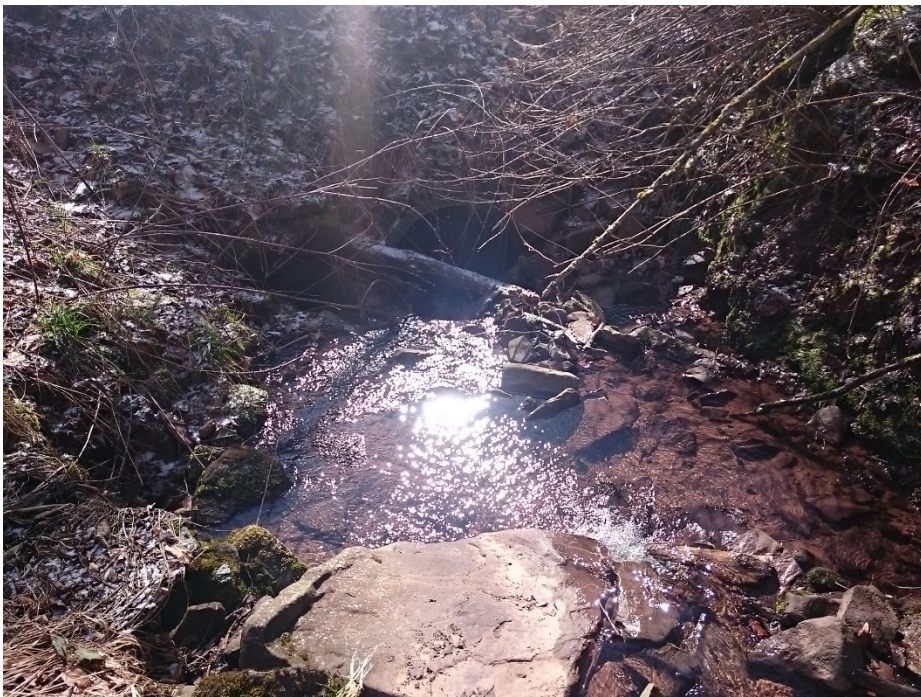
Waterbody SPOC111 facing southeast downstream

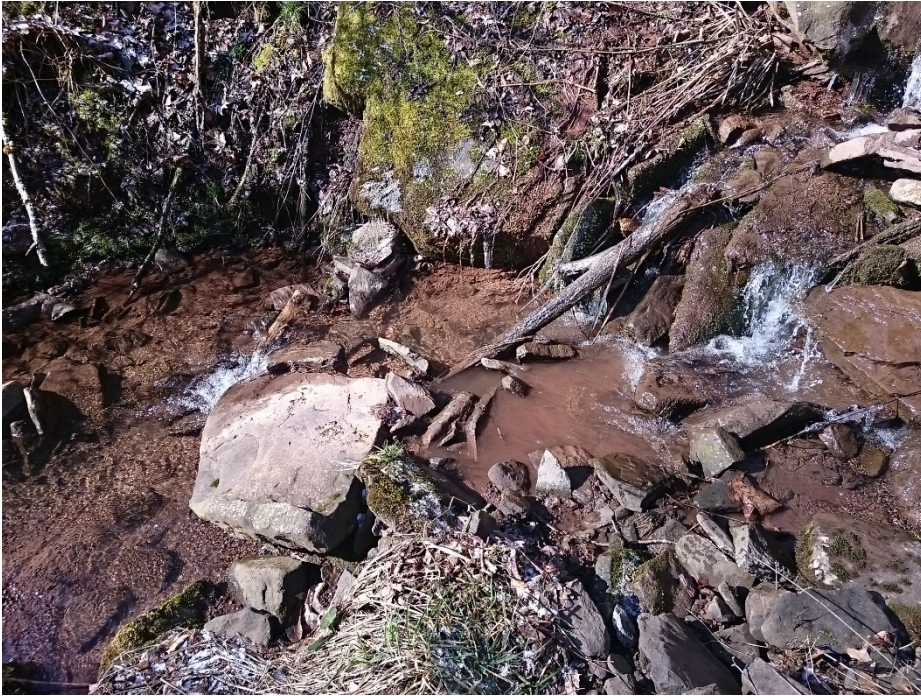
Waterbody SPOC111 facing southwest across

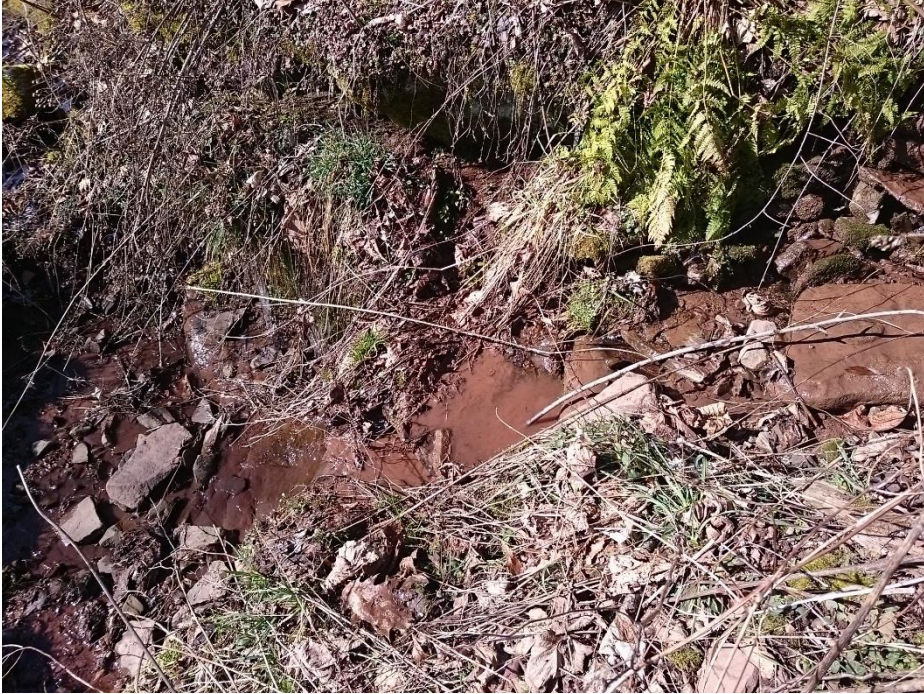
Waterbody SPOC110 facing southwest across

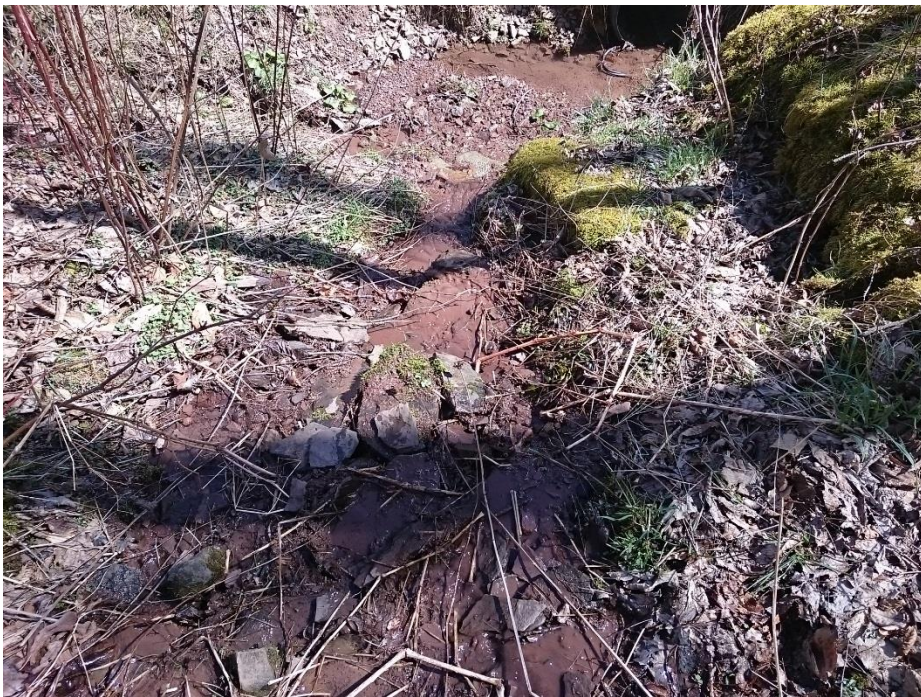
Waterbody SPOC109 facing east downstream

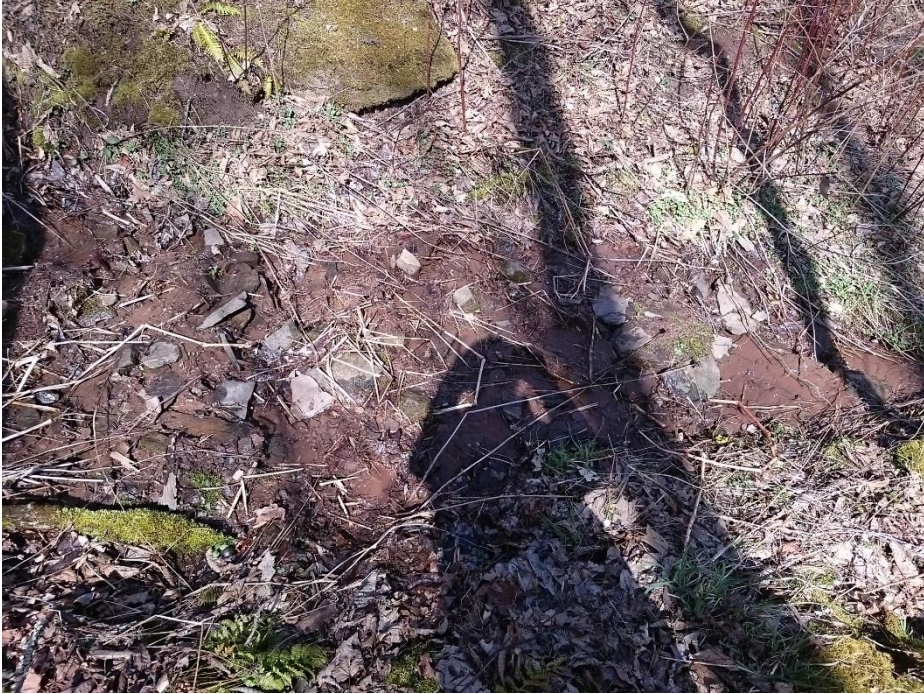
Waterbody SPOC109 facing north across

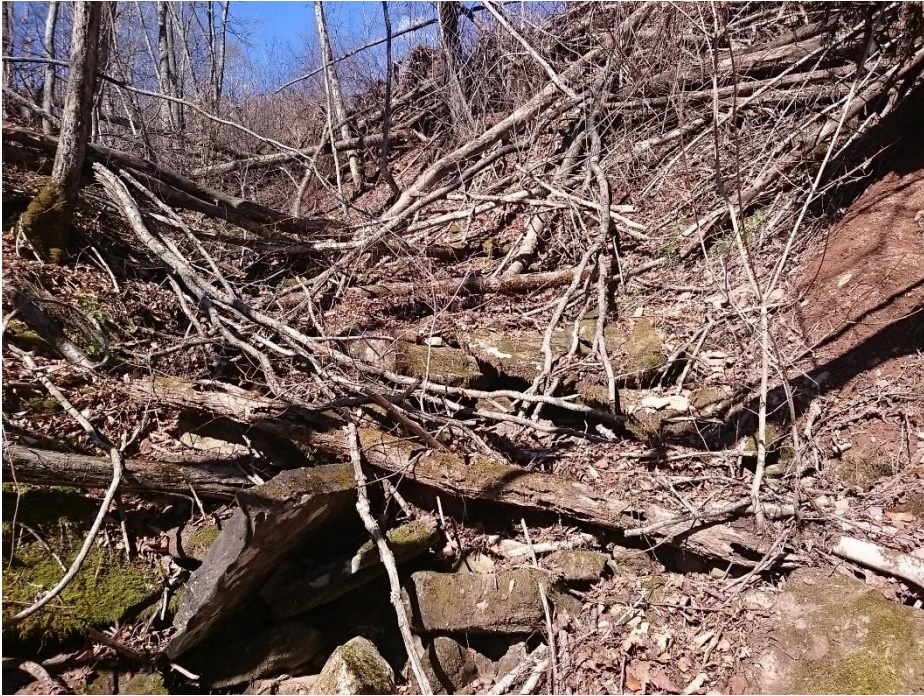
SPOC107 facing northwest upstream

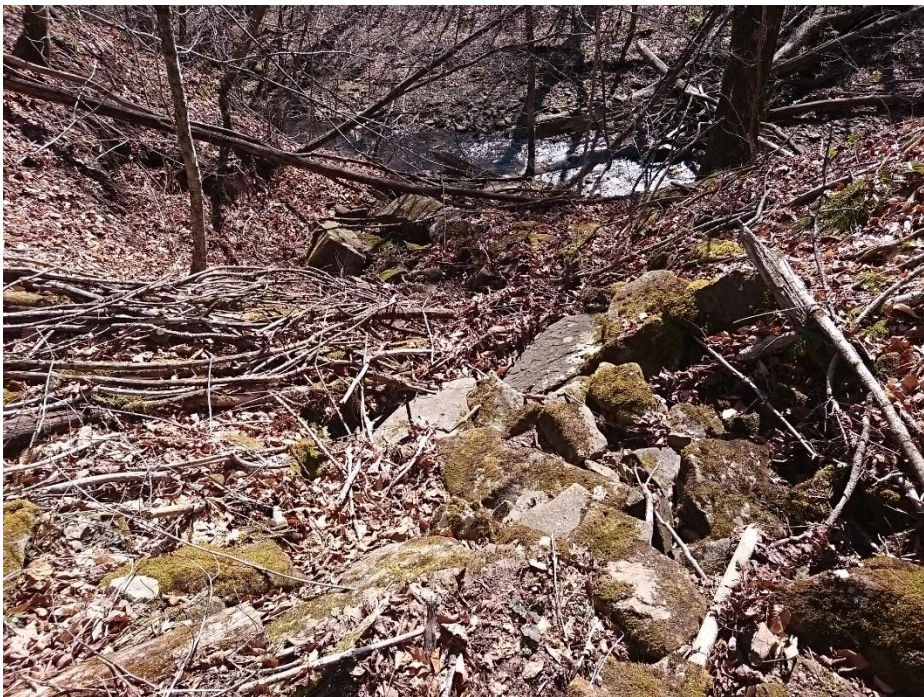
SPOC107 facing southeast downstream

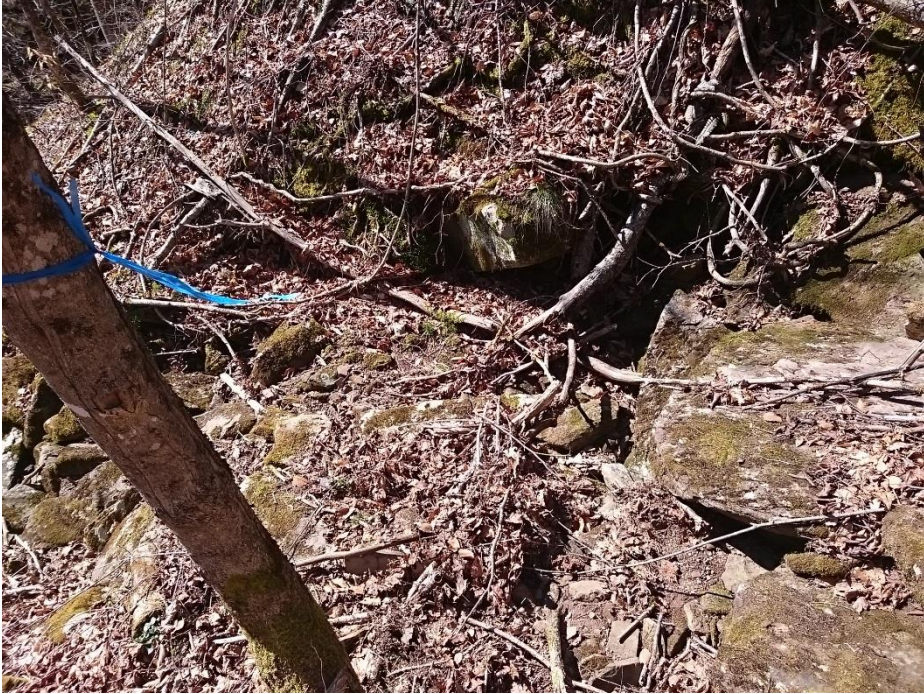
SPOC107 facing southwest across

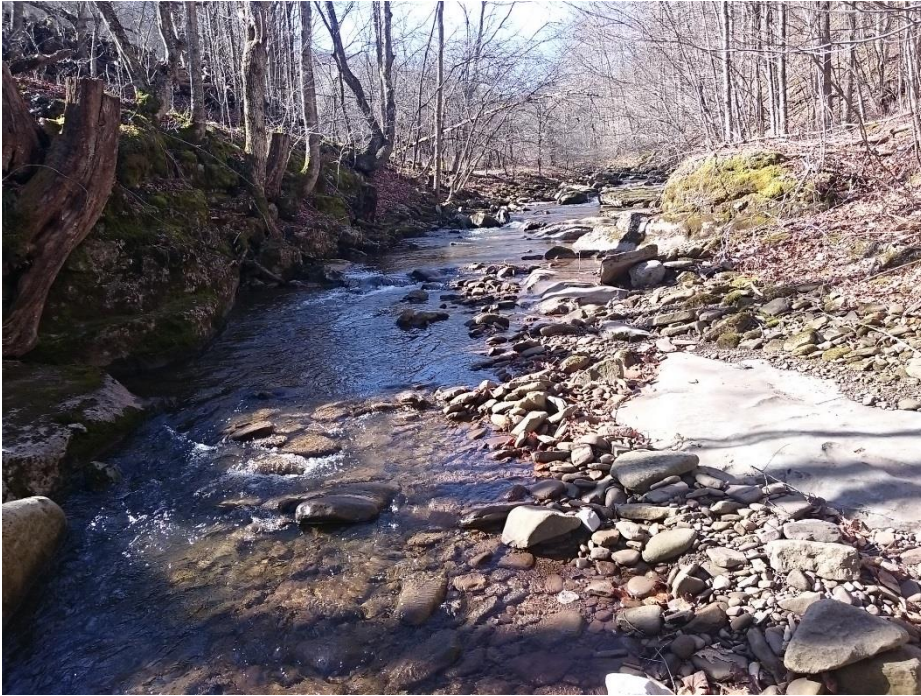
Waterbody SPOC106 facing northeast upstream

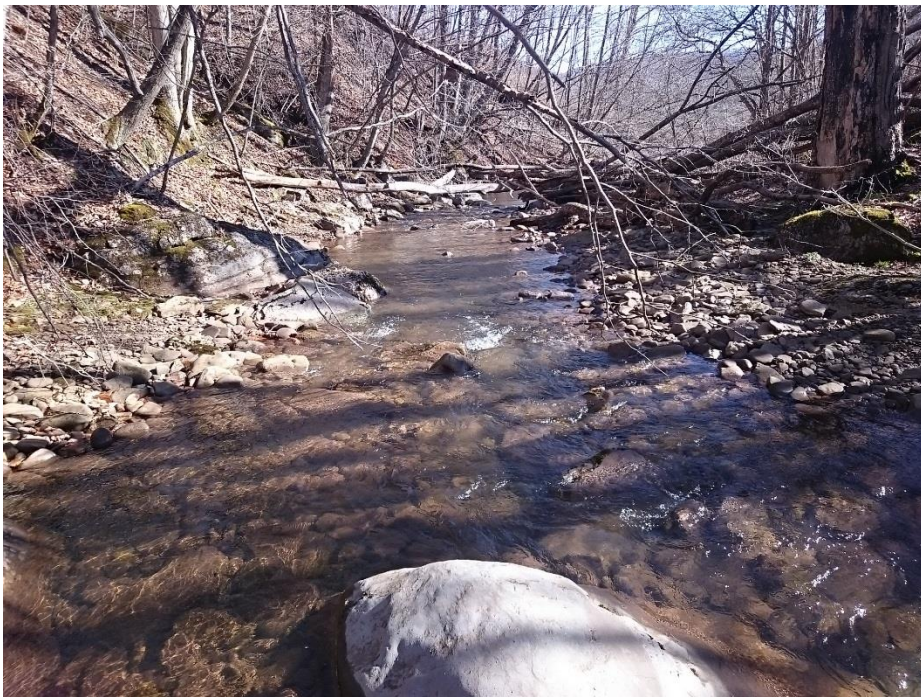
Waterbody SPOC106 facing southwest downstream

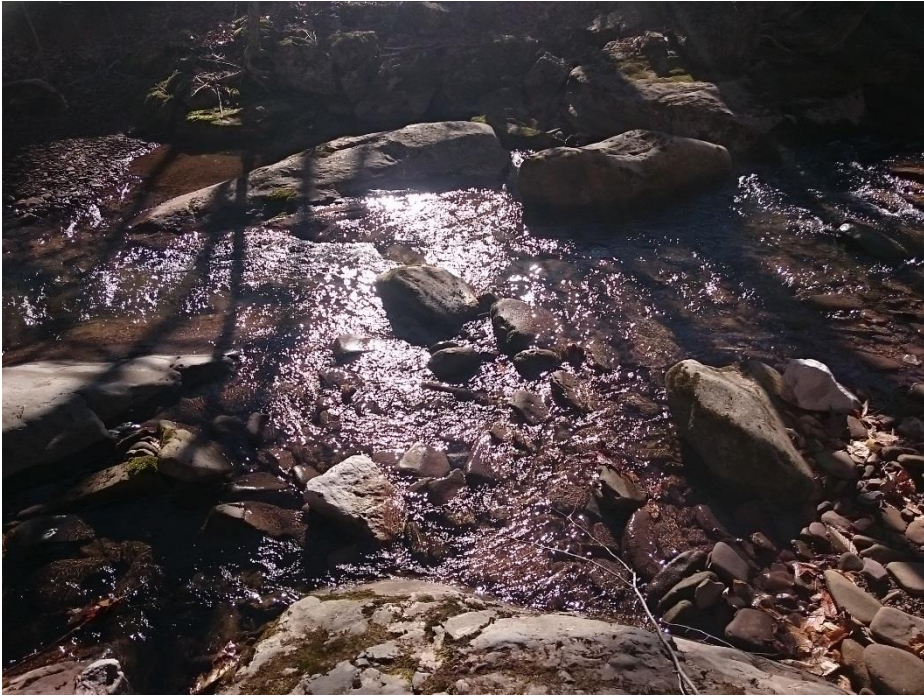
Waterbody SPOC106 facing southeast across

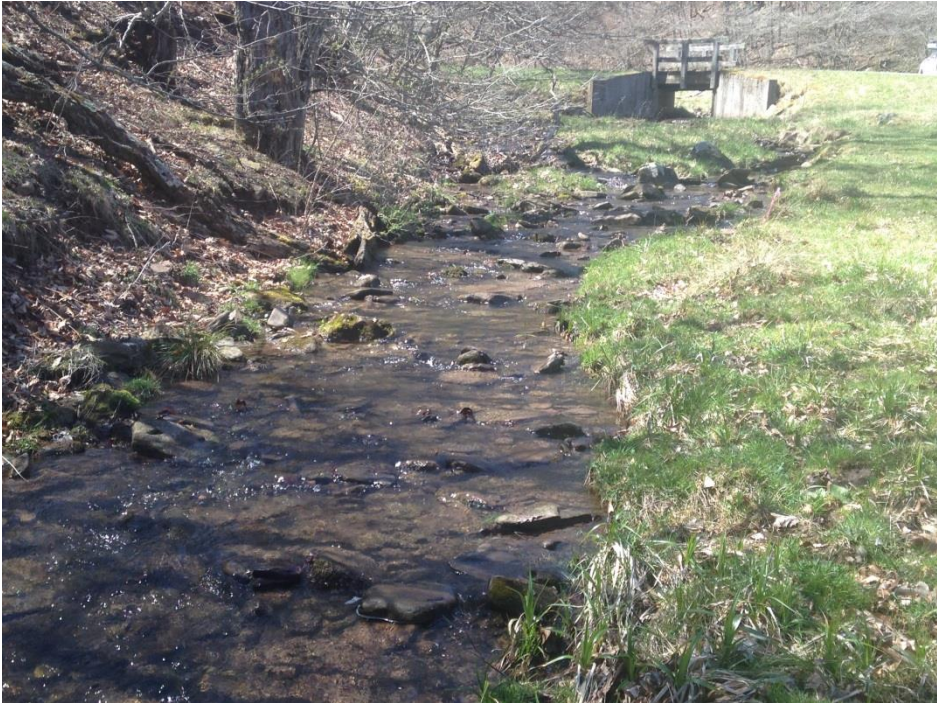
Waterbody SPOC120 facing southwest upstream

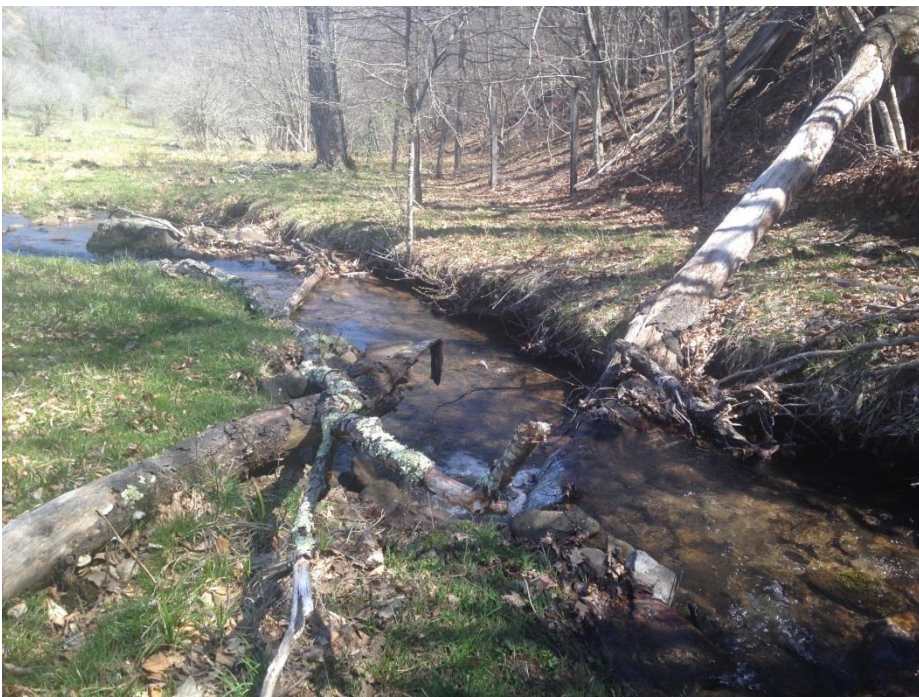
Waterbody SPOC120 facing northeast downstream
