Linear Waterbody Data Sheet

Survey Description			
Project Name: Atlantic Coast Pipeline		Waterbody Name: UNT to Slaty Fork	
Waterbody ID: spoa420		Date: 6/1/2016	
State: West Virginia	County: Pocahontas	Company: NRG/ERM	Crew Member Initials: GB, KO
Photos: 4 photos			
Tract Number(s): access road 05-001-C008.AR1		Nearest Milepost: 72.1	Associated Wetland ID(s): none
Survey Type: <i>(check one)</i> <input type="checkbox"/> Centerline <input type="checkbox"/> Re-Route <input checked="" type="checkbox"/> Access Road <input type="checkbox"/> Other:			
Physical Attributes			
Stream Classification: <i>(check one)</i> <input type="checkbox"/> Ephemeral <input checked="" type="checkbox"/> Intermittent <input type="checkbox"/> Perennial			
Waterbody Type: <i>(check one)</i> <input type="checkbox"/> River <input checked="" type="checkbox"/> Stream <input type="checkbox"/> Ditch <input type="checkbox"/> Canal <input type="checkbox"/> Other:

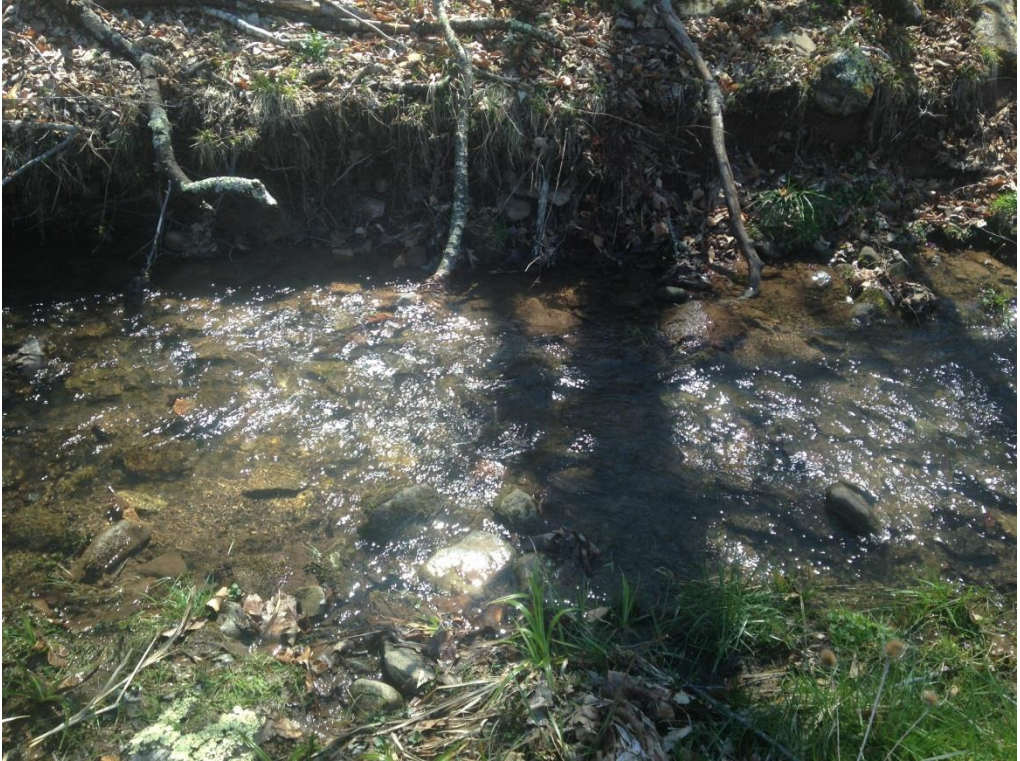
Waterbody SPOC120 facing southeast across

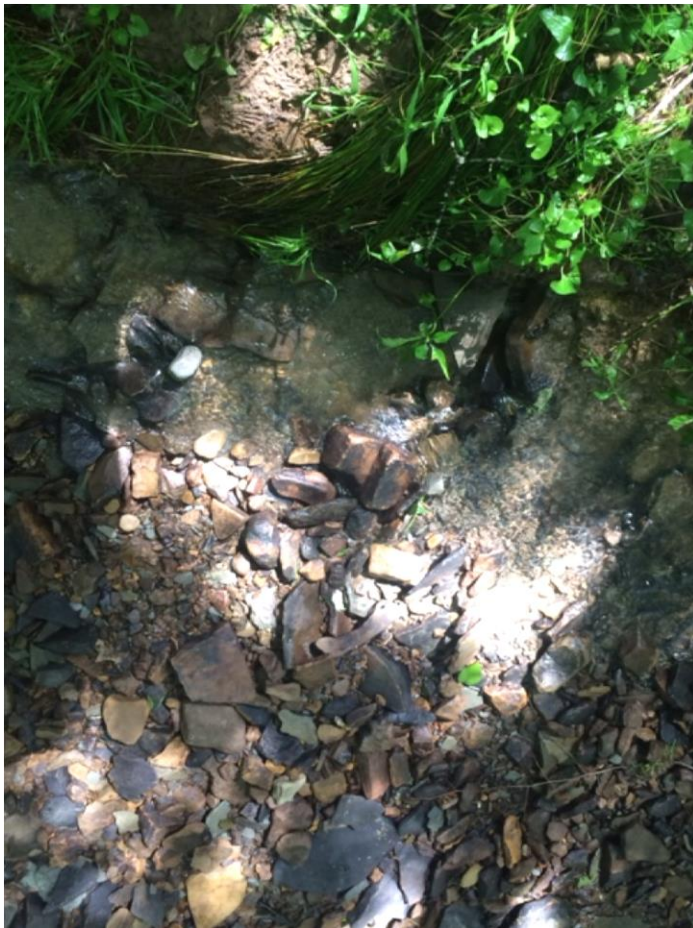
Waterbody SPOE032 facing west across

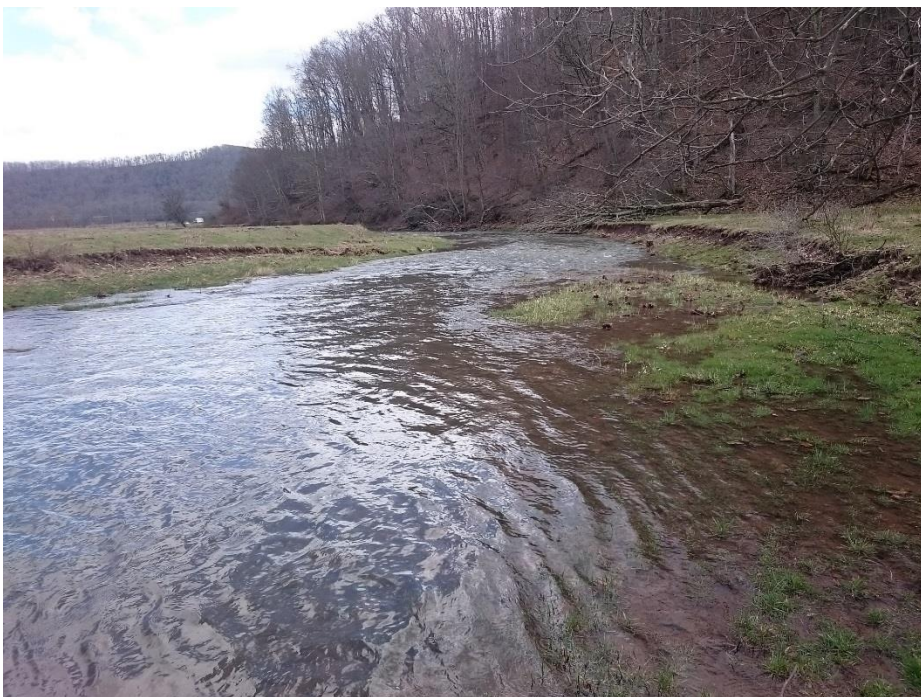
Waterbody SPOC101 facing south downstream

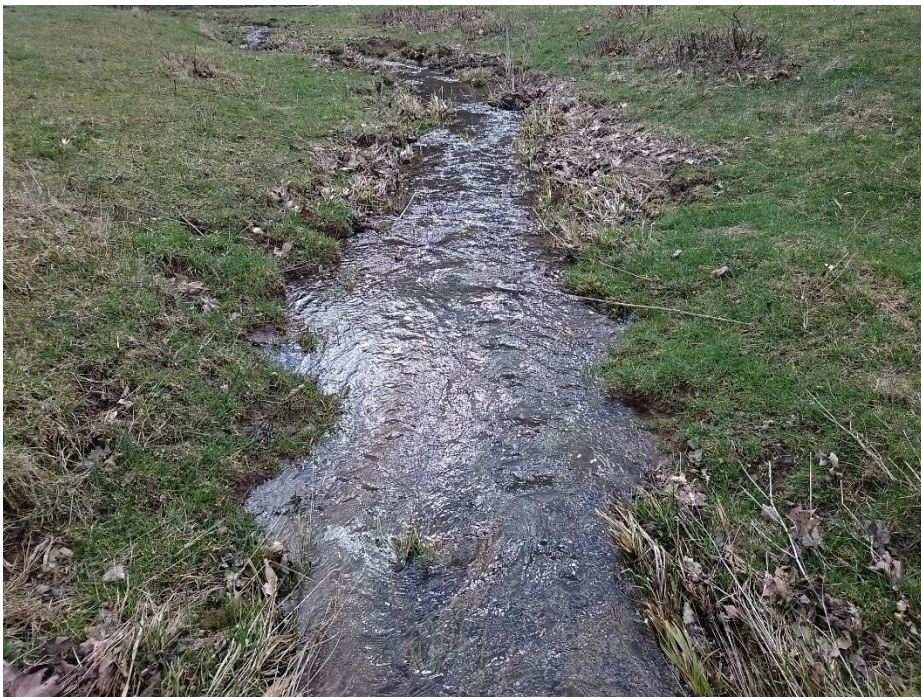
Waterbody SPOC102 facing west downstream

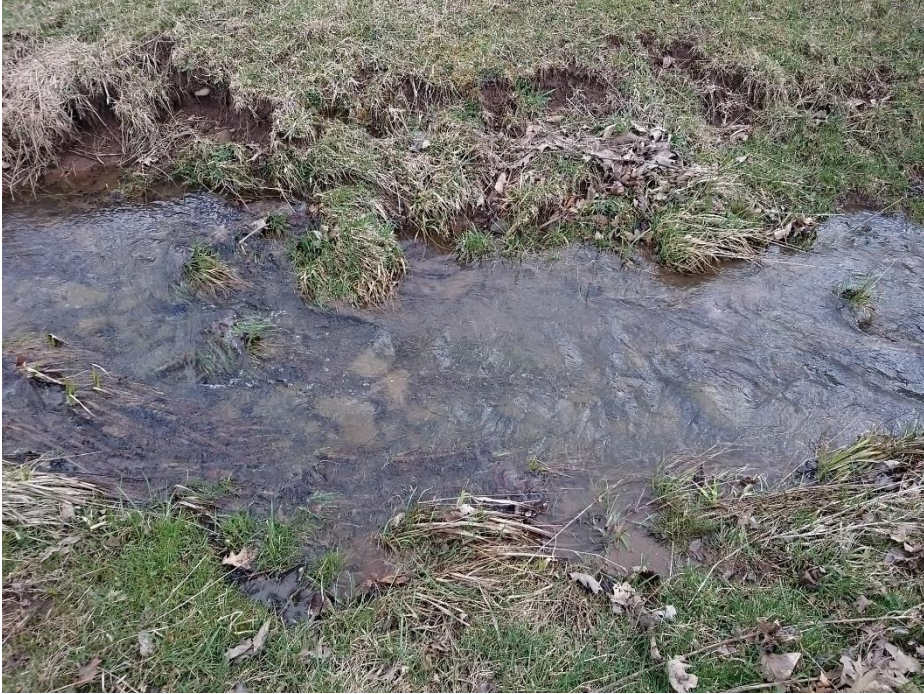
Waterbody SPOC102 facing south across

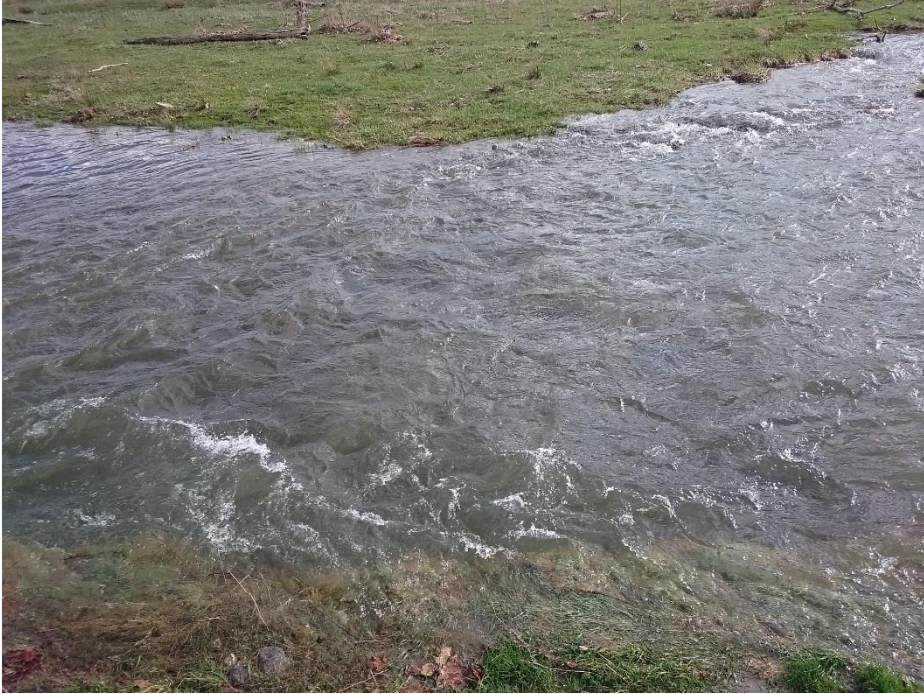
Waterbody SPOC103 facing south-southwest across

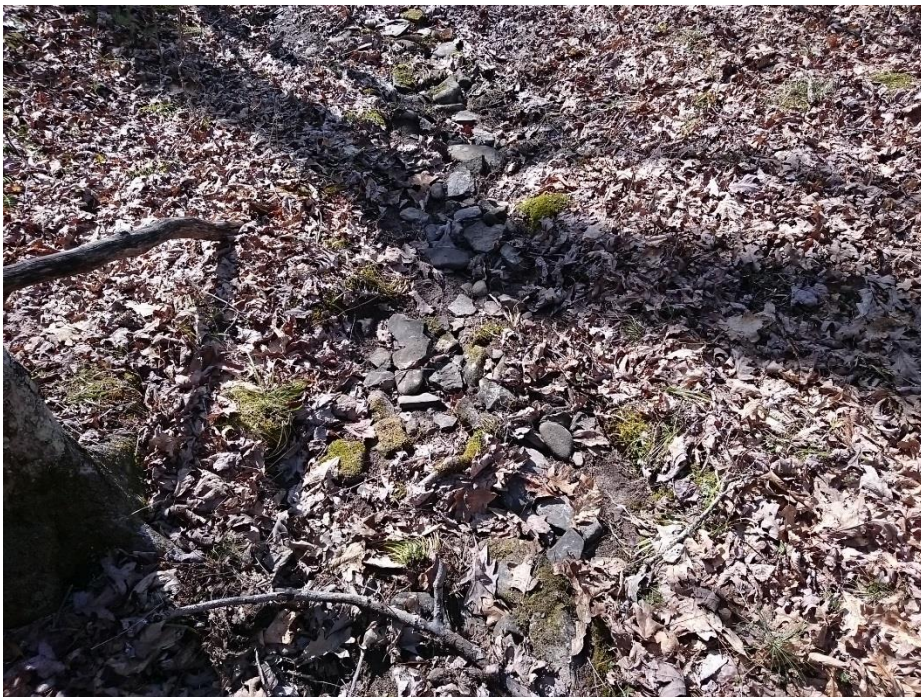
Waterbody SPOC119 facing southwest downstream
