Linear Waterbody Data Sheet

Survey Description				
Project Name: Southeast Reliability		Waterbody Name: UNT to DRY CREEK		Waterbody ID: SCUK037
State: Virginia		County: Cumberland	Company: W&C	Crew Member Initials: JS, BG
Tract Number(s): 10-025		Nearest Milepost: 211		Associated Wetland ID(s): NA
Survey Type: <i>(check one)</i> <input checked="" type="checkbox"/> Centerline <input type="checkbox"/> Re-Route <input type="checkbox"/> Access Road <input type="checkbox"/> Other:				
Physical Attributes				
Stream Classification: <i>(check one)</i> <input checked="" type="checkbox"/> Ephemeral <input type="checkbox"/> Intermittent <input type="checkbox"/> Perennial				
Waterbody Type: <i>(check one)</i> <input type="checkbox"/> River <input checked="" type="checkbox"/> Stream <input type="checkbox"/> Ditch <input type="checkbox"/> Canal <input type="checkbox"/> Other:				
OHWM Width: <u>2</u> ft. Height: <u>0.5</u> ft. N/A <input type="checkbox"/>		OHWM Indicator: <i>(check all that apply)</i> <input checked="" type="checkbox"/> Clear line on bank <input type="checkbox"/> Shelving <input type="checkbox"/> Wrested vegetation <input type="checkbox"/> Scouring <input type="checkbox"/> Wa

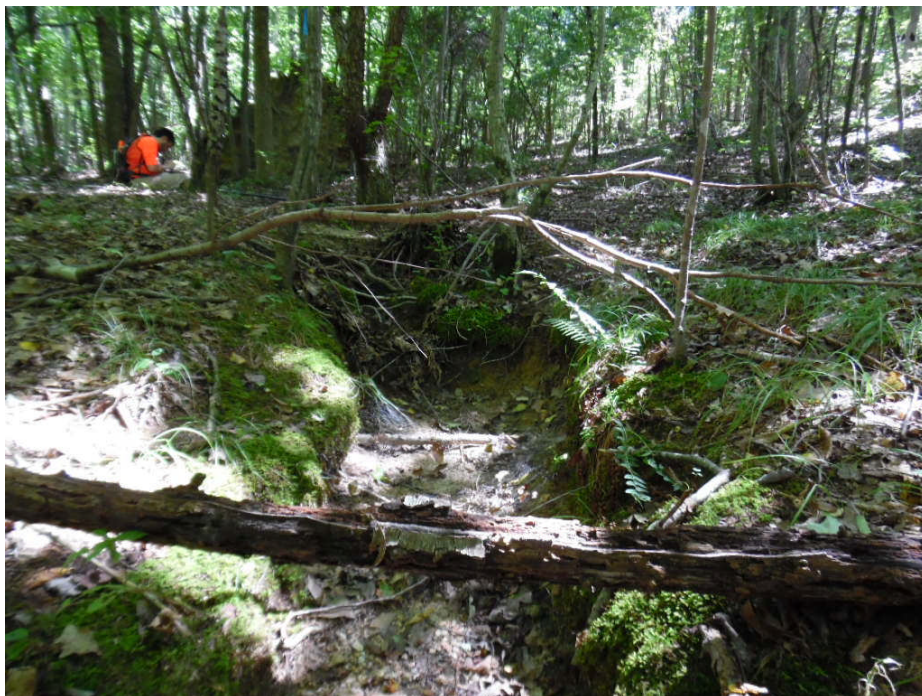
DRY EPHEMERAL STREAM BED. LOW QUALITY DUE TO LACK OF AQUATIC HABITATS.

Waterbody point scuk037 facing North and downstream

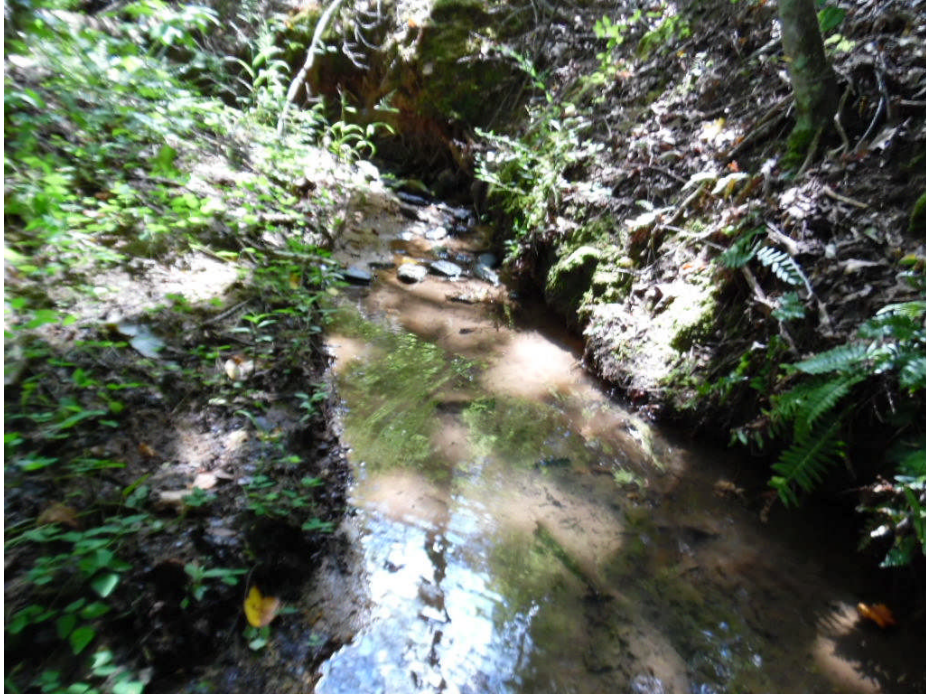
PORTION OF DRY CREEK. SMALL SEGMENT RE-ENTERS ROW.

Waterbody point scuk038 facing East and upstream

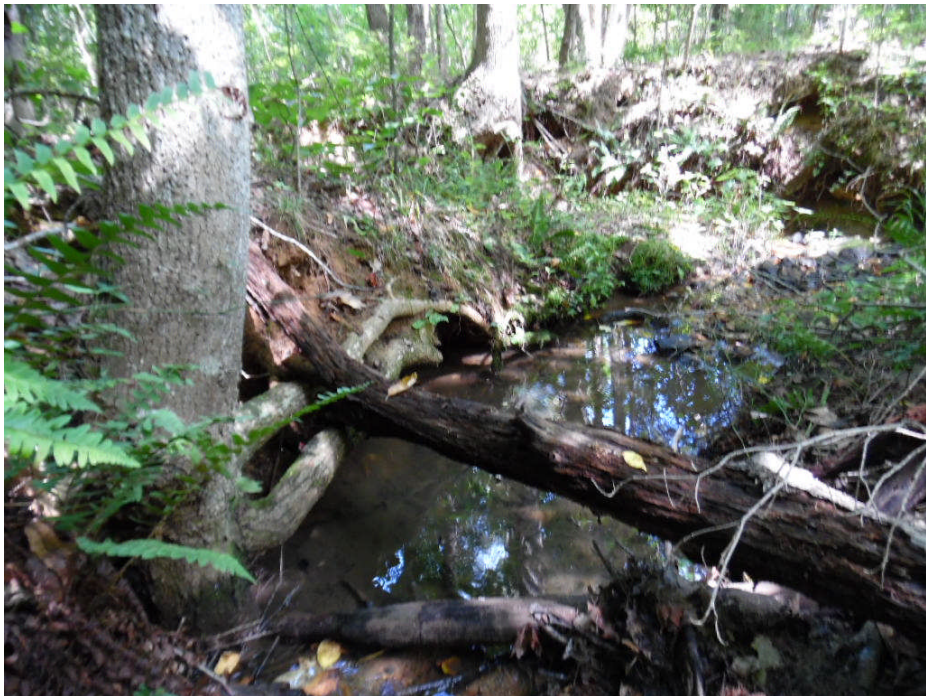
Waterbody point scuk038 facing West and downstream

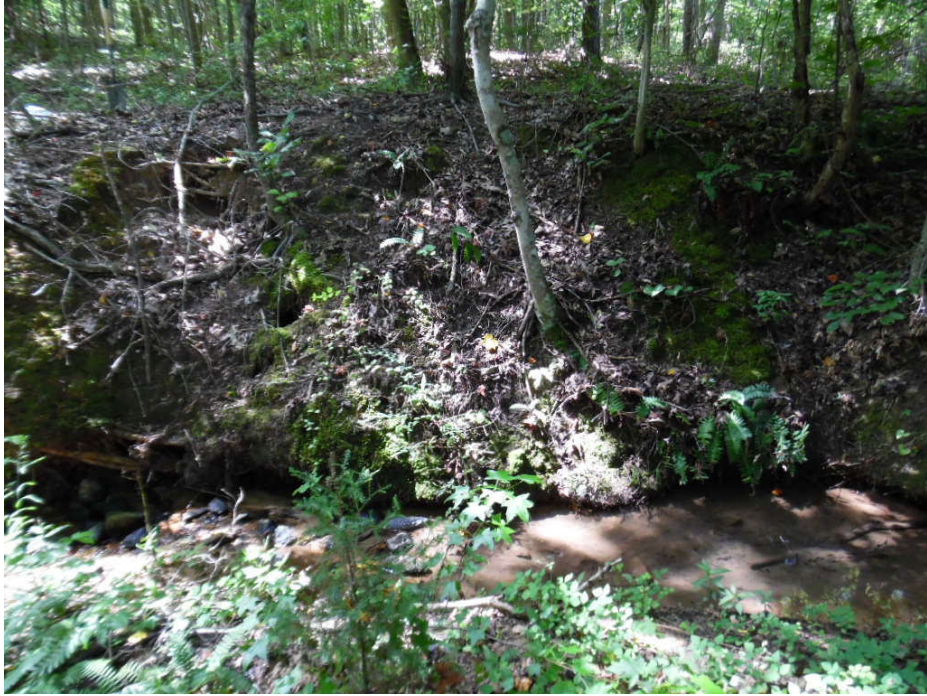
Waterbody point scuk038 facing South and across

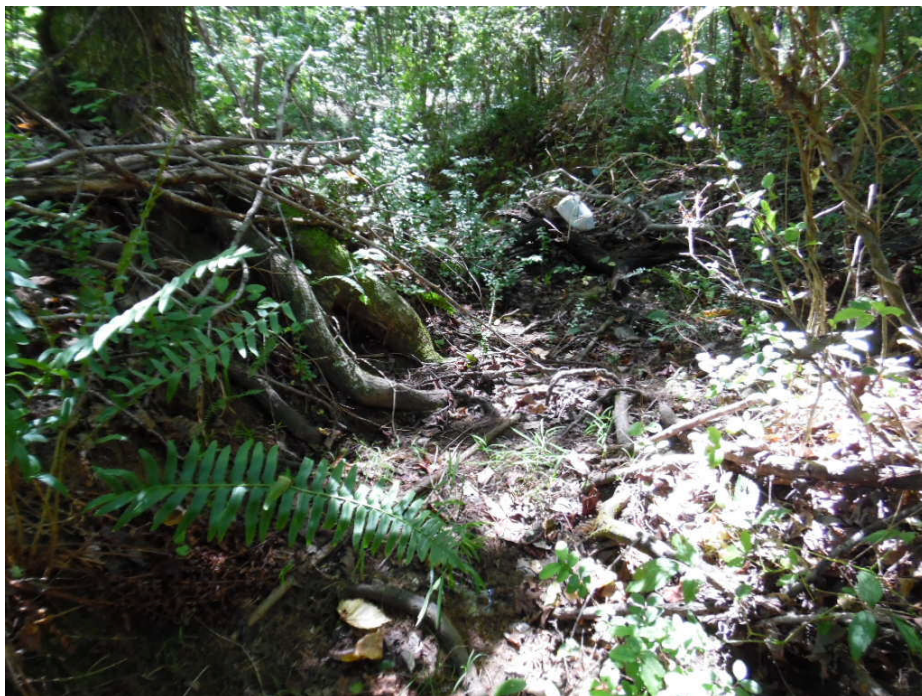
EPHEMERAL REACH PORTION. LOTS OF GARBAGE IN CHANNEL AND ON BANKS (DUMP).

Waterbody point scuk039a facing South and downstream

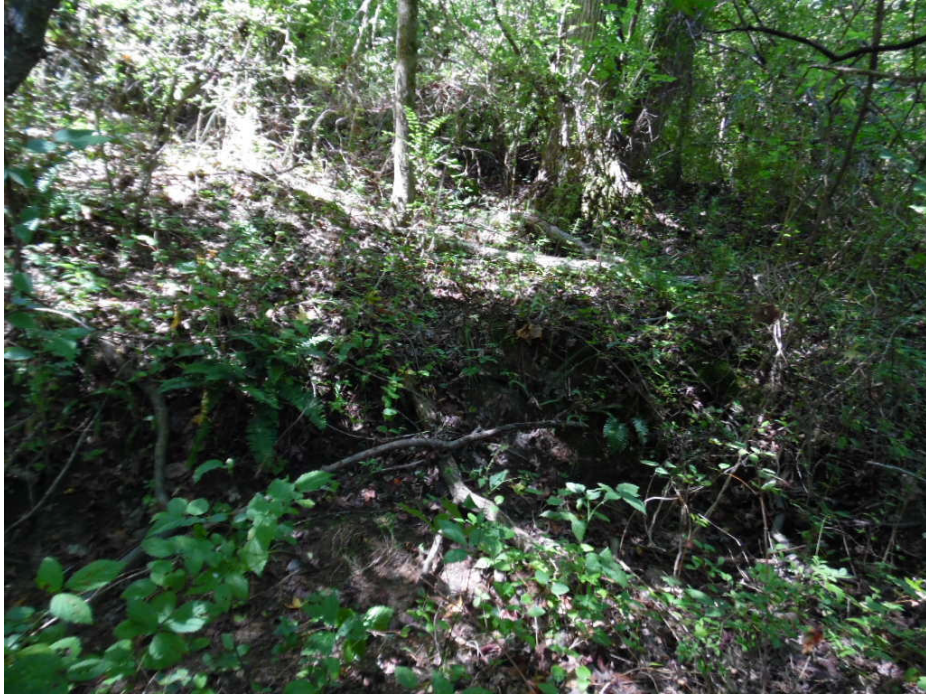
Waterbody point scuk039a facing West and across

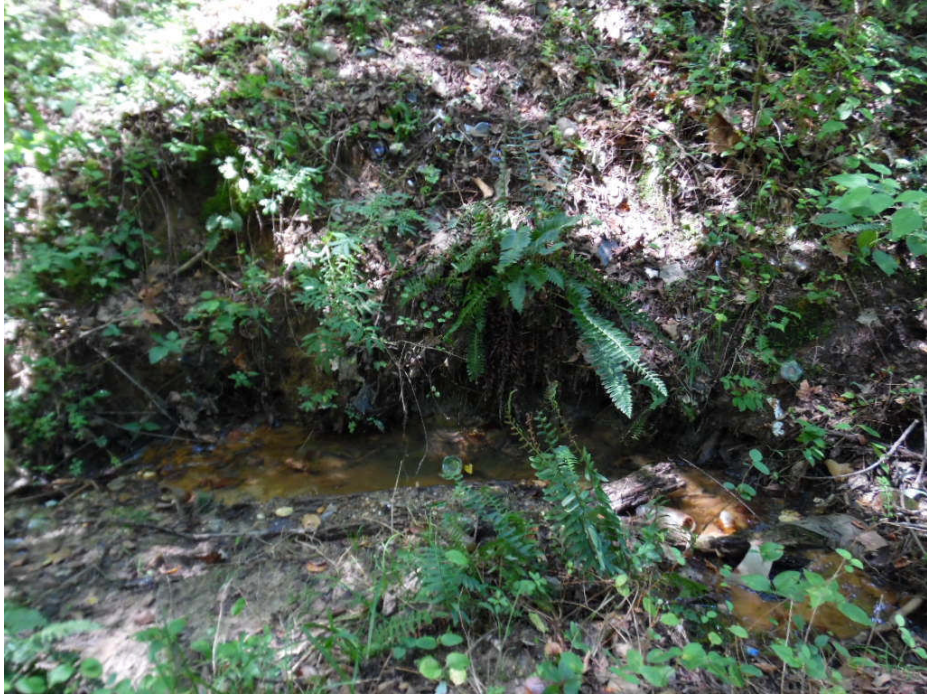
INTERMITTENT REACH PORTION. LOTS OF GARBAGE IN CHANNEL AND ON BANKS (DUMP). NO FLOW. POOLS PRESENT.

Waterbody point scuk039b facing West and across

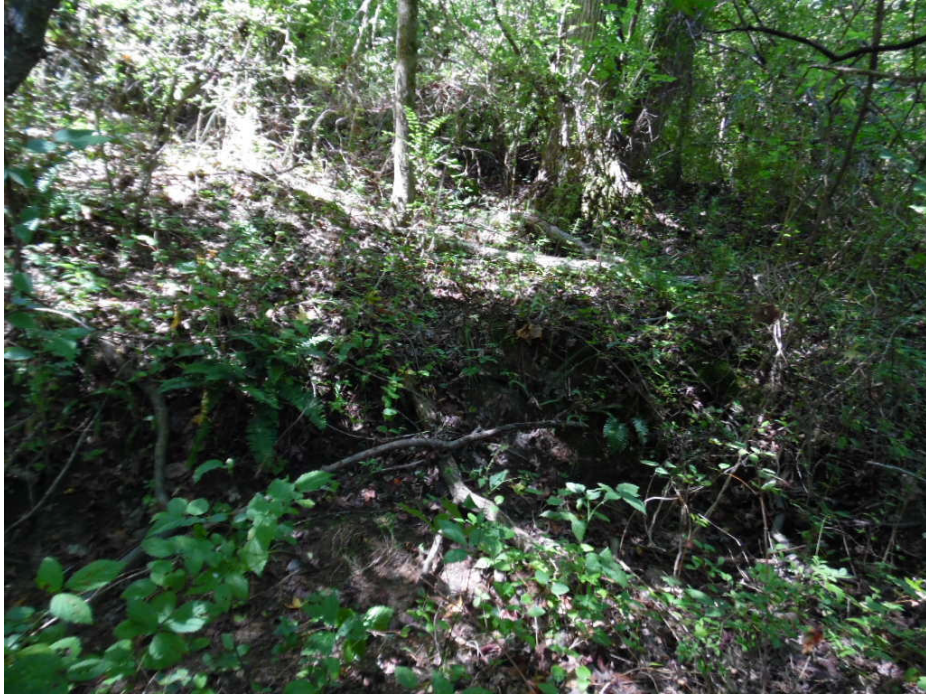
EPHEMERAL REACH PORTION. LOTS OF GARBAGE IN CHANNEL AND ON BANKS (DUMP).

Waterbody point scuk039a facing West and across

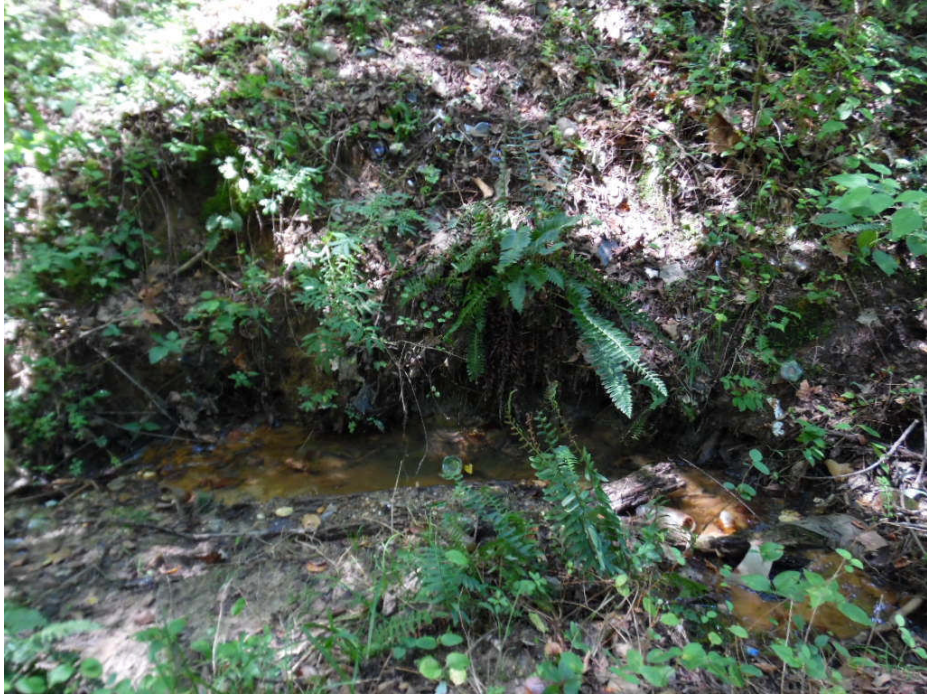
INTERMITTENT REACH PORTION. LOTS OF GARBAGE IN CHANNEL AND ON BANKS (DUMP). NO FLOW. POOLS PRESENT.

Waterbody point scuk039b facing West and across

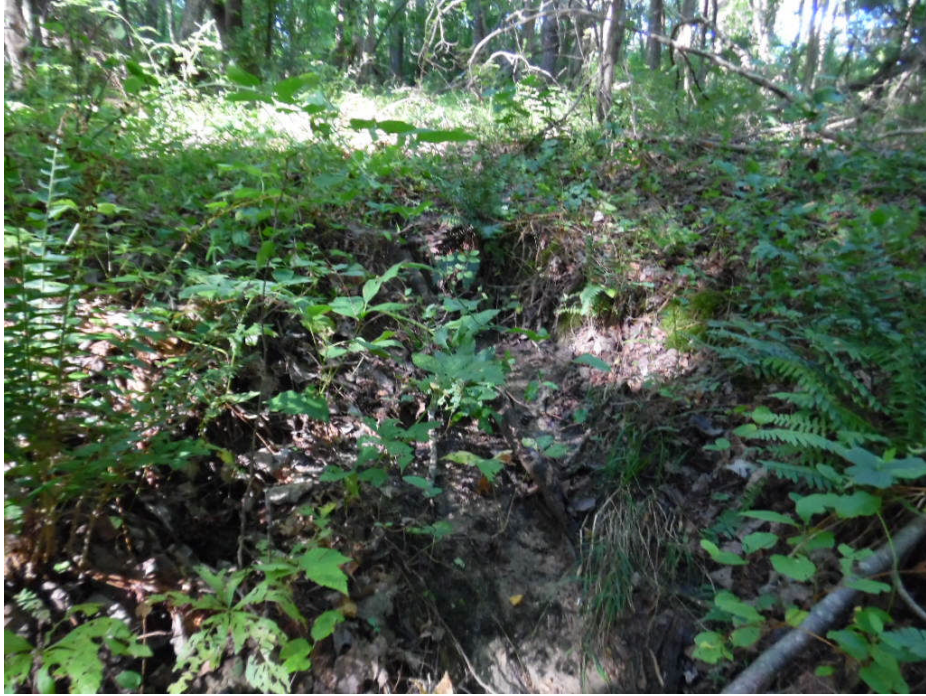
EPHEMERAL REACH WITH HEADWATER WETLAND LOCATED OFF ROW.

Waterbody point scuk041 facing Southwest and upstream

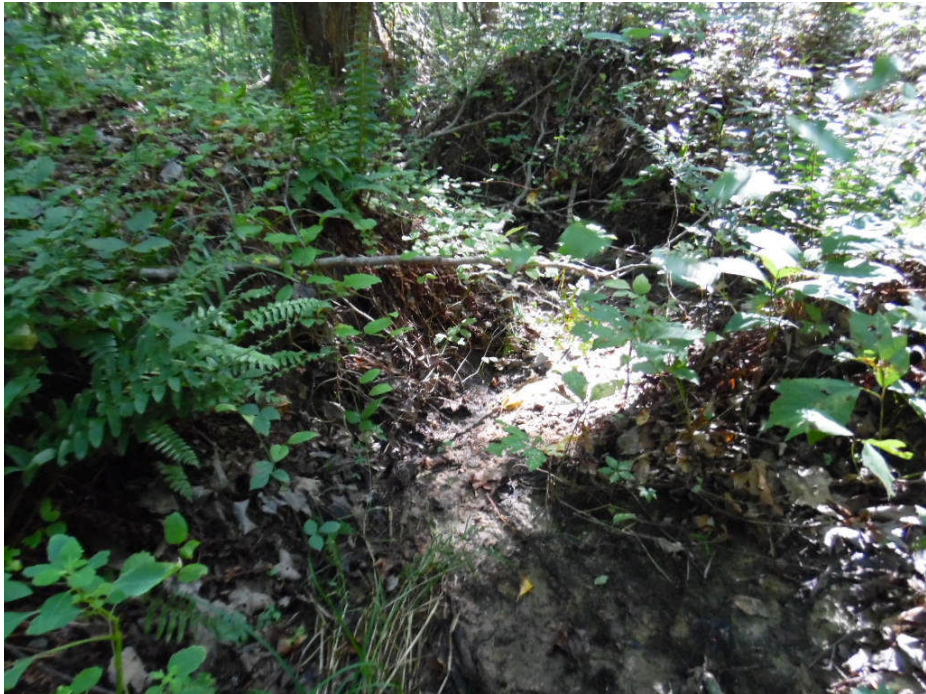
Waterbody point scuk041 facing Northeast and downstream

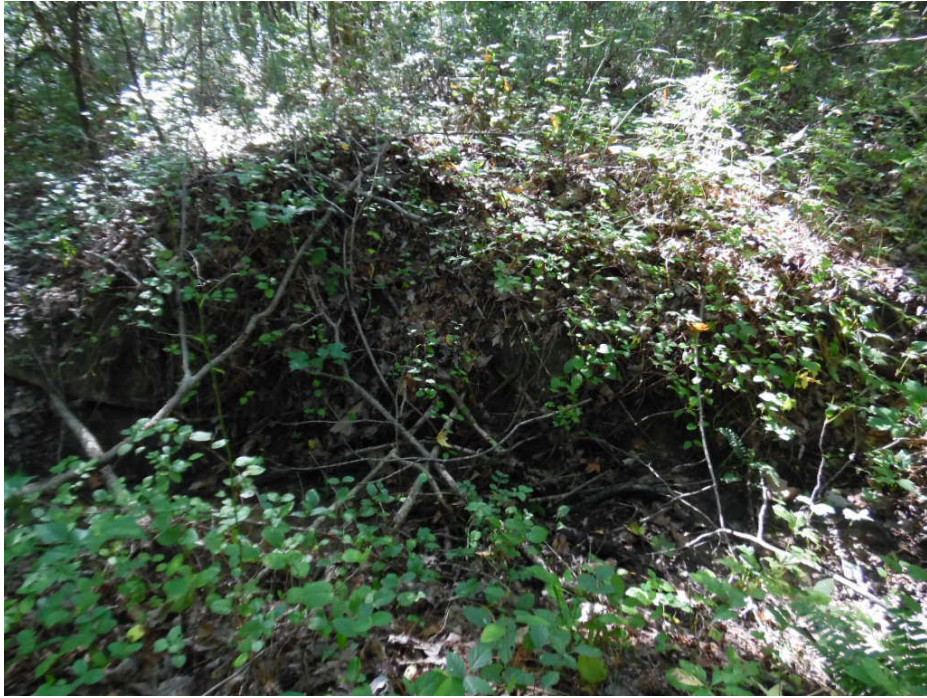
Waterbody point scuk041 facing Southeast and
across

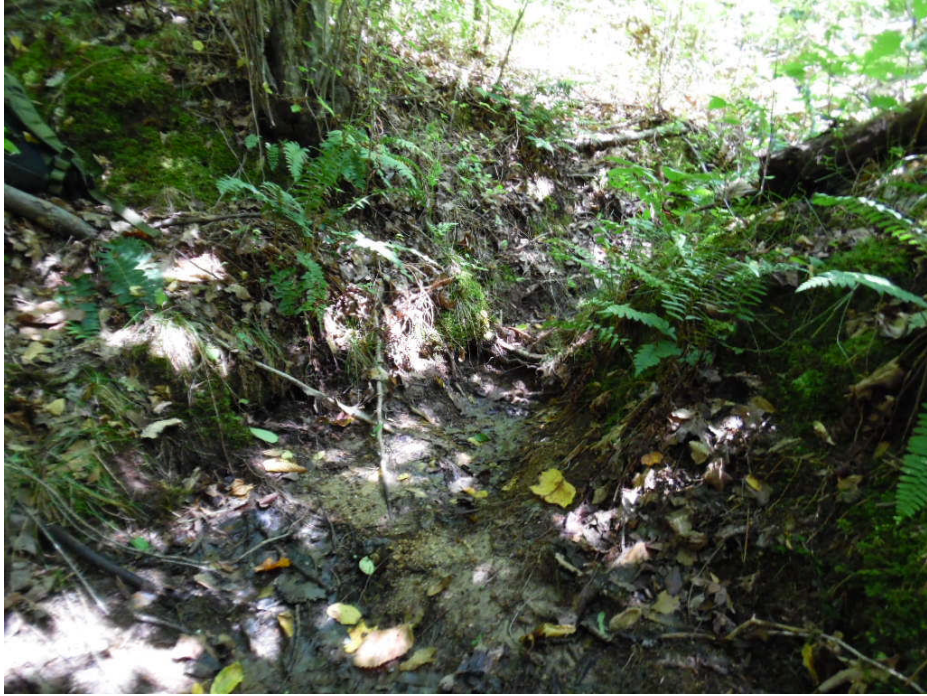
EPHEMERAL STREAM LACKING AQUATIC HABITATS AND ORGANISMS.

Waterbody point scuk040 facing Northeast and upstream

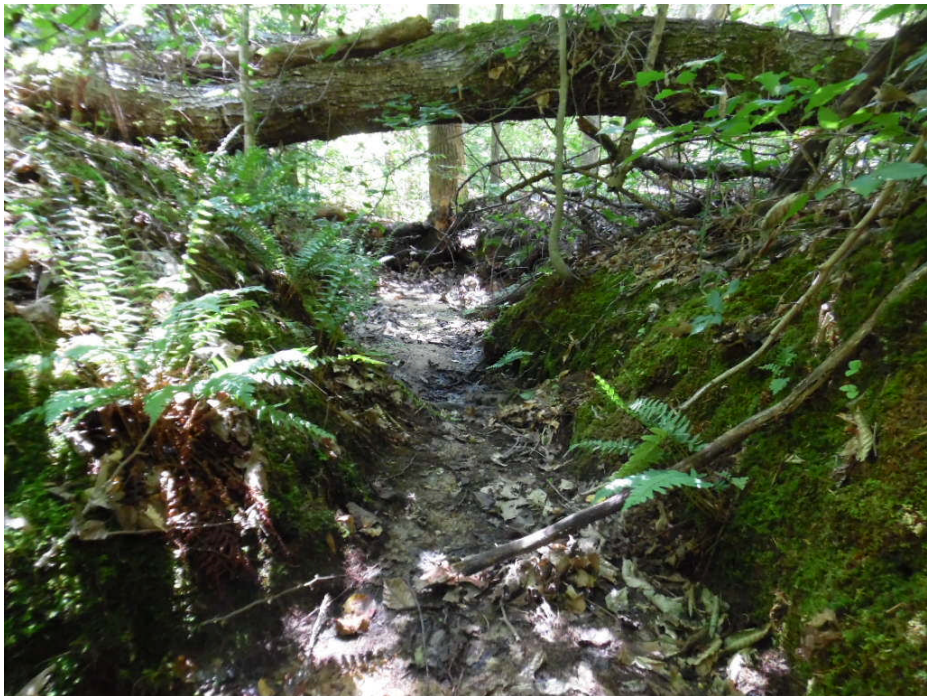
Waterbody point scuk040 facing Southwest and downstream

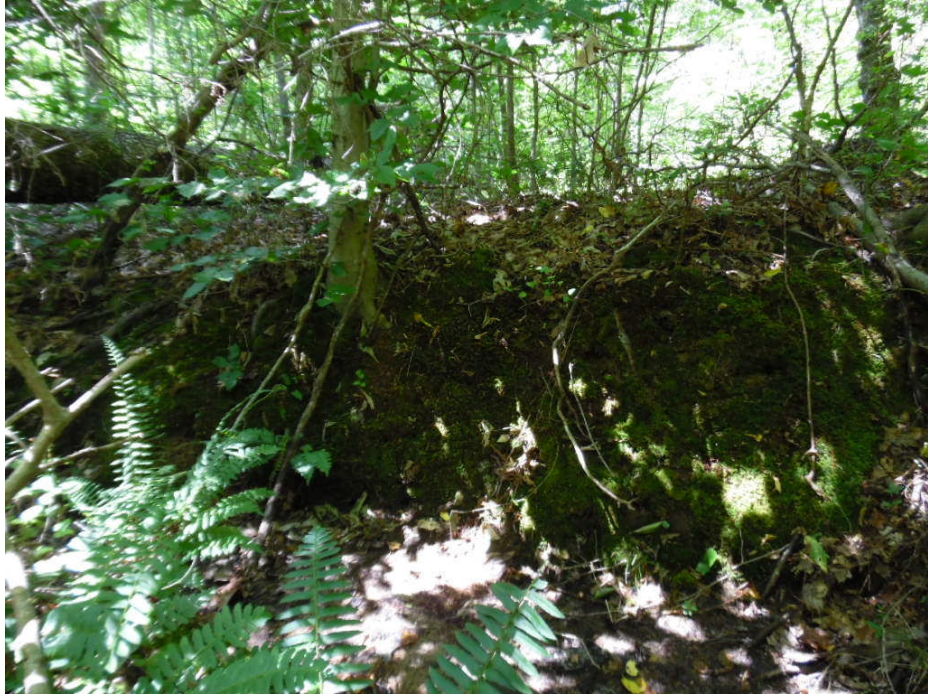
Waterbody point scuk040 facing Southeast and
across

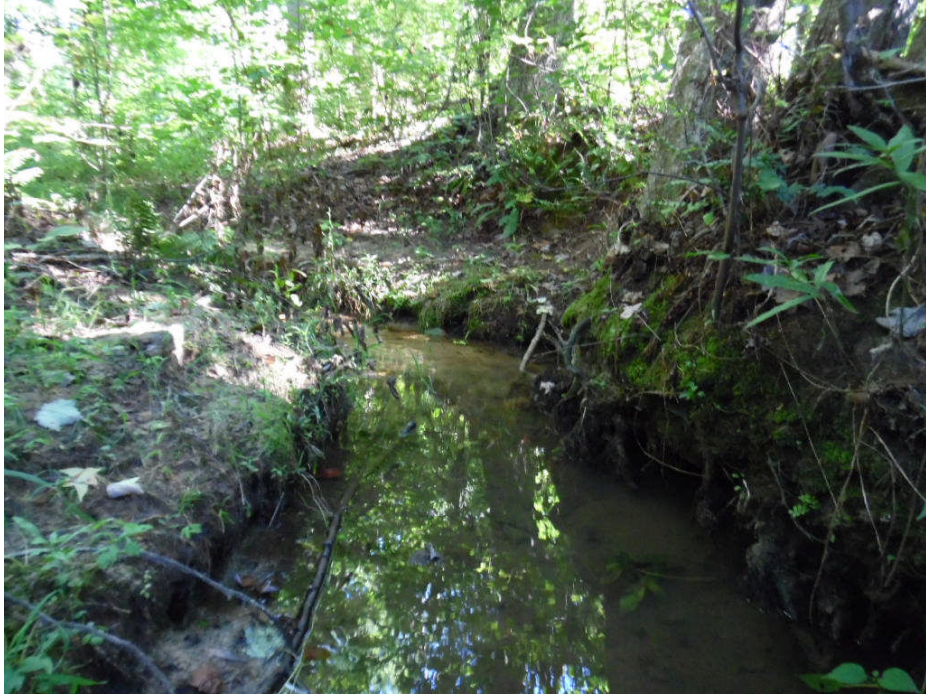
NICE SMALL PERENNIAL STREAM WITH LOW FLOW AND VOLUME AT TIME OF SURVEY. STREAM FLOW CULVERTED AT NORTH EDGE OF ROW.

Waterbody point scuk042 facing North and upstream

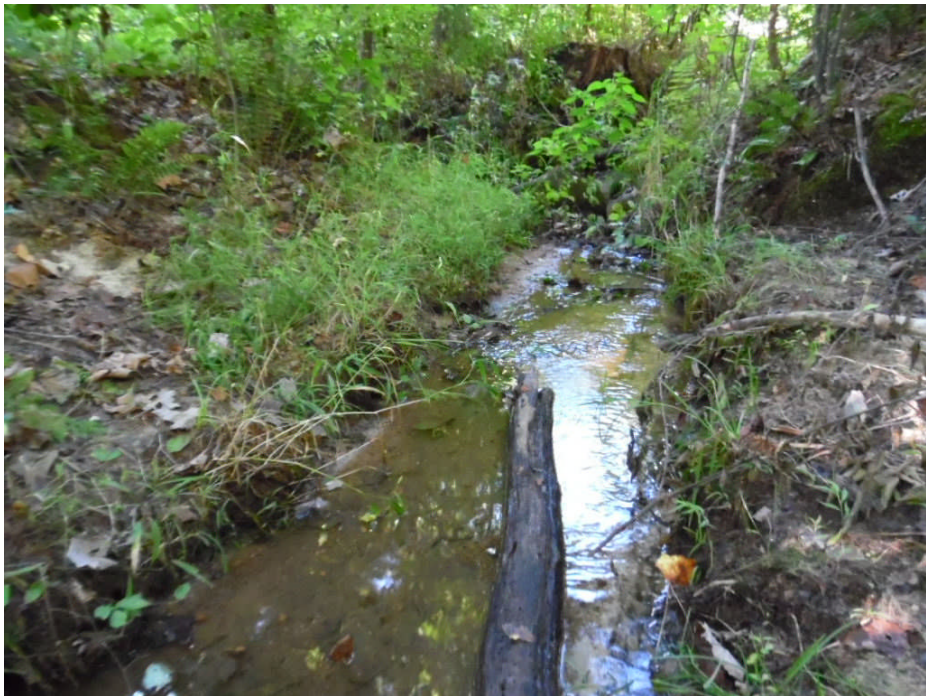
Waterbody point scuk042 facing South and downstream

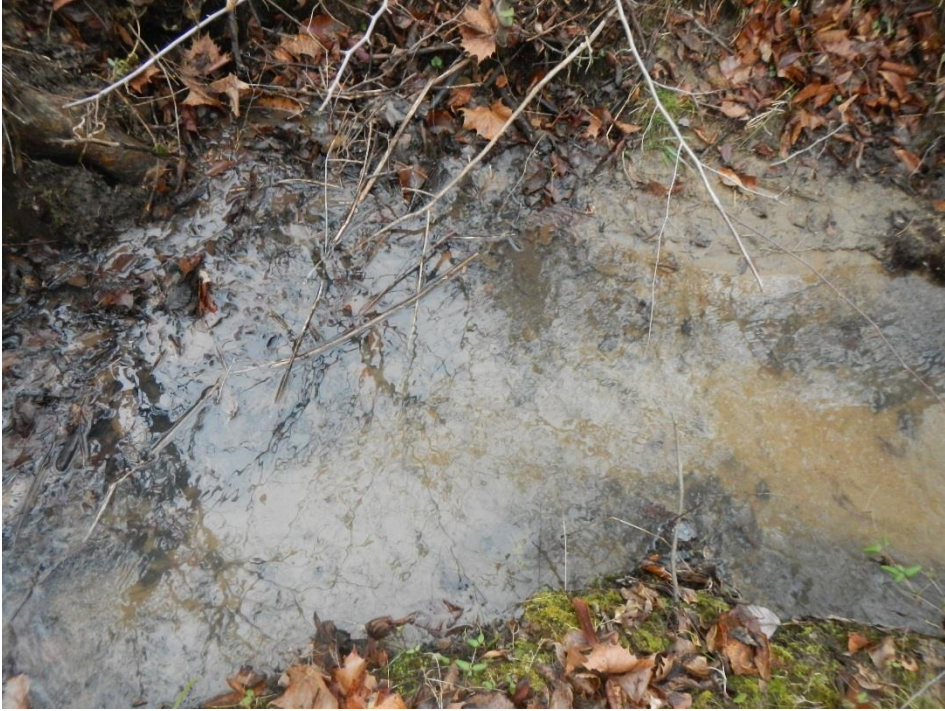
Recent sediment deposits are found with the stream and both banks are down cut

Waterbody SCUC004 facing across

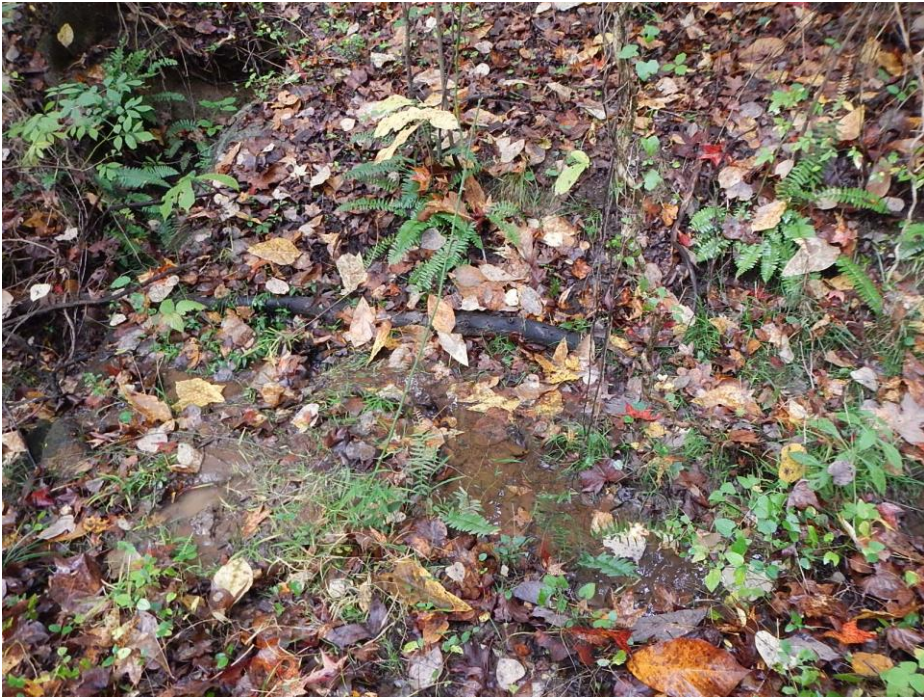
Begins as a headcut near edge of corridor, downstream continues out; located in a finger of mixed hardwoods between hayfields.

Waterbody SCUA002 facing west across

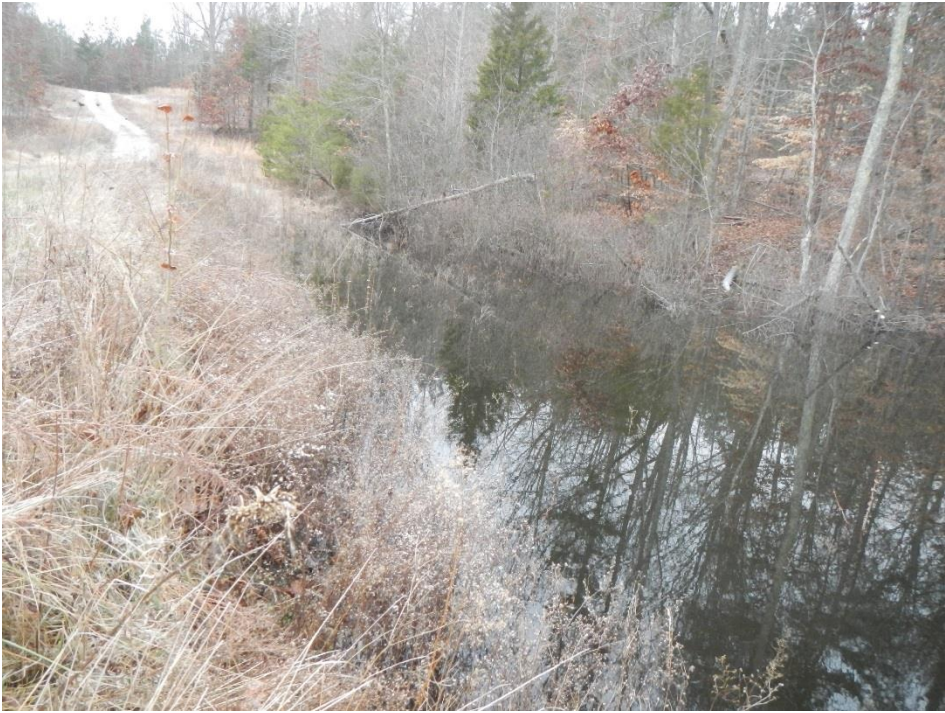
Pond is dammed and appears to drain under the road near the photo point. Pond is about 70 feet across and the top of the banks of the pond are about 90 feet across.

Open Waterbody OCUC001 facing west

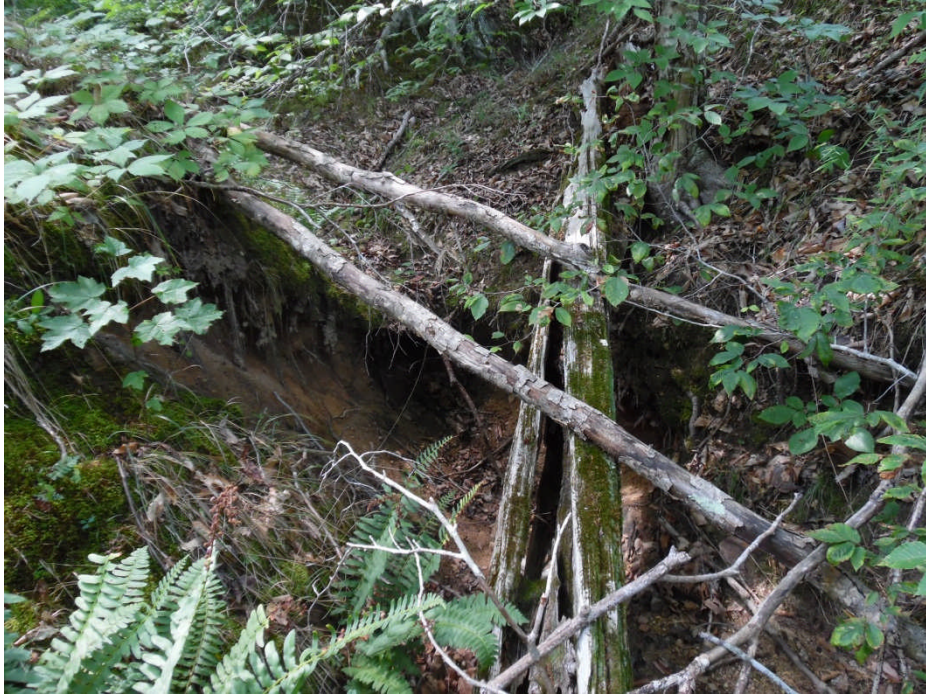
EPHEMERAL STREAM IN UPLAND HW FOREST WITH NO FLOW AND STEEP GRADIENT, MINIMUM HUMAN DISTURBANCE.

Waterbody point scuk025 facing west and upstream

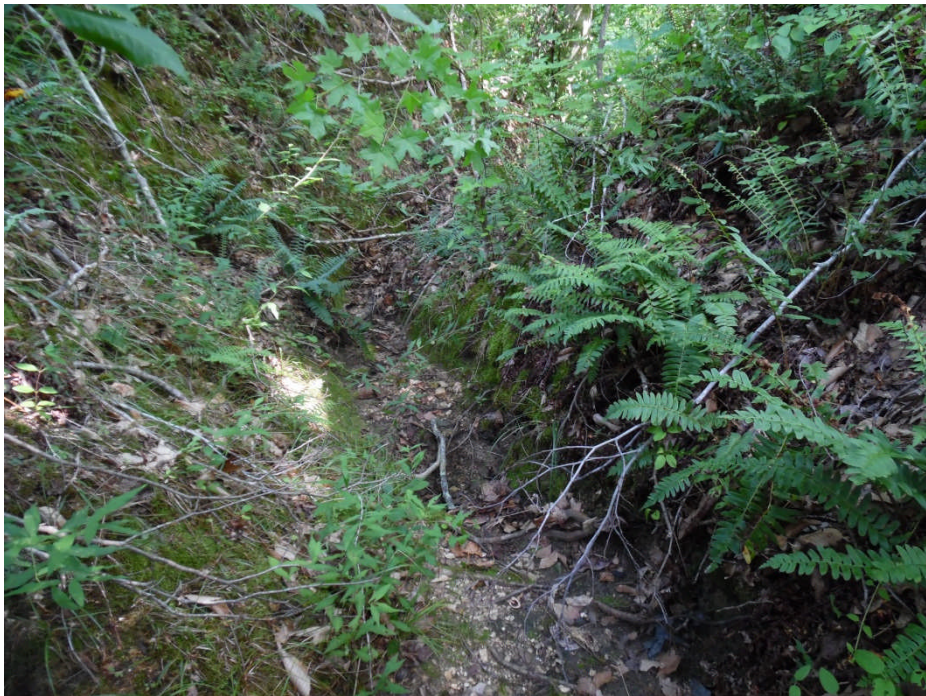
Waterbody point scuk025 facing east and downstream

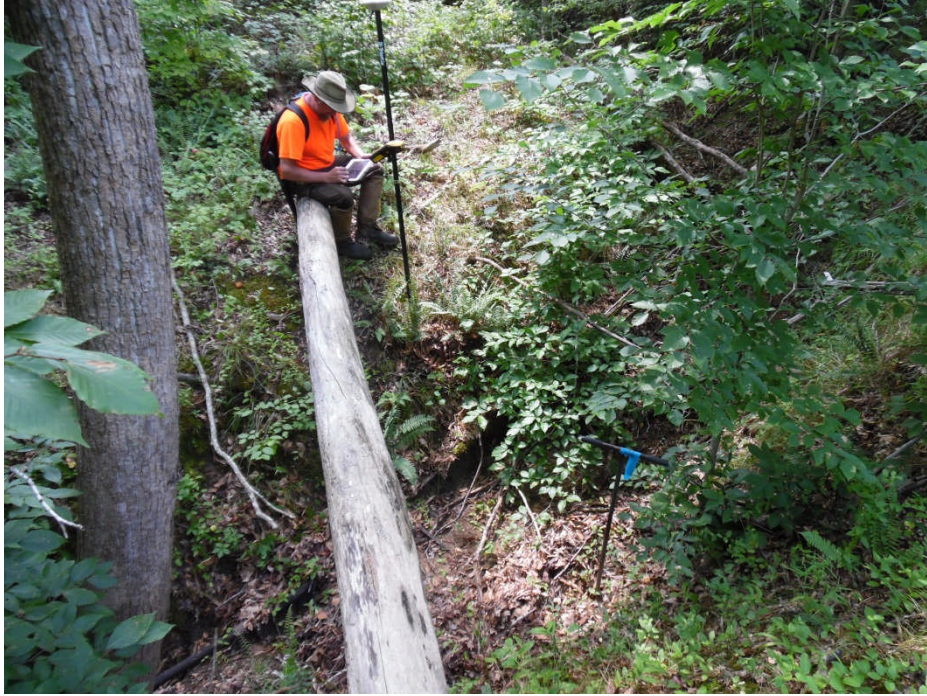
Waterbody point scuk025 facing east and across
