Linear Waterbody Data Sheet

Survey Description				
Project Name: ACP		Waterbody Name: Unit to Meherrin River		Waterbody ID: SSDP002
State: VA		County/Parish: Southampton	Company: ESI	Date: 4/1/15
Tract Number(s): 25-001-A005, 25-001-A001, 25-001-A003		Nearest Milepost: 2.5 (new)	Crew Member Initials: LR, RT	
Survey Type: <small>(check one)</small>		Associated Wetland ID(s): WSOP001		
<input type="checkbox"/> Centerline		<input checked="" type="checkbox"/> Re-Route		
<input type="checkbox"/> Access Road		<input type="checkbox"/> Other:		
Physical Attributes				
Stream Classification: <small>(check one)</small>				
<input type="checkbox"/> Ephemeral				
<input type="checkbox"/> Intermittent				
<input checked="" type="checkbox"/> Perennial				
Waterbody Type: <small>(check one)</small>				
<input type="checkbox"/> River				
<input type="checkbox"/> Stream				
<input type="checkbox"/> Ditch				
<input checked="" type="checkbox"/> Canal

Environmental Field Surveys
Waterbody Photo Page

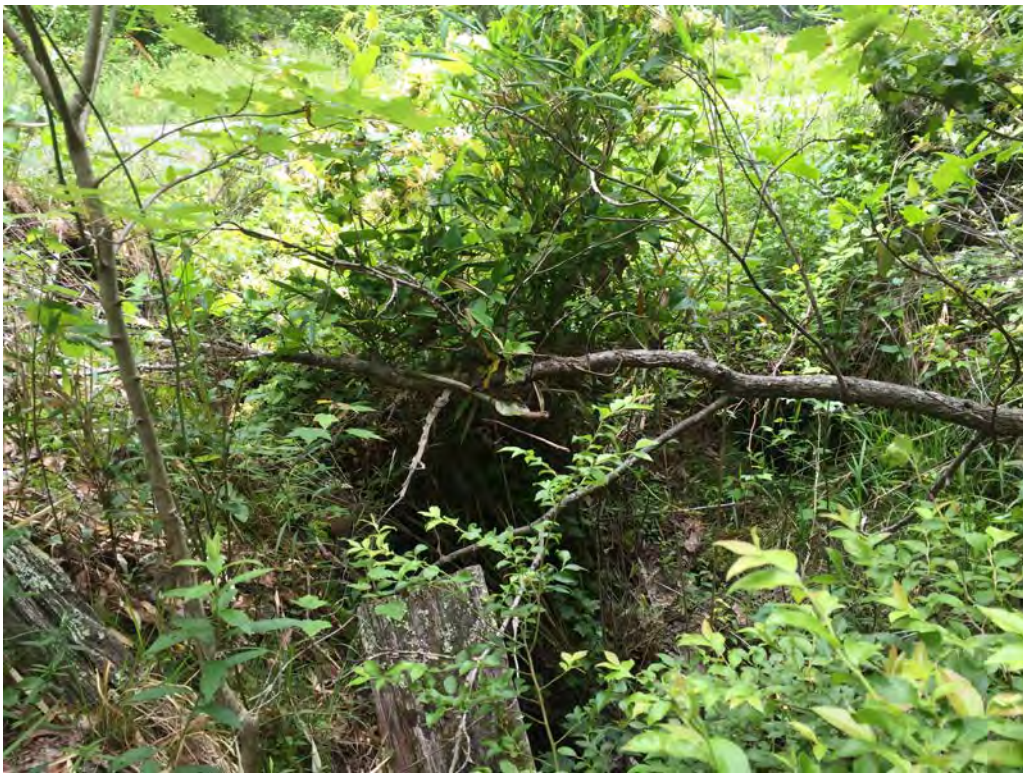
Waterbody ssoo018 facing west upstream at culvert crossing.

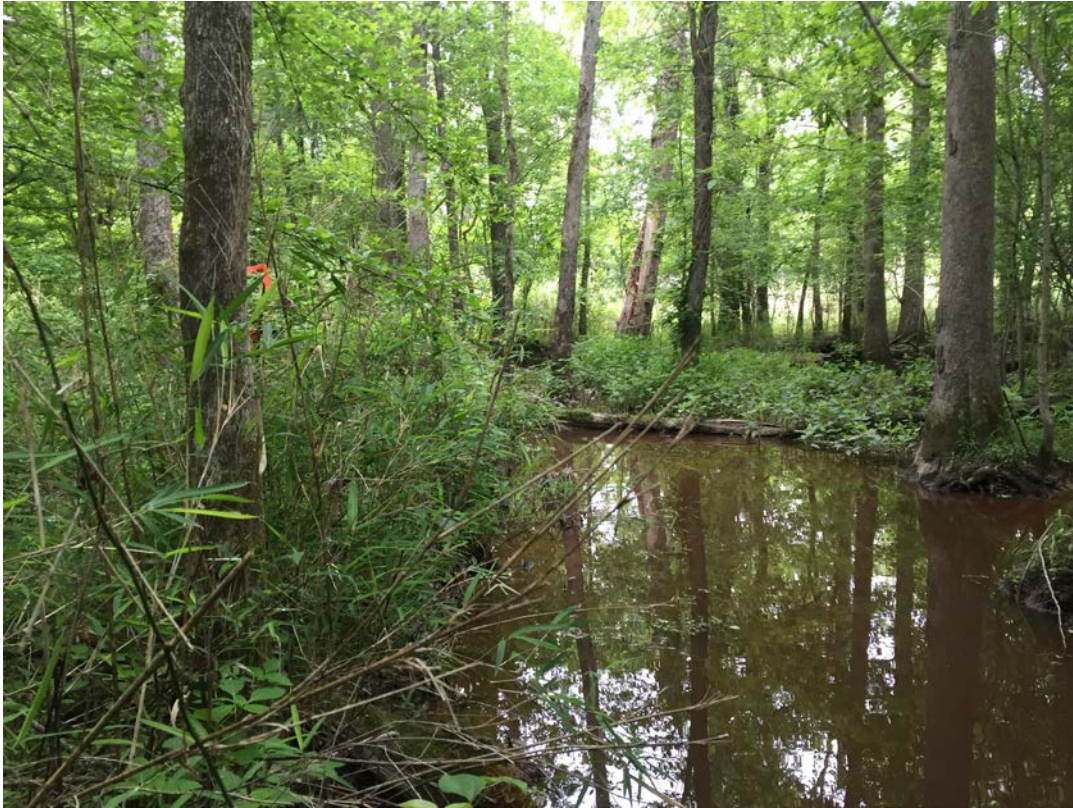
Waterbody data point ssoo017 facing north upstream.

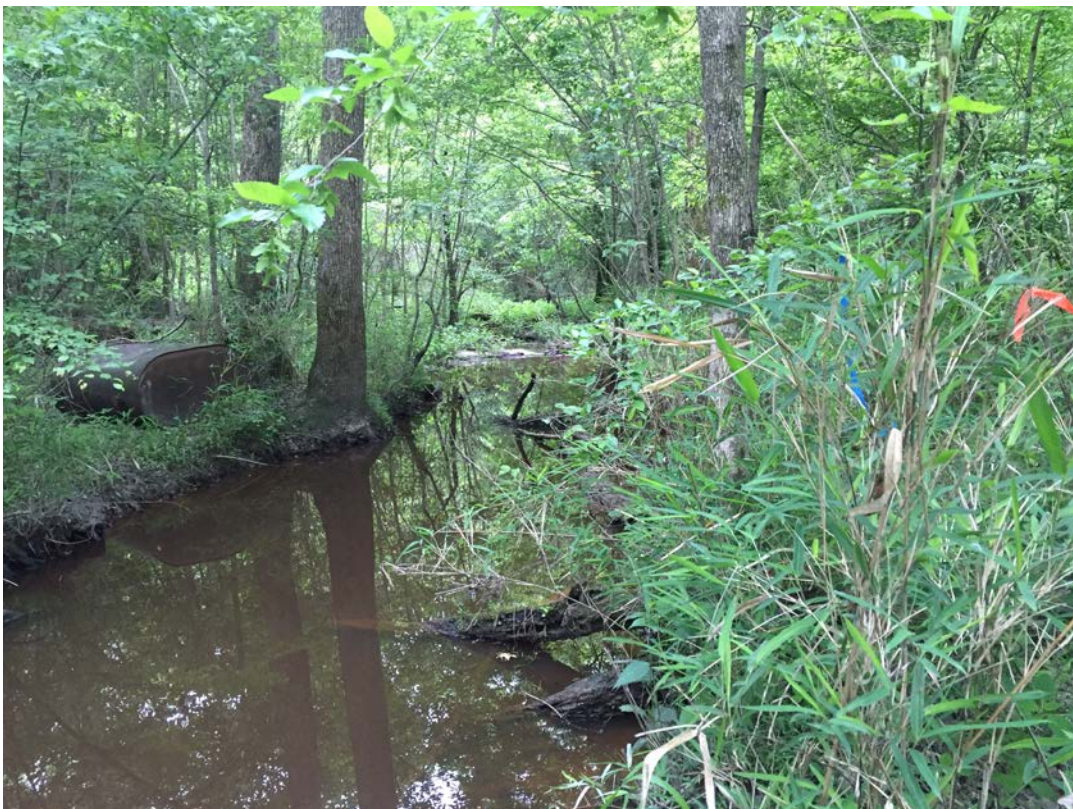
Waterbody data point ssoo017 facing south downstream.

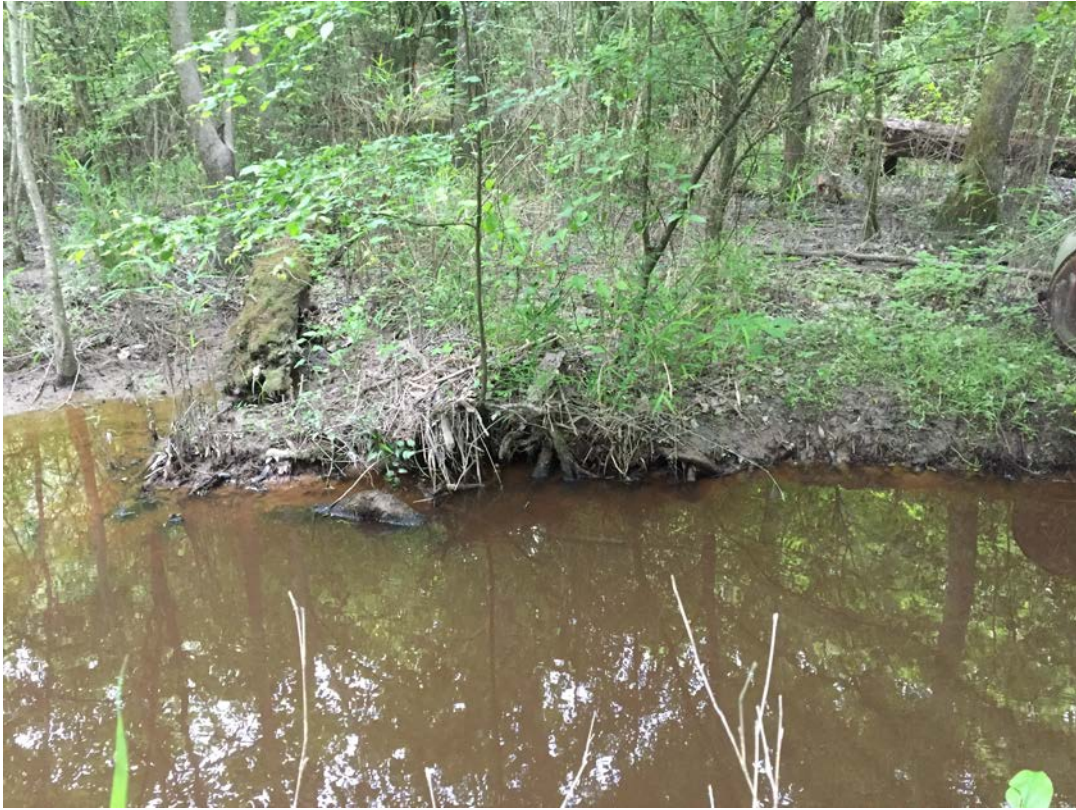
Waterbody data point ssoo017 facing east across bank.

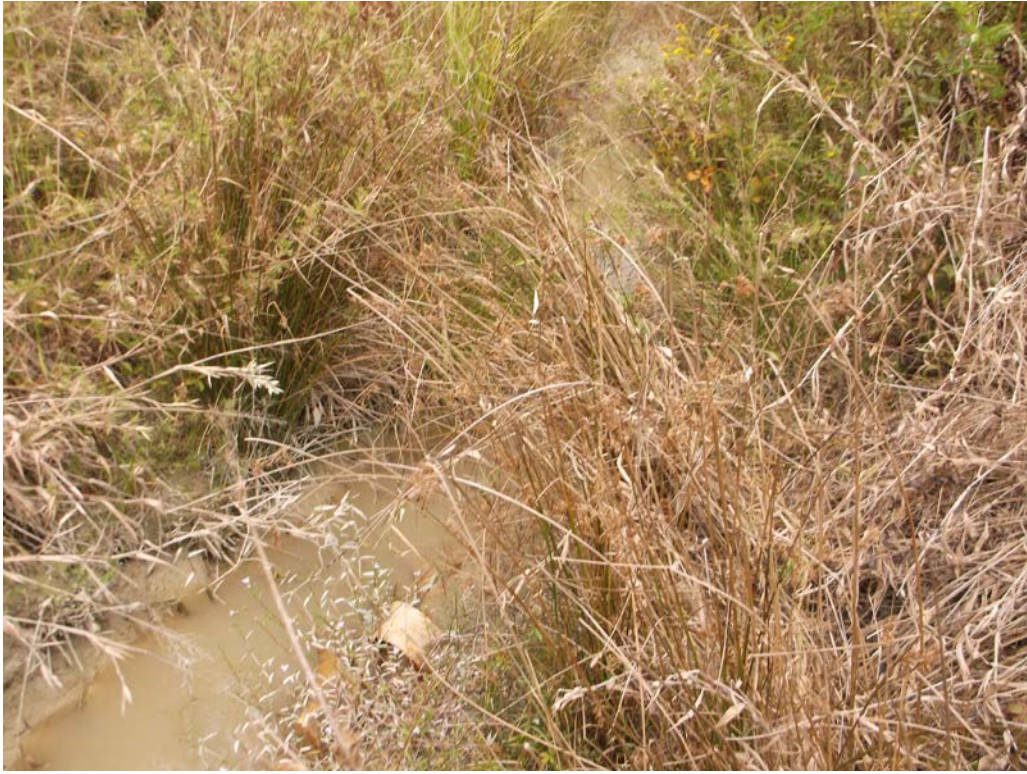
Waterbody ss0015 facing north upstream.

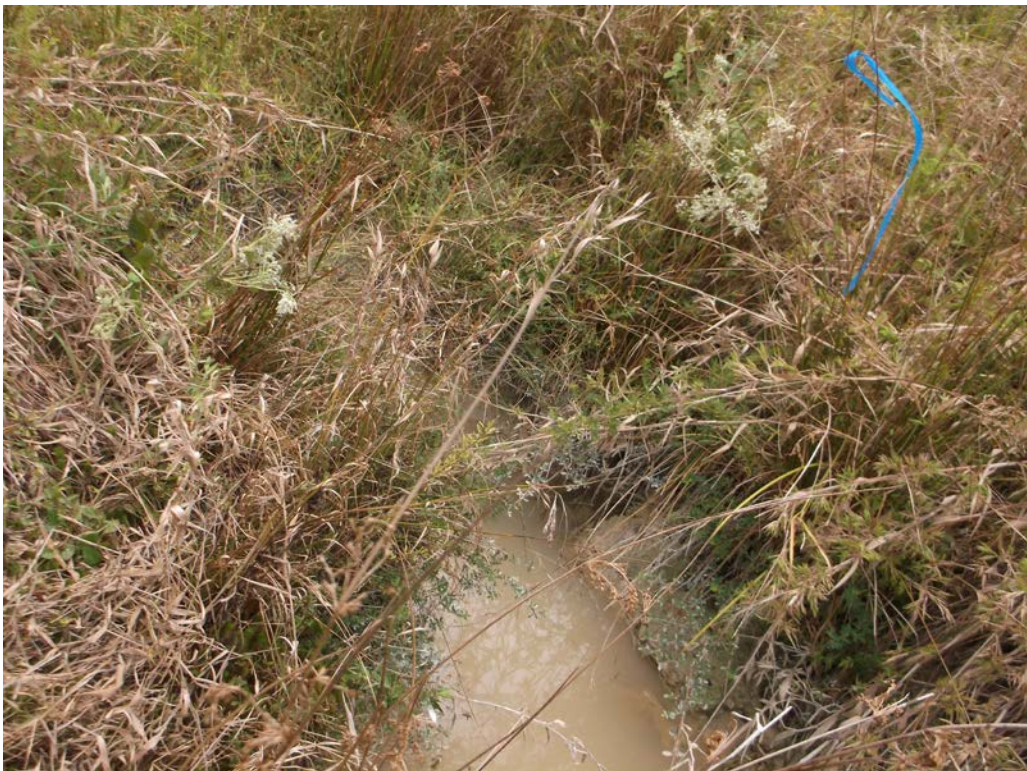
Waterbody ss0015 facing south downstream.

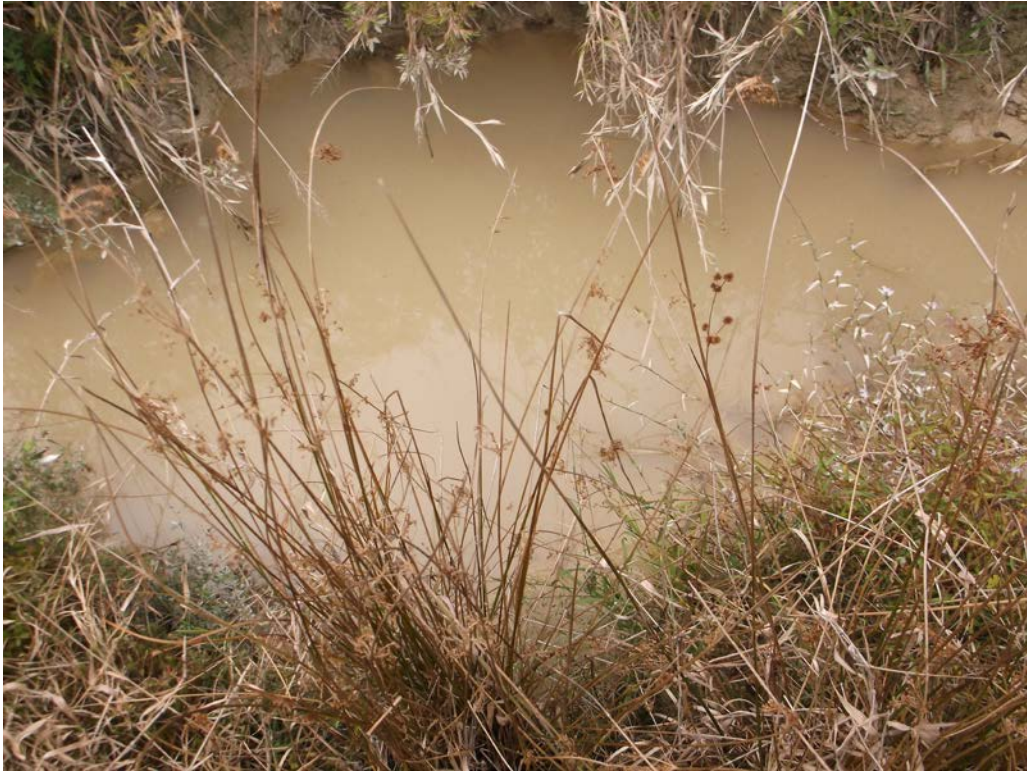
Waterbody ss0015 facing west across bank.

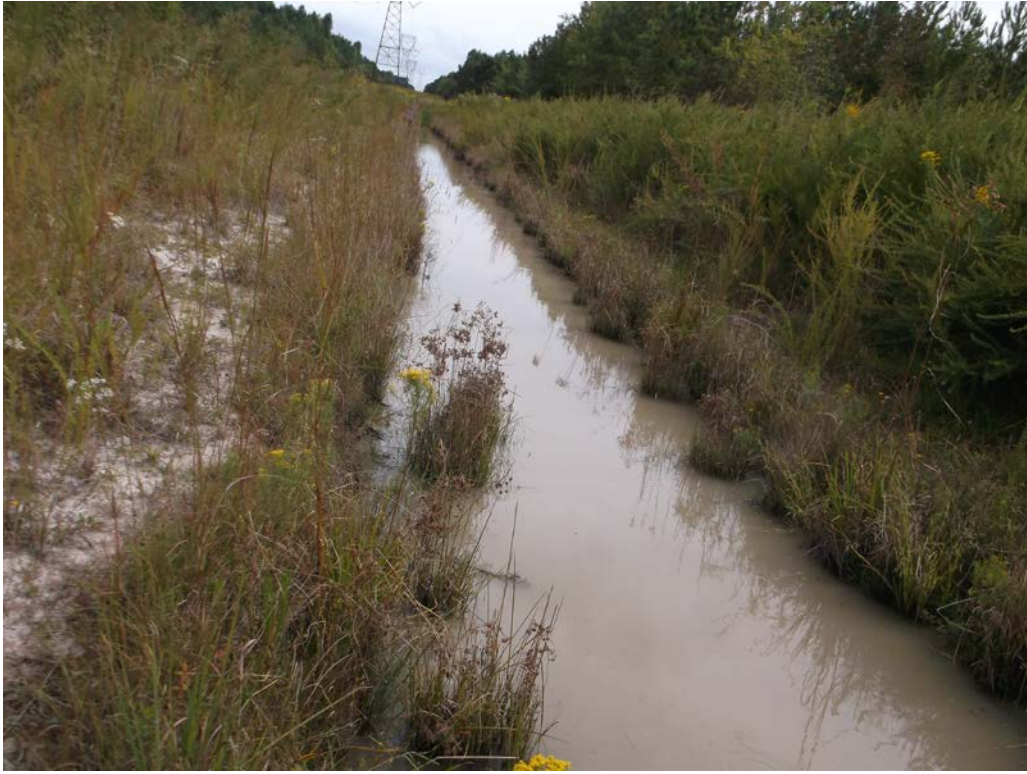
Waterbody ssoo014 facing east upstream.

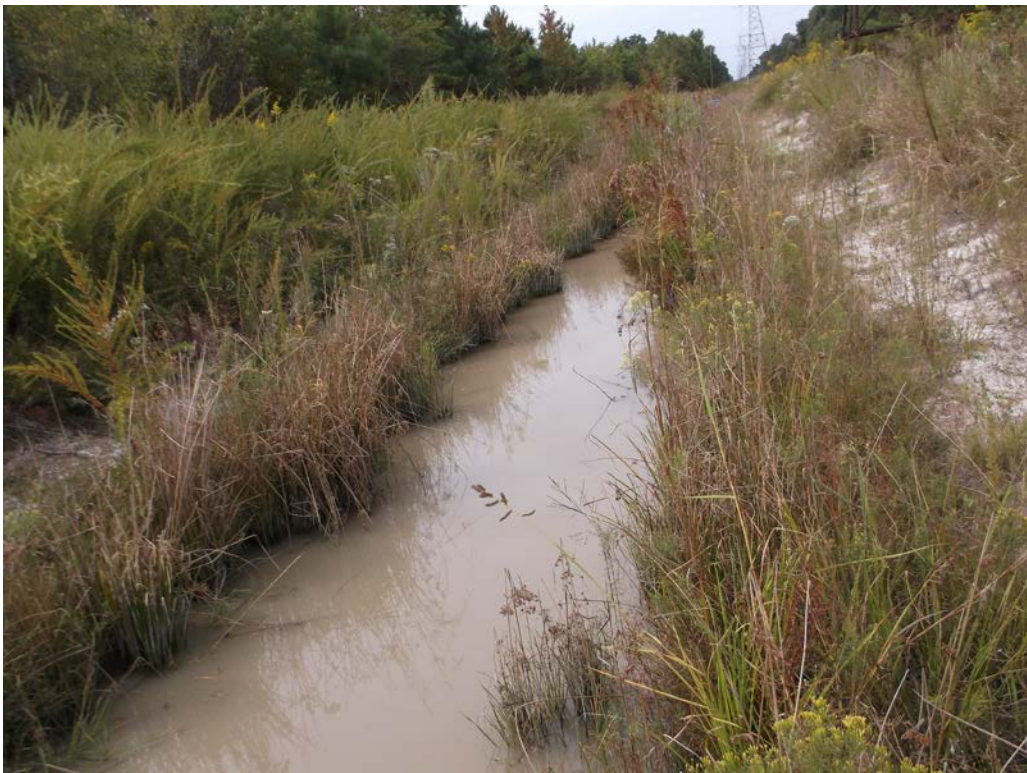
Waterbody ssoo014 facing west downstream.

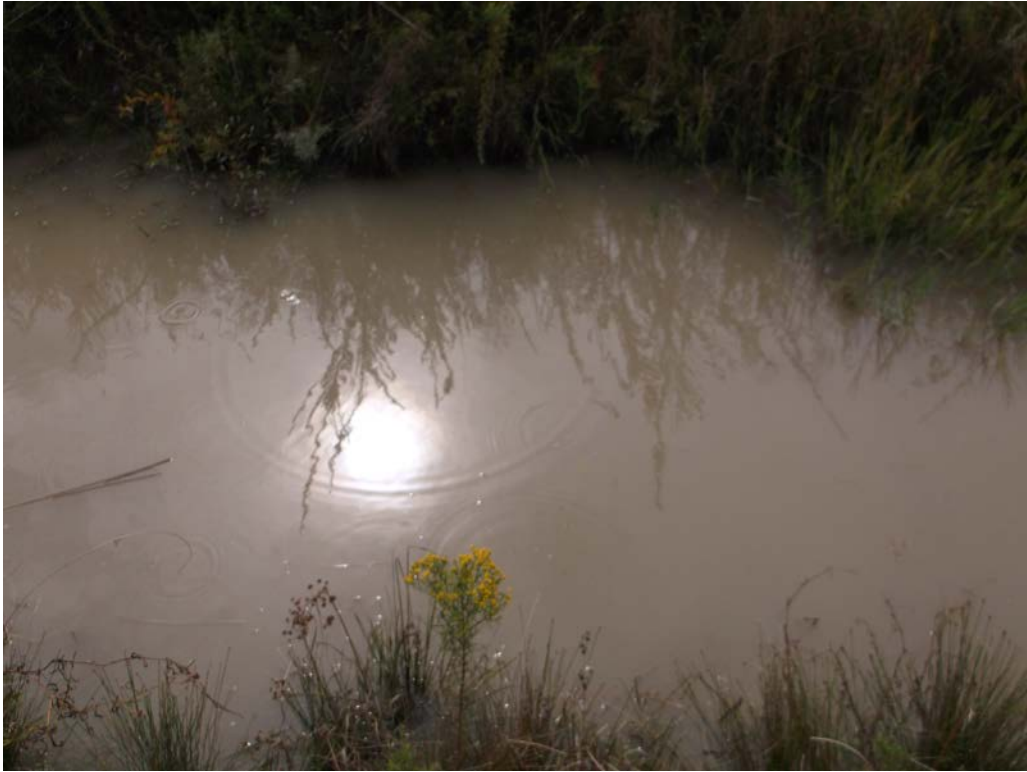
Waterbody ssoo014 facing south across bank.

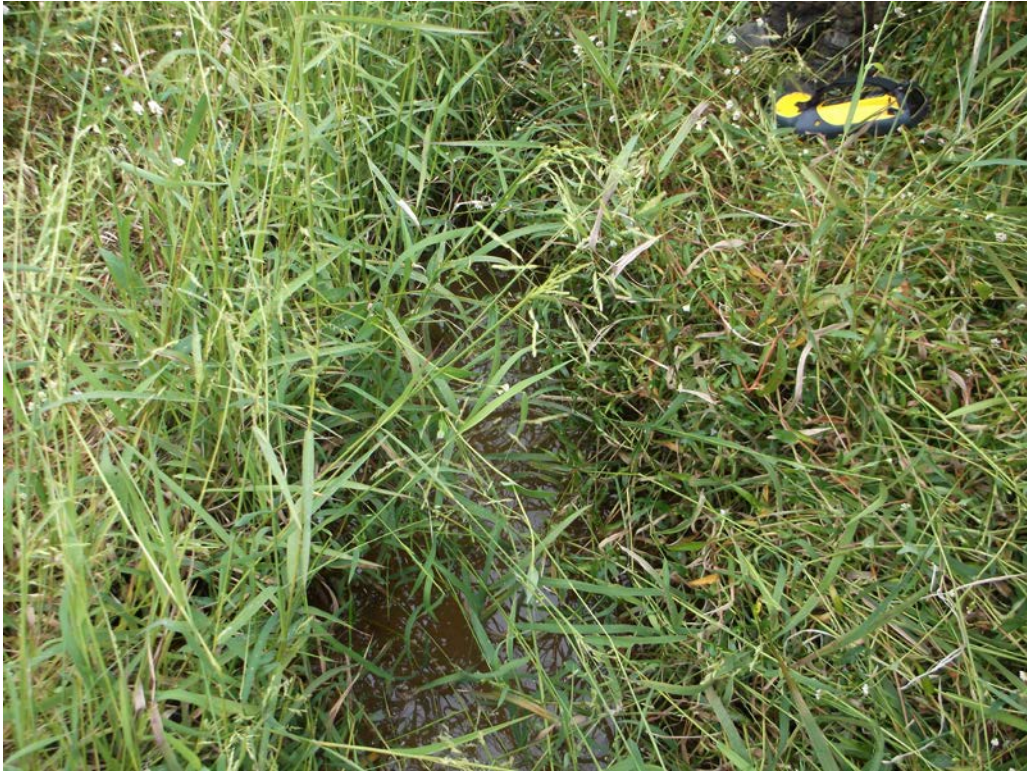
Waterbody ss0005 facing south upstream.

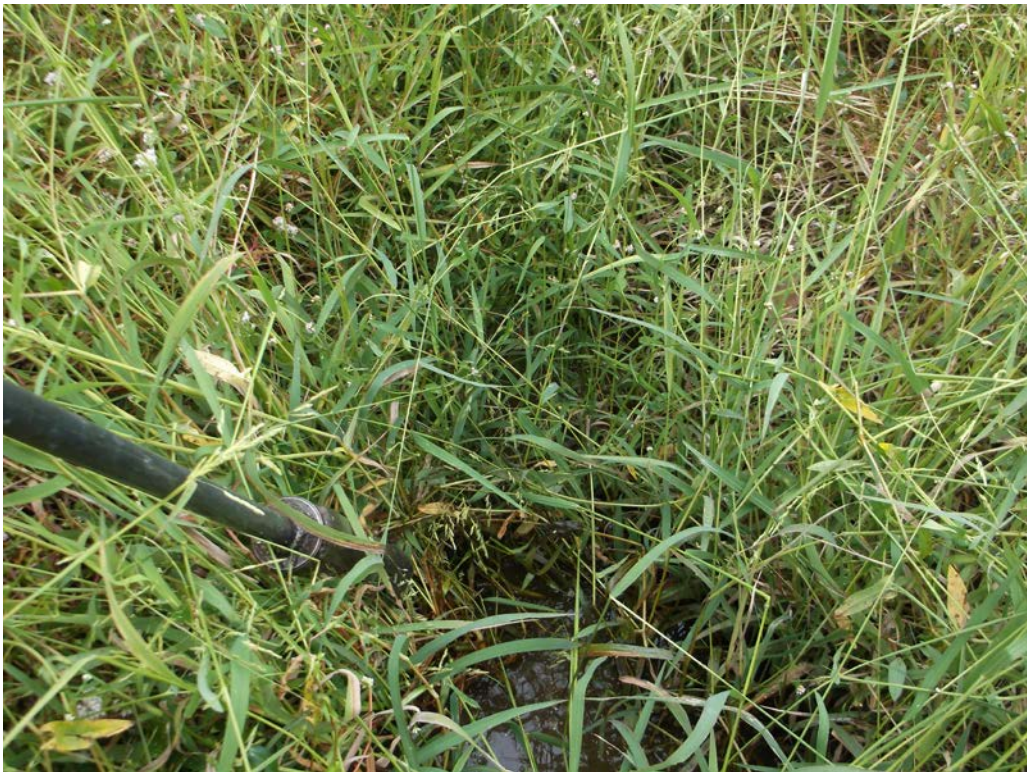
Waterbody ss0005 facing north downstream.

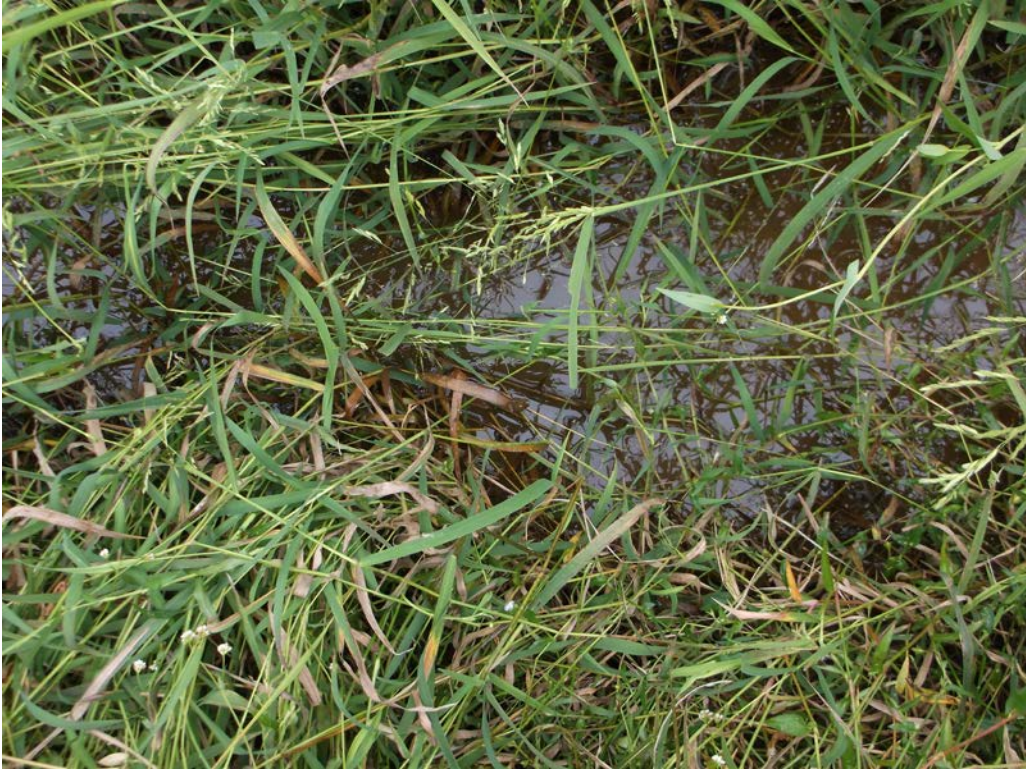
Waterbody ssoo005 facing east across bank.

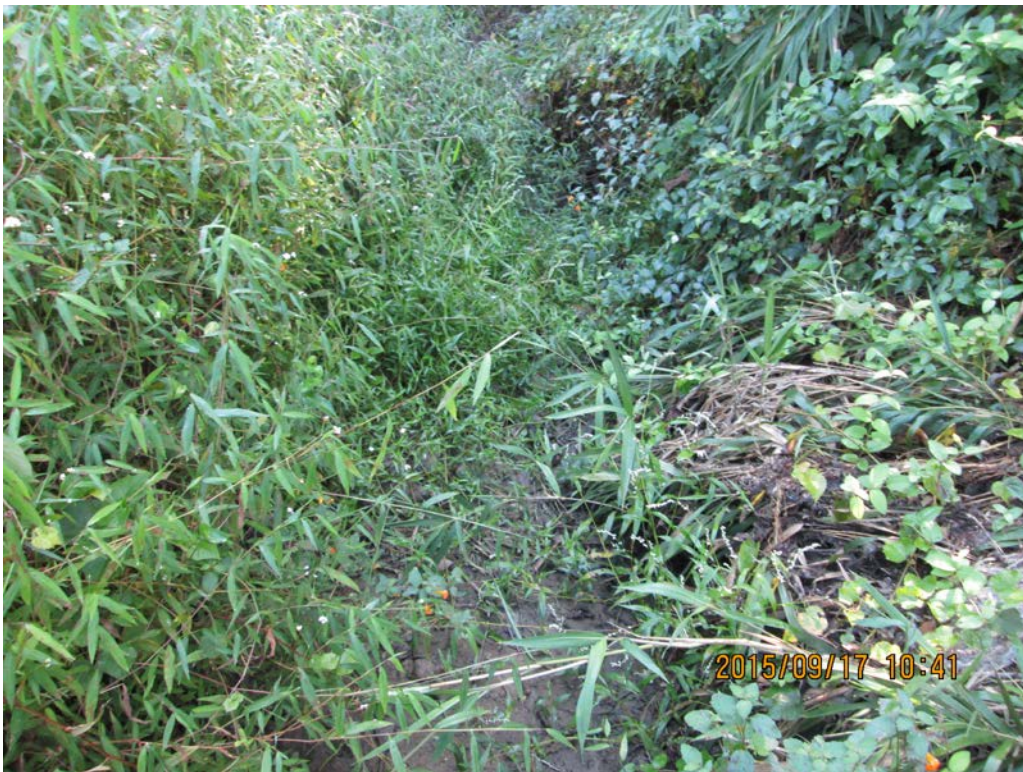
Waterbody ssop008 facing southeast downstream.

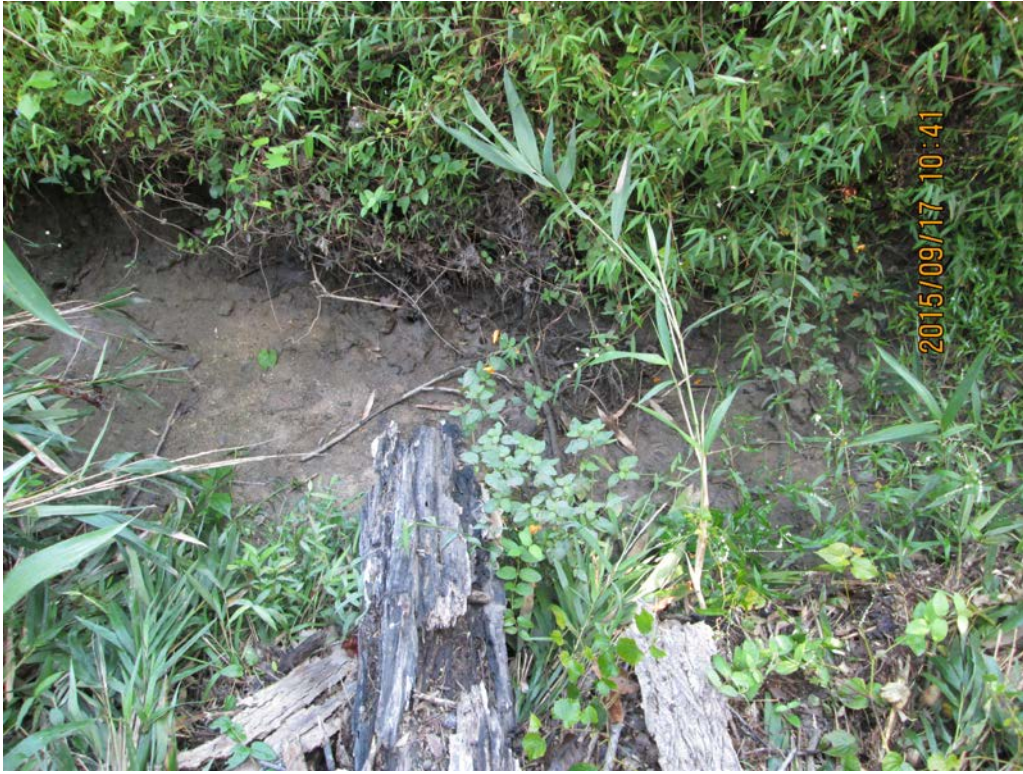
Waterbody ssop008 facing northeast across bank.

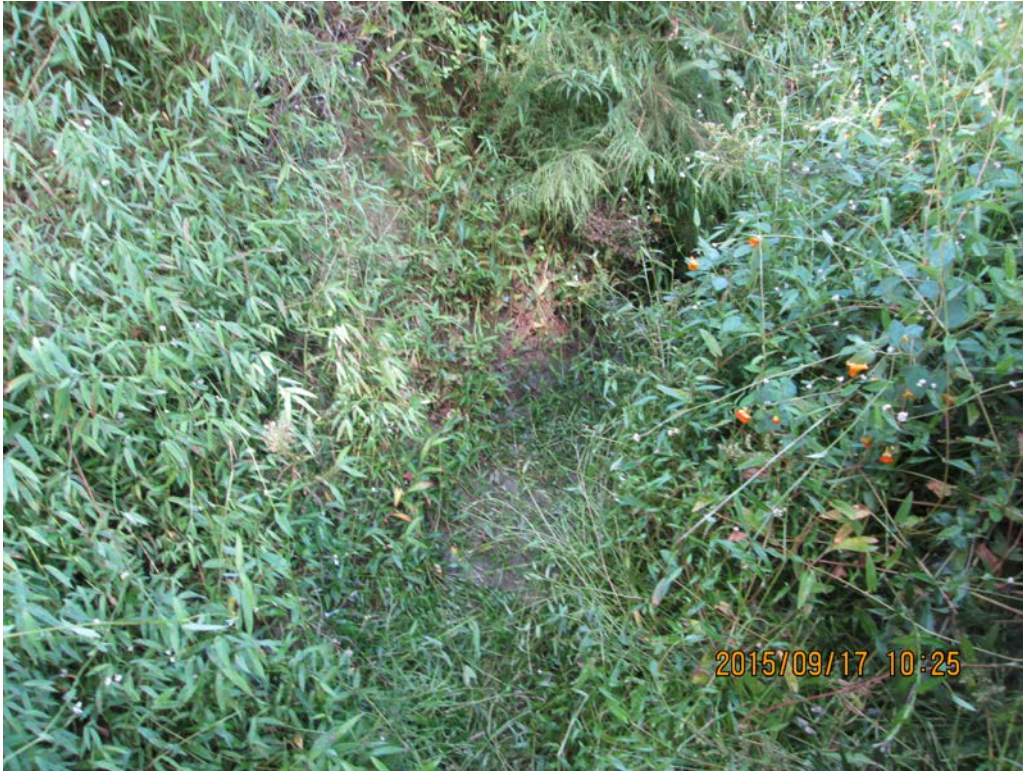
Waterbody ssop009 facing north upstream.

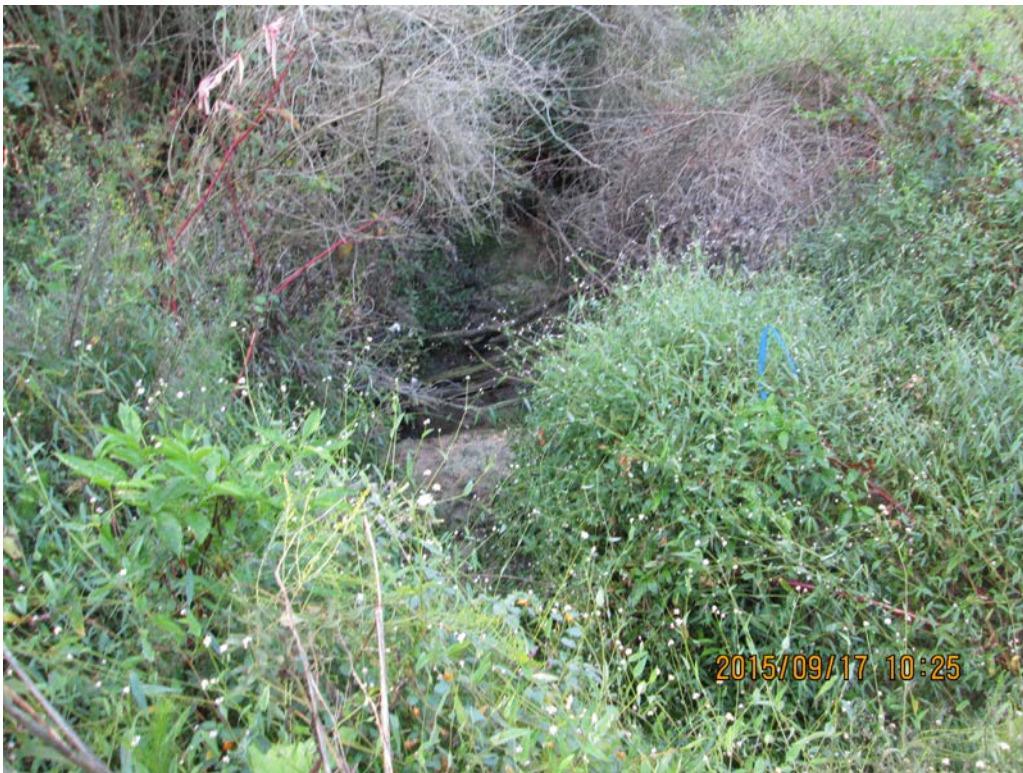
Waterbody ssop009 facing southwest downstream.

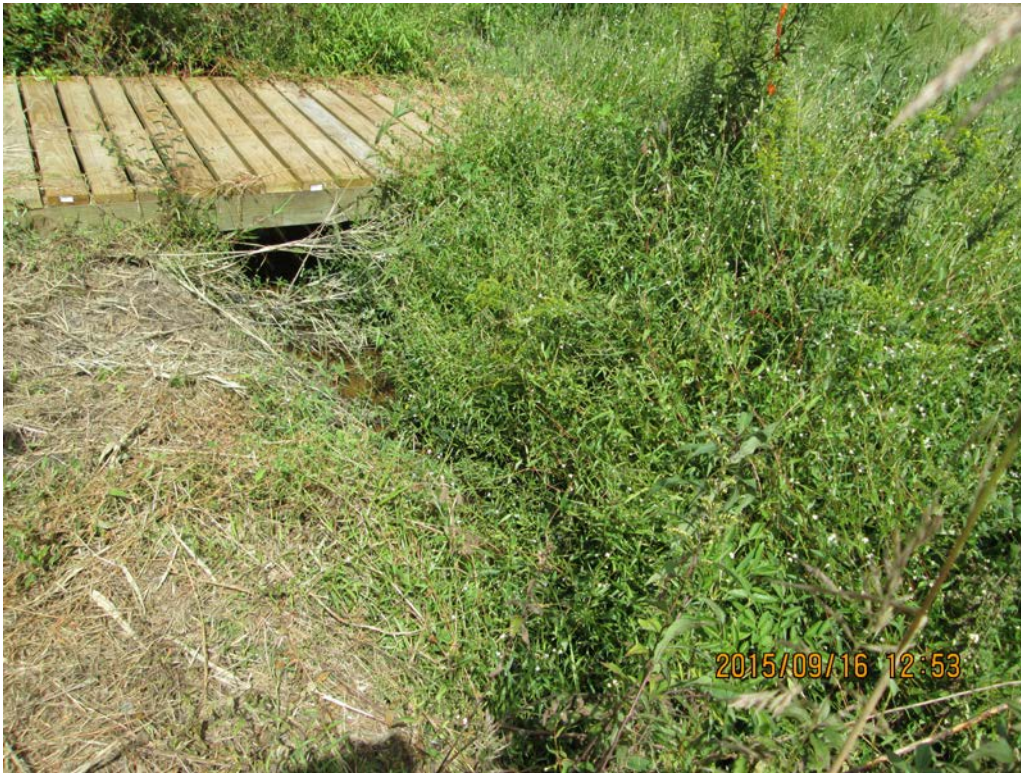
Waterbody ssop007 facing north upstream.

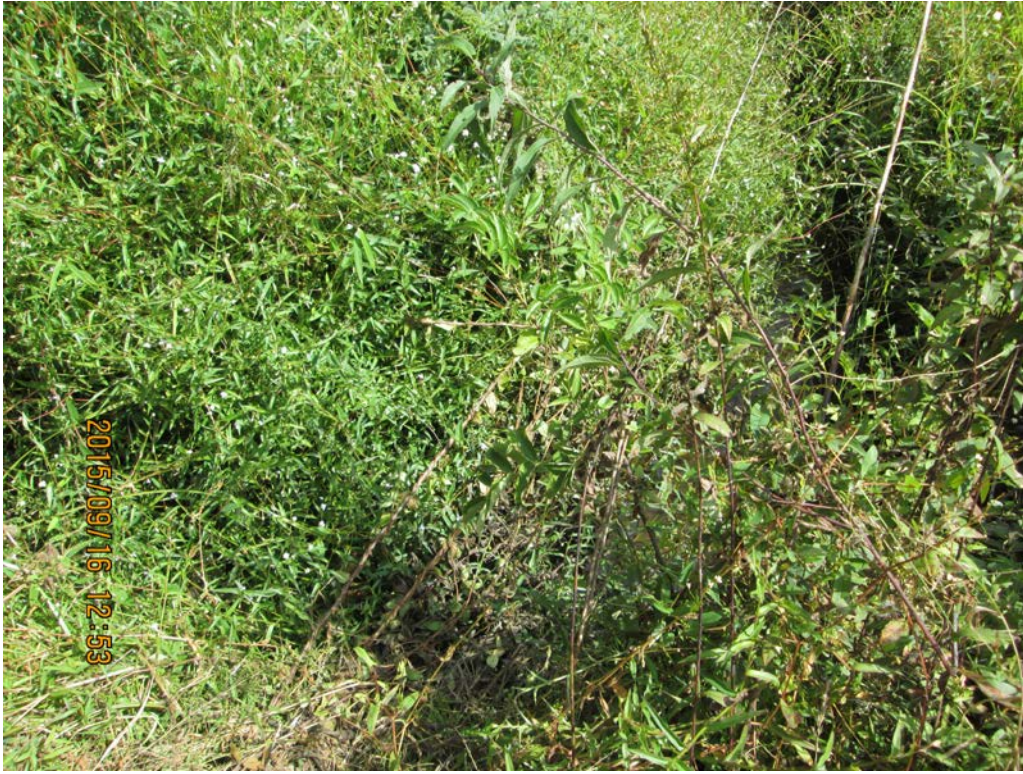
Waterbody ssop007 facing east across bank.

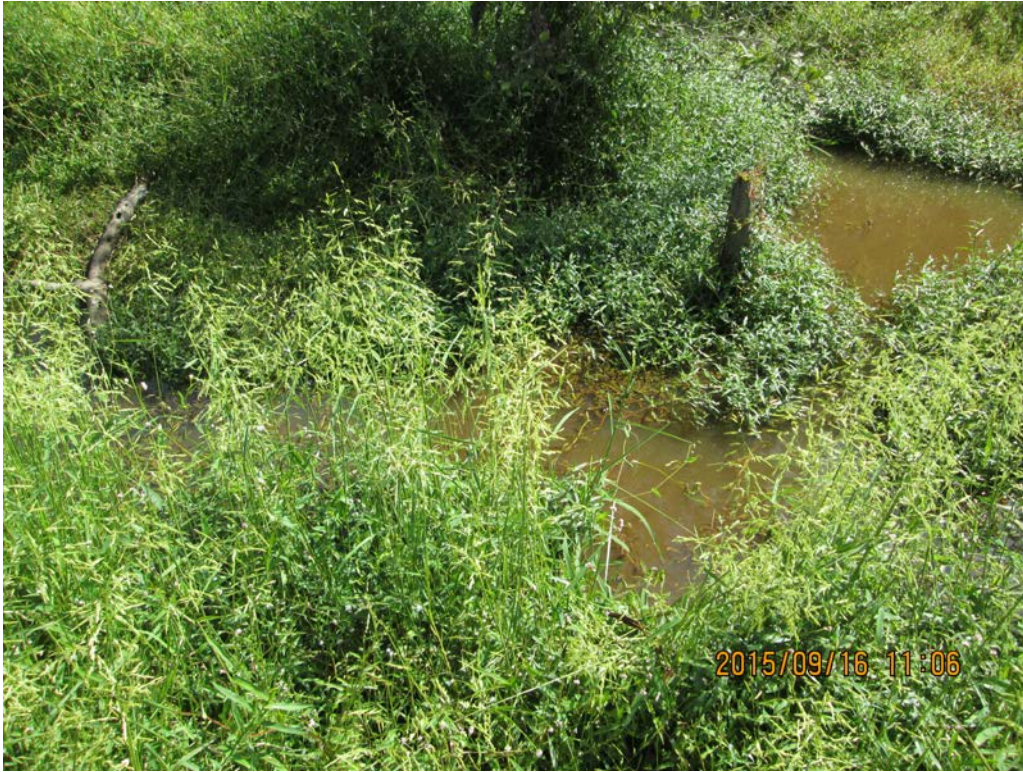
Waterbody ssop006 facing east across bank.

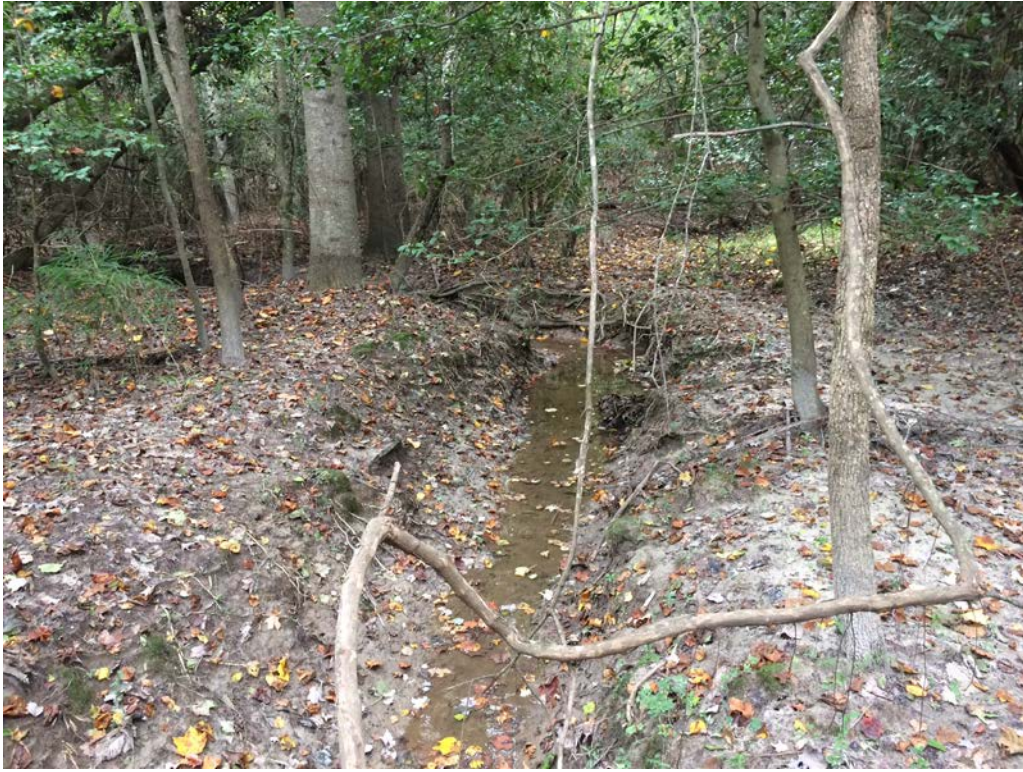
Waterbody ssoo008 facing southwest upstream.

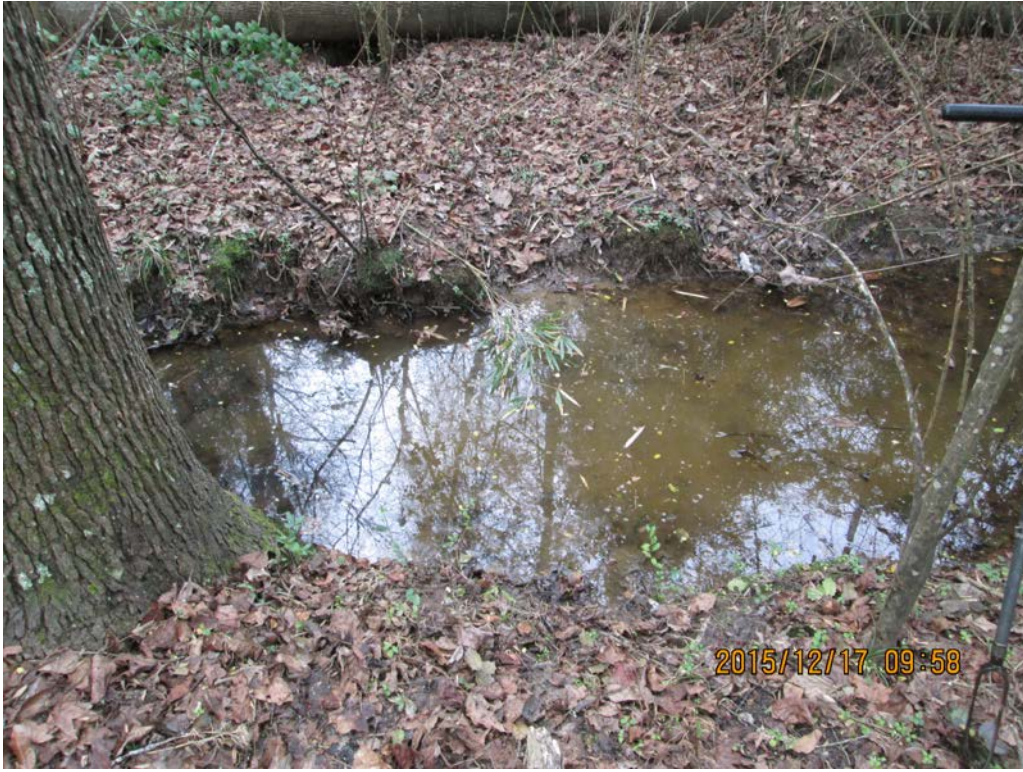
Waterbody ssoo011 facing south across bank.

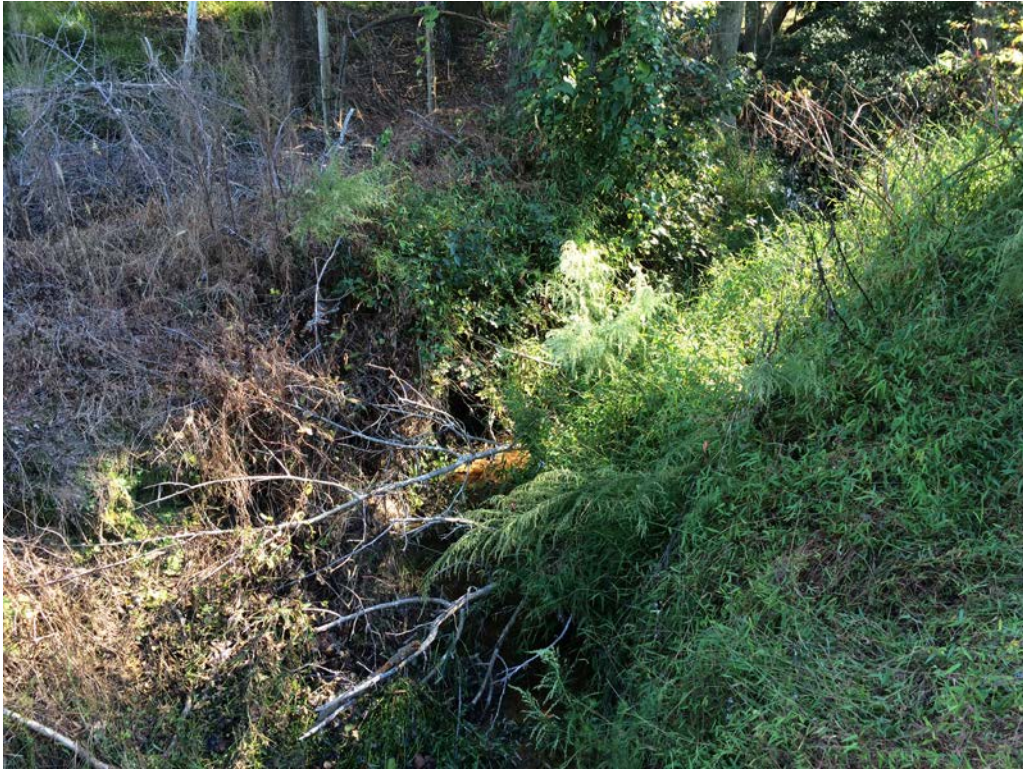
Waterbody ssoo010 facing southwest upstream.

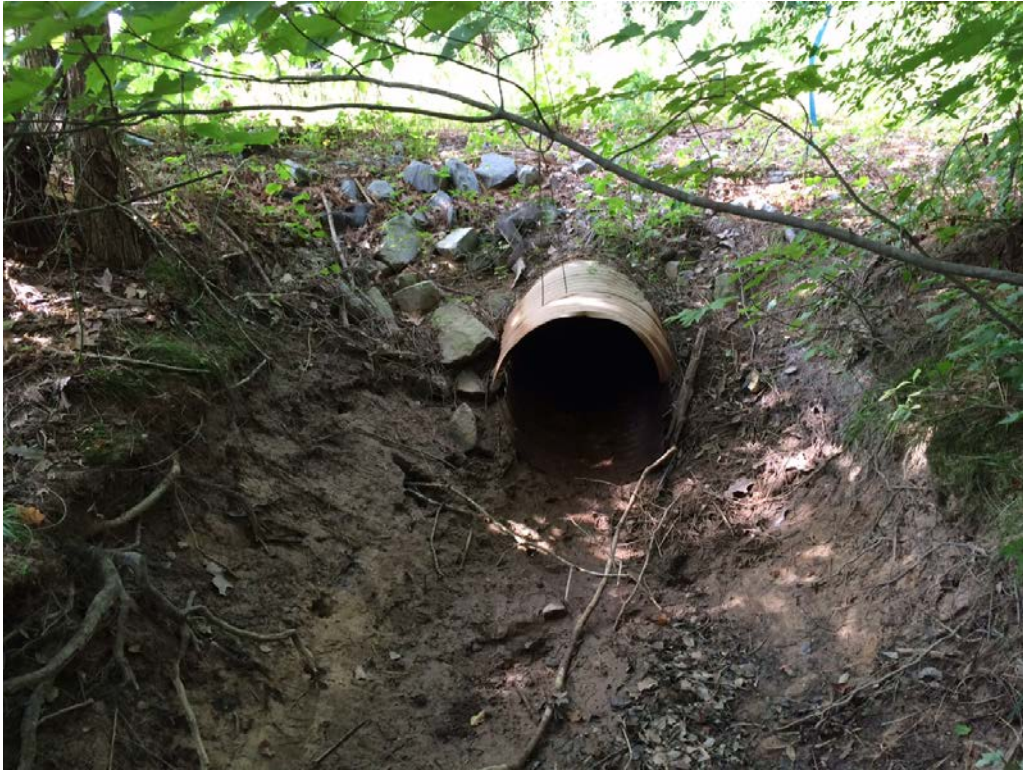
Waterbody ssoo001 facing south upstream.

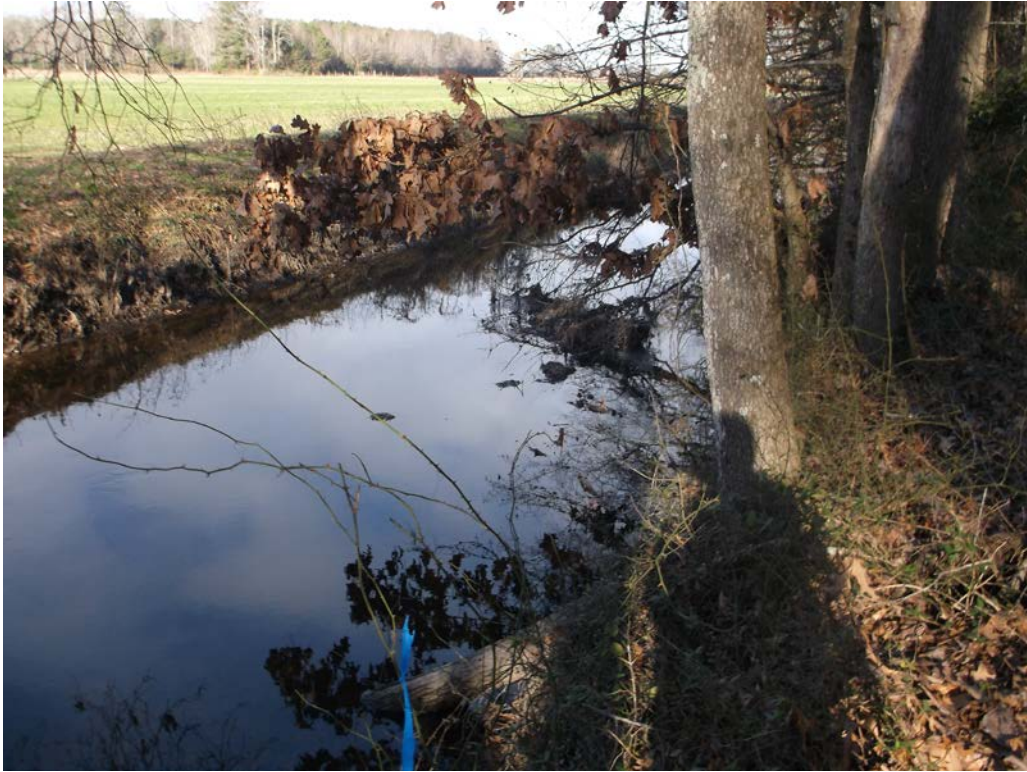
Waterbody ssoo012 facing north upstream.

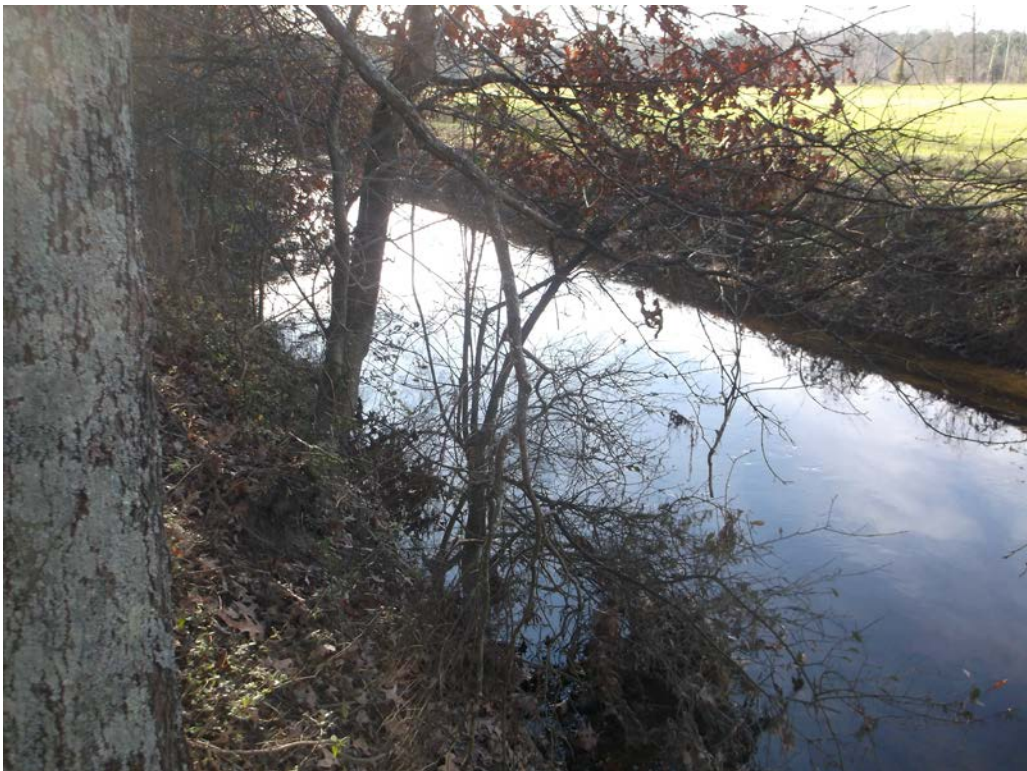
Waterbody ssoo012 facing south downstream.

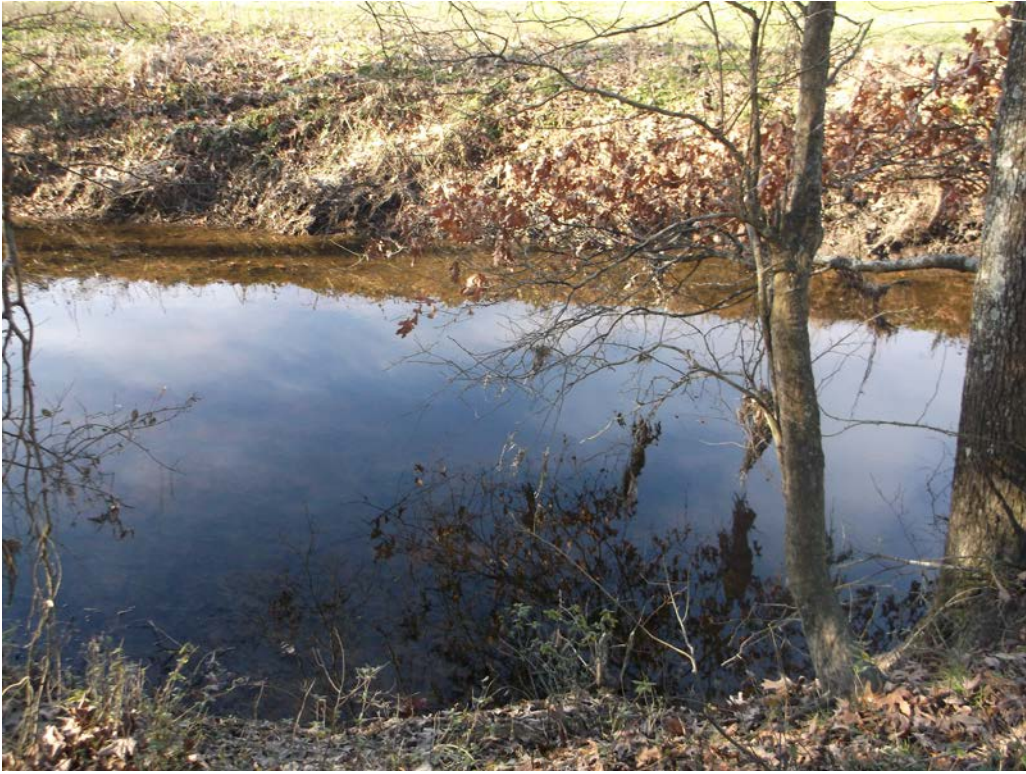
Waterbody ss0012 facing west across bank.

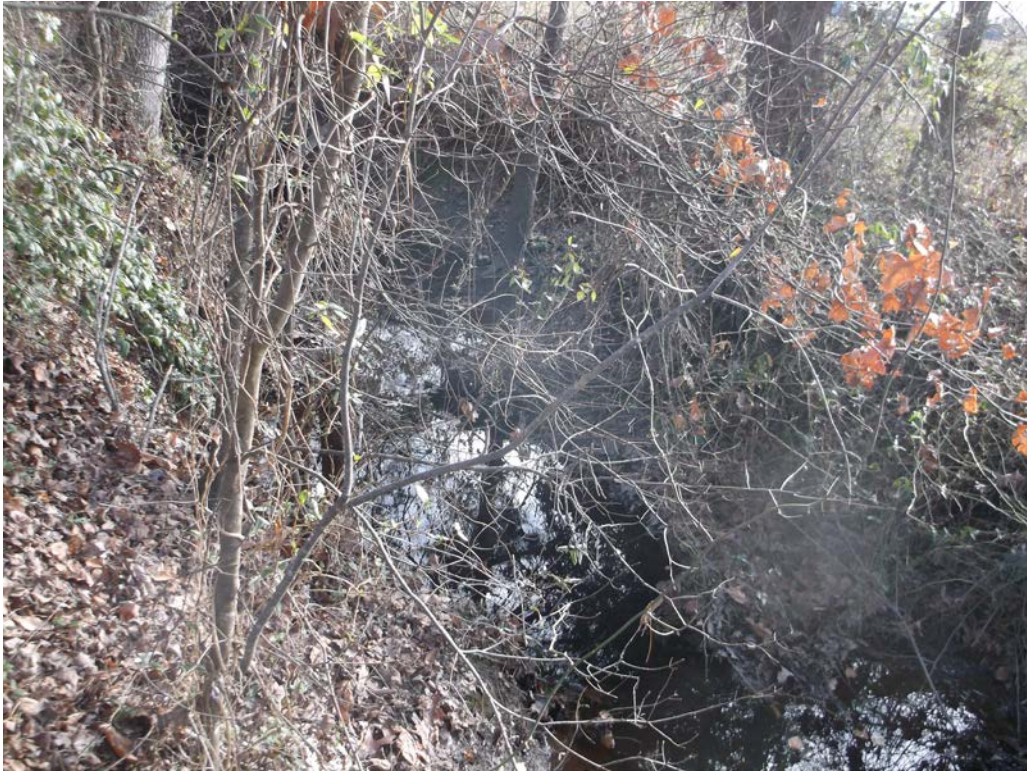
Waterbody ss0013 facing west upstream.
