Linear Waterbody Data Sheet

Survey Description				
Project Name: ACP		Waterbody Name: Unit to Meherrin River		Waterbody ID: SSDP002
State: VA		County/Parish: Southampton	Company: ESI	Date: 4/1/15
Tract Number(s): 25-001-A005, 25-001-A001, 25-001-A003		Nearest Milepost: 2.5 (new)	Crew Member Initials: LR, RT	
Survey Type: <small>(check one)</small>		Associated Wetland ID(s): WSOP001		
<input type="checkbox"/> Centerline		<input checked="" type="checkbox"/> Re-Route		
<input type="checkbox"/> Access Road		<input type="checkbox"/> Other:		
Physical Attributes				
Stream Classification: <small>(check one)</small>				
<input type="checkbox"/> Ephemeral				
<input type="checkbox"/> Intermittent				
<input checked="" type="checkbox"/> Perennial				
Waterbody Type: <small>(check one)</small>				
<input type="checkbox"/> River				
<input type="checkbox"/> Stream				
<input type="checkbox"/> Ditch				
<input checked="" type="checkbox"/> Canal

Environmental Field Surveys
Waterbody Photo Page

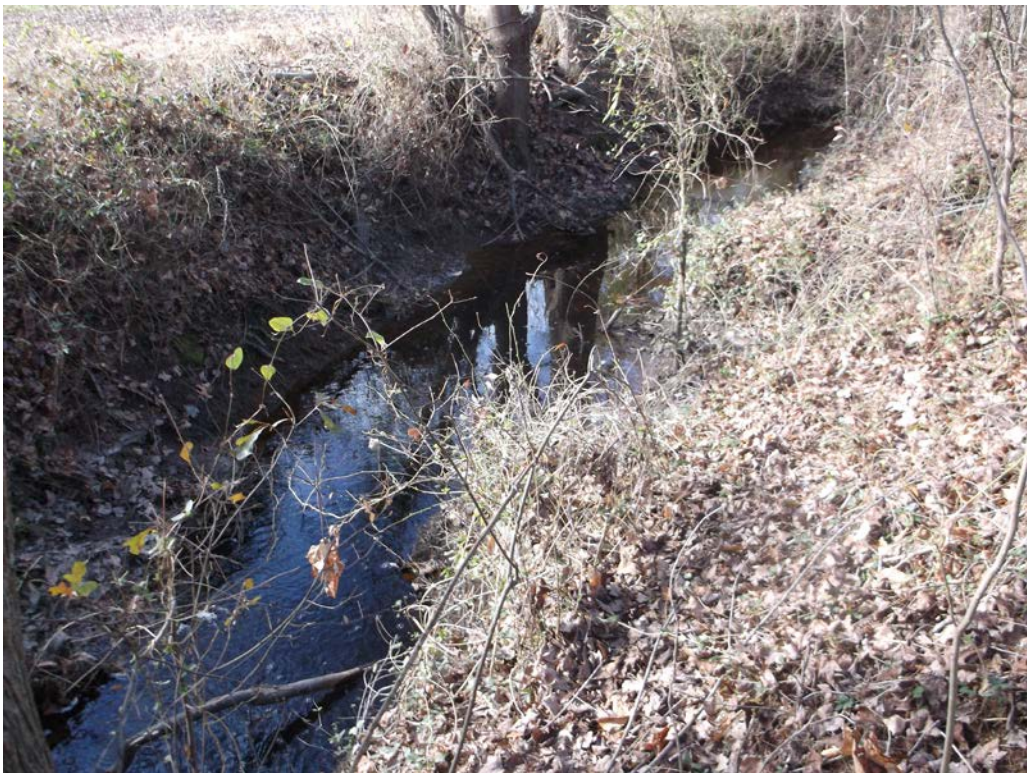
Waterbody ss0013 facing east downstream.

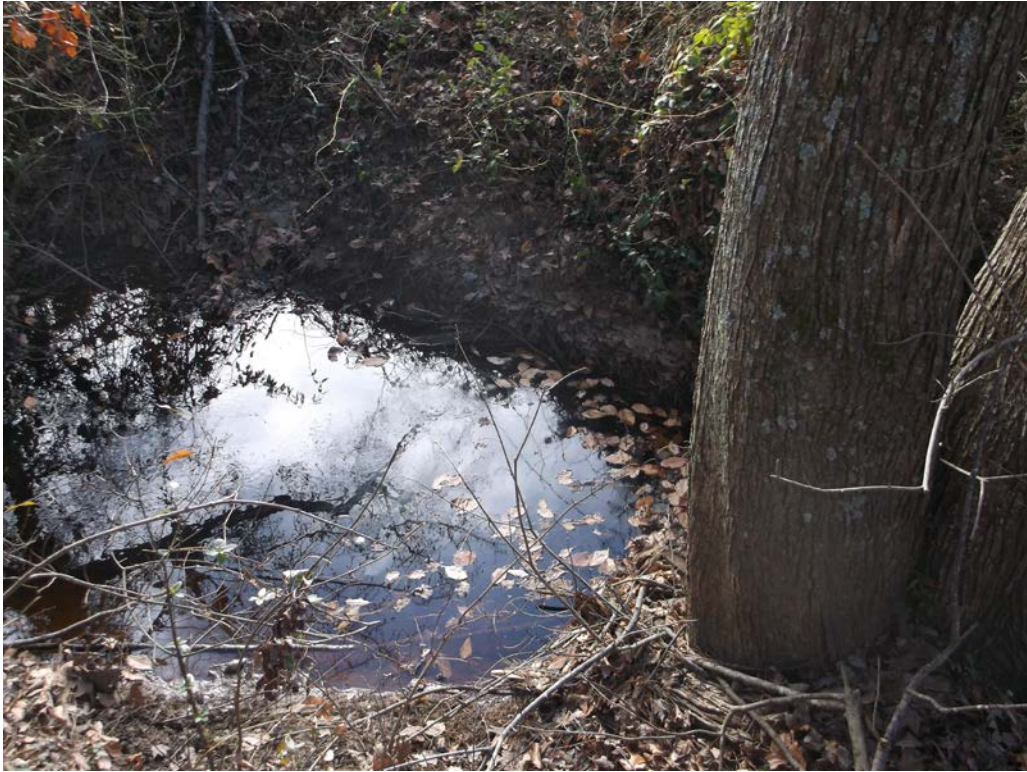
Waterbody ssoo013 facing north across bank.
