PHASE 2 - RAPID STREAM RECONNAISSANCE
Photographic Record

Client: Atlantic Coast Pipeline

Project Number: TXG0007

Subject Site: SC_0760 (Dowell's Draft at MP AP-1 117.07)

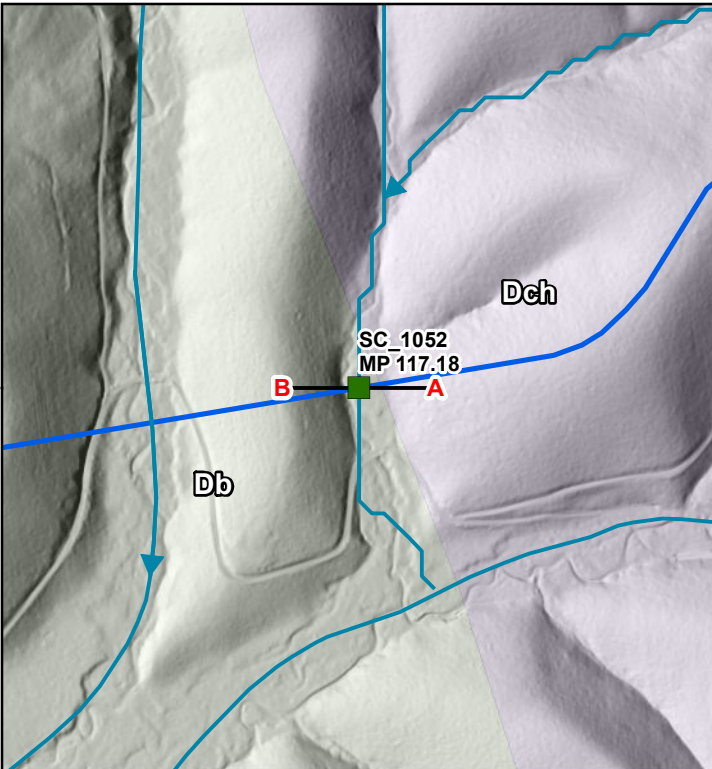
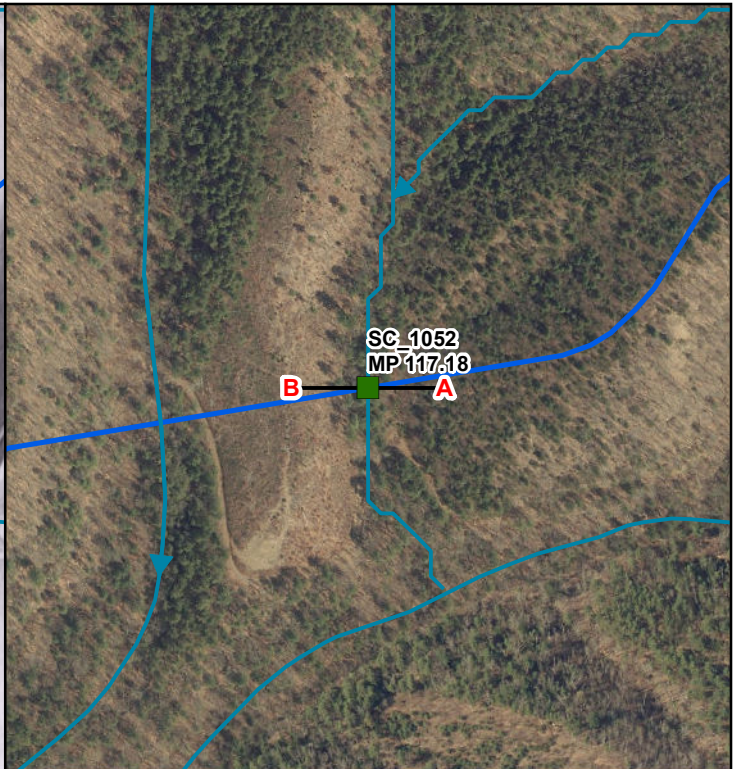
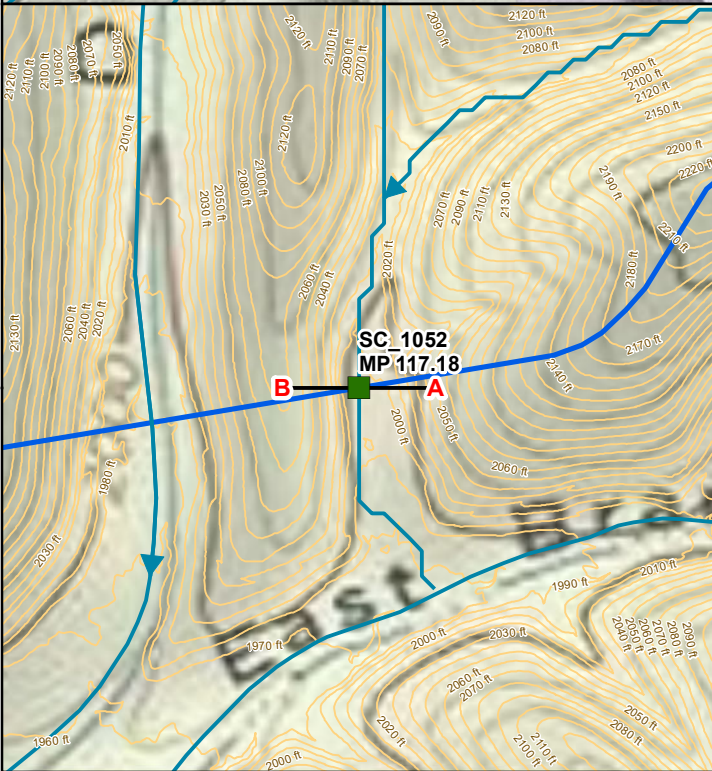
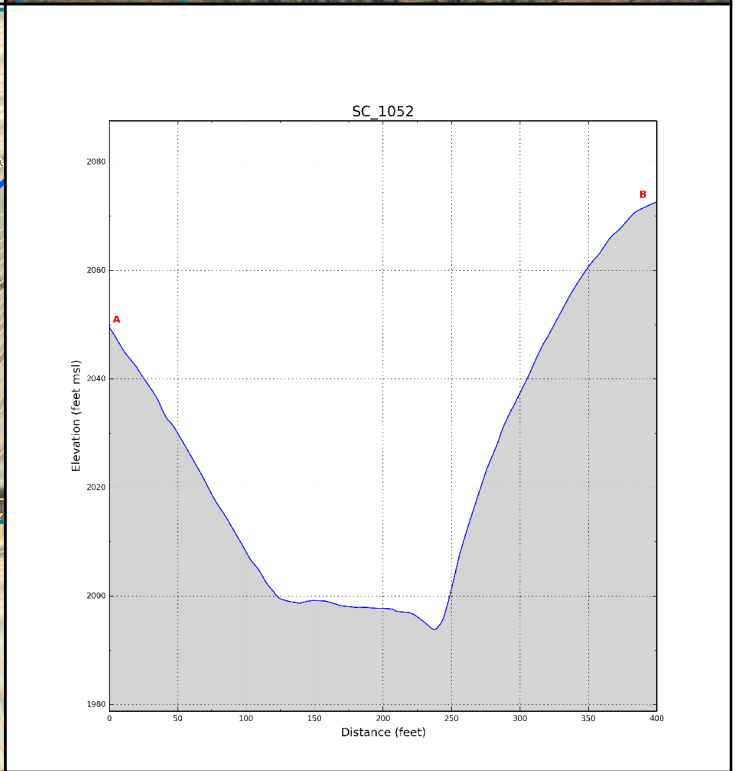
Stream Crossing Plan View and Profile

- Bankfull channel width is 8.5 feet and bankfull depth is 1.16 feet.
- Stream is confined on the right bank by steep slope with rock outcrop with strike and dip of N25°W 22°.
- Stream is laterally stable. No significant indicators of lateral mobility towards the left bank where the floodplain is comprised of several alluvial terraces.
- Pipeline crossing located upstream of a forest road culvert crossing.
- Stream located in a mixed deciduous and coniferous forest.
- Narrow valley with active floodplain approximately 54 feet wide.
- Additional information on stream crossing is available on stream reconnaissance form.

Given debris flow hazard, it is recommended to bury pipeline into bedrock with at least 1.5-foot of cover above the crown from valley wall to valley wall.

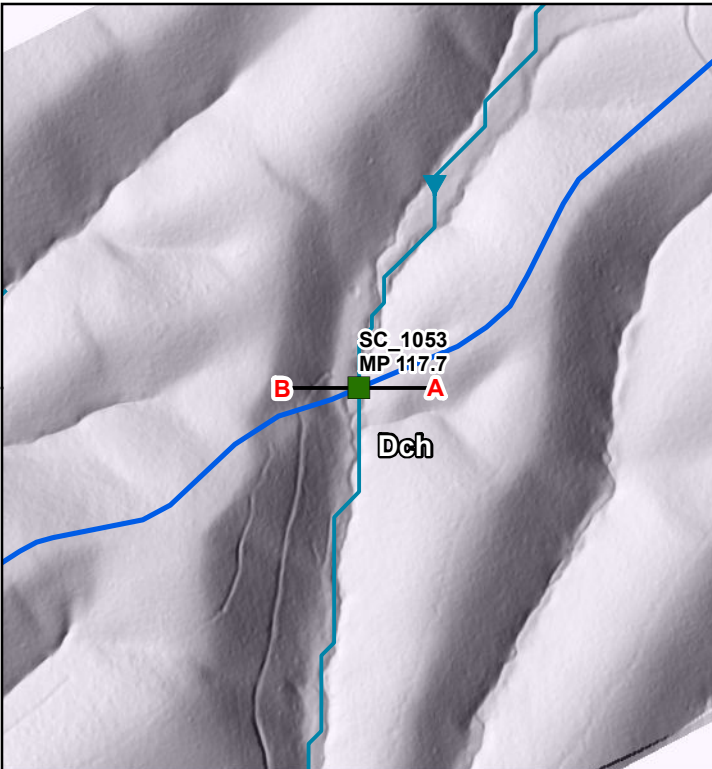
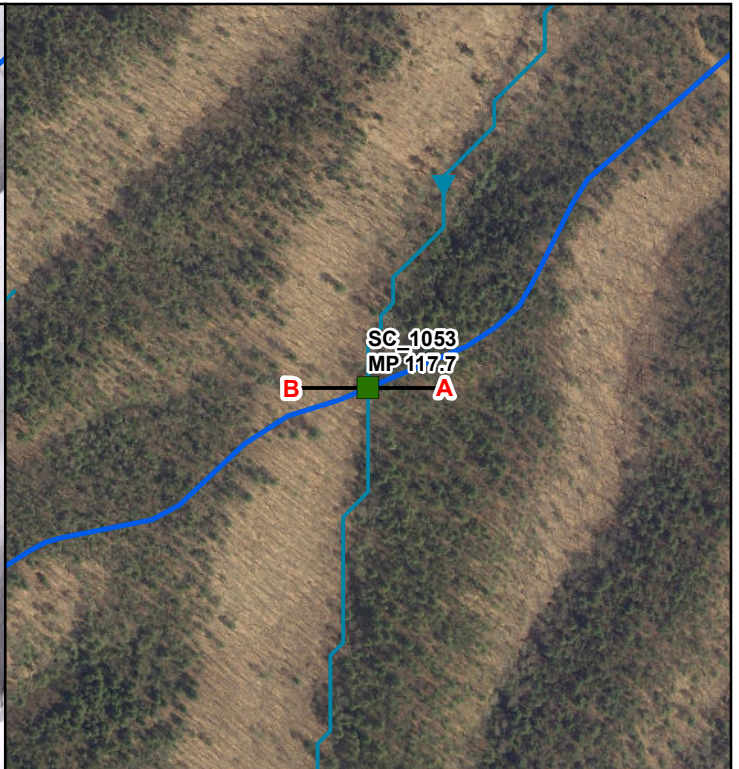
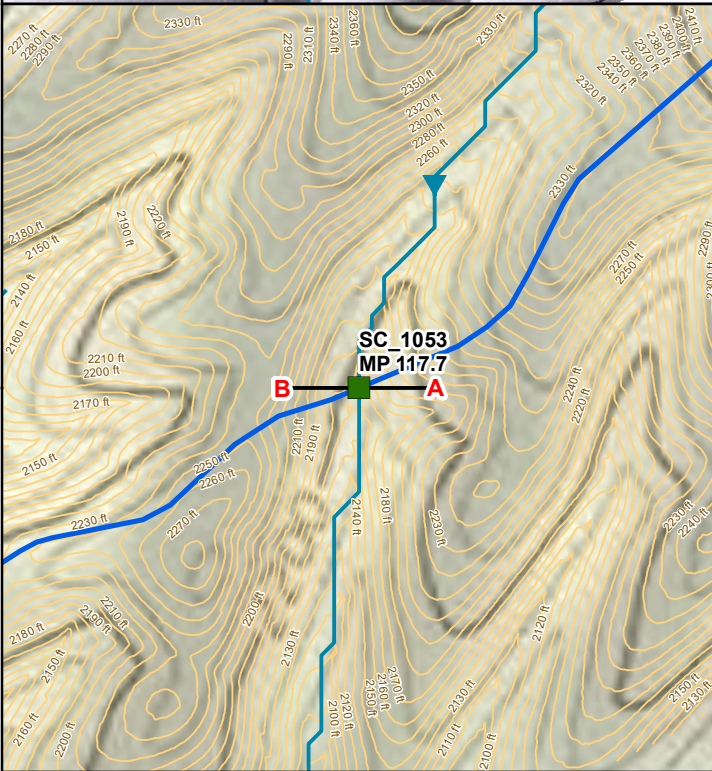
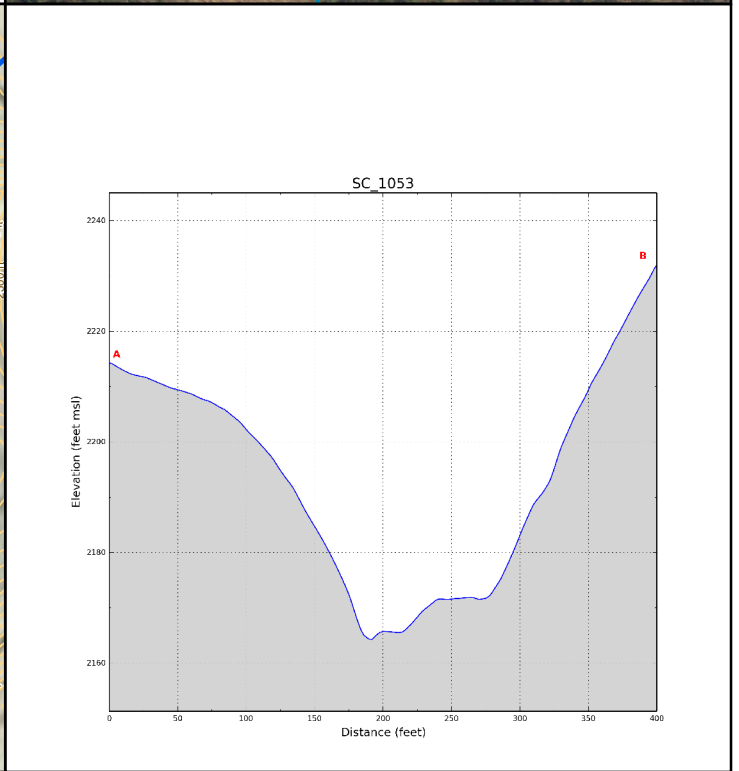
Stream Crossing Plan View and Profile

- Stream is located within a narrow, colluvial valley (51-feet wide) that is densely forested.
- Bankfull channel width is 4 feet and bankfull channel depth is 0.65 feet.
- Stream is confined on the left bank by a steep slope with the floodplain beyond the right bank with evidence of past mass sediment movements.
- Sections of stream flow go sub-surface downstream of the crossing.
- Belt width of channel is approximately 40 feet.
- Relatively steep longitudinal channel slope estimated in the field at 2.78%.
- Rock outcrop identified approximately 50 feet upstream of pipeline crossing where the stream is cascading over the bedrock(see photo log).
- Stream bed comprised of angular to sub-angular cobble and gravel-sized particles where bedrock is not outcropping.
- Additional information on stream crossing is available on stream reconnaissance form.

Given debris flow hazard, it is recommended to bury pipeline into bedrock with at least 1.5-foot of cover above the crown from valley wall to valley wall.

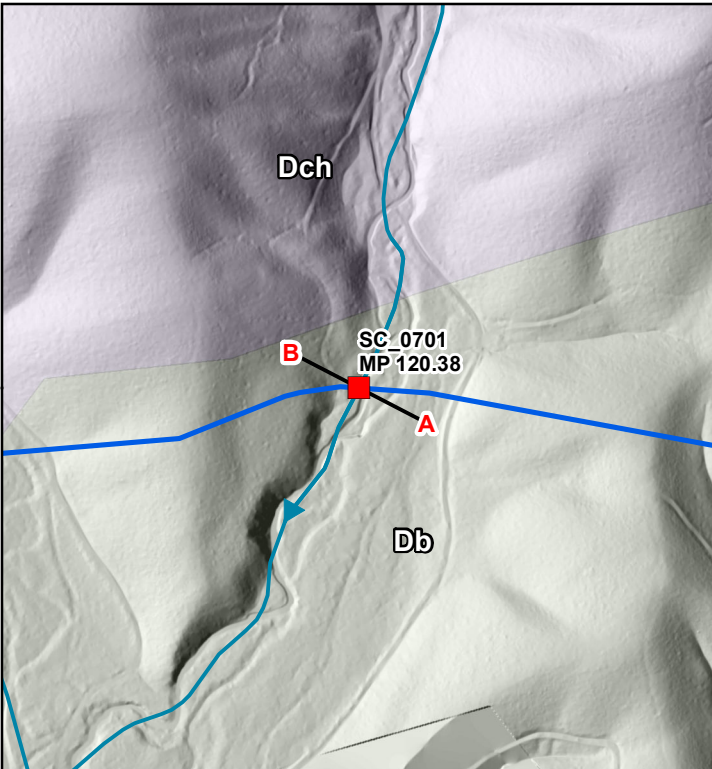
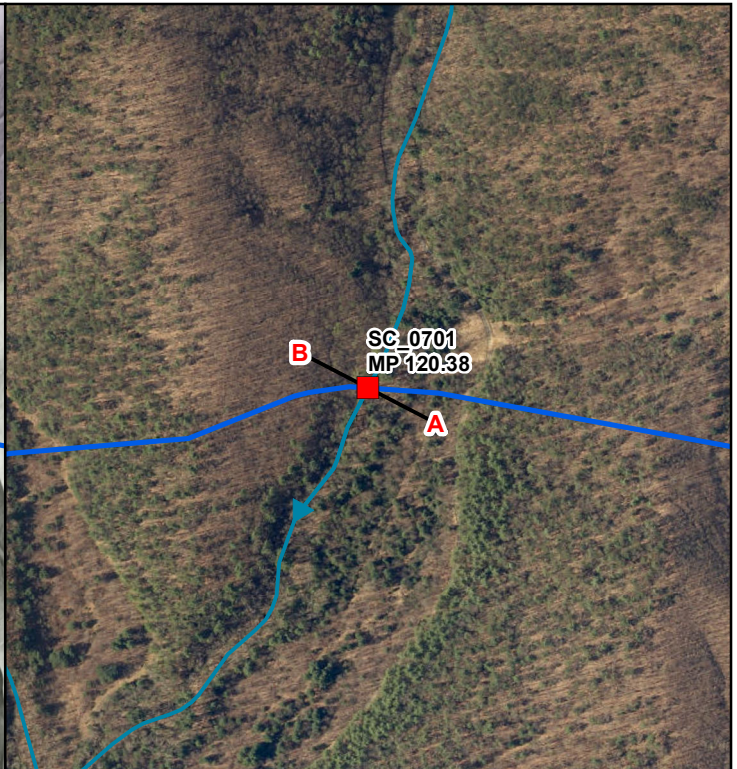
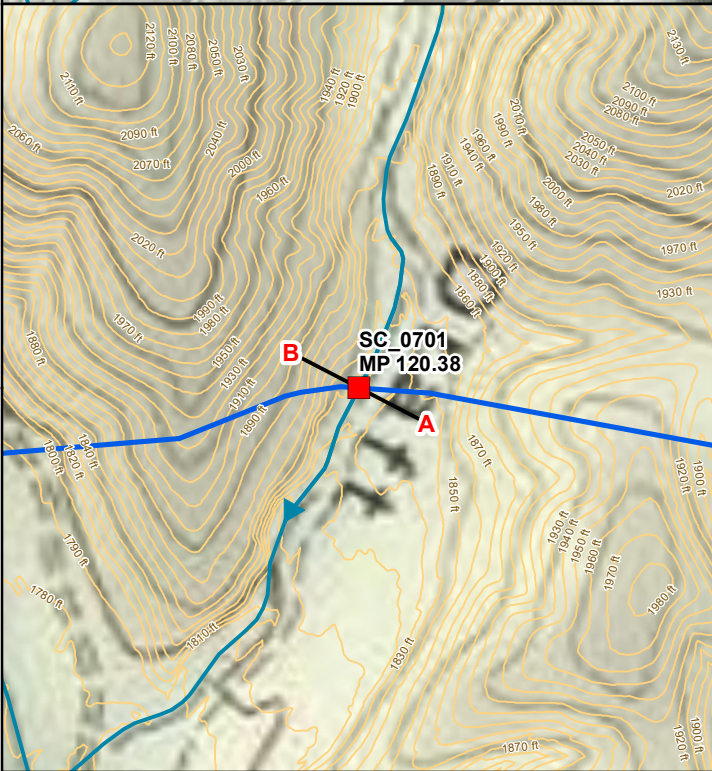
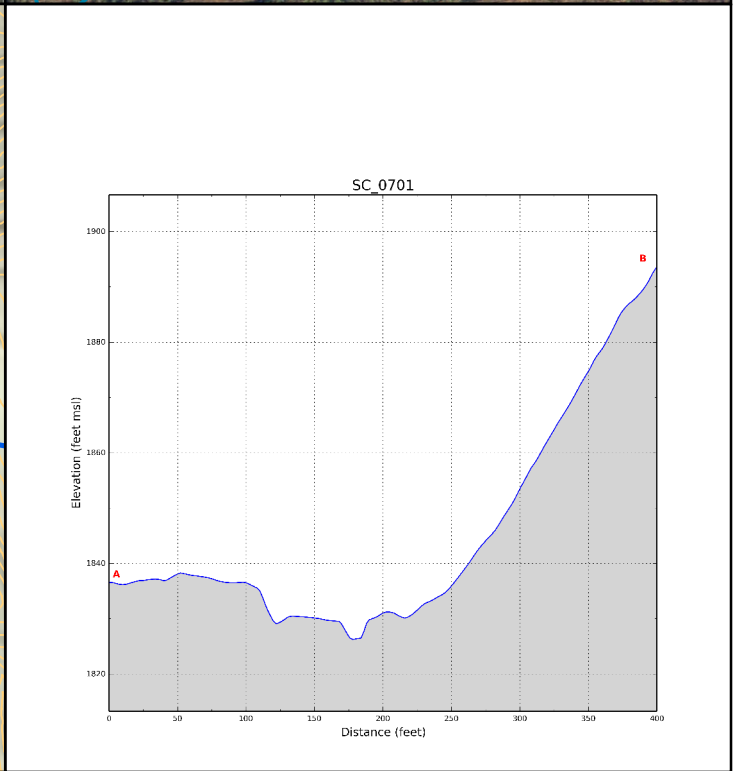
- Stream is located within a densely forested valley.
- Step-pool stream morphology that is showing signs of geomorphic lateral and vertical instability.
- Bankfull channel width is 12.6 feet and bankfull channel depth is 0.86 feet.
- Stream bed comprised of sub-angular to sub-rounded boulder and cobble-sized particles.
- Signs of debris flow including large downed trees, upstream braiding.
- Bedrock outcrop identified approximately 170 feet downstream of pipeline crossing (S80°W 51°).
- Pebble count not conducted due to high hazard and recommendation for bedrock burial.
- The left bank has been extensively eroded about 30 yards downstream with steep, near vertical, banks between 10 and 15 feet high.
 - Top of bank height is approximately 2.5 feet in vicinity of crossing.
- Additional information on stream crossing is available on stream reconnaissance form.

Given debris flow hazard, it is recommended to bury pipeline into bedrock with at least 1.5-foot of cover above the crown from valley wall beyond right bank to valley wall beyond left bank.

Geotechnical investigation to determine depth to bedrock at stream crossing is required (or crossing can be moved 170 ft downstream where bedrock was observed).

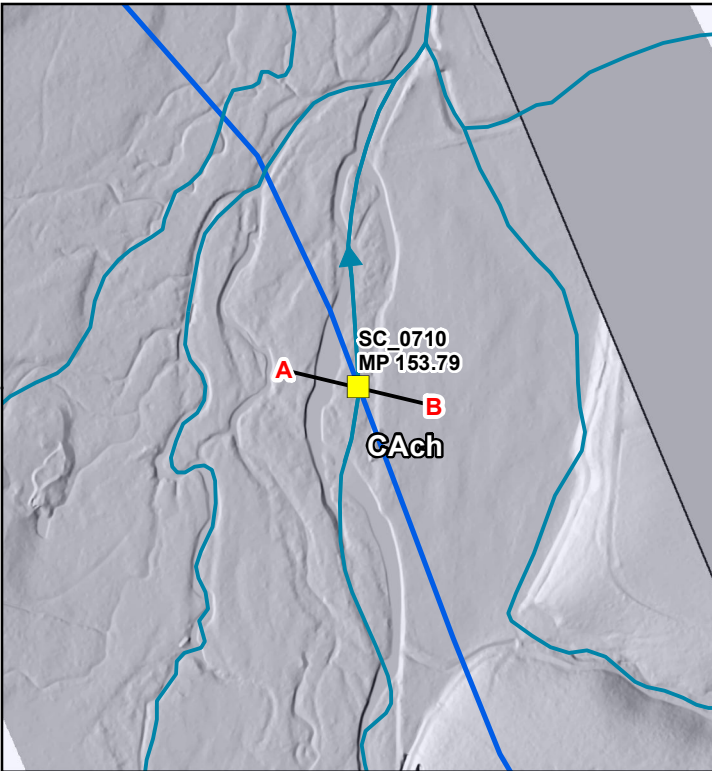
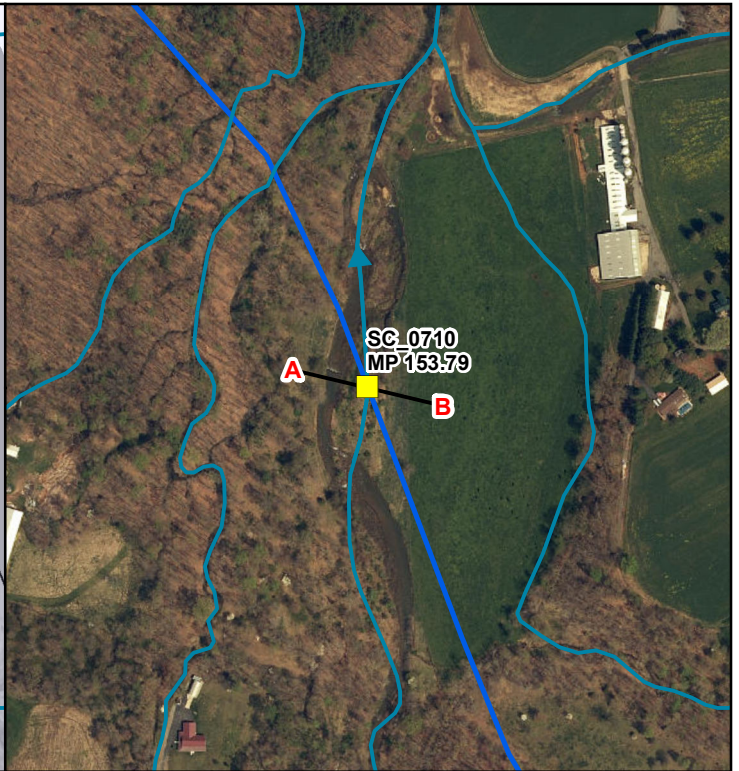
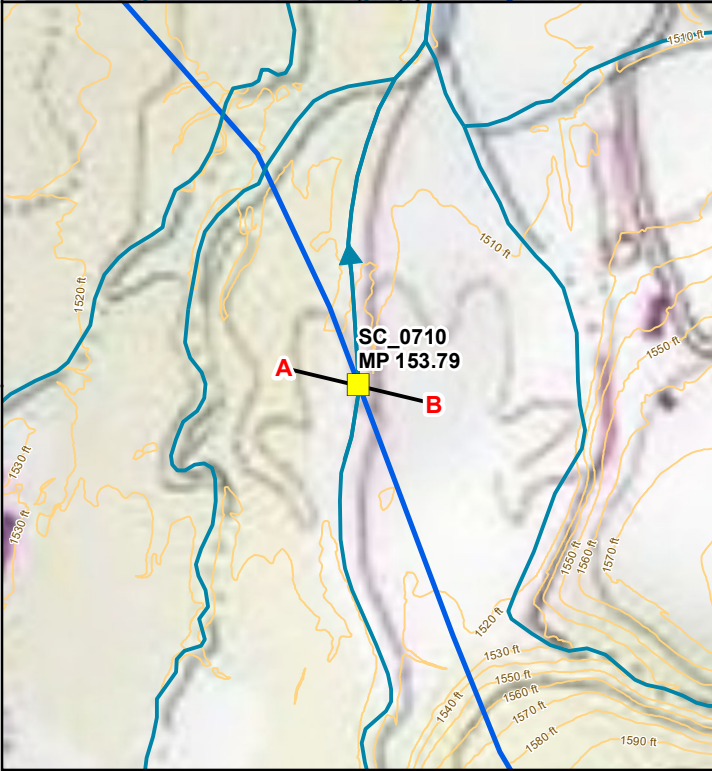
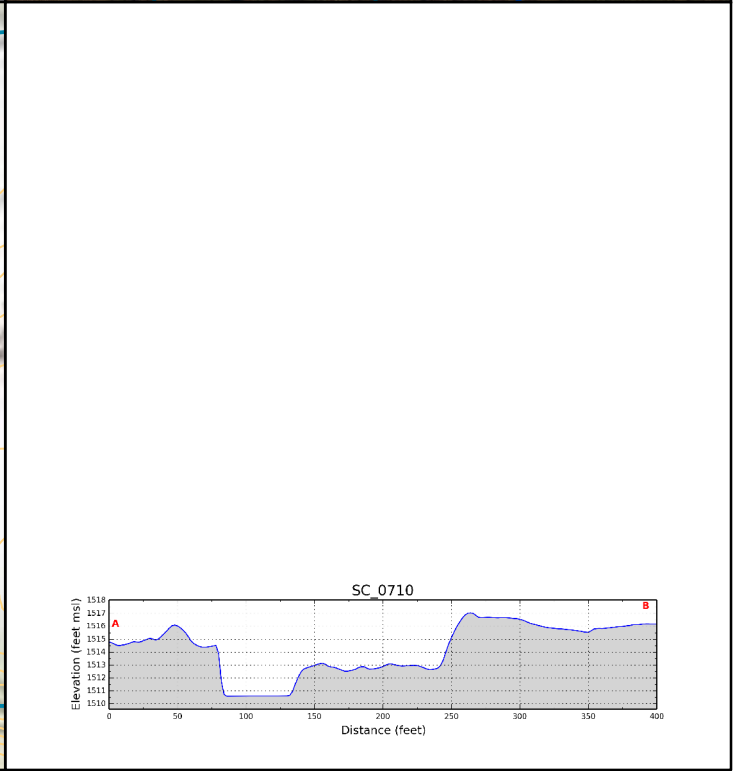
- Deep pool at confluence, greater than 5 pool depth below water surface.
 - Beaver (dam materials) just downstream of confluence.
- Several head cuts observed above and below crossing location.

Evaluate scour depth for pipeline burial depth. Lateral migration does not appear to be a significant hazard as landowners will likely strive to maintain current stream course. Place sag bends outside of riparian buffer on right bank (approximately three river widths wide). Location of sag bend beyond left bank to be determined by additional investigation.
