Linear Waterbody Data Sheet

Survey Description			
Project Name: Southeast Reliability		Waterbody Name: UNT Greenville Creek	
Waterbody ID: Sgra015		Date: 8/18/2014	
State: Virginia	County: Greenville	Company: NRG	Crew Member Initials: GB, LE
Photos: 3 photos			
Tract Number(s): 15-007		Nearest Milepost: 278.15-278.3	Associated Wetland ID(s): Wgra016
Survey Type: <i>(check one)</i> <input checked="" type="checkbox"/> Centerline <input type="checkbox"/> Re-Route <input type="checkbox"/> Access Road <input type="checkbox"/> Other:			
Physical Attributes			
Stream Classification: <i>(check one)</i> <input type="checkbox"/> Ephemeral <input checked="" type="checkbox"/> Intermittent <input type="checkbox"/> Perennial			
Waterbody Type: <i>(check one)</i> <input type="checkbox"/> River <input checked="" type="checkbox"/> Stream <input type="checkbox"/> Ditch <input type="checkbox"/> Canal <input type="checkbox"/> Other:			
OHWM Width: 3.0 ft.		OHWM Indicator: <i>(check all that apply)</i> <input checked="" type="checkbox"/> Clear line on bank <input type="checkbox"/> Shelving <input type="checkbox"/> Wrested vegetation <input checked="" type="checkbox"/> Scouring <input type="checkbox"/>

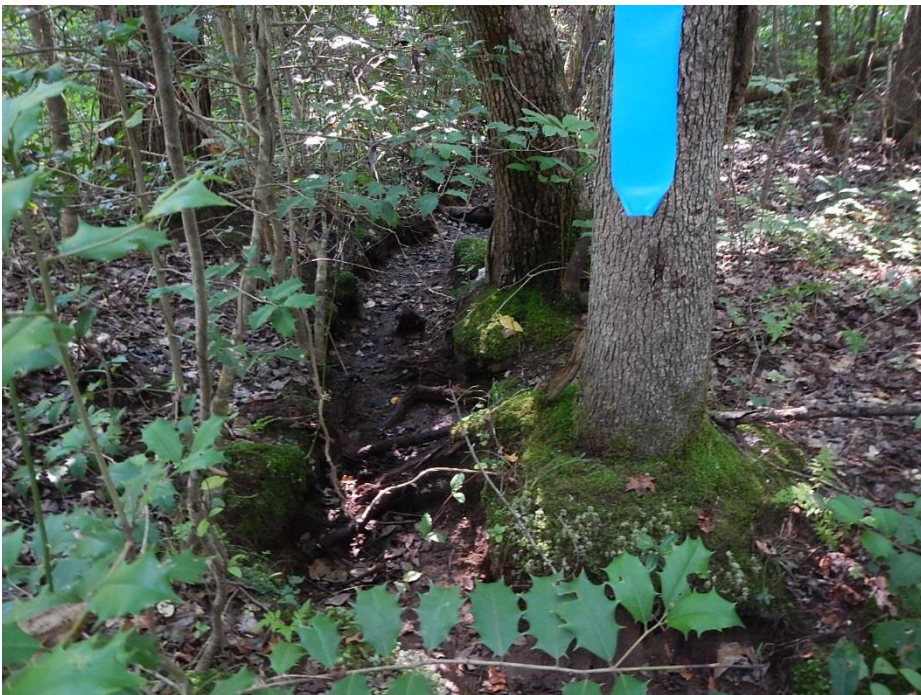
Waterbody SGRA015 facing south downstream

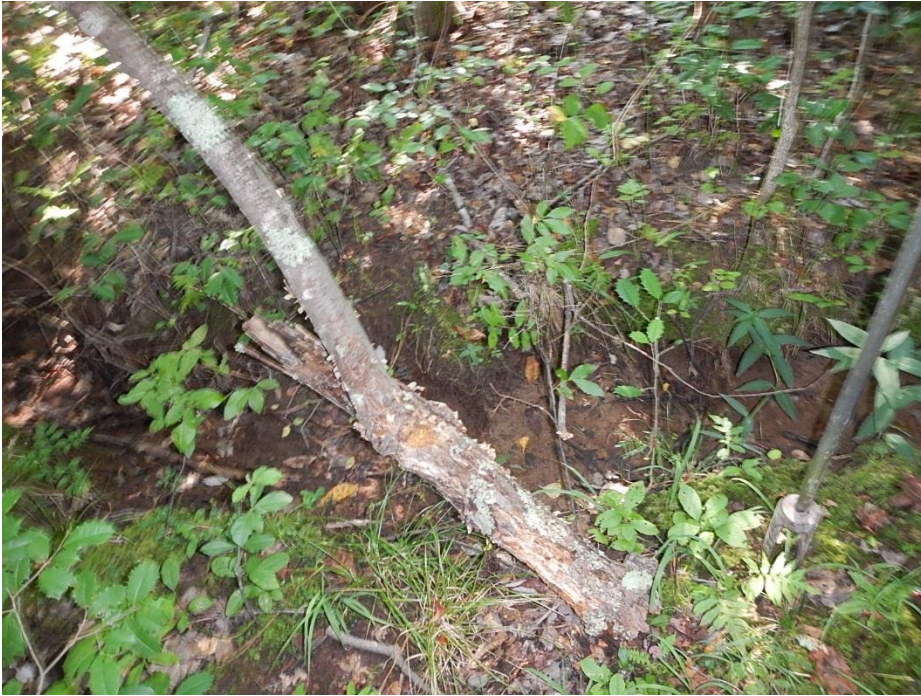
Waterbody SGRA015 facing east across

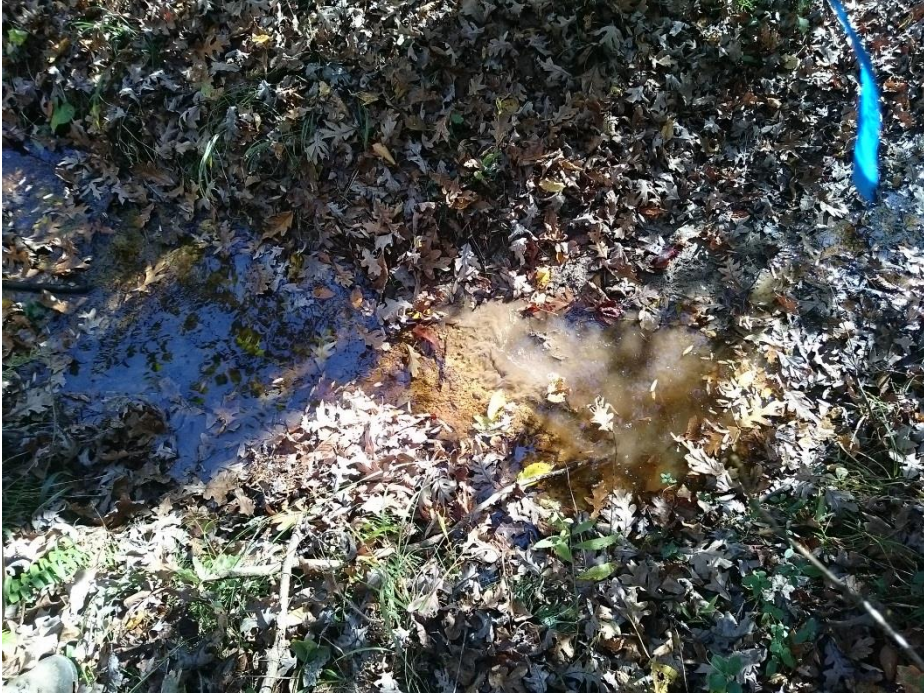
Waterbody SGRC103 facing south across

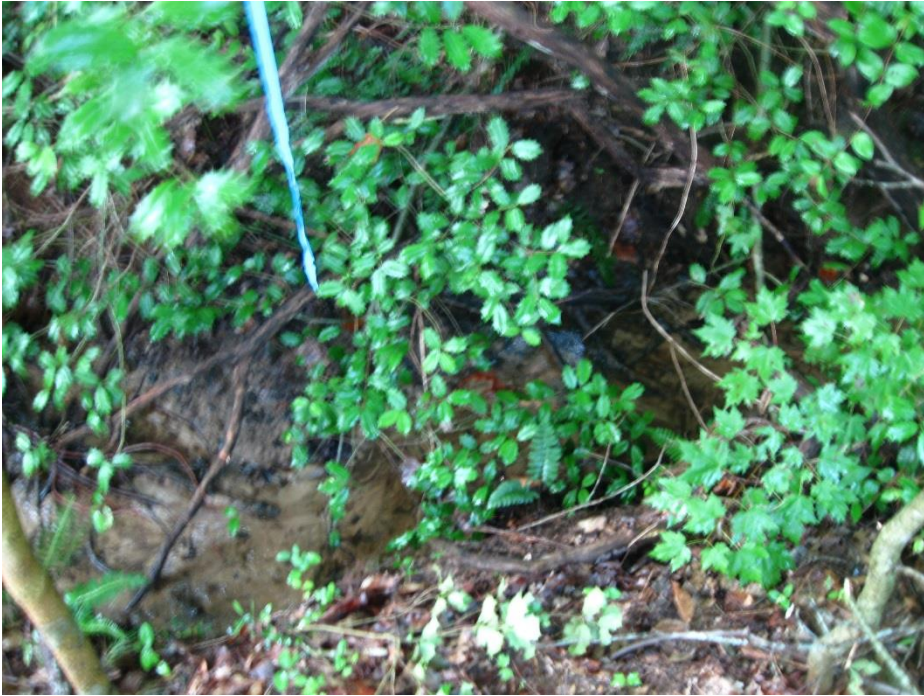
Waterbody SGRA011 facing south across

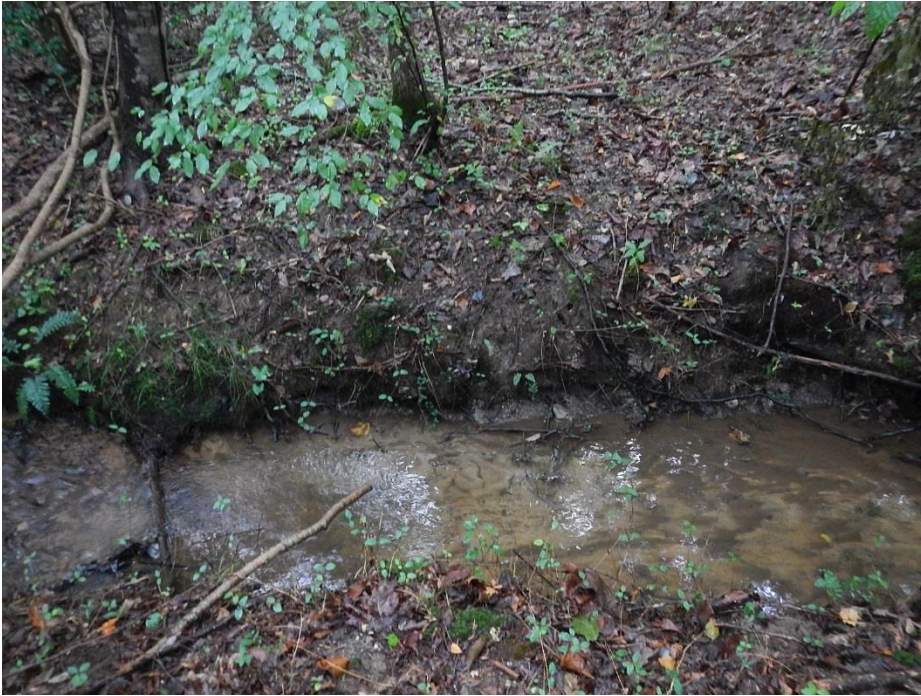
Waterbody SGRA012 facing southeast across

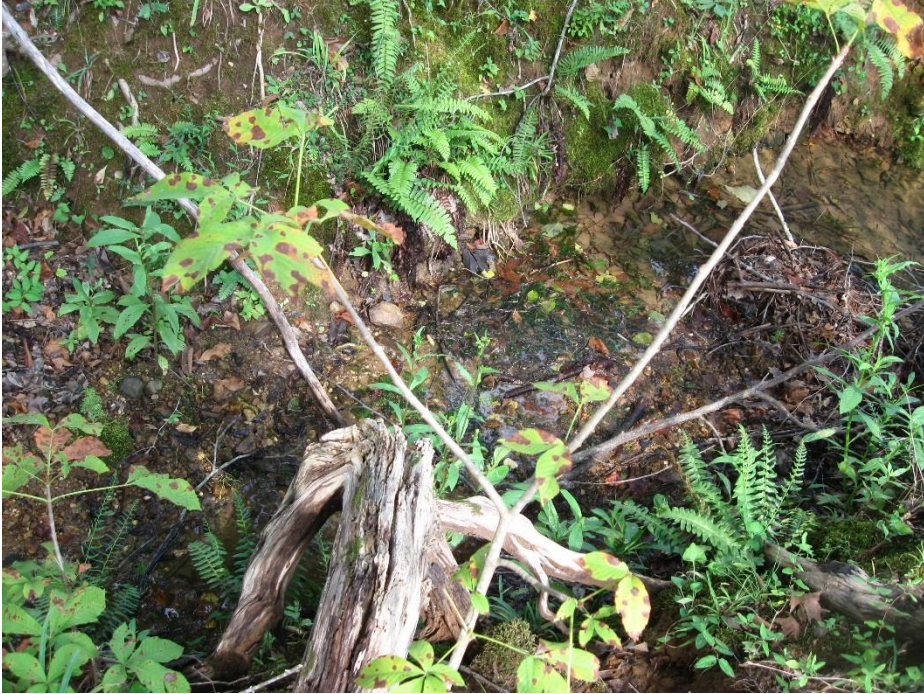
Waterbody SGRA013 facing west across

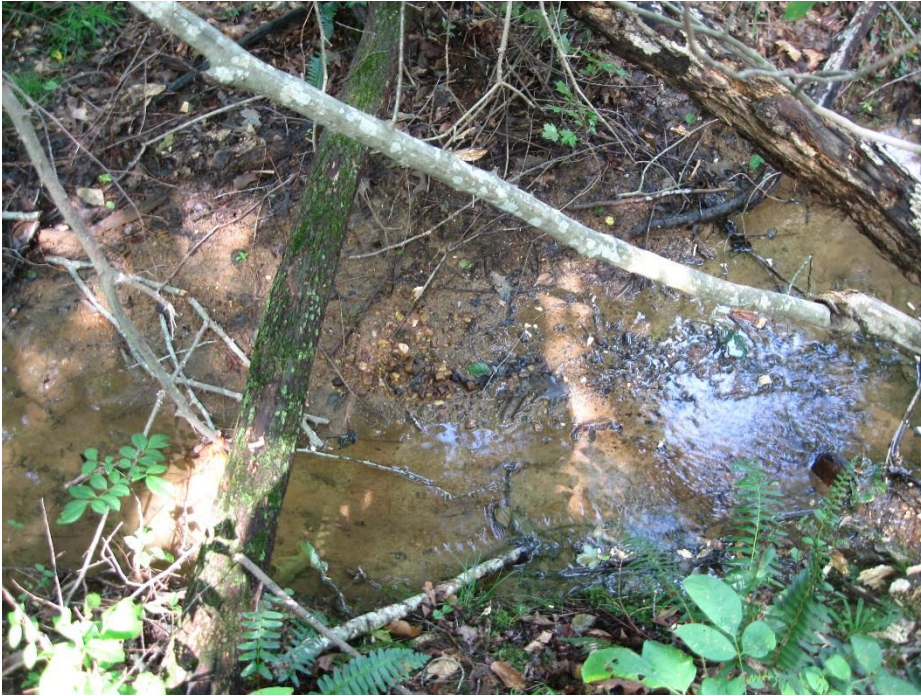
Waterbody SGRA014 facing west across

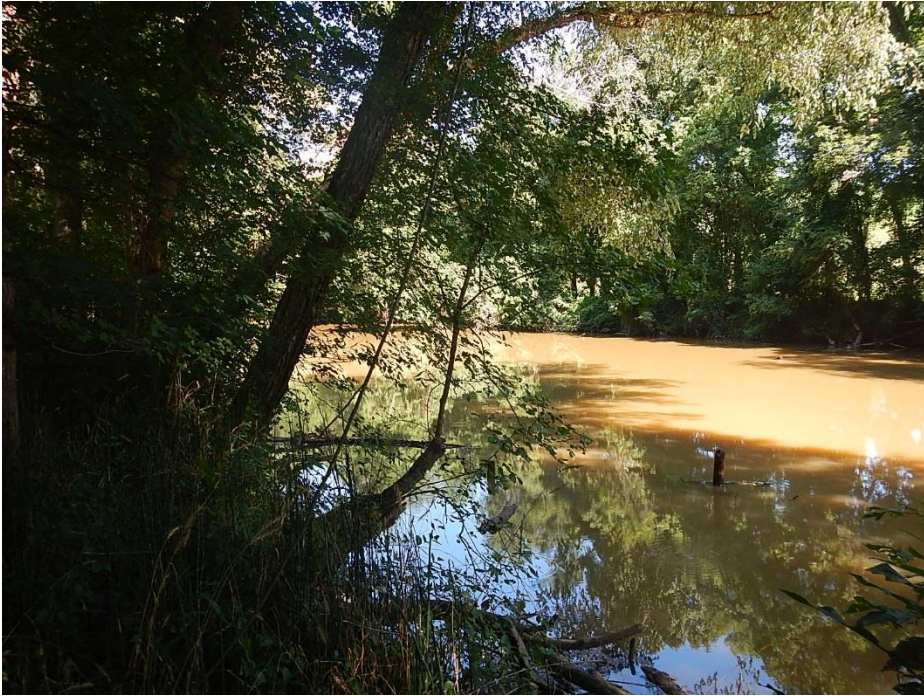
Waterbody SGRA007 facing west upstream

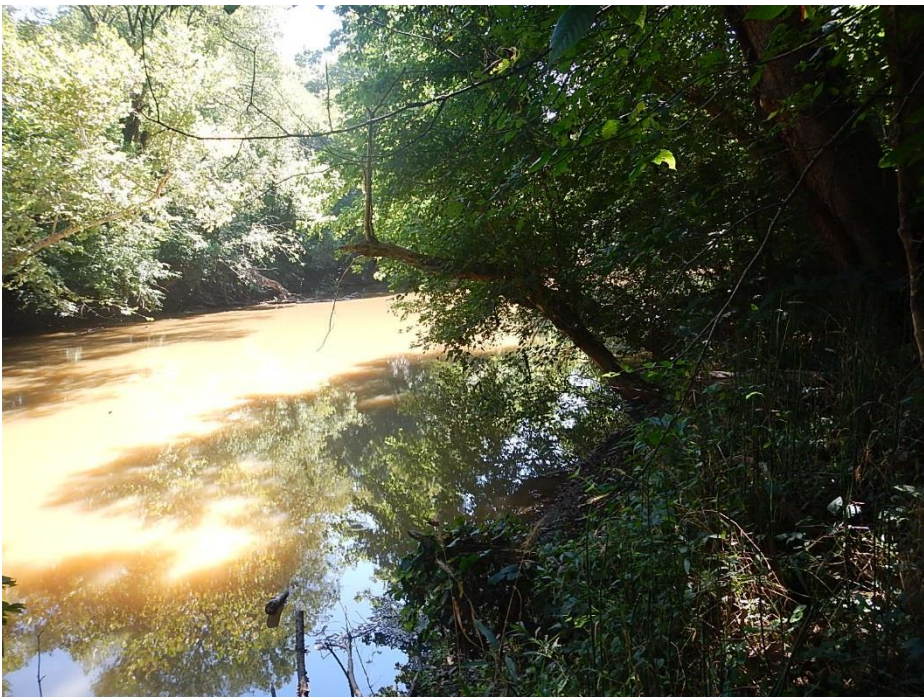
Waterbody SGRA007 facing east downstream

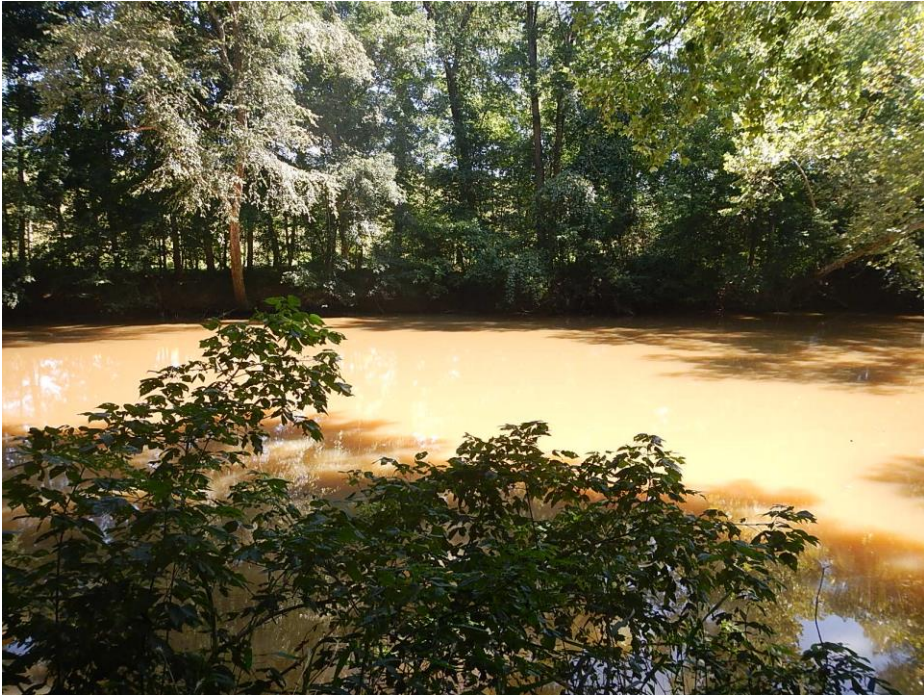
Waterbody SGRA007 facing north across

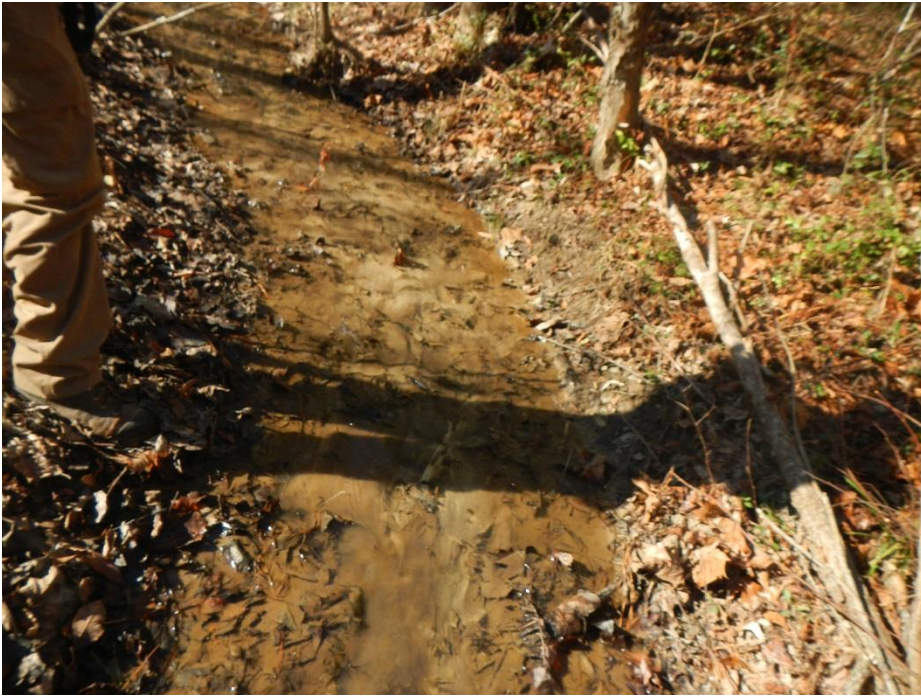
Waterbody SGRC001 facing west upstream

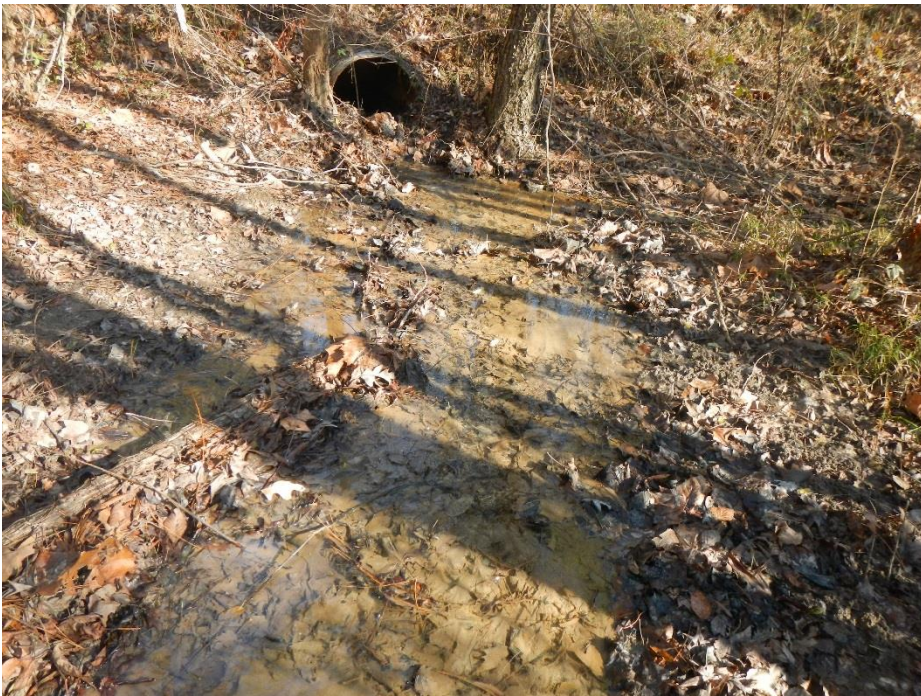
Waterbody SGRC001 facing east downstream

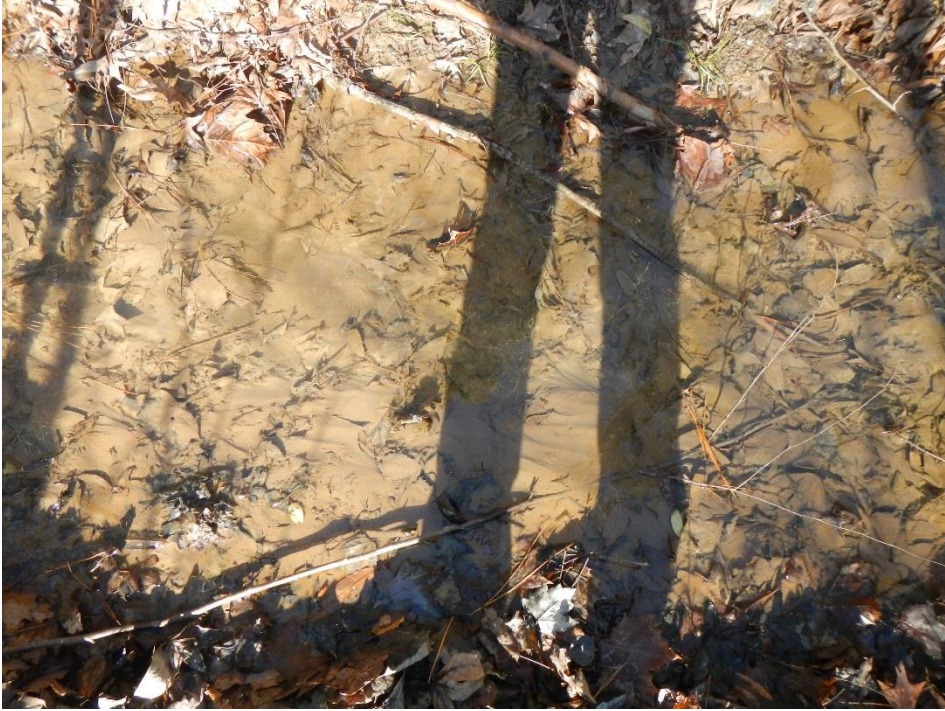
Waterbody SGRC001 facing north across

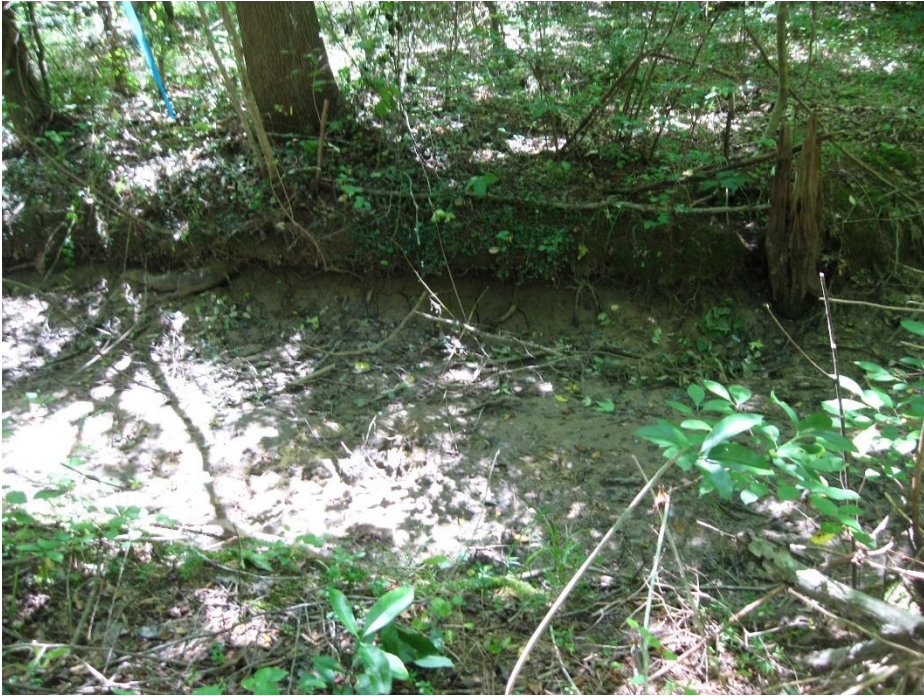
Waterbody SGRA008 facing south across

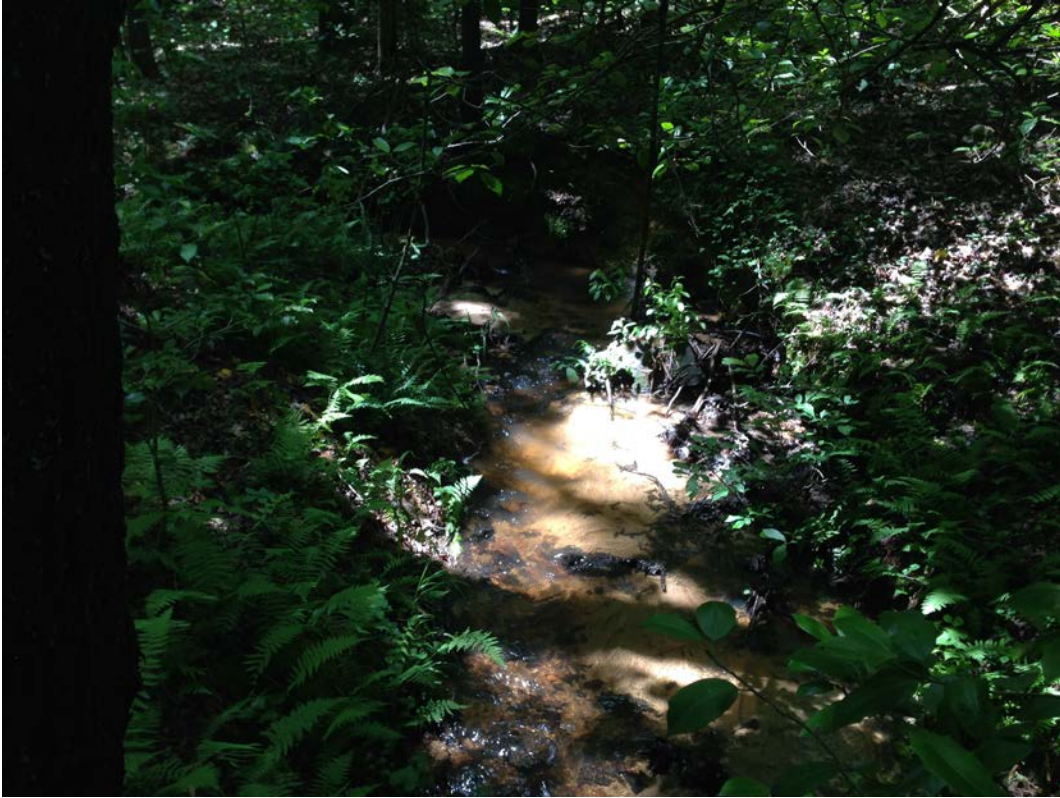
Waterbody data point sgro003 facing west upstream.

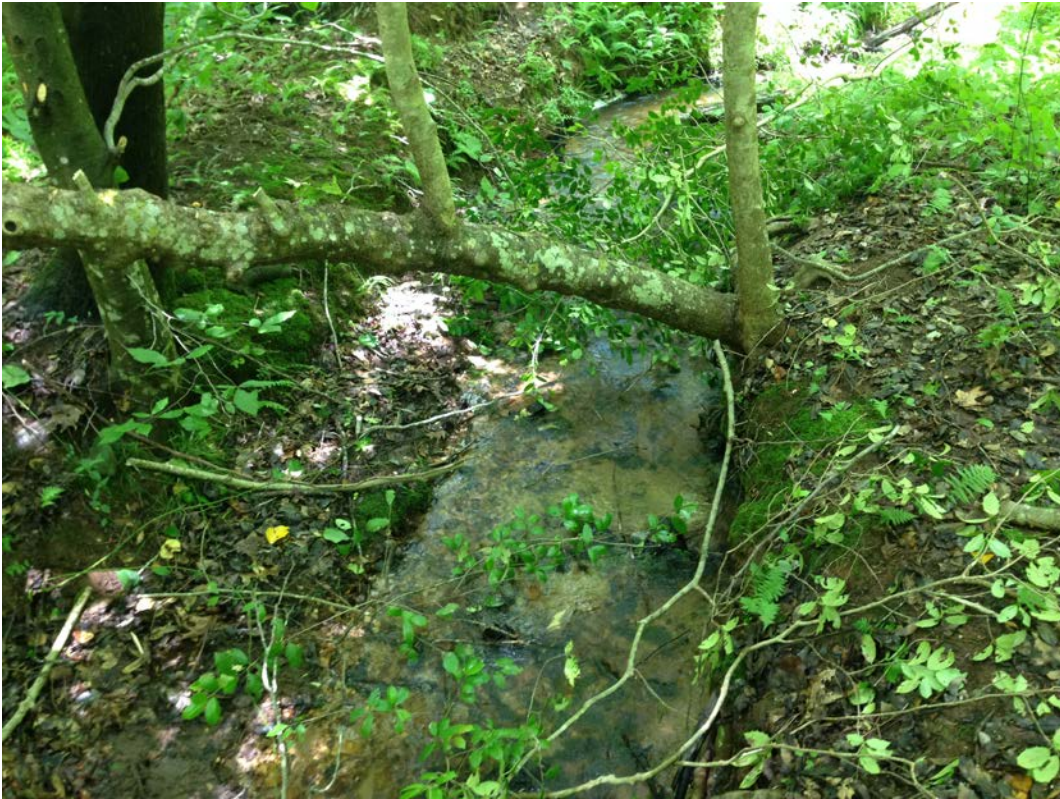
Waterbody data point sgro003 facing northeast downstream.

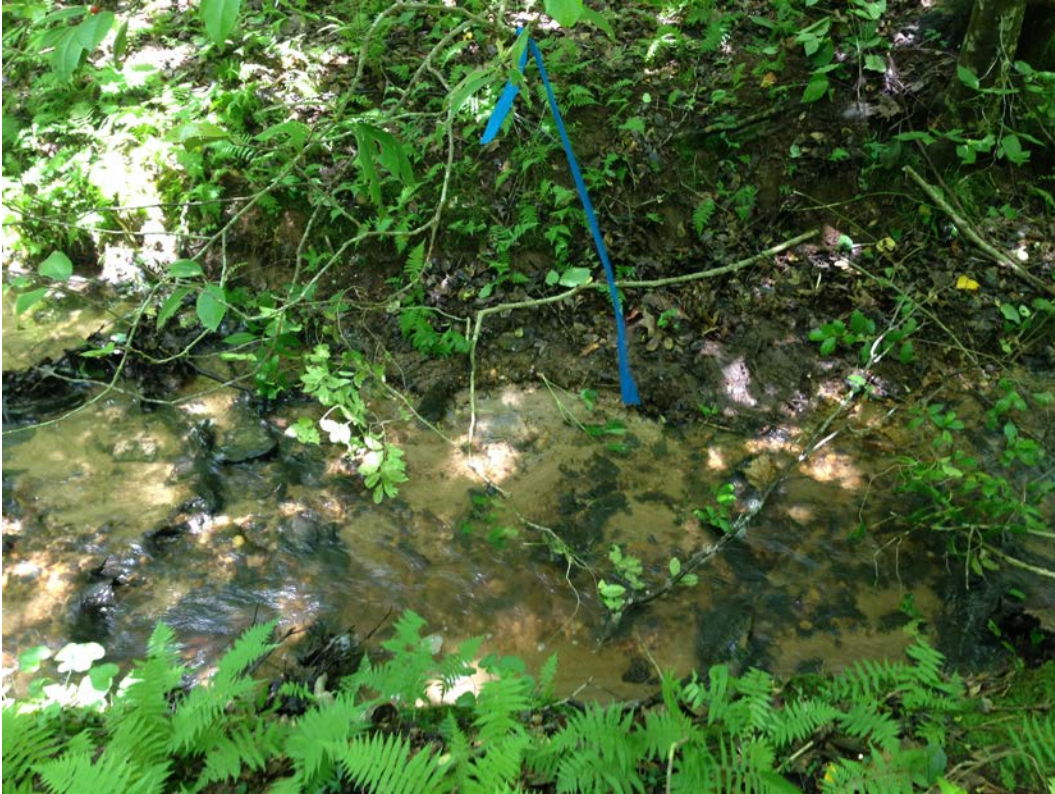
Waterbody data point sgro003 facing northwest across bank.

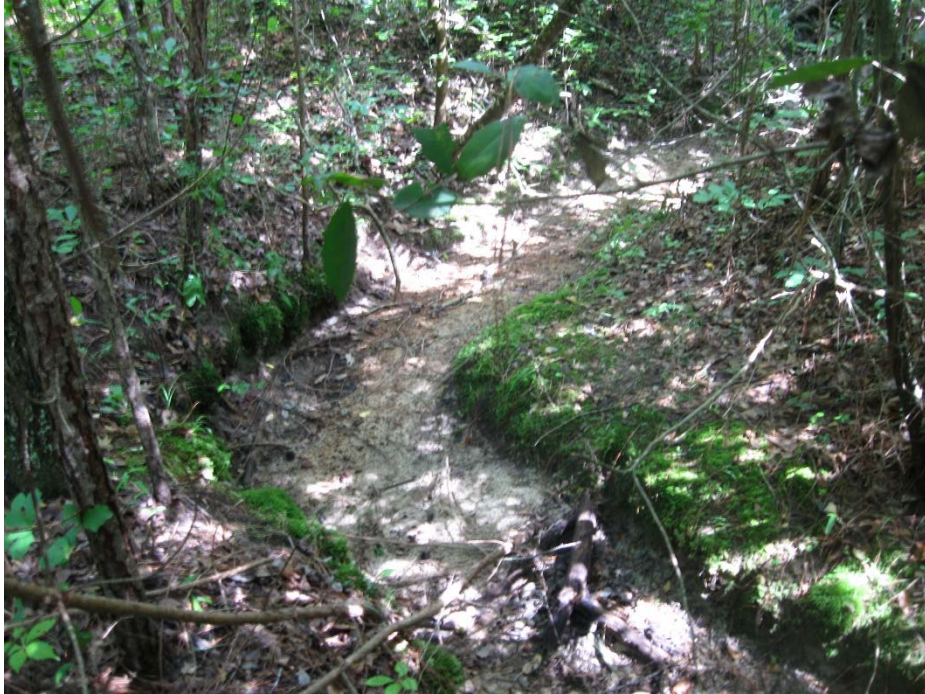
Waterbody SGRA001 facing north upstream

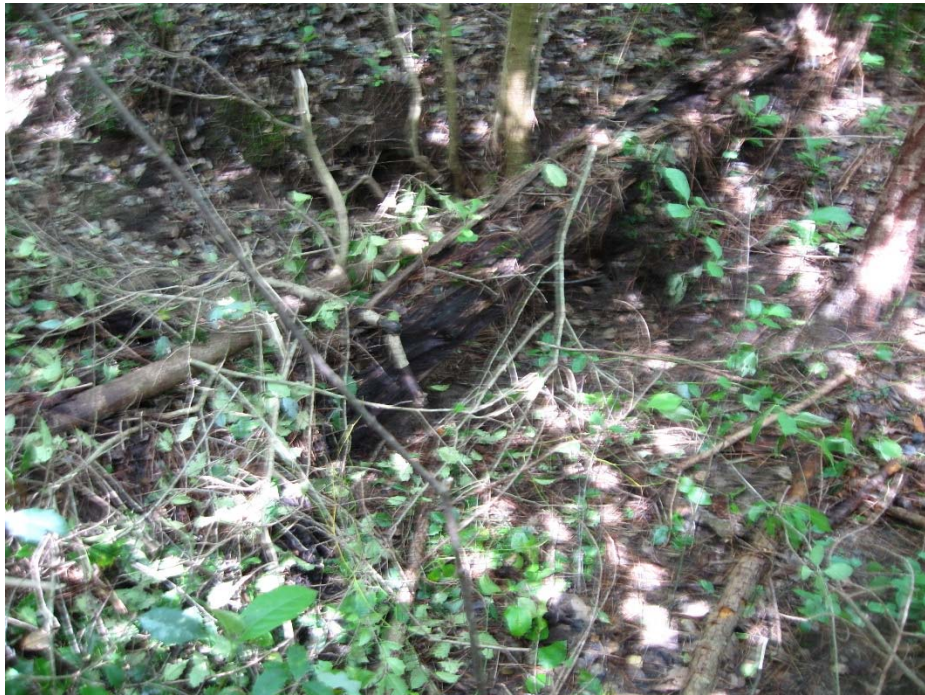
Waterbody SGRA001 facing west downstream

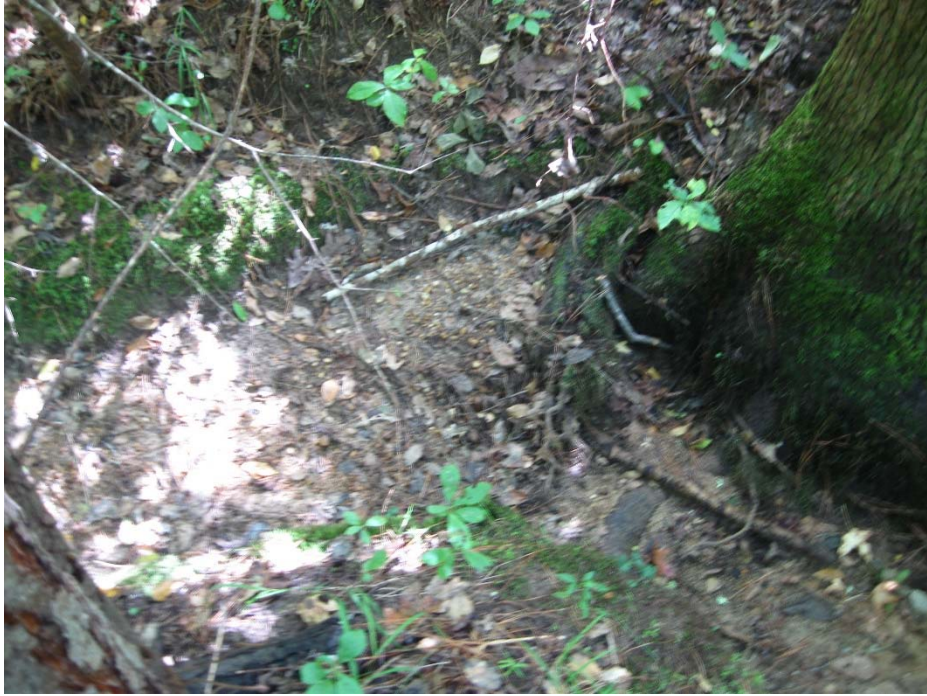
Waterbody SGRA001 facing east across

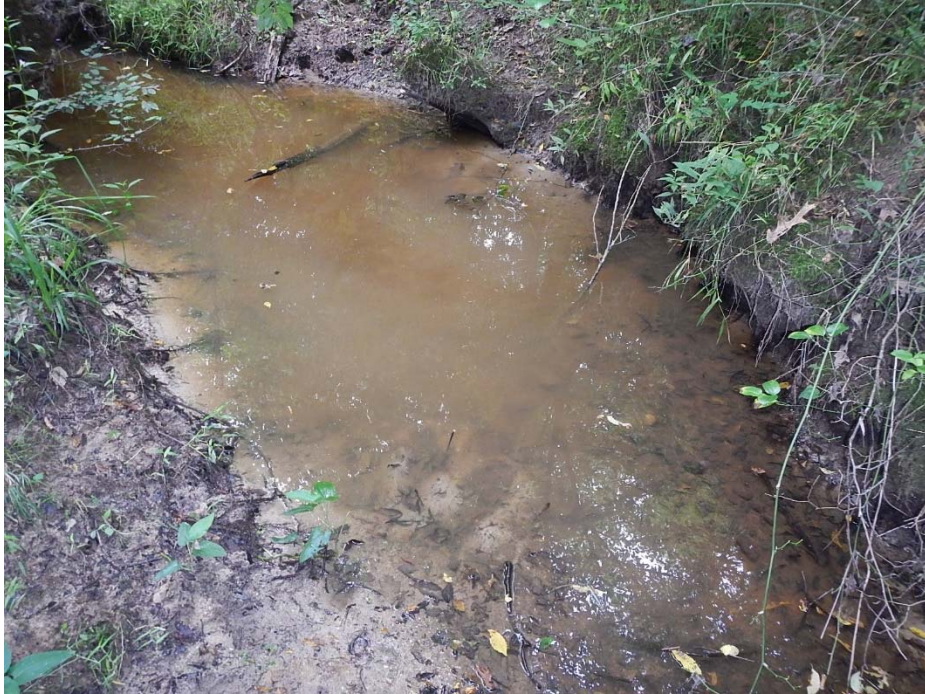
Waterbody SGRA002 facing west upstream

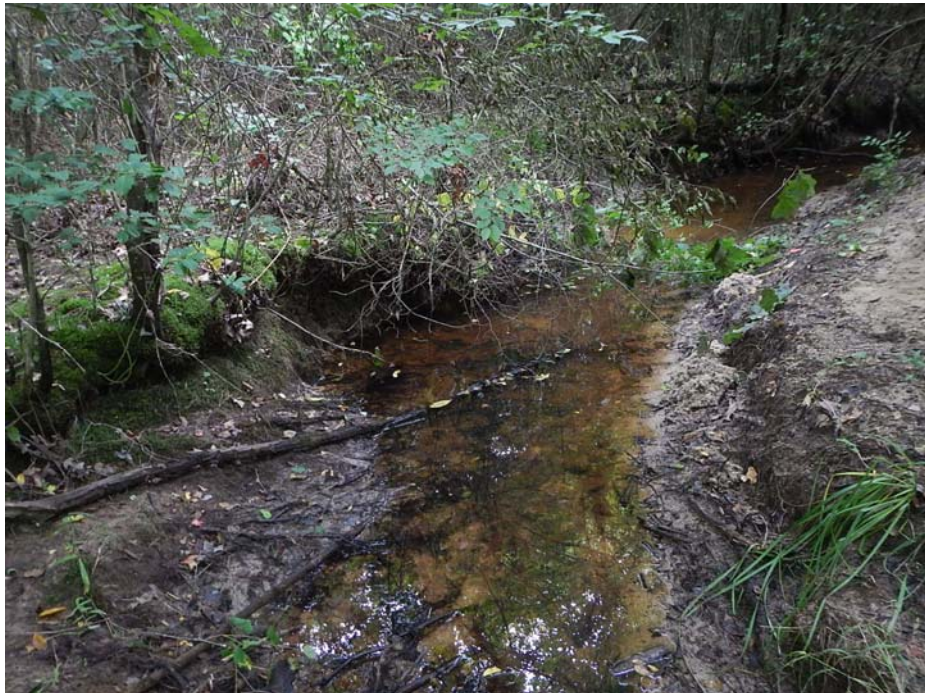
Waterbody SGRA002 facing east downstream

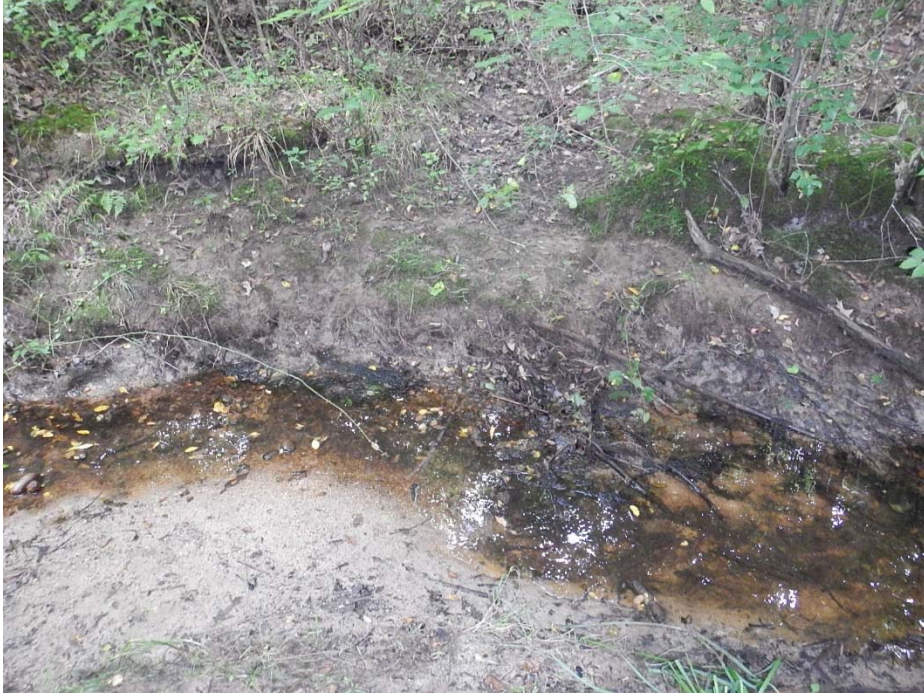
Waterbody SGRA002 facing north across

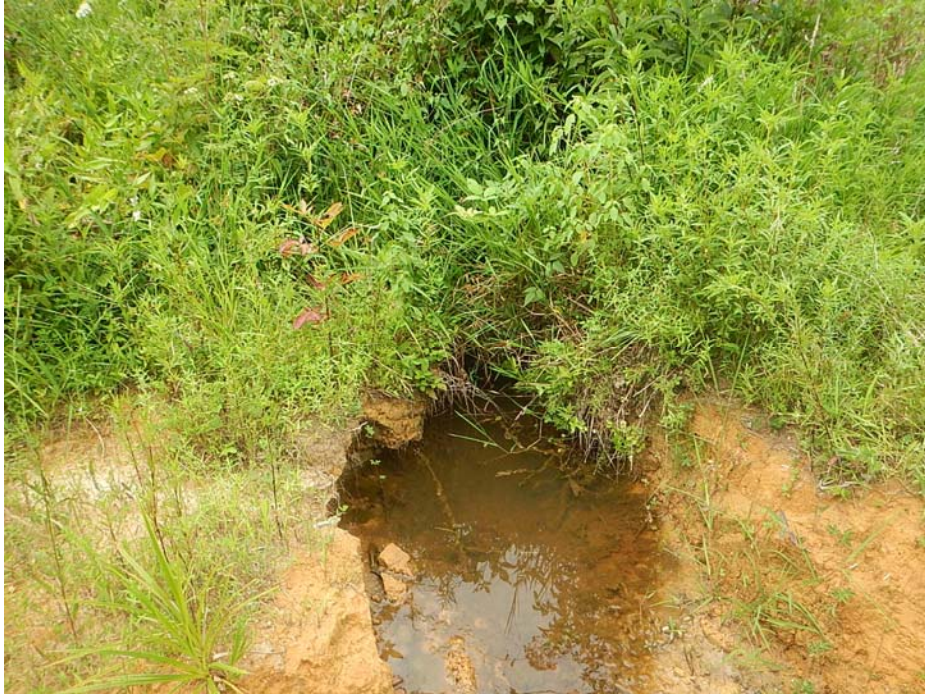
Waterbody SGRA003 facing west upstream

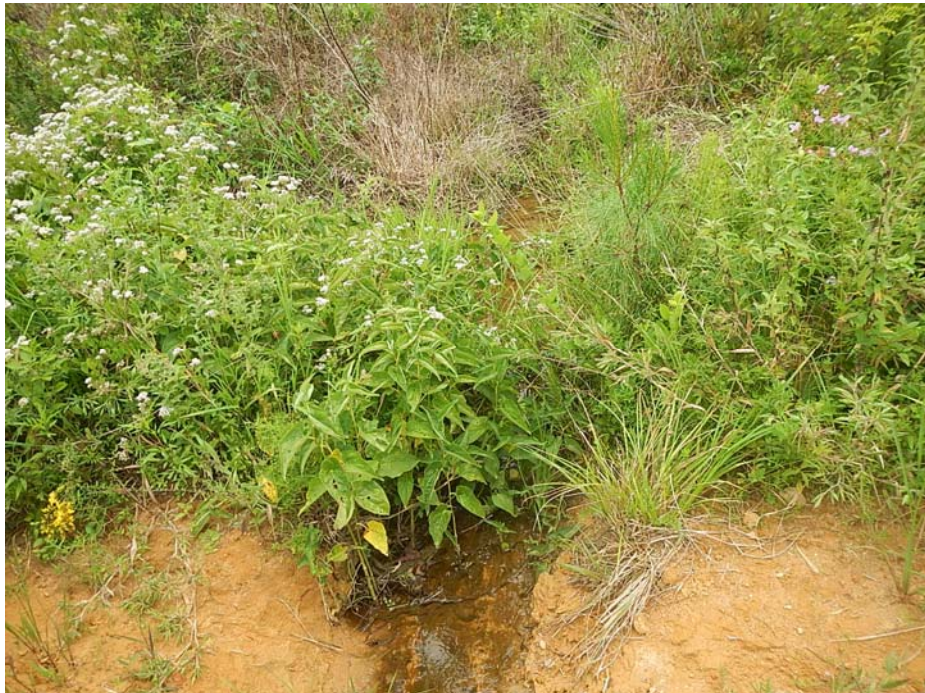
Waterbody SGRA003 facing east downstream

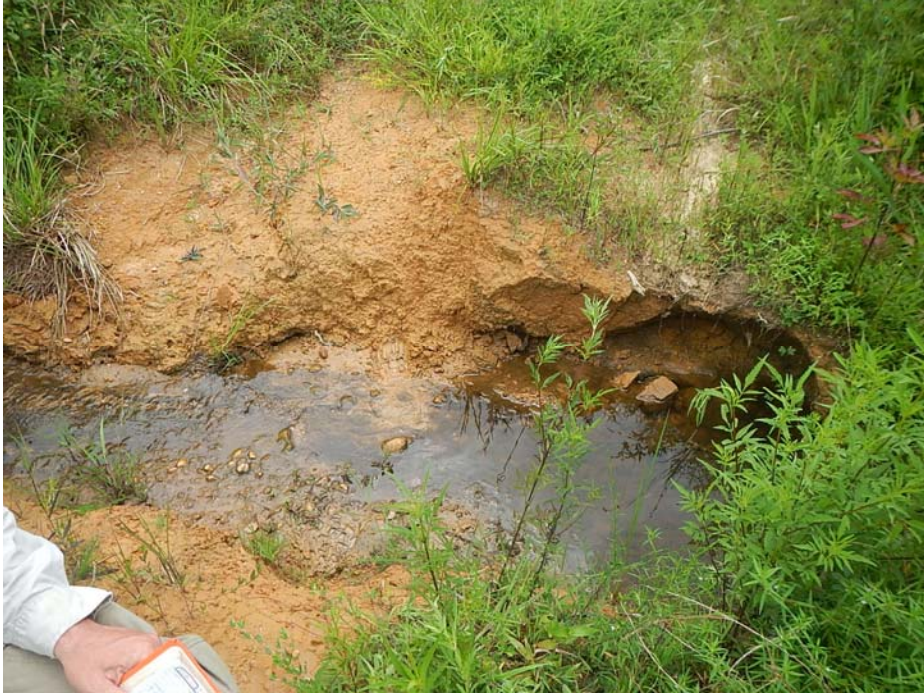
Waterbody SGRA003 facing south across

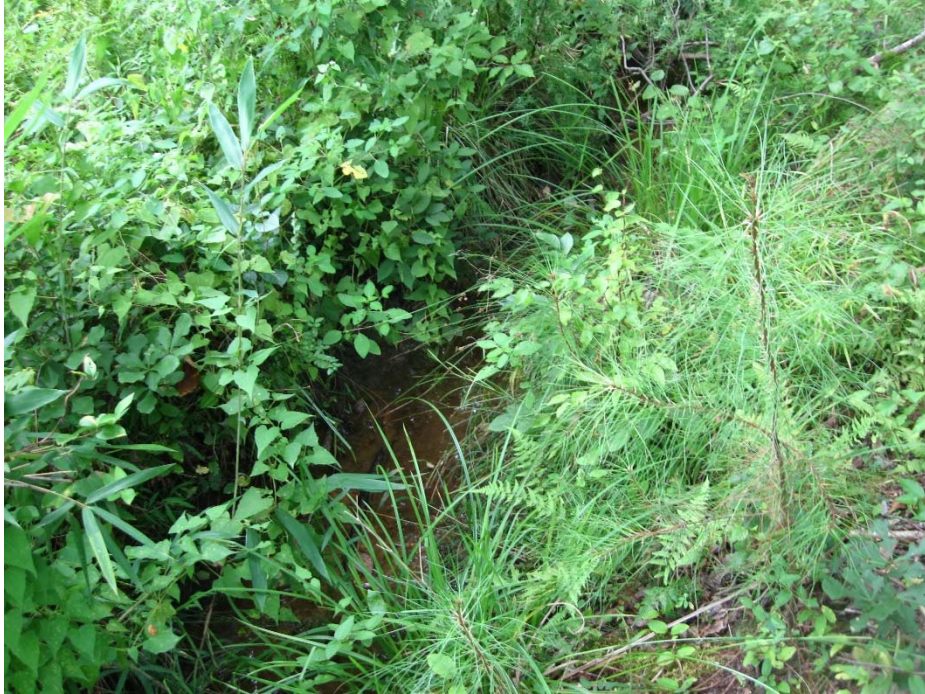
Waterbody SGRA004 facing north upstream

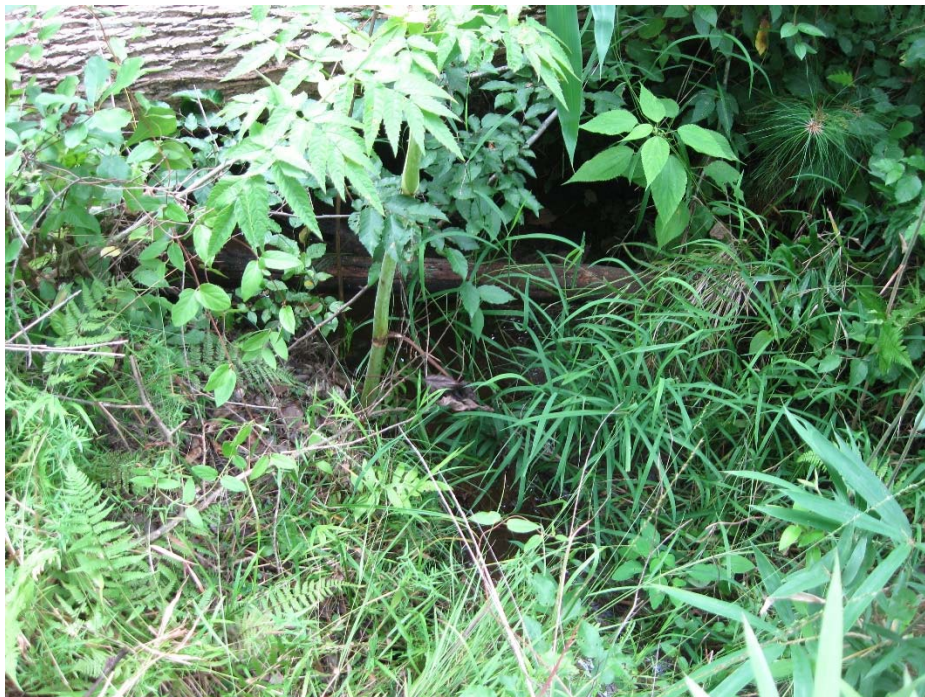
Waterbody SGRA004 facing south downstream

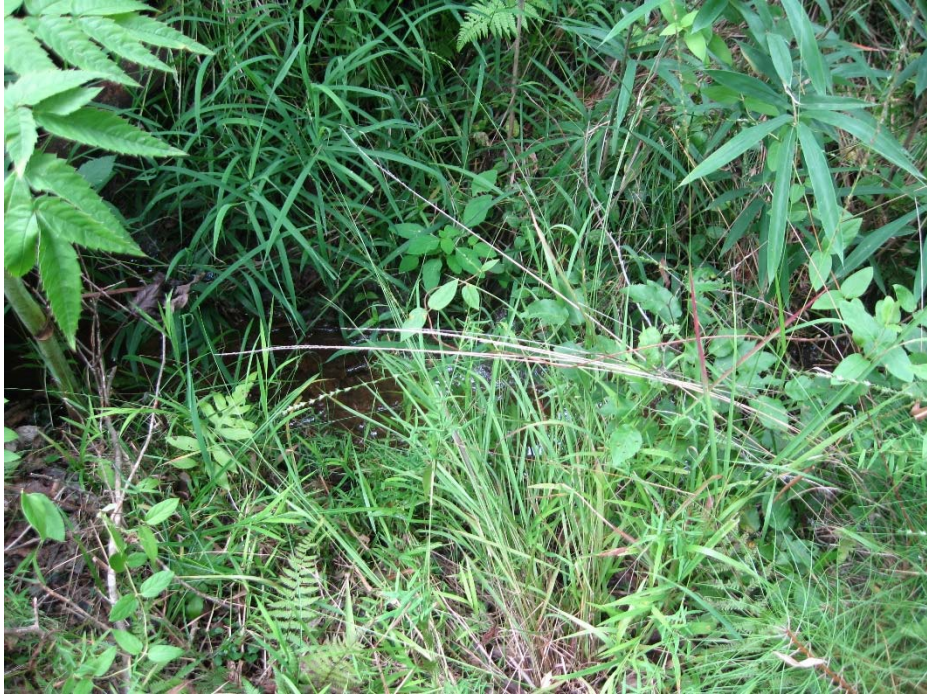
Waterbody SGRA004 facing west across

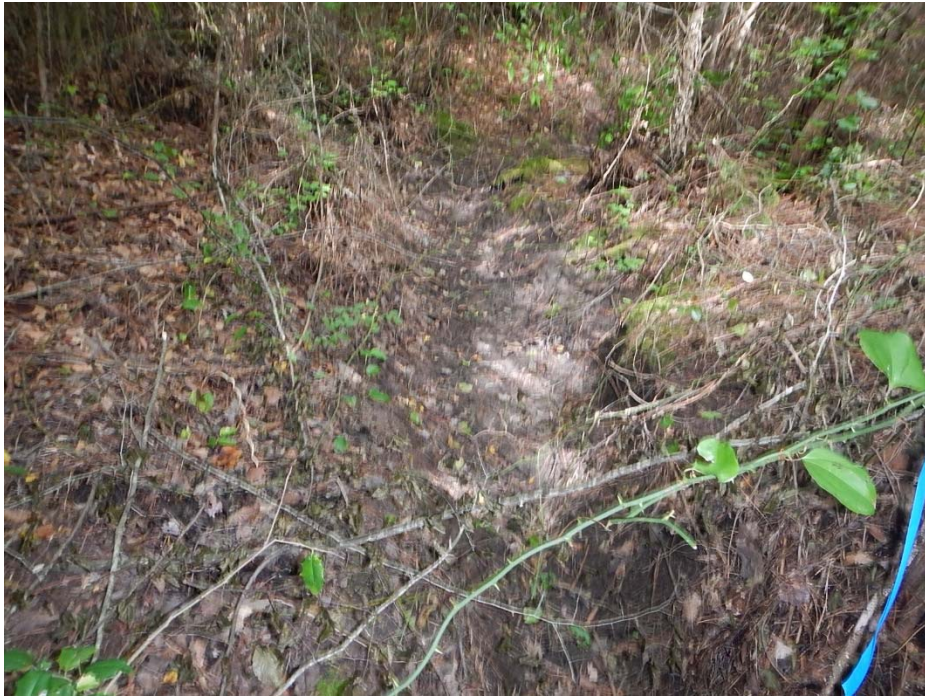
Waterbody SGRA005 facing east upstream

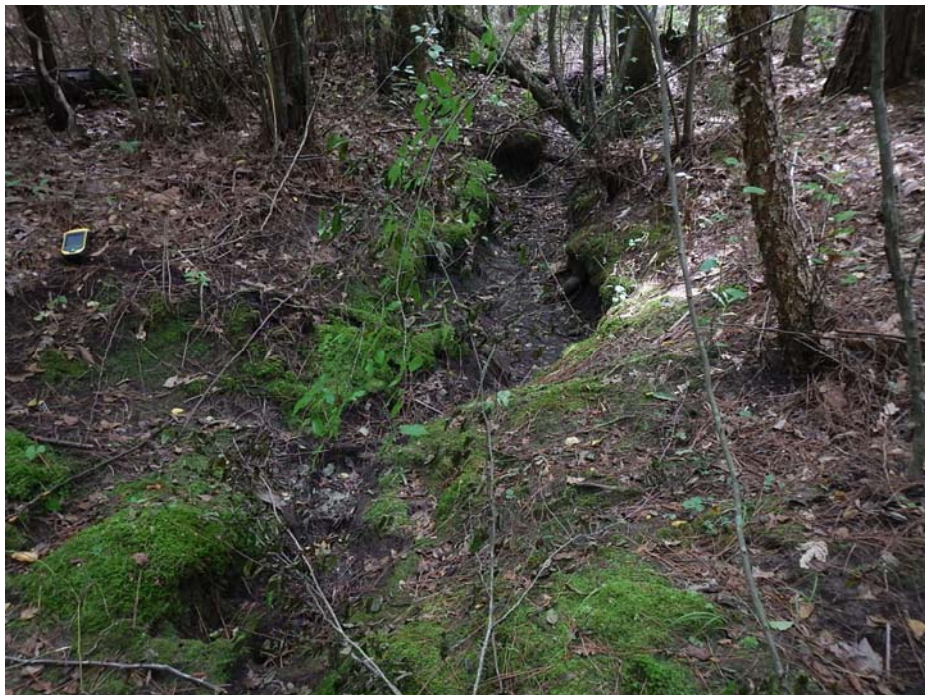
Waterbody SGRA005 facing west downstream

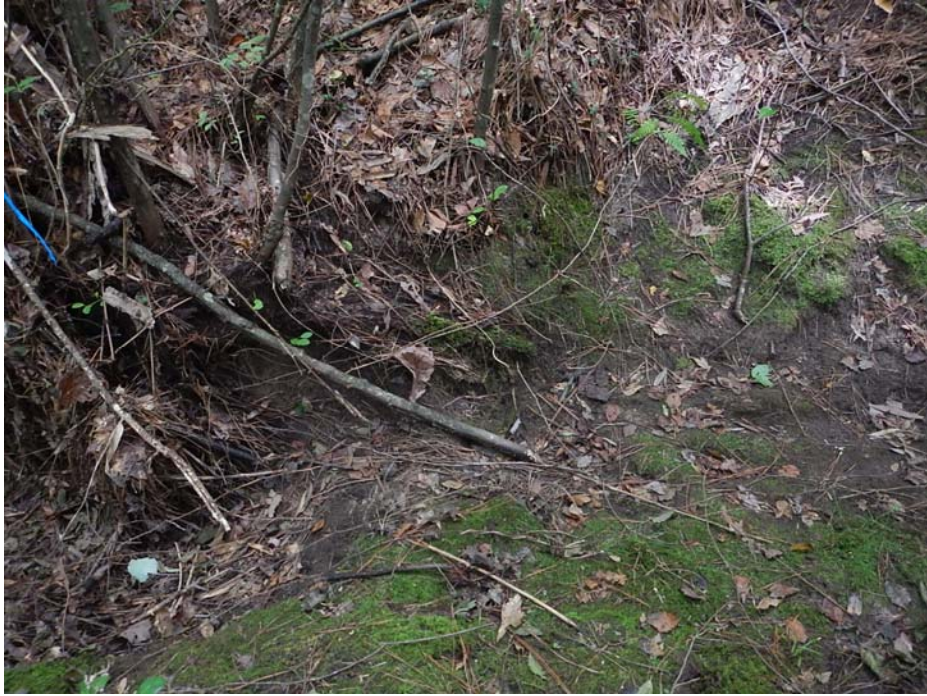
Waterbody SGRA005 facing north across

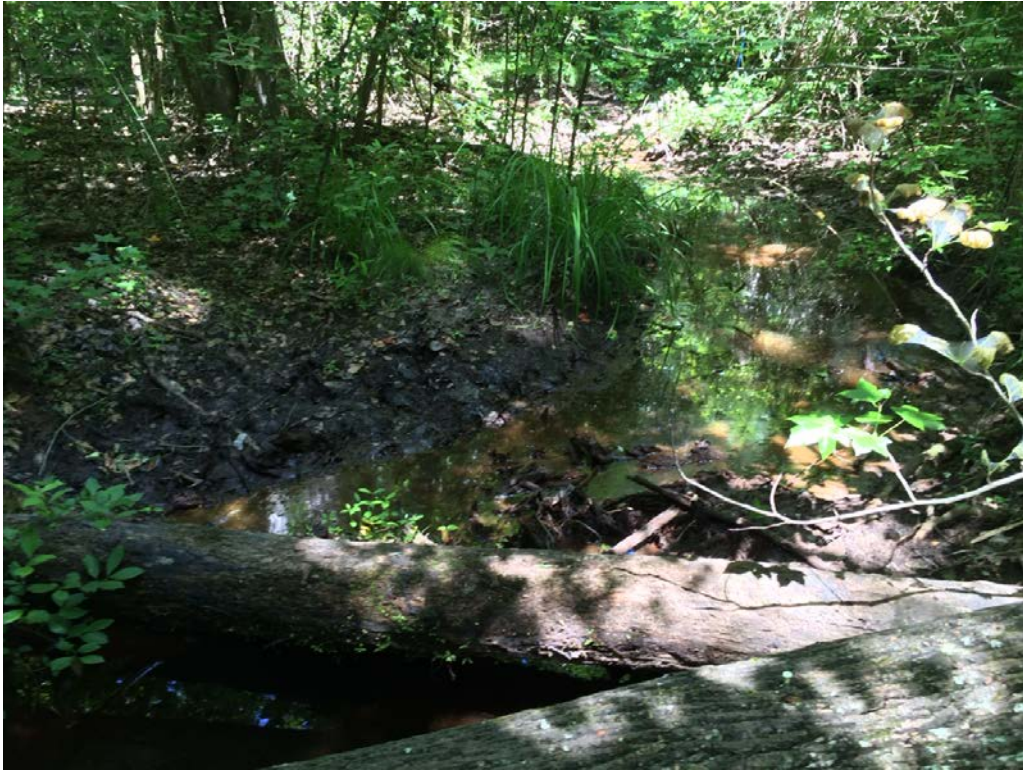
Waterbody sgrp002 facing north upstream.
