Linear Waterbody Data Sheet

Survey Description			
Project Name: Southeast Reliability		Waterbody Name: UNT Greenville Creek	
Waterbody ID: Sgra015		Date: 8/18/2014	
State: Virginia	County: Greenville	Company: NRG	Crew Member Initials: GB, LE
Photos: 3 photos			
Tract Number(s): 15-007		Nearest Milepost: 278.15-278.3	Associated Wetland ID(s): Wgra016
Survey Type: <i>(check one)</i> <input checked="" type="checkbox"/> Centerline <input type="checkbox"/> Re-Route <input type="checkbox"/> Access Road <input type="checkbox"/> Other:			
Physical Attributes			
Stream Classification: <i>(check one)</i> <input type="checkbox"/> Ephemeral <input checked="" type="checkbox"/> Intermittent <input type="checkbox"/> Perennial			
Waterbody Type: <i>(check one)</i> <input type="checkbox"/> River <input checked="" type="checkbox"/> Stream <input type="checkbox"/> Ditch <input type="checkbox"/> Canal <input type="checkbox"/> Other:			
OHWM Width: 3.0 ft.		OHWM Indicator: <i>(check all that apply)</i> <input checked="" type="checkbox"/> Clear line on bank <input type="checkbox"/> Shelving <input type="checkbox"/> Wrested vegetation <input checked="" type="checkbox"/> Scouring <input type="checkbox"/>

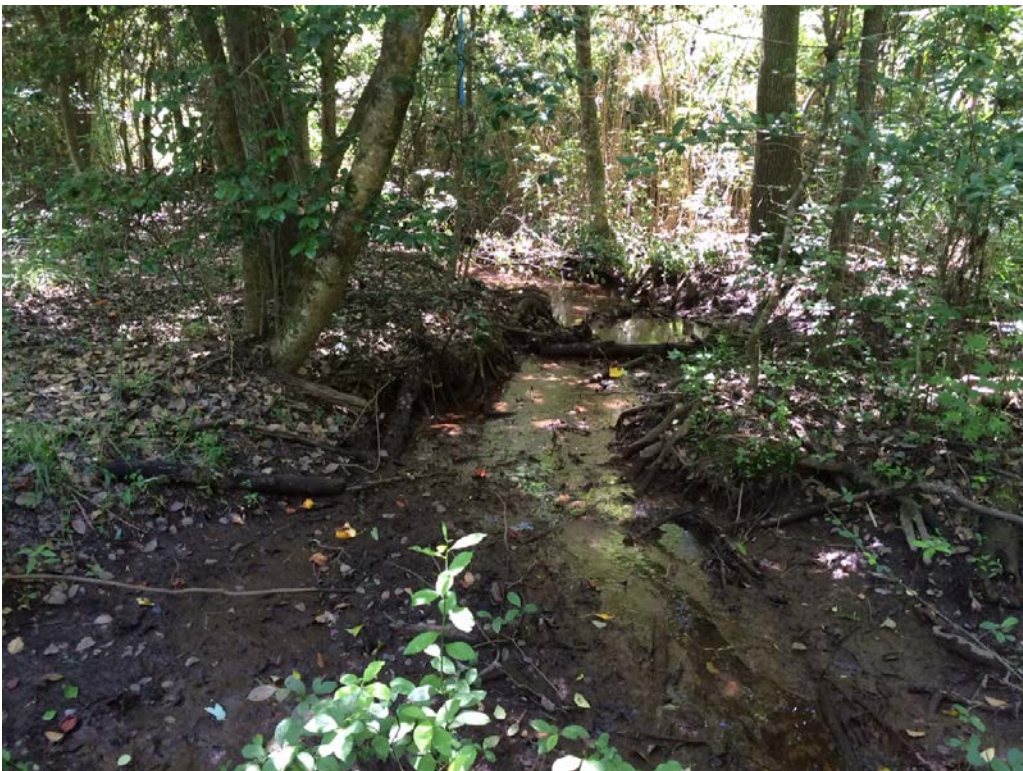
Waterbody sgrp002 facing east downstream.

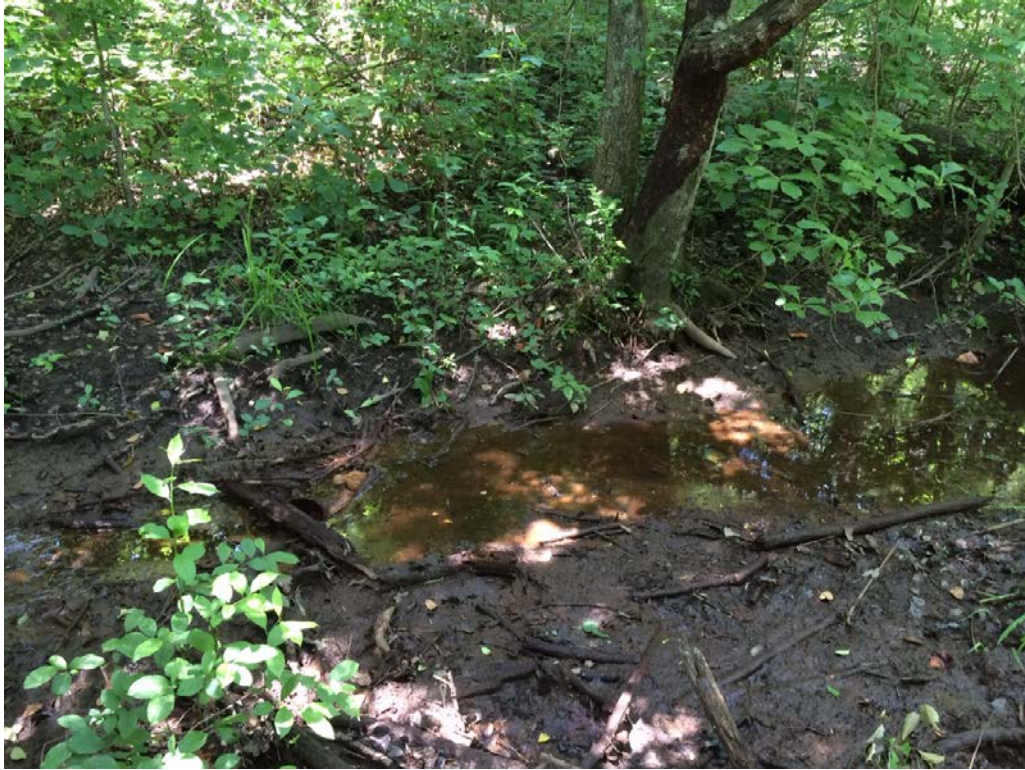
Waterbody sgrp002 facing north across bank.

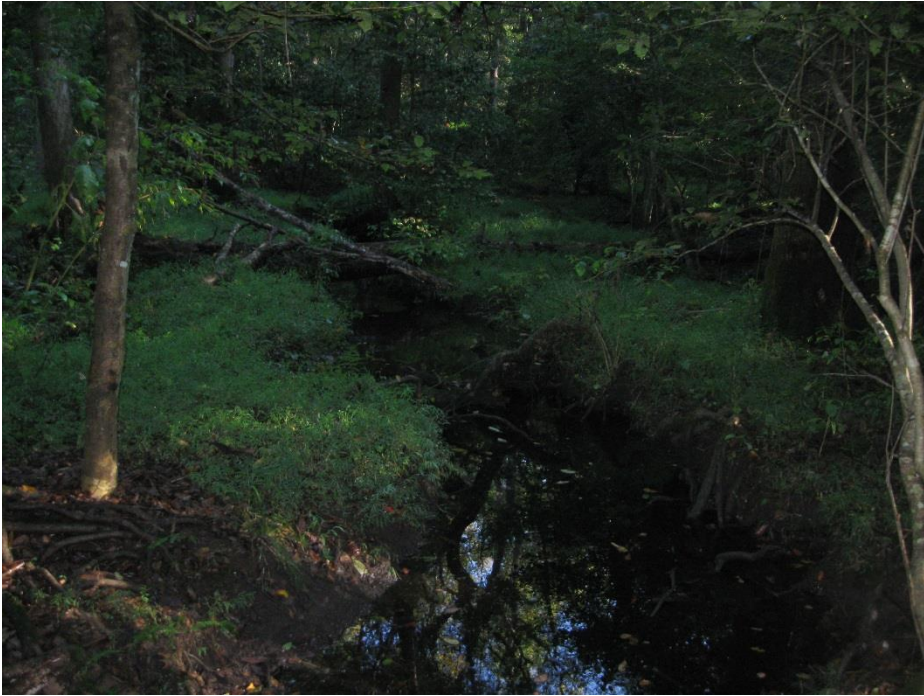
Waterbody SGRB001 facing northeast upstream

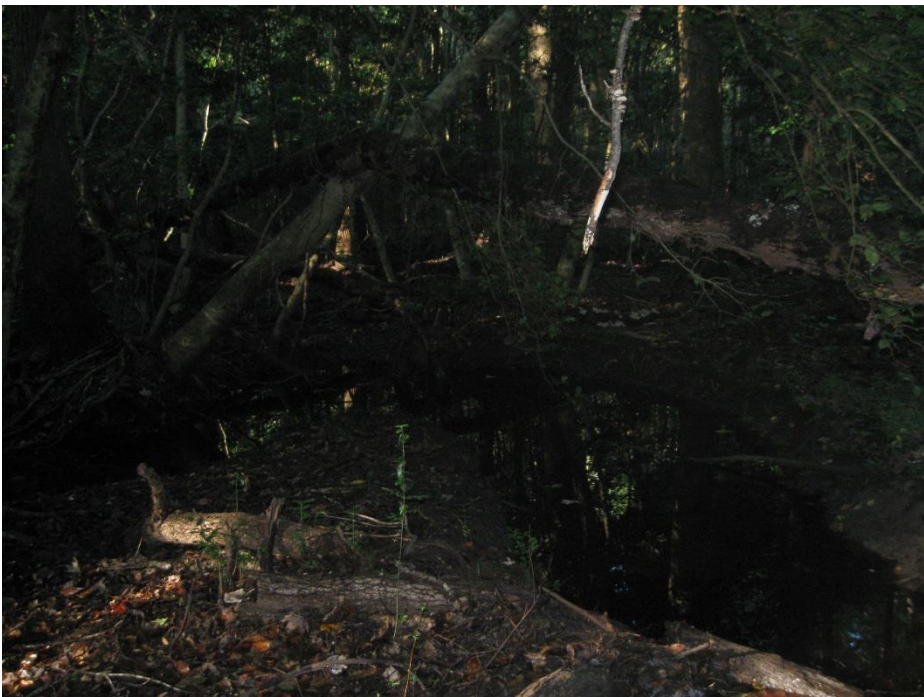
Waterbody SGRB001 facing southwest downstream

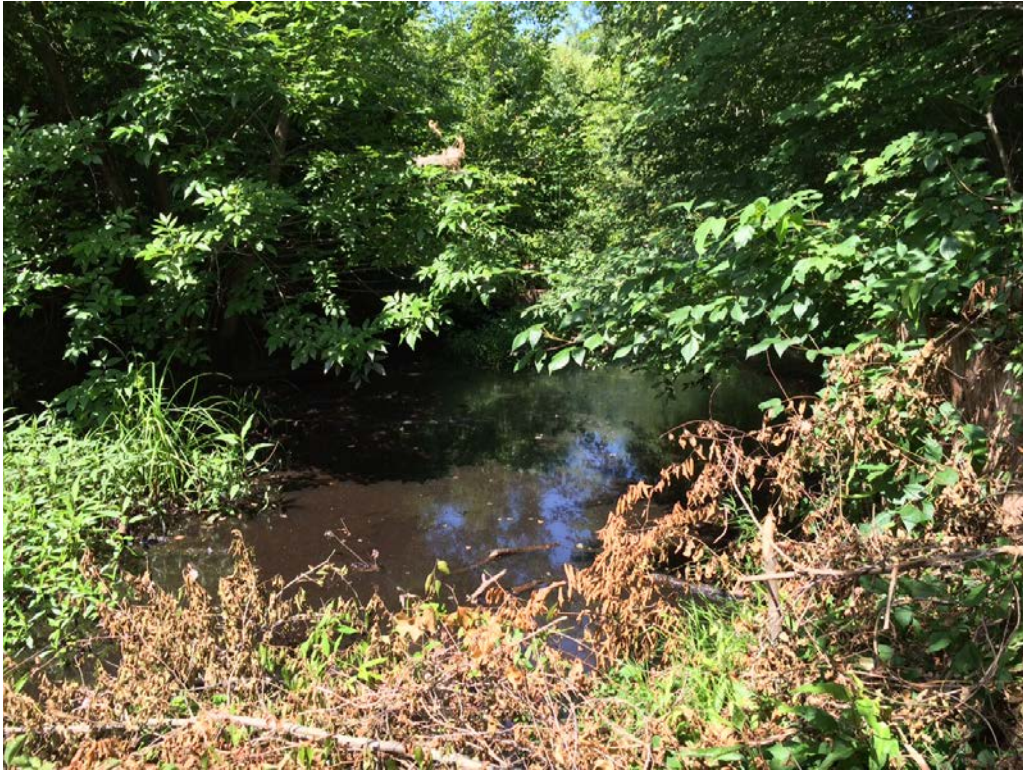
Waterbody sgrp004 facing northwest upstream.

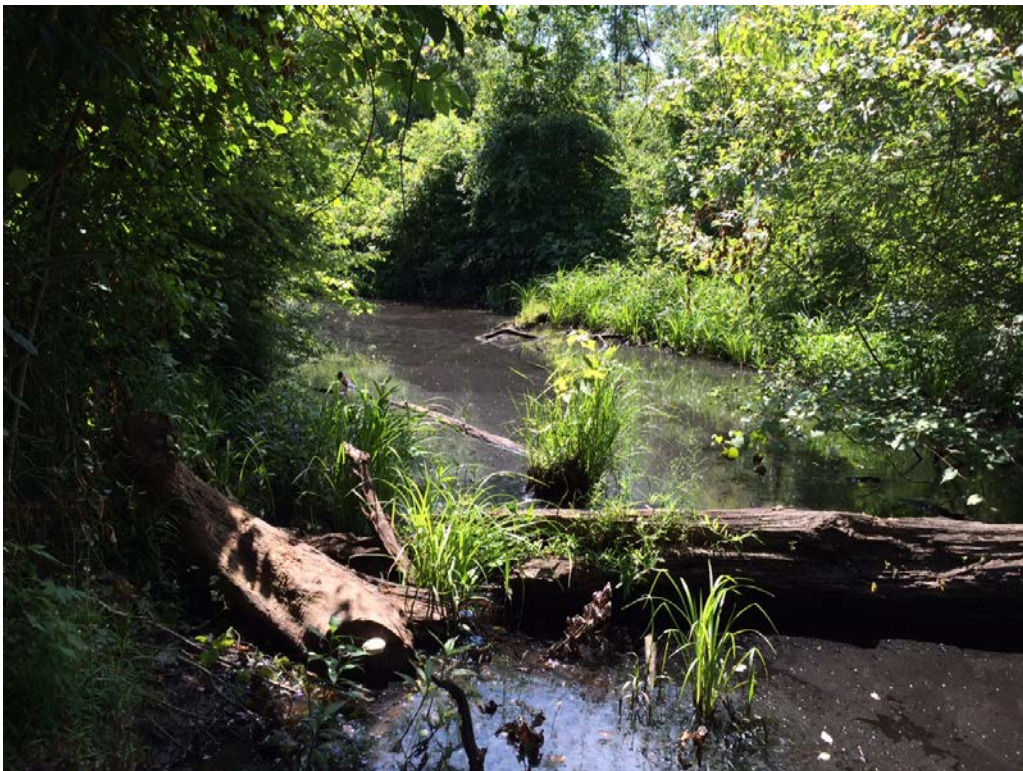
Waterbody sgrp004 facing southeast downstream.

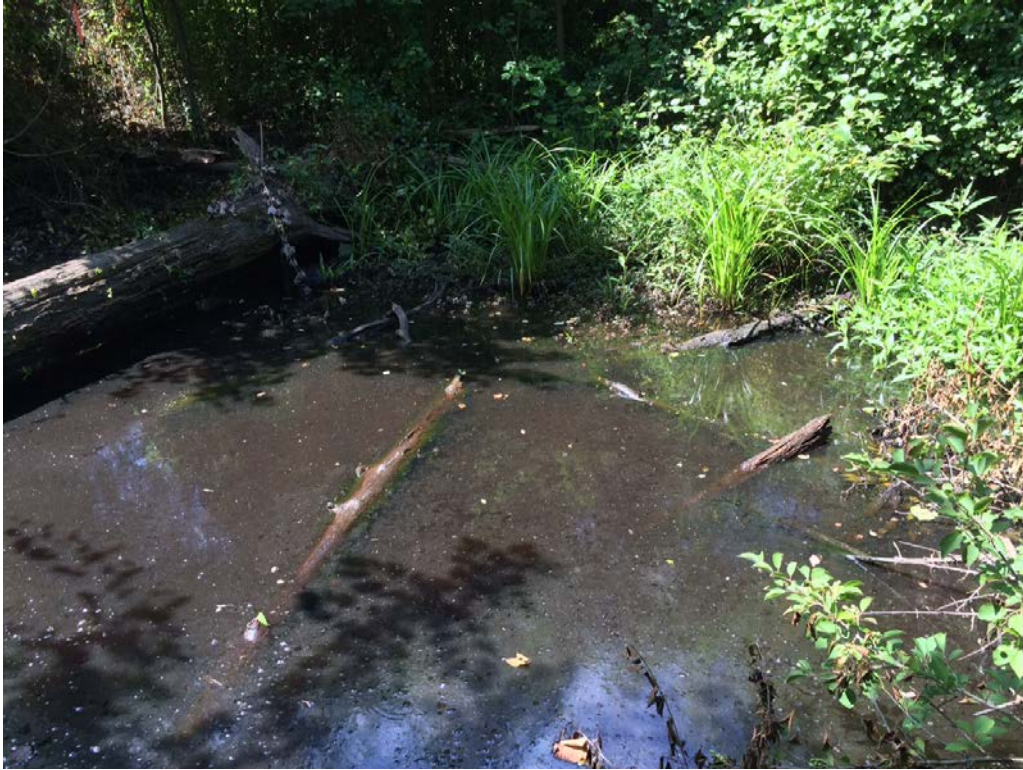
Waterbody sgrp004 facing southwest across bank.

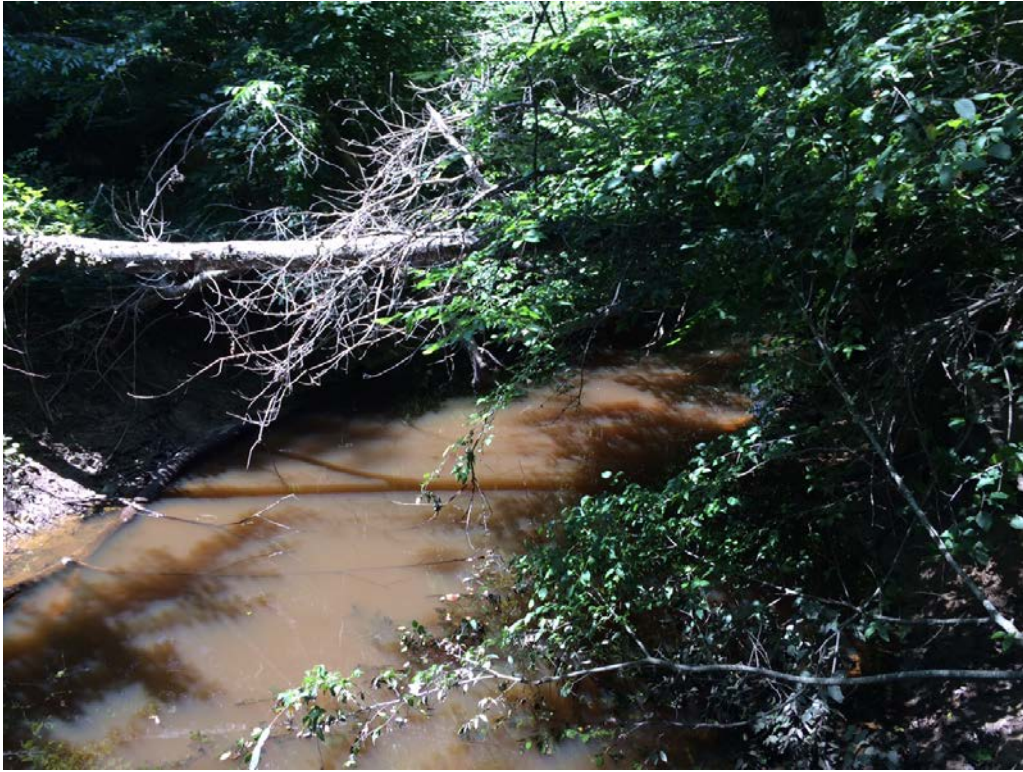
Waterbody sgrp005 facing west upstream.

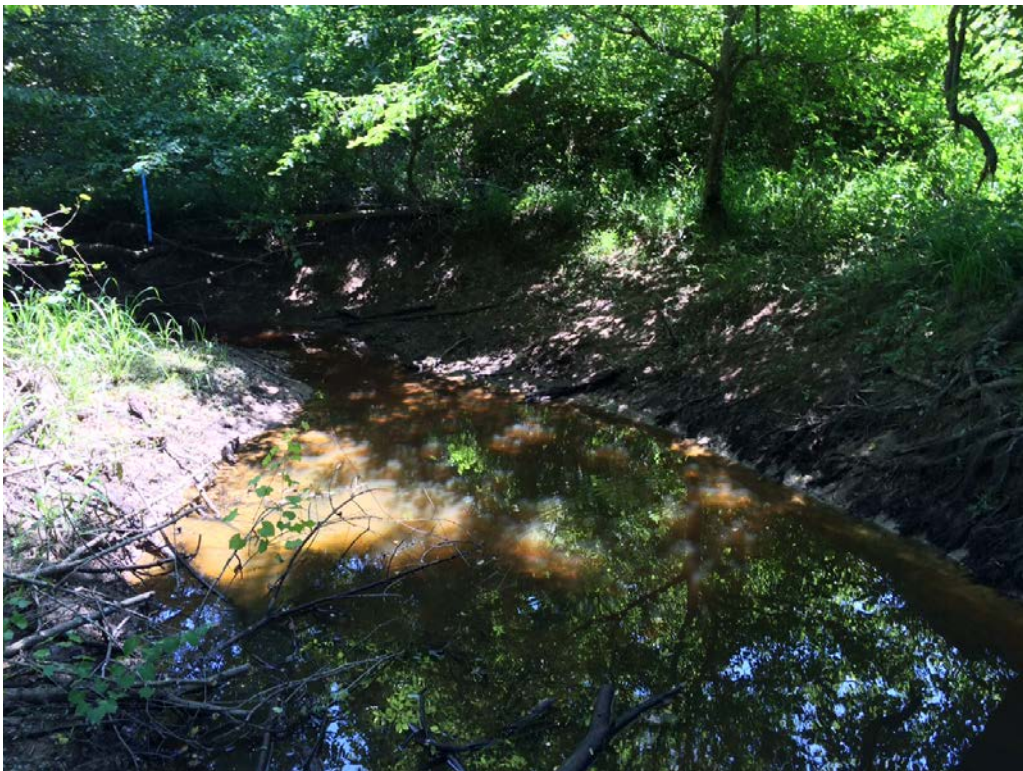
Waterbody sgrp005 facing east downstream.

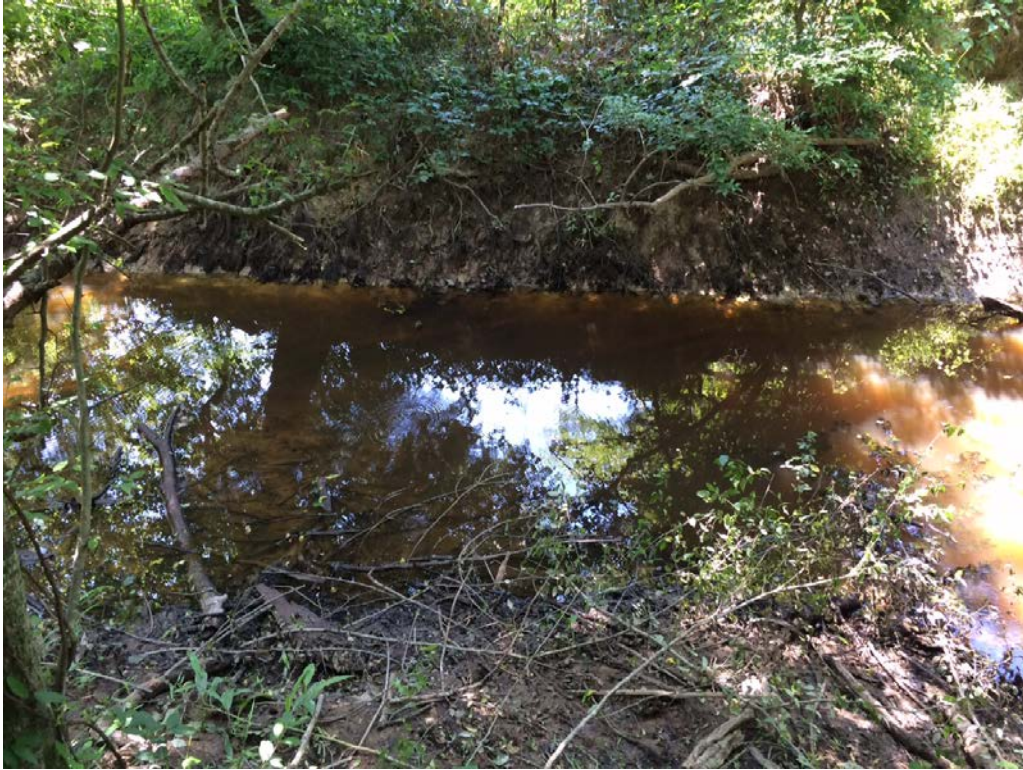
Waterbody sgrp005 facing south across bank.

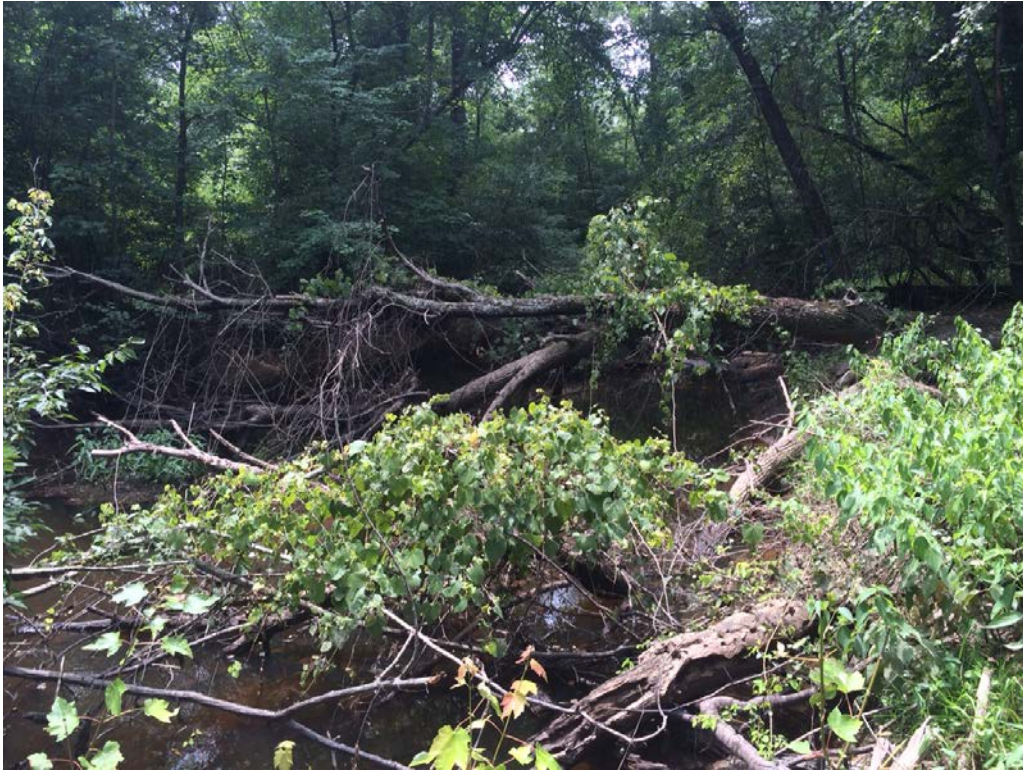
Waterbody sgro002 facing west upstream.

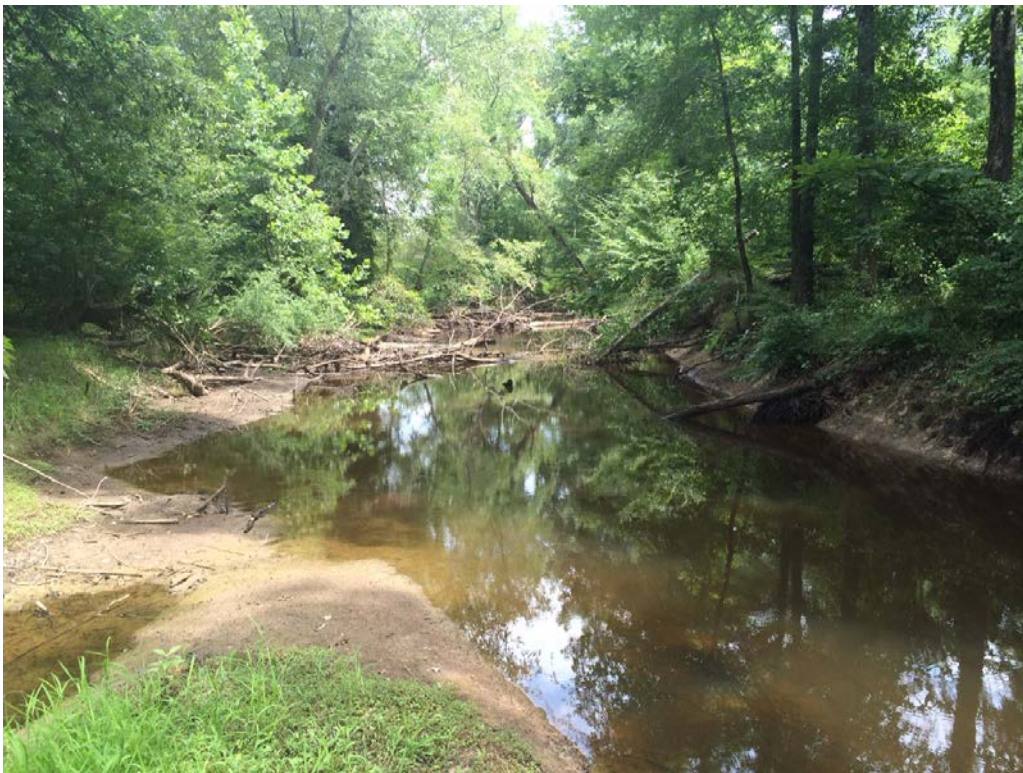
Waterbody sgro002 facing east downstream.

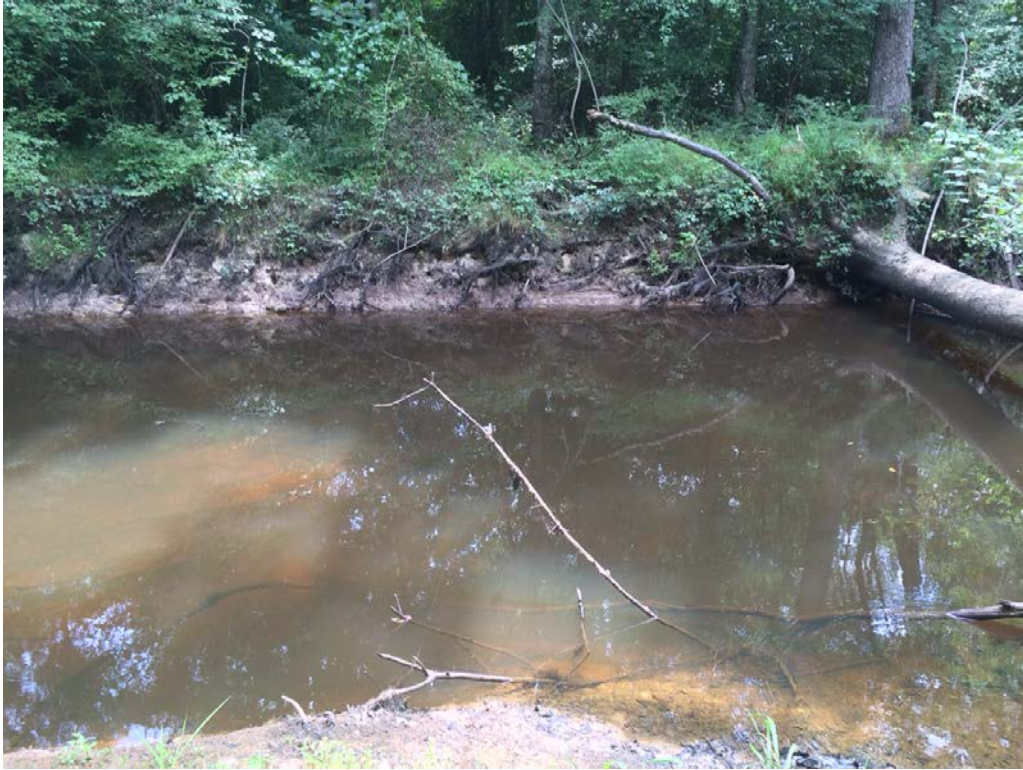
Waterbody sgro002 facing south across bank.

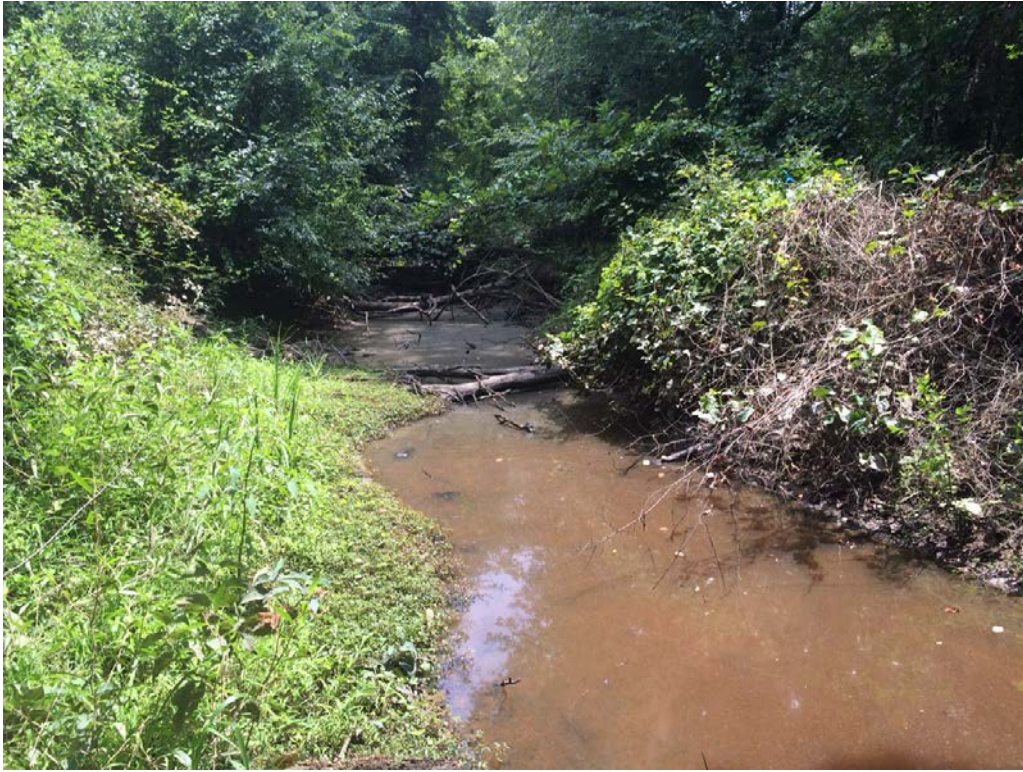
Waterbody sgro001 facing southeast upstream.

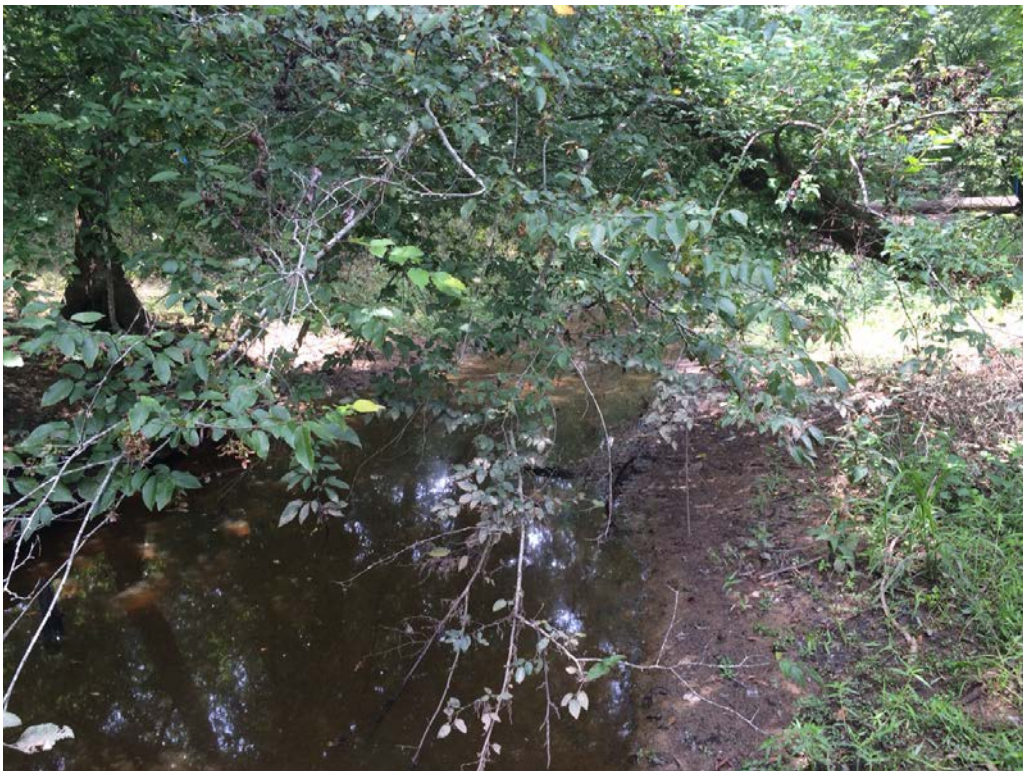
Waterbody sgro001 facing northwest downstream.

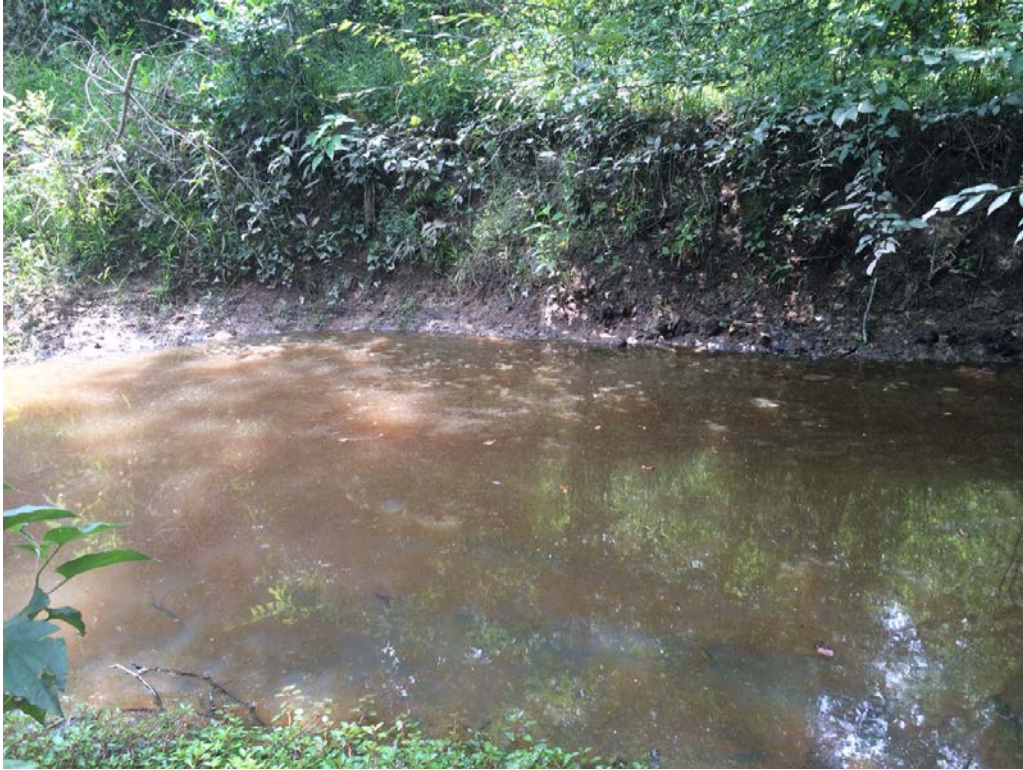
Waterbody sgro001 facing southwest across bank.
