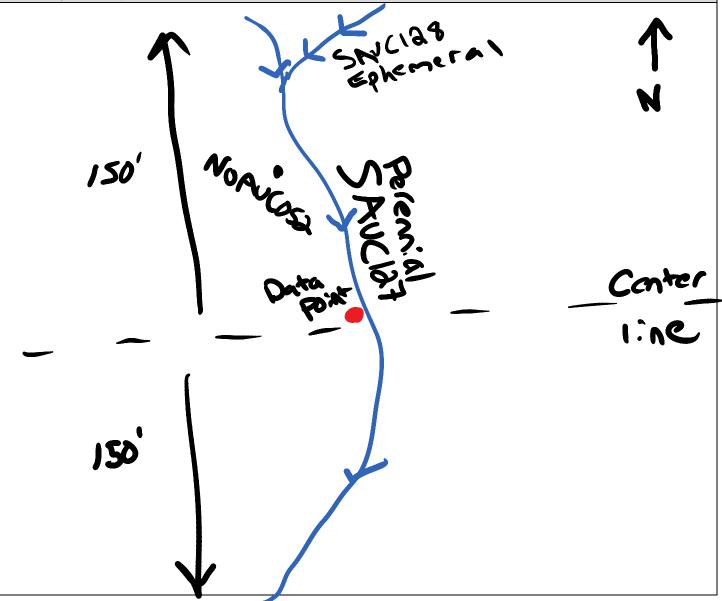
ivestock have historically had access to the stream and have altered hydrology

Waterbody SAUC127 facing northeast upstream

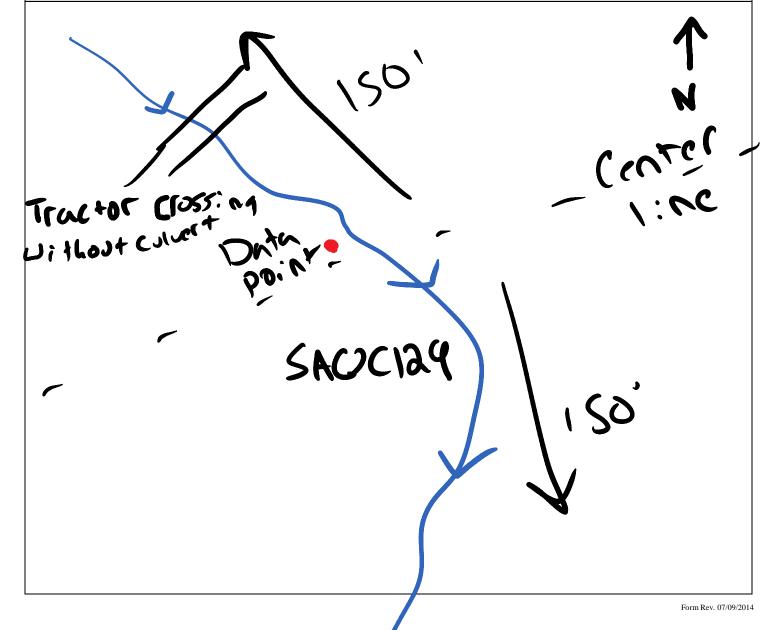
Highly degraded stream that contains hammocks from cattle access,, manure, and algae. The banks are highly susceptible to erosion.

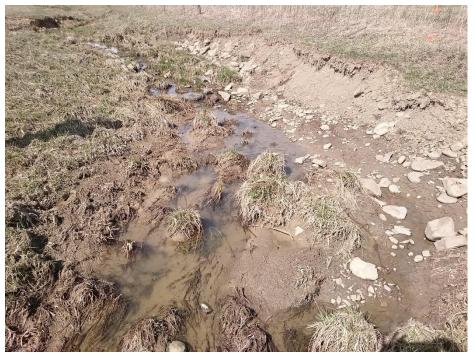
Waterbody SAUC129 facing north upstream

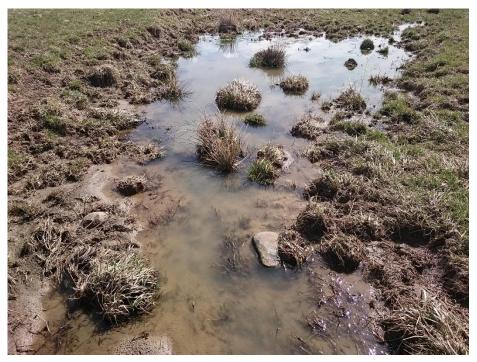
Waterbody SAUC129 facing south downstream

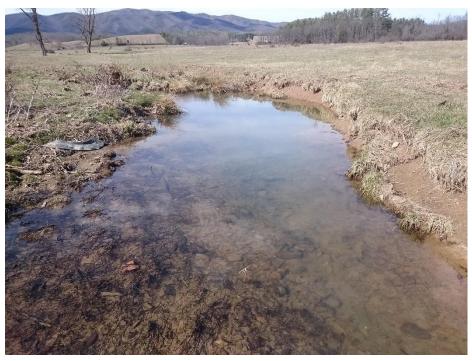
Highly degraded stream that contains hammocks from cattle access. The banks are highly susceptible to erosion.

Waterbody SAUC131 facing north upstream

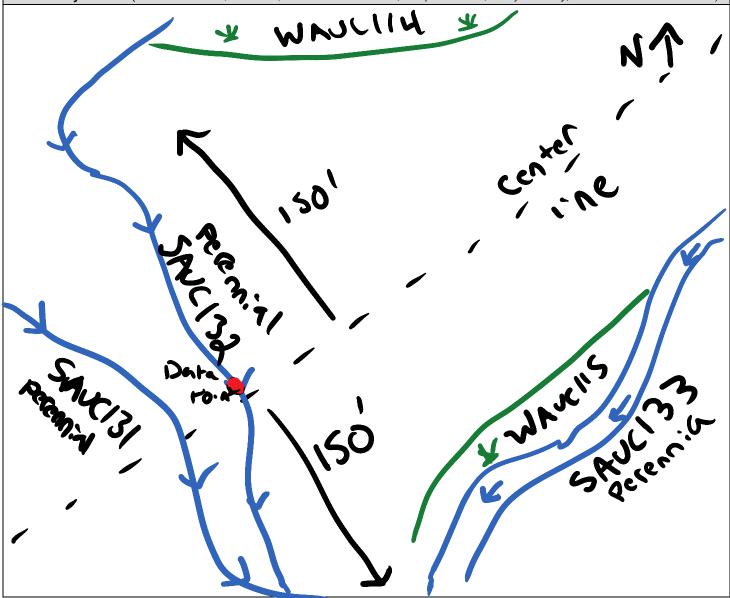
Stream has cattle access. The banks are slightly susceptible to erosion.

Waterbody SAUC132 facing northeast upstream

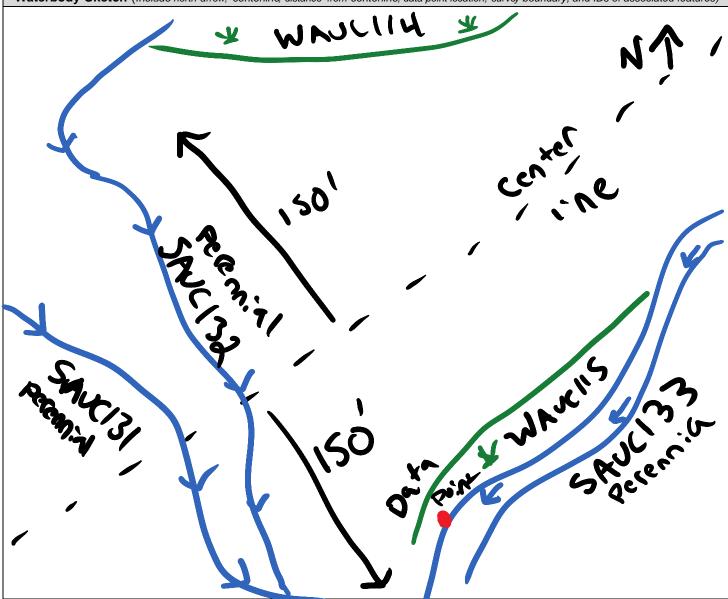
Stream has cattle access and manure in stream. The banks are highly susceptible to erosion. SAUR010 is part of SAUC133. This stream was extended to include that part of the stream.

Waterbody SAUC133 facing northeast upstream

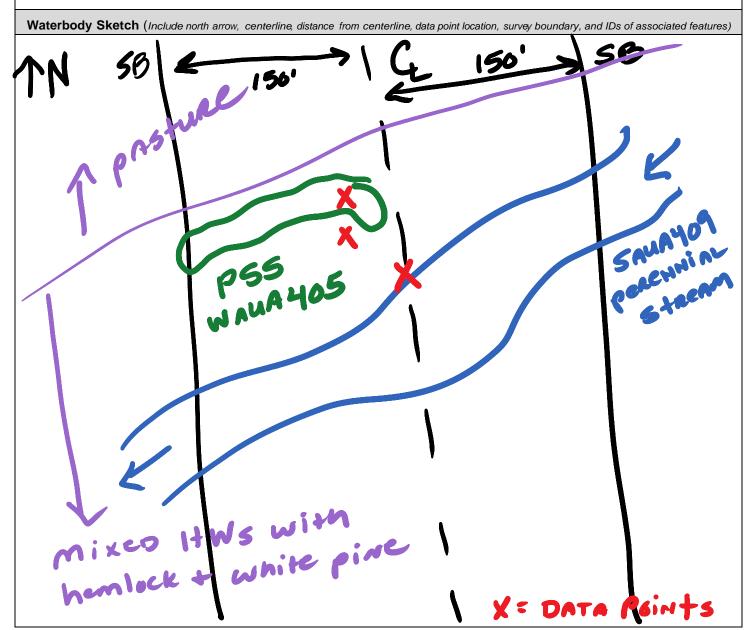
Stream continues out of corridor in both directions; PSS wetland waua405 located on floodplain but there is no surface connection between features; Mixed hardwoods with hemlock and white pine; canopy thin in places due to mortality caused by beavers.

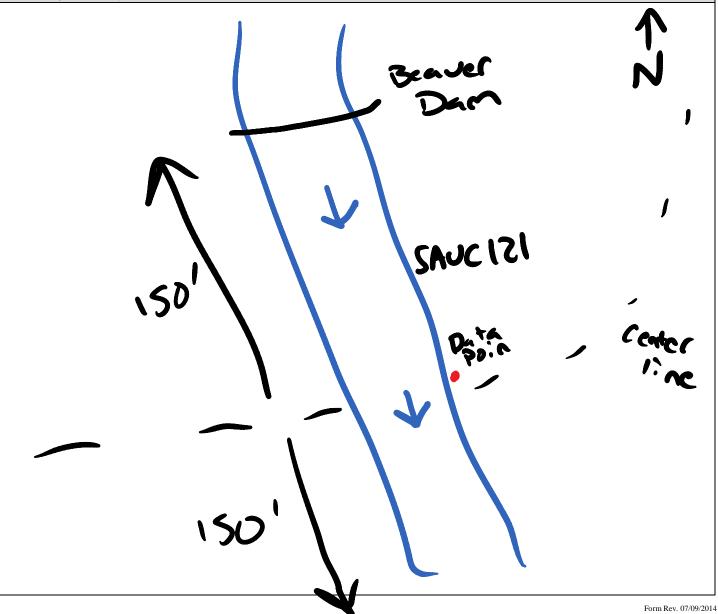
Stream is partially dammed by beaver

Waterbody SAUC121 facing north upstream
