Linear Waterbody Data Sheet

Survey Description			
Project Name: Atlantic Coast Pipeline		Waterbody Name: UNT to Calfpasture River	
Waterbody ID: SAUB105		Date: 4/23/2015	
State: Virginia	County: Augusta	Company: NRG	Crew Member Initials: TP, AS
Photos: 01-03			
Tract Number(s): 07-001-A005, 07-001-A007		Nearest Milepost: 110.55	Associated Wetland ID(s): WAUB100
Survey Type: <small>(check one)</small> <input checked="" type="checkbox"/> Centerline <input type="checkbox"/> Re-Route <input type="checkbox"/> Access Road <input type="checkbox"/> Other:			
Physical Attributes			
Stream Classification: <small>(check one)</small> <input type="checkbox"/> Ephemeral <input checked="" type="checkbox"/> Intermittent <input type="checkbox"/> Perennial			
Waterbody Type: <small>(check one)</small> <input type="checkbox"/> River <input checked="" type="checkbox"/> Stream <input type="checkbox"/> Ditch <input type="checkbox"/> Canal <input type="checkbox"/> Other:

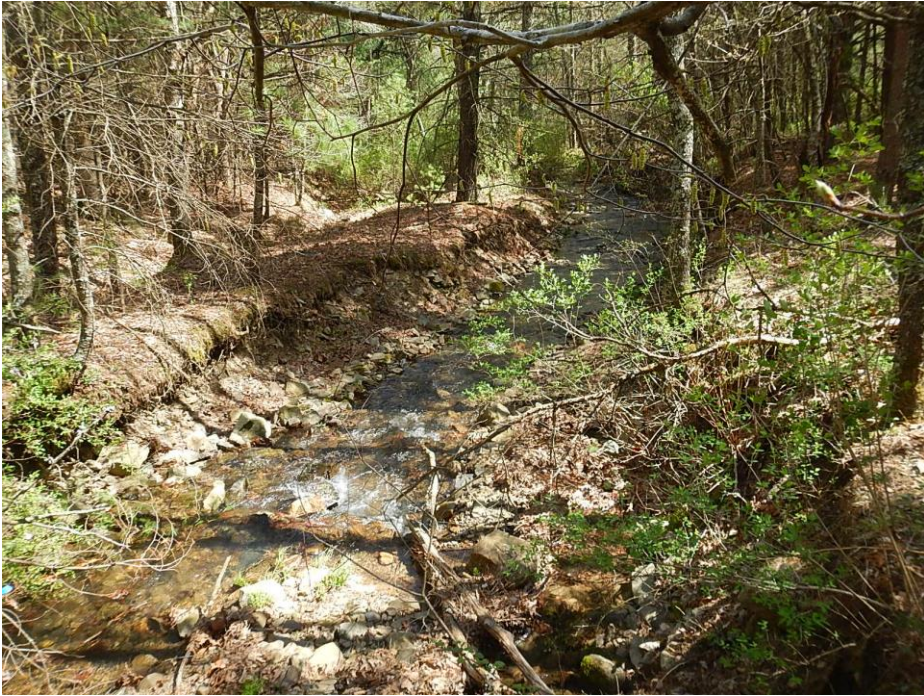
Waterbody SAUB104 facing south downstream

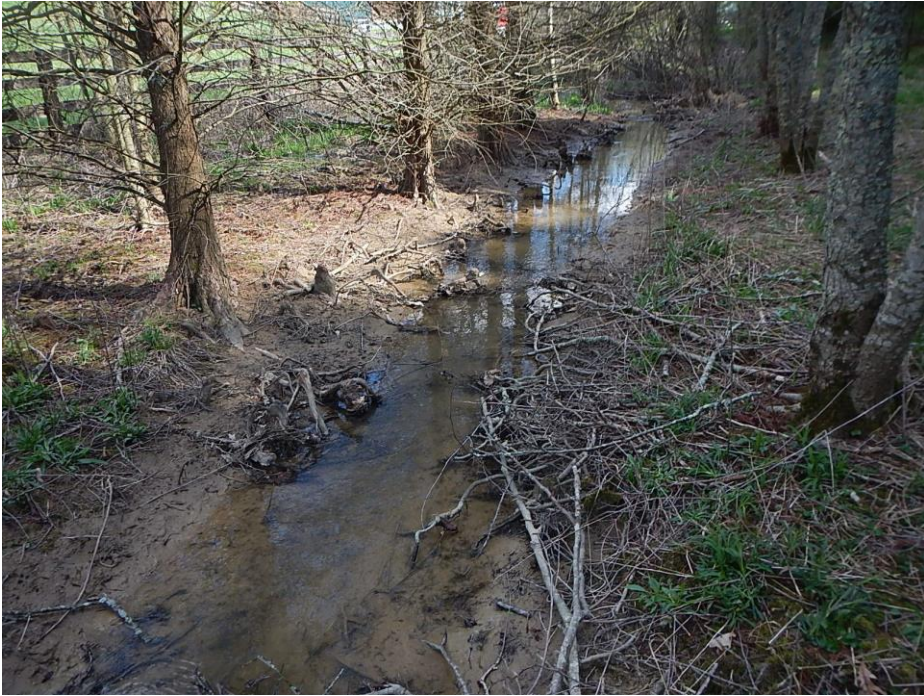
Waterbody SAUB105 facing south downstream

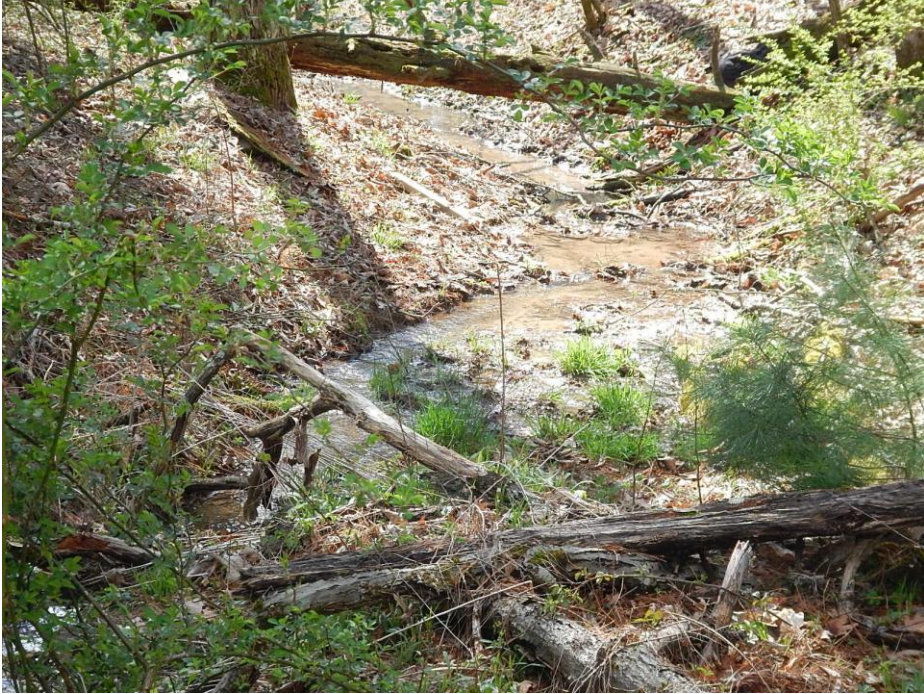
Waterbody SAUB106 facing southeast downstream

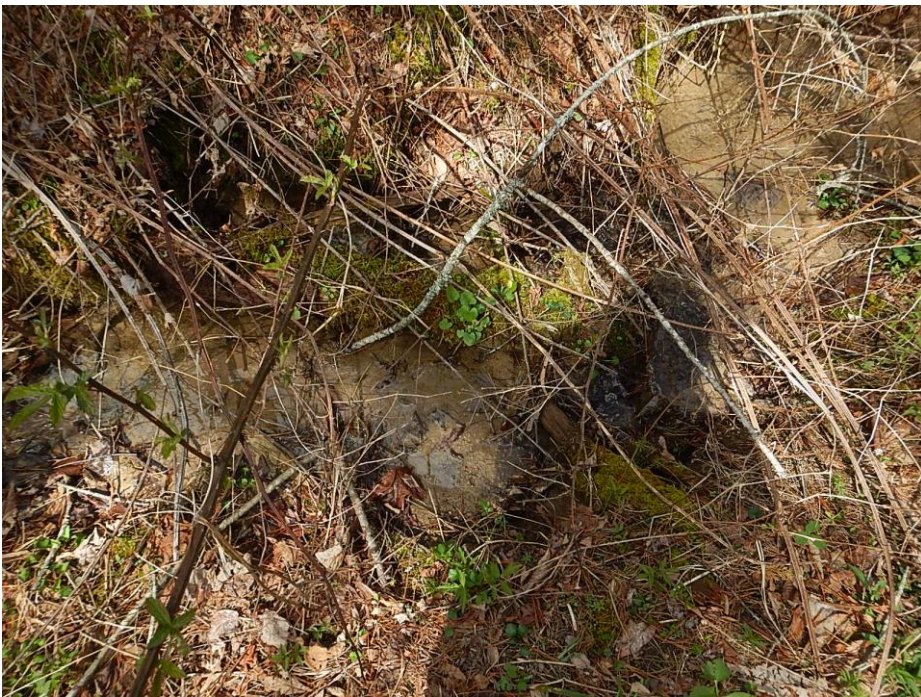
Waterbody SAUB107 facing west across

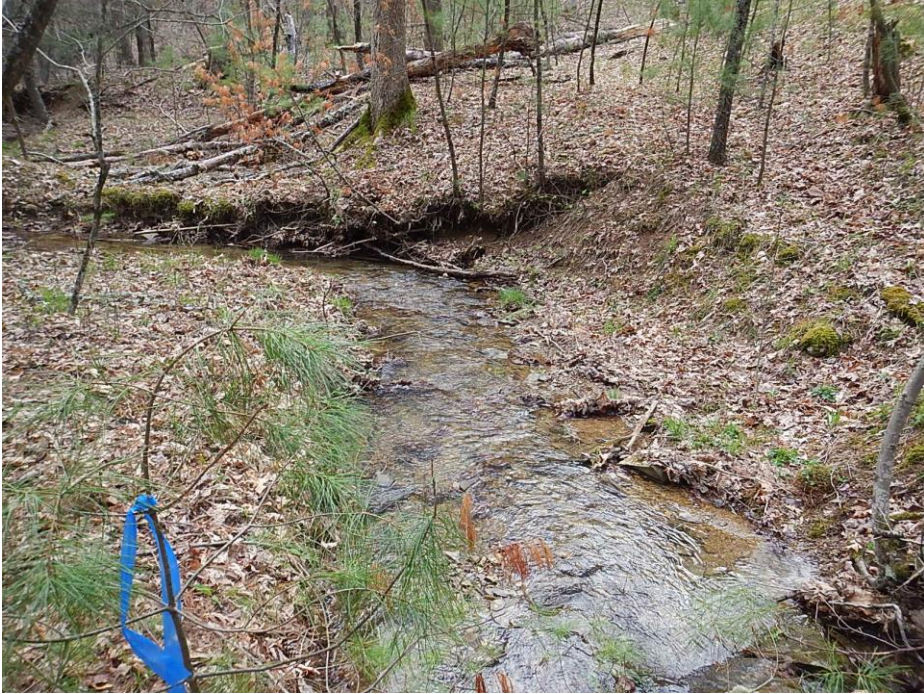
Waterbody SAUB109 facing south downstream

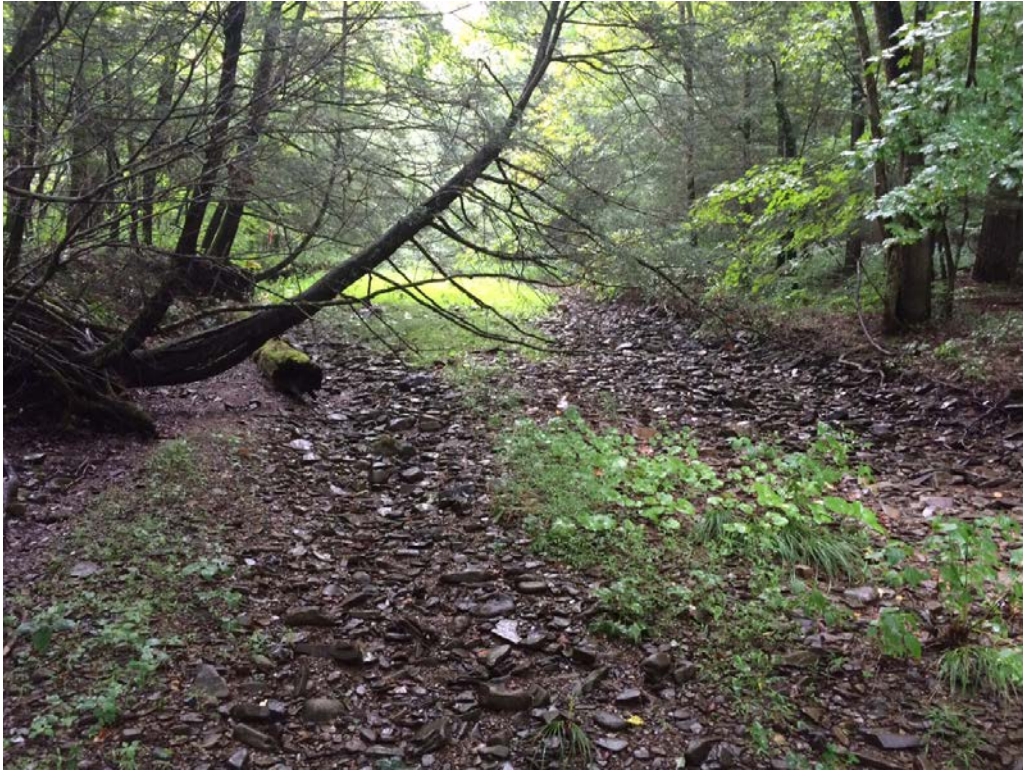
Waterbody sau435 facing north upstream.

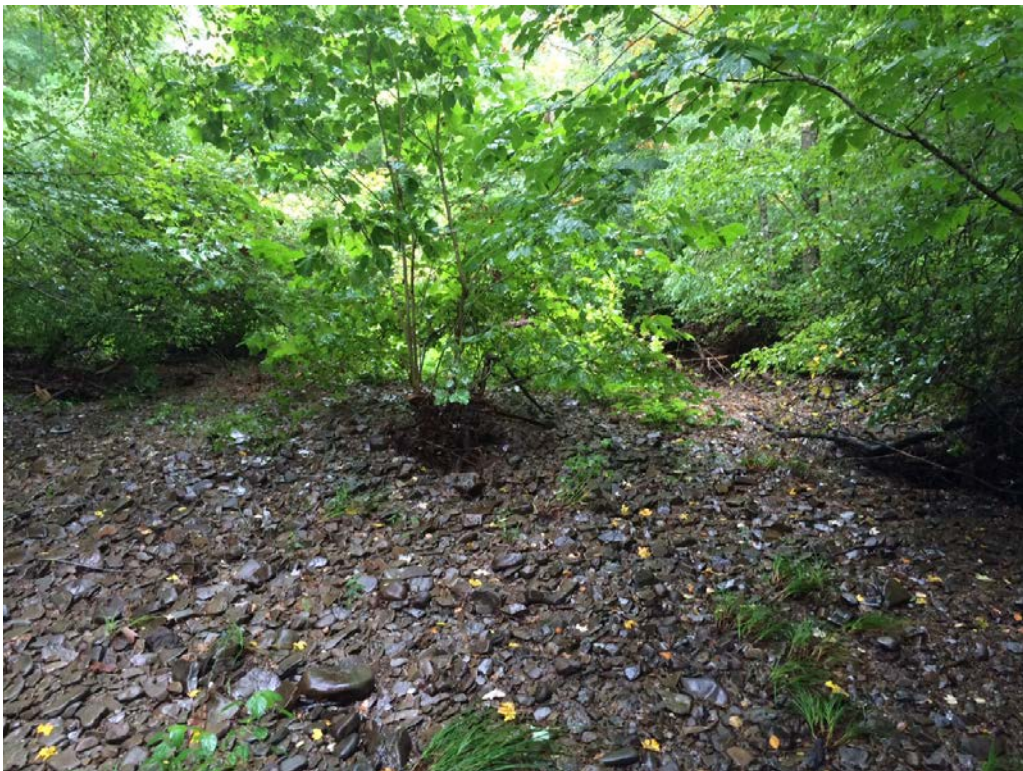
Waterbody sau435 facing south downstream.

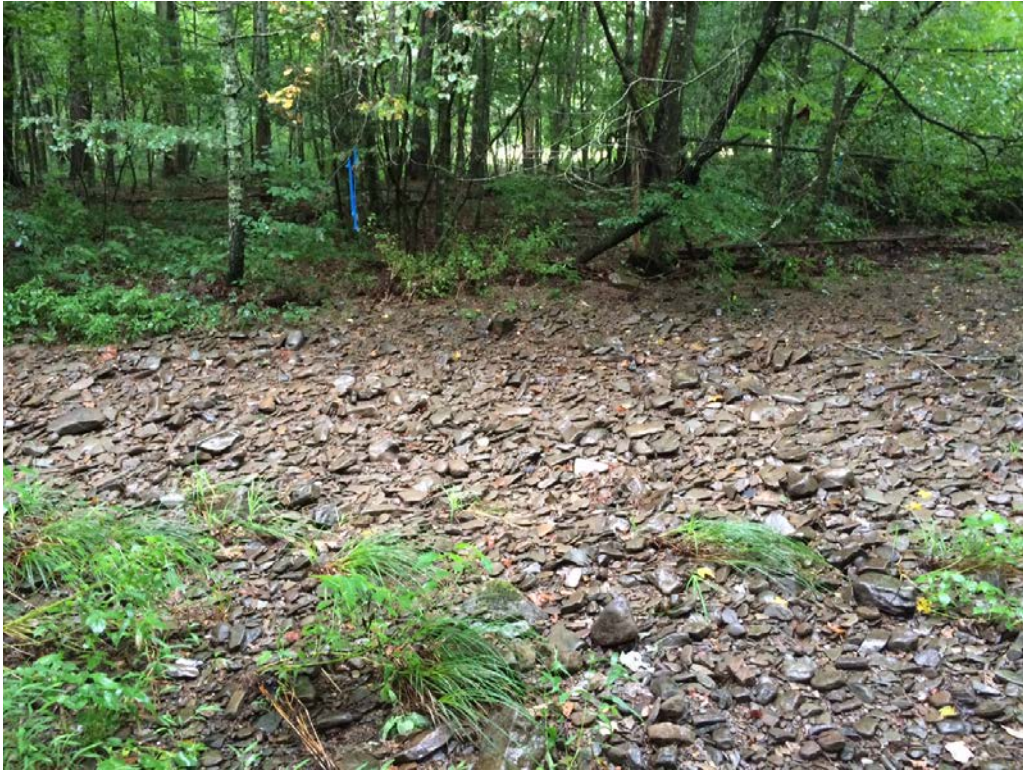
Waterbody saua435 facing east across bank.

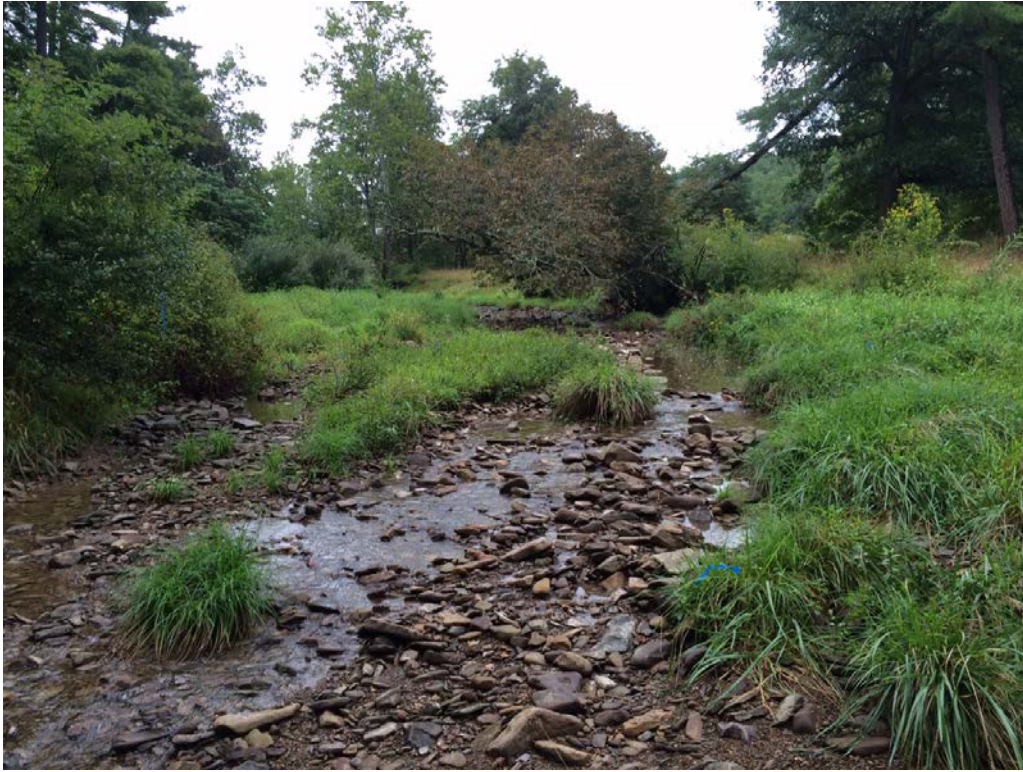
Waterbody saup004 facing northeast upstream.

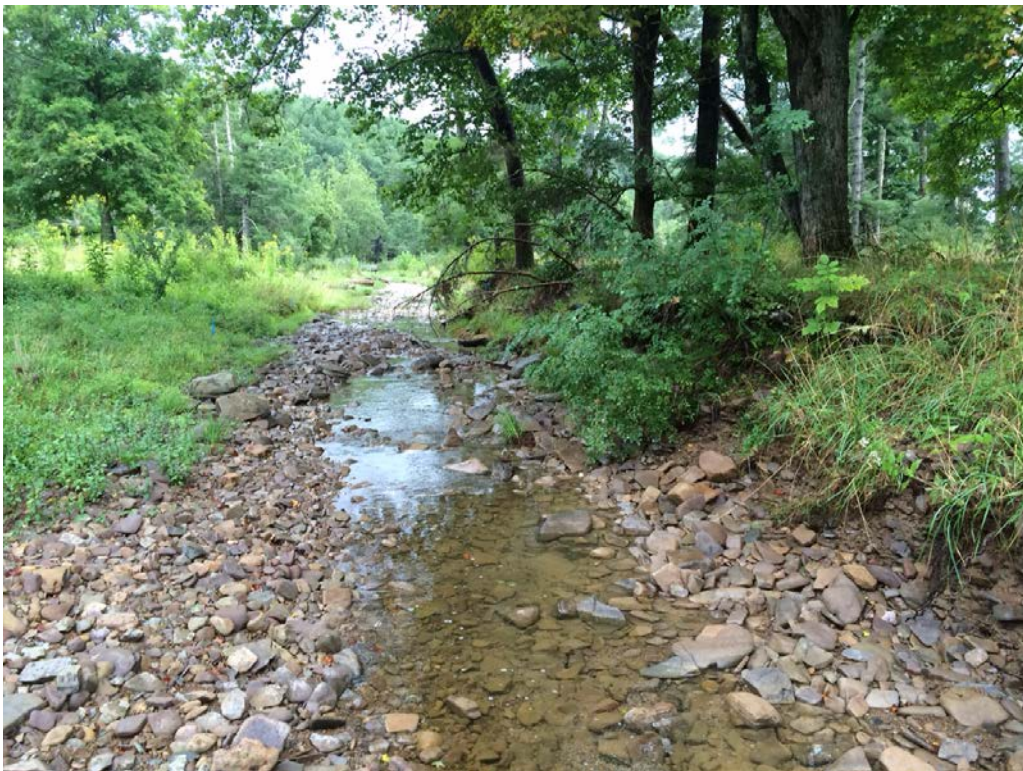
Waterbody saup004 facing south downstream.

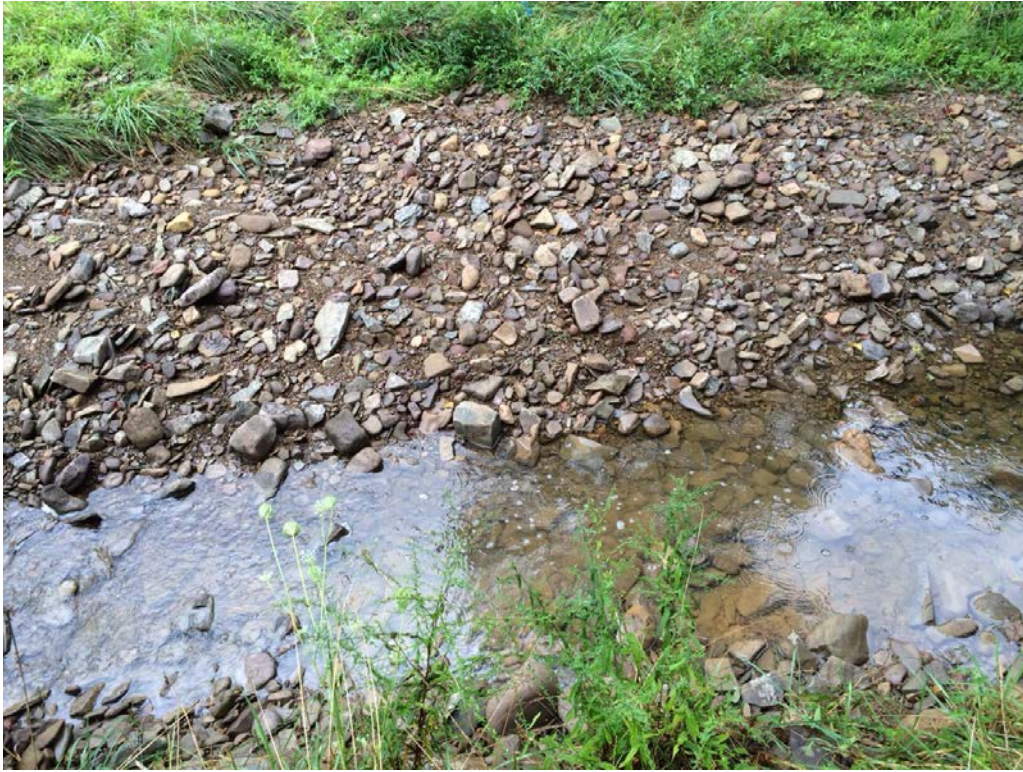
Waterbody saup004 facing east across bank.

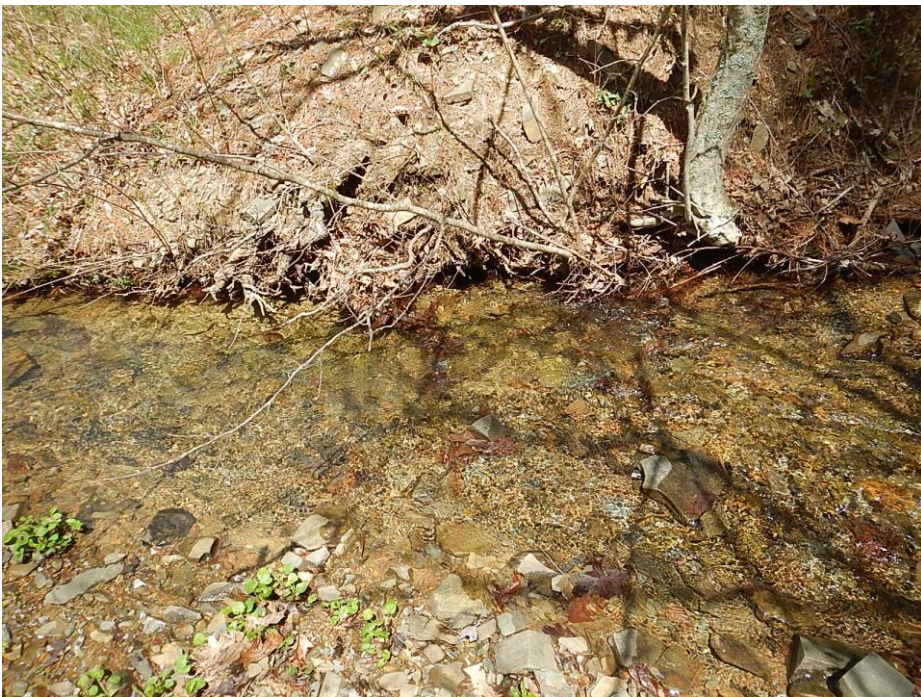
Waterbody SAUA420 facing north across

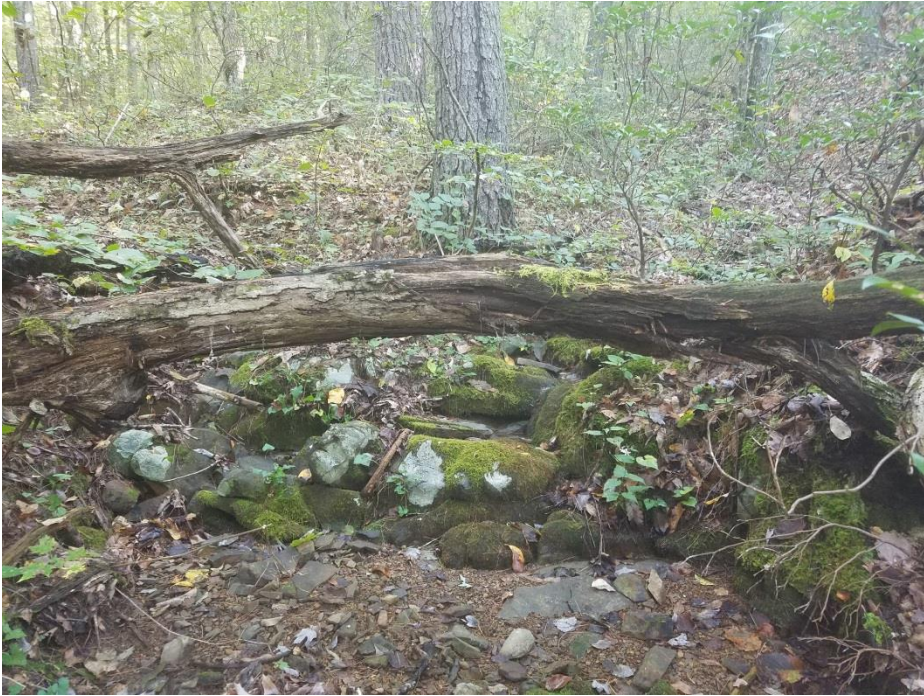
Waterbody sau419 headcut

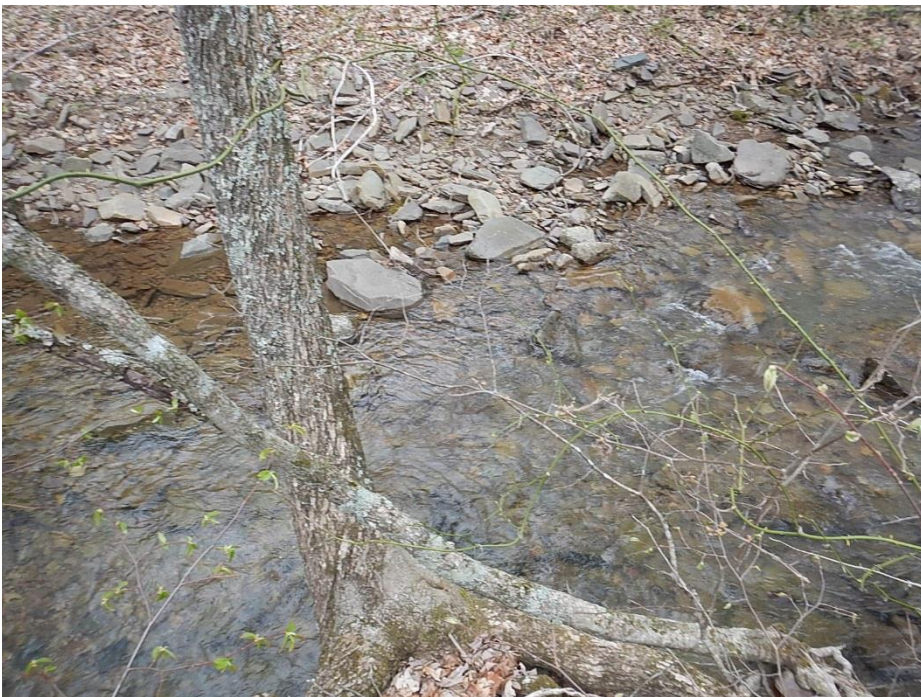
Waterbody SAUA424 facing west across

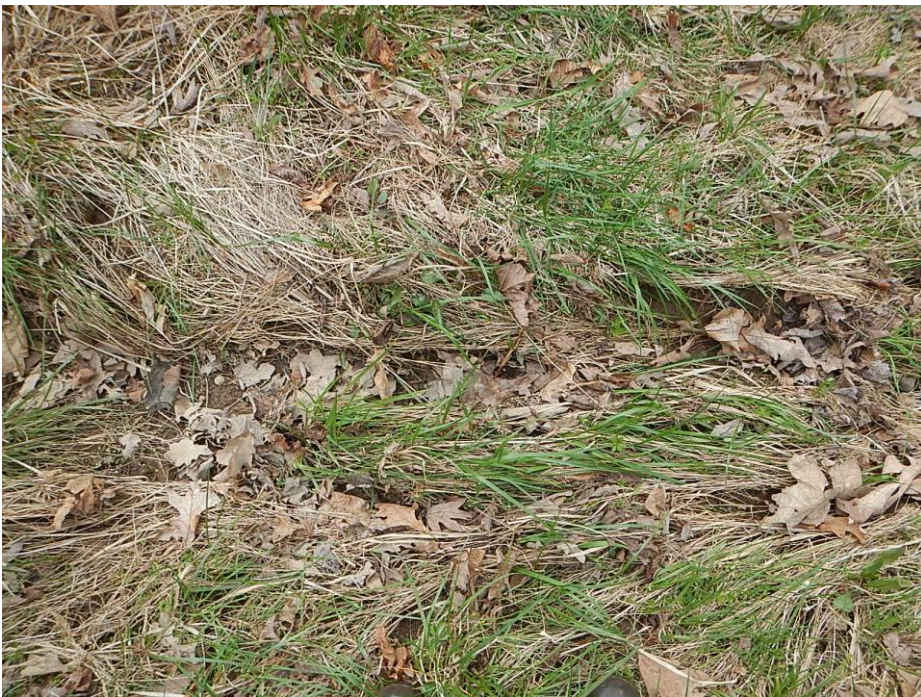
Waterbody SAUA425 facing east across

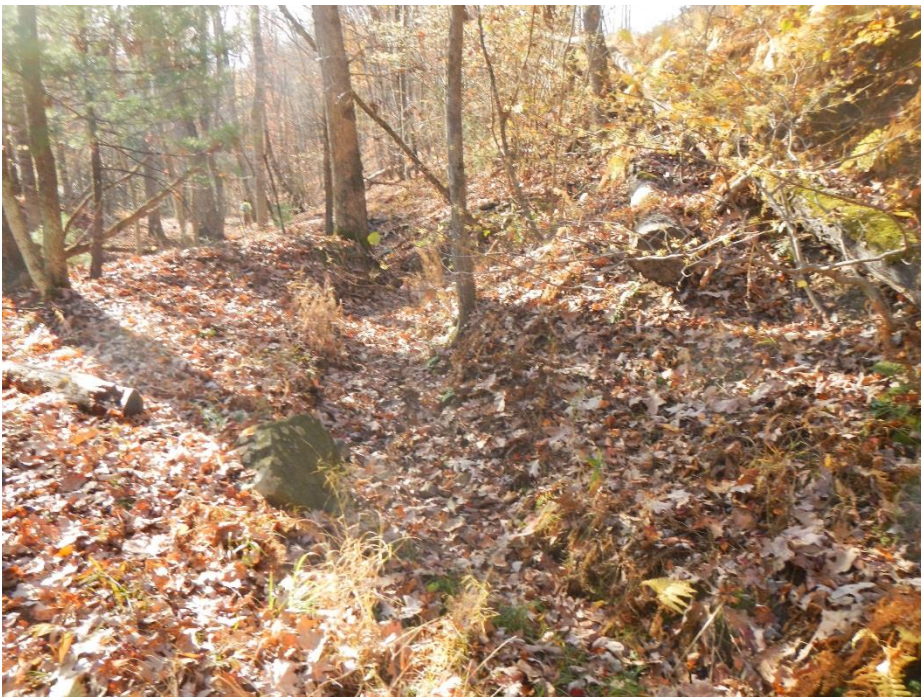
SAUB013 facing south downstream

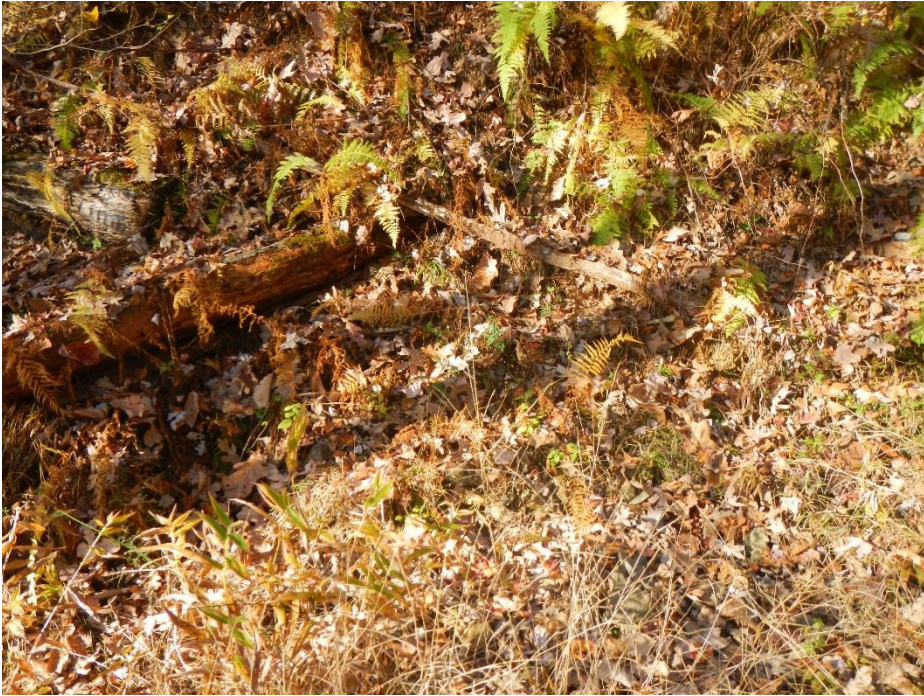
SAUB013 facing west across

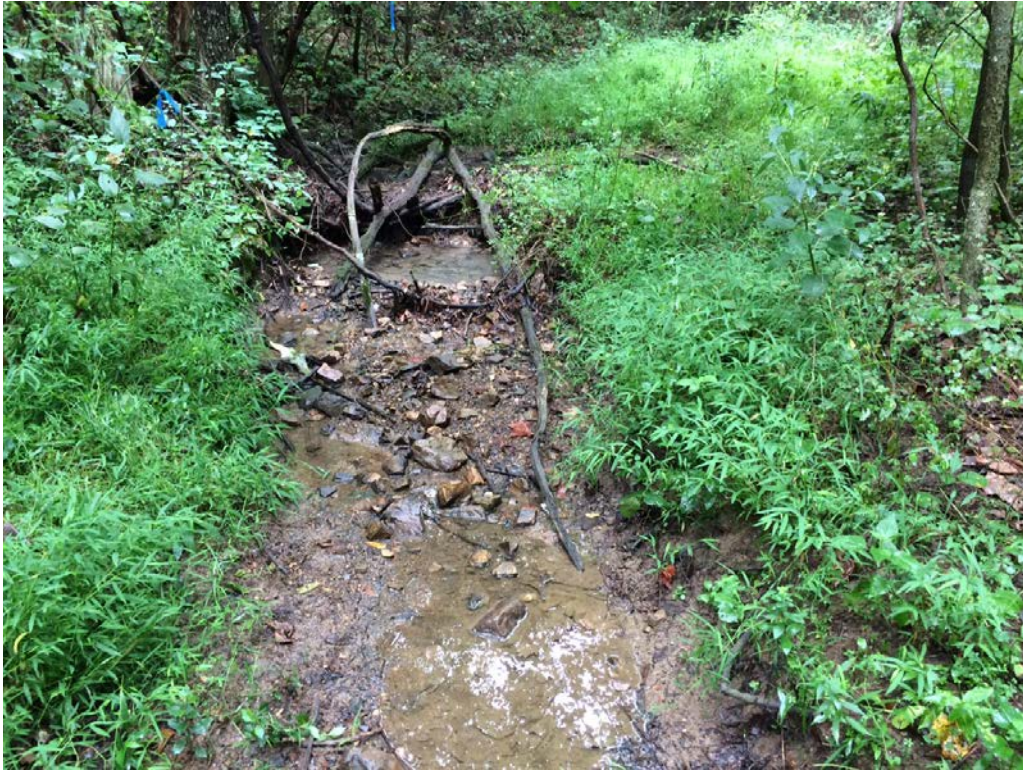
Waterbody saup006 facing northwest upstream.

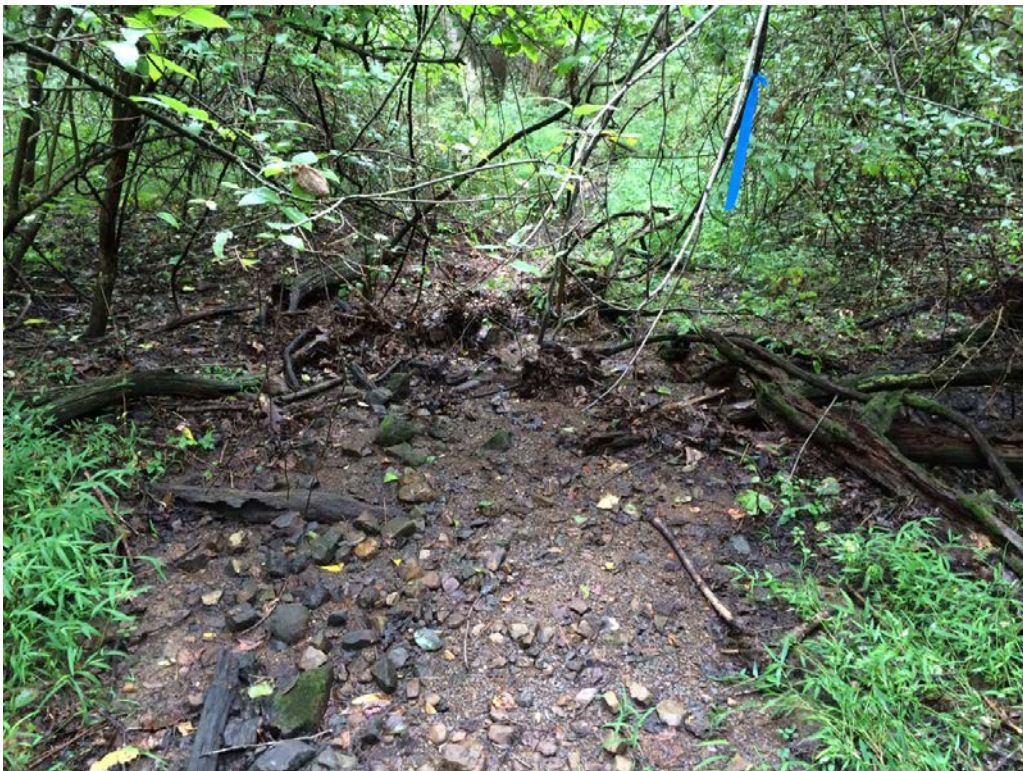
Waterbody saup006 facing southeast downstream.

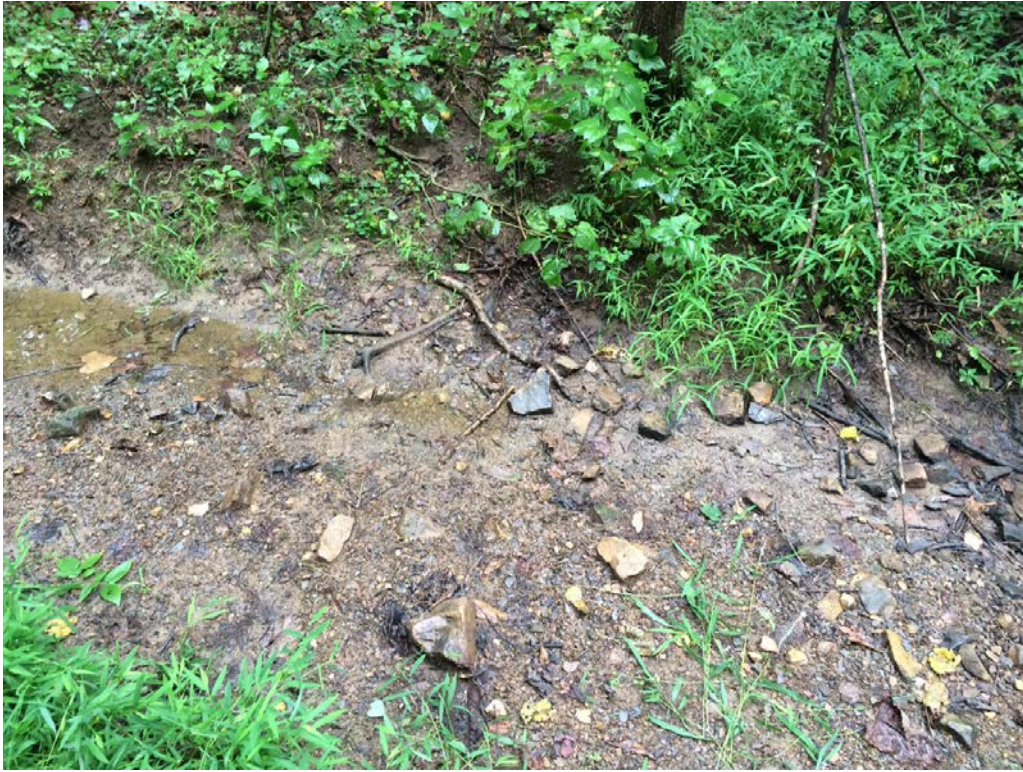
Waterbody saup006 facing northeast across bank.

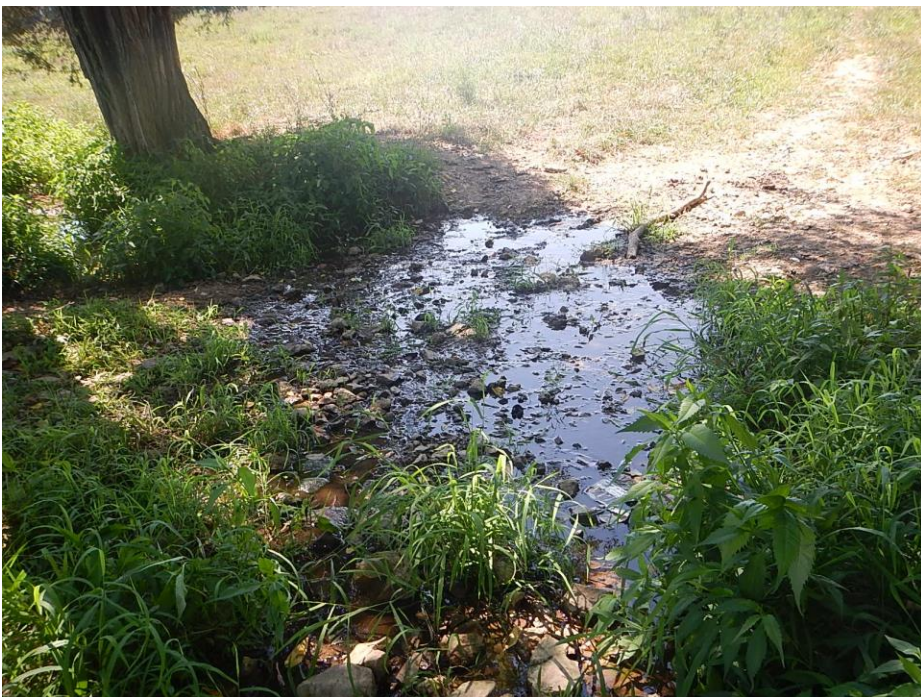
Degraded intermittent stream in cattle pasture. Noted bank failures due to livestock access, which has create fringe wetlands on either side of stream.

Waterbody SAUB119 facing south downstream

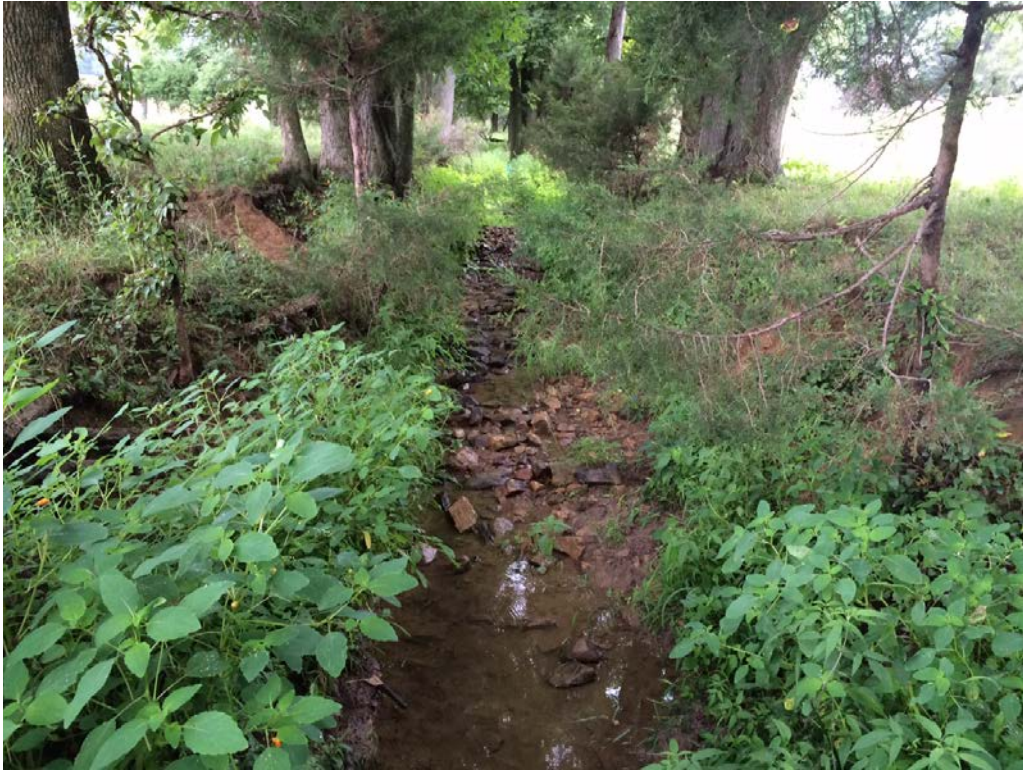
Waterbody saup005 facing north upstream.

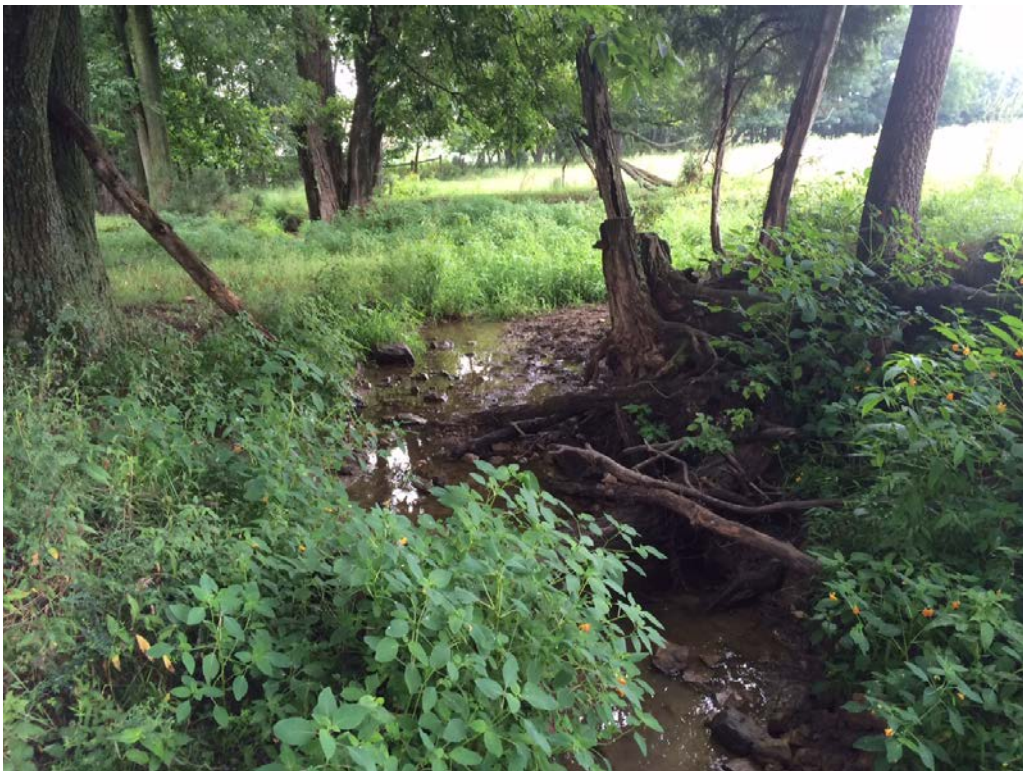
Waterbody saup005 facing south downstream.

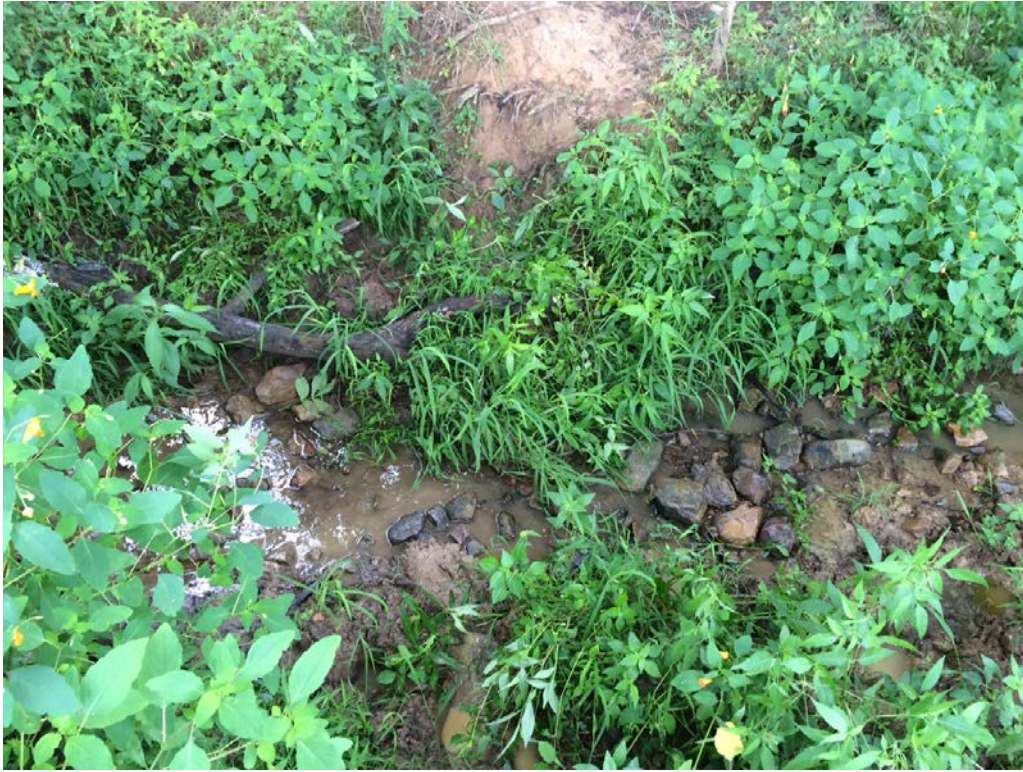
Waterbody saup005 facing east across bank.

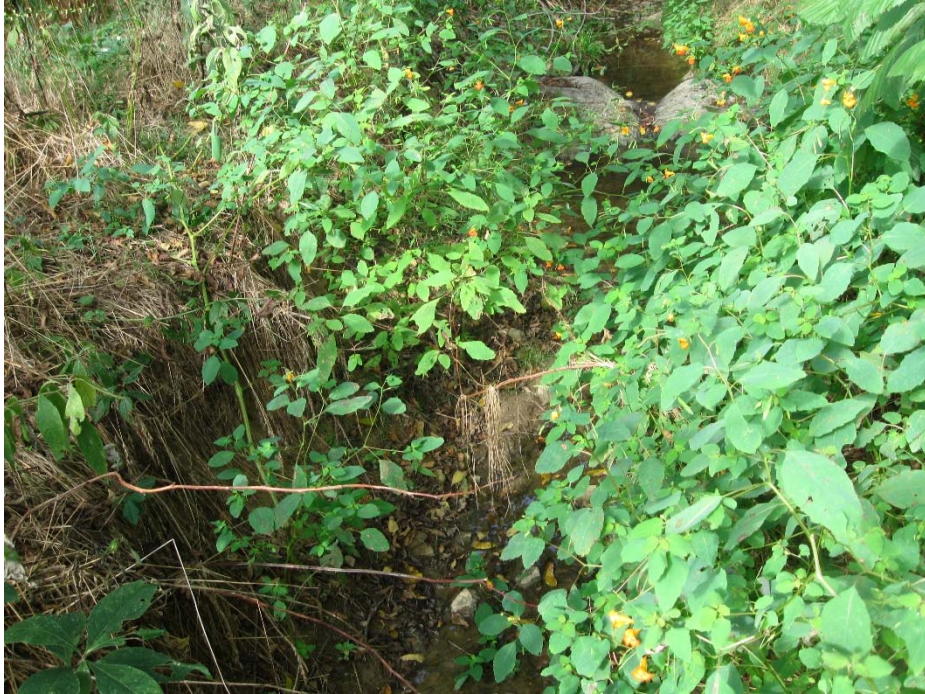
Waterbody SAUB004 facing west upstream

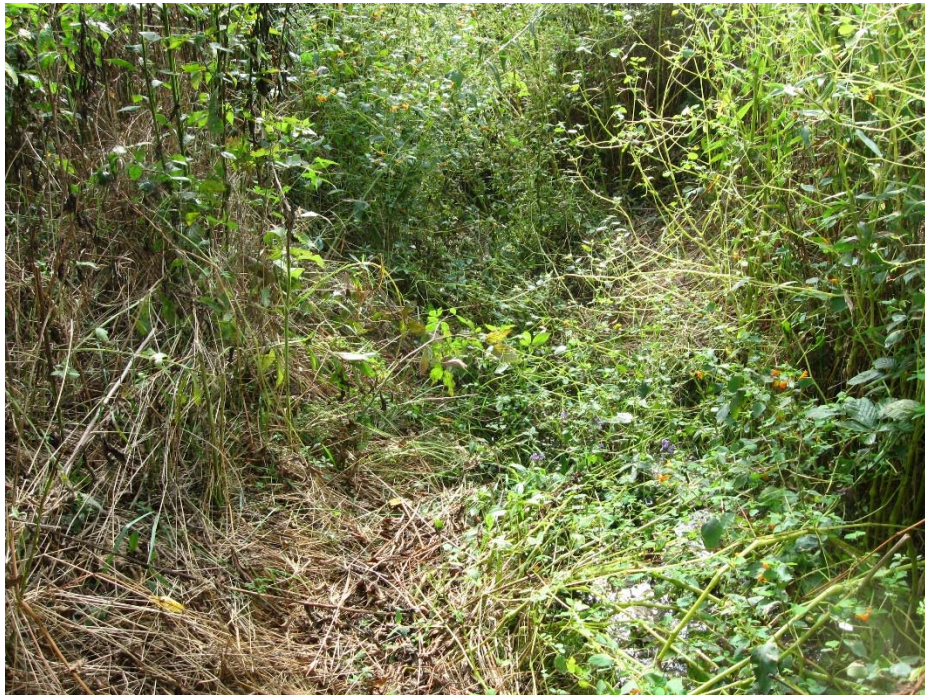
Waterbody SAUB004 facing east downstream

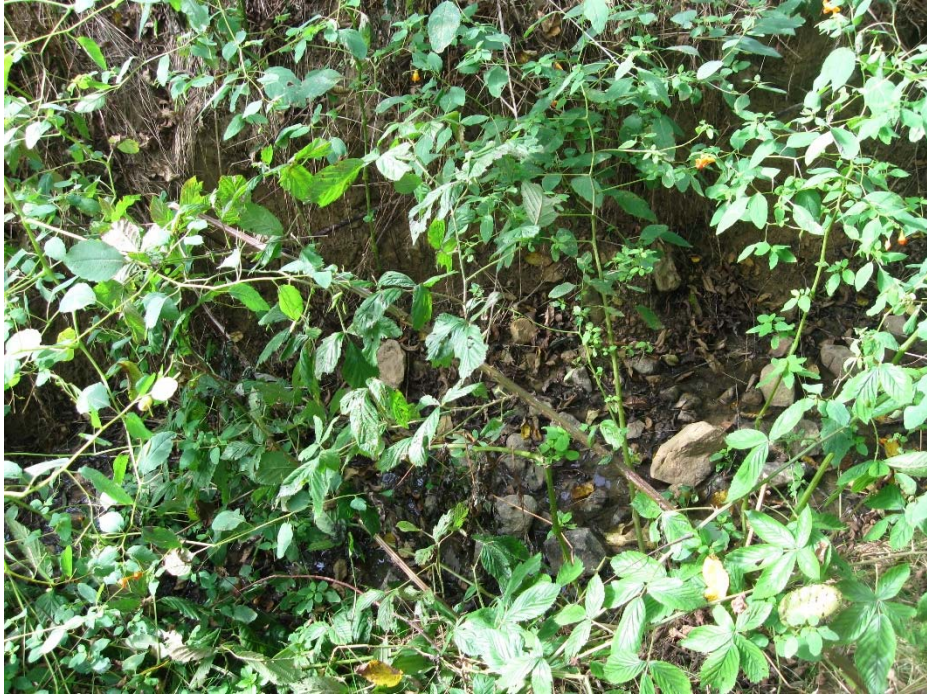
Waterbody SAUB004 facing south across

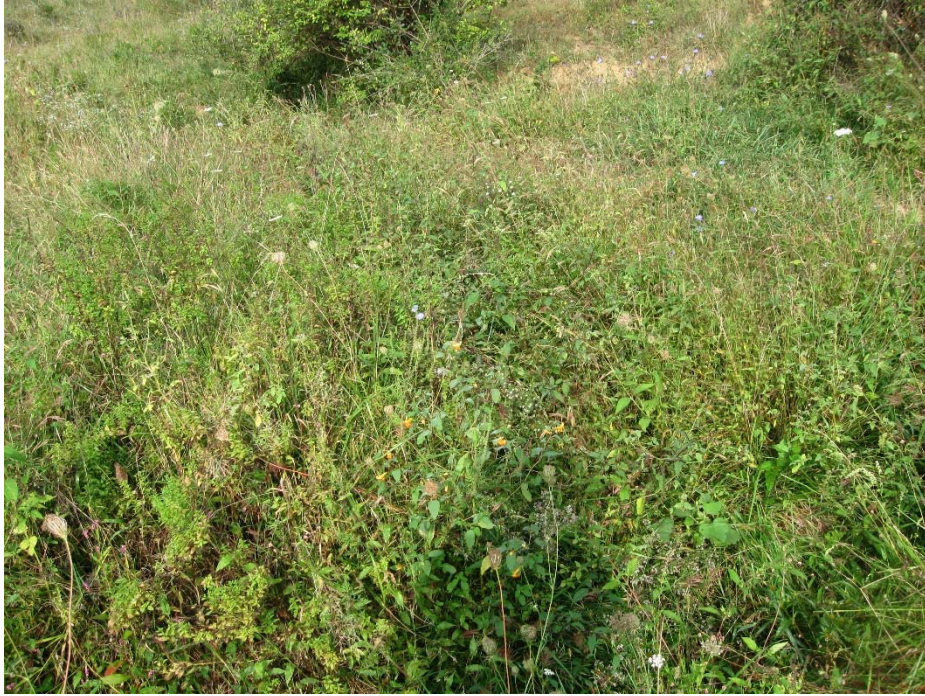
Waterbody SAUB003 facing west upstream

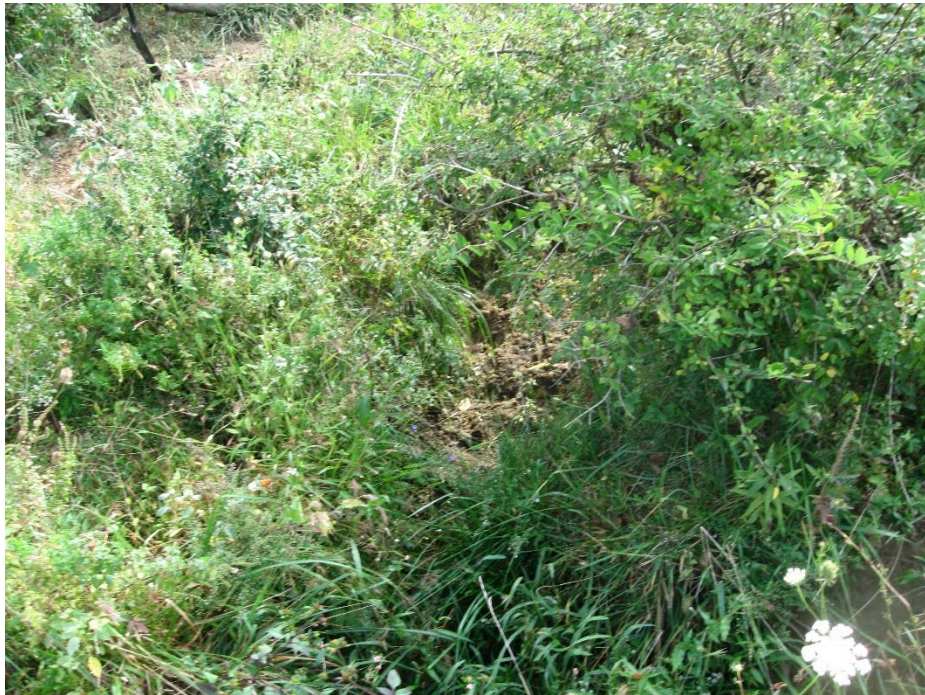
Waterbody SAUB003 facing east downstream

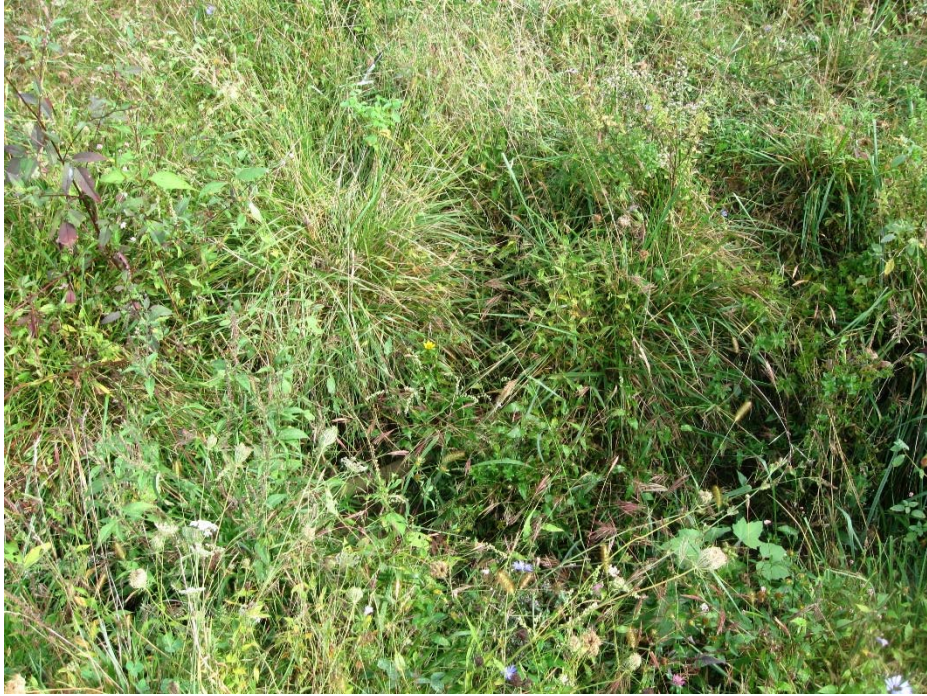
Waterbody SAUB003 facing north across

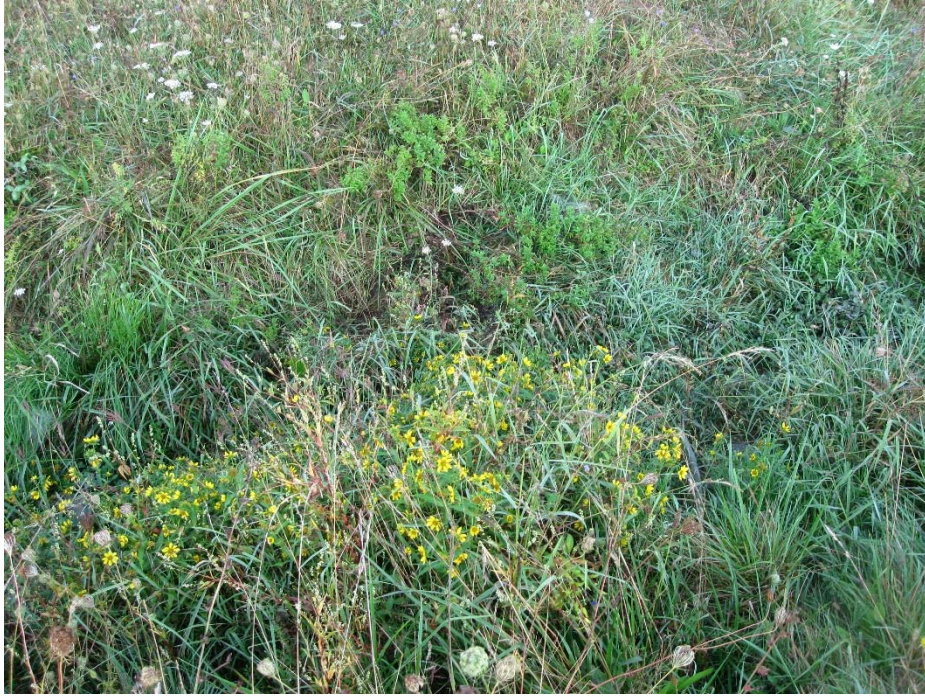
Waterbody SAUB002 facing west upstream

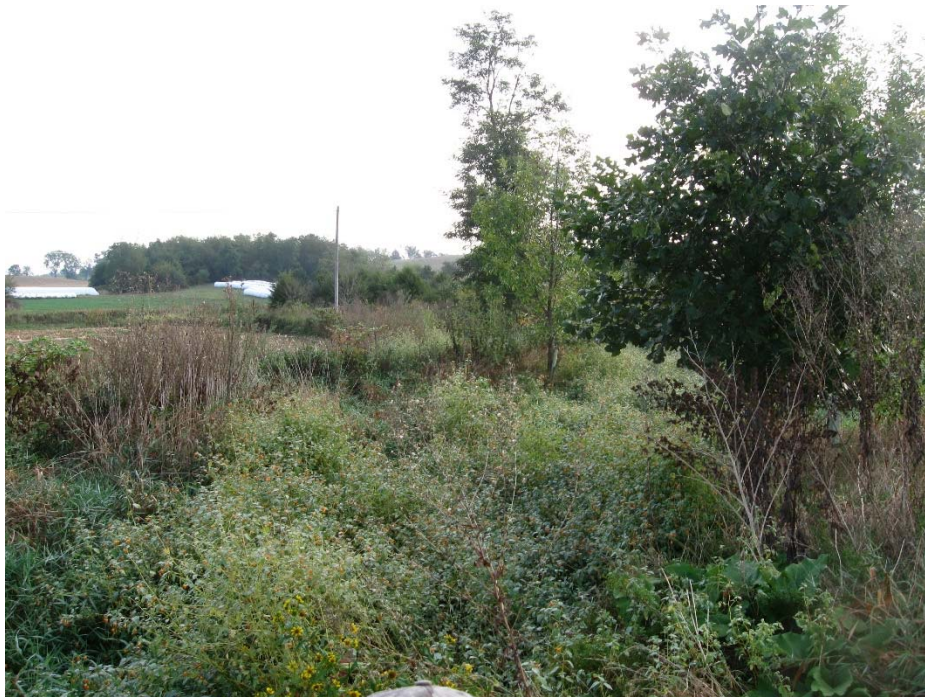
Waterbody SAUB002 facing east downstream
