Linear Waterbody Data Sheet

Survey Description			
Project Name: Atlantic Coast Pipeline		Waterbody Name: UNT to Calfpasture River	
Waterbody ID: SAUB105		Date: 4/23/2015	
State: Virginia	County: Augusta	Company: NRG	Crew Member Initials: TP, AS
Photos: 01-03			
Tract Number(s): 07-001-A005, 07-001-A007		Nearest Milepost: 110.55	Associated Wetland ID(s): WAUB100
Survey Type: <small>(check one)</small> <input checked="" type="checkbox"/> Centerline <input type="checkbox"/> Re-Route <input type="checkbox"/> Access Road <input type="checkbox"/> Other:			
Physical Attributes			
Stream Classification: <small>(check one)</small> <input type="checkbox"/> Ephemeral <input checked="" type="checkbox"/> Intermittent <input type="checkbox"/> Perennial			
Waterbody Type: <small>(check one)</small> <input type="checkbox"/> River <input checked="" type="checkbox"/> Stream <input type="checkbox"/> Ditch <input type="checkbox"/> Canal <input type="checkbox"/> Other:

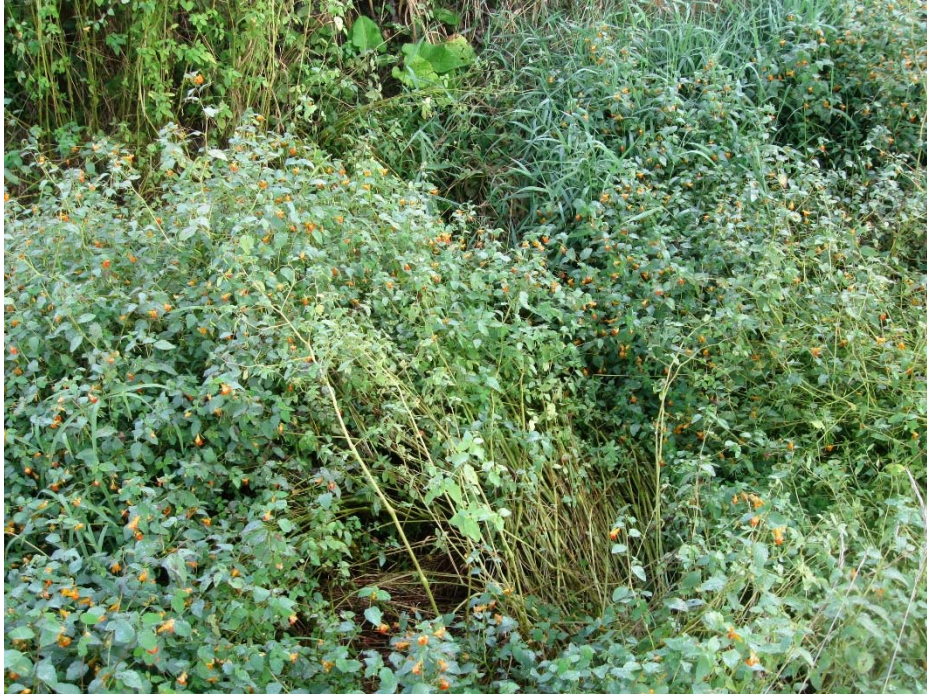
Waterbody SAUB002 facing north across

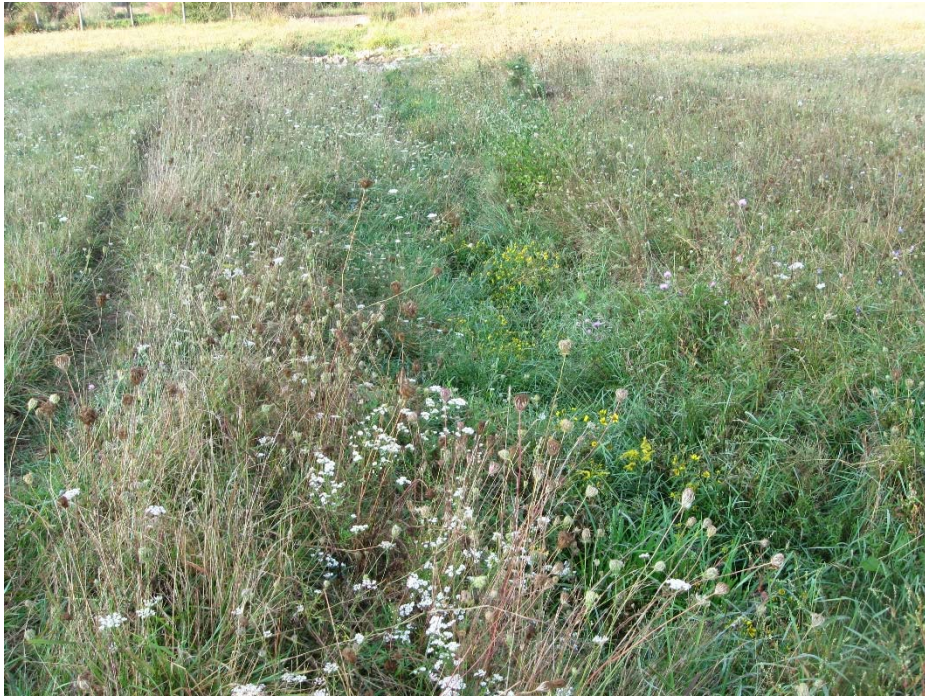
Waterbody SAUB001 facing south upstream

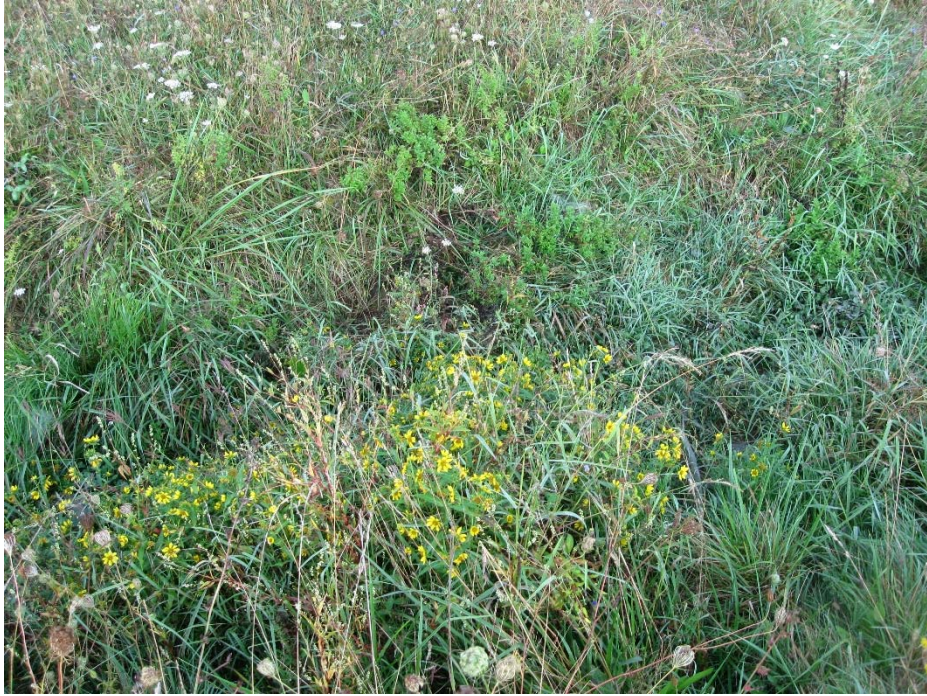
Waterbody SAUB001 facing west across

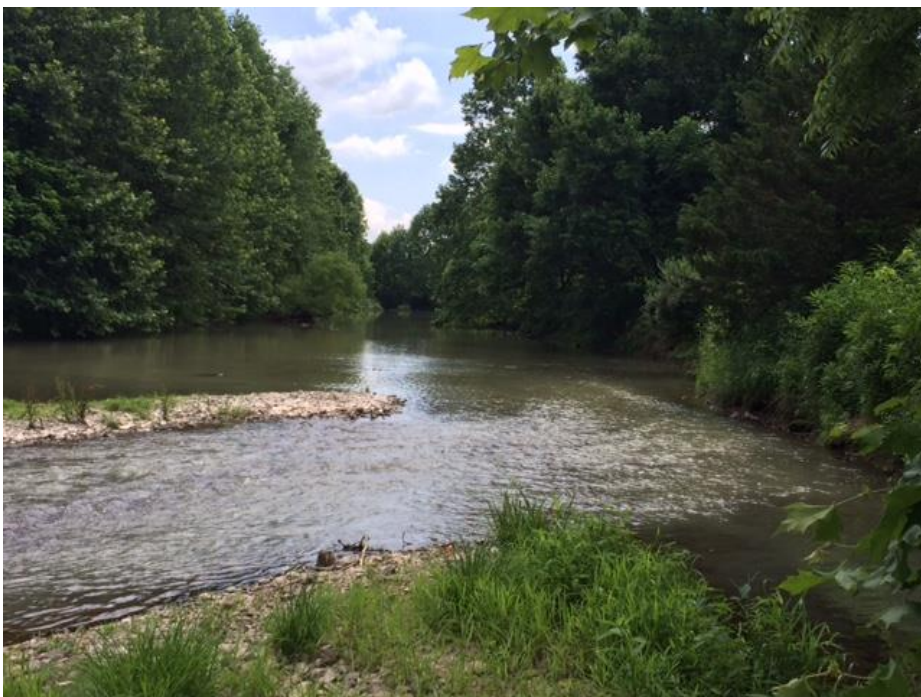
Waterbody SAUA413 facing east downstream
