# Linear Waterbody Data Sheet

Survey Description			
Project Name: Atlantic Coast Pipeline		Waterbody Name: Middle River	
Waterbody ID: saua070		Date: 5/12/2015	
State: Virginia	County: Augusta	Company: NRG	Crew Member Initials: GB, SA
Photos: 3 photos			
Tract Number(s): 07-001-A079; 07-001-A080; 07-001-A081		Nearest Milepost: 125.6	Associated Wetland ID(s): No wetlands within corridor
Survey Type: <i>(check one)</i> <input checked="" type="checkbox"/> Centerline <input type="checkbox"/> Re-Route <input type="checkbox"/> Access Road <input type="checkbox"/> Other:			
Physical Attributes			
Stream Classification: <i>(check one)</i> <input type="checkbox"/> Ephemeral <input type="checkbox"/> Intermittent <input checked="" type="checkbox"/> Perennial			
Waterbody Type: <i>(check one)</i> <input checked="" type="checkbox"/> River <input type="checkbox"/> Stream <input type="checkbox"/> Ditch <input type="checkbox"/> Canal <input type="checkbox"/> Other:

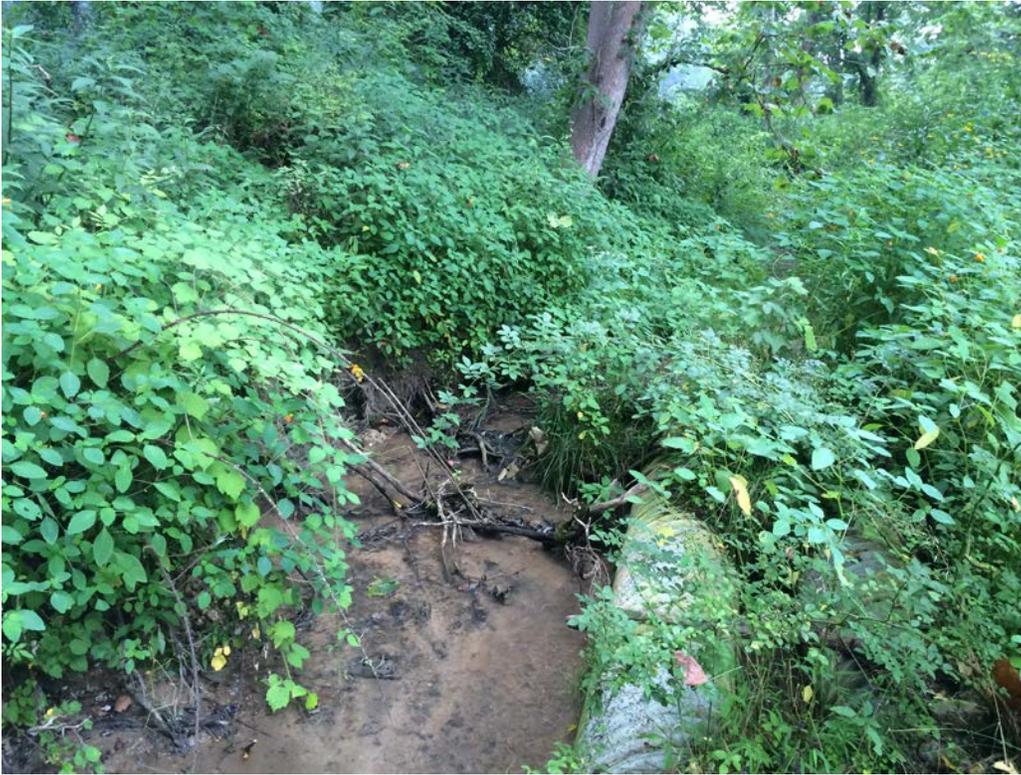
**Waterbody saup002 facing west upstream.**

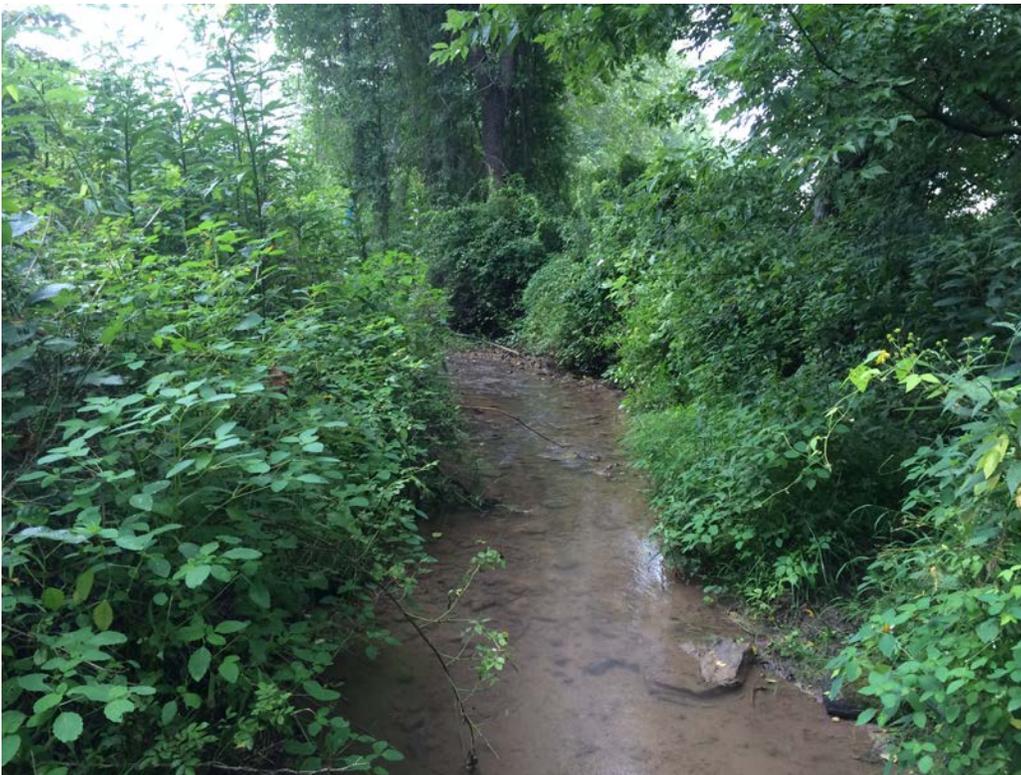
**Waterbody saup002 facing east downstream.**

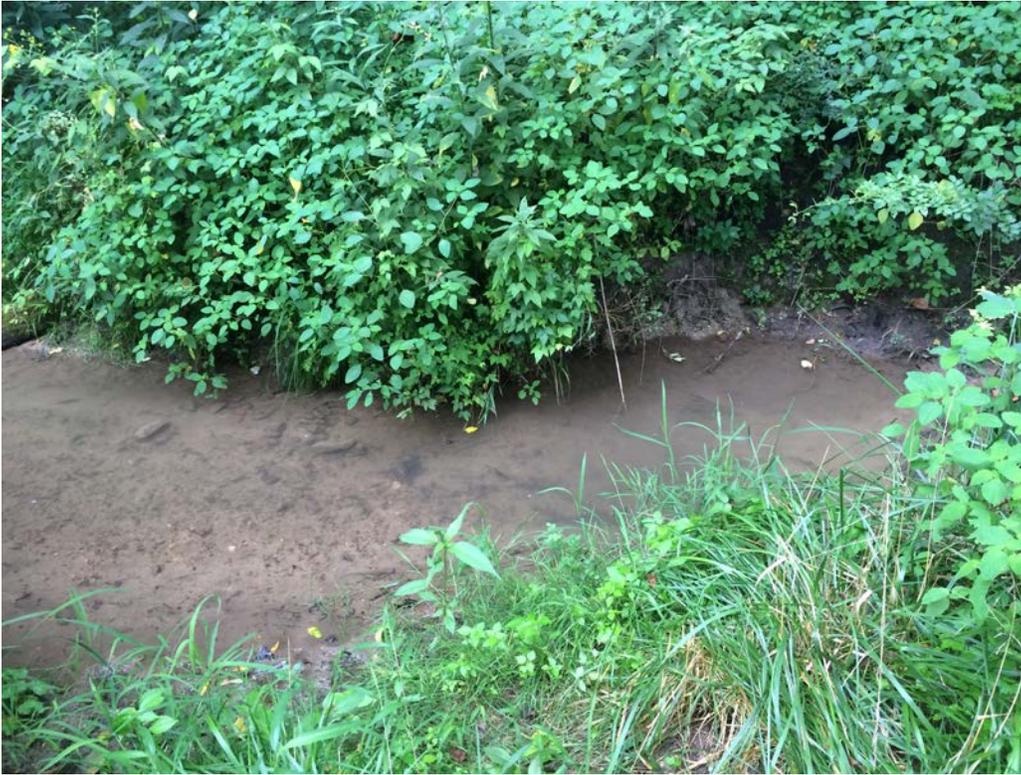
**Waterbody saup002 facing south across bank.**

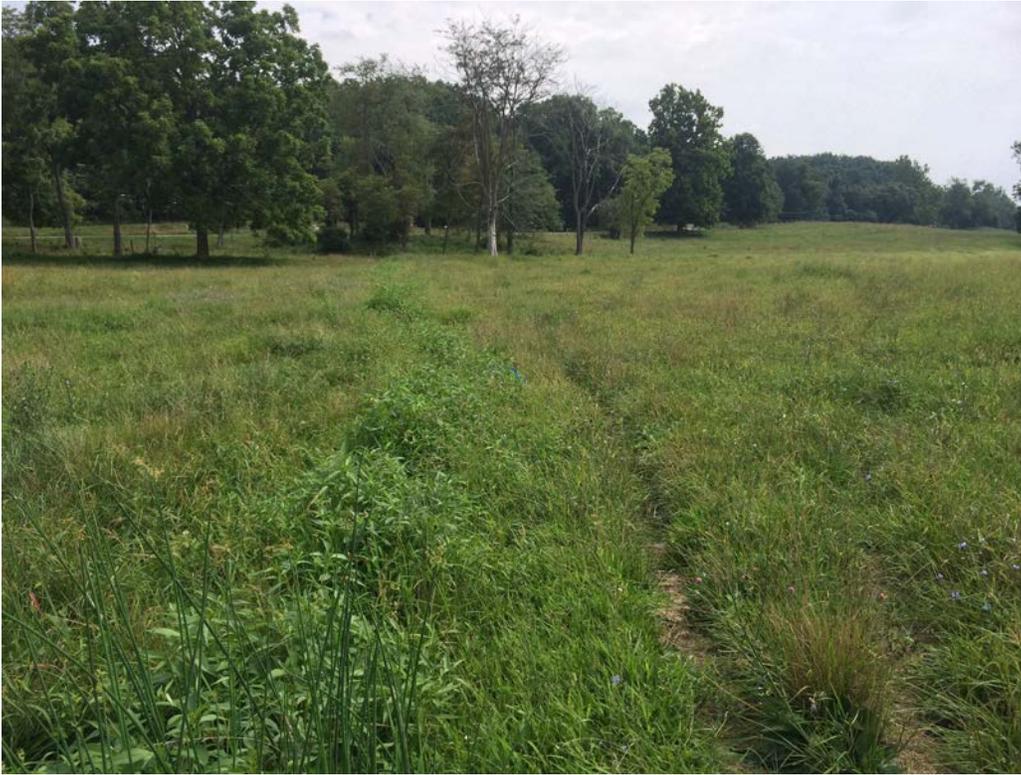
Small, straightend & ditched channel w/in active pastureland.

**Waterbody saup001 facing southwest upstream.**

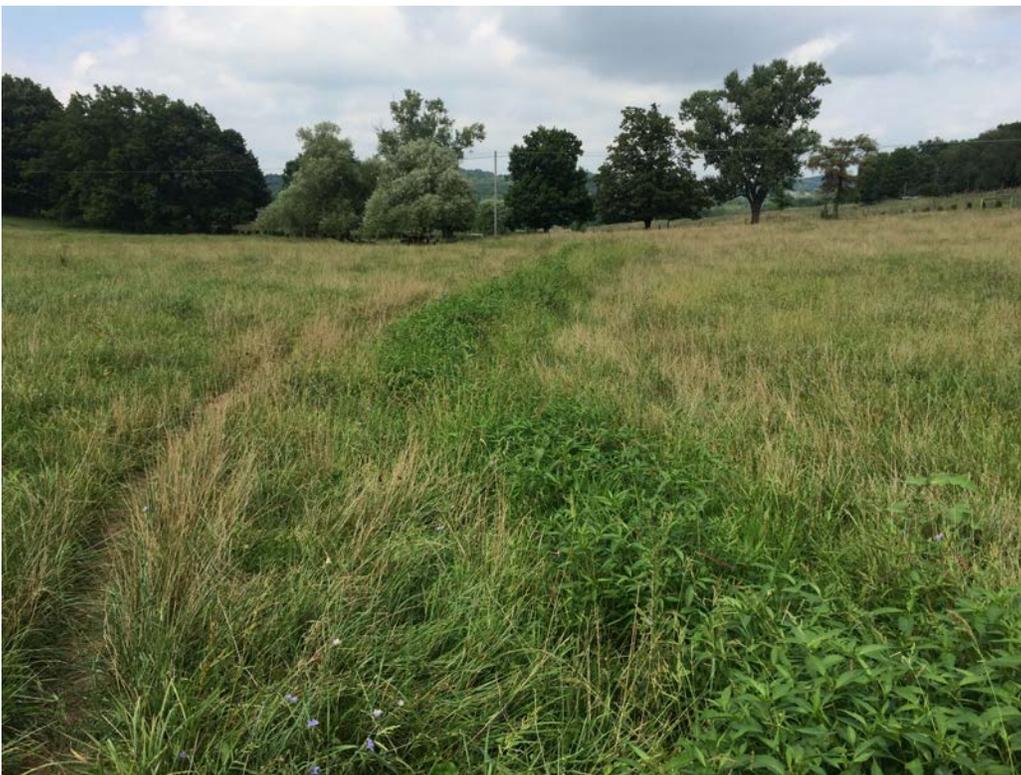
**Waterbody saup001 facing northeast downstream.**

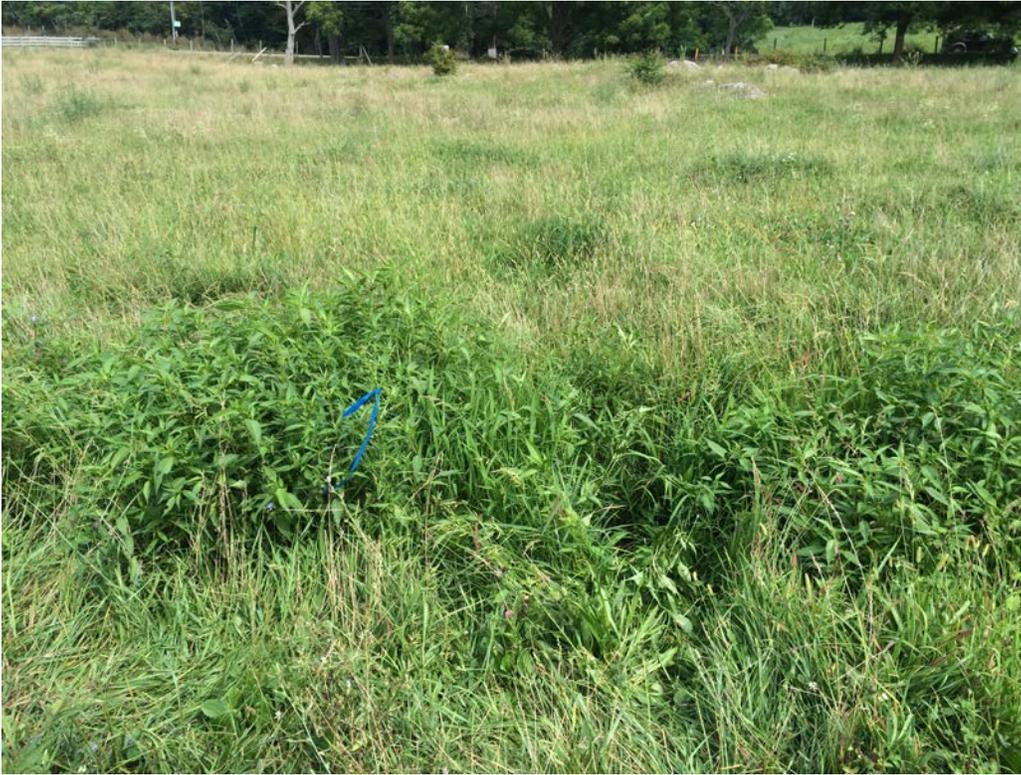
**Waterbody saup001 facing southeast across bank.**

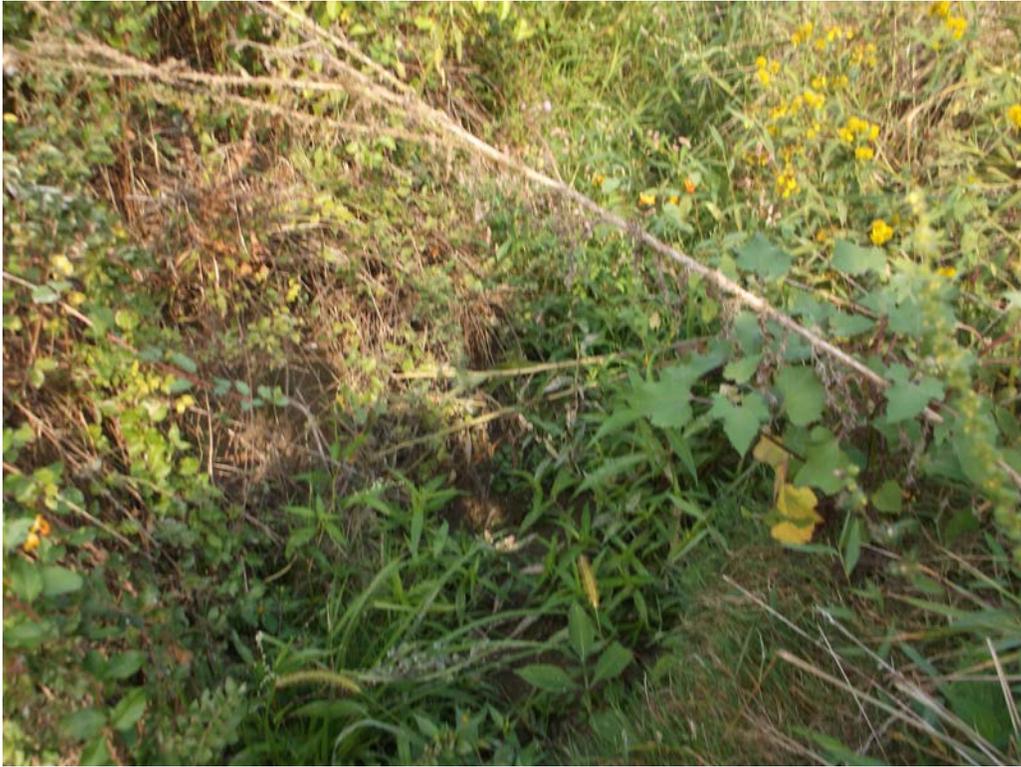
**Waterbody saup007 facing north upstream.**

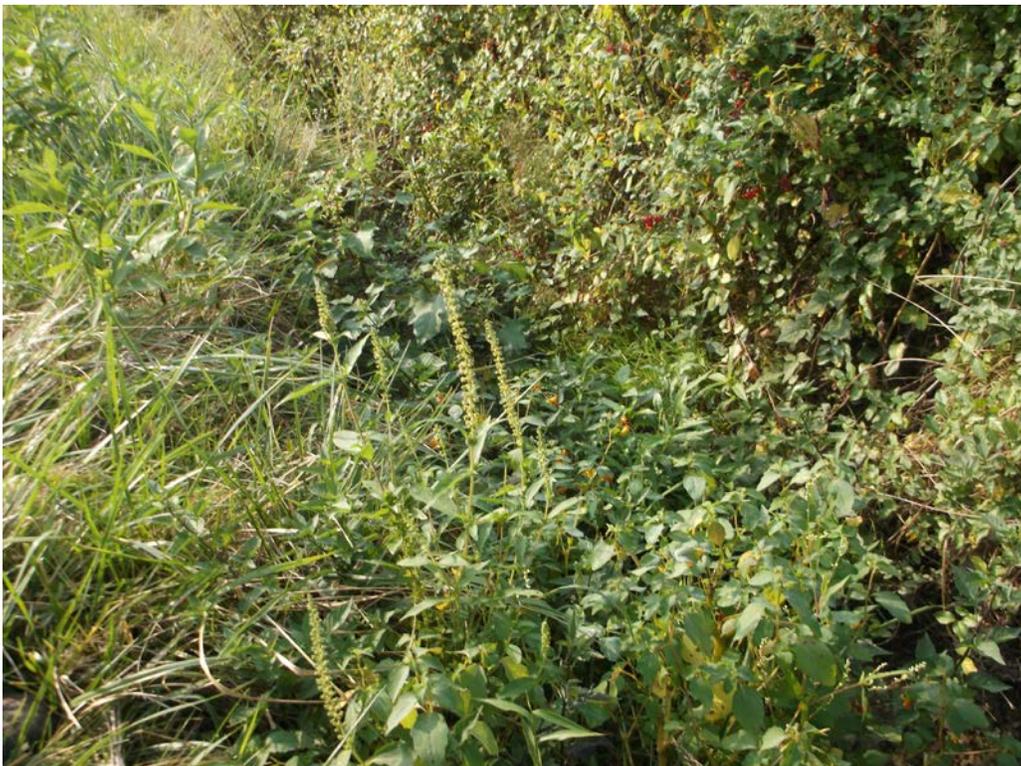
**Waterbody saup007 facing south downstream.**

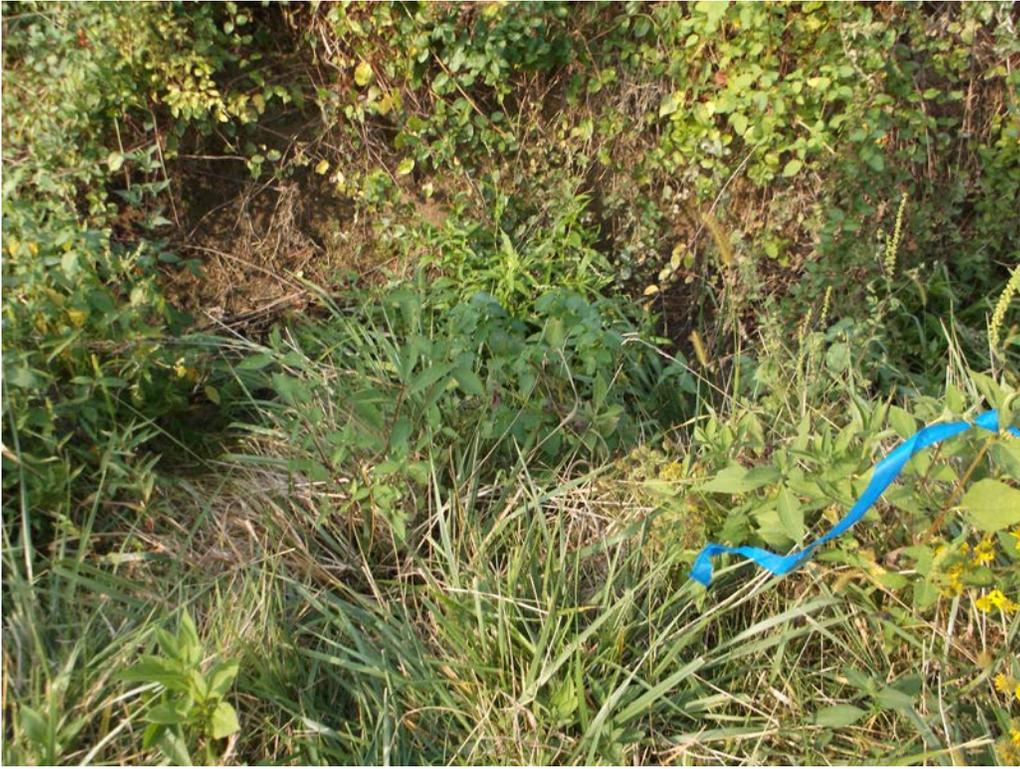
**Waterbody saup007 facing west across bank.**

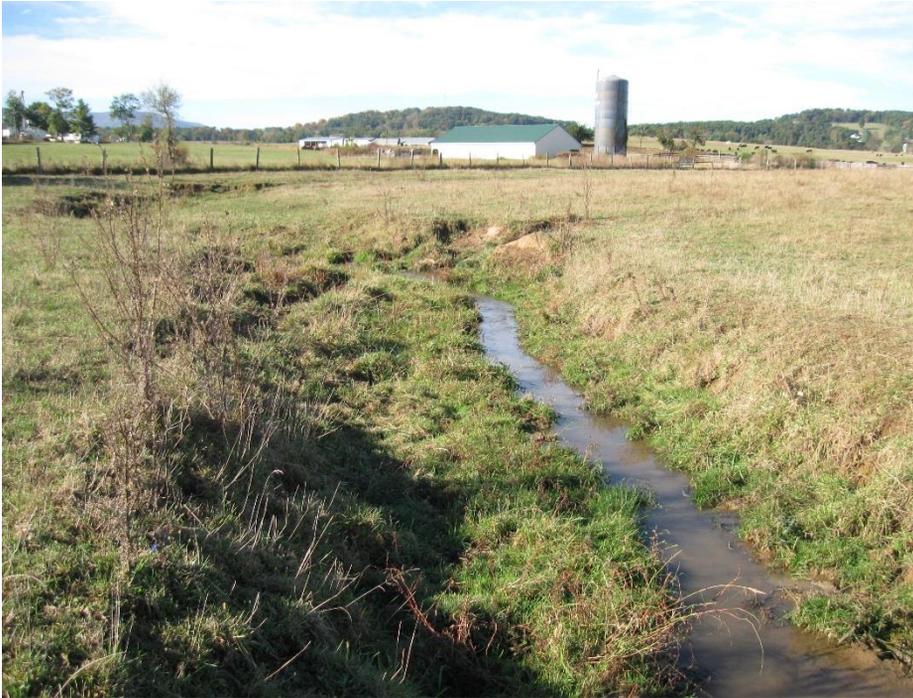
Slightly incised/eroded stream in cattle pasture. Numerous bank failures. Possibly ditched and slightly straightened for agriculture. Weak sinuosity.

Waterbody SAUB011 facing southwest upstream

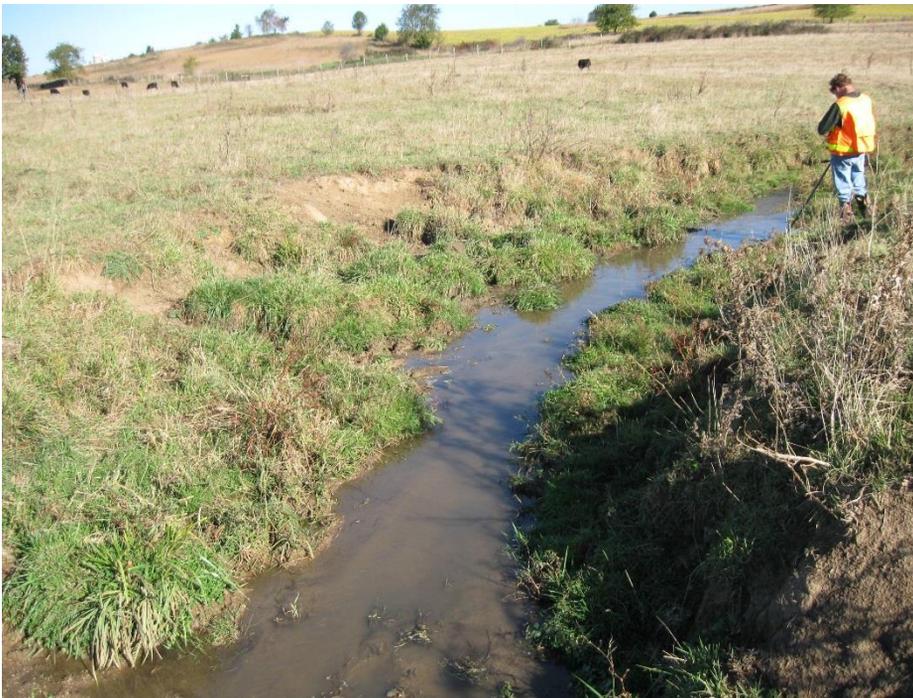
Waterbody SAUB011 facing northeast downstream

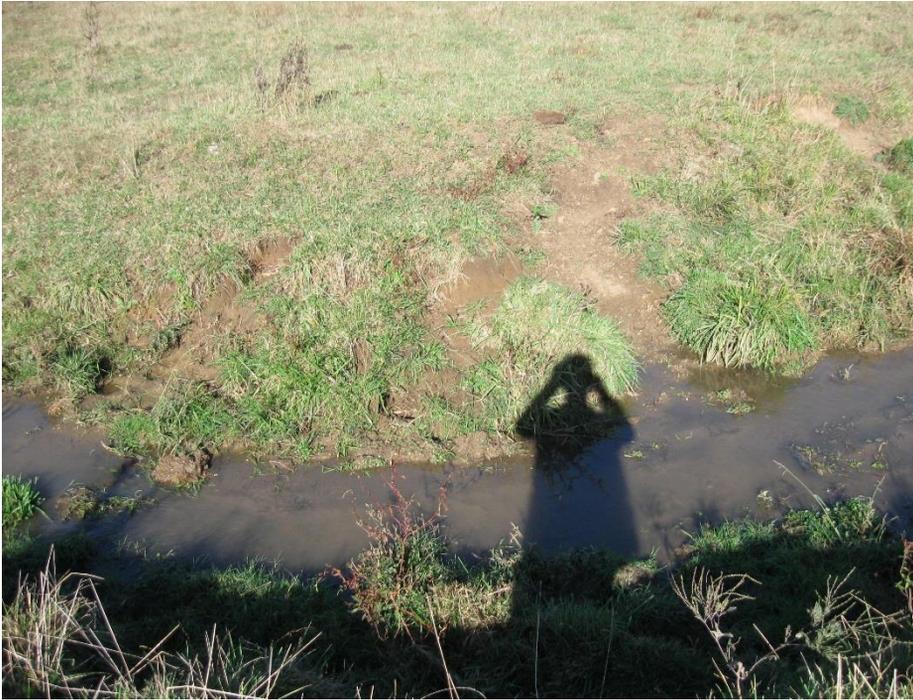
Waterbody SAUB011 facing northwest across

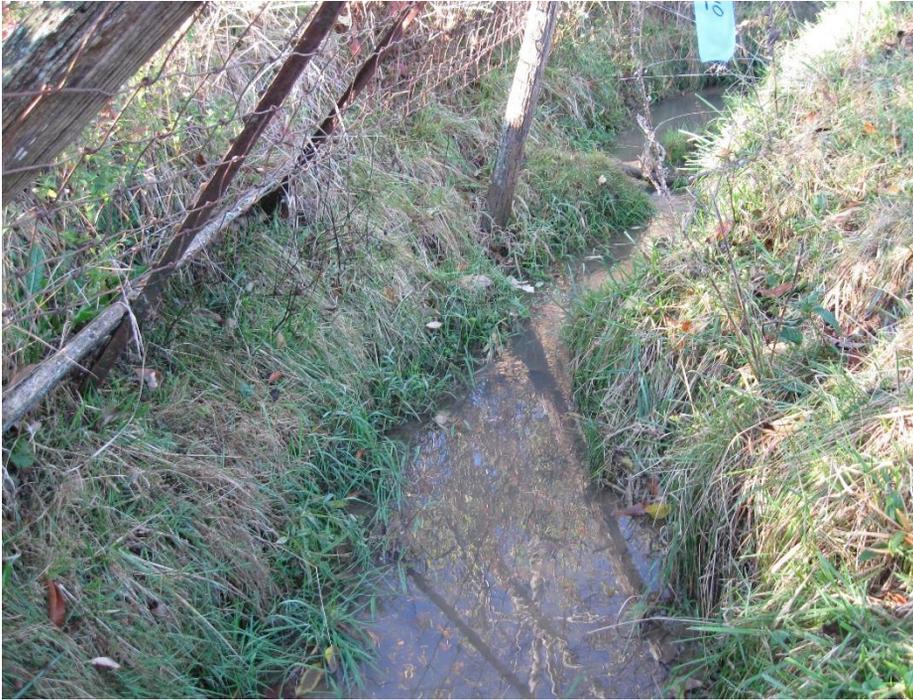
Deeply incised/eroded stream in cattle pasture. Numerous bank failures. Possibly ditched and slightly straightened for agriculture. Weak sinuosity.

Waterbody SAUB010 facing southwest upstream

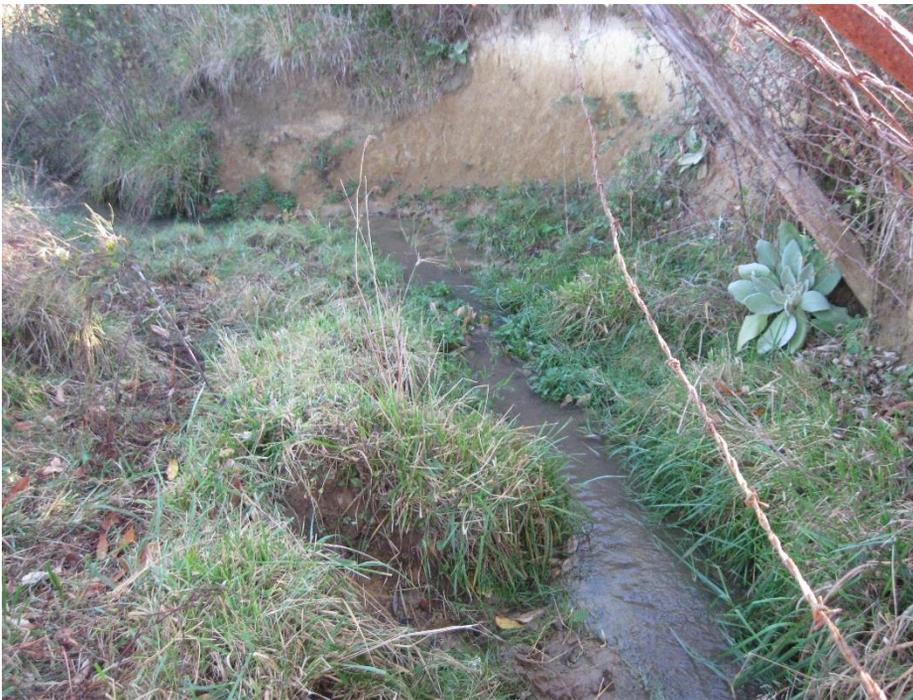
Waterbody SAUB010 facing northeast downstream

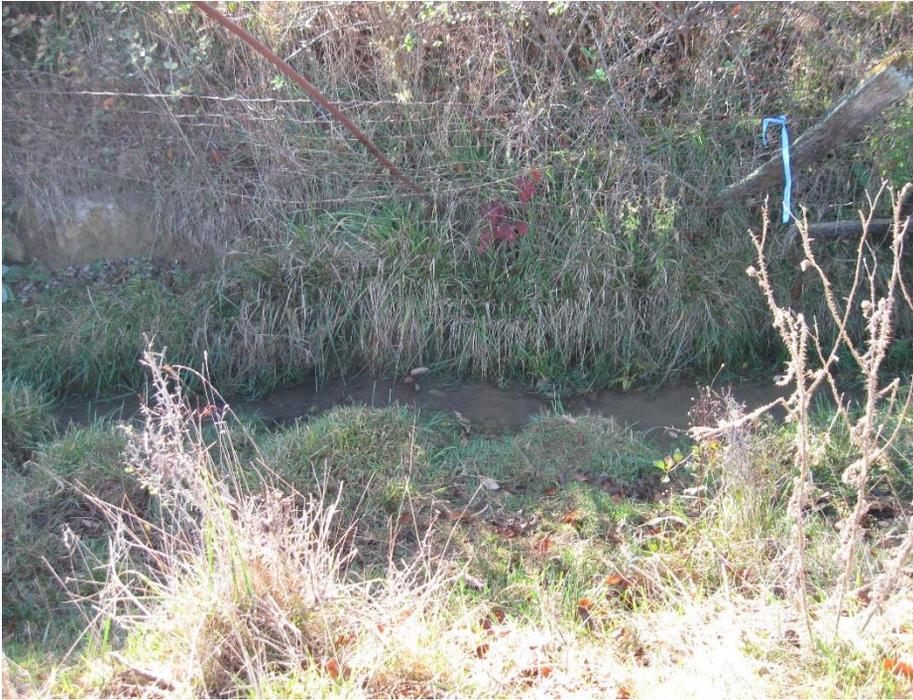
Waterbody SAUB010 facing southeast across

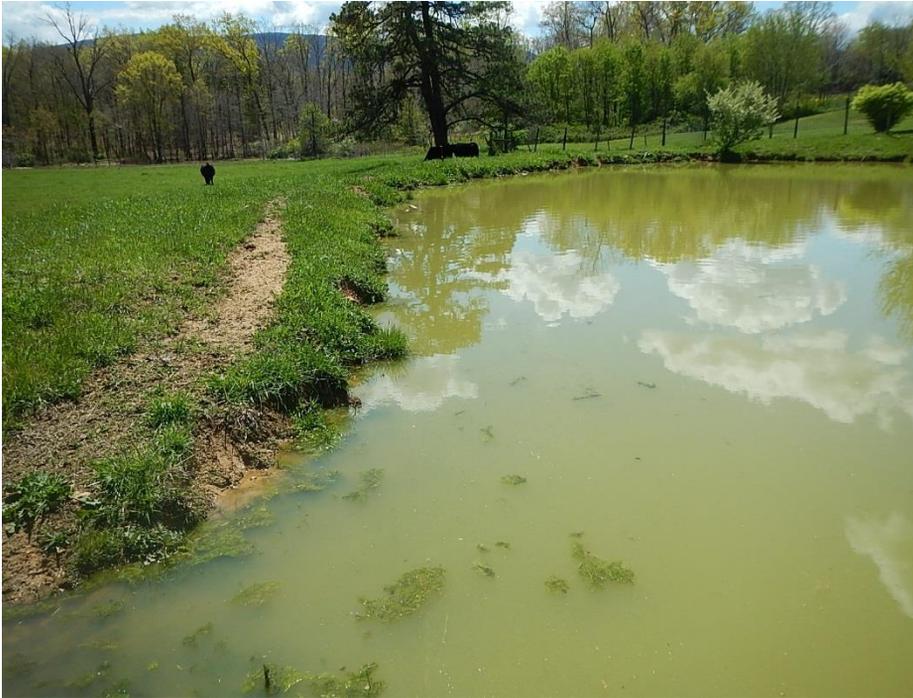
Degraded cattle pond approximately 70x100 feet. Does not appear to have a hydrologic connection to jurisdictional feature. No riparian buffer present.

Open waterbody OAUB101 facing south

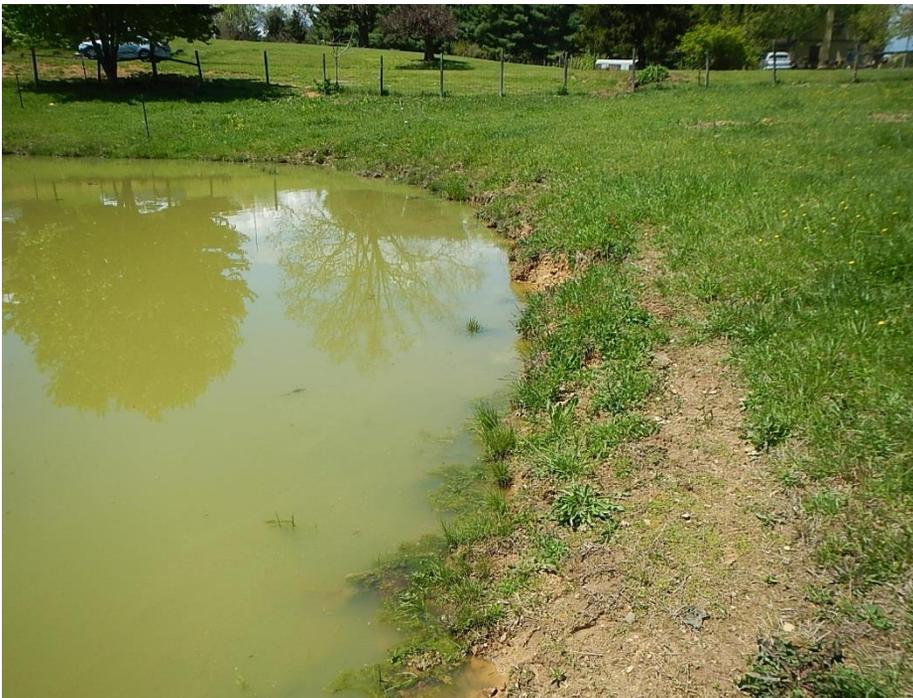
Open waterbody OAUB101 facing west

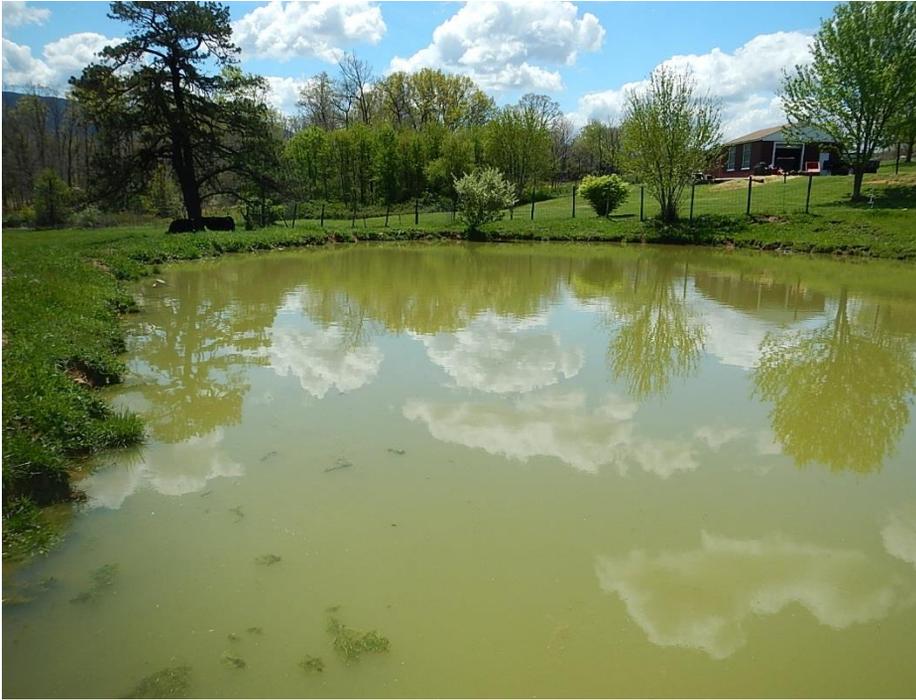
Open waterbody OAUB101 facing southwest
