# Linear Waterbody Data Sheet

Survey Description			
Project Name: Southeast Reliability		Waterbody Name: UNNAMED TRIB TO NORTH RIVER	
Waterbody ID: SBUK005		Date: 7/18/2014	
State: Virginia	County: Buckingham	Company: WOODARD & CURRAN	Crew Member Initials: RS, JS
Photos: 0052-0054			
Tract Number(s): 09-045		Nearest Milepost: 191	Associated Wetland ID(s): NA
Survey Type: <i>(check one)</i> <input checked="" type="checkbox"/> Centerline <input type="checkbox"/> Re-Route <input type="checkbox"/> Access Road <input type="checkbox"/> Other:			
Physical Attribute			
Stream Classification: <i>(check one)</i> <input type="checkbox"/> Ephemeral <input type="checkbox"/> Intermittent <input checked="" type="checkbox"/> Perennial			
Waterbody Type: <i>(check one)</i> <input type="checkbox"/> River <input checked="" type="checkbox"/> Stream <input type="checkbox"/> Ditch <input type="checkbox"/> Canal <input type="checkbox"/> Other:			
OHWM Width: <u>10</u> ft.		OHWM Indicator: <i>(check all that apply)</i> <input checked="" type="checkbox"/> Clear line on bank <input checked="" type="checkbox"/> Shelving <input checked="" type="checkbox"/> Wrested vegetation <input checked="" type="checkbox"

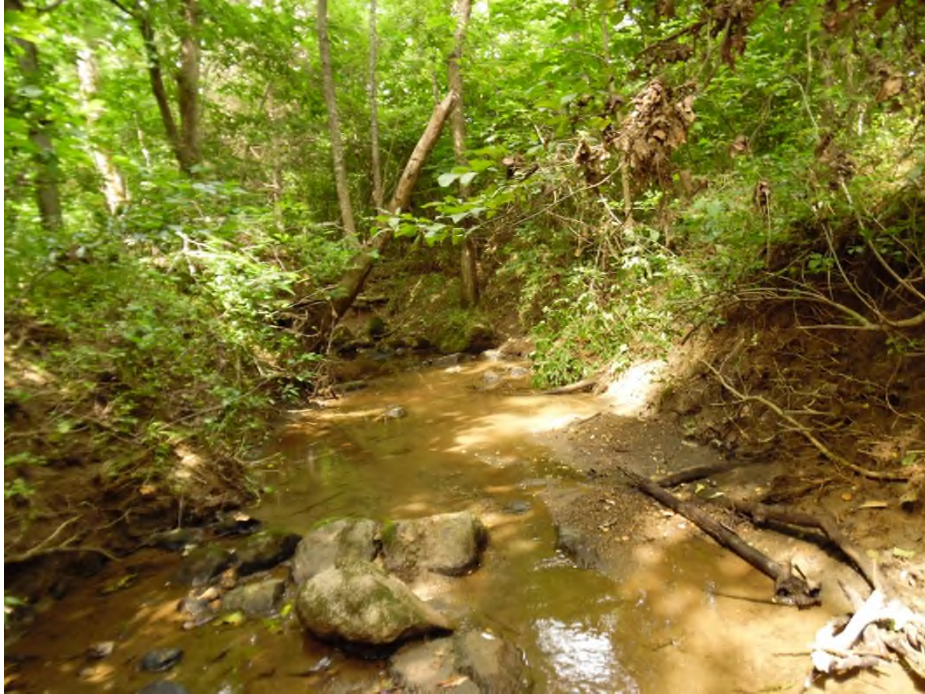
Waterbody point sbuk005 facing northeast and downstream

PERENNIAL STREAM WITH MODERATE FLOW AND VOLUME. NUMEROUS AQUATIC ORGANISMS OBSERVED. RIFFLES, POOLS AND GLIDES PRESENT. CHANNEL DEEPLY INCISED AND FLOODPLAIN WETLANDS ABSENT DUE TO WELL DRAINED LOAMY SOILS.

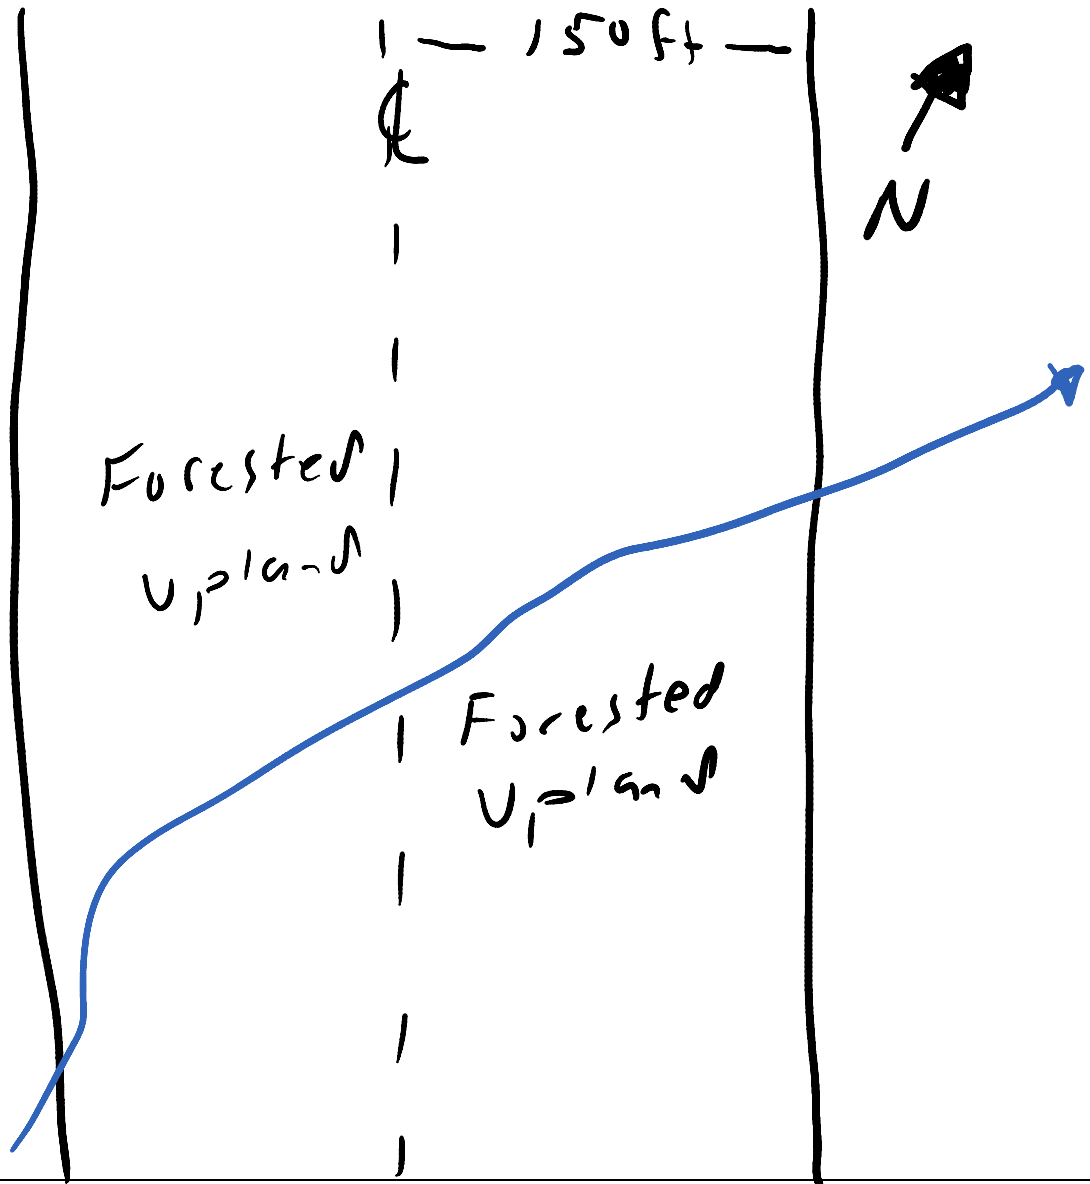
SMALL EPHEMERAL STREAM WITH WELL DEFINED BED AND BANK. FLOWS DIAGONALLY ACROSS ROW. LEAVES AND DEBRIS IN CHANNEL. SMALL HEAD CUTS PRESENT. NO FLOW AT TIME OF SURVEY. BRAIDED CHANNEL AT HEADWATERS ON SE SIDE OF ROW.

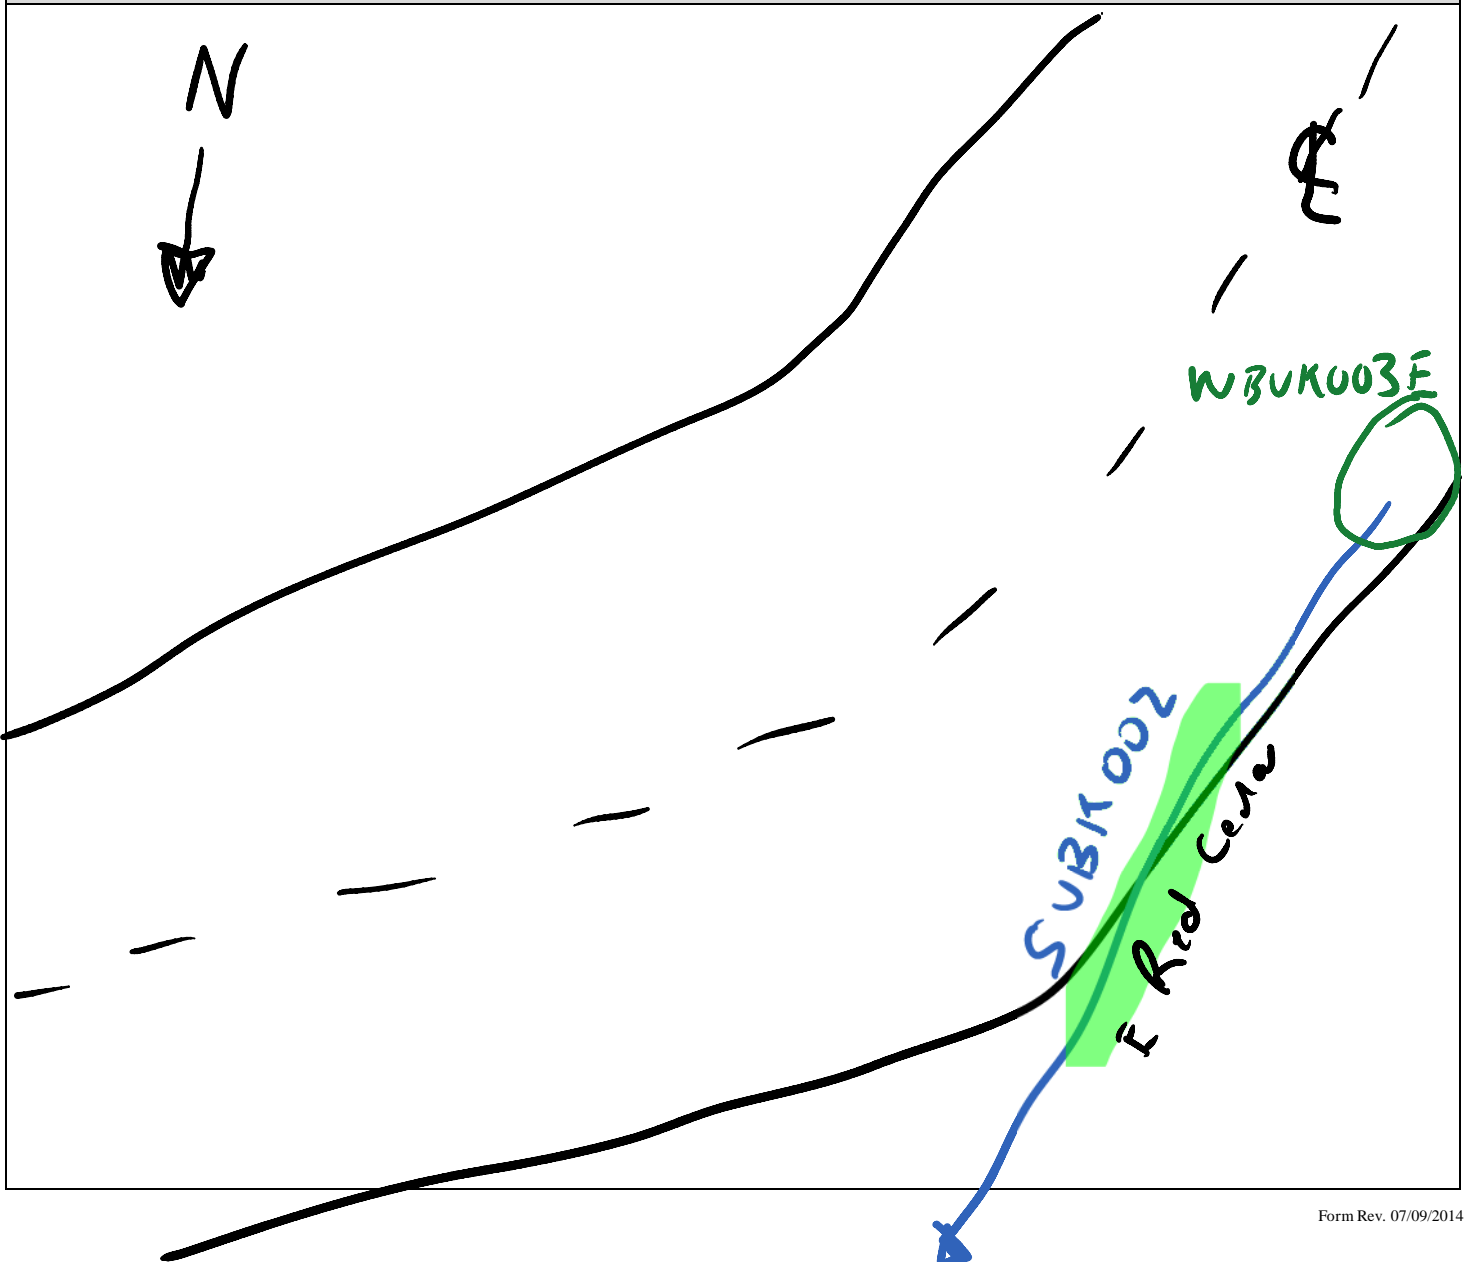
INCISED STREAM WITHIN PASTURE DEGRADED BY CATTLE. POOLS PRESENT WITH SLIGHT FLOW. SPRING FED.

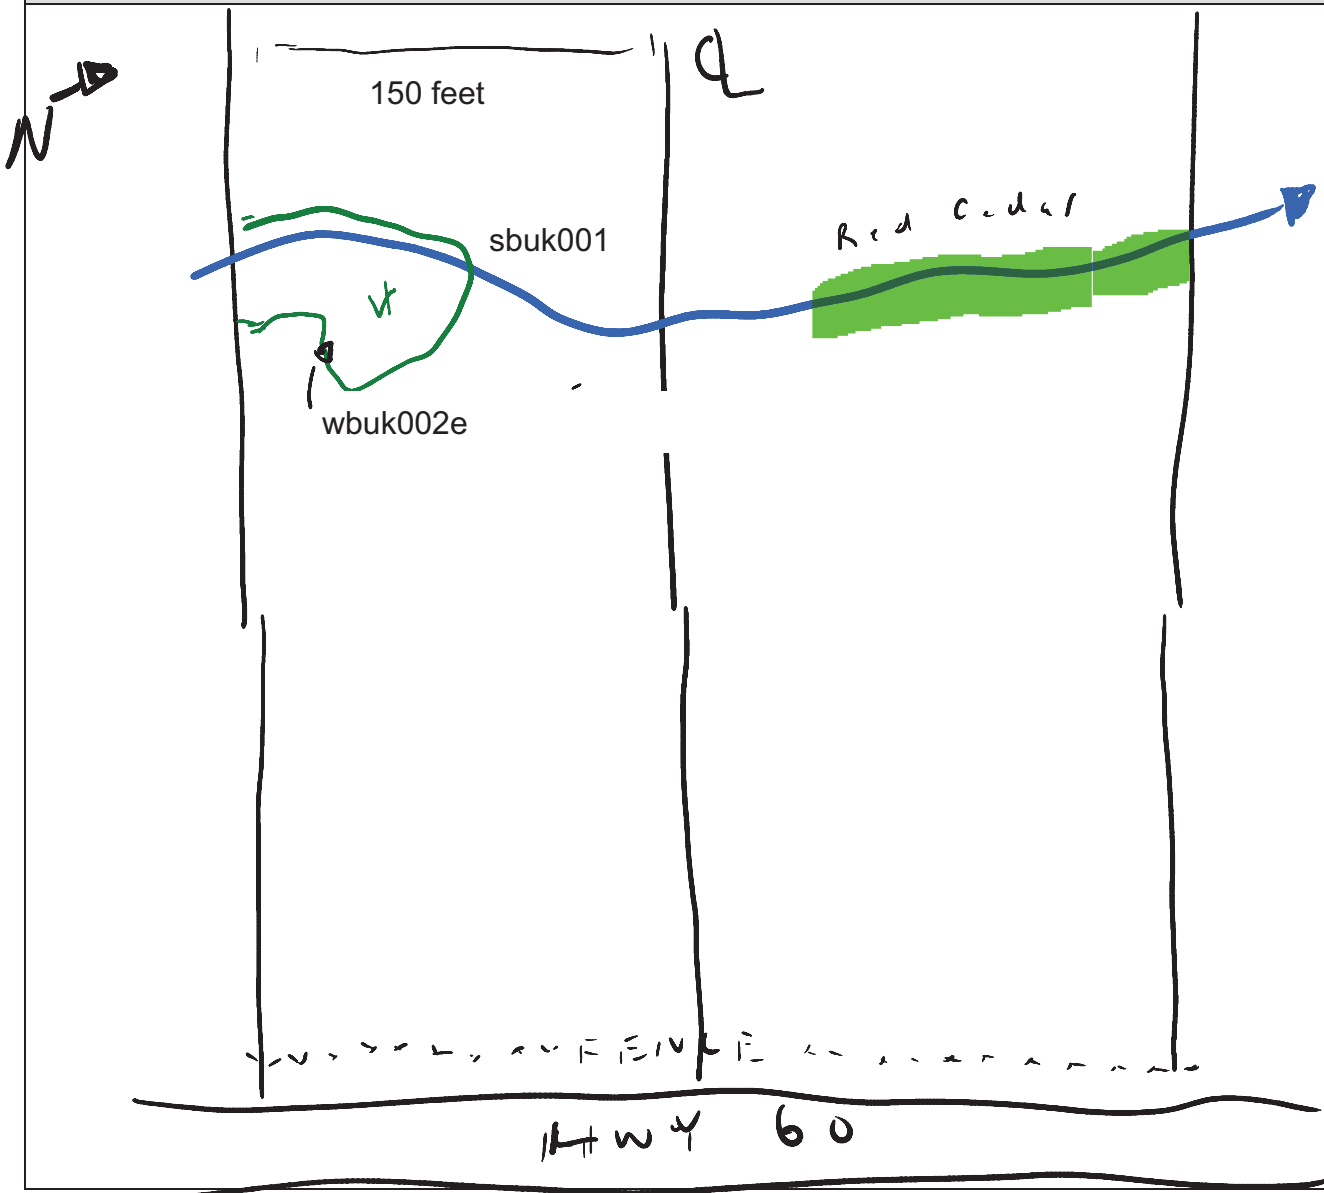
INCISED STREAM WITHIN PASTURE DEGRADED BY CATTLE. NO FLOW AT TIME OF SURVEY. POOLS PRESENT

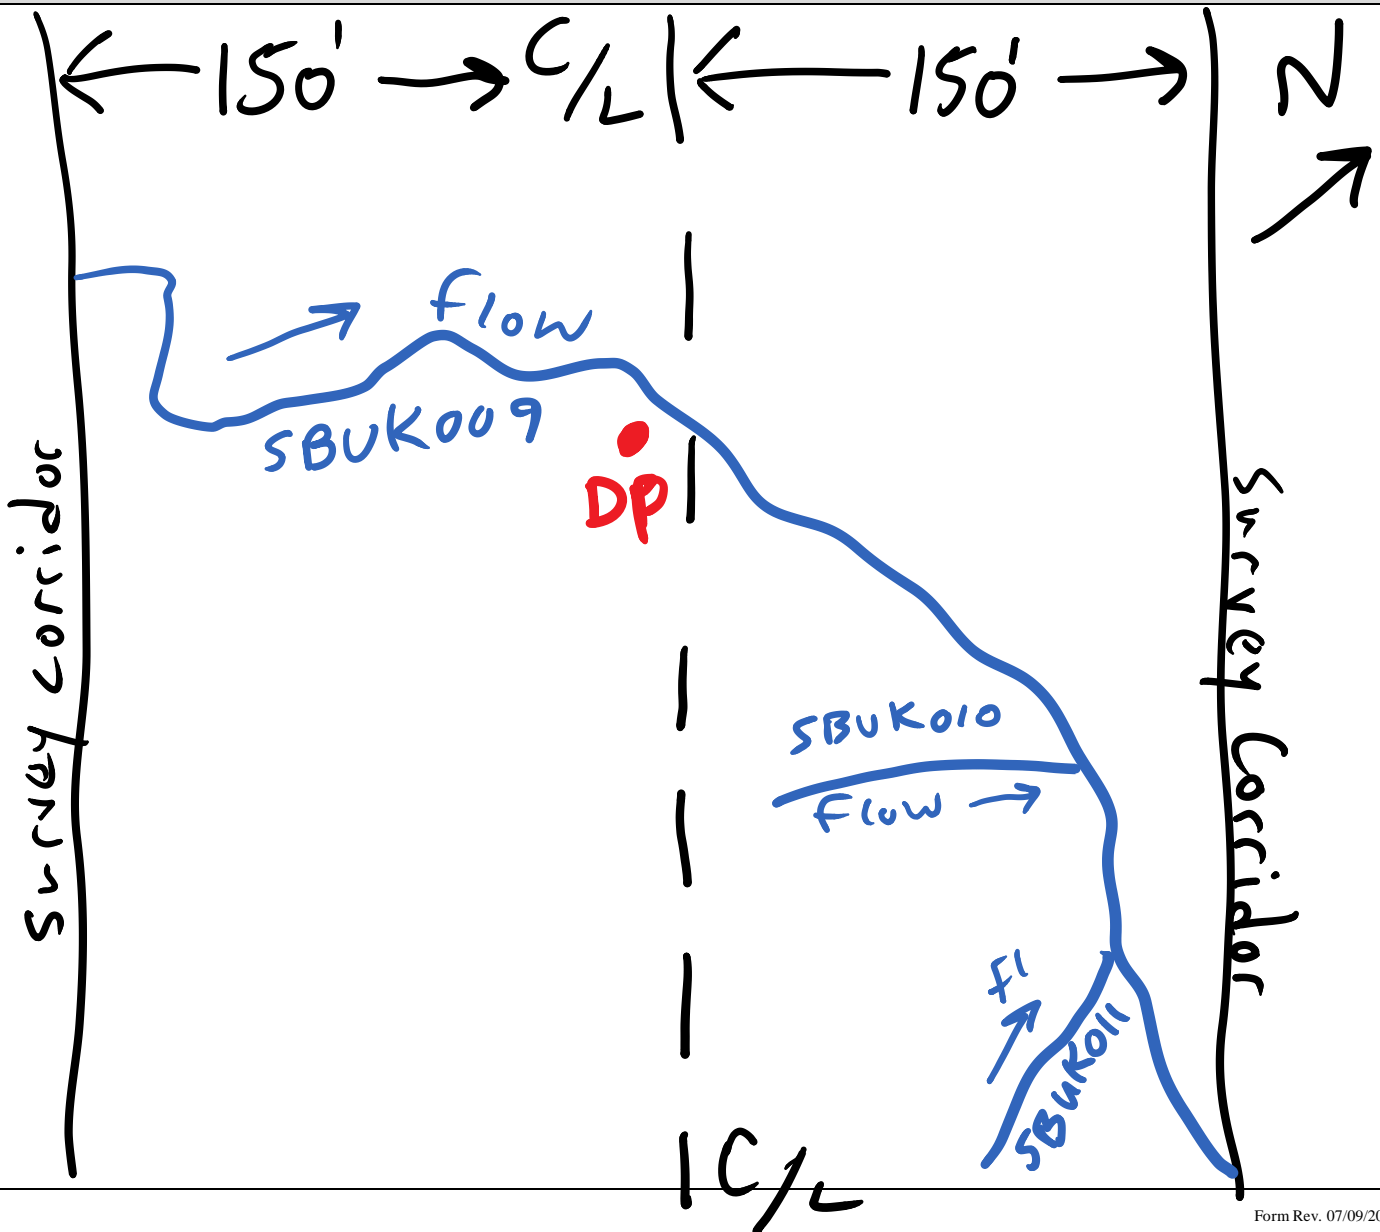
PERENNIAL STREAM WITH SIGNS OF TORRENT. LOW FLOW AND MODERATE VOLUME AT TIME OF SURVEY. LEFT BANK WITH SIGNS OF EROSION NEAR CENTERLINE. FLOOD PLAIN WITH WELL DRAINED SOILS. NO WETLANDS PRESENT. WILDLIFE TRACKS INCLUDING WHITETAIL DEER, RACCOON, BOBCAT.

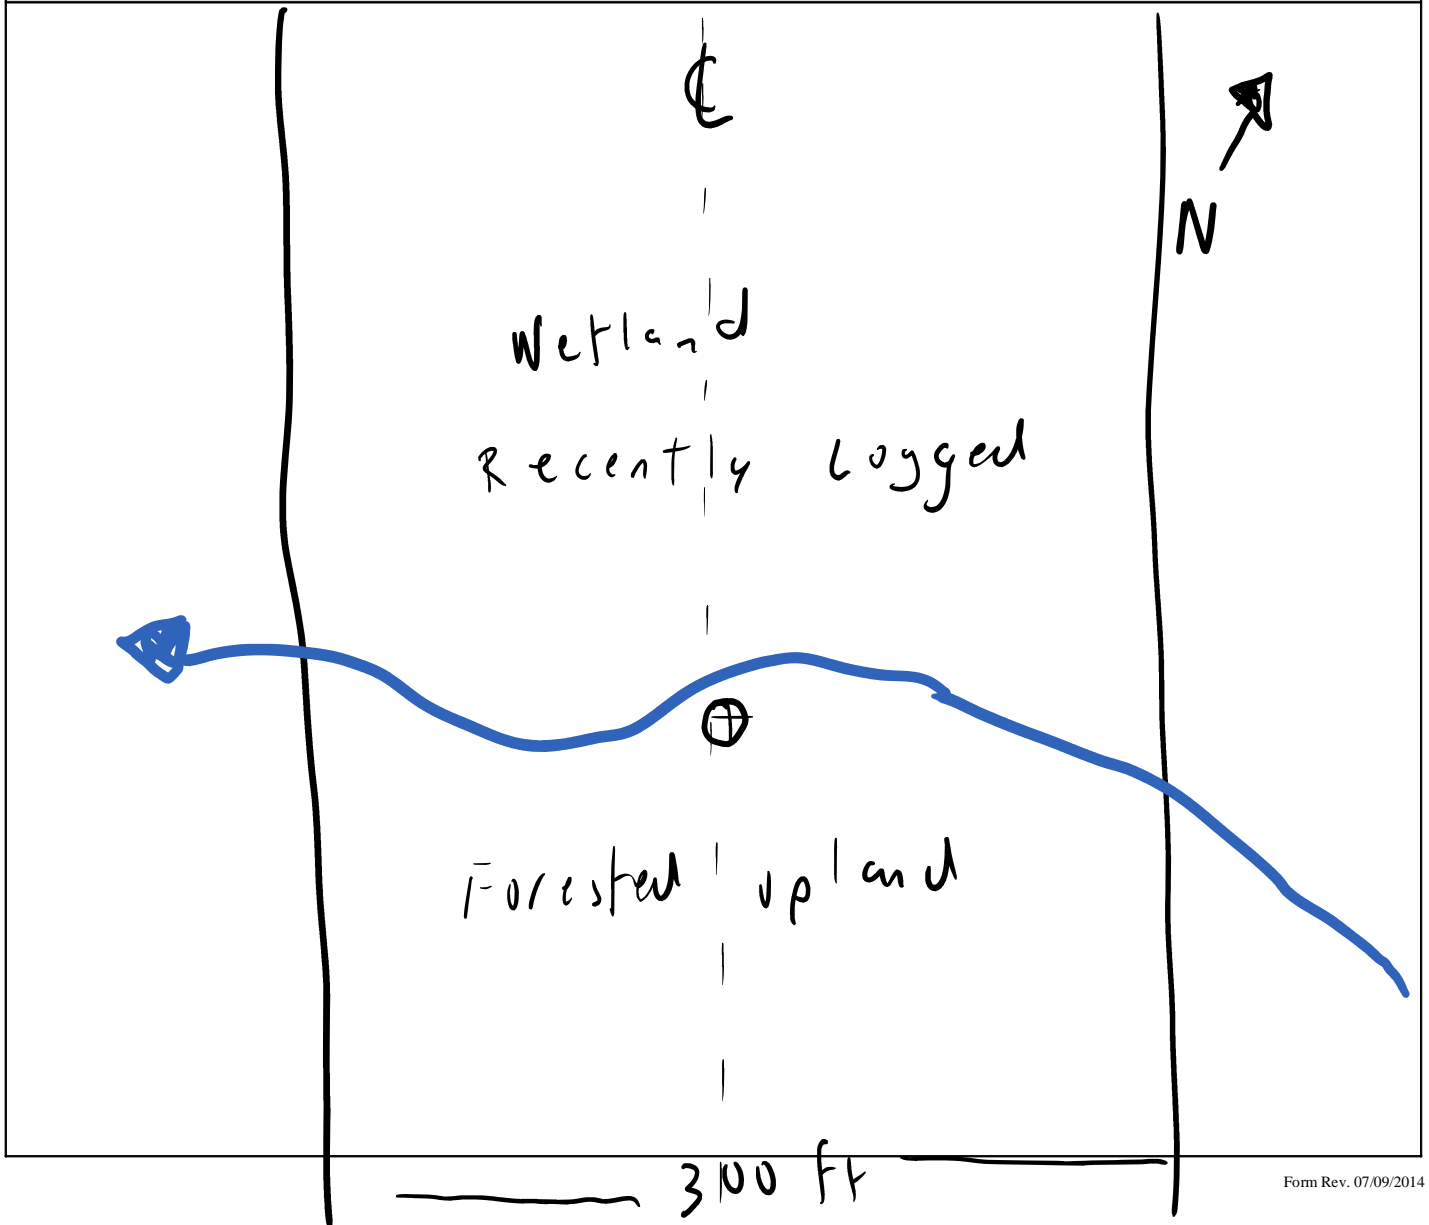
NICE PERENNIAL STREAM. MODERATE QUALITY DUE TO SEDIMENTATION, BANK EROSION, LOGGING OF RIPARIAN ZONE ON RIGHT BANK, PRESENCE OF ASIATIC CLAM.

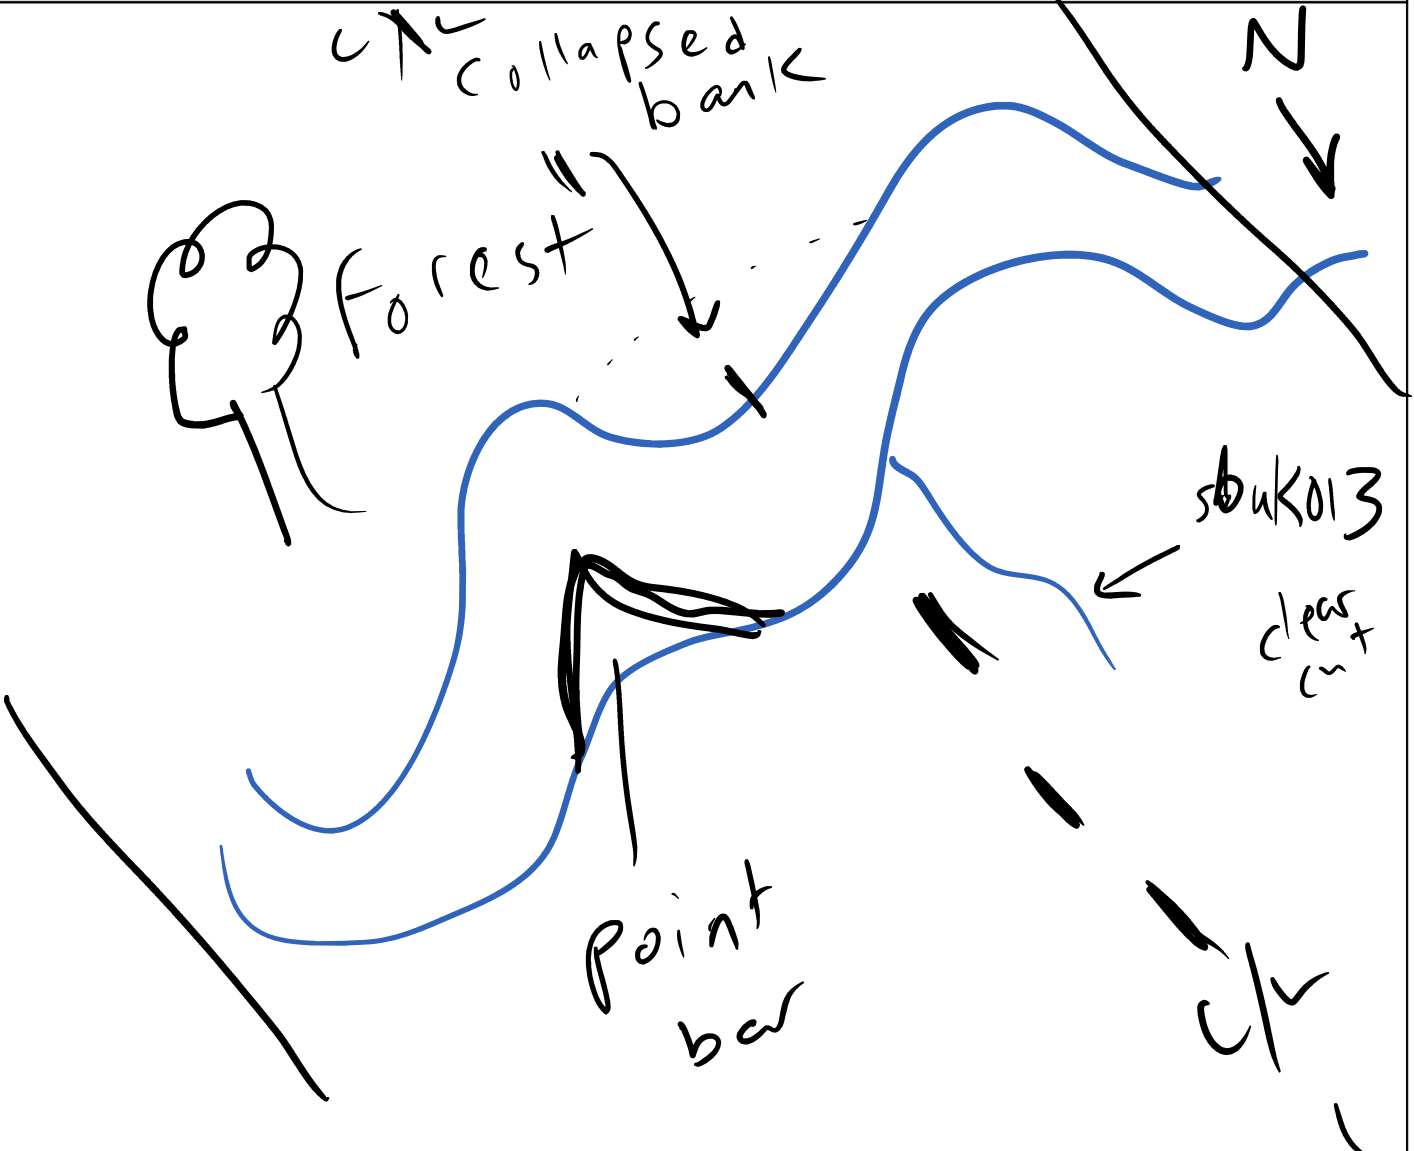
SMALL PERENNIAL STREAM, SOME BANK EROSION AND SEDIMENTATION, TYPICAL PIEDMONT SMALL STREAM FOREST COMMUNITY

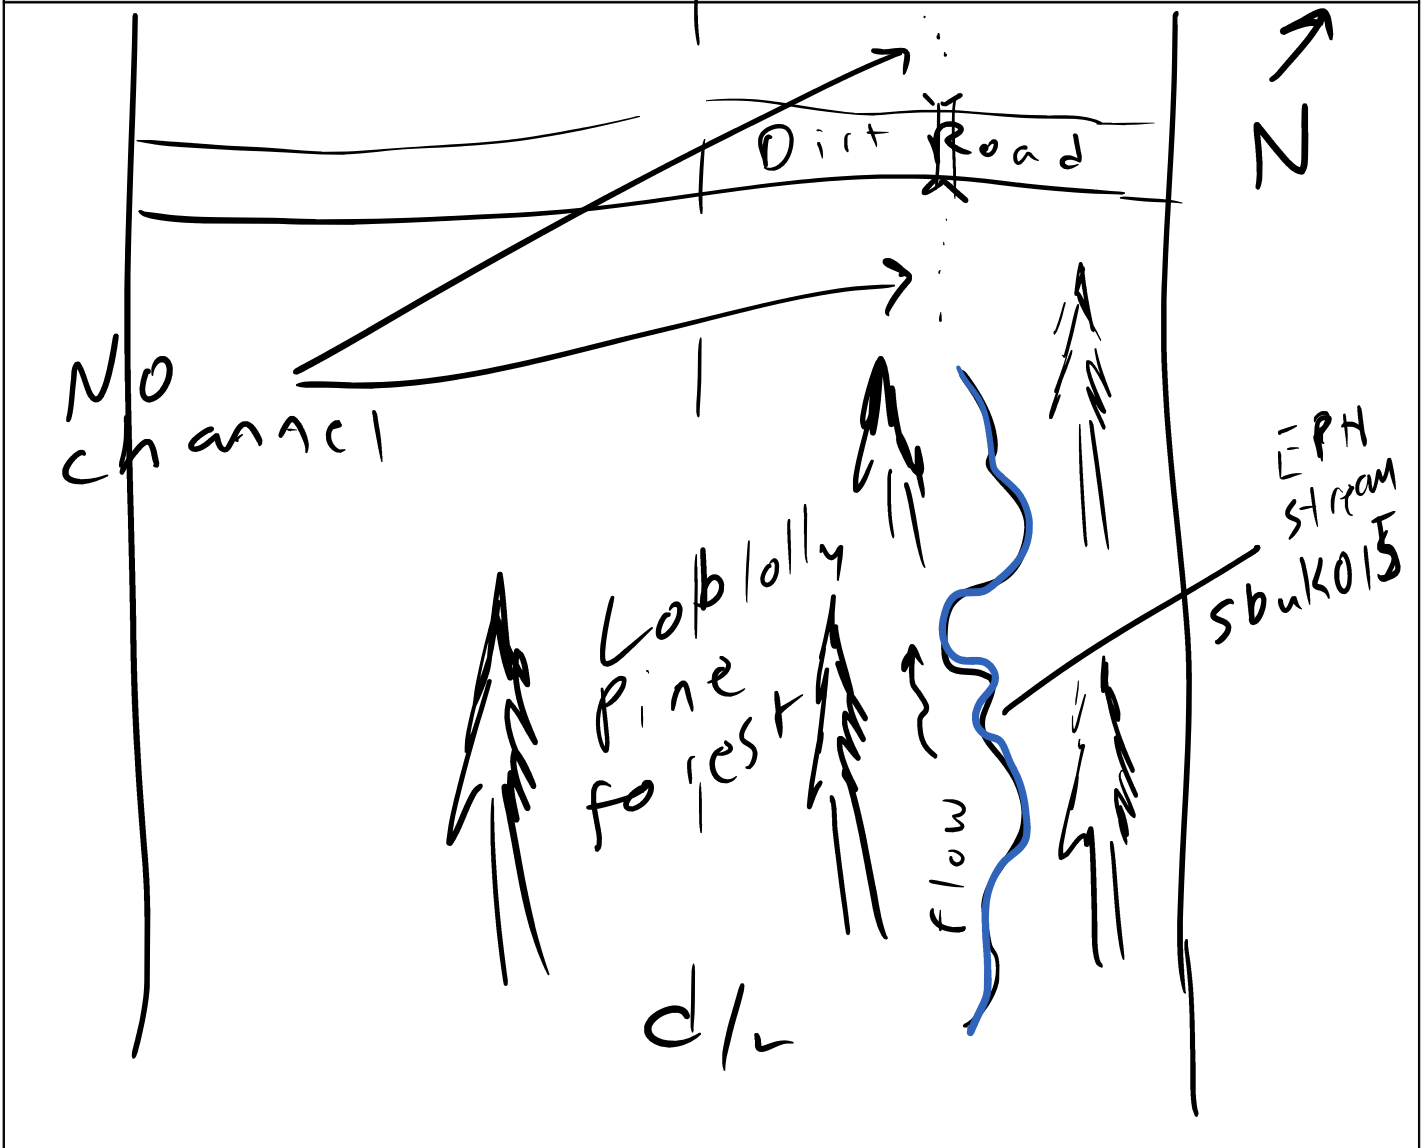
SMALL EROSIONAL EPHEMERAL STREAM WITH A DISCONTINUOUS CHANNEL
