Linear Waterbody Data Sheet

Environmental Field Surveys
Waterbody Photo Page

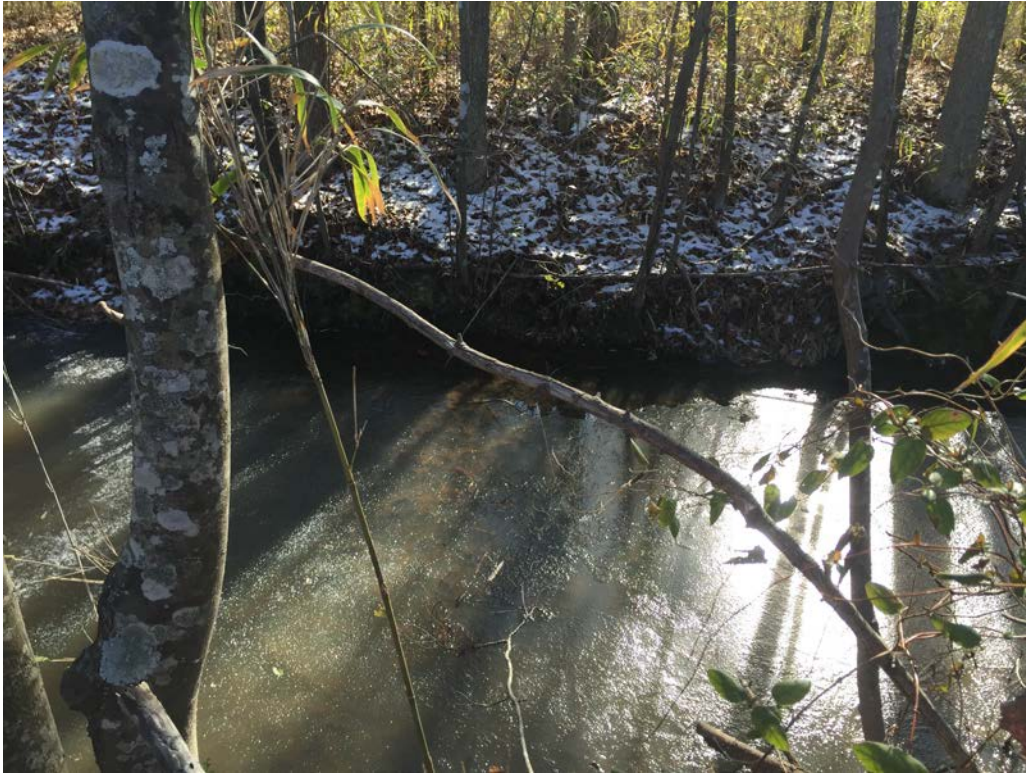
Waterbody schr009 facing south across bank.

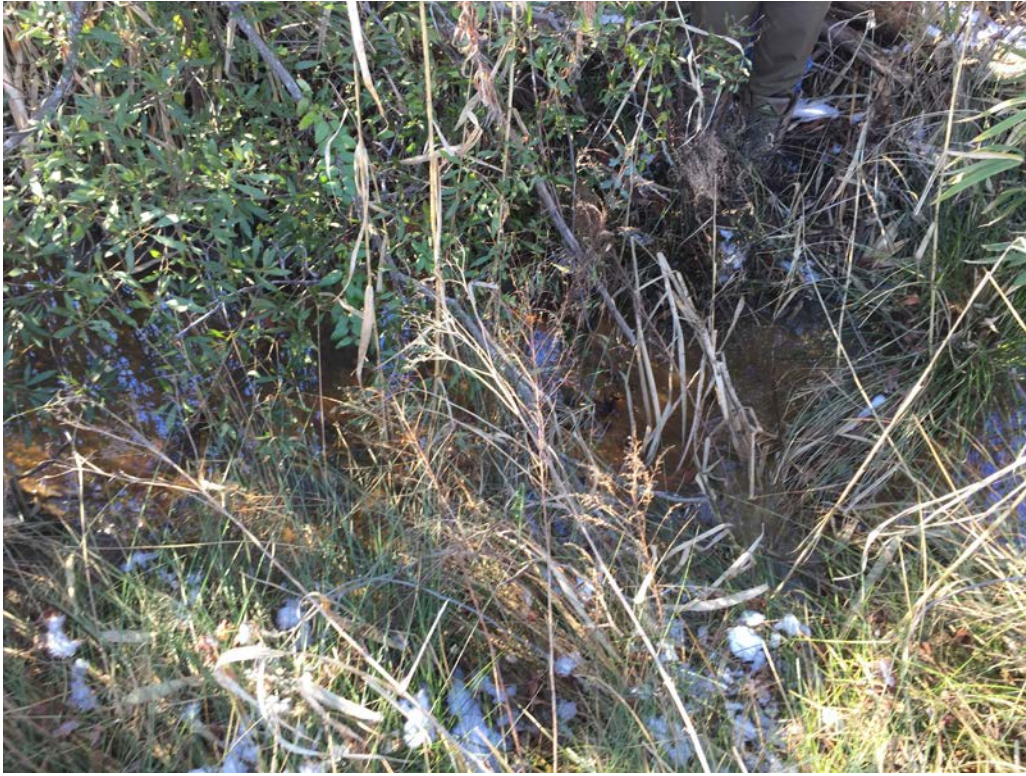
Waterbody schr010 facing west across bank.

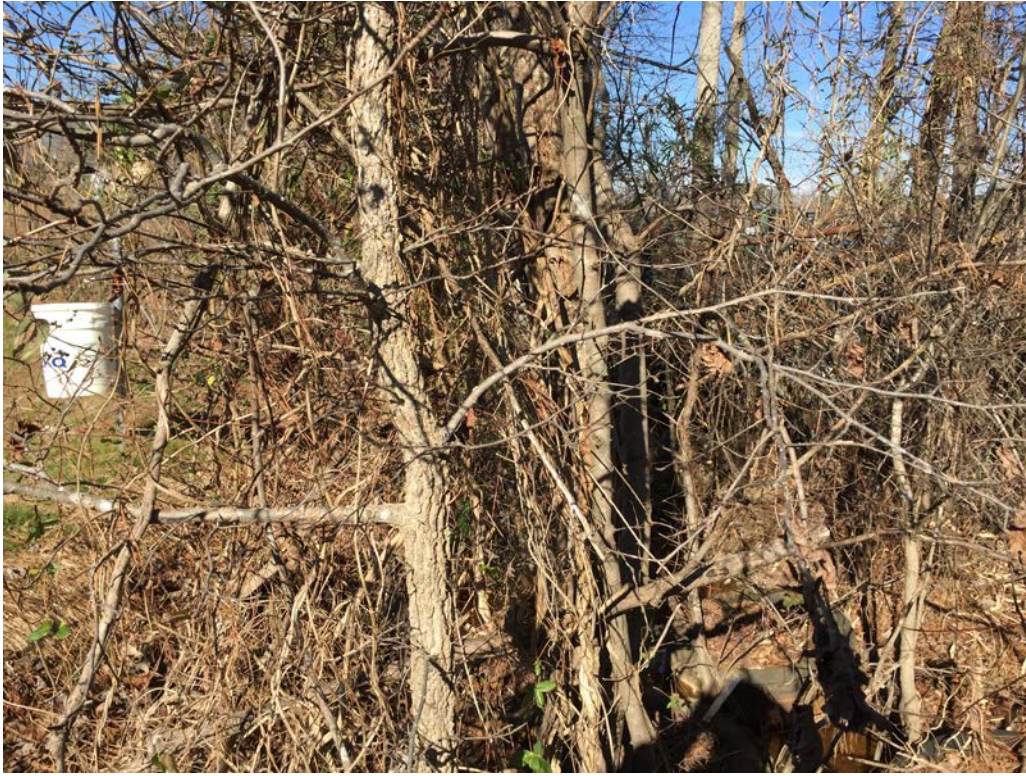
Waterbody schr011 facing north upstream.

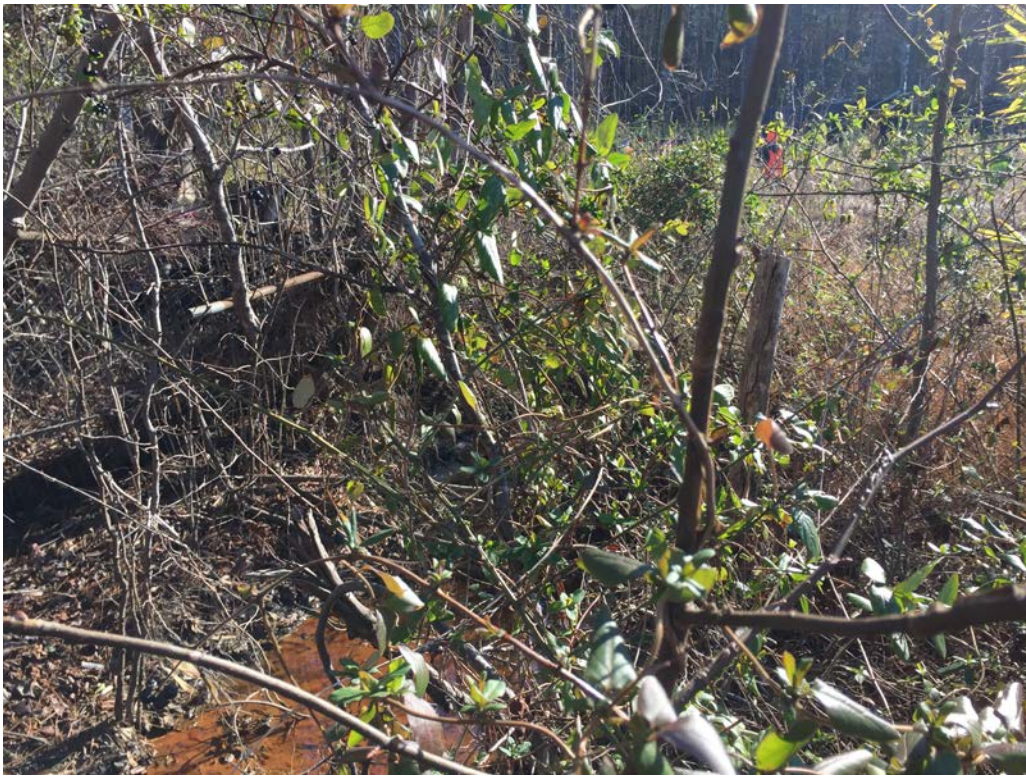
Waterbody schr011 facing south downstream.

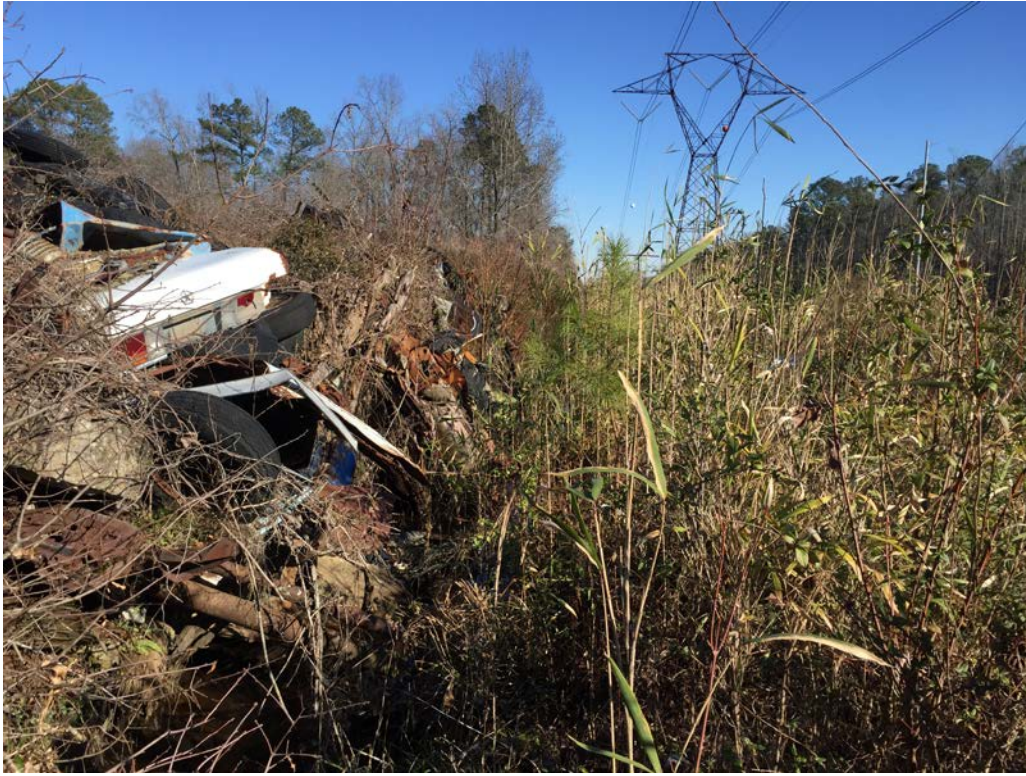
Waterbody schr012 facing west upstream.

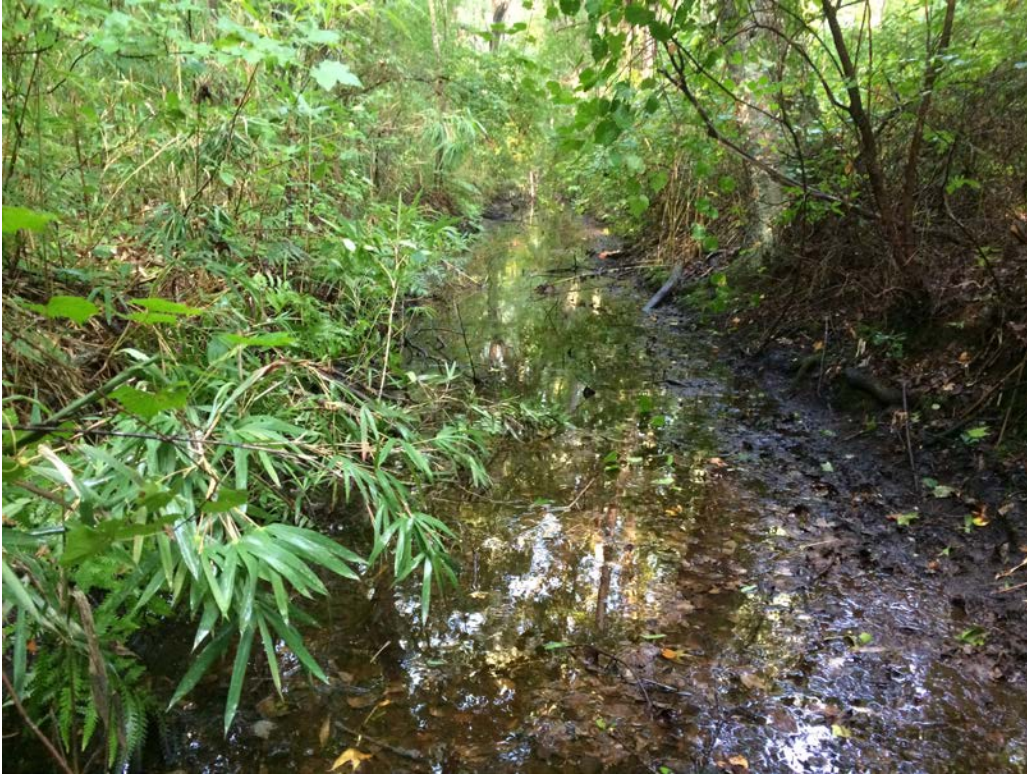
Waterbody schr006 facing west upstream

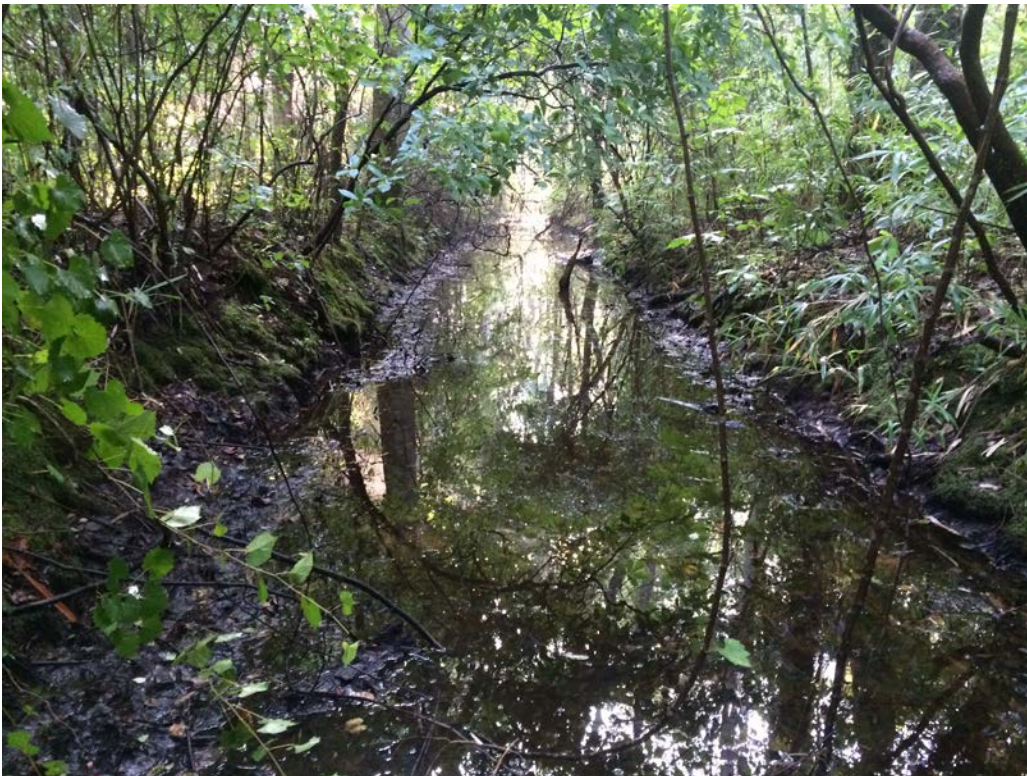
Waterbody schr006 facing east downstream

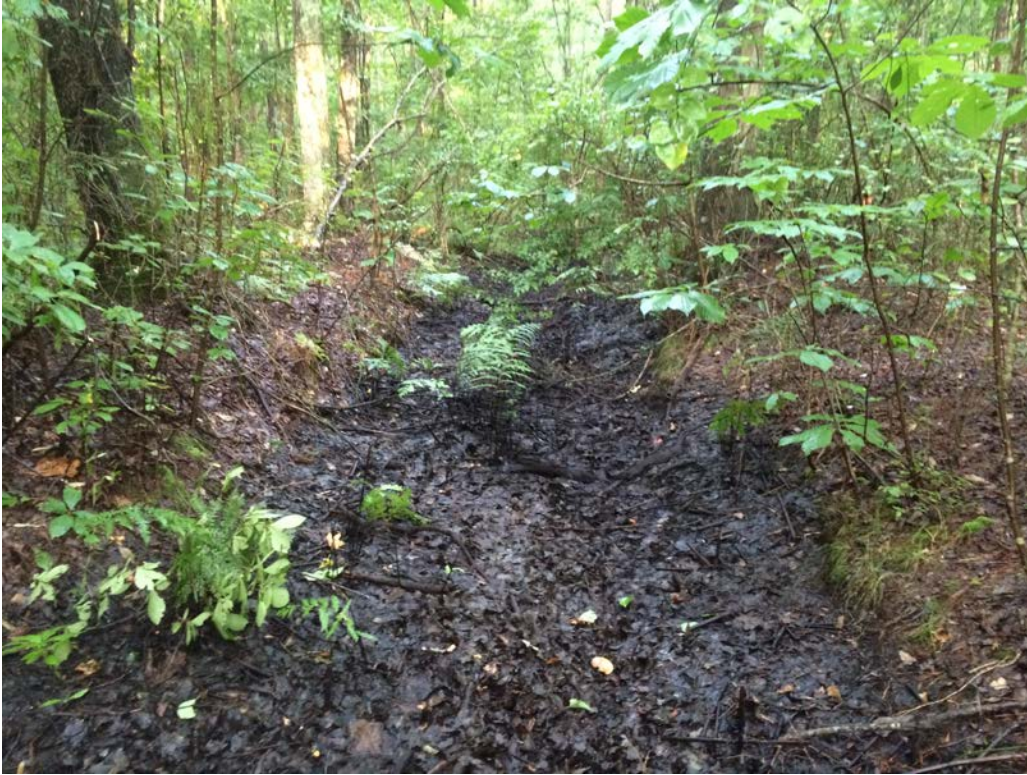
Waterbody schr005 facing west upstream

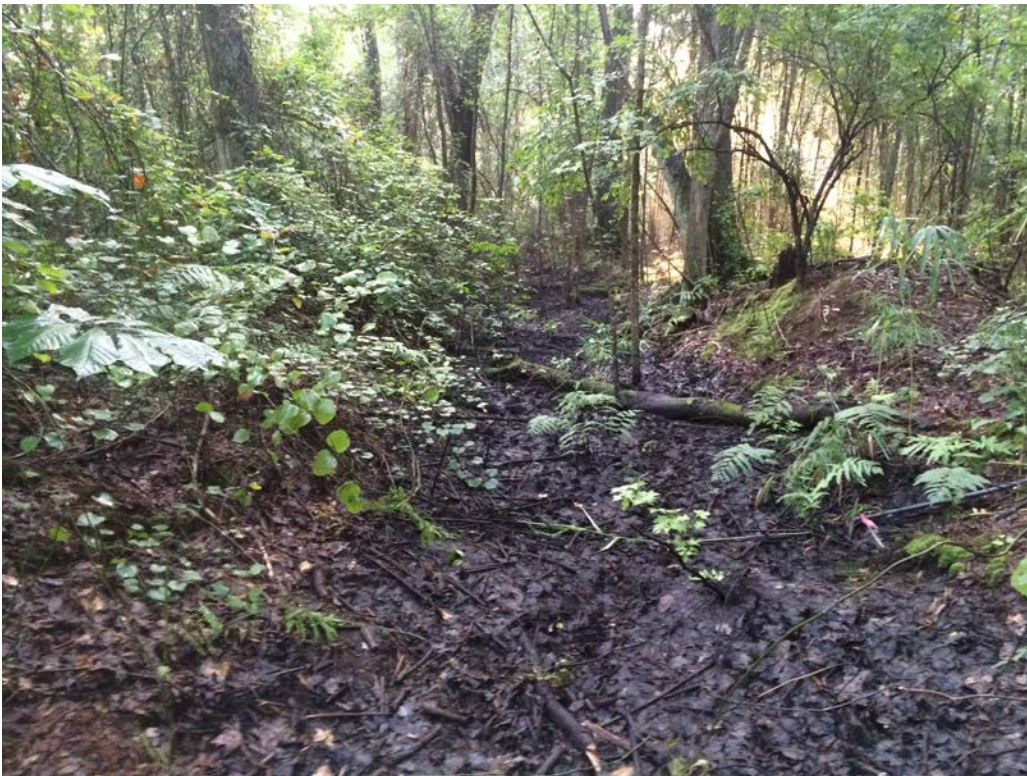
Waterbody schr005 facing east downstream

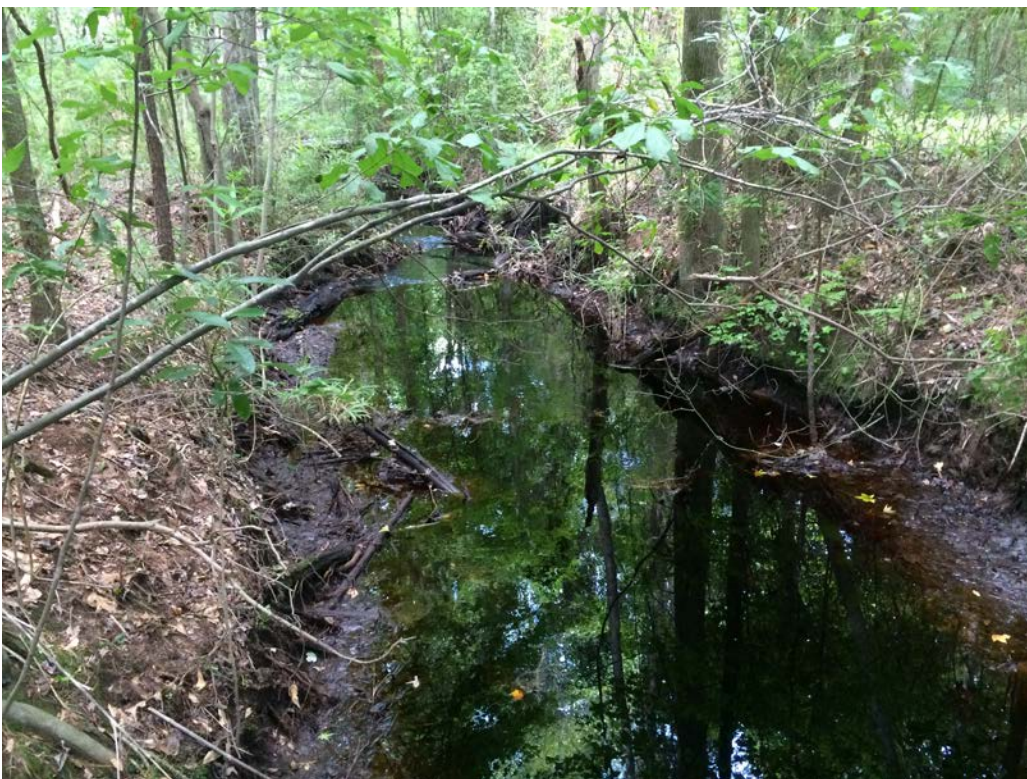
Waterbody schr004 facing east downstream

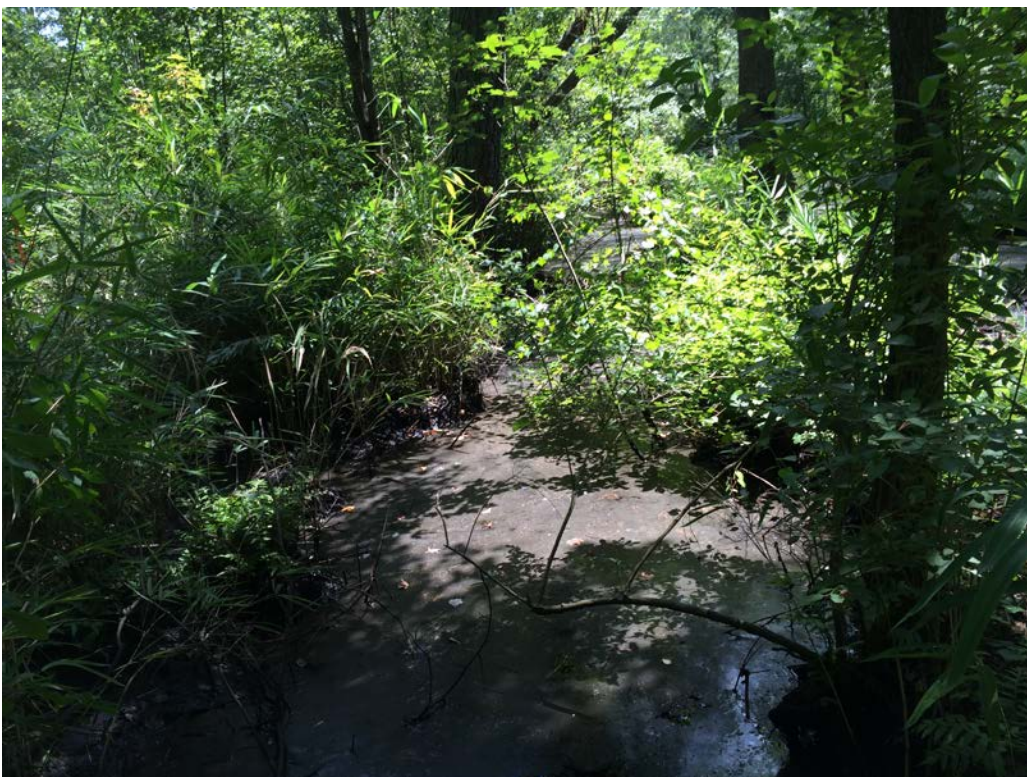
Waterbody schr003 facing south downstream

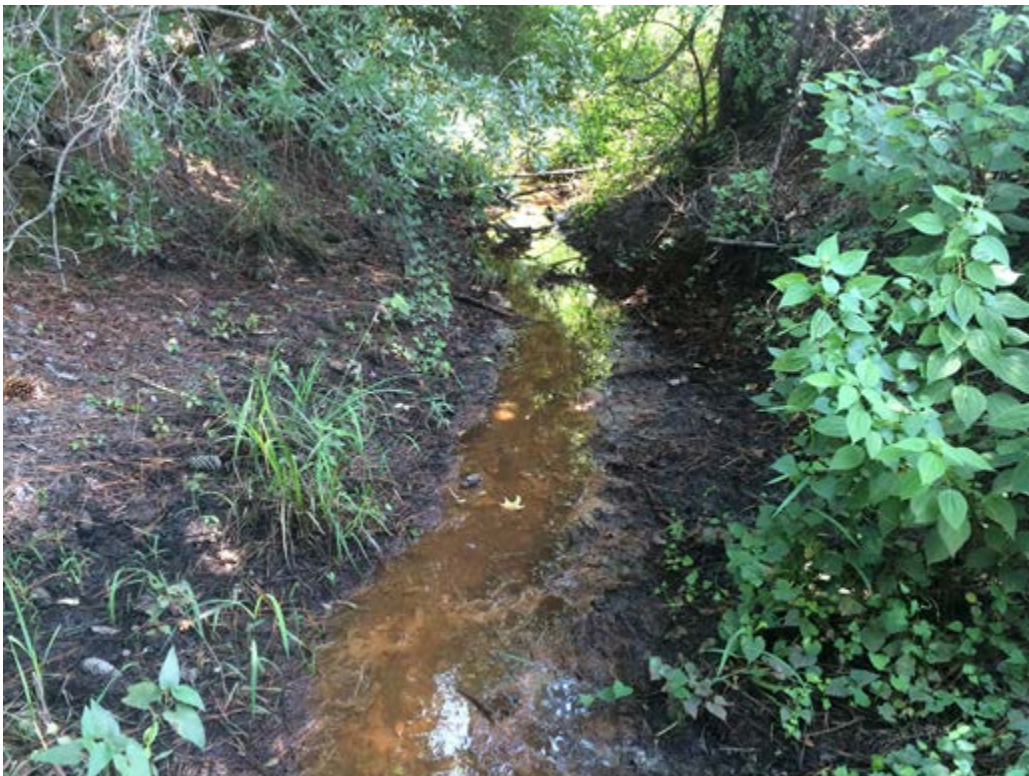
Waterbody schr002 facing east downstream

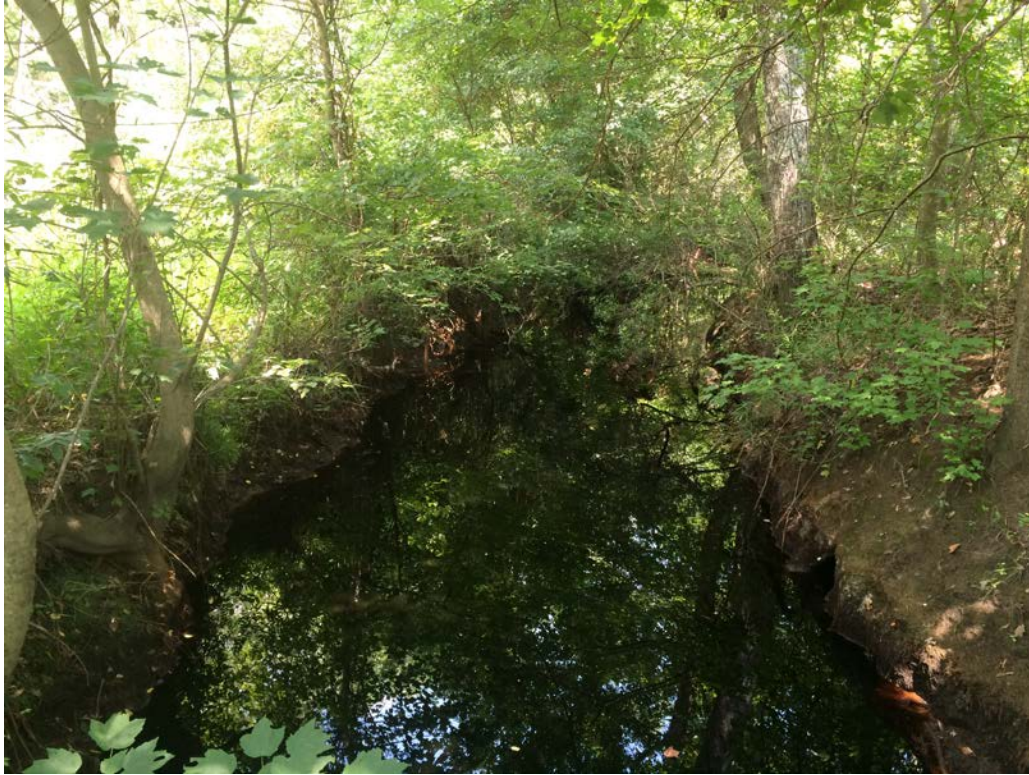
Waterbody schr001 facing north upstream

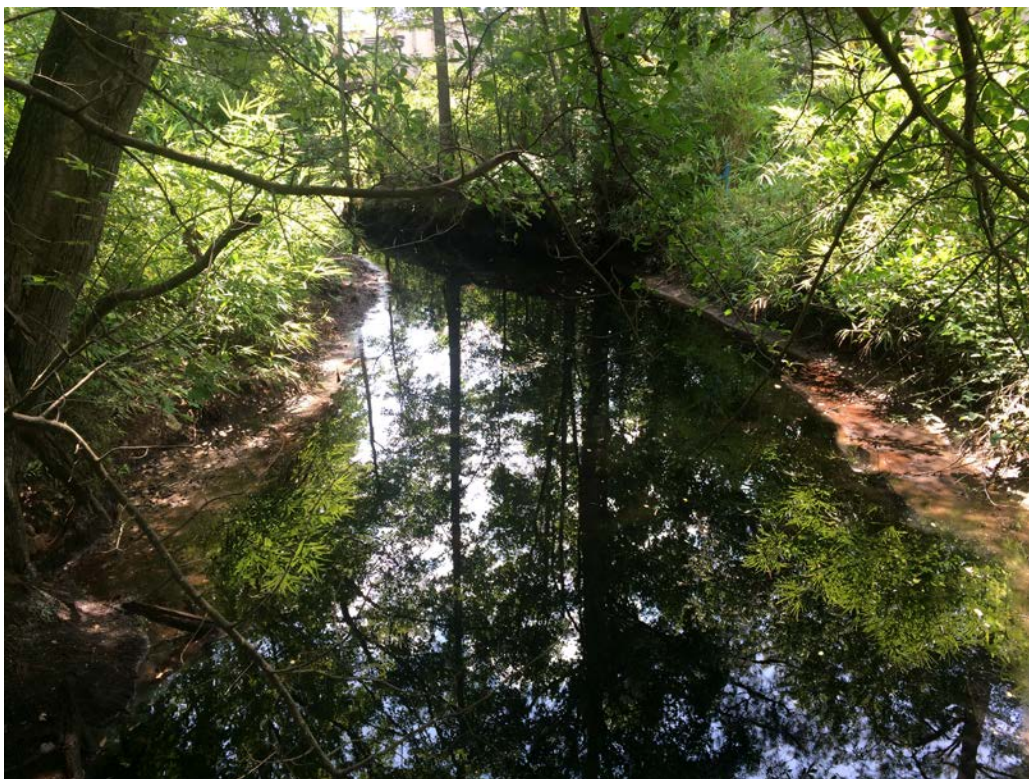
Waterbody schr001 facing south downstream

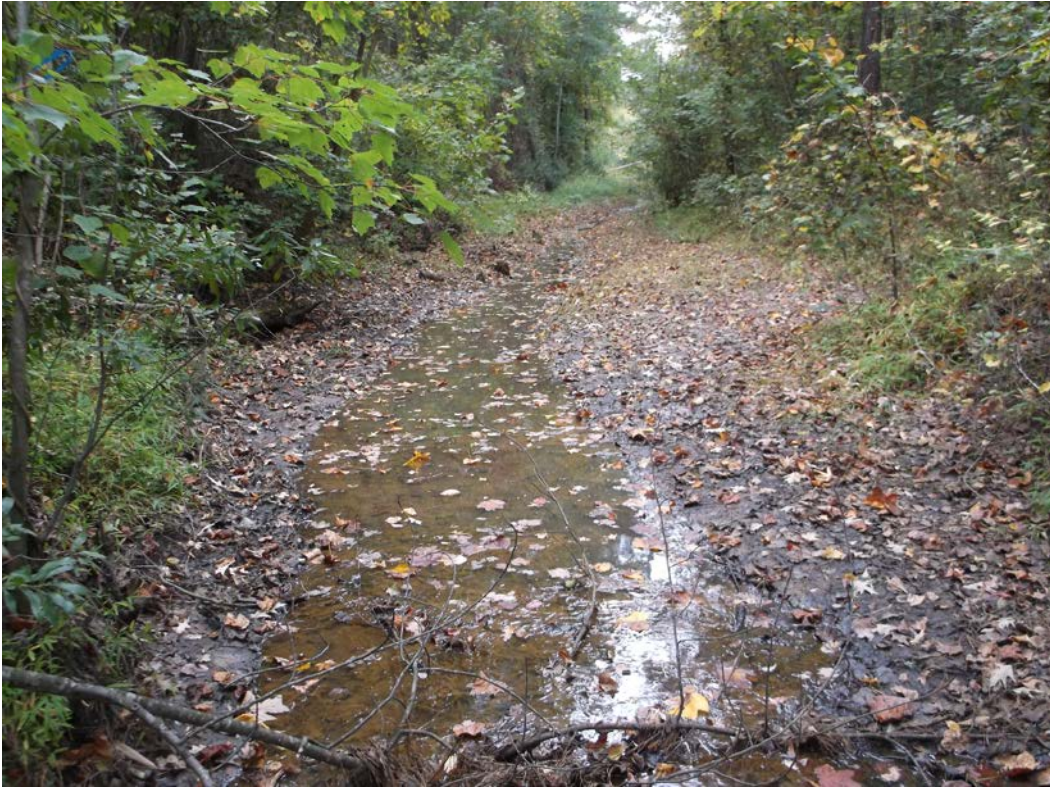
Waterbody schp002 facing northwest upstream.

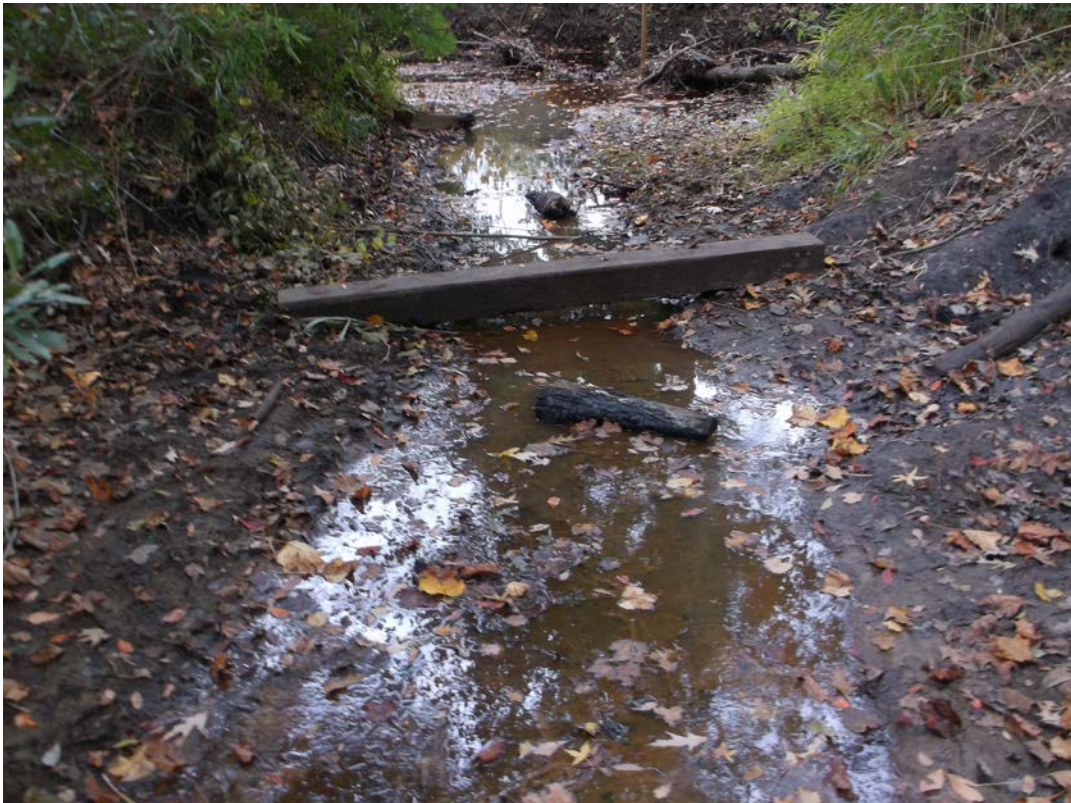
Waterbody schp002 facing southwest downstream.

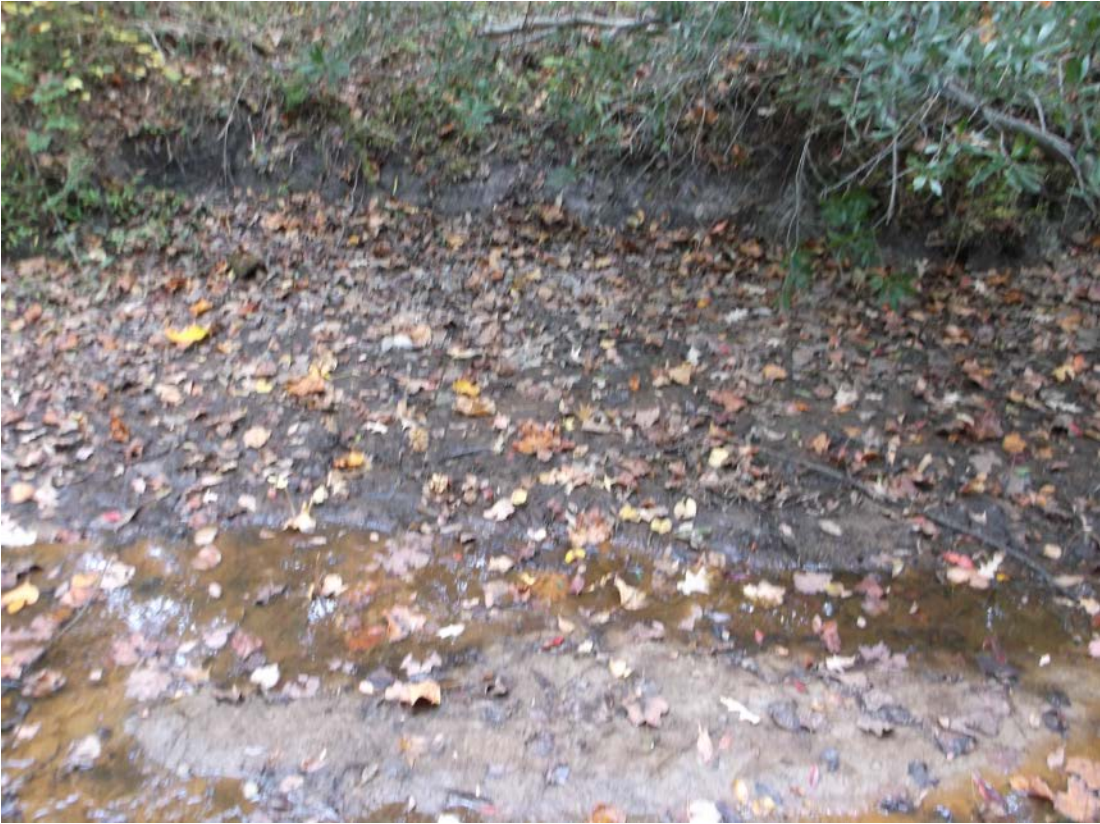
Waterbody schp002 facing northeast across bank.

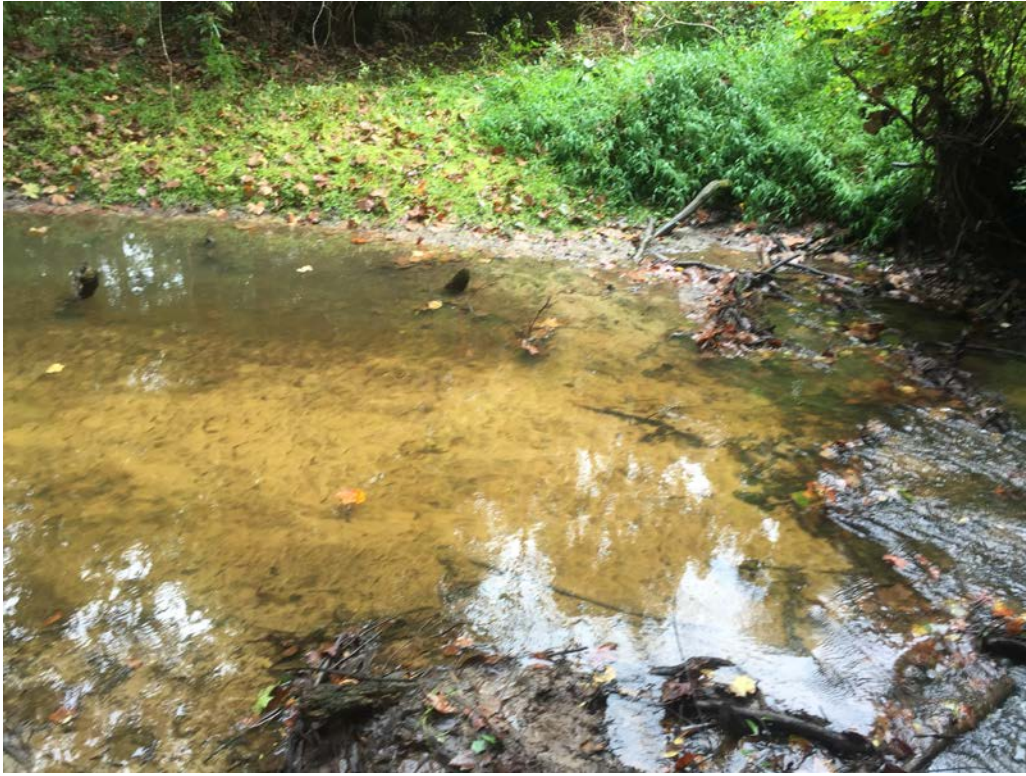
Waterbody scho001 facing east across bank.

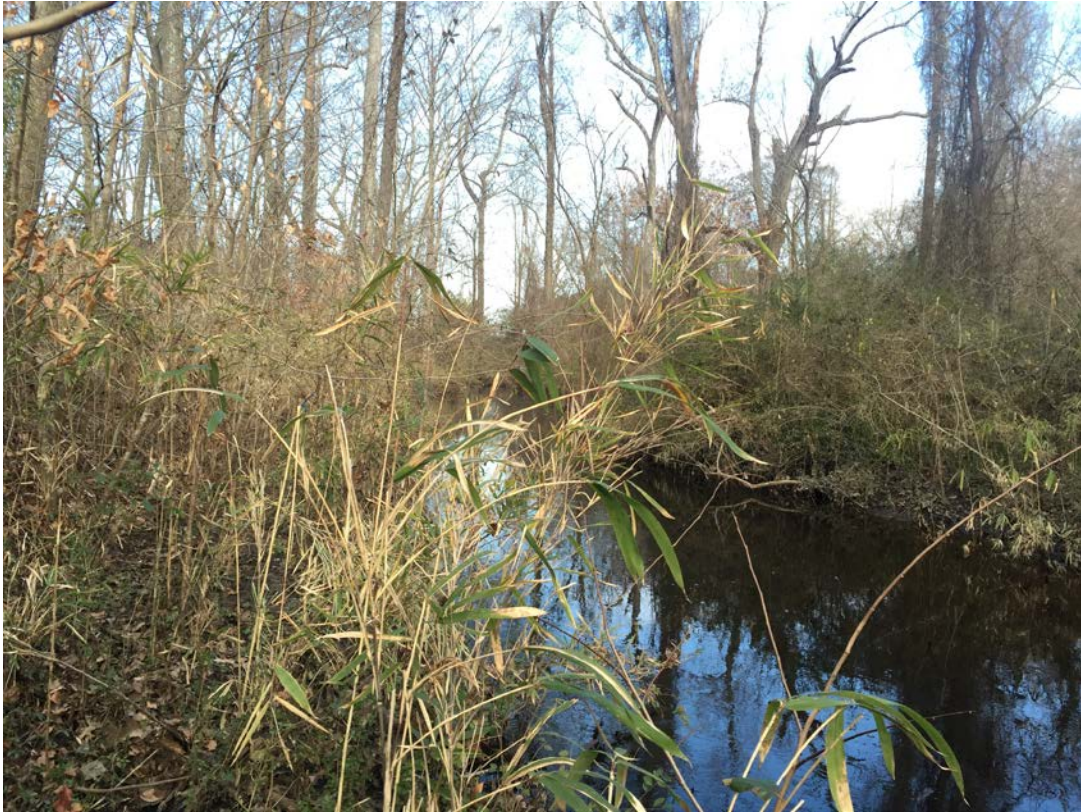
Waterbody data point scho001_s2 facing north upstream.

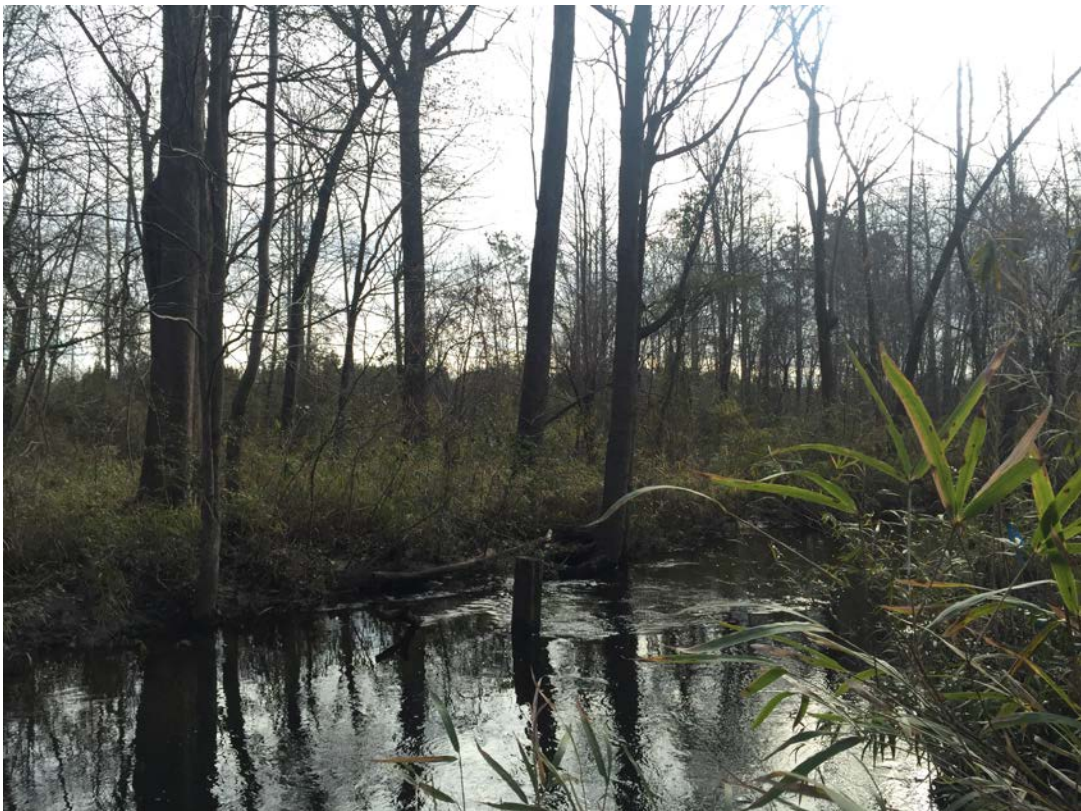
Waterbody data point scho001_s2 facing south downstream.

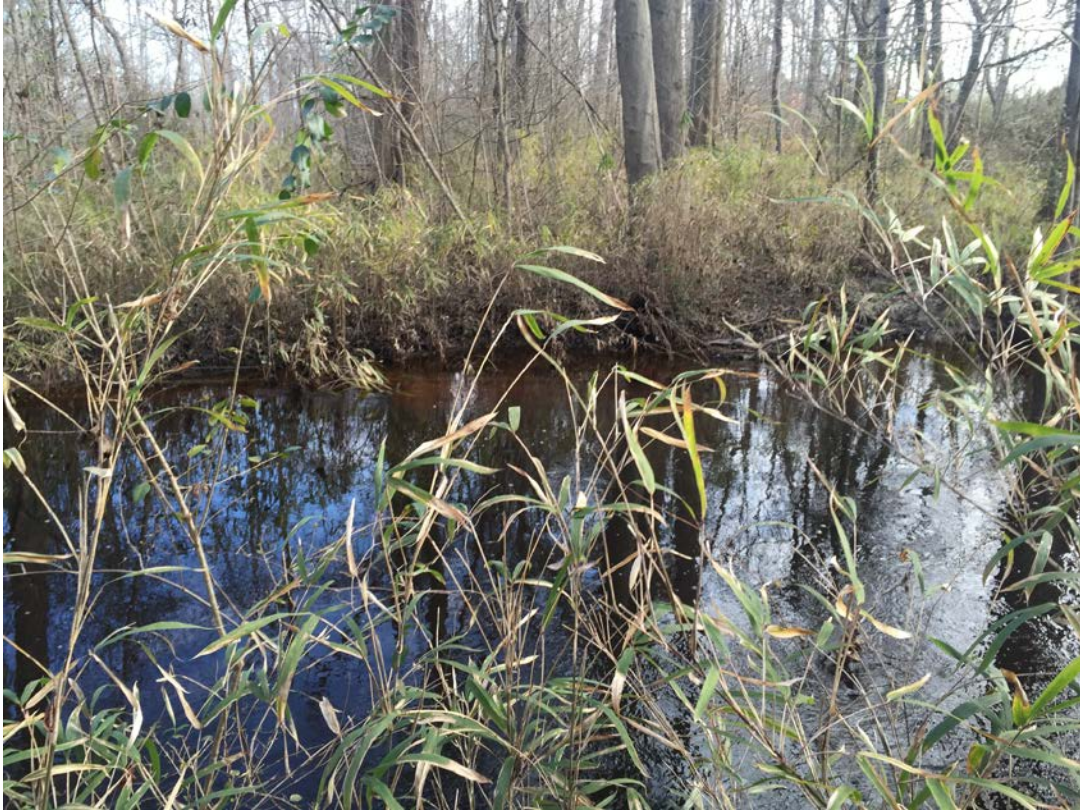
Waterbody data point scho001_s2 facing east across.

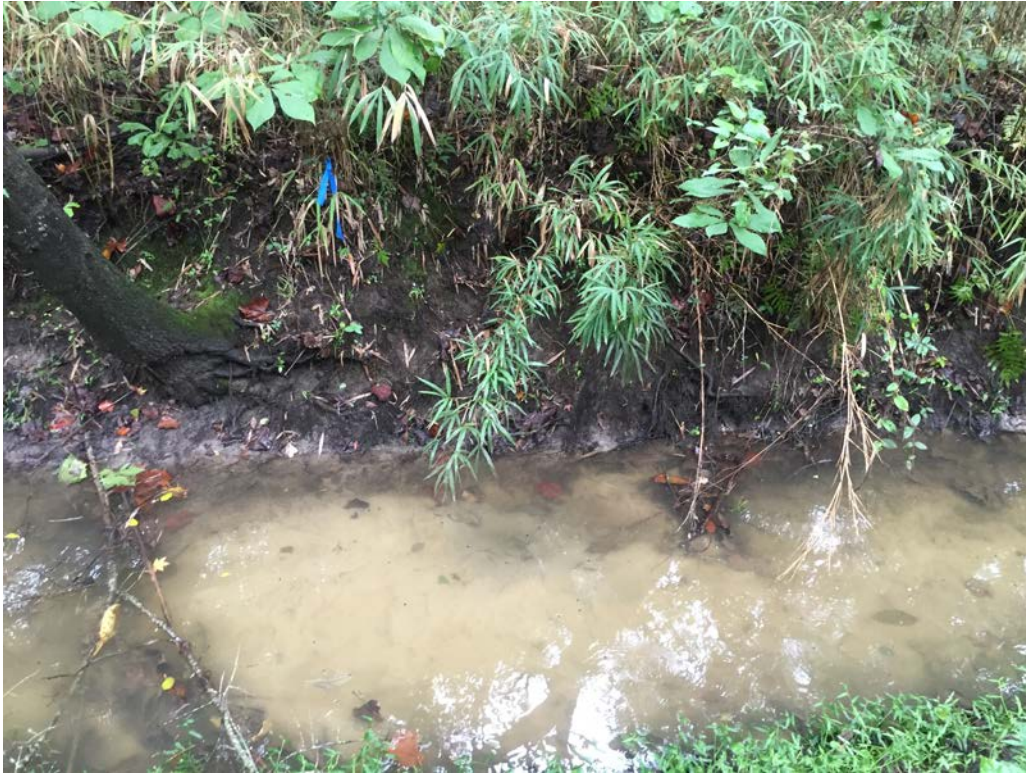
Waterbody scho002 facing northwest across bank.

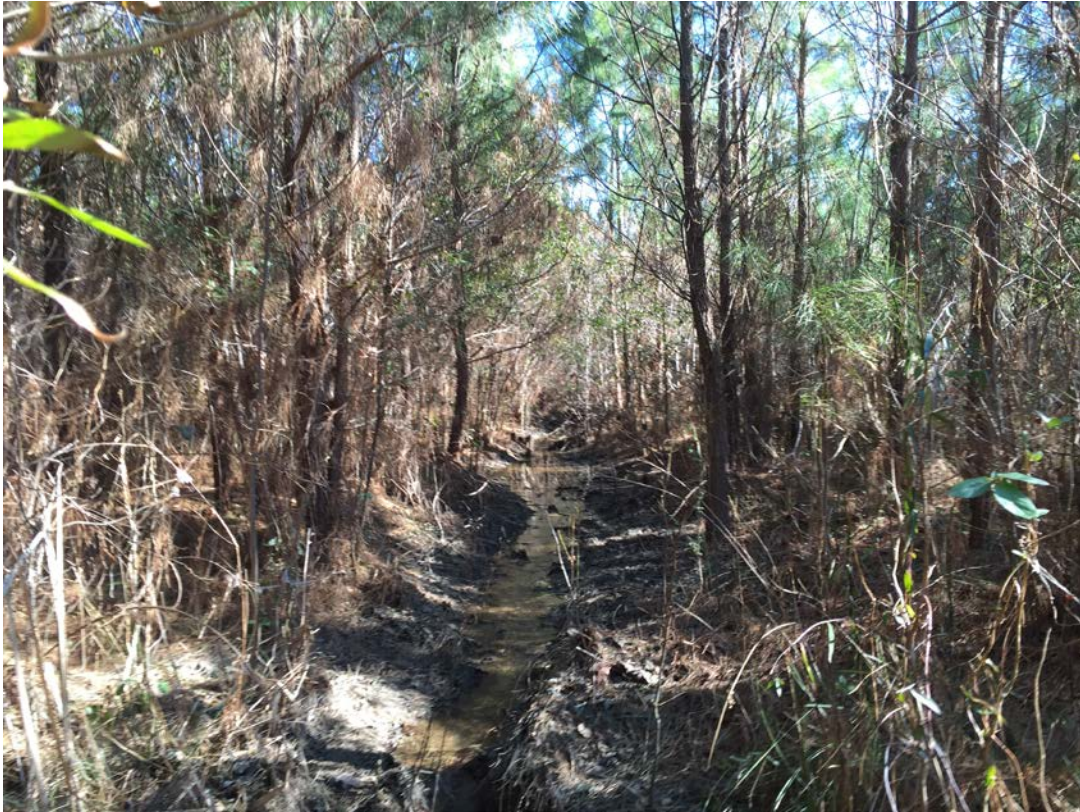
Waterbody data point scho013 facing east upstream.

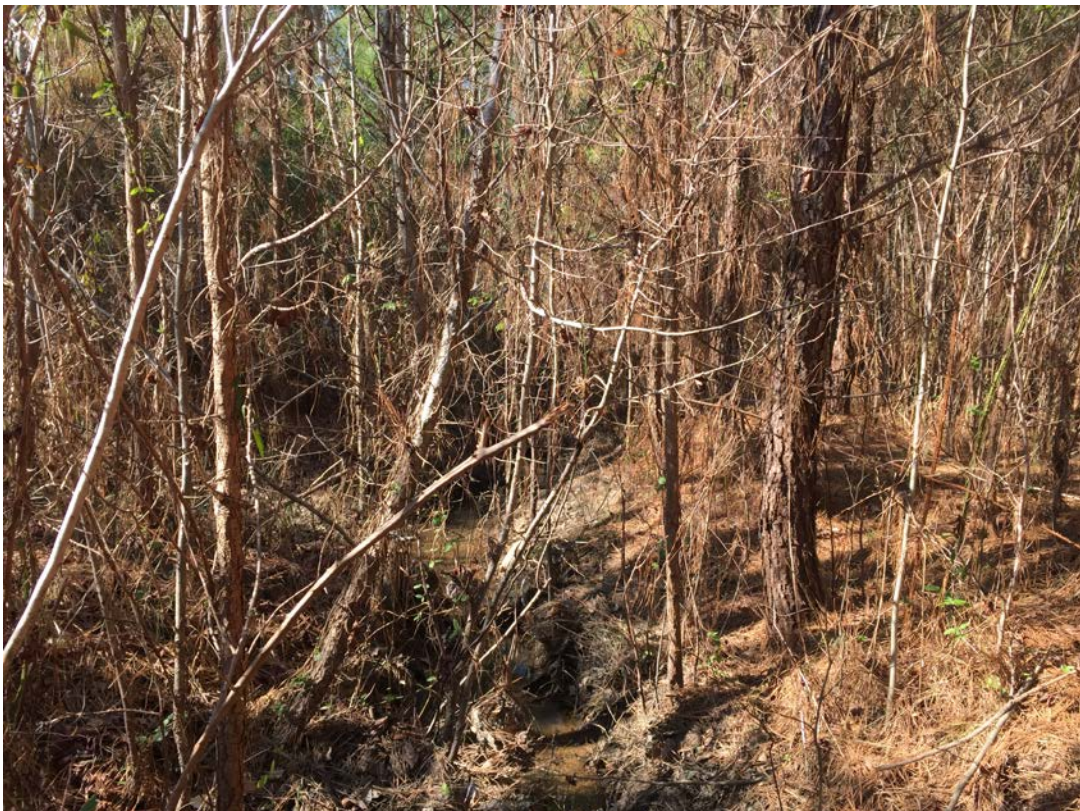
Waterbody data point scho013 facing west downstream.

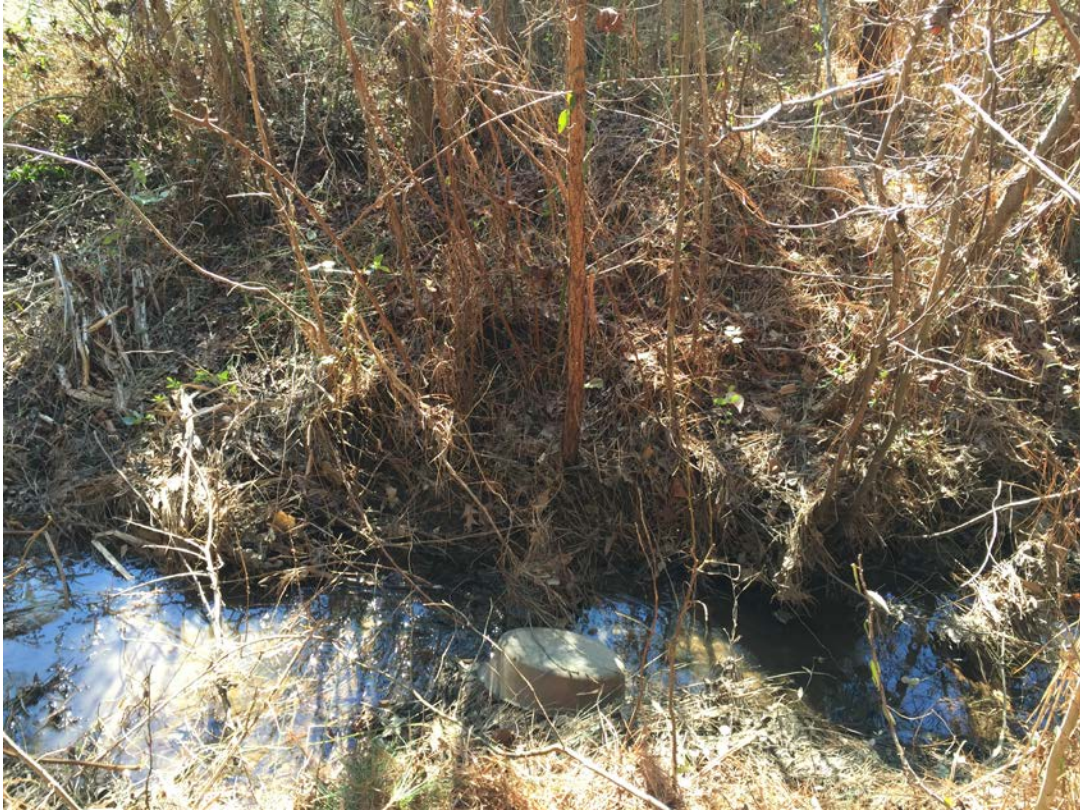
Waterbody data point scho013 facing south across.

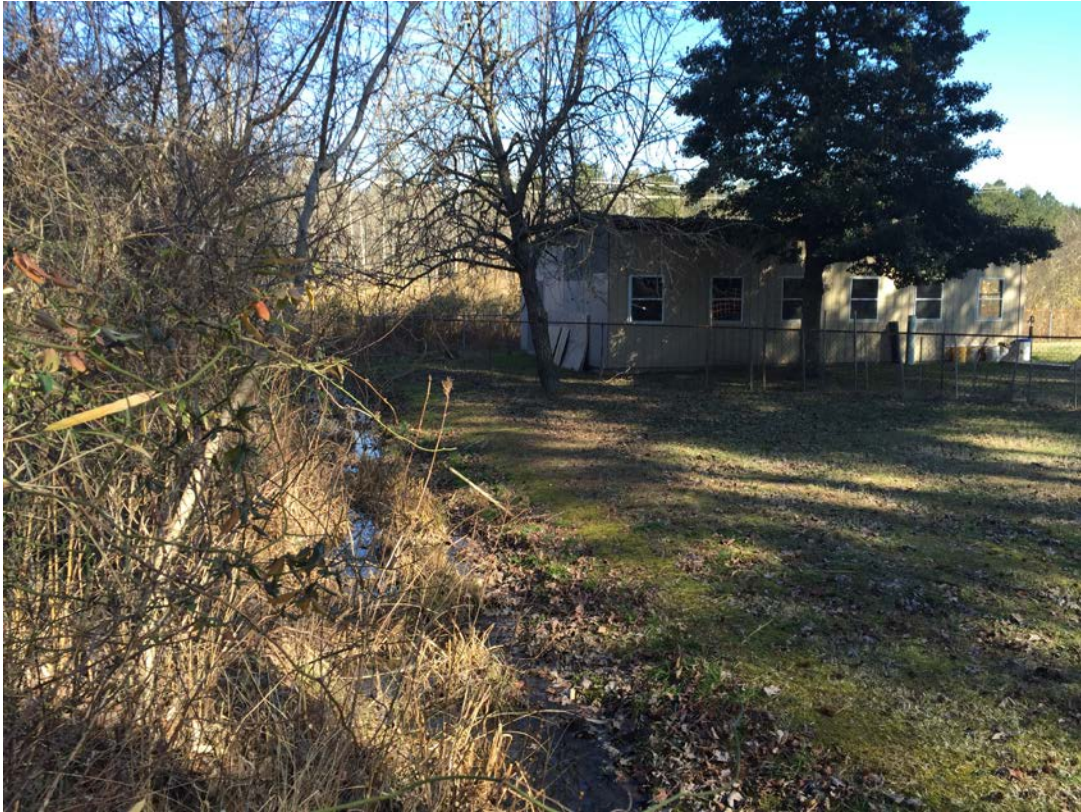
Waterbody data point scho014 facing north upstream.

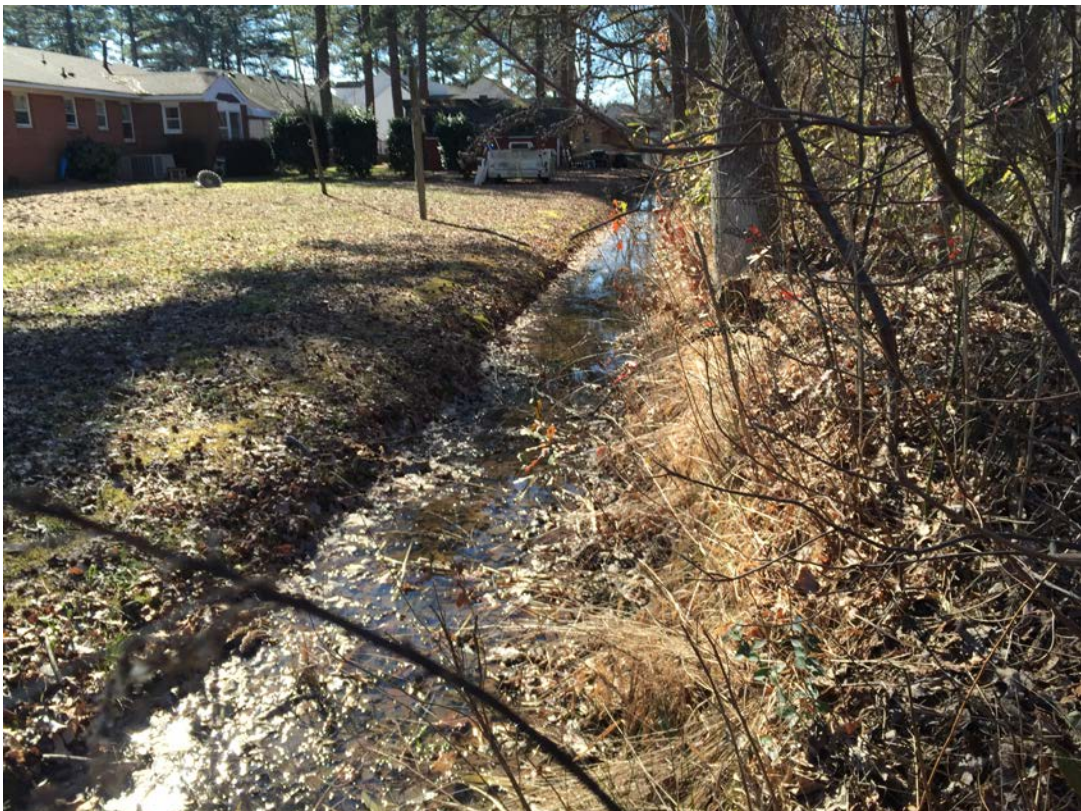
Waterbody data point scho014 facing south downstream.
