Linear Waterbody Data Sheet

Environmental Field Surveys
Waterbody Photo Page

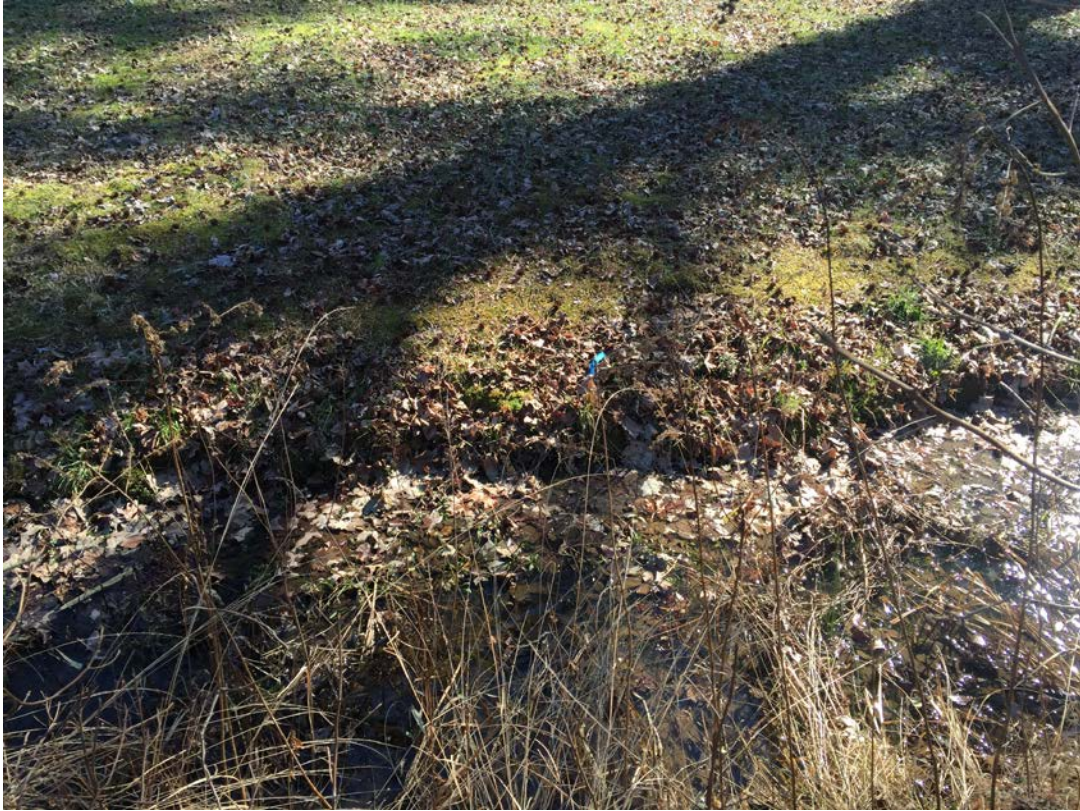
Waterbody data point scho014 facing east across.

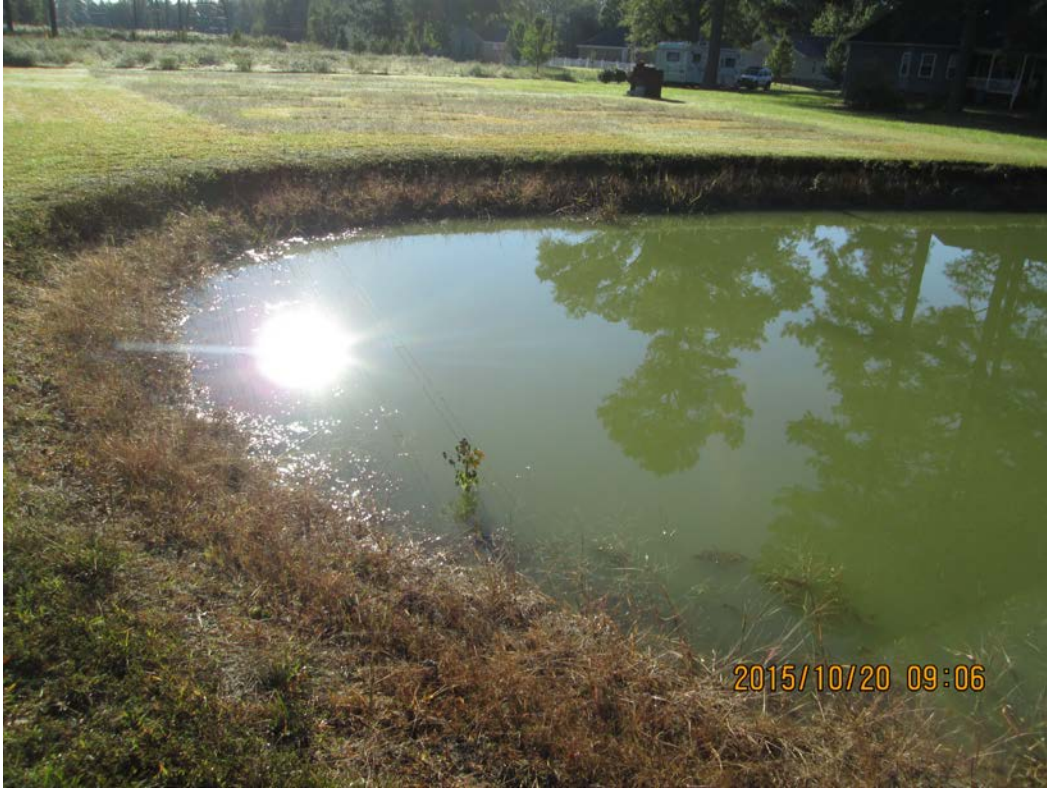
Waterbody ocho003 facing southeast.

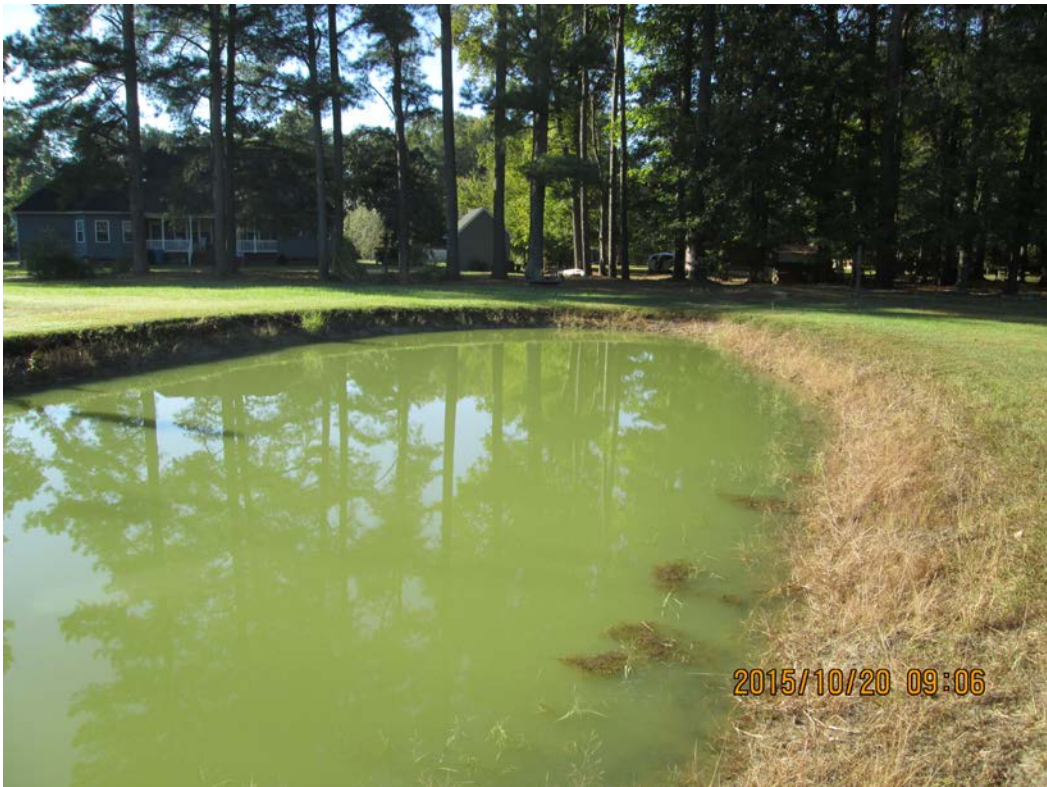
Waterbody ocho003 facing southwest.

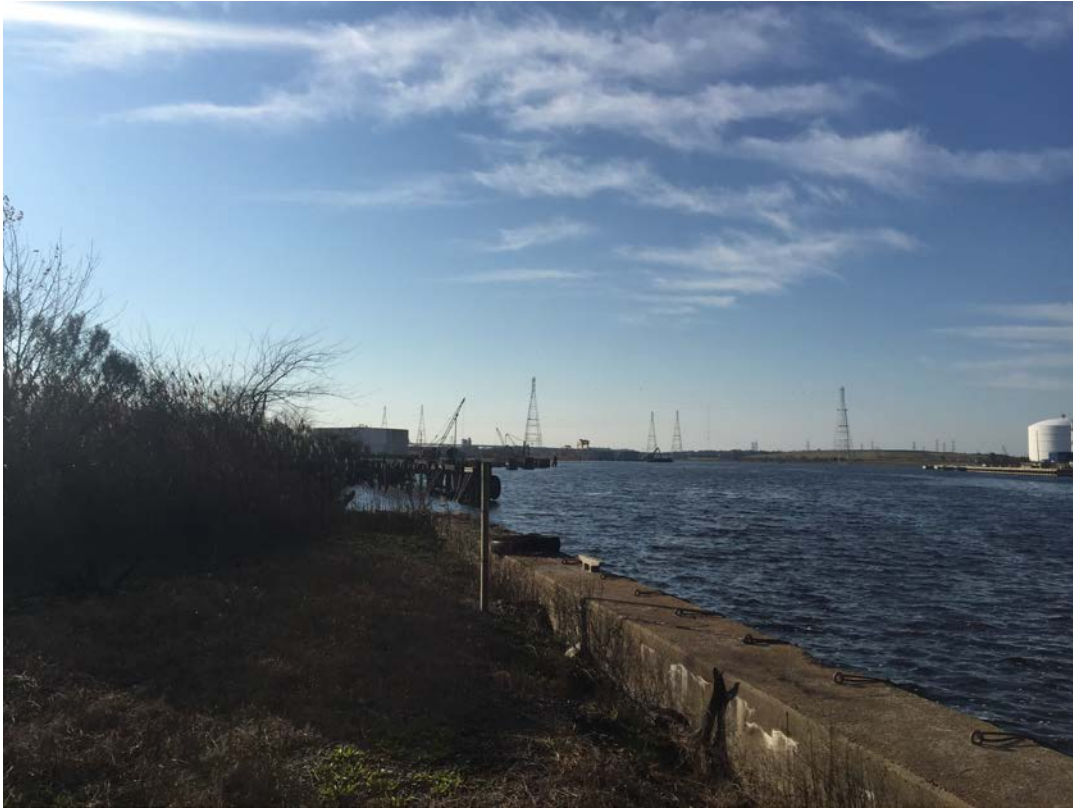
Waterbody data point schp001 facing west upstream.

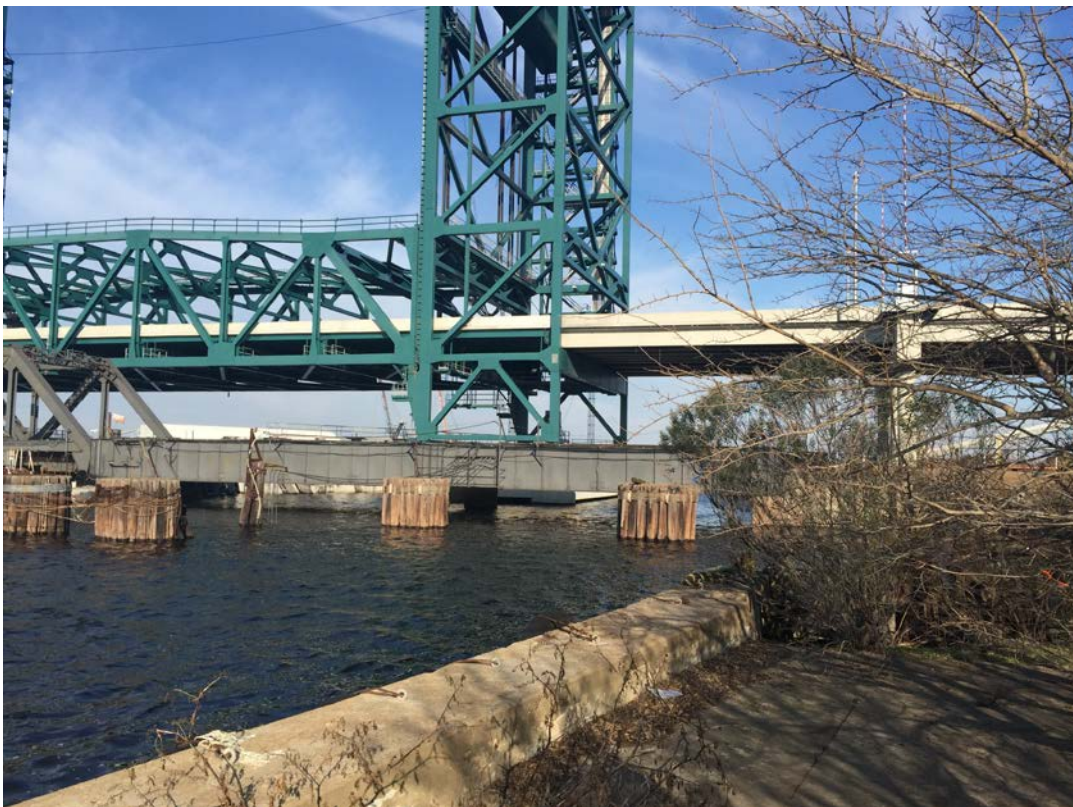
Waterbody data point schp001 facing east downstream.

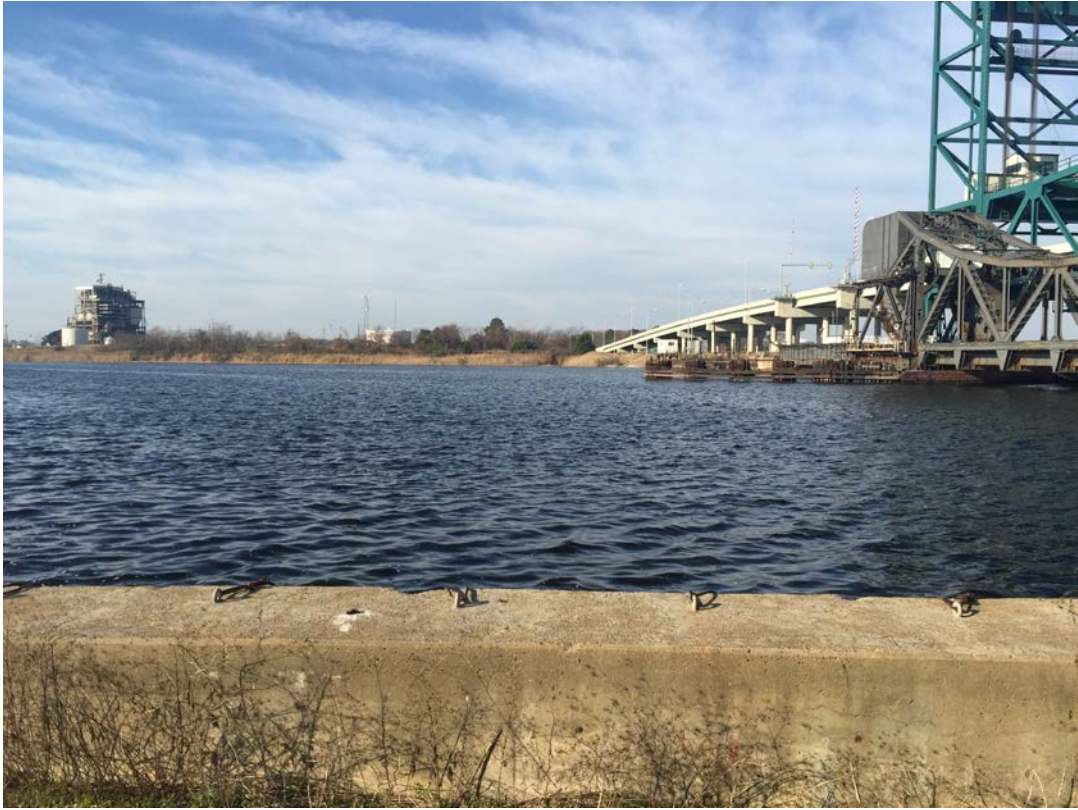
Waterbody data point schp001 facing north across bank.

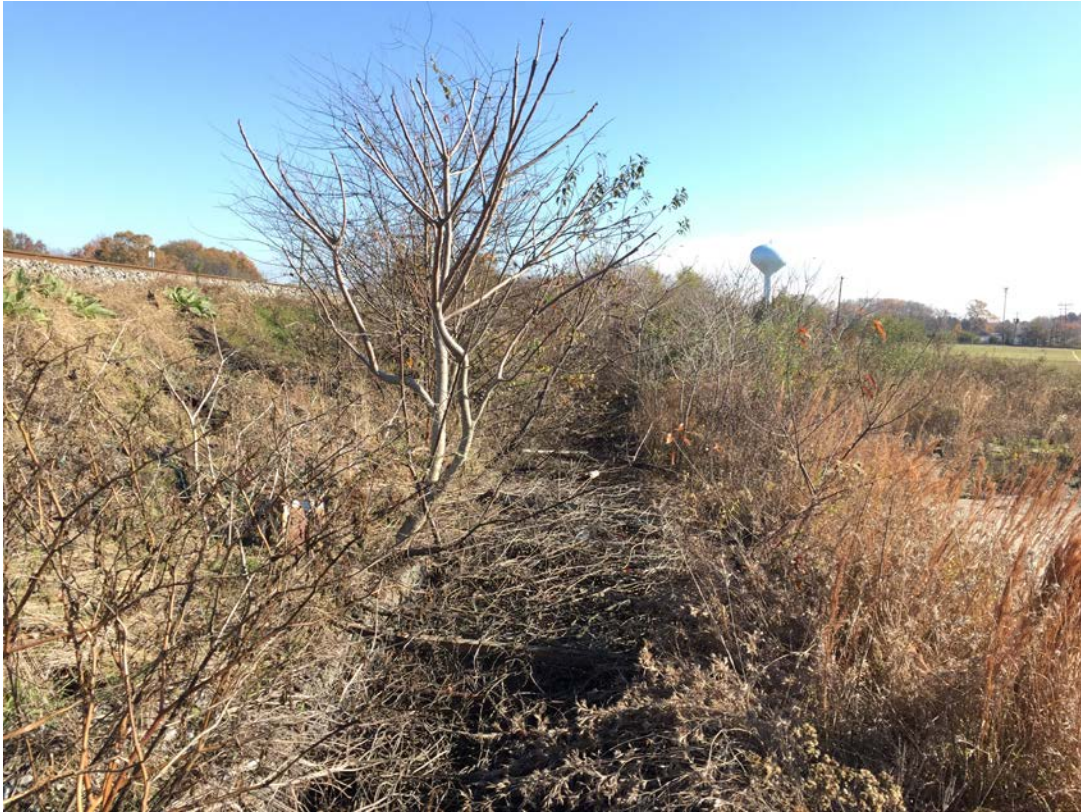
Waterbody data point schp003 facing north upstream.

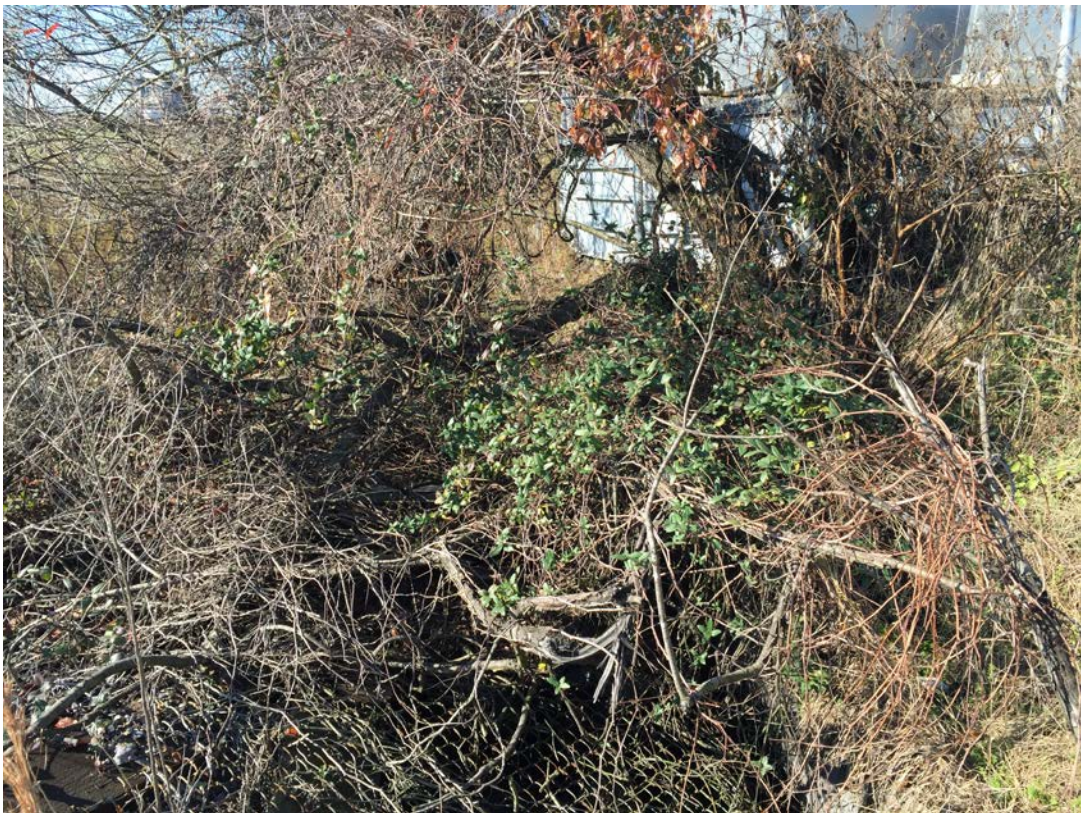
Waterbody data point schp003 facing west downstream.

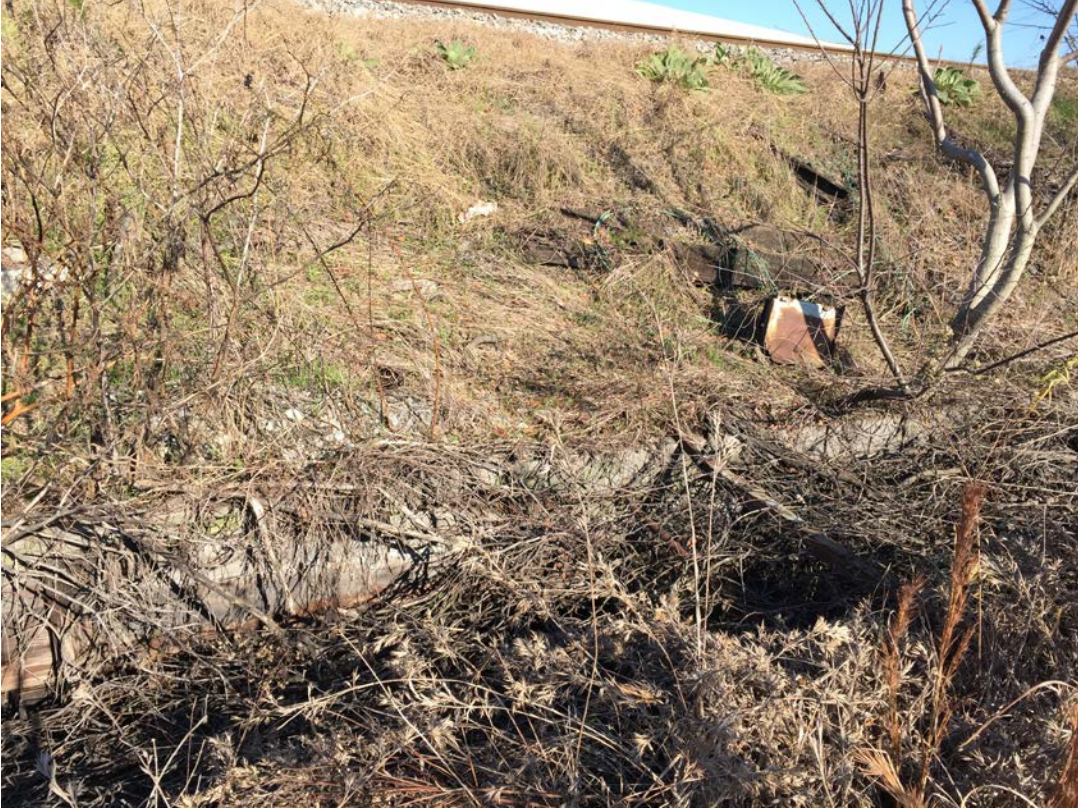
Waterbody data point schp003 facing east across bank.

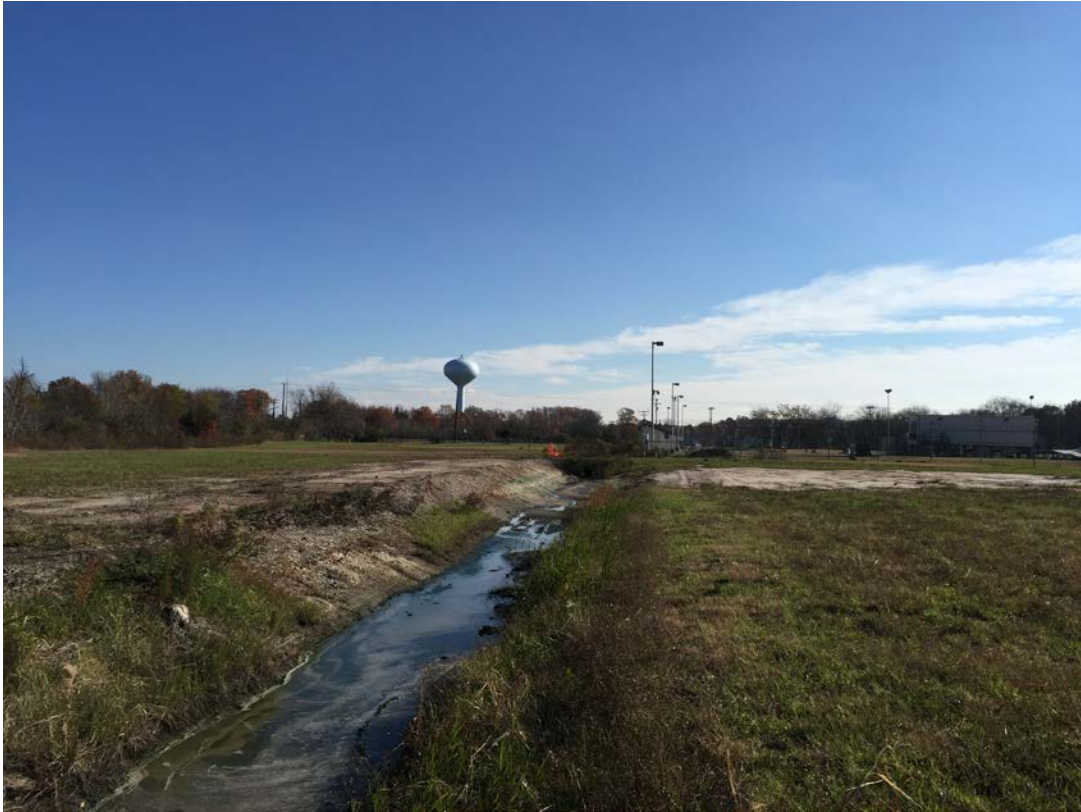
Waterbody data point schp004 facing southeast upstream.

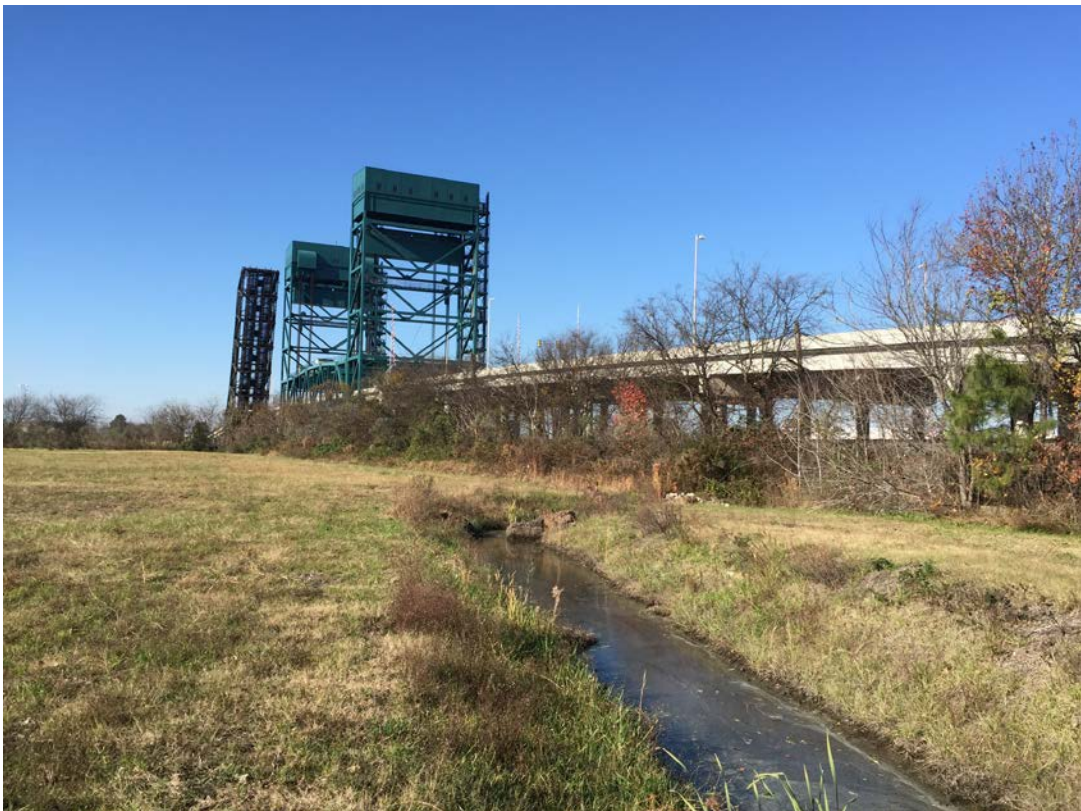
Waterbody data point schp004 facing west downstream.

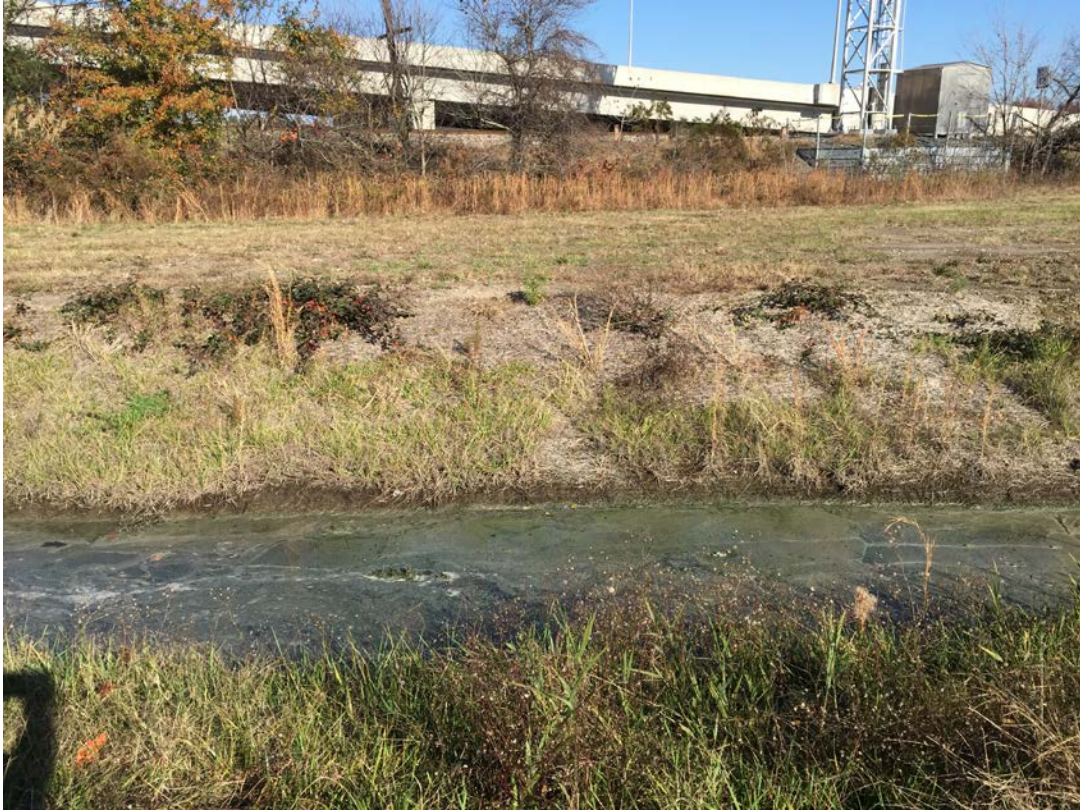
Waterbody data point schp004 facing northeast across bank.
