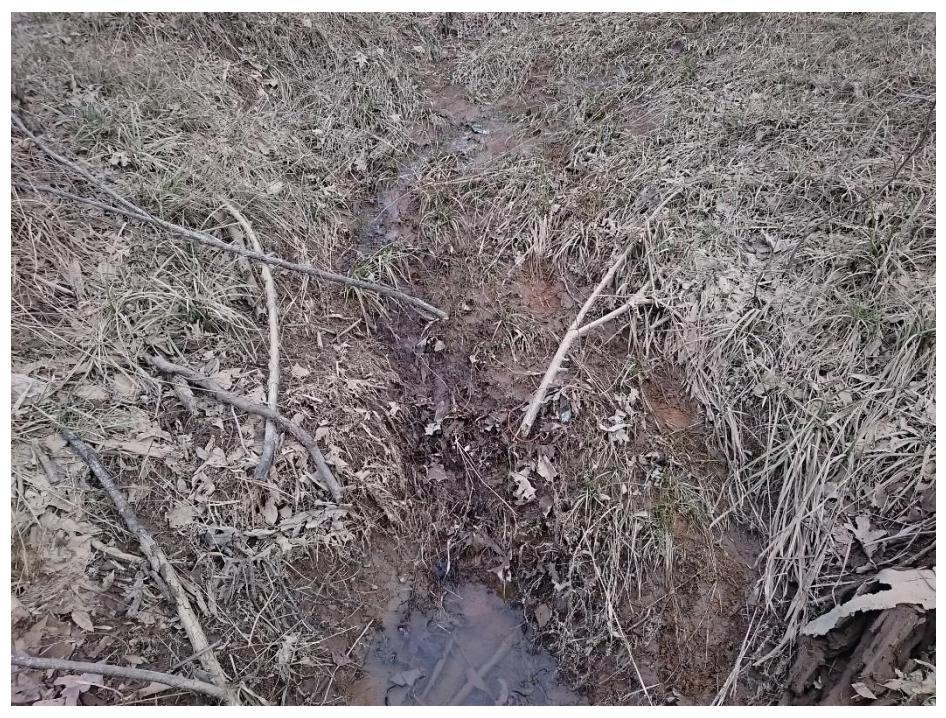
Stream begins within PEM wetland in an active livestock pasture outside of corridor; downstream flows into Appomattox River at edge of survey corridor. Loses bed and bank in segments where trampled by cattle, but lacks hydric soils.

Waterbody SPEA400 facing northeast upstream

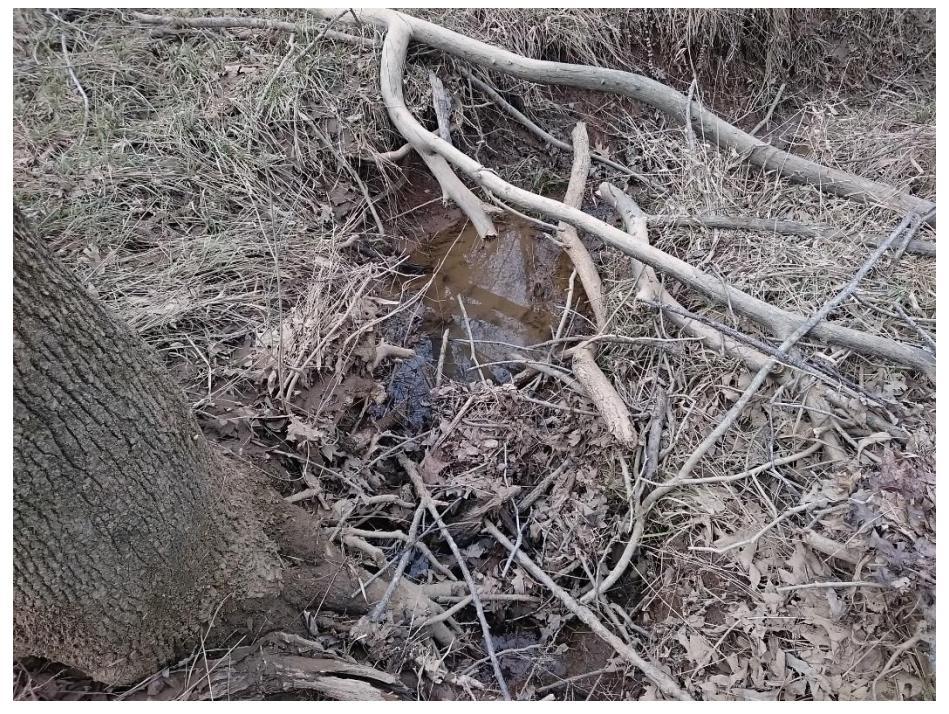
Waterbody SPEA400 facing northwest downstream

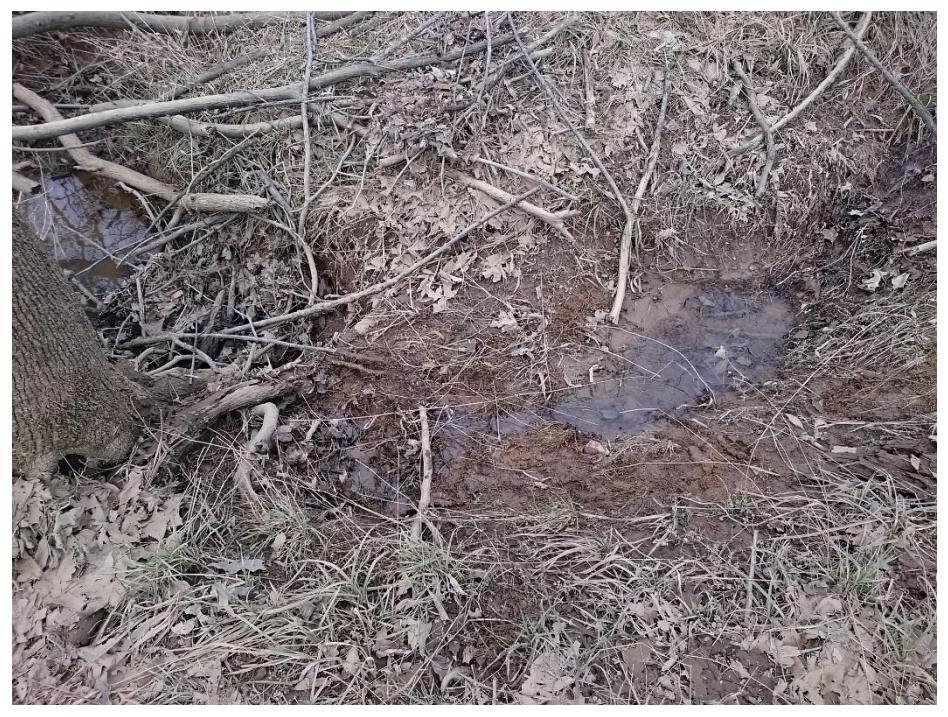
Waterbody SPEA400 facing north across

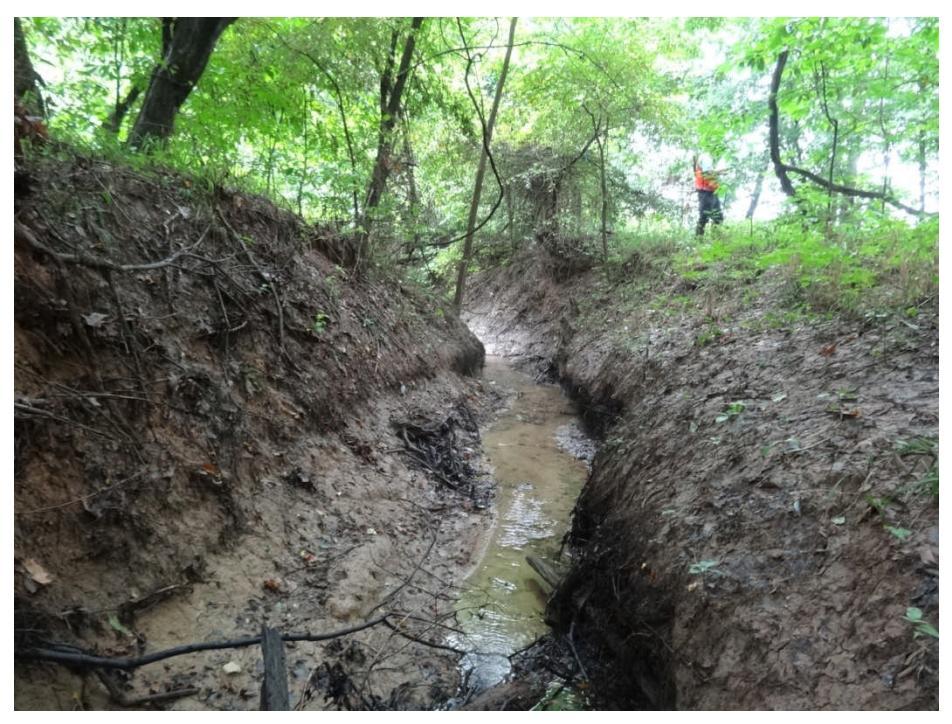
PERENNIAL STREAM IN BOTTOMLAND HW FOREST; INCISED CHANNEL AT DATA POINT

Waterbody point spek003 facing northeast and downstream

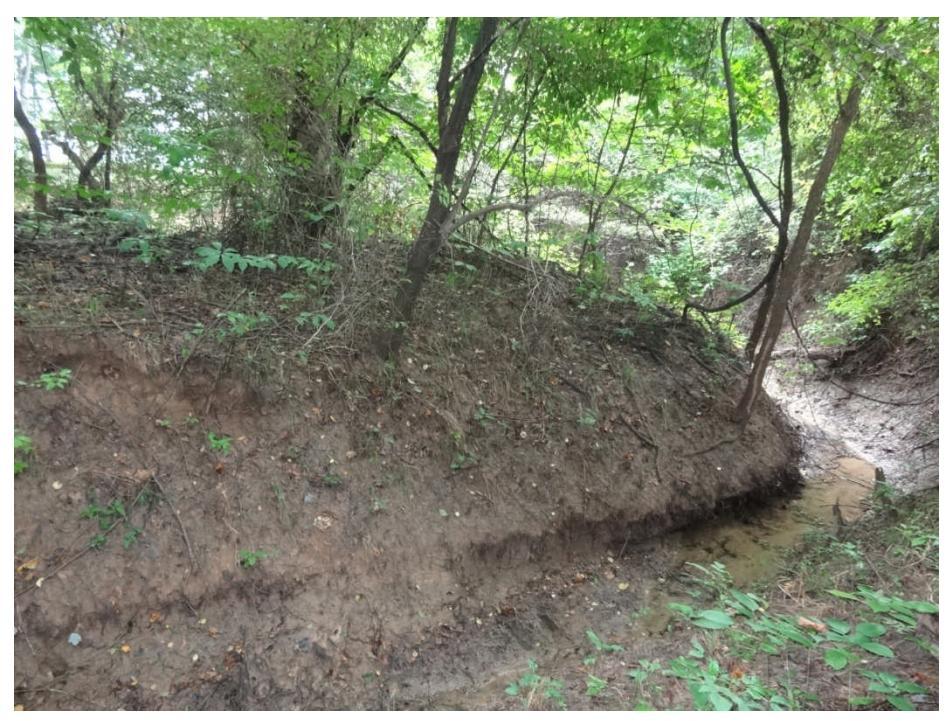
Waterbody point spek003 facing north and across

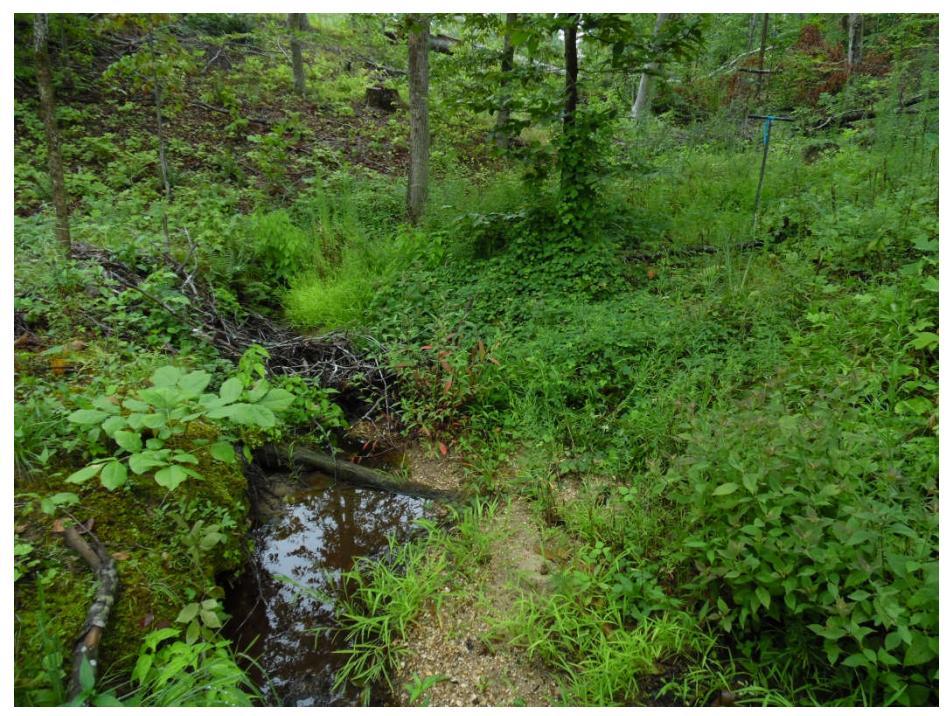
PERENNIAL STREAM IN HARDWOOD FOREST; WELL CONNECTED TO SMALL FLOODPLAIN AREA; GOOD AQUATIC HABITAT; SOME SEEPY STREAMBANK AREAS

Waterbody point spek004 facing South and upstream

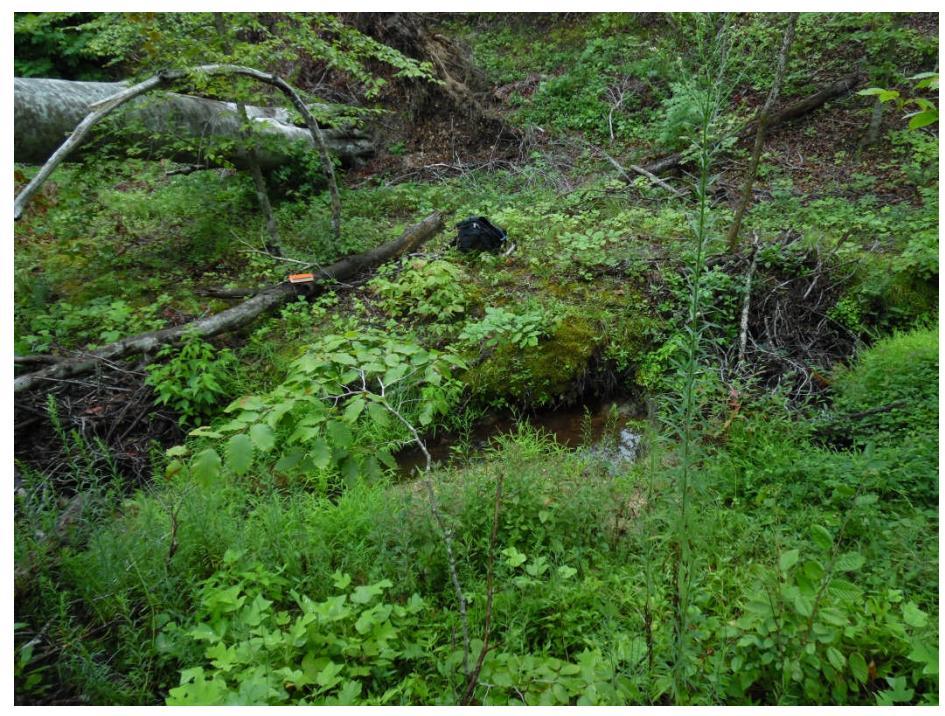
Waterbody point spek004 facing East and across

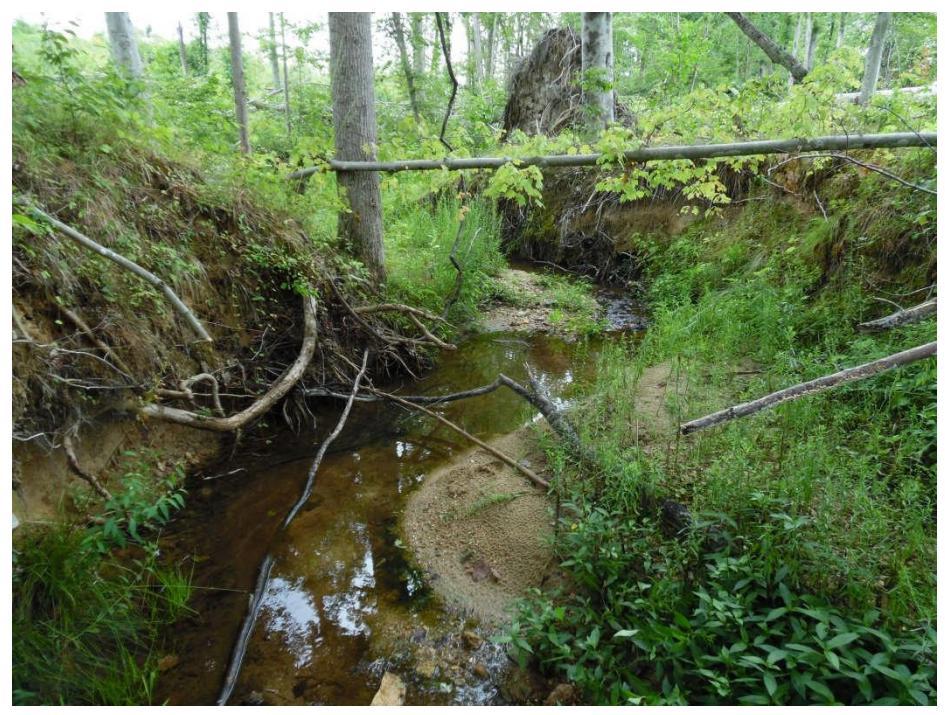
PERENNIAL STREAM IN HARDWOOD FOREST; WELL CONNECTED TO SMALL FLOODPLAIN AREA; GOOD AQUATIC HABITAT; SOME SEEPY STREAMBANK AREAS

Waterbody point spek006 facing North and downstream

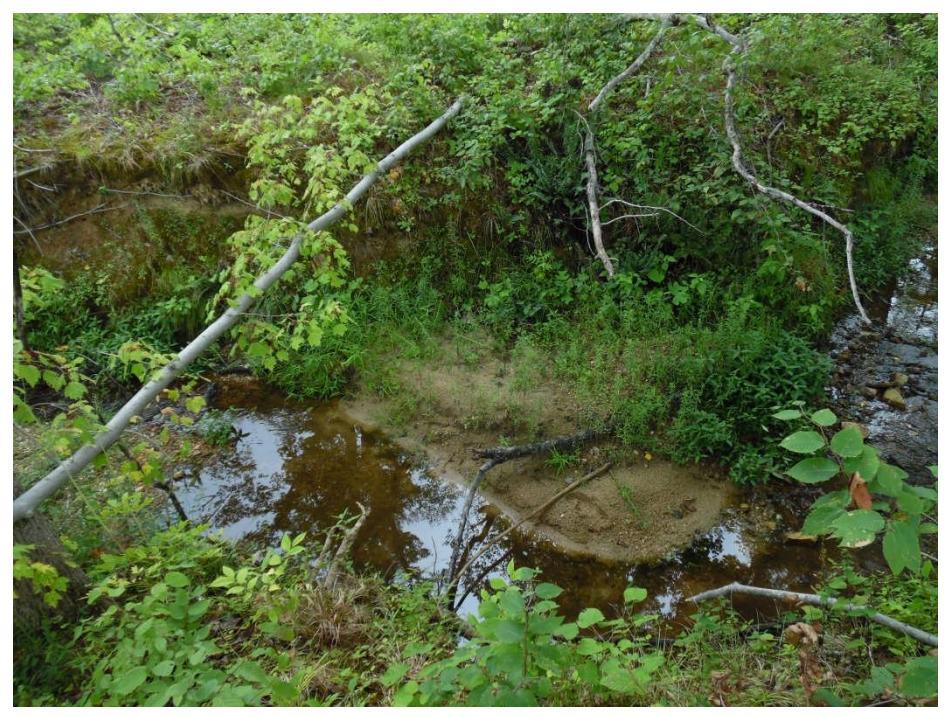
Waterbody point spek006 facing East and across

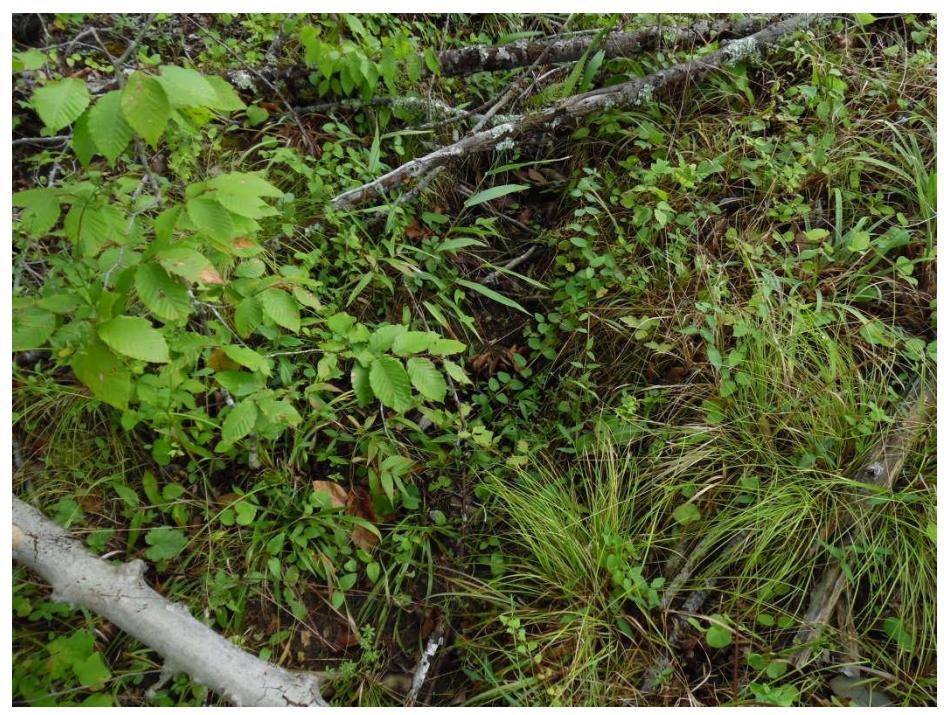
EPHEMERAL STREAM IN HARDWOOD FOREST; NOT CONNECTED TO FLOODPLAIN AREA; DRAINS UPSTREAM HILLSIDE WETLAND AREA

Waterbody point spek005 facing West and upstream

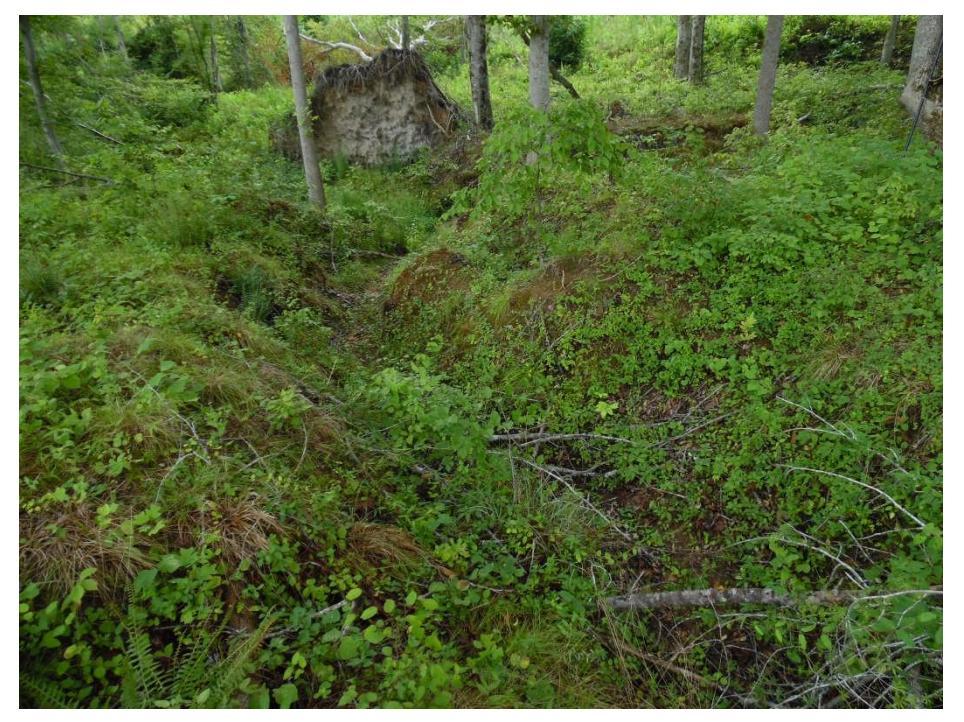
Waterbody point spek005 facing East and downstream

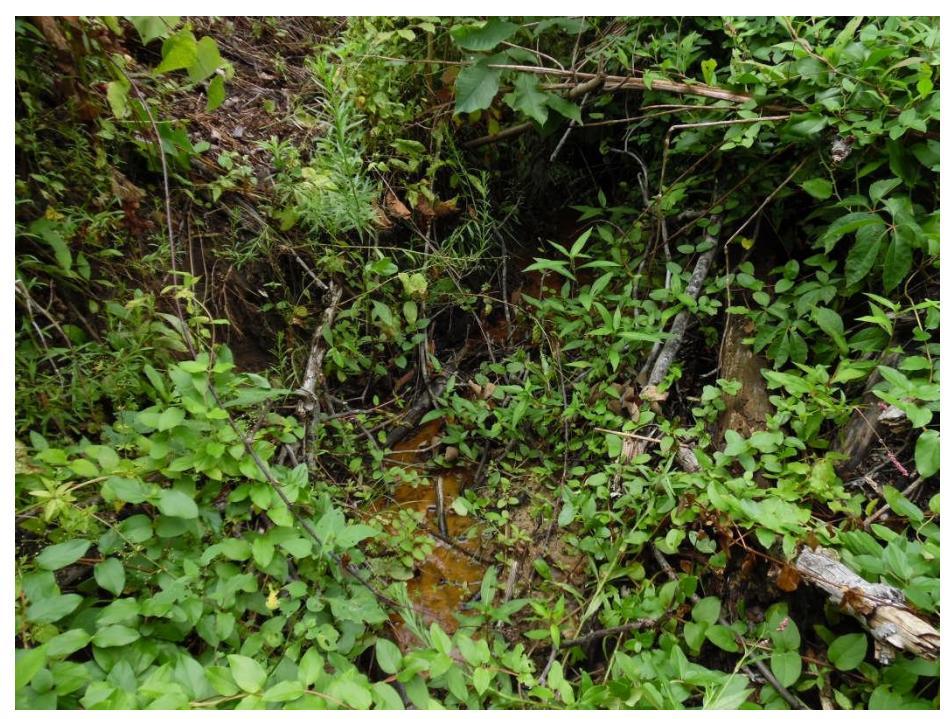
HEADWATER INTERMITTENT STREAM IN CLEARCUT; POOR AQUATIC HABITAT; SOME SEEPY STREAMBANK AREAS

Waterbody point spek007 facing South and upstream

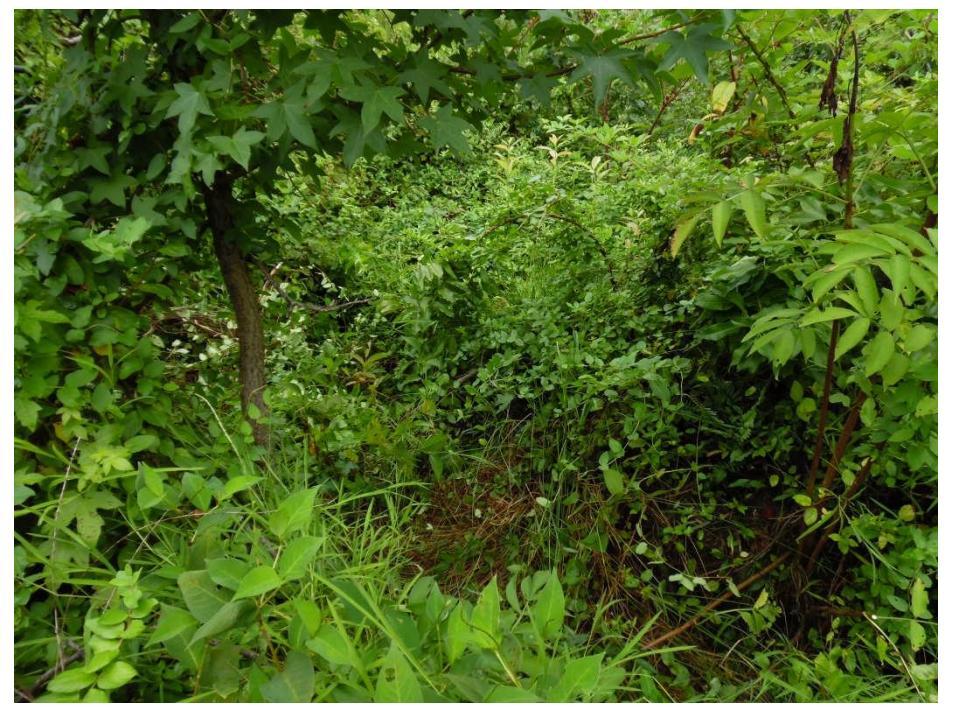
Waterbody point spek007 facing North and downstream

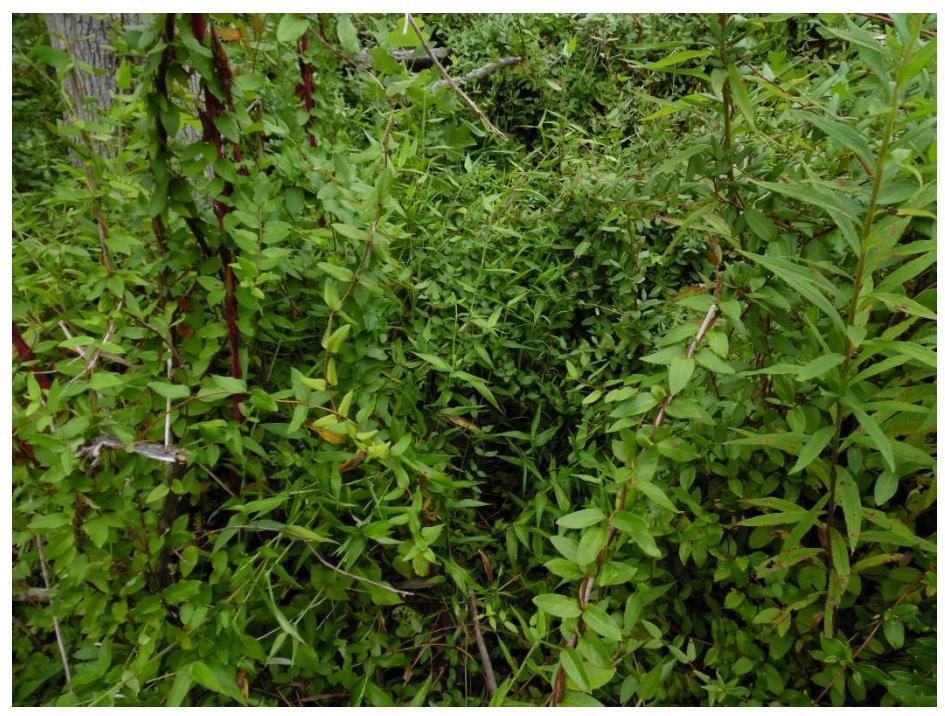
HEADWATER INTERMITTENT STREAM IN CLEARCUT; POOR AQUATIC HABITAT; SOME SEEPY STREAMBANK AREAS

Waterbody point spek008 facing South and upstream

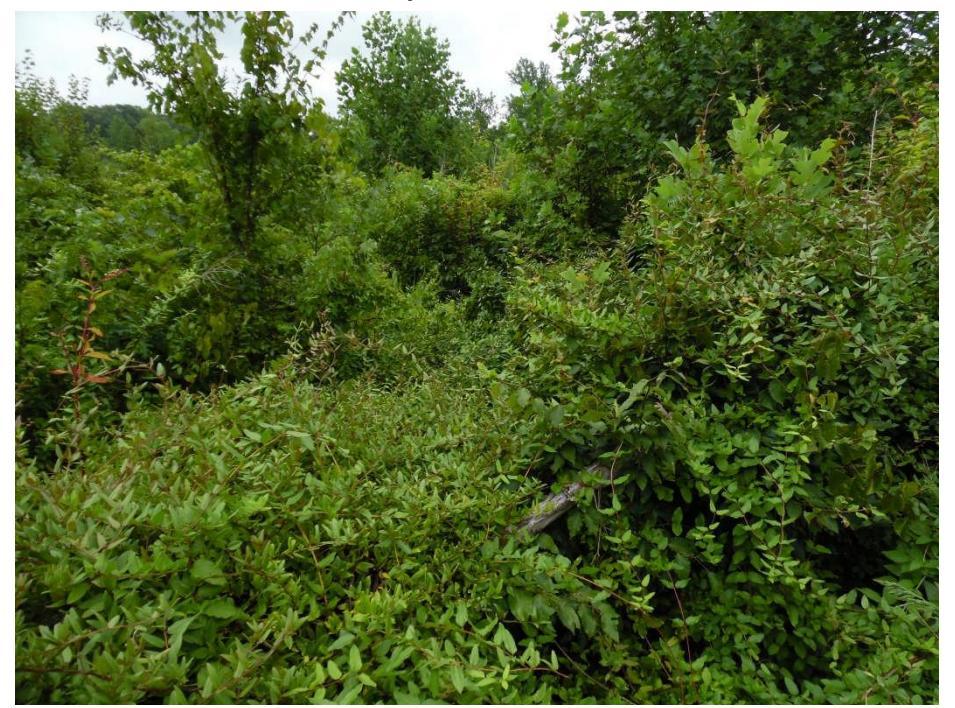
Waterbody point spek008 facing North and downstream

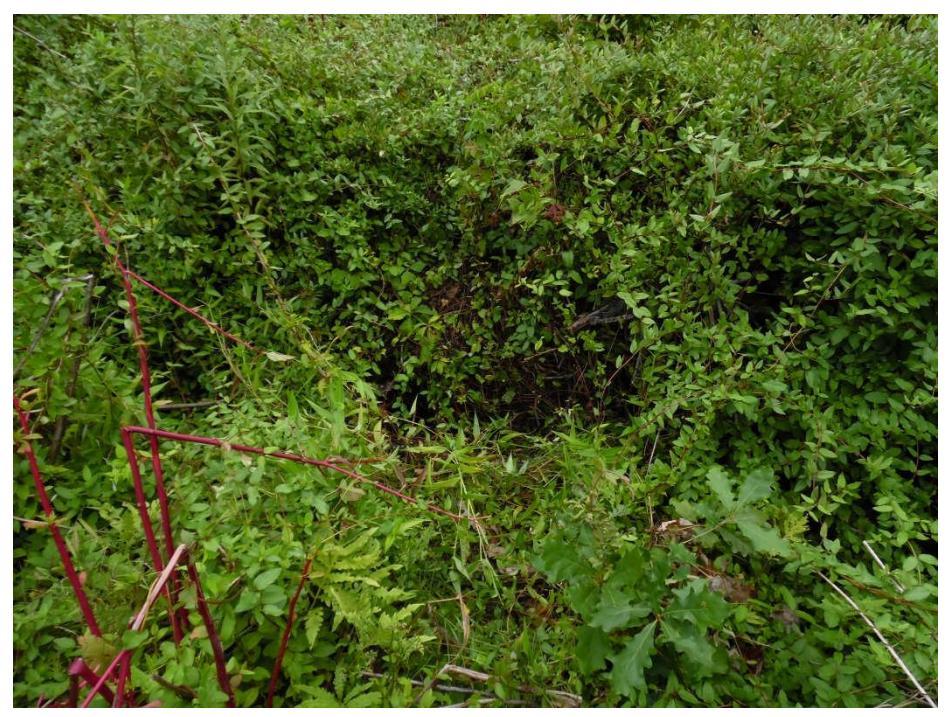
Waterbody point spek008 facing West and across

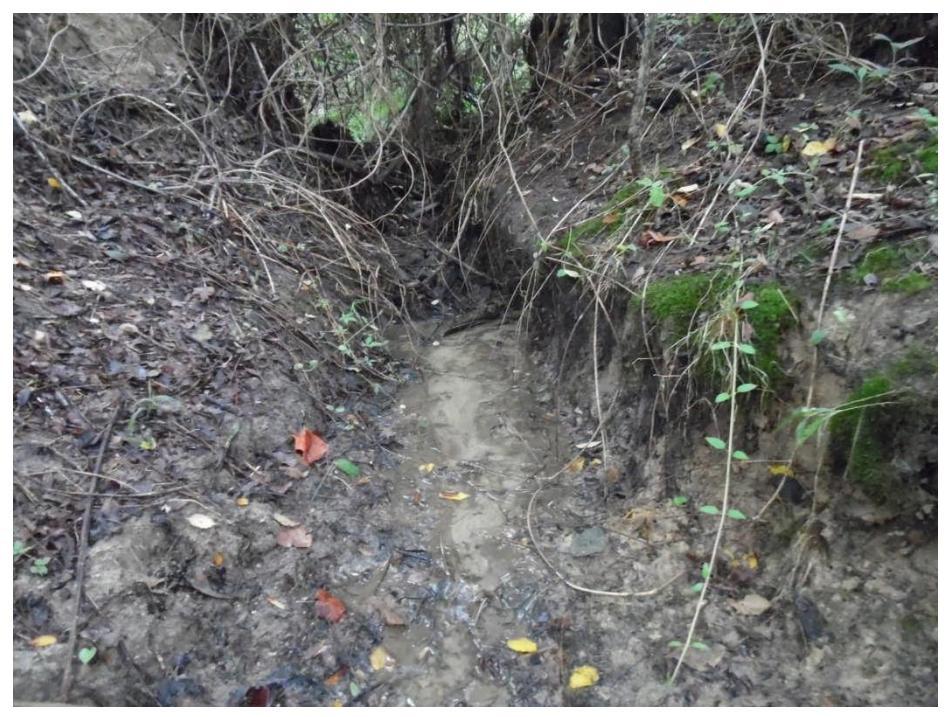
INTERMITTENT STREAM WITH SIGNIFICANT DISTURBANCE; POOR AQUATIC HABITAT

Waterbody point spek011 facing South and upstream

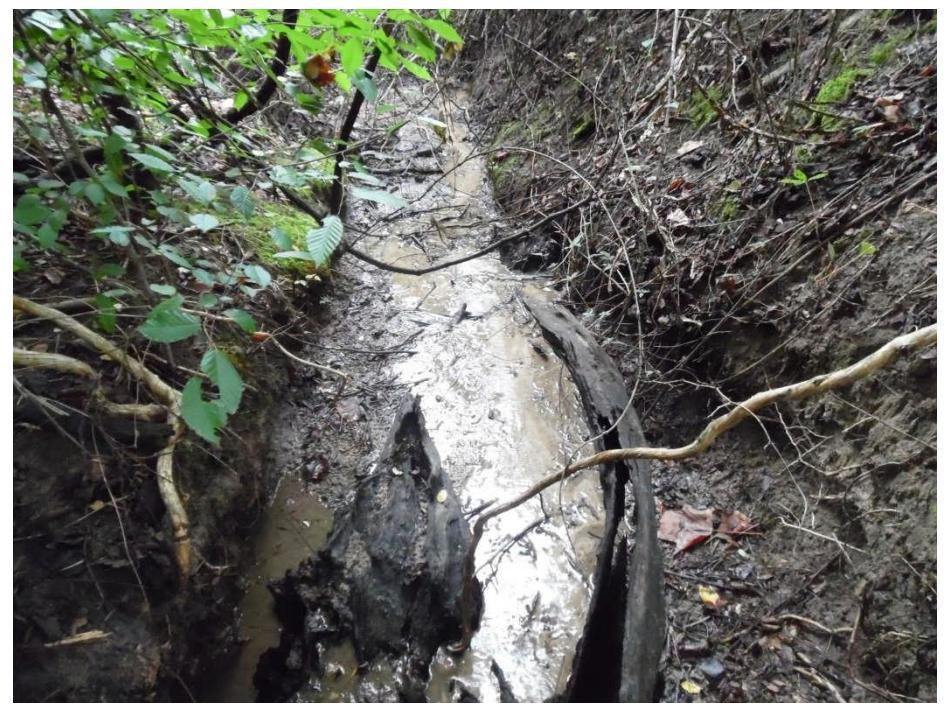
Waterbody point spek011 facing North and downstream

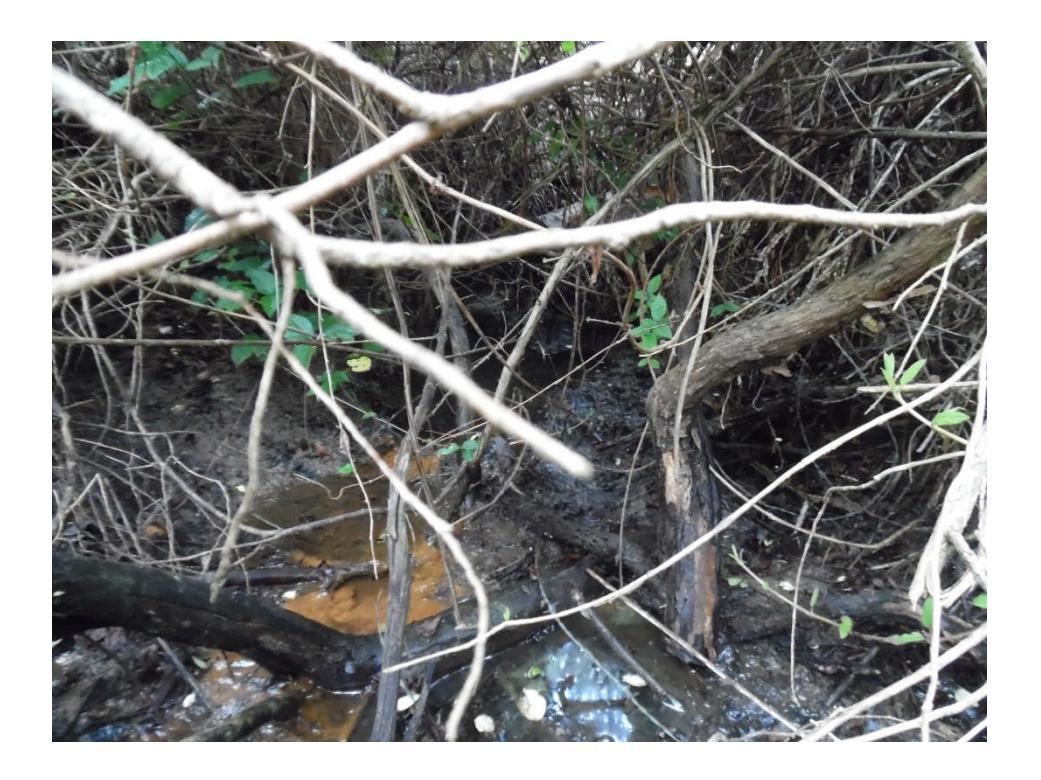
INTERMITTENT STREAM WITH SIGNIFICANT DISTURBANCE; POOR AQUATIC HABITAT

# Waterbody point spek012 facing North and upstream

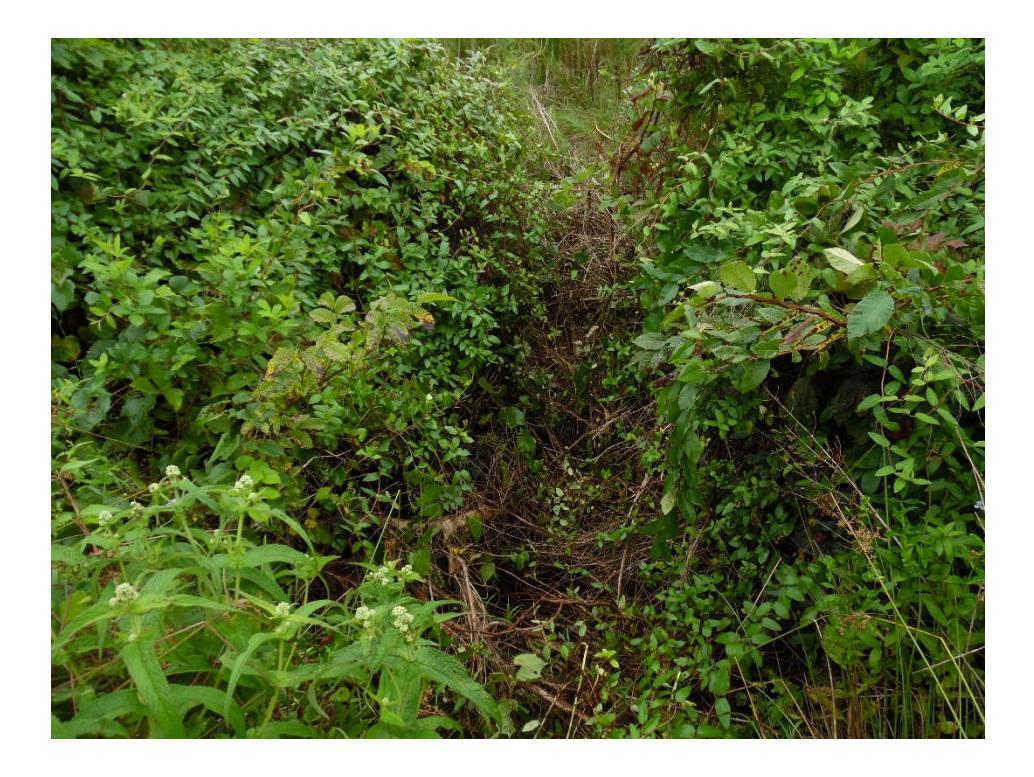
# Waterbody point spek012 facing West and across

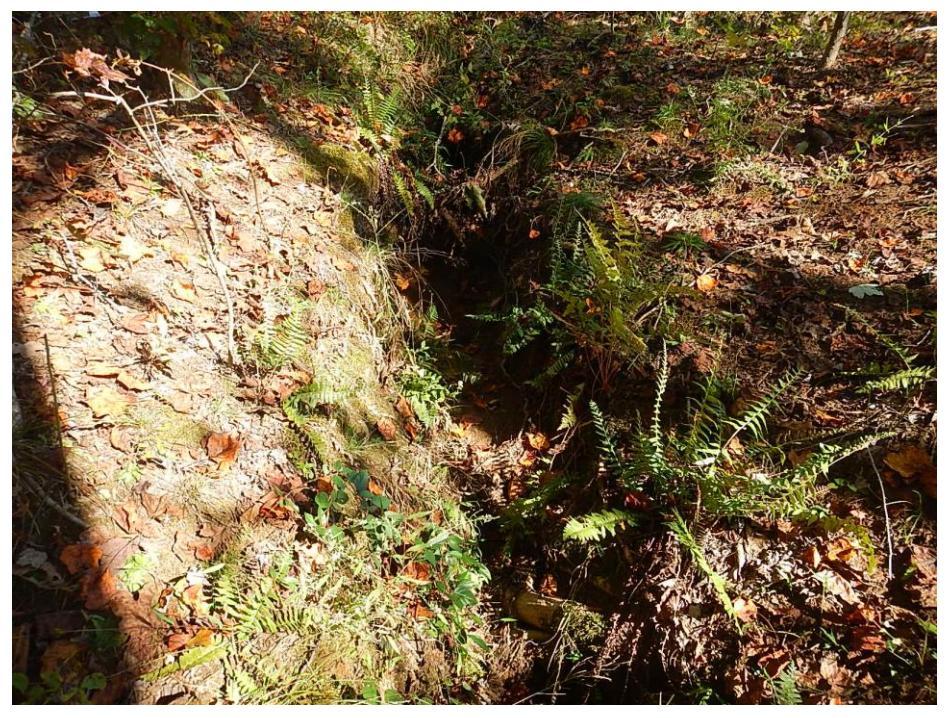
none									
T&E Species Observed	l (list):								
none									
Disturbances (ex: livesto	ock access, manure i	in waterbody, wast	e discharge pipe	es):					
Recent clear cut, hi	gh sediment lo	ad and down	cutting						
Tributary is: (check one)	⊠ Natural	□ Ar	tificial, man-m	ade 🗆 Manipu	ulated				
Stream Quality <sup>a</sup> : (check one)	□ High		oderate	⊠ Low

Waterbody SPEA005 facing northeast upstream

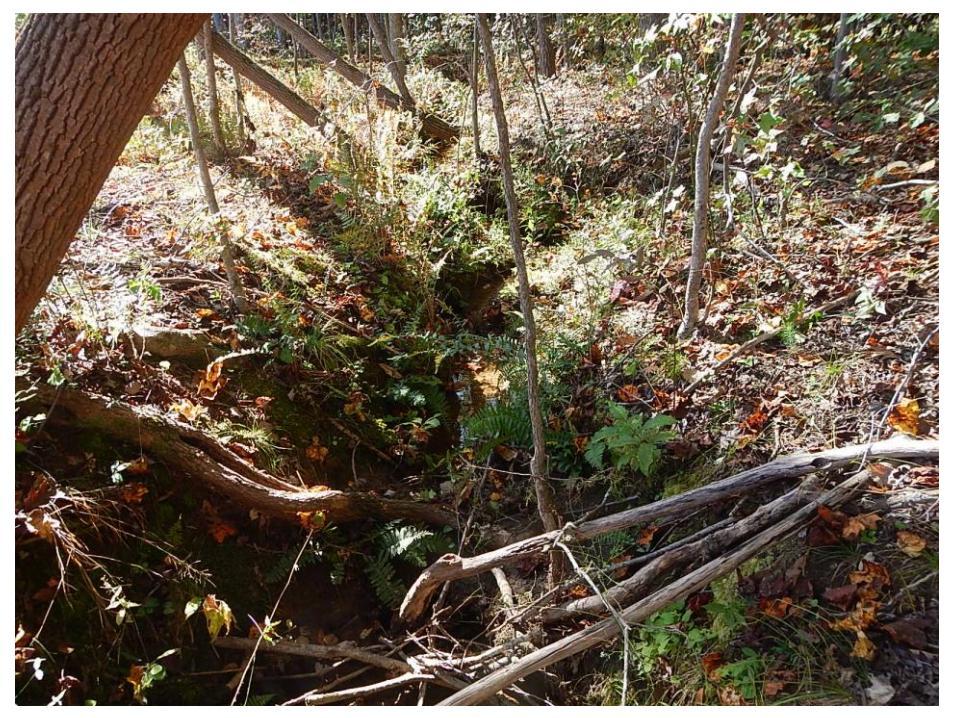
Waterbody SPEA005 facing southwest downstream

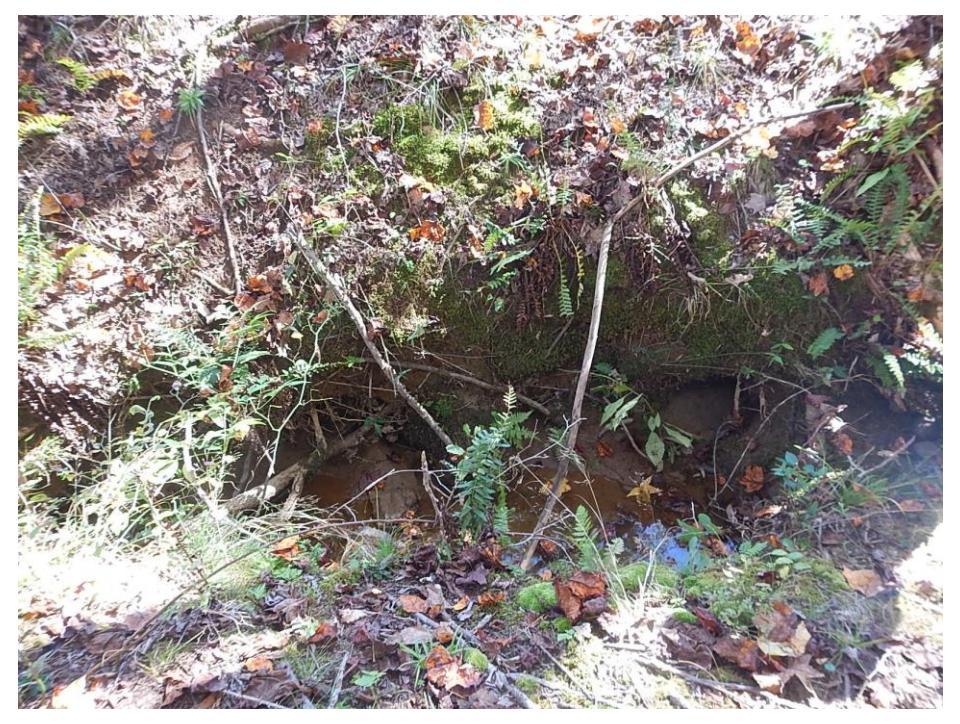
# Waterbody SPEA005 facing southeast across
## Linear Waterbody Data Sheet
