Linear Waterbody Data Sheet

Survey Description				
Project Name: ACP		Waterbody Name: UNT to WESTERN BRANCH RESERVOIR	Waterbody ID: SSU0100	Date: 3-8-16
State: VA	County/Parish: Suffolk	Company: ESI	Crew Member Initials: LR, WV	Photos: Facing E, W, N
Tract Number(s): 26-060-4068		Nearest Milepost: 61.8	Associated Wetland ID(s): WSU0029	
Survey Type: (check one) <input checked="" type="checkbox"/> Centerline <input type="checkbox"/> Re-Route <input type="checkbox"/> Access Road <input type="checkbox"/> Other:				
Physical Attributes				
Stream Classification: (check one) <input type="checkbox"/> Ephemeral <input type="checkbox"/> Intermittent <input checked="" type="checkbox"/> Perennial				
Waterbody Type: (check one) <input type="checkbox"/> River <input checked="" type="checkbox"/> Stream <input type="checkbox"/> Ditch <input type="checkbox"/> Canal <input type="checkbox"/> Other:				
OHWM Width: 3 ft.	OHWM Height: 0.5 ft.	OHWM Indicator: (check all that apply) <input checked="" type="checkbox"/> Clear line on bank <input type="checkbox"/> Shelving <input checked="" type="checkbox"/> Wrested vegetation <input type="checkbox"/> Scouring <input checked="" type="checkbox"/> Water s

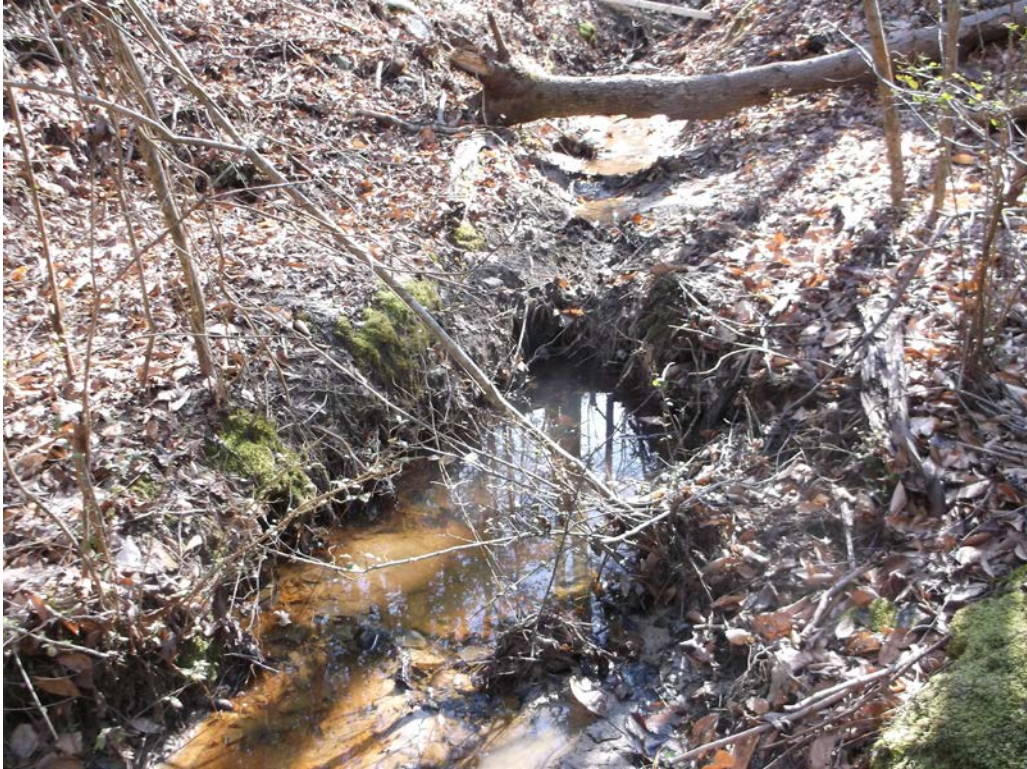
Waterbody data point ssuo100 facing east upstream.

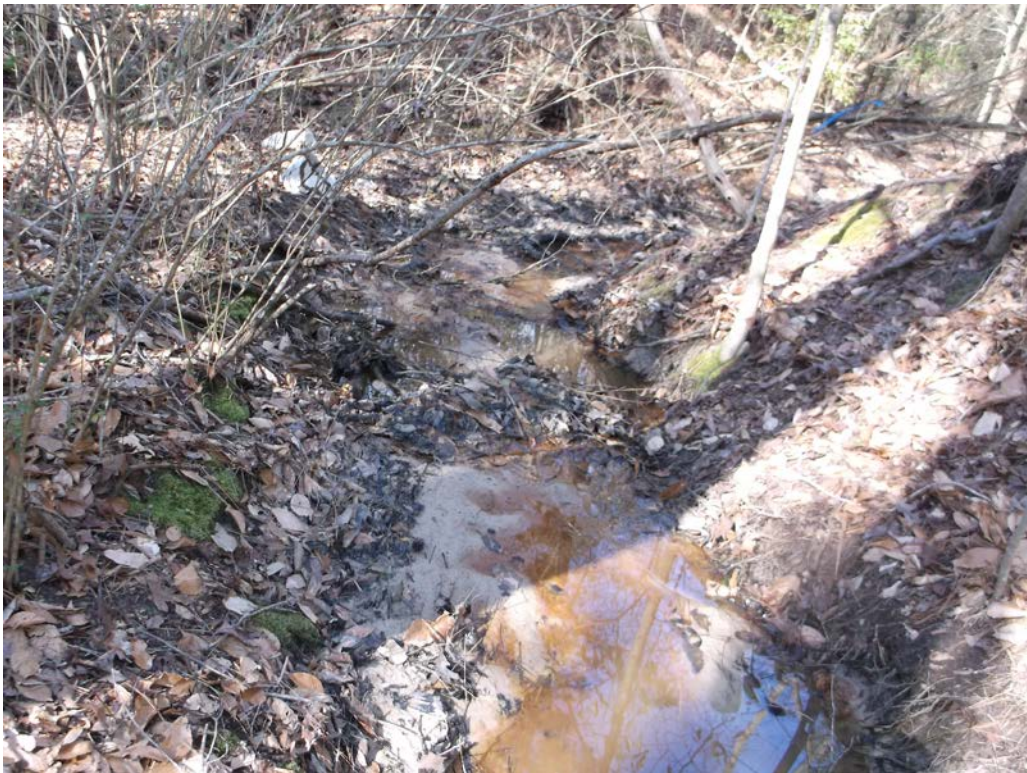
Waterbody data point ssuo100 facing west downstream.

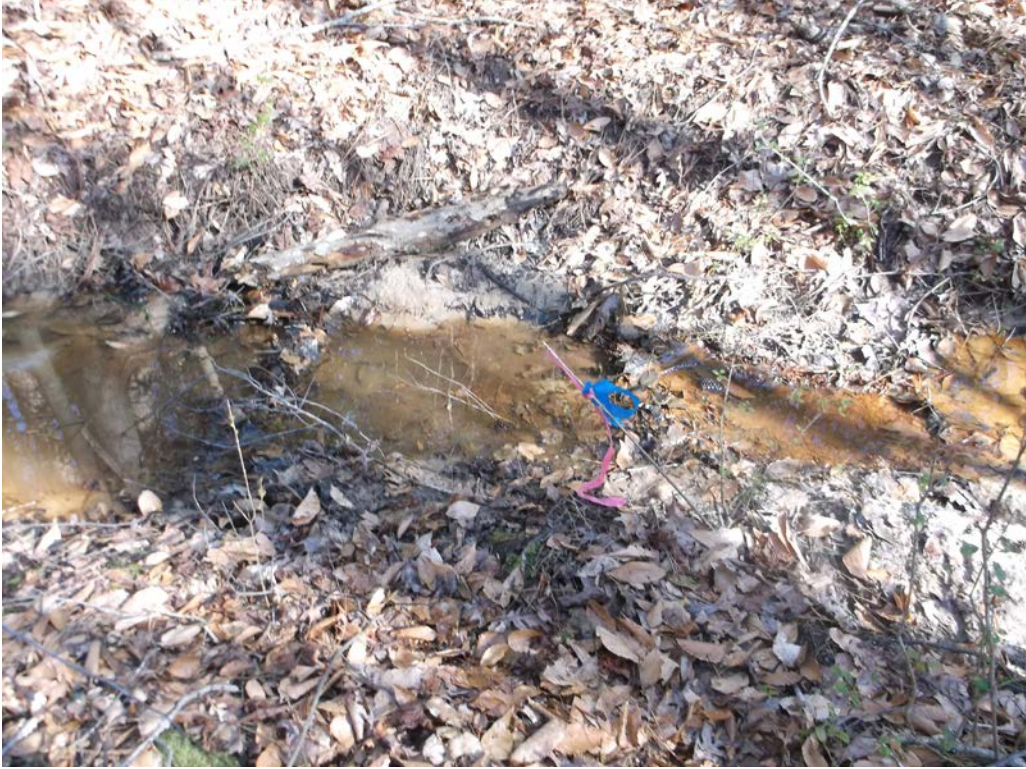
Waterbody data point ssuo100 facing north across.

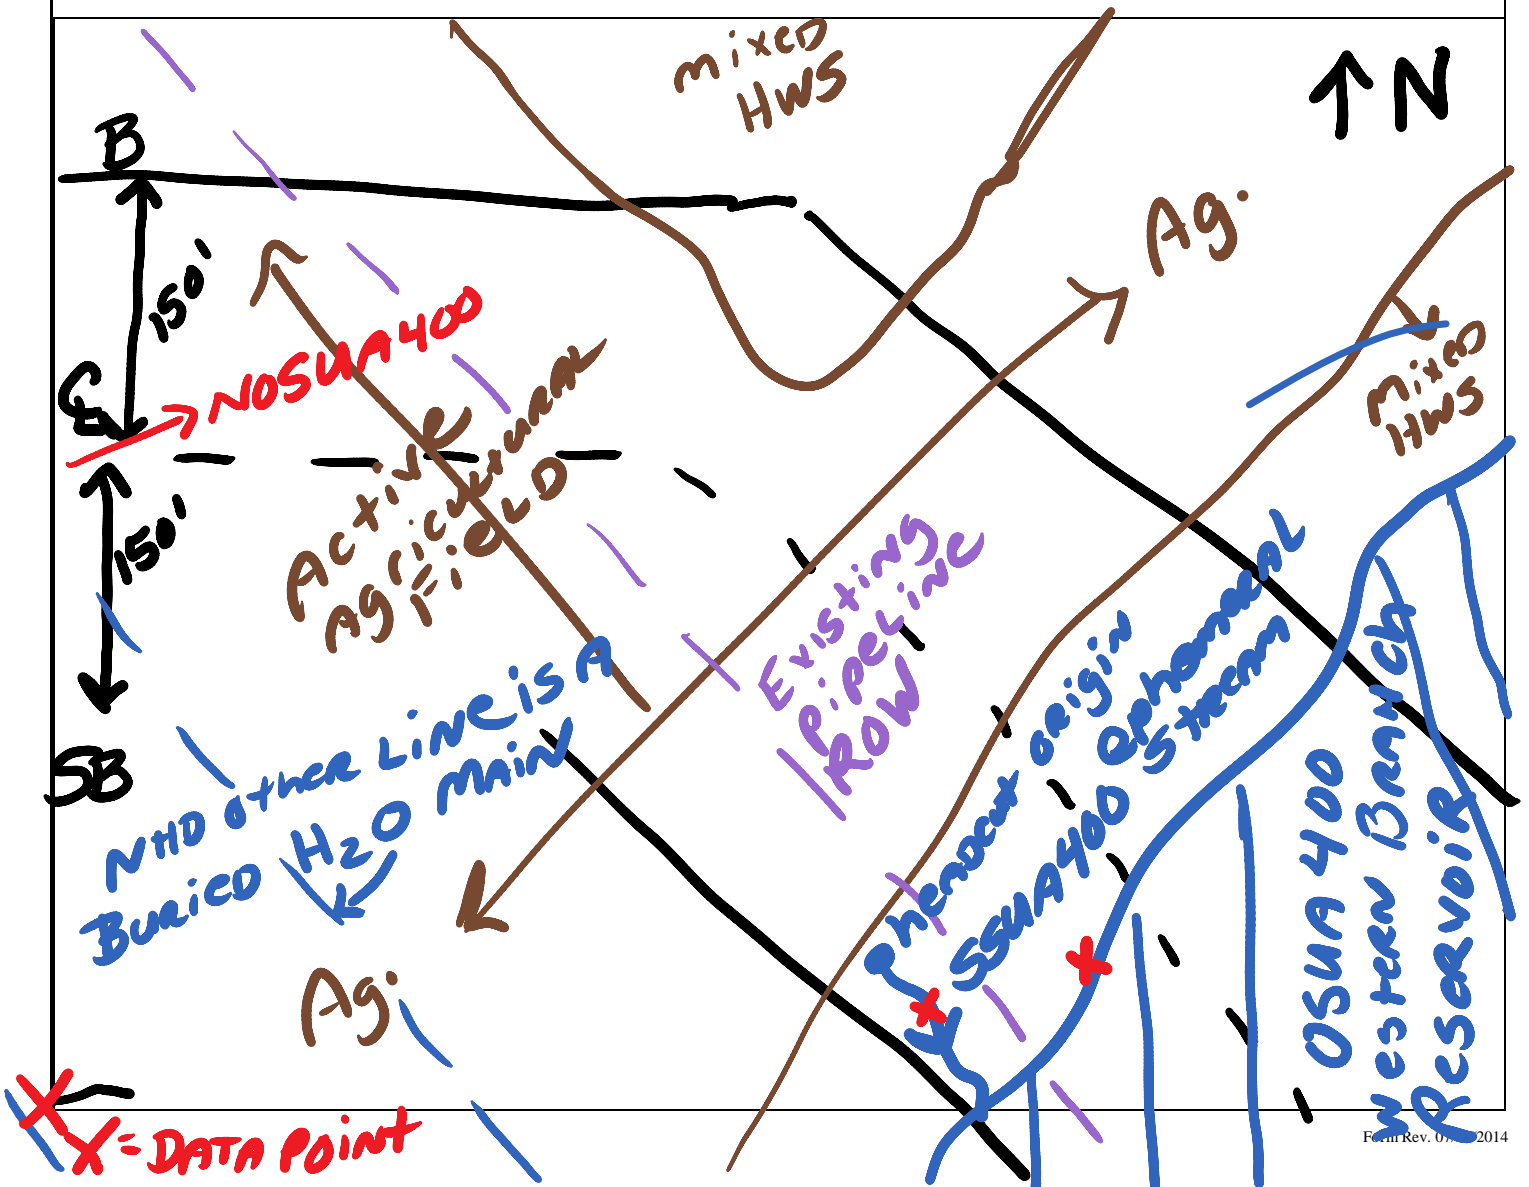
Begins within corridor at headcut at edge of agricultural field; parallels existing pipeline ROW; downstream flows into reservoir osua400 near edge of survey corridor.

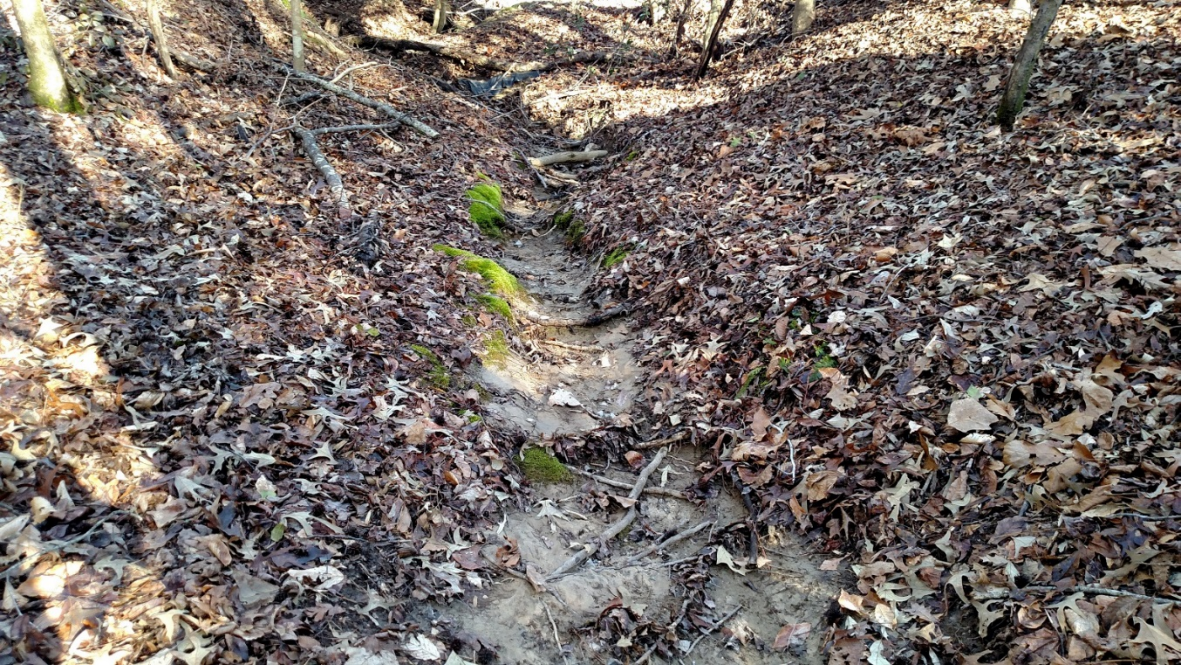
Waterbody ssua400 facing northwest upstream

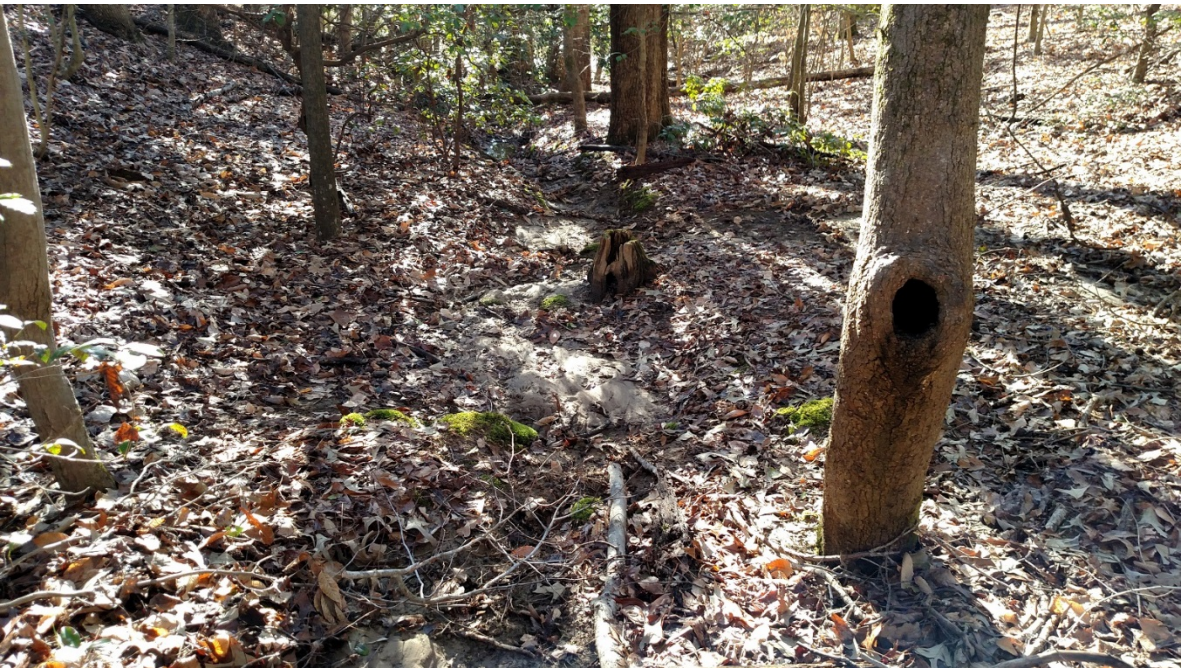
Waterbody ssua400 facing southeast downstream

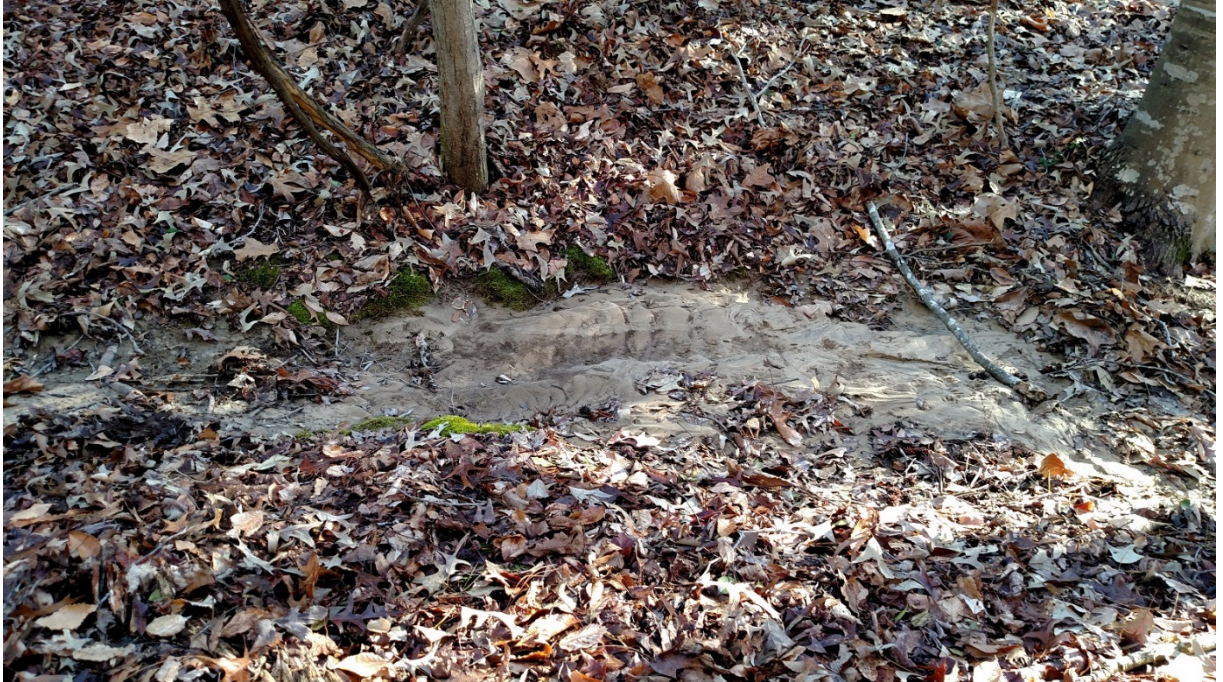
Waterbody ssua400 facing northeast across

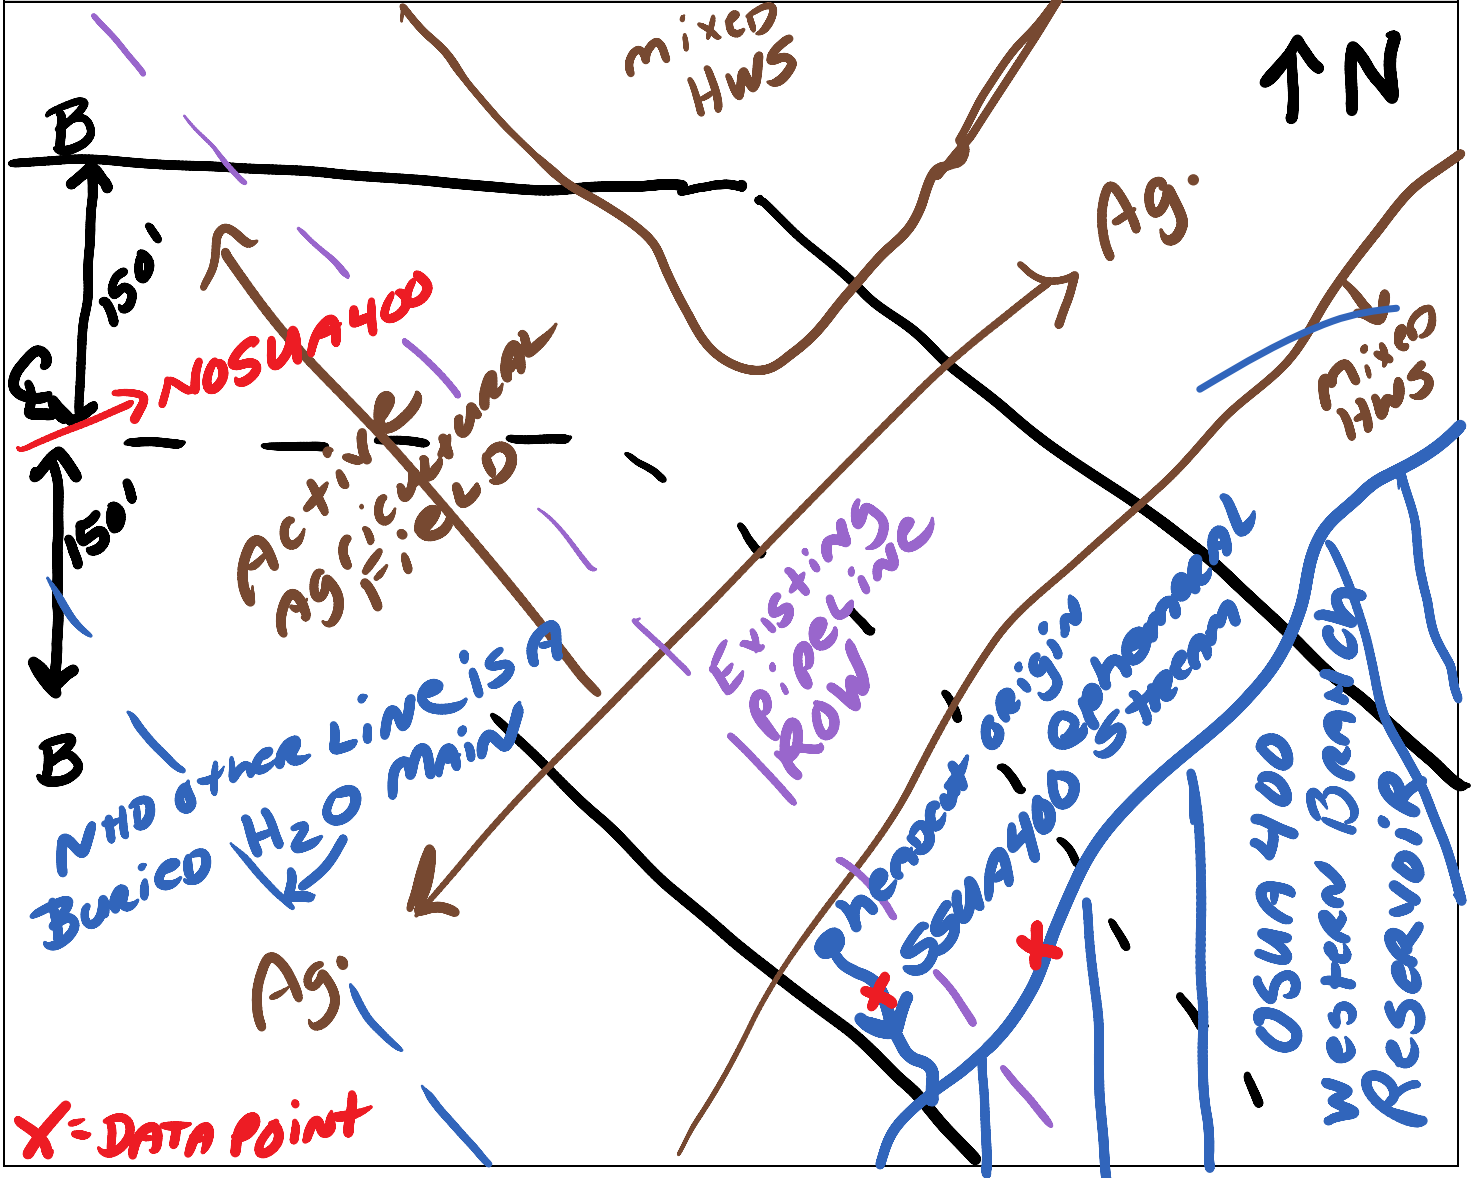
Artificial water supply reservoir; ephemeral stream ssua400 is a tributary; crossing is at an arm of reservoir.

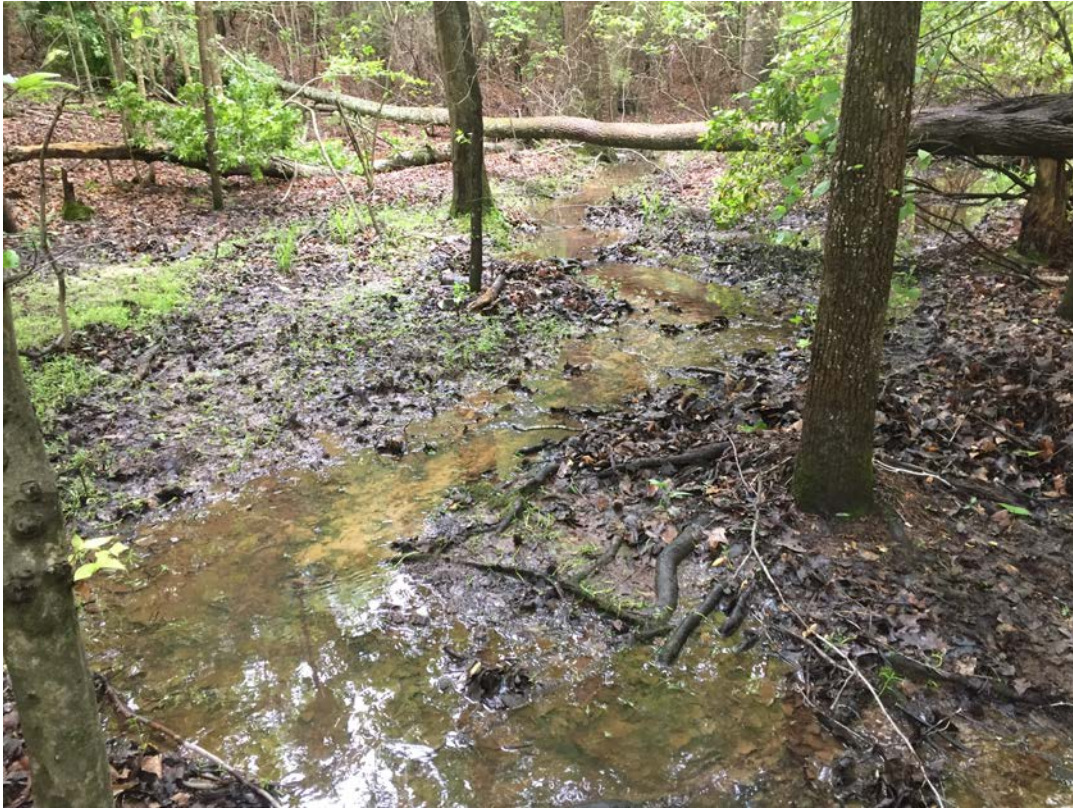
Waterbody data point ssuo114 facing south upstream.

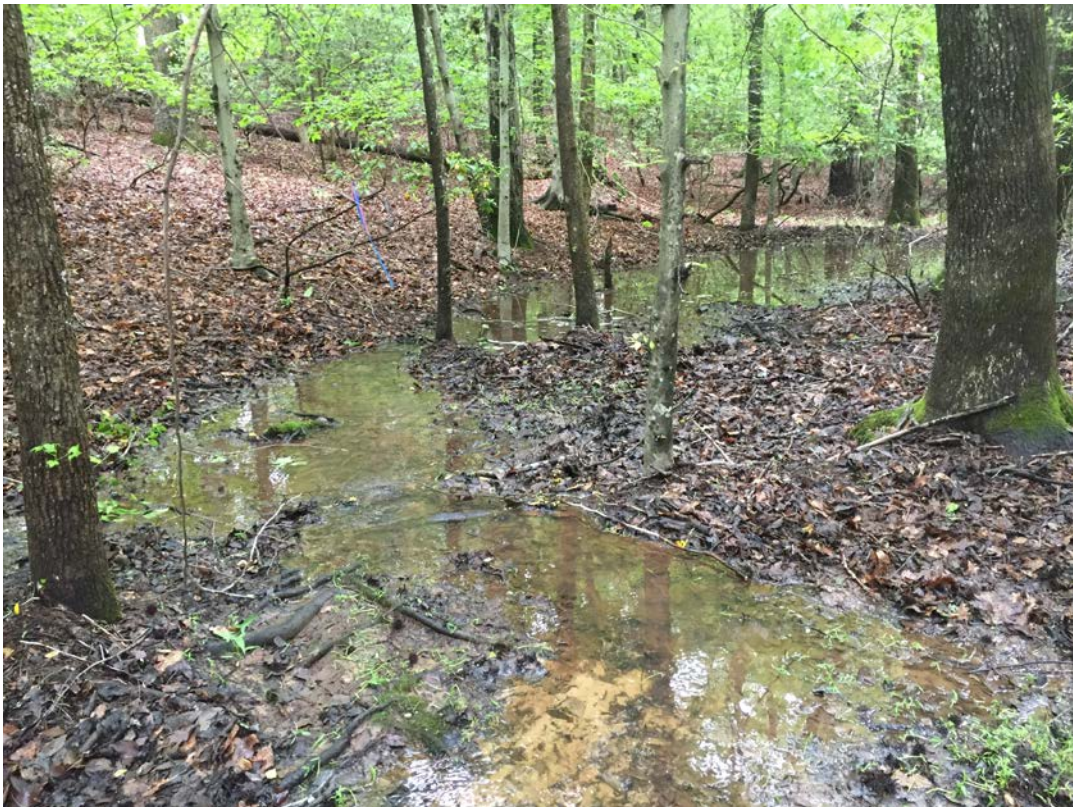
Waterbody data point ssuo114 facing north downstream.

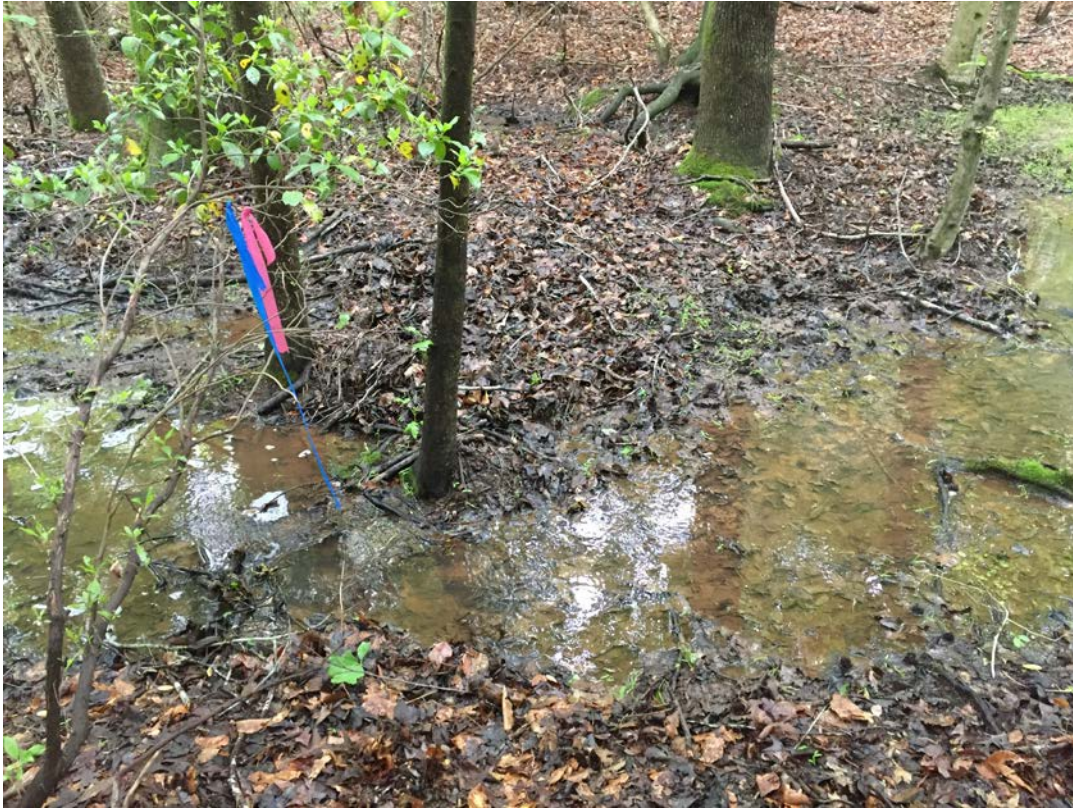
Waterbody data point ssuo114 facing east across bank.

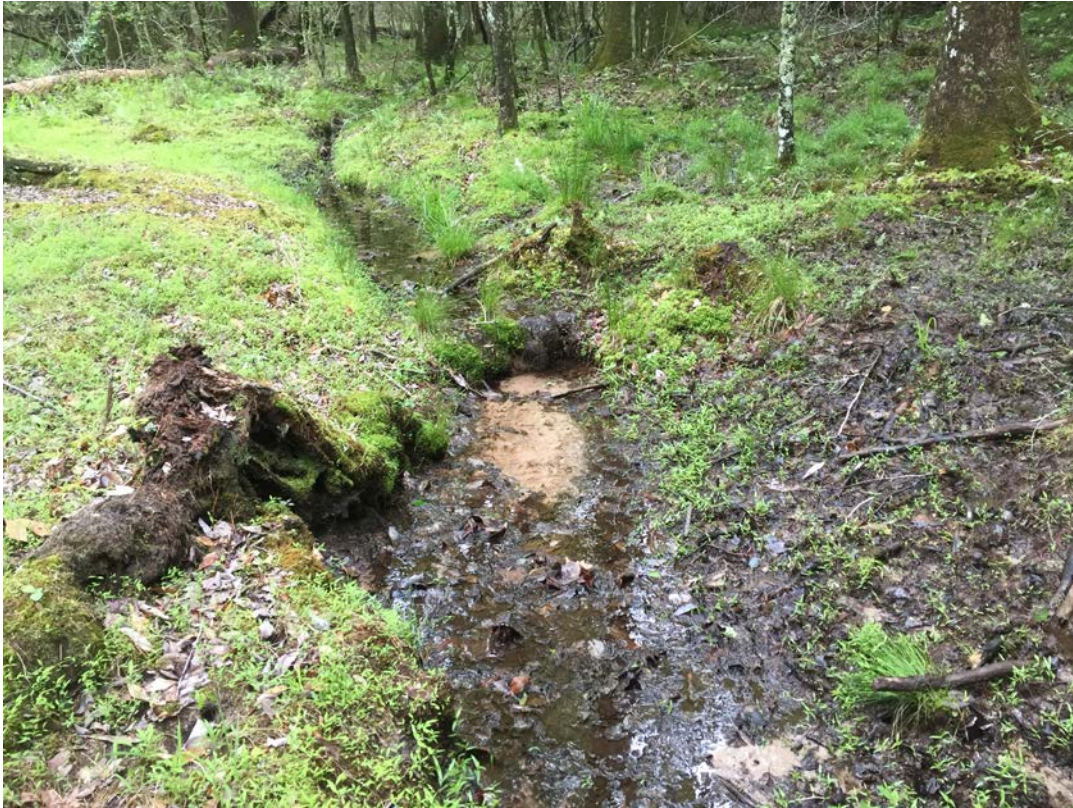
Waterbody data point ssuo116 facing south upstream.

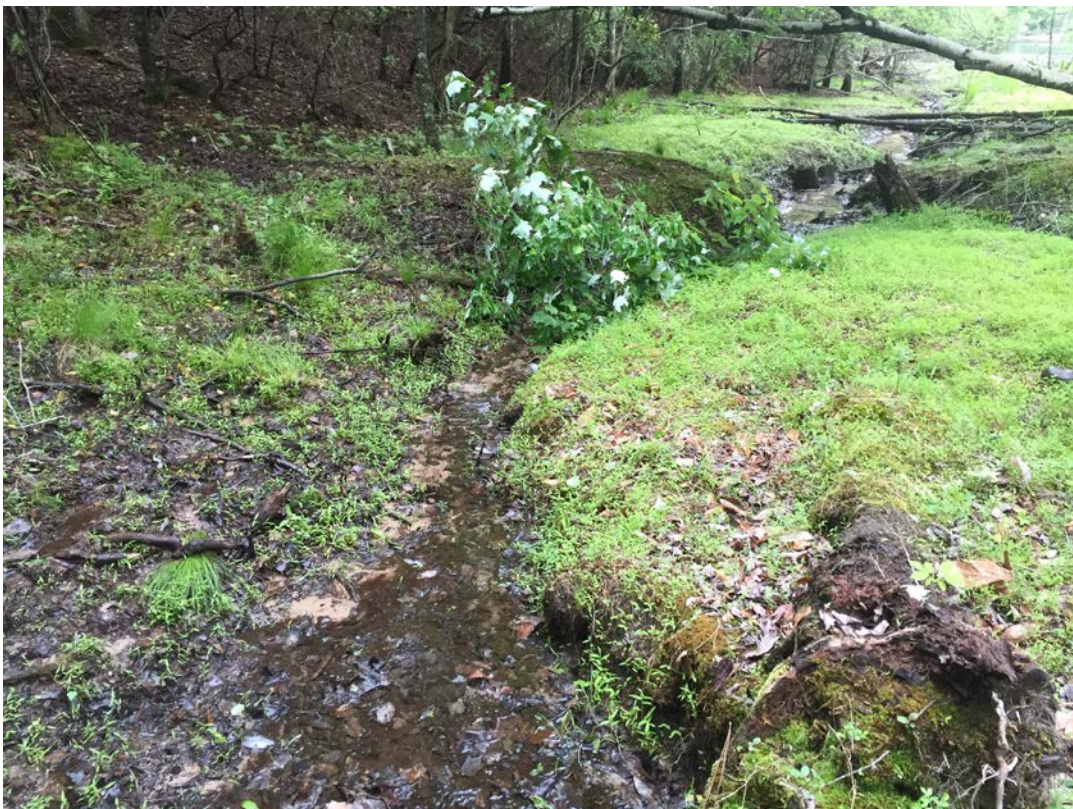
Waterbody data point ssuo116 facing north downstream.

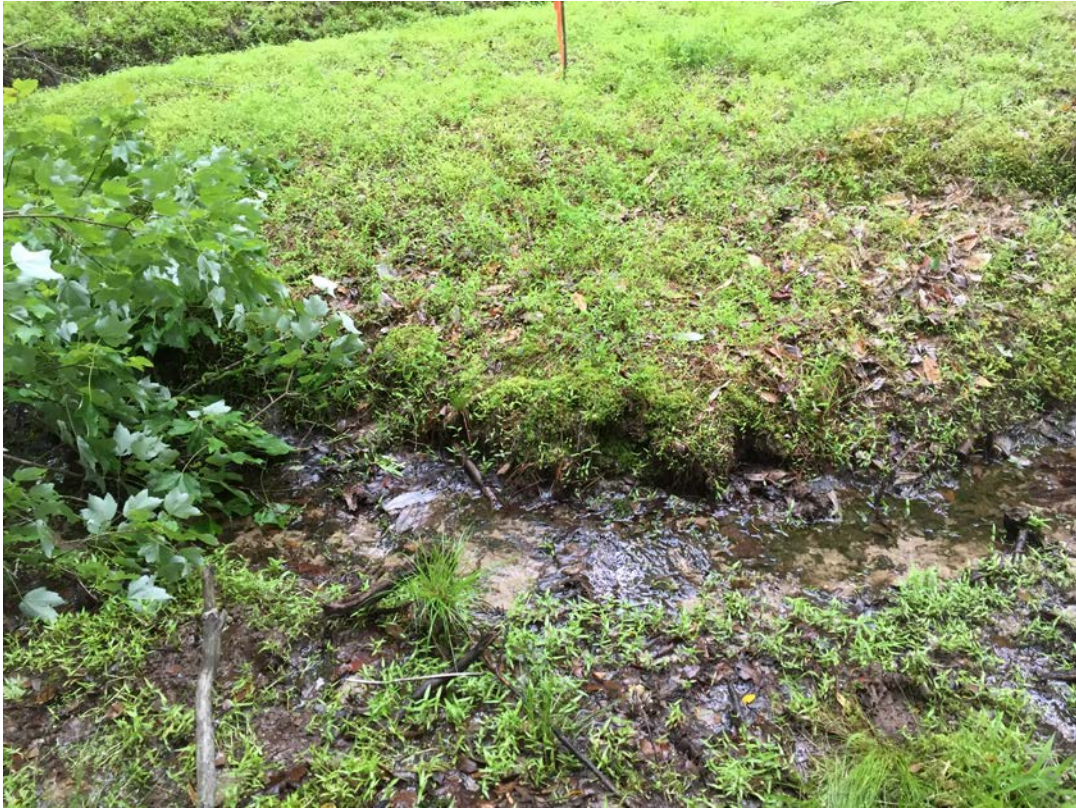
Waterbody data point ssuo116 facing east across bank.

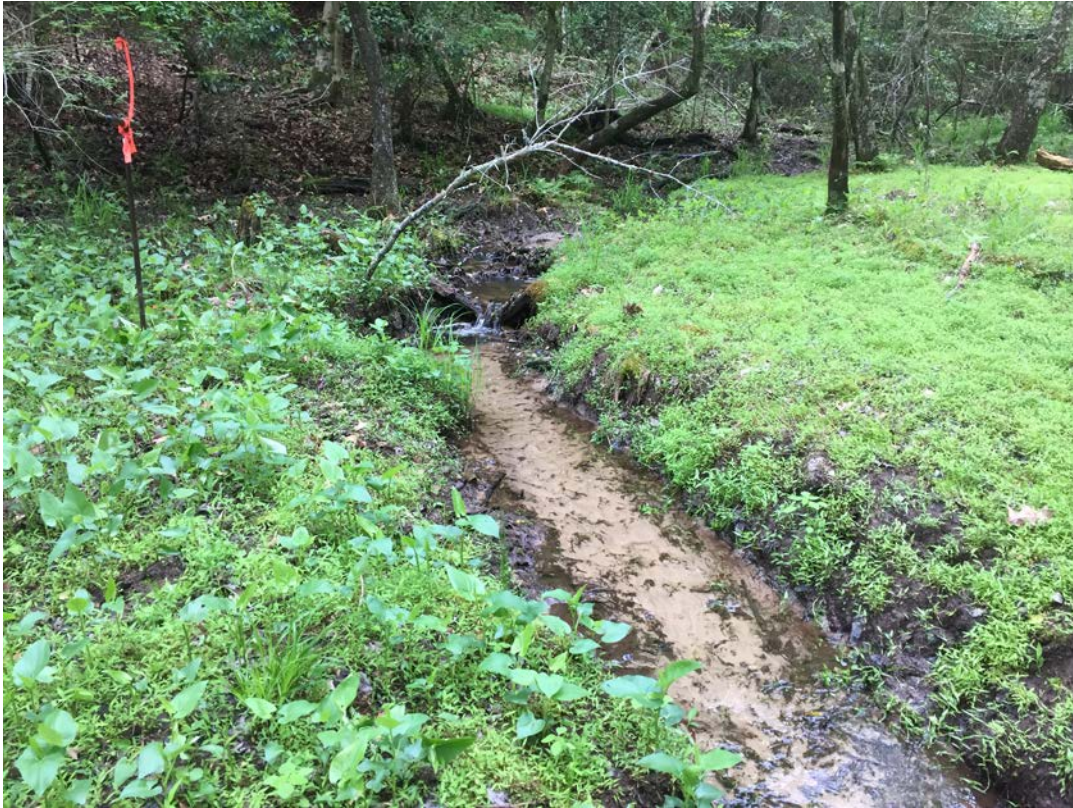
Waterbody data point ssuo115 facing southeast upstream.

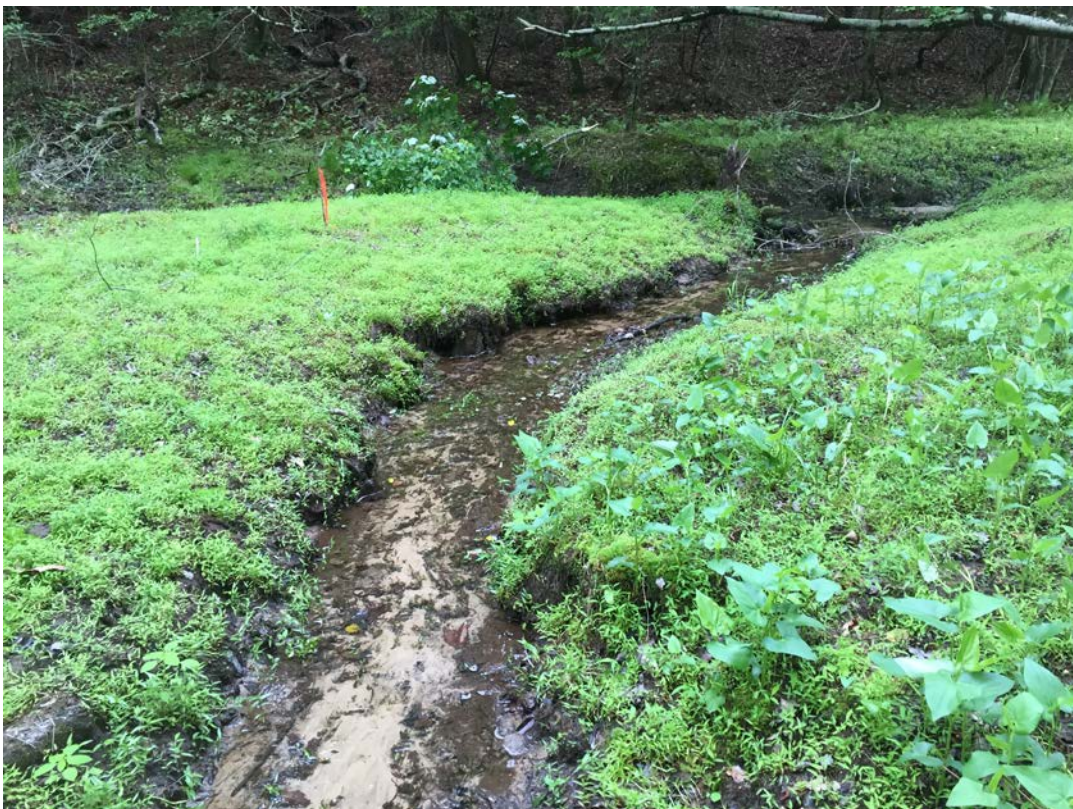
Waterbody data point ssuo115 facing northwest downstream.

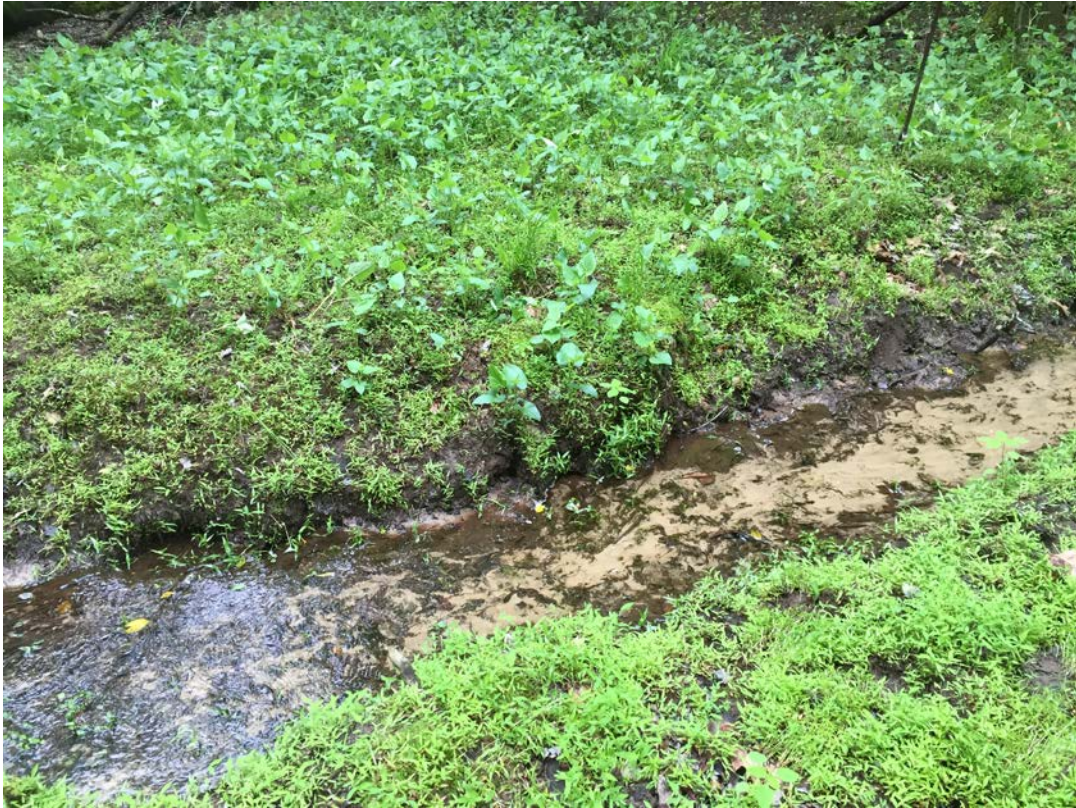
Waterbody data point ssuo115 facing northeast across bank.

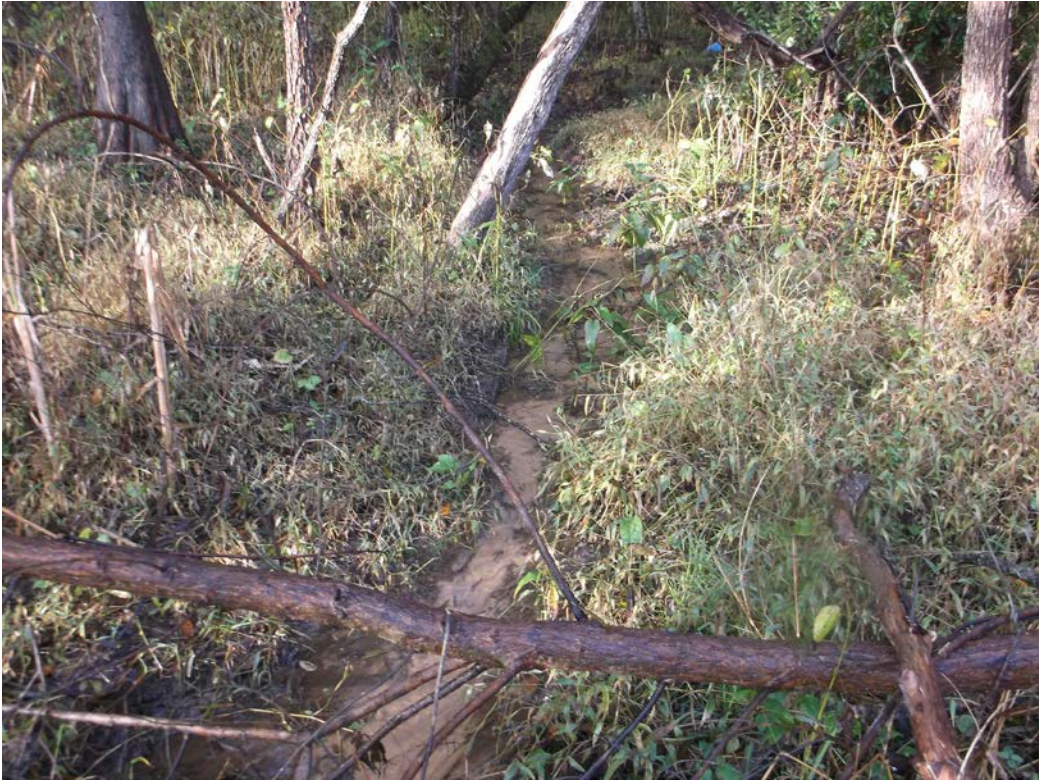
Waterbody ssup014 facing southwest upstream.

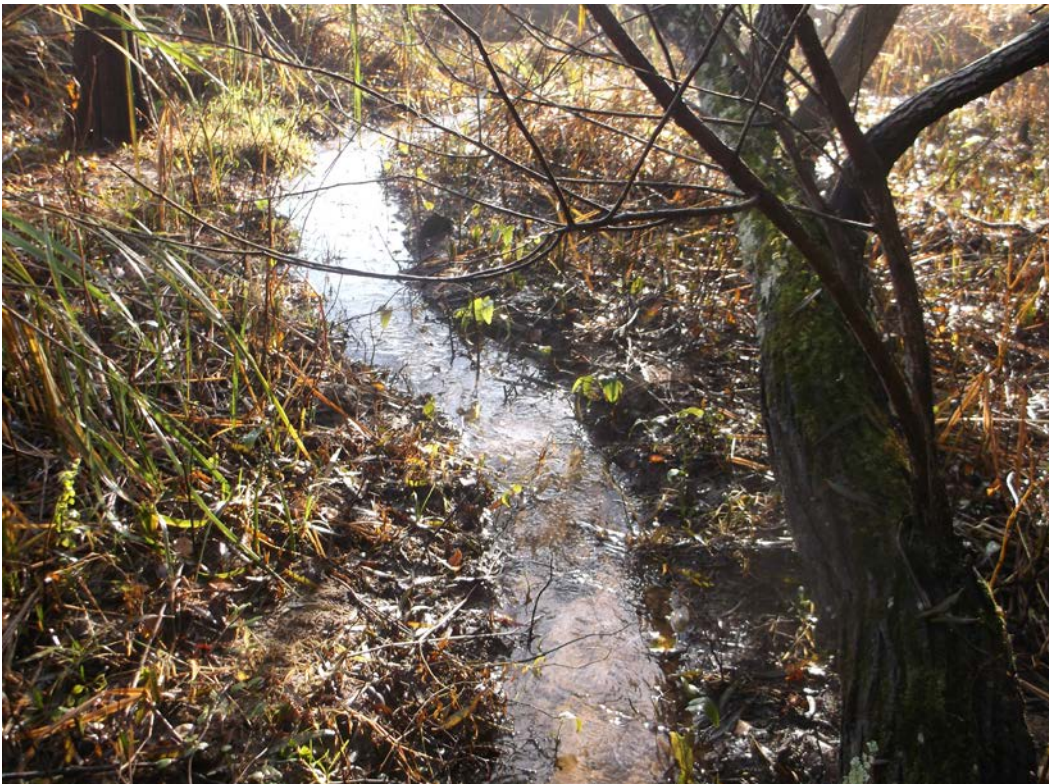
Waterbody ssup014 facing east downstream.

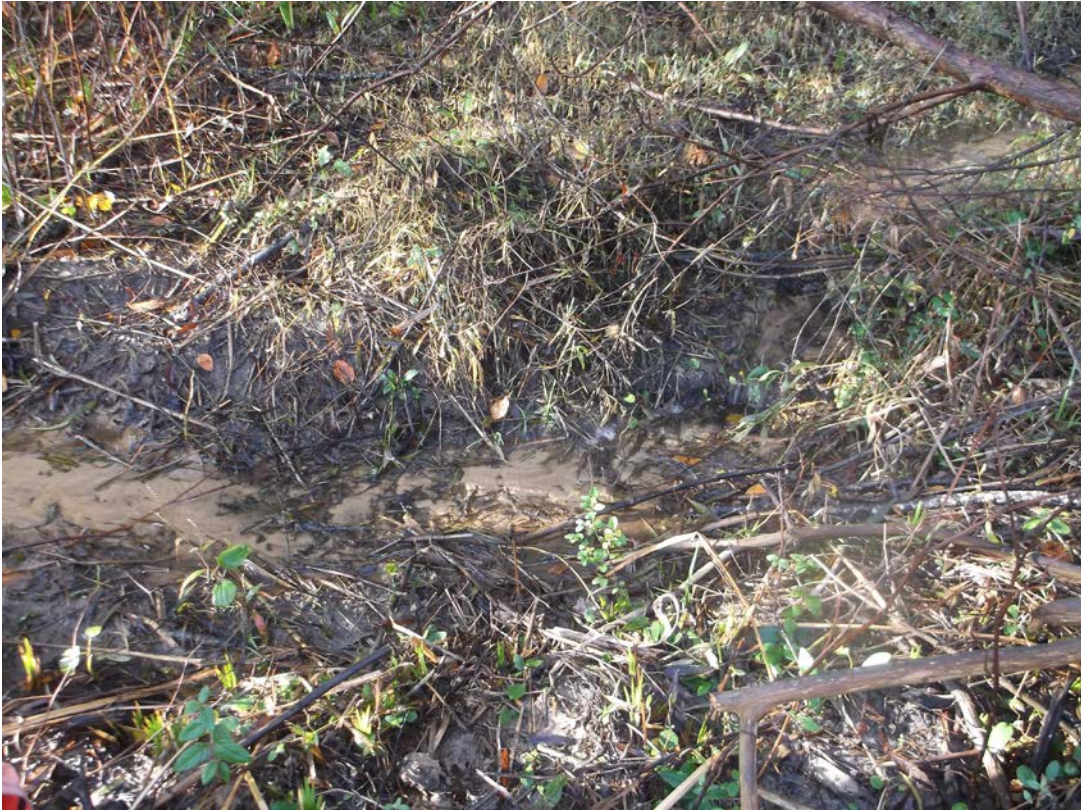
Waterbody ssup014 facing south across bank.

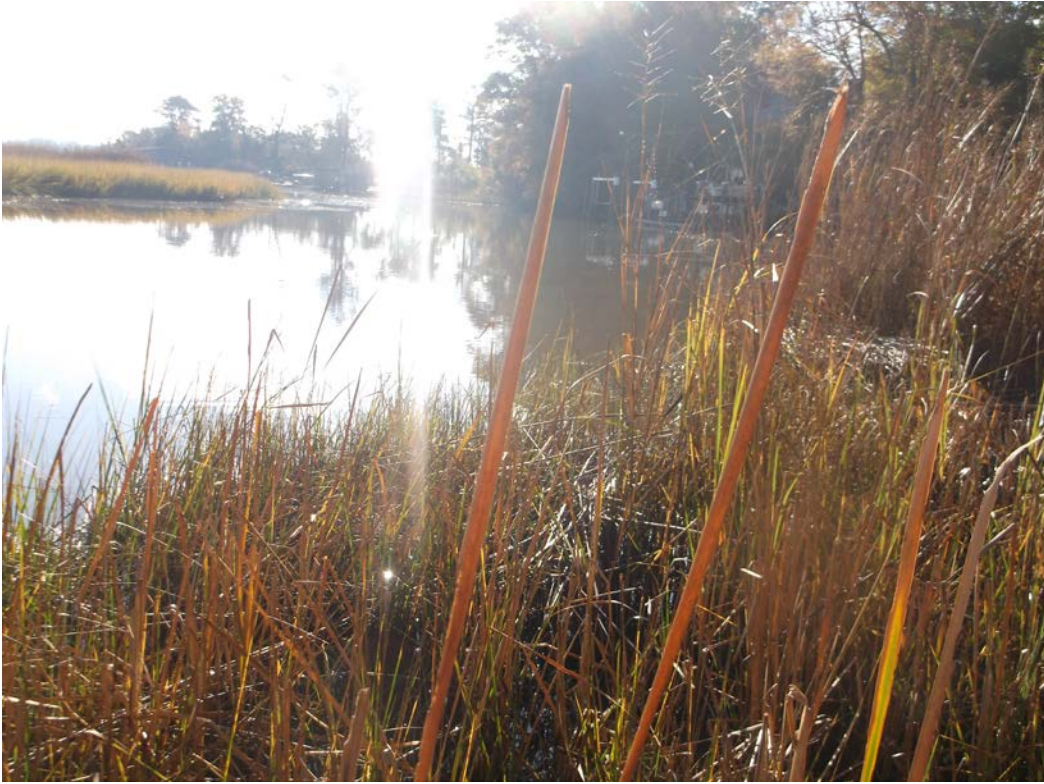
Waterbody ssup013 facing south upstream.

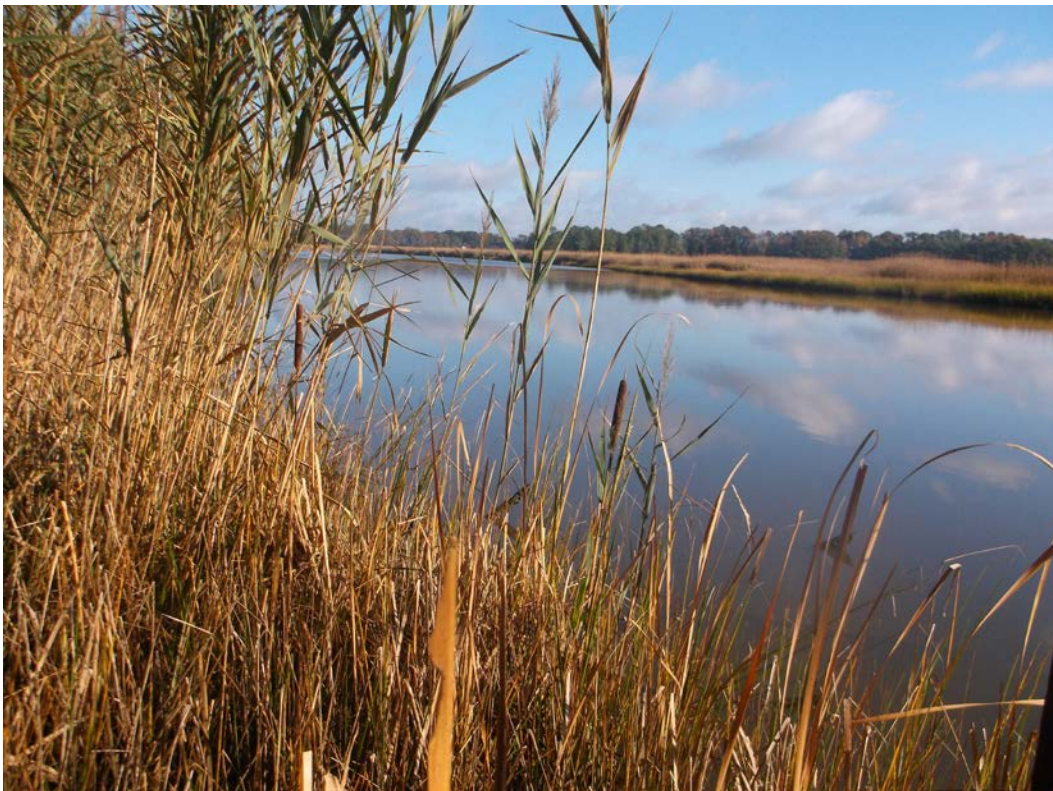
Waterbody ssup013 facing north downstream.

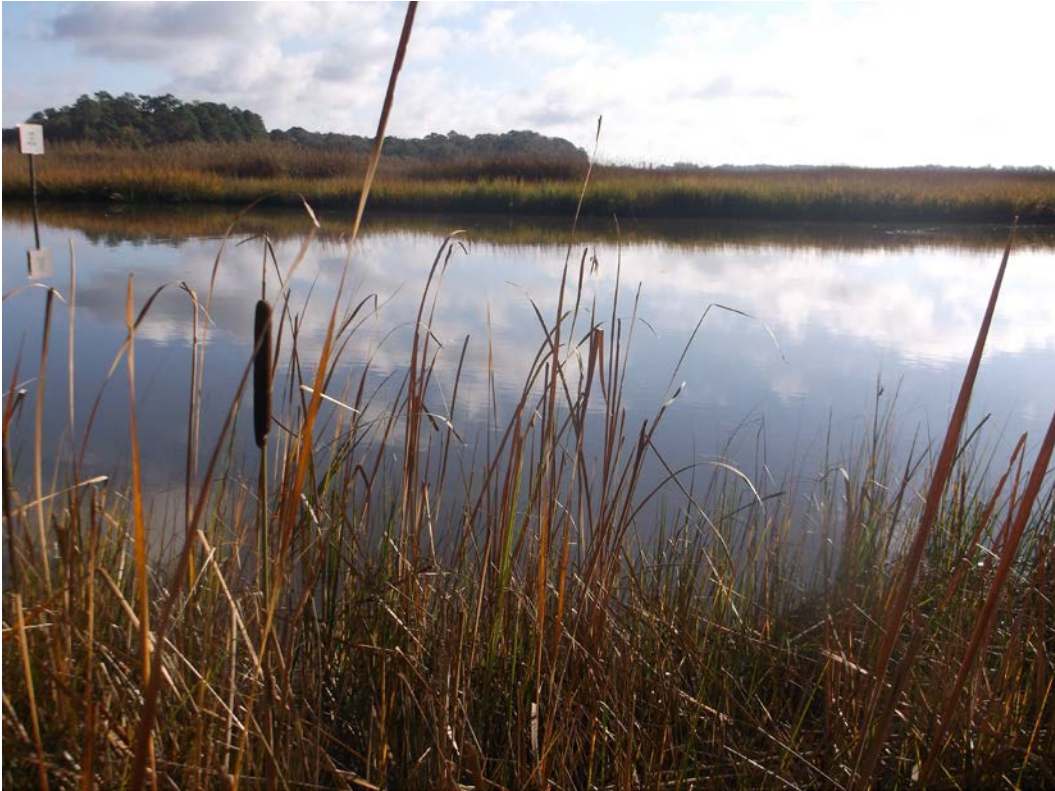
Waterbody ssup013 facing east across bank.

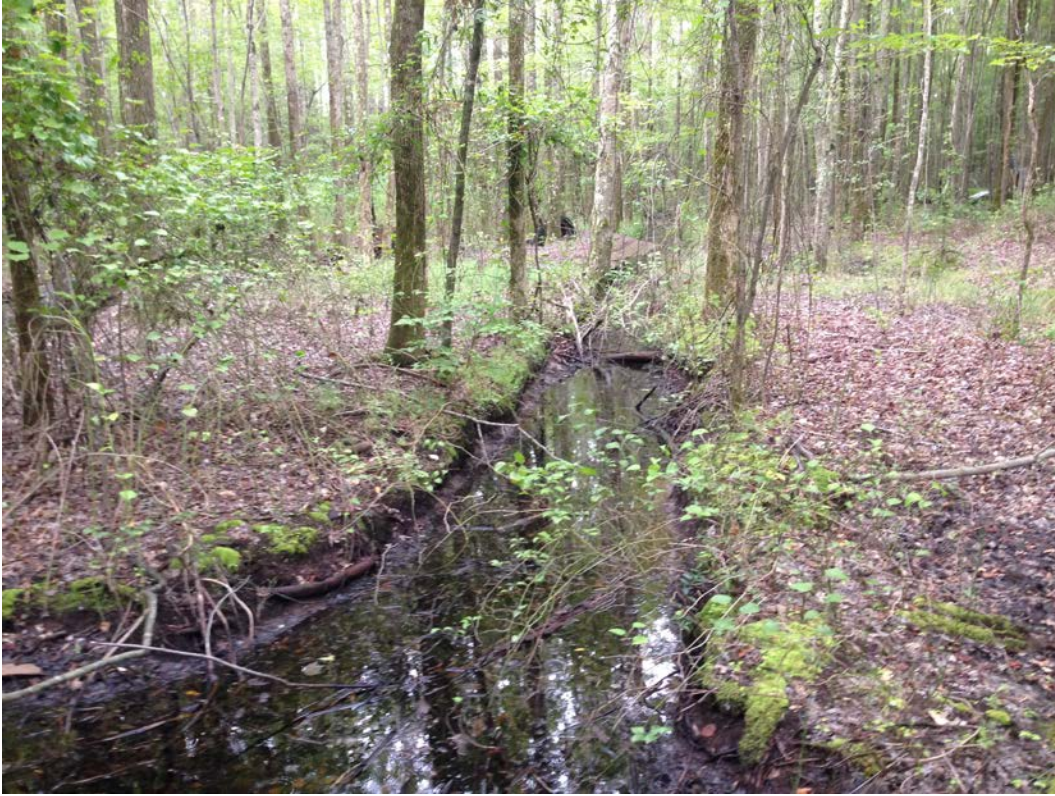
Waterbody data point ssus004 facing south upstream.
