Linear Waterbody Data Sheet

Survey Description				
Project Name: ACP		Waterbody Name: UNT to WESTERN BRANCH RESERVOIR	Waterbody ID: SSU0100	Date: 3-8-16
State: VA	County/Parish: Suffolk	Company: ESI	Crew Member Initials: LR, WV	Photos: Facing E, W, N
Tract Number(s): 26-060-4068		Nearest Milepost: 61.8	Associated Wetland ID(s): WSU0029	
Survey Type: (check one) <input checked="" type="checkbox"/> Centerline <input type="checkbox"/> Re-Route <input type="checkbox"/> Access Road <input type="checkbox"/> Other:				
Physical Attributes				
Stream Classification: (check one) <input type="checkbox"/> Ephemeral <input type="checkbox"/> Intermittent <input checked="" type="checkbox"/> Perennial				
Waterbody Type: (check one) <input type="checkbox"/> River <input checked="" type="checkbox"/> Stream <input type="checkbox"/> Ditch <input type="checkbox"/> Canal <input type="checkbox"/> Other:				
OHWM Width: 3 ft.	OHWM Height: 0.5 ft.	OHWM Indicator: (check all that apply) <input checked="" type="checkbox"/> Clear line on bank <input type="checkbox"/> Shelving <input checked="" type="checkbox"/> Wrested vegetation <input type="checkbox"/> Scouring <input checked="" type="checkbox"/> Water s

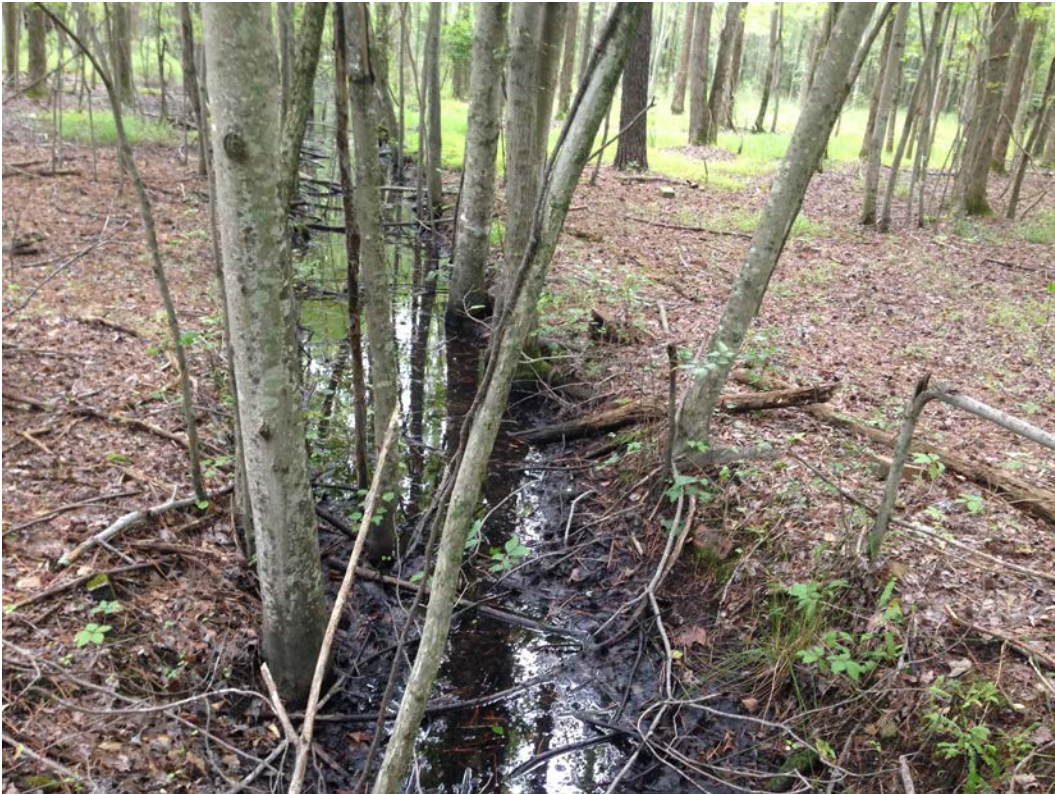
Waterbody data point ssus004 facing north downstream.

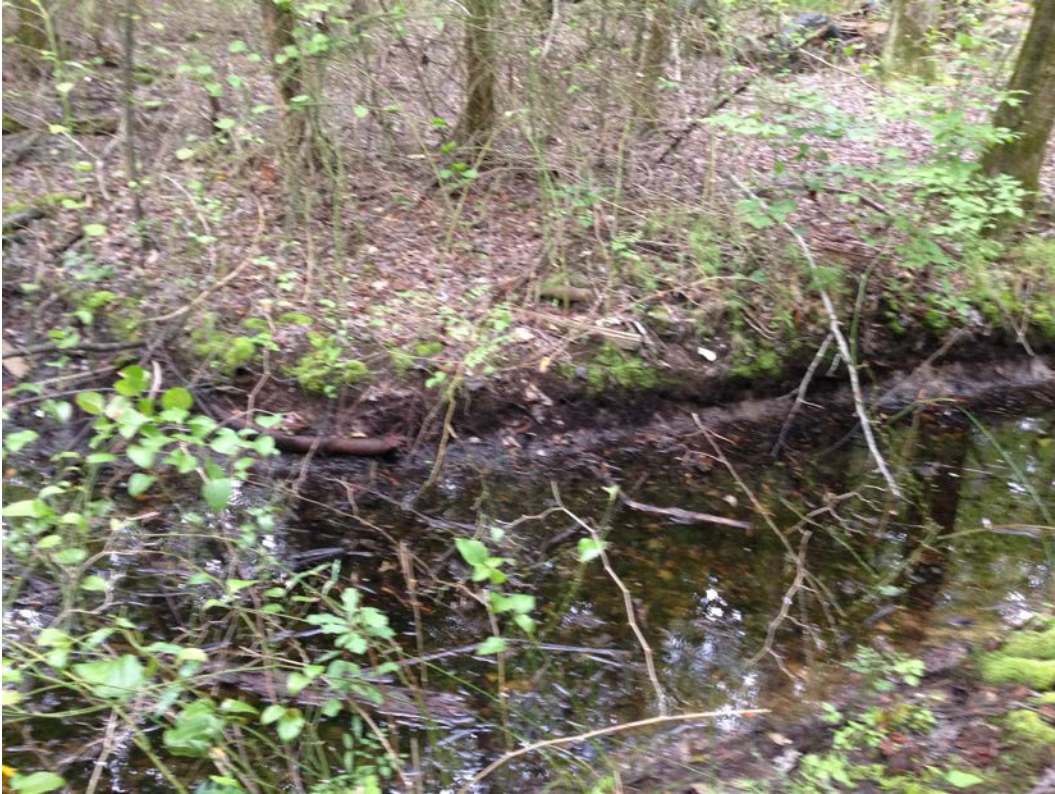
Waterbody data point ssus004 facing east across bank.

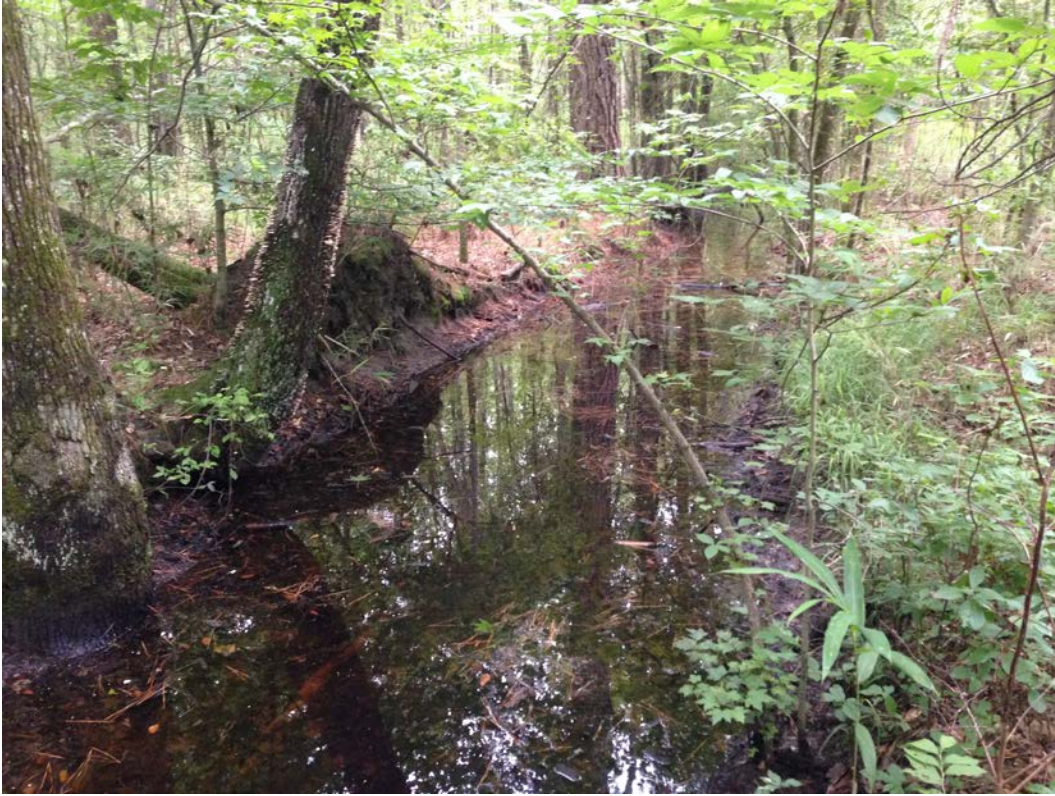
Waterbody data point ssus003 facing west upstream.

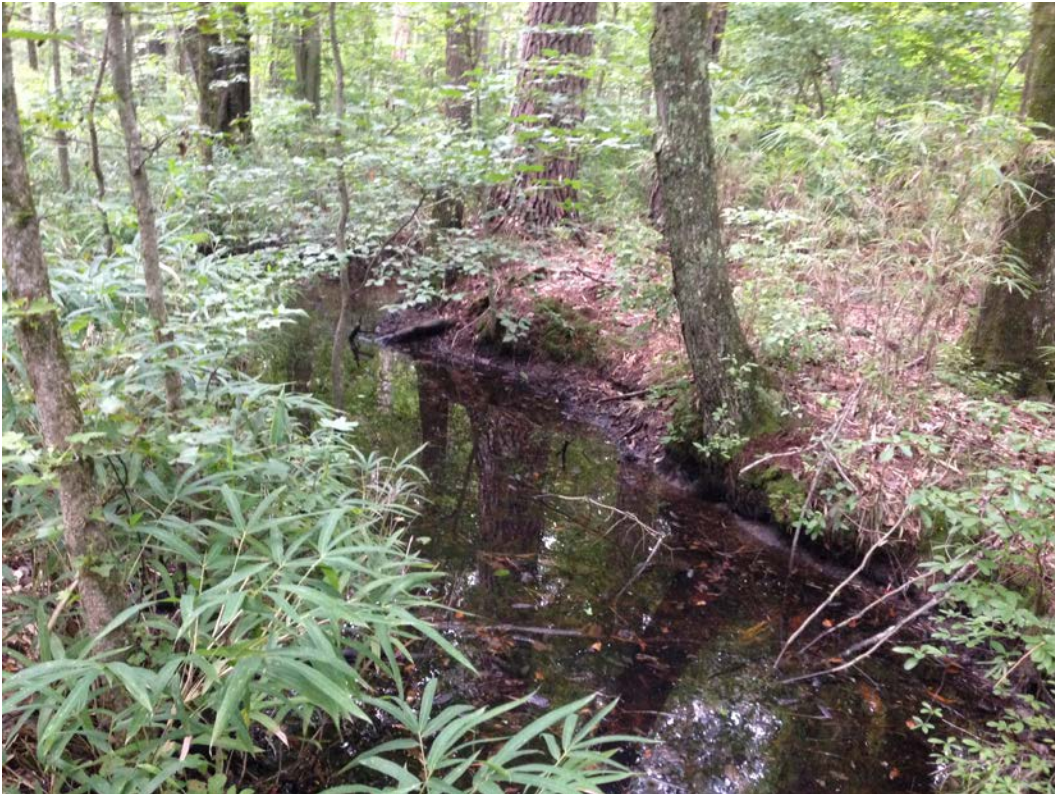
Waterbody data point ssus003 facing east downstream.

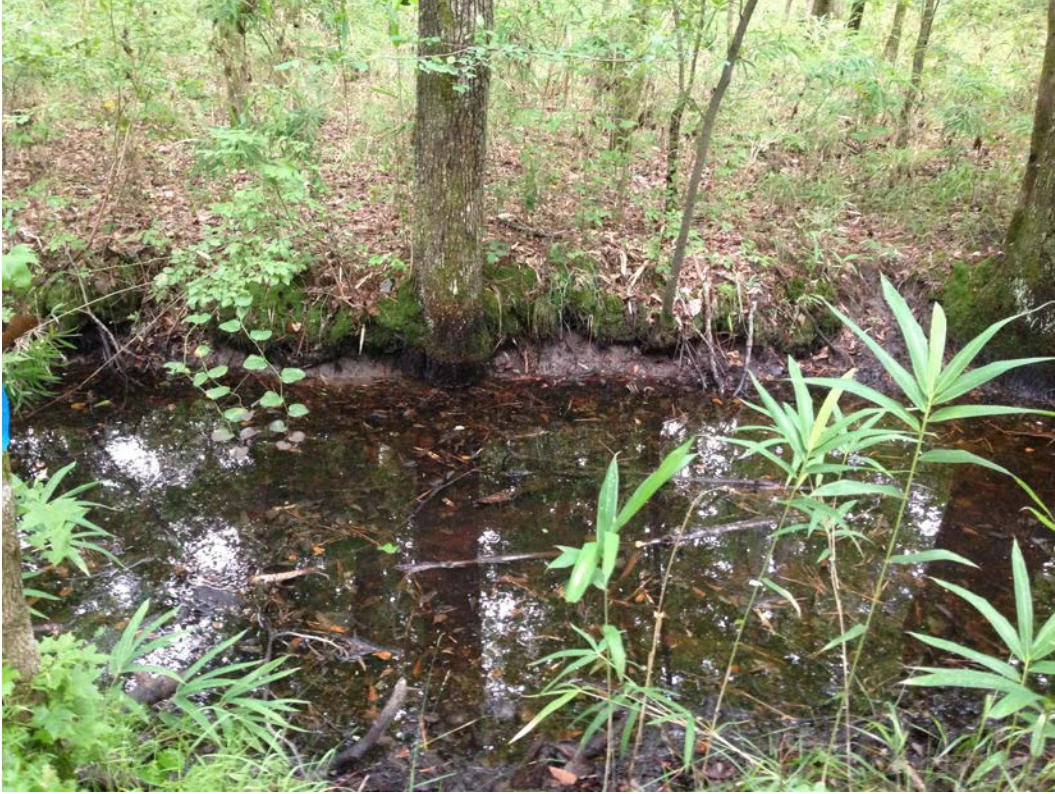
Waterbody data point ssus003 facing south across bank.

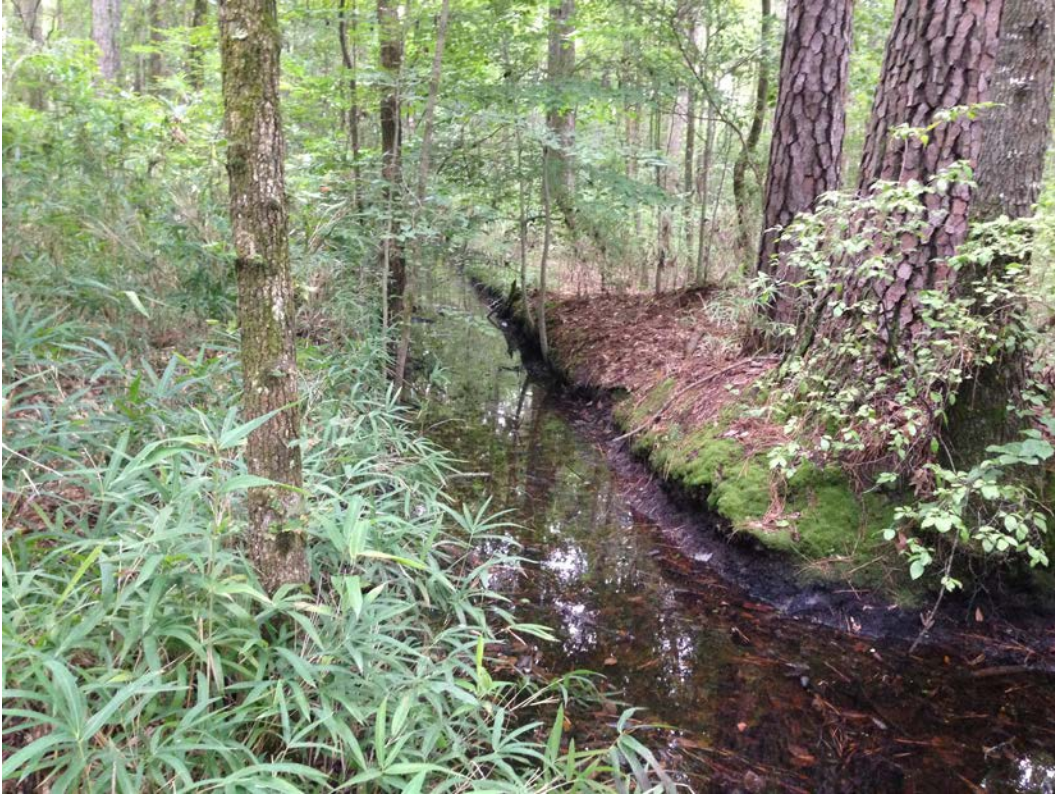
Waterbody data point ssus002 facing south upstream.

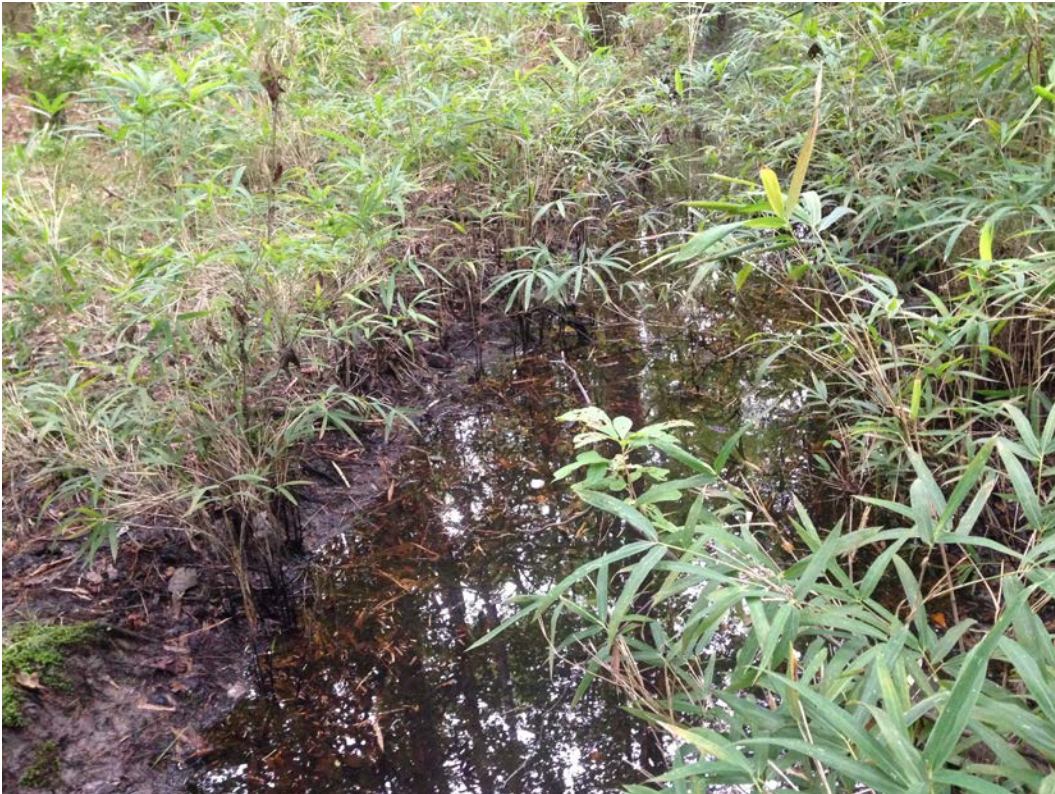
Waterbody data point ssus002 facing north downstream.

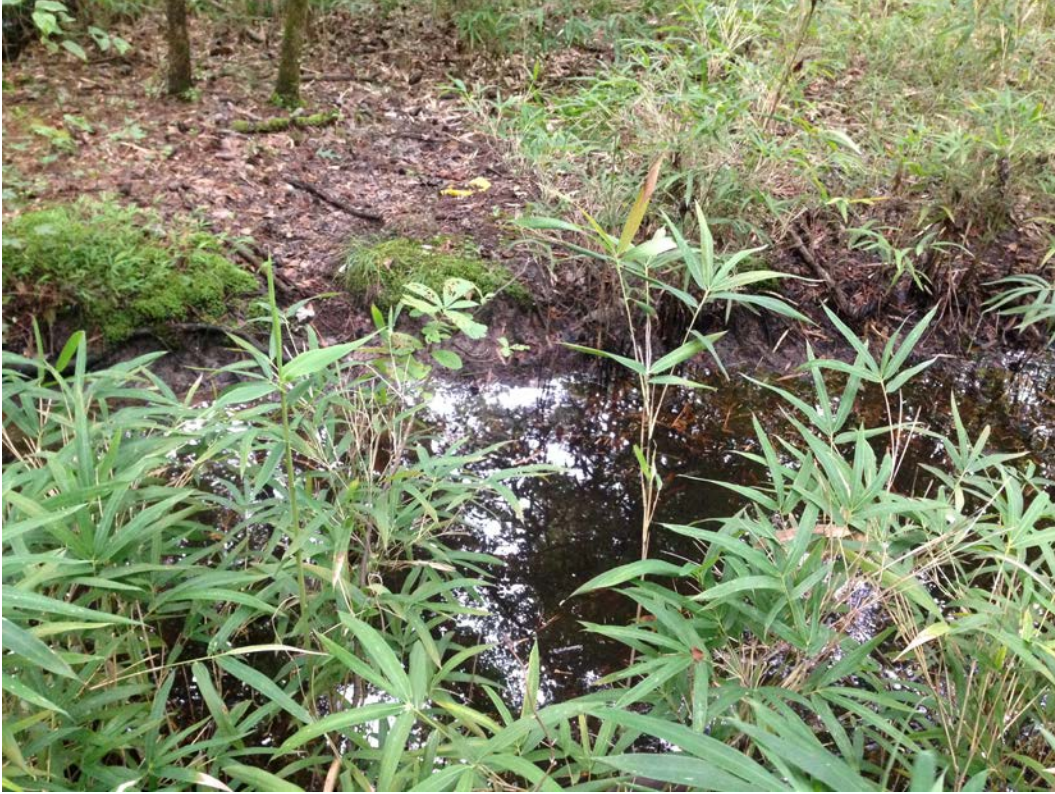
Waterbody data point ssus002 facing west across bank.

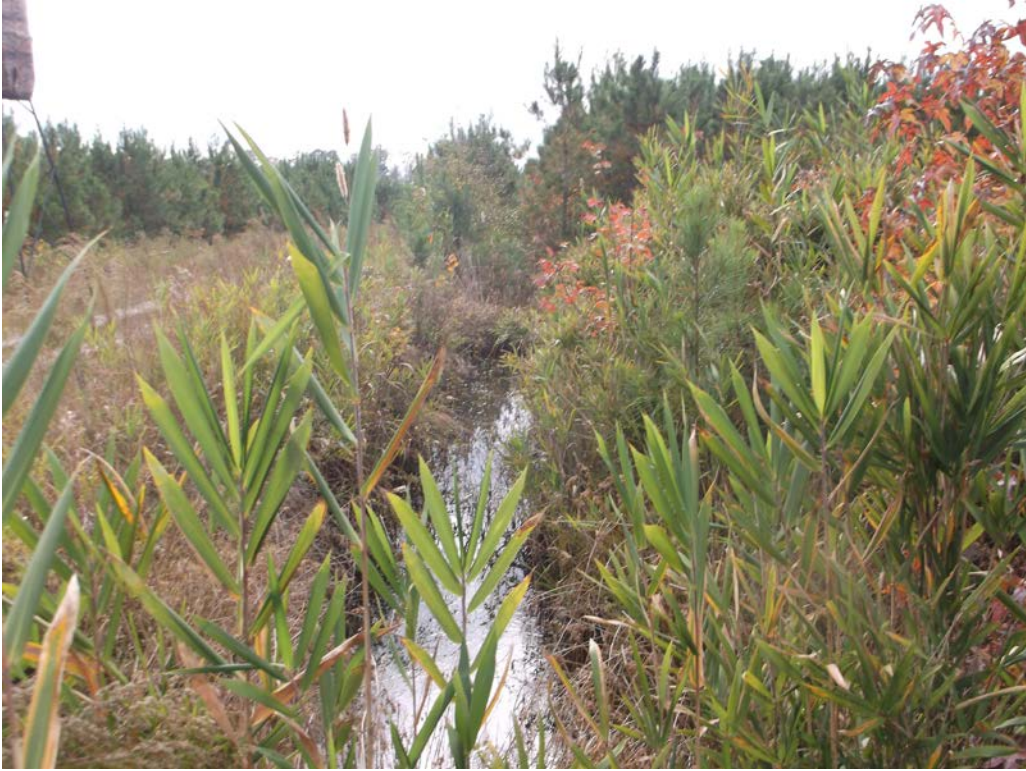
Waterbody ssuo019 facing southwest upstream.

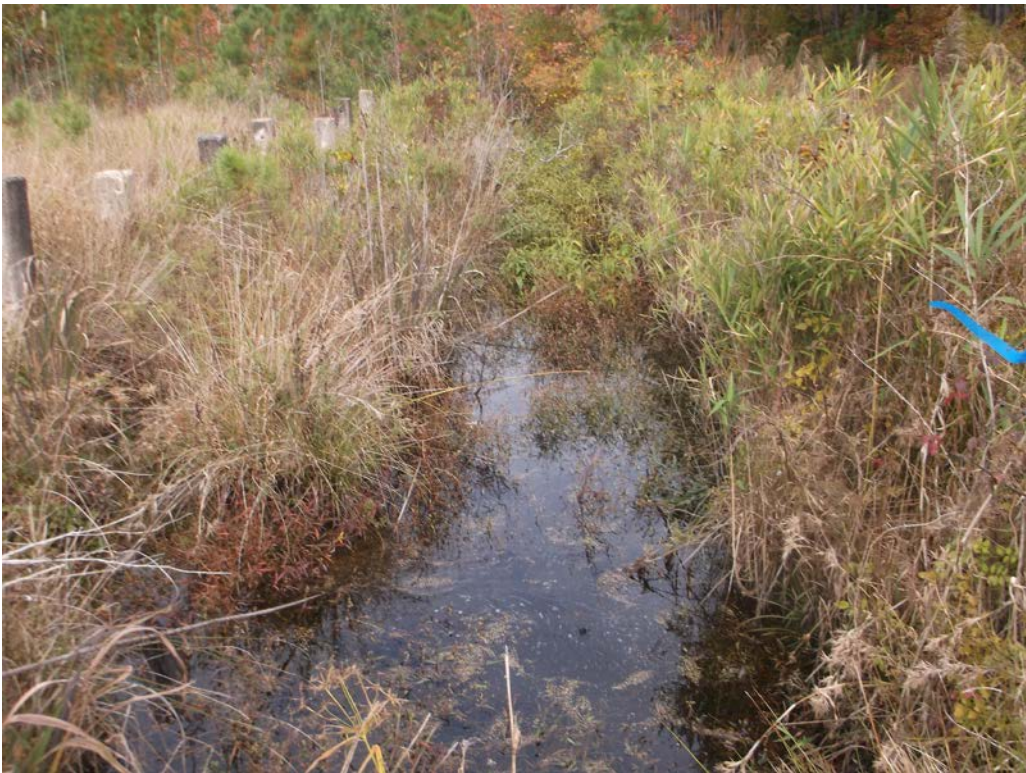
Waterbody ssuo019 facing northeast downstream.

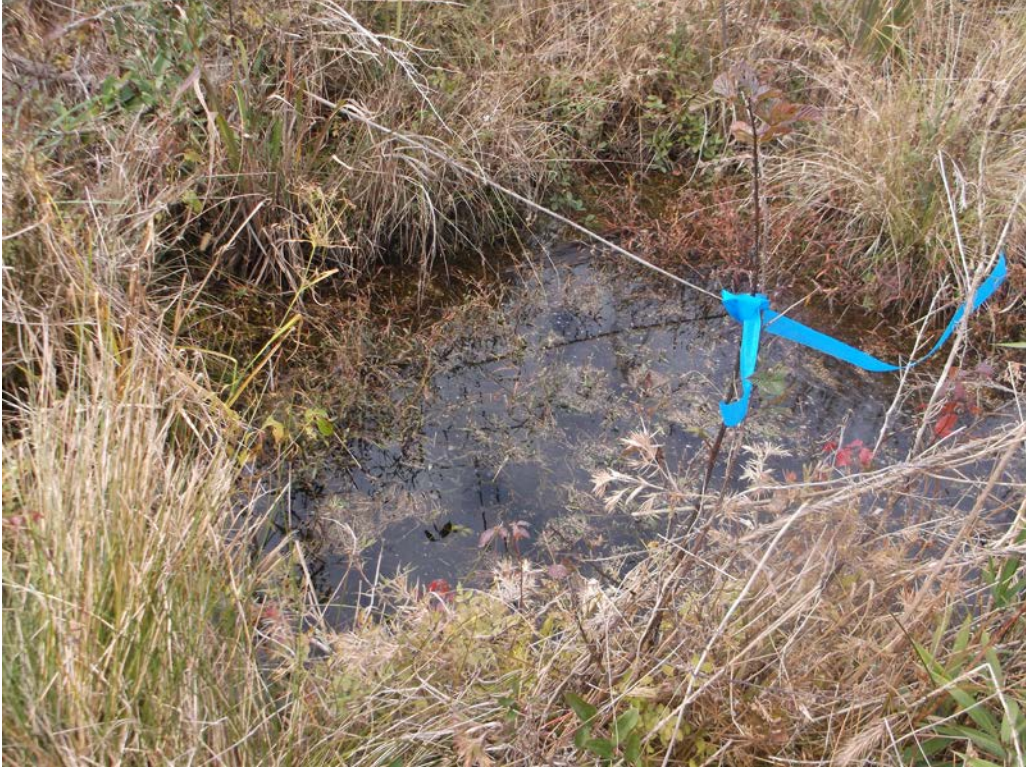
Waterbody ssuo019 facing west across bank.

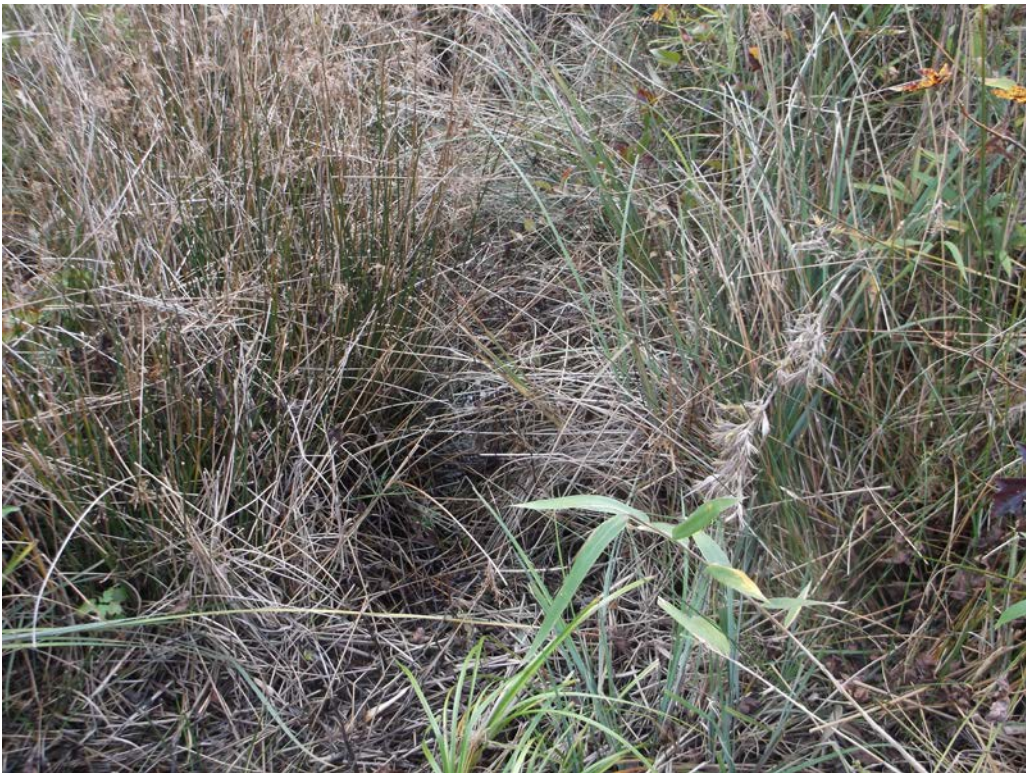
Waterbody ssuo020 facing west downstream.

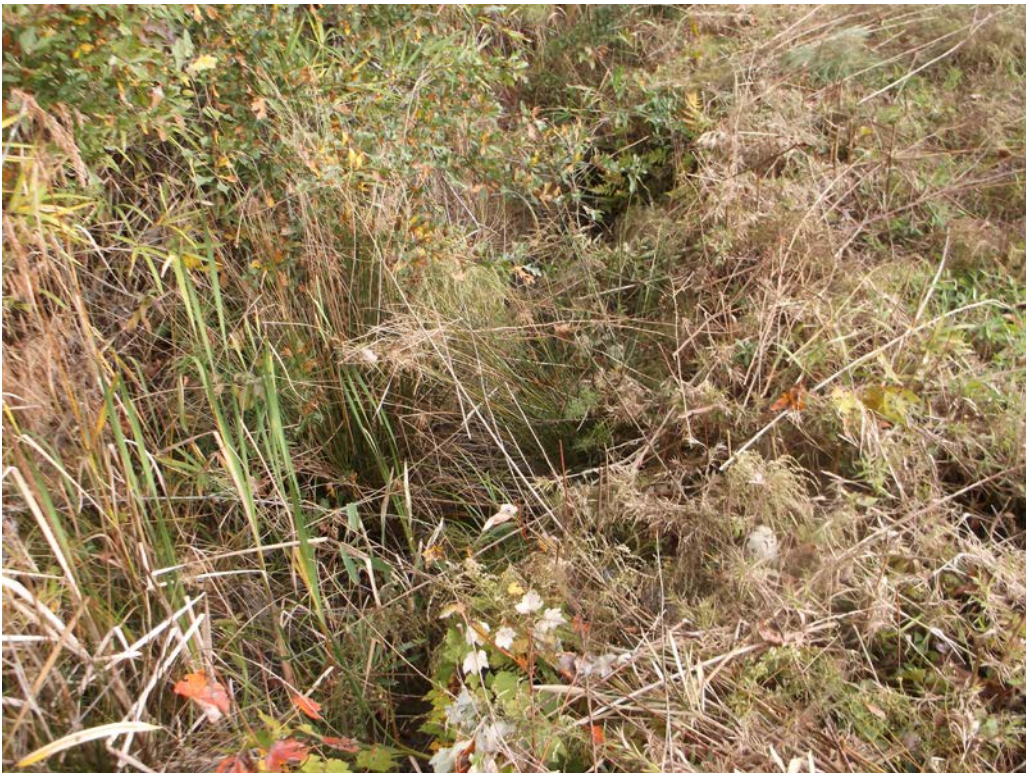
Waterbody ssuo021 facing southeast downstream.

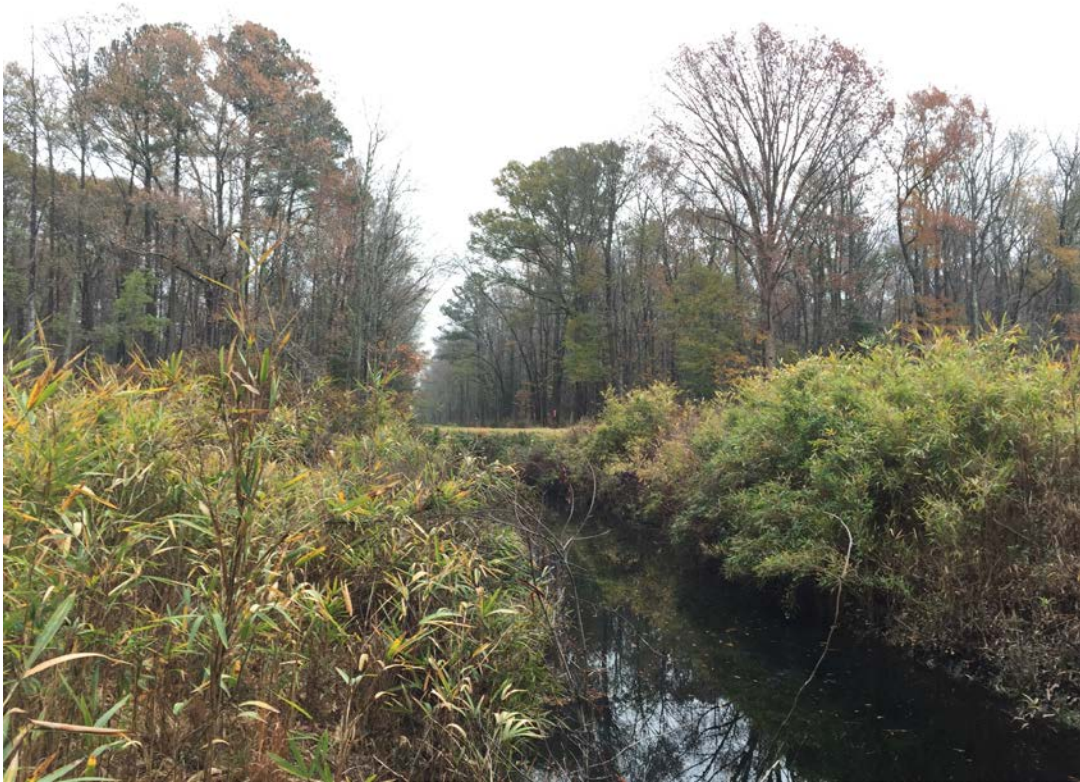
Waterbody data point ssup028 facing east upstream.

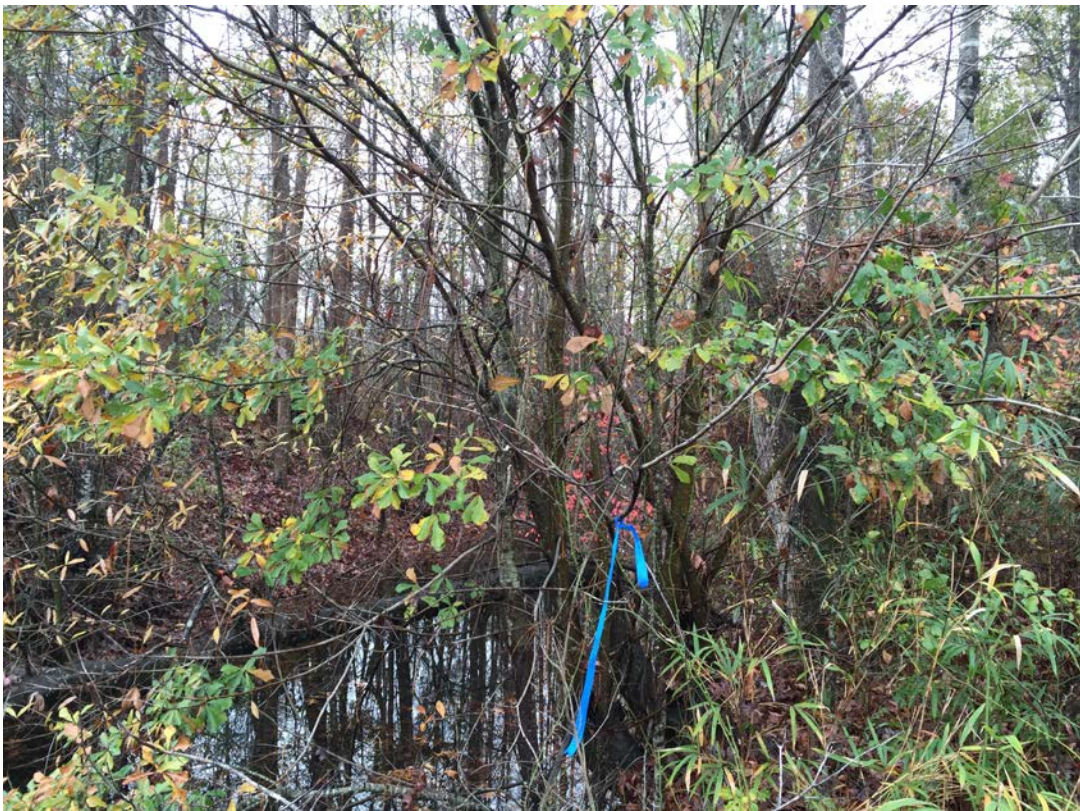
Waterbody data point ssup028 facing west downstream.

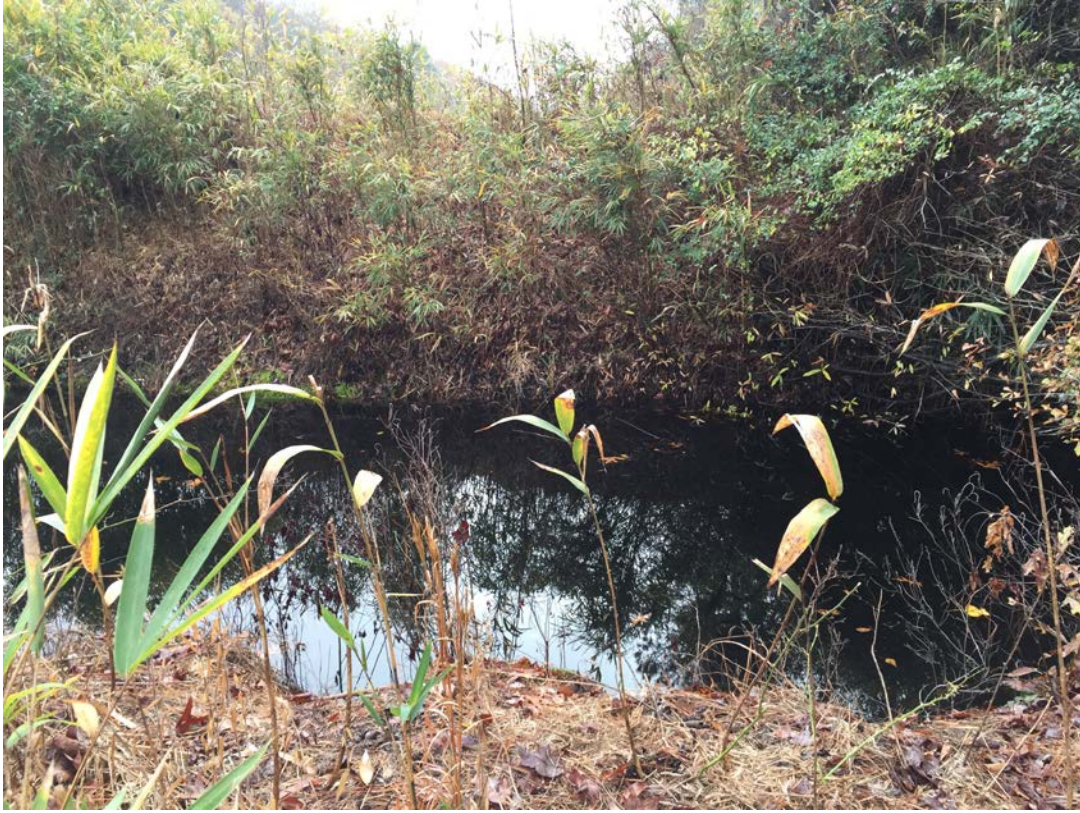
Waterbody data point ssup028 facing south across bank.

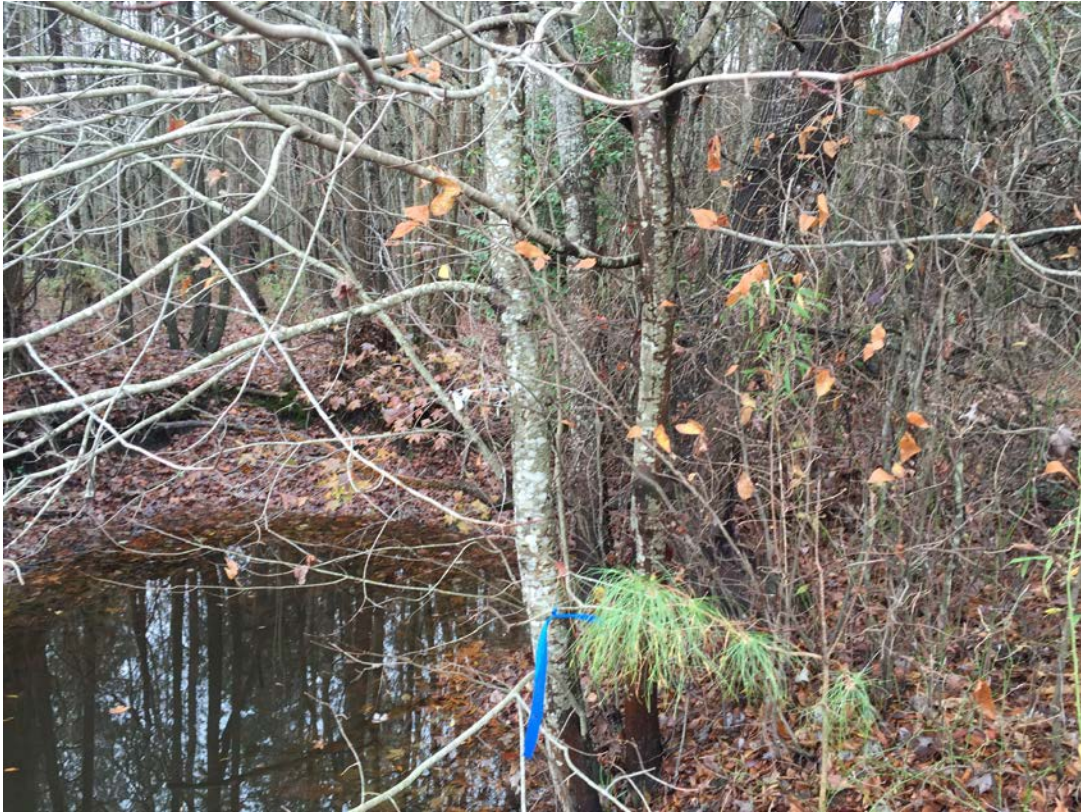
Waterbody data point ssup029 facing west upstream.

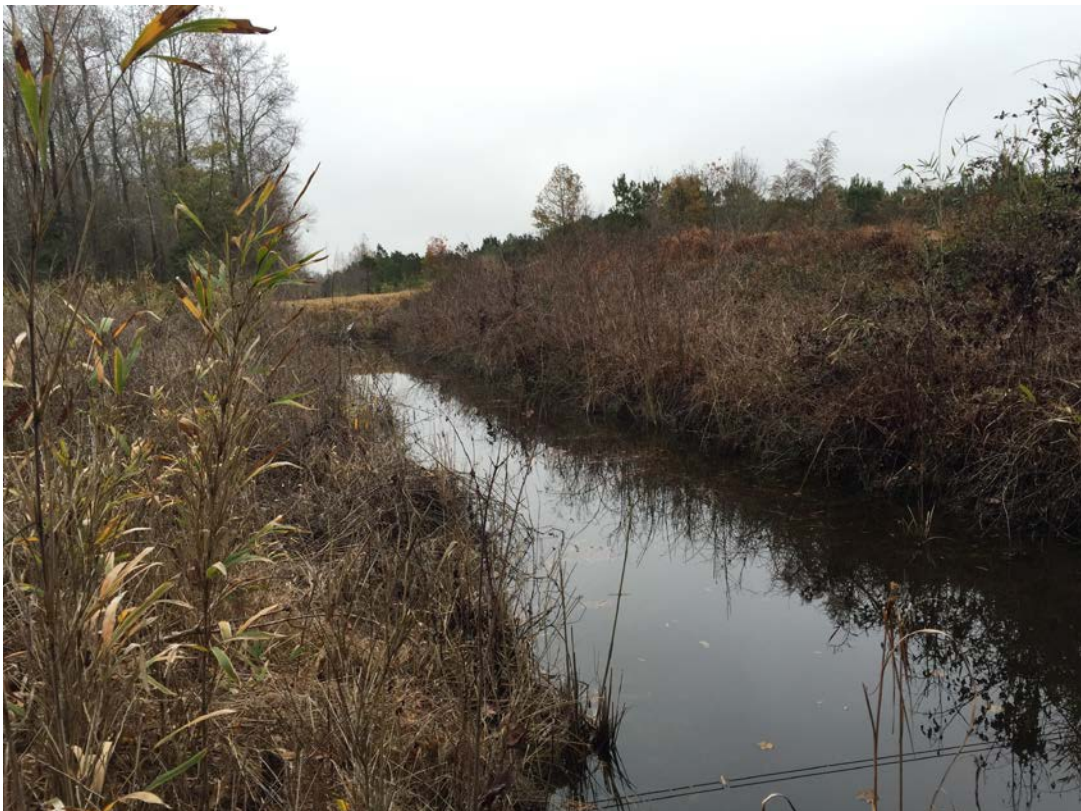
Waterbody data point ssup029 facing east downstream.

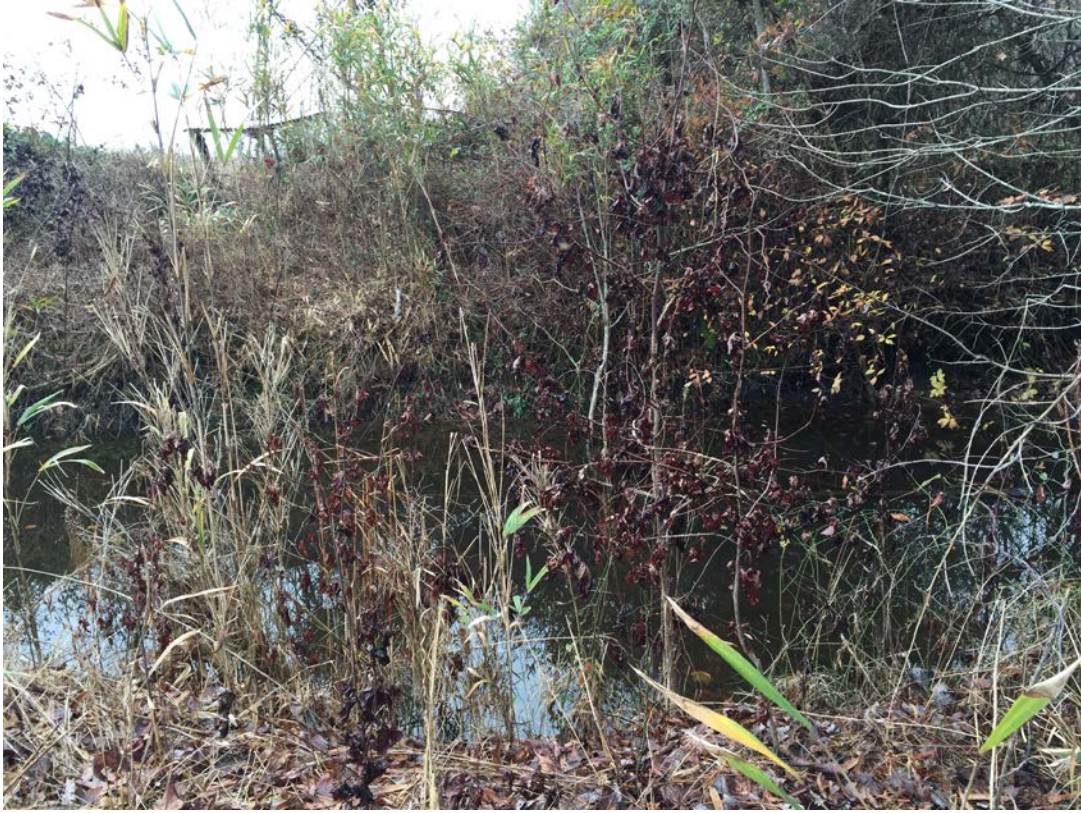
Waterbody data point ssup029 facing south across bank.

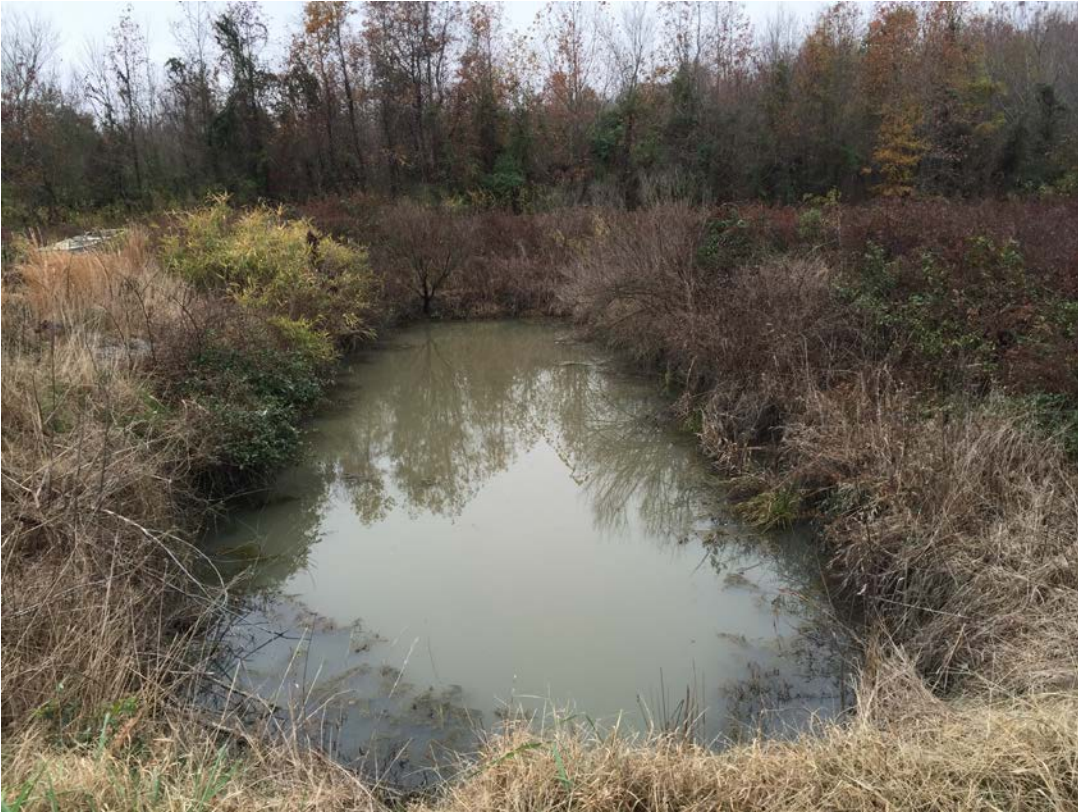
Waterbody data point osup002 facing west.

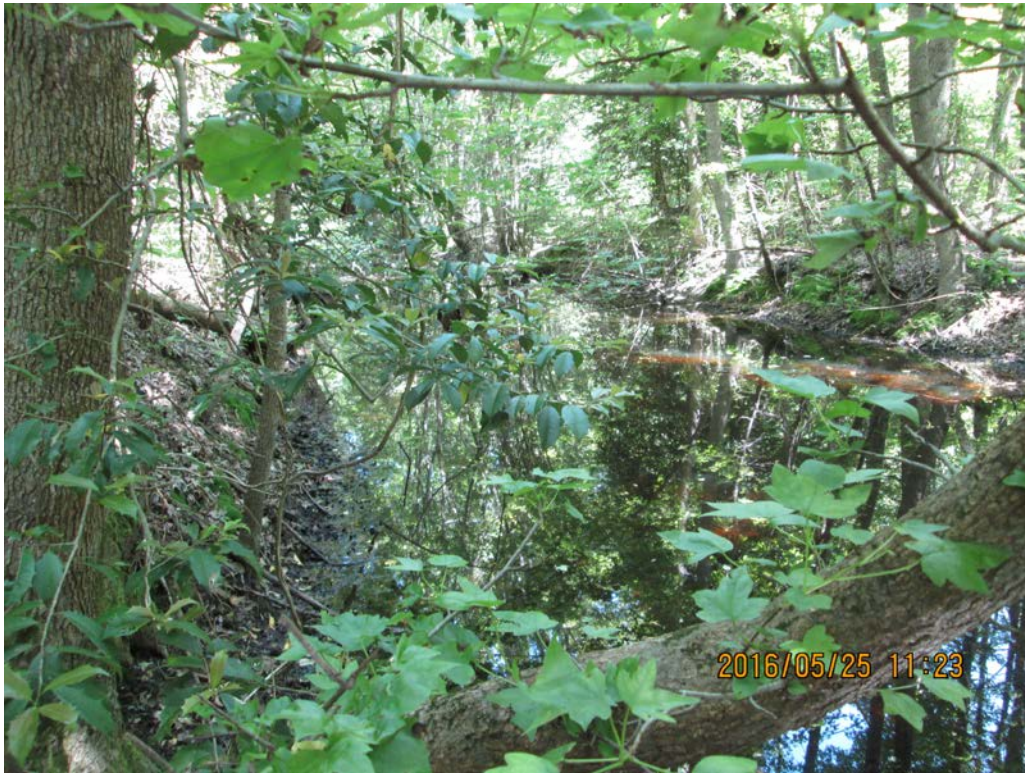
Waterbody ssup038 facing north upstream.

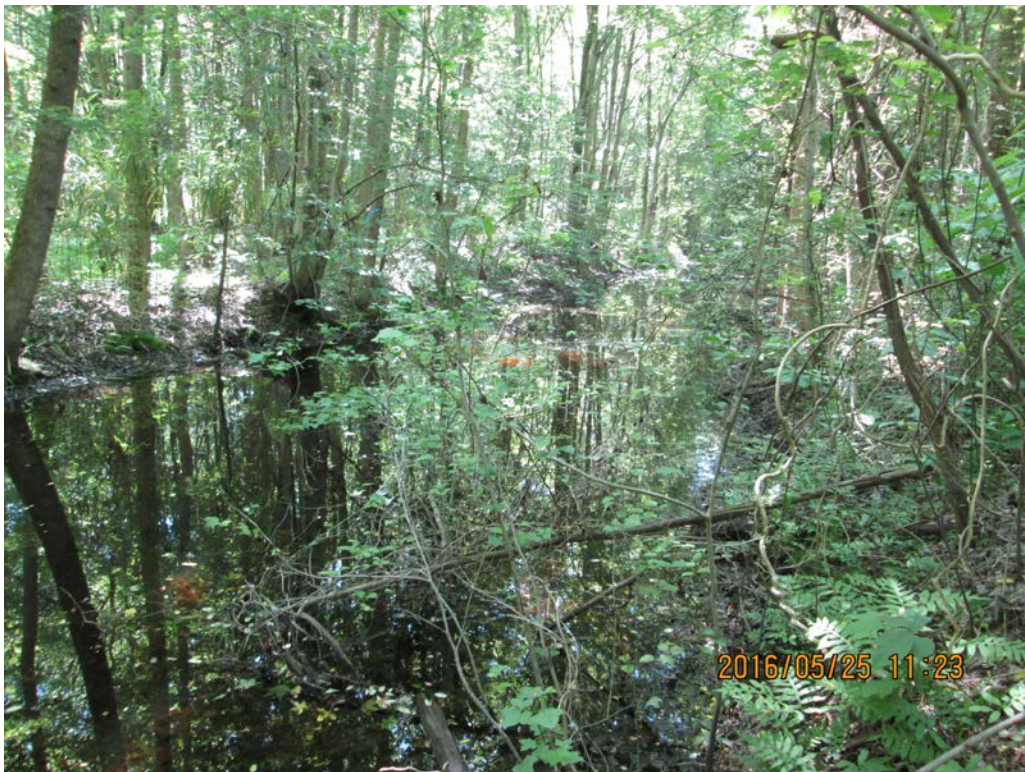
Waterbody ssup038 facing south downstream.

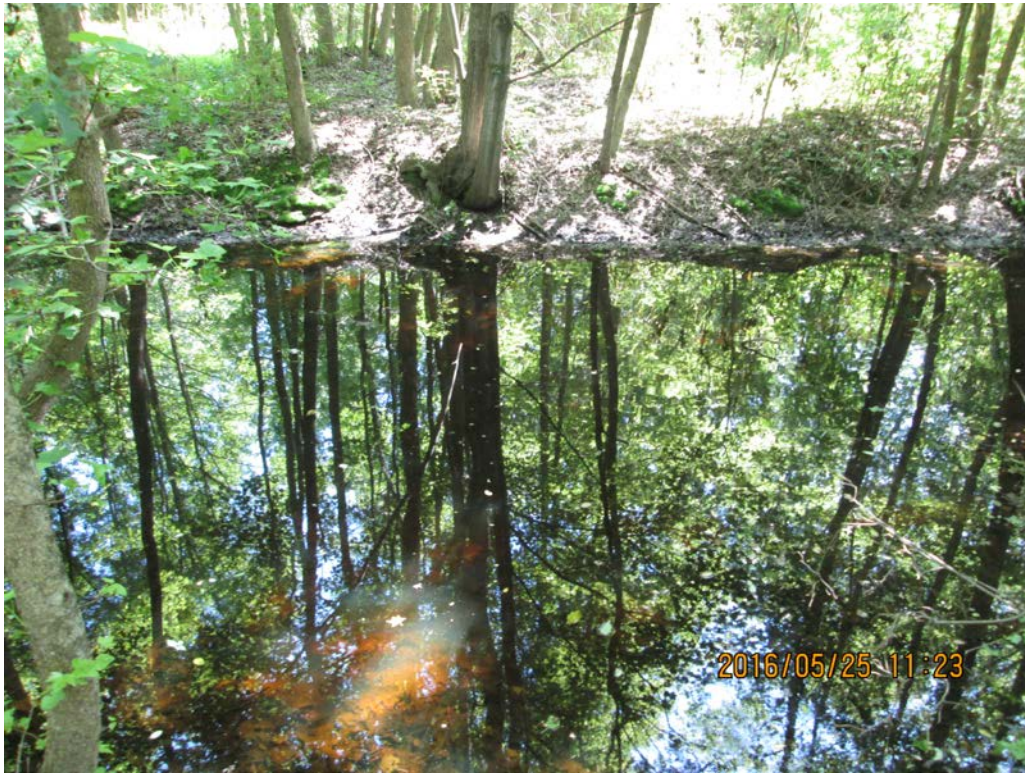
Waterbody ssup038 facing east across bank.

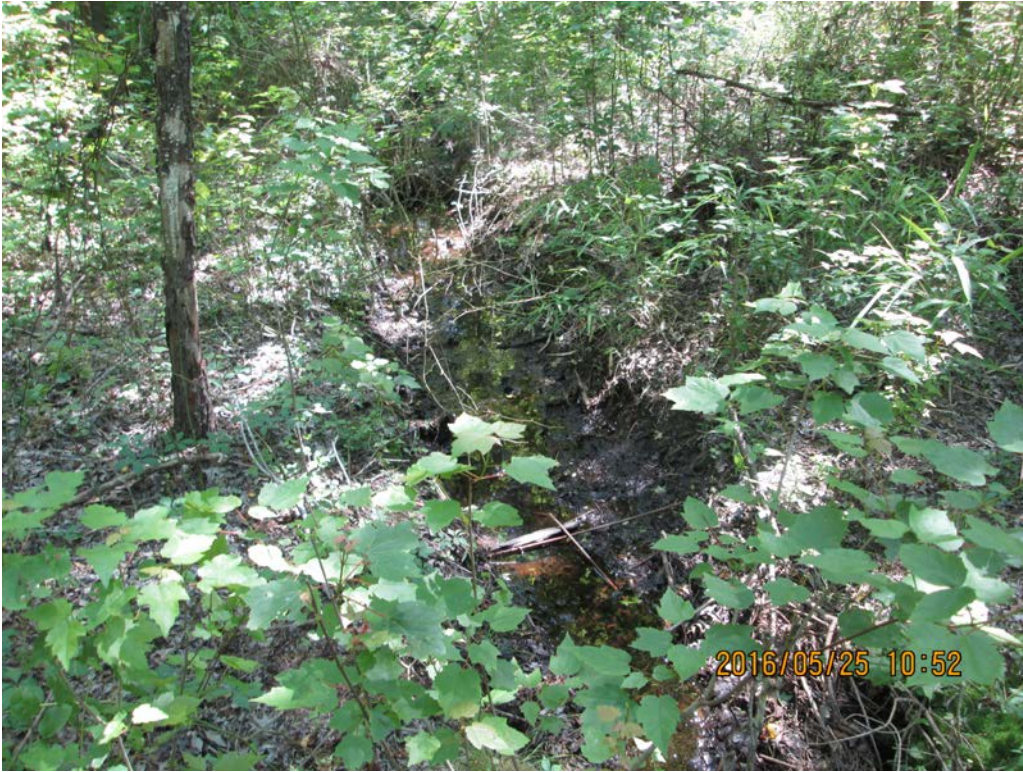
Waterbody ssup039 facing east upstream.

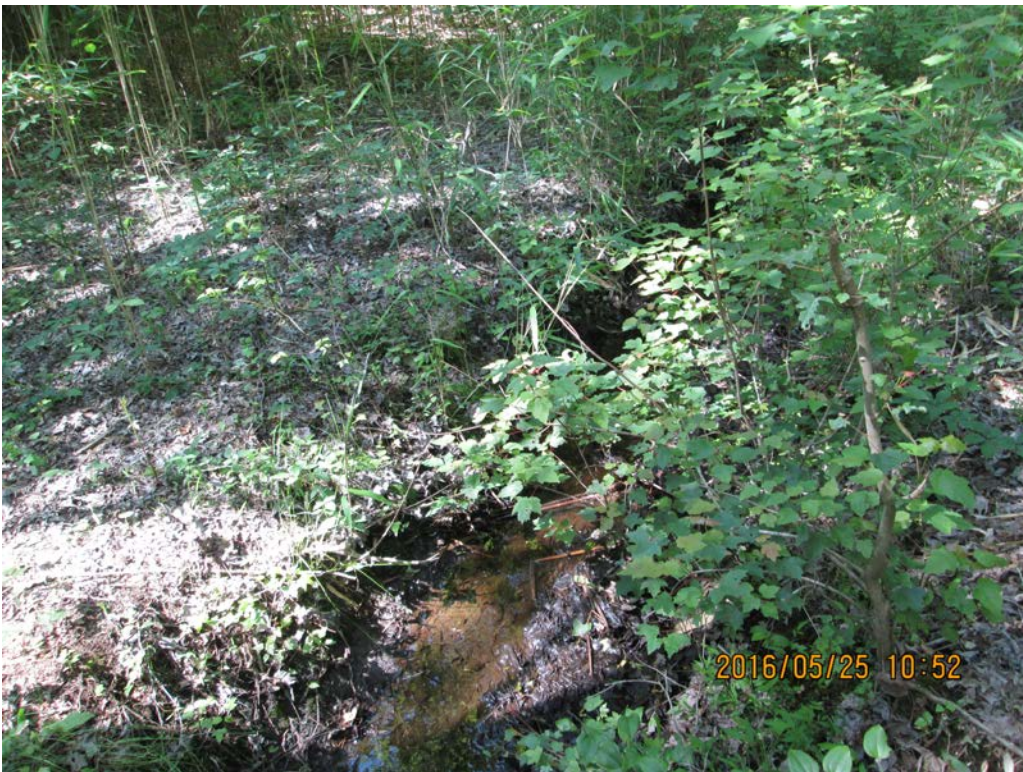
Waterbody ssup039 facing west downstream.

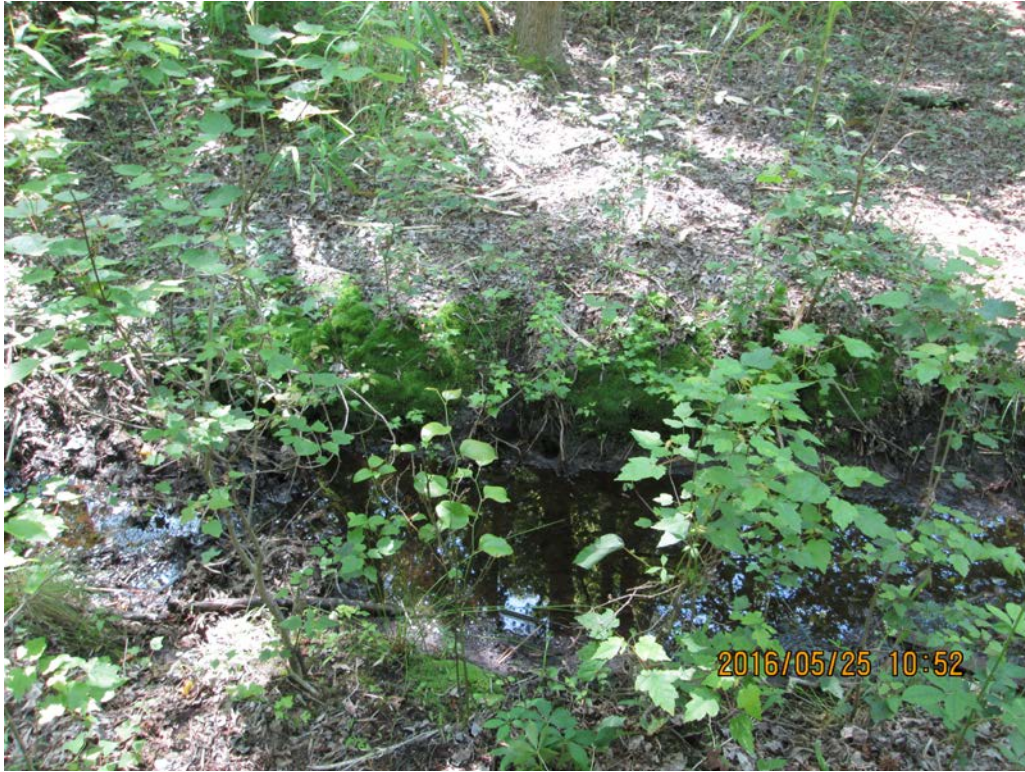
Waterbody ssup039 facing south across bank.

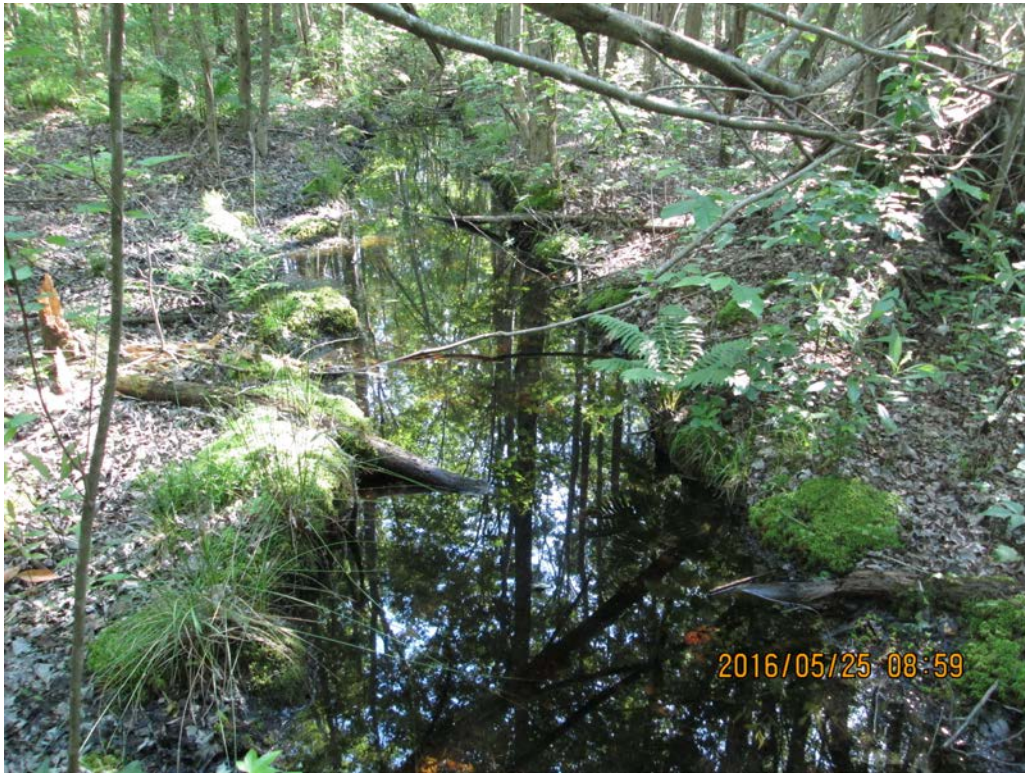
Waterbody ssup037 facing northeast upstream.
