Linear Waterbody Data Sheet

Survey Description				
Project Name: ACP		Waterbody Name: UNT to WESTERN BRANCH RESERVOIR	Waterbody ID: SSU0100	Date: 3-8-16
State: VA	County/Parish: Suffolk	Company: ESI	Crew Member Initials: LR, WV	Photos: Facing E, W, N
Tract Number(s): 26-060-4068		Nearest Milepost: 61.8	Associated Wetland ID(s): WSU0029	
Survey Type: (check one) <input checked="" type="checkbox"/> Centerline <input type="checkbox"/> Re-Route <input type="checkbox"/> Access Road <input type="checkbox"/> Other:				
Physical Attributes				
Stream Classification: (check one) <input type="checkbox"/> Ephemeral <input type="checkbox"/> Intermittent <input checked="" type="checkbox"/> Perennial				
Waterbody Type: (check one) <input type="checkbox"/> River <input checked="" type="checkbox"/> Stream <input type="checkbox"/> Ditch <input type="checkbox"/> Canal <input type="checkbox"/> Other:				
OHWM Width: 3 ft.	OHWM Height: 0.5 ft.	OHWM Indicator: (check all that apply) <input checked="" type="checkbox"/> Clear line on bank <input type="checkbox"/> Shelving <input checked="" type="checkbox"/> Wrested vegetation <input type="checkbox"/> Scouring <input checked="" type="checkbox"/> Water s

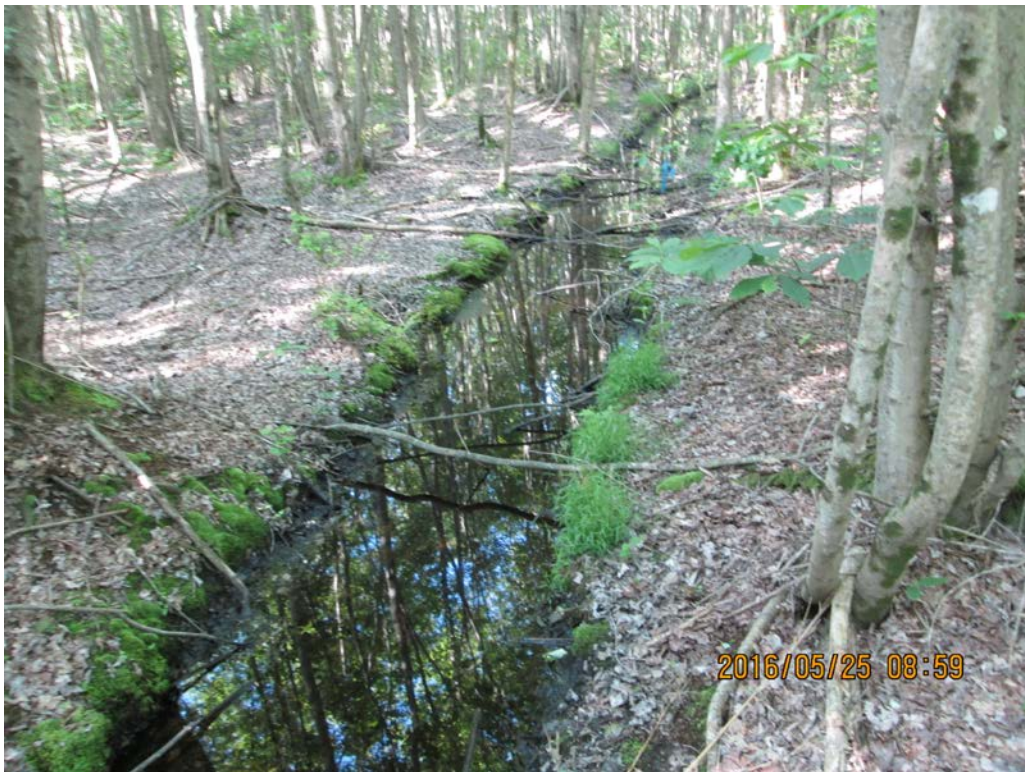
Waterbody ssup037 facing southwest downstream.

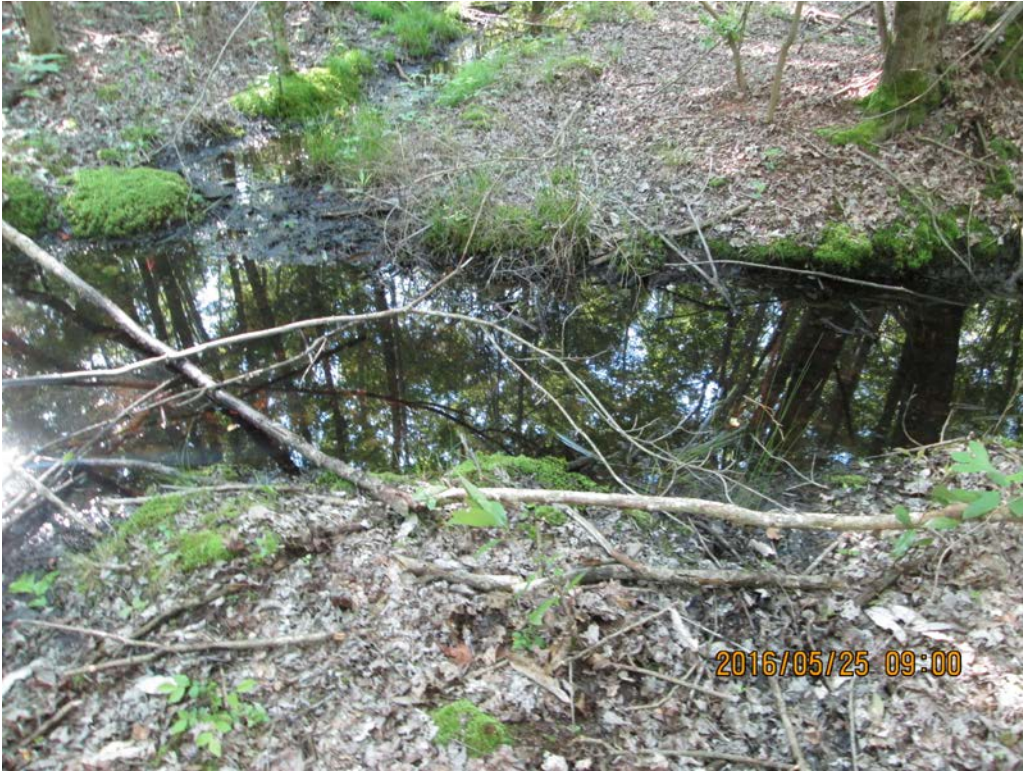
Waterbody ssup037 facing southeast across bank.

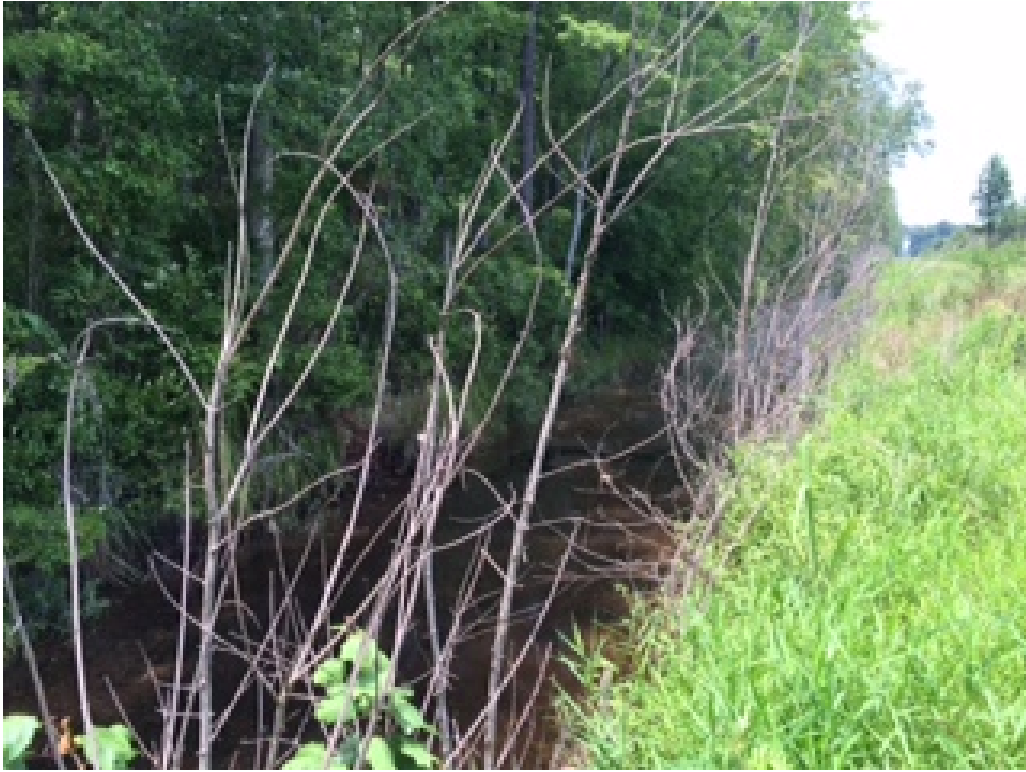
Waterbody ssuo005 facing north upstream.

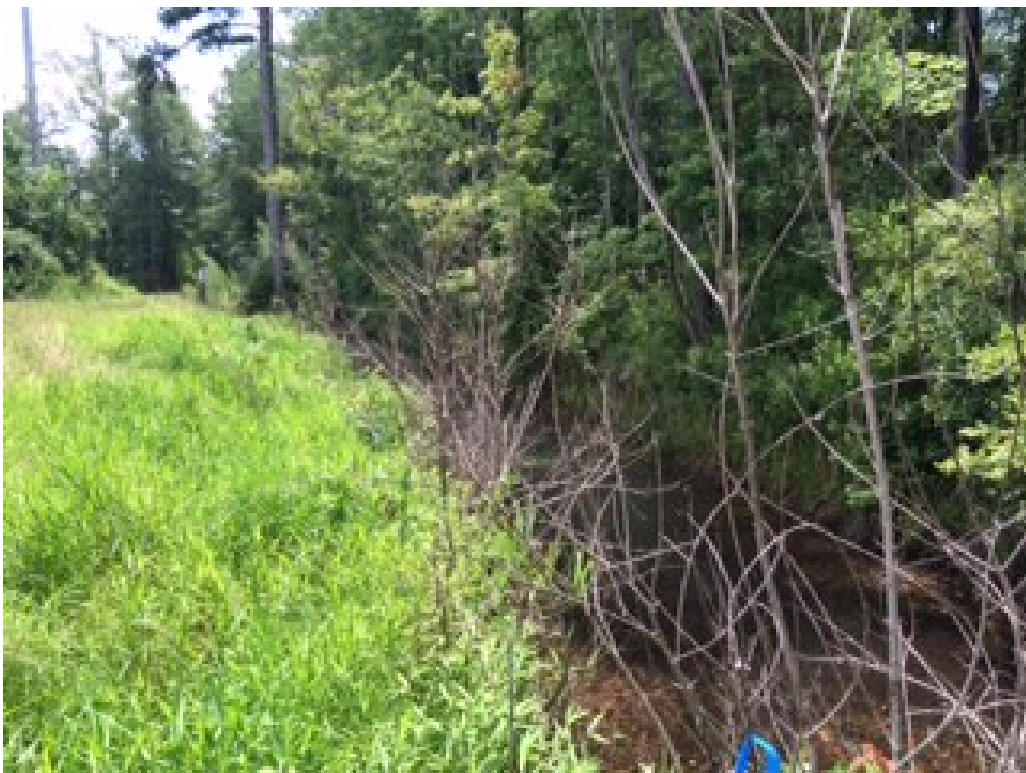
Waterbody ssuo005 facing south downstream.

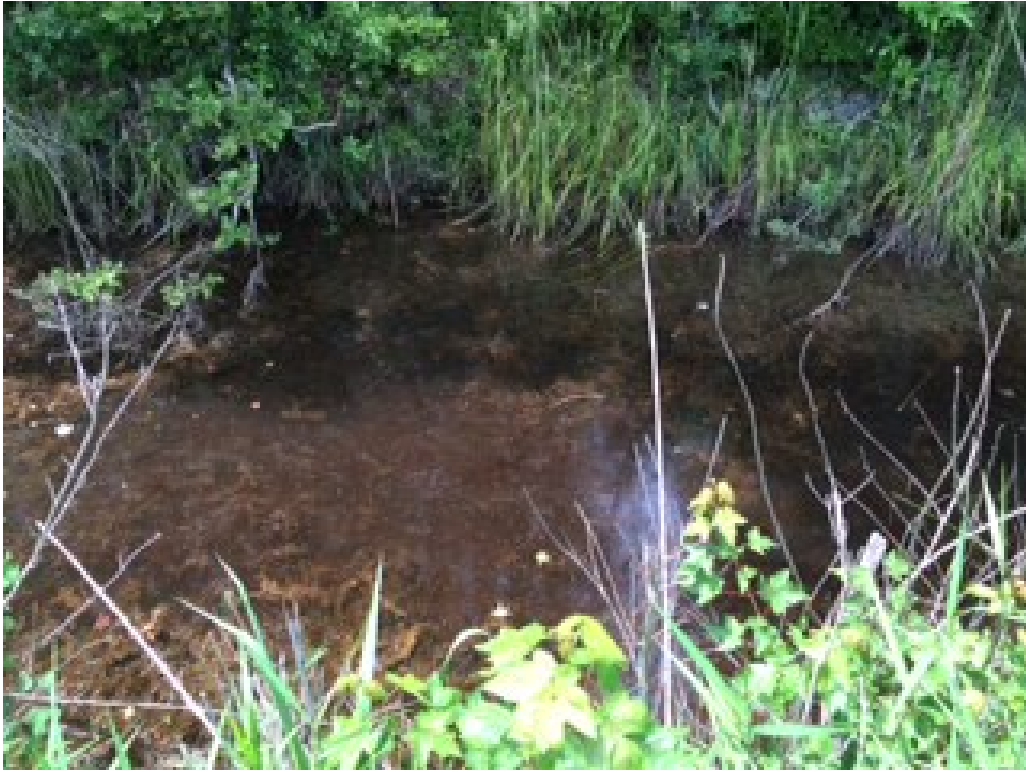
Waterbody ssuo005 facing west across bank.

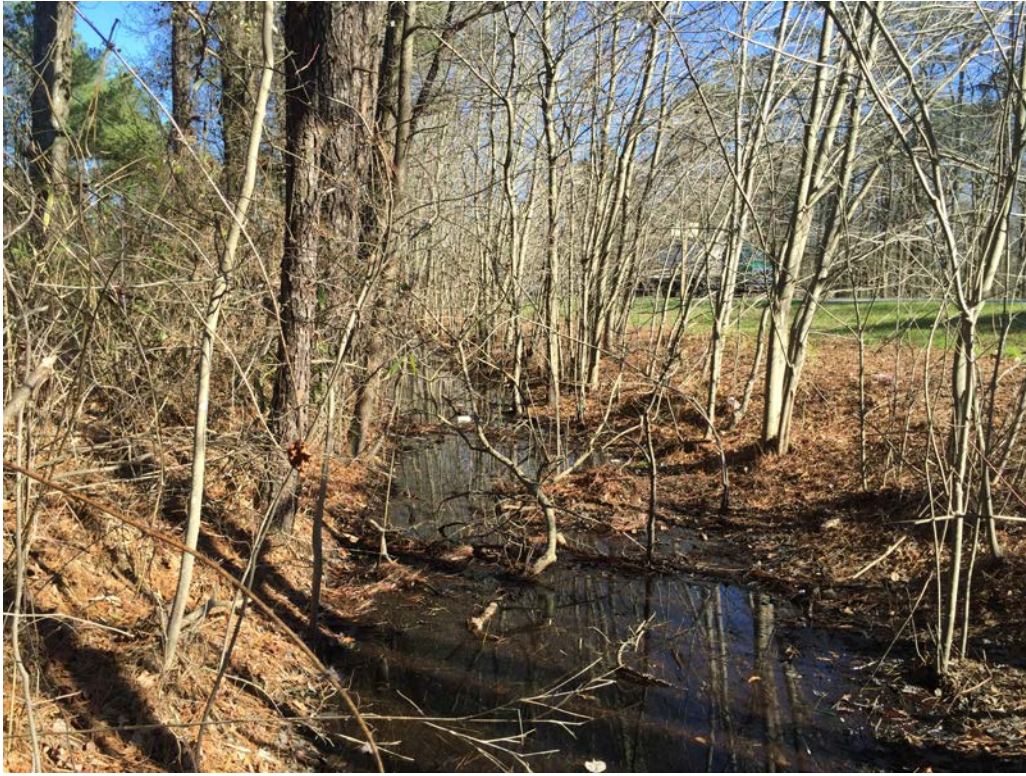
Waterbody ssur006 facing east upstream.

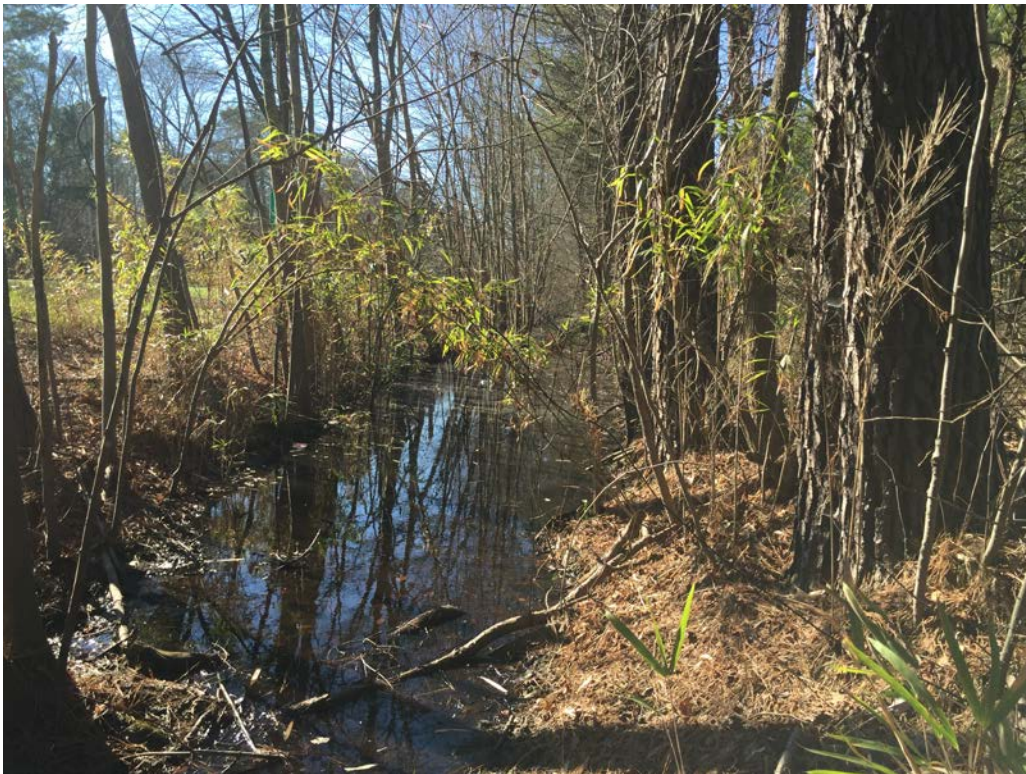
Waterbody ssur006 facing west downstream.

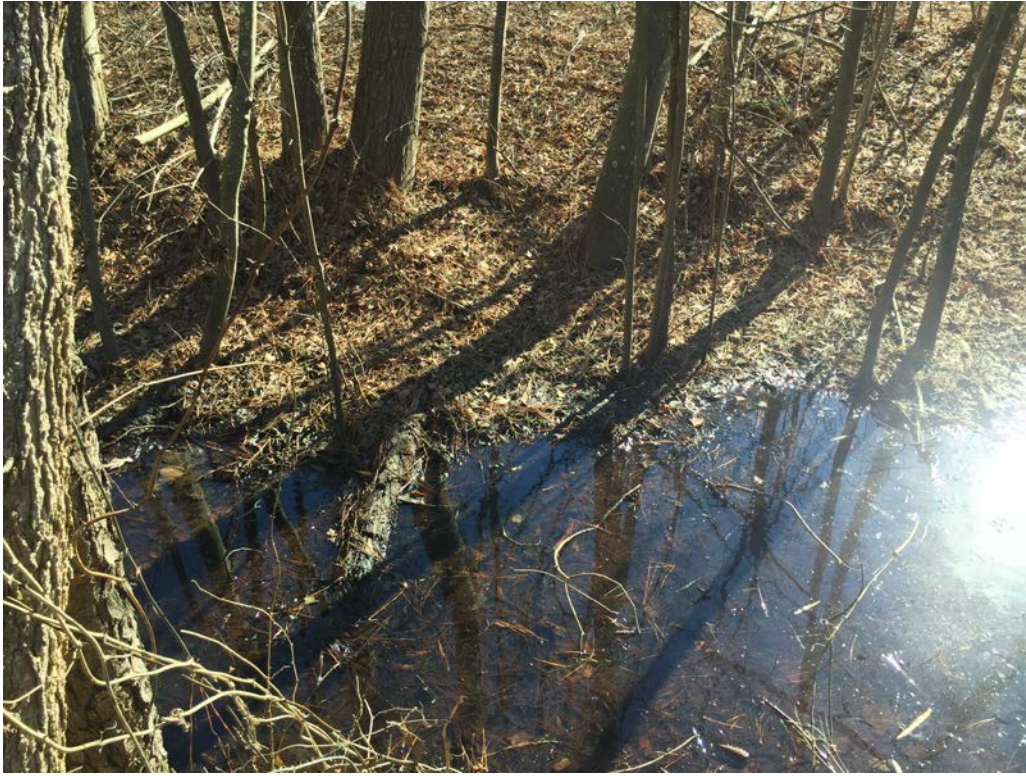
Waterbody ssur006 facing south across bank.
