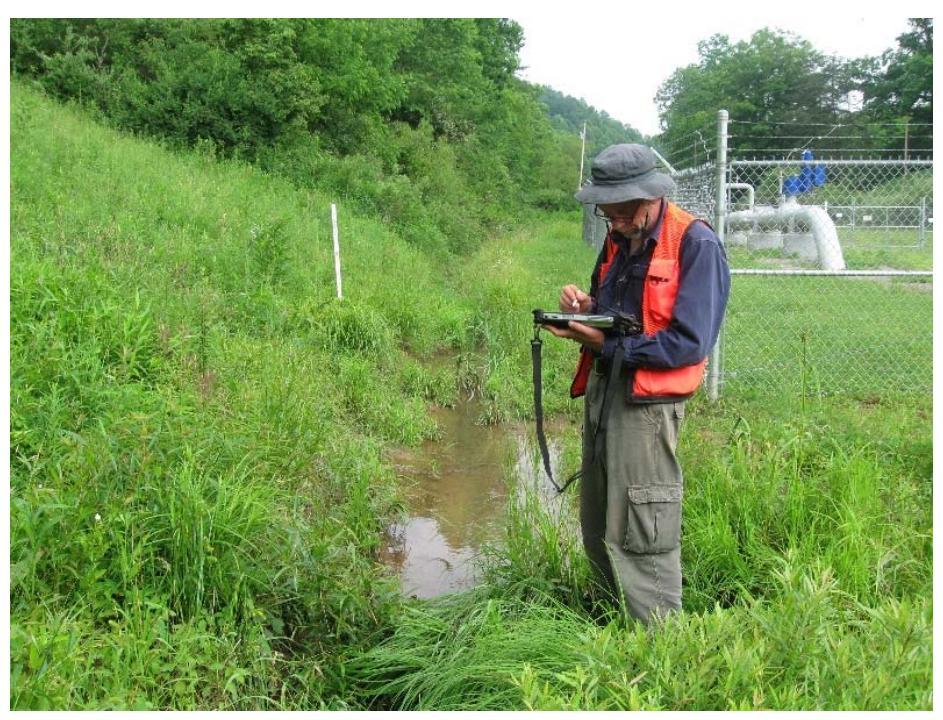
Waterbody SHAA001 facing north upstream

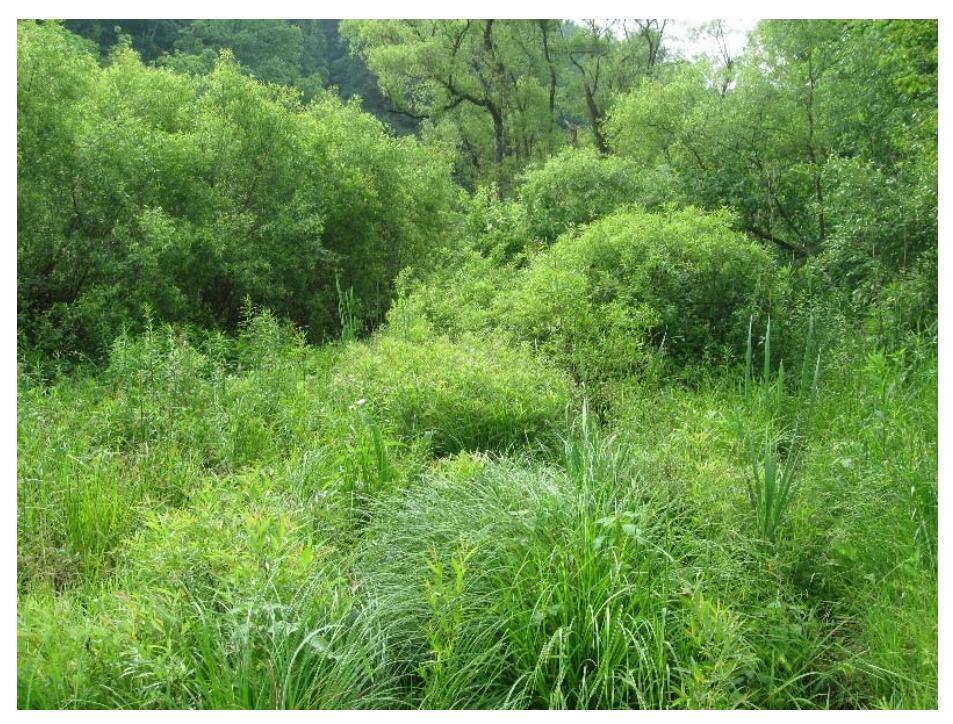
Waterbody SHAA001 facing south downstream

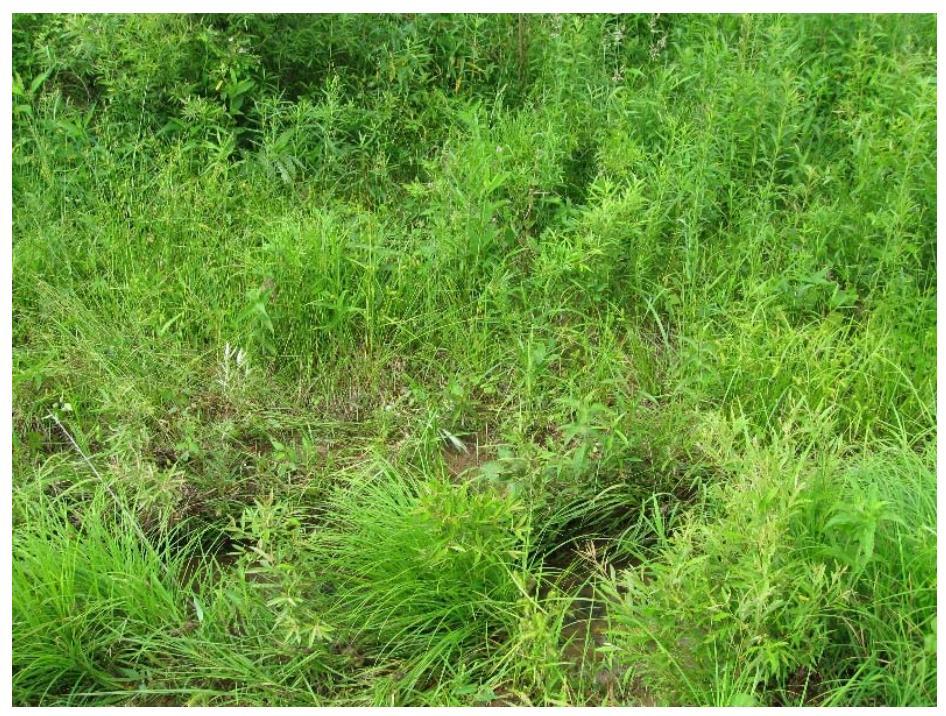
Waterbody SHAA001 facing north across

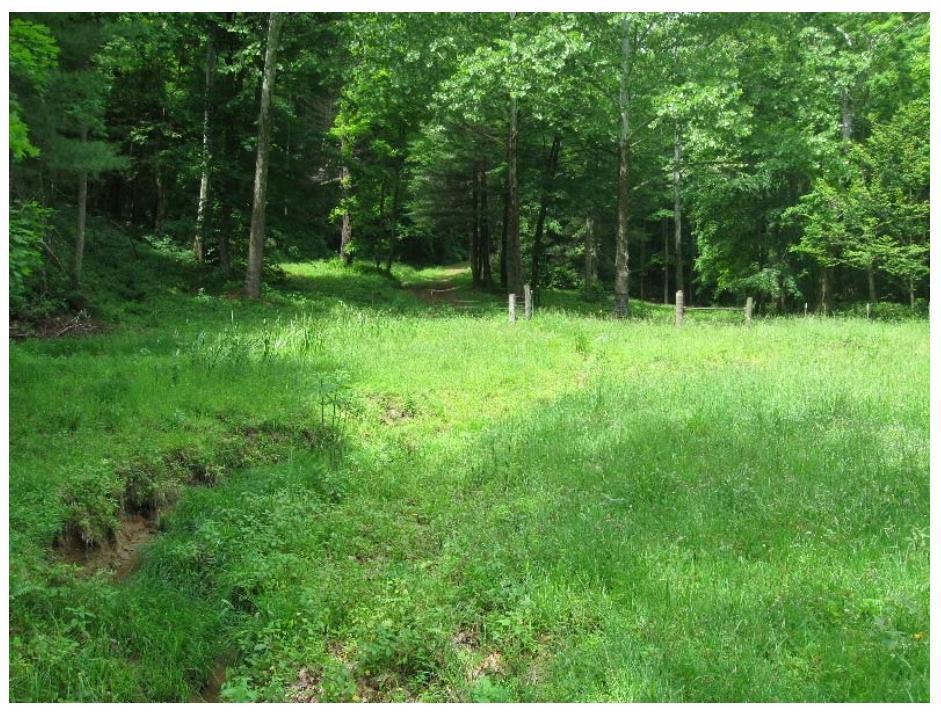
Waterbody SHAA003 facing west upstream

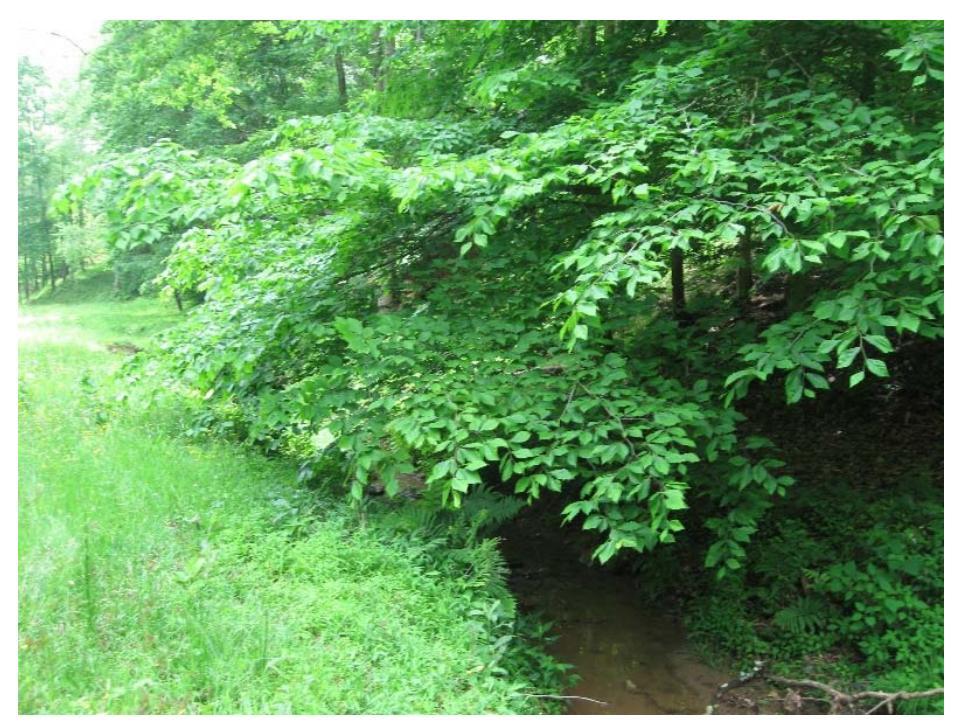
Waterbody SHAA003 facing east downstream

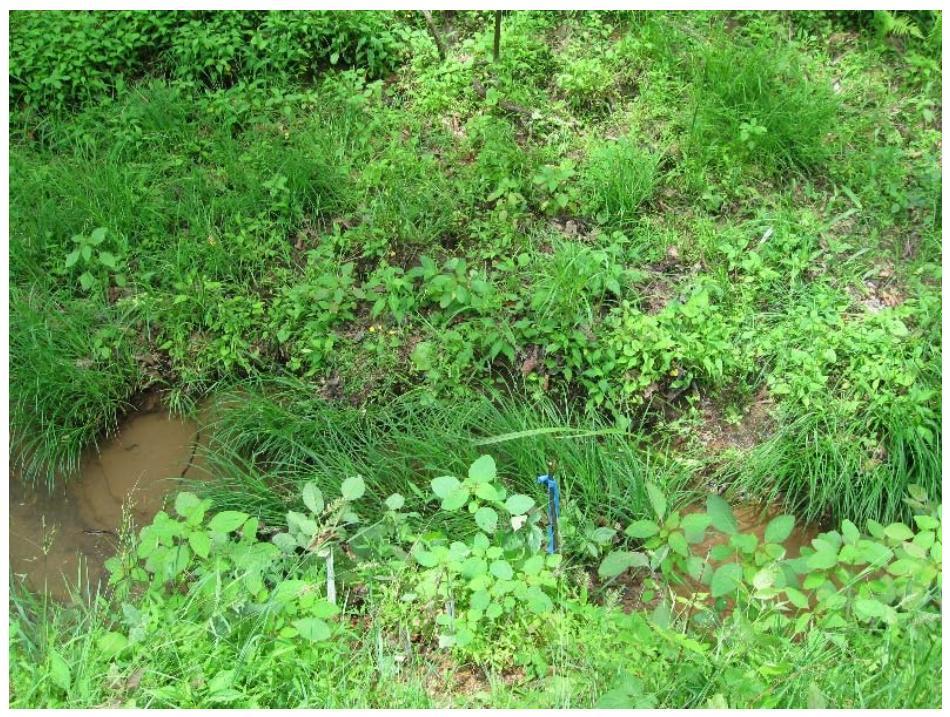
Waterbody SHAA003 facing south across

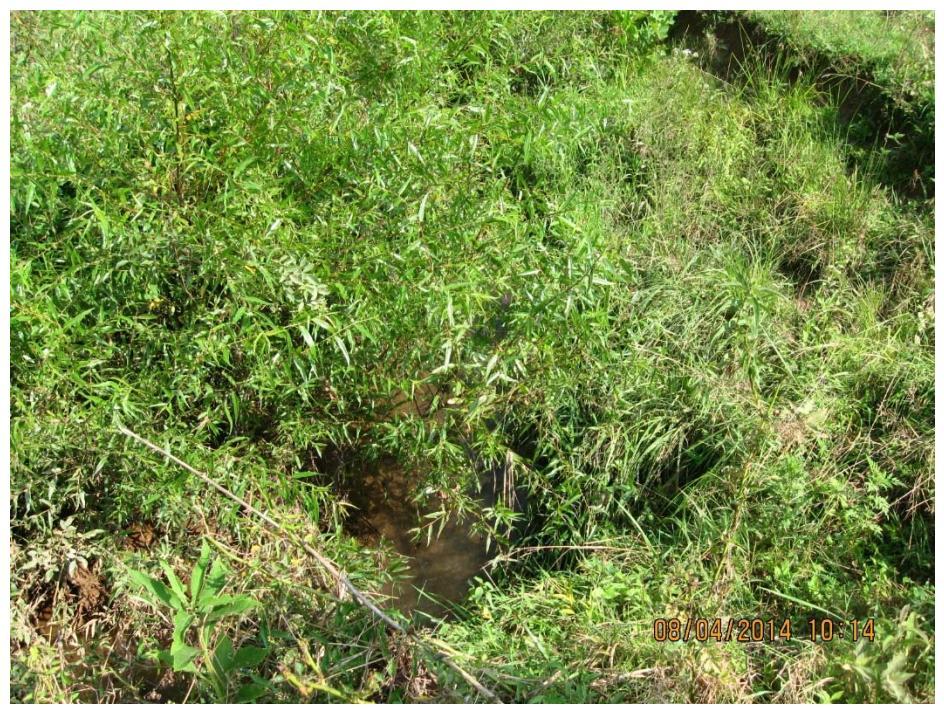
Stream is degraded due to cattle access, no riparian buffers present. Lots of sediment deposition, weak meanders, weak riffle pool sequence. Waterbody ID in Waterbody Sketch was updated to SHAB101 on 9/9/14 JM.

Waterbody SHAB101 facing north upstream

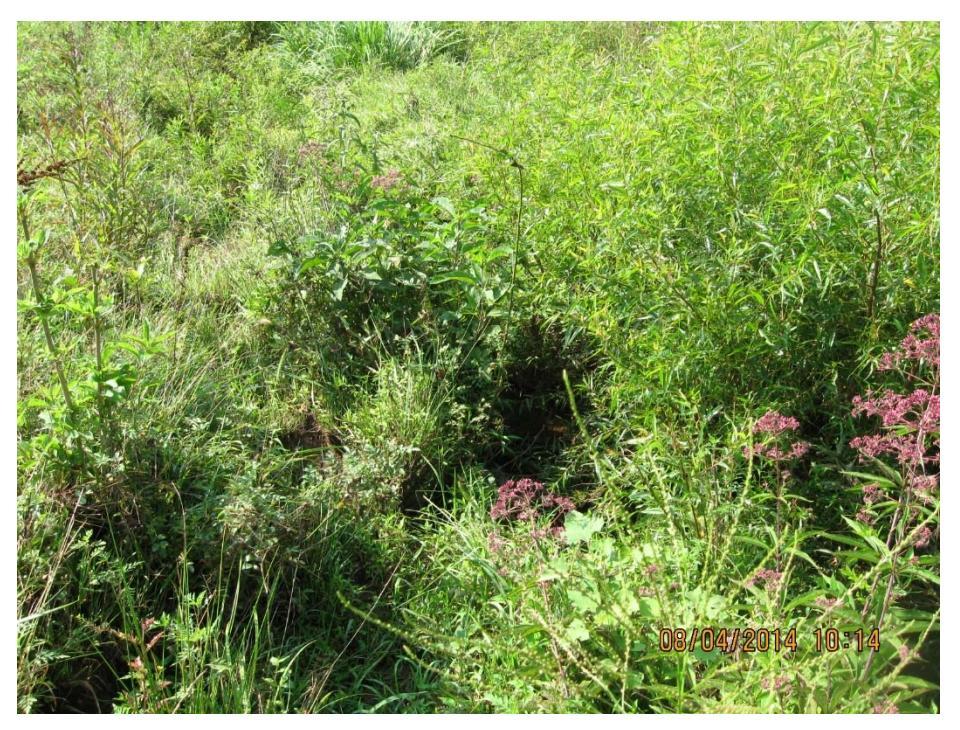
Waterbody SHAB101 facing south downstream

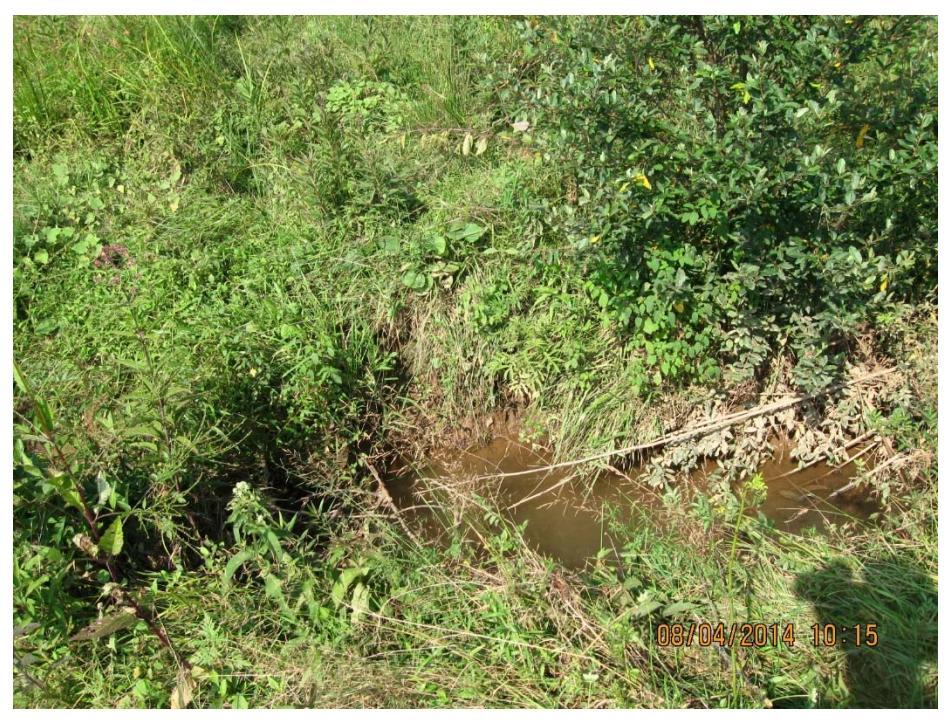
Waterbody SHAB101 facing west across

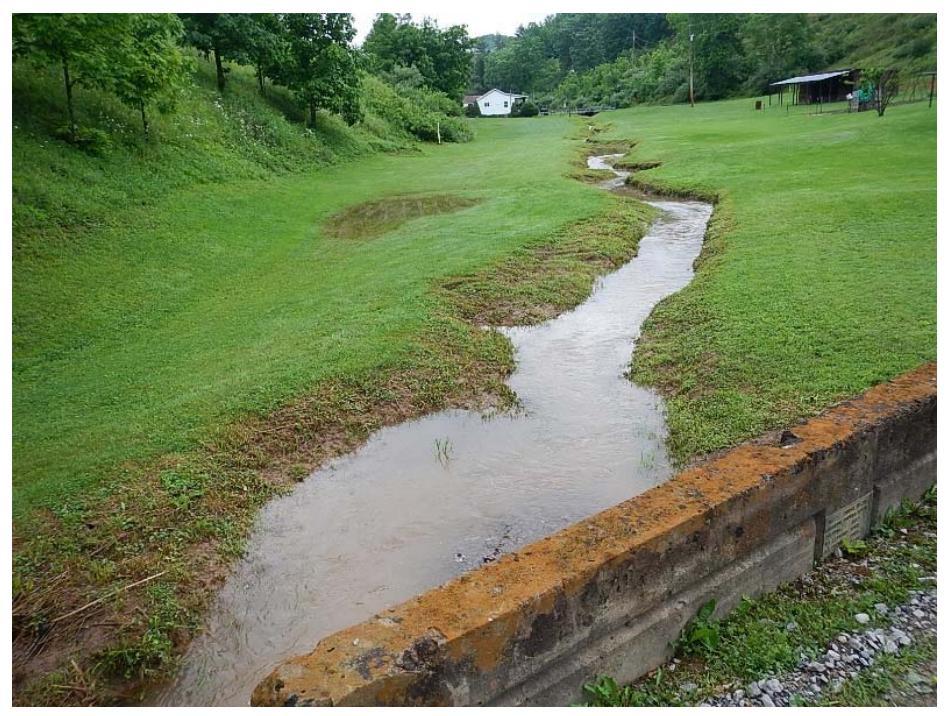
Waterbody SHAA002 facing north upstream

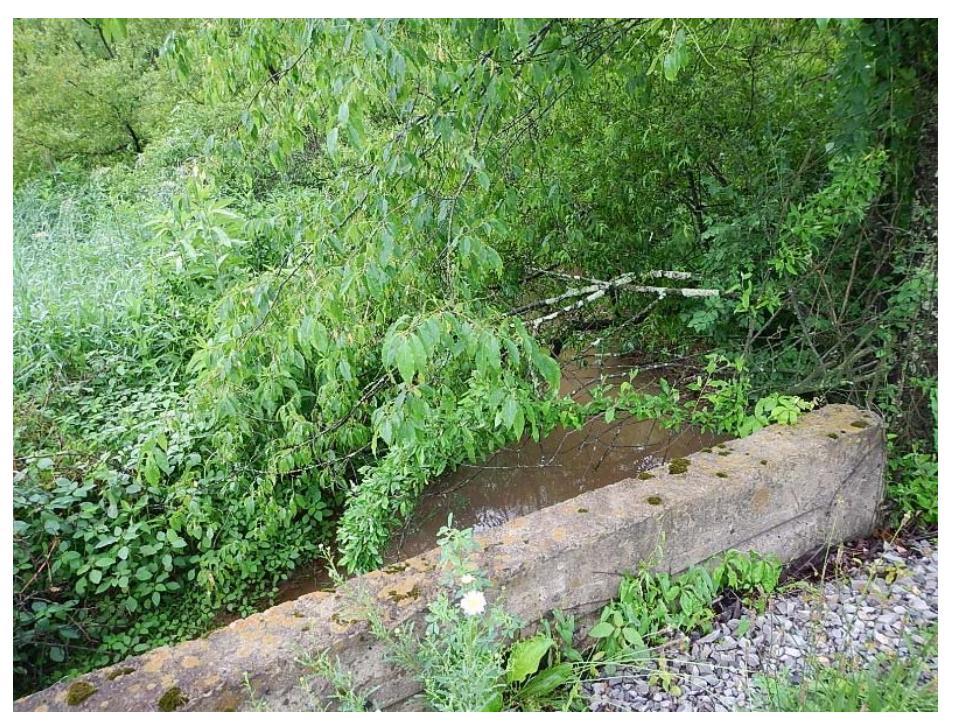
Waterbody SHAA002 facing south downstream

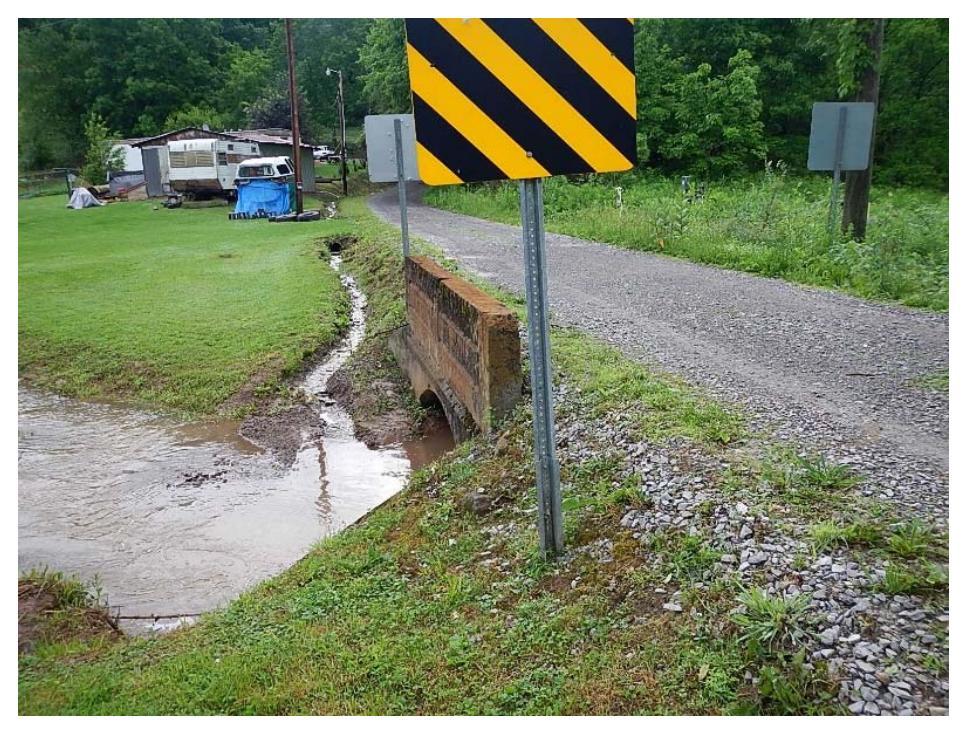
Waterbody SHAA002 facing east across
