# Linear Waterbody Data Sheet

Survey Description			
Project Name: Atlantic Coast Pipeline		Waterbody Name: Broad Run	
Waterbody ID: SLEB120i		Date: 4/11/2015	
State: West Virginia	County: Lewis	Company: NRG	Crew Member Initials: TP, SA
Photos: 01-03			
Tract Number(s): 02-065		Nearest Milepost: 10.4	Associated Wetland ID(s): None
Survey Type: <small>(check one)</small>			
<input type="checkbox"/> Centerline <input type="checkbox"/> Re-Route <input checked="" type="checkbox"/> Access Road <input type="checkbox"/> Other:			
Physical Attributes			
Stream Classification: <small>(check one)</small>			
<input type="checkbox"/> Ephemeral <input checked="" type="checkbox"/> Intermittent <input type="checkbox"/> Perennial			
Waterbody Type: <small>(check one)</small>			
<input type="checkbox"/> River <input checked="" type="checkbox"/> Stream <input type="checkbox"/> Ditch <input type="checkbox"/> Canal <input type="checkbox"/> Other:			
OHWM Width: 3.0 ft.		OHWM Indicator: <small>(check all that apply)</small>

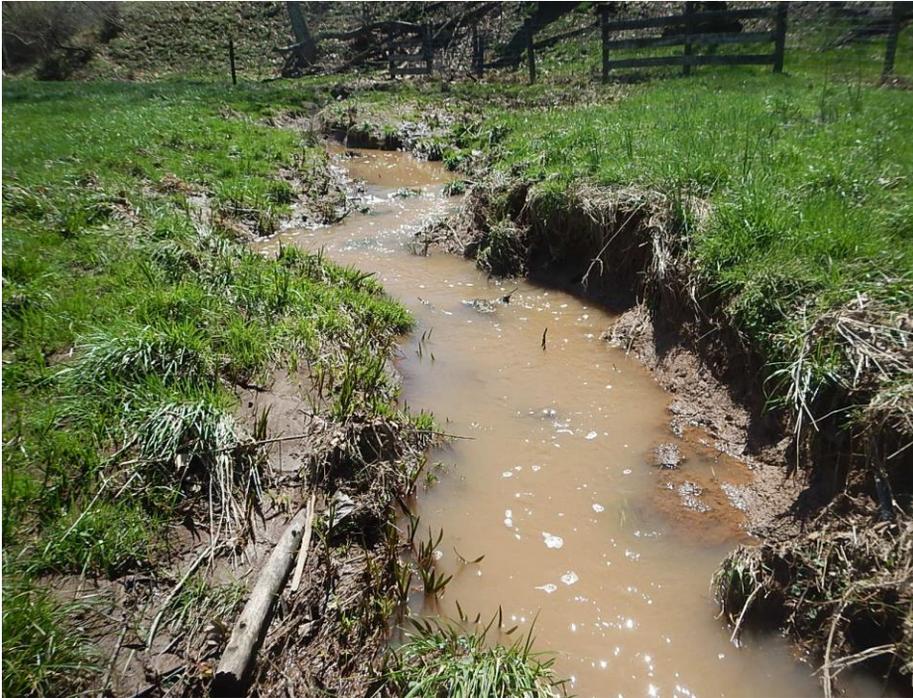
Degraded perennial stream in livestock pasture. Part of stream is intermittent. Noted bank failures, moderate grade control, weak sinuosity, weak bars and benches, rooted wetland plants in channel, and no macrobenthos.

Waterbody SLEB120i facing south upstream

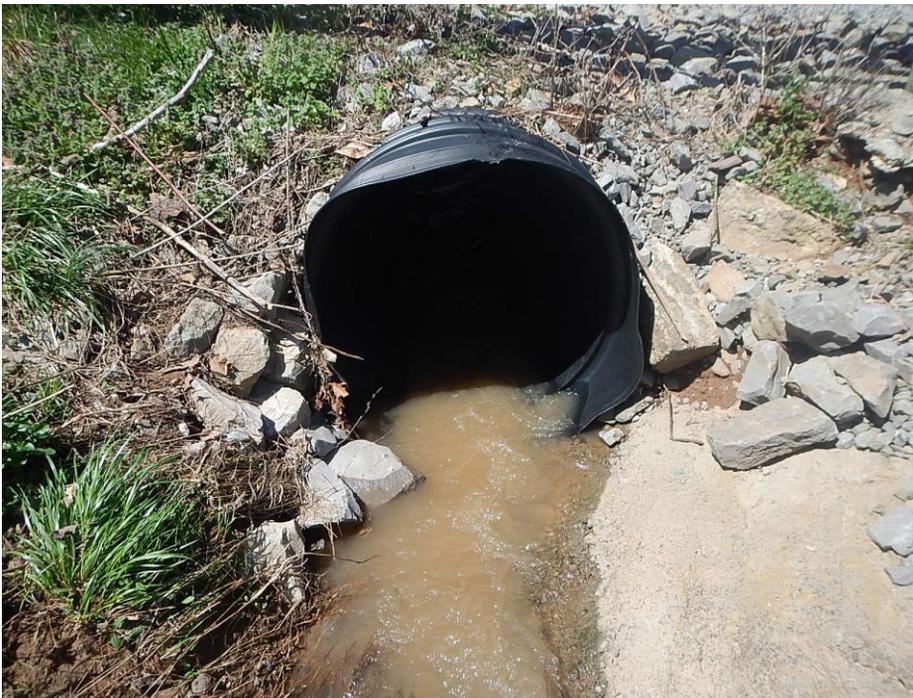
Waterbody SLEB120i facing northwest downstream

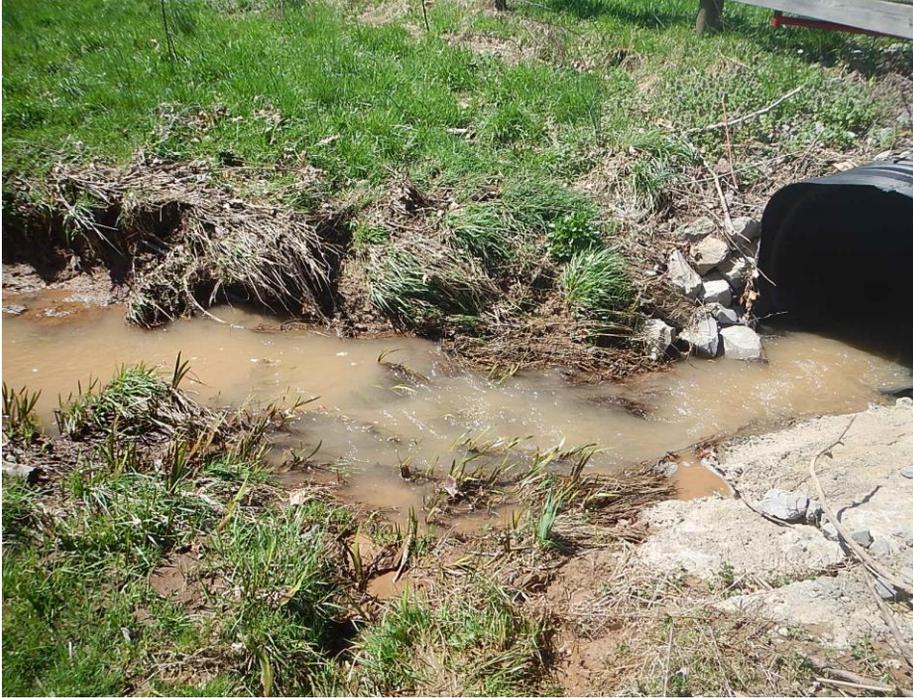
Waterbody SLEB120i facing west across

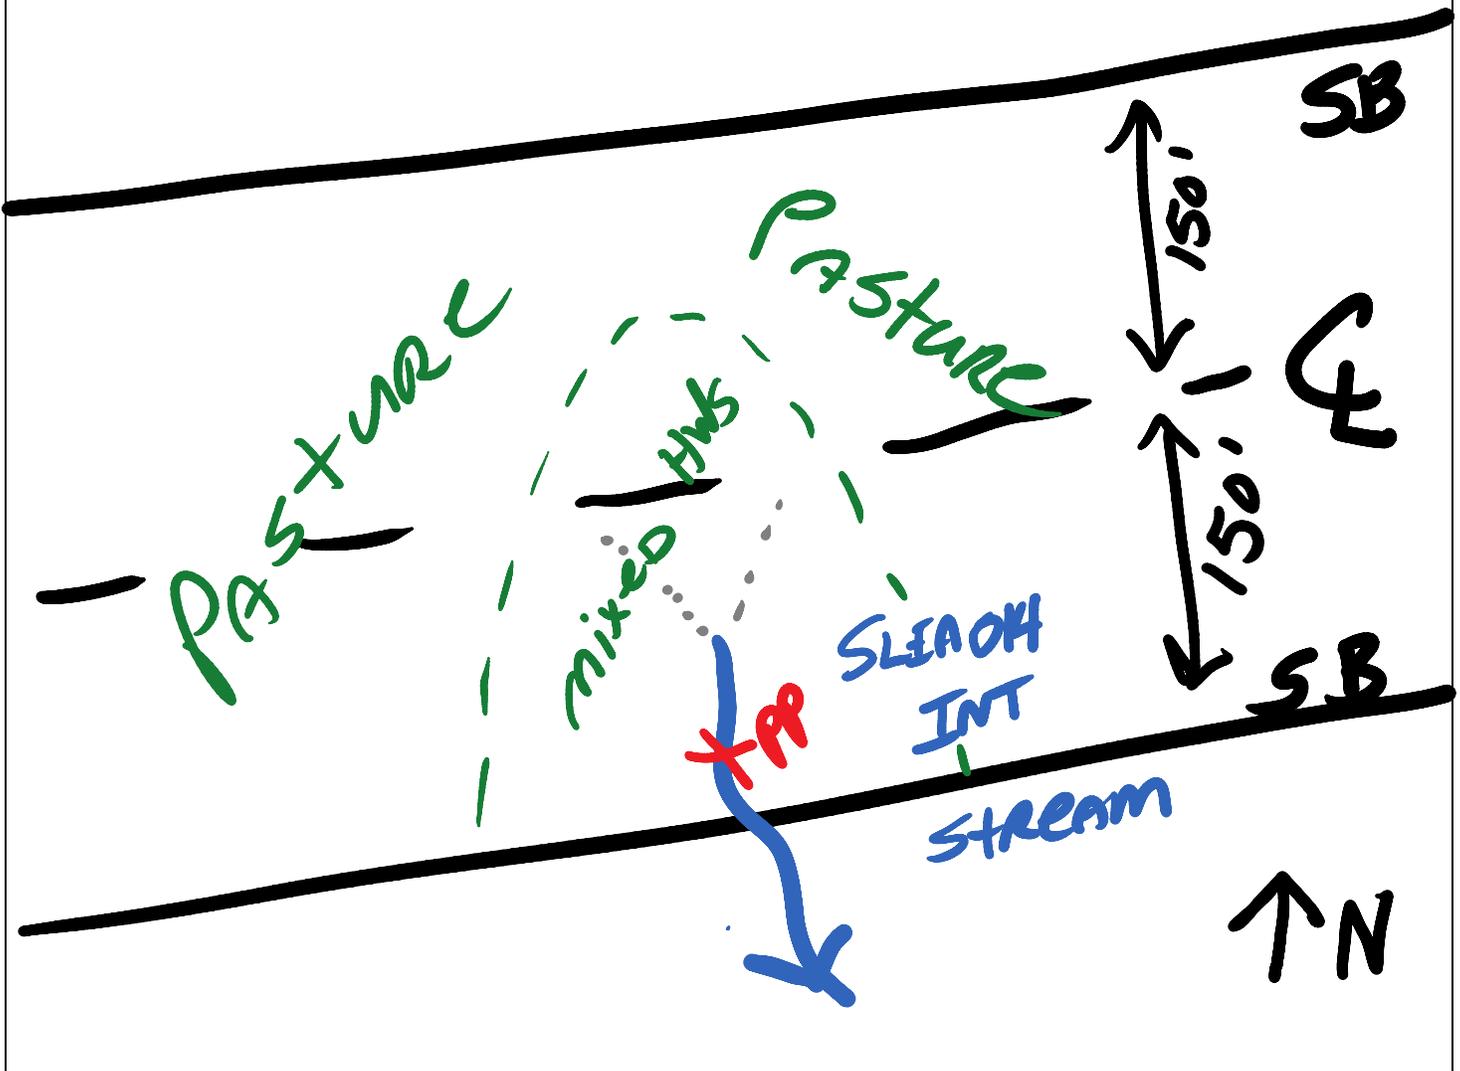
Origin within corridor where two erosional features converge, downstream continues out of corridor, severely impacted by cattle.

Waterbody SLEA014 facing northeast upstream

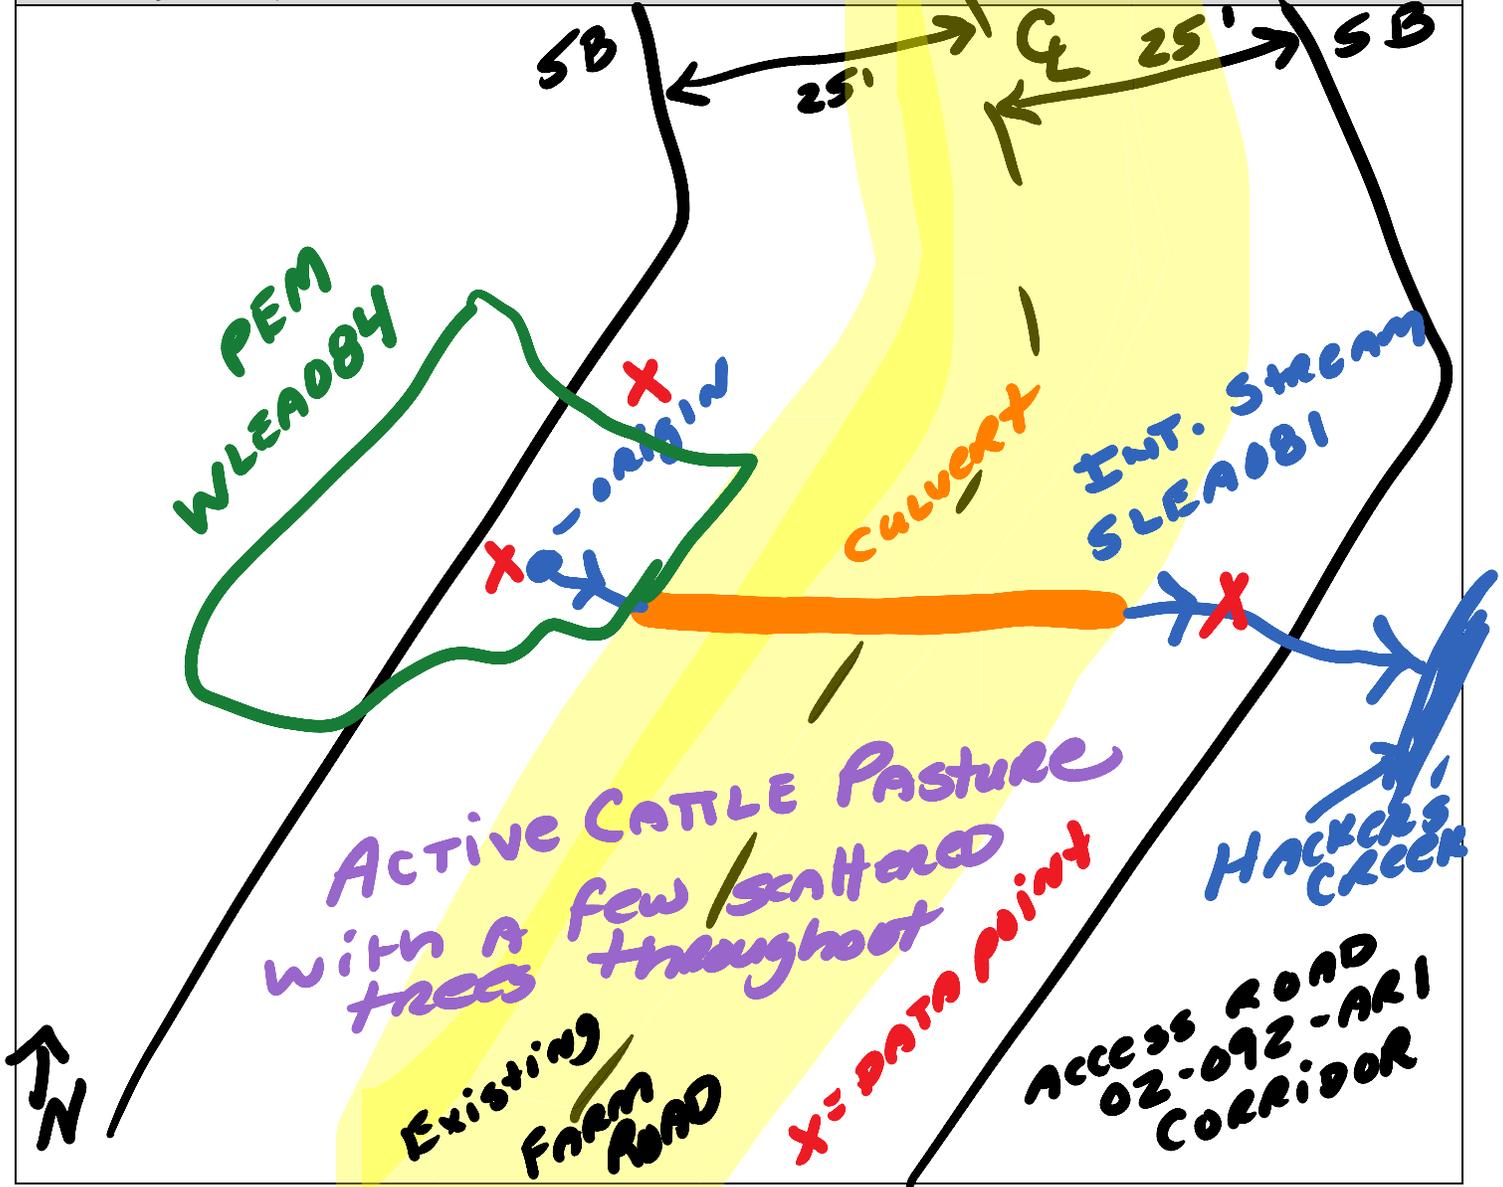
Stream begins within PEM wetland wlea084; downstream continues out of corridor and flows into Hacker's Creek. There is a culvert crossing for existing road. Stream is in very poor condition due to cattle trampling.

Waterbody SLEA081 facing northwest upstream

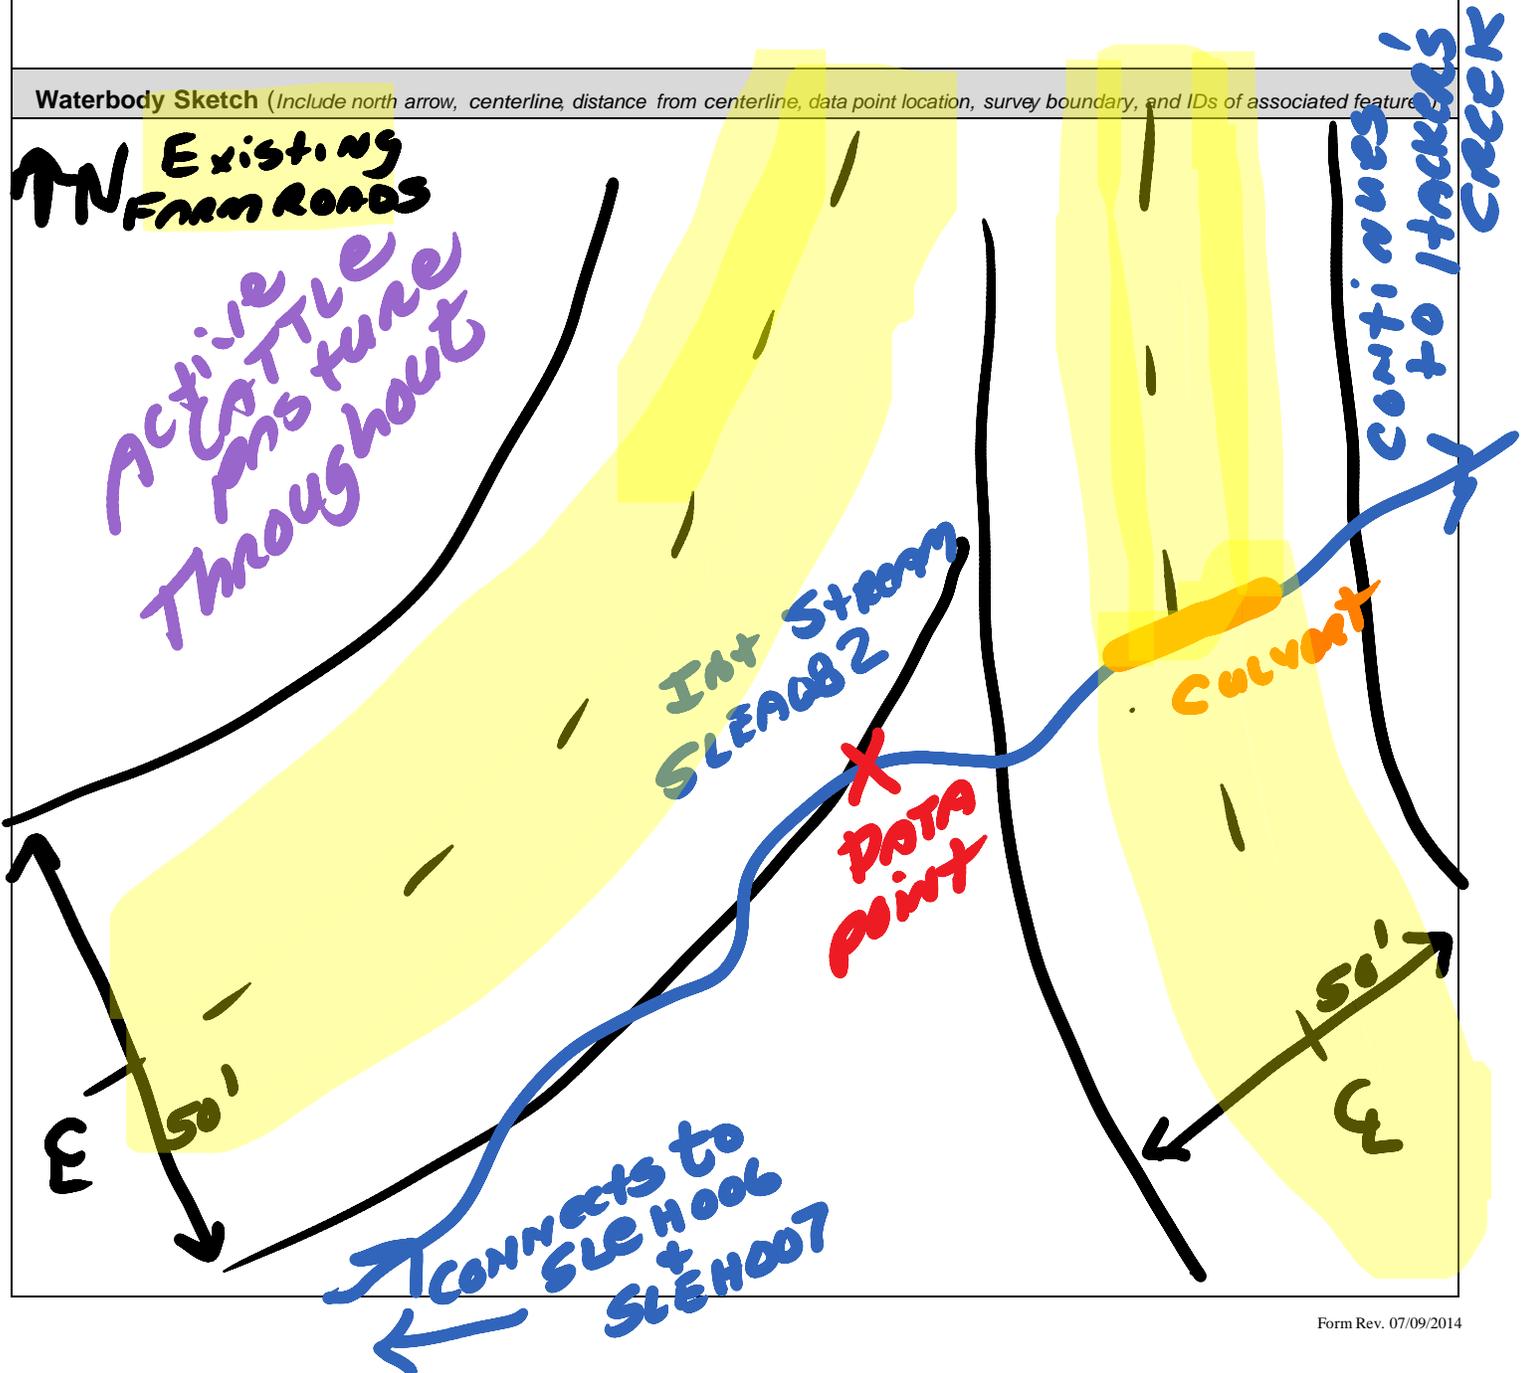
Stream continues out of access road 02-094-AR1 corridor in both directions, culvert crossing for existing farm road (culvert is partially exposed); parallels existing farm road in 02-095-A001-AR1 corridor for long distance; ties to previously delineated streams sleh006 & slea007. Flows through active cattle pasture, stream is severely trampled/degraded with numerous bank failures.

Waterbody SLEA082 facing southwest upstream

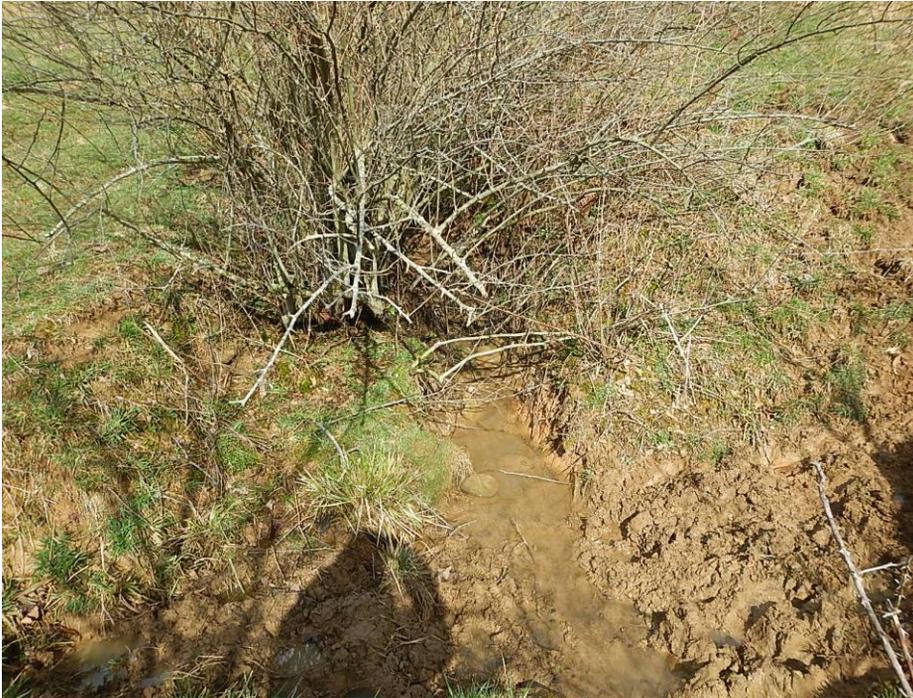
Degraded/erosional gully in cattle pasture. Noted a few bank failures. Rain in last 24 hours contributed to flow. Stream was weakly sinuous, lacked bars and benches, no riffle pool sequence, had moderate grade control, and no roots along bank.

Waterbody SLEB110 facing northwest upstream

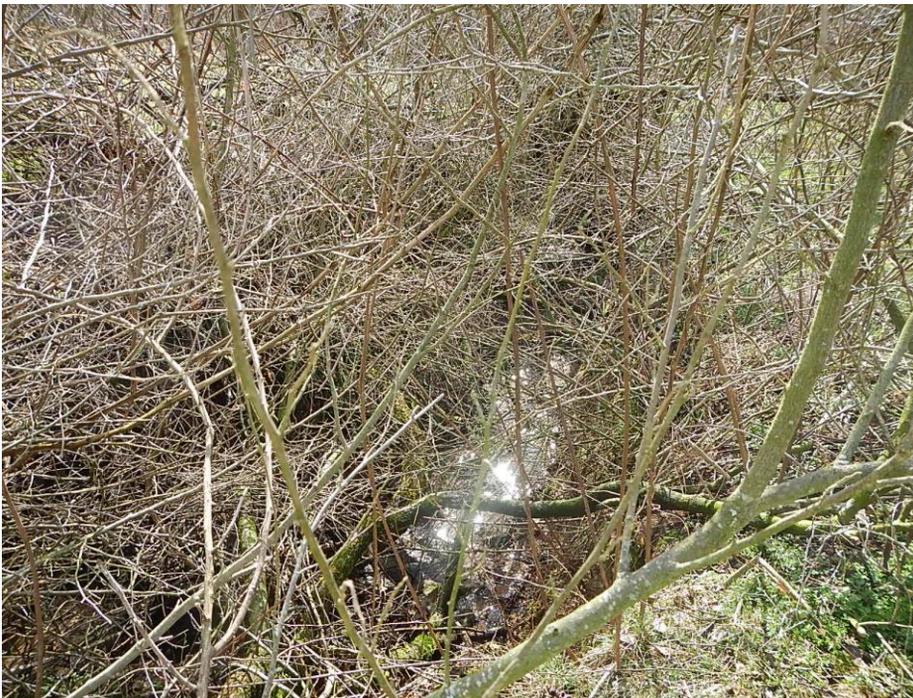
Waterbody SLEB110 facing southeast downstream

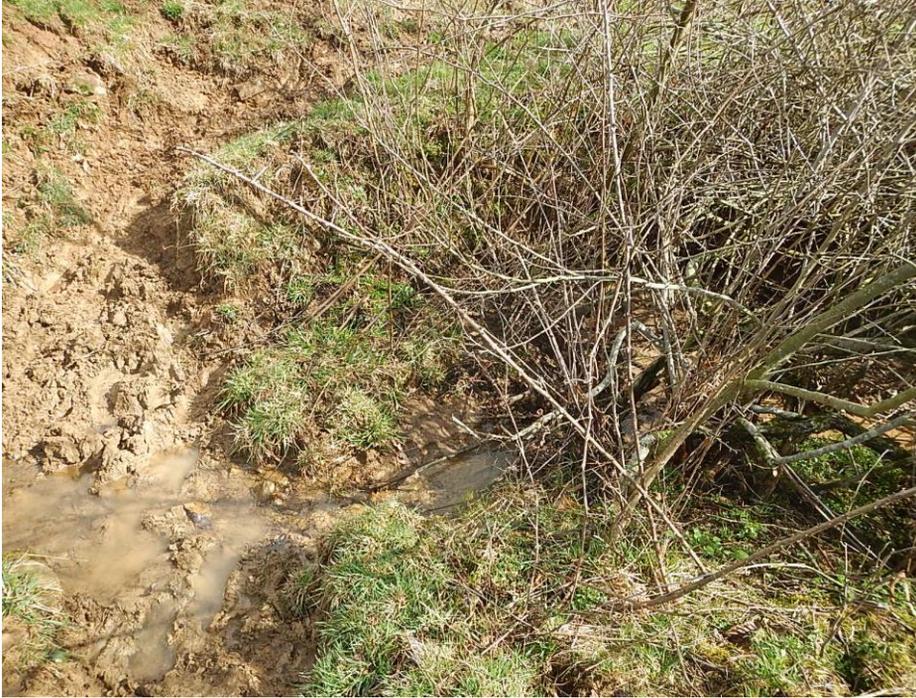
Waterbody SLEB110 facing northeast across

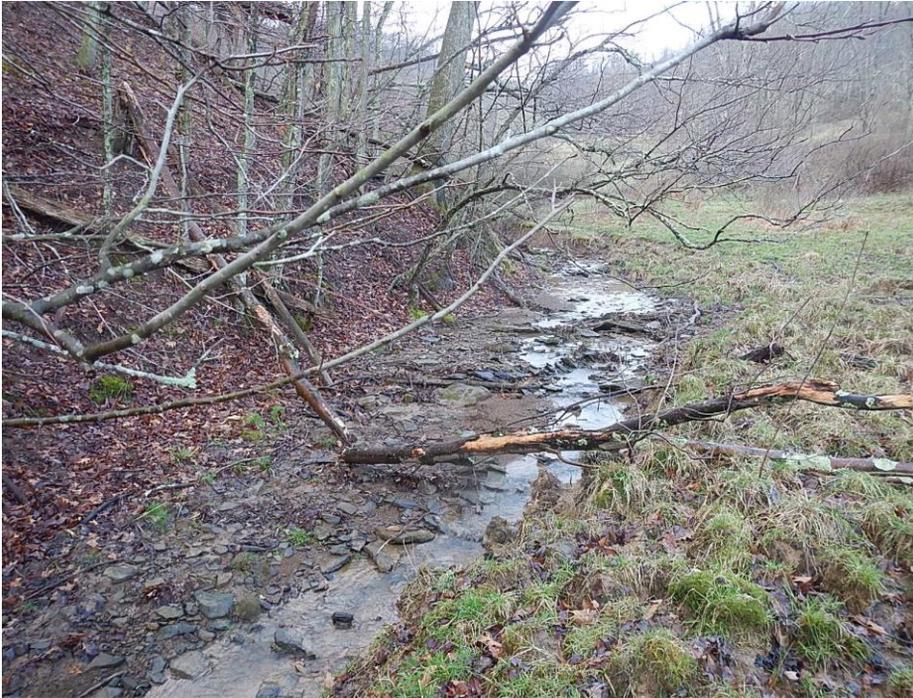
Degraded intermittent stream in cattle pasture. Noted a few bank failures. The only forest buffer is a short segment along the right bank that extends about 100 feet. Rain in last 24 hours contributed to flow. Stream was weakly to moderately sinuous, good bars and benches, weak riffle pool complex, and no roots along bank.

Waterbody SLEB109 facing west upstream

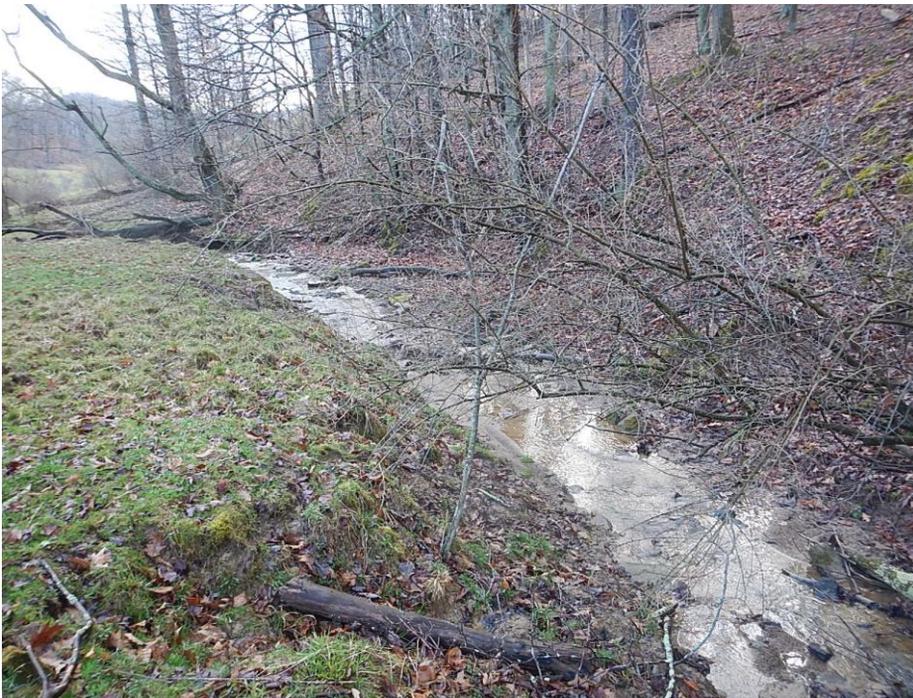
Waterbody SLEB109 facing east downstream

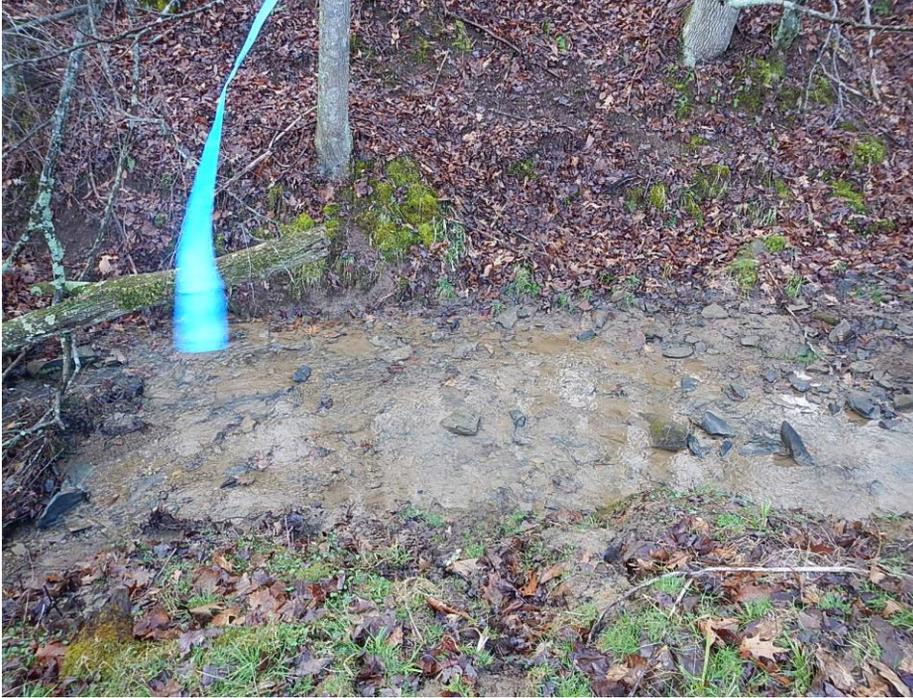
Waterbody SLEB109 facing south across

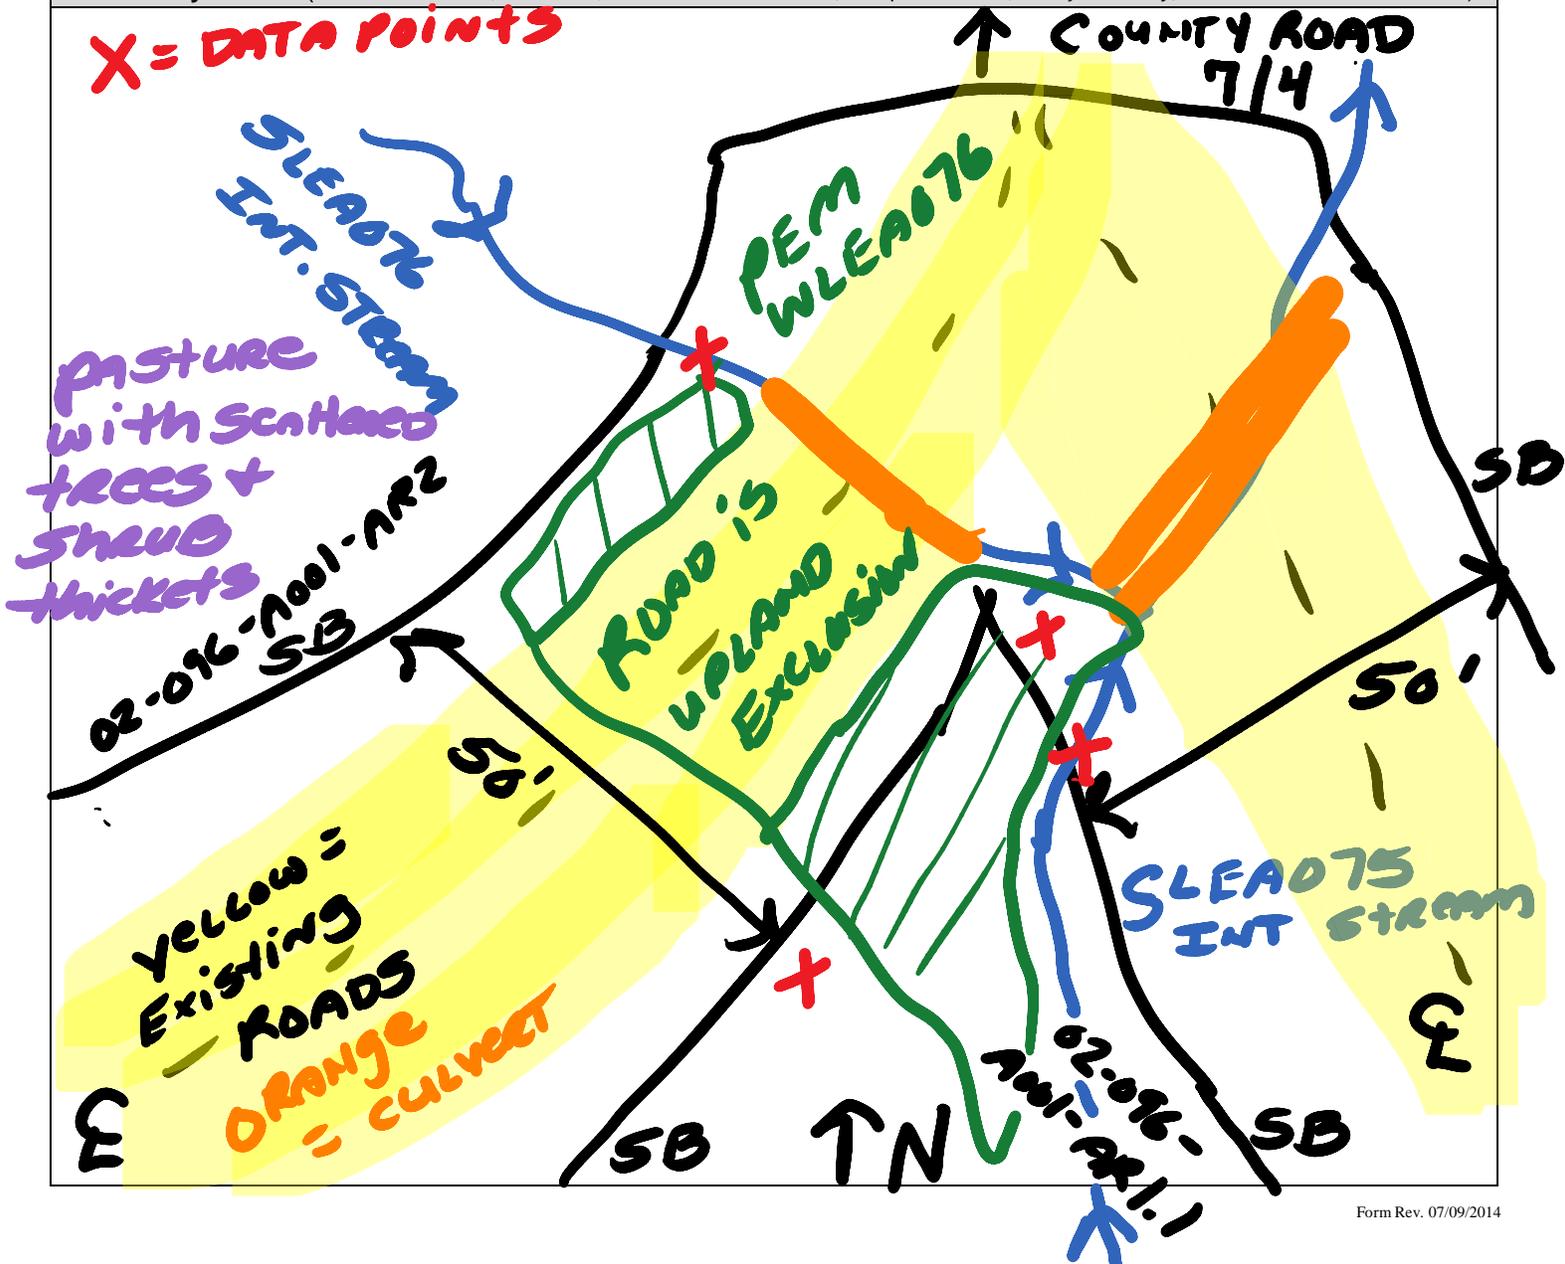
Continues out of corridor in both directions; parallels existing road for considerable distance; connected to wetland wlea076; slea076 is a tributary; culvert crossing for existing road; severely degraded due to livestock access.

Waterbody SLEA075 facing south upstream
