Linear Waterbody Data Sheet

Survey Description			
Project Name: Southeast Reliability		Waterbody Name: UNT to Jenks Fork	
Waterbody ID: SRAB101		Date: 8/19/2014	
State: West Virginia	County: Randolph	Company: NRG	Crew Member Initials: TP, S
Photos: 001-003			
Tract Number(s): 04-002-A002, 04-002-A003		Nearest Milepost: 43.05	Associated Wetland ID(s): none
Survey Type: <i>(check one)</i> <input checked="" type="checkbox"/> Centerline <input type="checkbox"/> Re-Route <input type="checkbox"/> Access Road <input type="checkbox"/> Other:			
Physical Attributes			
Stream Classification: <i>(check one)</i> <input type="checkbox"/> Ephemeral <input checked="" type="checkbox"/> Intermittent <input type="checkbox"/> Perennial			
Waterbody Type: <i>(check one)</i> <input type="checkbox"/> River <input checked="" type="checkbox"/> Stream <input type="checkbox"/> Ditch <input type="checkbox"/> Canal <input type="checkbox"/> Other:			
OHWM Width: 4 ft.		OHWM Indicator: <i>(check all that apply)</i> <input checked="" type="checkbox"/> Clear line on bank <input type="checkbox"/> Shelving <input type="checkbox"/> Wrested vegetation <input type="checkbox"/> Scouring <input type="checkbox"/> Water

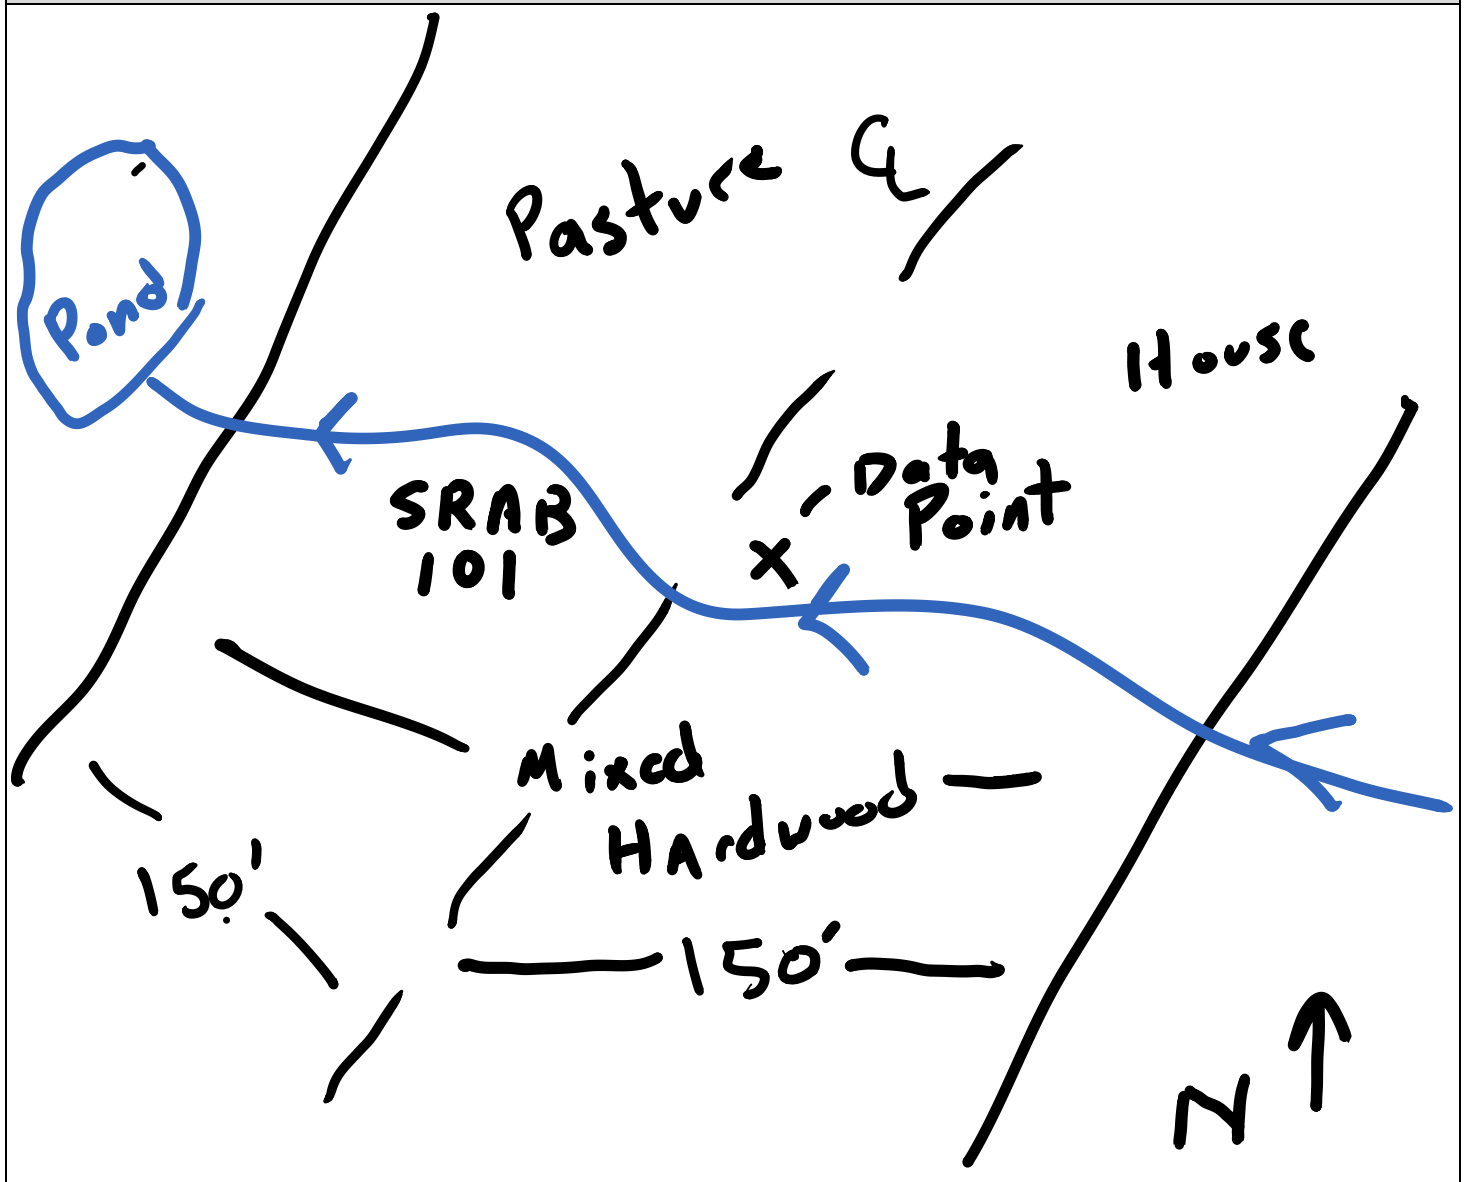
Waterbody Sketch (Include north arrow, centerline, distance from centerline, data point location, survey boundary, and IDs of associated features)

Stream has a weak bed and bank, weak sinuosity, lots of grade control, no bars or benches, goes underground for about 20 feet below centerline.

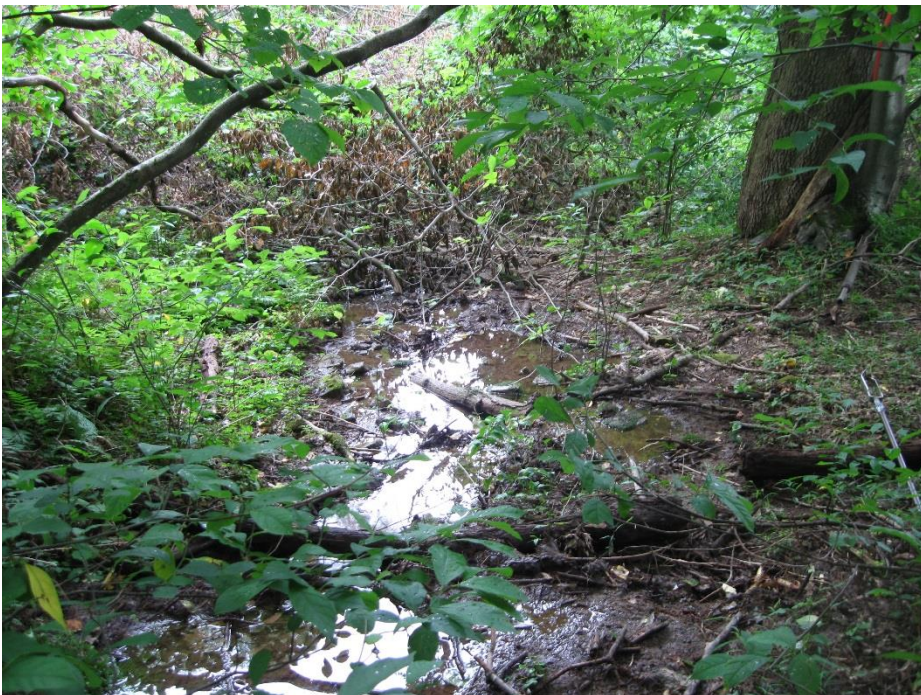
Waterbody SRAB101 facing northwest downstream

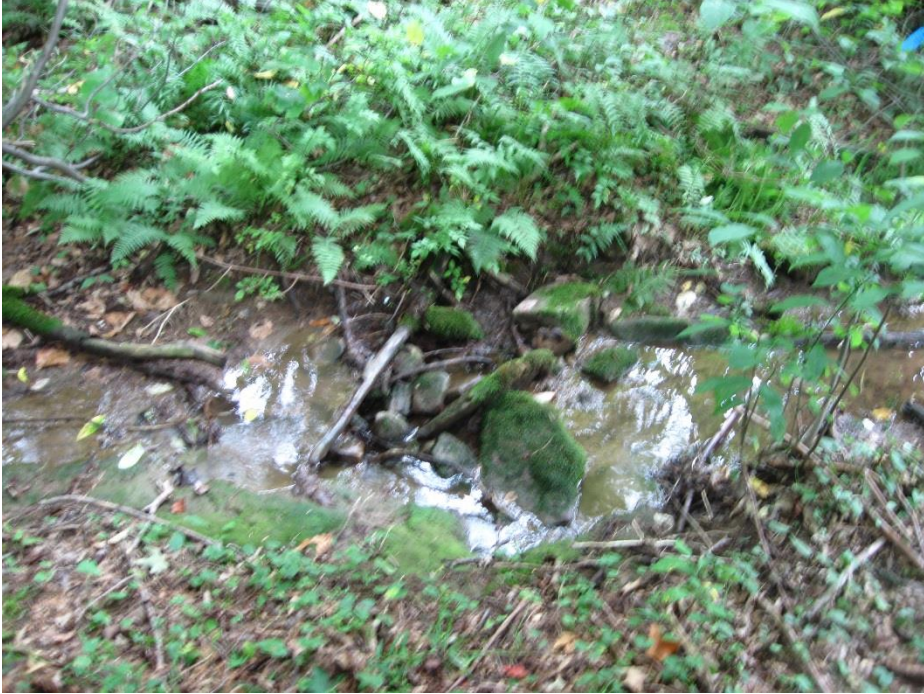
Waterbody SRAB101 facing southwest across

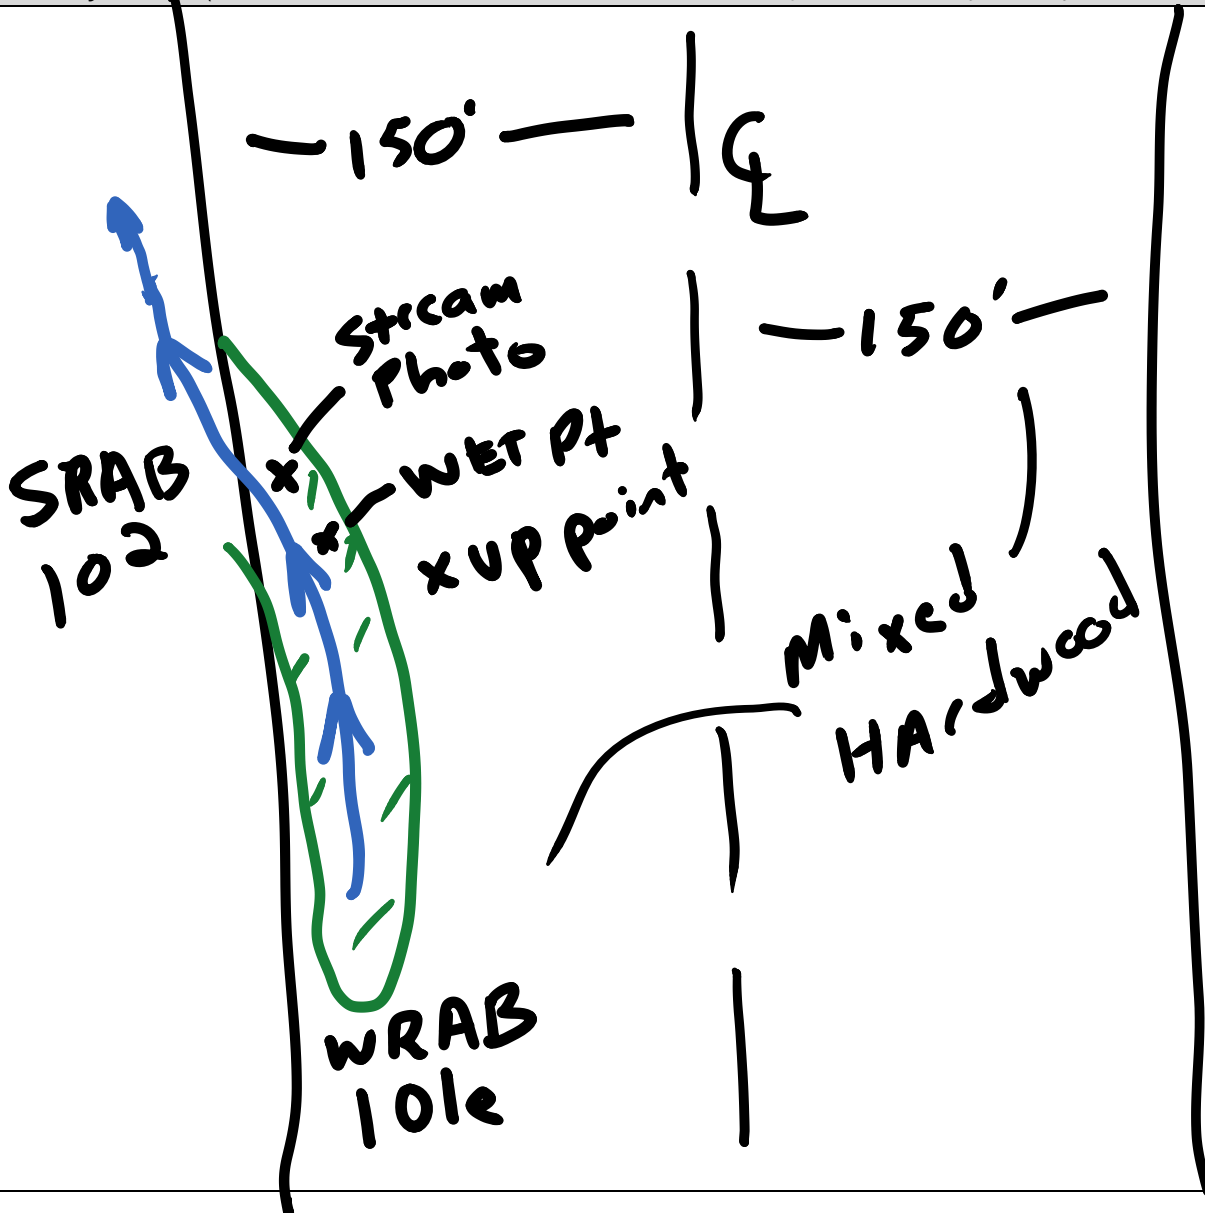
Waterbody Sketch (Include north arrow, centerline, distance from centerline, data point location, survey boundary, and IDs of associated features)

Stream has a weak bed and bank, moderate sinuosity. Originates as a seep in a broad swale.

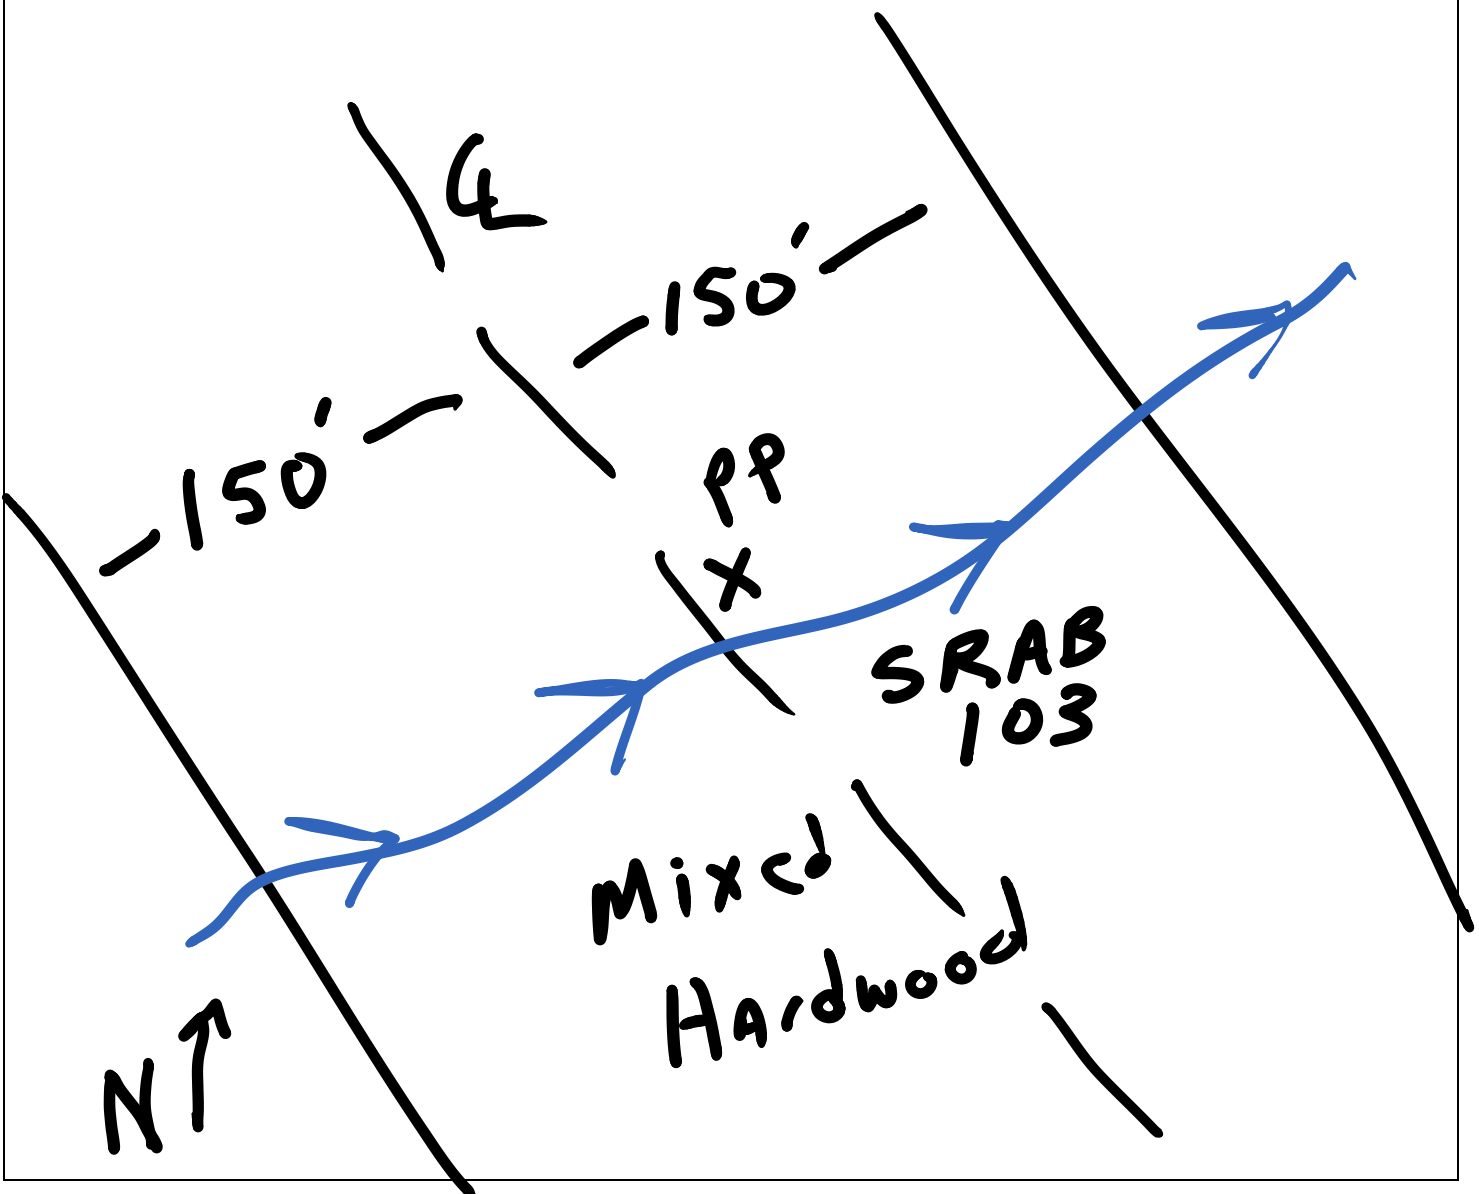
Waterbody Sketch (Include north arrow, centerline, distance from centerline, data point location, survey boundary, and IDs of associated features)

Stream has a weak bed and bank, moderate sinuosity, good grade control, lots of wrack lines, good bars and benches..

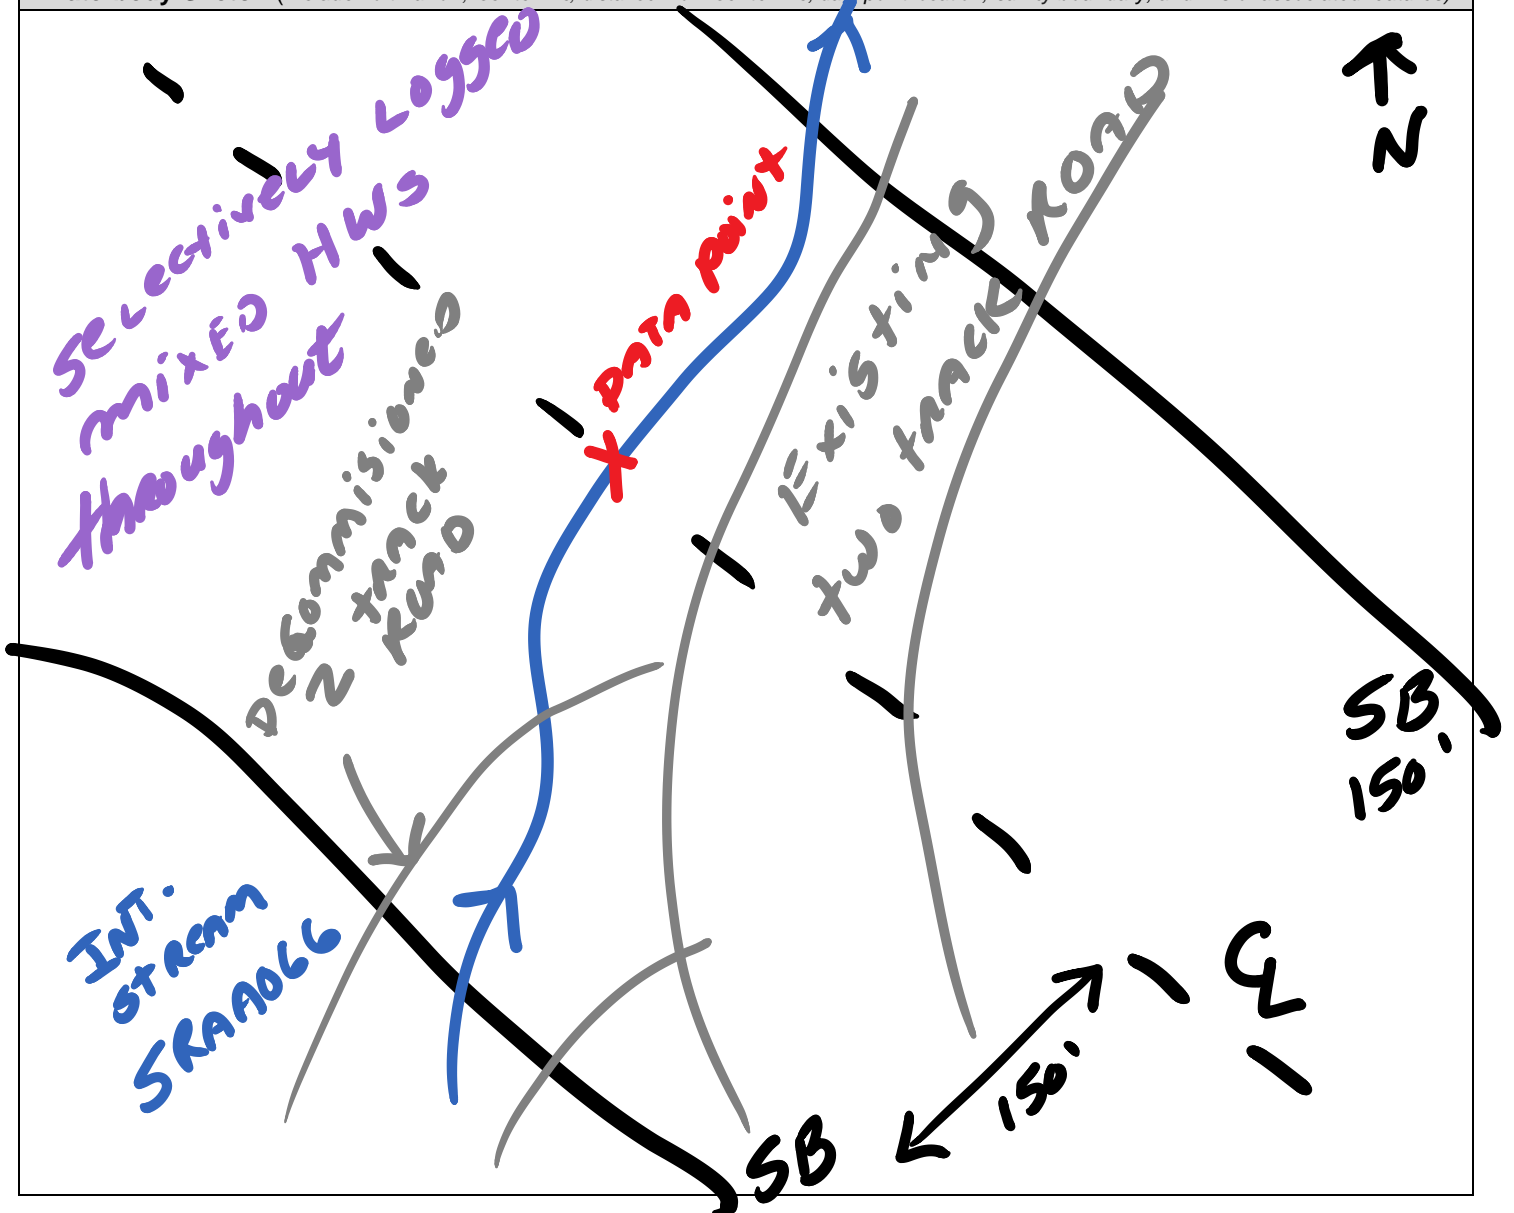
Waterbody Sketch (Include north arrow, centerline, distance from centerline, data point location, survey boundary, and IDs of associated features)

Continues out of corridor in both directions, area is selectively logged mixed hardwoods; formerly a strip mine

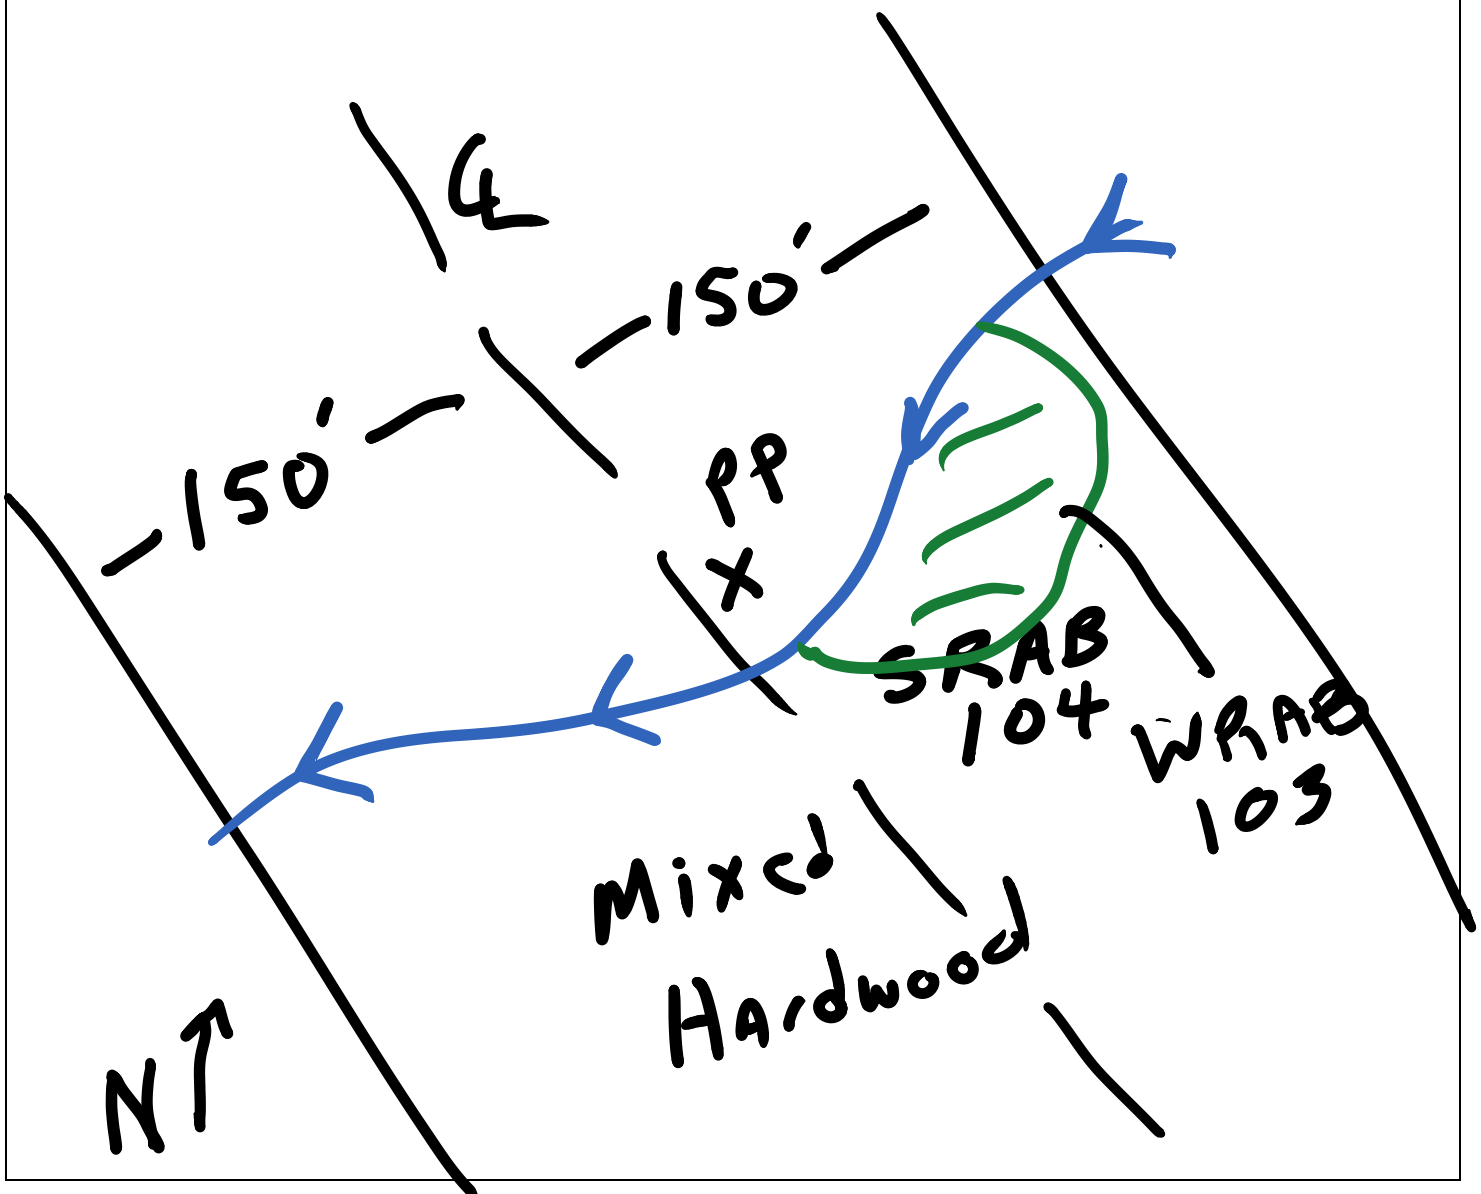
Waterbody Sketch (Include north arrow, centerline, distance from centerline, data point location, survey boundary, and IDs of associated features)

Stream has a good bed and bank, moderate sinuosity, good grade control, lots of wrack lines, good bars and benches, and lots of nick points, as well as a decent riffle pool complex.

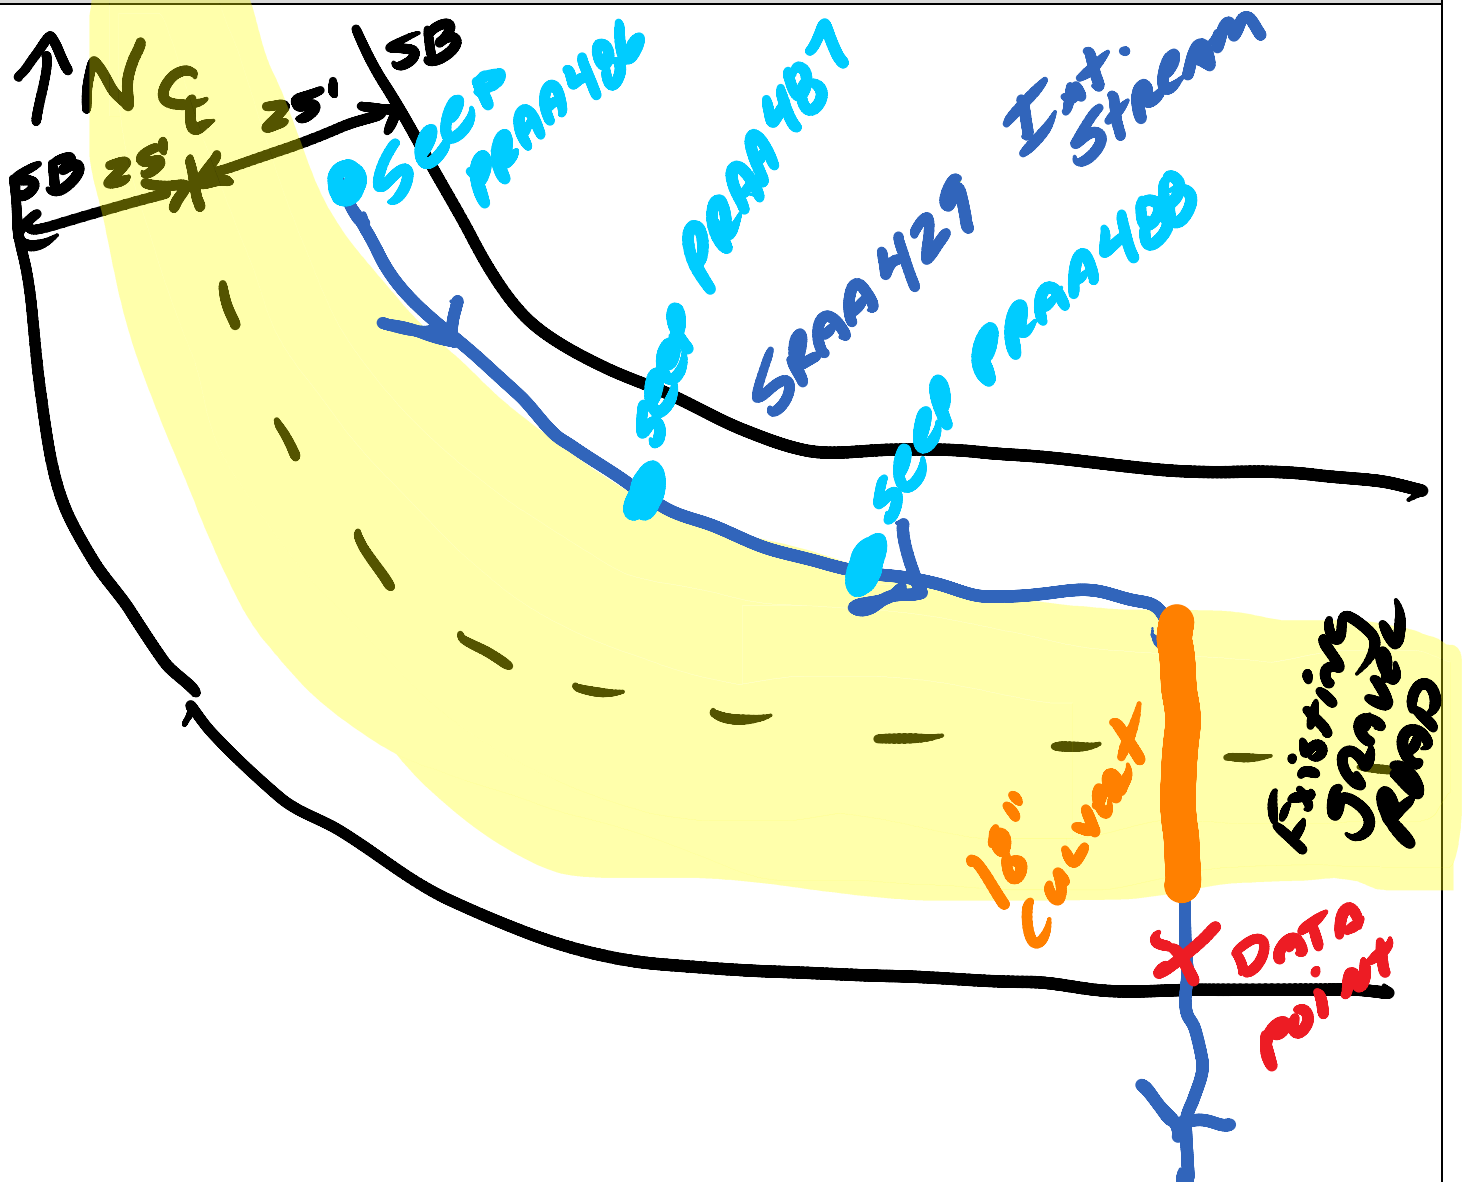
Waterbody Sketch (Include north arrow, centerline, distance from centerline, data point location, survey boundary, and IDs of associated features)

Stream is confined to ditch along existing road; begins at a knick point seep (praa486) within ditch; downstream crosses under road via 18" culvert and continues out of access road corridor; receives outflow from road cut seeps praa487 & 488.

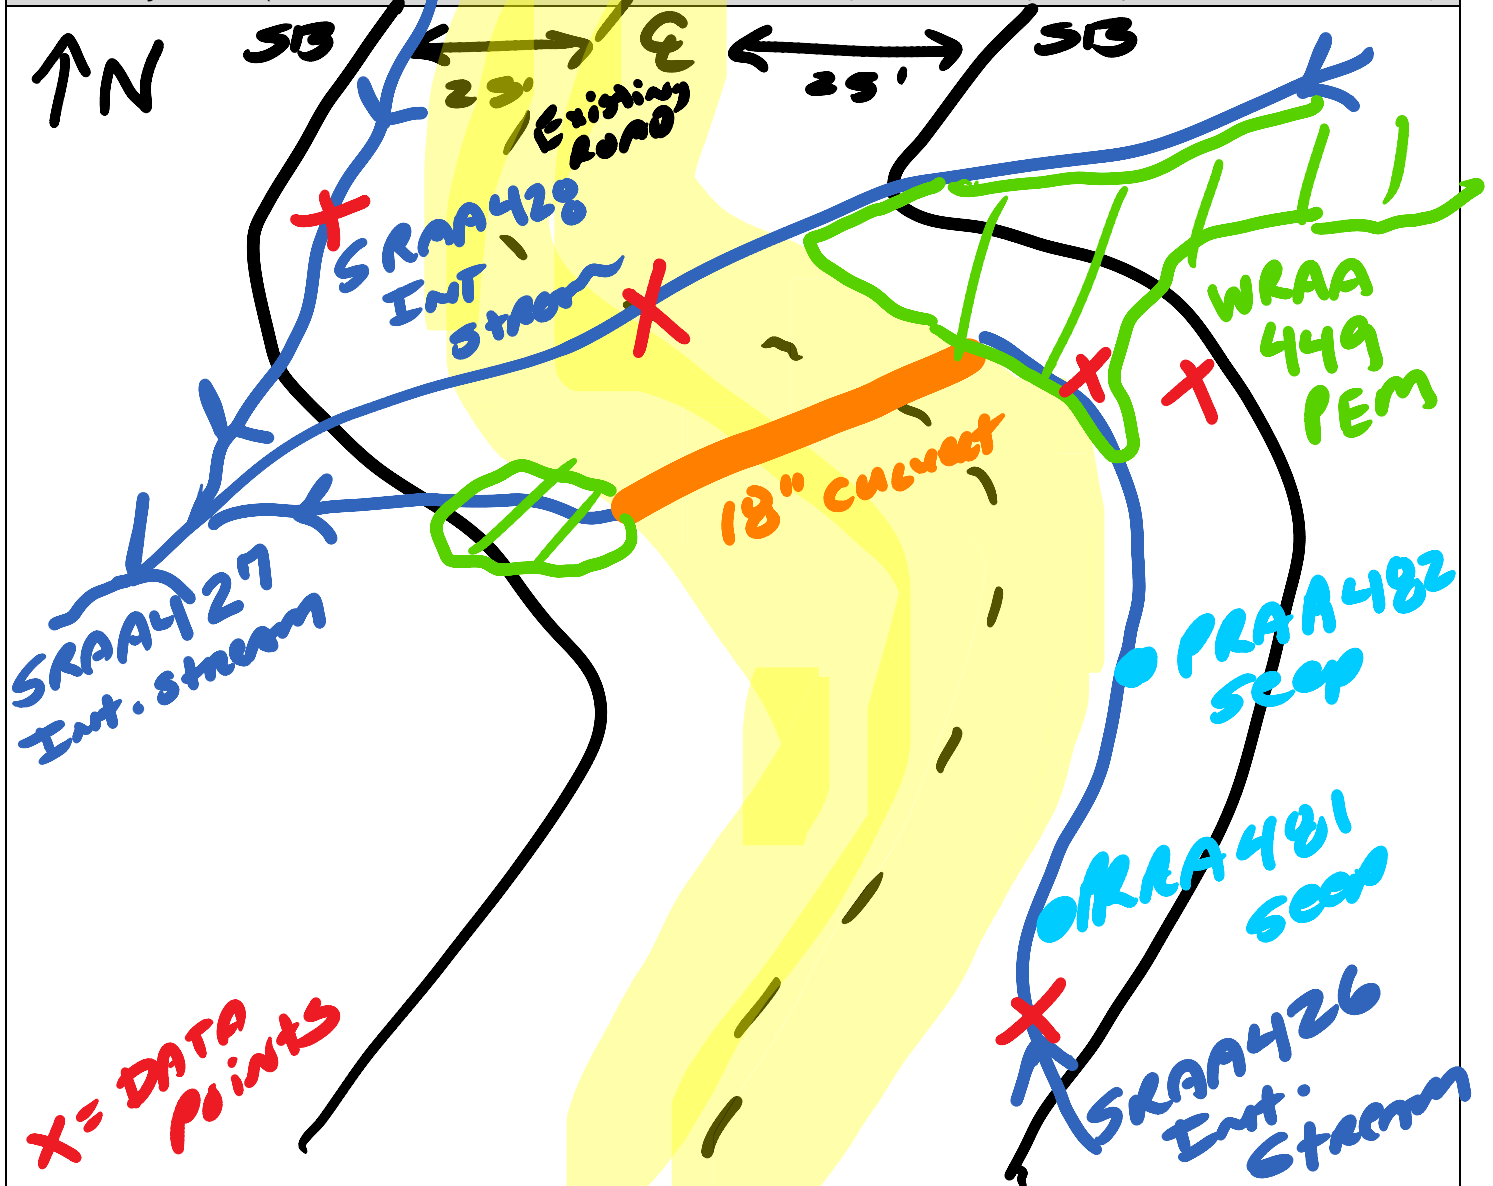
Waterbody Sketch (Include north arrow, centerline, distance from centerline, data point location, survey boundary, and IDs of associated features)

Upstream continues out of access road corridor; crosses under existing gravel road via culvert; downstream continues out of access road corridor where it flows into sraa427; confined to ditch along existing gravel road; connected to PEM wetland wraa449; receives outflow from road cut seeps praa481 & 482.

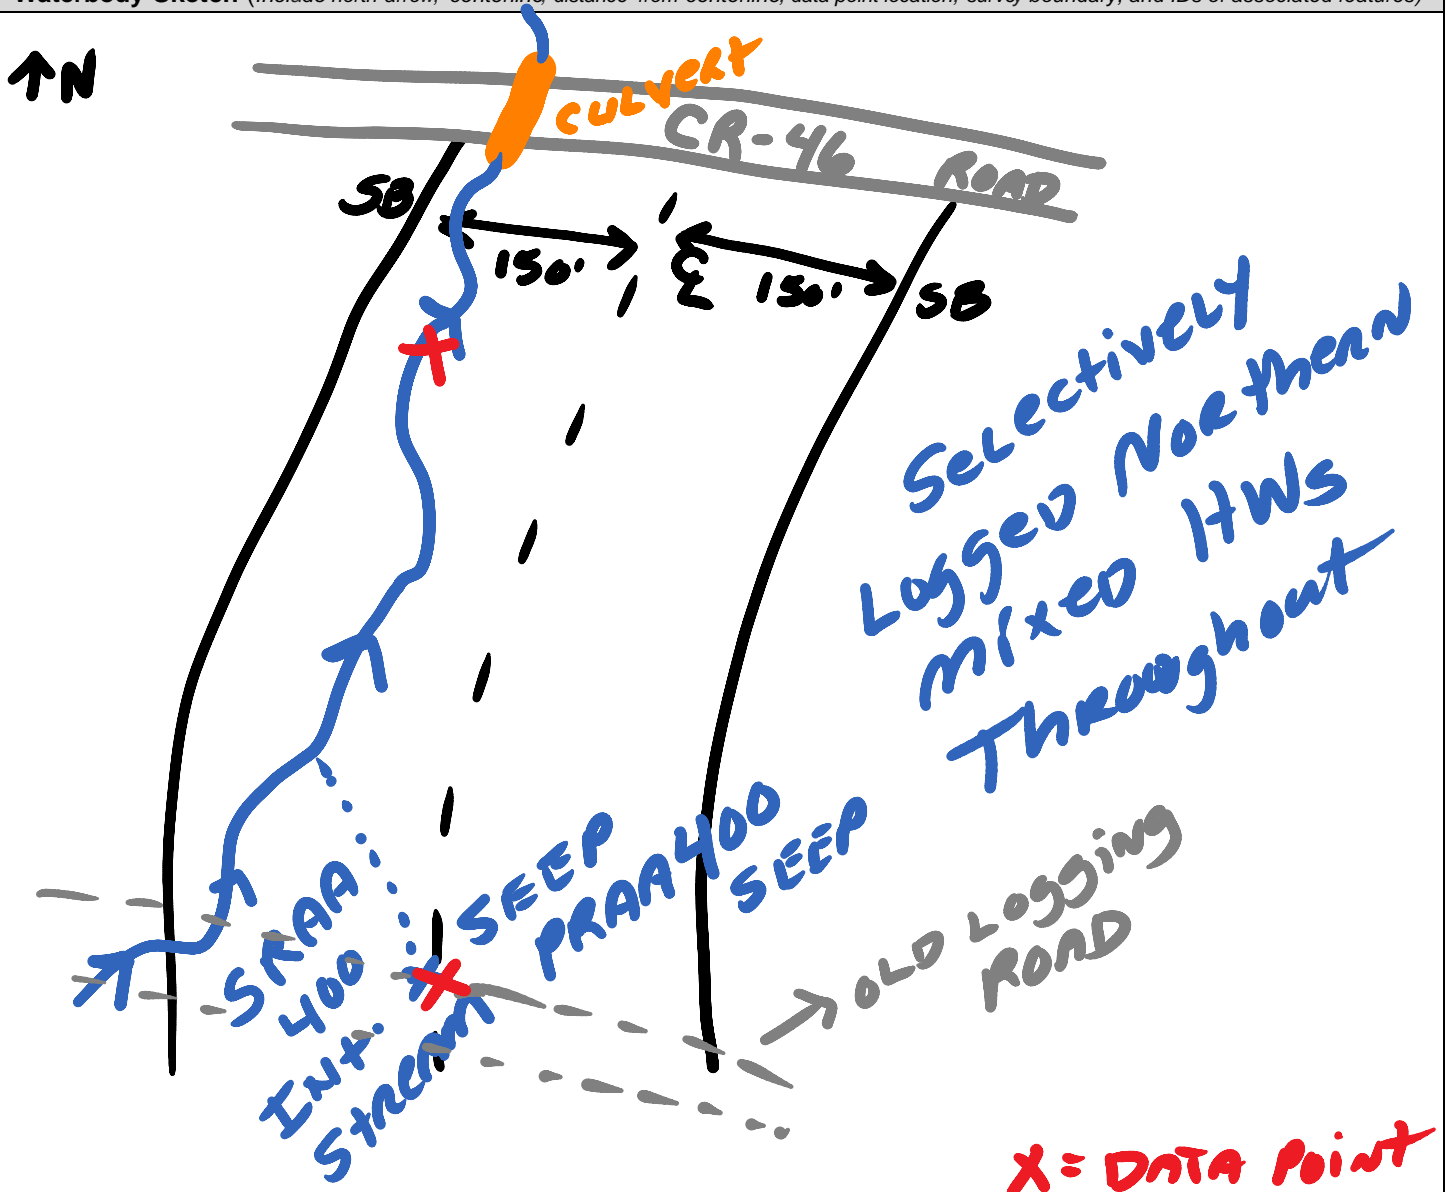
Waterbody Sketch (Include north arrow, centerline, distance from centerline, data point location, survey boundary, and IDs of associated features)

Upstream continues out of corridor, downstream flows under county road 46 via culvert and continues out of corridor
