SUPPLY HEADER PROJECT ENVIRONMENTAL SURVEY

Wetland and Waterbody Delineation Report

APPENDIX B

Waterbody Datasheets and Photo Pages

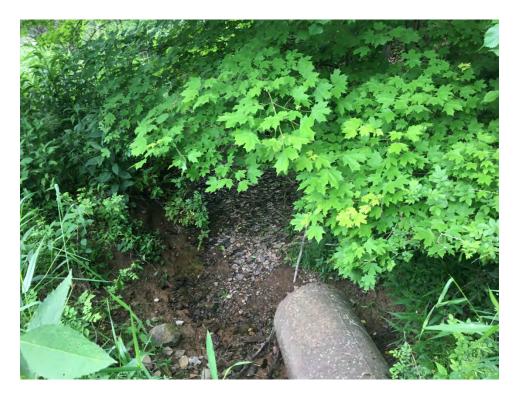
Aquatic Organisms C	Observed ((list):										
n/a												
Disturbances (ex: live culvert	stock access	s, manure	in waterbo	dy, waste discha	arge pi	ipes):						
Observation Notes:												
This manipulated stre	am lies adj	acent to	a habitati	ons and oil/gas	s infra	astructure and	as a result is	littered with a	nthropogenic f	ill and disturbances.

Waterbody sdoa023 facing upstream

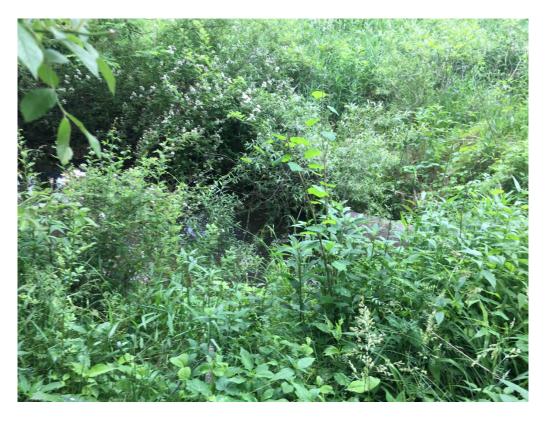
Waterbody sdoa023 cross stream

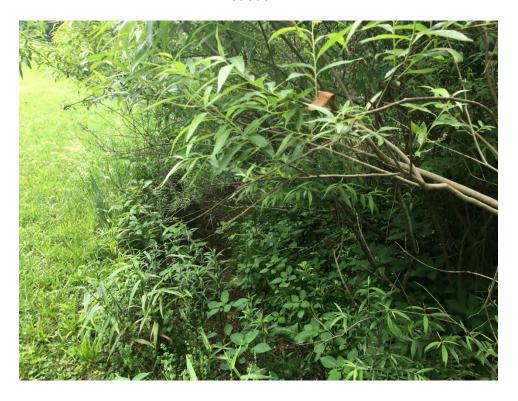
Aquatic Organisms (Observed ((list):										
n/a												
Disturbances (ex: live			in waterboo	dy, waste discha	arge pi	ipes):						
near homes and mair	itained land	iscapes										
Observation Notes:												
This stream lies adjac	cent to a ya	rd that is	maintaine	ed up to the st	ream	bank.

Waterbody sdoa022 facing upstream

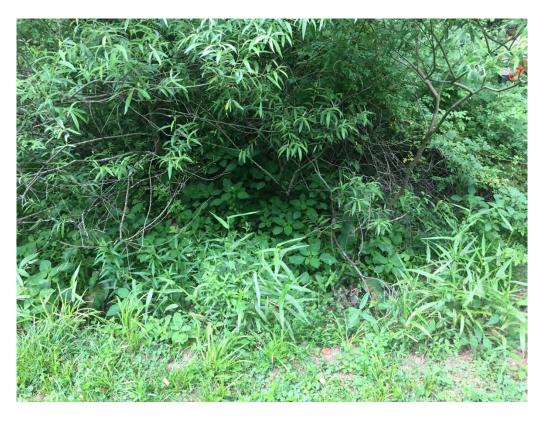
Waterbody sdoa022 cross stream

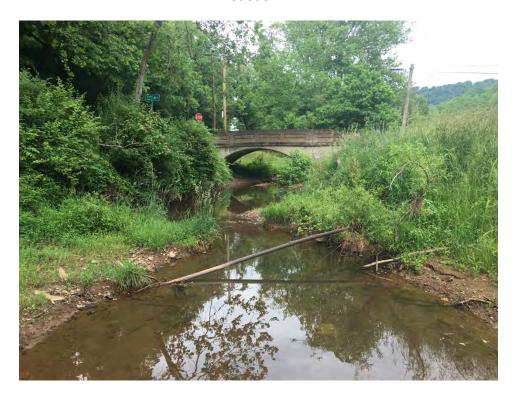
Observation Notes:										
Waterway manipulated	by culver	ts and di	sturbed w	ith anthropoge	enic f	fill from adjace	nt roads.

Waterbody sdoa021 facing upstream

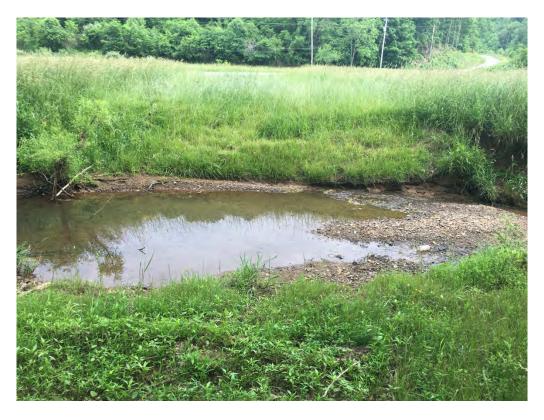
Waterbody sdoa021 cross stream

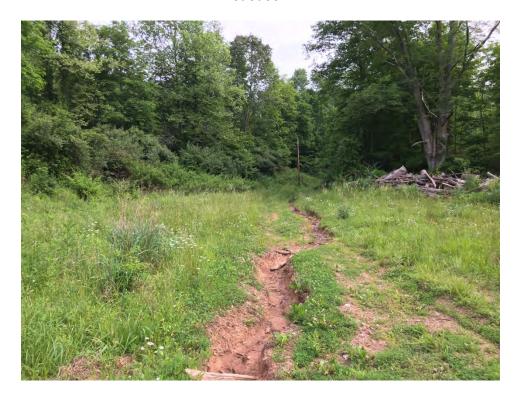
Aquatic Organisms C	bserved ((list):								
n/a										
Disturbances (ex: live n/a	stock acces	s, manure	in waterboo	dy, waste discha	rge pi	ipes):				
Observation Notes:										
Ephemeral drainage;	caused by	dirt road.

Waterbody sdoa004 facing upstream

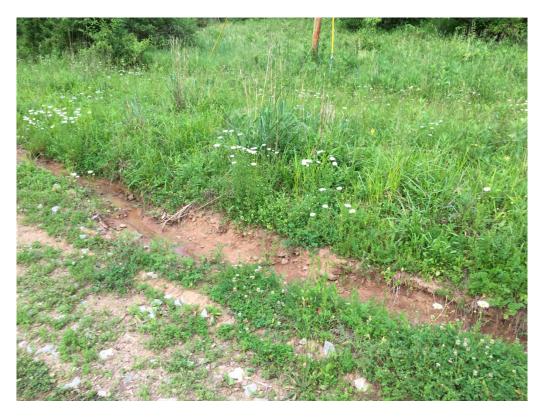
Waterbody sdoa004 cross stream

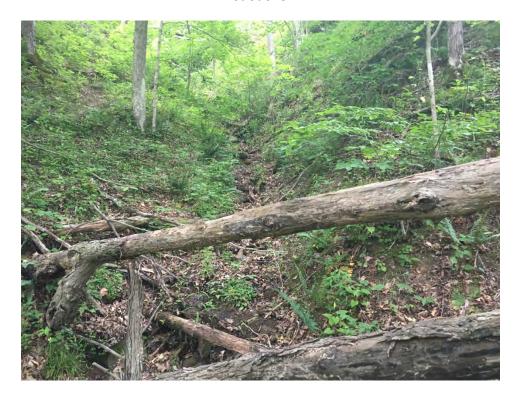
n/a										
Disturbances (ex: live				-	arge p	ipes):				
apparent recent loggir	ng/clearing	adjacent	t to draina	ige.						
Observation Notes:										
Drainage is well define	ed on a ste	ep slope	but choke	ed with litter a	nd de	ebris from land	clearing.

Waterbody sdoa019 facing upstream

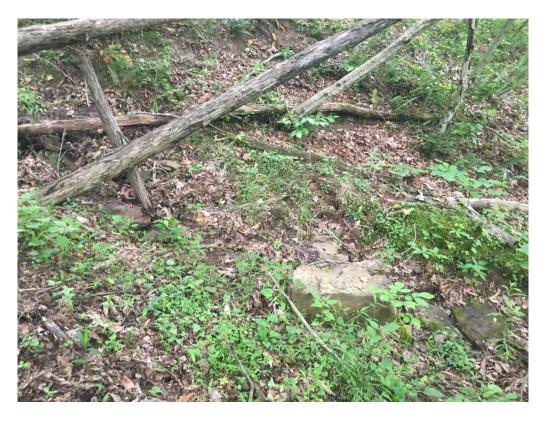
Waterbody sdoa019 cross stream

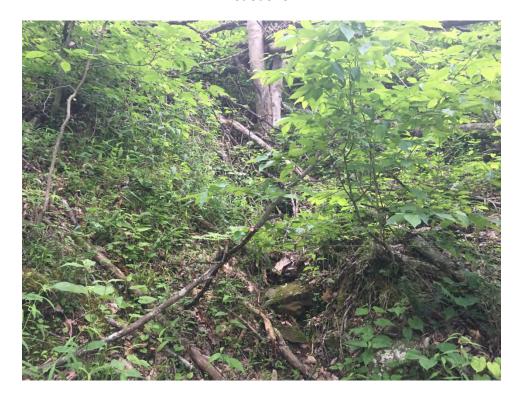
Aquatic Organisms (Observed ((list):								
n/a										
Disturbances (ex: live					arge pi	ipes):				
apparent recent loggi	ng/clearing	adjacen	t to draina	ige.						
Observation Notes:										
Drainage is well defin	ed on a ste	ep slope	but choke	ed with litter a	ınd de	bris from land	clearing.

Waterbody sdoa020 facing upstream

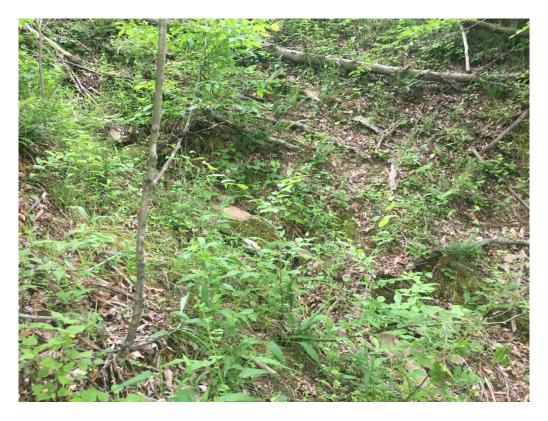
Waterbody sdoa020 cross stream

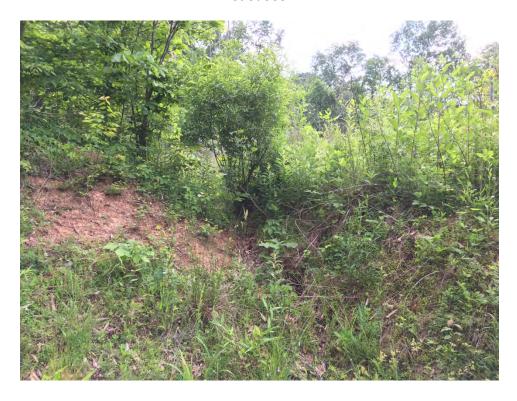
n/a											
Disturbances (ex: live anthropogenic fill	stock acces	s, manure	in waterbo	dy, waste discha	rge p	ipes):					
Observation Notes:											
Ephemeral drainage of	cuts across	surveye	d access	road.

Waterbody sdoa005 facing upstream

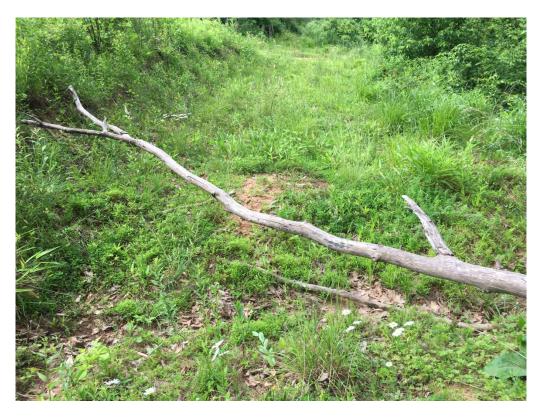
Waterbody sdoa005 cross stream

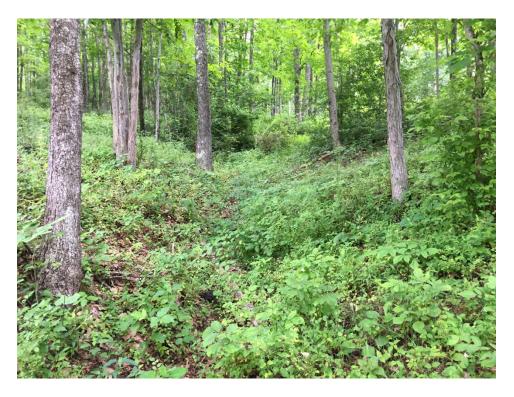
Aquatic Organisms (Observed ((list):									
n/a											
Disturbances (ex: live livestock access	stock access	s, manure	in waterbo	dy, waste discha	rge pi	ipes):					
Observation Notes:											
Cattle and horse acce	ess to ephe	meral str	eam that	is overgrown w	ith ir	nvasive plants

Waterbody sdoa012 facing upstream

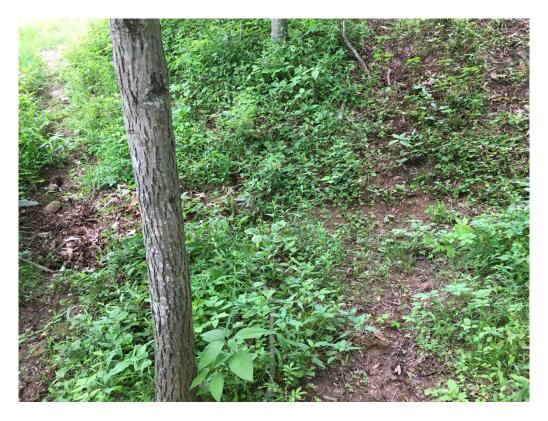
Waterbody sdoa012 cross stream
