**SUPPLY HEADER PROJECT ENVIRONMENTAL SURVEY**

**Waterbody Datasheets and Photo Pages**

**TL-635**

**Tyler County**

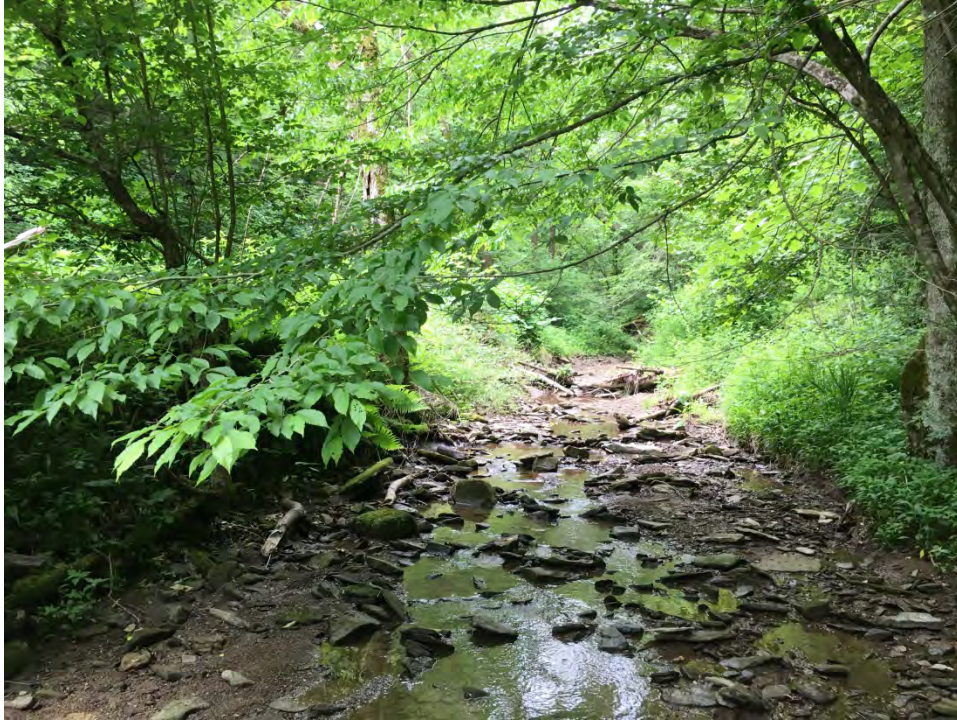
swaa002

| Description | | | |
|---|---|---|---|
| <b>Observation Notes:</b><br>Riparian area with diverse flora and fauna. | | | |

Waterbody swza002 facing upstream

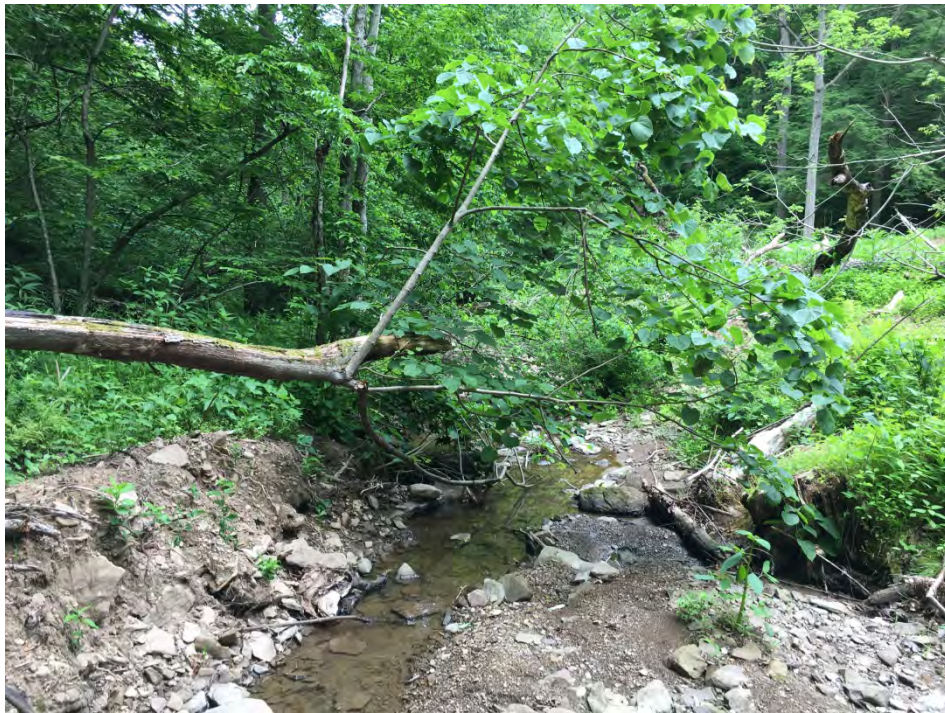
Waterbody swza002 facing downstream

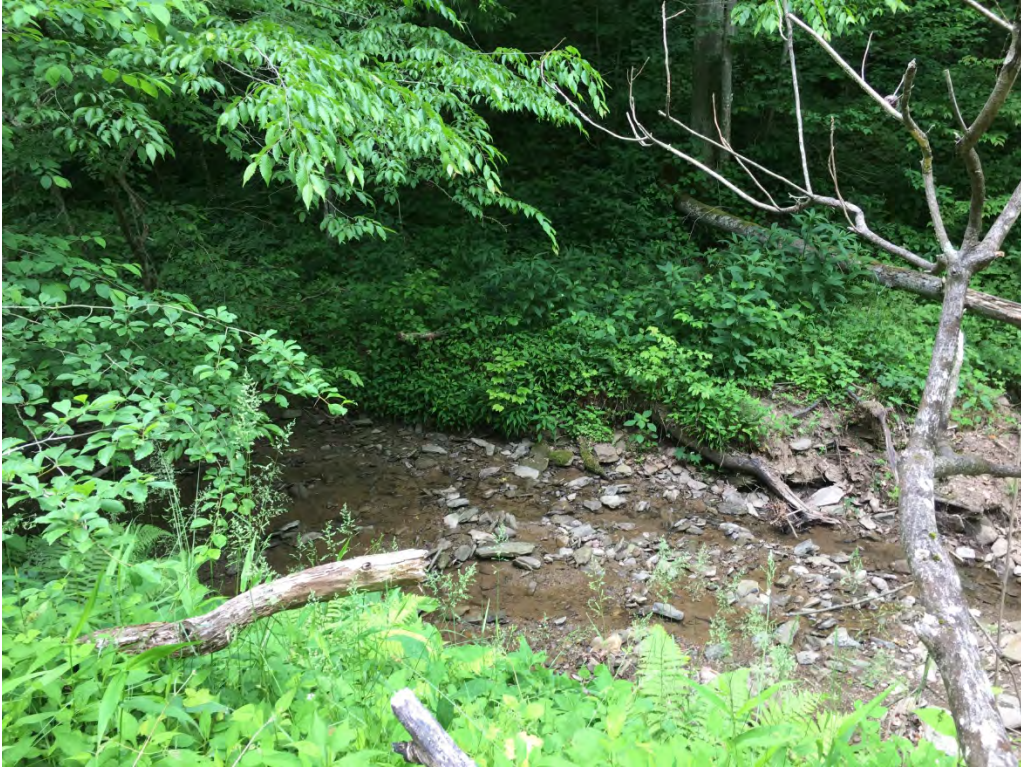
Waterbody swza002 cross stream

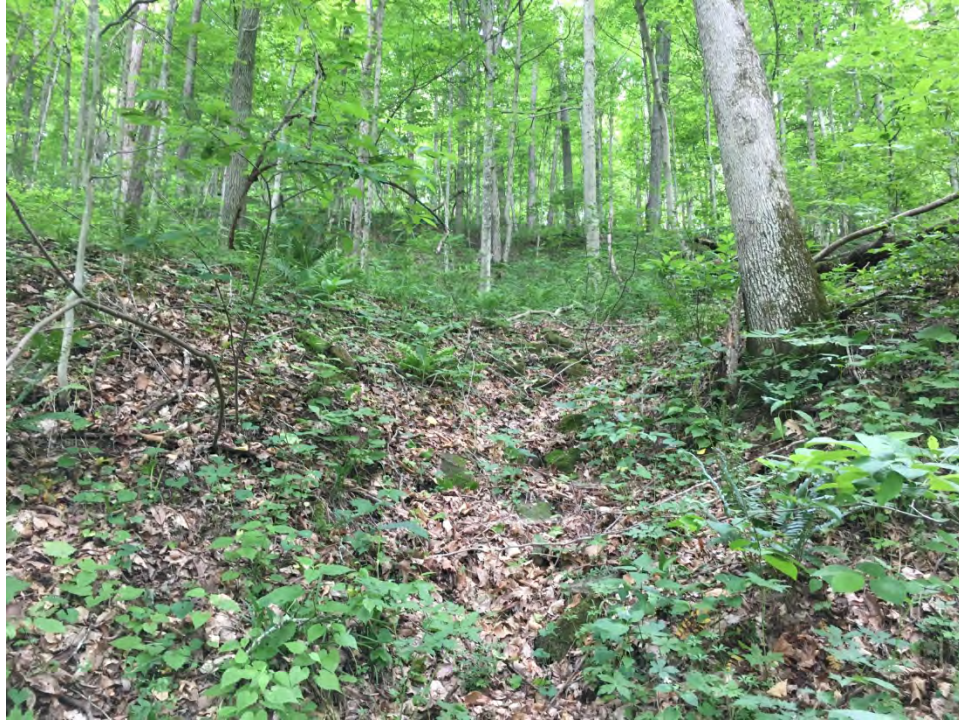
| Description | | | |
|---|---|---|---|
| <b>Observation Notes:</b><br>steep slope; flow appears rare | | | |

Waterbody swza001 facing upstream

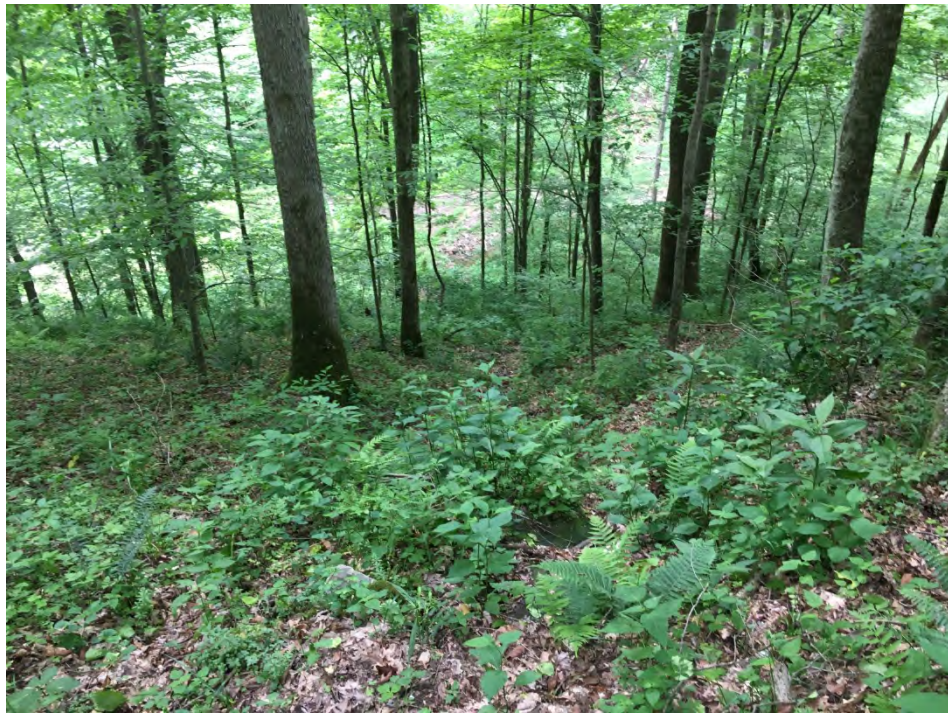
Waterbody swza001 facing downstream

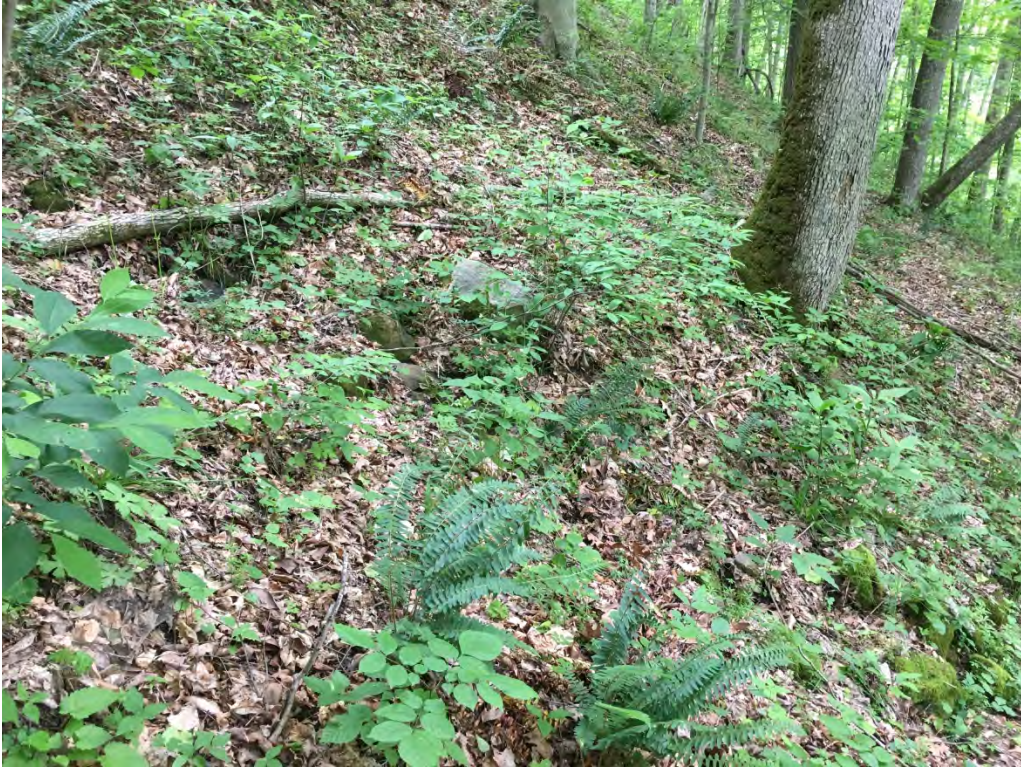
Waterbody swza001 cross stream

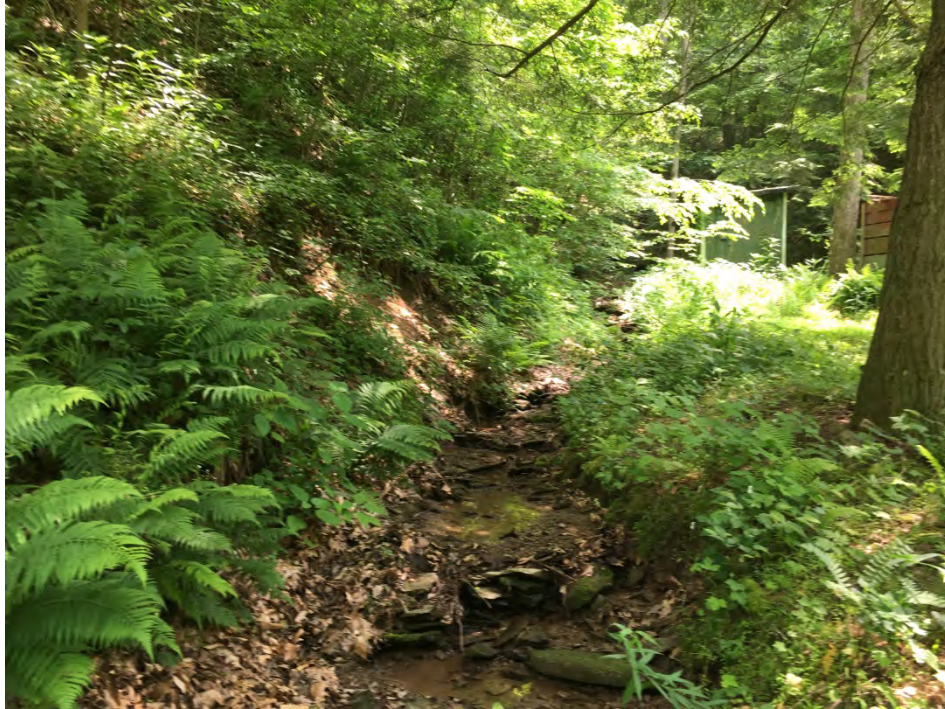
| Description | | | |
|---|---|---|---|
| <b>Observation Notes:</b><br>Very nice intermittent stream with cascading pools and seeping rocky banks. | | | |

Waterbody swza003 facing upstream

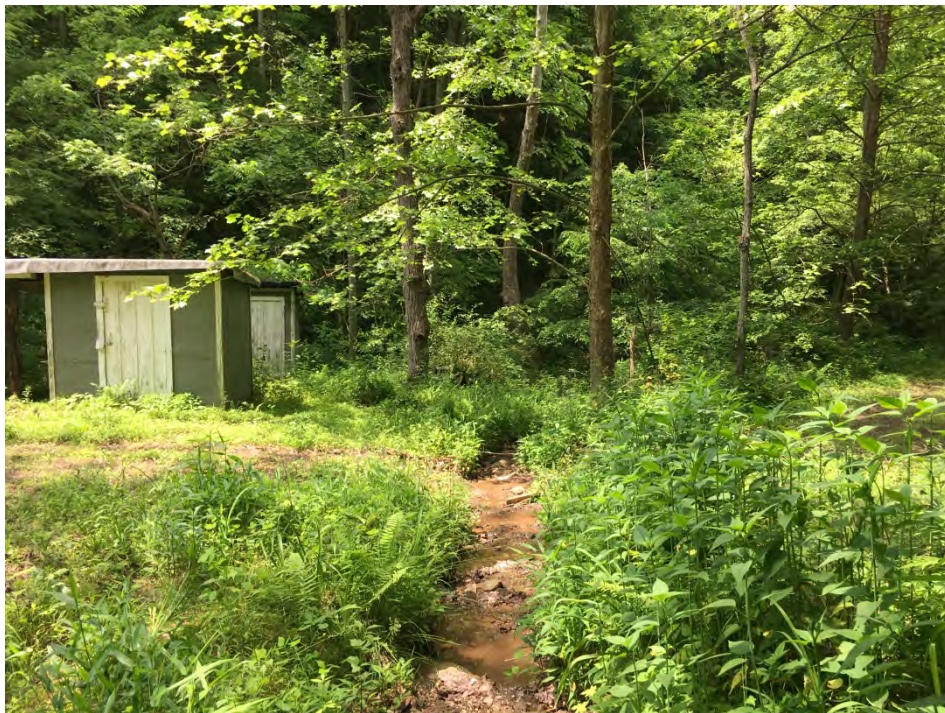
Waterbody swza003 facing downstream

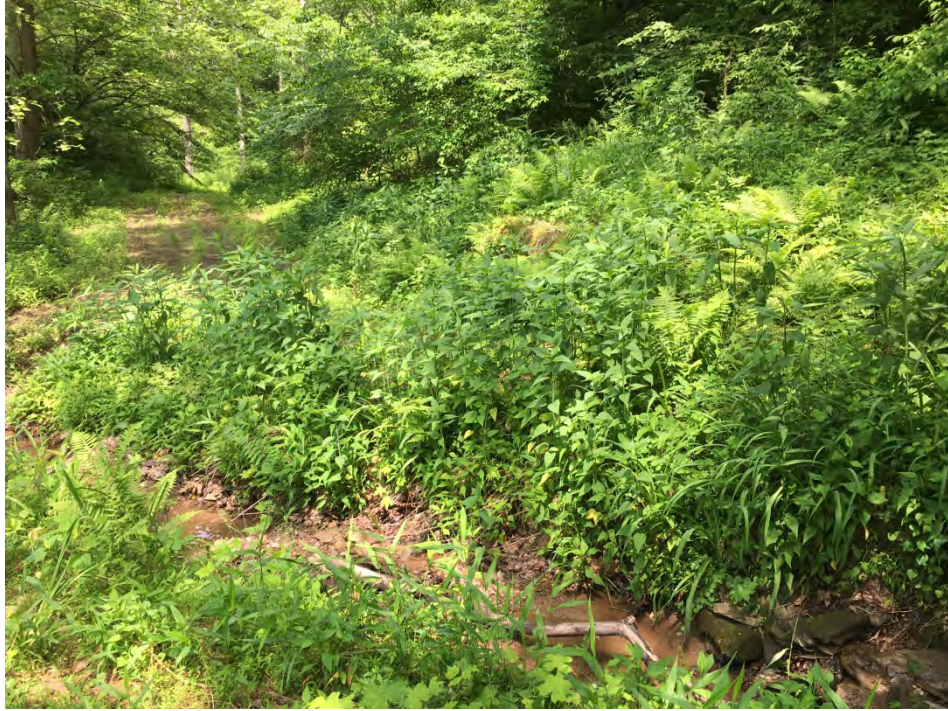
Waterbody swza003 cross stream

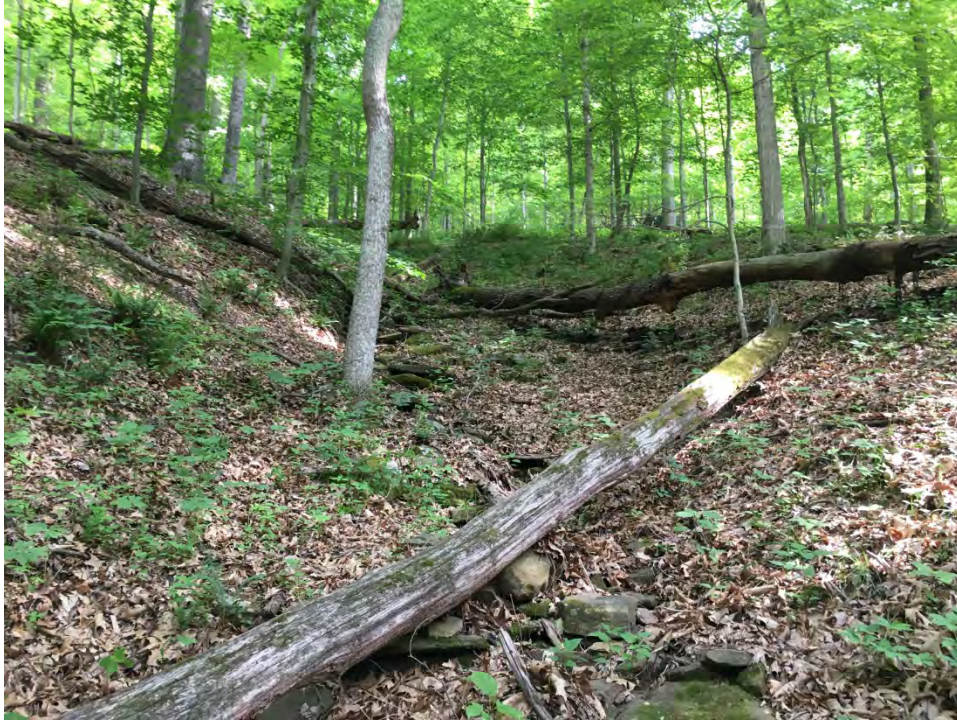
| Description | | | | | | |
|---|--|---|---|---|---|---|
| <b>Observation Notes:</b><br>Upland drainage ephemeral stream | | | | | | |

Waterbody swza006 facing upstream

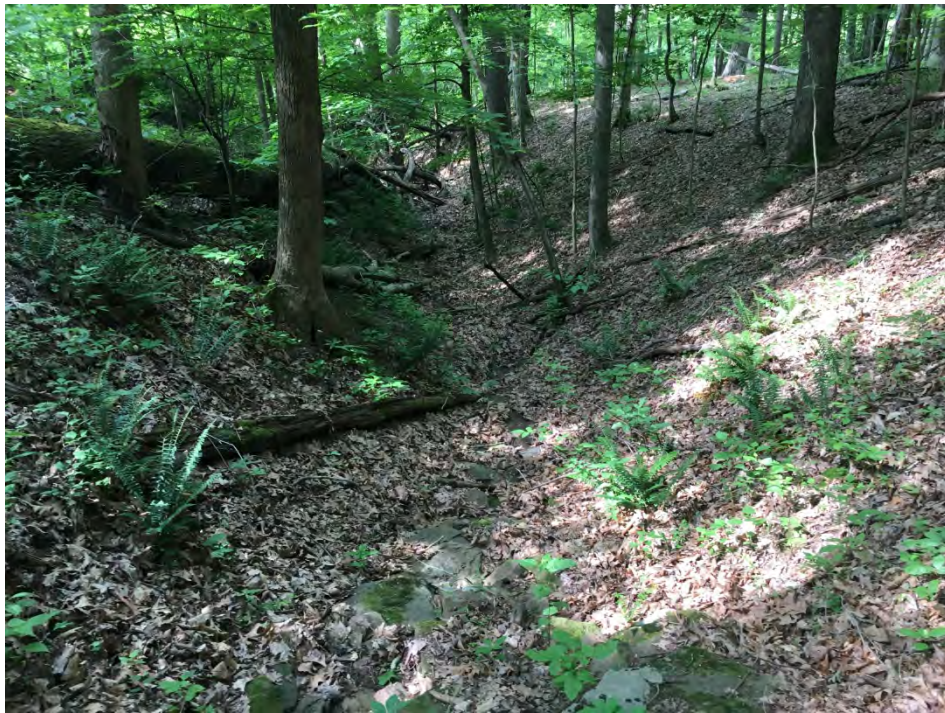
Waterbody swza006 facing downstream

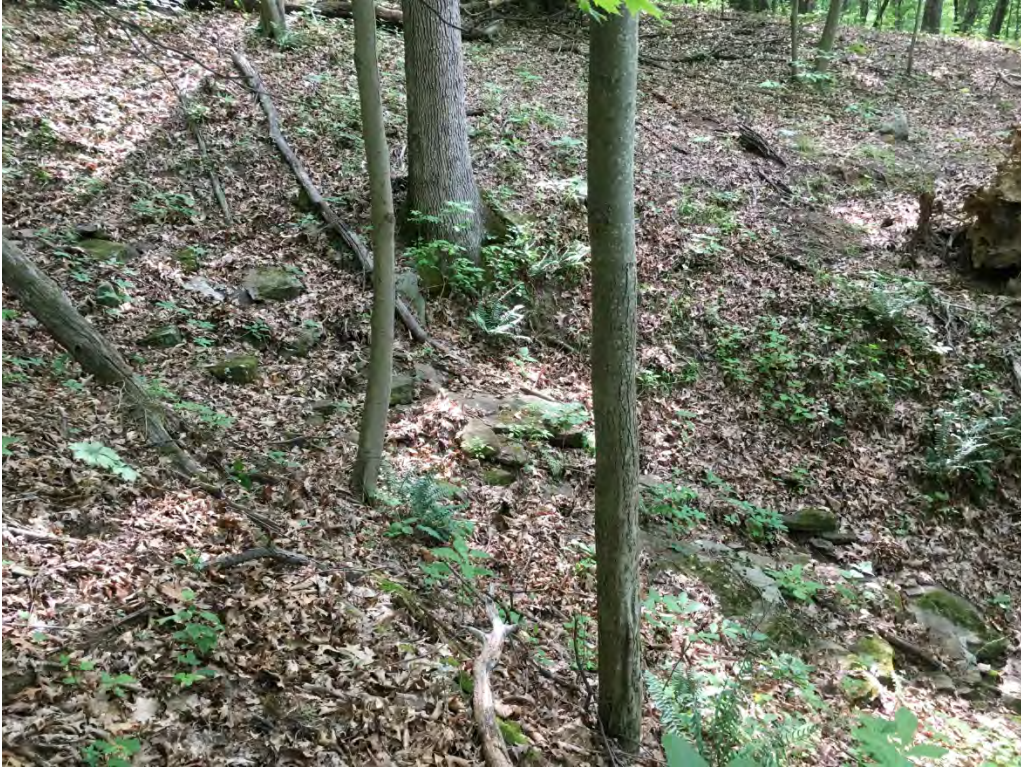
Waterbody swza006 cross stream

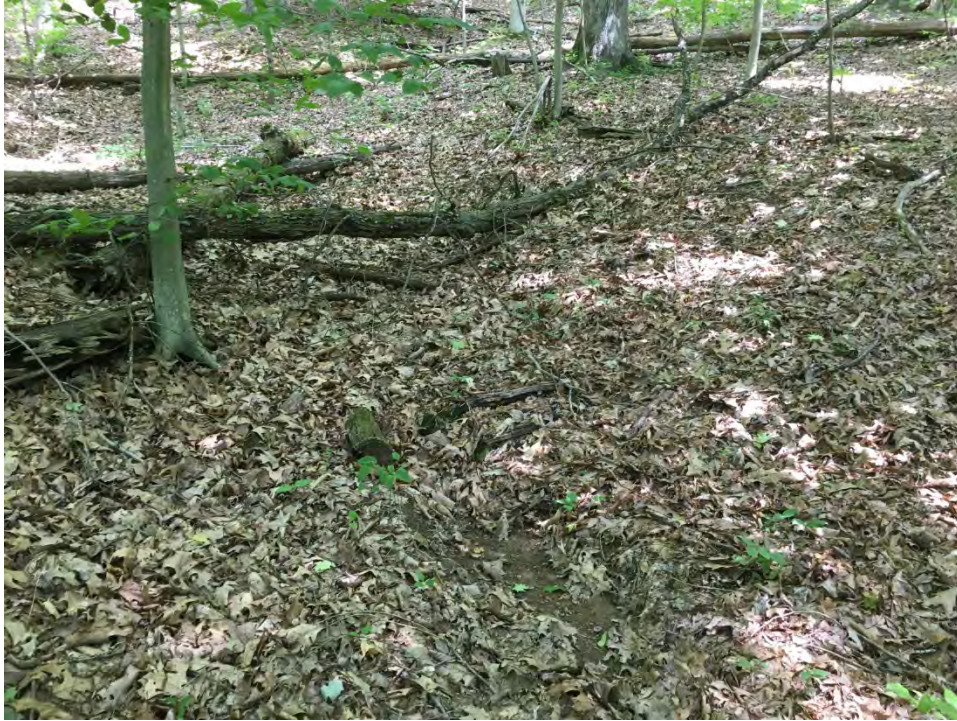
| Description | | | |
|---|---|---|---|
| <b>Observation Notes:</b><br>Upland drainage ephemeral stream; confluence with swza008. | | | |

Waterbody swza007 facing upstream

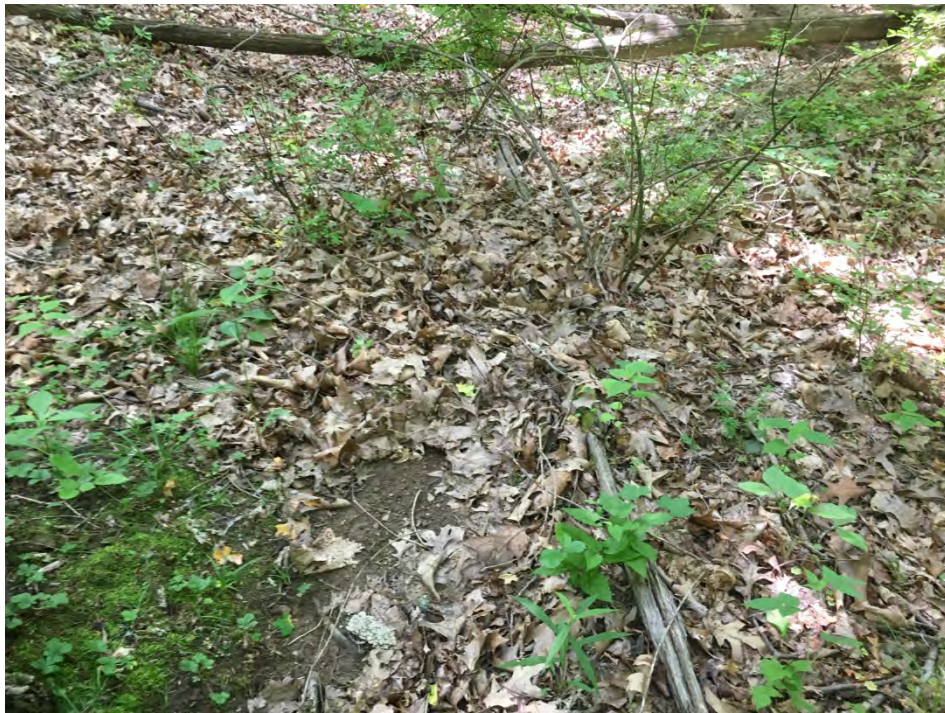
Waterbody swza007 facing downstream

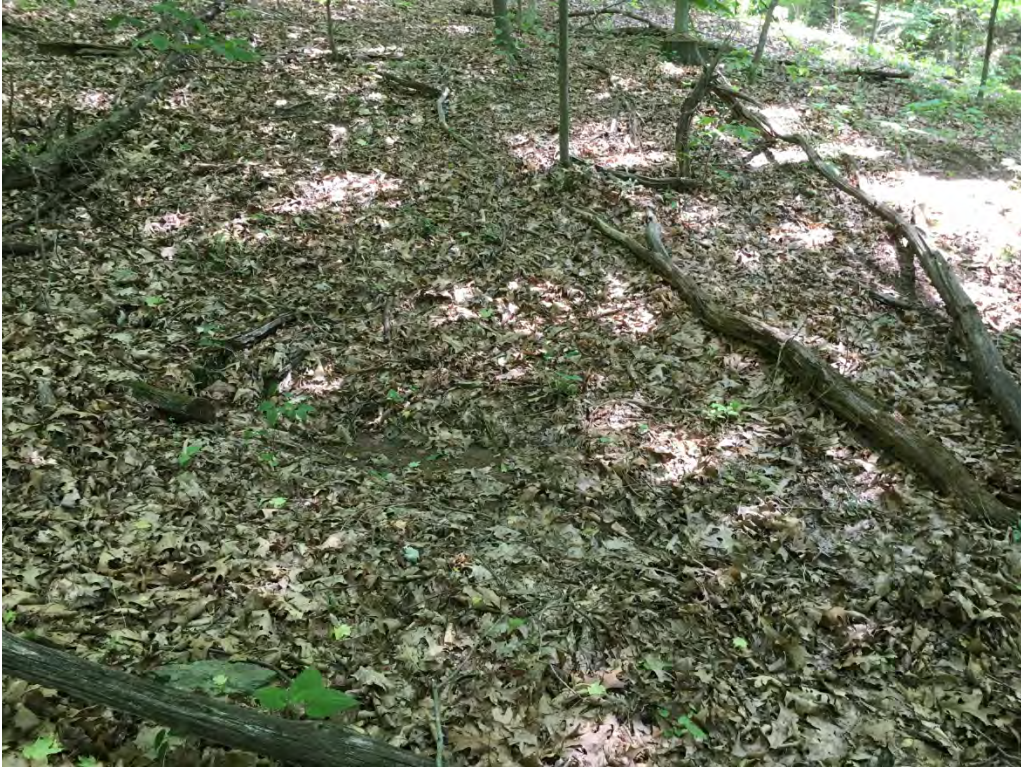
Waterbody swza007 cross stream

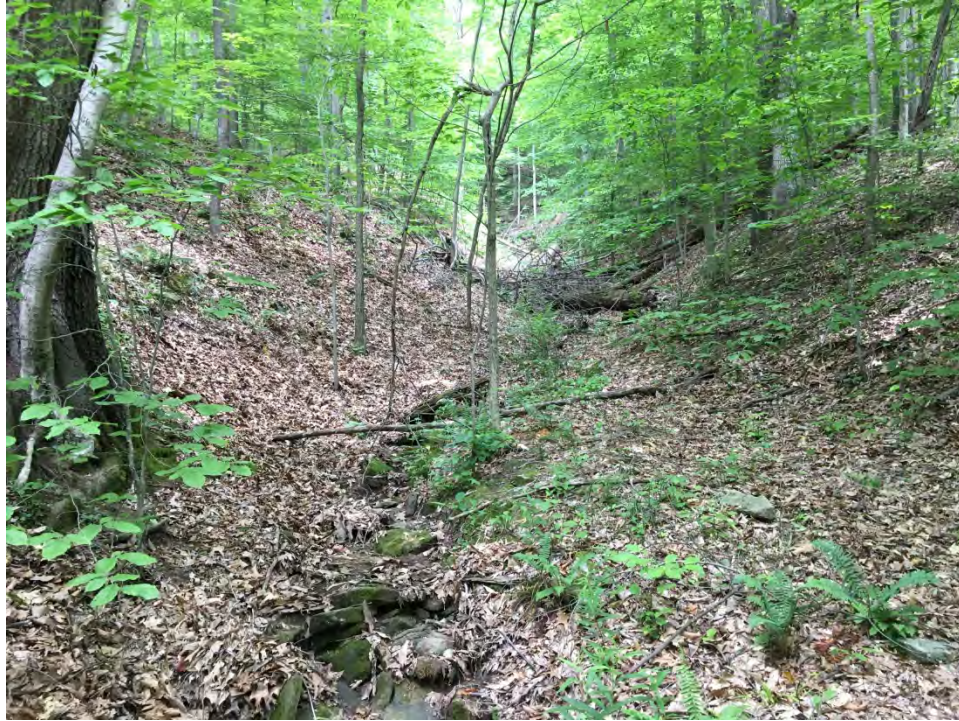
| Description | | | |
|---|---|---|---|
| <b>Observation Notes:</b><br>Upland drainage ephemeral stream | | | |

Waterbody swza008 facing upstream

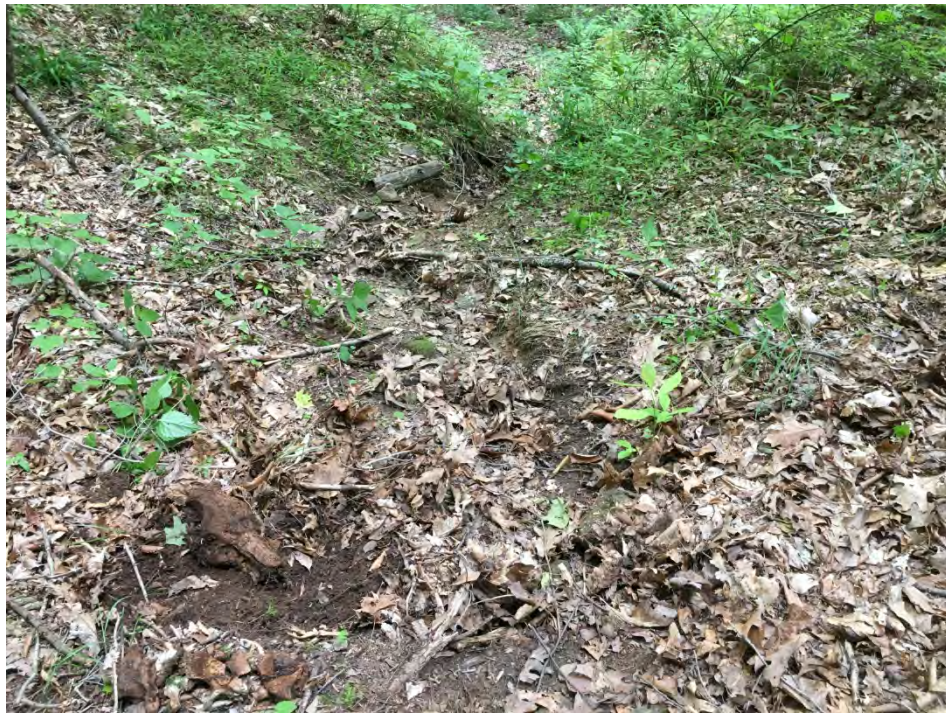
Waterbody swza008 facing downstream

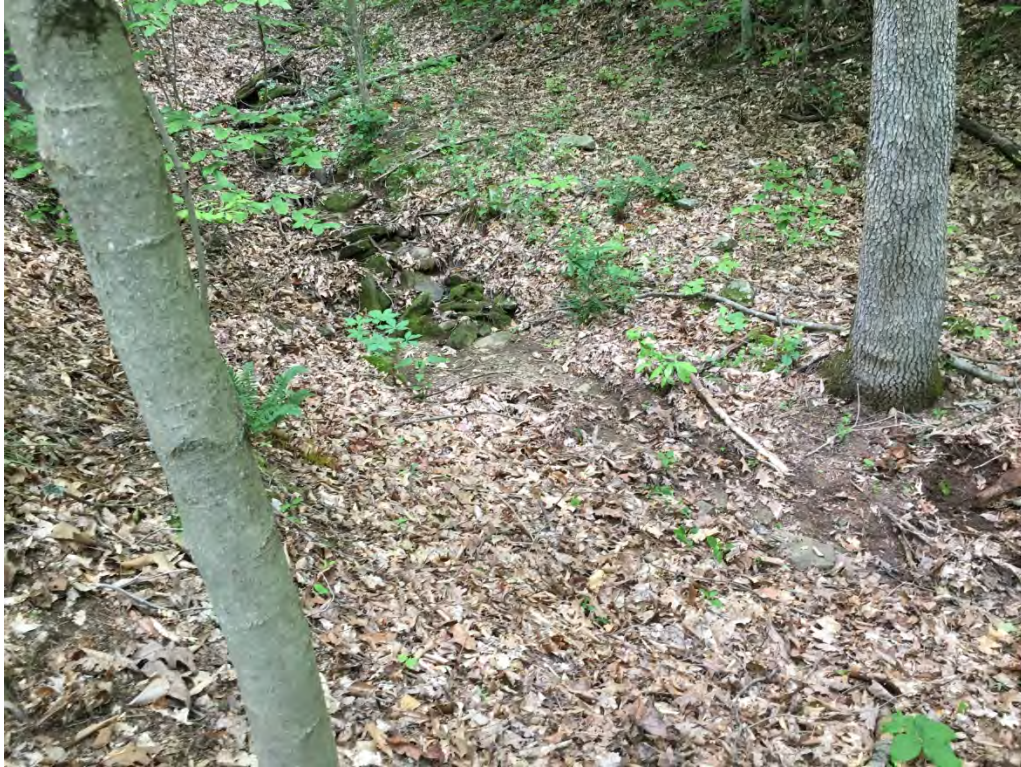
Waterbody swza008 cross stream
