Linear Waterbody Data Sheet

Survey Description			
Project Name: Atlantic Coast Pipeline		Waterbody Name: UNT to Slaty Fork	
Waterbody ID: spoa425		Date: 6/2/2016	
State: West Virginia	County: Pocahontas	Company: NRG/ERM	Crew Member Initials: GB, KO
Photos: 3 photos			
Tract Number(s): access road 05-001-C008.AR1		Nearest Milepost: 72.0	Associated Wetland ID(s): wpoa411
Survey Type: <i>(check one)</i> <input type="checkbox"/> Centerline <input type="checkbox"/> Re-Route <input checked="" type="checkbox"/> Access Road <input type="checkbox"/> Other:			
Physical Attributes			
Stream Classification: <i>(check one)</i> <input type="checkbox"/> Ephemeral <input checked="" type="checkbox"/> Intermittent <input type="checkbox"/> Perennial			
Waterbody Type: <i>(check one)</i> <input type="checkbox"/> River <input checked="" type="checkbox"/> Stream <input type="checkbox"/> Ditch <input type="checkbox"/> Canal <input type="checkbox"/> Other:

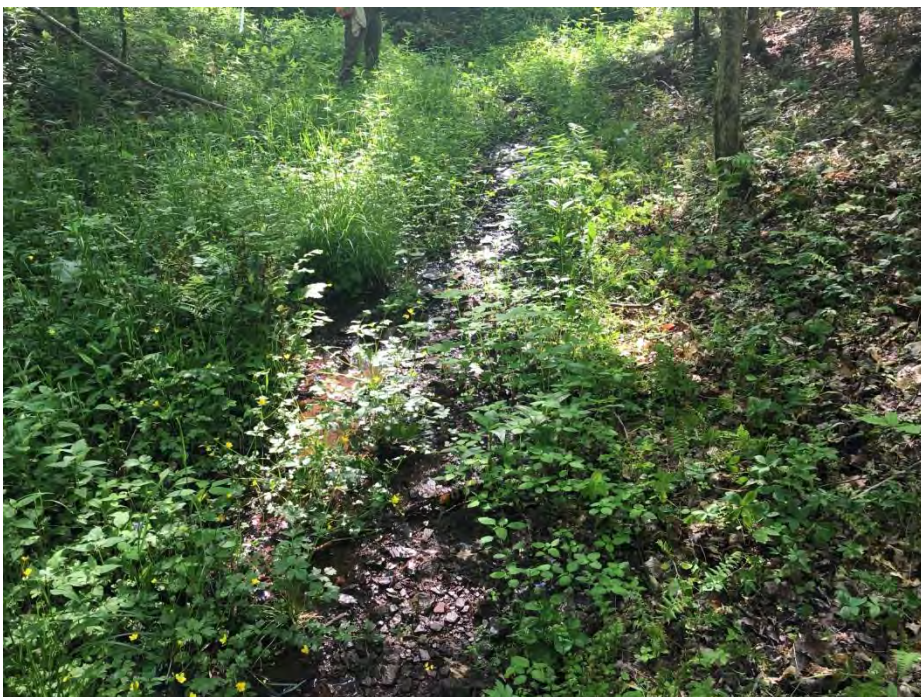
Waterbody spoa425 facing east downstream

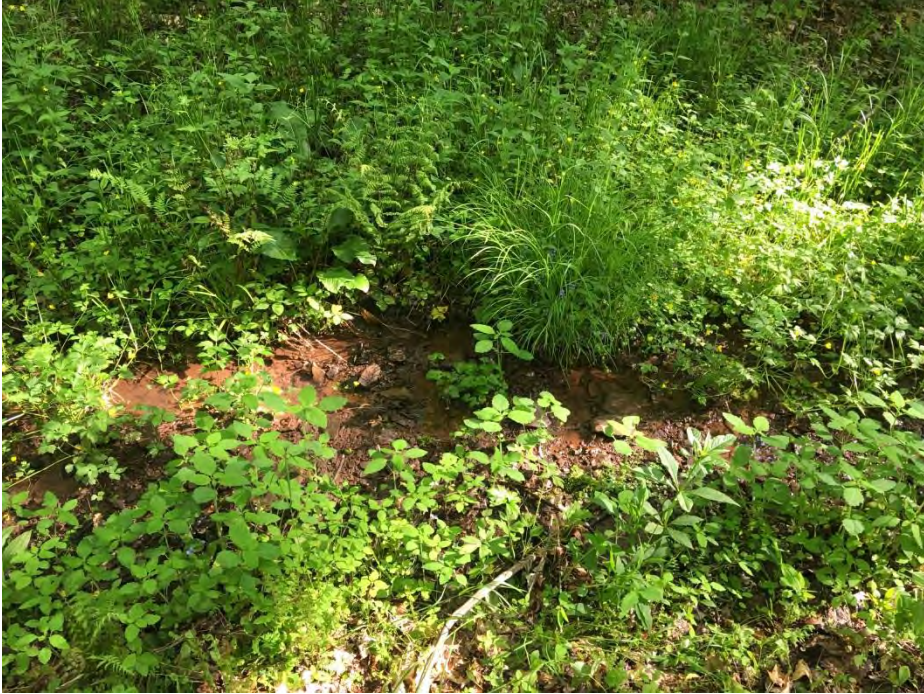
Waterbody spoa425 facing north across

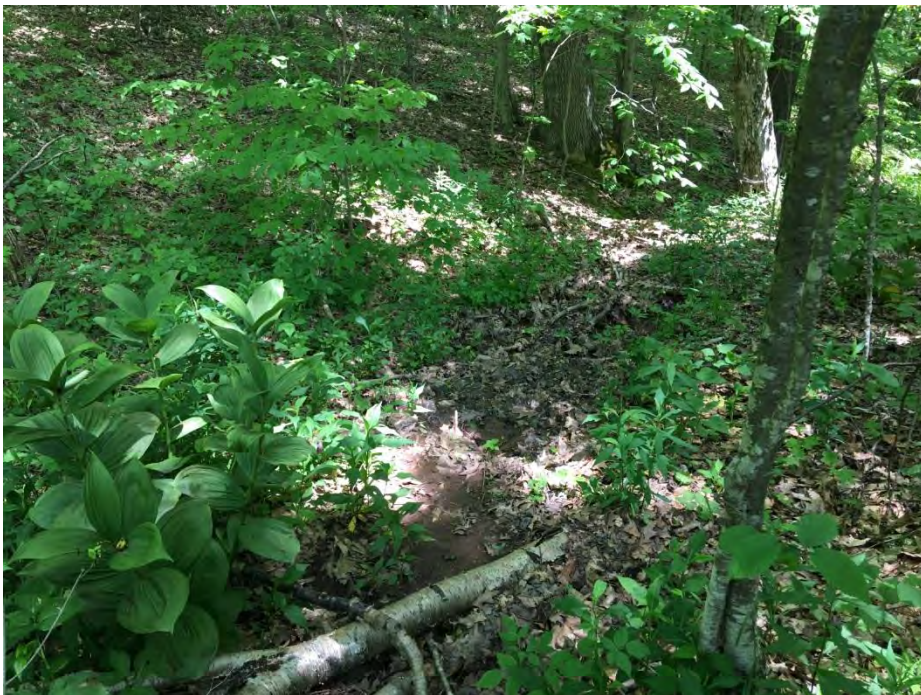
Waterbody spoa422 facing northeast downstream

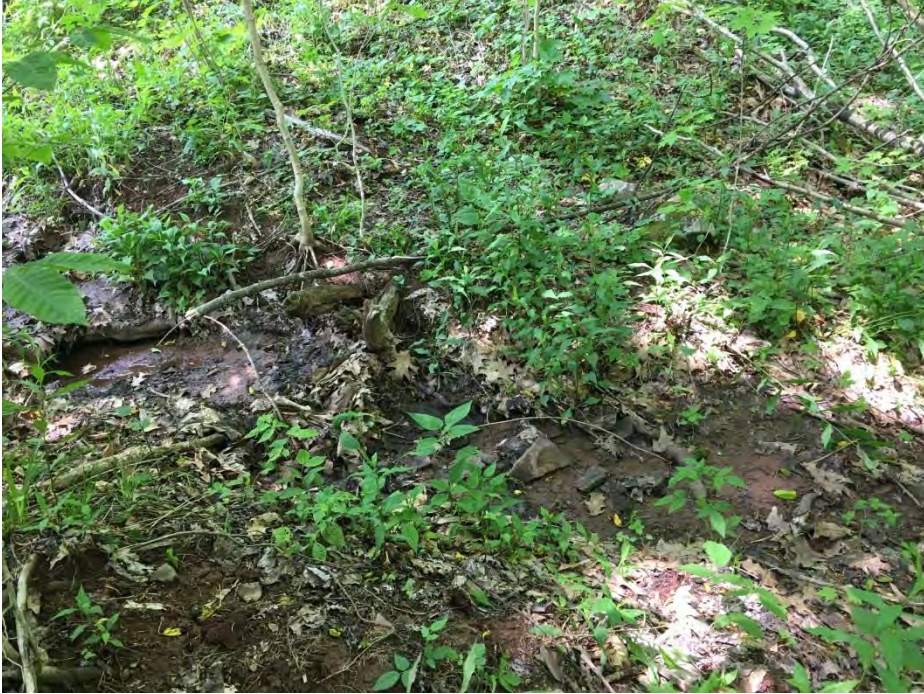
Waterbody spoe422 facing northwest across

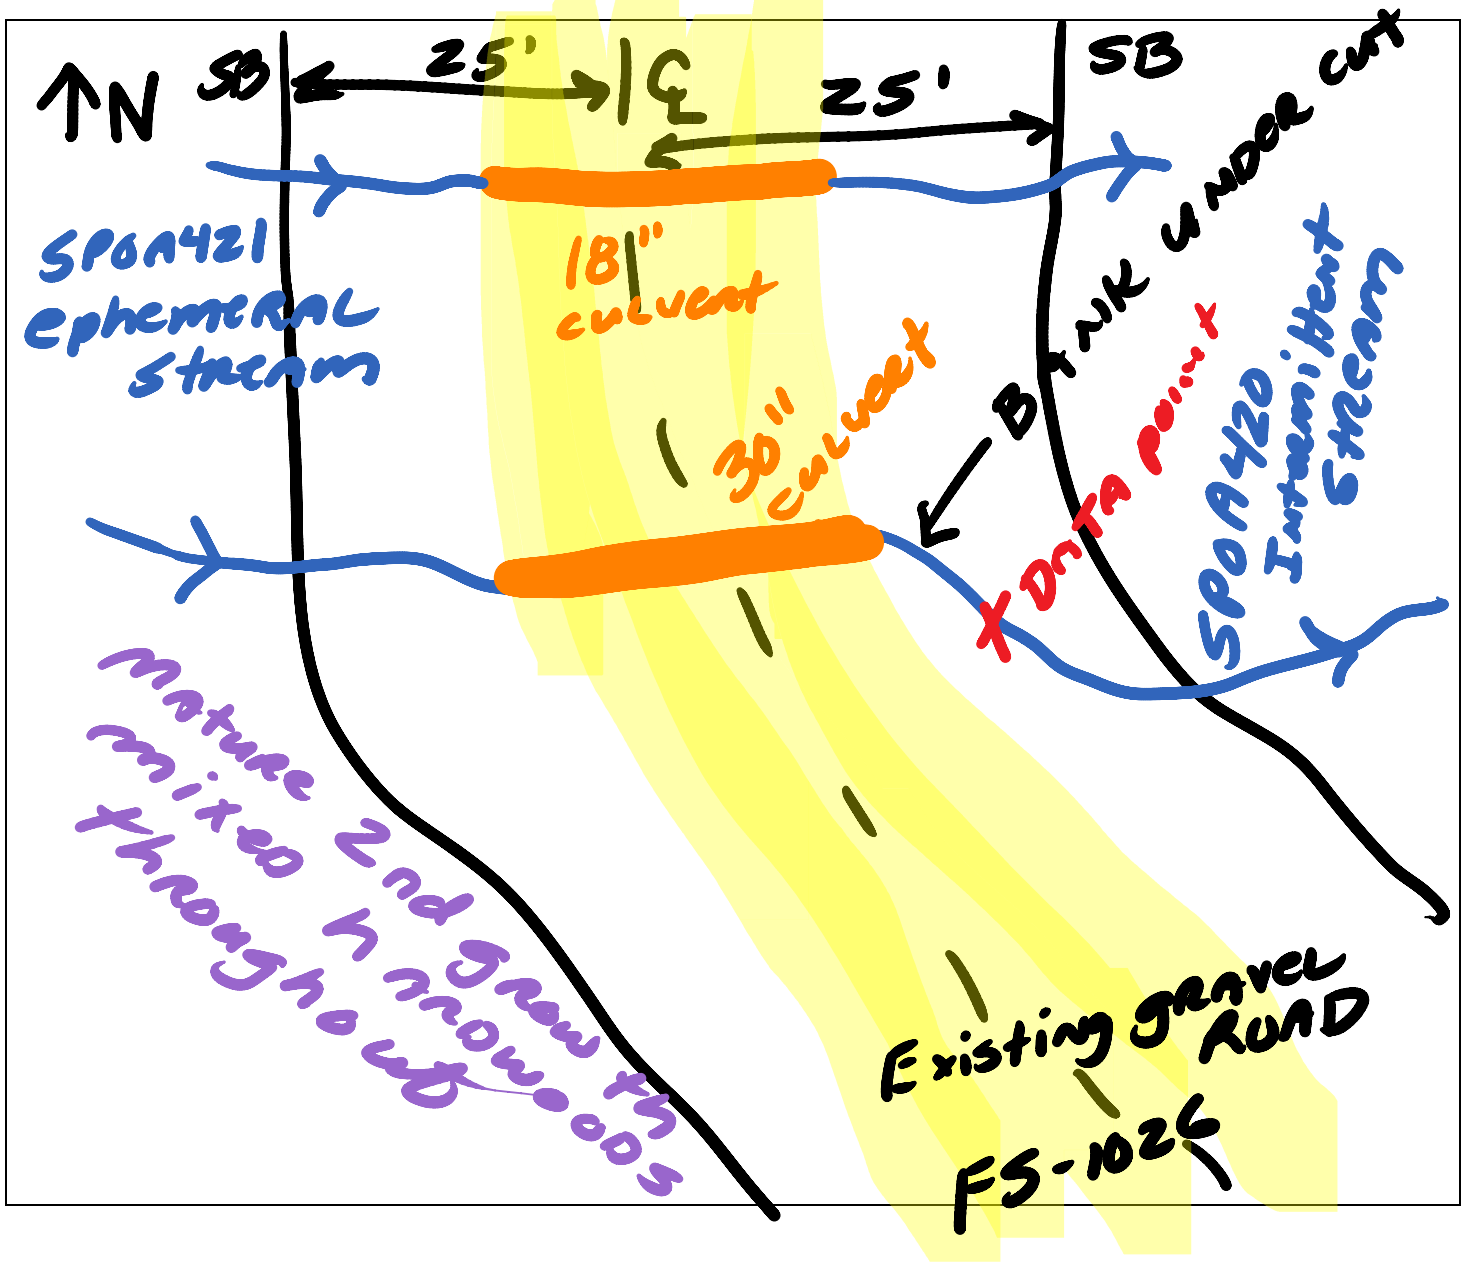
N/A <input type="checkbox"/>		Bank height Right: 6.0 ft. Left: 3.0 ft.	
Bank slope Right: 65 degrees Left: 80 degrees			
Analysis of Bank Stability (i.e. root structure, vegetation, substrate characteristics): Banks exhibit loose soil/rock and exposed roots and is being undercut at culvert outlet			
Qualitative Attributes			
Water Appearance: <i>(check one)</i> <input type="checkbox"/> No water <input checked="" type="checkbox"/> Clear <input type="checkbox"/> Turbid <input type="checkbox"/> Sheen on surface <input type="checkbox"/> Surface scum <input type="checkbox"/> Algal mats <input type="checkbox"/> Other:			
Substrate: <i>(check all that apply)</i> <input type="checkbox"/> Bedrock <input checked="" type="checkbox"/> Boulder <input checked="" type="checkbox"/> Cobble <input checked="" type="checkbox"/> Gravel <input type="checkbox"/> Sand <input checked="" type="checkbox"/> Silt/ clay <input checked="" type="checkbox"/> Organic <input type="checkbox"/> Other:

Waterbody spoa420 facing east upstream

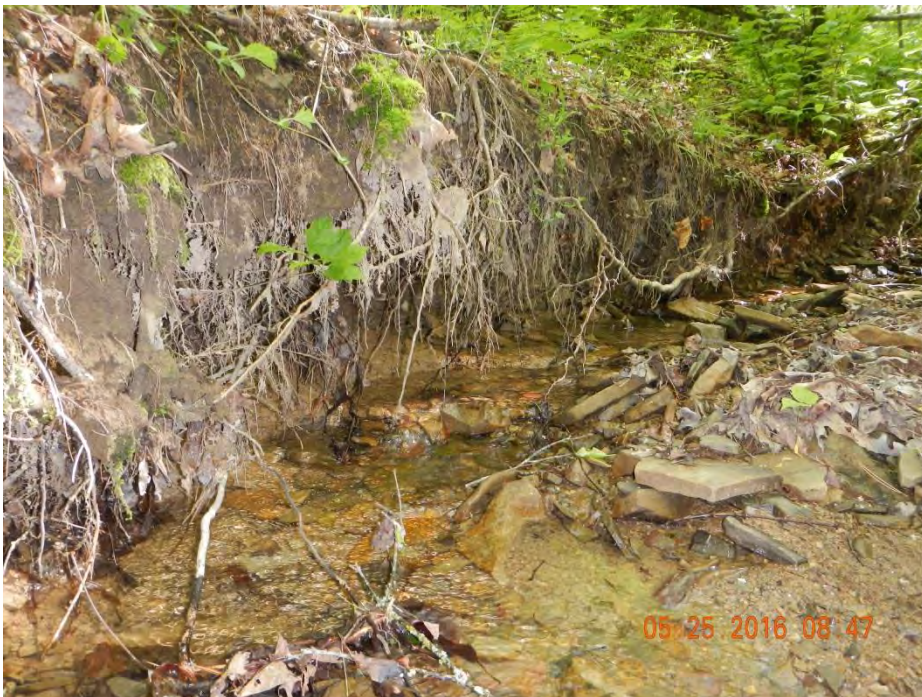
Waterbody SPOA408 scouring facing northwest across

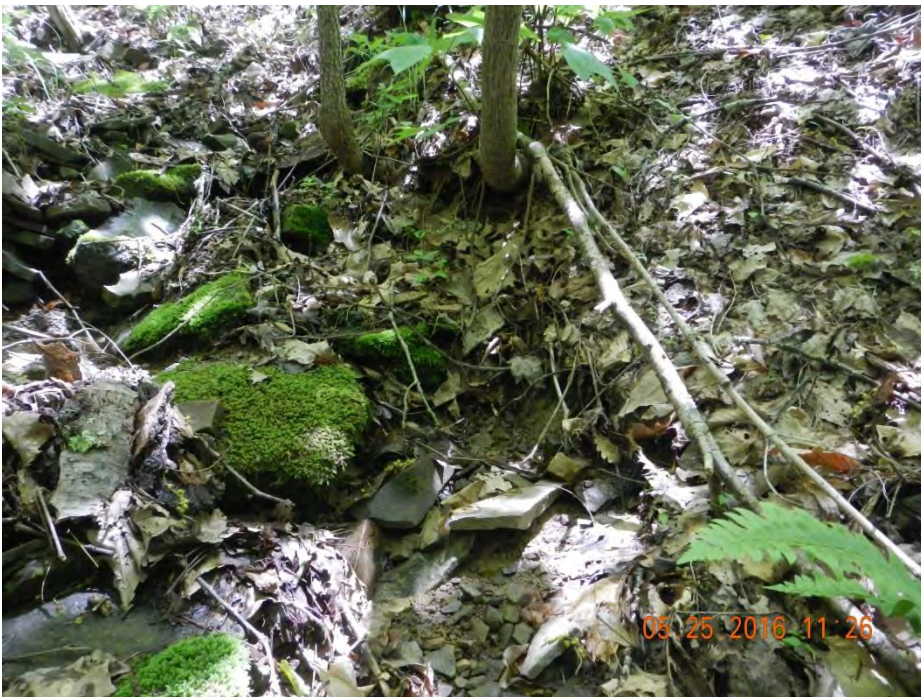
Waterbody SPOA410 scouring facing east
