**ATLANTIC COAST PIPELINE, LLC  
ATLANTIC COAST PIPELINE**

**DOMINION TRANSMISSION, INC.  
SUPPLY HEADER PROJECT**

**Supplemental Filing  
March 10, 2017**

**Correspondence for the Atlantic Coast Pipeline**

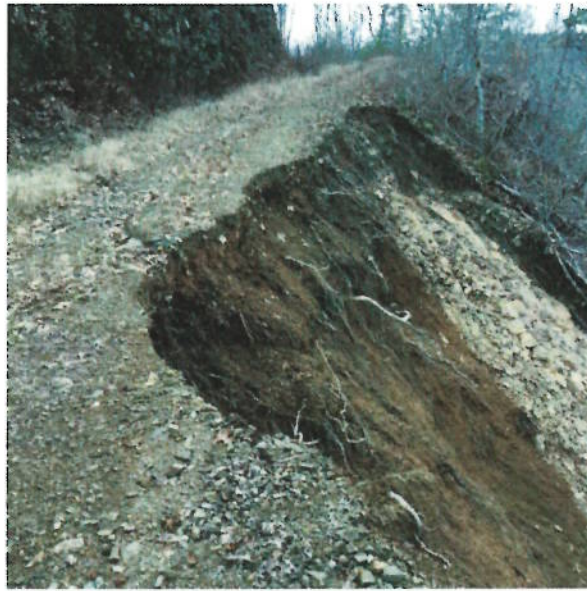
**Photo 01 – Landslide Group 1 – FR 719 - Road Fill Failure Site “H/L” – 18-Jan-2017      GEO\_0771**  
A sliver road fill was constructed over shallow steeply dipping bedrock. There is evidence that significant surface runoff flowed down the road and seeped into the road fill causing it to fail.

failed, probably due rapid infiltration of surface runoff into, or along the base of the fill, during the June 2016 high-intensity precipitation event (see Photo 01).

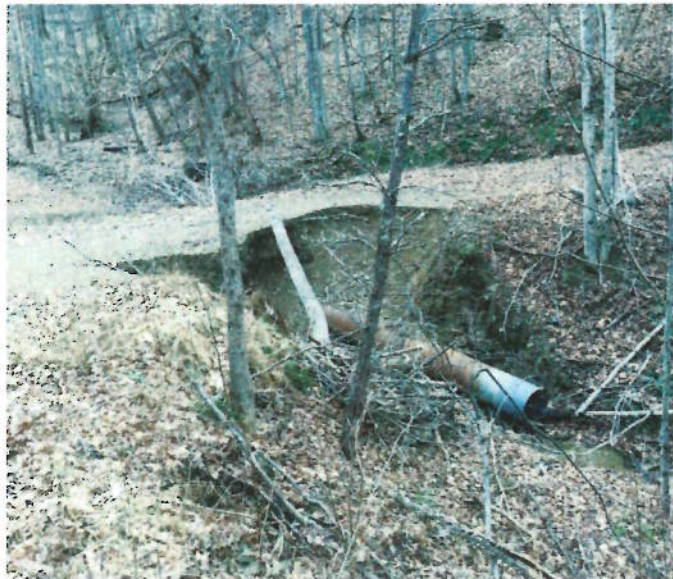
**Photo 02 – Landslide Group 1 – FR 719 – Culvert Washout Site “G” - 18-Jan-2017      GEO\_0774**  
An existing culvert inlet appears to have plugged and runoff crossed the roadway eroding the road fill.

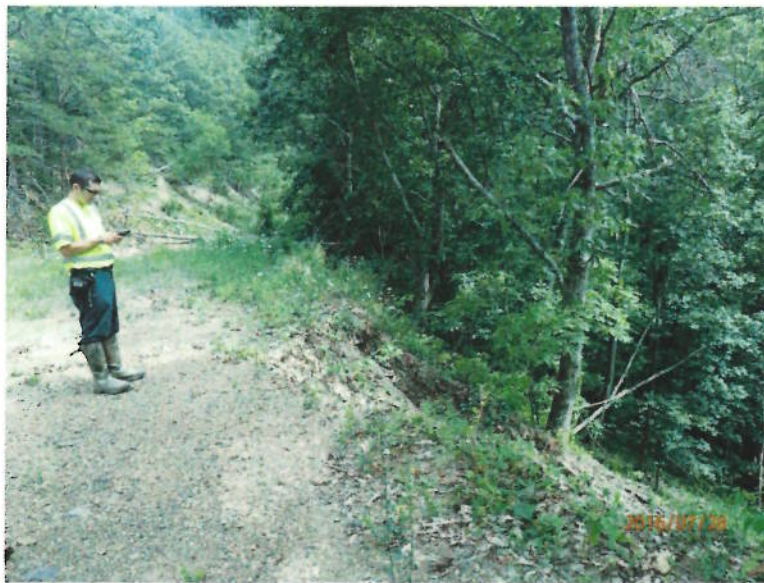
**Photo 03 – Landslide Group 1 – FR 719 – Unidentified road fill failure – 28-Jul-2016 FS\_P7280791**  
Evidence that surface runoff ponded on the roadway is visible left of the individual shown. This likely raised pore water pressure in the road fill which failed and subsequently erosion of the fill occurred.

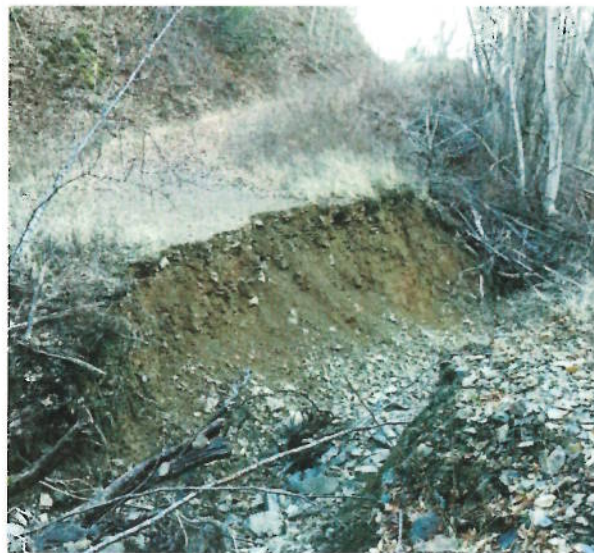
**Photo 04 – Landslide Group 1 – FR 719 – Debris Flow Culvert Washout – 18-Jan-2017 GEO\_0777**  
This location was not assigned a Landslide Point, but was observed to be a significant culvert washout.

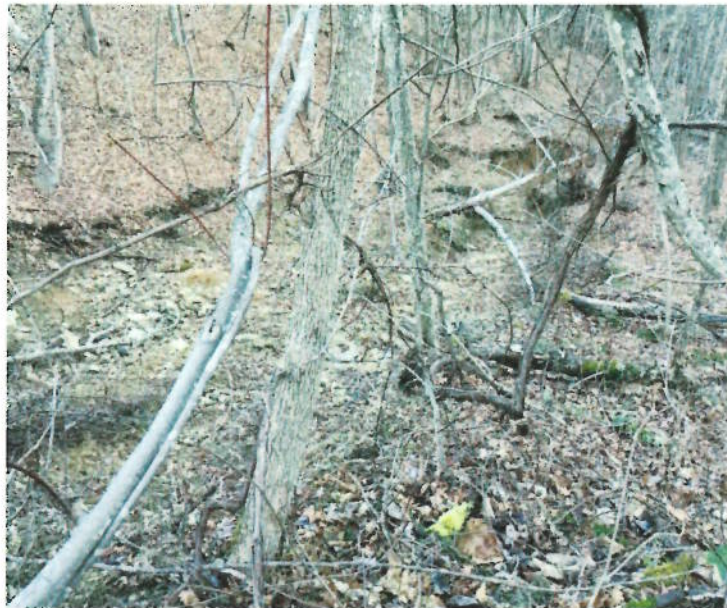
**Photo 05 – Landslide Group 1 – FR 719 – Road Fill Erosion Site “C” – 18-Jan-2017**      **GEO\_0779**  
Runoff across the roadway (located above and left), resulting from a plugged culvert inlet, caused some erosion of the road fill and the cutting of a new erosion channel on the hillside below (right).

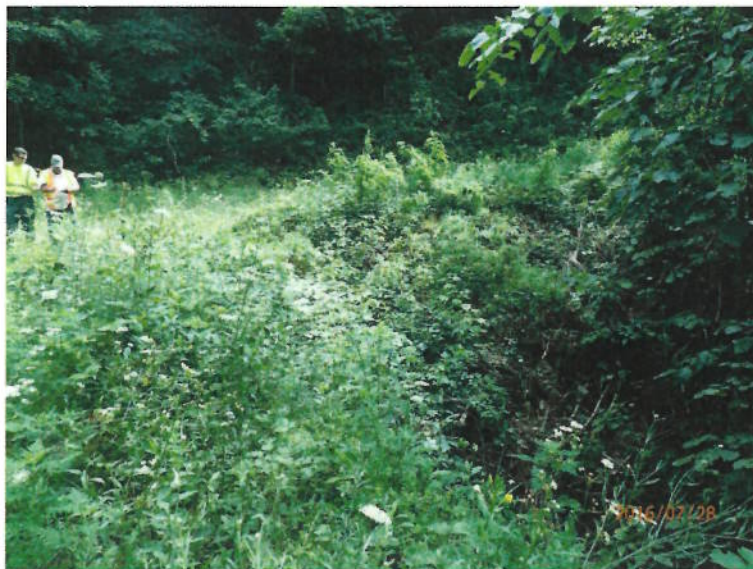
**Photo 06 – Landslide Group 1 – FR 719 – Unidentified road fill failure – 28-Jul-2016**      **FS\_P7280818**  
Fill failure and erosion caused by creek runoff diverted onto road at plugged culvert inlet (top right).

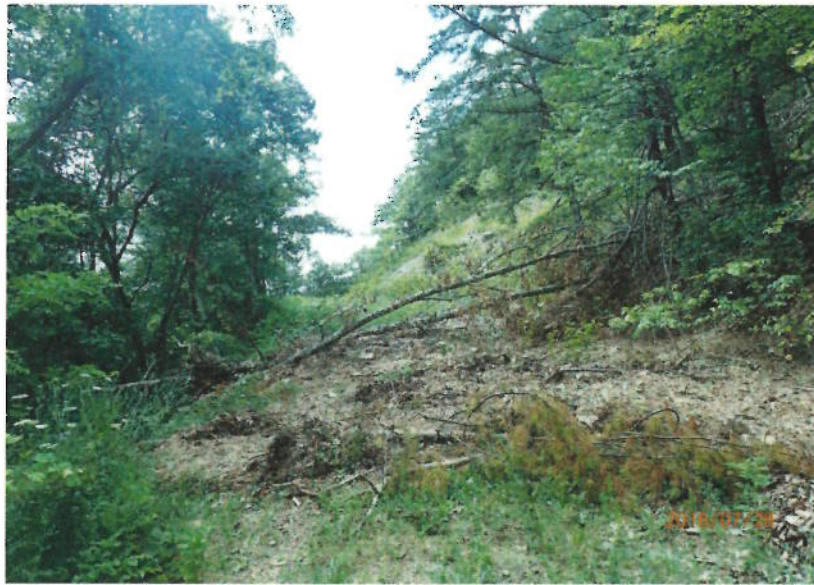
**Photo 07 – Landslide Group 1 – FR 719 – Unidentified road cut erosion –28-Jul-2016 FS\_P7280807**  
Significant runoff from hillside above and to the right resulted in erosion of the cut slope and deposition of soil, rock, and other debris on the existing road surface.

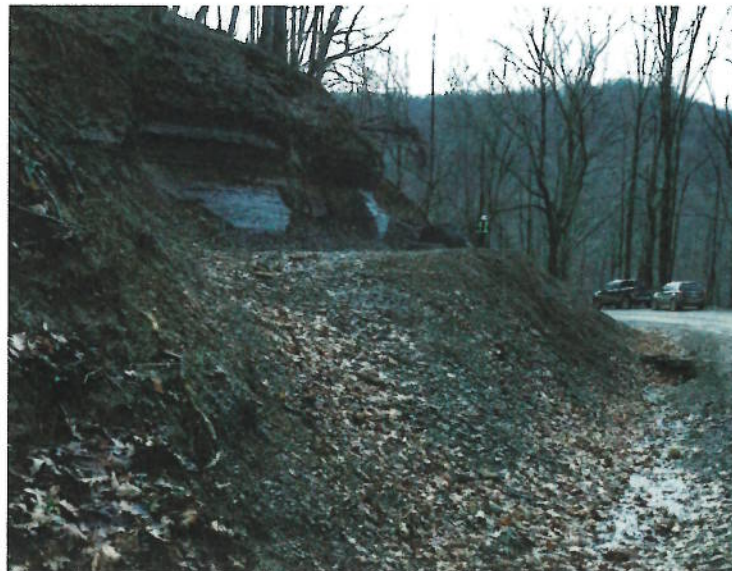
**Photo 08 – Landslide Group 2 – FR 101 – Cut Slope Failure Repair –19-Jan-2017 GEO\_0784**  
Fifteen Landslide Points were attributed to this one cut slope failure site (seen here after repair work).

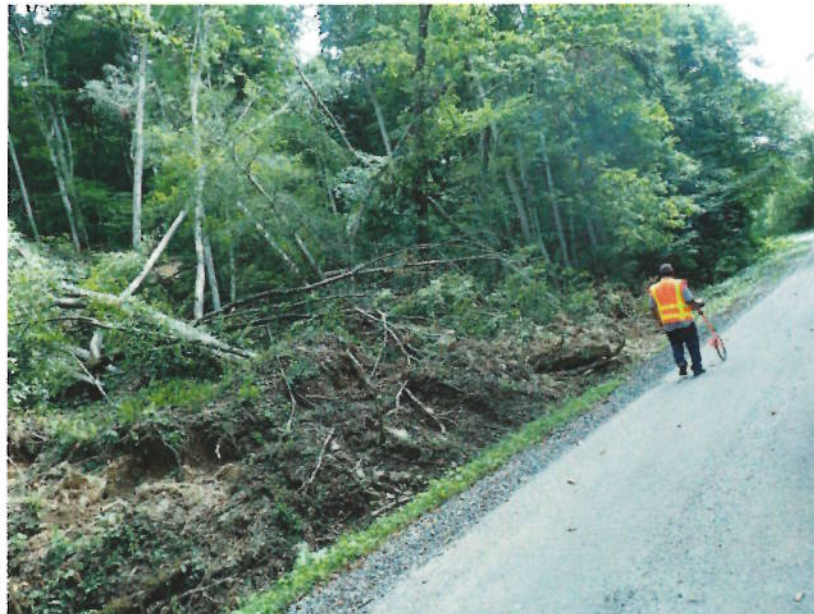
**Photo 09 – Landslide Group 3 – FR 86 – MP 14.7 Williams River Road –26-Jul-2016 FS\_P7260421**  
Pre-existing landslide site on the west side of the Williams River that appears to have been recently reactivated by high-intensity precipitation. Geosyntec was unable to visit this site.

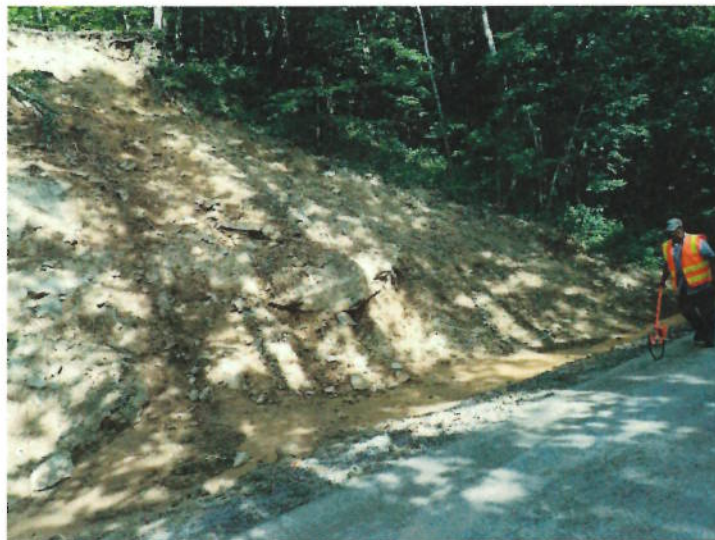
**Photo 10 – Landslide Group 3 – FR 86 – MP 15.9 Williams River Road –26-Jun-2016 FS\_P7260488**  
Cut slope failure on east side of the Williams River. Geosyntec was unable to visit this site.

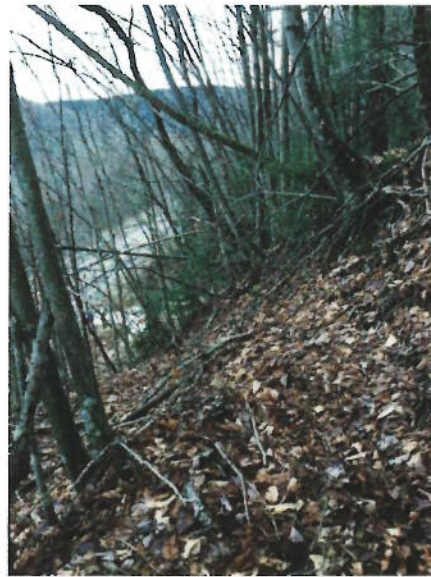
**Photo 11 – Landslide Group 4 – SR 150 Highland Scenic Highway Landslide –19-Jan-2017– GEO\_0792**  
Highway construction resulted in significant excavation into the toe of this large landslide which extends over 1,000 feet upslope and there appears to be ongoing cut slope maintenance issues here.

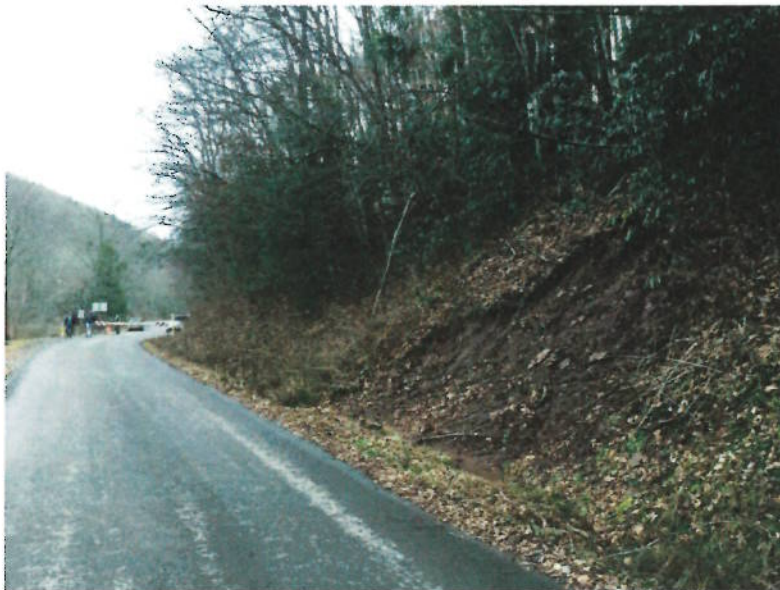
**Photo 12 – Landslide Group 4 – FR 86 Cut slope failure -Tea Creek Campsite–19-Jan-2017–GEO\_0800**  
On west side of Williams River a small cut slope failure occurred at the toe of an existing landslide.

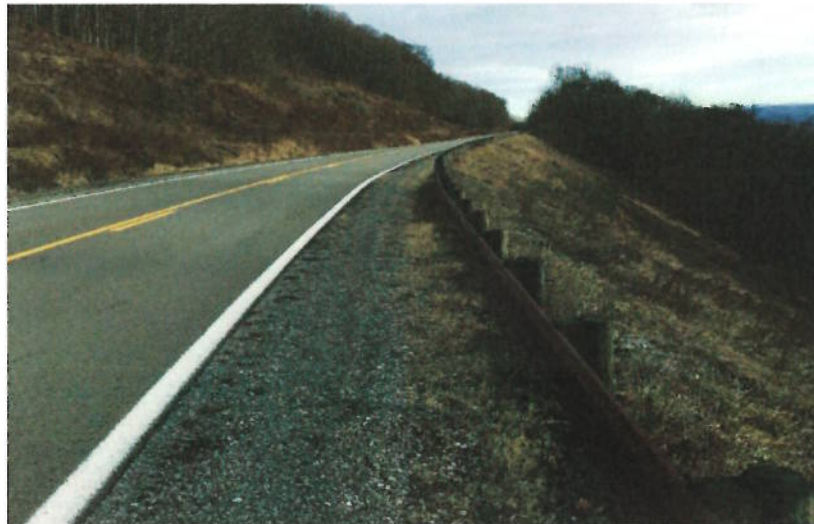
**Photo 14 – Landslide Group 4 – SR 150 Red Lick Slip fill slope site –19-Jan-2017– GEO\_0804**  
This is a large road fill site where movement may be ongoing but no landslide was observed.

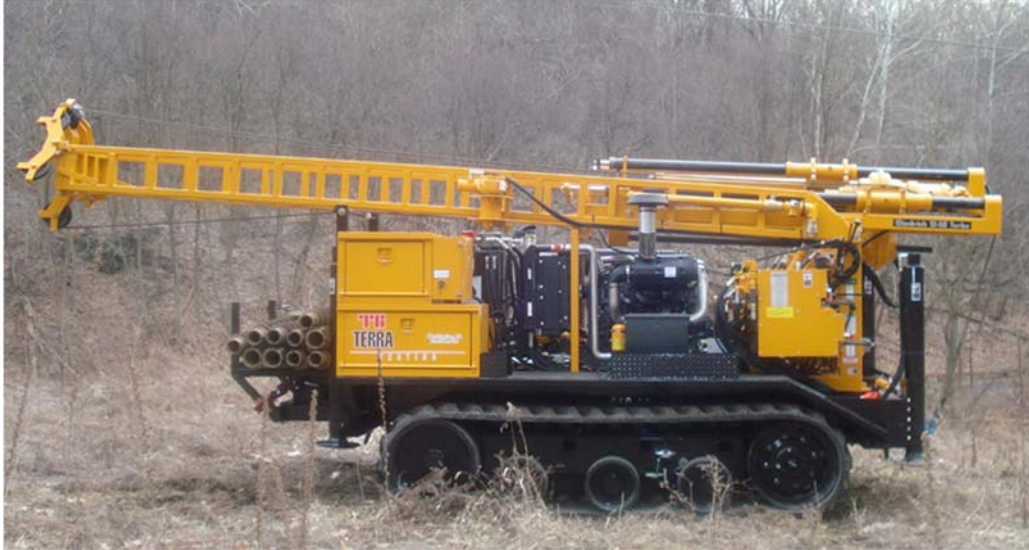
### **Drilling Rig Proposed by Terra Testing, Inc.**

The drilling investigation would entail advancing two land-based nominal 4 to 6 inch diameter vertical boreholes to a depth of 40 feet (or to the bedrock surface and a maximum 10 feet into the bedrock) to sample overburden and bedrock materials, near locations A and B shown on the plan at the top of Page 3, and described respectively below as follows:

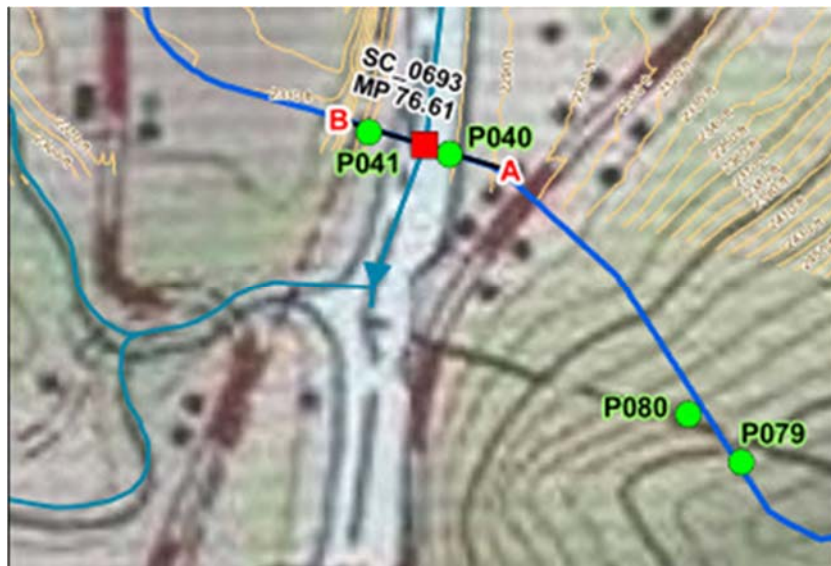
### **Plan of the Greenbrier River Crossing Showing Approximate Location of Boreholes**

- along the edge of the wetted perimeter of the west side (right bank) of the river, 25 feet south of the proposed pipe centerline alignment (near point P041 on the plan on Page 3).

In-river drilling will only be carried out if the water level is low enough to allow a safe traverse by the drilling rig from the east side to the west side to drill the borehole and to traverse back upon completion of the borehole. Weather conditions and water levels will be monitored to guide decisions regarding safe operations. The drilling rig will be removed from the river at the end of each day. The drilling rig has a winch should it be needed to get back out of the river.

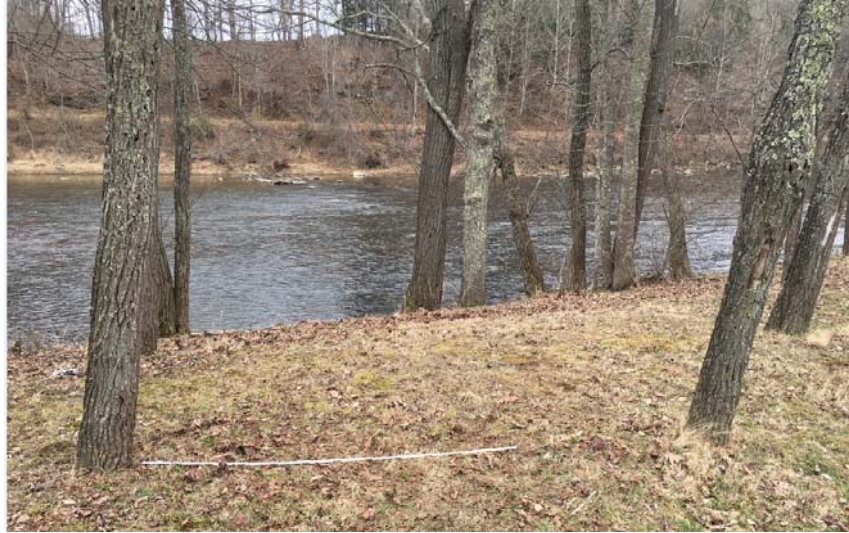
#### **Drill Access Route on East Side of River**

Access to the river will be achieved on the east bank at the point shown in the photo at the top of Page 4. The drilling rig has a narrow footprint and it should be possible to maneuver it between the trees but there is a remote possibility that one small diameter (6 inch DBH) dead tree may need to be removed. If this is required, the stump will be cut flush to the ground and the wood will be bucked into lengths manageable to move by hand. Areas disturbed by the drilling rig, along the bank will be raked smooth, to the extent practical, and covered with locally sourced straw.

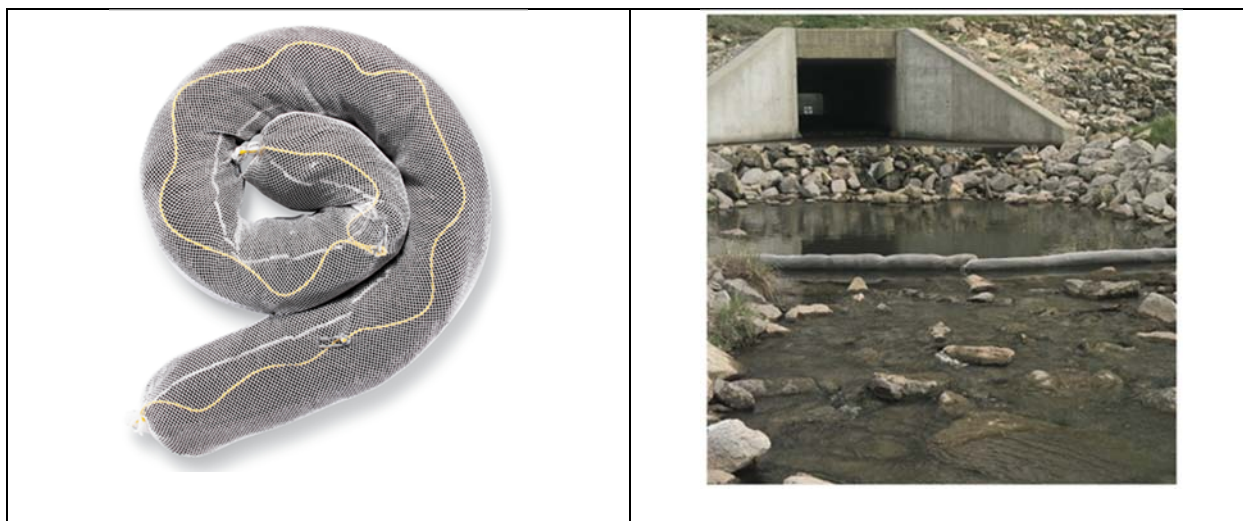
### **Proposed Floating Absorbent Booms**

Once each borehole is complete, water from the steel tub will be pumped through a floating discharge hose to a temporary containment located on land above normal high water level where it will infiltrate into the ground. The discharge hose will be secured to prevent the hose from floating downstream. The discharge hose will be connected to the pump on the drilling rig side with a ball valve that will be closed before the discharge hose is disconnected from the drilling rig to prevent backflow of water into the river. Terra proposes to grout only the bedrock portion of the shallow boreholes in the river in order to minimize the possibility of cementitious material getting into the water. The augers will be removed after being filled with water and slowly reverse-rotated out of the ground. An estimated 50 to 100 gallons of water will be required for coring each hole and this will be drawn directly from the river which should be permissible under the 1 January 2015 WV DEP minimum reporting threshold guidance.

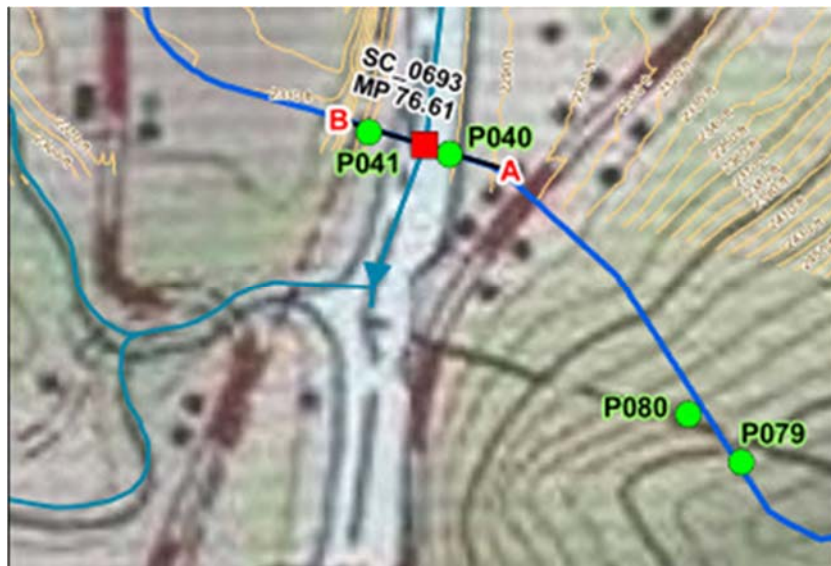
### **Plan of the Greenbrier River Crossing Showing Approximate Location of Boreholes**

- along the edge of the wetted perimeter of the west side (right bank) of the river, 25 feet south of the proposed pipe centerline alignment (near point P041 on the plan on Page 3).

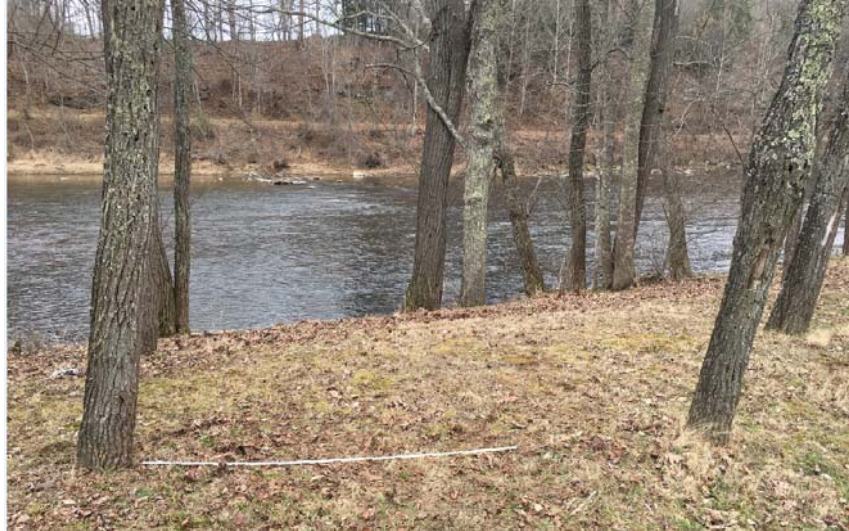
#### **Drill Access Route on East Side of River**

Access to the river will be achieved on the east bank at the point shown in the photo at the top of Page 4. The drilling rig has a narrow footprint and it should be possible to maneuver it between the trees but there is a remote possibility that one small diameter (6 inch DBH) dead tree may need to be removed. If this is required, the stump will be cut flush to the ground and the wood will be bucked into lengths manageable to move by hand. Areas disturbed by the drilling rig, along the bank will be raked smooth, to the extent practical, and covered with locally sourced straw.

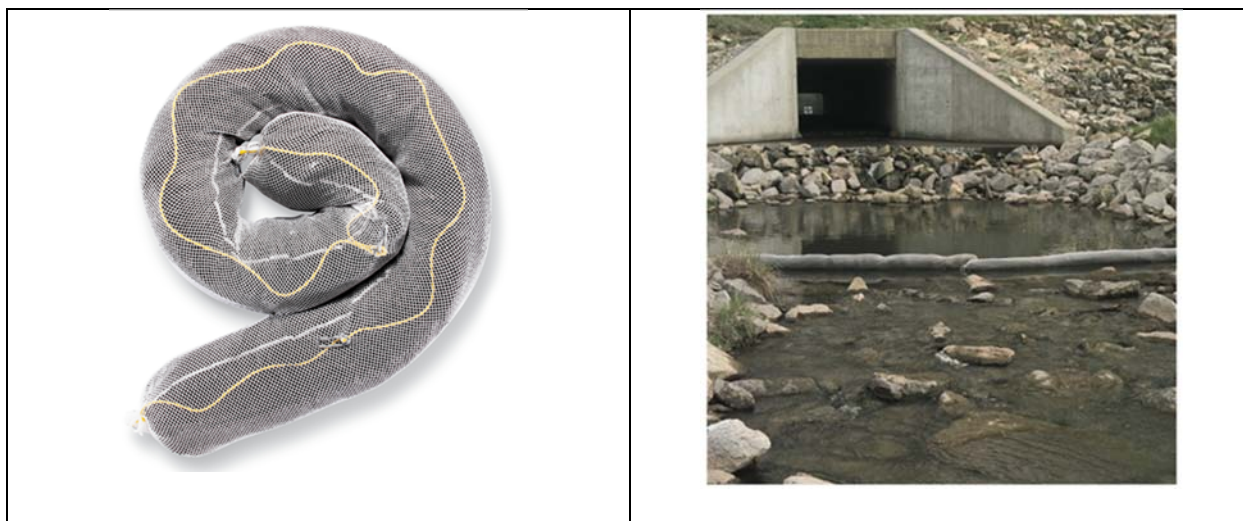
### **Proposed Floating Absorbent Booms**

Once each borehole is complete, water from the steel tub will be pumped through a floating discharge hose to a temporary containment located on land above normal high water level where it will infiltrate into the ground. The discharge hose will be secured to prevent the hose from floating downstream. The discharge hose will be connected to the pump on the drilling rig side with a ball valve that will be closed before the discharge hose is disconnected from the drilling rig to prevent backflow of water into the river. Terra proposes to grout only the bedrock portion of the shallow boreholes in the river in order to minimize the possibility of cementitious material getting into the water. The augers will be removed after being filled with water and slowly reverse-rotated out of the ground. An estimated 50 to 100 gallons of water will be required for coring each hole and this will be drawn directly from the river which should be permissible under the 1 January 2015 WV DEP minimum reporting threshold guidance.

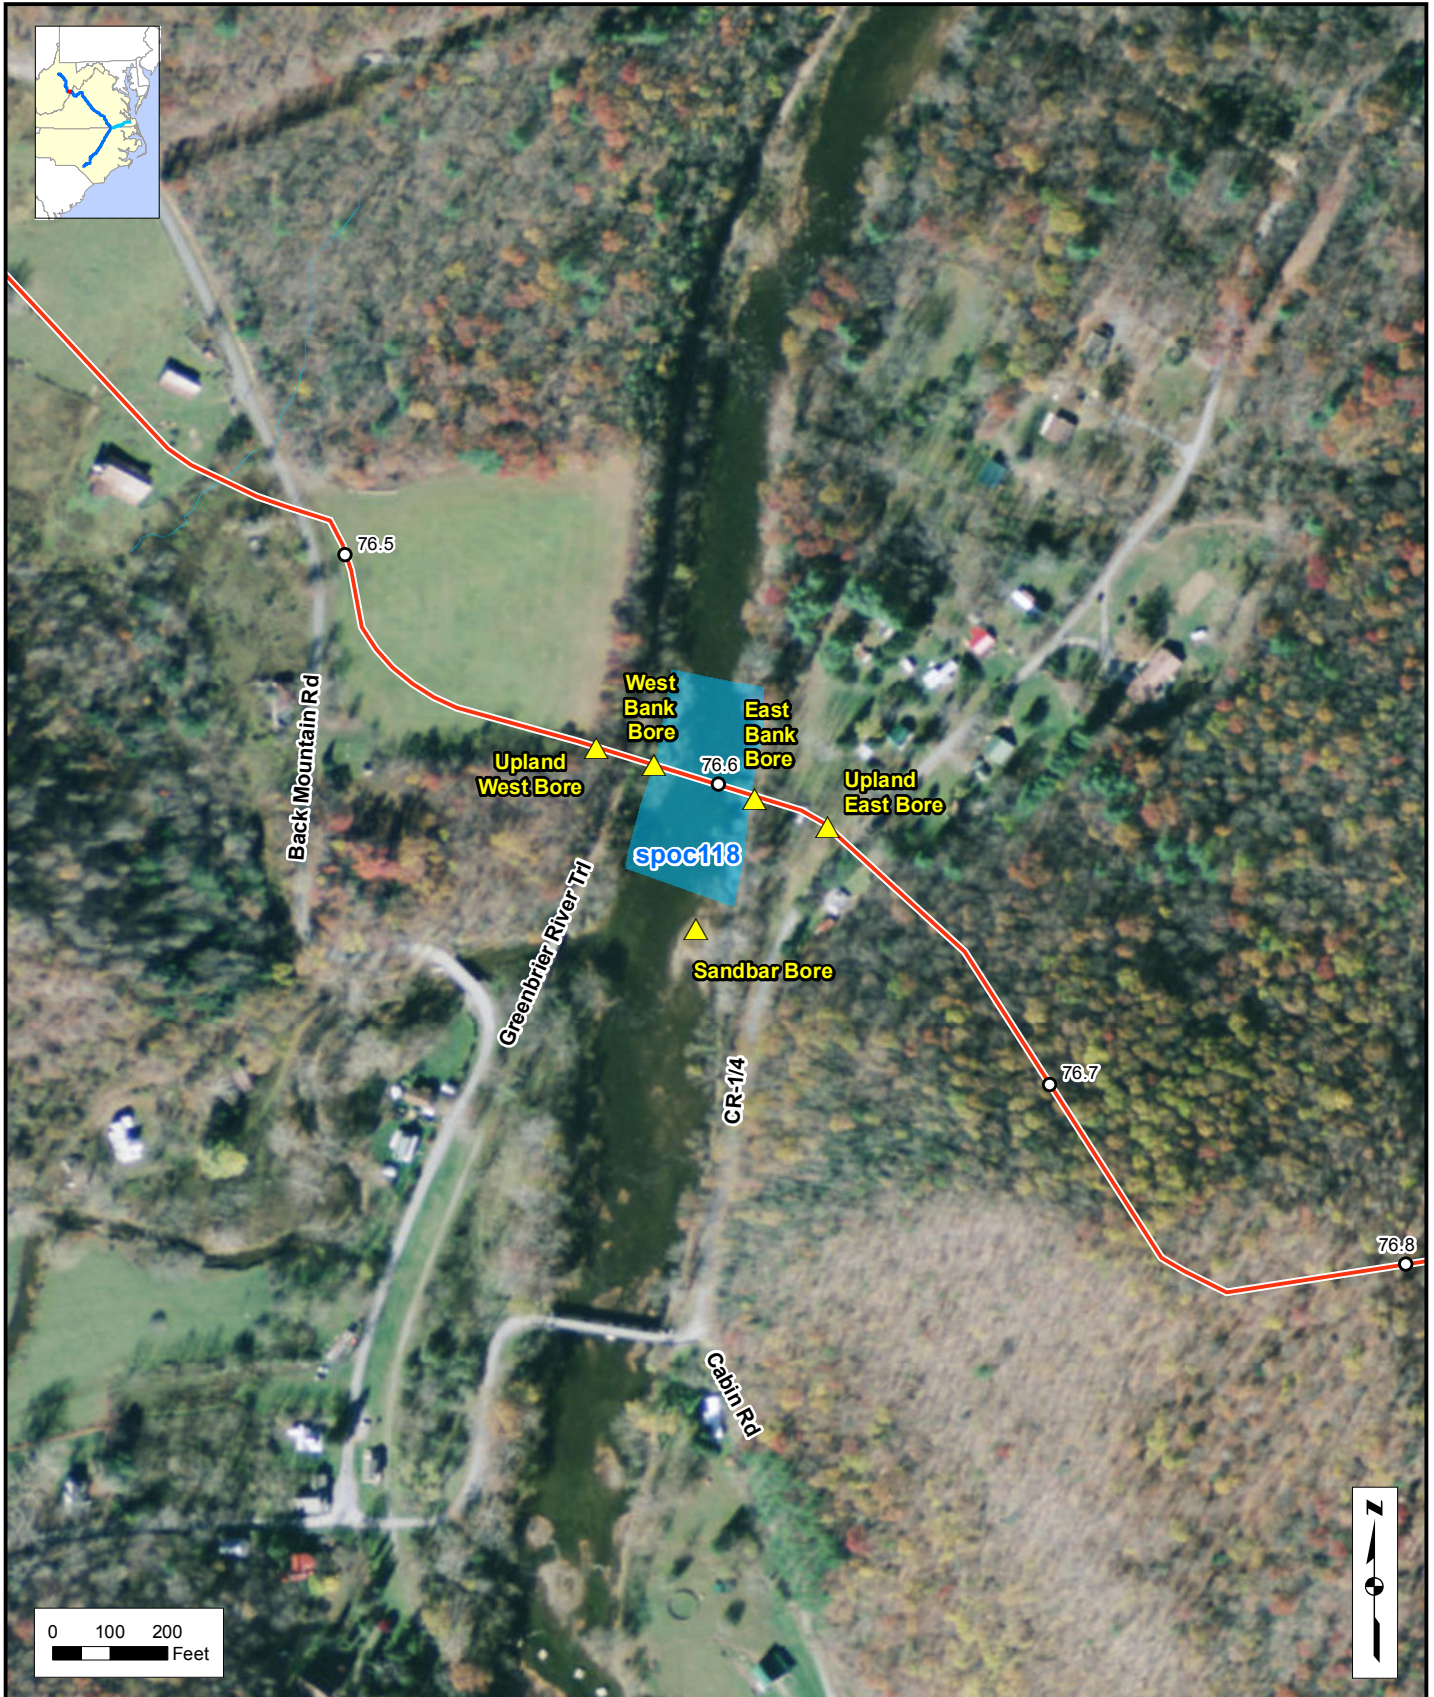
Map of Approximate Locations of Boring Locations  
for the Greenbrier River

**Atlantic Coast Pipeline**  
 Proposed Geotechnical  
 Investigation of the Greenbrier  
 River Crossing

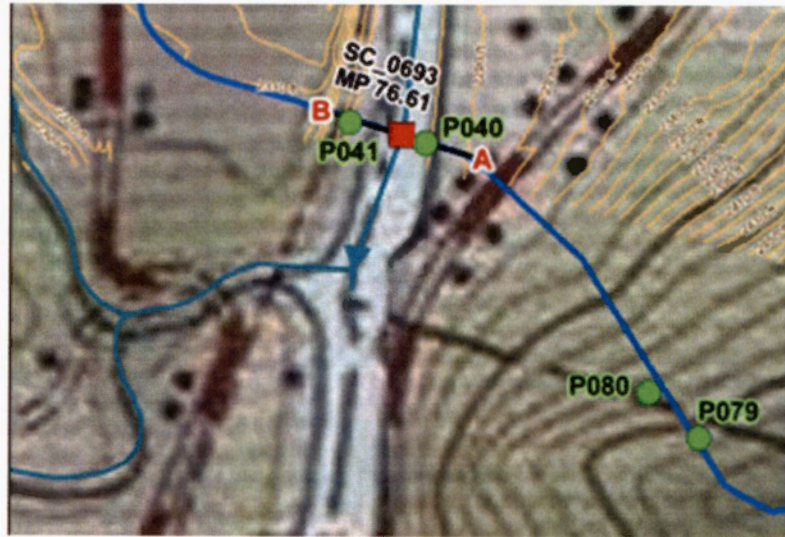
#### **Plan of the Greenbrier River Crossing Showing Approximate Location of Boreholes**

- along the edge of the wetted perimeter of the west side (right bank) of the river, 25 feet south of the proposed pipe centerline alignment (near point P041 on the plan on Page 3).

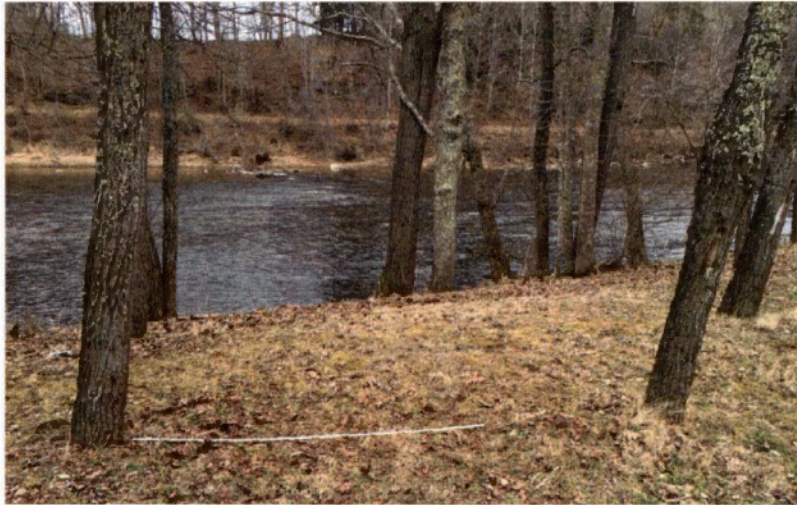
#### **Drill Access Route on East Side of River**

Access to the river will be achieved on the east bank at the point shown in the photo at the top of Page 4. The drilling rig has a narrow footprint and it should be possible to maneuver it between the trees but there is a remote possibility that one small diameter (6 inch DBH) dead tree may need to be removed. If this is required, the stump will be cut flush to the ground and the wood will be bucked into lengths manageable to move by hand. Areas disturbed by the drilling rig, along the bank will be raked smooth, to the extent practical, and covered with locally sourced straw.

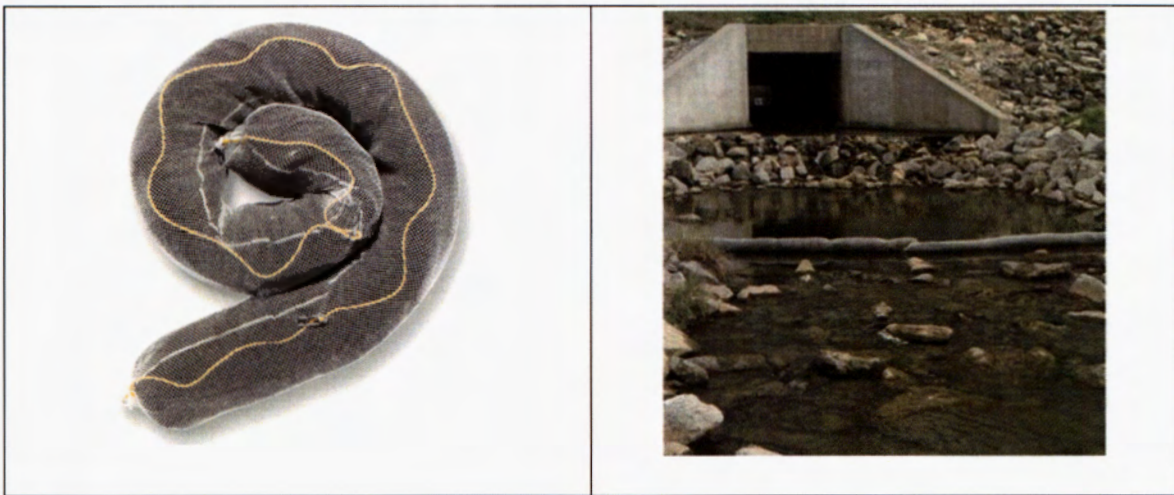
#### **Proposed Floating Absorbent Booms**

Once each borehole is complete, water from the steel tub will be pumped through a floating discharge hose to a temporary containment located on land above normal high water level where it will infiltrate into the ground. The discharge hose will be secured to prevent the hose from floating downstream. The discharge hose will be connected to the pump on the drilling rig side with a ball valve that will be closed before the discharge hose is disconnected from the drilling rig to prevent backflow of water into the river. Terra proposes to grout only the bedrock portion of the shallow boreholes in the river in order to minimize the possibility of cementitious material getting into the water. The augers will be removed after being filled with water and slowly reverse-rotated out of the ground. An estimated 50 to 100 gallons of water will be required for coring each hole and this will be drawn directly from the river which should be permissible under the 1 January 2015 WV DEP minimum reporting threshold guidance.
