<b>TID</b>	SC_0767	<b>ACP Segment</b>	AP-1
<b>Stream Name</b>	Hodges Draft	<b>MP</b>	112.60
<b>Survey Date</b>	07-April-2016	<b>Start Time</b>	1545 hrs

PHASE 2 - RAPID STREAM RECONNAISSANCE  
Photographic Record

**Subject Site:** SC\_0767, Hodges Draft at MP 112.60 (AP-1)

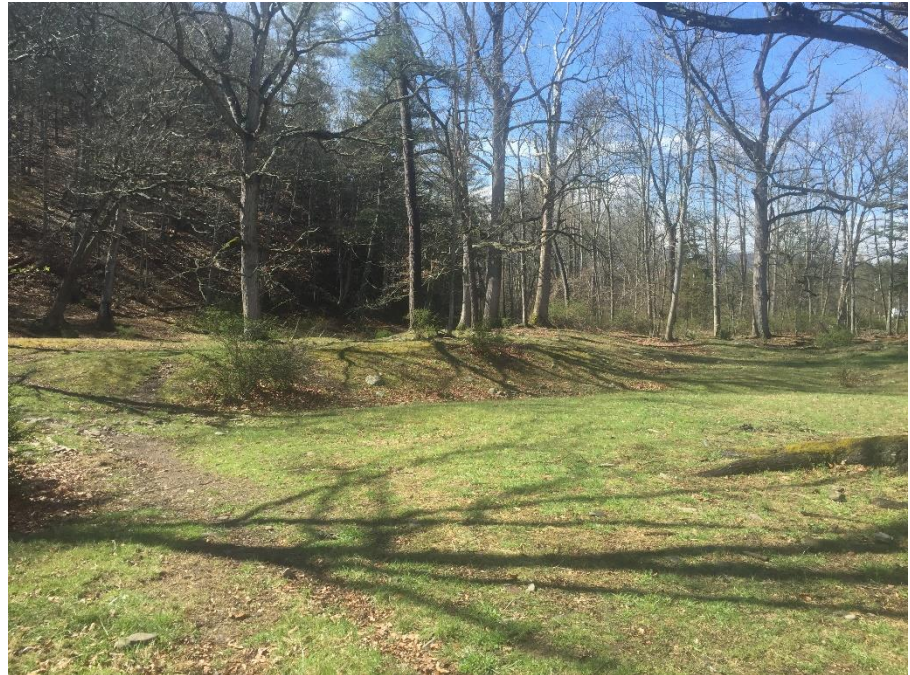
Description: View of hummocky terrain on the right bank of the stream indicative of debris flow deposits. Also steep slope to the right of the stream.

Given debris flow hazard bury pipeline into bedrock with at least 1.5-foot of cover above the crown from valley wall on right bank through the extent of the riparian buffer on the left bank.

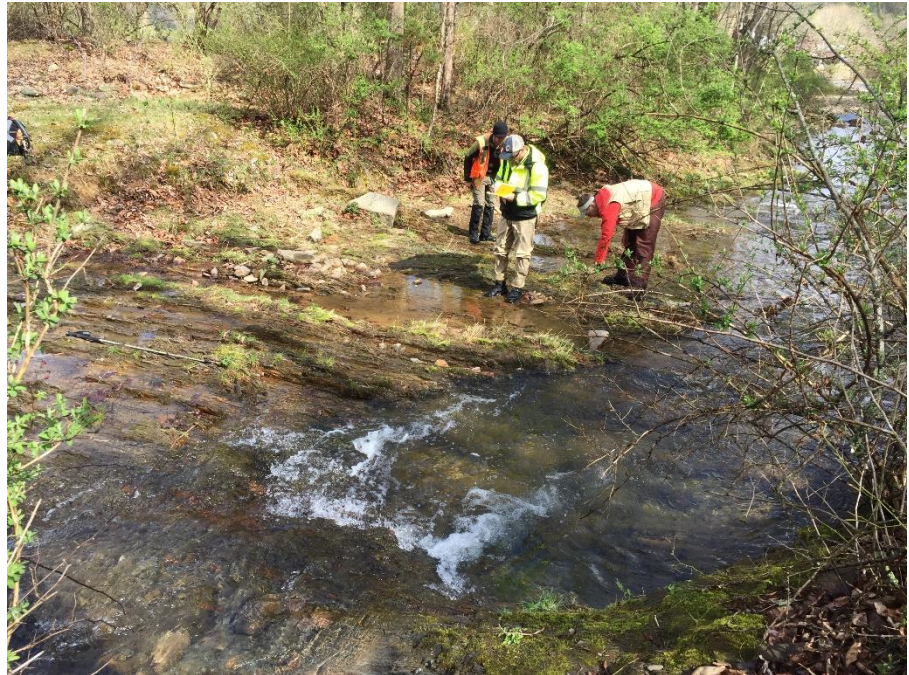
Photograph 2  
(IMG\_008.jpg)

Description: View of rock  
outcrop near stream  
crossing

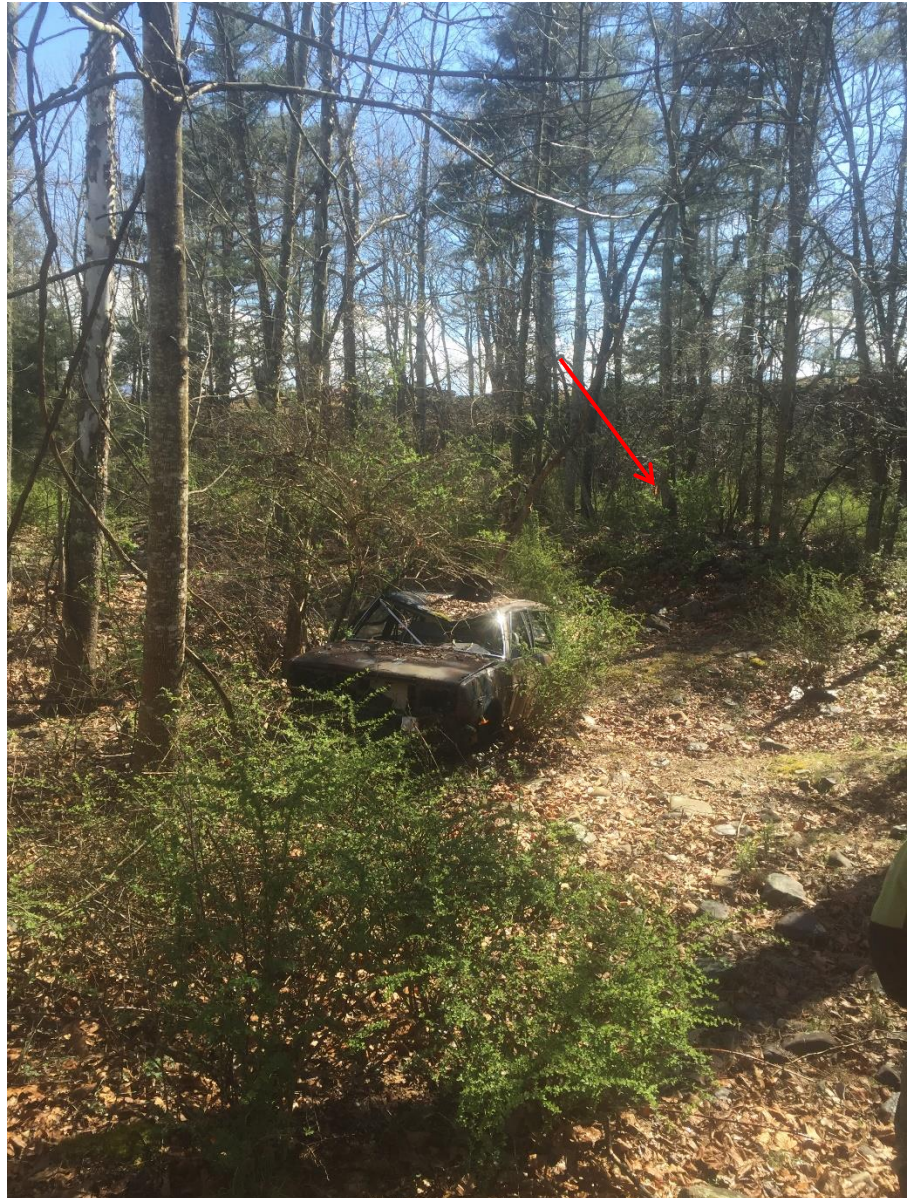
Photograph 3  
(075.jpg)

Description: FIAT 131 Superbrava vehicle logged in trees indicative of the strength of the stream during flood stages. Last registration on vehicle license plate is 1986. Arrow point to survey flag.

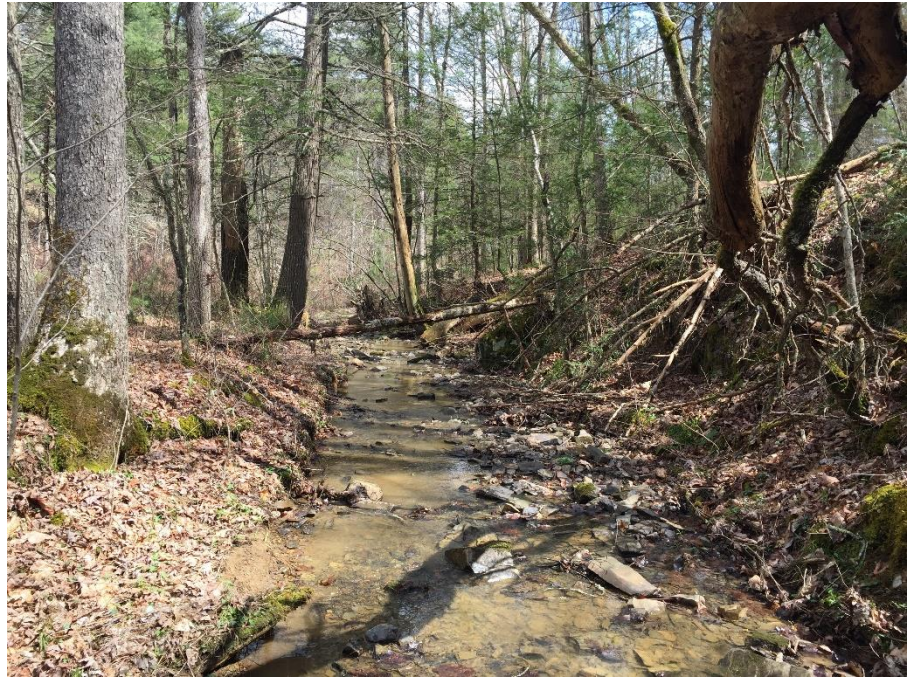
Description: Stream runs within narrow valley (notice left valley wall in background) and against steep slope of right valley wall. Angular and subangular gravel and cobble-sized particles in stream bed.

Bury pipeline into bedrock with at least 1.5-foot of cover above the crown from valley wall valley wall.

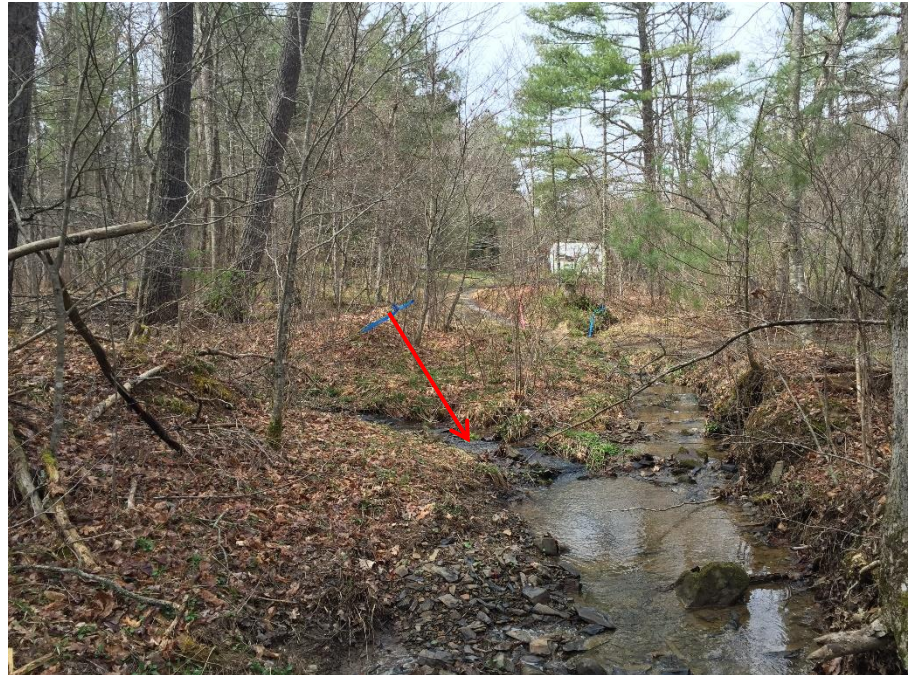
Description: View of anastomosing of stream upstream and bedrock on stream bed (red arrow).

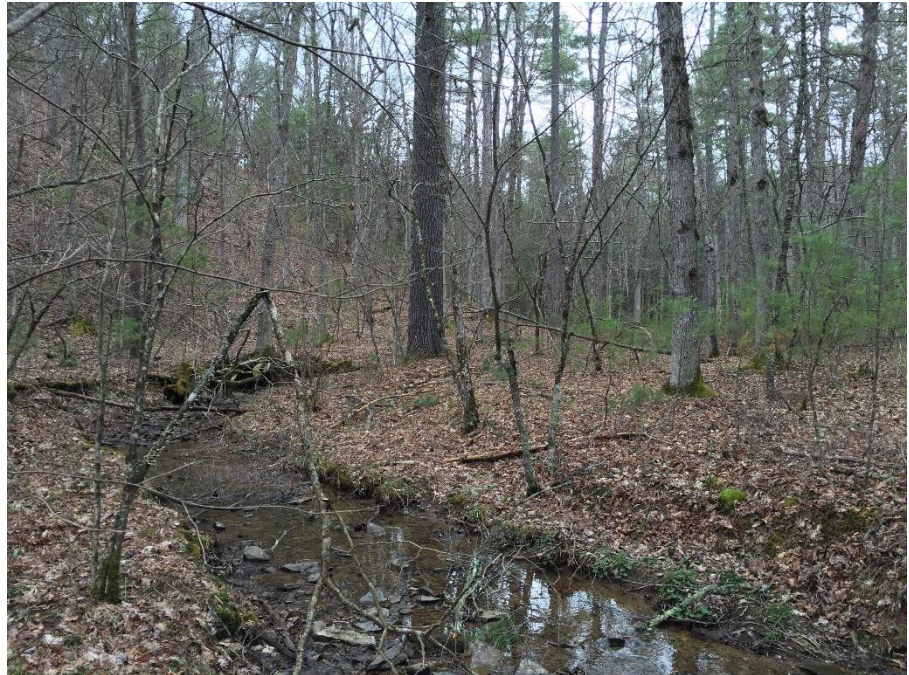
Description: View of slope on right bank and gravel and cobble-sized laminar and subangular particles on stream bed.

Given channel migration potential, it is recommended to bury pipeline into bedrock with at least 1.5-foot of cover above the crown from valley wall on right bank to valley wall.

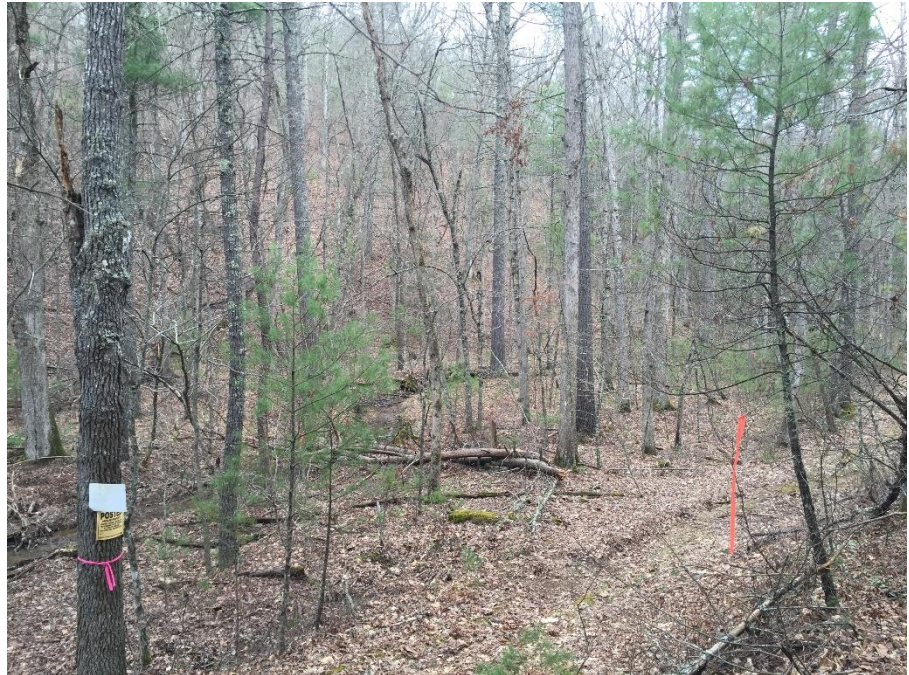
Description: View of narrow valley from left valley wall.

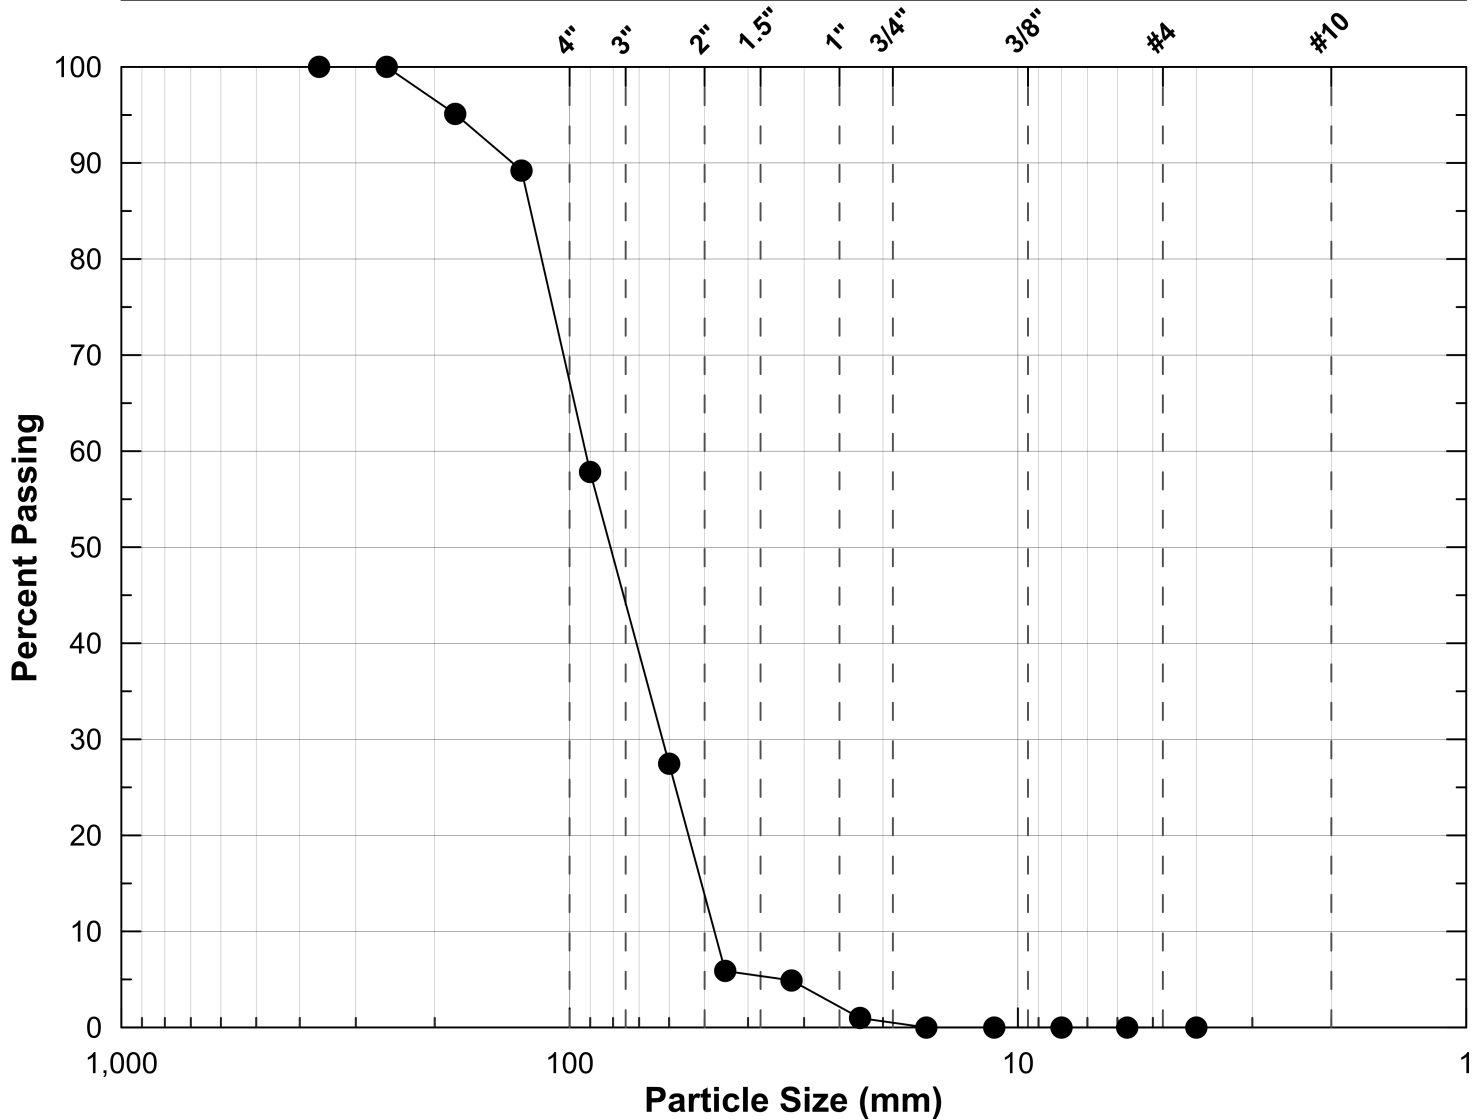
# Wolman Pebble Count at SC\_0758

Boulders	Cobbles	Gravel				Sand	
		coarse		fine		coarse	medium

Evaluate scour depth for pipeline burial depth. Lateral migration does not appear to be a significant hazard, as landowner will likely ensure that stream stays within current channel. Left bank sag bend should be placed at least two stream widths from existing left bank. Right bank sag bend should be located at valley wall due to channel avulsion potential and lateral and vertical geomorphic instability of stream.

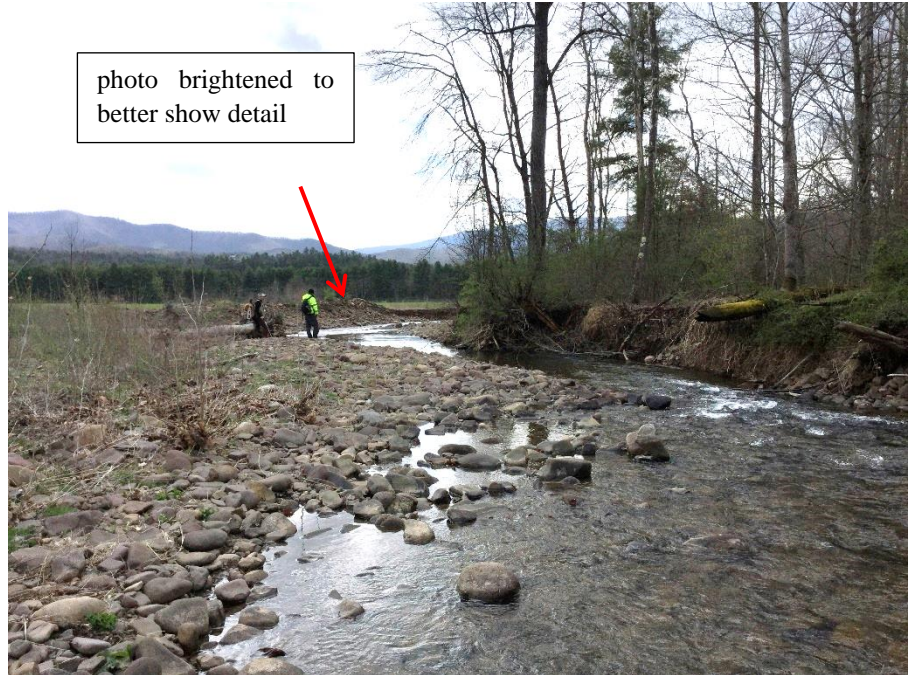
Description: Stream bed comprising cobbles with  $D_{50} = 81 \text{ mm}$  (3.2"). No riparian buffer on left bank. Left bank slope is shallow and connected to flood plain. Man-made obstruction (red arrow) about 30 yards downstream.

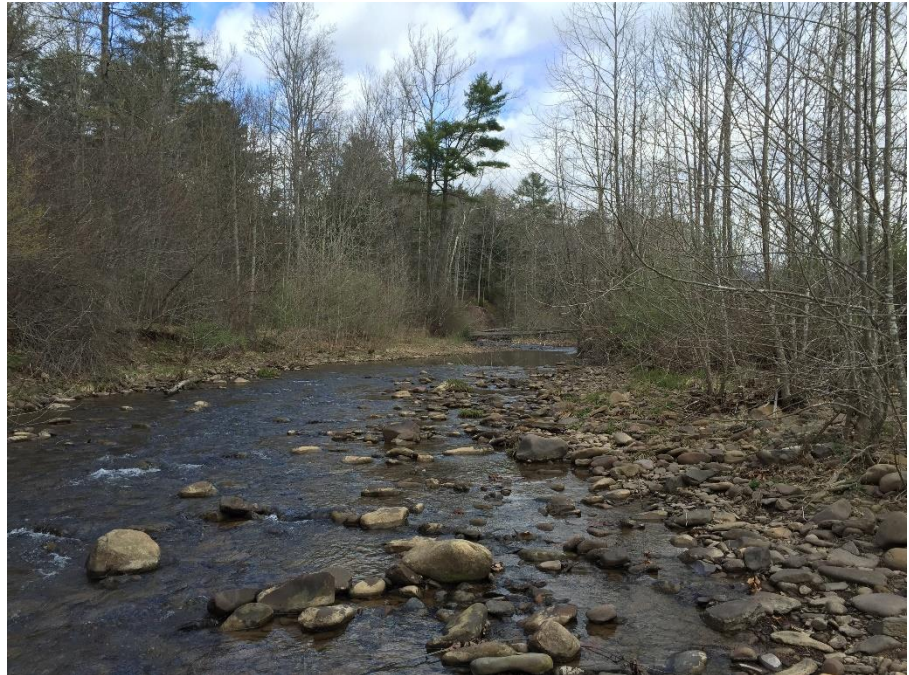
Description: Dense deciduous forest riparian buffer on right bank. Occasional boulders on stream.

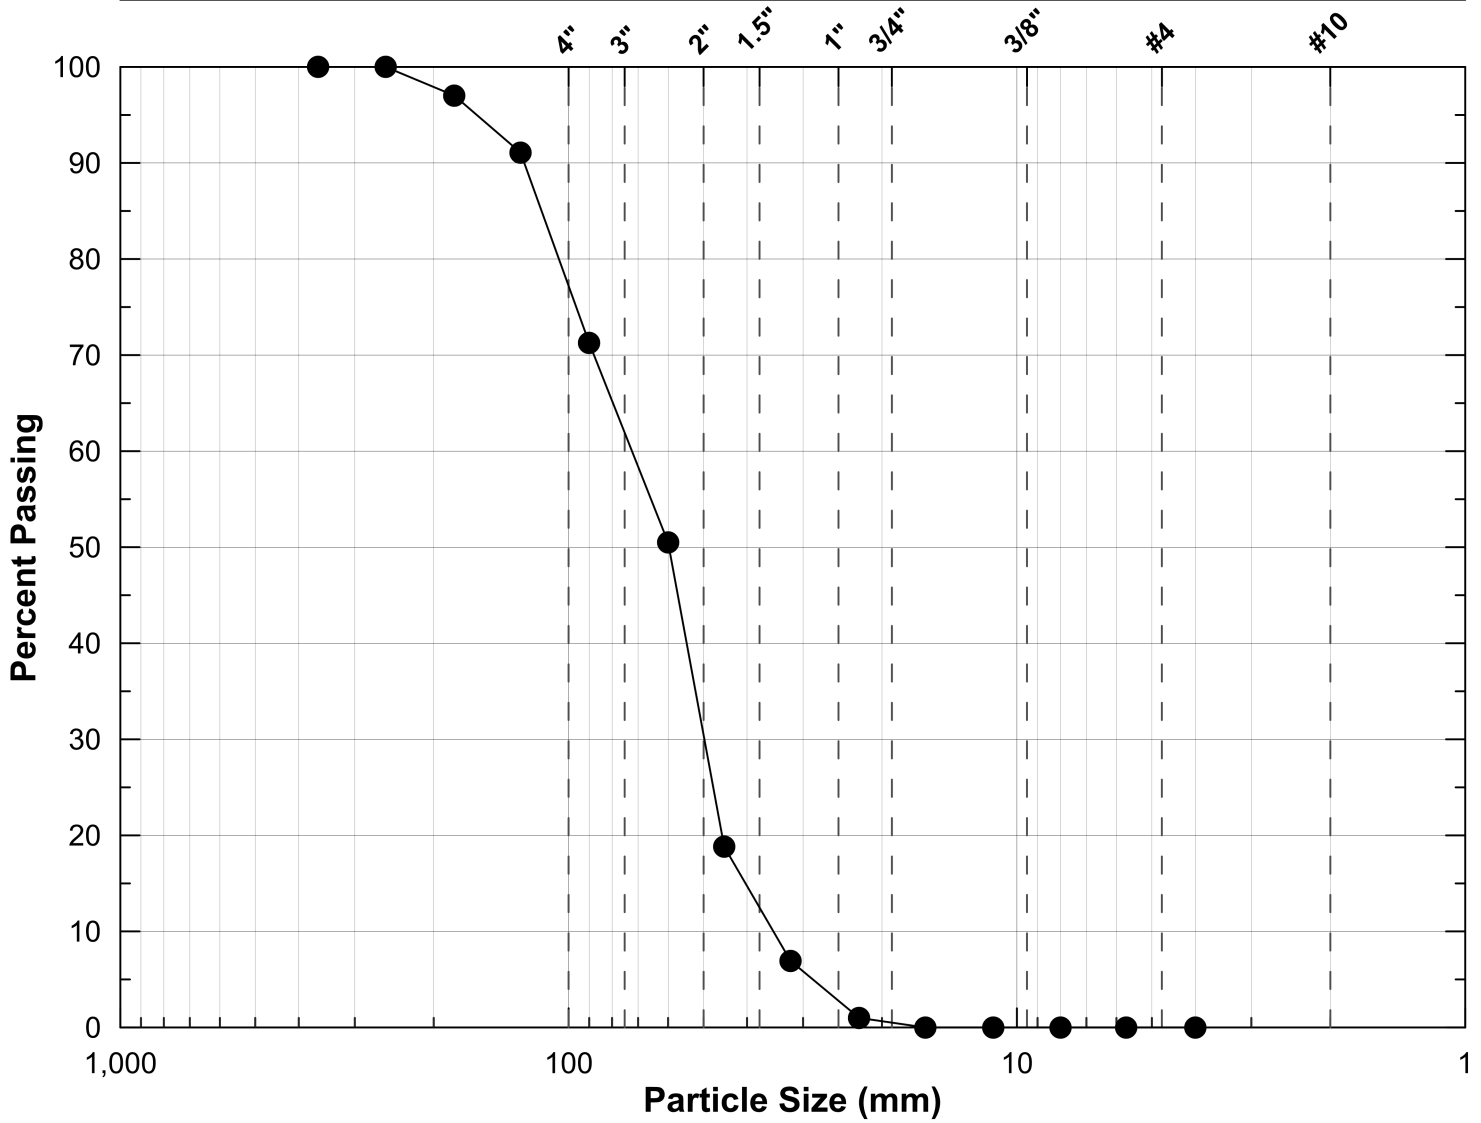
# Wolman Pebble Count at SC\_0759

Boulders	Cobbles	Gravel				Sand	
		coarse		fine		coarse	medium

Given debris flow hazard, it is recommended to bury pipeline into bedrock with at least 1.5-foot of cover above the crown across valley bottom.

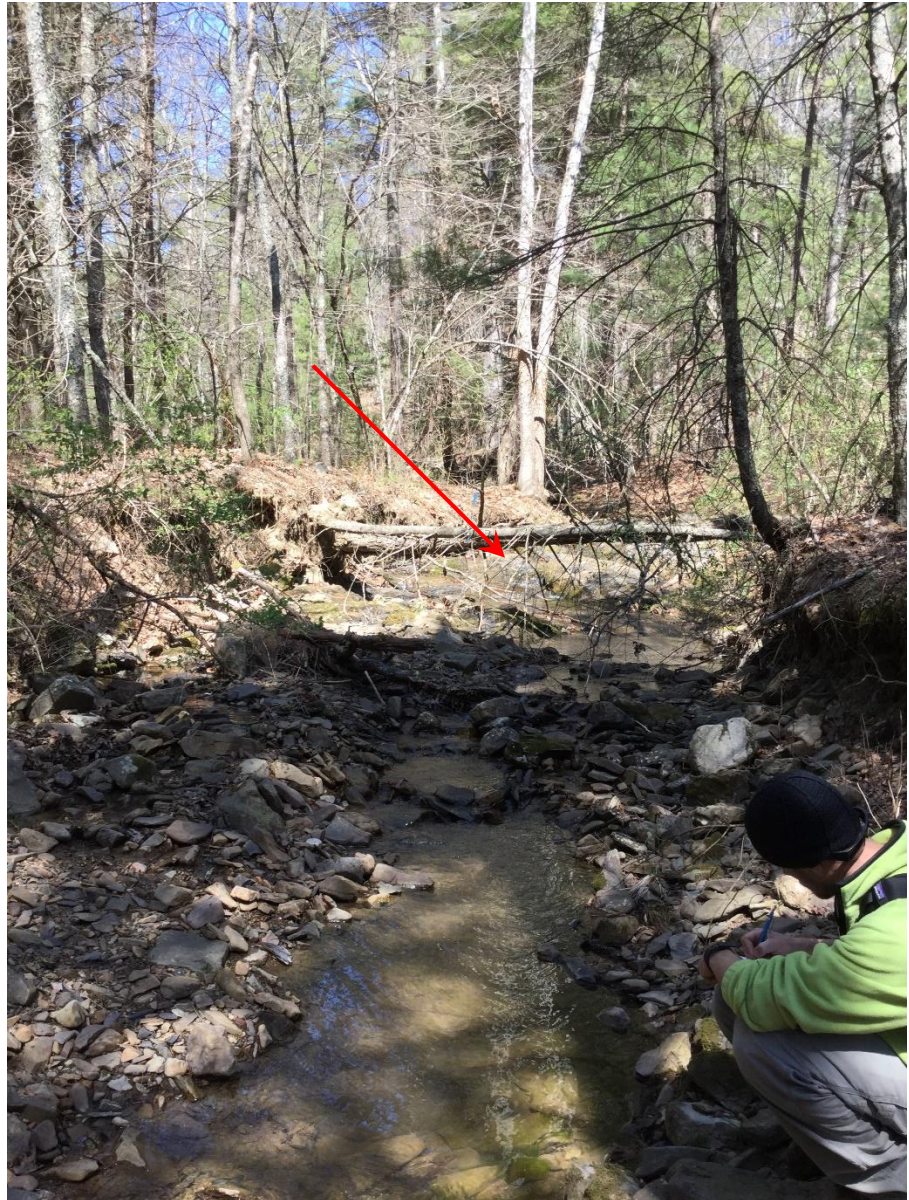
Description: Stream located in dense deciduous forest within banks about 2.5-ft high. Sub-angular to sub-rounded coarse gravel and cobble sized particles. Shale outcrop identified about 100 feet upstream of pipeline crossing (red arrow).

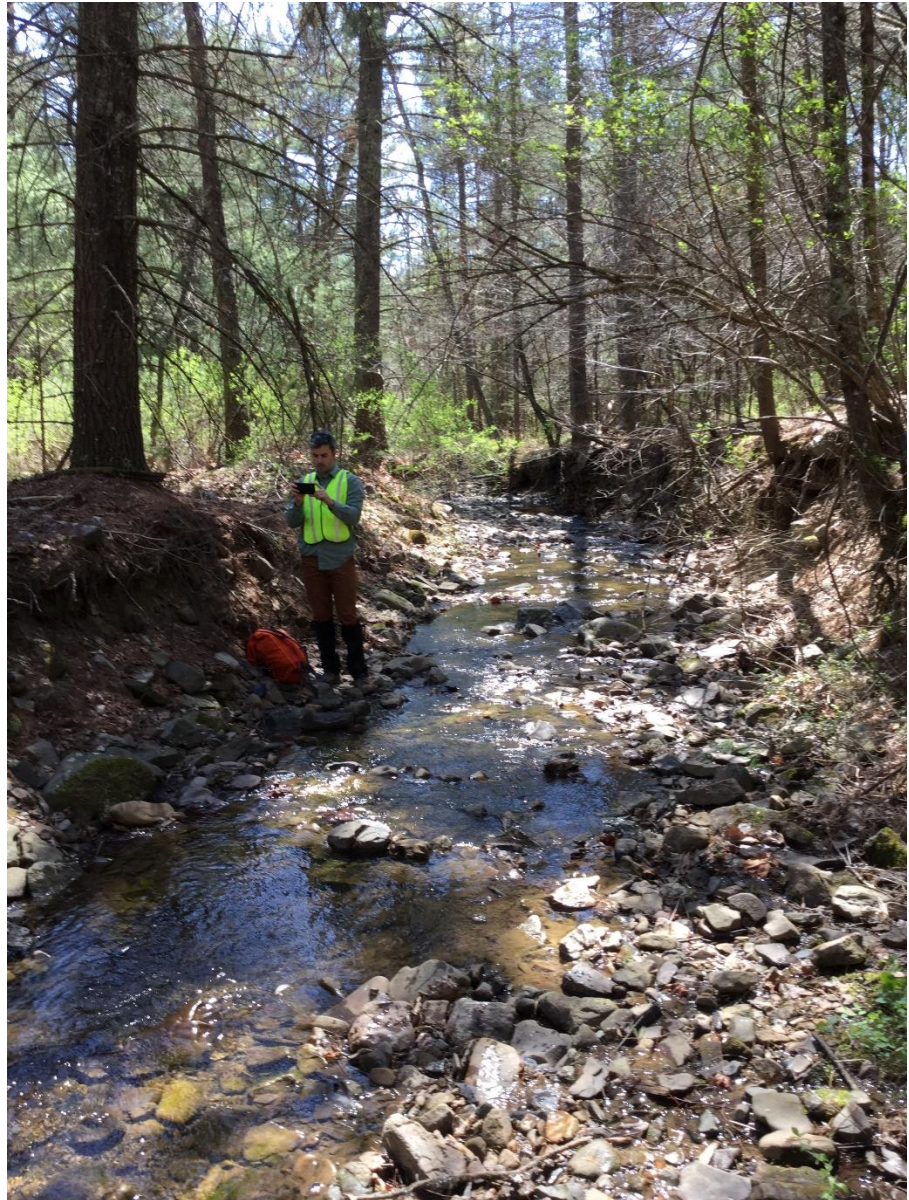
Description: Notice approximately 5-ft high banks incised into floodplain.

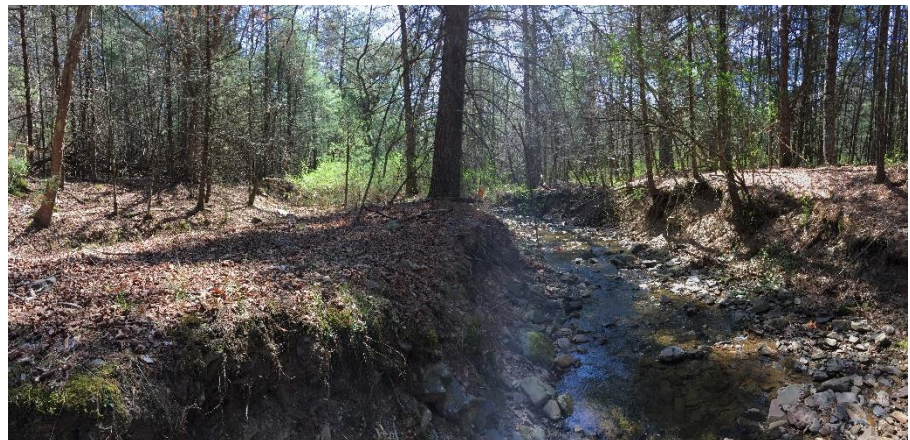
Description: Panoramic view of current stream and relic stream channel on the left.

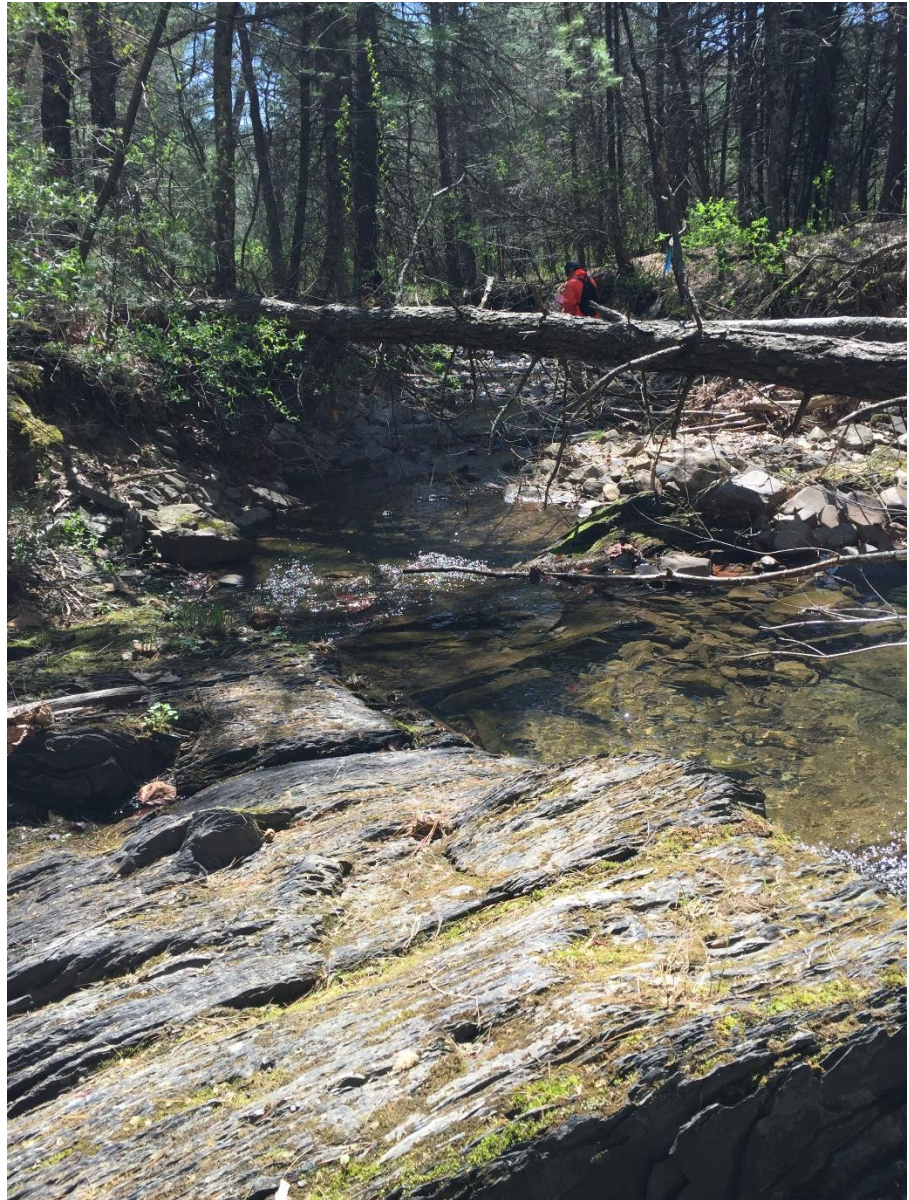
Description: Closer view  
of bedrock outcrop in  
stream.

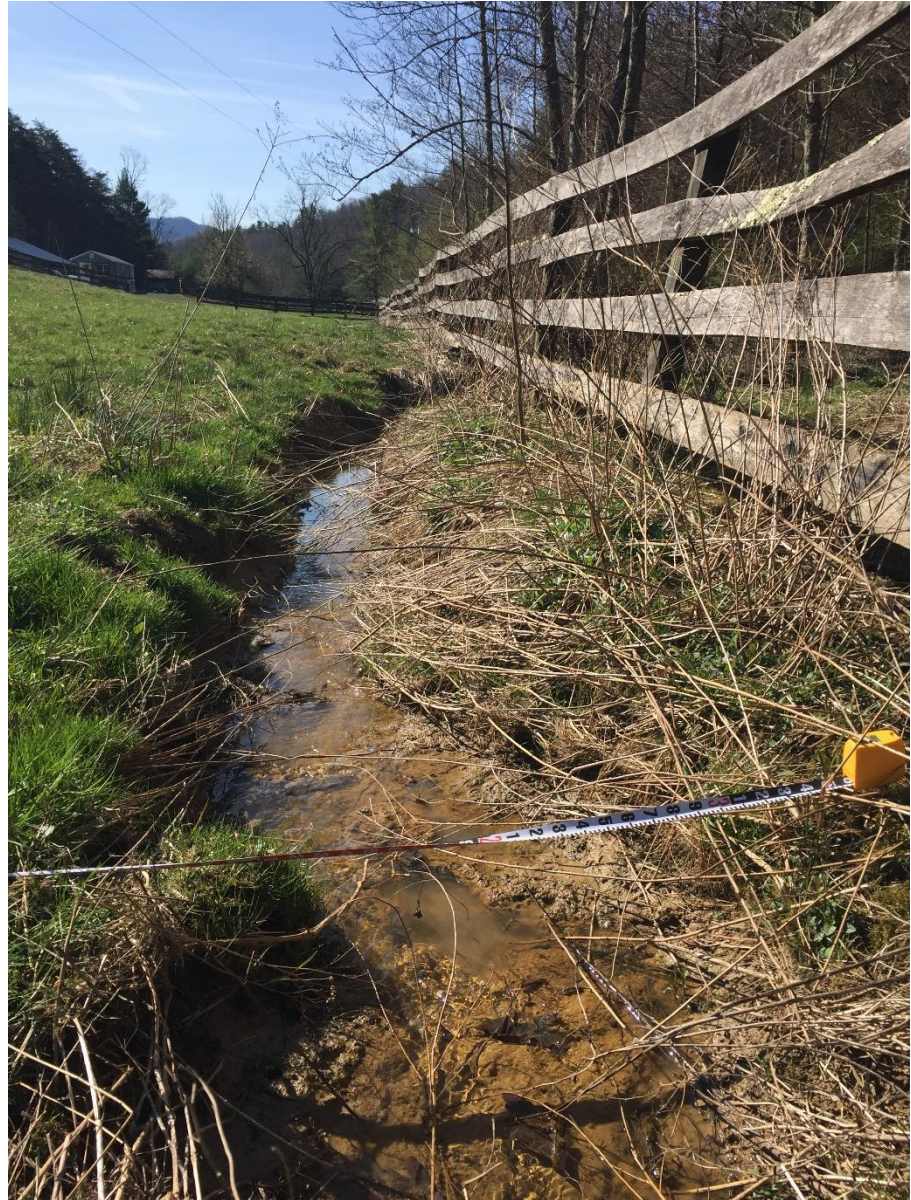
Description: Stream located in a narrow pasture meadow. Stream bed is comprised of stiff clay. Stream width at bankfull is 2.2 ft.

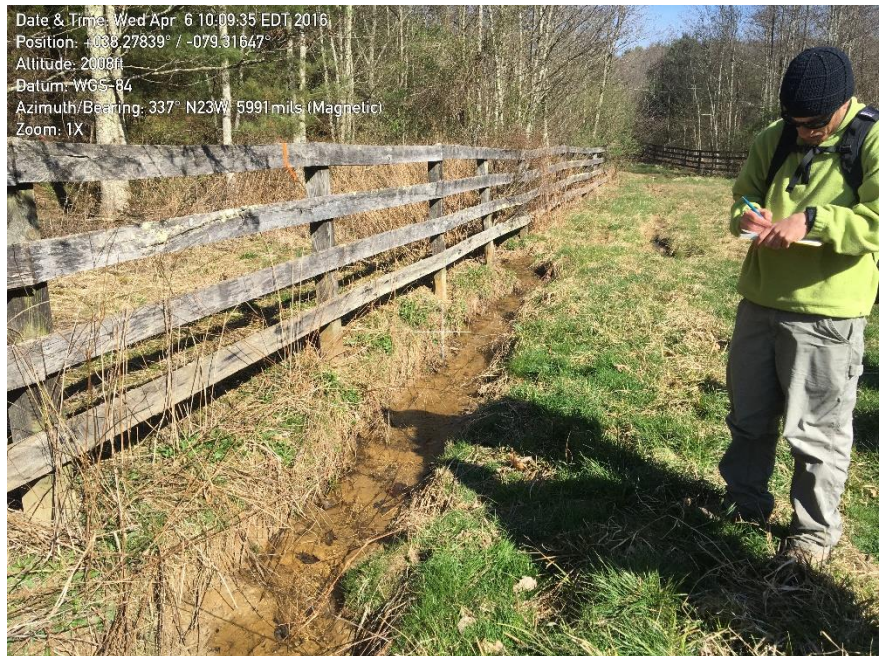
Description: Riparian area on right bank is young and left bank is a wet meadow.

No further studies required due to low hazard rating. Use typical pipeline burial procedures.

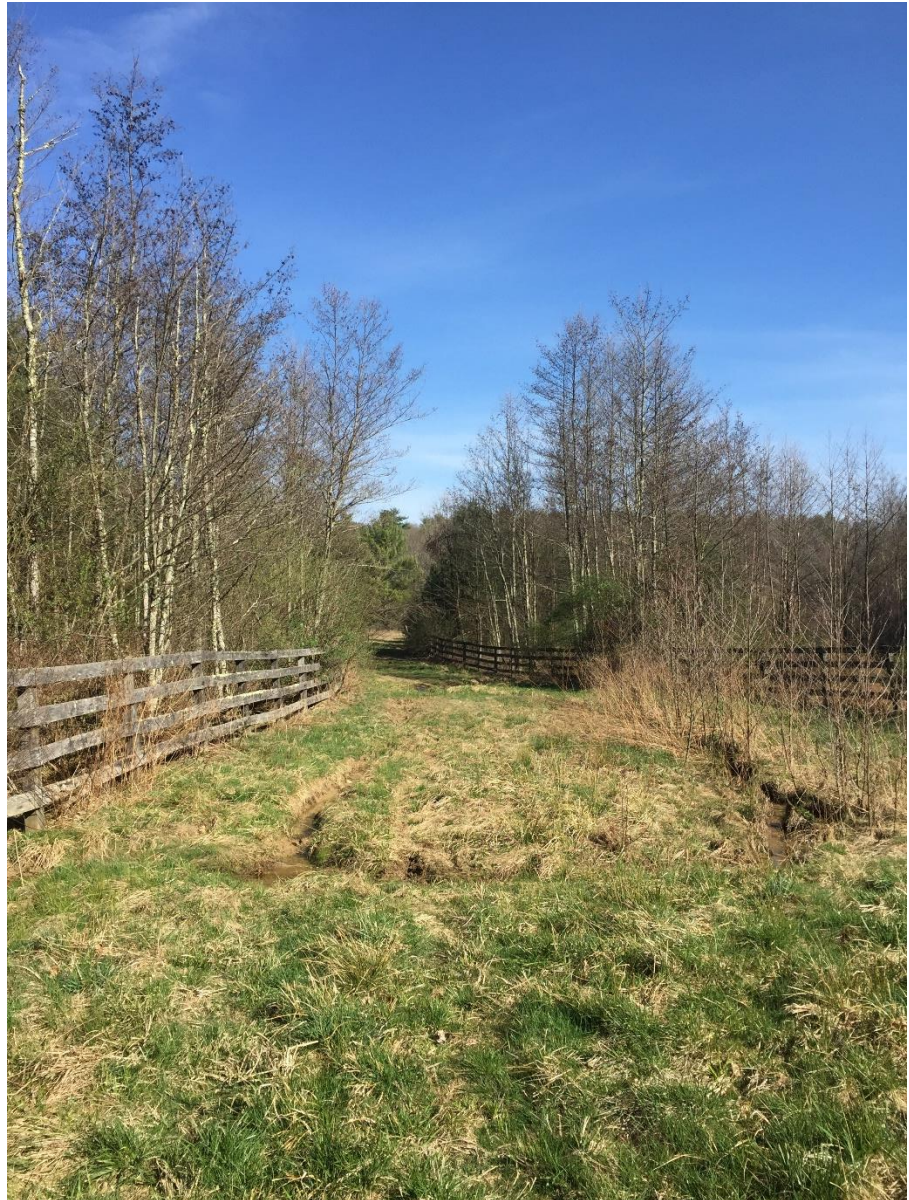
Description: Stream crossing meadow from right to left upstream of pipeline crossing

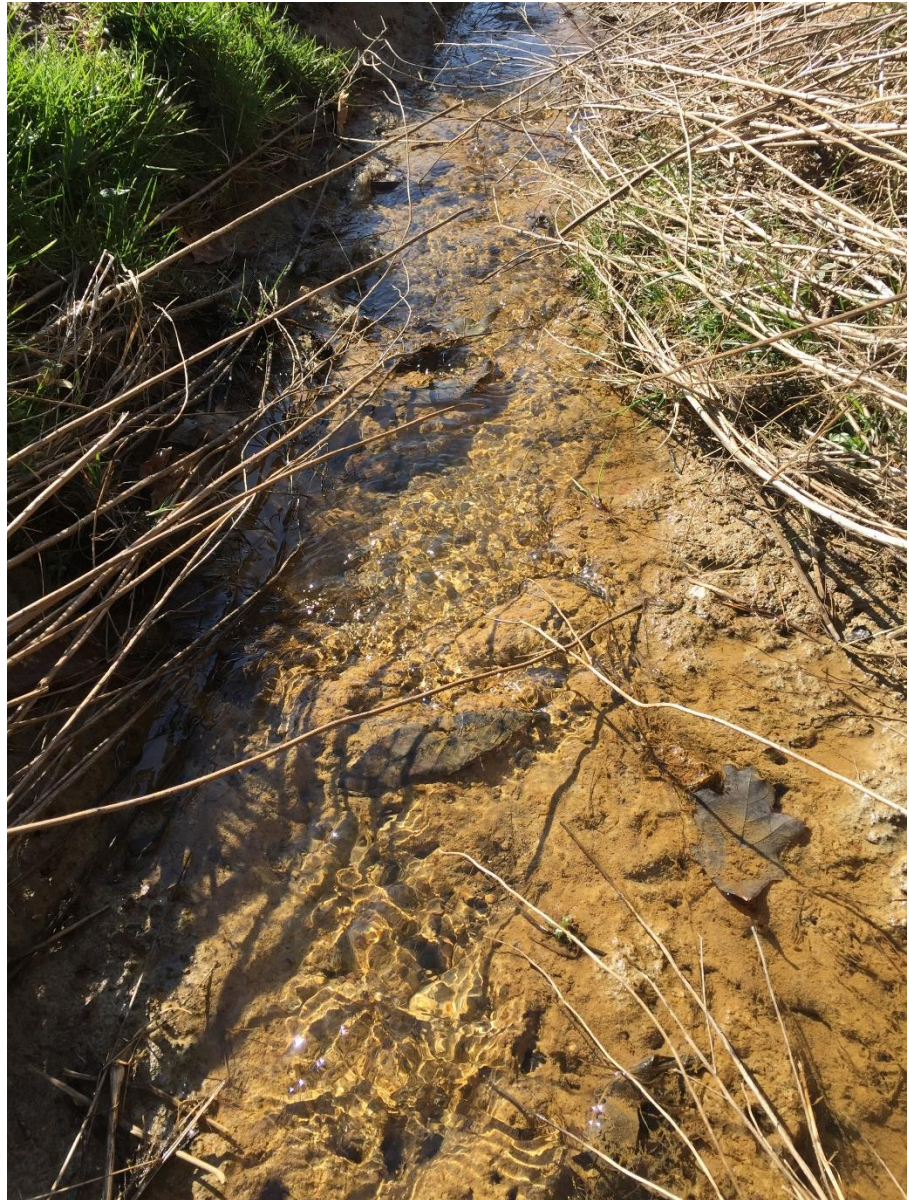
Description: Closer view  
of stiff clay in stream bed.

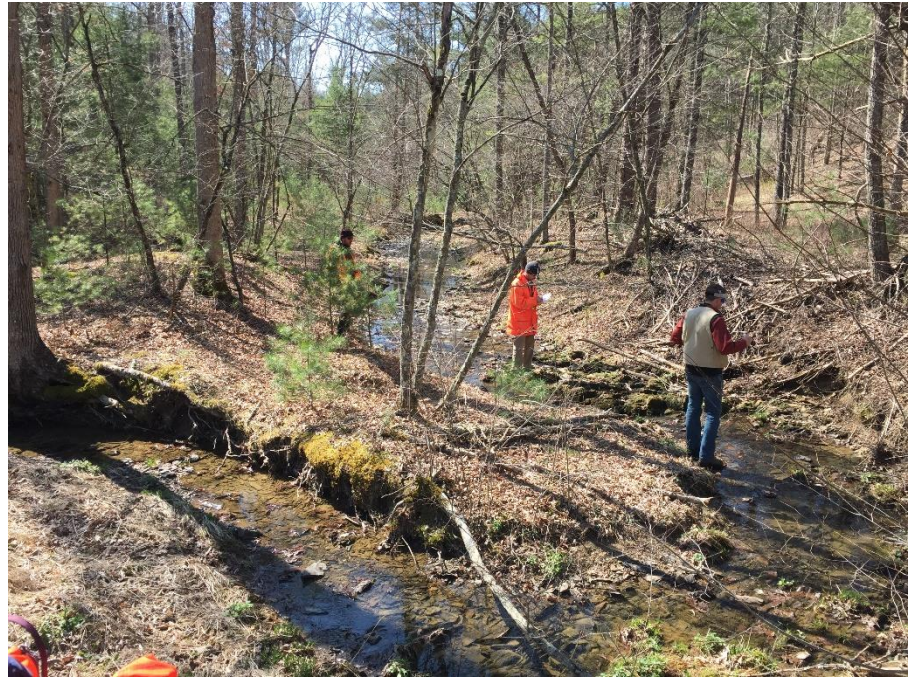
Description: Stream bed with angular to subangular cobble and gravel-sized particles in braided stream with tight meanders. Stream within Dense deciduous forest.

Due to meander migration across floodplain it is recommended that sag bends be placed at each valley edge and pipeline be buried in bedrock due to its close proximity to the surface. No further studies required due to low hazard rating.

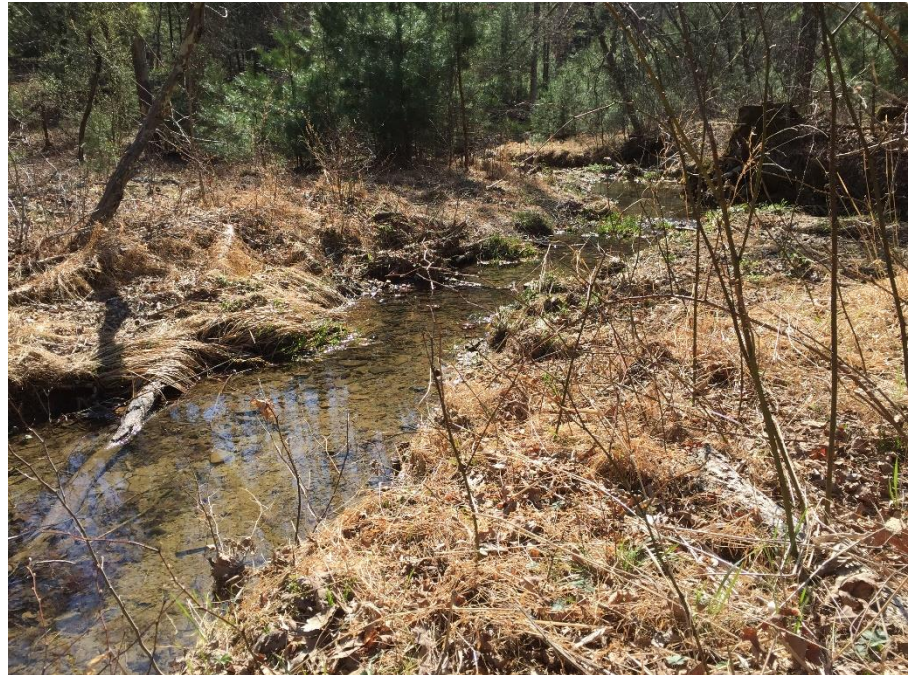
Description: Notice laminar and angular and subangular gravel and cobble-sized particles in stream bed

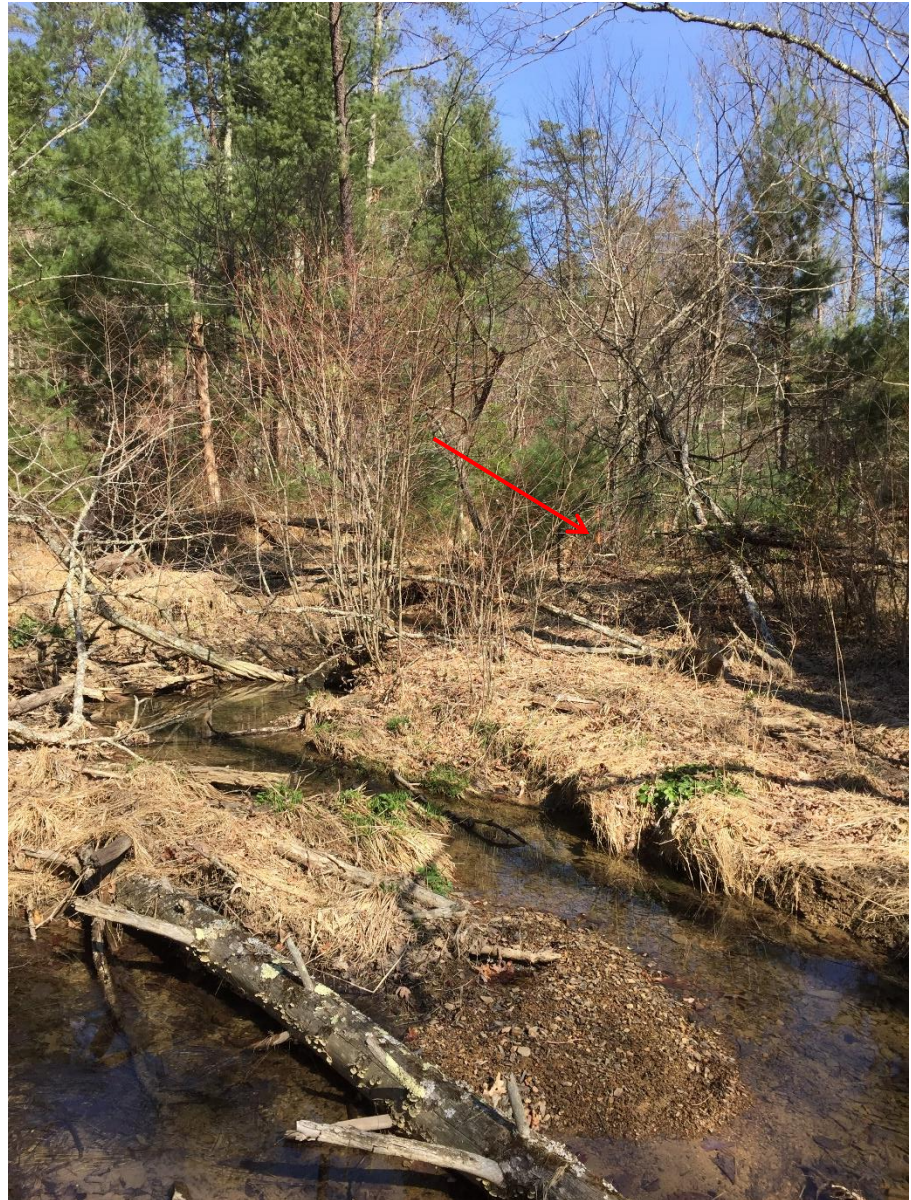
Description: numerous  
felled trees along stream.  
Pipeline alignment at  
orange tape (red arrow)

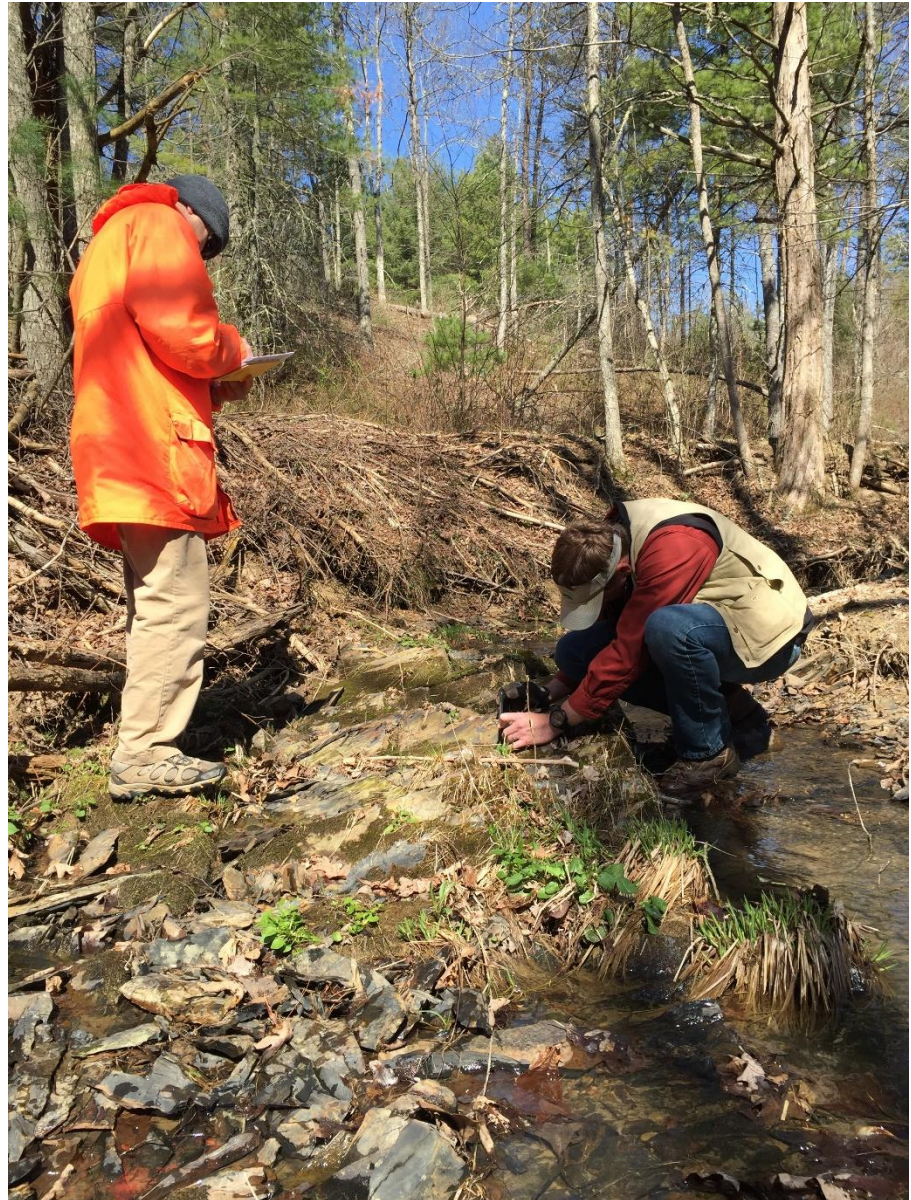
Description: Rock outcrop located approximately 100 yards upstream from pipeline crossing. Also notice valley wall following the left bank.

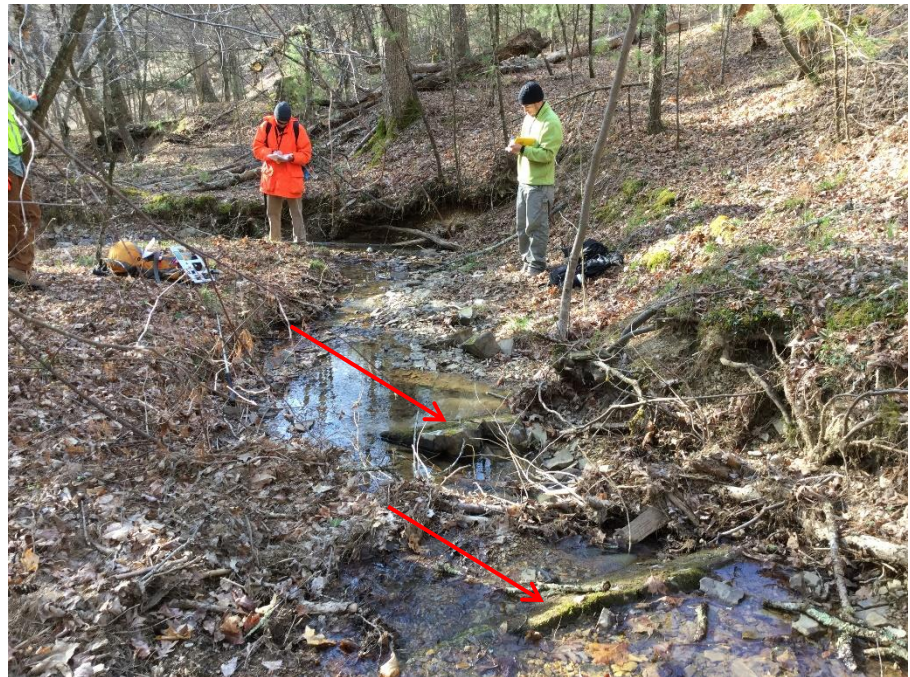
Description: Stream located in dense deciduous forest within narrow valley. Rock outcrops noticeable on stream bed (red arrows). Valley wall (left bank) noticeable.

Given debris flow hazard, it is recommended to bury pipeline into bedrock with at least 1.5-foot of cover above the crown across valley bottom.

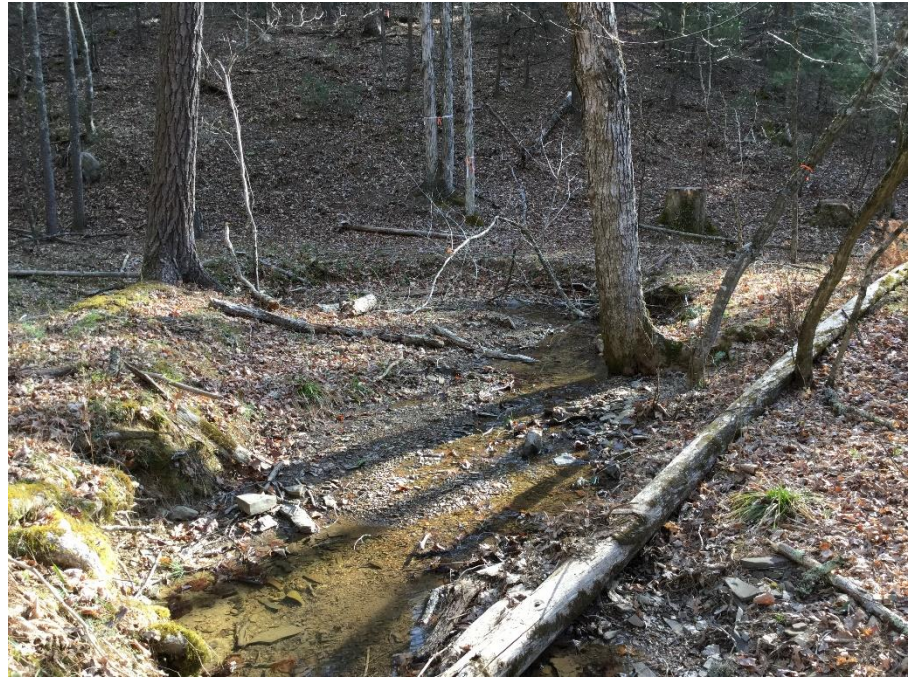
Description: View of pipeline alignment (orange tags on trees) and valley wall. Notice angular cobble and gravel-sized particles on stream bed.
