<b>TID</b>	SC_0767	<b>ACP Segment</b>	AP-1
<b>Stream Name</b>	Hodges Draft	<b>MP</b>	112.60
<b>Survey Date</b>	07-April-2016	<b>Start Time</b>	1545 hrs

PHASE 2 - RAPID STREAM RECONNAISSANCE  
Photographic Record

**Subject Site:** SC\_0767, Hodges Draft at MP 112.60 (AP-1)

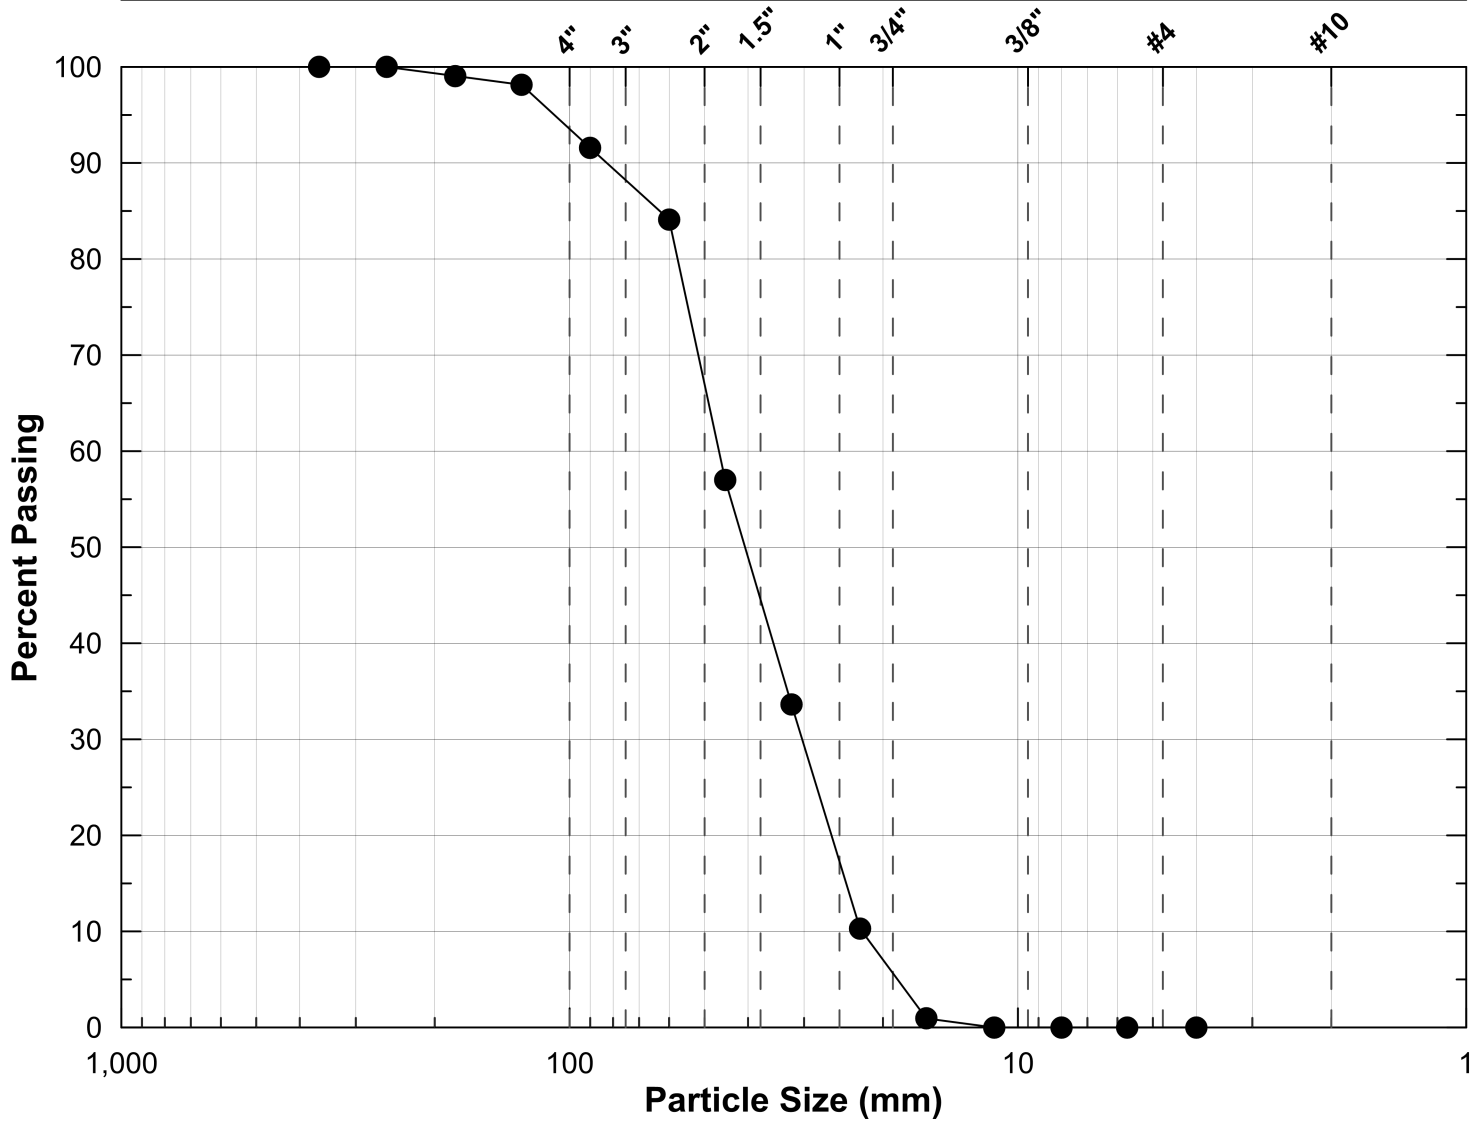
# Wolman Pebble Count at SC\_0789

Boulders	Cobbles	Gravel		Sand	
		coarse	fine	coarse	medium

Evaluate scour depth for pipeline burial depth. Lateral migration hazard towards the left bank with thin riparian buffer to be accounted for through placement of sag bends approximately three to four channel widths from left bank. Place sag bends within right bank riparian buffer approximately two to three channel widths from right bank.

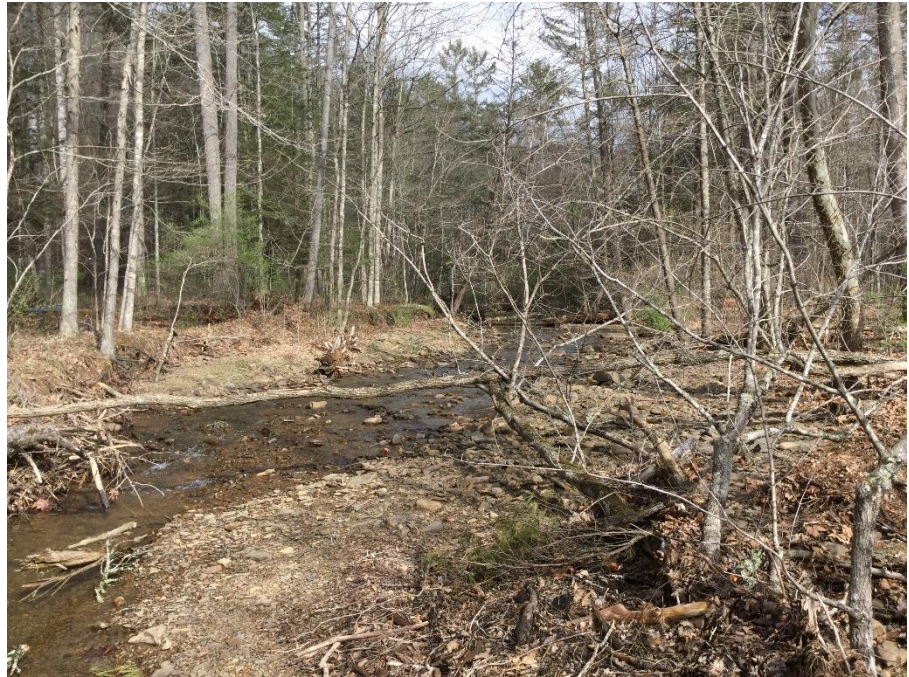
Description: View of stream channel along a riffle comprising subangular and subrounded gravel and cobble-sized particles

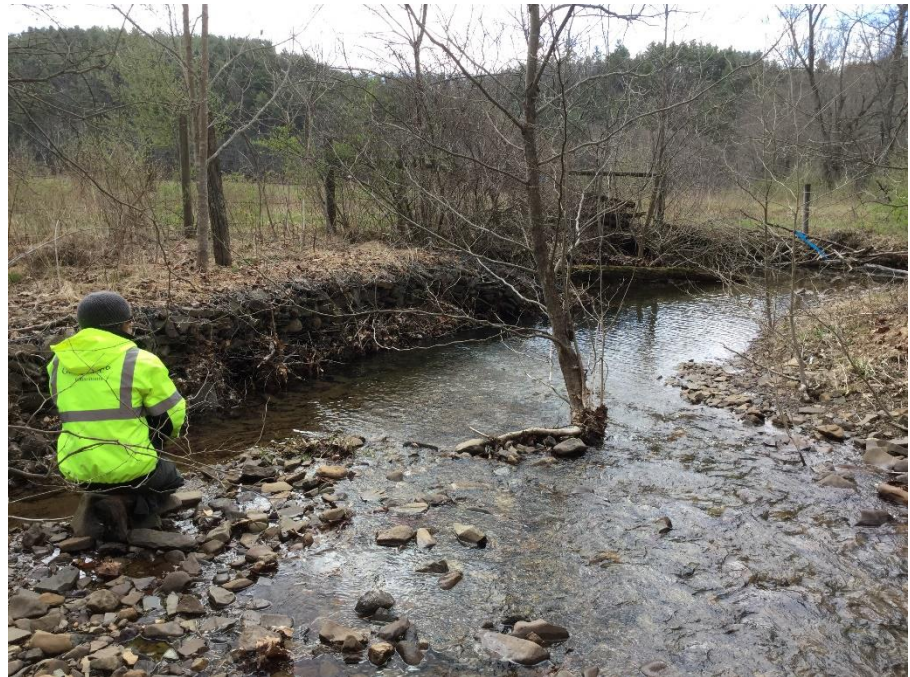
- Bankfull channel width is 23.2 feet and bankfull depth is 1.8 feet.
- Meander belt width is 150 ft. Meander wavelength is approximately 225 feet.
- Riffle-pool stream morphology with mid-channel bar comprised of cobbles, emerging transverse bar near gabion protected left bank. Gabions actively failing due to erosion left bank meander bend).

Description: View of gabion wall presumably built by landowner along left bank to mitigate erosion.

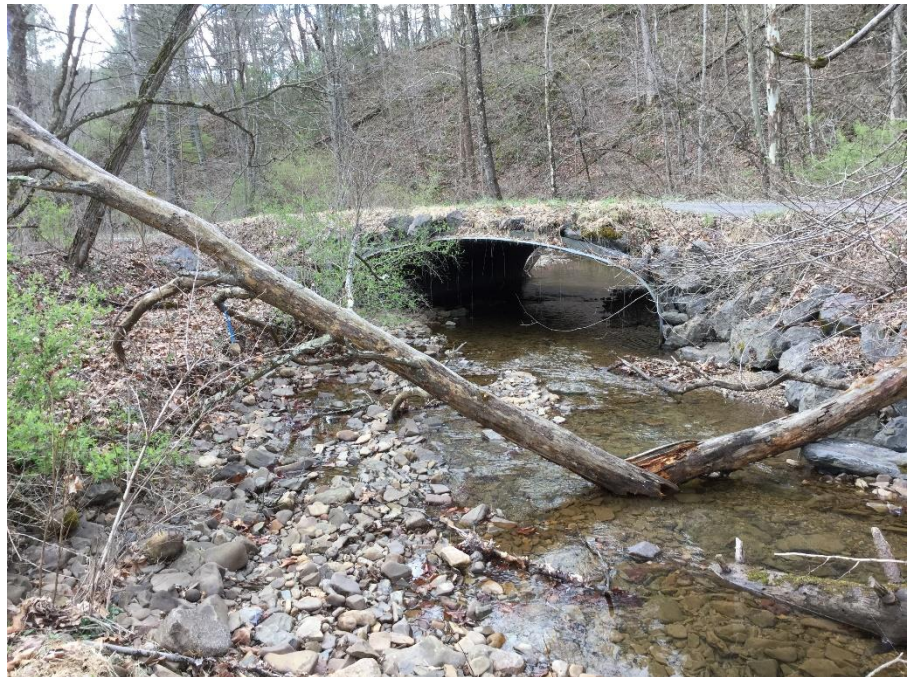
Description: View of  
culvert under road and  
riprap protection

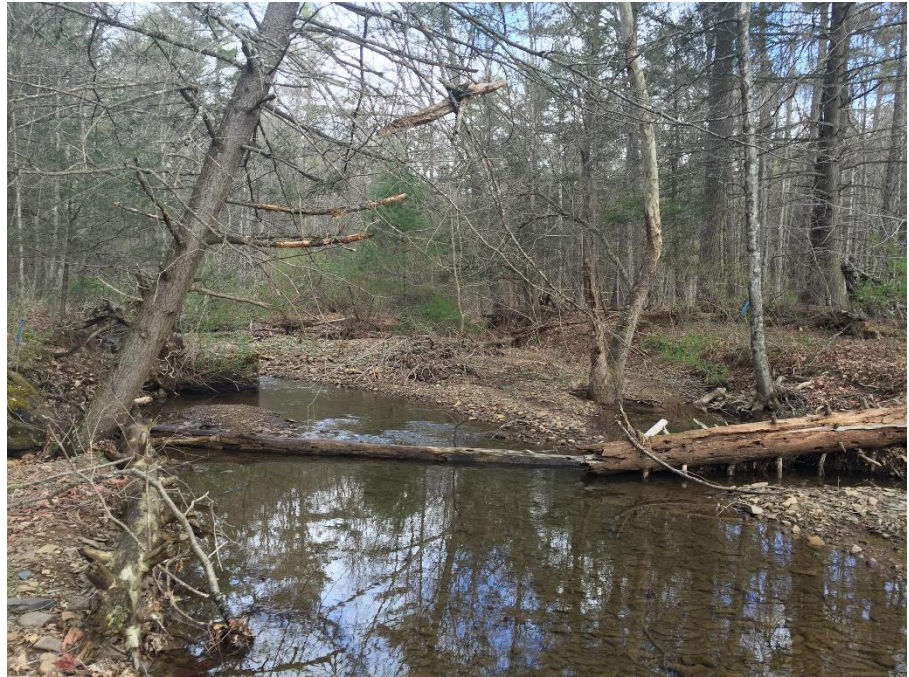
Description: Mid channel bar approximately 60 yards upstream of pipeline crossing.

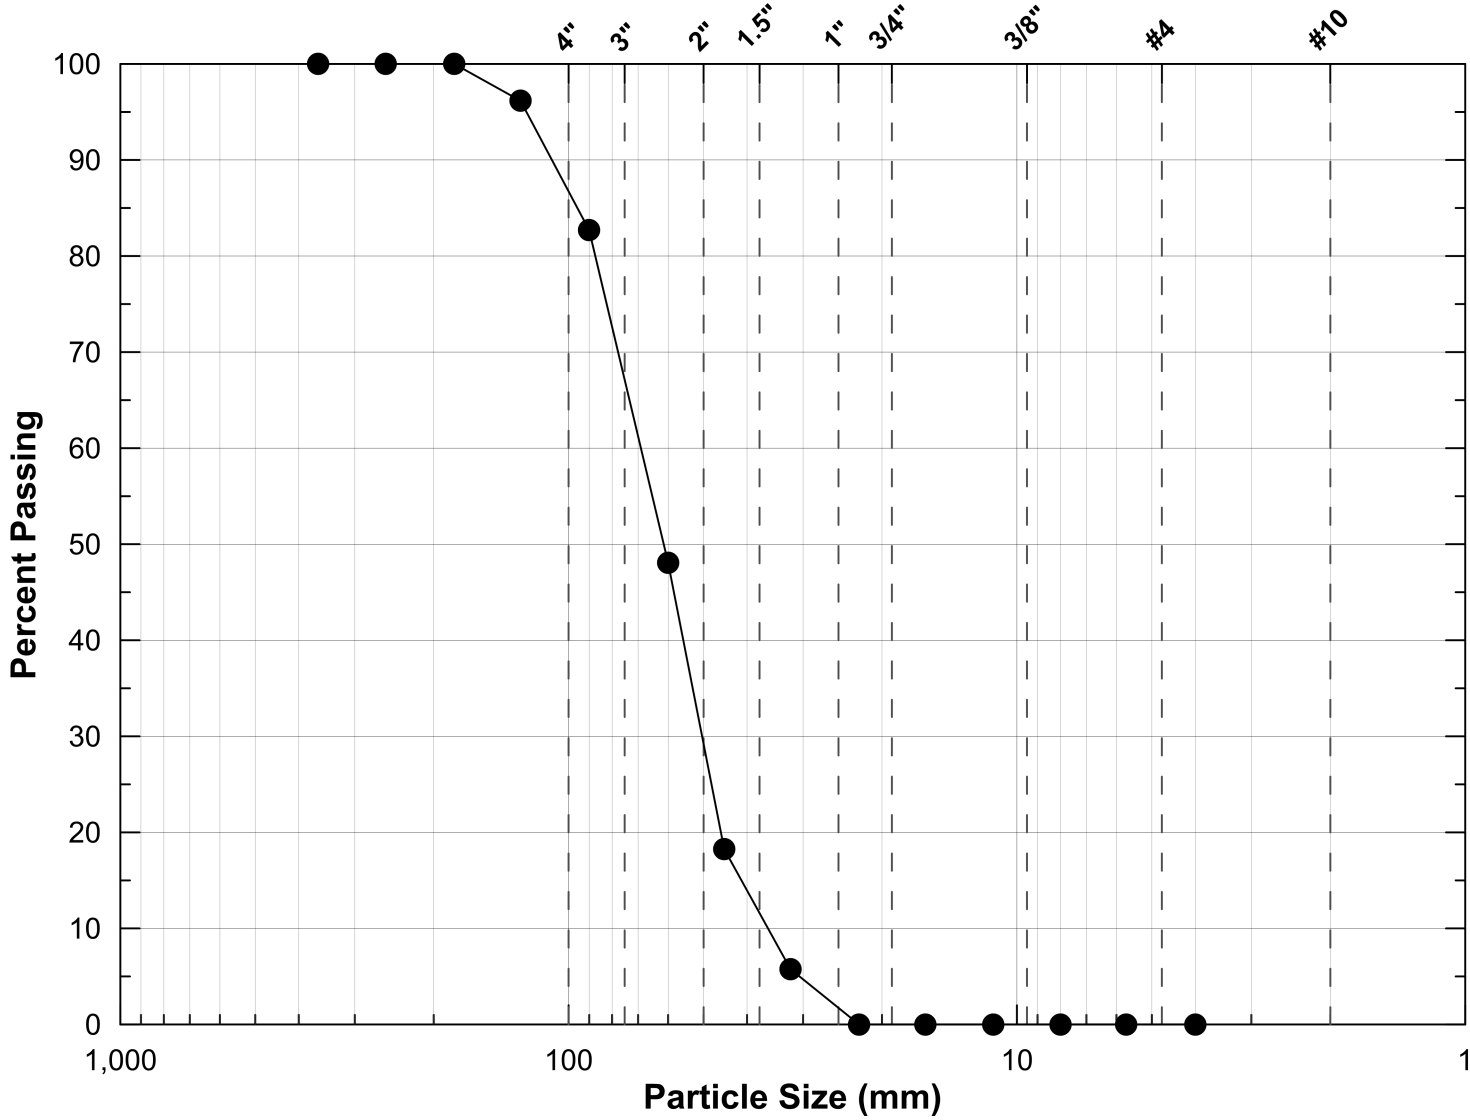
# Wolman Pebble Count at SC\_0672

Boulders	Cobbles	Gravel		Sand	
		coarse	fine	coarse	medium

Evaluate scour depth for pipeline burial depth. Lateral migration does not appear to be a significant hazard beyond the existing left and right bank terraces. Place sag bends at a minimum of one river widths beyond each terrace bank.

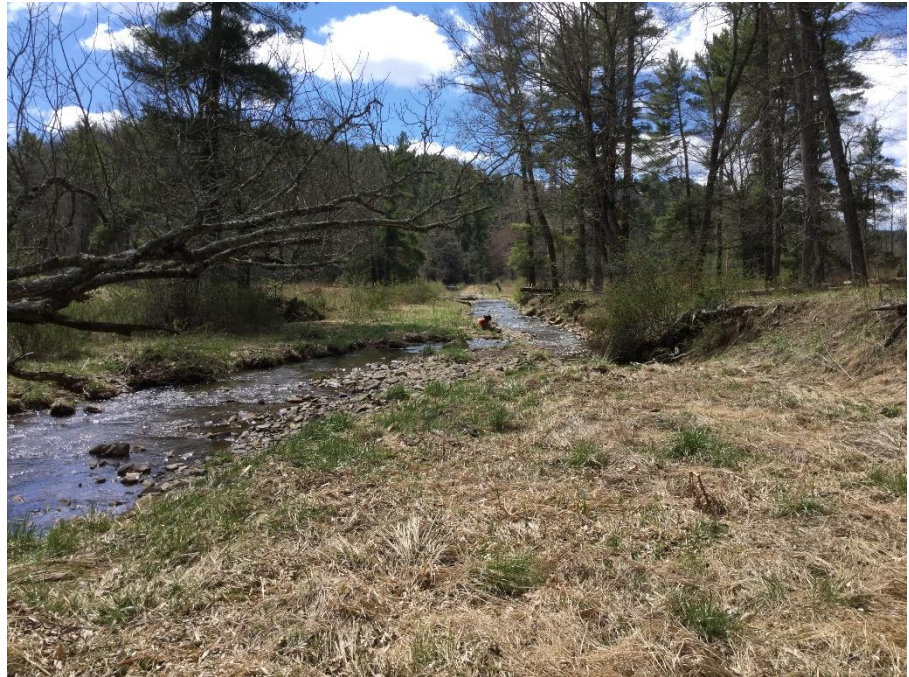
Description: Evidence of  
bank erosion on left bank  
(right side of photo) and  
terracing.  
Note cobbles in stream.

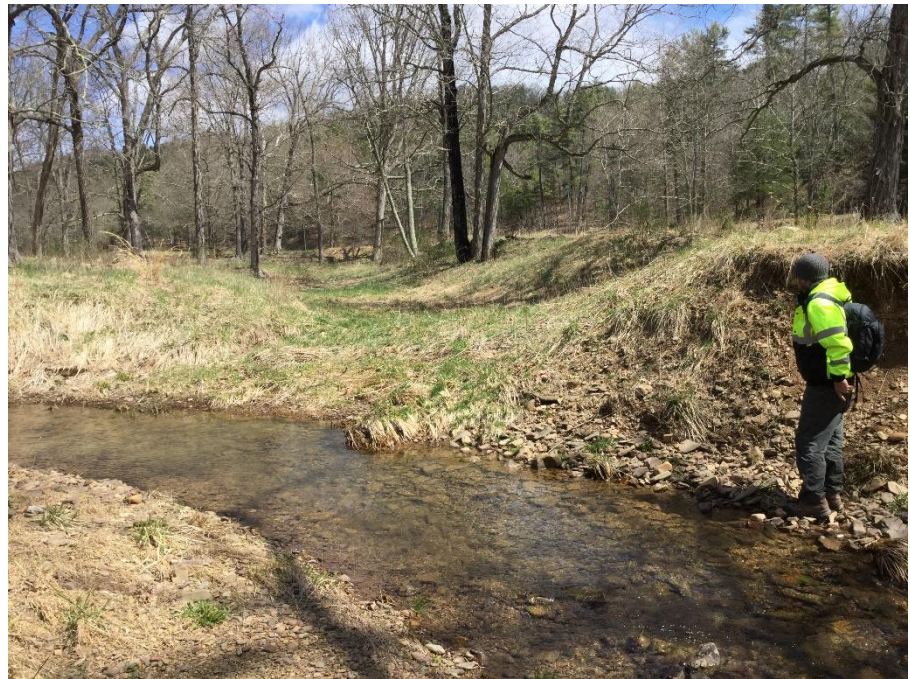
Description: Relic stream  
channel.  
Note that tree density in  
riparian buffer is sparse.

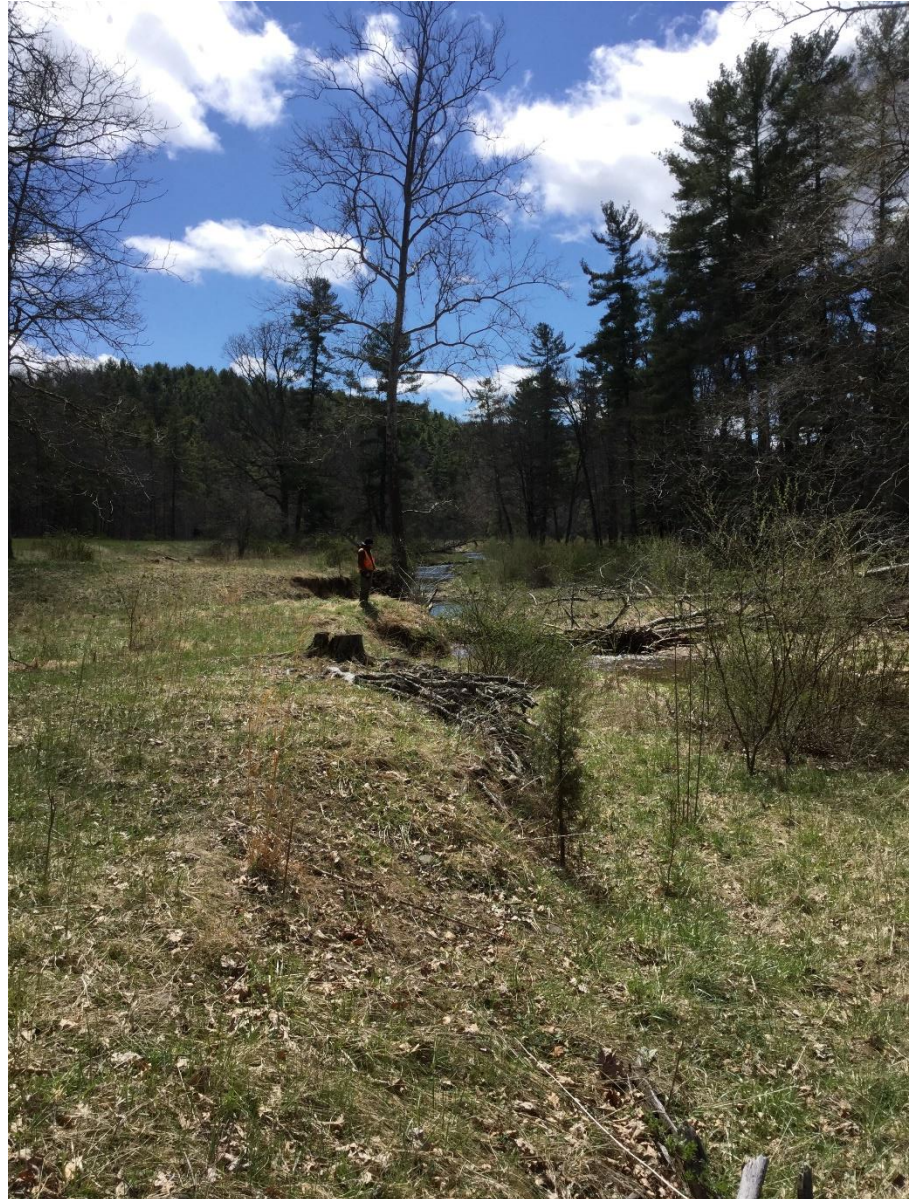
Description: Evidence of  
fluvial erosion along left  
bank

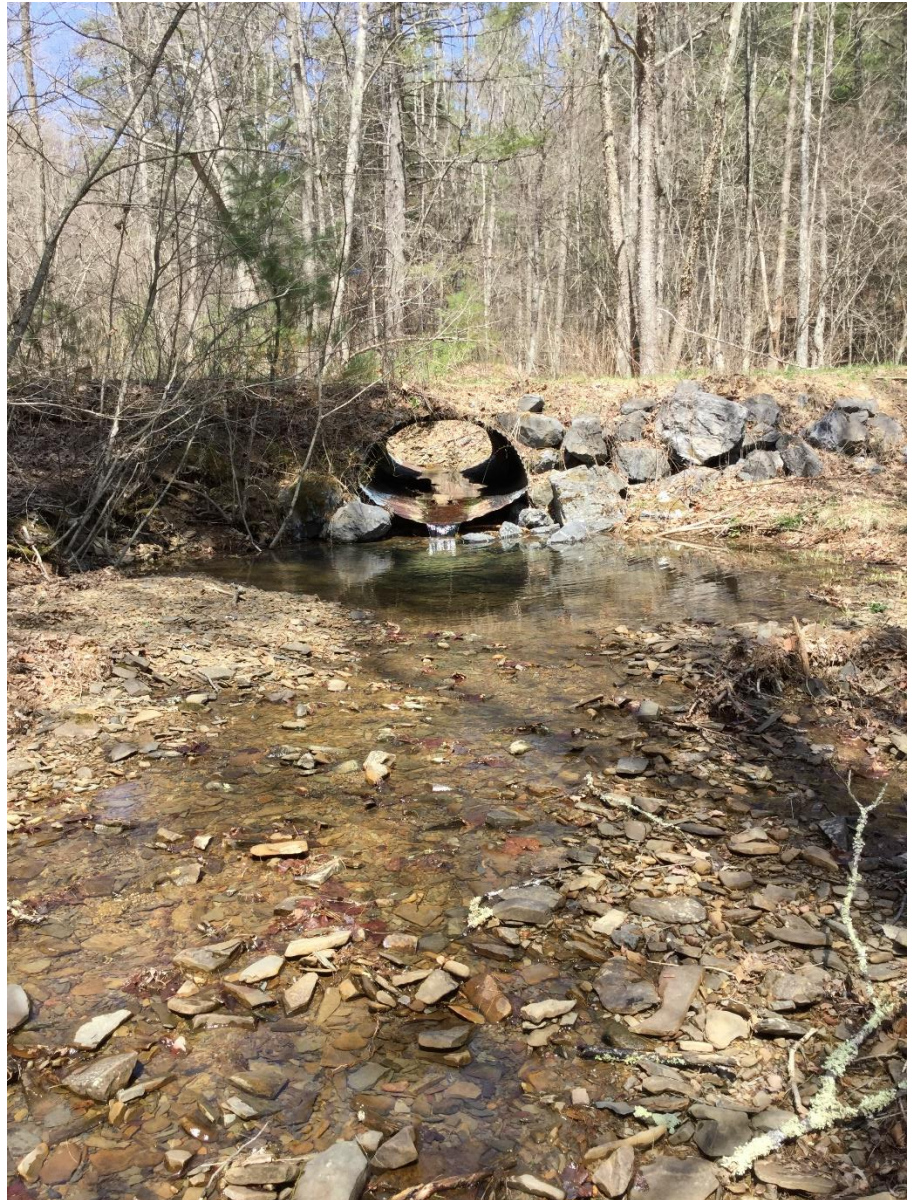
Description: View of embankment and culvert for forest road protected with rip rap

Given debris flow hazard, it is recommended to bury pipeline into bedrock with at least 1.5-foot of cover above the crown from valley wall to valley wall.
