**Subject: Section 106 Review –Architectural Survey Report REVISED Addendum 4  
Atlantic Coast Pipeline, LLC, Atlantic Coast Pipeline Project  
DHR File No. 2014-0710**

**PHASE I HISTORIC ARCHITECTURAL SURVEY OF THE  
ATLANTIC COAST PIPELINE PROJECT**

**Virginia Addendum 4 Report**

**DHR File No. 2014-0710**

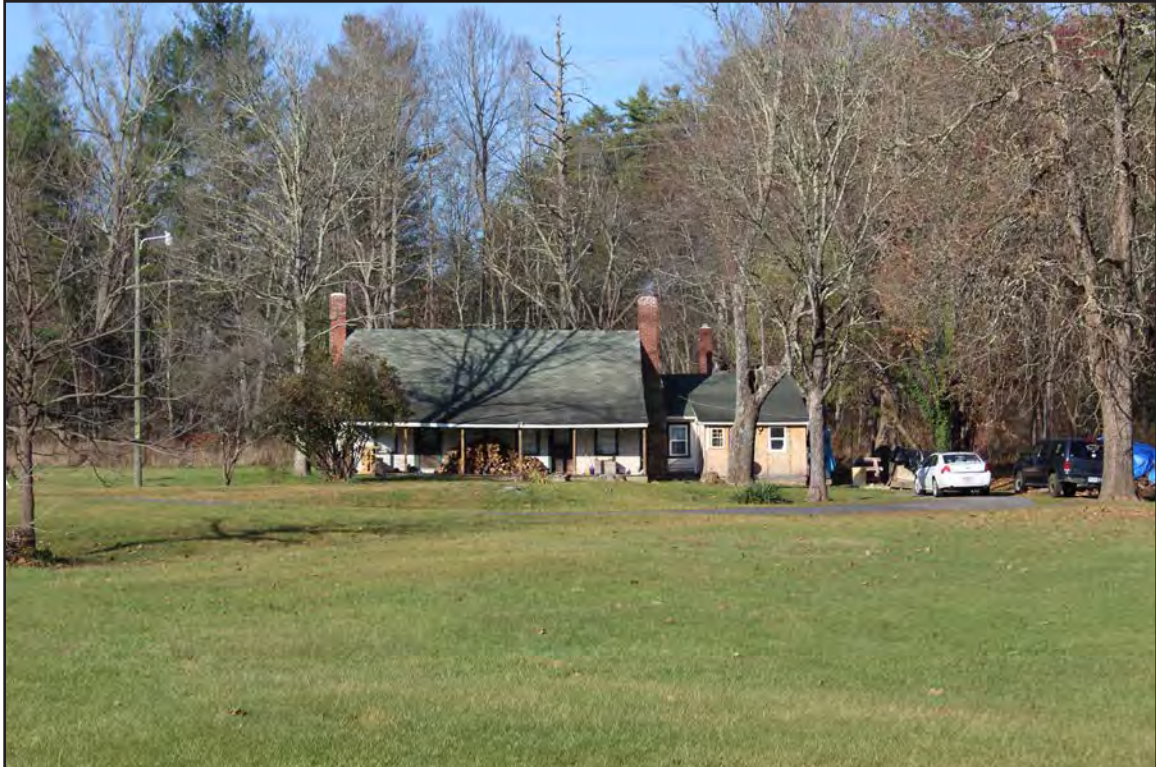
Figure 2. 007-0447, facing north.

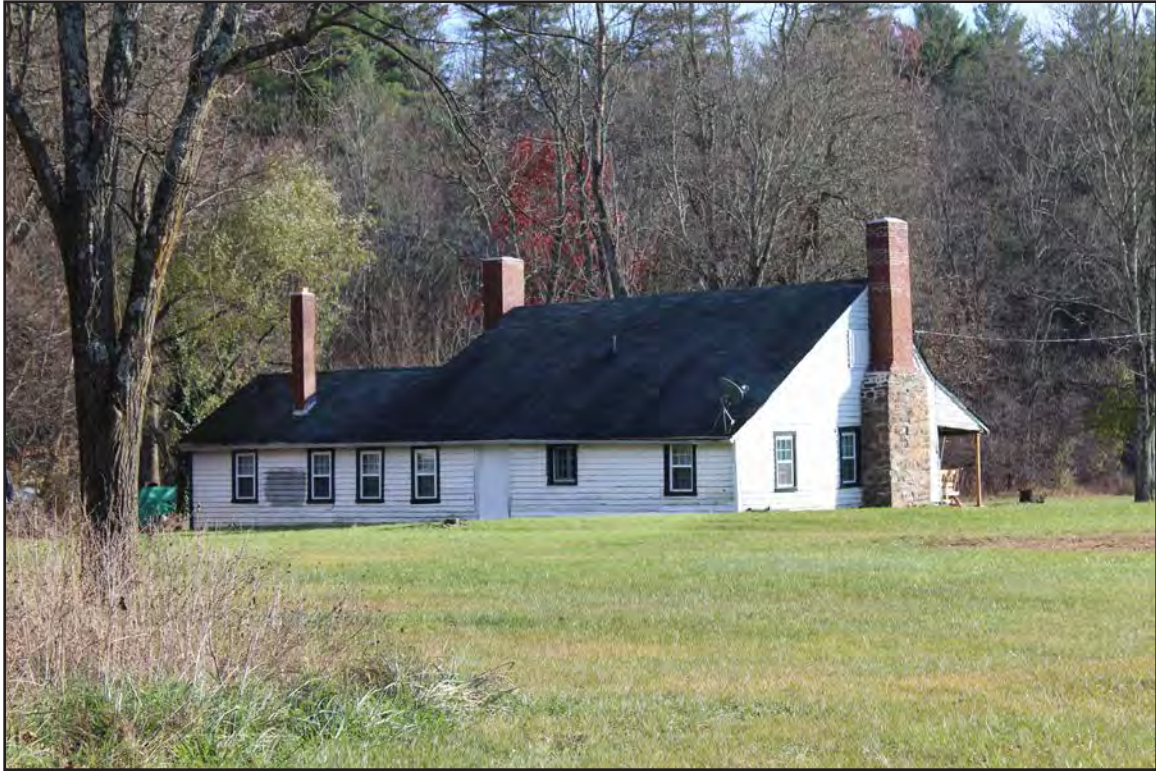
Figure 3. 007-0447, facing east.

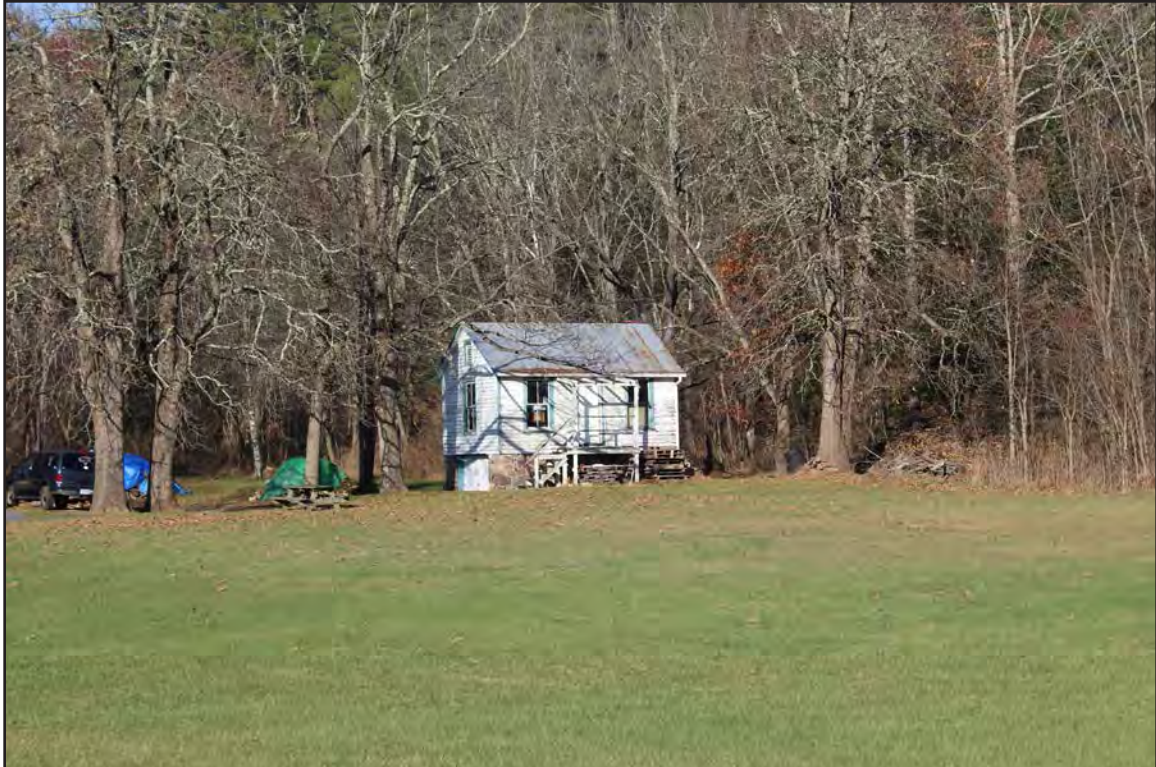
Figure 4. 007-0447. Outbuilding 1, facing southeast.

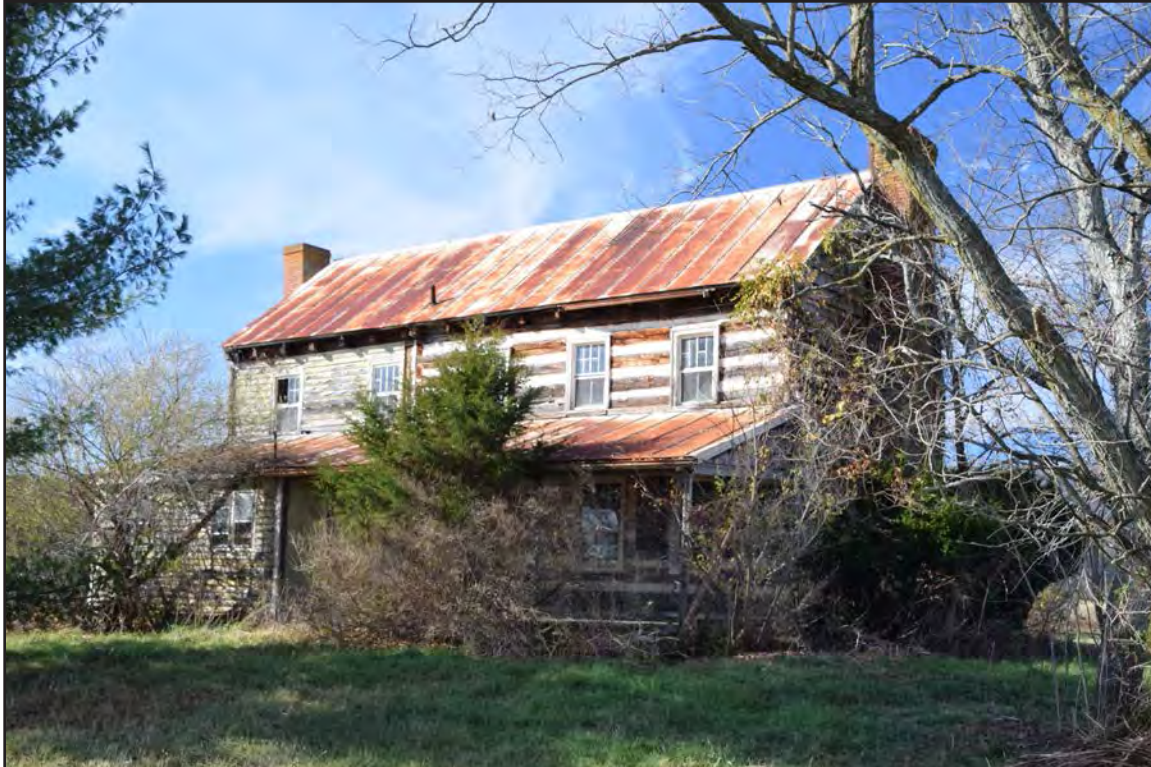
Figure 6. 007-0463, facing west.

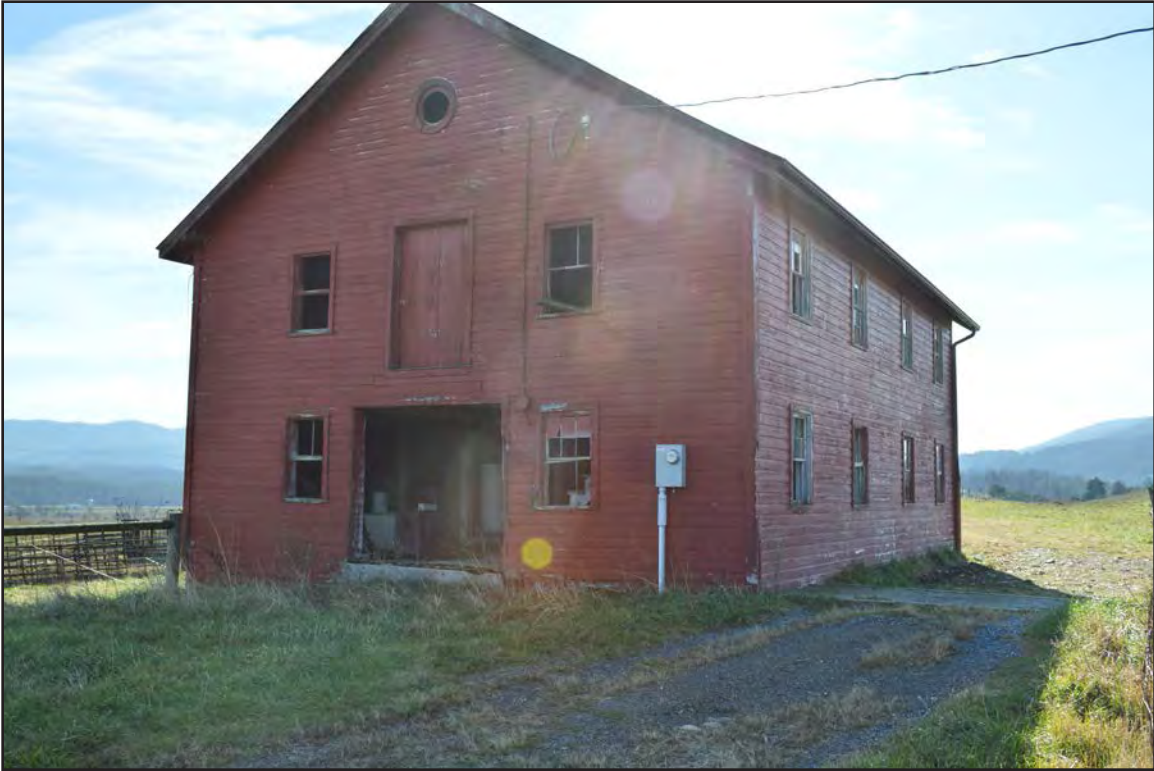
Figure 7. 007-0463, Barn 1, facing south.

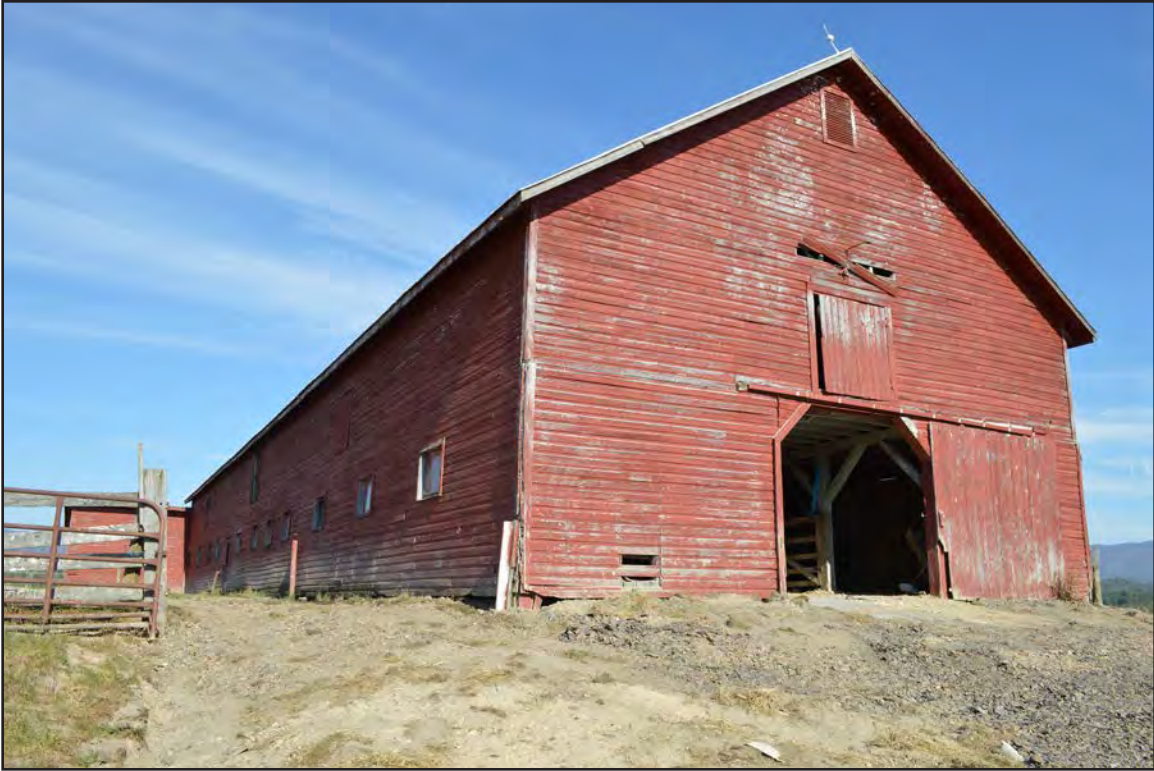
Figure 8. 007-0463, Barn 2, facing northeast.

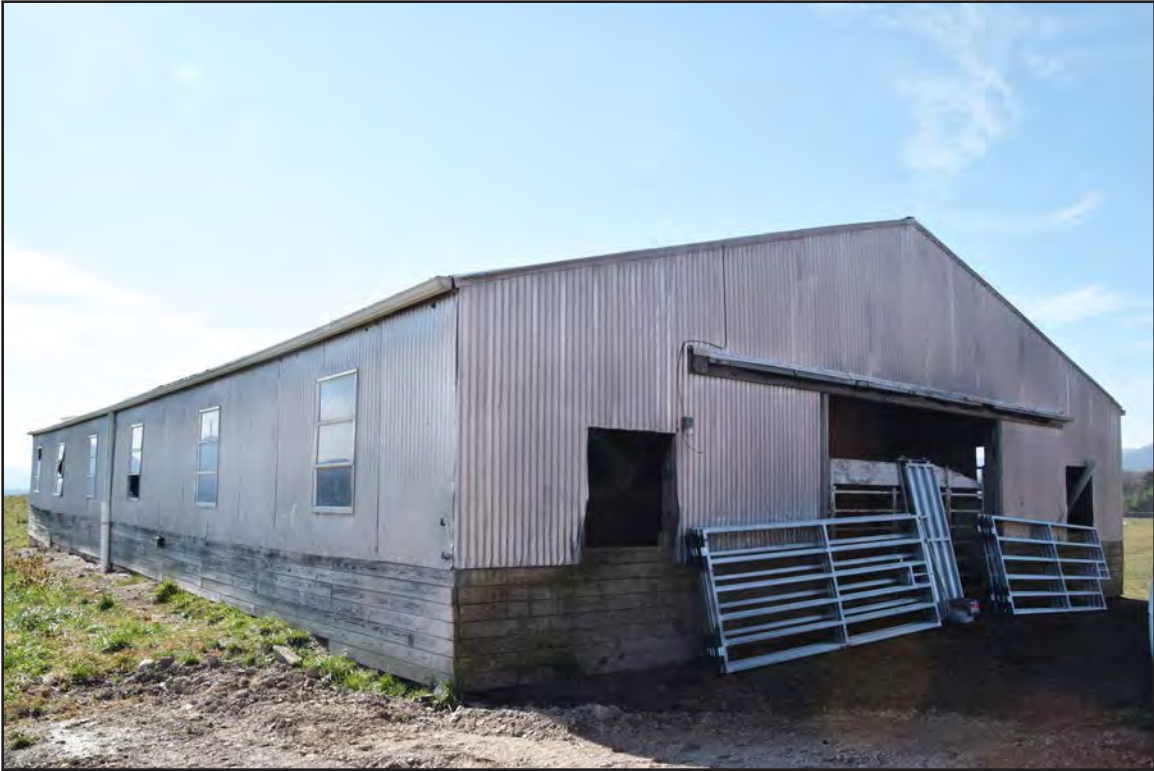
Figure 9. 007-0463, Barn 3, facing southeast.

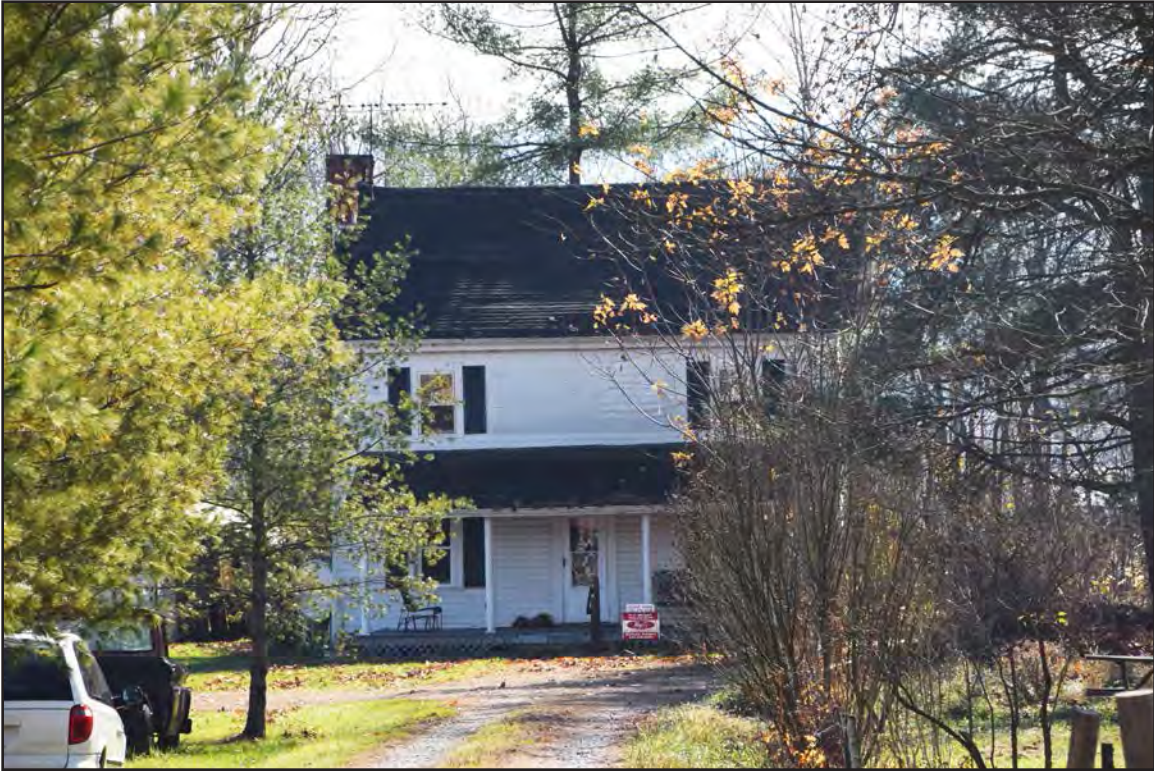
Figure 11. 007-0467, house, facing southeast.

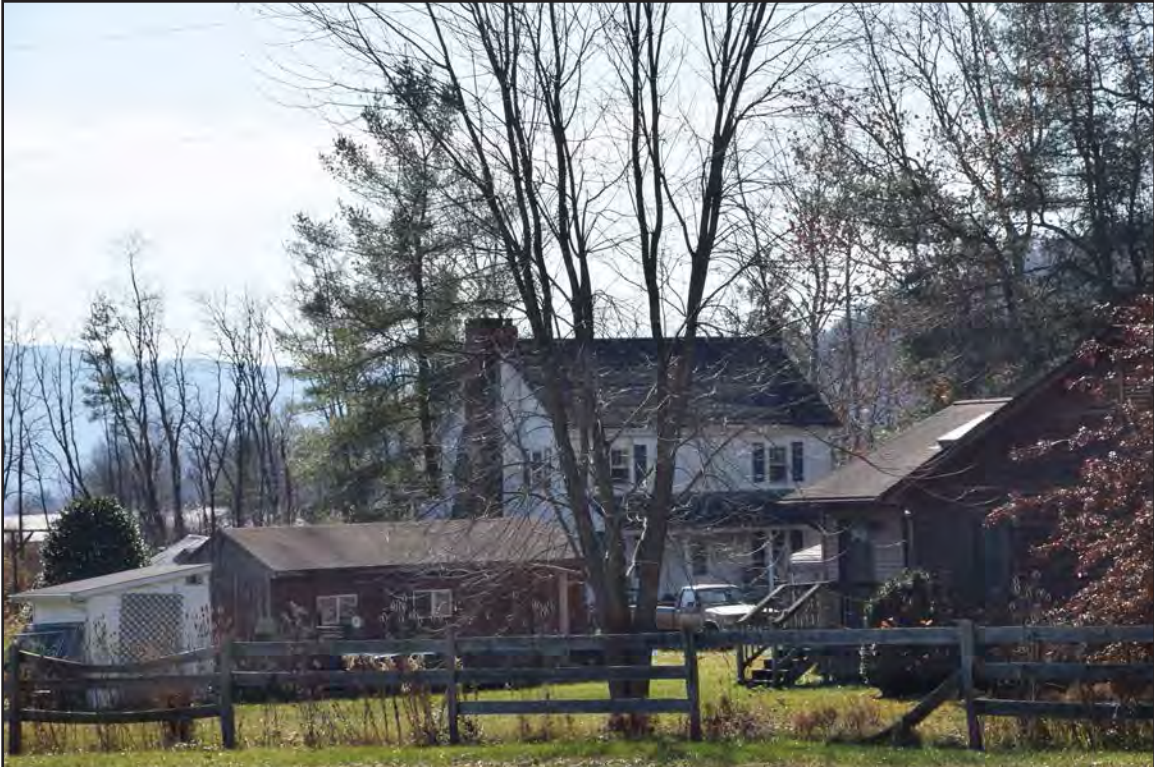
Figure 12. 007-0467, house, facing south.

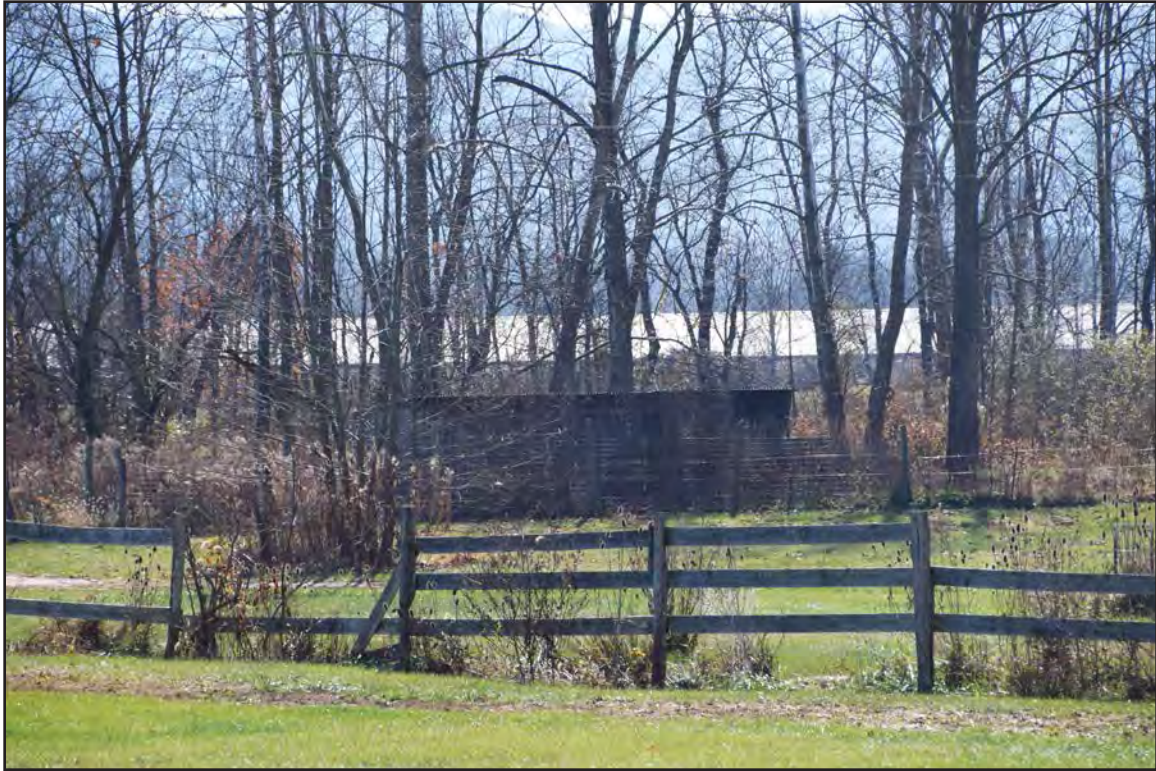
Figure 13. 007-0467, chicken house, facing southwest.

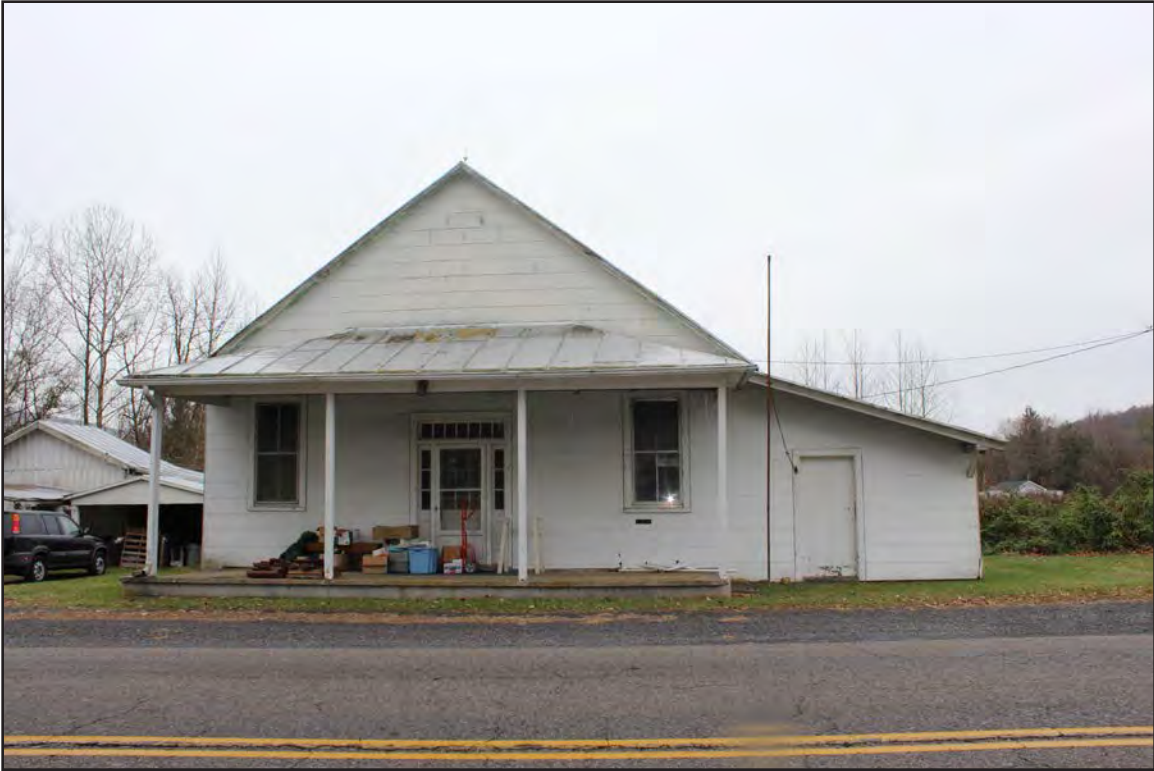
Figure 15. 007-0476, store, facing south.

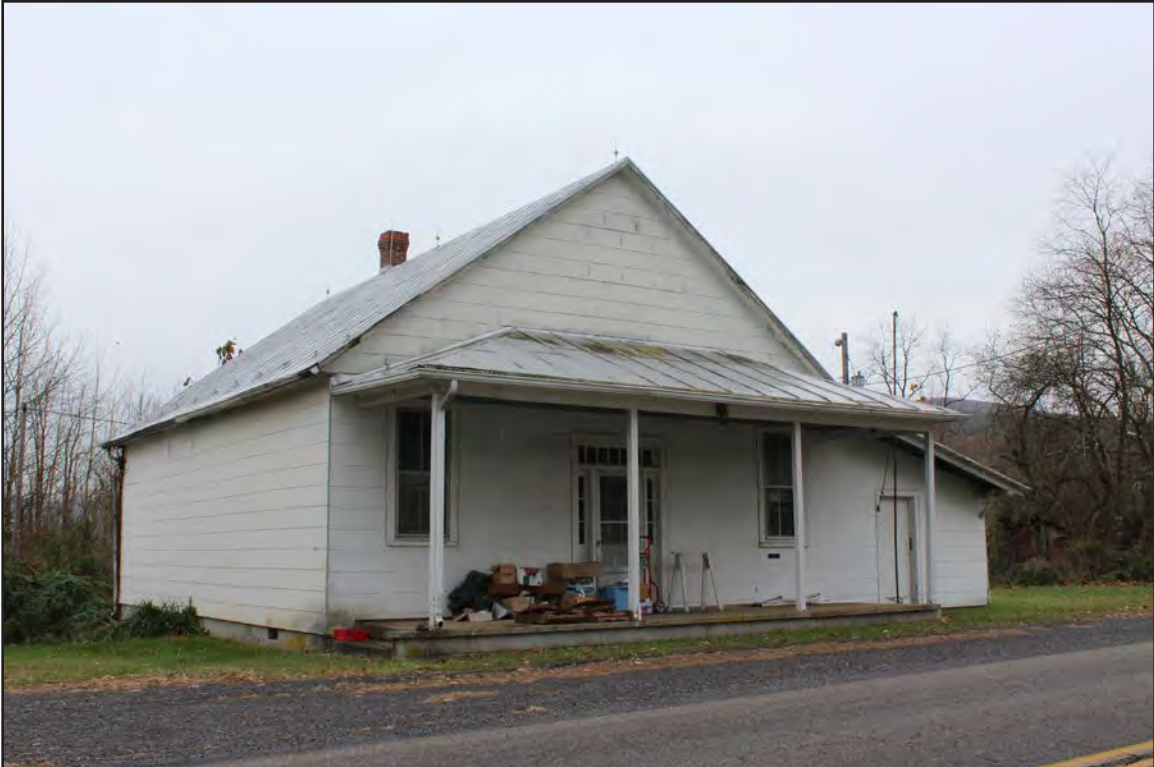
Figure 16. 007-0476, store, facing southwest.

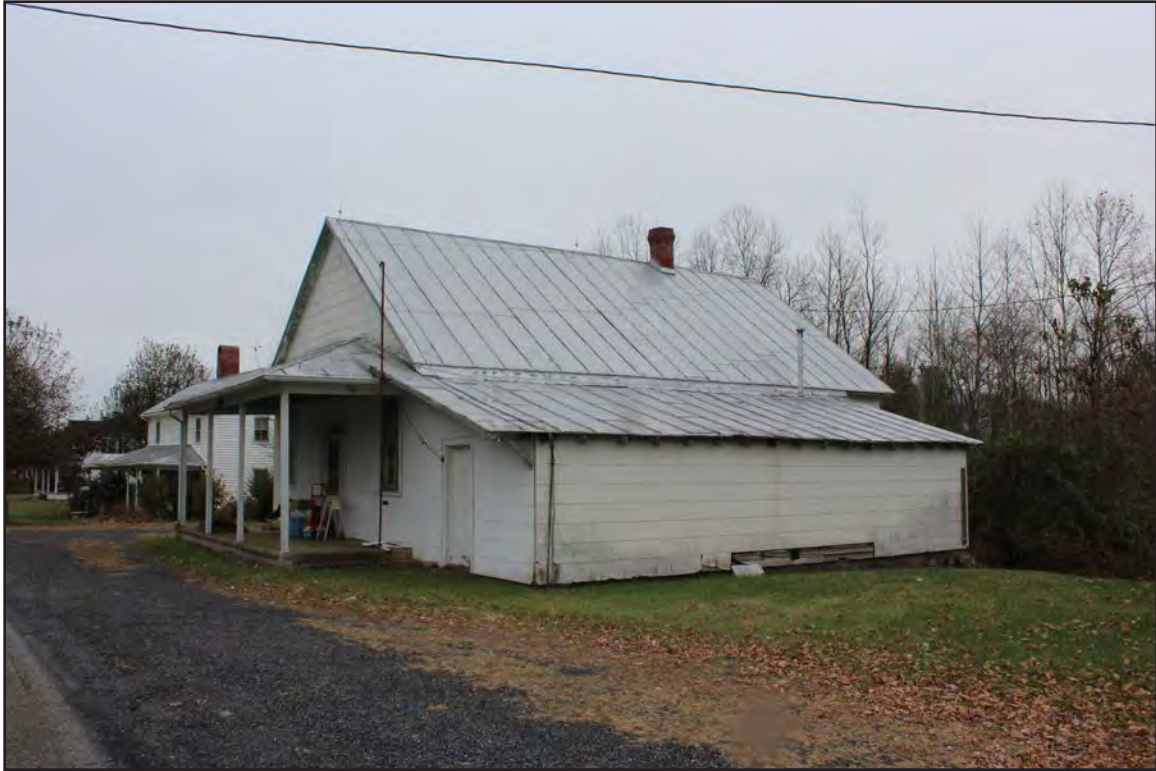
Figure 17. 007-0476, store, facing southeast.

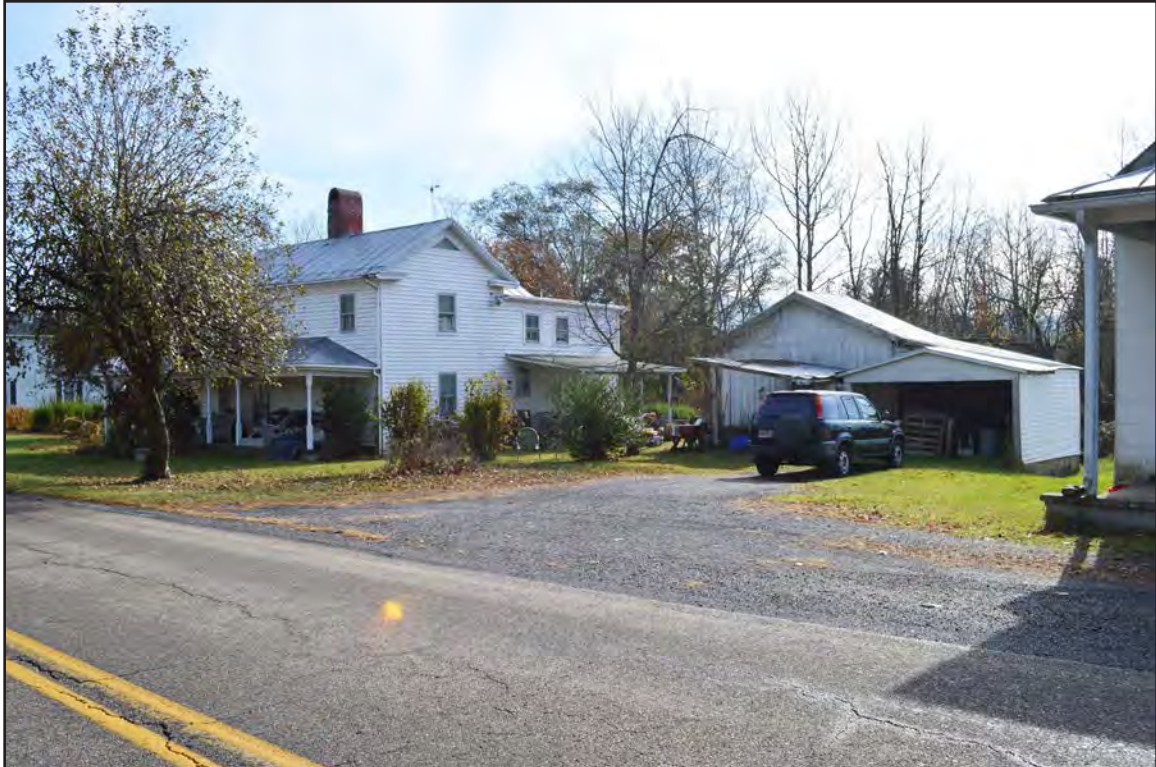
Figure 18. 007-0476, dwelling house, facing southwest.

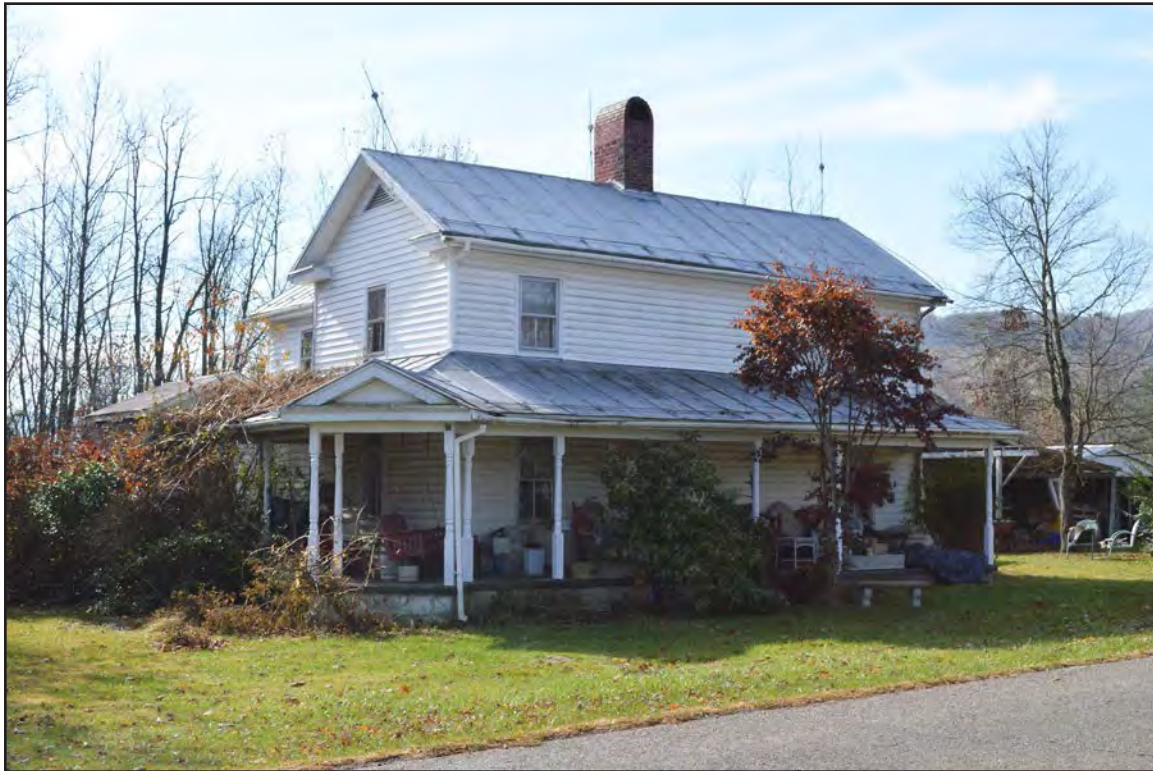
Figure 19. 007-0476, dwelling house, facing southwest.

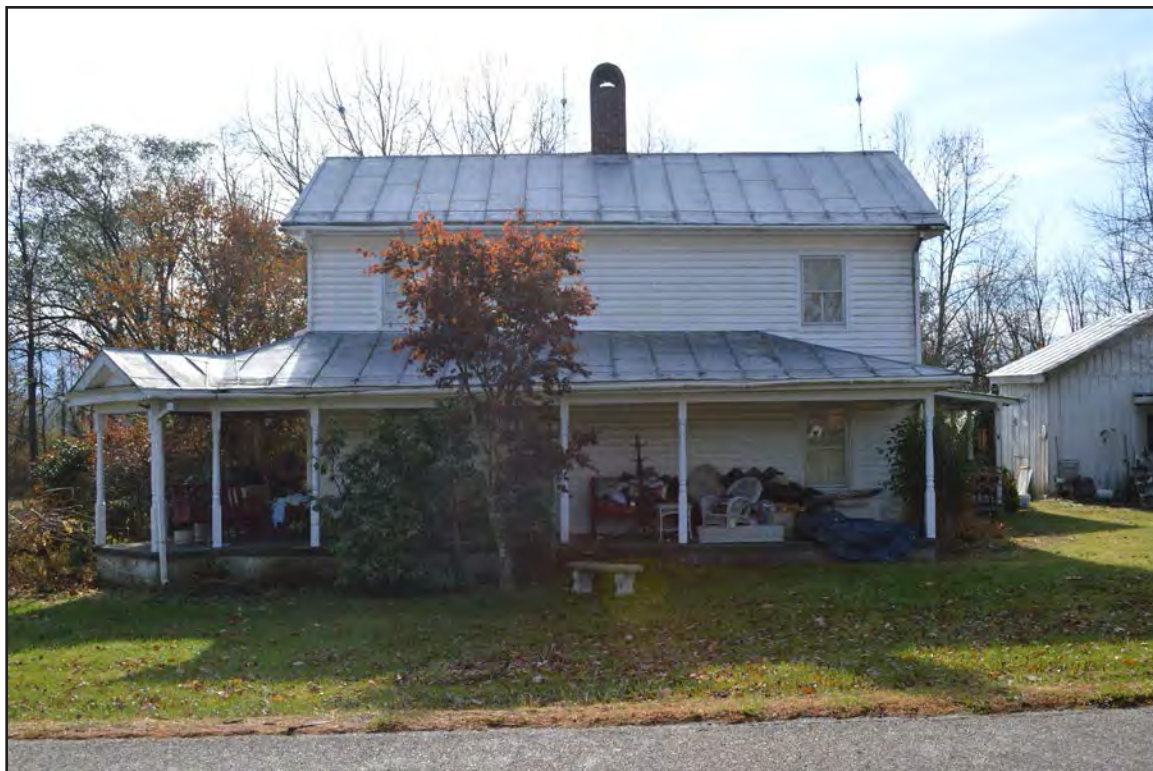
Figure 20. 007-0476, dwelling house, facing south-southwest.

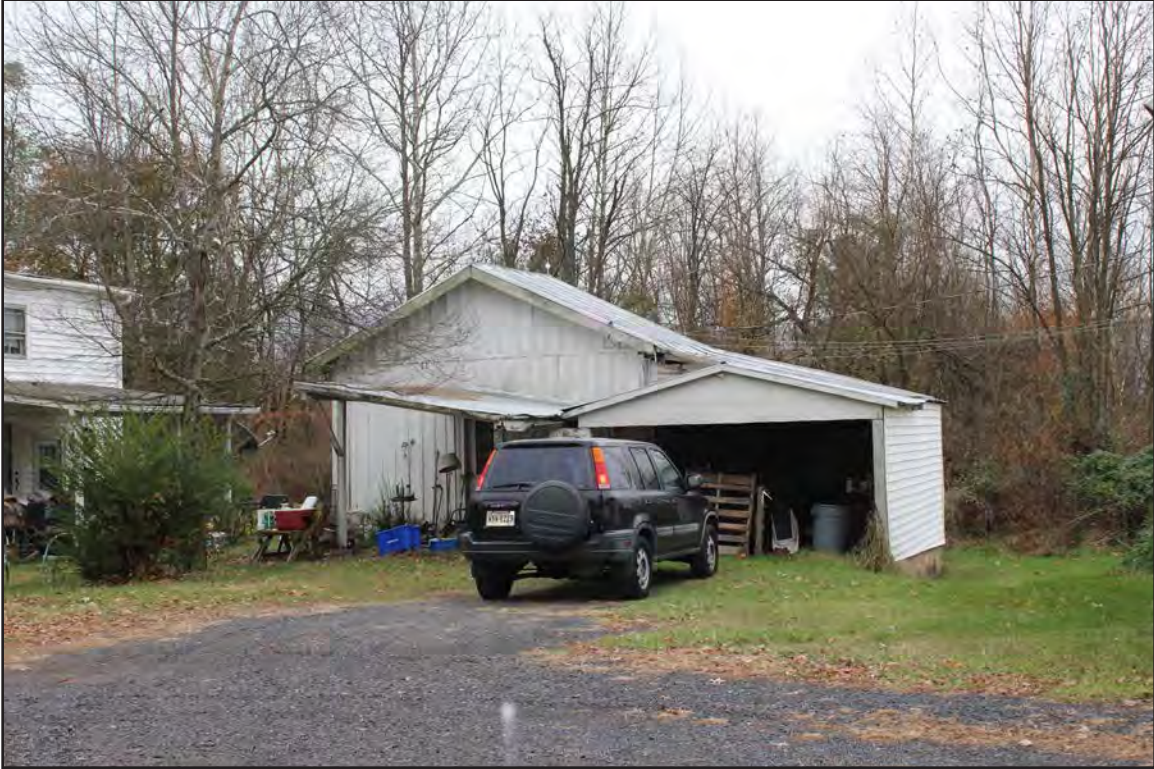
Figure 21. 007-0476, garage and shed, facing southeast.

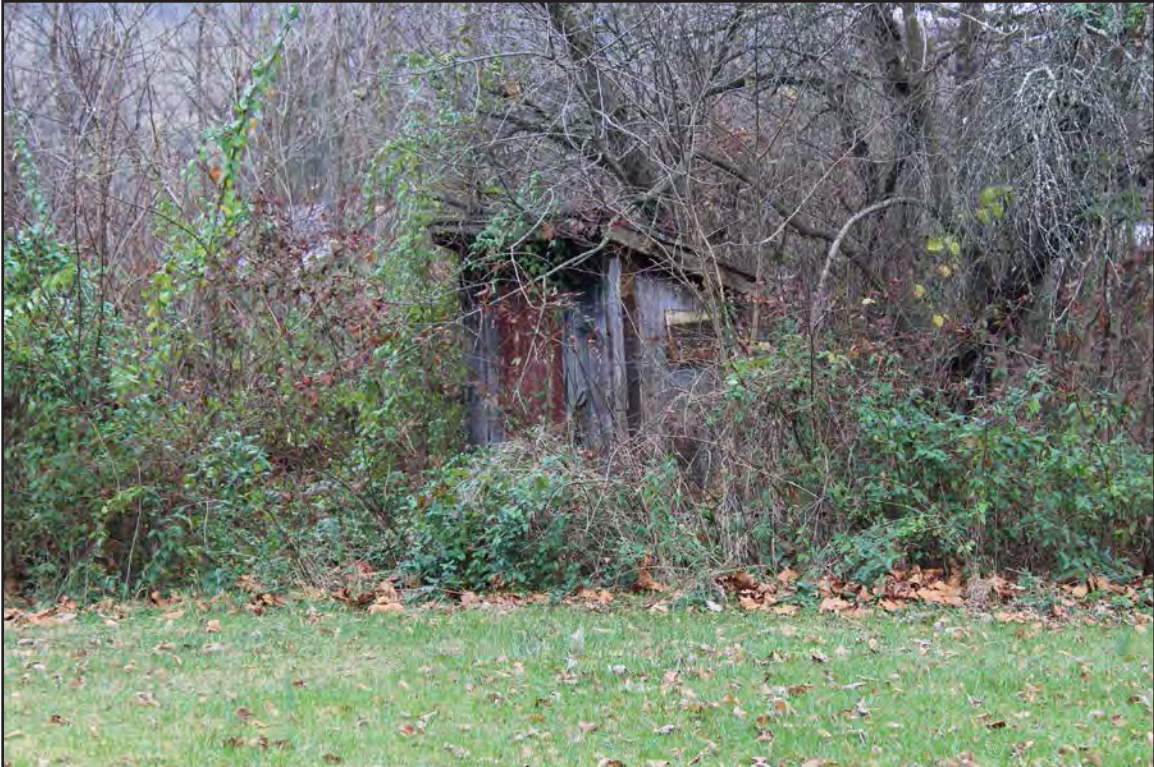
Figure 22. 007-0476, outhouse, facing southwest.

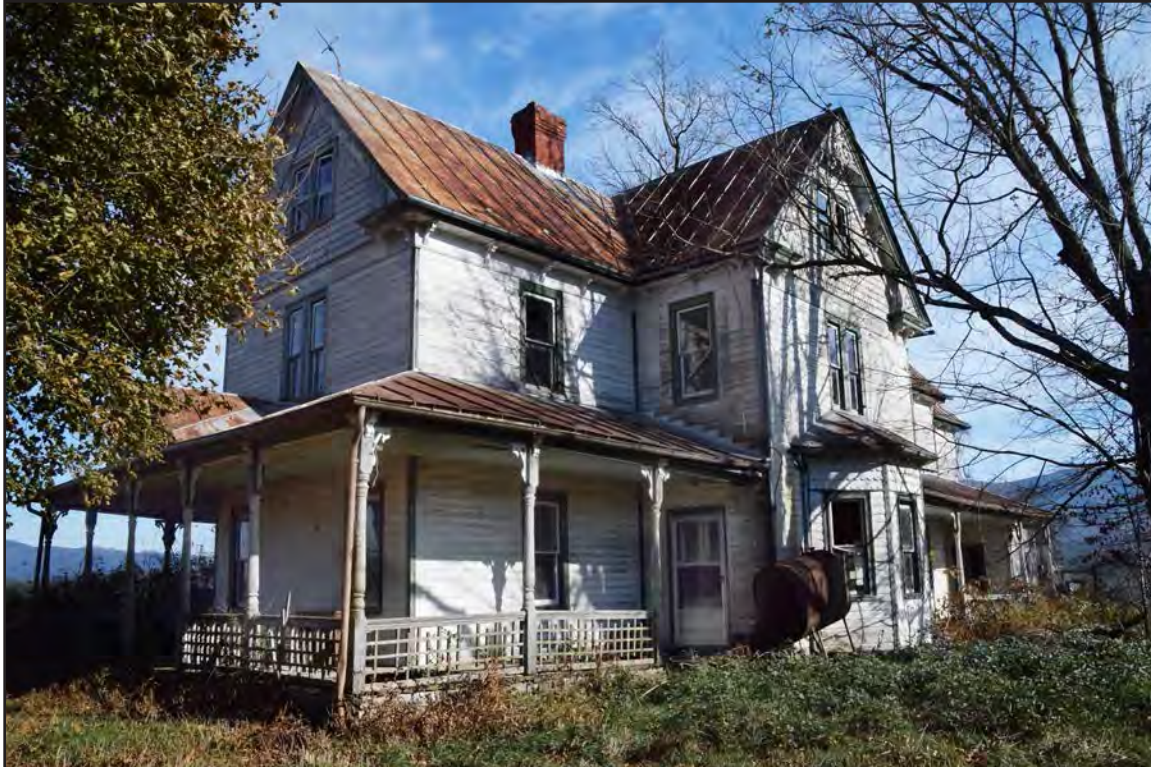
Figure 24. 007-0487, house, facing north.

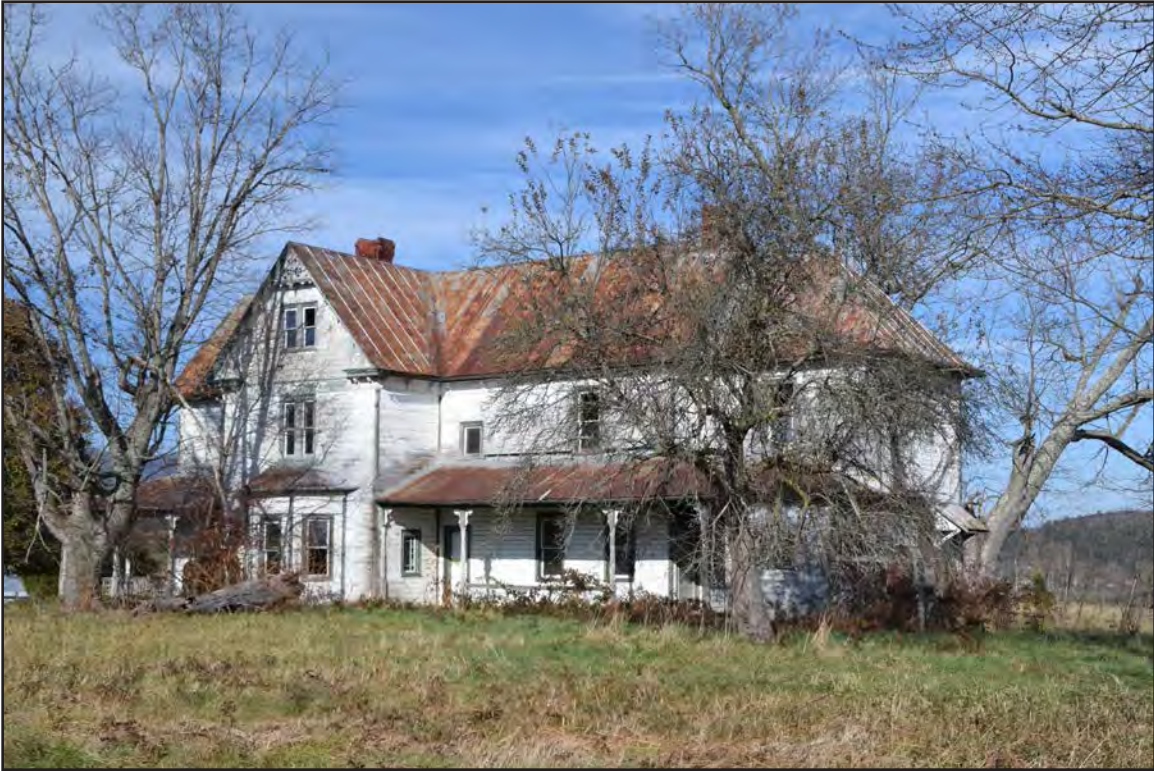
Figure 25. 007-0487, house, facing east.

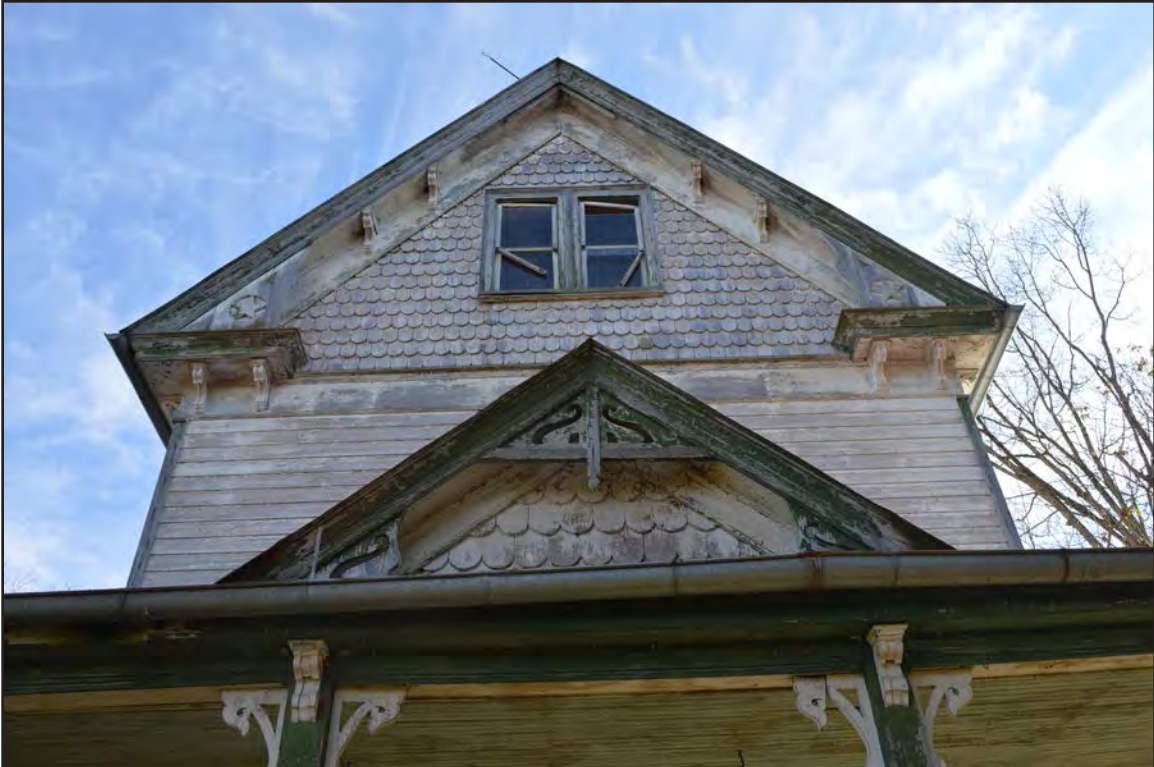
Figure 26. 007-0487, gable details on house, facing southeast.

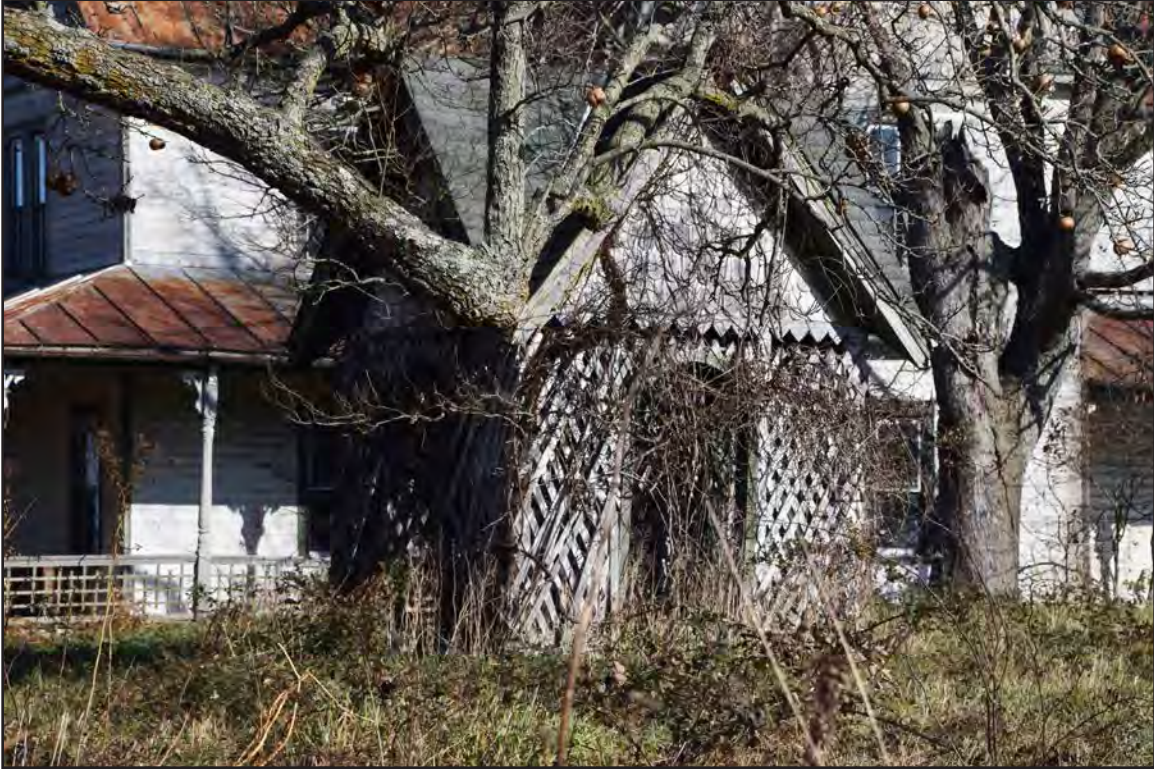
Figure 27. 007-0487, gazebo, facing east.

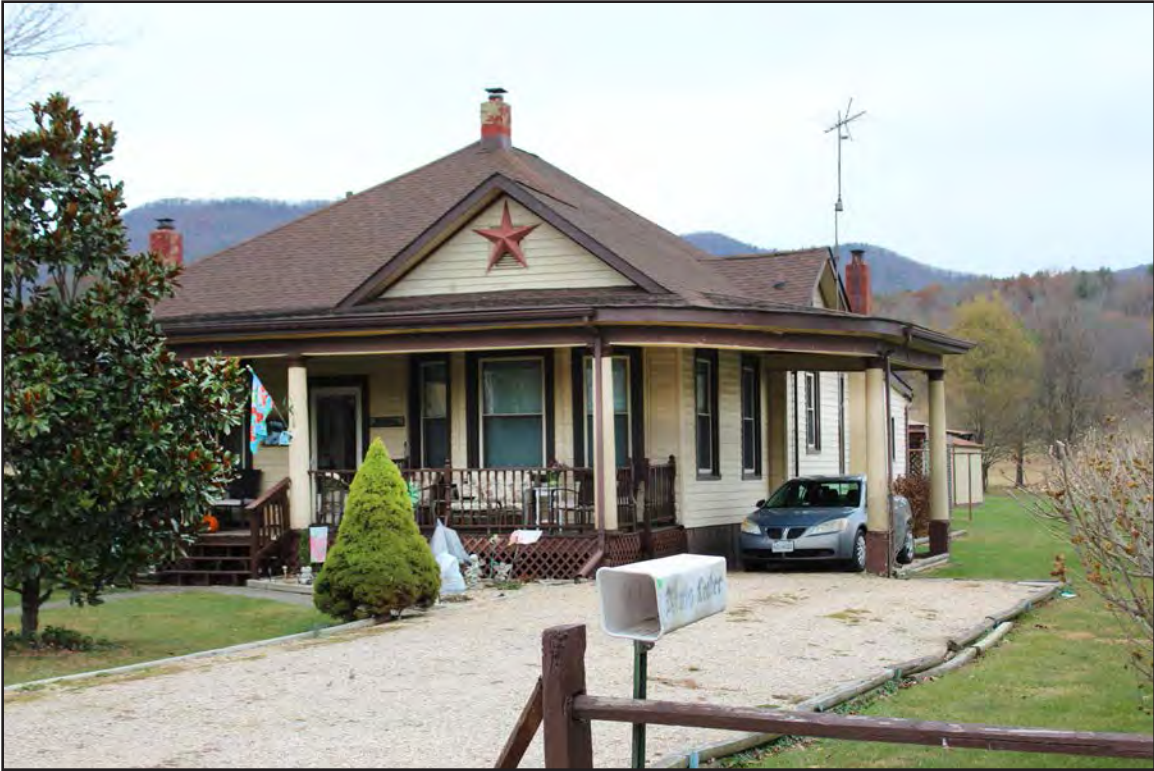
Figure 29. 007-0490, facing northwest.

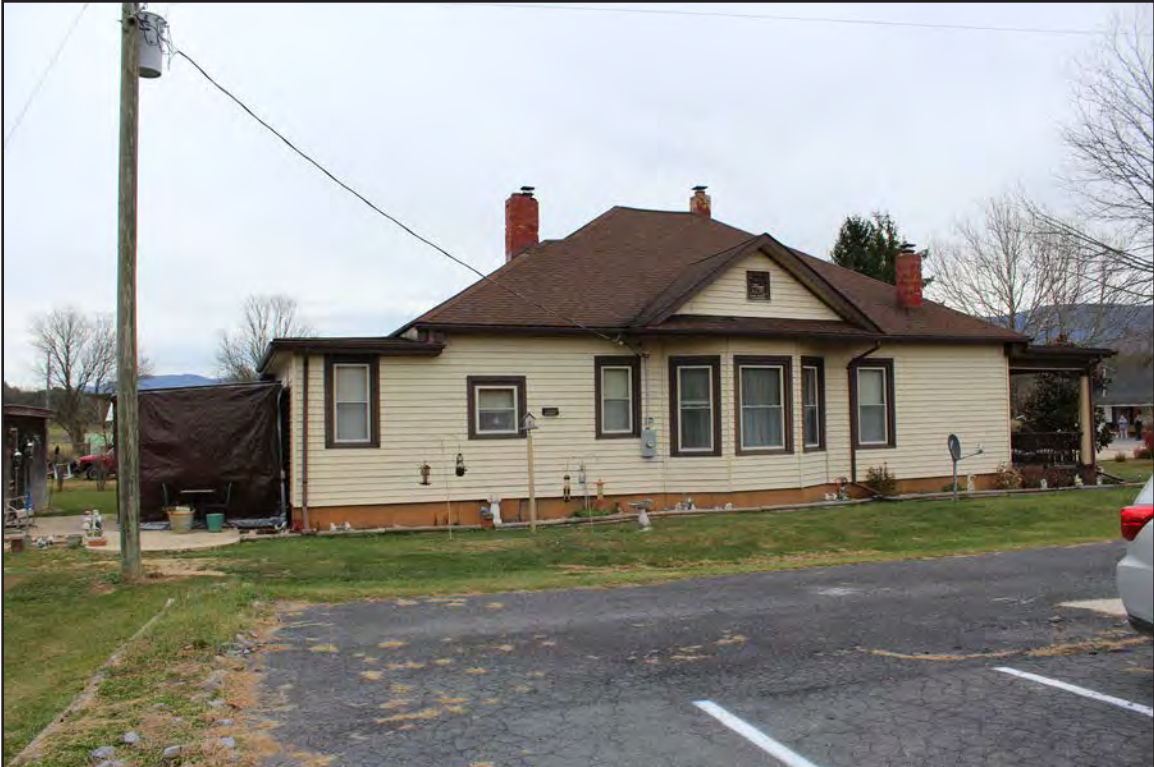
Figure 30. 007-0490, facing east.

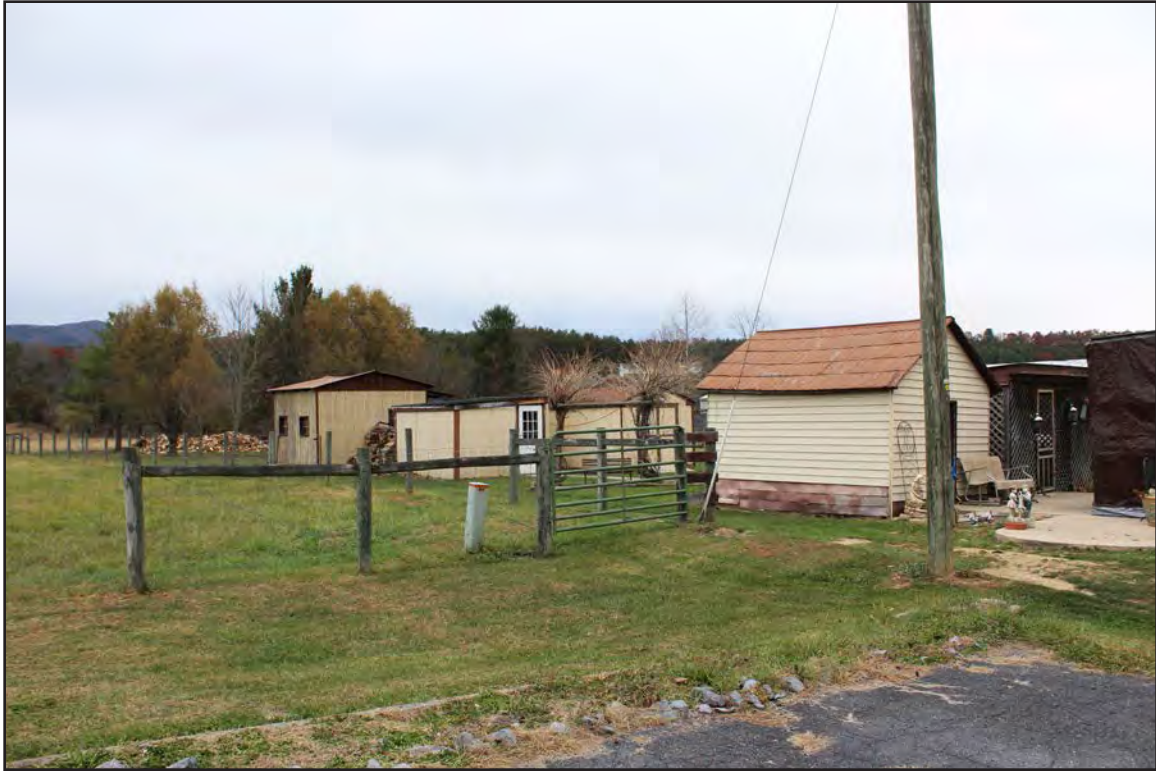
Figure 31. 007-0490, sheds, facing northeast.
