**Subject: Section 106 Review –Architectural Survey Report REVISED Addendum 4  
Atlantic Coast Pipeline, LLC, Atlantic Coast Pipeline Project  
DHR File No. 2014-0710**

**PHASE I HISTORIC ARCHITECTURAL SURVEY OF THE  
ATLANTIC COAST PIPELINE PROJECT**

**Virginia Addendum 4 Report**

**DHR File No. 2014-0710**

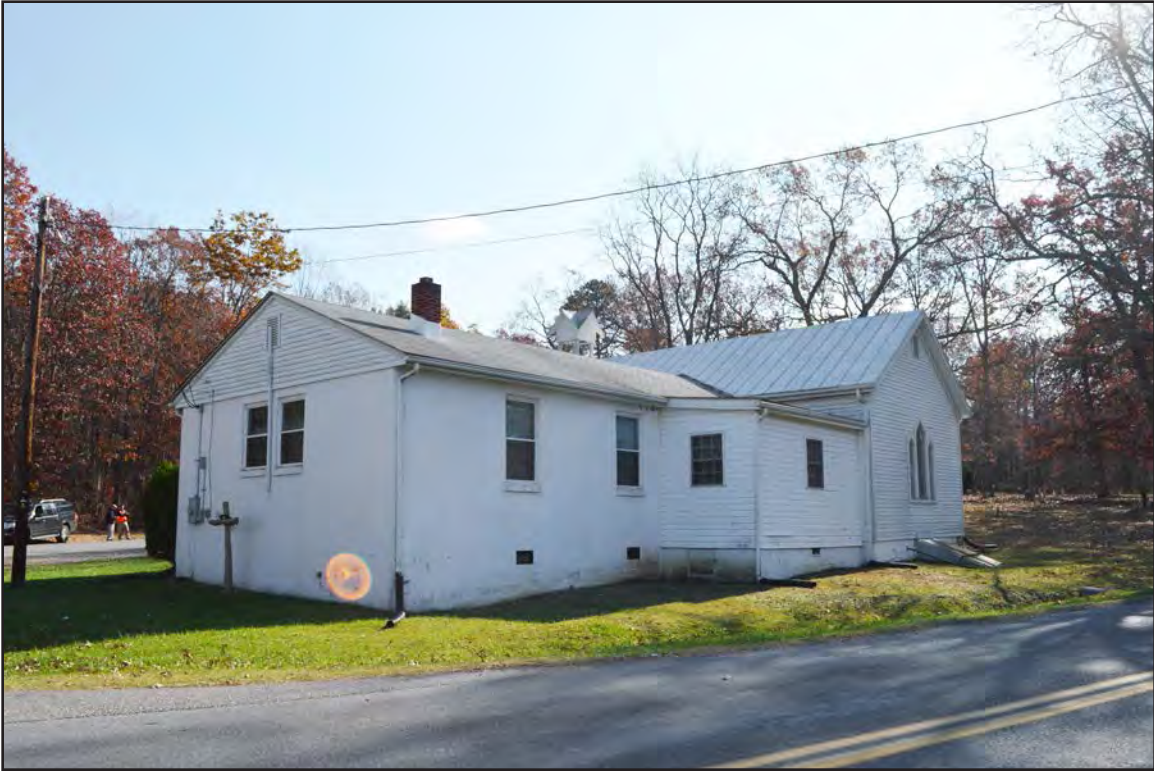
Figure 33. 007-0863, facing southeast.

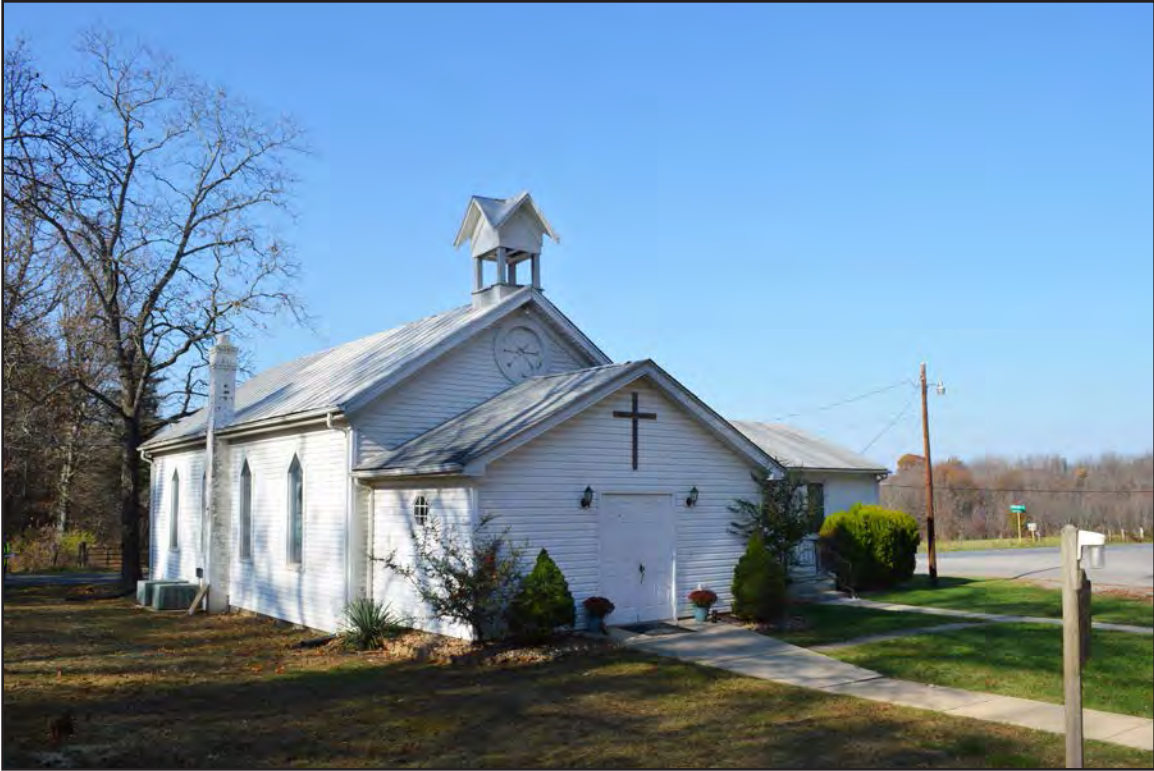
Figure 34. 007-0863, church, facing southwest.

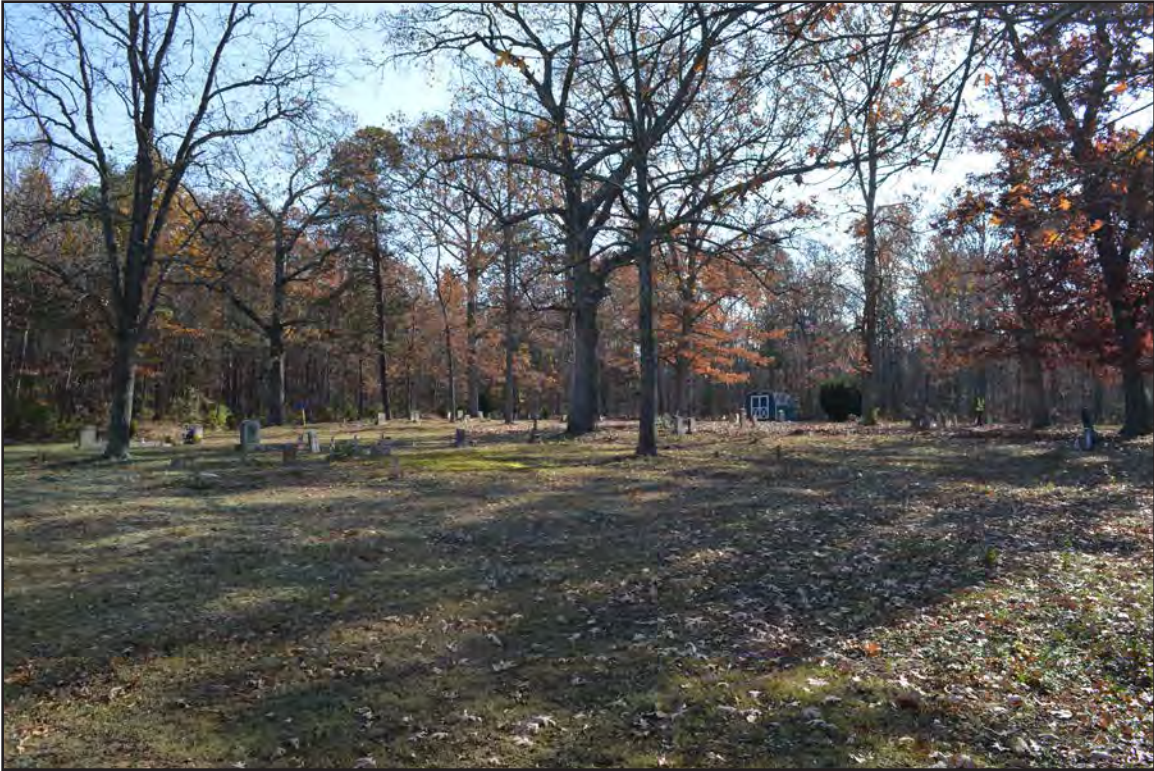
Figure 35. 007-0863, cemetery, facing southeast.

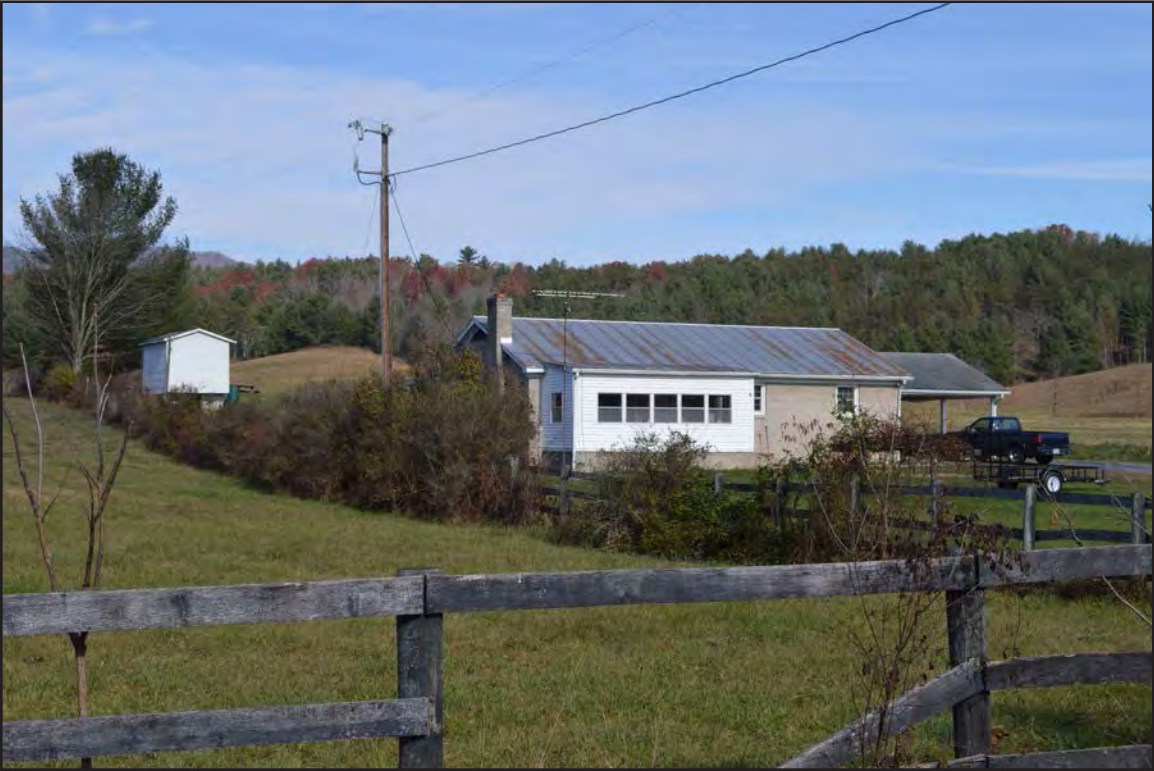
Figure 37. 007-5703, facing northeast.

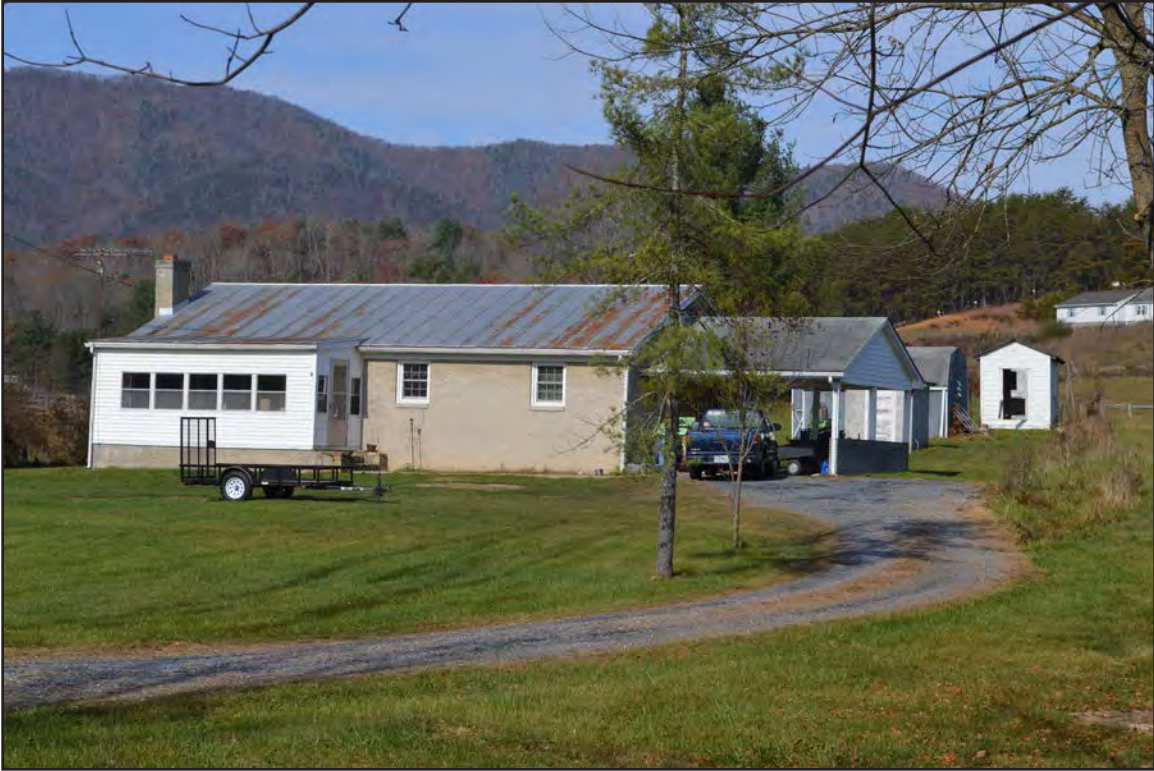
Figure 38. 007-5703, facing northwest.

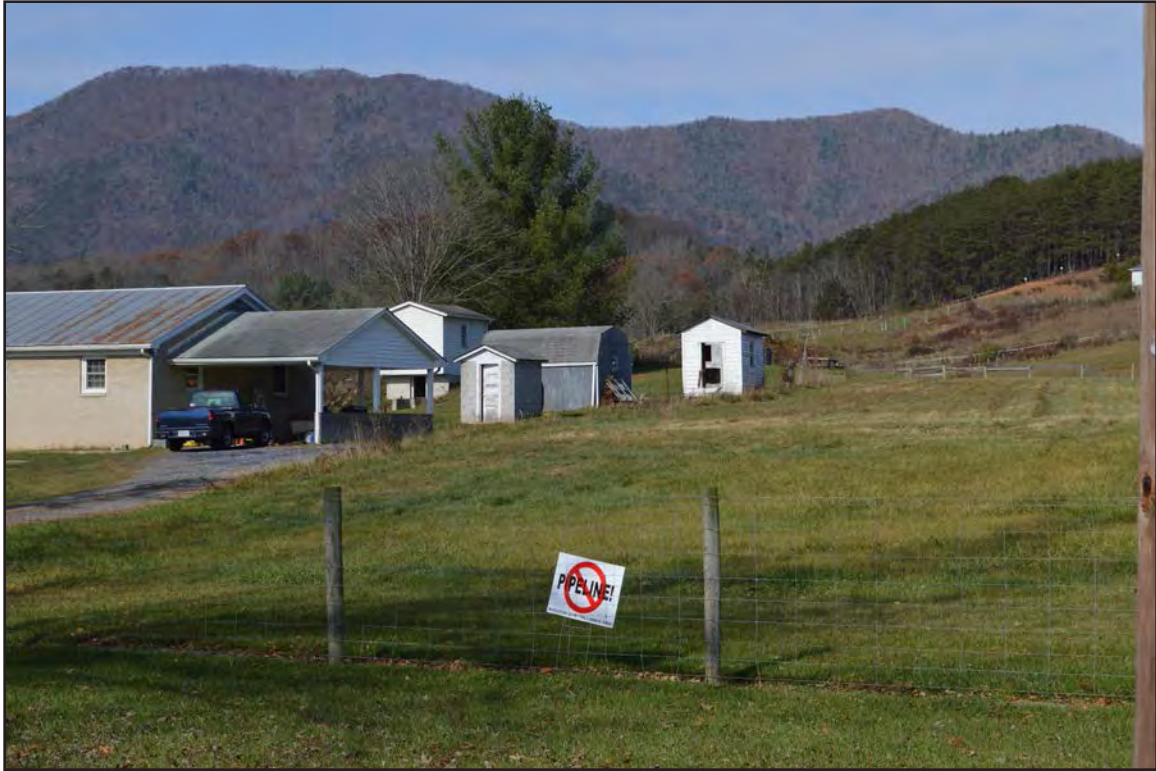
Figure 39. 007-5703, outbuildings, facing northwest.

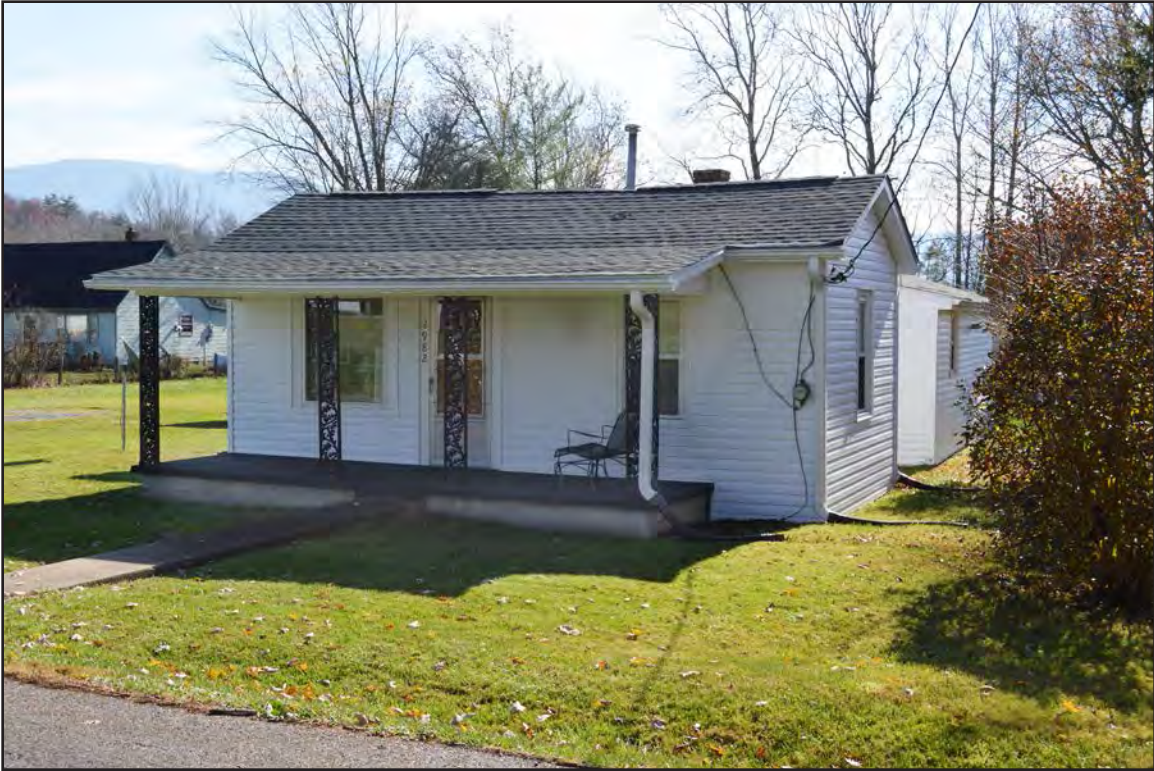
Figure 41. 007-5704, house, facing southeast.

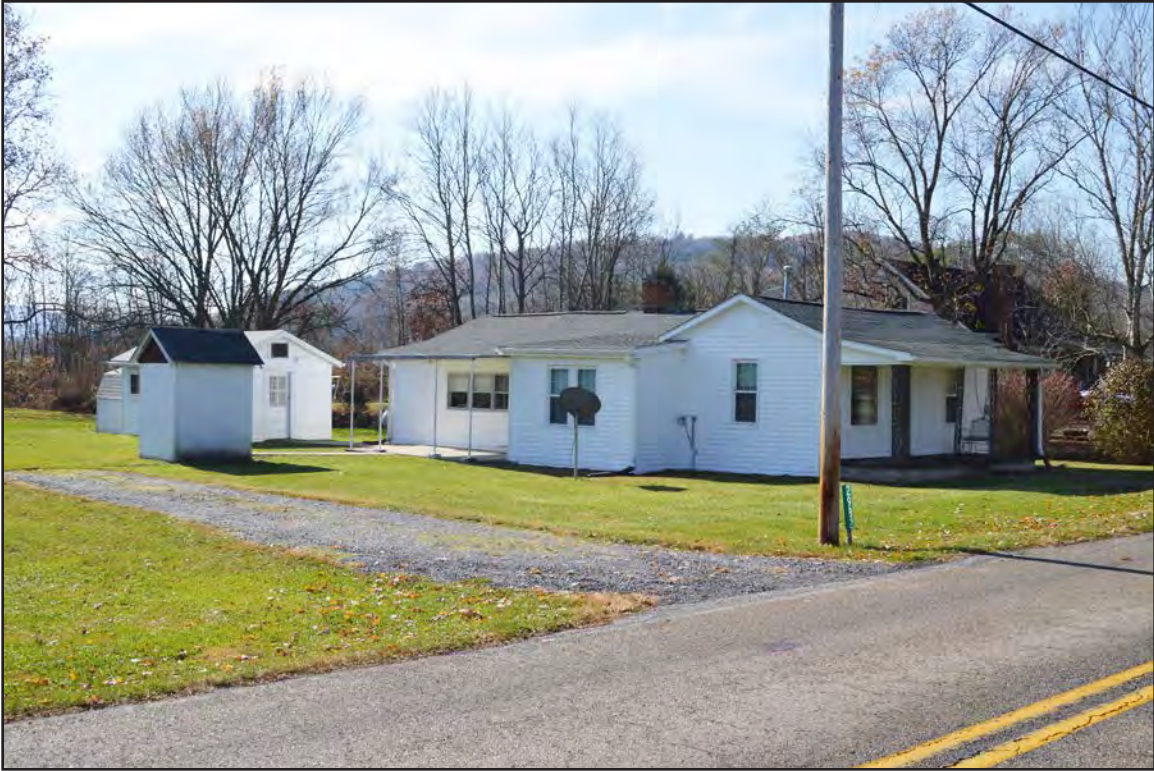
Figure 42. 007-5704, house and outbuildings, facing southwest.

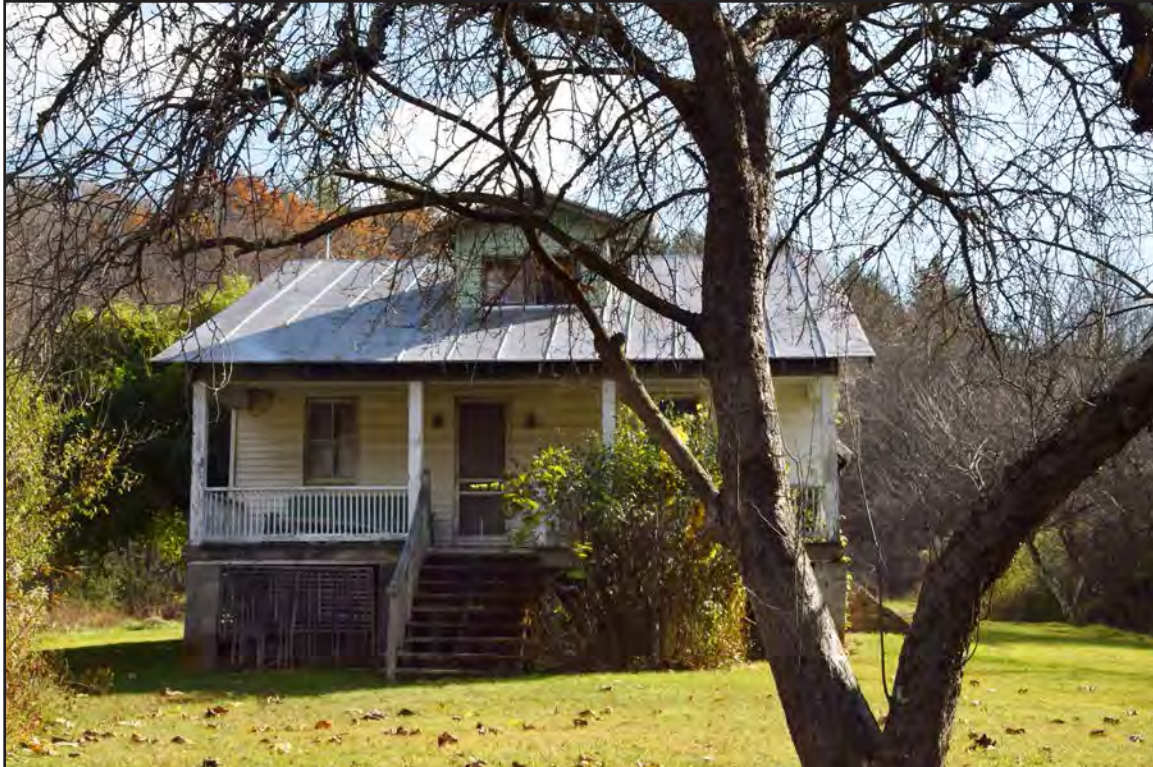
Figure 44. 007-5705, facing southeast.

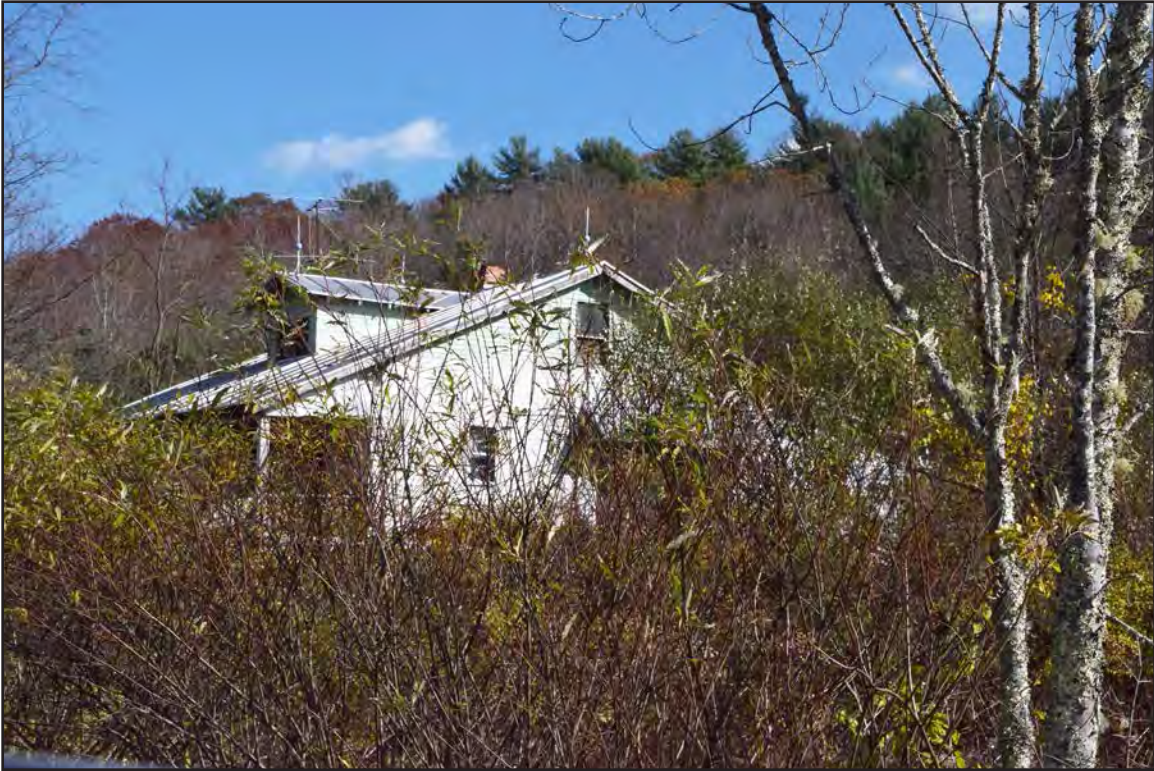
Figure 45. 007-5705, facing east

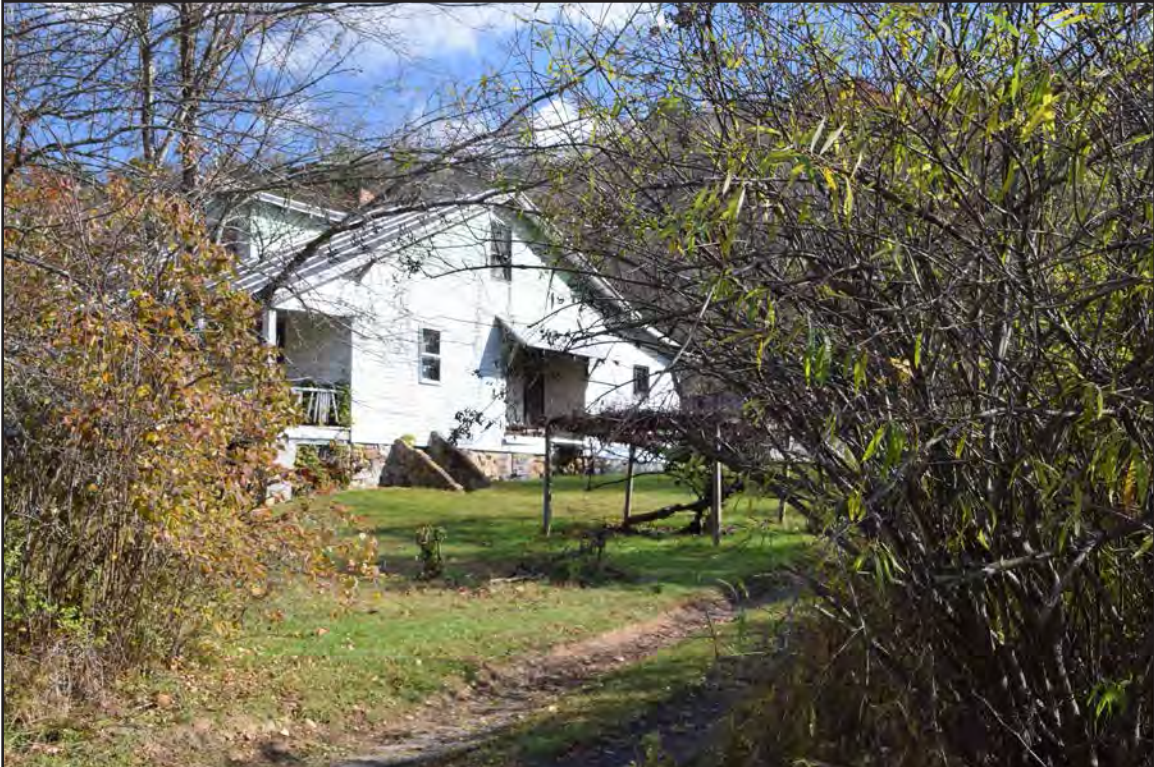
Figure 46. 007-5705, facing east.

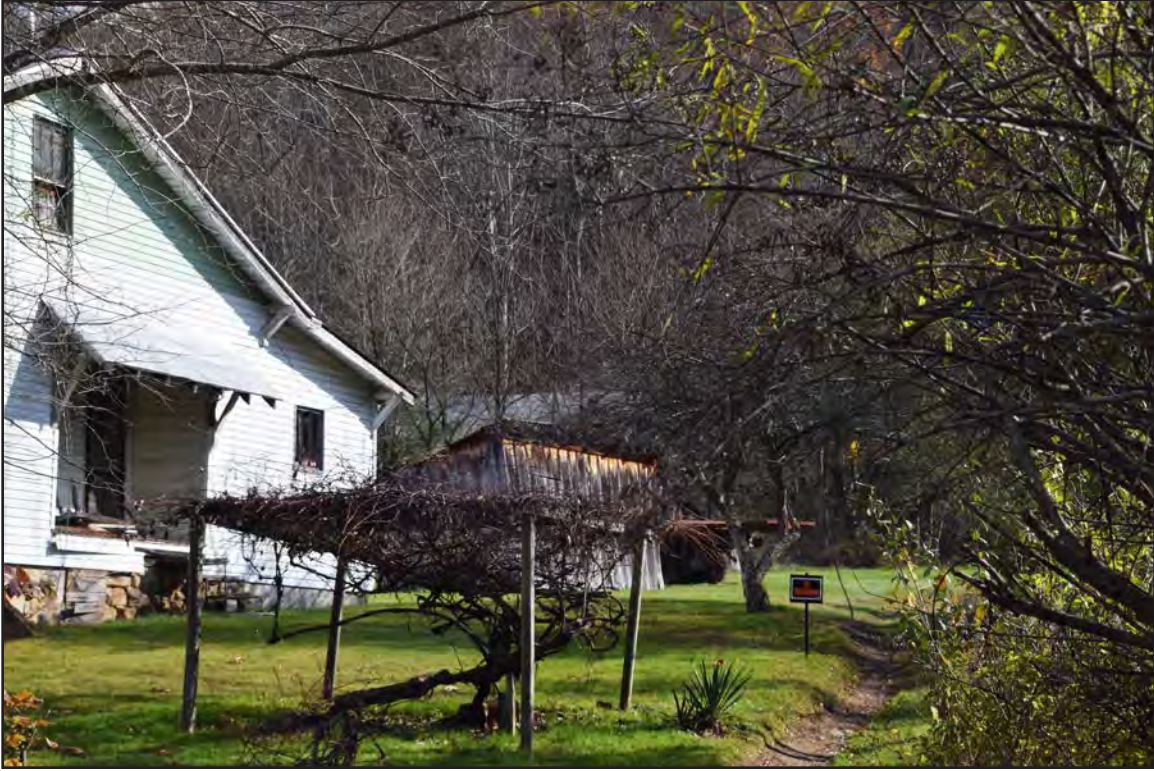
Figure 47. 007-5705, facing south-southeast.

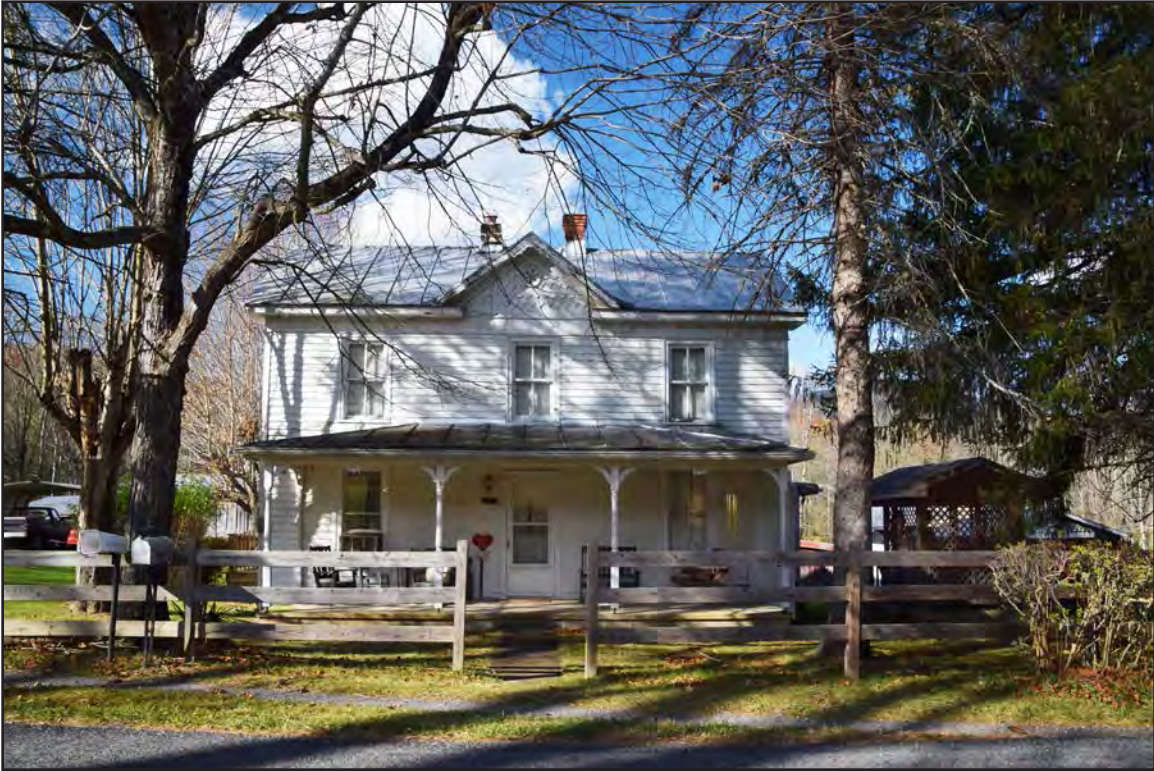
Figure 73. 007-5711, facing northwest.

Built ca. 1900, the two-story dwelling features a three bay front elevation and a two-bay side elevation with Folk Victorian elements (Appendix B, Figures 72–74). The gabled-T plan has had shed-roofed additions added to both the east and west elevations. This dwelling demonstrates the Folk Victorian style with its symmetrical façade, the presence of decorative sawn woodwork detailing, turned porch columns, and a relatively simple frame. Two chimneys are found at the

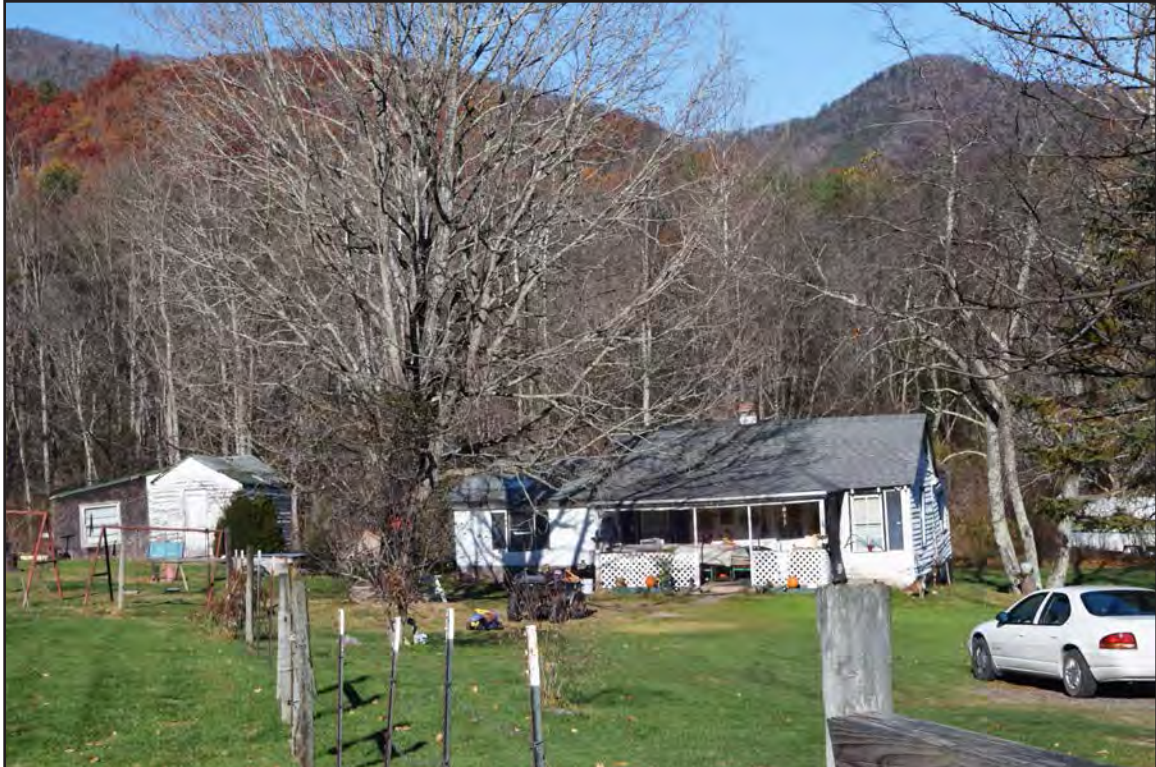
Figure 80. 007-5712, facing northwest.

Built ca. 1925, 007-5712 is a one-story, side-gable vernacular dwelling composed of three parts (Appendix B, Figures 79–81). The main wing is a one-story, moderately pitched, side-gable roof dwelling with a wood frame and central brick chimney at ridgeline. The roof is covered in compositional asphalt shingles. A shed-roof, one-story, wood frame addition is found at the rear of the building. A second one-story, moderately pitched, gable roof wood frame addition is found on the western elevation of the building. Fenestration on the main block is two-over-one double hung wood sash windows. The gable roof addition has one-over-one aluminum frame windows, while the windows visible in the shed roof addition appear to be sliding vinyl windows. The front elevation includes a three-bay, hip-roof porch. The porch is wrapped with modern replacement lattice and has a concrete slab foundation. The porch roof is supported by modern replacement wood beams and posts. The ca. 1950 one-story gable section features an open-eave cornice, while the one-story addition is constructed with a closed cornice. The exterior is clad with vinyl siding on the front elevation and wood weatherboard siding on the east and rear addition. The western addition is covered with what appears to be manufactured wood panels; that is possibly T1-11 siding, painted white. A skylight has been integrated into the roof. The foundation on the main house appears to be a combination of stone and concrete blocks, parged in some places, suggesting that the concrete block is infill used as stabilization. The eastern and rear elevation foundations are wrapped in black corrugated metal. The ca. 1950 western one-story addition has a smooth concrete foundation. The sliding window on the rear shed addition suggests that the addition was added ca. 1970.

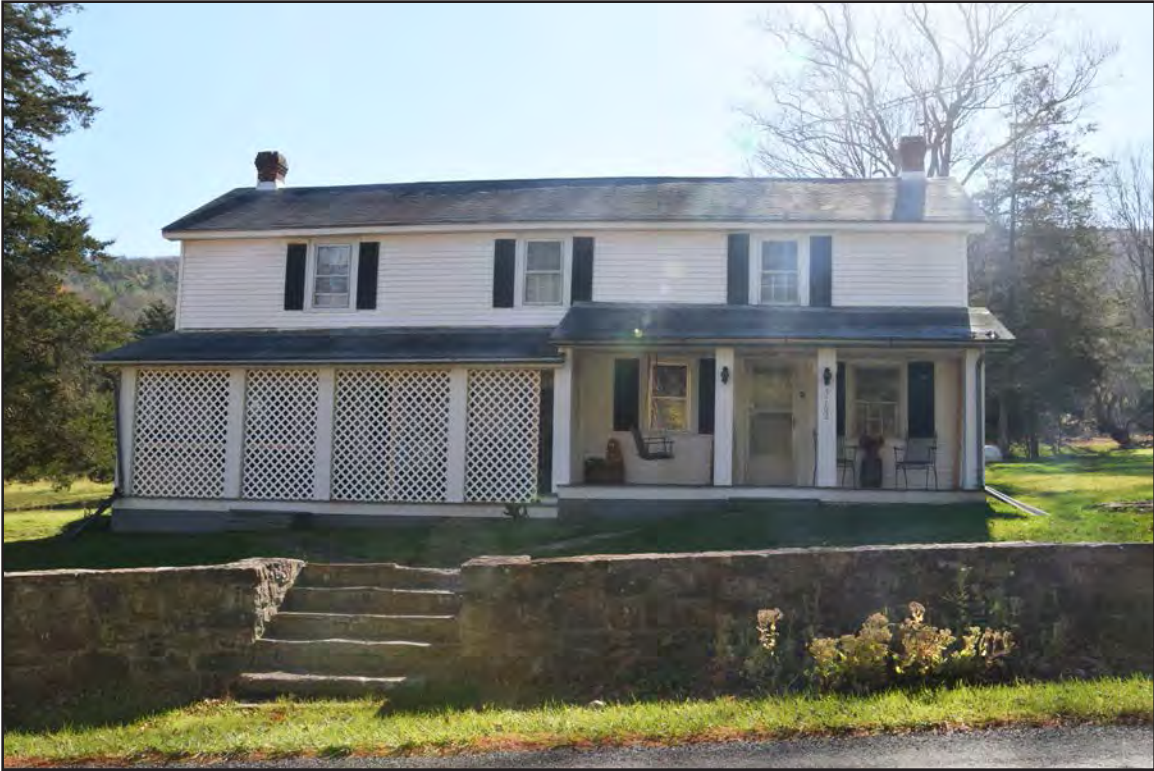
Figure 85. 007-5713, house, facing southeast.

The resource is a ca. 1900s, two-story, wood-frame, vernacular I-house set on a fieldstone foundation and clad in vinyl siding (Appendix B, Figures 84–86). In response to the slope on which the original block was constructed, the current front porch consists of two sections that differ slightly in elevation. The porch is full-length, and has a shed roof clad in asphalt shingles, supported by posts that are clad in wood. There are wood, paneled-door entrances under both parts of the porch. The lower side of the porch is screened by wood lattice panels. The windows throughout the house are wood-frame, six-over-six, double-hung replacement windows, except on a 1960s addition at the rear of the house, which features aluminum sliding windows. The roof of the house is side-gabled and clad in asphalt shingles, and there are two interior, corbeled brick chimneys near either end of the house. At the rear of the house are two, single-story additions. One has the same characteristics of the original block, including a central, interior, corbeled brick chimney set on the ridgeline; it was likely added in the early 1900s. The second addition is a 1960s, single-story, shed-roof addition attached to two elevations on the southwest; it is set on concrete block and clad in asbestos siding. Its roof is clad in standing-seam metal.

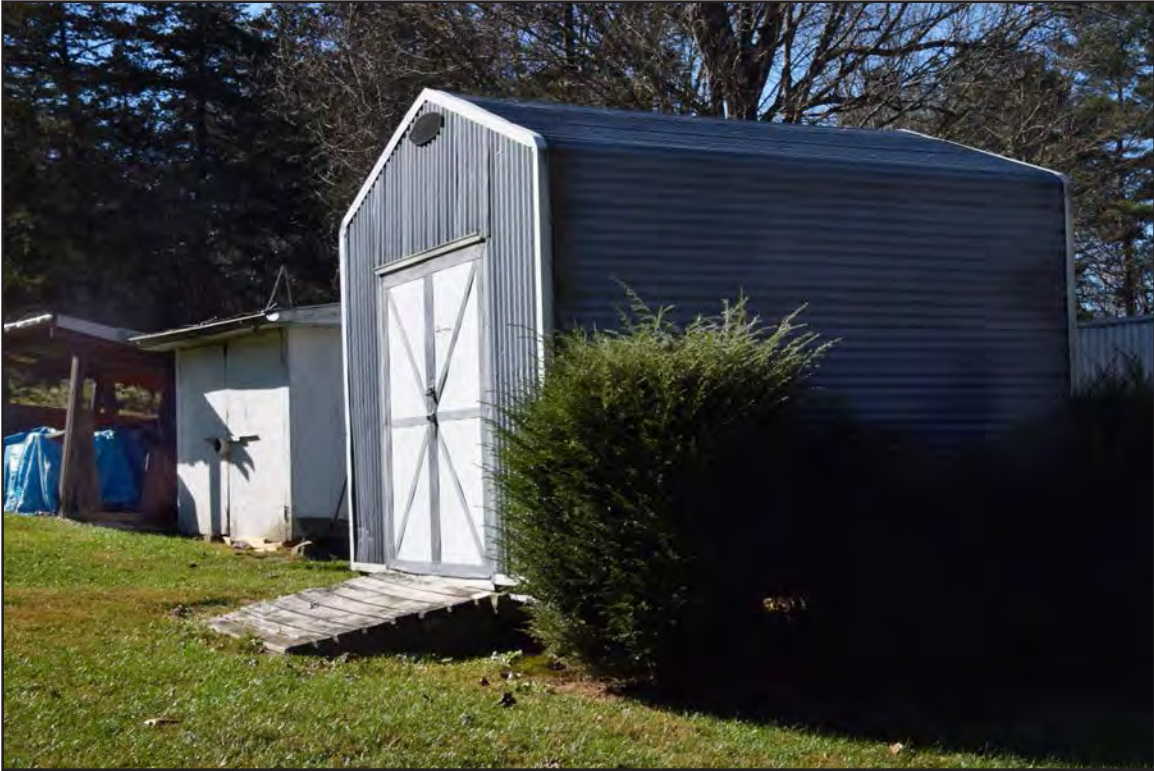
Figure 87. 007-5713, outbuildings, facing south.

The house has five nonhistoric outbuildings associated with it. The first is a ca. 1980s, prefabricated, corrugated-metal shed set on concrete blocks (Appendix B, Figure 87). It has a gabled roof that is continuous with the corrugated metal siding. It has aluminum double doors on its southeast elevation. Nearby are two more sheds that sit adjacent to one another. One is a ca. 1970s, wood-frame, plywood-clad shed that rests on fieldstones and replacement, wood blocks. Plywood, double doors are on the northwest elevation. It has a shallow-pitched, side-gabled roof clad in corrugated metal. The other shed is a ca. 1990s, wood-frame, open-air shed with one bay opening facing northwest. It is clad in wood lattice and set on concrete blocks. The roof is a shed-roof clad in aluminum sheets. There has also is a detached ca. 1990s, wood-frame garage with two, open bays. It is set on posts, is clad in ribbed metal, and has a ribbed-metal, shed roof. The final building is a ca. 2000s makeshift shed to the south at the edge of the tree line. It is composed of various components, namely corrugated metal, concrete block, wood lumber and an aluminum, garage door to build a structure that houses equipment.

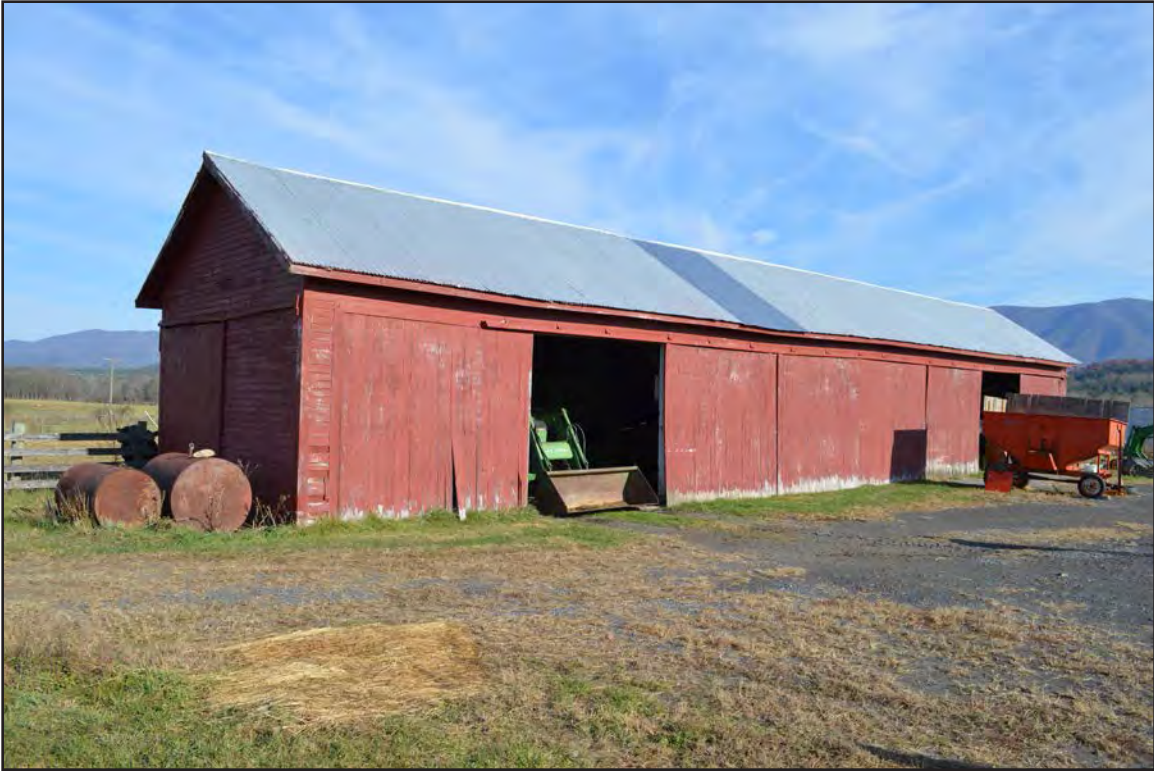
Figure 89. 007-5714, barn, facing east.

The resource is a ca. 1920s-1930s one-story, wood-frame, vernacular barn set on a mix of poured-concrete and stone foundation and clad in clapboard siding (Appendix B, Figures 88 and 89). A residence across the road, which was outside the project APE, may be associated with the farm buildings. The barn is a long building and its southwest, or primary, elevation has a series of three sliding doors constructed of vertical-board facing the gravel driveway; heavy equipment and supplies are stored within. The roof is side-gabled and clad in corrugated metal. The only feature on the northwest elevation is a sliding door. On the southeast elevation are two wood-frame, fixed-pane, four-light windows. The northeast elevation is relatively plain, with a wood-frame, six-over-six, double-hung window on the southeastern end.

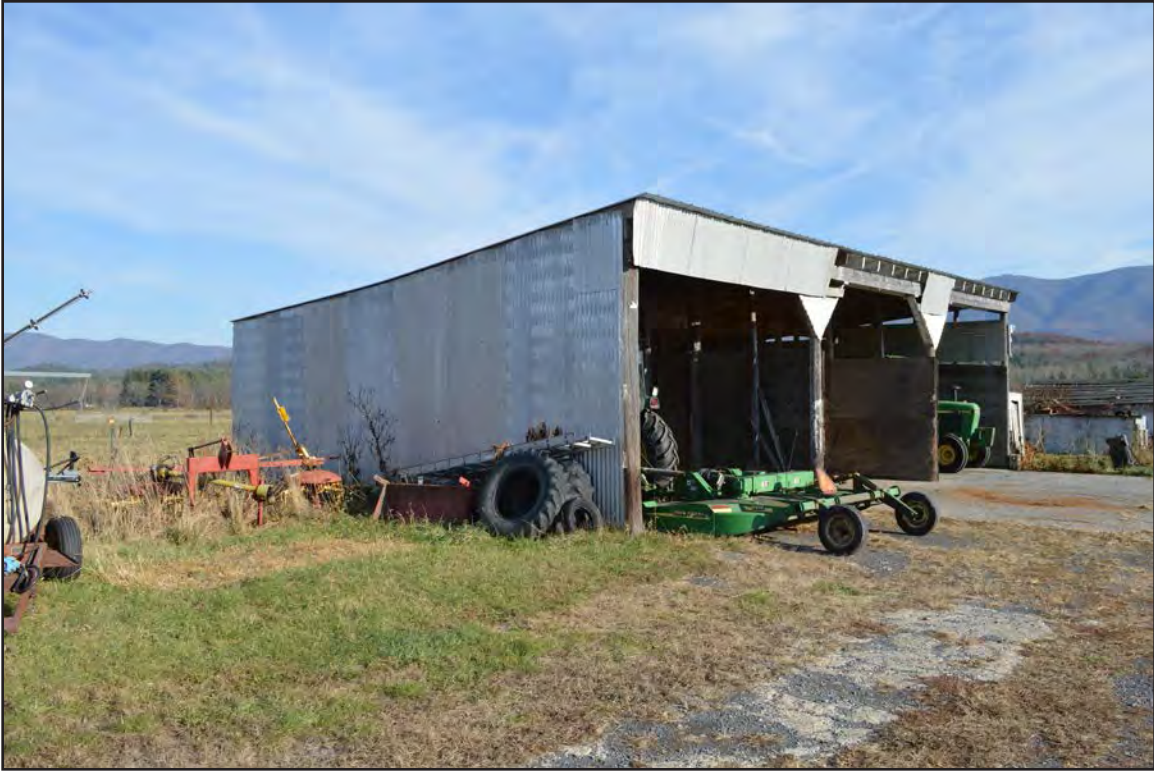
Figure 90. 007-5714, shed, facing east.

There are three other structures associated with the barn, a ca. 1960s shed, a ca. 1950s outhouse, and chicken coop (Appendix B, Figures 90 and 91). The shed is a single-story, wood-frame structure set on posts and clad in corrugated metal. It has three open bays facing southwest where heavy equipment and supplies are currently stored. It has a shed roof that slopes down towards the northeast. The northwest bay is open on the rear of the building, while the other two bays are enclosed on the rear with the exception of a clerestory band of openings. The outhouse is adjacent to the building to the southeast. It is wood-framed, clad in vertical lumber, and has a vertical lumber door facing to the southwest. It has a shed roof clad in corrugated metal and features a wood, vent projection with corrugated shed roof. The final outbuilding is a wood-frame structure clad in vertical lumber siding. It is side-gabled and no longer has any roof covering aside from the wood sheathing. There are several openings visible, one of which is covered with a hinged, vertical lumber shutter. Some rusted equipment rests nearby the structure to the northwest.

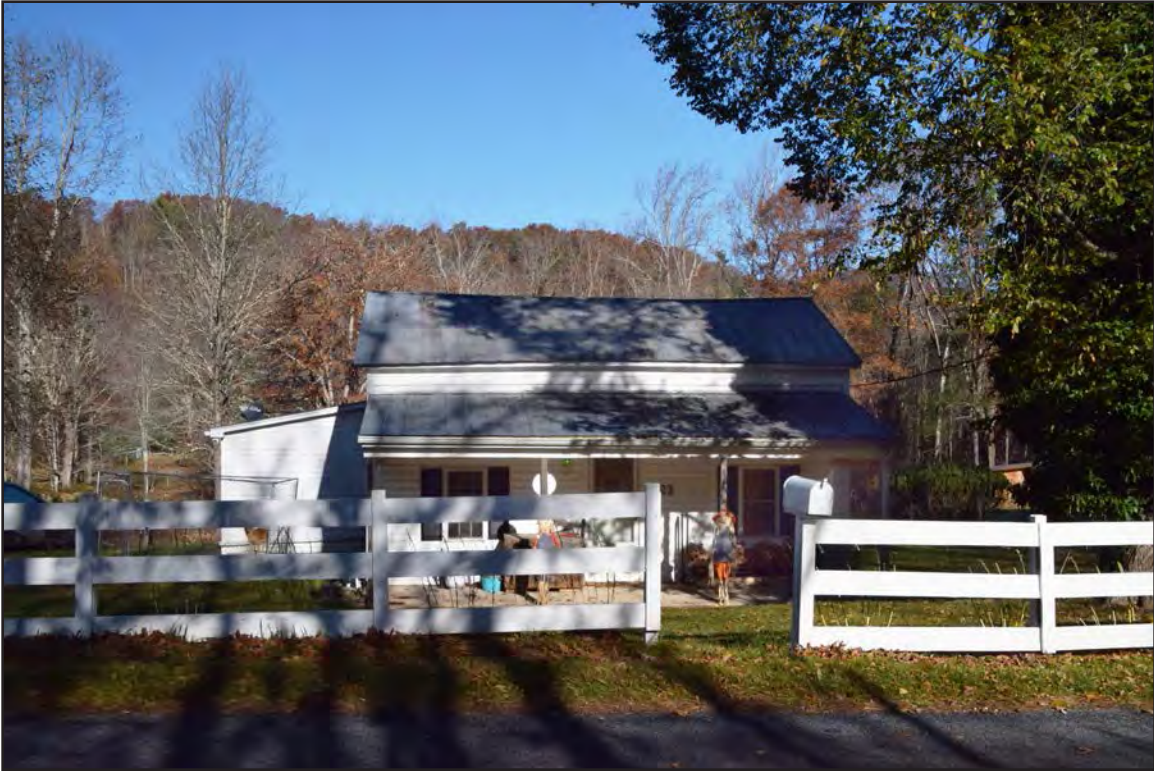
Figure 93. 007-5715, house, facing northwest.

The house on this property was built ca. 1930s. The house is a one-and-a-half-story, side-gable vernacular house built on a central hall plan (Appendix B, Figures 92 and 93). The entire house is clad in horizontal vinyl drop siding, and has a standing seam metal roof. All windows appear to be vinyl replacements. The rear portion of the house has a ca. 1940s one-story front-gable addition with shed additions dating to the 1960s or 1970s attached to either side, also with standing-seam metal roofing. The foundation of the original block and additions appears to be concrete, although it is difficult to observe on the original block. The house is three bays wide. The west elevation of the gable addition has an exterior concrete block chimney (Appendix B, Figure 94). The south façade has a standing-seam metal shed-roof porch that extends the full width of the house. The porch has a poured concrete at-grade floor and replacement timber supports. The first story of the house has six-over-six windows with fixed decorative shutters. Fenestration on the façade is symmetrical with two windows flanking a single-light wood-panel door covered with a screened door in the center. The second story on the façade does not have windows. The west elevation of the house has a single six-over-six window with fixed shutters on both the first and second story. The central massing of the east elevation of the house follows the same fenestration as the west. The rear shed addition on the east has two, one-over-one windows (Appendix B, Figure 95). There is a modern, prefabricated shed constructed ca. 2000 on the property that sits at the end of the driveway.

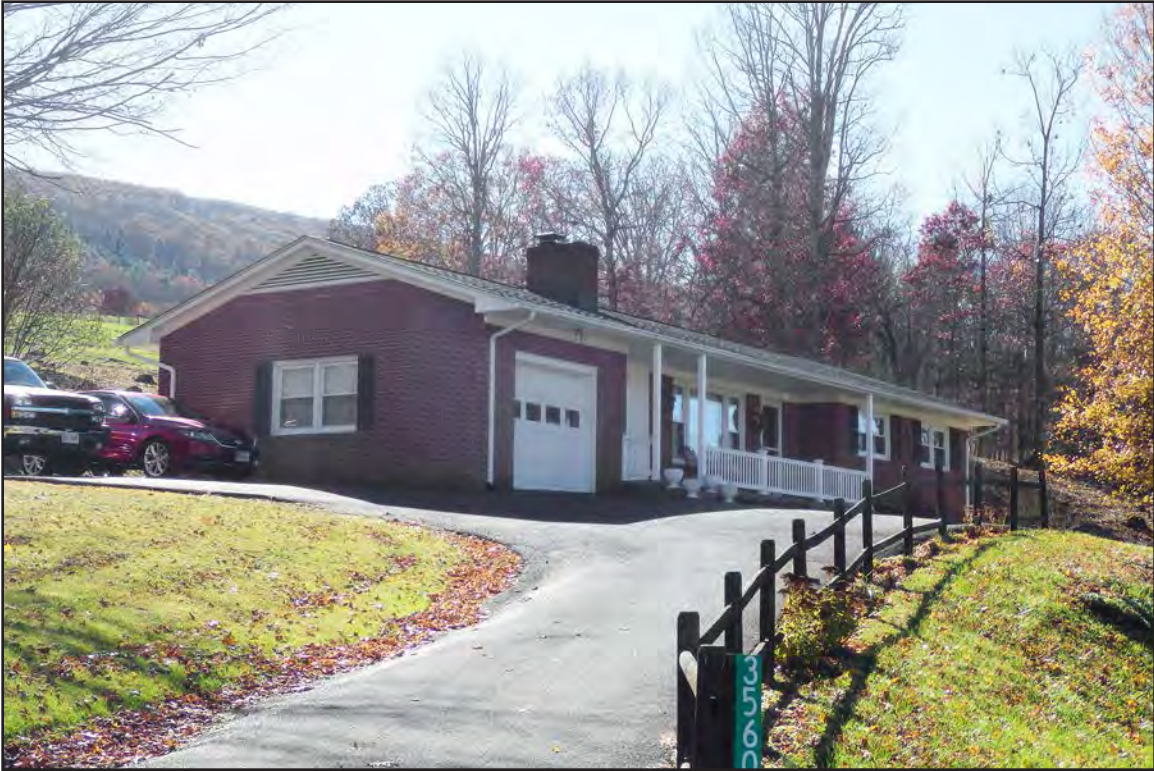
Figure 97. 007-5716, facing southwest.

The ca. 1960s one-story side-gabled brick Ranch house has seven bays, with an integral garage at its northeast end with an updated vinyl door. The structure has an asphalt shingle roof, with vinyl siding at the top of the gable ends, and a wide internal brick chimney (Appendix B, Figures 96 and 97). Its foundation was not visible from the public road. The three central bays are recessed and are fronted by a partial-width front porch at the main northwest façade (Appendix B, Figure 98). The porch is framed by square wood posts, with plain balusters in the railing panels between them, and it appears to have a poured concrete floor. The entrance to the porch is adjacent to the garage and is accessed by steps. The main entrance at the southwest end of the porch has an updated wood door with a large oval light in the center, and it is covered by a vinyl storm door. Adjacent to the entrance is a large fixed picture window flanked by a pair of one-over-one double-hung windows, which appear to be original. A second door near the steps is also covered by a vinyl storm door. The two pairs of one-over-one windows at the southwest end of the main façade, the pair of one-over-one windows at the northeast façade, and the two one-over-one windows at the southwest façade are framed by decorative shutters (Appendix B, Figure 99). The house is in overall good condition.

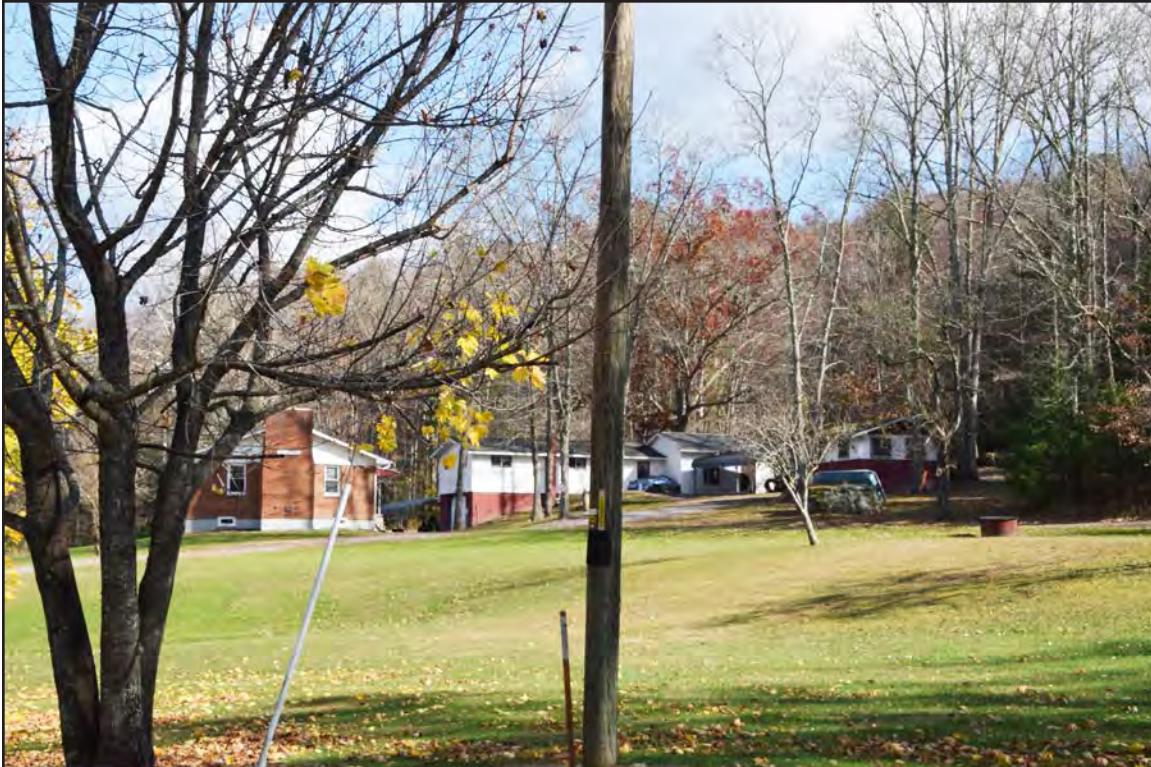
Figure 126. 007-5723, facing east.

The ca. 1970 L-plan split-level gabled residence responds to the site's slope (Appendix B, Figures 125 and 126). A one-story end-gabled section is sited higher on the slope than the side-gabled wing. Its foundation is not visible from the road. It has vinyl siding and an asphalt shingle roof. At its main west façade, it has a large one-over-one vinyl window and a weathered paneled wood door. A ca. 1990s metal carport is sited immediately adjacent to this façade. A two-story -gabled wing extends to the north of this section, with its north façade accessed by the driveway shared with the neighboring residence; the two-story section may be a later addition. The two-story section has a concrete masonry foundation and a roll-up vinyl garage door at its lower level (Appendix B, Figure 127). There is a concrete masonry chimney at its west façade, and its upper level has vinyl siding, one-over-one double-hung and sliding vinyl windows, and an asphalt shingle roof. This end-gabled section has a one-story gabled addition sited perpendicularly at the lower level of its east façade. The addition's foundation is not visible from the road. It appears to be clad with wood siding, and has an asphalt shingle roof. The addition has an updated vinyl door at its north façade and a sliding vinyl window. It is in good condition. A circa 1960-1970s one-story gabled accessory structure is located approximately 60 feet to the west of the residence. Its foundation is not visible from the public road. It appears to be constructed of concrete masonry, with an asphalt shingle roof (Appendix B, Figure 128). Its window openings appear to be filled with a solid material.
