**Subject: Section 106 Review –Architectural Survey Report REVISED Addendum 4  
Atlantic Coast Pipeline, LLC, Atlantic Coast Pipeline Project  
DHR File No. 2014-0710**

**PHASE I HISTORIC ARCHITECTURAL SURVEY OF THE  
ATLANTIC COAST PIPELINE PROJECT**

**Virginia Addendum 4 Report**

**DHR File No. 2014-0710**

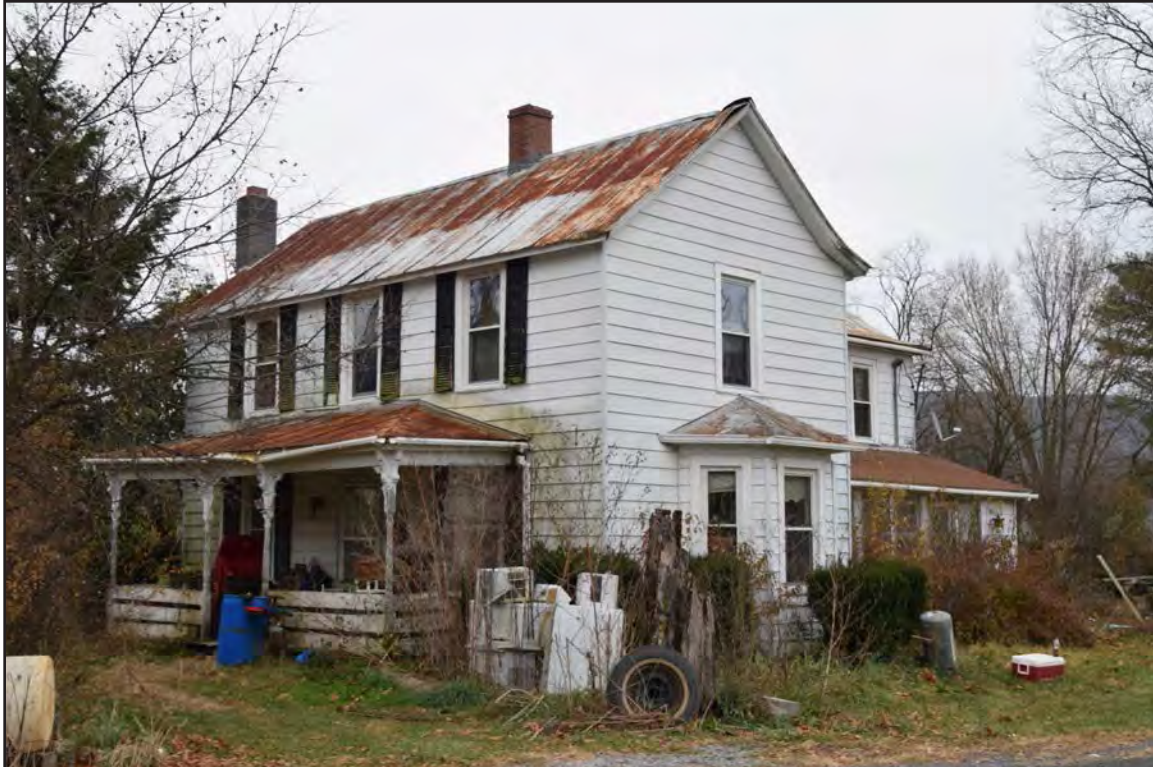
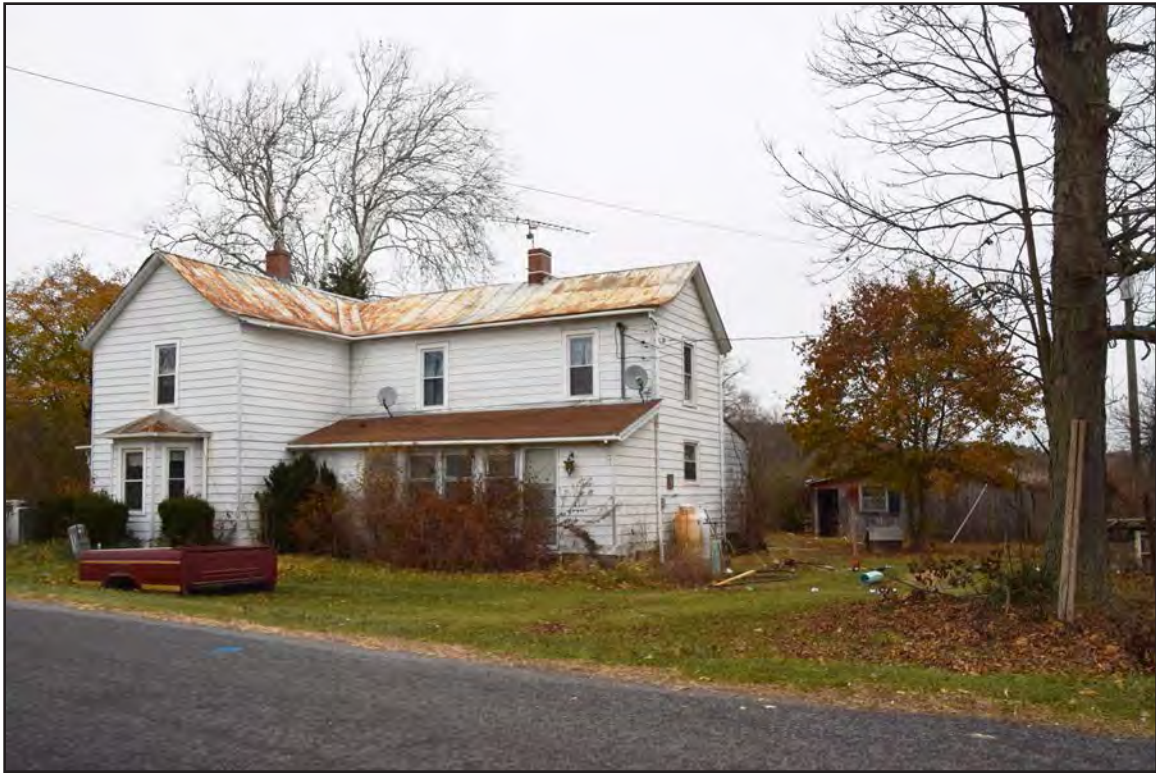
The main structure is a ca. 1900s, two-story, wood-frame, Folk Victorian I-house set on a fieldstone-pier foundation with concrete infill, clad in vinyl siding (Appendix B, Figures 129–131). Its primary elevation faces northwest and is three bays wide. On the first story is a central, wood-panel door and two, vinyl-frame, one-over-one, double-hung windows. This style of replacement window is seen throughout the house. The first floor on façade also features a partial-width, wood-frame porch with a hipped roof clad in standing-seam metal. It is supported by turned wood posts with ornate porch and post face brackets. The porch balustrade consists of three horizontal, wood boards. The windows on the façade are the only ones that feature decorative louvered shutters. The roof is side-gabled and clad in standing-seam metal; it features lines of inflection on the rear roof slopes of the main block and the T wing. There is an interior, brick chimney at the center on the ridge line of the main block, and an external, concrete-block chimney on the northeast elevation. On the southwest side of the I-house, facing Marble Valley Road, is a hipped roof bay window. At the rear of the house is a two-story gabled T wing. A ca. 1960s, shed-roof addition is along the first story of the rear wing's west side. It features aluminum-frame, one-over-one, double-hung windows and has two vinyl doors becoming blocked by overgrown shrubbery. Another similar shed addition is on the other side, though access restrictions limited the view of any specific details.

Figure 130. 007-5724, house, facing east.

Figure 131. 007-5724, facing north.

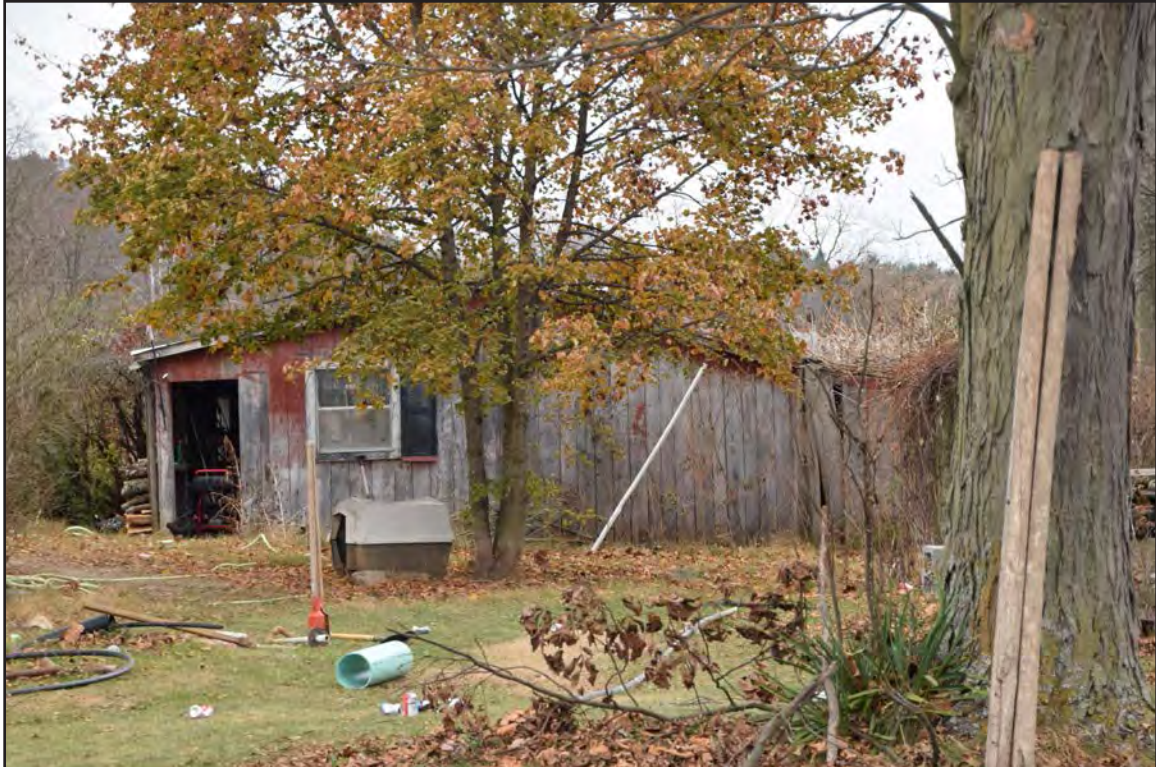
Figure 132. 007-5724, shed, facing northeast.

There is one outbuilding associated with the house (Appendix B, Figure 132). It is a ca. 1970s, wood-frame shed clad in vertical board. The gabled roof is clad in standing-seam metal. It has a door opening on the northwest end of the southwest elevation, and a wood-frame, two-light, aluminum window. There is a wood decorative shutter on one side. The southeast side of the shed has a shed-roof addition that continues the pitch of the roof. It is overgrown by shrubbery on that end.

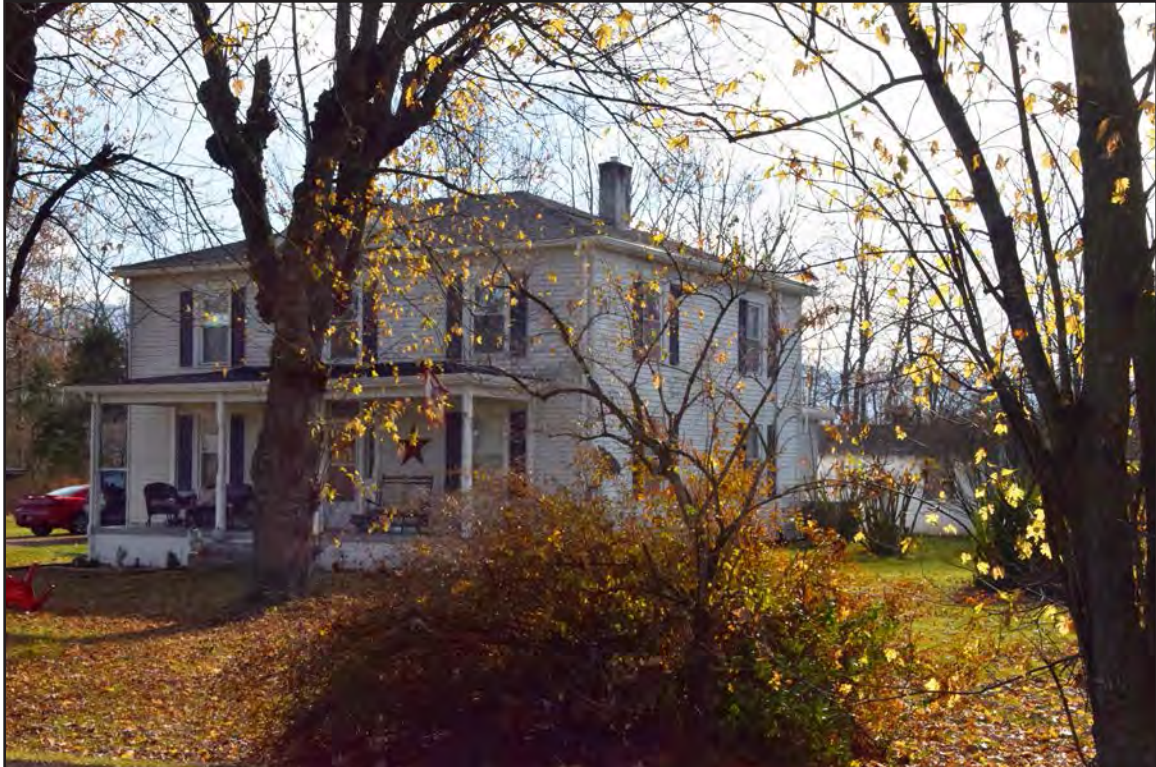
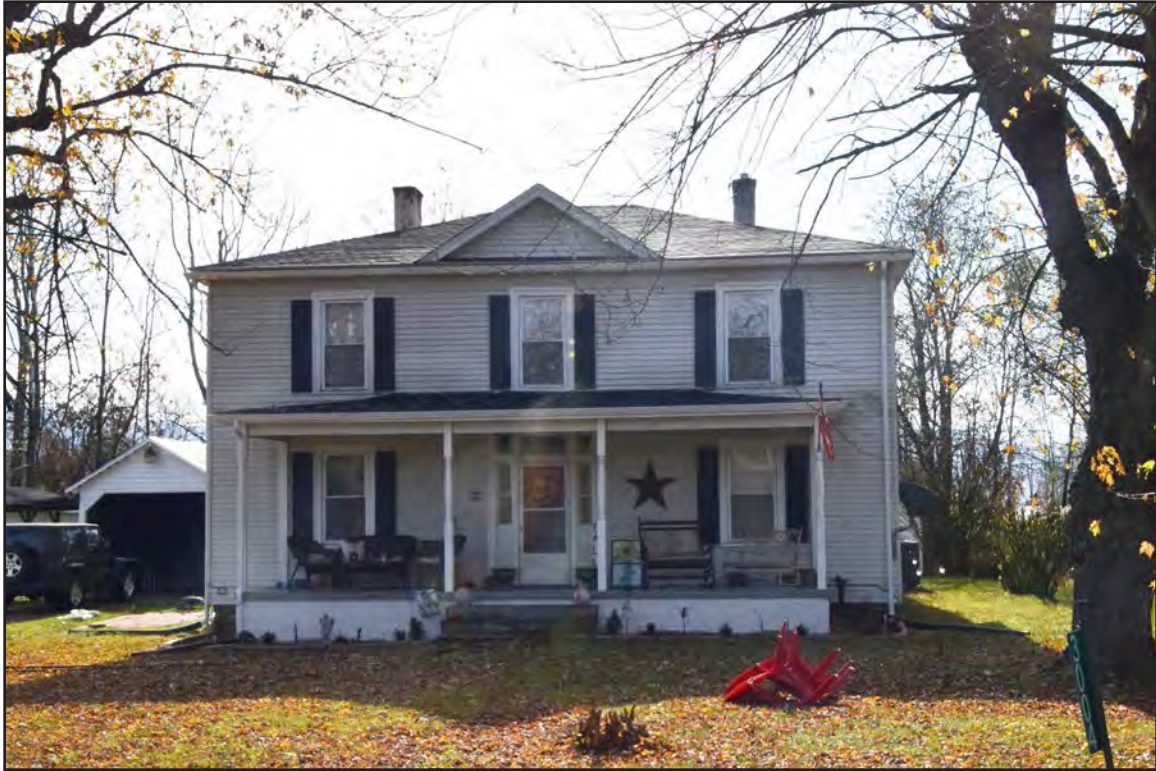
The resource is a ca. 1900, two-story, wood-frame, American Foursquare set on a coursed stone foundation and clad in vinyl siding (Appendix B, Figures 133–135). The hipped roof is clad in asphalt shingles and features a small, pediment on the façade. The primary elevation faces north and is three bays wide at front and the main house massing is two bays deep. At center is a wood, paneled door with rectangular transom and side lights, covered by storm door and storm windows. The other two bays feature vinyl-frame, one-over-one, double-hung, replacement windows with decorative louvered shutters. An almost full-length porch is located on the first story, with a concrete-block replacement foundation. The hipped roof is covered in asphalt shingles and is supported by turned wood replacement posts. There are two internal, brick chimneys spaced equidistant along the centerline of the house from west to east. At the back (south) of the house is a ca. 1930 wood-frame addition set on a concrete block foundation and clad in vinyl siding. It appears to have a hipped roof clad in asphalt shingles. The addition may have at one time been a porch that has since been enclosed.

Figure 134. 007-5725, house, facing southeast.

Figure 135. 007-5725, house, facing south.

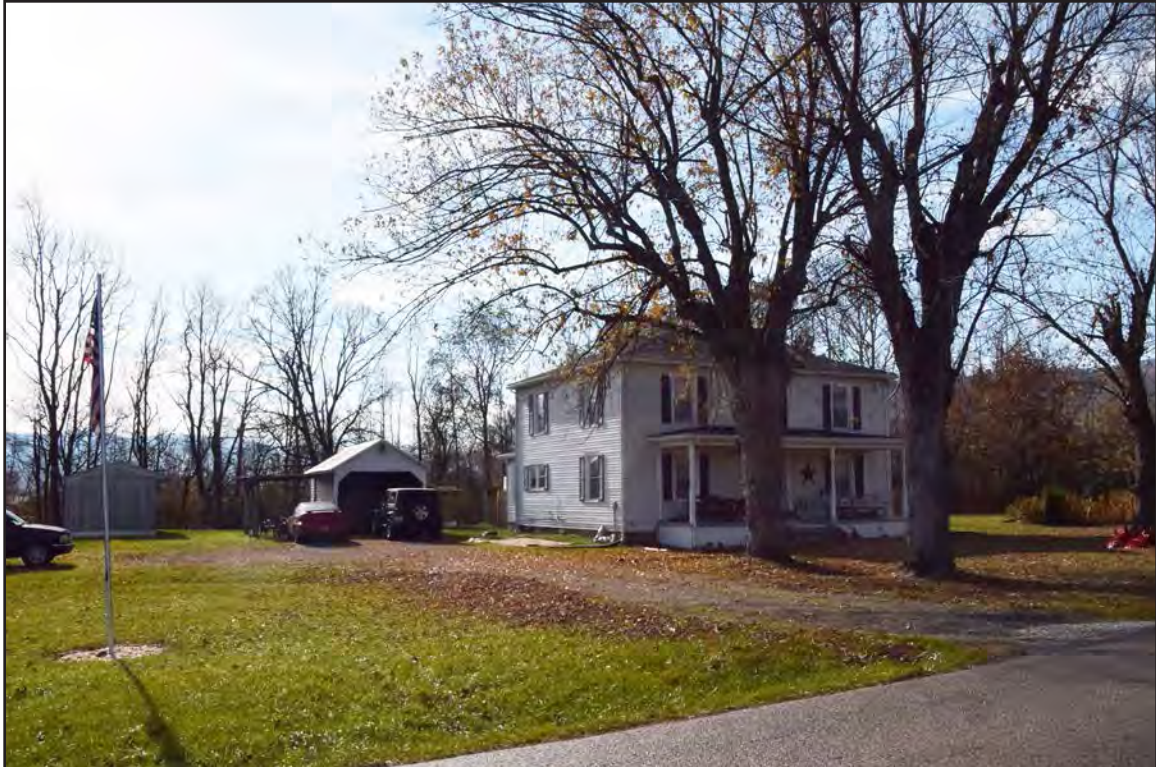
Figure 136. 007-5725, house and outbuildings, facing southwest.

The house has five outbuildings associated with it. Storage shed I, built in ca. 1990, is located southeast of the house. The wood-frame shed is set on a poured-concrete foundation and clad in T1-11 siding (Appendix B, Figure 136). It has three wood-brace doors on its west elevation. The roof is side-gabled and clad in asphalt shingles. Also southeast of the house is a ca. 1950 wood-frame garage set on a poured-concrete foundation. It is clad in vinyl siding, has a large, open bay facing north, and features an extended, wood-frame carport on its east elevation, with a shed roof clad in standing-seam metal. The roof of the garage is gable-end and clad in standing-seam metal. The remaining structure to the southeast is a dilapidated shed. It has clapboard and Bricktex siding, and it has a gabled roof clad in asphalt shingles. It rests on a concrete block foundation. The last structure visible from the public right-of-way is Storage Shed II. The building is constructed of concrete block, and has a single wood-frame, four-light, fixed-pane window visible. The roof is side-gabled and composed of asphalt shingles. The top of a concrete-block chimney is visible near the center of the building on the southern end of the ridgeline. A final structure, small and rectangular in shape, was noted in an aerial photograph to the southwest of the house; however, it was not visible from the road due to shrubbery and trees.

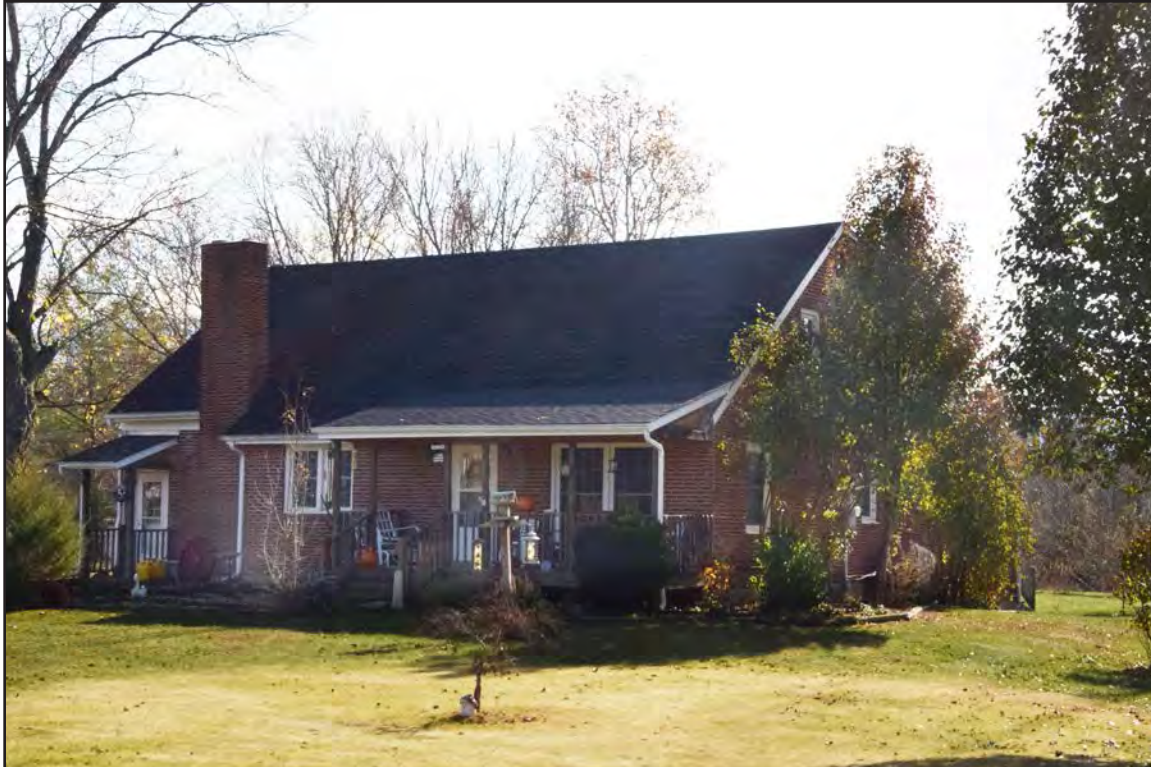
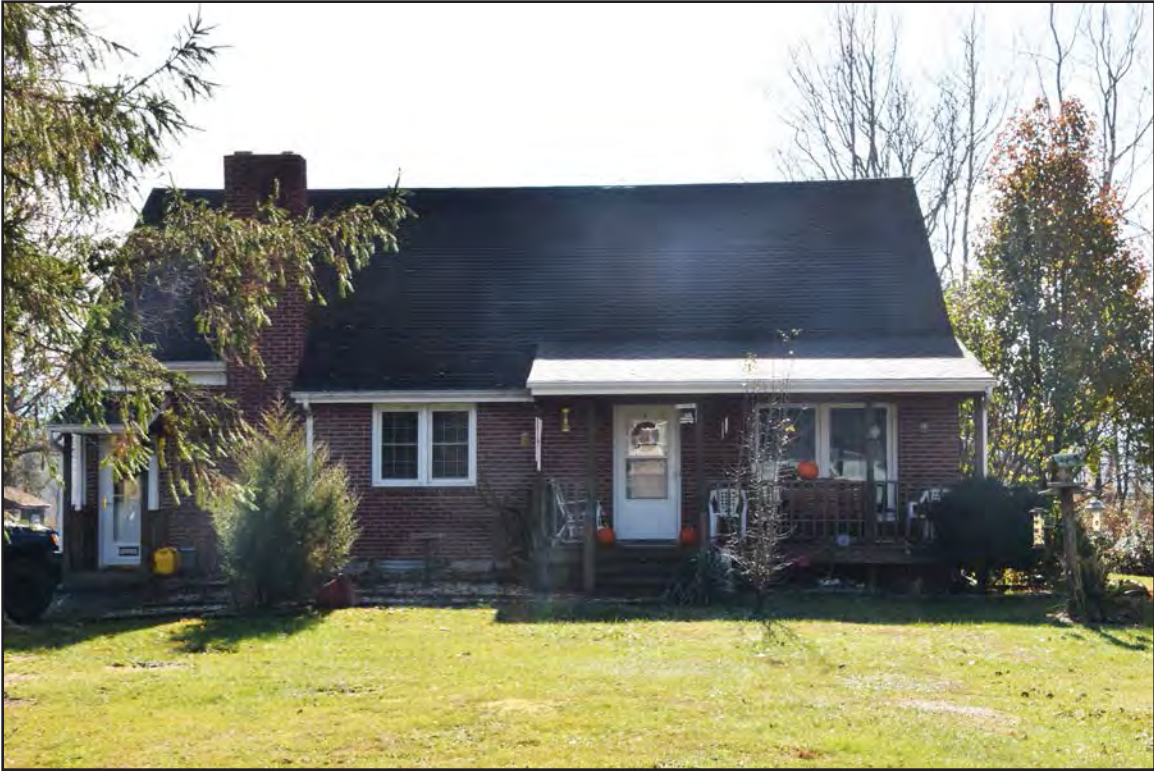
The resource is a ca. 1960, one-and-a-half story, vernacular house set on a poured-concrete foundation and clad in common-bond brick and vinyl siding on the east elevation (Appendix B, Figures 137–139). It features a large brick exterior chimney on the façade, reminiscent of Tudor Revival style. The house is four-bays wide on its north, or primary, elevation, with a wood-frame porch covering the west side of the north-facing façade. It has wood posts and a shed roof with asphalt shingles. Within the porch is the primary entrance consisting of a wood paneled door with nine-lights and a storm door, and to the left of the door are paired, vinyl-frame, eight-over-eight, double-hung windows. On the section of the elevation not covered by the porch are paired, vinyl-frame, six-over-six, double-hung windows, the wide chimney, and a wood paneled door with nine lights and a storm door on the end. This door has a simple shed-roof portico, supported by wood posts, and clad with asphalt shingles. This part of the house may represent a ca. 1970 addition, at which point, the chimney may have been added. The roof of the house is side-gabled and clad in asphalt shingles. It has a relatively steep pitch. On the sides of the house is vinyl siding mixed with brick, unlike the north elevation which is all brick. The house features vinyl-frame, six-over-six double-hung windows throughout its other elevations. On the rear of the building are two additions identifiable from the public right-of-way, the main one extends the second floor with a shed roof wood frame addition covered in vinyl siding. A one-story shed roof porch has been added to this addition. Property access restrictions do not allow for further details to be described.

Figure 138. 007-5726, house, facing southeast.

Figure 139. 007-5726, house, facing southwest.

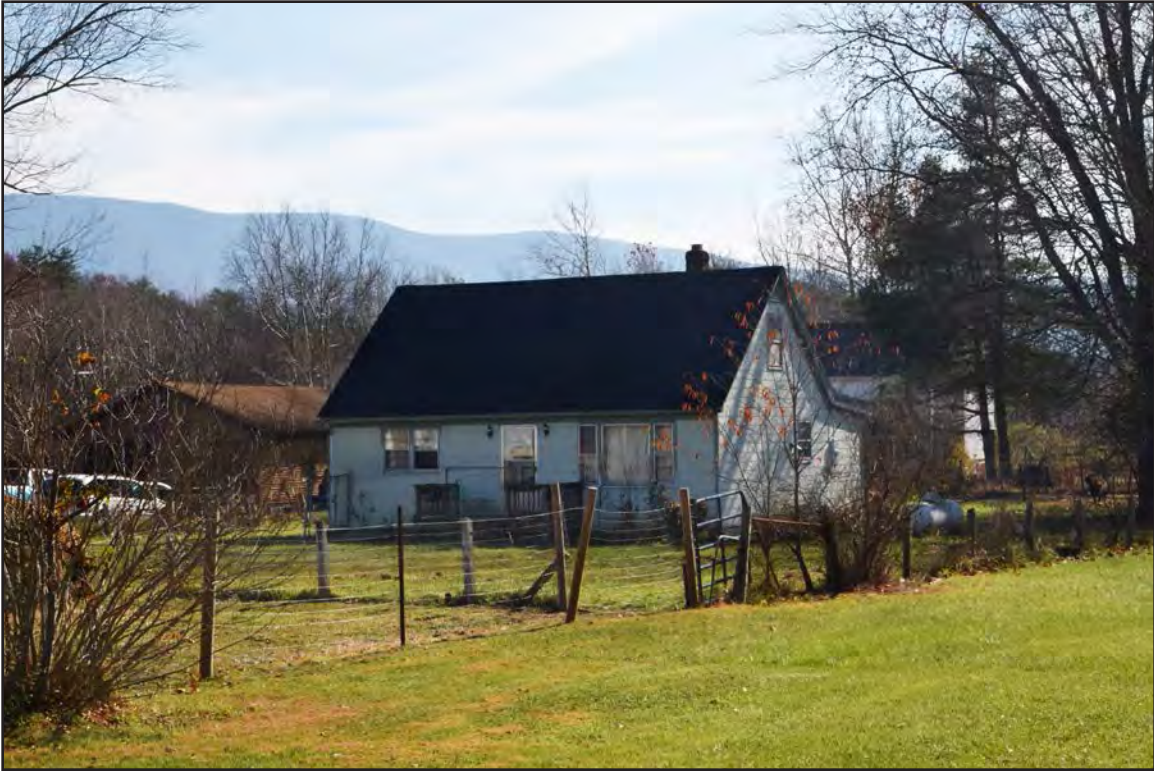
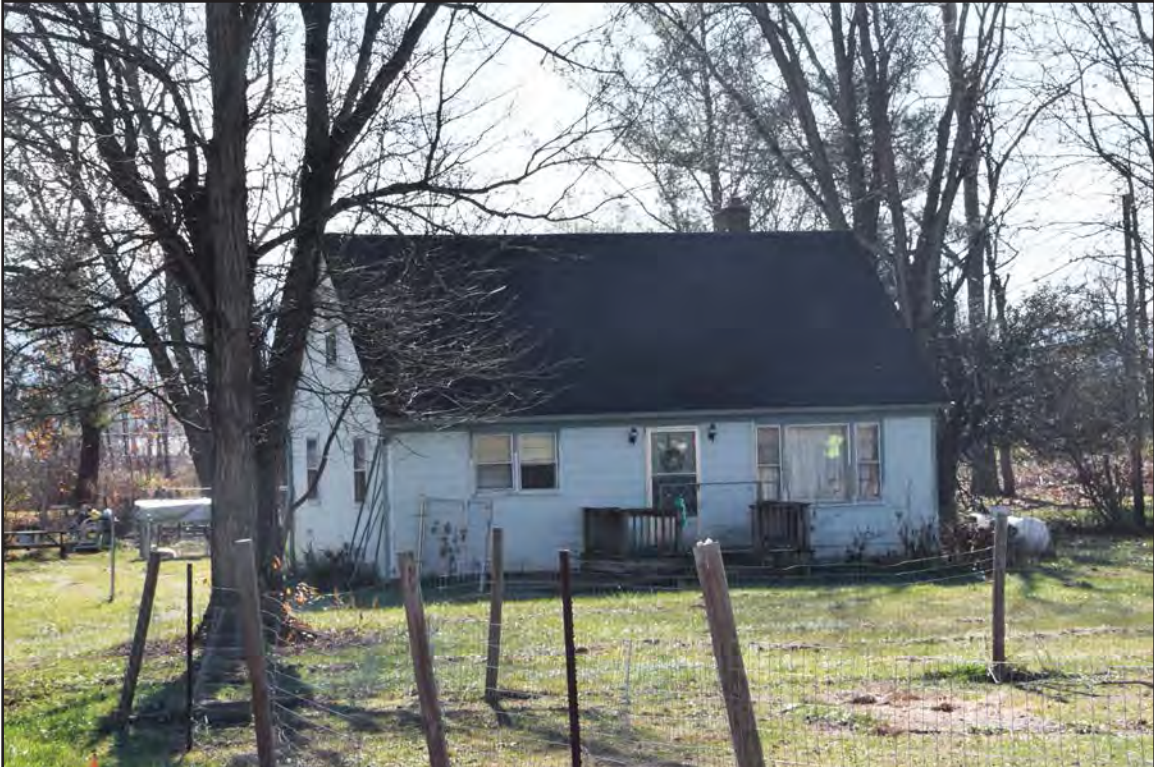
The resource is a ca. 1960s, one-and-a-half story, wood-frame, Cape Cod Revival house set on a poured-concrete foundation and clad in asbestos siding (Appendix B, Figures 140–142). The north, or primary, elevation has a central wood panel door with three, diagonal lights, and is covered by an aluminum-frame storm door. There is a modern partial-width wood deck providing access to the door. Fenestration includes a three-part picture window on the western side of the door, comprised of a large fixed-pane window flanked by two, two-over-two, double-hung windows. All of the windows throughout the house are original aluminum units. On the eastern side of the door are paired, two-over-two, double-hung windows. The side-gable roof is a steeply pitched, clad in asphalt shingles. There is a brick chimney south of the ridgeline of the roof on the western end. The west and east elevations of the house feature two-over-two, double-hung windows—two on the first floor and one on the second. At the rear of the house is a shed-roof addition; however, access restrictions limited the view of that elevation. Tax records indicate that there is also a porch on the rear of the structure. The one outbuilding on the property is a wood-frame, clapboard-clad shed to the southwest. It has a shed roof, but the trees and shrubs around it are overgrown and any further detail on the structure cannot be viewed from the public right-of-way.

Figure 141. 007-5727, house, facing southeast.

Figure 142. 007-5727, house, facing southwest.

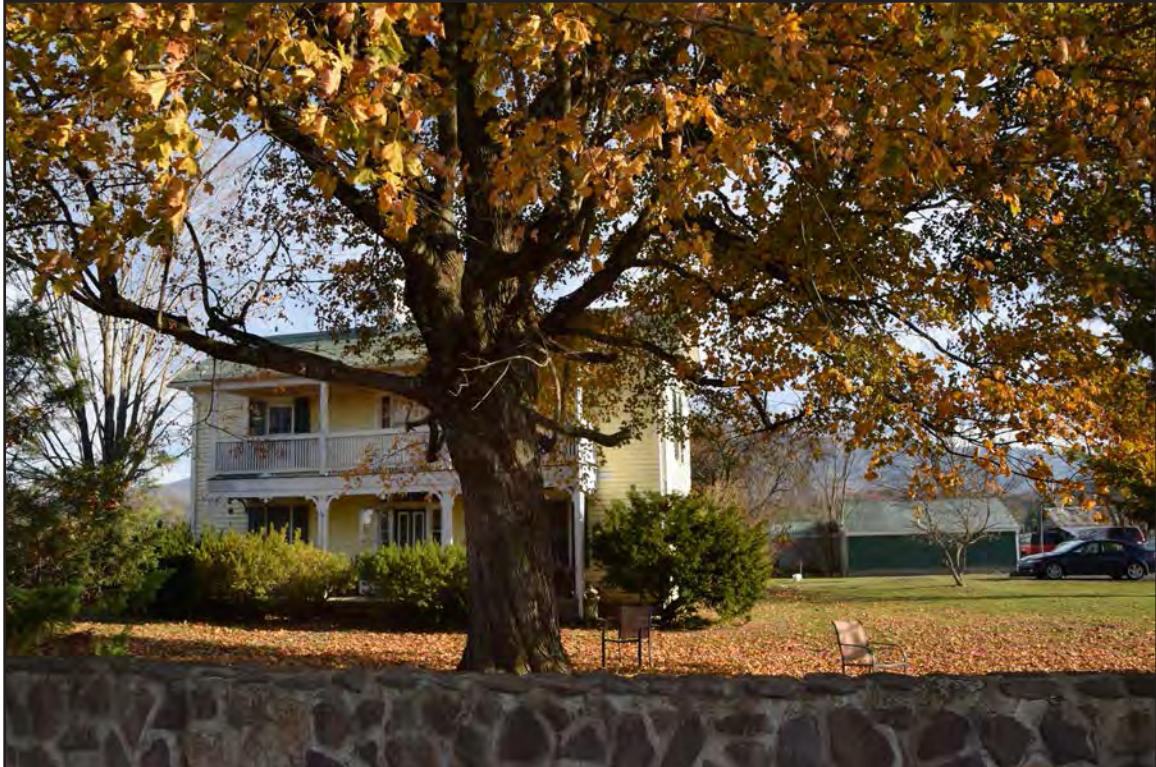
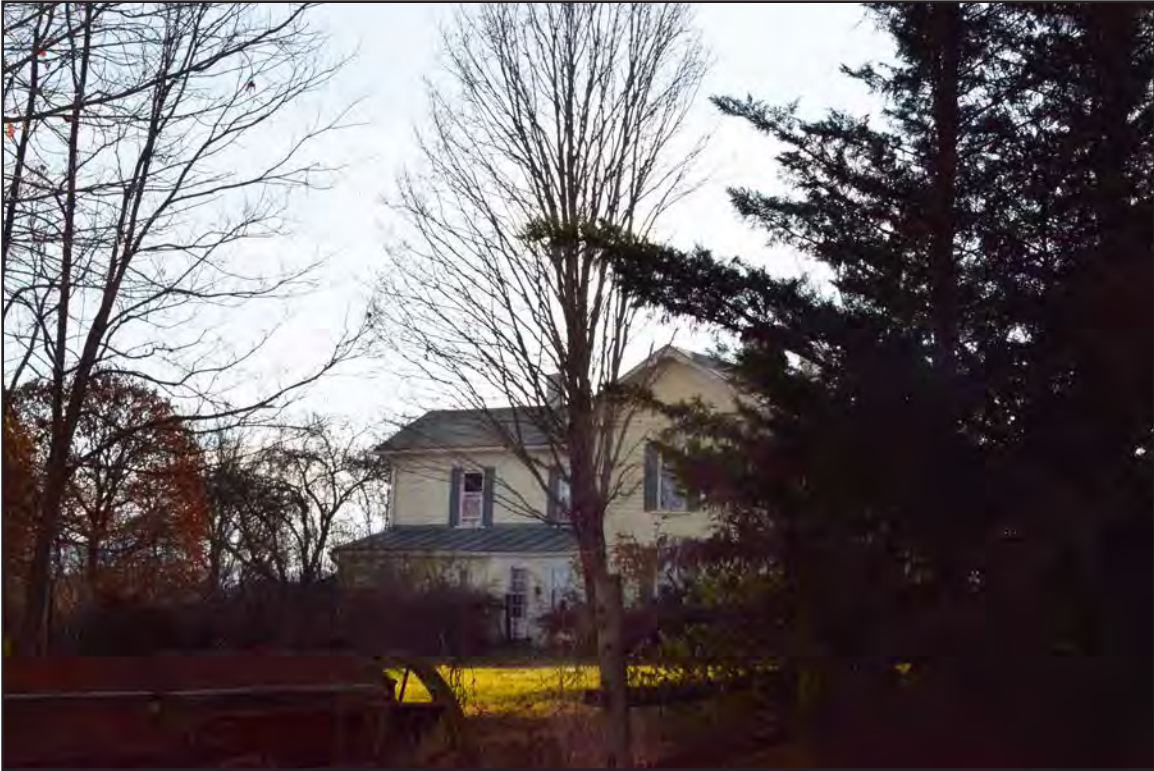
The house on the property was constructed ca. 1900 (Appendix B, Figures 143–145). The house is an I-house with a rear wing that creates an overall T shaped plan. The house has a stone foundation and clapboard siding. The side-gable metal roof is pierced by two interior, brick chimneys along the ridgeline and features a decorative bargeboard and gable returns. The rear

Figure 144. 007-5728, house, facing southeast.

Figure 145. 007-5728, house, facing south.

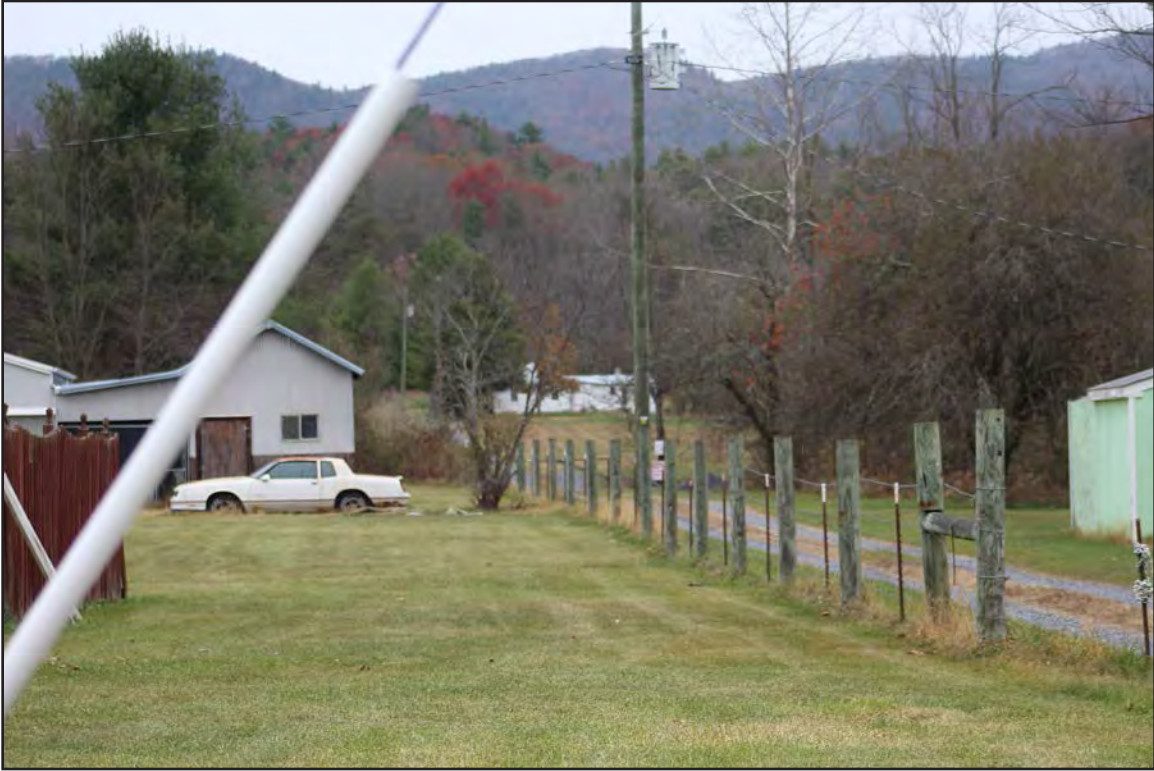
Figure 173. 007-5735, facing north.

Built ca. 1930, 3057 Deerfield Valley Road is a one-story wood frame dwelling with metal roof (Appendix B, Figures 172 and 173). The dwelling includes a rectangular plan with a central hip portion flanked by a shed bump-out to the west and a side-gable wing with shed roof extension to the west. Windows are two-over-two, and the foundation and chimneys appear to be concrete block. Property access restrictions made it impossible to describe additional features of the dwelling.

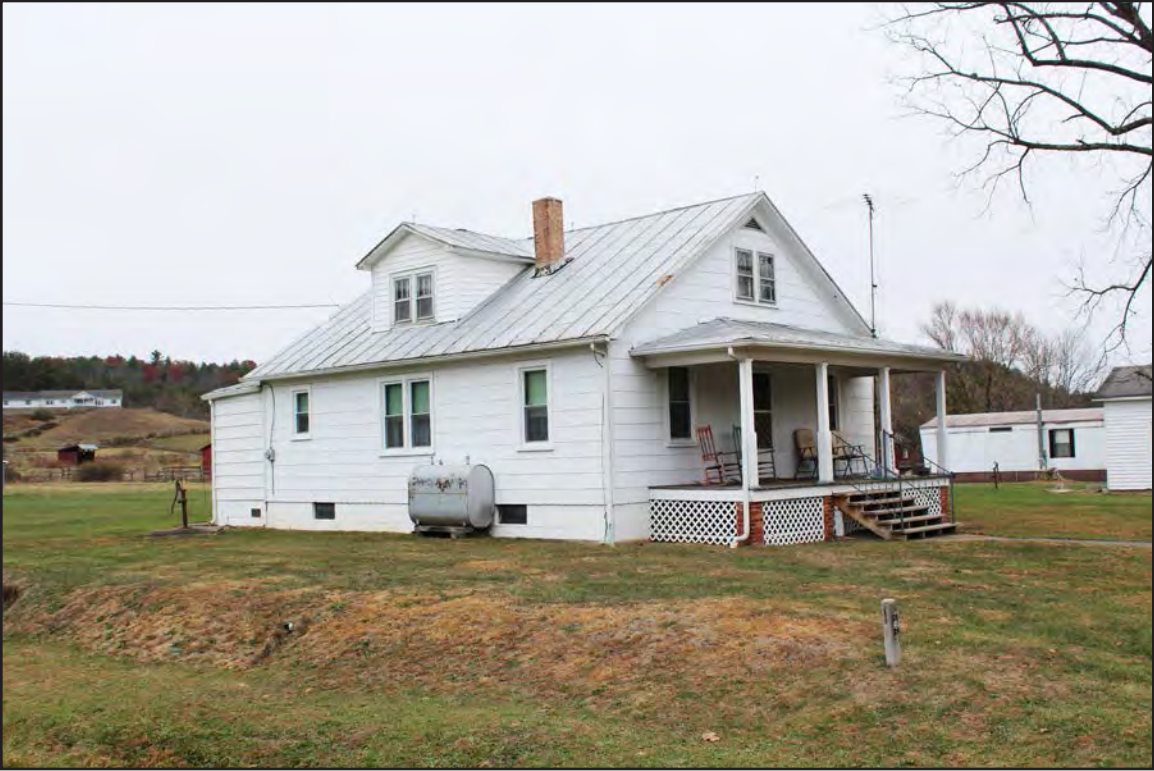
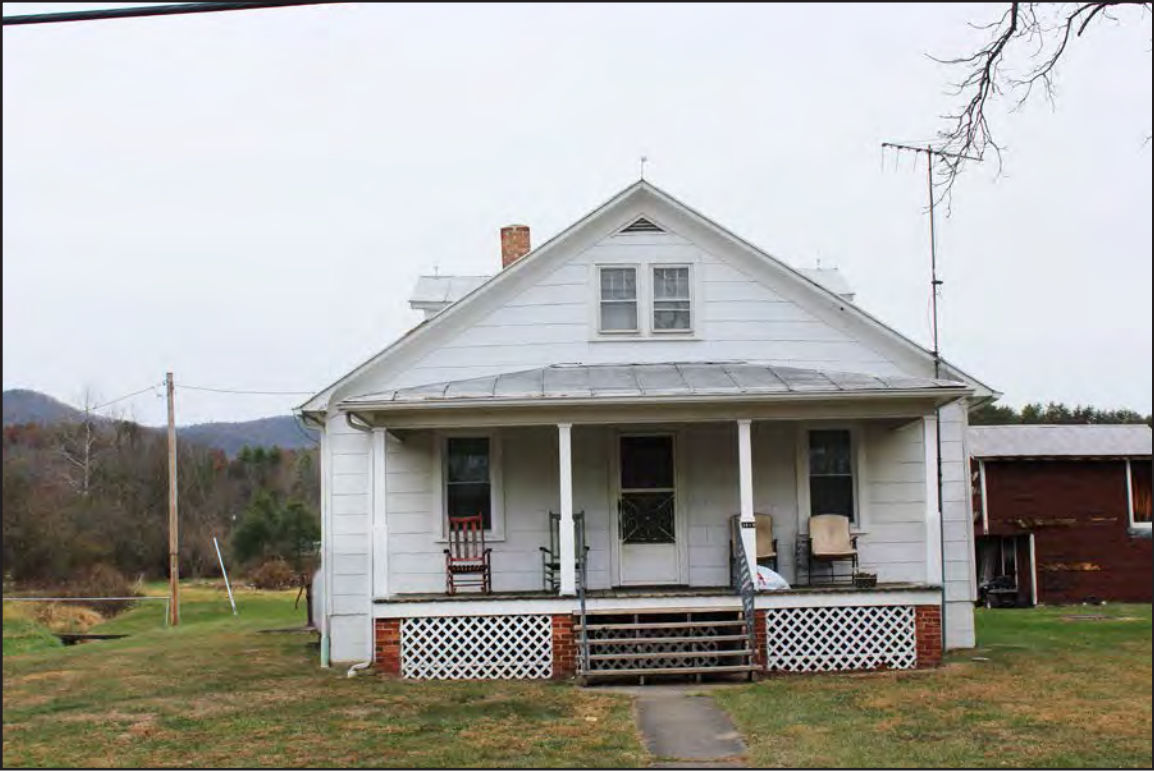
A dwelling appears to be shown in the location of 007-5736 as early as 1932 (USDA 1932), but was certainly in existence by 1945 (USGS 1945). Based on architectural features, it appears that 007-5736 is a front-gable vernacular bungalow built circa 1930 (Appendix B, Figures 174–176). The rectangular plan dwelling is one-and-a-half story and features a moderate pitch gable roof with gable dormers on each roof slope. The dwelling features closed eaves and a nearly full-width front porch with a low-pitch hipped roof supported by tiered square wood columns. The gable roof is clad with standing seam metal and features two off-center brick chimneys within the roof structure; one chimney is in front of and one chimney is behind the dormers. The dormers are vinyl-sided with paired three-over-one windows. The remainder of the exterior on the original block is clad with wavy edge asbestos siding. The façade includes paired three-over-one windows at the gable and a three-bay ground floor. The central entrance is flanked by replacement one-over one windows. The front porch has a brick pier foundation with lattice sheathing. The east and west elevations feature three bays with vinyl replacement one-over-one windows except for one remaining original three-over-one wood window. The foundation is continuous concrete block with two windows at ground level on each side elevation. The rear elevation includes a ca. 1960 one-story shed-roof addition featuring aluminum siding.

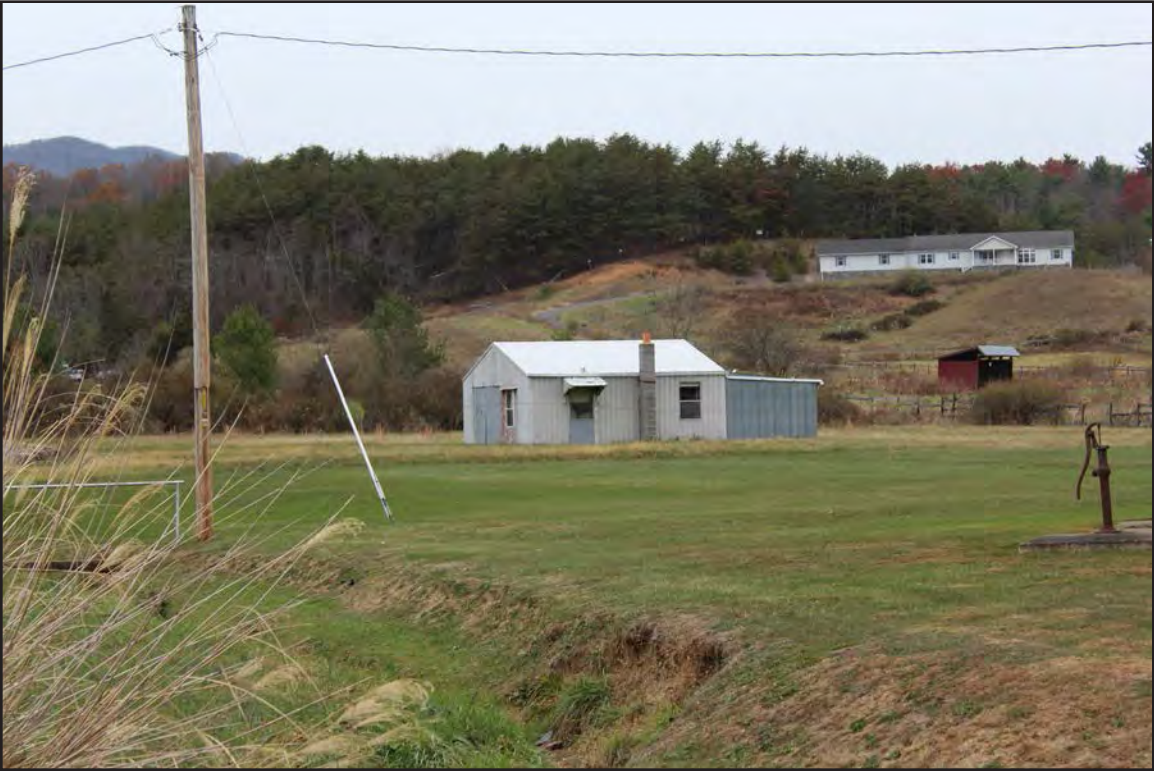
Figure 177. 007-5736, outbuilding, facing northeast.

The outbuildings include a one-story gable building with a shed roof addition (Appendix B, Figure 177). The building is constructed with metal walls and modern aluminum windows. An external concrete block chimney is found on the north elevation of the outbuilding. The one-story gable outbuilding has an unknown foundation. The other outbuilding is a two-story building found on the east side of the property, that appears to have been constructed around 1920 based on form and materials; however, it does not appear on historic maps from 1932 to 1967 (USDA 1932; USGS 1945, 1967) (Appendix B, Figure 178). The two-story building features a corrugated metal roof, includes Bricktex asphaltic siding, and a shed-roof lean-to addition on the north elevation. The building includes a second story door with no stairs, and a recessed single-bay entry at the northeast corner. The siding is peeling on the two-story building and reveals a vertical diagonal wood plank construction. The foundation appears to be brick. The structure is similar to one located at the rear of 007-5734, which is recorded as a dwelling in 1967. This structure is not recorded as a dwelling on USGS topographic maps (USGS 1945, 1967), but it may have originated as an outbuilding and was converted to residential use at one time. It may also have been relocated to its current location after the construction of 007-5722.

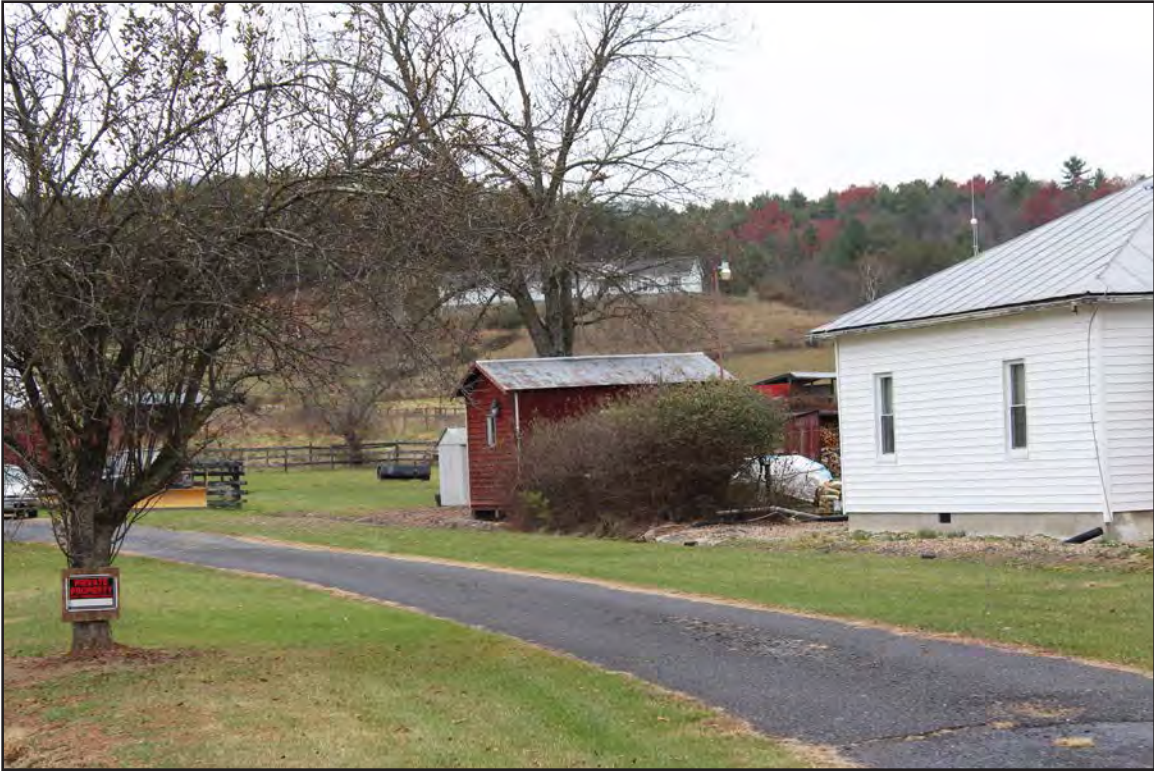
Figure 185. 007-5738, outbuilding, facing north.

Resource 007-5738 has seven outbuildings associated with the agricultural use of the property. The first outbuilding is a one-story shed with a metal roof and wood clapboard siding located north of the dwelling. The outbuilding rests on a wood platform on a concrete block foundation. A single window is found at the gable ends and a central entrance is located on the southern elevation (Appendix B, Figure 185). A small prefabricated corrugated metal shed with a gable roof is north of the first shed. Entry is through an opening in the gable end. A three-bay English barn is located at the northern rear of the property. Built ca. 1920, the side gable barn features central doors along the southern elevation, a metal roof and board and batten siding. The barn is approximately 40-feet wide by 80-feet deep (Appendix B, Figure 186). The fifth outbuilding on the property is located northeast of the barn in a pasture, which has been fenced in with wood corral fencing. The outbuilding is oriented northeast by northwest and features a low pitched gable roof with shed roof extension and three open stalls. The exterior of the outbuilding is vertical boards similar to the barn. Northeast of the dwelling is an outbuilding featuring a flat metal roof and vertical board siding. The sixth outbuilding on the property has three bays; there is one open bay used as a wood shed, and the other two bays have hinged doors constructed of vertical boards. What appears to be a privy is a narrow, single-room rectangular frame structure with a gable roof and vertical board wall treatment (Appendix B, Figure 187). All the outbuildings appear to have been built around the same time as the barn with the exception of modern corrugated metal pre-fabricated shed.

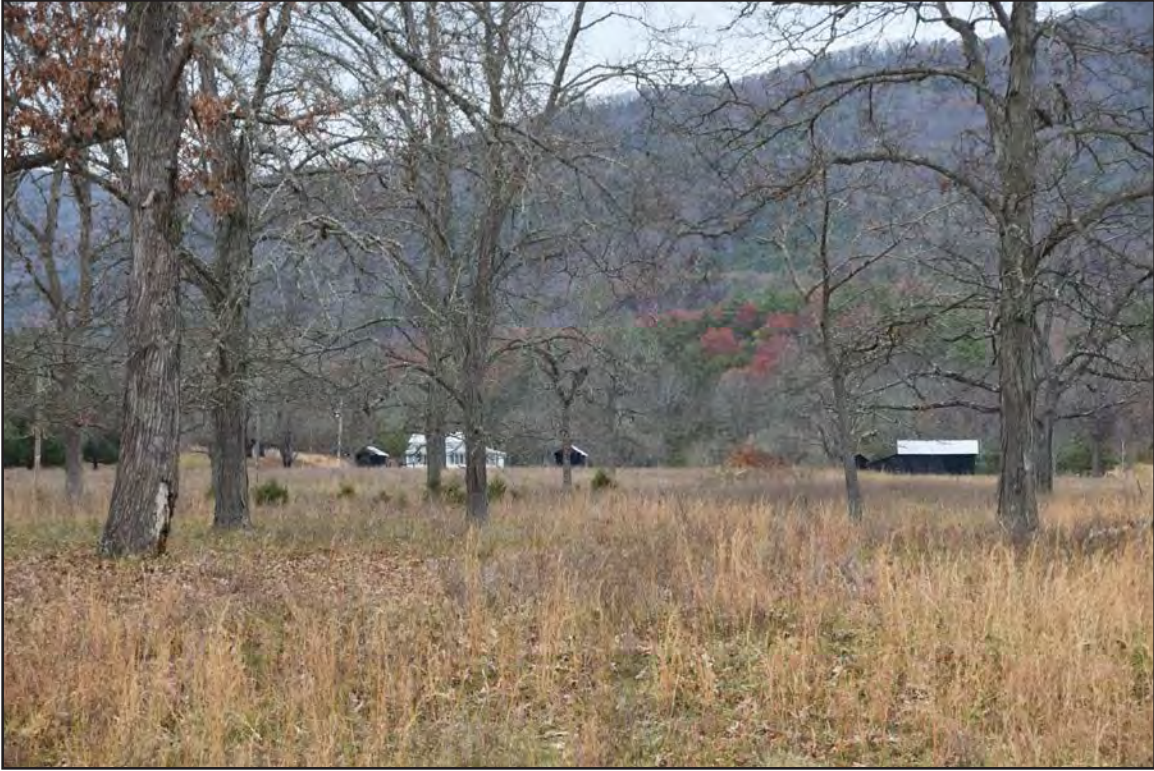
Figure 189. 007-5739, facing northwest.

Built in 1917, the one-and-a-half-story dwelling features a metal, side-gable roof (Appendix B, Figures 188 and 189). The dwelling has a screened, wraparound porch with a metal, hipped roof. While the porch roofline is likely original or an early alteration, the porch has been modified with modern screens and sided knee walls around the mid-twentieth century. According to property records, the dwelling has a pier foundation and wood frame construction. The dwelling is reported to have two-bedrooms and one-bathroom with approximately, 900-square feet of living space.

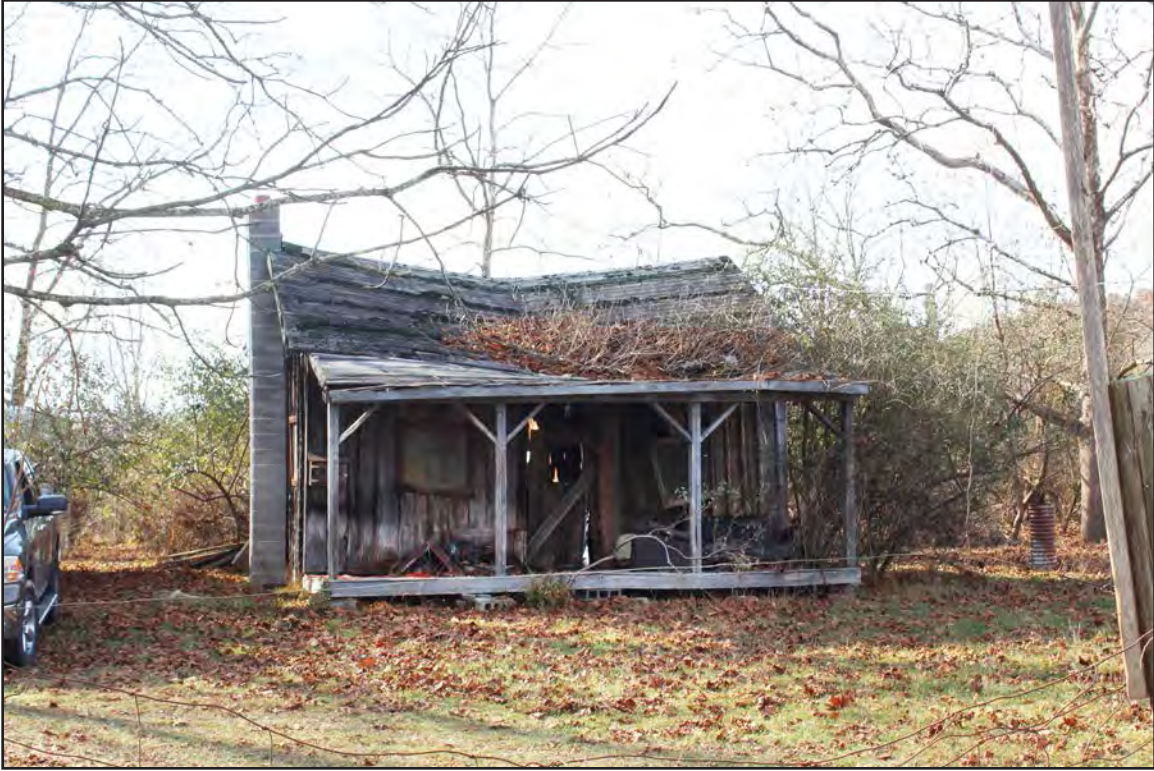
Figure 191. 007-5740, facing west.

Built in ca. 1940, the residence is a one-story, wood-framed double-pen wood structure clad in board-and-batten (Appendix B, Figures 190 and 191). It has fixed, six-paned windows and a side-gabled, asphalt shingle roof. It has an external end, replacement, concrete masonry unit chimney on the southwest elevation. The primary entrance is on the northwest elevation and is filled with an original wood board door with one upper light. The northwest elevation also includes a full-length porch addition with a wooden deck supported by lumber with braces. The foundation consists of replacement concrete masonry unit piers. The house is extremely dilapidated and in poor condition.

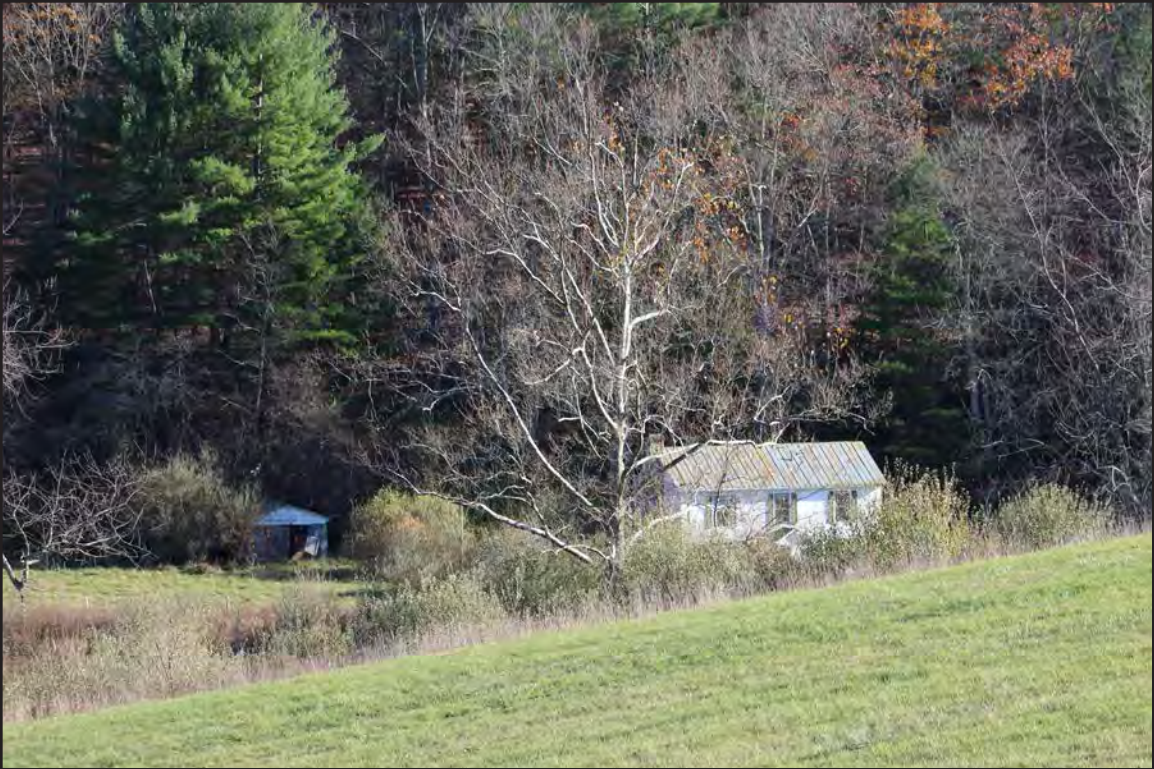
Figure 200. 008-0011, facing south.

The second dwelling on the tax parcel is located approximately 2,300 feet northeast of the main house. The dwelling is located approximately 600 feet southeast from Deerfield Valley Road. The secondary house includes a root cellar and an outbuilding (Appendix B, Figure 200, see Figure 193). Built in ca. 1890, the dwelling is a two-story, wood-frame, vernacular I-house. The dwelling has three bays, a side-gabled, metal roof, a rubble stone exterior chimney on the northeast elevation, a central entrance covered with a gable portico, and six-over-six double-hung wood windows with exterior aluminum storm windows and decorative shutters. The house is in fair condition. The foundation is unknown. The secondary dwelling has root cellar, which is located east of the house. The root cellar is a front-gabled structure with an asphalt shingle roof and clapboard on the gable ends. The other outbuilding is a storage shed with a gable roof and wood frame construction. The outbuilding is located southeast from the rear of the house. The outbuilding is in poor condition.
