**Subject: Section 106 Review –Architectural Survey Report REVISED Addendum 4  
Atlantic Coast Pipeline, LLC, Atlantic Coast Pipeline Project  
DHR File No. 2014-0710**

**PHASE I HISTORIC ARCHITECTURAL SURVEY OF THE  
ATLANTIC COAST PIPELINE PROJECT**

**Virginia Addendum 4 Report**

**DHR File No. 2014-0710**

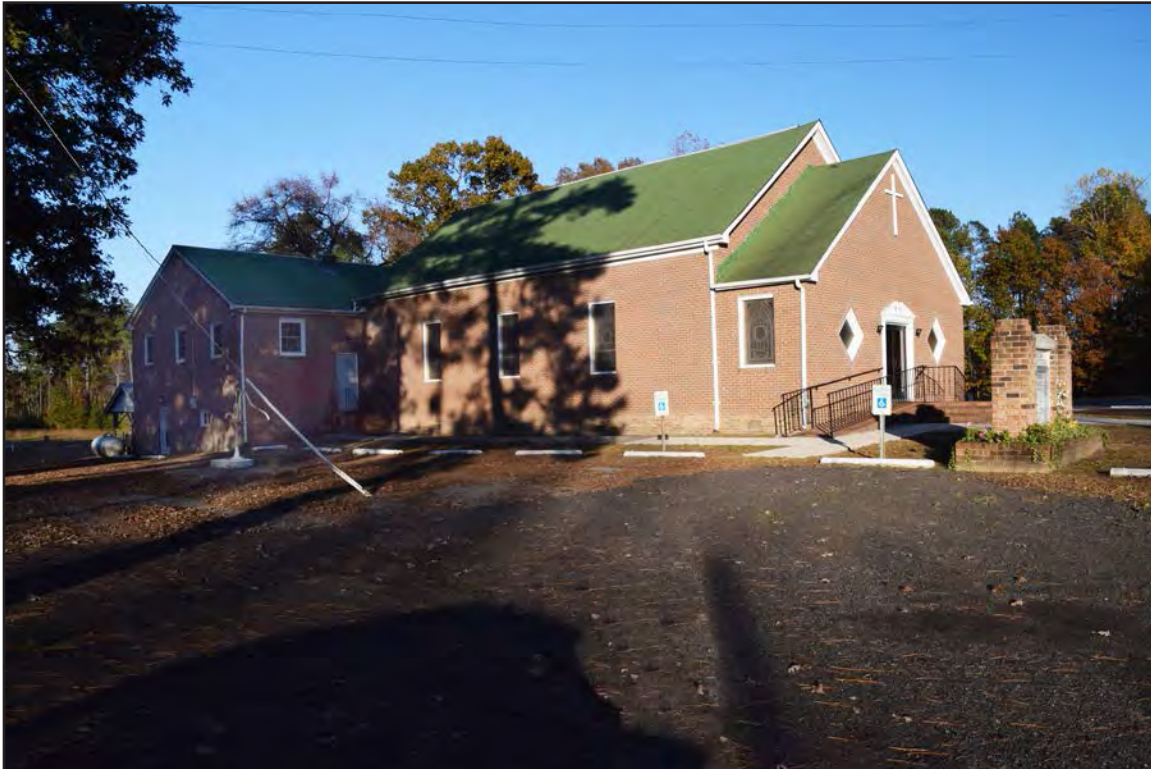
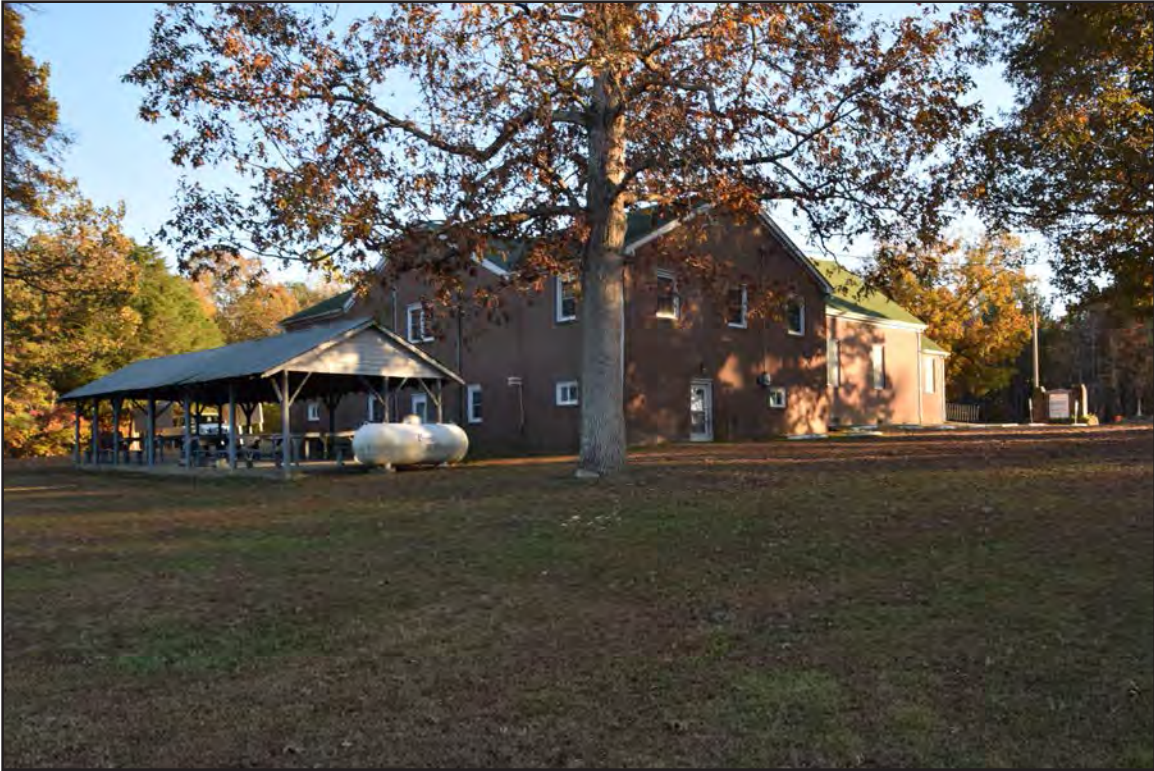
Figure 238. 026-5257, church, facing northeast.

The resource is a ca. 1960s, two-story, front-gable vernacular church set on a brick foundation and clad in common-bond brick (Appendix B, Figures 237–239). It appears from historic map research that the current church has been in place since at least 1963 (NETR Online 2016). A large, two-story rear addition creates a T-plan. The south, or primary elevation of the original block faces the road, and features a gable vestibule with a large cross in its gable end, centered modern double-doors with a Classical Revival door surround in the broken pediment and finial style, and wood-frame, diamond-shaped, fixed-pane windows on either side of the entrance. All portions of the roof are clad in asphalt roll roofing. The vestibule features rectangular, stained-glass windows on its side elevations matching the ones on the sanctuary. To the rear of the front-gable sanctuary is a ca. 1980s-gabled addition that features vinyl-frame, one-over-one windows with mullion inserts, a small sliding window, and modern doors of different styles on the west, north, and east elevations. At the rear of the church is one modern outbuilding, a wood-frame, gabled picnic shelter set on a poured concrete foundation. It features round, wood posts and a gabled roof clad in corrugated metal and with clapboard siding in its gable-ends.

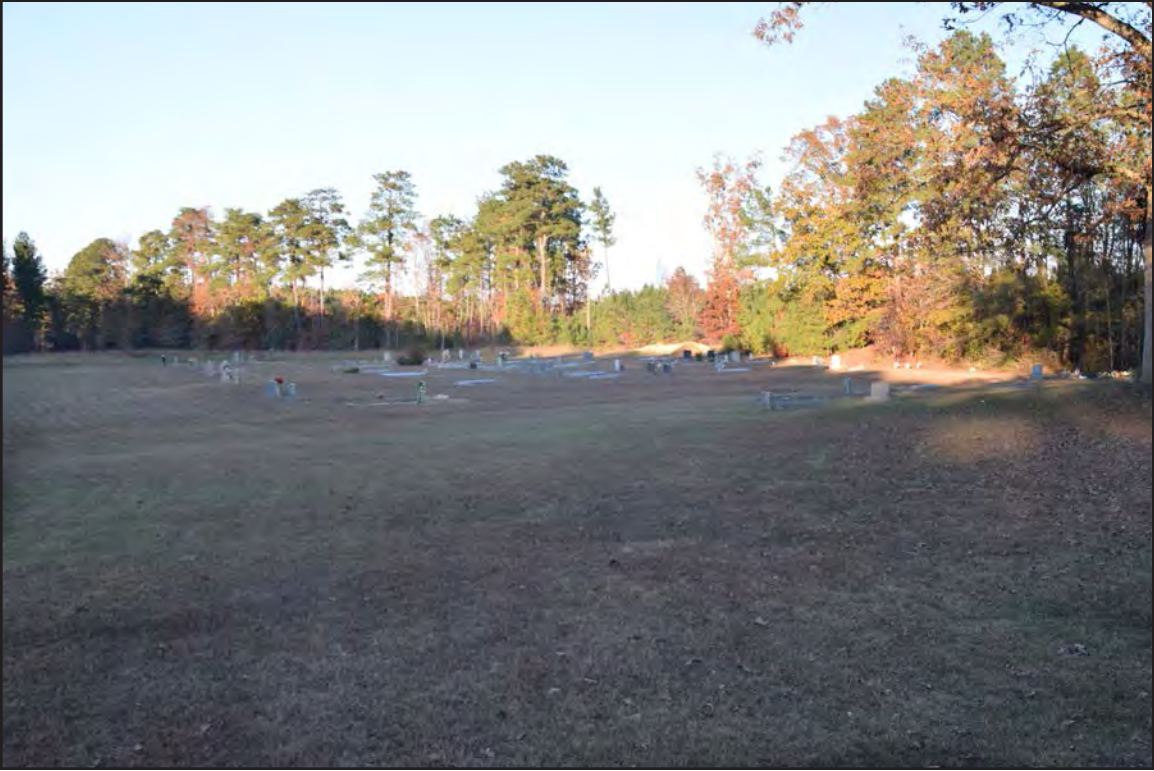
Figure 240. 026-5257, cemetery, facing north.

The cemetery associated with the church occupies a cleared area that surrounds the church to the north and east (Appendix B, Figure 240). The markers are primarily ledger style and granite headstones set on bases, and the markers face to the east. The ledger styles are curved, or curved on the edges, and composed primarily of concrete. There are also three obelisks in the cemetery as well. Military markers and plaques are also prevalent, likely due to the proximity to the Fort Pickett Military Reserve. There are approximately 214 markers in total, and the vast majority are twentieth century markers, though the oldest stone dates to 1891. No family surnames stand out over others, though common names include Bland, Boswell, Cousins, Epperson, Gilliam, Jordan, Moore, Rhodes, and Tabon.

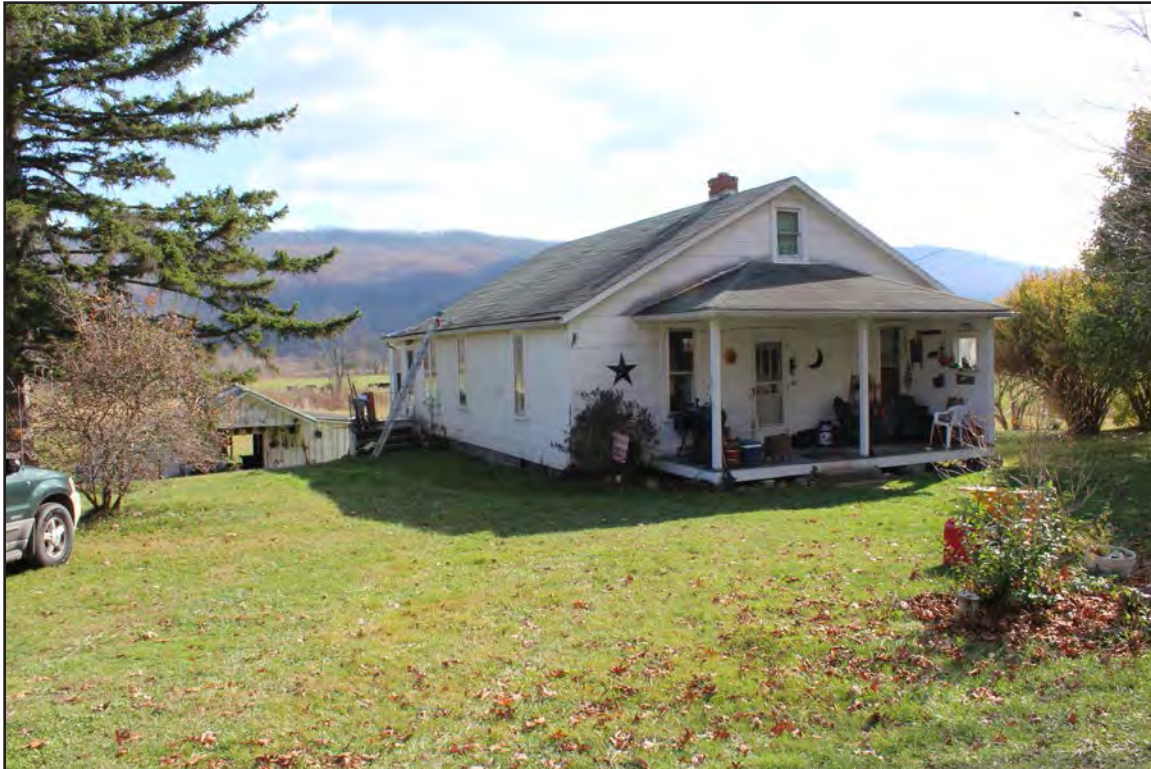
Figure 242. 045-5088, facing south.

The property includes a house and a shed. The house is a one-and-a-half story ca. 1930 wood-frame vernacular structure (Appendix B, Figures 241 and 242). The front-gable roof is covered in asphalt shingles and has an interior, on-peak, brick chimney, and an interior brick chimney on the east slope. The house is clad in wavy edge asbestos siding and rests on brick piers with concrete block infill. Fenestration on the building is replacement one-over-one aluminum framed windows and an original three-light wood panel door behind a modern storm door. Entry is gained through a partial-width porch that is mostly composed of replacement components. The hipped roof may be the only original feature. It is supported by wood posts on a wood deck which rests on concrete piers. The east side of the porch has had a wall added to it, with aluminum siding and a small, single fixed light window. A rear (south) elevation has a ca. 1960 hipped-roof addition. A secondary entry off the addition is through a wood panel door and storm door accessed via a poured concrete stoop with twisted metal hand rails and balustrade.

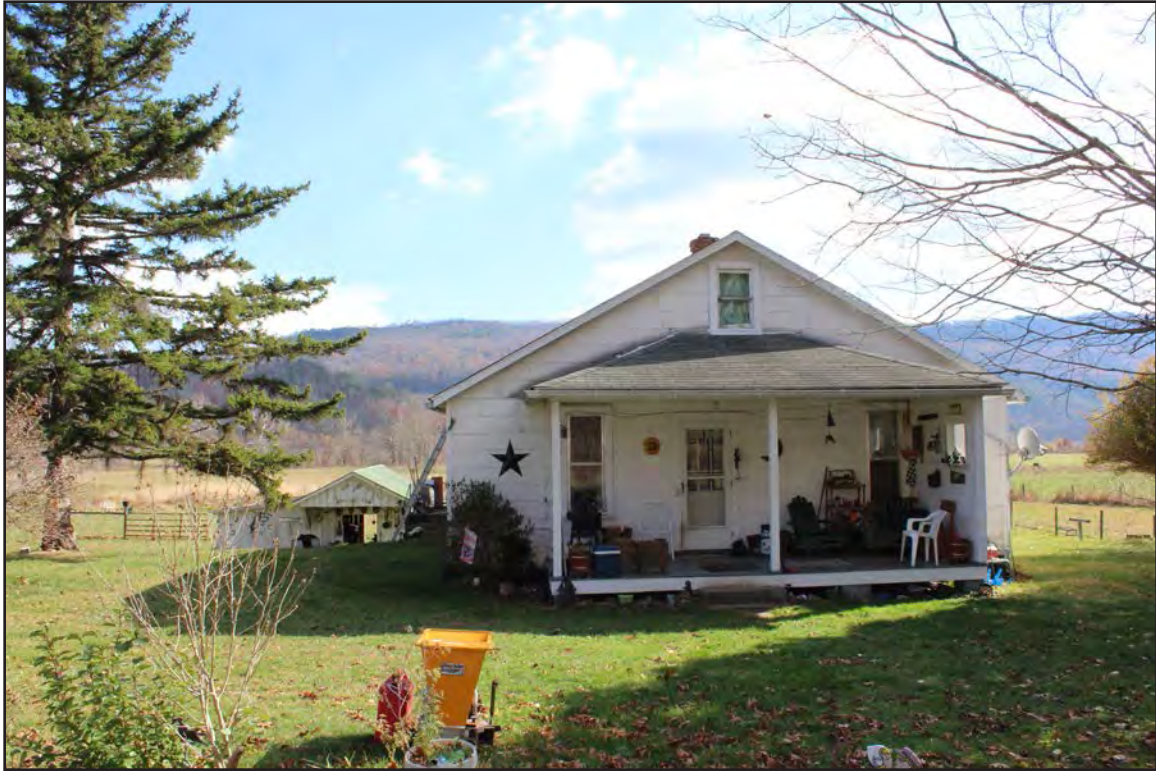
Figure 243. 045-5088, facing south.

Adjacent to the house is a circa 1960 front-gabled shed (Appendix B, Figure 243). The structure is clad in board-and-batten with a standing-seam metal roof and an overhang supported by wooden braces. It has side shed wings to the northeast and northwest elevations with corrugated metal roofs.

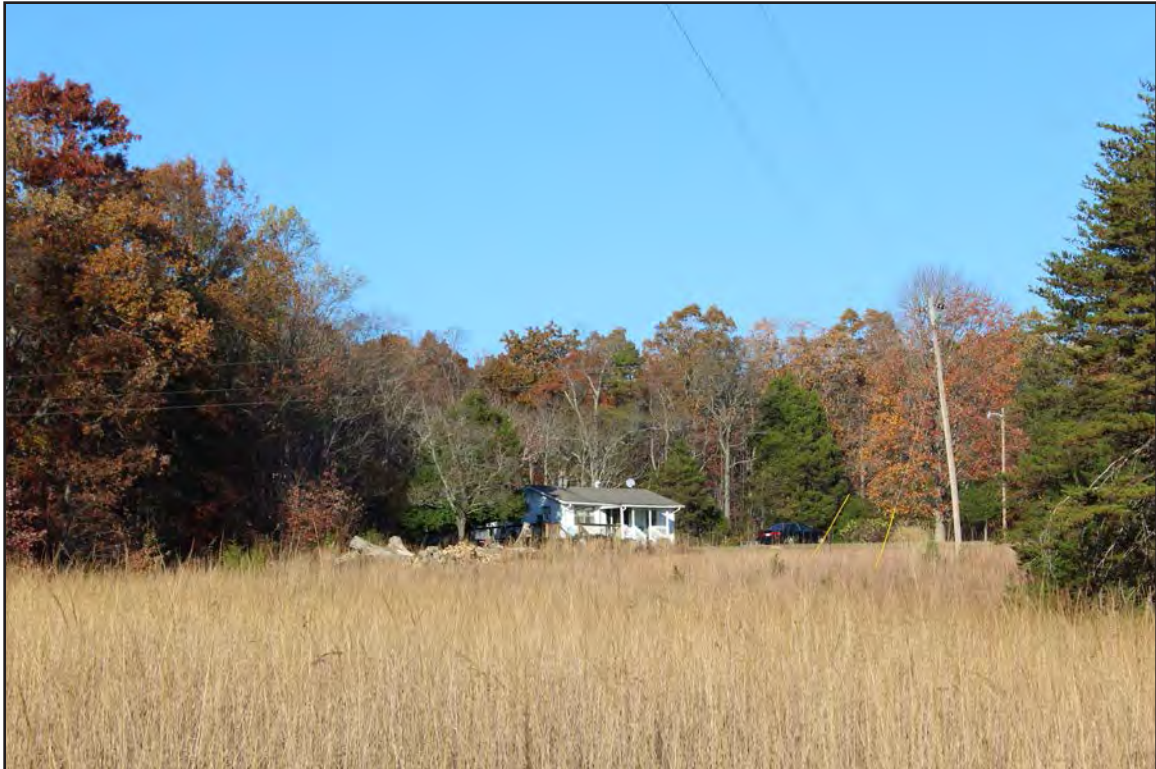
Figure 244. 062-5160, Pauline White House, facing northeast.

Due to lack of access to the property, some aspects of the resource were difficult to observe. However, the Pauline White House is a vernacular one-story side-gable structure that appears to have been constructed ca. 1950 (Appendix B, Figure 244). It features a compositional asphalt roof, an internal concrete masonry ridge-line chimney, and an on-peak rotating roof vent. The walls are clad in vinyl siding, there is rectangular louvered vent in the gable end on the west elevation, and single and paired one-over-one double-hung aluminum windows were observed on the visible elevations. The foundation was not visible at the time of survey. Entry is through a central door on the south façade. It is accessed through a partial-width porch with a shed roof extension of the main roofline. The roof is supported by wood columns and there is a turned wood balustrade and hand rails, which appear to reflect a late twentieth century remodel. A modern deck, which wraps around to the west elevation has been attached to the porch. Aerial imagery indicates that an ell has been added to the west side of the north elevation.

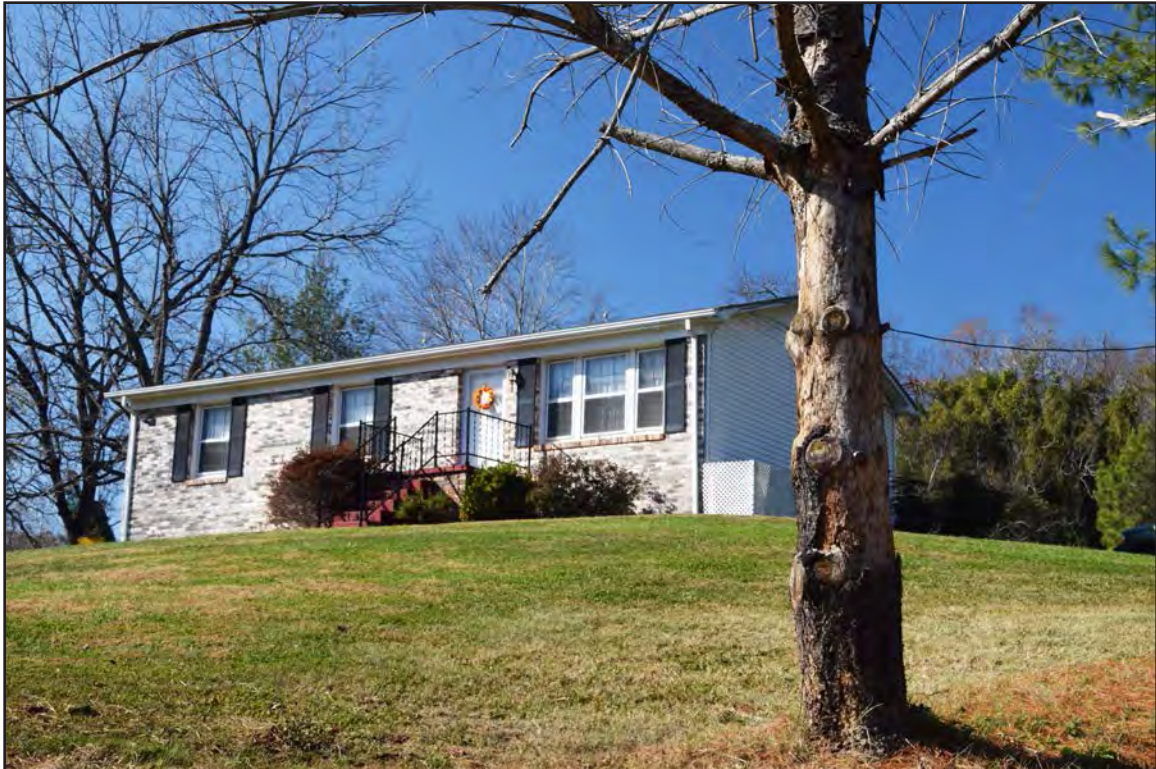
Figure 246. 062-5223, house, facing west.

The resource is a ca. 1960s single-story, wood-frame, modest Ranch style house set on a poured-concrete foundation and featuring brick veneer on the southeast façade only, set in common-bond; vinyl siding can be found on the other elevations (Appendix B, Figures 245 and 246). It features an off-center entrance with concrete and brick steps leading up to a vinyl door and glass storm door. Twisted metal rails and balustrade are present up the steps and on the stoop. To the southwest of the door are two, wood-frame, six-over-six, double-hung windows. Fenestration on the façade uniformly consists of vinyl replacements. To the northeast of the entrance is a six-over-six, double-hung window flanked by two wood-frame, four-over-four, double-hung windows on either side. Two six-over-six, double-hung windows are found to the northeast of the entrance. There are wood decorative shutters on the primary façade. The roof is side-gabled and clad in asphalt shingles. It has an exterior, concrete-block chimney at the rear, or northwest elevation. A secondary entrance is through a vinyl, back door off an at-grade concrete patio. An asphalt driveway is to the northeast of the house, and a concrete sidewalk leads to the front door. The house appears to replace an older house that was on the property, as seen on older topographic maps.

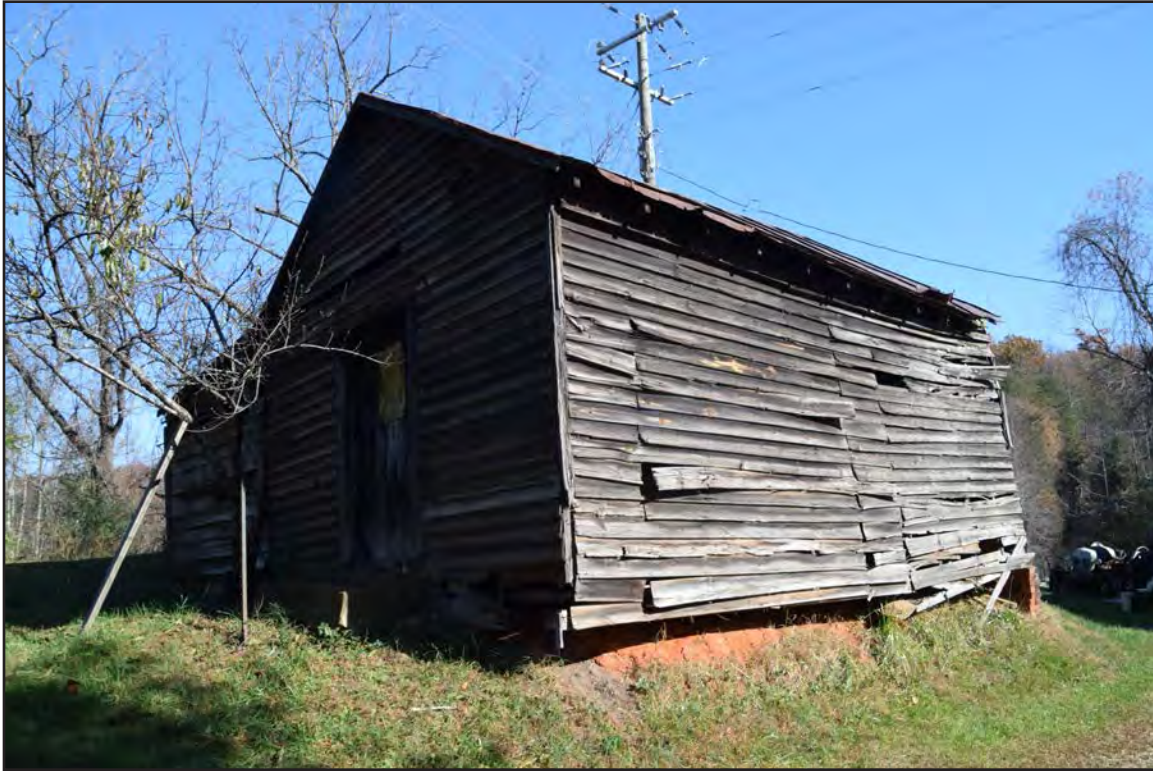
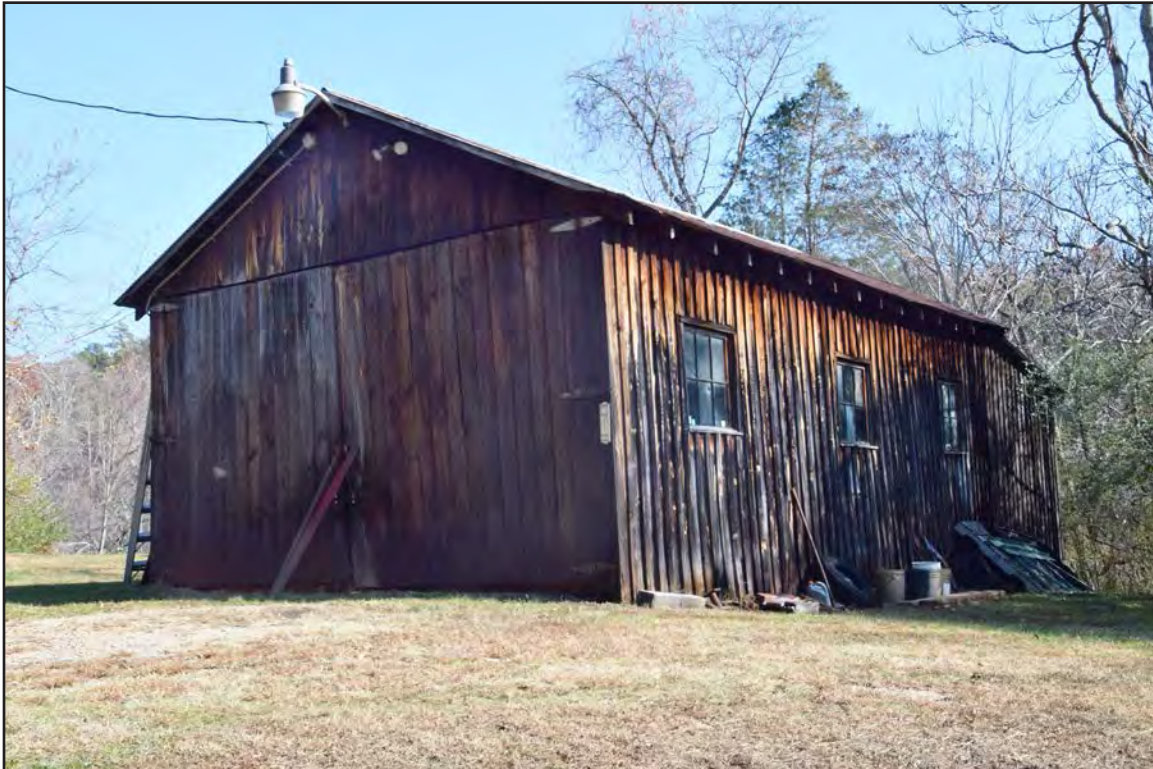
Figure 247. 062-5223, outbuilding, facing southeast.

There are several outbuildings on the property that pre-date the house. As the dwelling historically associated with the outbuildings is no longer extant, it is difficult to discern their date of construction; however all appear to pre date 1940. The outbuilding is a single-story, wood-frame, gable-end building set on a fieldstone and brick-pier foundation and clad in clapboard siding (Appendix B, Figure 247). It has a single, vertical-board door on its northwest elevation at center, beneath a gable-end roof which is clad in standing-seam metal. There is shed-roof addition on the northeast elevation with the same building material; however the clapboard siding is not uniform in size. The shed is a wood-frame structure clad in vertical board. It features large, vertical-board double-doors facing northwest, a gable-end roof clad in standing-seam metal, and an exterior, concrete-block chimney on the northeast elevation. The garage is a wood-frame structure clad in board-and-batten siding (Appendix B, Figure 248). It has large, vertical-plank, double-doors on the northwest elevation. The roof is gable-end and clad in standing-seam metal, with exposed rafter ends. On the southwest elevation are three, wood-frame, fixed-pane, six-light windows. At the rear, or southeast elevation, there is a shed-roof addition featuring the same materials as the main body of the garage. The foundation was not visible at the time of survey.

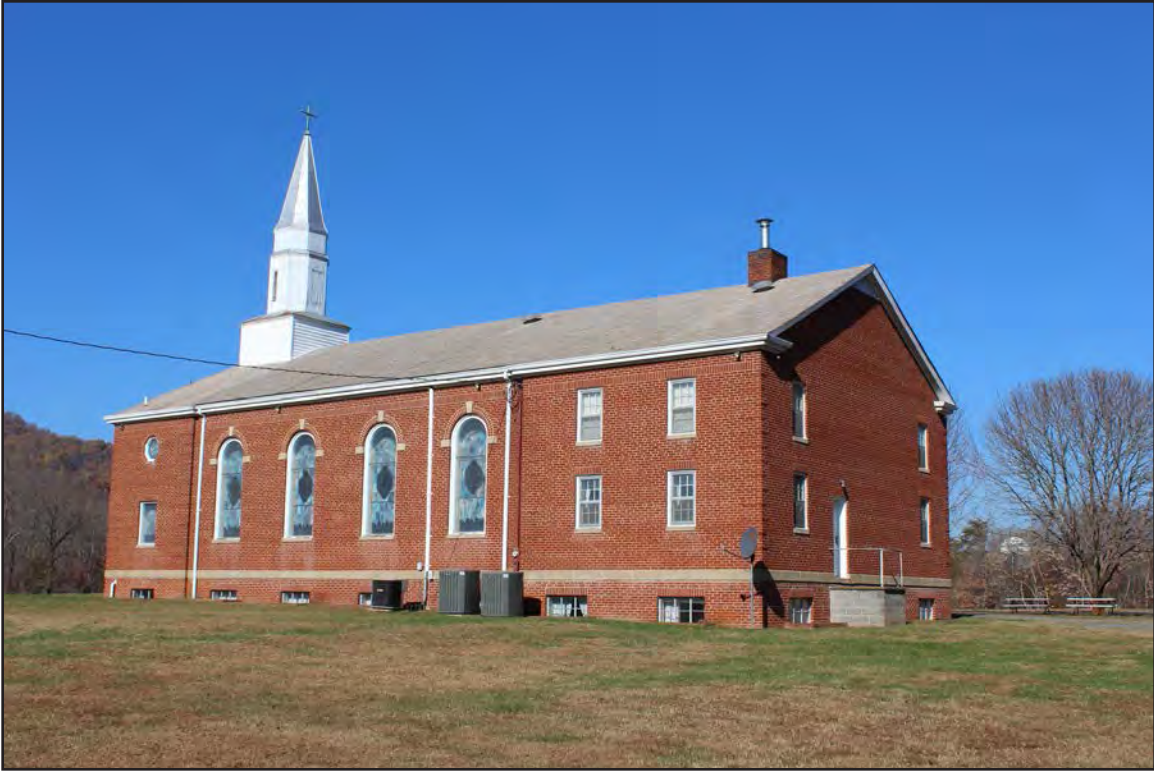
Figure 252. 062-5229, facing northwest.

Resource 062-5229 includes a church, parsonage, cemetery, three sheds, and a well house. The central nave church is clad in common bond brick and has a square vinyl base steeple with a hexagonal metal top. The brick exterior and foundation are punctuated by a concrete water table. The church has a front-gabled, asphalt shingle roof, a brick chimney on the center ridge of the roof near the eastern elevation, boxed returned eaves, and a decorative brick soldier course near the roof line. The primary entrance is centered on the west elevation and is filled with a wooden double door surmounted by a decorative drip lintel featuring a final design (Appendix B, Figures 249 and 250). The façade also includes two hexagonal windows and two bricked-in arched window openings. Four concrete steps lead to a portico with a poured concrete floor, supported by four squared, wooden columns, and a ramp leading to the door. The pediment features vinyl siding. Fenestration on the north and south elevations include small hexagonal stained glass windows, stained glass arched windows framed by brick voussoirs and concrete keystones and imposts; the windows have concrete sills as well (Appendix B, Figure 251). The rectangular windows—including stained glass and double-hung six-over-six windows in the rear—have soldier-course brick lintels and concrete sills. The basement level has nine-paned louvered windows with brick soldier-course lintels. The north elevation's fenestration matches that of the south elevation except for the presence on the north of a metal personnel door with one upper light flanked by two electric lights, and a concrete block with the year "1956" inscribed. The east elevation has six-over-six double-hung, vinyl windows and a small concrete block stoop leading to a Masonite door surmounted with an electric light (Appendix B, Figure 252). The church is in good condition.

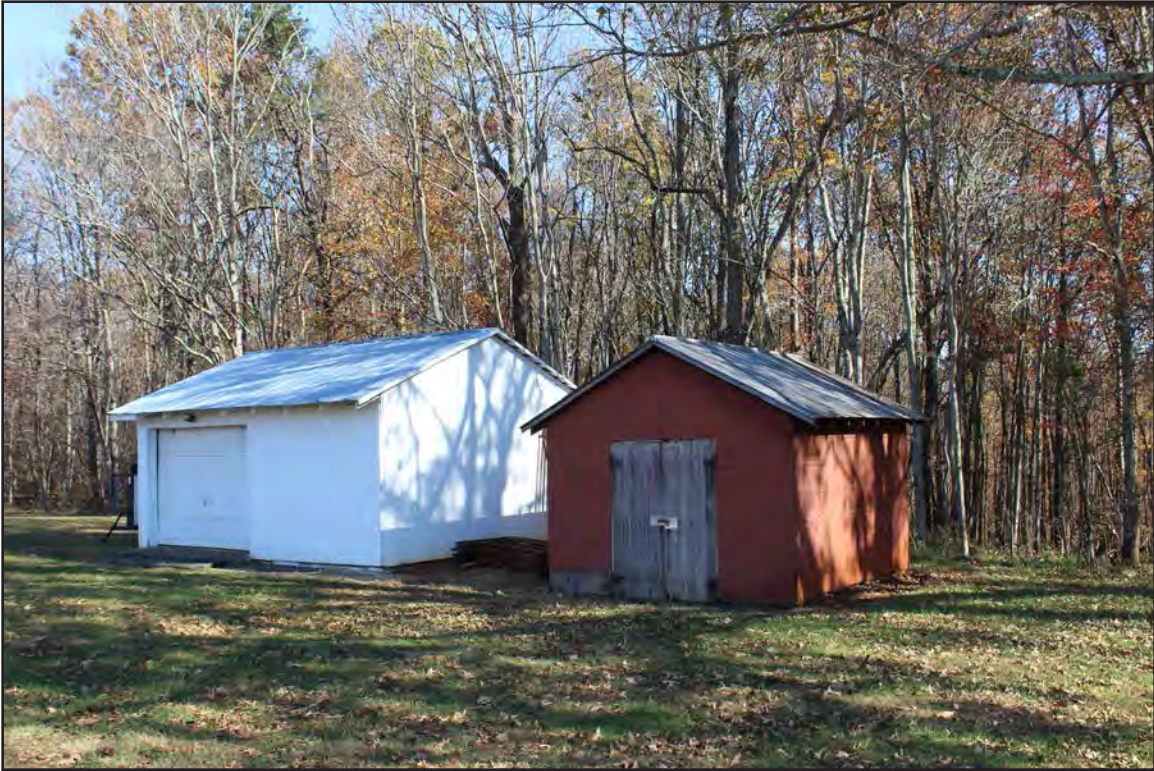
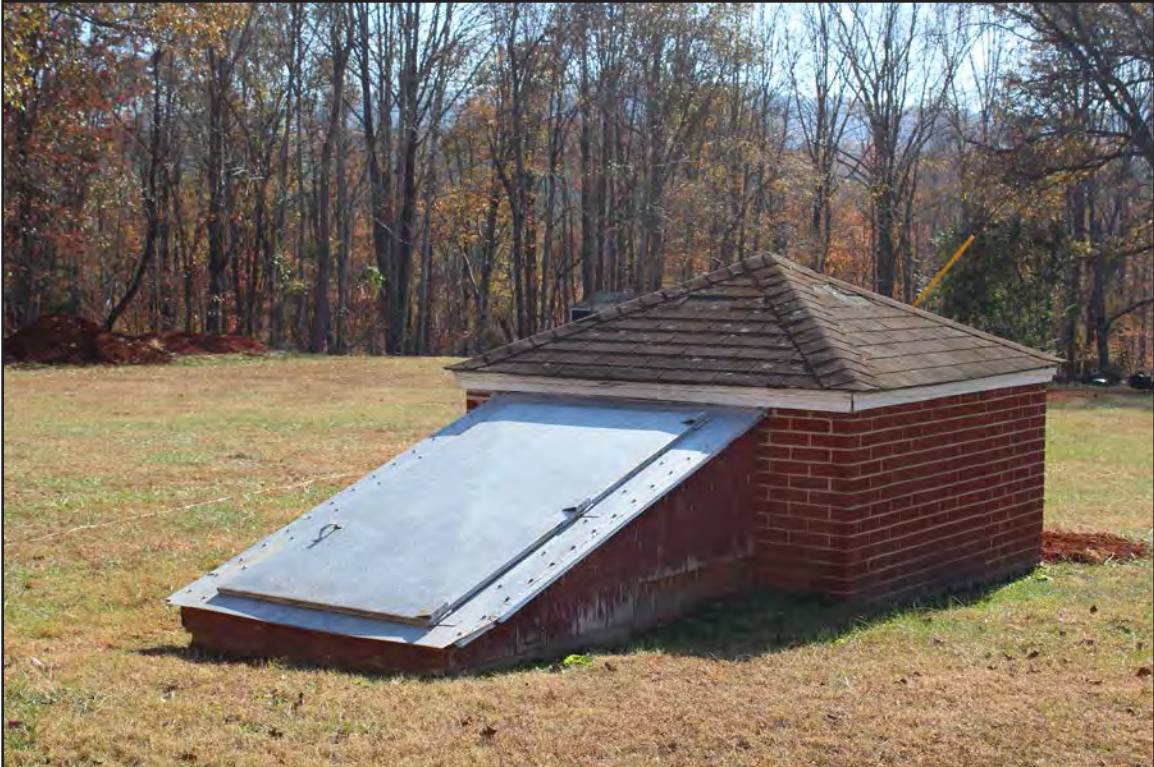
Figure 253. 062-5229, Shed 1 and Shed 2, facing northeast.

Adjacent to the church are three sheds, a parsonage, and a well house. The first shed is east of the church and is a side-gabled structure with T1-11 siding and a standing seam metal roof. It has a bay with a roll-up garage door on the west elevation. The second shed is directly south of the first shed and is a front-gabled structure with Bricktex siding and a standing seam metal roof. This shed has exposed rafters and a double plank door on the west elevation's gable end (Appendix B, Figure 253). The third shed is a prefabricated shed with a modern door opening on the west elevation's gable end. A well house is southeast of the church and has an asphalt shingle pyramidal roof and a brick exterior. The well house has a composite wood cellar door with a metal handle (Appendix B, Figure 254). All of the outbuildings are in good condition and were built in circa 1950-1970.

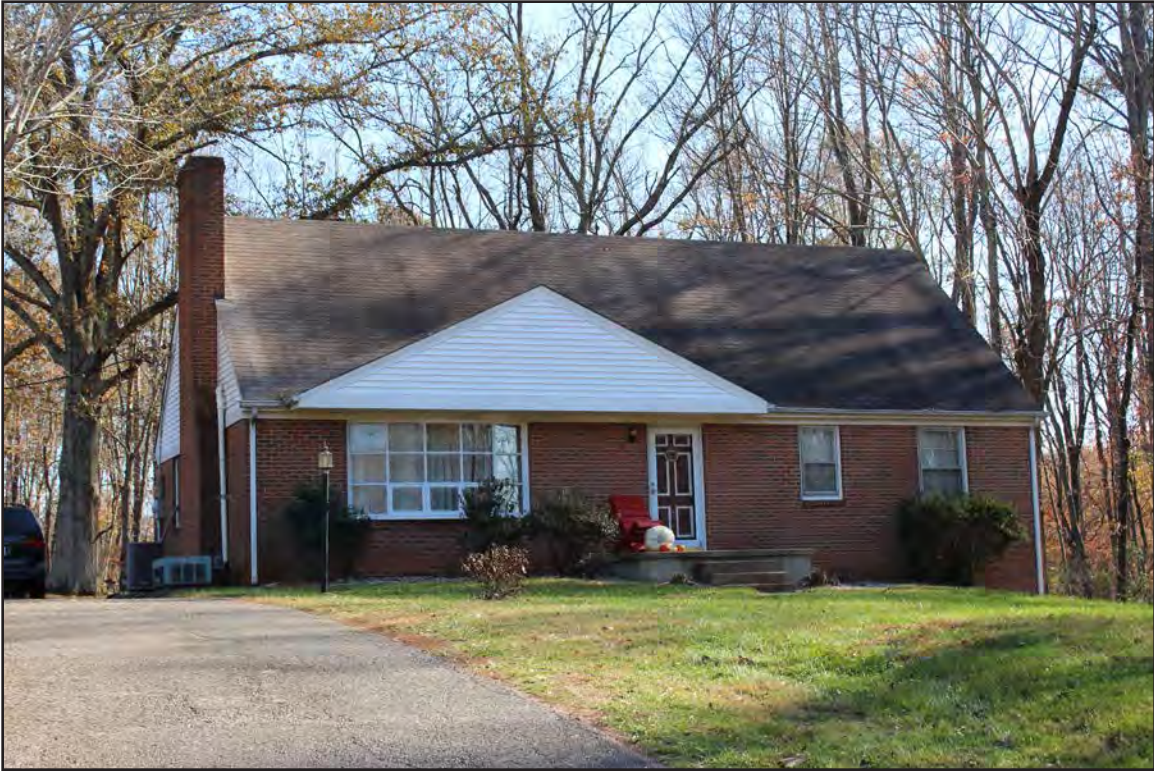
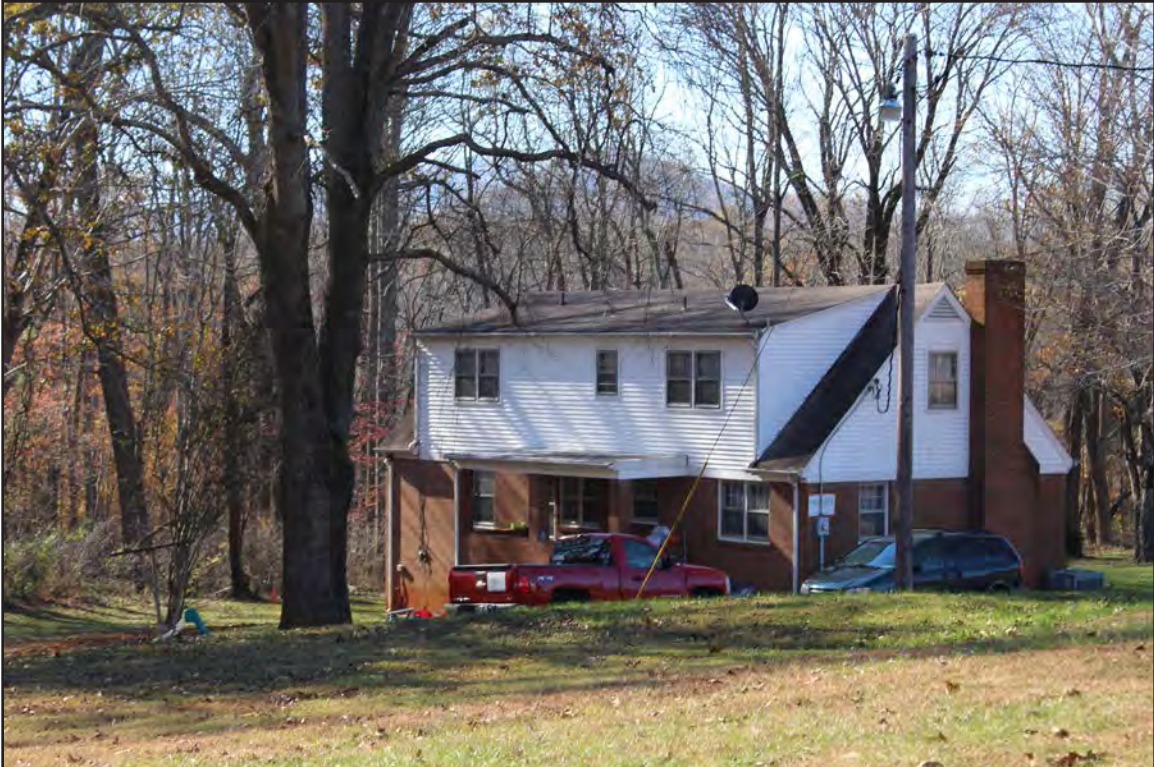
Figure 255. 062-5229, parsonage, facing east-southeast.

The church property also includes a ca. 1950-1960 parsonage. This one-and-a-half story, side-gabled Minimal Traditional structure has a sub-floor that responds to the terrain on the south and part of the east elevation. It has a projecting vinyl-clad gable on the west-facing façade, and an exterior-end brick chimney on the north elevation. The structure is clad in running bond brick veneer except the gable ends and the rear dormer addition, which feature vinyl siding. The parsonage has an asphalt shingle roof and six-over-six, double-hung aluminum windows with brick rowlock sills. The primary entrance is on the west elevation and is filled with a Masonite door and a vinyl storm door (Appendix B, Figure 255). The façade also includes a 15-paned bow window north of the door and two six-over-six vinyl double-hung replacement windows south of the door. The front door is accessed via three poured concrete steps that lead to a concrete stoop. The east elevation has a vinyl-clad, shed-roofed dormer addition on the

upper story that extends across nearly the entire length of the elevation. The east elevation also includes a flat roof porch on the sub-story, supported by brick columns and knee walls; it has a poured concrete floor (Appendix B, Figure 256). The parsonage is in good condition.

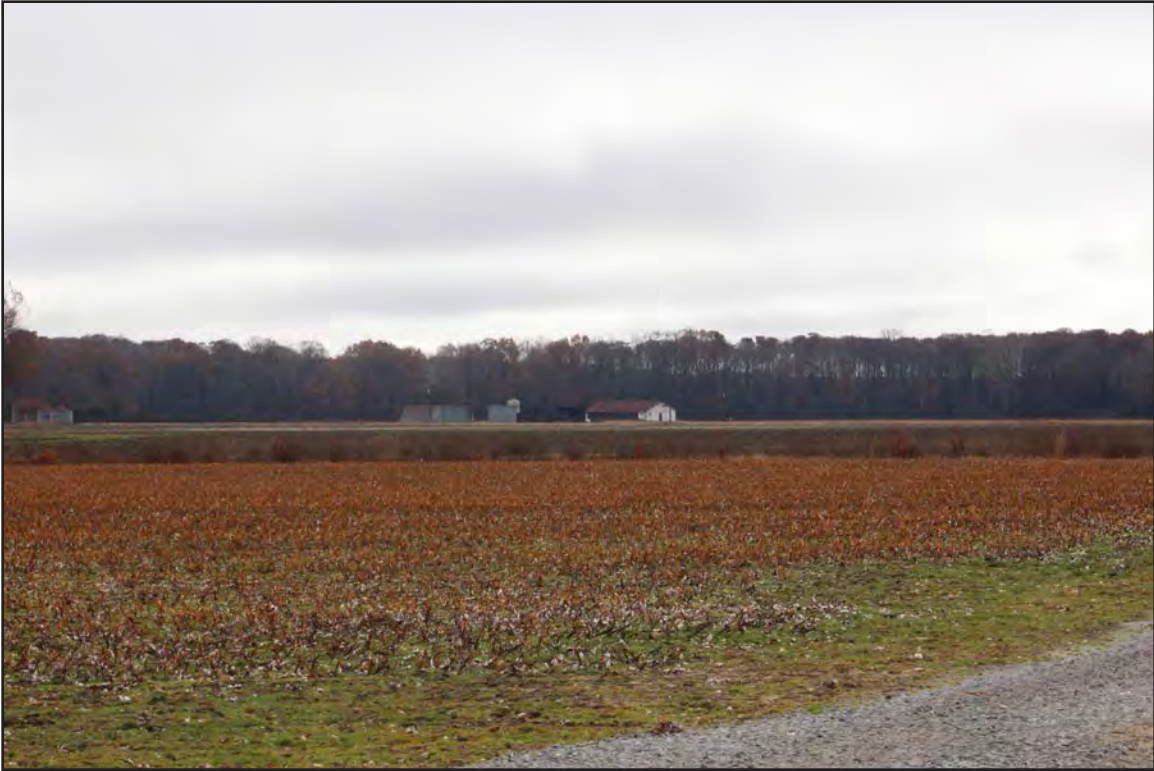
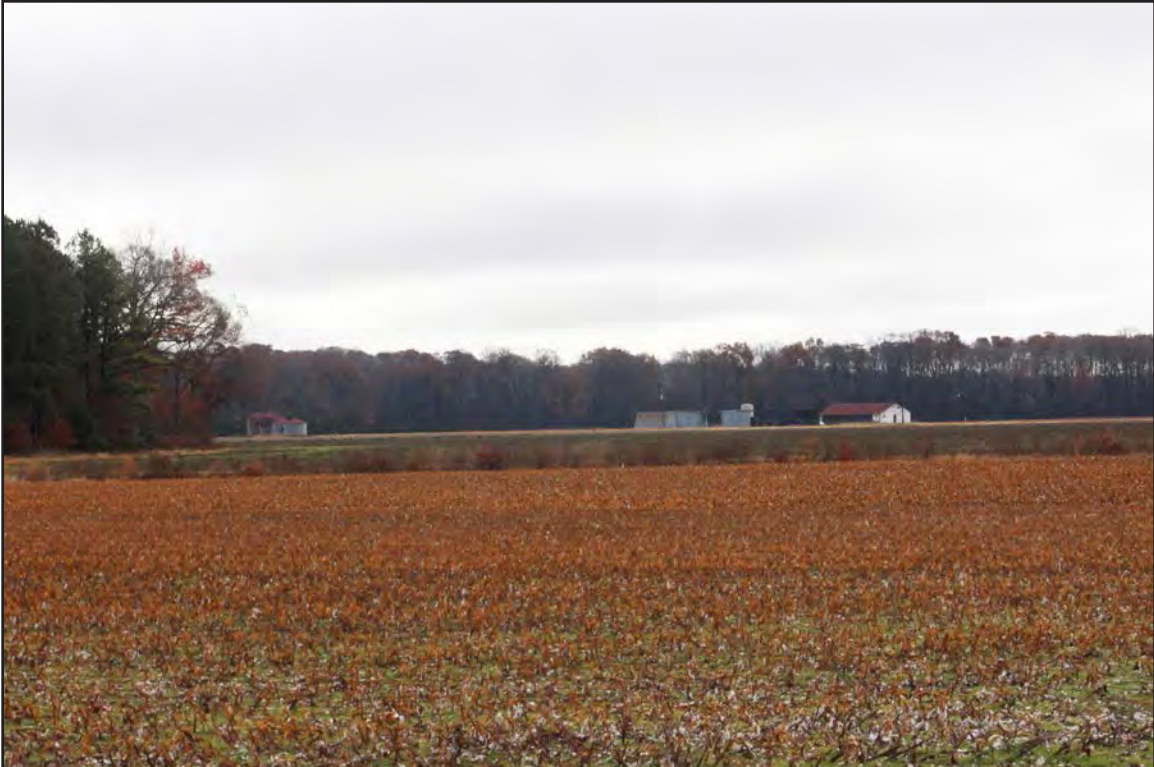
Figure 259. 087-5669, facing southeast.

Figure 260. 087-5669, facing southeast.

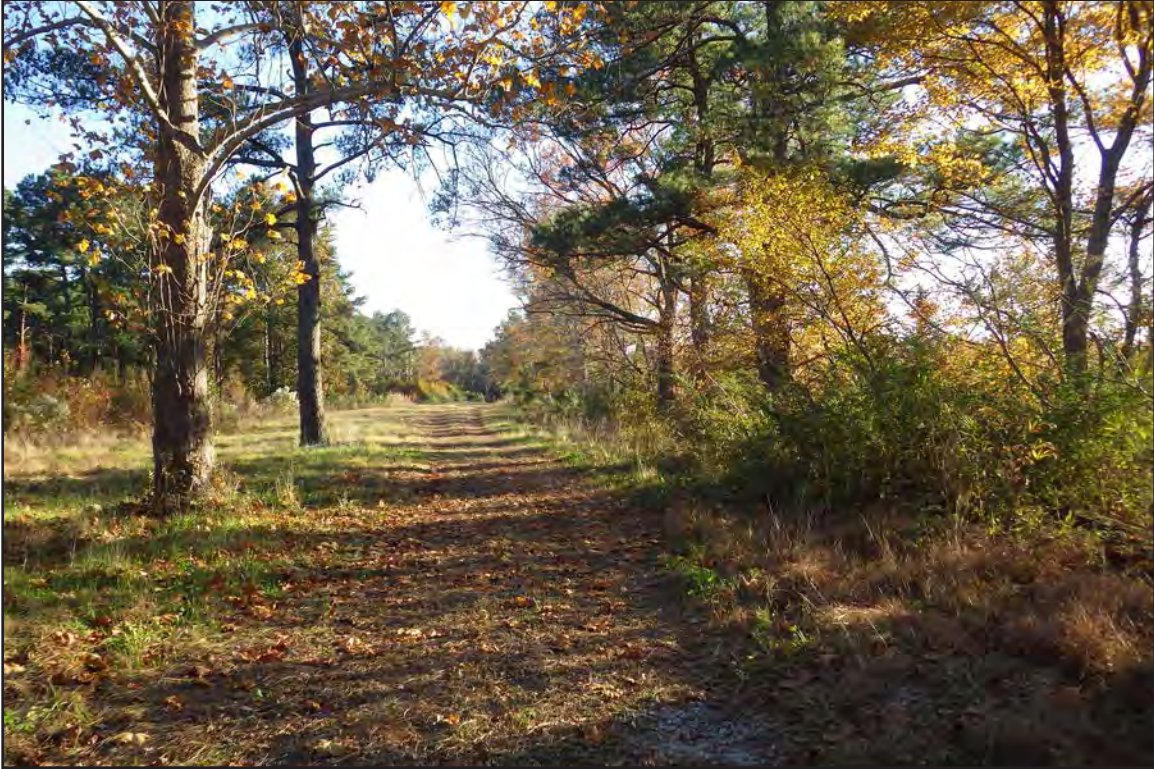
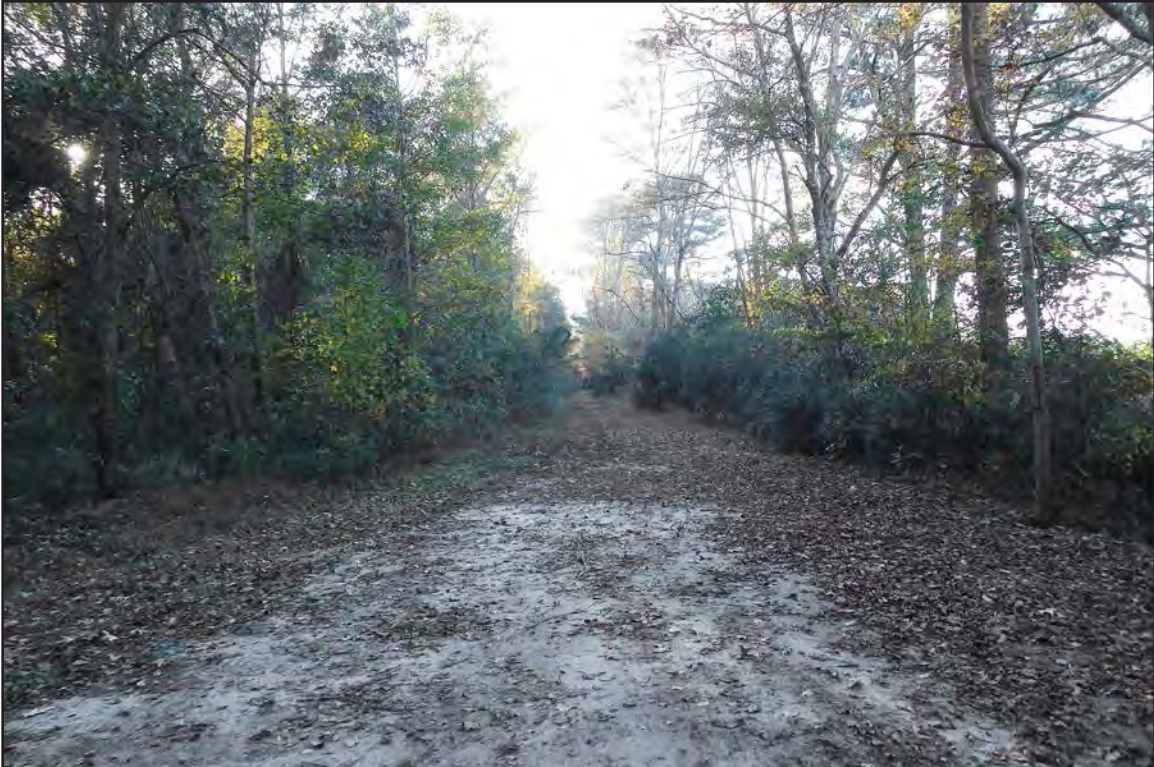
Two proposed access roads for the Project border or cross a portion of the NRHP boundary of the historic district (Appendix B, Figures 261 and 262). The proposed roads utilize existing rights-of-way and are located in a sparsely settled portion of the district (Appendix A, Sheet 16). The surrounding area is rural with expanses of open land that is either forested or being used for agricultural purposes. Four individual Historic District properties abut or are intersected by

Figure 261. 131-5325, proposed access road 27-06-AR1, facing south.

Figure 262. 131-5325, proposed access road 27-002-AR1, facing west.
