**Subject: Section 106 Review –Architectural Survey Report REVISED Addendum 4  
Atlantic Coast Pipeline, LLC, Atlantic Coast Pipeline Project  
DHR File No. 2014-0710**

**PHASE I HISTORIC ARCHITECTURAL SURVEY OF THE  
ATLANTIC COAST PIPELINE PROJECT**

**Virginia Addendum 4 Report**

**DHR File No. 2014-0710**

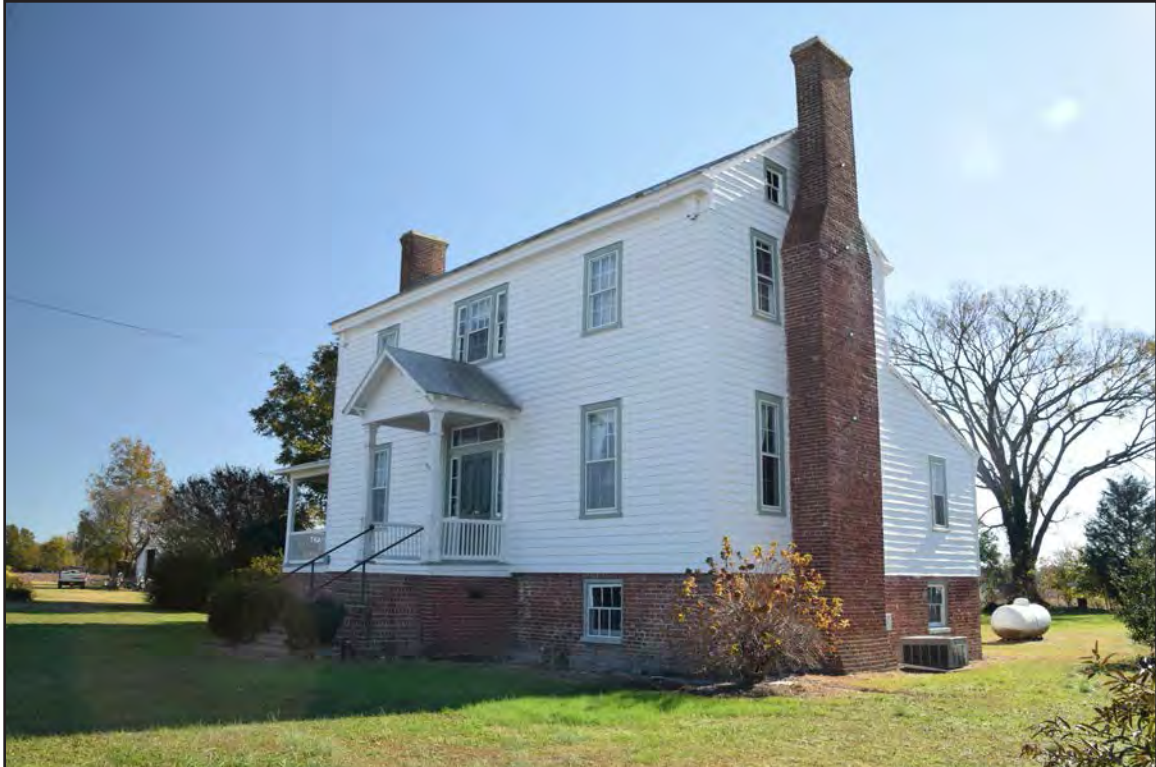
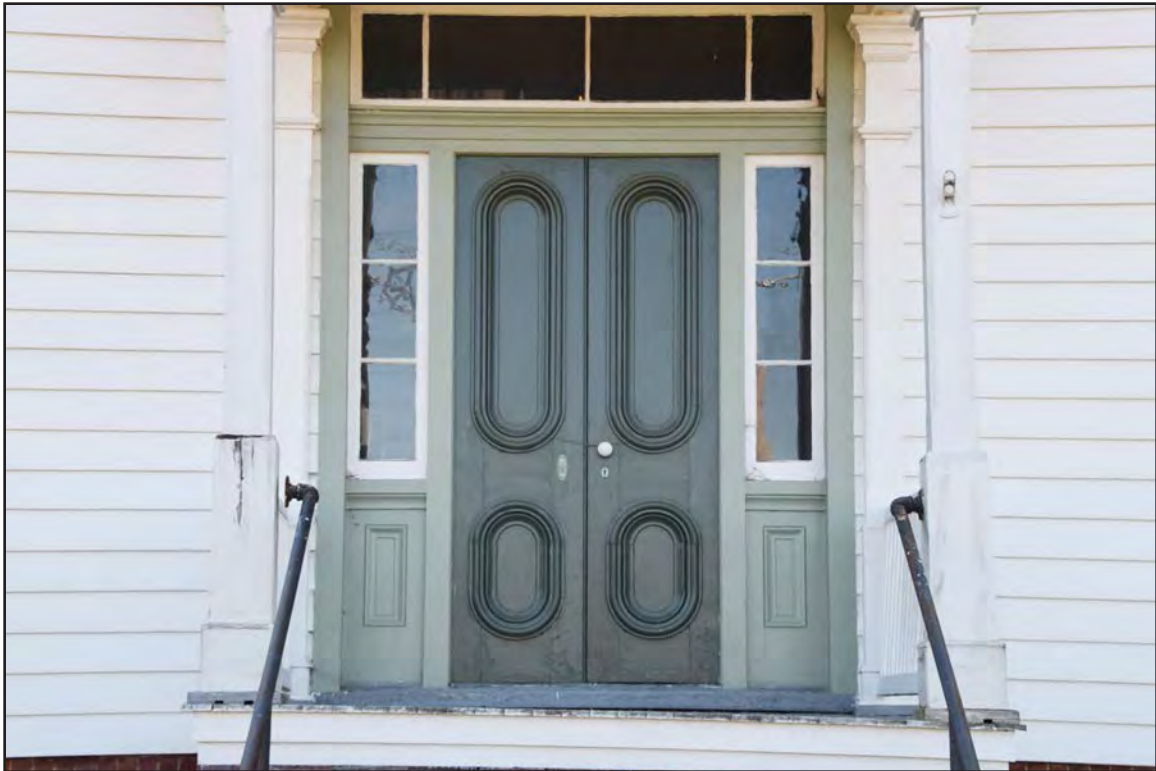
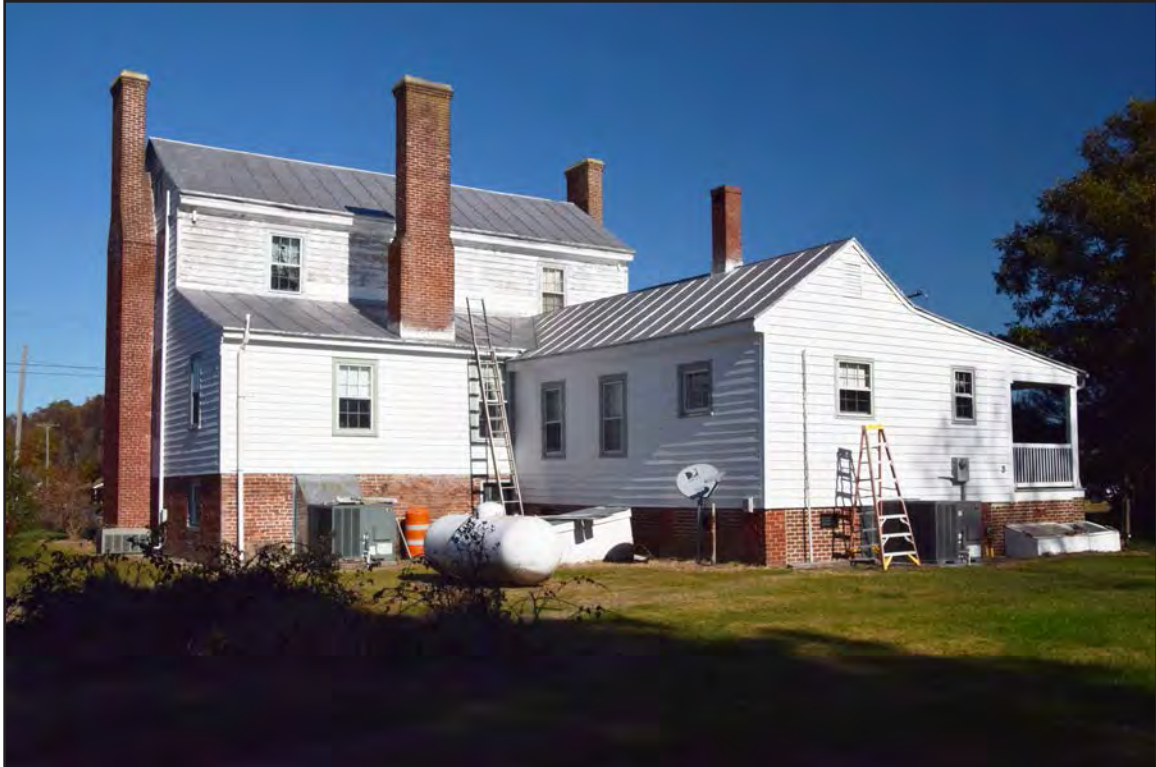
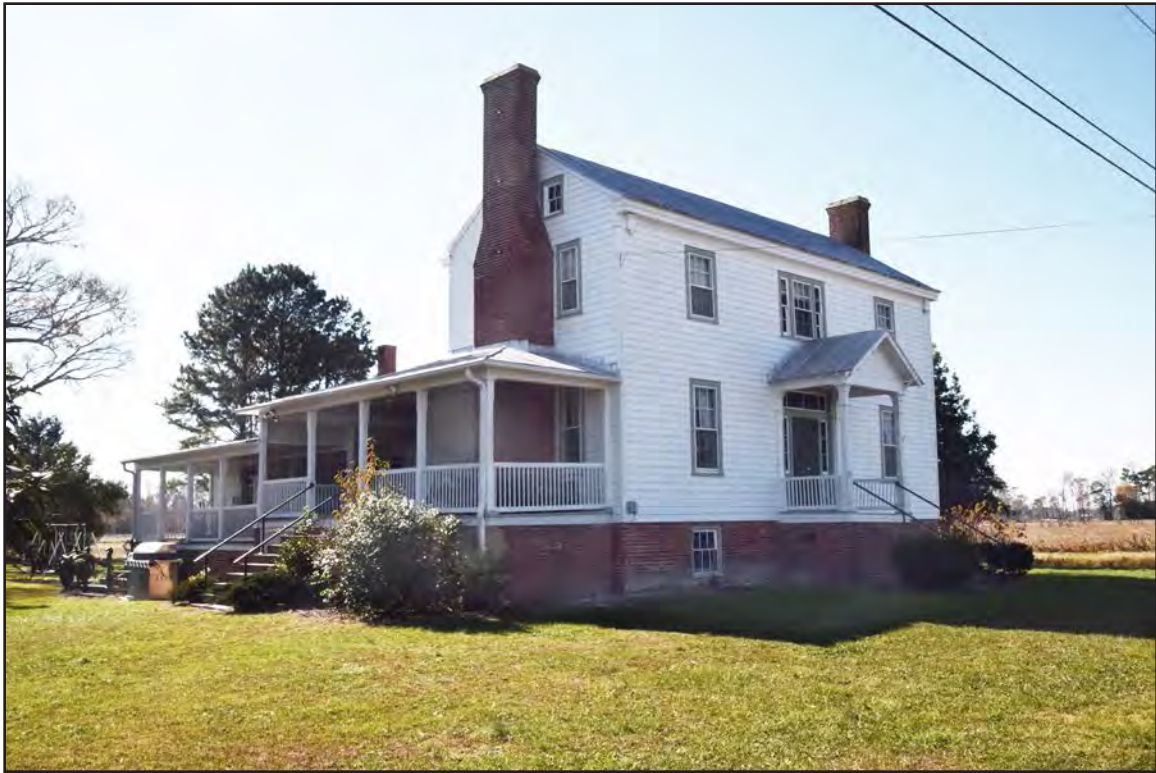
The house is a two-and-a-half story side-gabled, wood-framed Federal/Adamesque I-house with an American bond brick foundation and clapboard and vinyl siding (Appendix B, Figures 263 and 264). It was built in ca. 1865 and is three bays wide with a standing seam metal roof and a molded cornice. The house includes two exterior end, brick chimneys with corbeled tops and double-hung replacement windows of different configurations. The brick basement level has three-over-three wood sash, double-hung wood windows and decorative metal vents. The northeast elevation has brick steps that lead to an entry portico with a standing-seam gabled roof with exposed rafters supported by decorative, squared, wooden columns. The portico features simple wooden balustrade, and metal hand rails line the brick steps. The primary entrance is on the northeast façade and is filled with an original panel door that is flanked by three-paned sidelights and a four-paned transom light (Appendix B, Figure 265). The entry porch also includes pilasters on either side of the door. The window opening above the entry porch has been filled with a double-hung, six-over-six wood-framed window flanked by narrow, two-over-two sidelights. All other windows on the façade are wood-framed, six-over-six, double-hung windows. There are two-over-two, wood-framed attic windows on either side of the gable ends, and four-over-four windows on the first and second floors of the side elevations. The resource includes many additions. The one-story shed-roof rear bay appears to be original to the house, as the chimney and foundation are consistent with the side-gable main block (Appendix B, Figure 266). The southwest elevation also includes a ca. 1900 one-story, rear ell addition with a gable roof and a brick pier foundation with brick infill laid in running bond. This addition has replacement windows that are generally consistent with the main block along with one small fixed six-paned, wood-framed window. On the southeast elevation of this addition, is a shed roof extension with a porch that is supported by wooden posts, and featuring a balustrade and wooden floor constructed on a brick foundation (Appendix B, Figure 267). The porch leads to a paneled wooden door with six lights. The original block's southeast elevation also has a porch addition with a hipped, standing seam metal roof supported by carved wood columns with a wood floor and brick stairs. This side porch on the original block is constructed on a higher plane than the adjacent side porch to the rear. The house is in good condition.

Figure 264. 133-0101, facing south.

Figure 265. 133-0101, primary entrance, facing southeast.

Figure 266. 133-0101, facing east.

Figure 267. 133-0101, facing west.

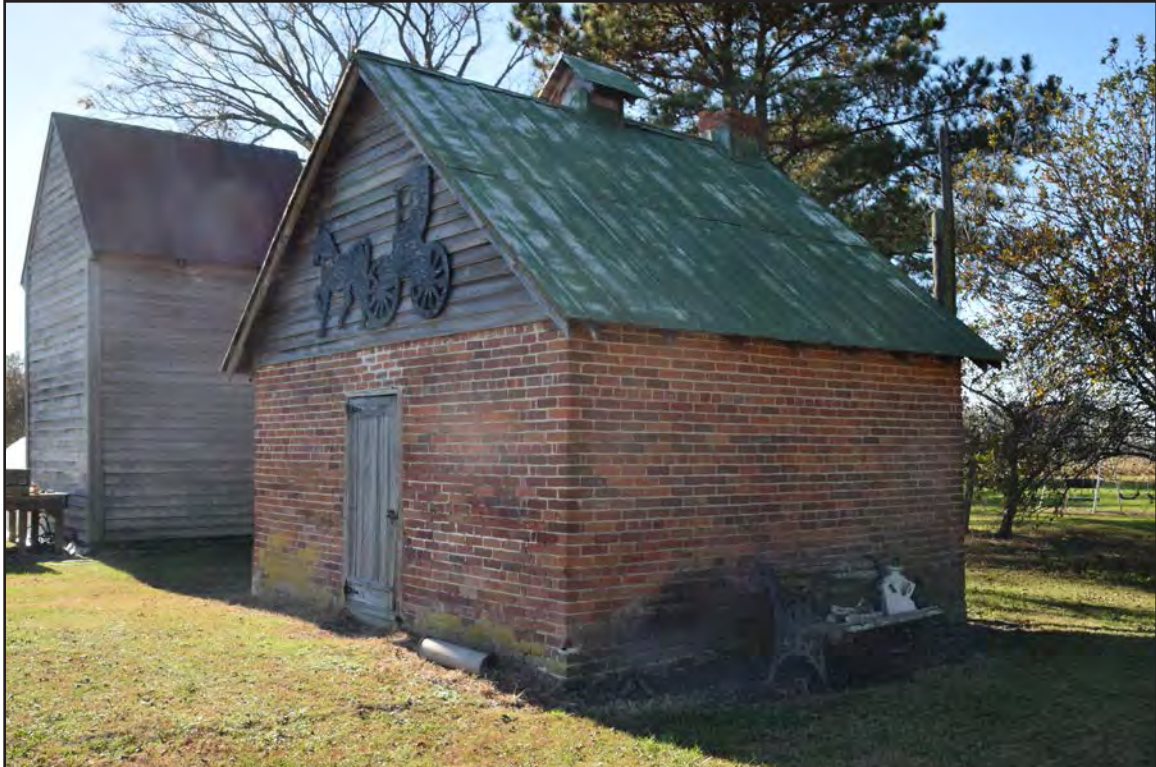
Figure 268. 133-0101, potato house, facing west.

To the south is a one-story potato house with five-course American bond brick construction and a front-gable standing-seam metal roof and exposed rafter tails (Appendix B, Figure 268). The previous survey provides a date of circa 1950 for the potato house, its design and materials could suggest earlier construction (Parker et al. 2015). It has clapboard siding on the gable ends and a small square gabled cupola. It has an on-peak, interior-end, brick chimney and vents at the bottom of the exterior, near the foundation. A wooden door with iron hardware is centered on the southeast elevation. The potato house has a decorative wood plaque of a horse and carriage on the southeast elevation's gable end. Further south of the potato house is a ca. 1865 wood-framed smokehouse with a brick foundation and front gable, standing seam metal roof (Appendix B, Figure 269). It has no windows with clapboard siding and a wood plank door on the northwest gable end. Next to the smokehouse is a ca. 1990 domed greenhouse that is covered in plastic sheeting. To the southeast is a circa 1950-1960 front-gabled standing seam metal roofed barn with corrugated metal walls on the northwest, southwest and southeast elevations, and composite board on the northeast elevation with decorative pisters (Appendix B, Figure 270). It has one large bay opening on the northeast elevation. The southwest elevation

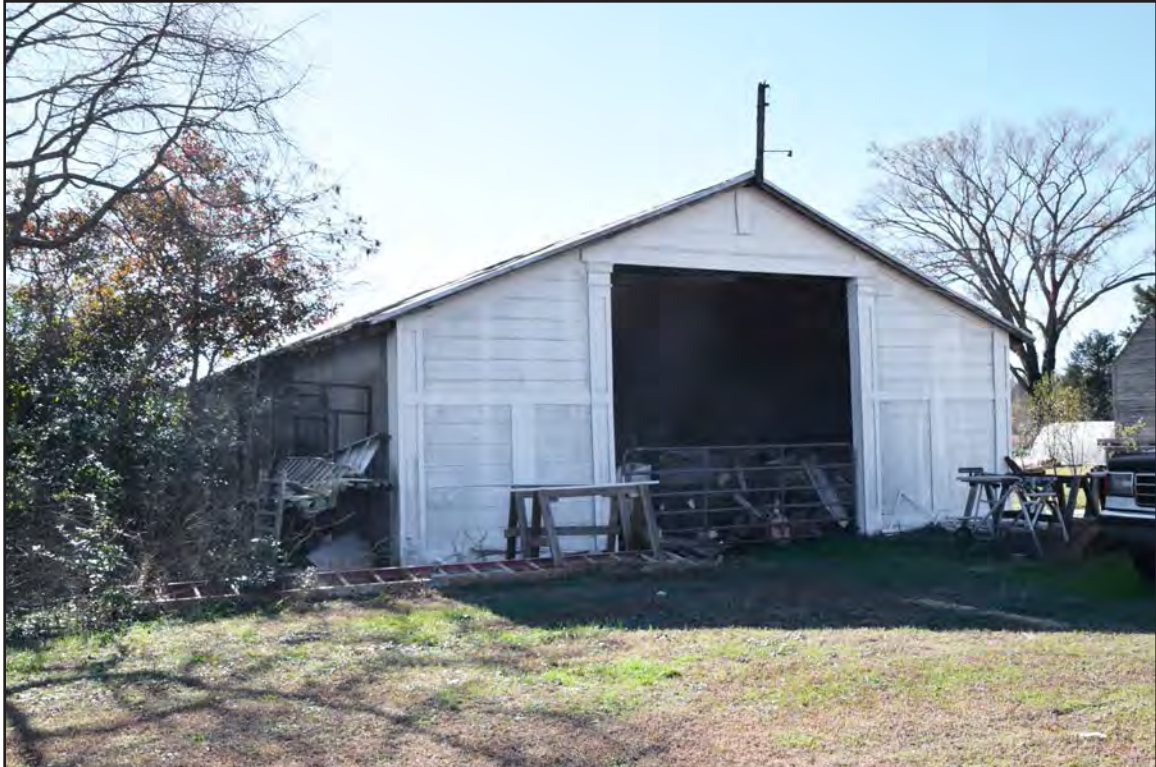
Figure 270. 133-0101, barn, facing southwest.

has large, paned windows and vinyl that partially cover the façade. This elevation also has a multi-light, vinyl door. Further southeast is a ca. 1900 log corn-crib with saddle-notched corners and the remnants of a metal roof (Appendix B, Figure 271). A wood paneled door is located on the center of the northeast elevation. It has a brick pier foundation, is much deteriorated, and in poor condition.

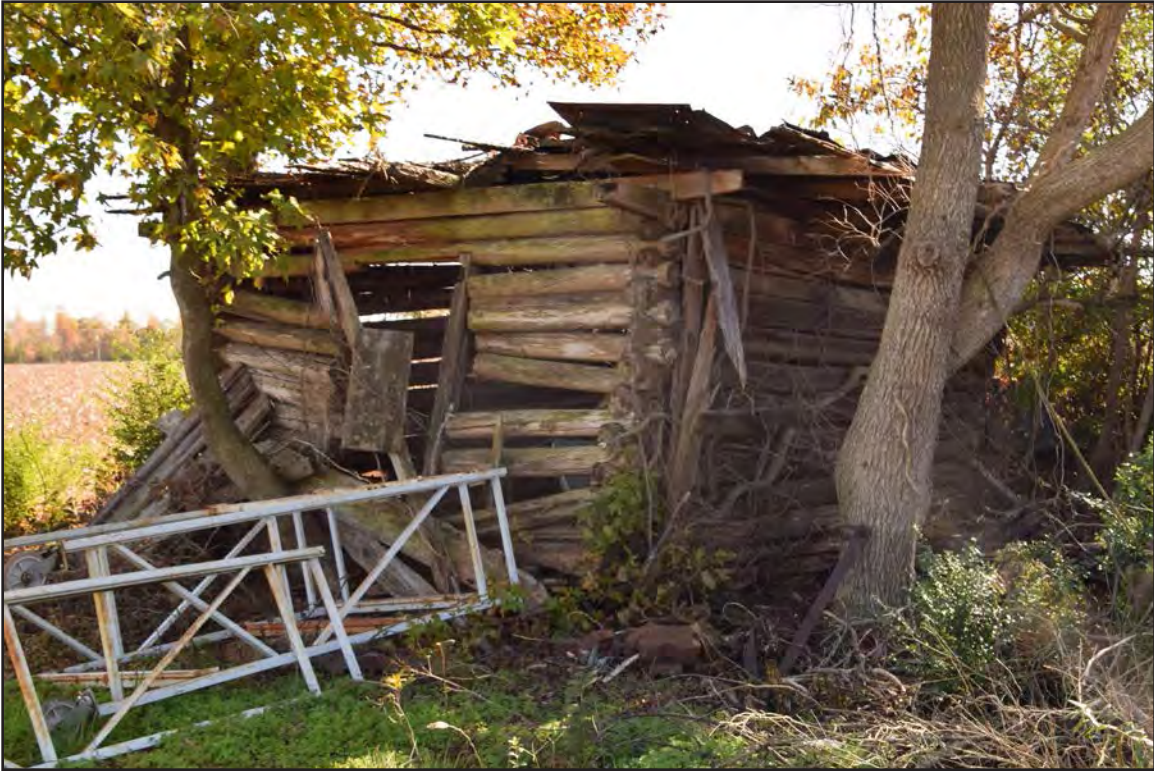
Figure 271. 133-0101, corn crib, facing south.

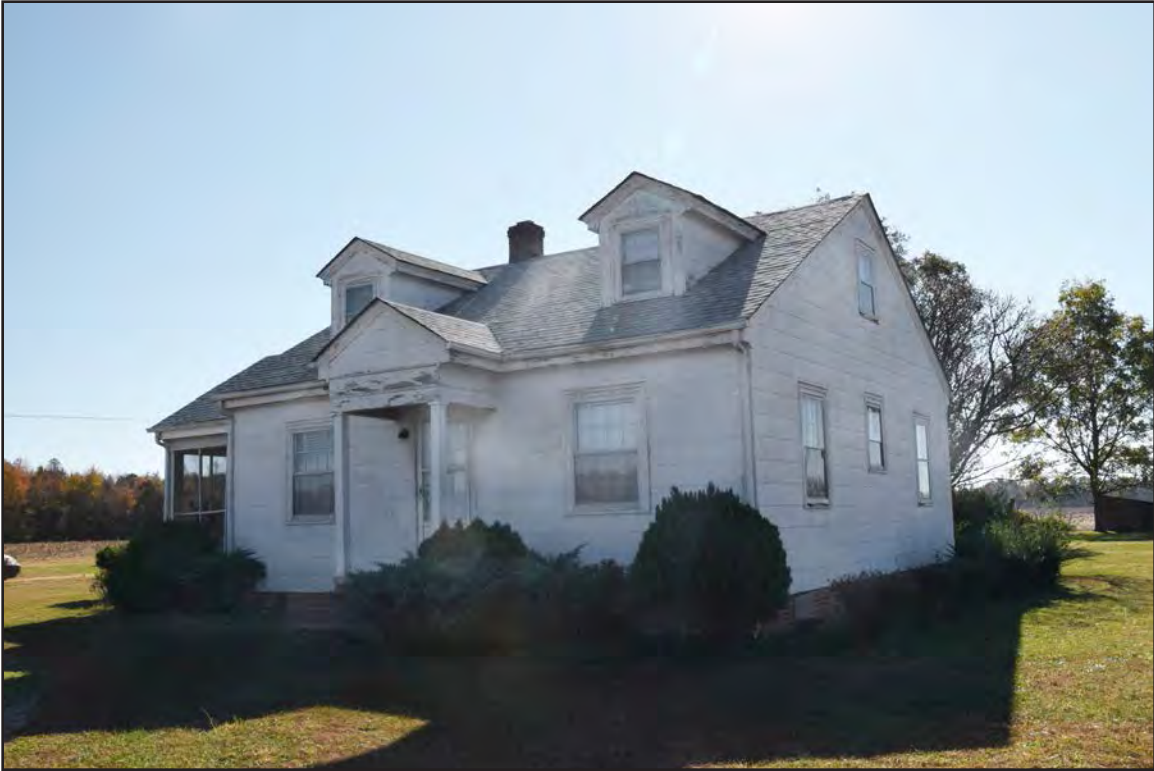
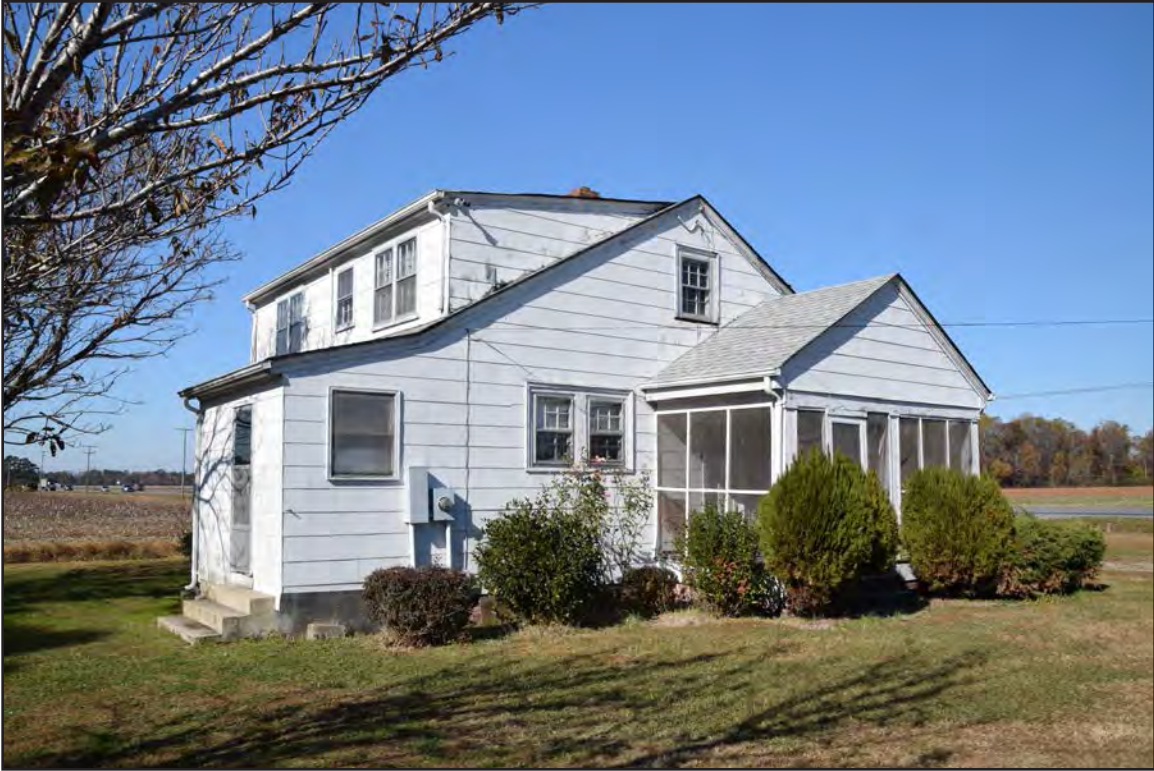
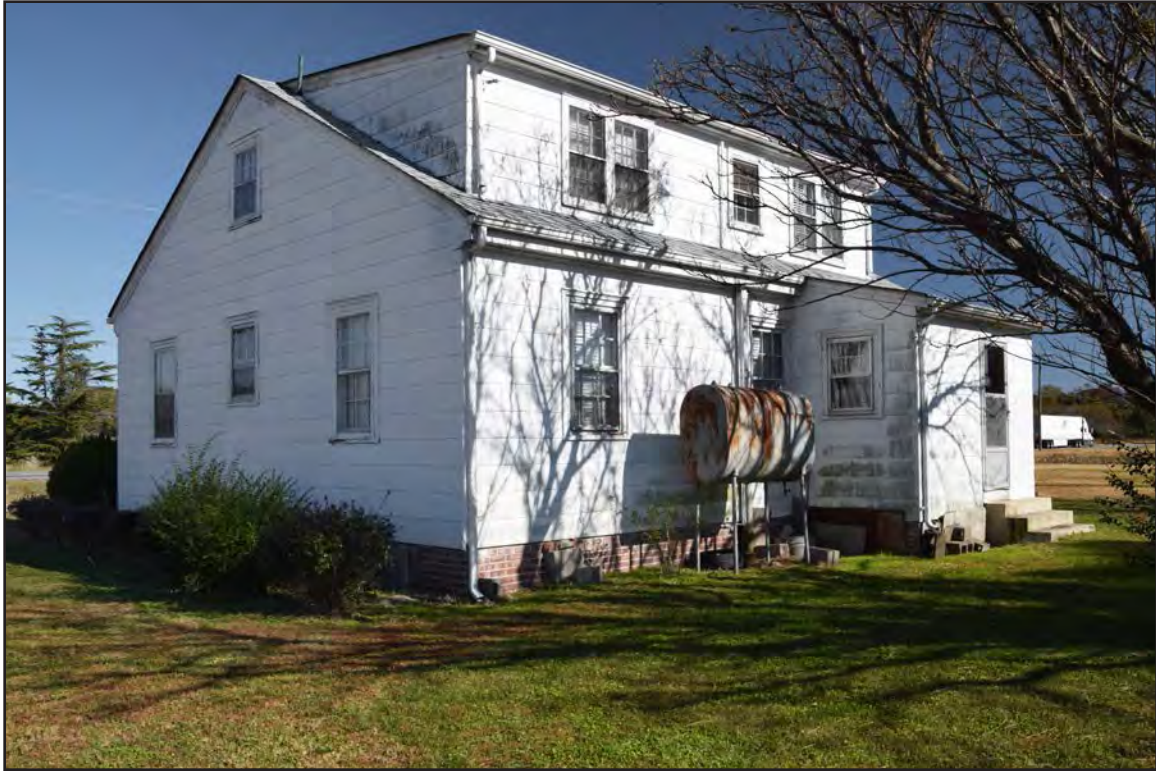
Built in ca. 1949, the one-and-a-half story vernacular Cape Cod residence has a side-gable compositional asphalt roof with gabled dormers, and a central on-peak brick chimney (Appendix B, Figures 272–275). The walls are clad in asbestos siding, and the residence sits on a continuous brick foundation. Entry is gained through a central wood panel door with three lights. The door is protected from the weather by a portico with a gable roof with an integrated pediment supported by square columns on a concrete stoop with concrete steps. Fenestration is paired and single eight-over-eight double-hung wood sash windows with wood surrounds. Replacement windows mimicking these are made of vinyl, and found throughout. A secondary entrance is off the ca. 1955 gable screened porch on the east elevation. The deck of the porch is composed of wood, which rests on a brick foundation. The south elevation has had a small ca. 1970 shed roof addition with a third entry. Fenestration is one-over one double hung aluminum windows. A ca. 1960 second floor shed dormer spans nearly the entire length of the southwest roof. It is composed of material consistent with the main block and has paired and single six-over-six double hung wood sash windows with wood surrounds.

Figure 273. 133-5443, facing southeast.

Figure 274. 133-5443, facing northwest.

Figure 275. 133-5443, facing northeast.

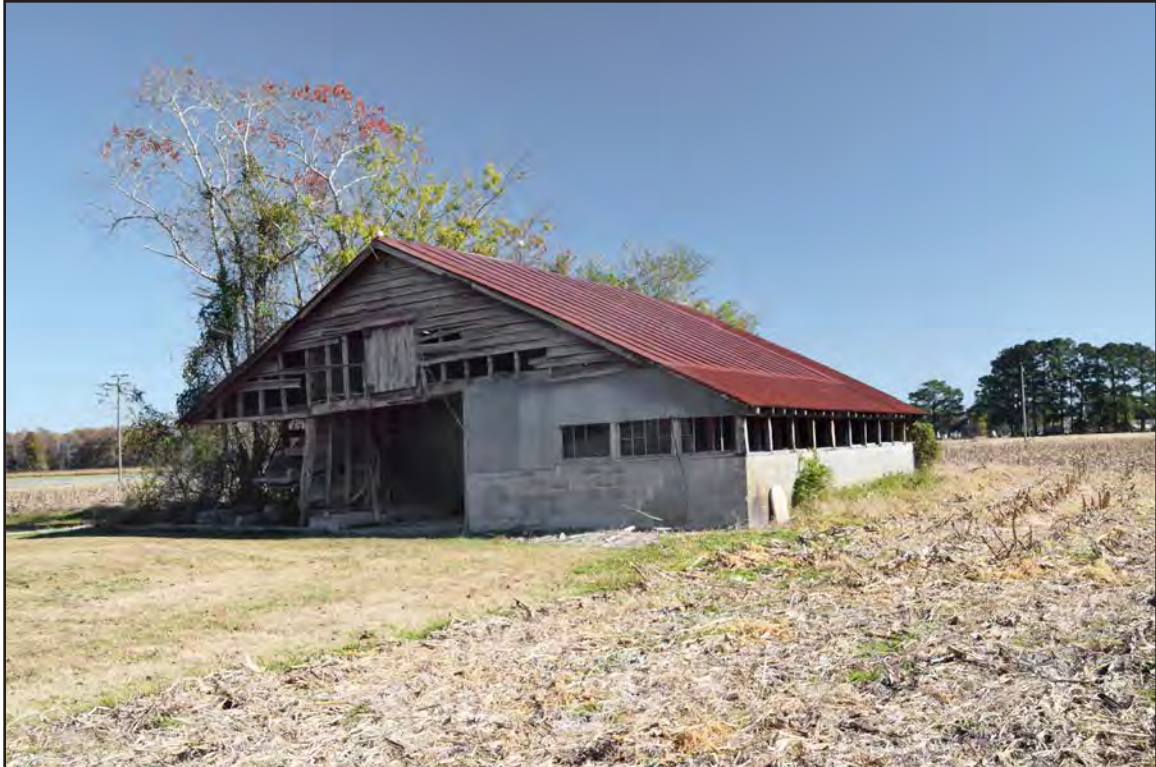
The chicken coop has a standing-seam metal shed roof, and walls composed of vertical lumber. The door opening is on the southeast side. A pump or well structure is next to the garage. It is composed of concrete masonry units and has no roof. There is a ca. 1980 one-bay front-gable garage with a standing-seam metal roof. The walls are clad in vertical lumber and shingles. A shed addition composed of plywood walls has been added to the southeast elevation. The barn located on this property was constructed circa 1948 and is one-story. According to the owner, the barn was built shortly after World War II. The metal roof on the barn is front-gable and features overhanging eaves. The foundation of the barn is a mixture of concrete slab and concrete block, which also is used for portions of the lower walls. The barn has wood-frame construction with horizontal clapboard siding at the gable end. A small wood door is located at the gable end. The interior pens used for animals are constructed of wood. Exterior walls of the barn have been patched with corrugated metal panels, but sections of siding are missing due to the barn's advanced state of deterioration. Surrounding vegetation is overtaking the northeast elevation of the barn, obscuring the visibility of architectural elements (Appendix B, Figure 276).

Figure 276. 133-5443, barn, facing east.

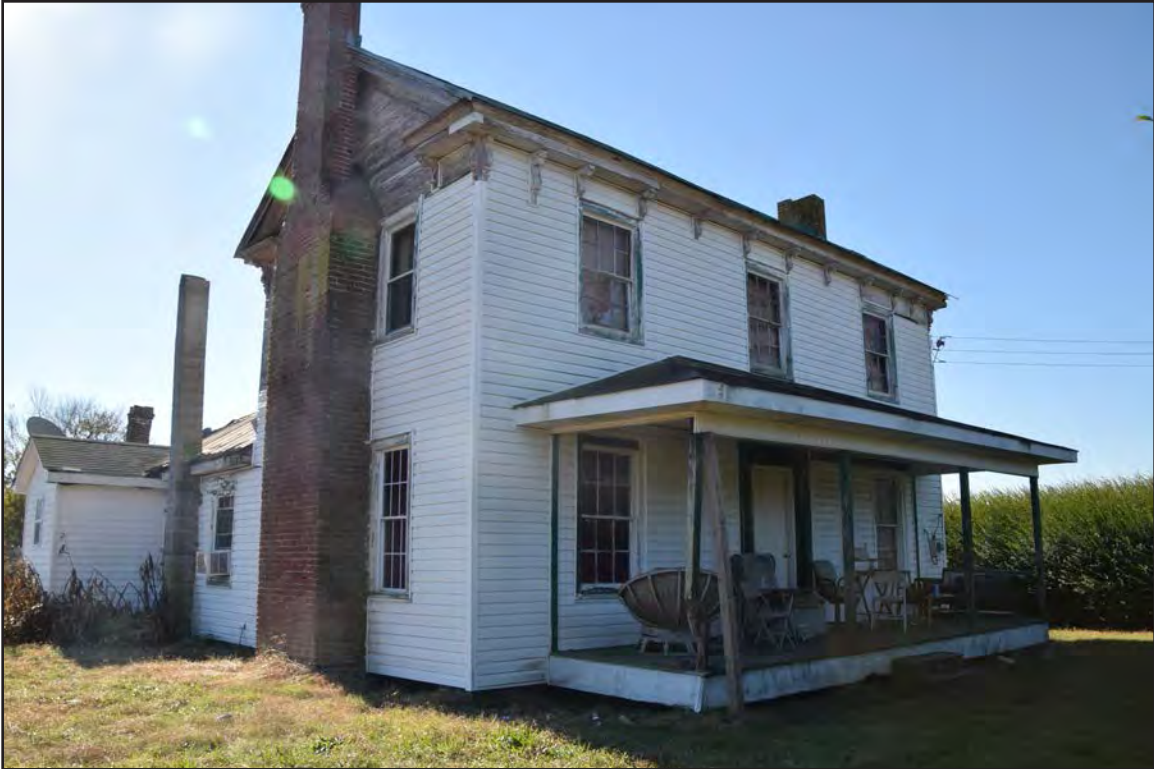
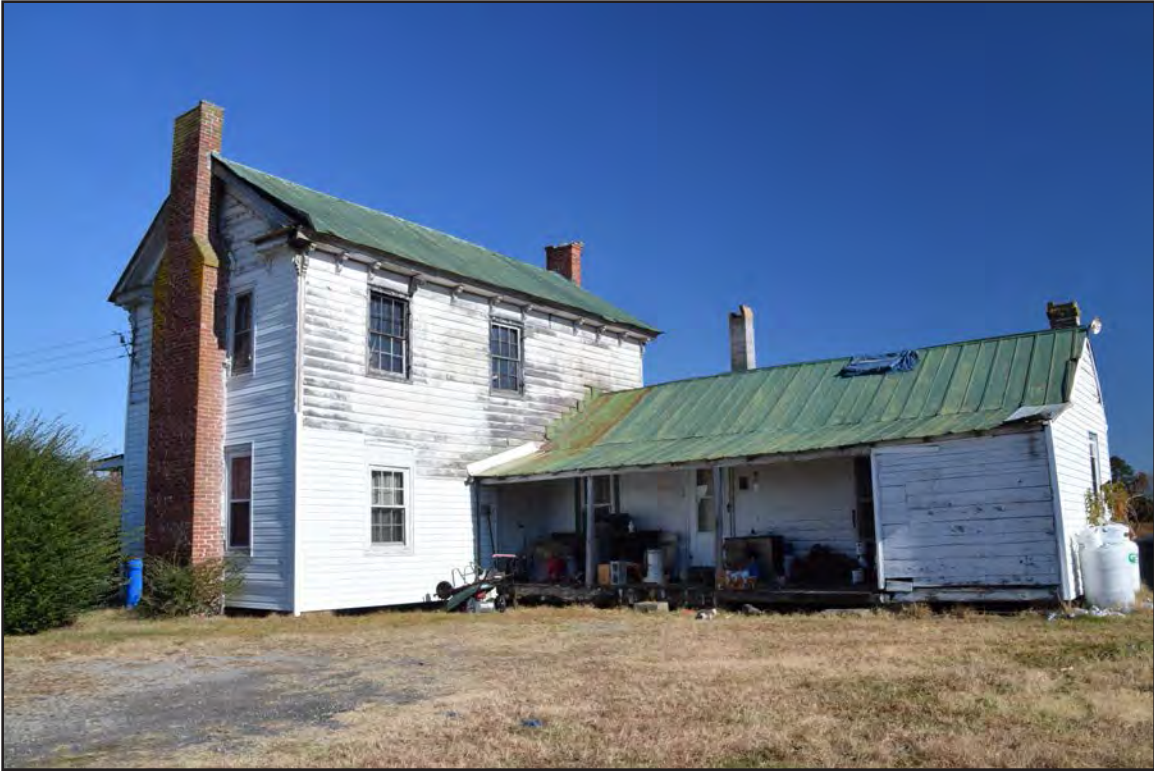
Built in circa 1880, the resource is a two story I-house covered in vinyl and clapboard siding (Appendix B, Figures 277–279). The side-gable roof is composed of standing seam metal. Boxed eaves supported by scrolled brackets reflect a Folk Victorian influence. Resource 133-5580 rests on a brick pier foundation with some replacement concrete masonry unit piers. The main block has an external brick chimney on both the east and west end gables. Fenestration consists of six-over-six double-hung wood sash windows with wood surrounds, some of which have been replaced by six-over-six double-hung vinyl windows also with wood surrounds. Entry is through a central wood panel replacement door off a partial-width porch on the north elevation. Although the door is a replacement, the four-light transom is original to the structure. The porch features a standing-seam metal hipped roof supported by lumber posts on a replacement wood floor, which rests on a CMU pier foundation. A ca. 1920 side-gable one-story addition has been added to the west end of the rear (south) of the main block. There is an internal brick chimney on the south end, and an external concrete masonry unit chimney on the west. Composed of materials consistent with the main block, the addition rests on brick and concrete masonry unit piers. Fenestration is six-over-six double-hung vinyl windows with wood surrounds. Entry to the addition can be gained through one of two wood panel doors off the partial-width integrated porch within the ell created by the addition. A small portion of the south end of the porch has been enclosed. The roof over the open portion of the porch is supported by lumber posts on a wood deck. A small ca. 2000 addition with a compositional asphalt front gable roof with boxed eaves has been added to the west of the ca. 1920 addition. The walls are clad in vinyl siding, and it rests on a continuous, modern concrete masonry unit foundation. One small four-over-four double-hung vinyl window is in the gable end of the addition. The USGS topographic map for this location indicates that an outbuilding once stood near the residence. Likely a barn, field studies found no evidence of this structure.

Figure 278. 133-5580, facing southwest.

Figure 279. 133-5580, facing northeast.

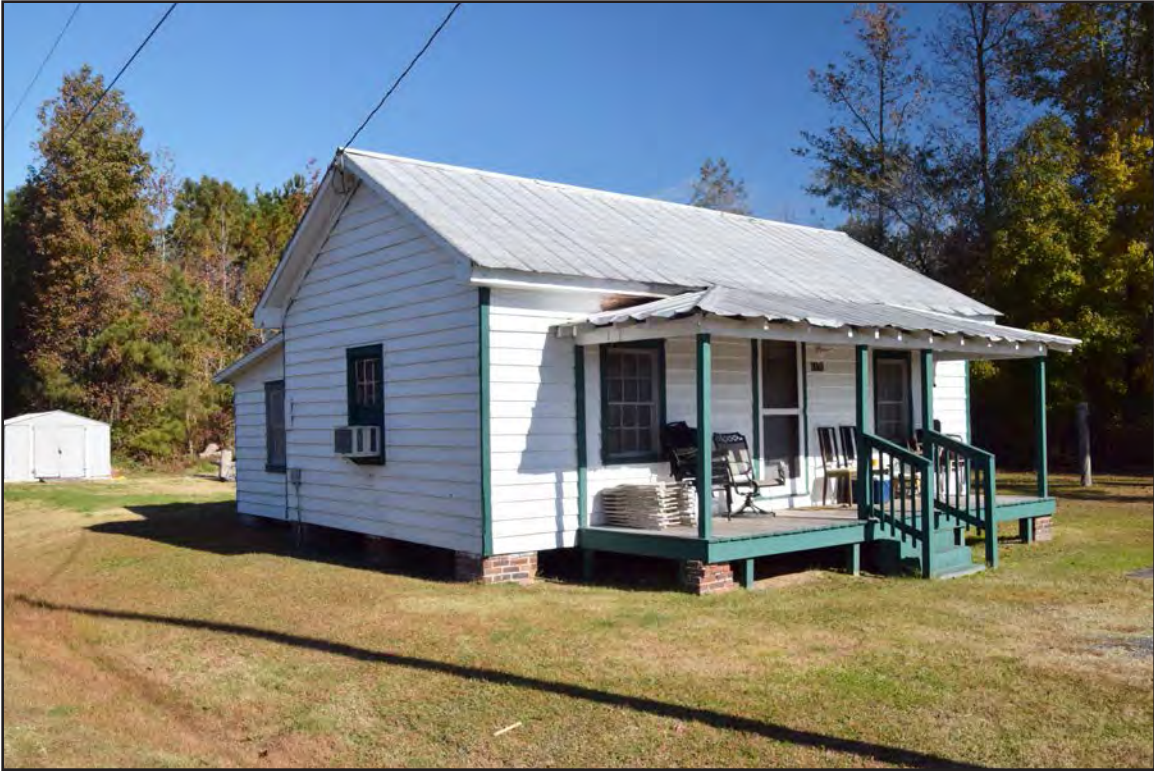
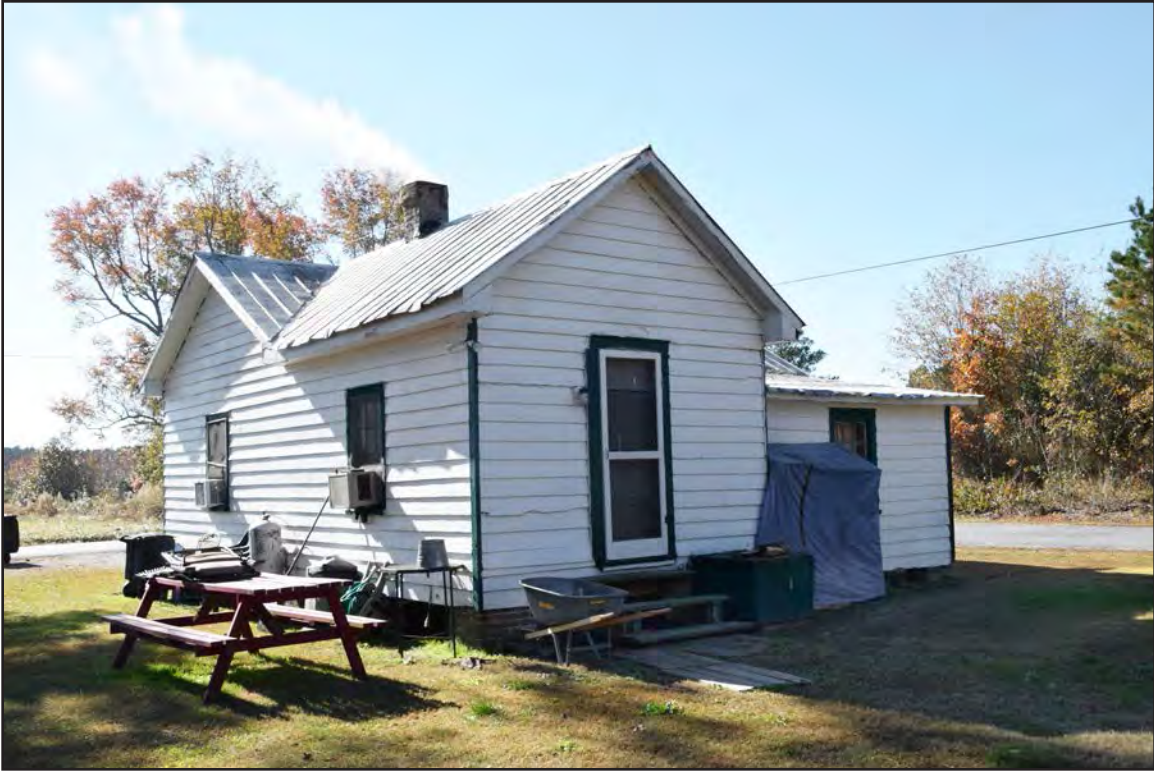
Built in circa 1950, the one-story single-pen gabled ell has a standing seam metal roof with boxed eaves and the walls are clad in clapboard siding (Appendix B, Figures 280–282). The central massing of the structure rests on a brick pier foundation. Fenestration on the structure consists of six-over-six double-hung wood sash windows with wood surrounds. The main entry is through a wood panel accessed via a partial-width hipped gable roof porch supported by lumber posts on a modern wood deck. The porch rests on brick piers. A secondary entrance at

Figure 281. 133-5581, facing northeast.

Figure 282. 133-5581, facing southeast.
