ATLANTIC COAST PIPELINE, LLC
ATLANTIC COAST PIPELINE
Docket Nos. CP15-554-000
CP15-554-001

**Response to USFS Request for Information for Construction
and Operations on Steep Slopes**
Monongahela National Forest
and
George Washington National Forest

March 2017

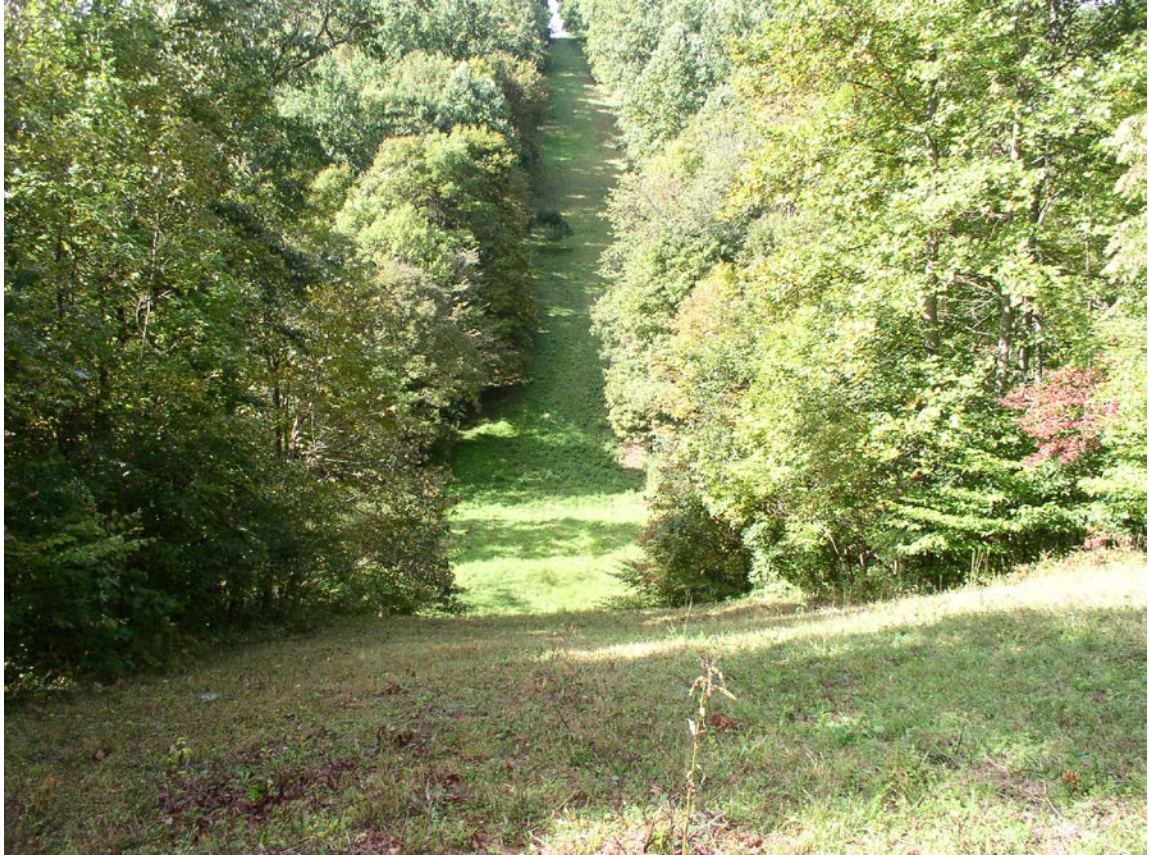
Figure 4 - TL 492 Ext 3, Three Years after Completion

- 12 miles of new 24-inch diameter gas transmission line
- FERC Jurisdictional Project
- Construction took place in 2008
- Nominal construction right-of-way width was 75-ft
- Restoration work included standard silt fence, water bars, trench breakers, erosion control fabric, coir logs, tracked slopes, approved seed and mulch per agency recommendations
- Additional restoration work included tighter spacing of water breakers and trench plugs in select areas
- Full time environmental inspectors were onsite throughout construction
- Post construction monitoring continued for approximately 6-8 months
- FERC inspections occurred periodically
- No instances of non-compliance or problem areas were noted during FERC Inspections
- At a minimum slope breakers and trench breakers were constructed at the FERC required spacing
- No bleeder drains were used
- Full restoration was accomplished

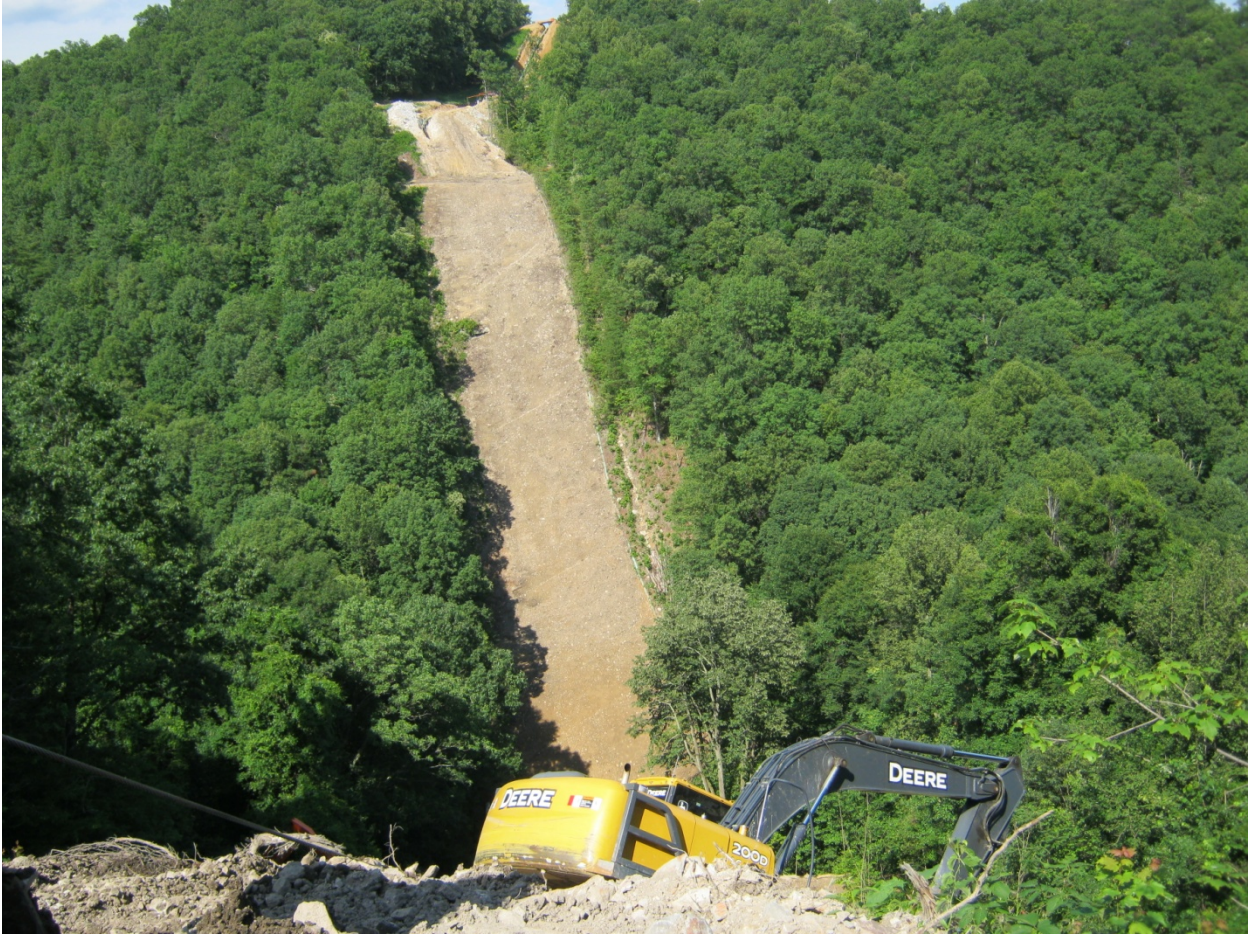
Figure 6 - TL 585, Final Grade Established

- At a minimum slope breakers and trench breakers were constructed at the FERC required spacing
- No bleeder drains were used
- Full restoration was accomplished

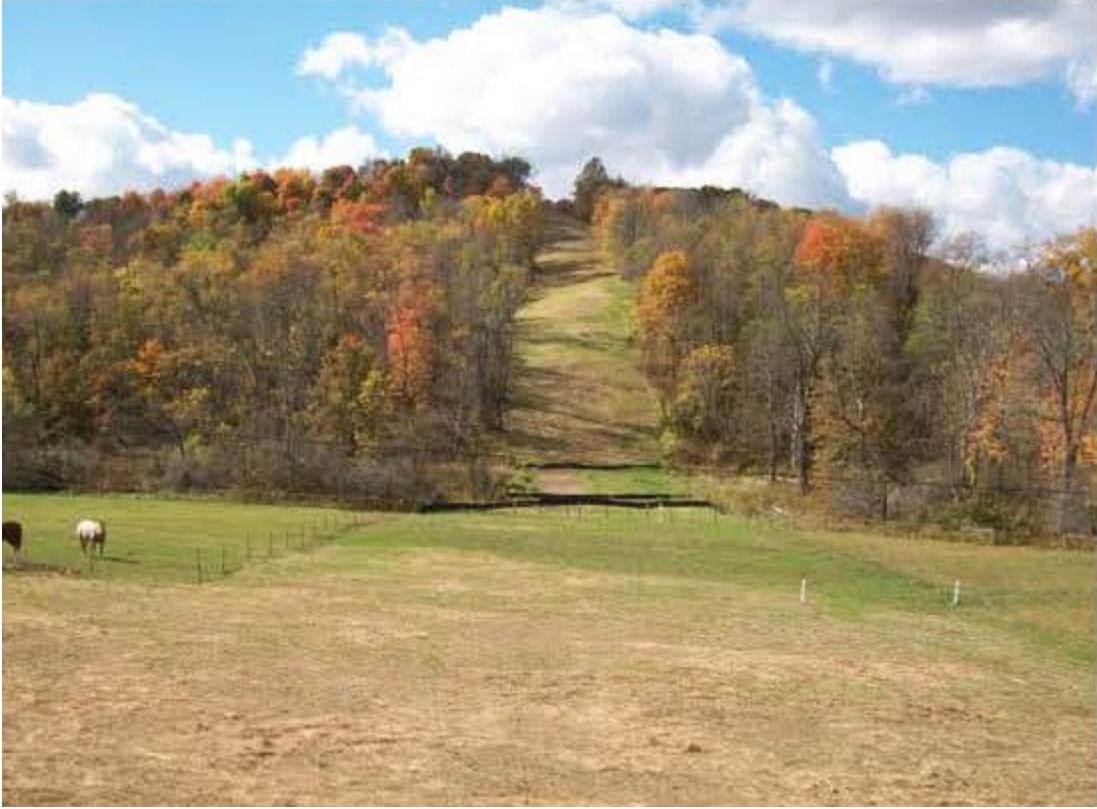
Figure 9 - TL 492 Ext 4, Restored Right of Way

- There were a couple noted slope stability issues as a result of buried layers of chips and water runoff control. Incremental measures to remediate included excavation, tracked back in, seeding, mulch and installation of a french drain system (measures included in the BIC program)

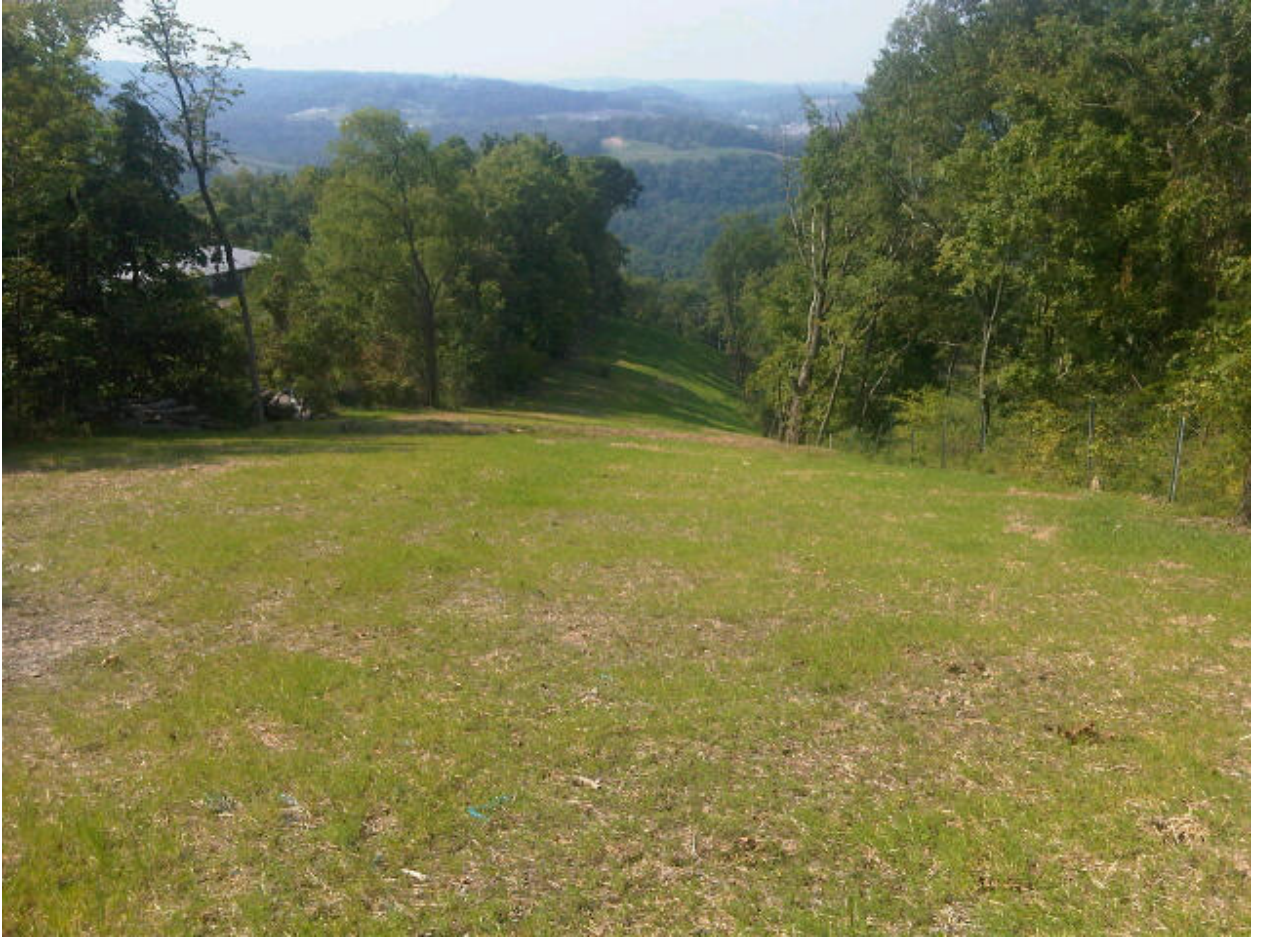
Figure 11 - TL 492 Ext 5, Restored Right of Way

- Several slope stability issues were noted as a result of buried layers of chips, water runoff control, and very steep slope with a road above. Incremental measures (i.e. BIC) included excavation, controlling water runoff with a french drain system, seeding, mulching, and installation of a retaining wall

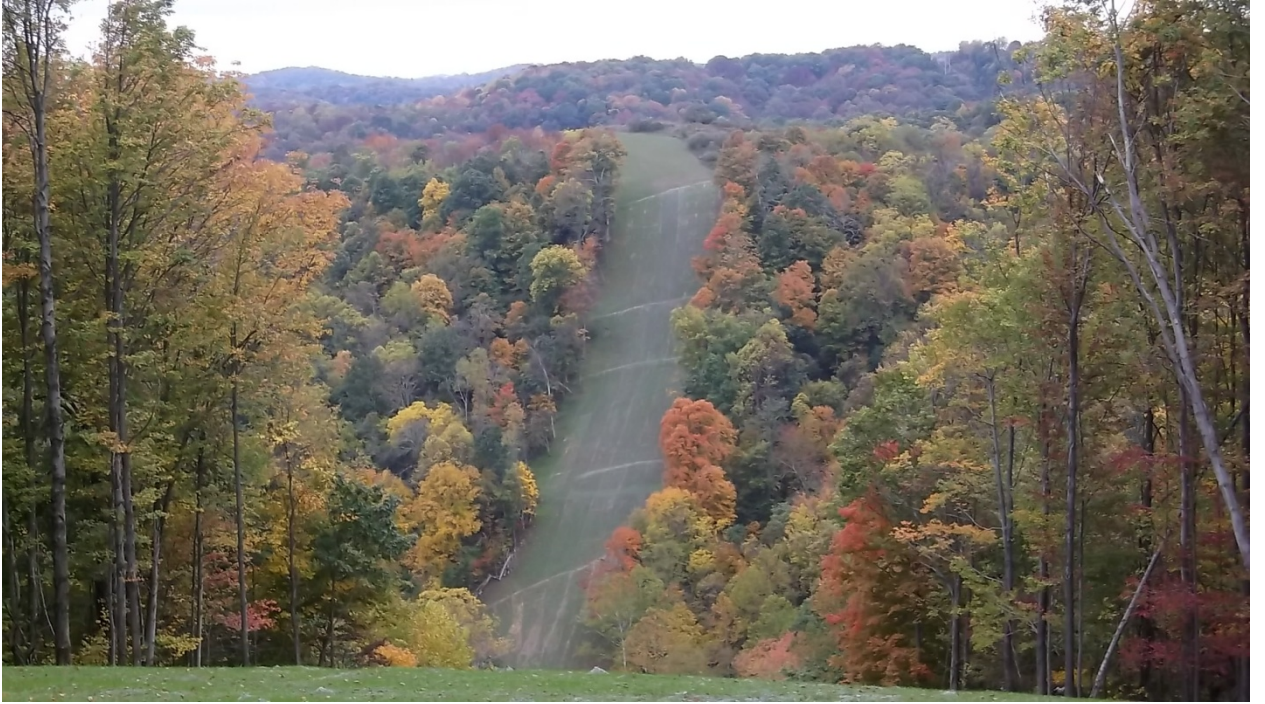
Figure 13 - TL 590, Restored Right of Way

- At a minimum slope breakers and trench breakers were constructed at the FERC required spacing
- Project has seen several slope stability issues but the most significant of these occurred in the Marshall County, WV. Reasons for the slope stability issues varied but included buried layers of chips and water control. Multiple new methods were implemented to stabilize the slopes including soil nails, retaining walls, peanut pipe, under drains, calcinate soil enhancers.

- Right of way restored. Continual monitoring of the right of way is ongoing to monitor for slope stability issues.

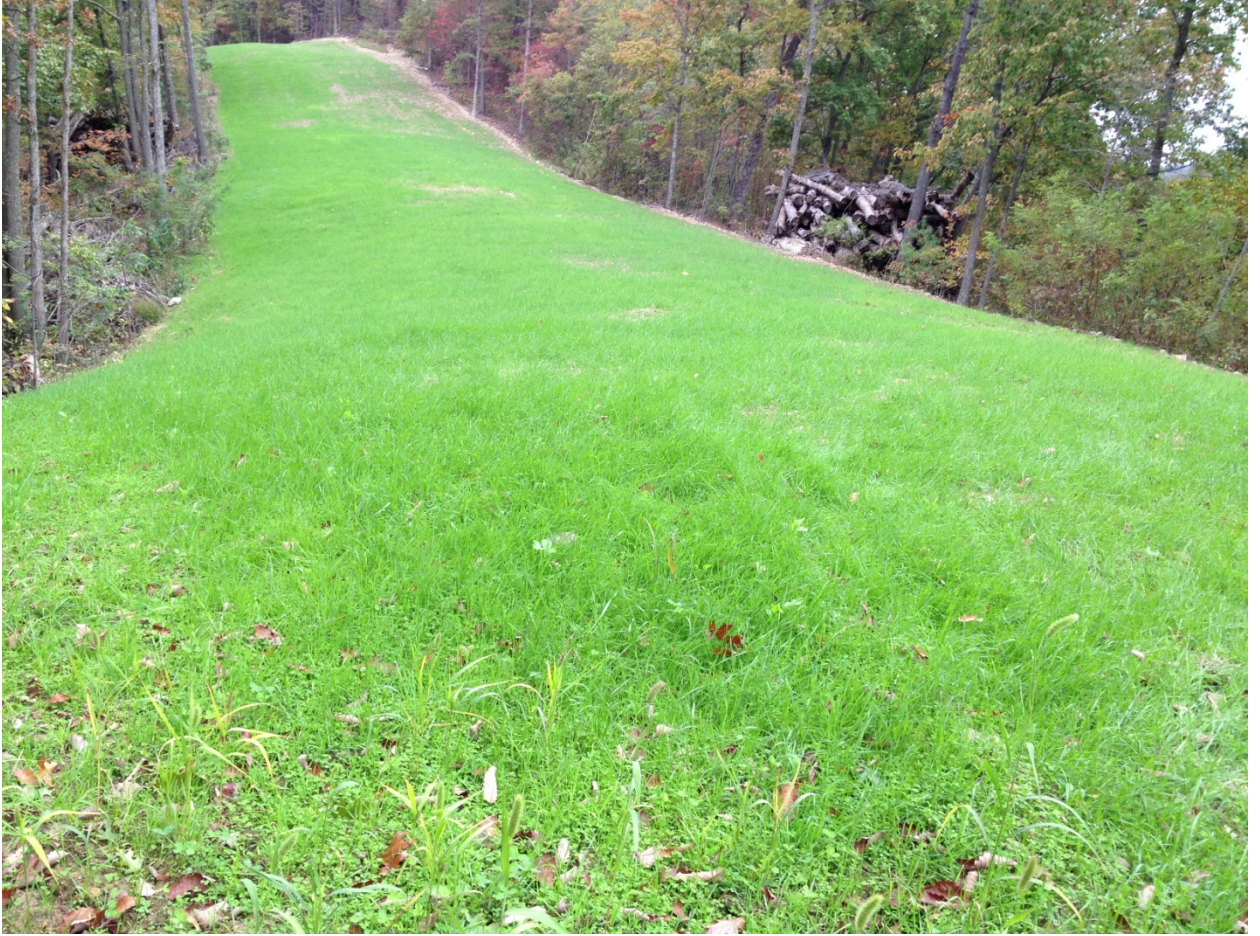
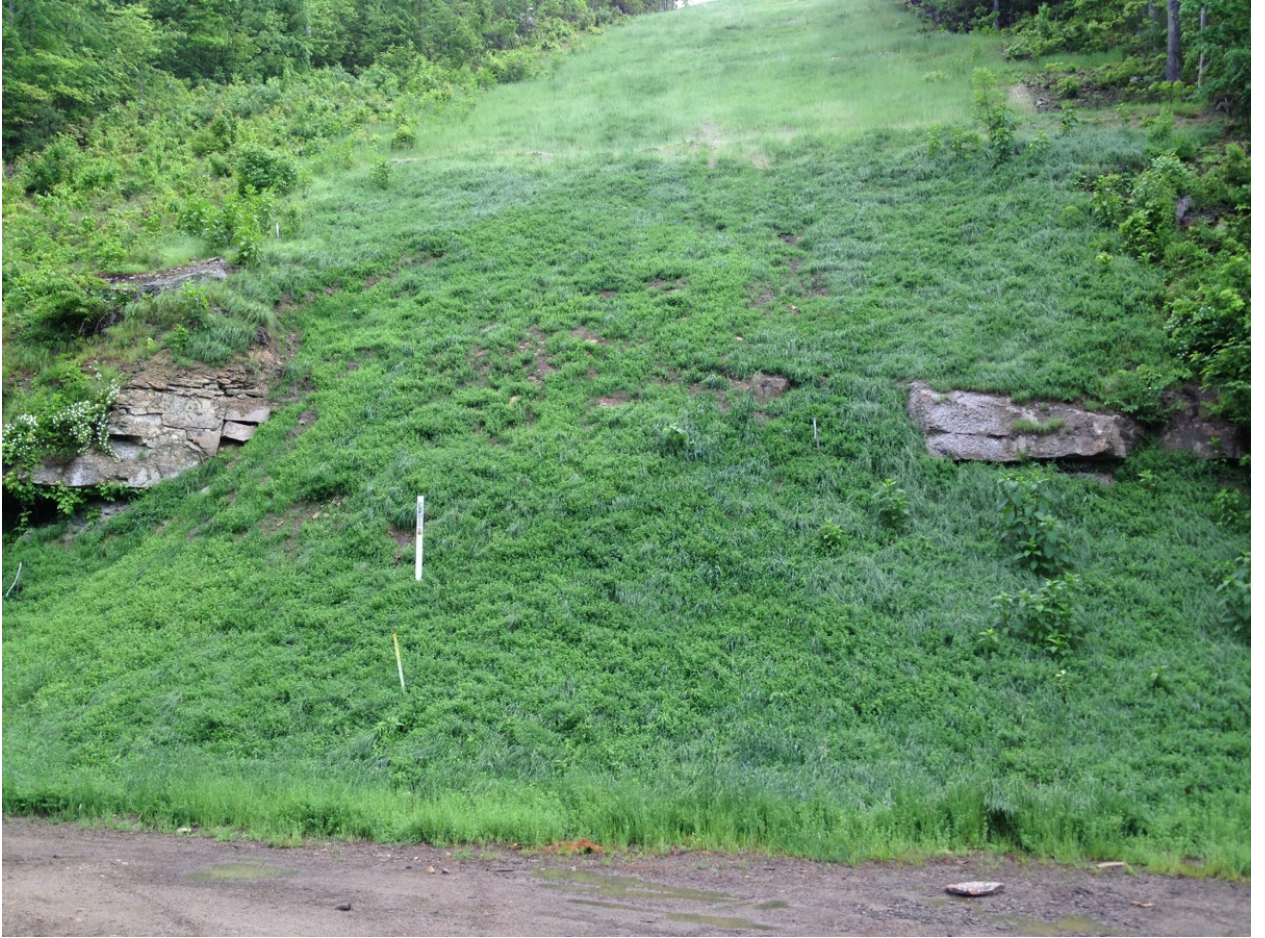
- Slope stability issues were observed due to improper installation of waterbars. Waterbars were reworked, seeded and mulched
- Full restoration was accomplished

Figure 15 - TL 570 Ext 1, Restored Right of Way, Ridge

Figure 16 - TL 570 Ext 1, Restored Right of Way, Steep Slope

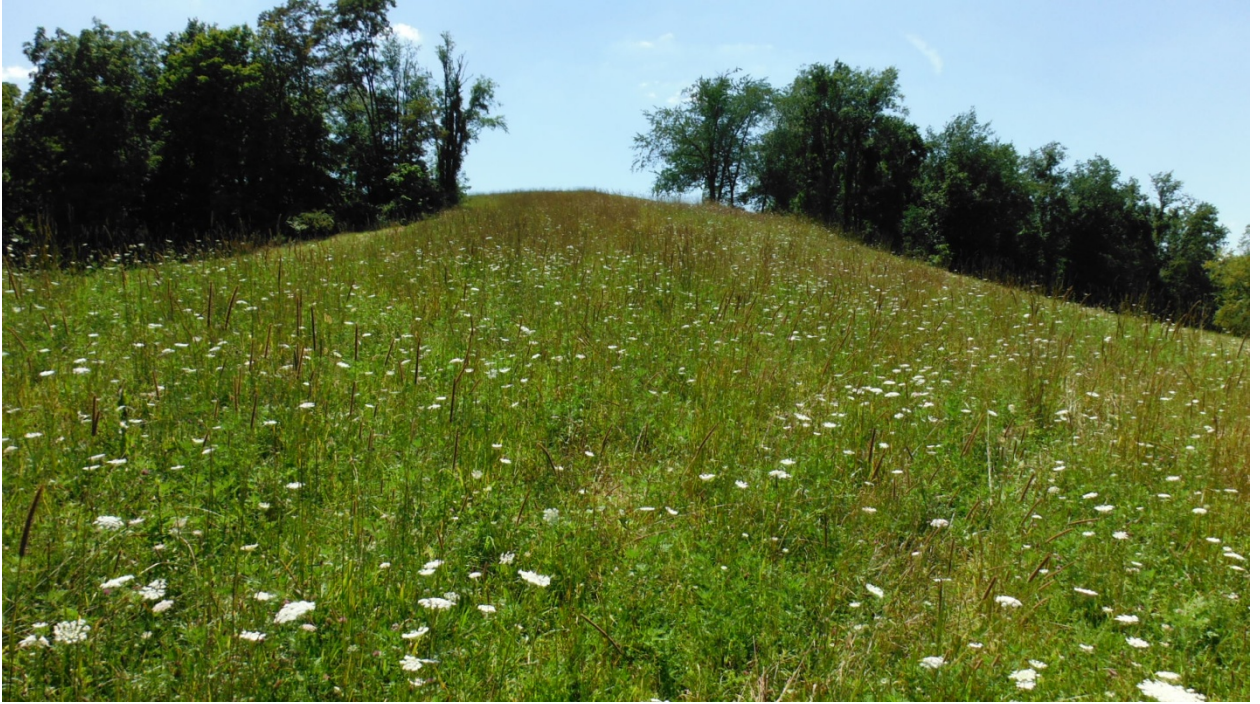
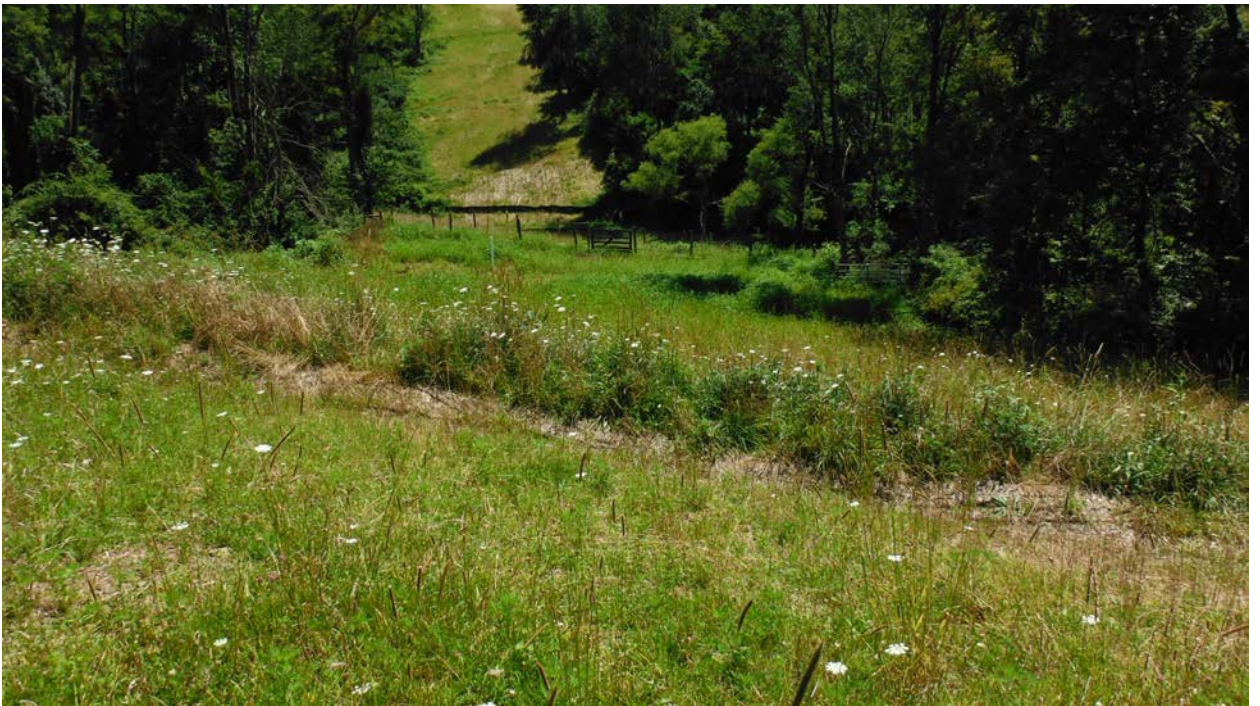
- Project has experienced slope stability issues throughout the alignment. Reasons for slope stability issues have been attributed to water control and non-optimal location of pipeline due to non-jurisdictional status. Many incremental controls were installed to stabilize slopes including soil nails, retaining walls, peanut pipe, under drains and calcinate soil enhancers.

Figure 18 - G 150, Restored Right of Way

Figure 19 - G 150, Restored Right of Way, Steep Slope

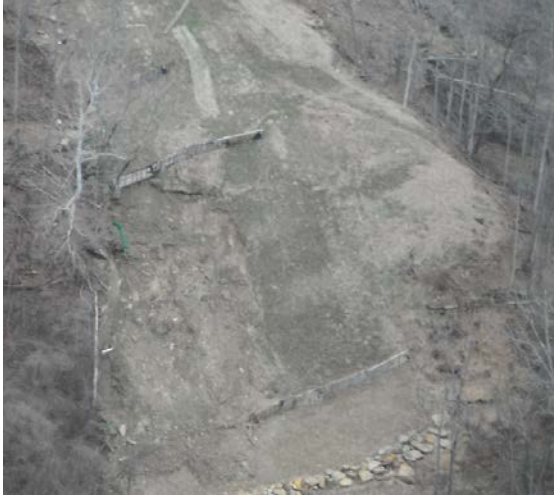
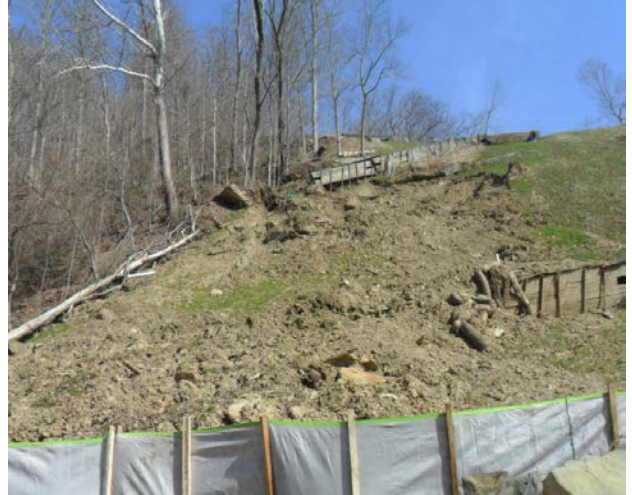
Mass soil movements occurred on the slope shown below. Retaining walls installed in a terraced fashion were utilized to hold soils in place to become successfully vegetated and stable. The walls failed after a large snow melt/rain event in March. The soil movement was approximately 95 ft wide by 160 ft long.

The pipeline was continuously being monitored post-construction by environmental inspectors. This mass movement was identified very early and temporary measures were installed as precautionary measures to protect sensitive resources nearby. Based on knowledge gained from construction and post construction restoration, it was noted that rock outcrops were present and the soil was not bonding to the shale and siltstone layer below. It was evident that the slope failures occurred due to very steep slopes (80-90%), construction activities and weather conditions, and surface and subsurface water.

Soil movement following event – Aerial view

Soil movement following event – looking upslope

When working on these types of slopes, it is critical to control surface and subsurface water, monitor the conditions of the soil when replacing it, and take note of the stratum below to ensure the soil has a layer to bond and will remain in place.

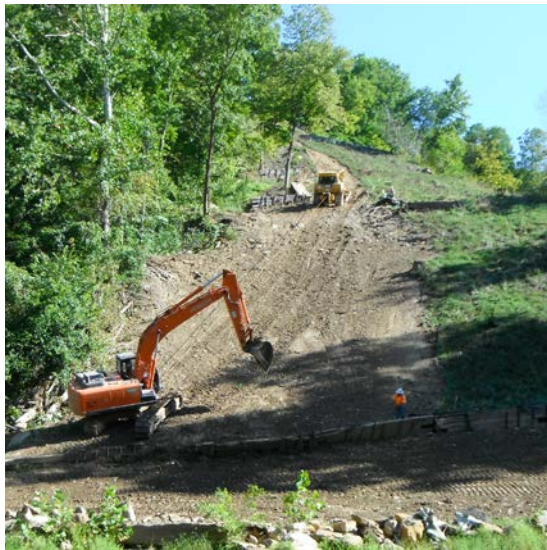
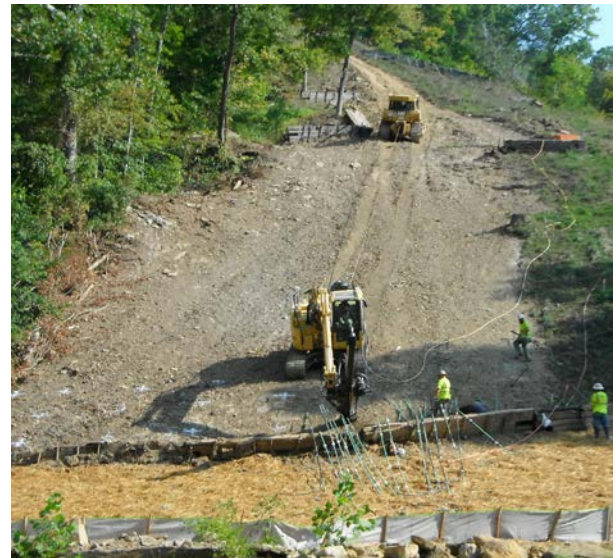
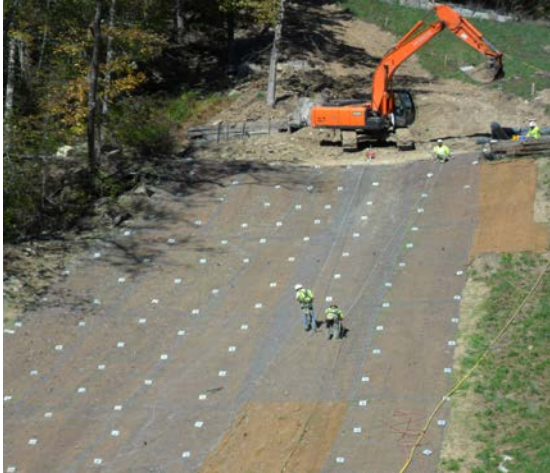
A plan for necessary repairs was developed and implementation began when the weather permitted around August. The plan consisted of stabilizing and bonding the soils utilizing subsurface drains, coconut erosion control blanket and a series of soil nails. One key factor identified necessary to ensure successful implementation of the repairs was completing the work during favorable weather conditions.

Restoration operations – final grading

Restoration operations – Installation of soil nails

Restoration operations – Installation of soil nails with TECO mesh

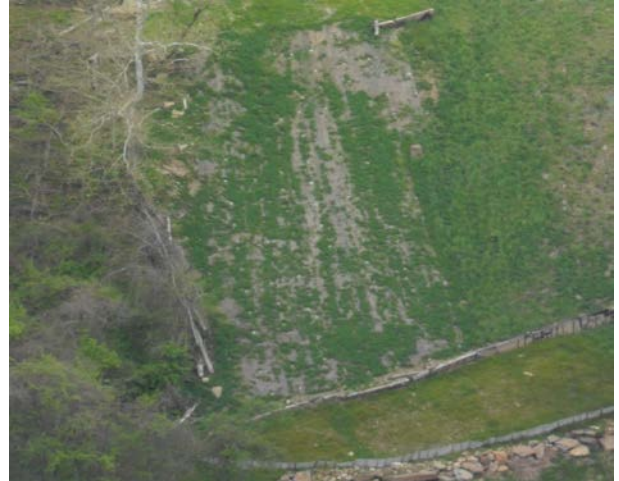
Restored ROW
