Project/Site: Atlantic Coast Pipeline	City/County: Augusta	County	Sampling Date: 8/18/2016			
Applicant/Owner: DOMINION		State: VA	Sampling Point: wauz013s_w			
	Section, Township, Ra					
Landform (hillslope, terrace, etc.): Floodplain						
Subregion (LRR or MLRA): S						
Soil Map Unit Name: Fluvaquents, nearly level	- ' '	NWI classific	ation: PSS			
Are climatic / hydrologic conditions on the site typ	ical for this time of year? Yes No _	(If no, explain in R	emarks.)			
Are Vegetation, Soil, or Hydrology	v significantly disturbed? Are	"Normal Circumstances" p	oresent? Yes No			
Are Vegetation, Soil, or Hydrolog						
SUMMARY OF FINDINGS – Attach s						
Hydrophytic Vegetation Present? Yes _	V No In the Sample					
	No lis the Samplet					
	No within a Wetla	nd? Yes	No			
Remarks:						
HYDROLOGY						
Wetland Hydrology Indicators:		Secondary Indica	tors (minimum of two required)			
Primary Indicators (minimum of one is required;	check all that apply)	Secondary midica Surface Soil

Wetland data point wauz013s_w

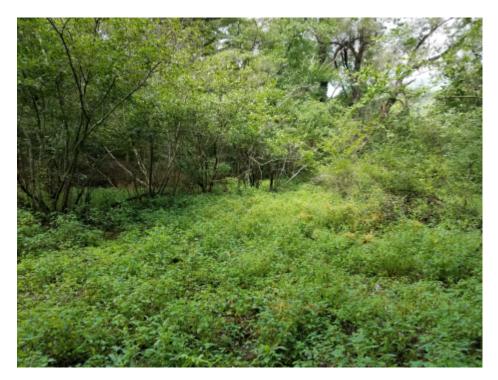
Redox (S5)		Piedmont Flo					wetland hydrology must be present,
-	d Matrix (S6)		Red Parent N					unless disturbed or problematic.
	Layer (if observed):		<u> </u>		, ,		<u></u>	'
Type:								
	ches):						Hydric So	oil Present? Yes <u>'</u> No
Remarks:							· L

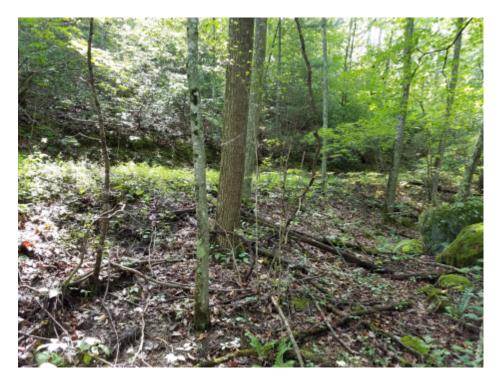
Upland data point wauz013_u

Redox (S5)		Piedmont Floodplain Soils (F19) (MLI		wetland hydrology must be present,
-	d Matrix (S6)		Red Parent Material (F21) (MLRA 12)		unless disturbed or problematic.
	Layer (if observed)	:		i	·
Туре:	,				
			_	I localada	Sail Brasanto Van Na V
	nches):		_	пуапс	Soil Present? Yes No
emarks:

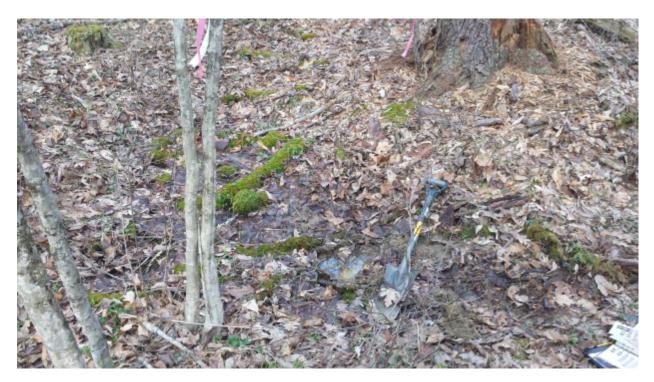
Photo 1 Wetland data point waua408f_w facing west

Type: R	ock							
Type	8							
Depth (in	ches): <u></u>						Hydric So	il Present? Yes No
Remarks:								
lydric soil pr	esent

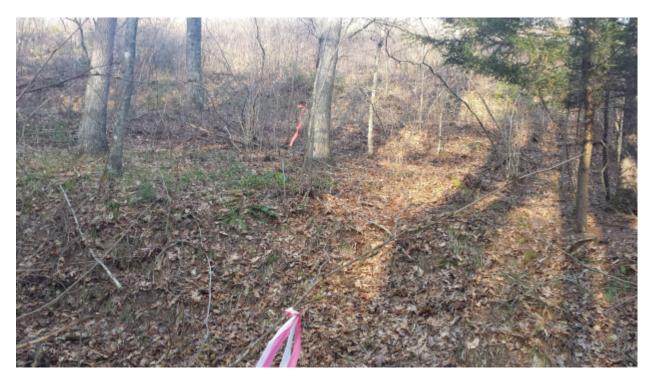
Photo 1 Upland data point waua408_u facing north

-	d Matrix (S6)		Red Parent N					unless disturbed or problematic.
	Layer (if observed):	<u> </u>			_ · / (,	′	annos antansos en prosicination
Type:		-						
	l \						l livelais of	Sail Brasanto Van Na V
	nches):						Hyaric S	Soil Present? Yes No
Remarks:								
lo hydric soi	il present

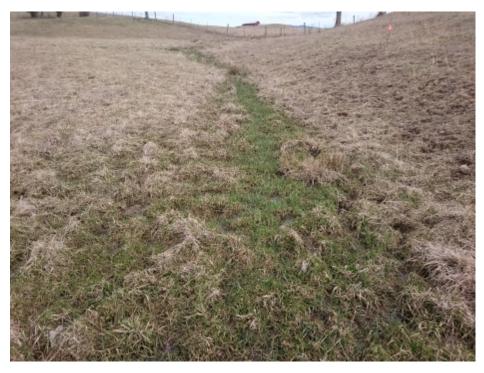
Photo 1
Wetland data point WAUC112e_w facing northeast

Stripped	l Matrix (S6)		Red Parent M	1aterial (F	21) (MLR	A 127, 147	7) u	nless disturbed or problematic.
Restrictive	Layer (if observed):							
Type:								
Depth (in	ches):						Hydric So	il Present? Yes No
Remarks:								
Hydric soil inc	dicators present

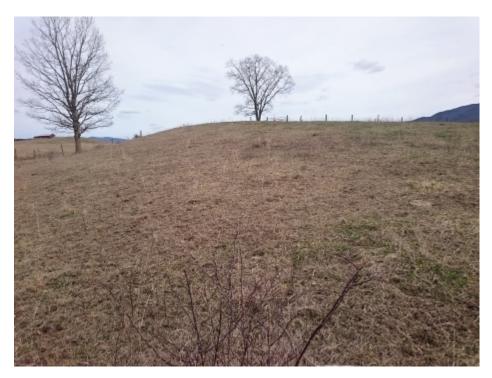
Photo 1 Upland data point WAUC112_u facing east

Redox (S5)	-			(F19) (MLRA 1 4	18)	wetland hydrology must be present,
-	d Matrix (S6)	•			(MLRA 127, 147		unless disturbed or problematic.
	Layer (if observed):			, ,	· · · · · · · · · · · · · · · · · · ·		·
Type:							
	ches):		_			Hvdr	ric Soil Present? Yes No
Remarks:			=			, .	
No hydric soi	l present						
ito ilyano oo	, procent

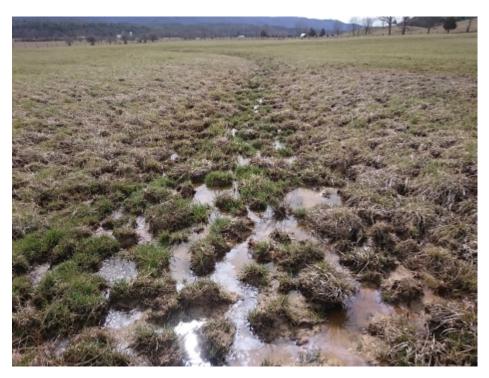
Photo 1
Wetland data point WAUC113e_w facing southwest

Redox (S5)		Piedmont Flo	odplain S	oils (F19)	(MLRA 14	18)	wetland hydro	plogy must be present,
-	d Matrix (S6)		Red Parent N					-	ed or problematic.
Restrictive	Layer (if observed):								
Type:									
	nches):						Hyd	ric Soil Present?	Yes No
							yu	THE CONTINUESCINE.	100
Remarks:									
Hydric soil p	resent

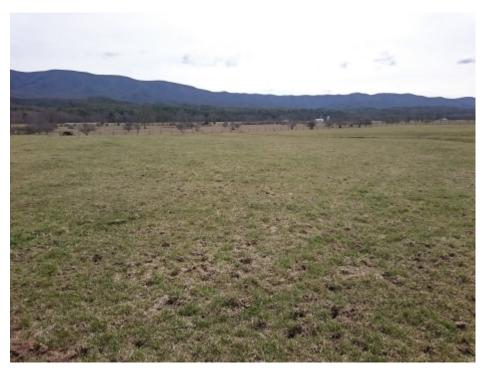
Photo 1
Upland data point WAUC113_u facing south

Redox (S5)		Piedmont Flo				10\	wetland hydrology must be present,
	d Matrix (S6)		Red Parent N					
	Layer (if observed):		Red Falentin	nateriai (F	ZI) (WILK	A 121, 141	')	unless disturbed or problematic.
	Layer (ii observed).							
Type:			_					
Depth (ir	nches):		_				Hydric	Soil Present? Yes No
Remarks:								
lo hydric soi	I present

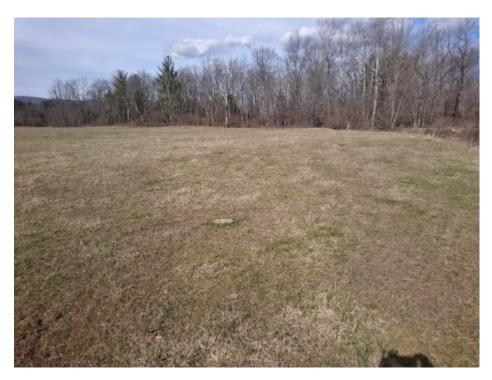
Photo 1
Upland data point WAUC115_u facing northeast

Sandy Mucky Mineral (S1) (LRR N,
MLRA 147, 148) Sandy Gleyed Matrix (S4) Sandy Redox (S5) Stripped Matrix (S6) Red Parent Material (F21) (MLRA 127, 147) Strippe: Depth (inches): Semarks: MLRA 136) Umbric Surface (F13) (MLRA 136, 122) MLRA 148) Wetland hydrology must be present, wetland hydrology must be present, unless disturbed or problematic. Hydric Soil Present? Yes No
Sandy Gleyed Matrix (S4)
Sandy Redox (S5)
Stripped Matrix (S6) Red Parent Material (F21) (MLRA 127, 147) unless disturbed or problematic. Restrictive Layer (if observed): Type: Depth (inches): Hydric Soil Present? Yes No ✓ Remarks:
Restrictive Layer (if observed): Type: Depth (inches): Remarks: Hydric Soil Present? Yes No
Type: Depth (inches):
Depth (inches): No Remarks:
Depth (inches): No Remarks:
Remarks:
No hydric soil present
l.

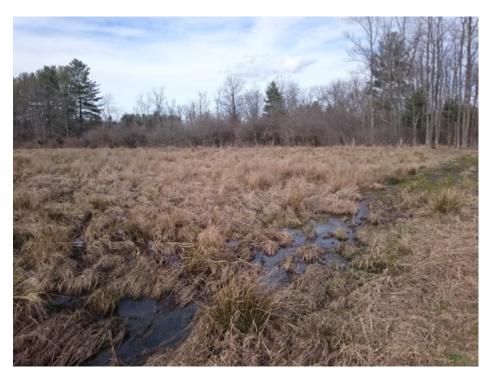
Photo 1
Wetland data point WAUC114e_w facing northeast

Layer (if observed):		Red r arent n	nateriai (i	Z1) (WILK	A 121, 141	, u	mess disturbed of problematic.
	Layer (ii observed).							
Type:								
Depth (ir	nches):						Hydric So	il Present? Yes No
Remarks:								
lydric soil in	dicators present

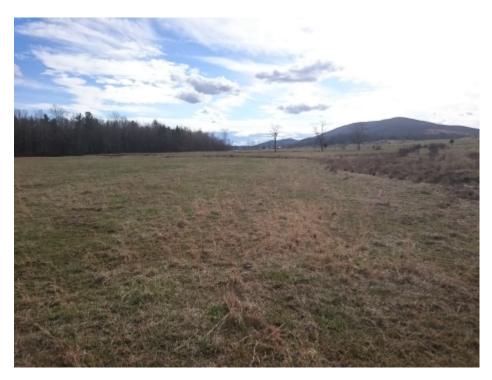
Photo 1
Upland data point wauc114_u facing southwest

ledox (S5)		Piedmont Flo					wetland hydrology must be present,
	Matrix (S6)		Red Parent N					unless disturbed or problematic.
	_ayer (if observed):				, (,	,	, , , , , , , , , , , , , , , , , , ,
Type:	, ,							
	ches):		_				Hydric Sc	oil Present? Yes No 🗸
Remarks:							Tiyano oc	711 1030Ht. 103 NO
No hydric soil	procent							
No flydric Soil	present

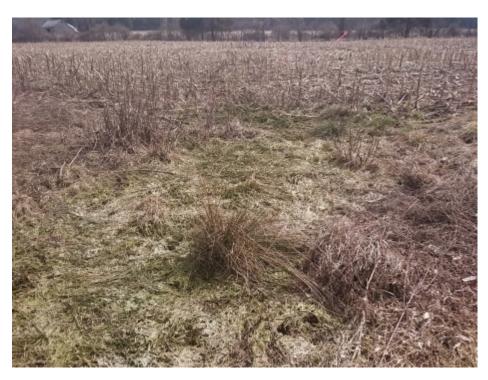
Photo 1
Wetland data point WAUC110e_w facing south

edox (S5)		Piedmont Flo					etland hydrology must be present,
	Matrix (S6)		Red Parent M					nless disturbed or problematic.
	ayer (if observed):		Neu Faieiii iv	iateriai (F2	21) (WILK	A 127, 147) ui	iless disturbed of problematic.
	ayer (ii observeu).							
Type:								
Depth (inc	ches):						Hydric Soi	I Present? Yes No
Remarks:								
Hydric soil ind	icators present

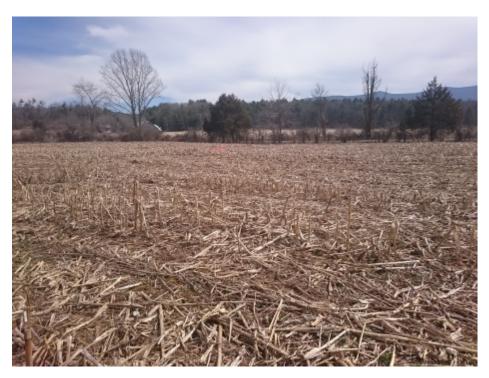
Photo 1 Upland data point WAUC110_u facing southeast

_ayer (if observed):				, (,	<u>, </u>			
Type:	, ,									
	ches):		_				Hydric S	oil Present?	Yes	No 🗸
	Jiles)		=				Tiyunc 30	on riesent:	163	NO
Remarks:	nrocent									
No hydric soil	present

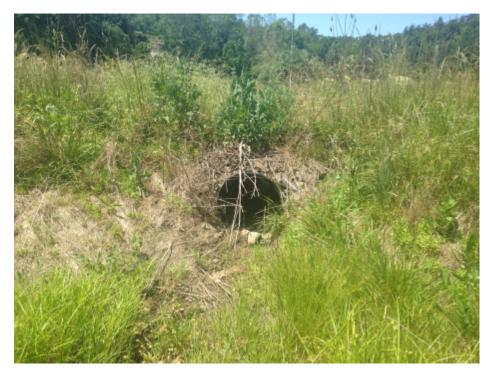
Wetland data point WAUZ009e_w facing southwest, culvert
