WETLAND DETERMINATION DATA FORM – Eastern Mountains and Piedmont Region

Project/Site: SE Reliability Project City/County: NA/Cumberland Sampling Date: 08/5/2014
 Applicant/Owner: Dominion Transmission State: VA Sampling Point: WCUK013 F-W
 Investigator(s): W. Medina, J. Dean Section, Township, Range: NA
 Landform (hillslope, terrace, etc.): bottomland Local relief (concave, convex, none): concave Slope (%): 1-2
 Subregion (LRR or MLRA): LRR P Lat: 37.344115109 Long: -78.343061369 Datum: NAD 1983
 Soil Map Unit Name: Chenopoda and Monacan soils 0 to 2% slopes freq. flooded NWI classification: PFO1C
 Are climatic / hydrologic conditions on the site typical for this time of year? Yes No (If no, explain in Remarks.)
 Are Vegetation Soil or Hydrology significantly disturbed? Are "Normal Circumstances" present? Yes No
 Are Vegetation Soil or Hydrology naturally problematic? (If needed, explain any answers in Remarks.)

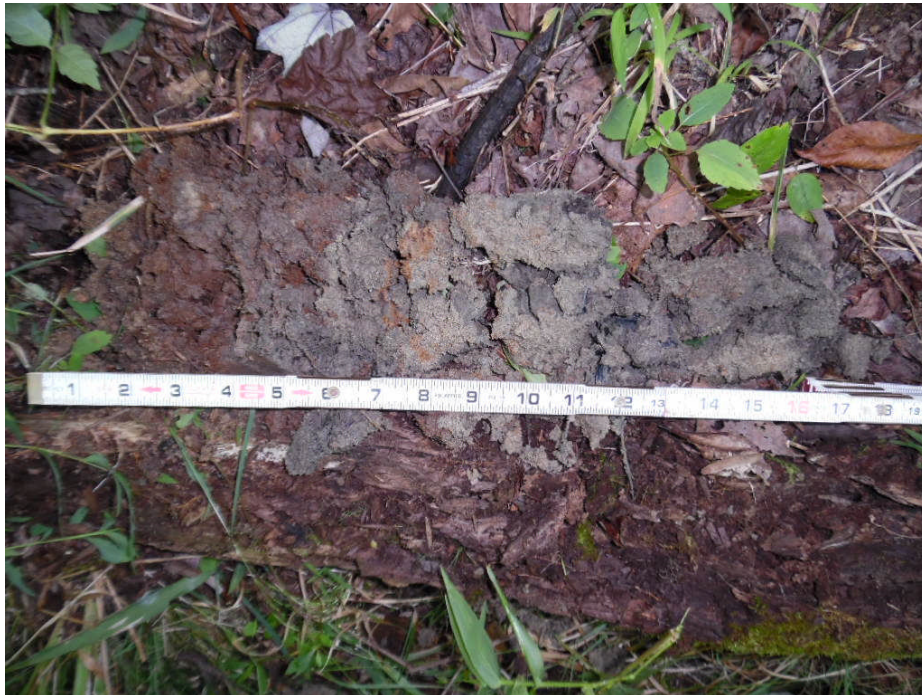
Wetland data point wcuk018e_w soil sample

Depth (inches)	Matrix		Redox Features				Texture	Remarks
	Color (moist)	%	Color (moist)	%	Type ¹	Loc ²		
0-4	10YR 4/1	60	7.5YR 4/6	30	C	PL	FINE SANDY LOAM	
			2.5Y 6/2	10	D	M	COARSE SAND	
4-18	2.5Y 4/1	50	-	-	-	-	FINE SANDY LOAM	} STRATIFIED LAYERS
	2.5Y 6/2	40	7.5YR 4/6	10	C	M	COARSE LOAMY SAND

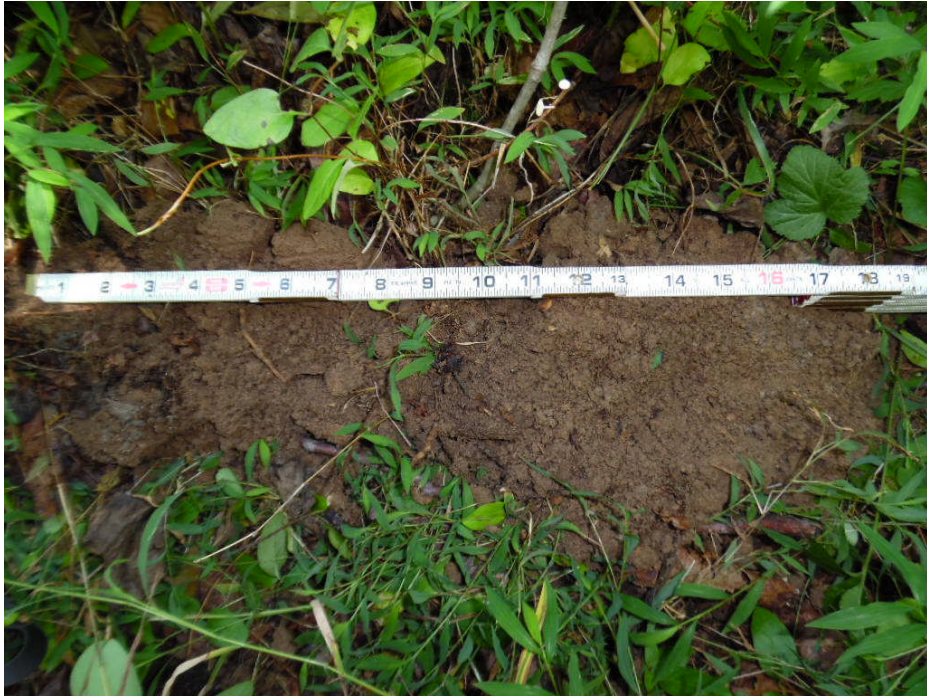
Upland data point wcuk018_u soil sample

Depth (inches)	Matrix		Redox Features				Texture	Remarks
	Color (moist)	%	Color (moist)	%	Type ¹	Loc ²		
0-11	7.5Y 4/3	100	—	—	—	—	Sandy loam	
11-18	7.5Y 4/3	99	10YR 5/1	1	D	M	Sandy loam

Remarks:
 NO INDICATORS OF WETLAND SOILS OBSERVED

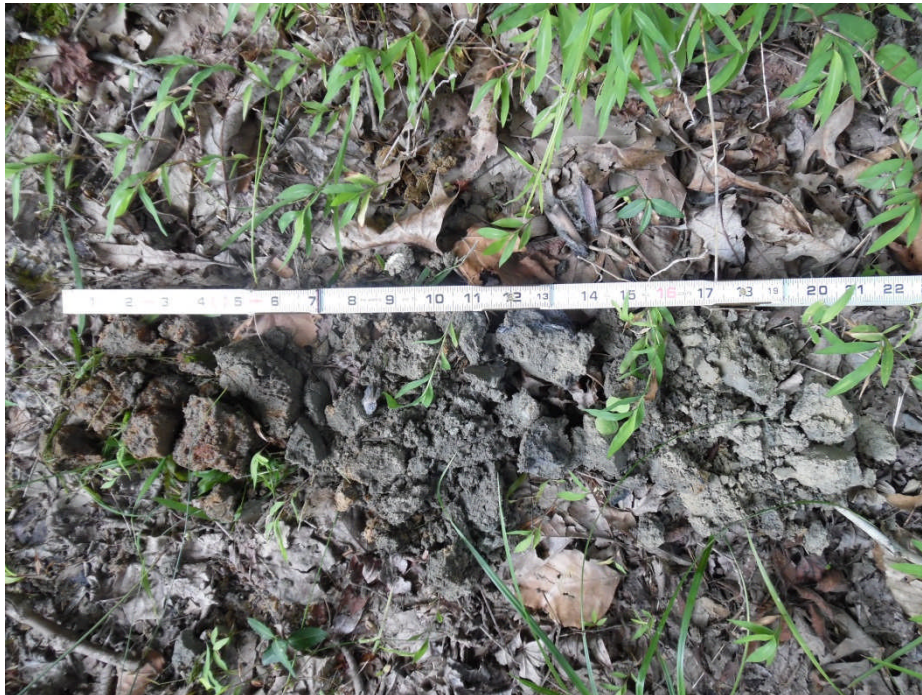
Wetland data point wcuk013f_w soil sample

Depth (inches)	Matrix		Redox Features				Texture	Remarks
	Color (moist)	%	Color (moist)	%	Type ¹	Loc ²		
0-7	10YR 4/1	70	7.5YR 5/8	15	C	PL	Sandy clay loam	
			5YR 4/6	15	C	PL		
7-16	10YR 4/1	60	-	-	-	-	Sandy clay loam	Mixed Matrix
	10YR 6/1	40	-	-	-	-		
16-20	10YR 6/3	50	-	-	-	-	sandy clay loam	Mixed Matrix
	10YR 5/2	50	-	-	-	-

Hydric soils criteria is met.

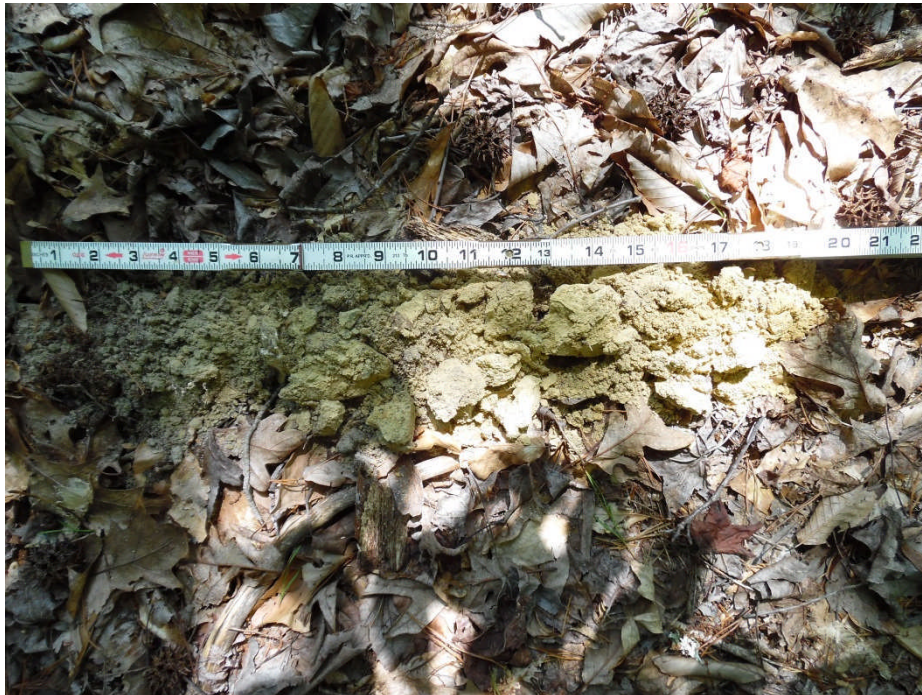
Upland data point wcuk013_u soil sample

Depth (inches)	Matrix		Redox Features				Texture	Remarks
	Color (moist)	%	Color (moist)	%	Type ¹	Loc ²		
0-5	10YR 6/3	100	---	---	---	---	Fine sandy loam	Some organic duff
5-16	10YR 7/6	90	10YR 5/8	10	C	M	FSL	
16-20	10YR 7/6	80	10YR 5/8	20	C	M	Fine sandy loam

Remarks: Hydric soils criteria is not met.

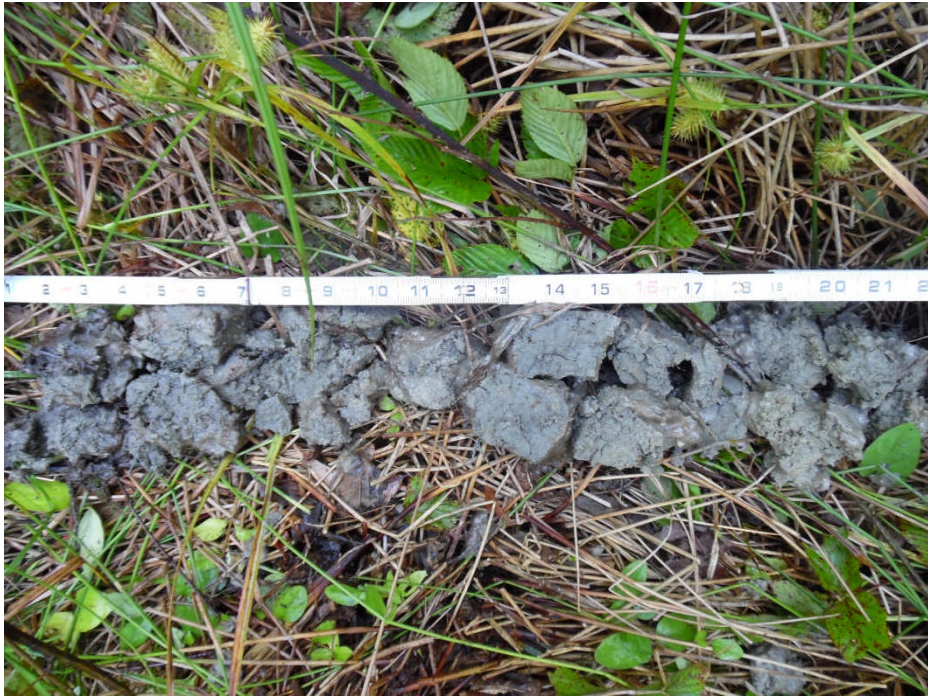
Wetland data point wcuk012s_w soil sample

Depth (inches)	Matrix		Redox Features				Texture	Remarks
	Color (moist)	%	Color (moist)	%	Type ¹	Loc ²		
0-1	10YR 2/2	100	-	-	-	-	Muck	
1-12	10YR 5/1	100	-	-	-	-	sandy loam	
12-20	10YR 5/1	95	10YR 6/6	5	C	M	clay	dense layer

Remarks: Hydric soils criteria met. At 12" of depth, a dense clay aquitard was encountered. This layer was not totally impermeable, but nonetheless is perching water.

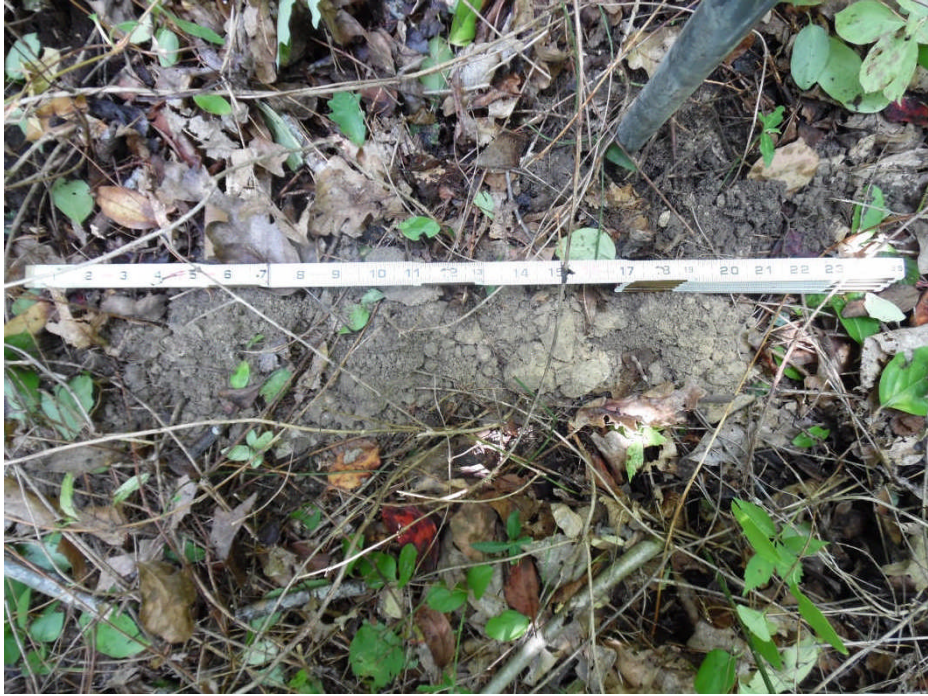
Upland data point wcuk012_u soil sample

Depth (inches)	Matrix		Redox Features				Texture	Remarks
	Color (moist)	%	Color (moist)	%	Type ¹	Loc ²		
0-11	10YR 4/3	100	---	-	-	-	sandy loam	some gravel
11-20	10YR 7/6	95	10YR 5/8	5	C	M	sandy clay loam	gravel

Remarks: Hydric soils criteria is not met.

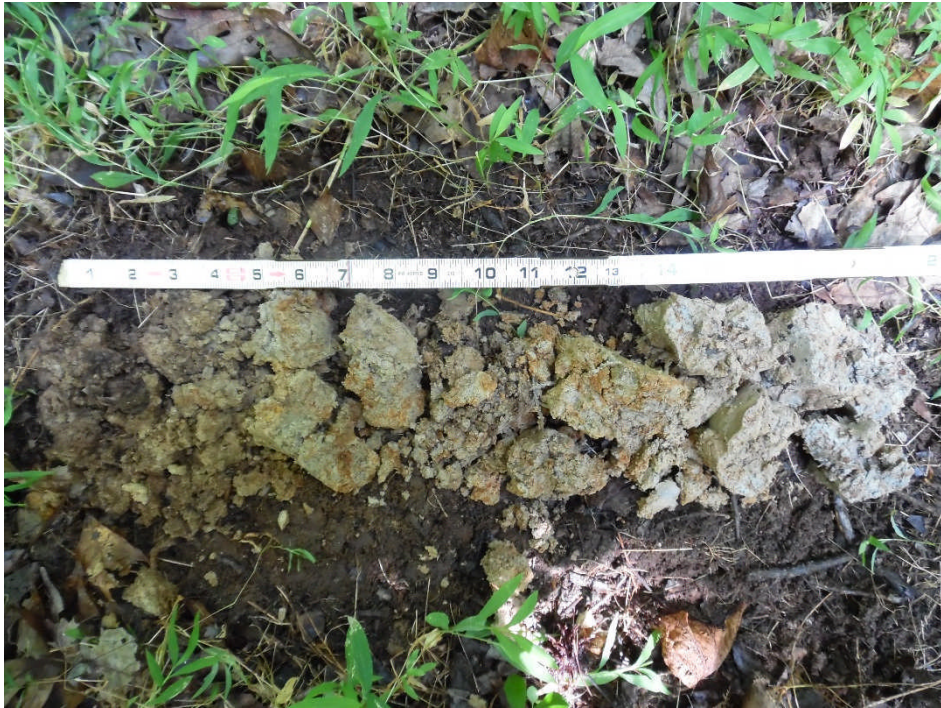
Wetland data point wcuk011f_w soil sample

Depth (inches)	Matrix		Redox Features				Texture	Remarks
	Color (moist)	%	Color (moist)	%	Type ¹	Loc ²		
0-4	10YR 4/3	85	7.5YR 5/8	15	C	M/PL	Sandy loam	Some organic content
4-15	10YR 5/1	70	5YR 4/6	30	C	PL	Sandy loam	
15-20	10YR 6/1	80	5YR 4/6	20	C	PL	Sandy clay loam	oxidized root channels

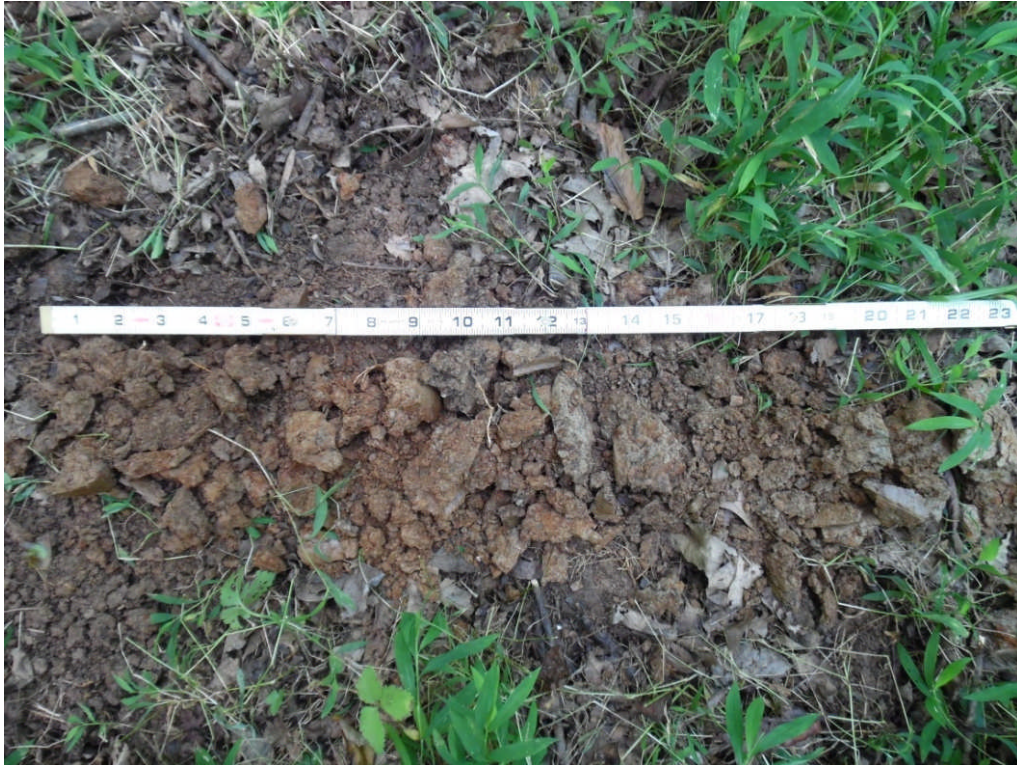
Wetland data point wcuk008f_w soil sample

Depth (inches)	Matrix		Redox Features				Texture	Remarks
	Color (moist)	%	Color (moist)	%	Type ¹	Loc ²		
0-6	7.5YR 4/3	80	5YR 4/6	20	C	PL	Clay loam	
6-18	7.5YR 5/2	70	5YR 5/8	15	C	PL	Clay loam	Mixed matrix
			5YR 4/6	15	C	PL		Mixed matrix
18-24	10YR 5/1	75	5YR 5/8	25	C	PL	Clay loam

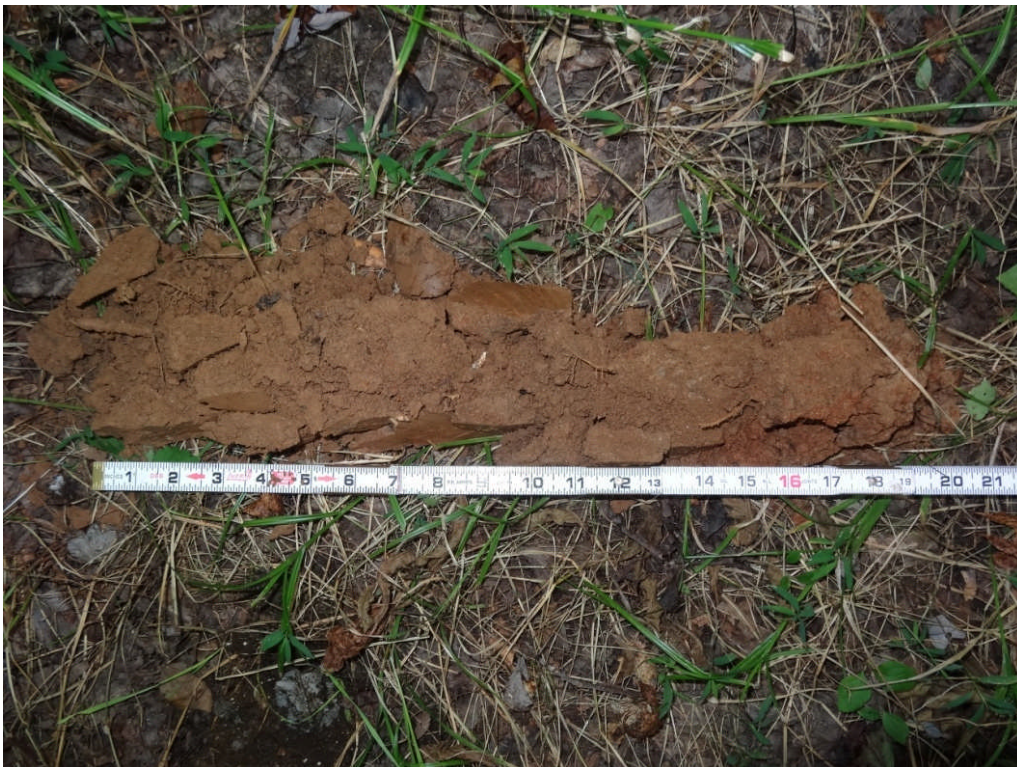
Upland data point wcuk008_u soil sample

Profile Description: (Describe to the depth needed to document the indicator or confirm the absence of indicators.)								
Depth (inches)	Matrix		Redox Features				Texture	Remarks
	Color (moist)	%	Color (moist)	%	Type ¹	Loc ²		
0-10	10YR 5/4	70	10YR 5/2	10	D	M	Silt Loam	NA
0-10	NA	NA	7.5YR 4/6	20	C	M	Silt Loam	NA
10-20	10YR 5/4	70	7.5YR 5/8	2	C	M	Silt Loam	Mottles
10-20	NA	NA	5YR 4/6	18	C	M	Silt Loam	Mottles

Remarks:
 No indicators of hydric soils observed due to high chroma matrix to 20".

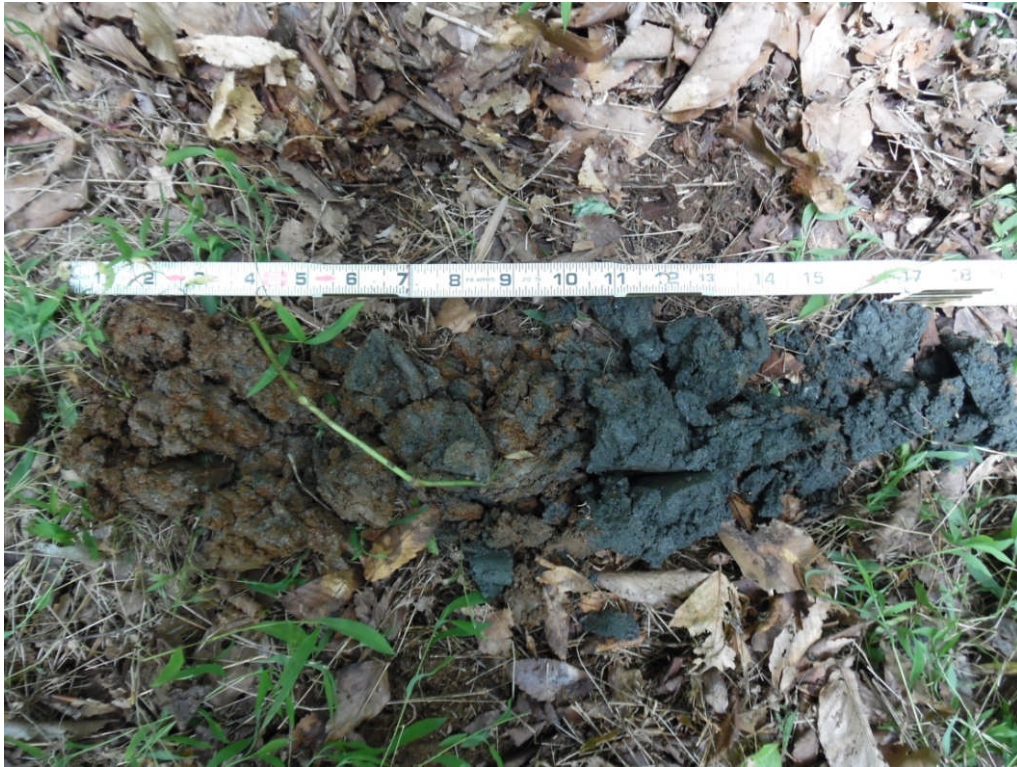
Wetland data point wcuk010e_w soil sample

Depth (inches)	Matrix		Redox Features				Texture	Remarks
	Color (moist)	%	Color (moist)	%	Type ¹	Loc ²		
0-6	10YR 4/1	65	5YR 4/6	35	C	PL	SCL	SCL - sandy clay loam; mica
6-10	10YR 4/1	85	5YR 4/6	15	C	PL	SCL	
10-20	2.5Y 3/1	100					SL	SL - sandy loam

Remarks: Hydric soils criteria is met. At 20 inches depth, a bedrock layer was encountered.

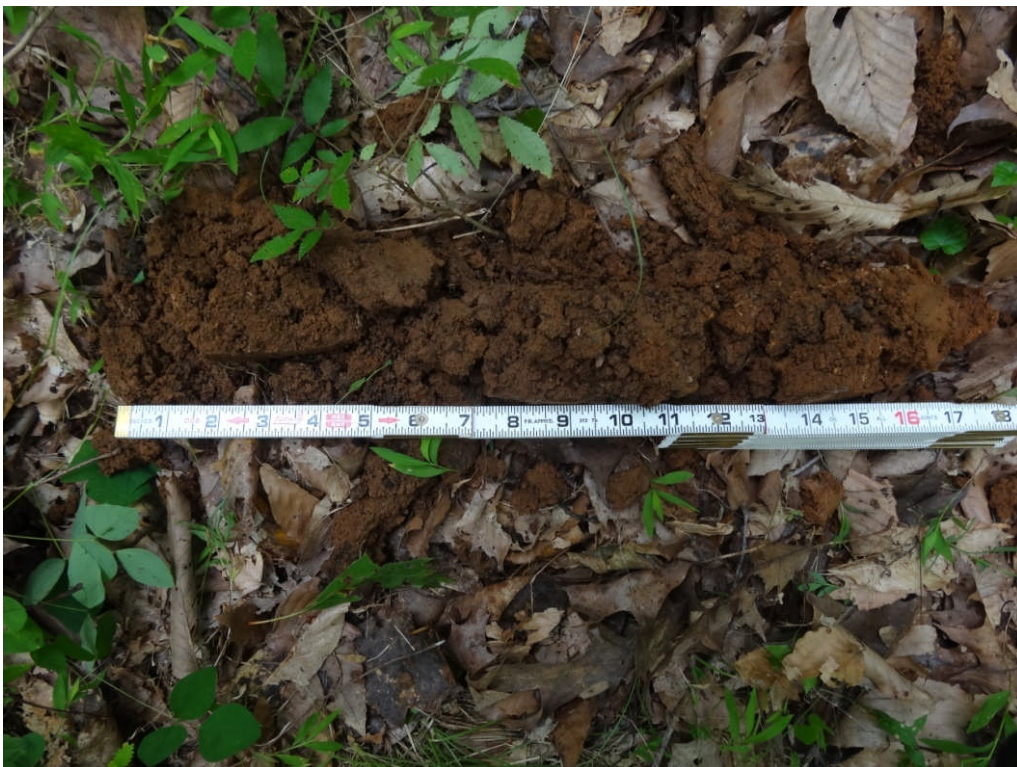
Upland data point wcuk010_u soil sample

Depth (inches)	Matrix		Redox Features				Texture	Remarks
	Color (moist)	%	Color (moist)	%	Type ¹	Loc ²		
0-14	7.5YR 3/4	100	NA	NA	NA	NA	sandy clay loam w/ gravel	
14-18	5YR 3/4	100	NA	NA	NA	NA	sandy clay loam w/ gravel

Remarks:
 No indicators of hydric soils observed due to high chroma matrix to 20".

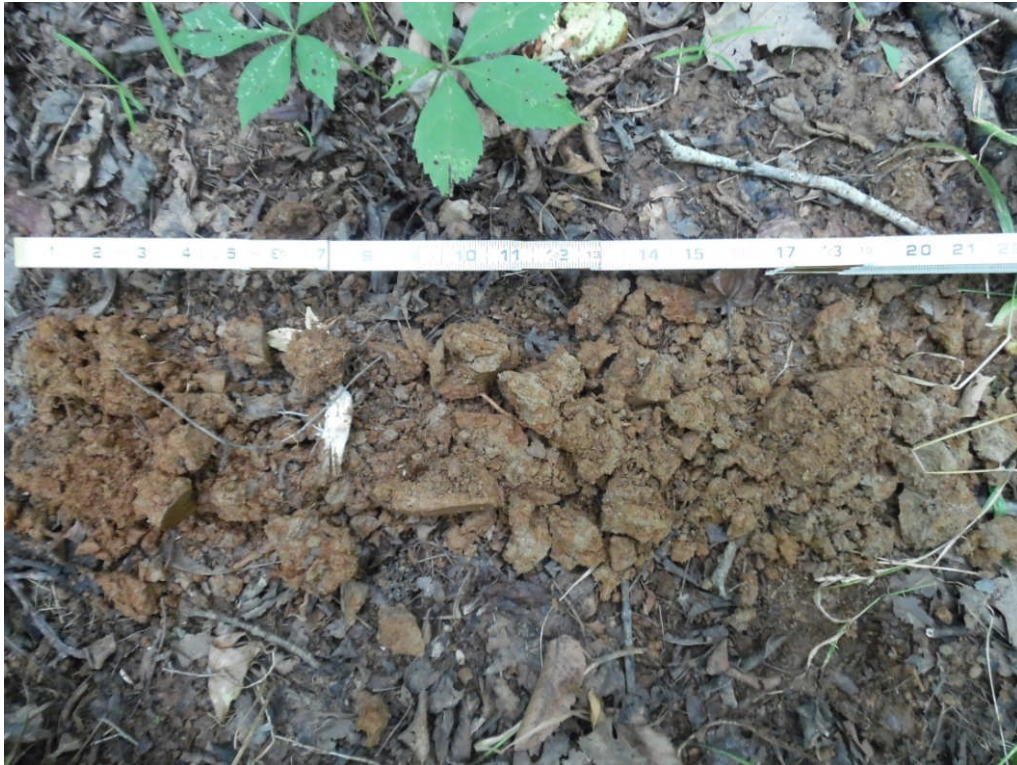
Wetland data point wcuk009f_w soil sample

Depth (inches)	Matrix		Redox Features				Texture	Remarks
	Color (moist)	%	Color (moist)	%	Type ¹	Loc ²		
0-12	10YR 4/2	60	7.5YR 4/6	40	C	PL	silty clay	
12-20	7.5YR 5/2	70	5YR 4/6	30	C	PL	silty clay

Remarks: Hydric soils criteria is met.

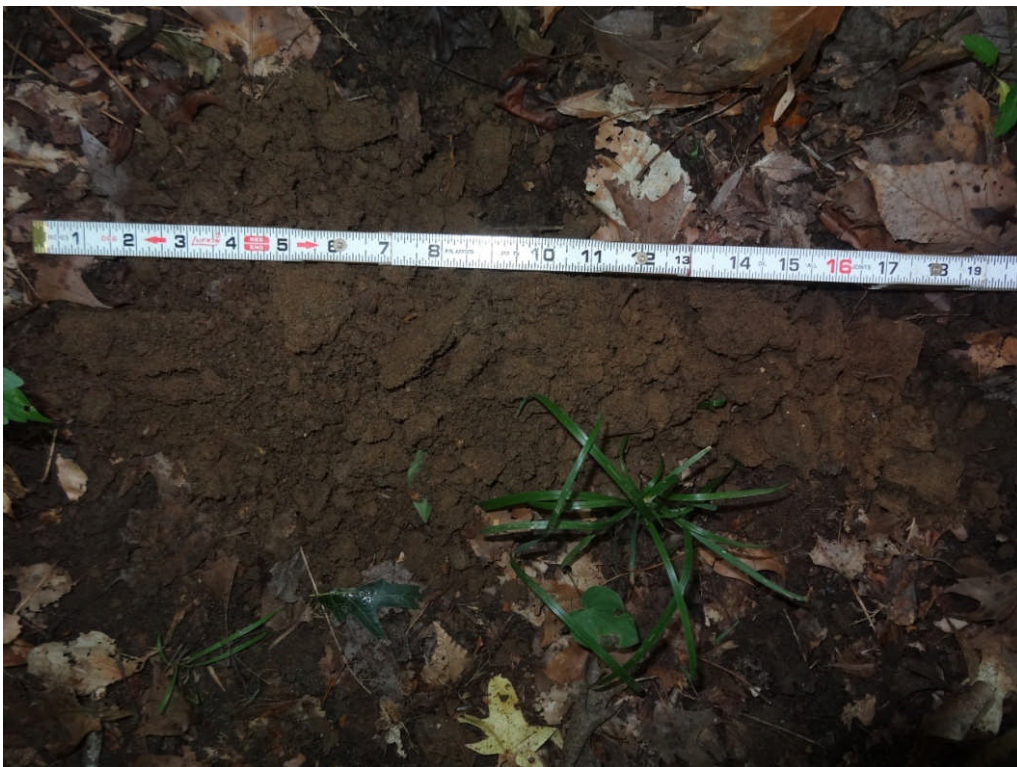
Upland data point wcuk009_u soil sample

Remarks:
 No indicators of hydric soils observed due to high chroma matrix to 20".

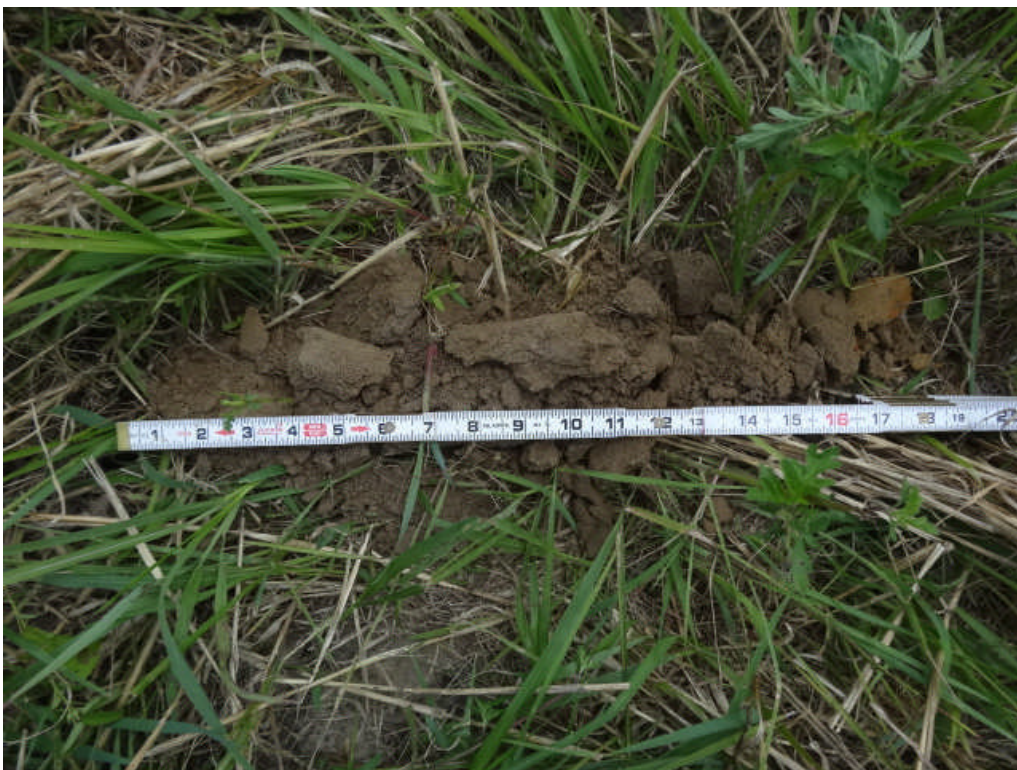
Upland data point wcuk007_u soil sample

Remarks:
 No indicators of hydric soils observed. Soils compacted and likely regularly cultivated.

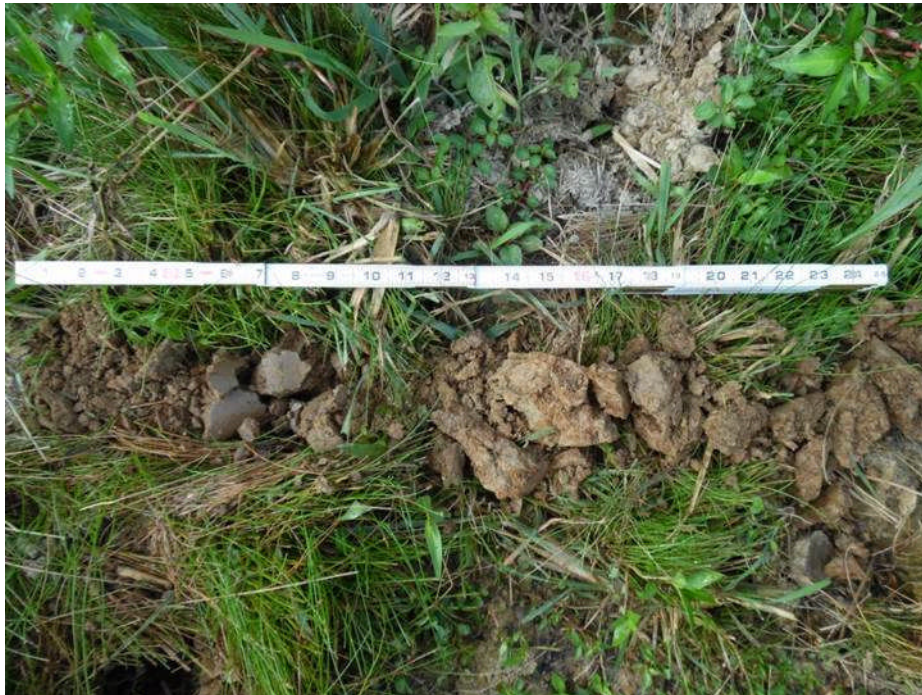
Wetland data point wcuk005e_w soil sample

Remarks: Hydric soils criteria is met. Very dense and compacted clay layer holds surface water.
