Linear Waterbody Data Sheet

Survey Description				
Project Name: Southeast Reliability		Waterbody Name: UNT to DRY CREEK		Waterbody ID: SCUK037
State: Virginia		County: Cumberland	Company: W&C	Crew Member Initials: JS, BG
Tract Number(s): 10-025		Nearest Milepost: 211		Associated Wetland ID(s): NA
Survey Type: <i>(check one)</i> <input checked="" type="checkbox"/> Centerline <input type="checkbox"/> Re-Route <input type="checkbox"/> Access Road <input type="checkbox"/> Other:				
Physical Attributes				
Stream Classification: <i>(check one)</i> <input checked="" type="checkbox"/> Ephemeral <input type="checkbox"/> Intermittent <input type="checkbox"/> Perennial				
Waterbody Type: <i>(check one)</i> <input type="checkbox"/> River <input checked="" type="checkbox"/> Stream <input type="checkbox"/> Ditch <input type="checkbox"/> Canal <input type="checkbox"/> Other:				
OHWM Width: <u>2</u> ft. Height: <u>0.5</u> ft. N/A <input type="checkbox"/>		OHWM Indicator: <i>(check all that apply)</i> <input checked="" type="checkbox"/> Clear line on bank <input type="checkbox"/> Shelving <input type="checkbox"/> Wrested vegetation <input type="checkbox"/> Scouring <input type="checkbox"/> Wa

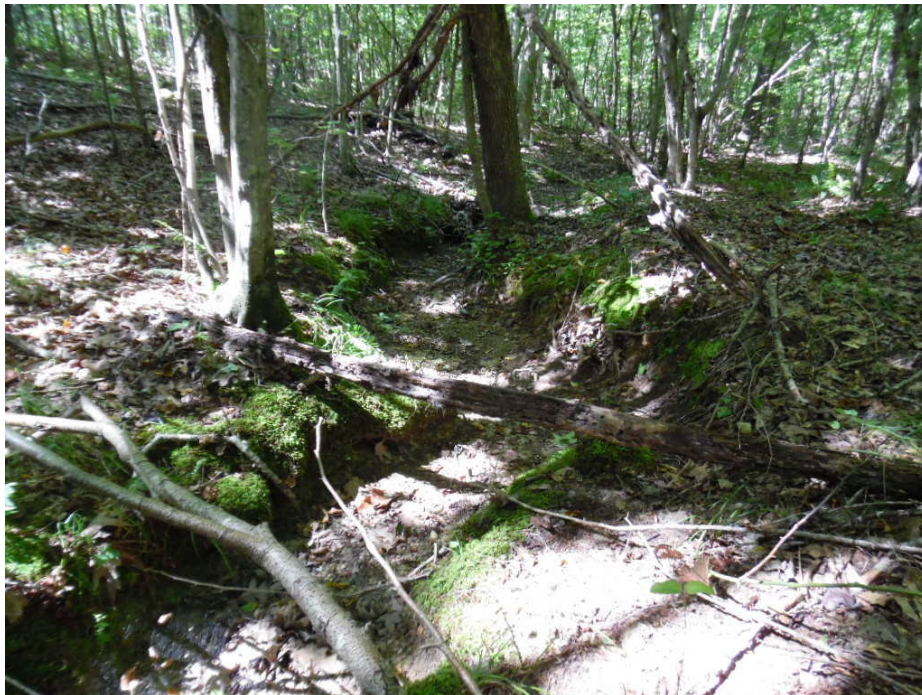
Waterbody point scuk037 facing South and upstream

DRY EPHEMERAL STREAM BED. LOW QUALITY DUE TO LACK OF AQUATIC HABITATS.

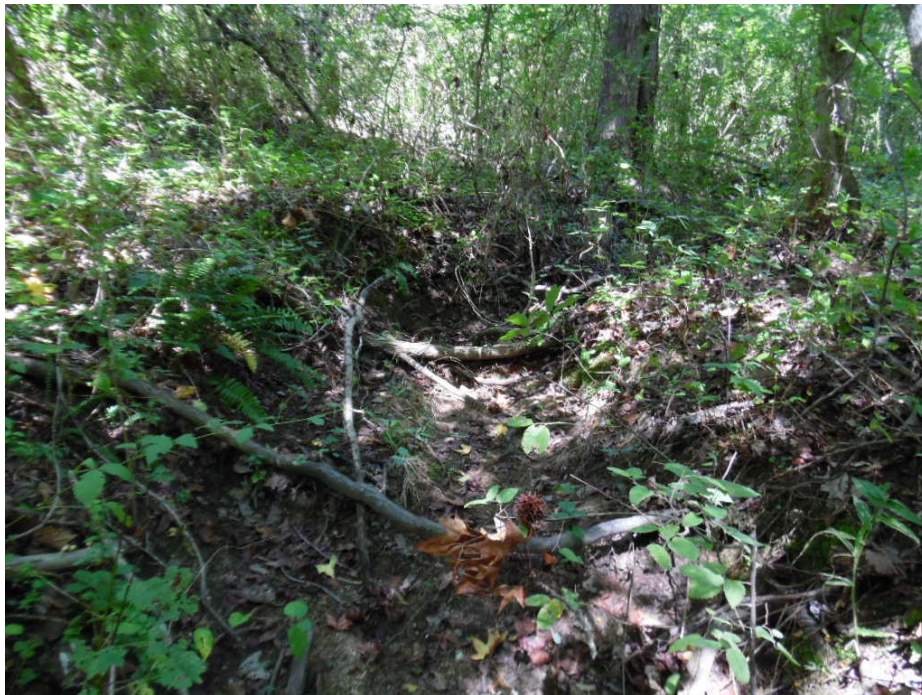
Waterbody point scuk039a facing North and upstream

EPHEMERAL REACH PORTION. LOTS OF GARBAGE IN CHANNEL AND ON BANKS (DUMP).

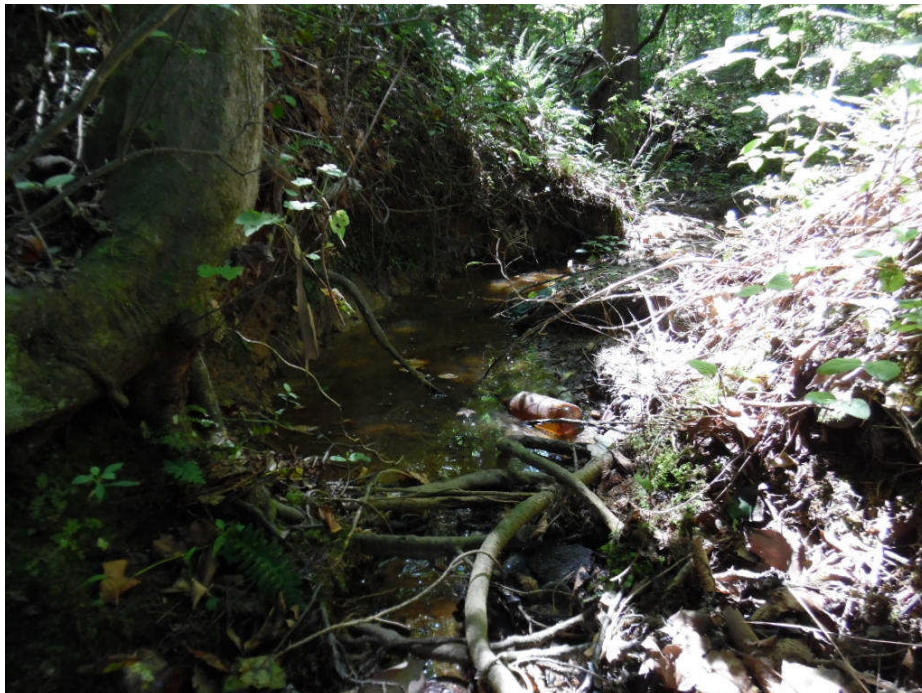
Waterbody point scuk039b facing North and upstream

INTERMITTENT REACH PORTION. LOTS OF GARBAGE IN CHANNEL AND ON BANKS (DUMP). NO FLOW. POOLS PRESENT.

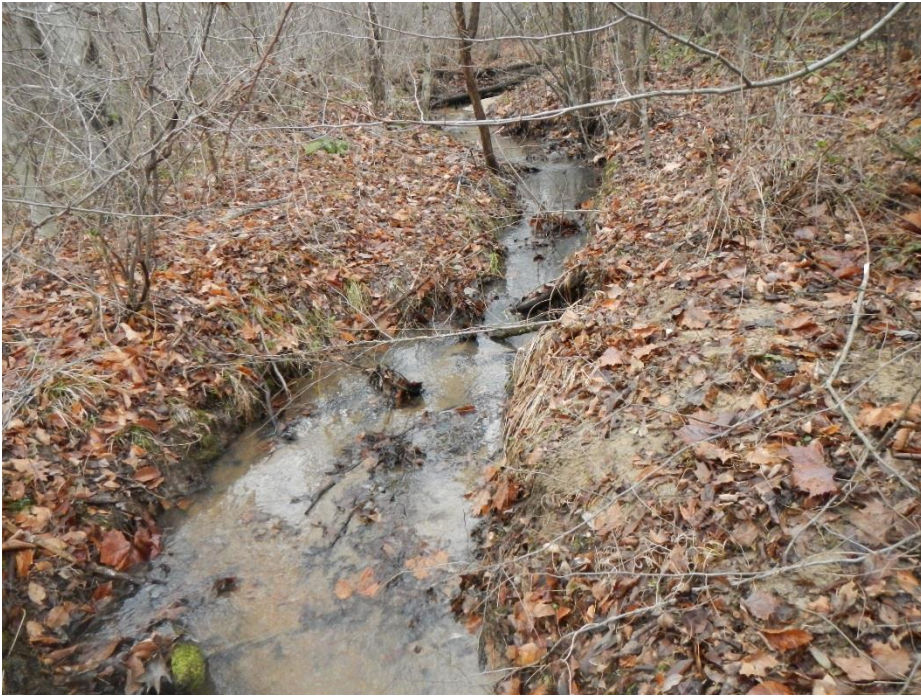
Waterbody SCUC004 facing upstream

Recent sediment deposits are found with the stream and both banks are down cut

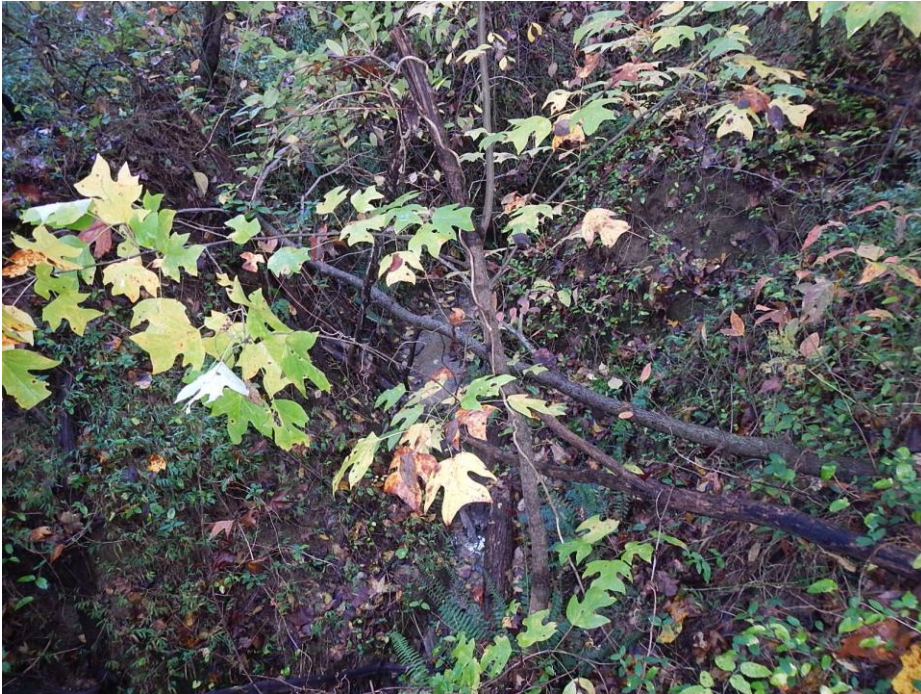
Waterbody SCUA001 facing north upstream

Begins as a deep headcut at centerline, downstream continues out; located in a finger of mixed hardwoods between hayfields, deeply incised channel.

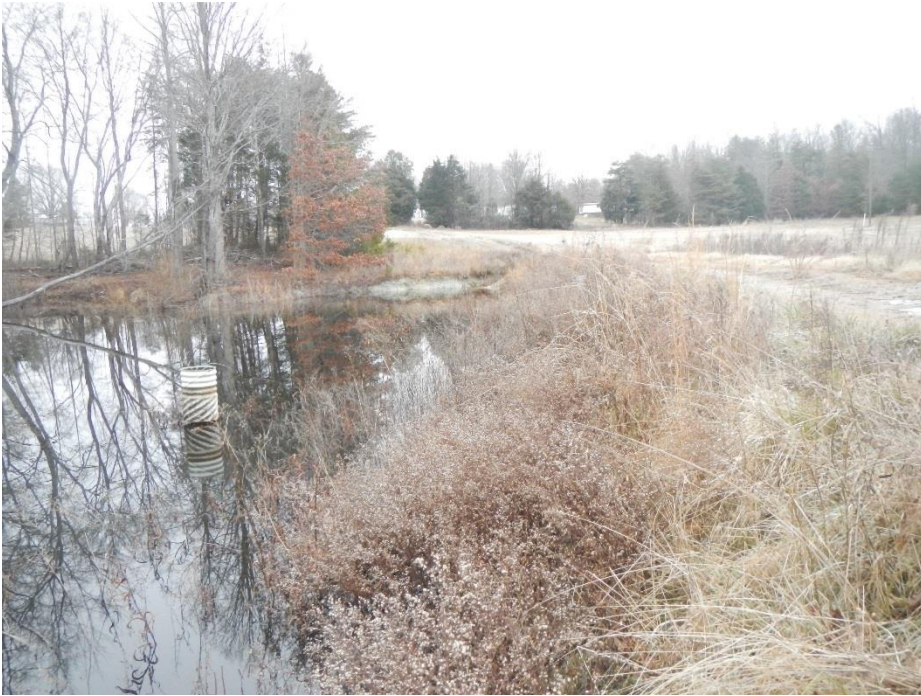
Open Waterbody OCUC001 facing east

Pond is dammed and appears to drain under the road near the photo point. Pond is about 70 feet across and the top of the banks of the pond are about 90 feet across.
