Linear Waterbody Data Sheet

Survey Description				
Project Name: ACP		Waterbody Name: Unit to Meherrin River		Waterbody ID: SSDP002
State: VA		County/Parish: Southampton	Company: ESI	Date: 4/1/15
Tract Number(s): 25-001-A005, 25-001-A001, 25-001-A003		Nearest Milepost: 2.5 (new)	Crew Member Initials: LR, RT	
Survey Type: <small>(check one)</small>		Associated Wetland ID(s): WSOP001		
<input type="checkbox"/> Centerline		<input checked="" type="checkbox"/> Re-Route		
<input type="checkbox"/> Access Road		<input type="checkbox"/> Other:		
Physical Attributes				
Stream Classification: <small>(check one)</small>				
<input type="checkbox"/> Ephemeral				
<input type="checkbox"/> Intermittent				
<input checked="" type="checkbox"/> Perennial				
Waterbody Type: <small>(check one)</small>				
<input type="checkbox"/> River				
<input type="checkbox"/> Stream				
<input type="checkbox"/> Ditch				
<input checked="" type="checkbox"/> Canal

Environmental Field Surveys
Waterbody Photo Page

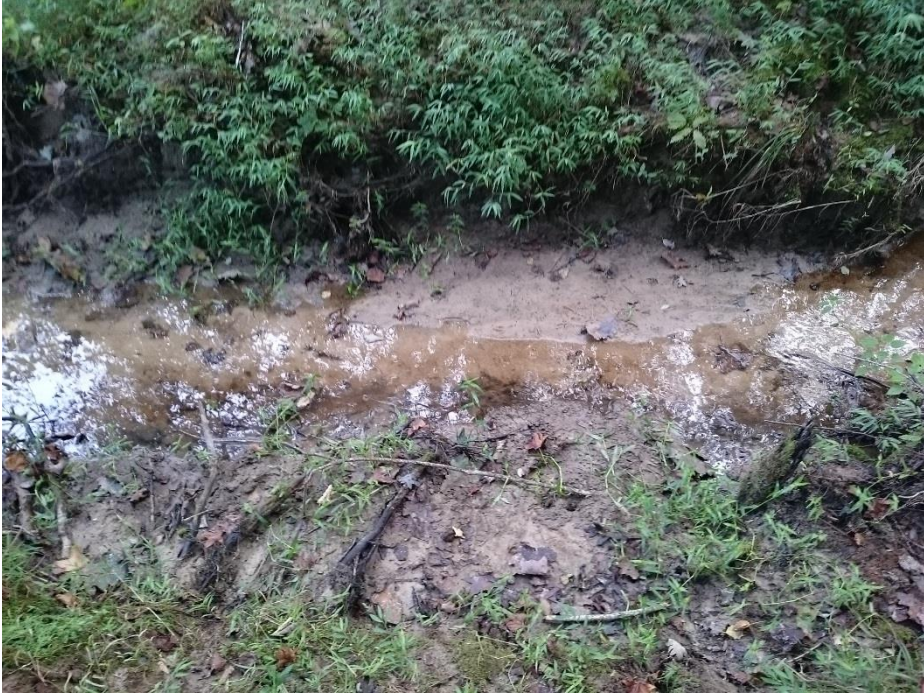
Stream continues out of corridor in both directions; flows through wetland complex wsoa076; sediment input from agricultural fields and existing power line ROW is excessive.

Waterbody SSOA074 facing northeast across

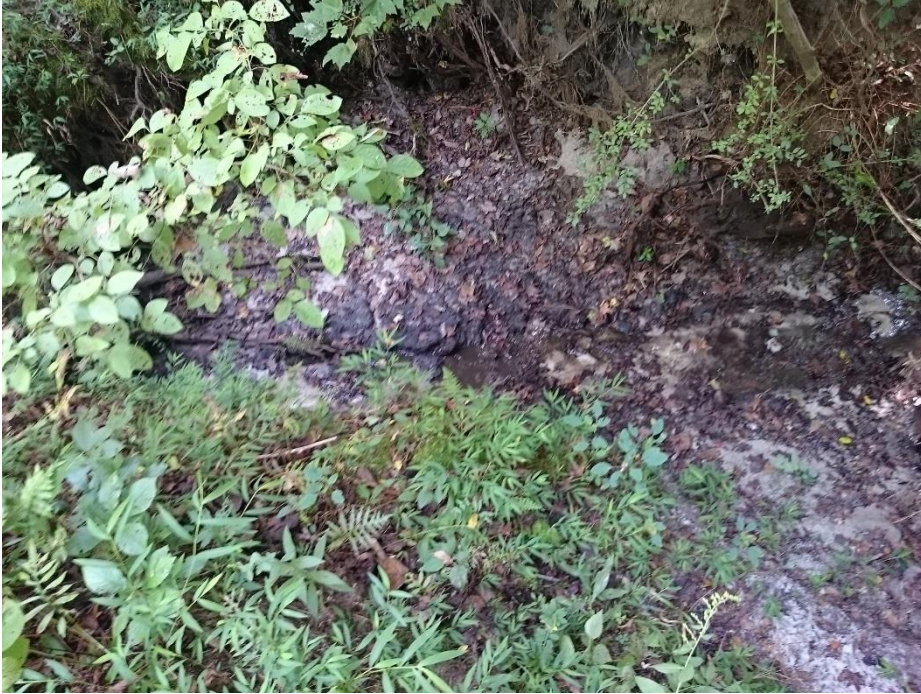
Flows through wetland complex WSOA075; continues out of corridor in both directions. The severe down cutting and numerous bank failures make this a very low quality feature.

Waterbody SSOA073 facing south across

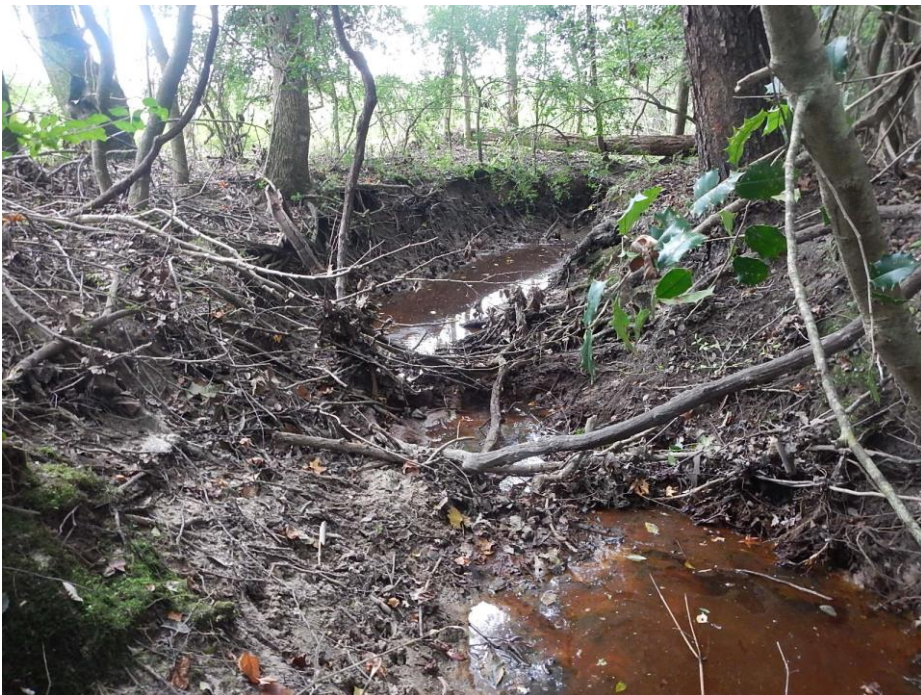
Continues out in both directions, iron oxidation sheen on water surface, stream is highly incised and has lowered water table in riparian zone eliminating probable past wetland abutting stream; PSS wetland wsoa006 is above floodplain in concave side slope below a slope break, this wetland is not directly connected to stream.

SSOA001 facing north downstream
