PHASE 2 - RAPID STREAM RECONNAISSANCE
Photographic Record

Client: Atlantic Coast Pipeline

Project Number: TXG0007

Subject Site: SC_0760 (Dowell's Draft at MP AP-1 117.07)

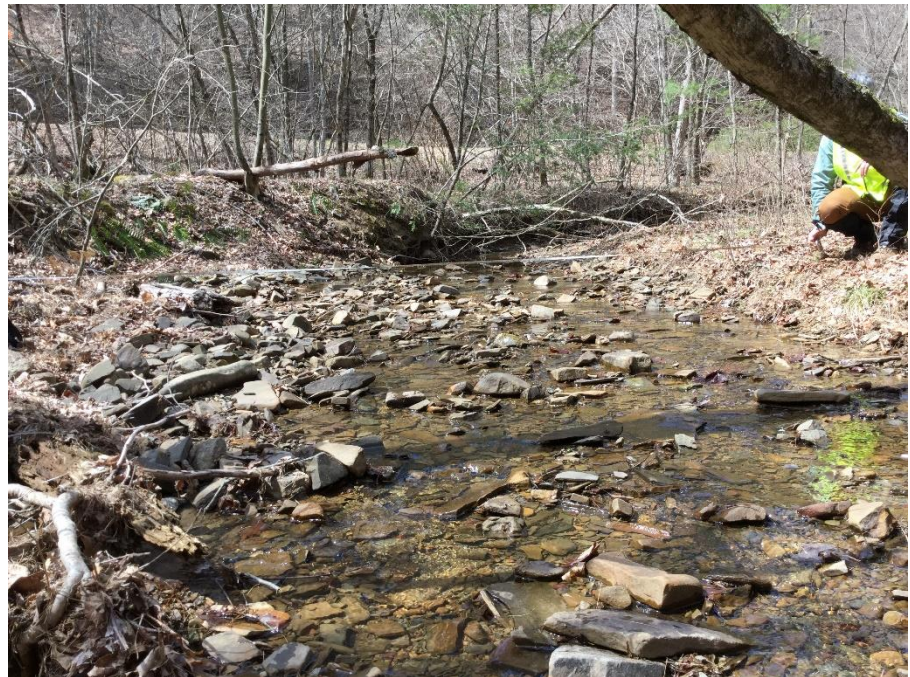
Photograph 2
(IMG_0625.jpg)

Description: View of stream bed comprising laminar angular to subangular gravel and cobble-sized particles. Note valley wall in background.

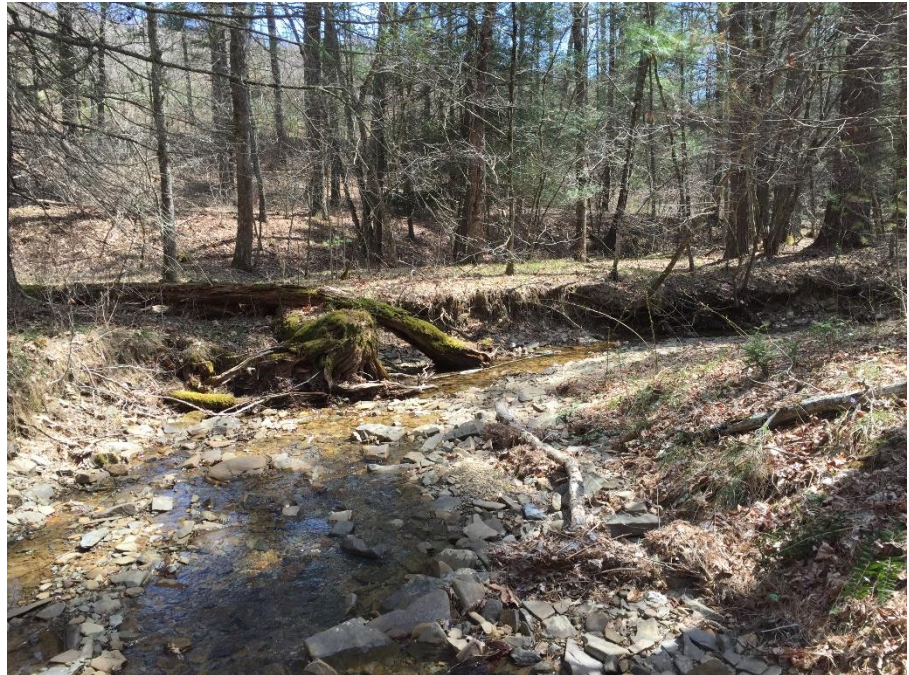
Photograph 3
(072.jpg)

Description: Terraces on
right bank.

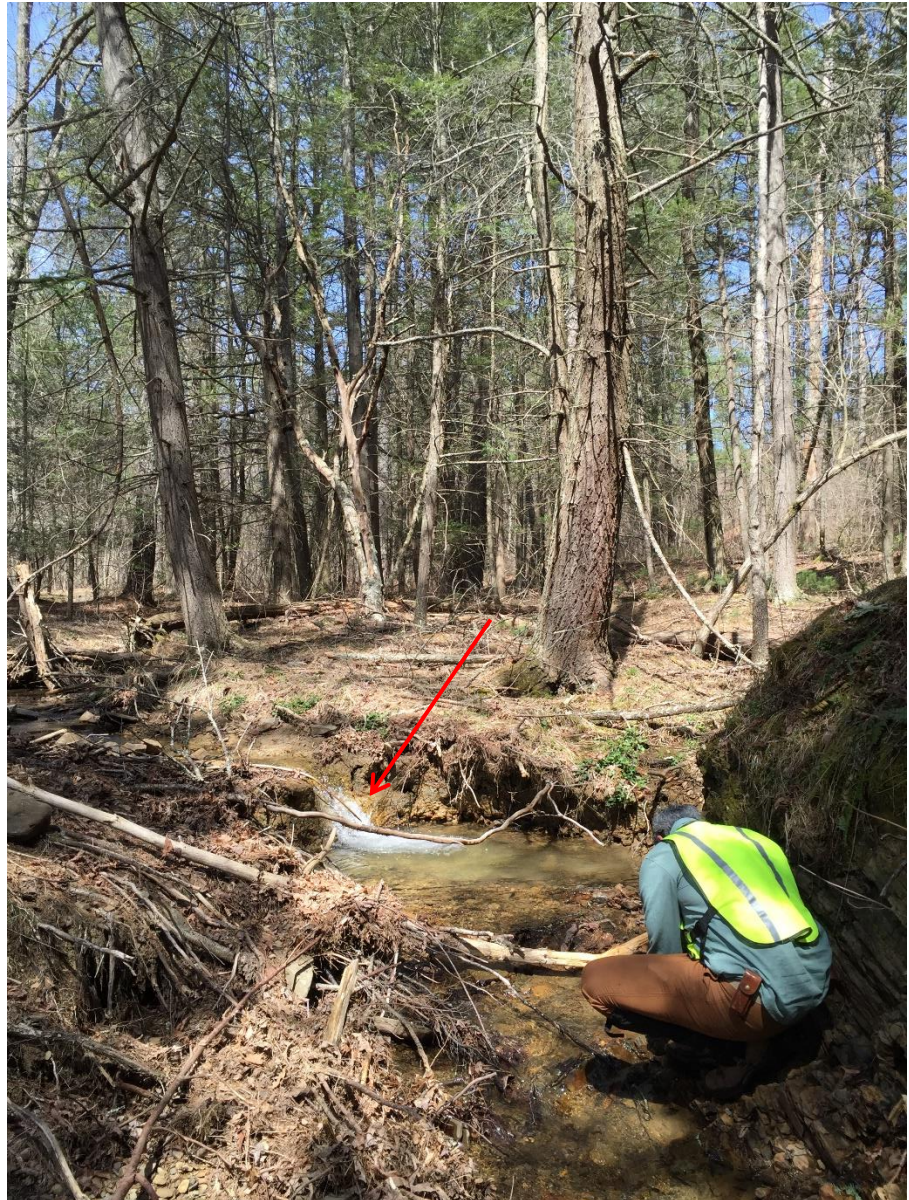
Photograph 4
(081.jpg)

Description: Rock outcrop located approximately 250-ft downstream of pipeline crossing. Also noticeable is a knick point on the stream.

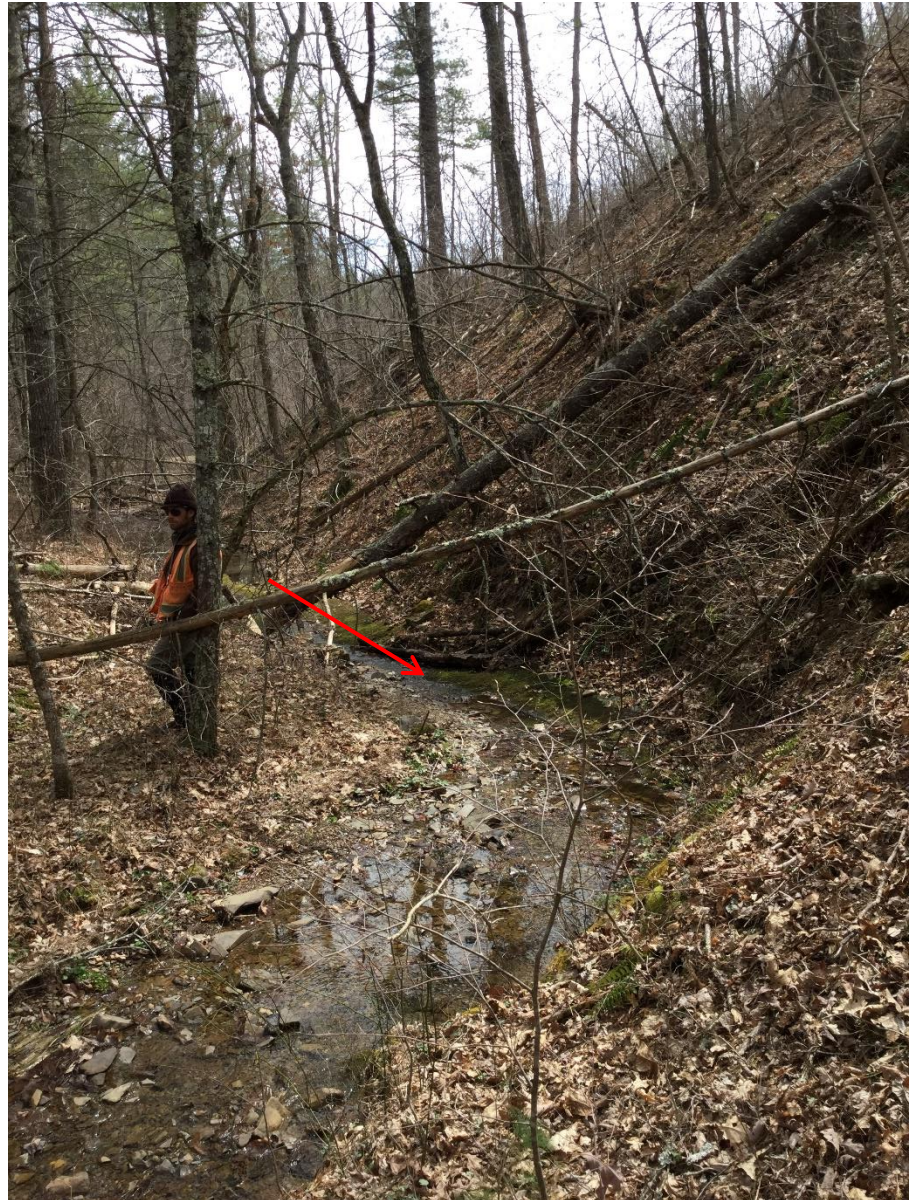
Description: View of steep slope providing confinement on right bank with rock outcropping at toe (red arrow)

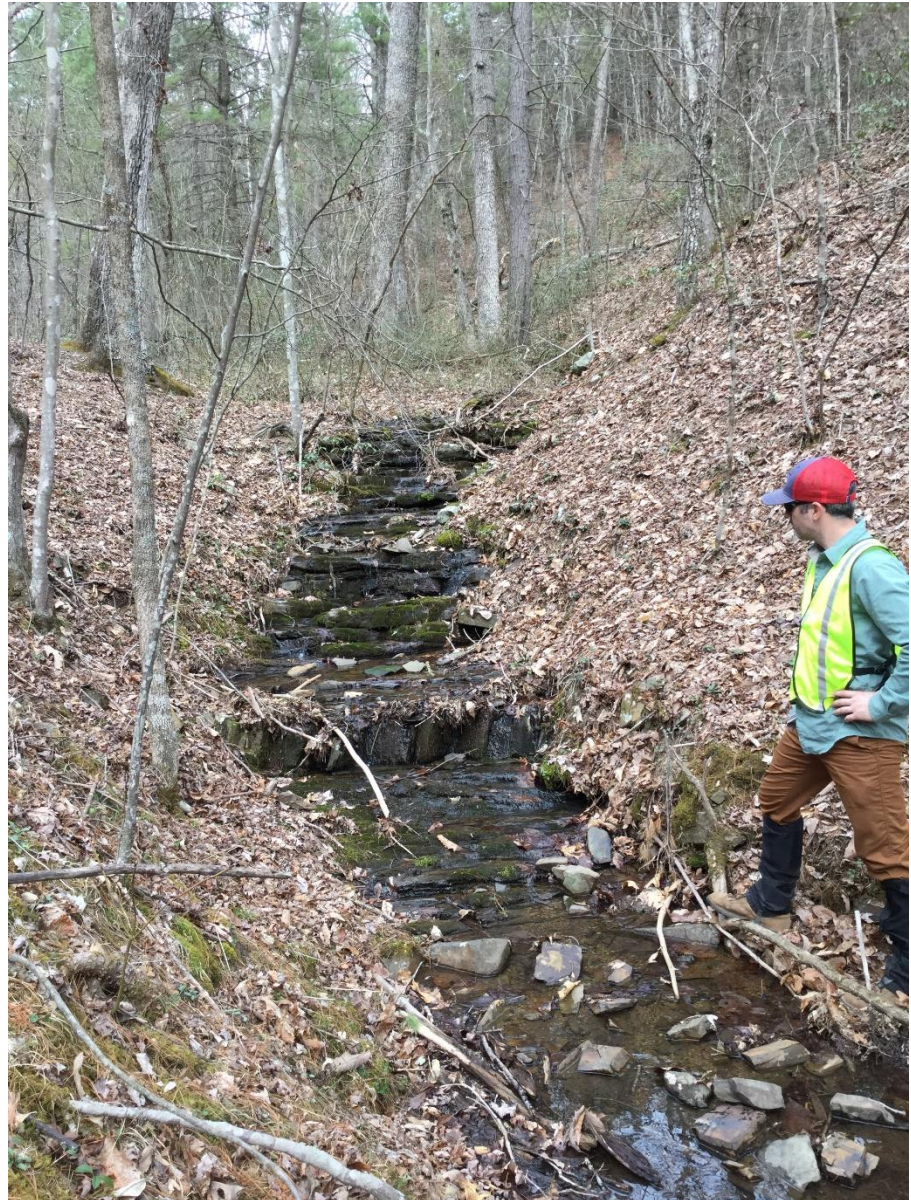
Description: Stream step-pool in bedrock approximately 50 feet upstream of crossing. Stream bed comprises angular to subangular cobble and gravel-sized particles when bedrock is not evident.

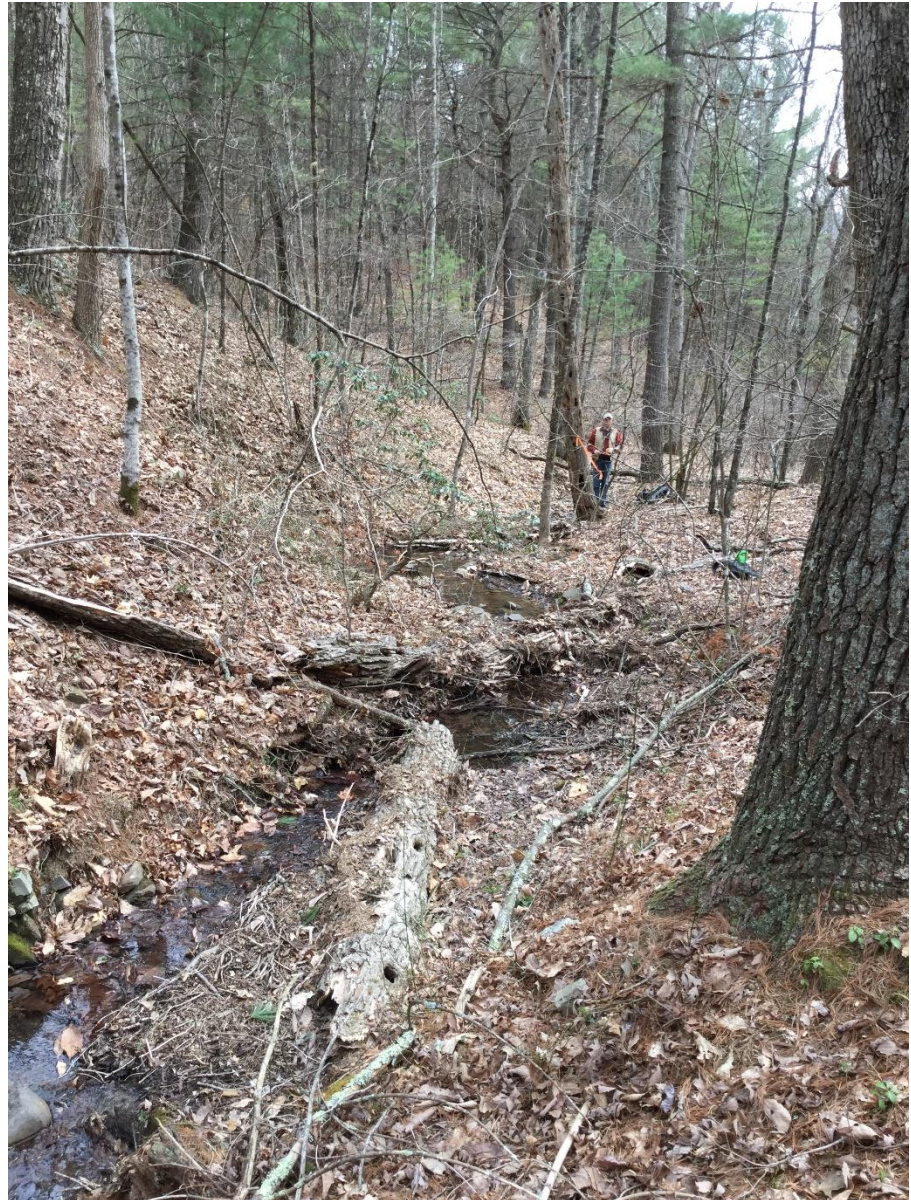
Description: View of crossing location (orange survey tape) within noticeable dense deciduous forest and lateral confinement at the left bank.

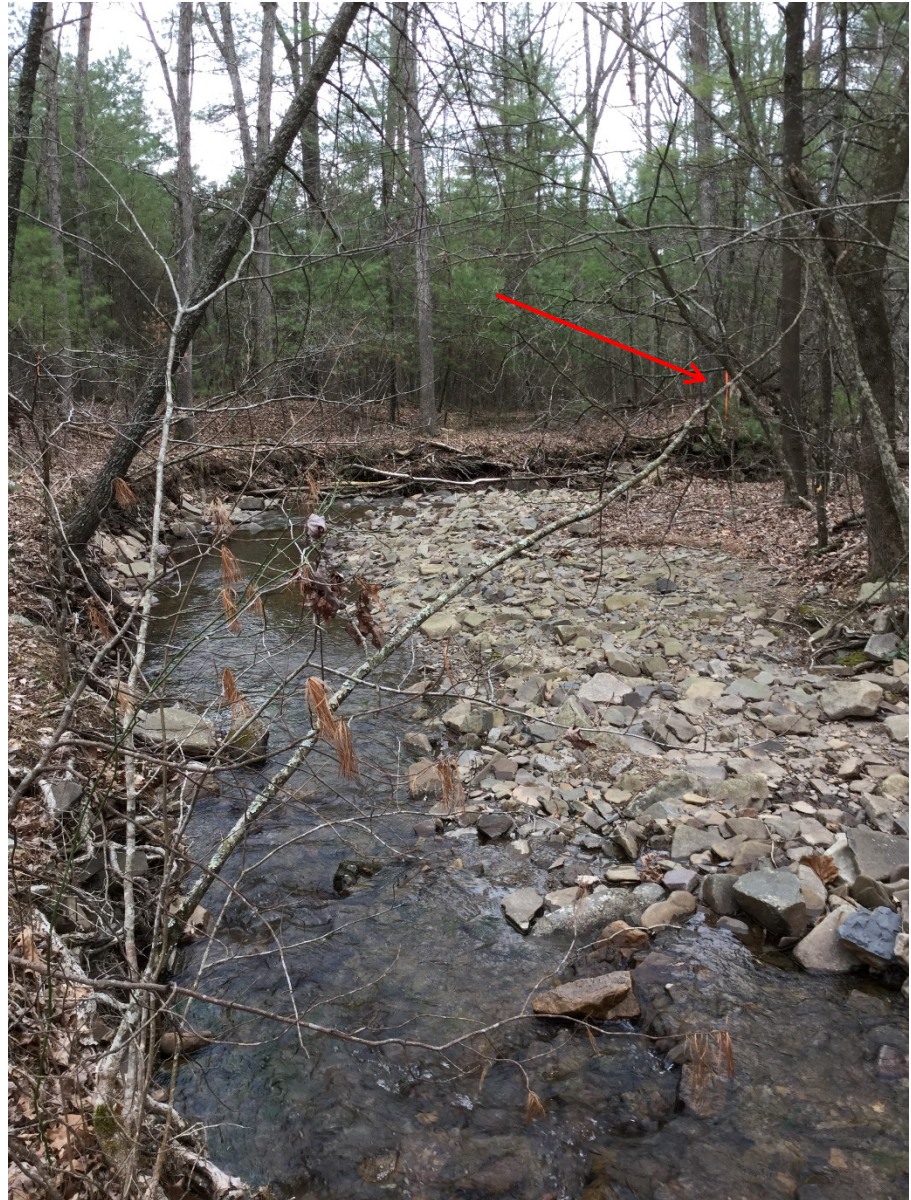
Description: Stream is located in dense deciduous forest. Bed comprises subangular and subrounded boulders and cobbles. Pipeline crossing is located at orange tape (red arrow).

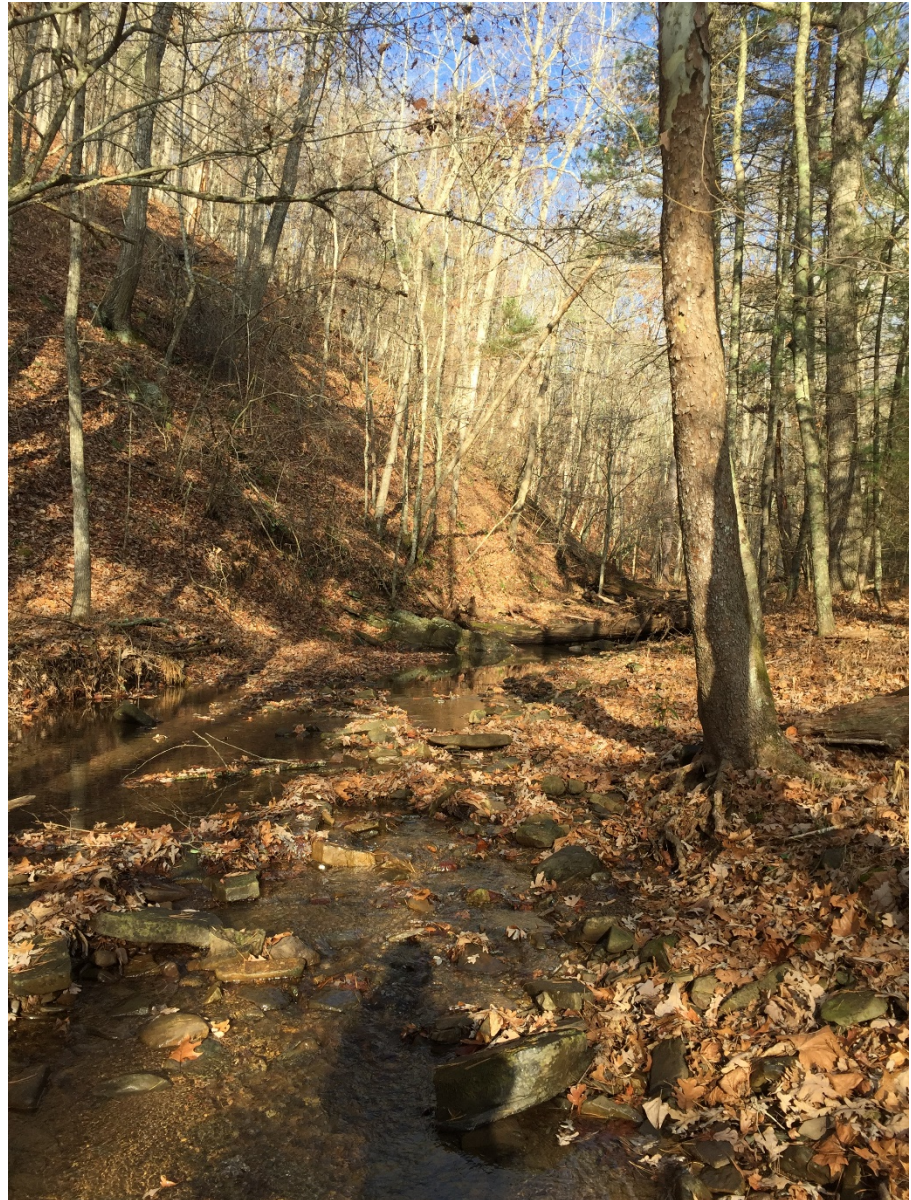
Description: View of
steep slope on right bank
of stream.

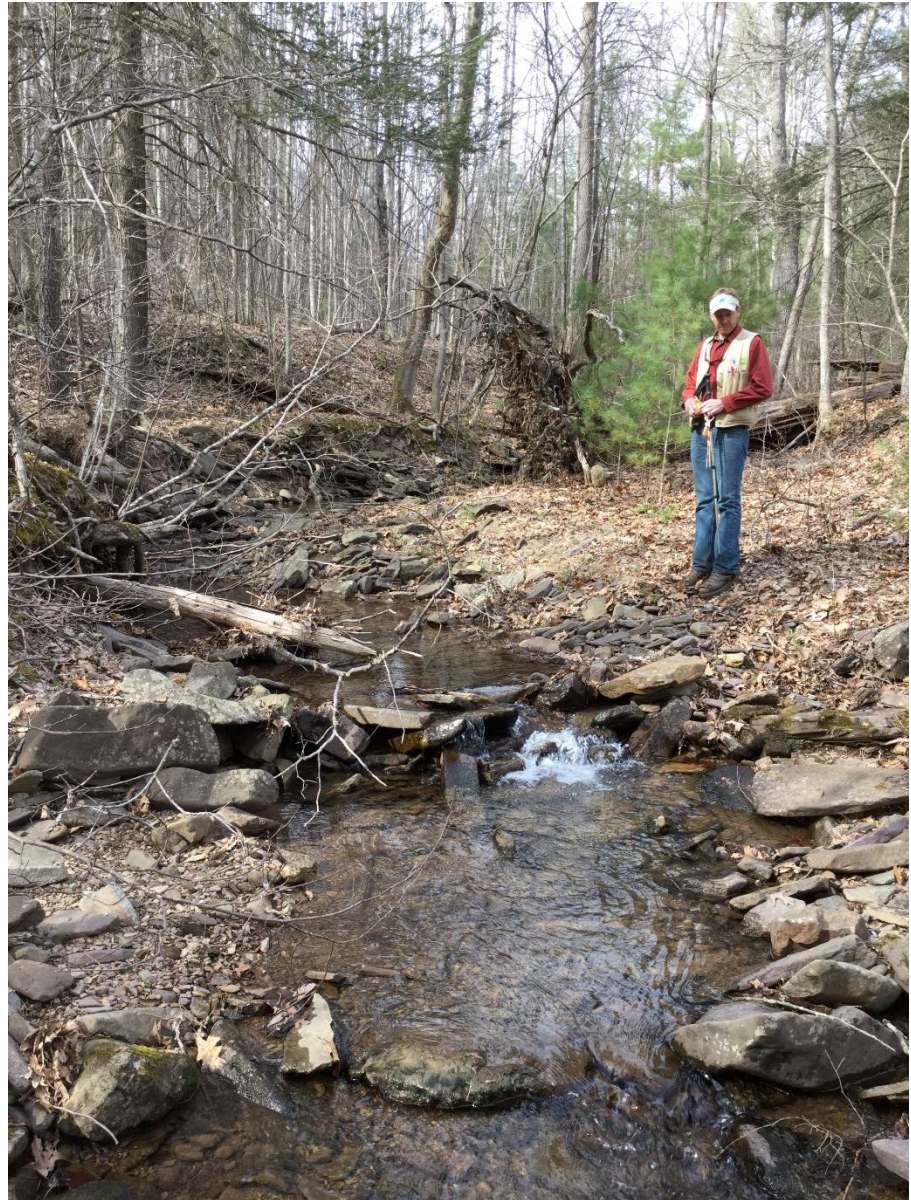
Description: Stream is located in dense deciduous forest. Bed comprises subangular and subrounded boulders and cobbles. Head cut in photo at location of crossing.

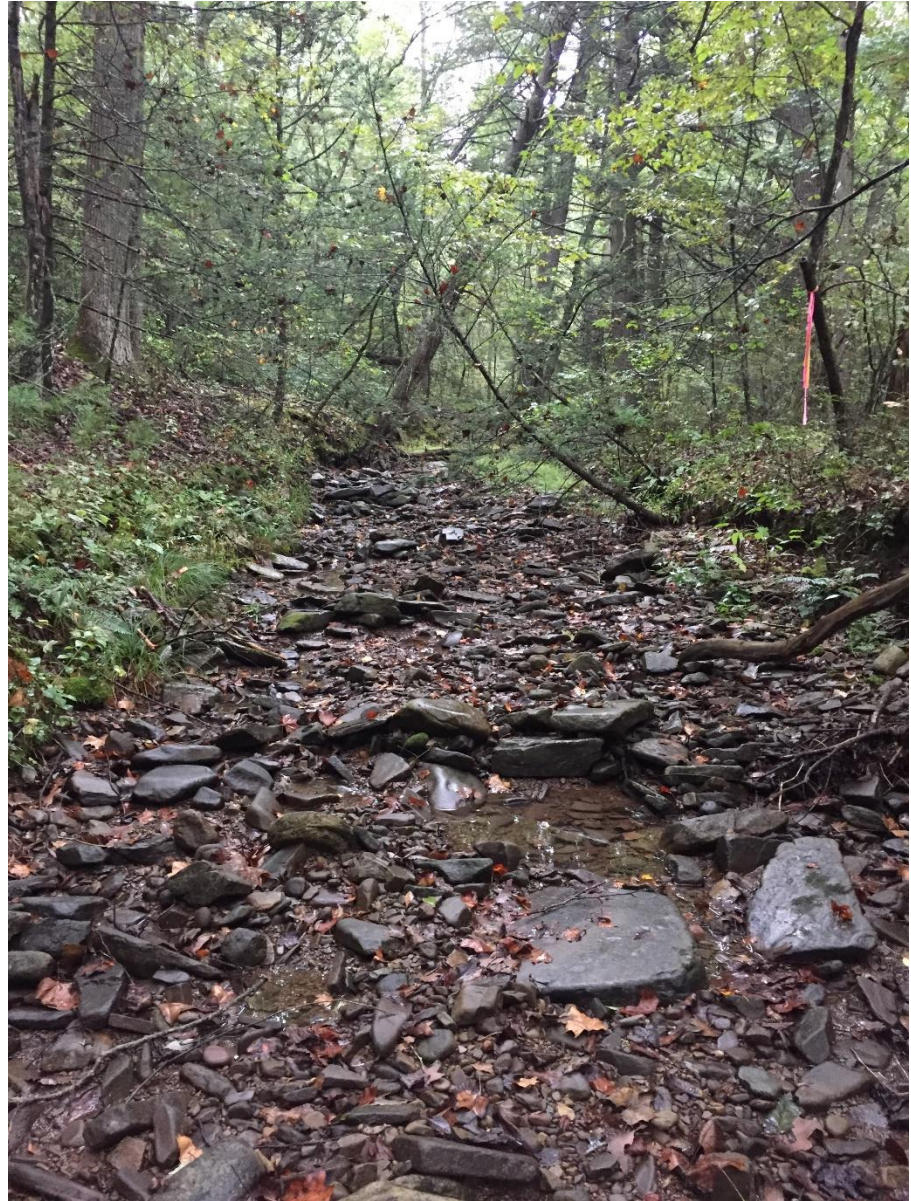
Description: Well defined
channel with cobble bed.
View from just
downstream of crossing
illustrating stable low
banks.

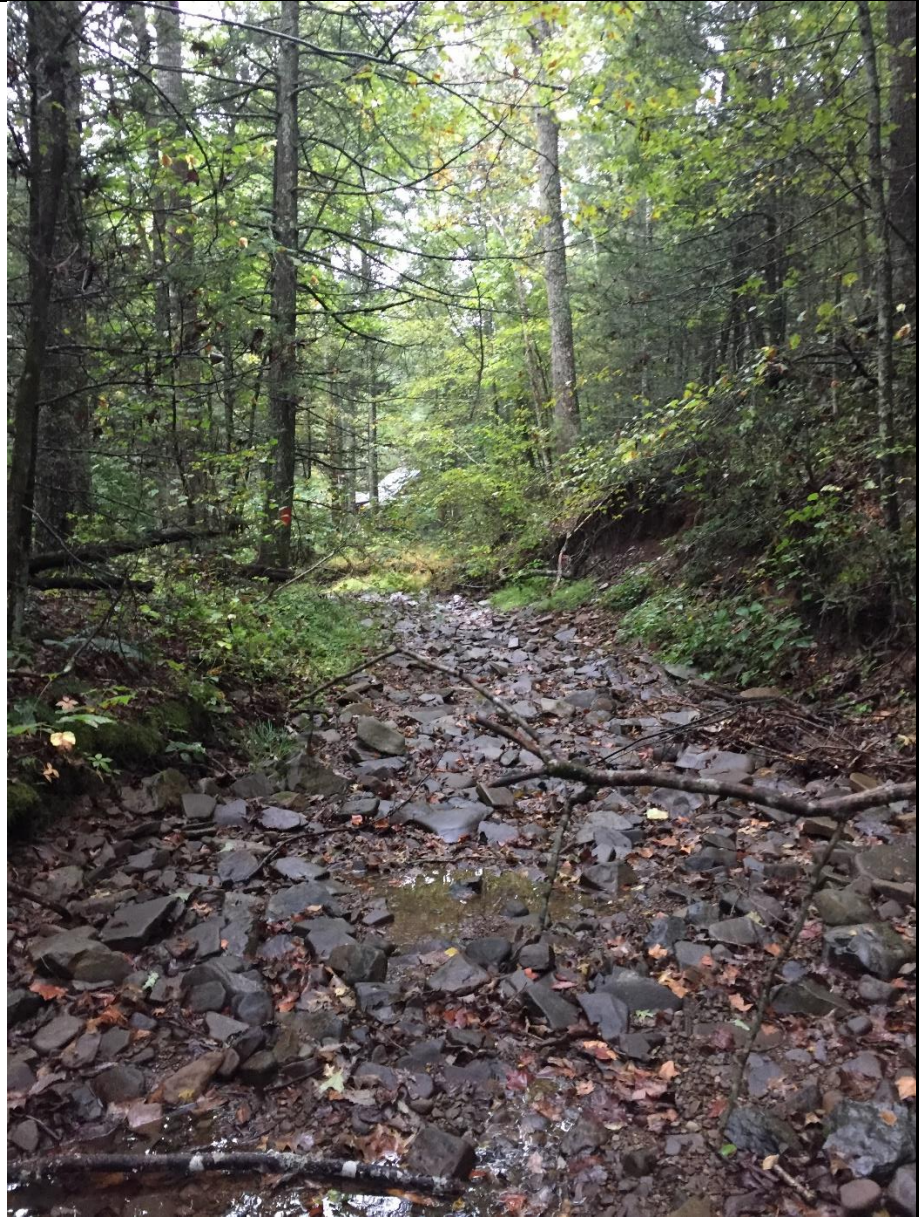
Description: Steep eroded
right bank on outside
bend, downstream of
crossing. Minor terraced
floodplain off left bank.

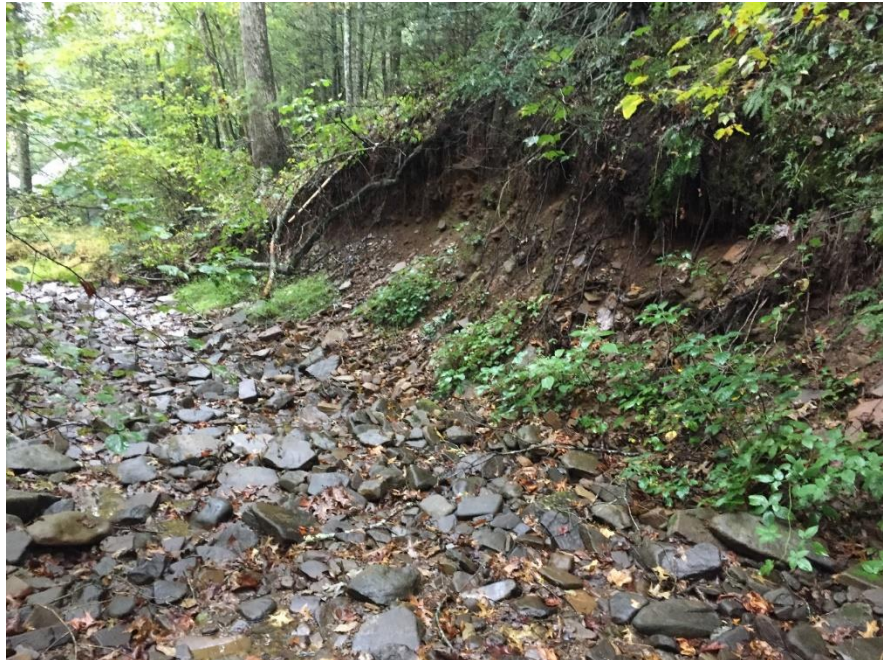
Description: Steep eroded
right bank on outside
bend downstream of
crossing. Channel bed
well armored.

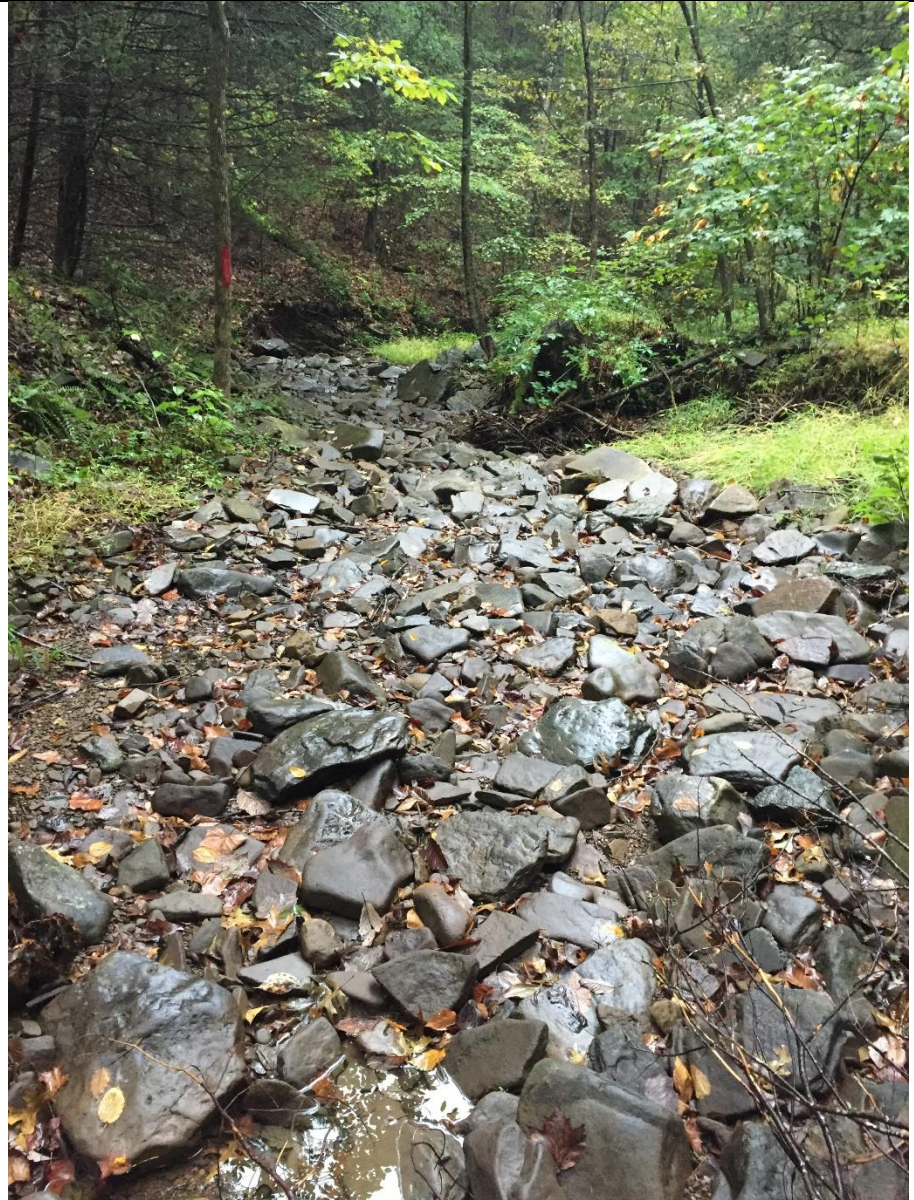
Description: Well armored meander bend downstream of crossing. Floodplain off right bank relatively accessible, structures present. Left bank of channel is confined by valley wall.

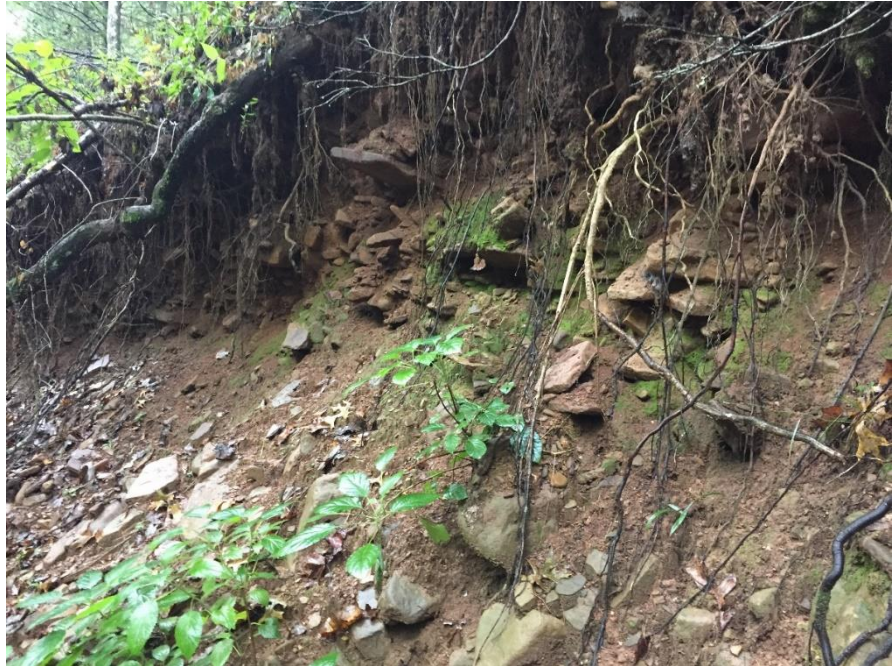
Description: Eroded bank showing signs of stratification. Potential historic debris flow or channel deposits.

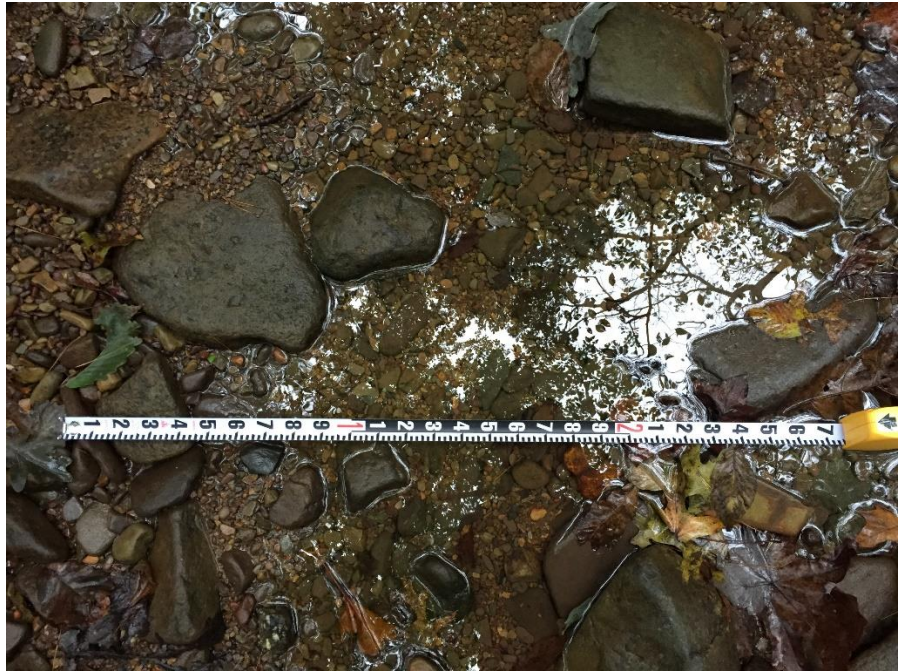
Description: Cobble bed
with some gravels.

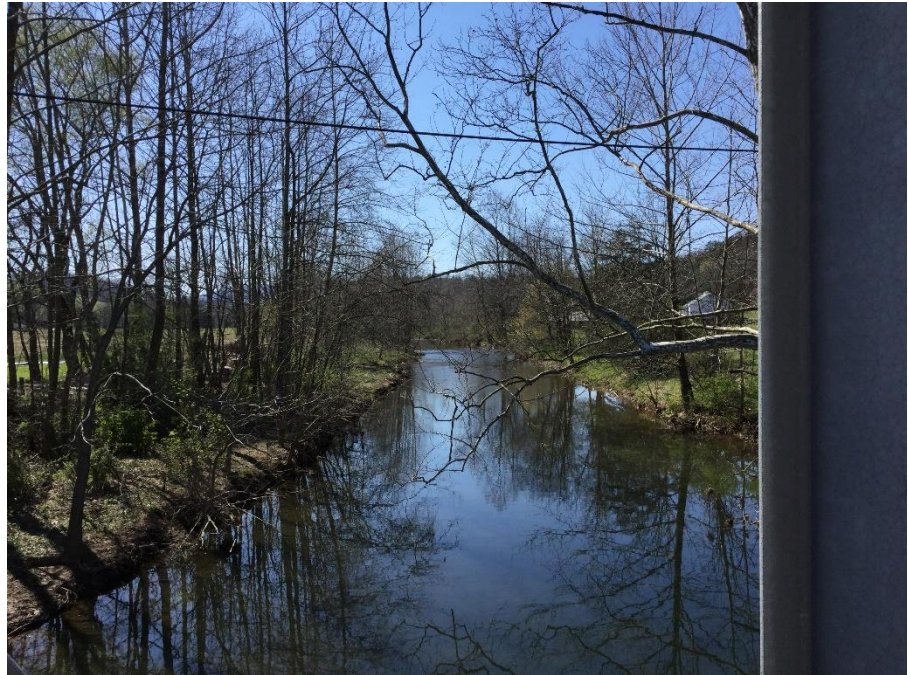
Description: View of thin riparian buffer near downstream bridge crossing over Hangers Mill Rd. located 0.5 miles downstream of pipeline crossing (located on red tract).

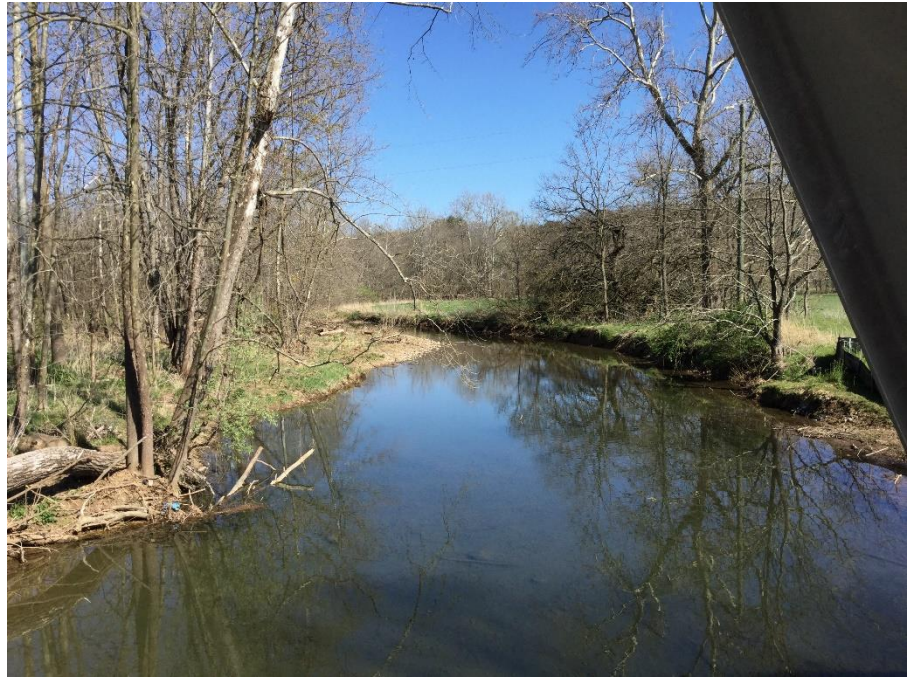
Description: View of
unconfined stream

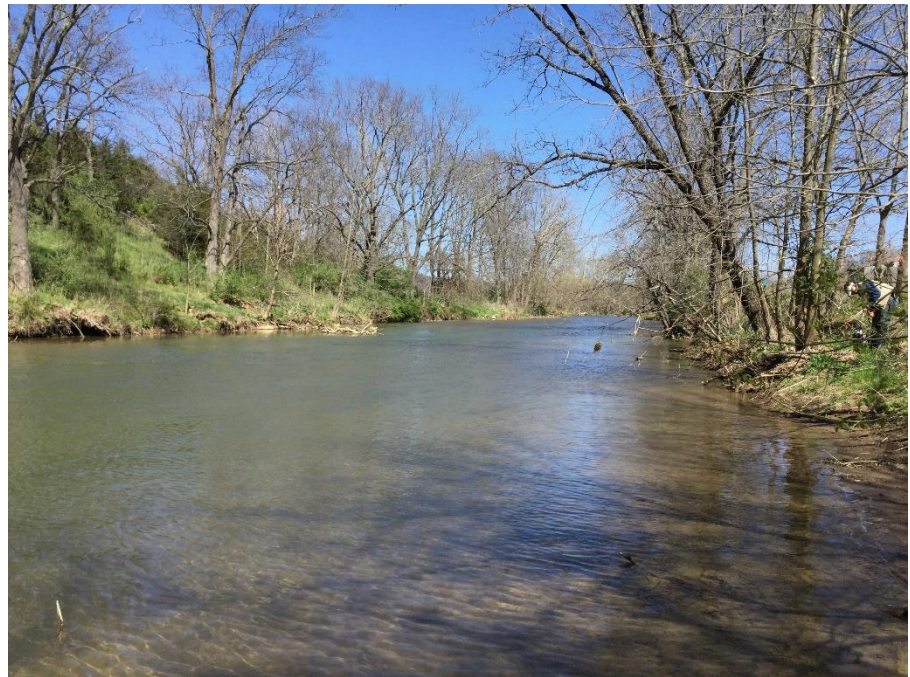
Description: Notice sloping left bank where rock outcrops were noticeable (not shown on photo). Right bank exhibits a gentle slope.

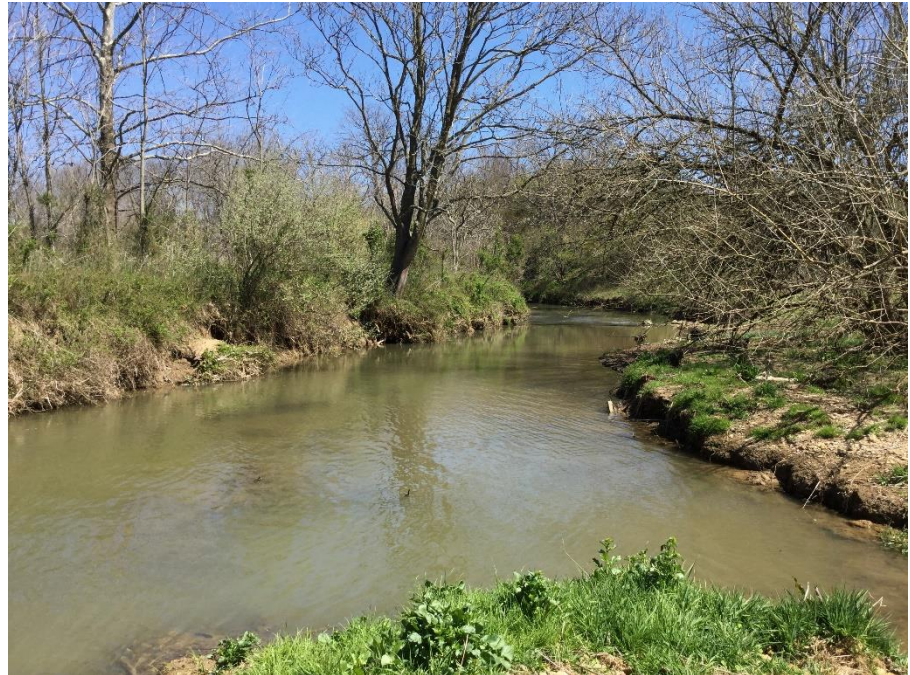
Description: View
looking downstream at
stream crossing location.

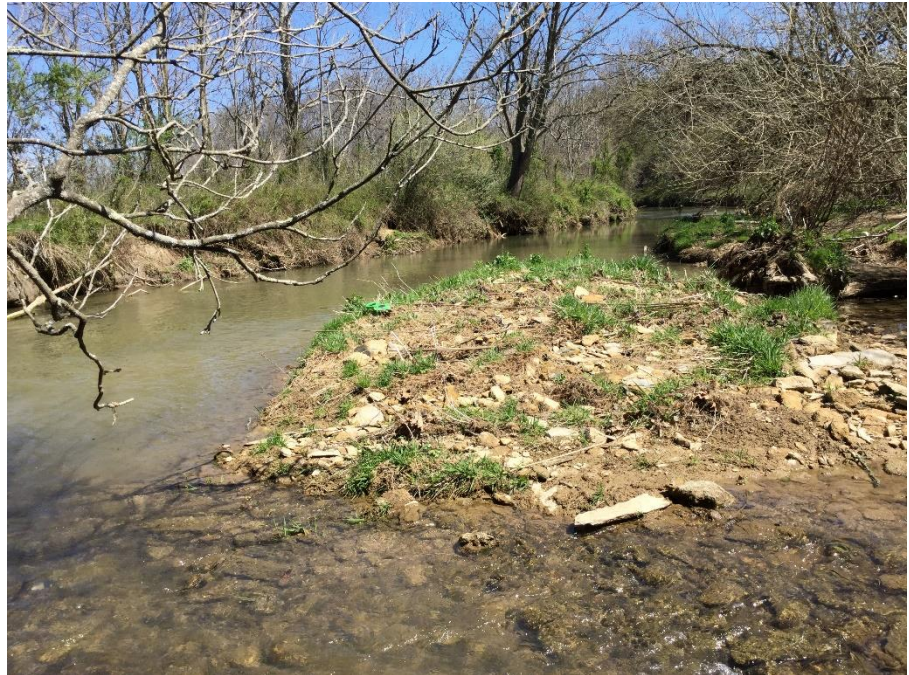
Description: View downstream from upstream cobble/gravel riffle at sharp meander bend where Wolman Pebble Count was conducted.

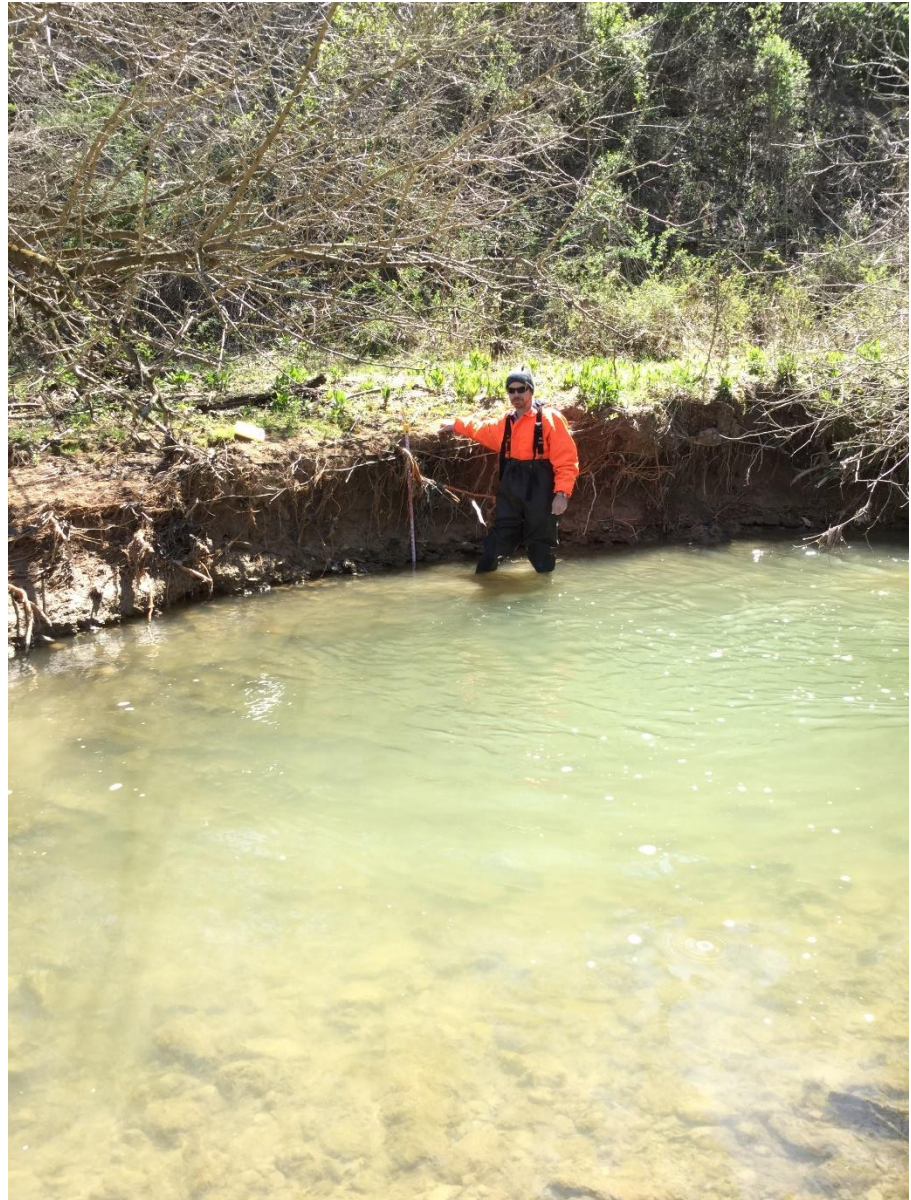
Description: View of meander upstream of cobble/gravel riffle in Photo where pool depth (below water) is 3.5 feet. Also noticeable in the photo is the terrace on the right bank.

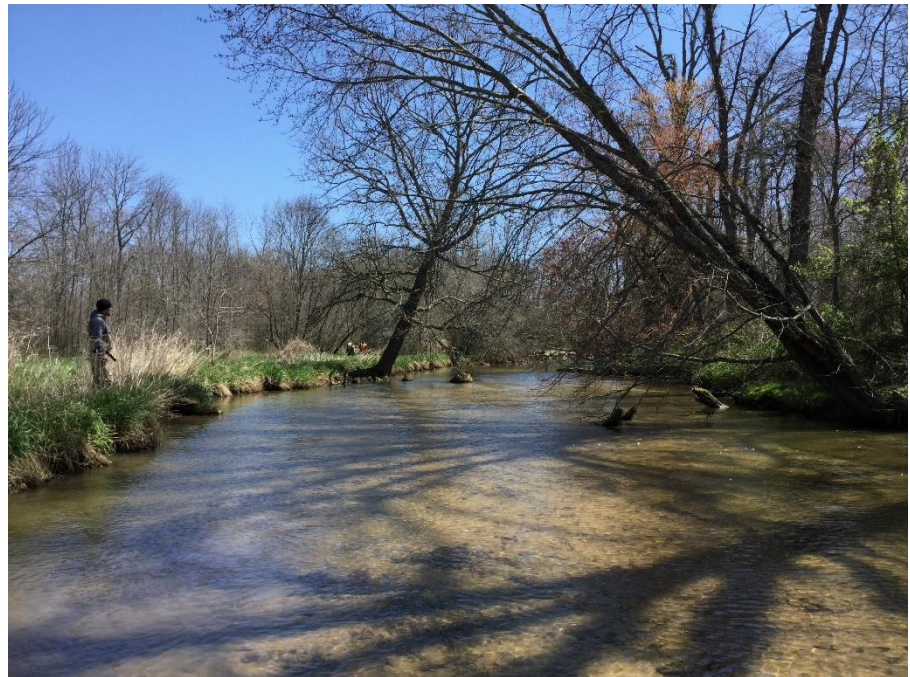
Description: Low gradient stream channel and stream bed comprised of silt and sand. Mid-channel bars from high-fine sediment load in channel direct the flow along both banks contributing to erosion of the banks and falling trees on both banks. The riparian buffer on the right bank is greater than five river widths (mature forested wetland) and four river widths on left bank (herbaceous and immature forested wetland). Bank height is about 1.5 ft high and comprised of fine-grained soils.

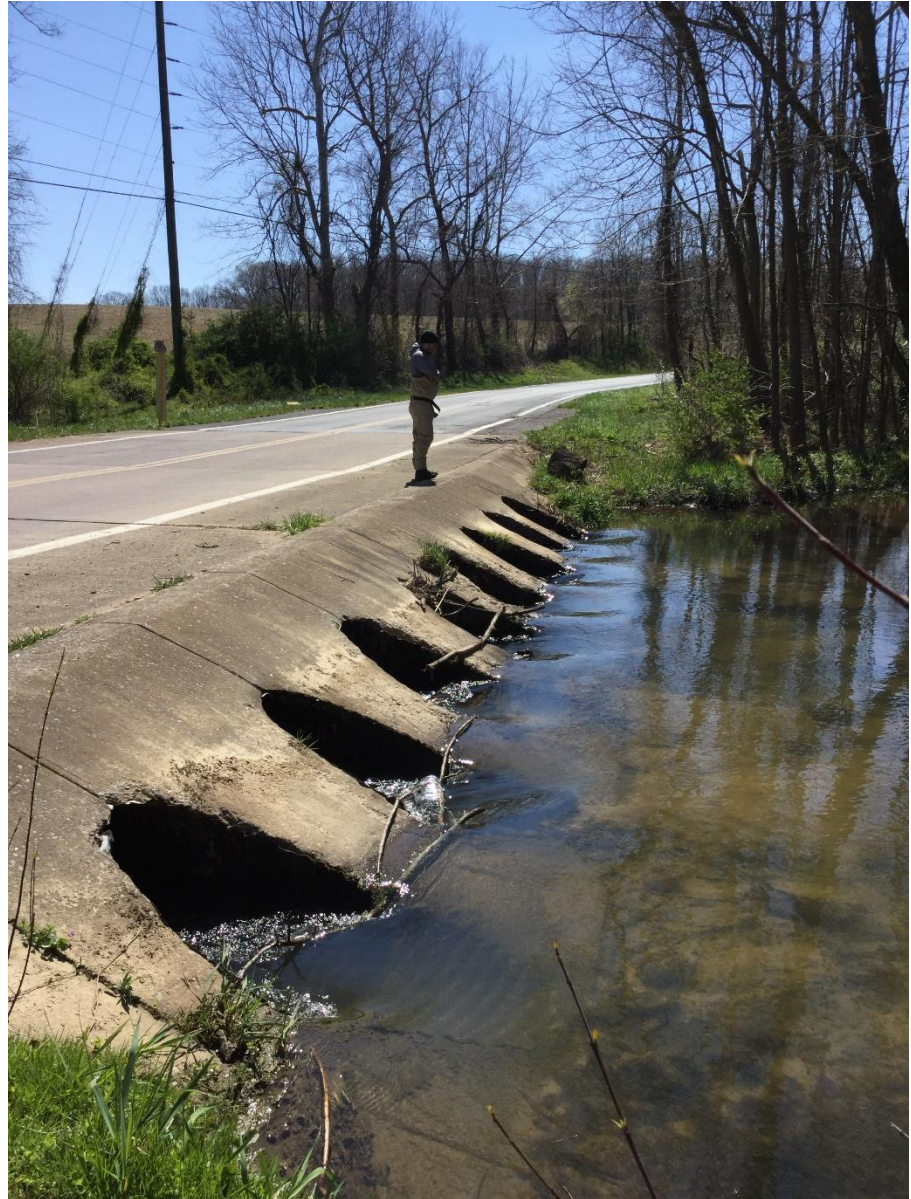
Description: Upstream side of Patton Farm Rd. (State Highway 634) where eight 3-ft diameter culverts convey the South River low flow conditions. The Culvert crossing is approximately 350 feet downstream of the stream crossing provides grade control for channel upstream.

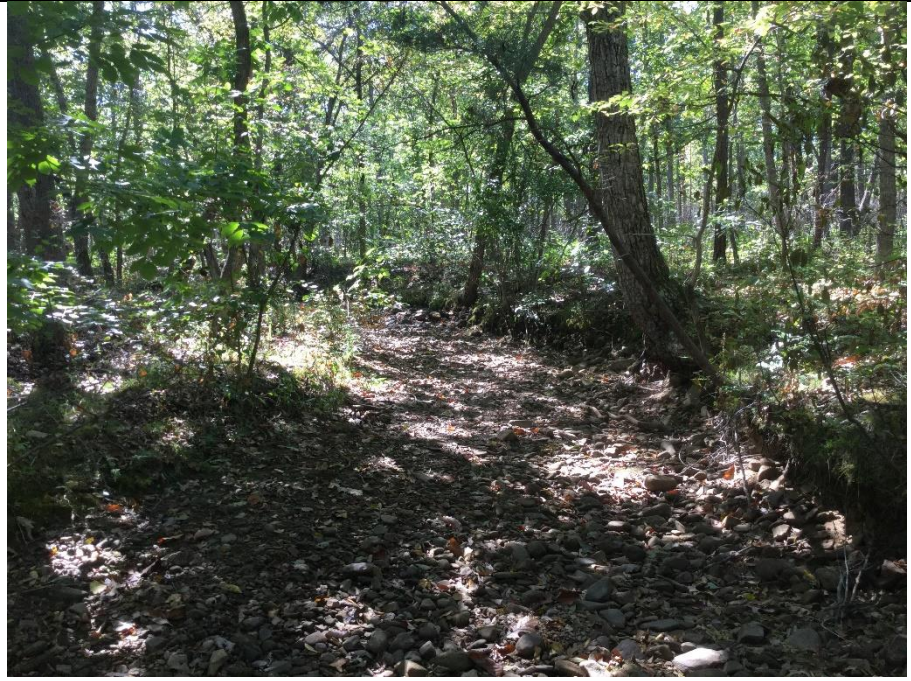
Description: View of coarse gravel and cobble-lined Mills Creek (dry) surveyed about 0.75 miles upstream of pipeline crossing. Stream is located in densely forested floodplain.

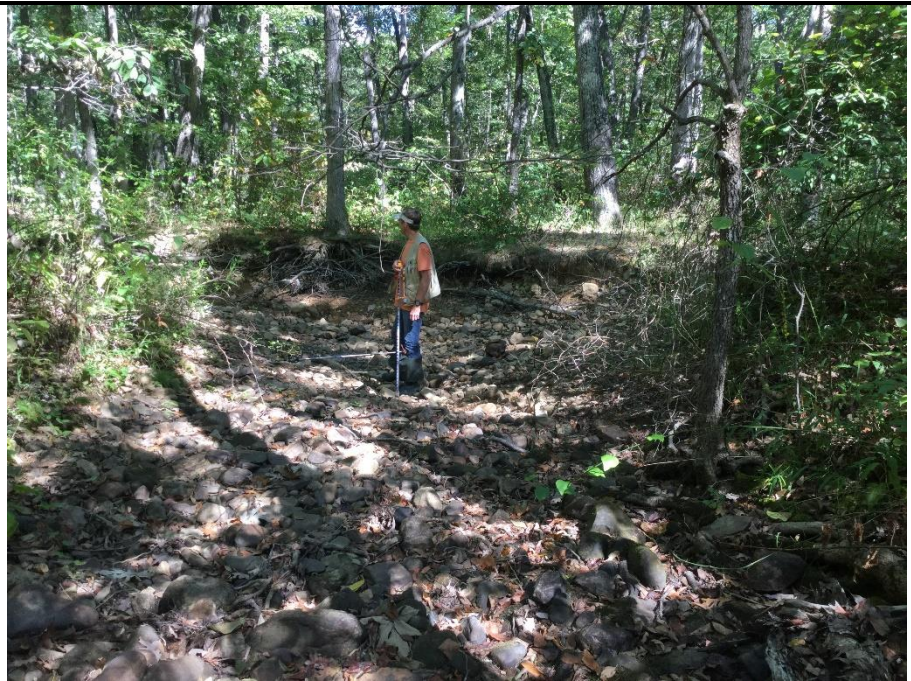
Photograph 2
(IMG_1155.JPG)

Description: View of pool where thalweg is 1.5 ft deeper than channel edge at bank toe.

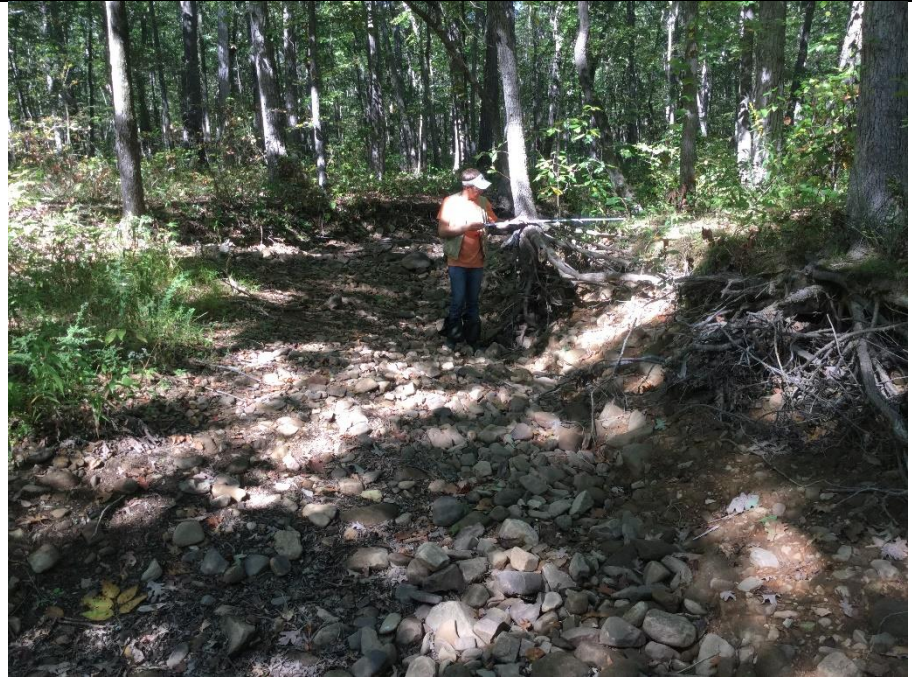
Description: View of erosion around tree roots on the right bank and progressive migration to the right. Channel is located on a historic alluvial fan and is showing signs of lateral and vertical migration.
