PHASE 2 - RAPID STREAM RECONNAISSANCE
Photographic Record

Client: Atlantic Coast Pipeline

Project Number: TXG0007

Subject Site: SC_0760 (Dowell's Draft at MP AP-1 117.07)

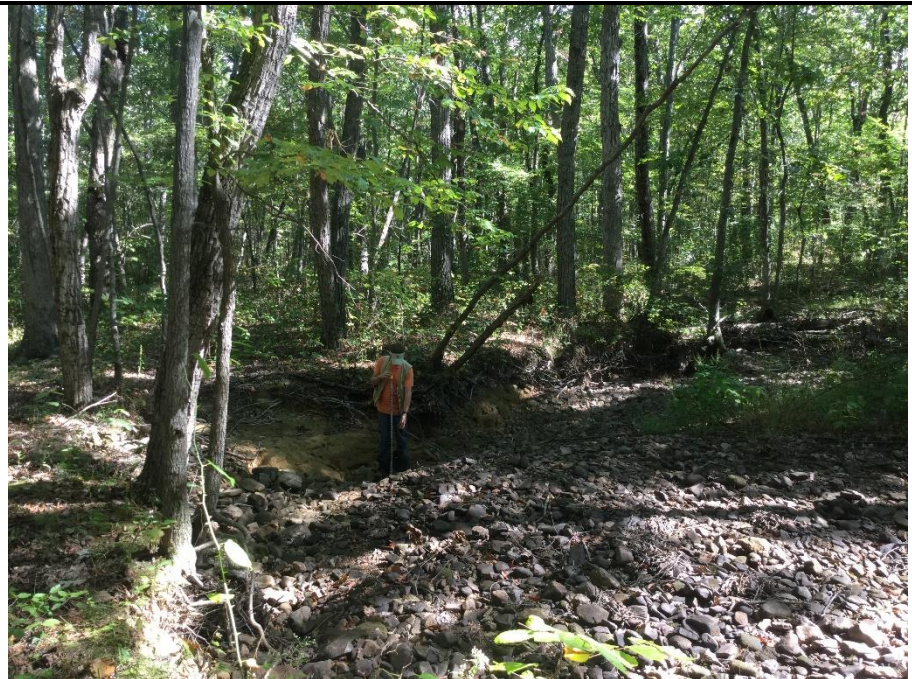
Photograph 4
(IMG_1159.JPG)

Description: Scour at tight (close to 90-degrees) bend where we measured about 2.6 ft of scour from the gravel channel bed (riffle immediately upstream).

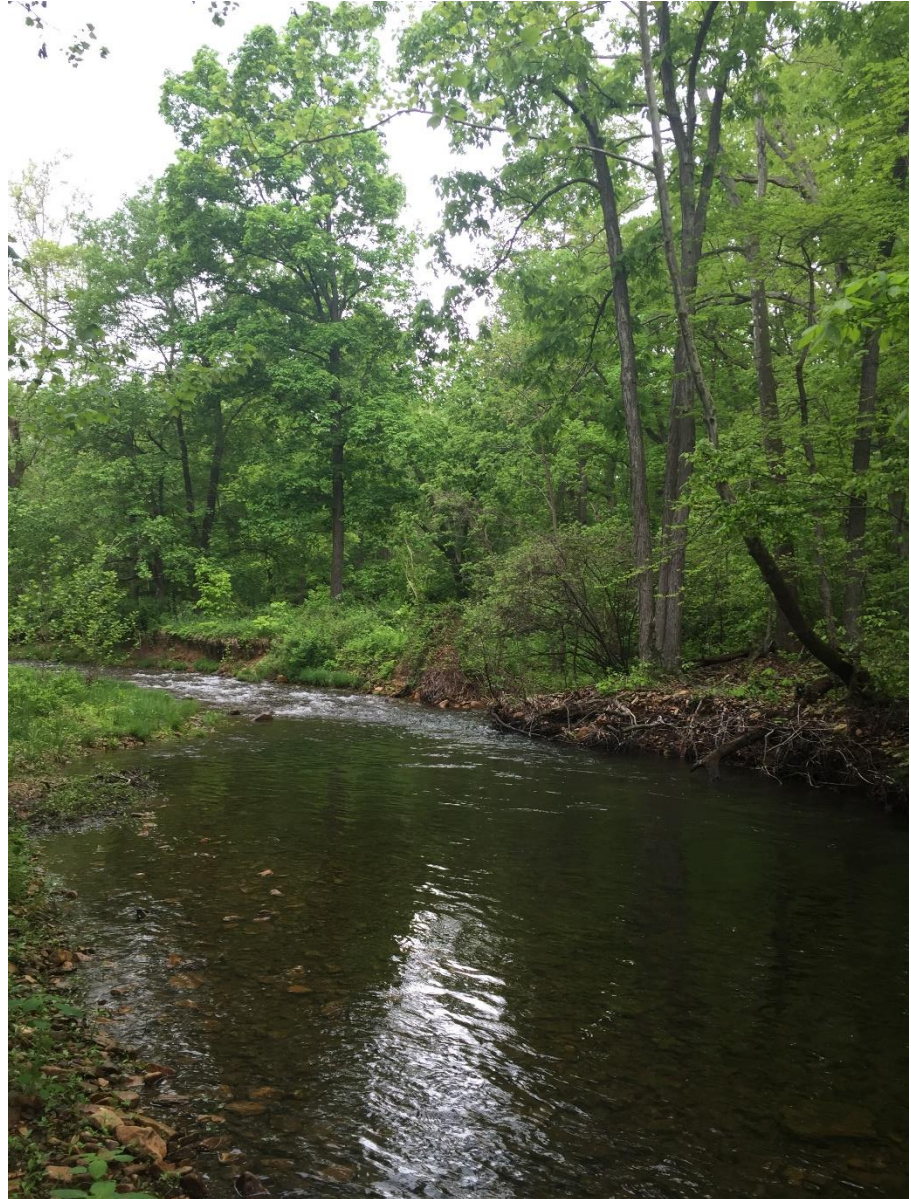
Description: Deep pool and head cut below riffle, just downstream of crossing.

Evaluate scour depth for pipeline burial depth. Lateral migration does not appear to be a significant hazard as landowners will likely strive to maintain current stream course. Place sag bends outside of riparian buffer on right bank (approximately three river widths wide). Location of sag bend beyond left bank to be determined by additional investigation.

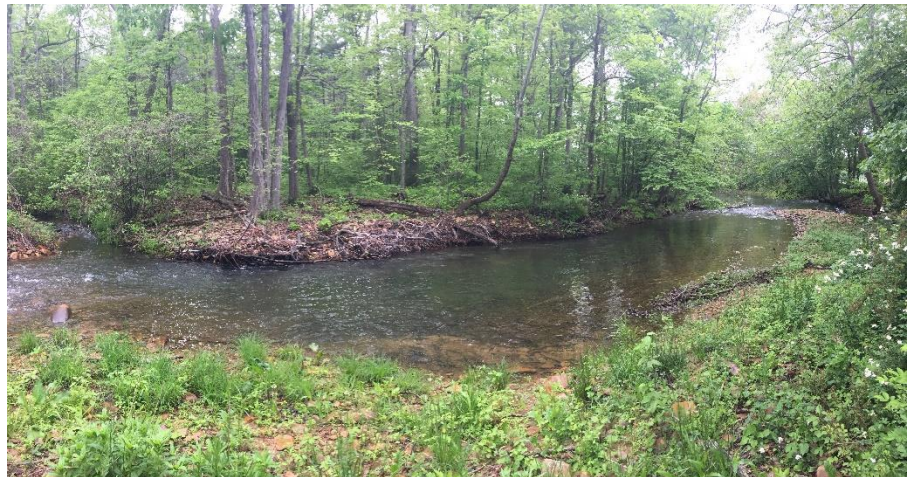
Photograph 2

Description: two tributary streams entering from left bank (from heavily forested floodplain) and right bank (from agricultural floodplain), both downstream of crossing.

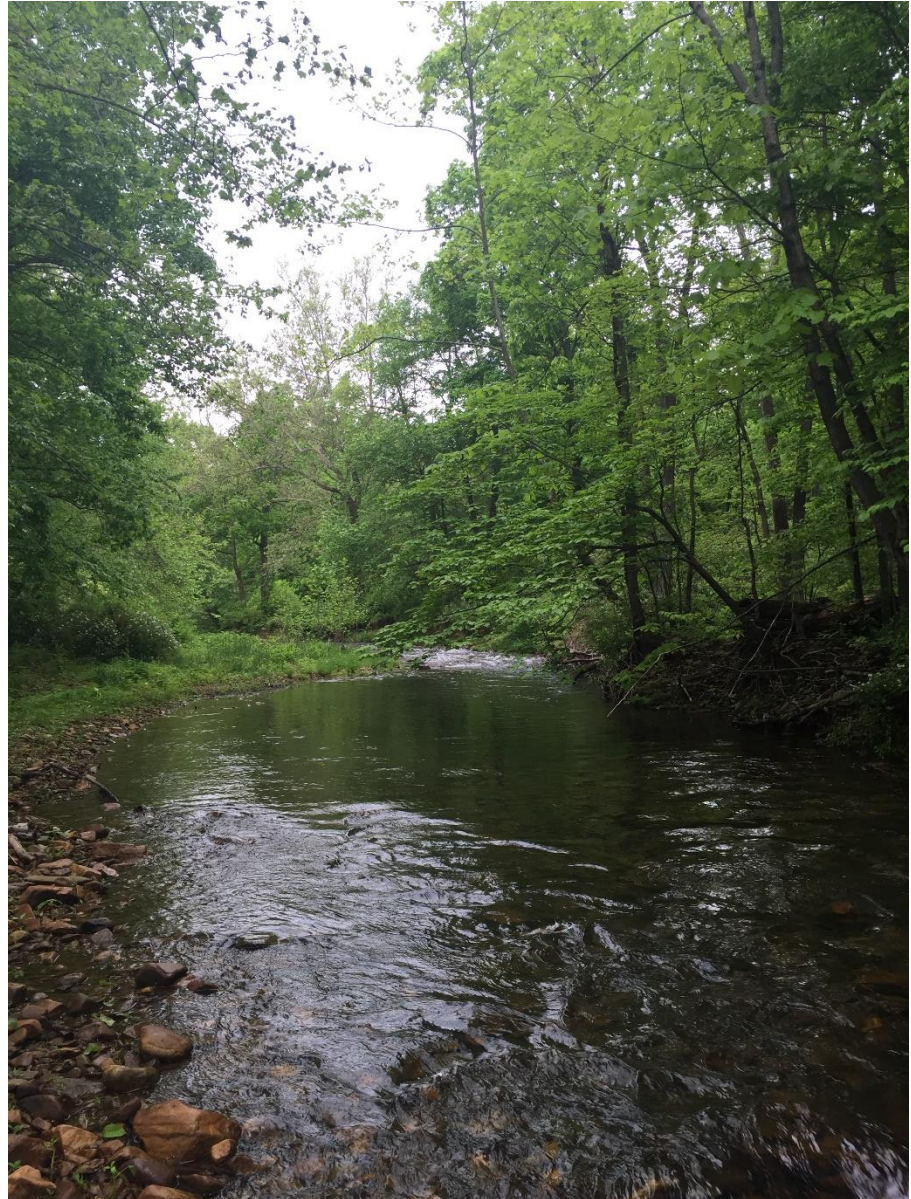
Description: well established riparian buffer off left bank with tributary inlet entering from left bank at bottom of visible riffle section. Signs of beaver activity and deep depths in pool below riffle/ head cut.

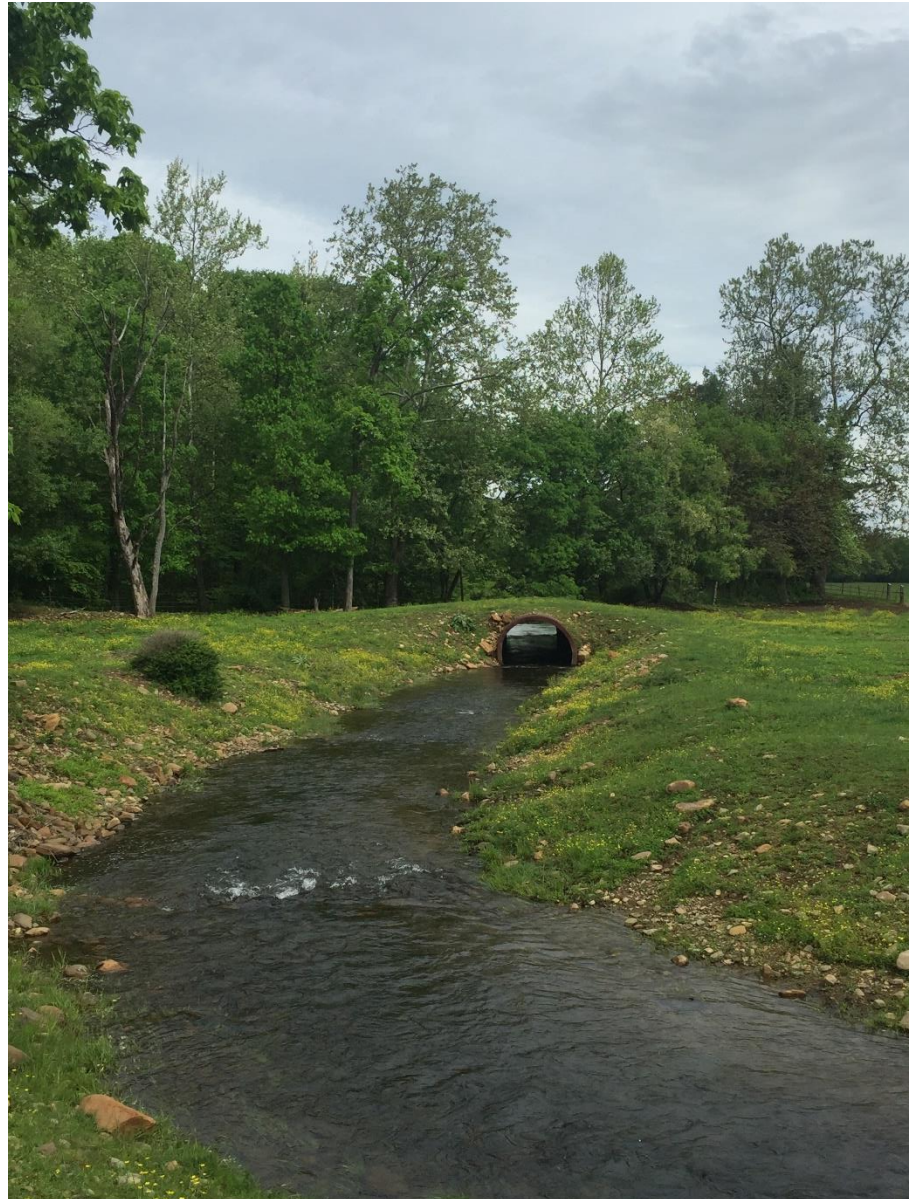
Photograph 4

Description: one of two
tributary streams entering
back creek downstream of
crossing. Flowing from
agricultural floodplain,
narrow riparian buffer
visible on right bank of
back creek, downstream
of culvert.
