TID	SC_0799	ACP Segment	AP-1
Stream Name	Pond Hollow	MP	158.91
Survey Date	13-May-2016	Start Time	1100 hrs

Client: Atlantic Coast Pipeline

Project Number: TXG0007

Stream Crossing Plan View and Profile

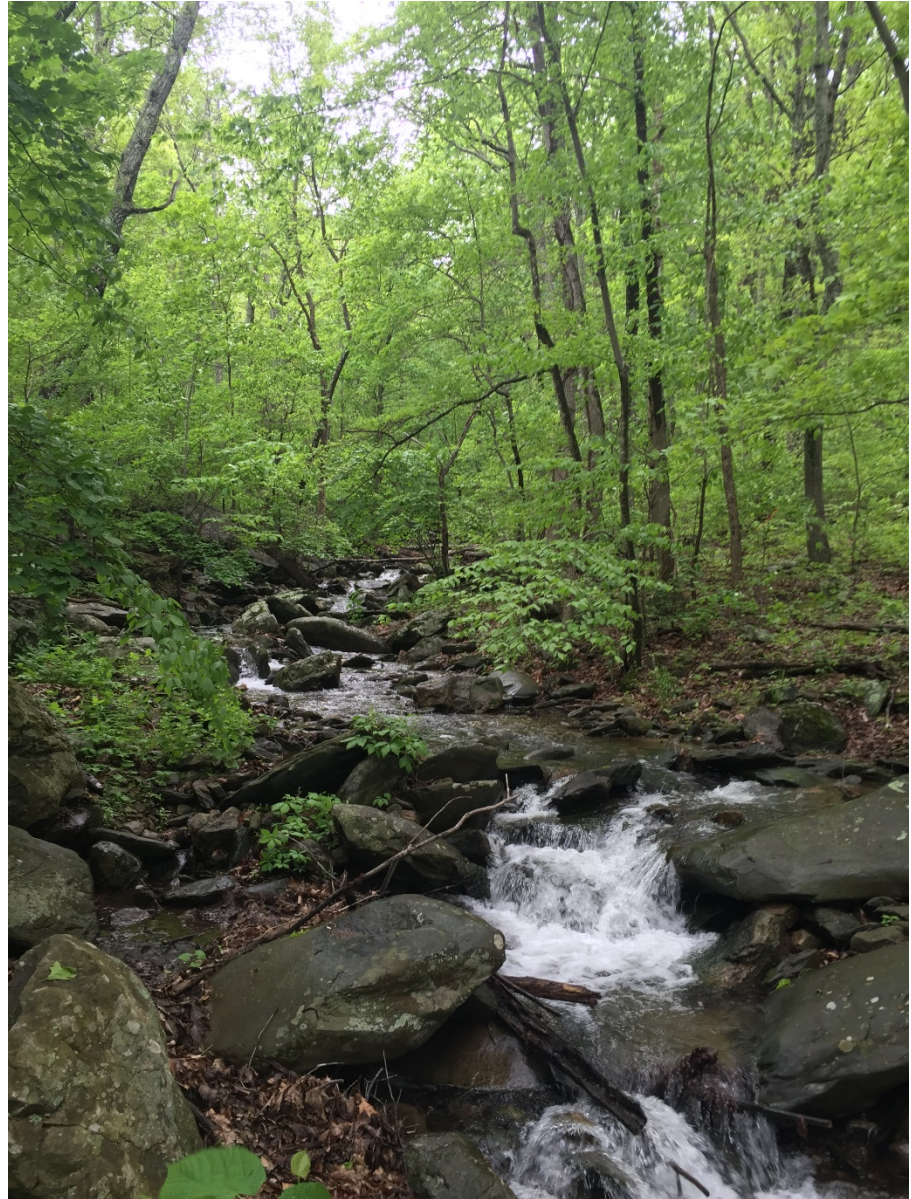
Direction: looking upstream

Description: Step pools with large boulders and well established riparian buffer.

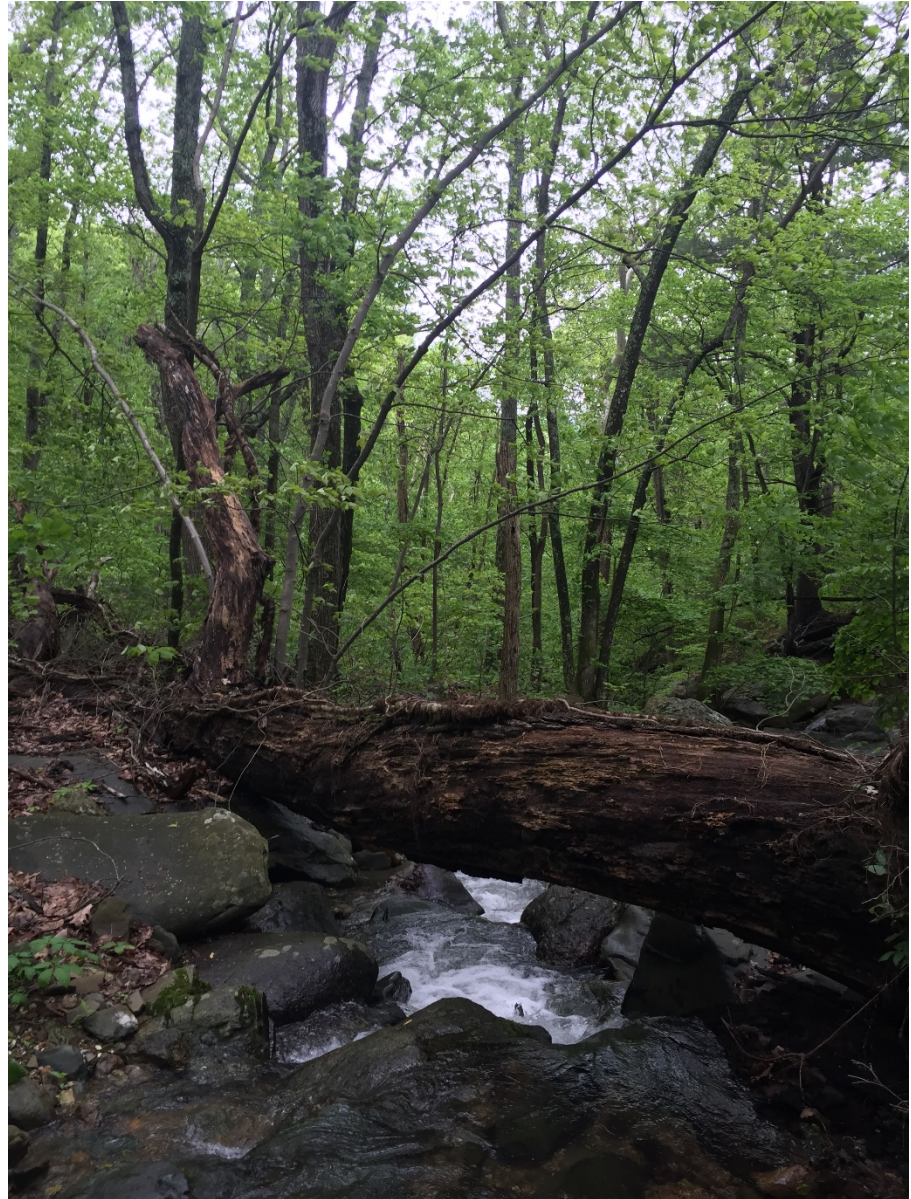
Photograph 2

Direction: looking
downstream

Description: large boulder and cobble bed with little signs of clear under scour at channel spanning log indicating relatively stable bed.

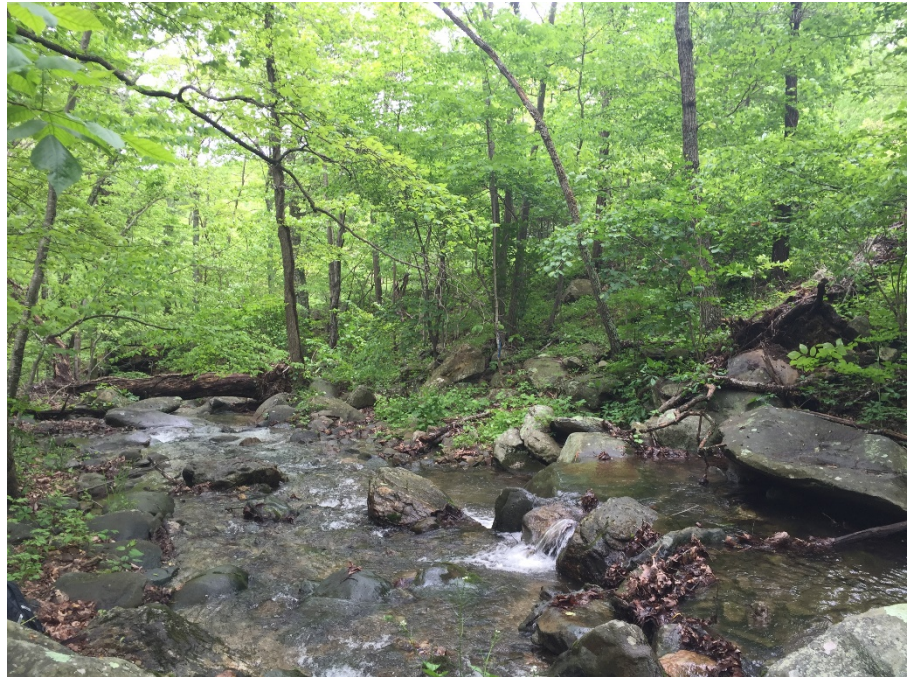
Direction: looking
downstream

Description: well established riparian buffer and valley walls providing lateral confinement. Vertical confinement provided by channel bed materials. Some sands and gravels in depositional pools.

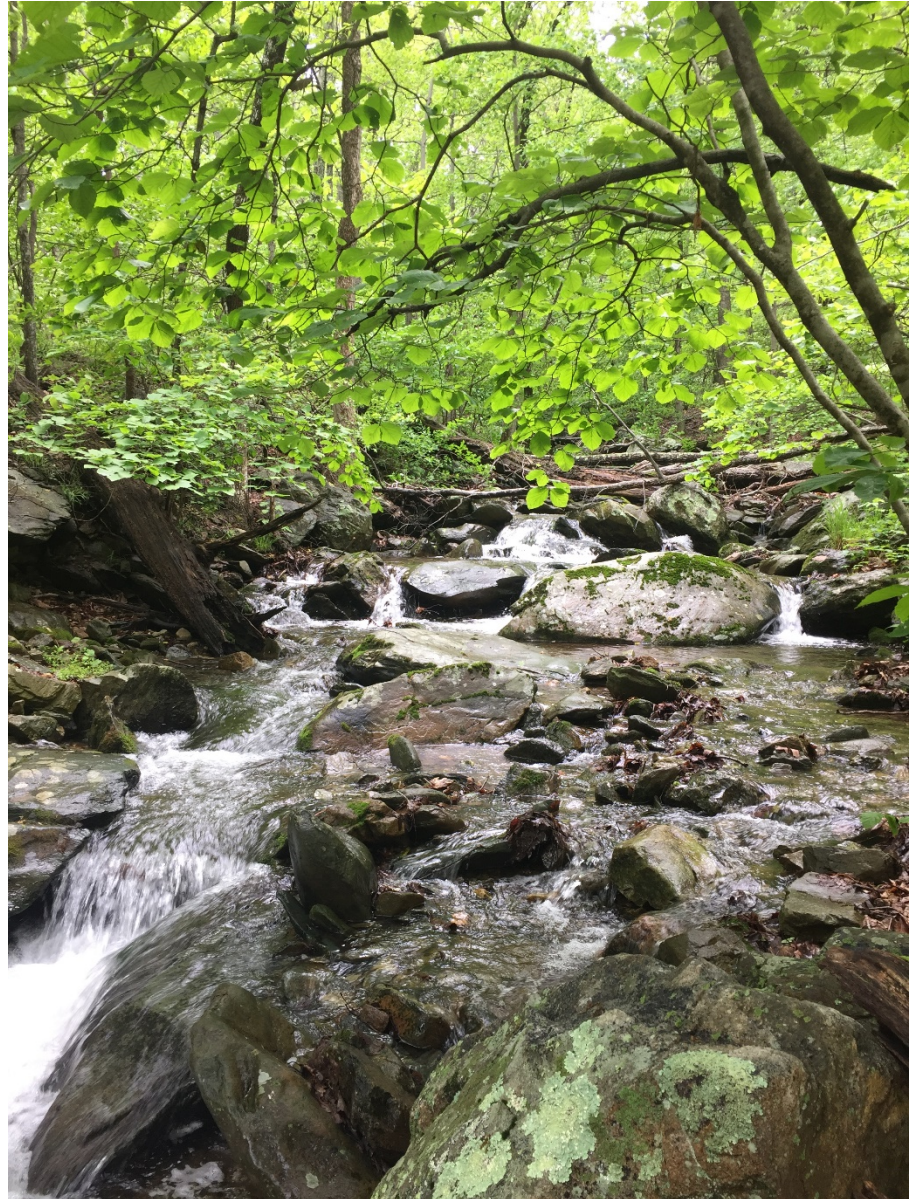
Direction: looking
upstream

Description: bed
characteristics and very
large boulders should be
maintained.

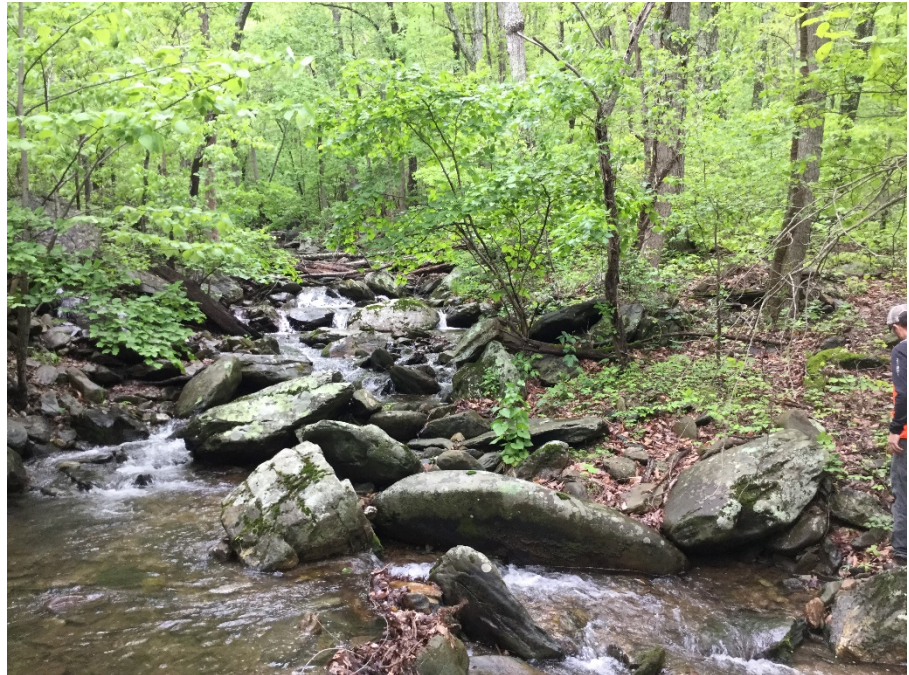
Direction: Upstream

Description: Large boulders (2 to 5 feet at smallest dimension) on cascade stream bed. Right bank is embankment slope to Beech Grove Rd. – State Highway 664.

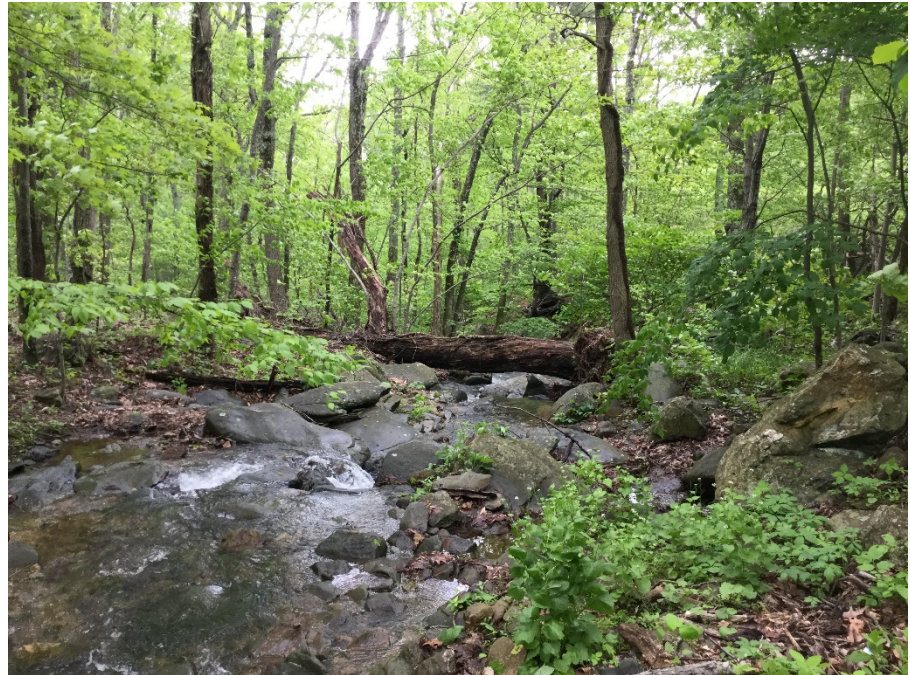
Direction: Downstream

Description: Notice dense
deciduous forest.

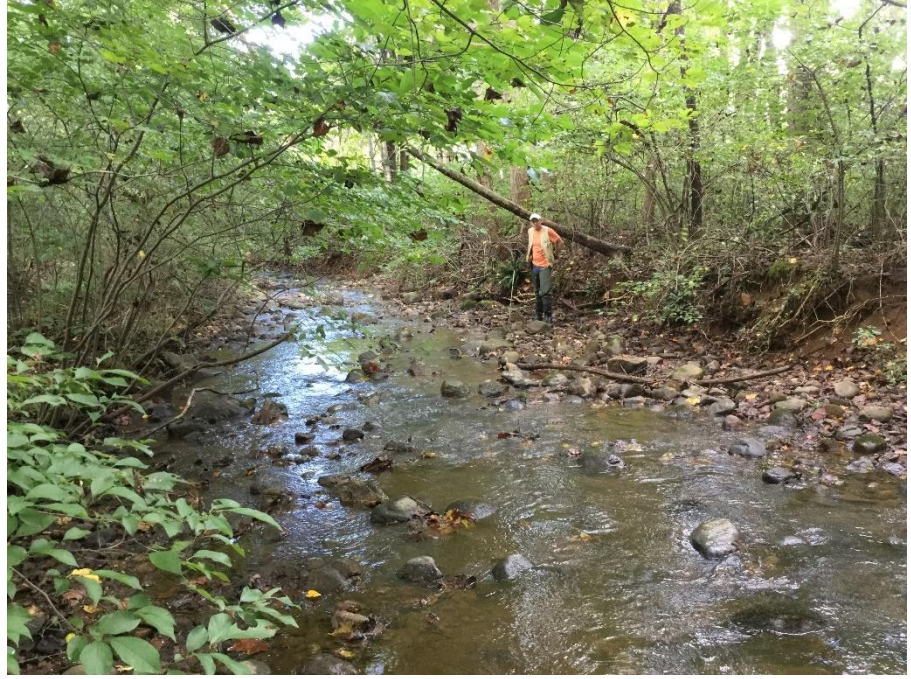
Direction: Downstream

Description: View of cobble-lined stream channel with dense vegetation mostly comprising shrubs and young deciduous trees.

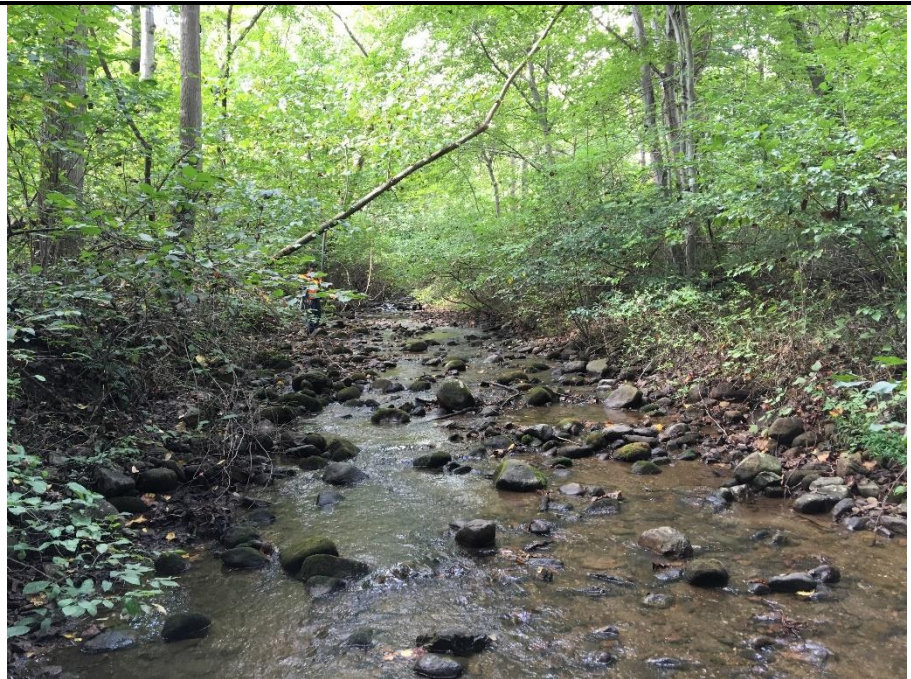
Photograph 2
(IMG_3959.jpg)

Direction: Upstream

Description: Stream bankfull depth (maximum) is approximately 1.8 ft (left bank). Right and left bank high terraces are approximately 4.5 and 5 ft, respectively, with an intermediate terrace on the left bank at 3.2 ft.

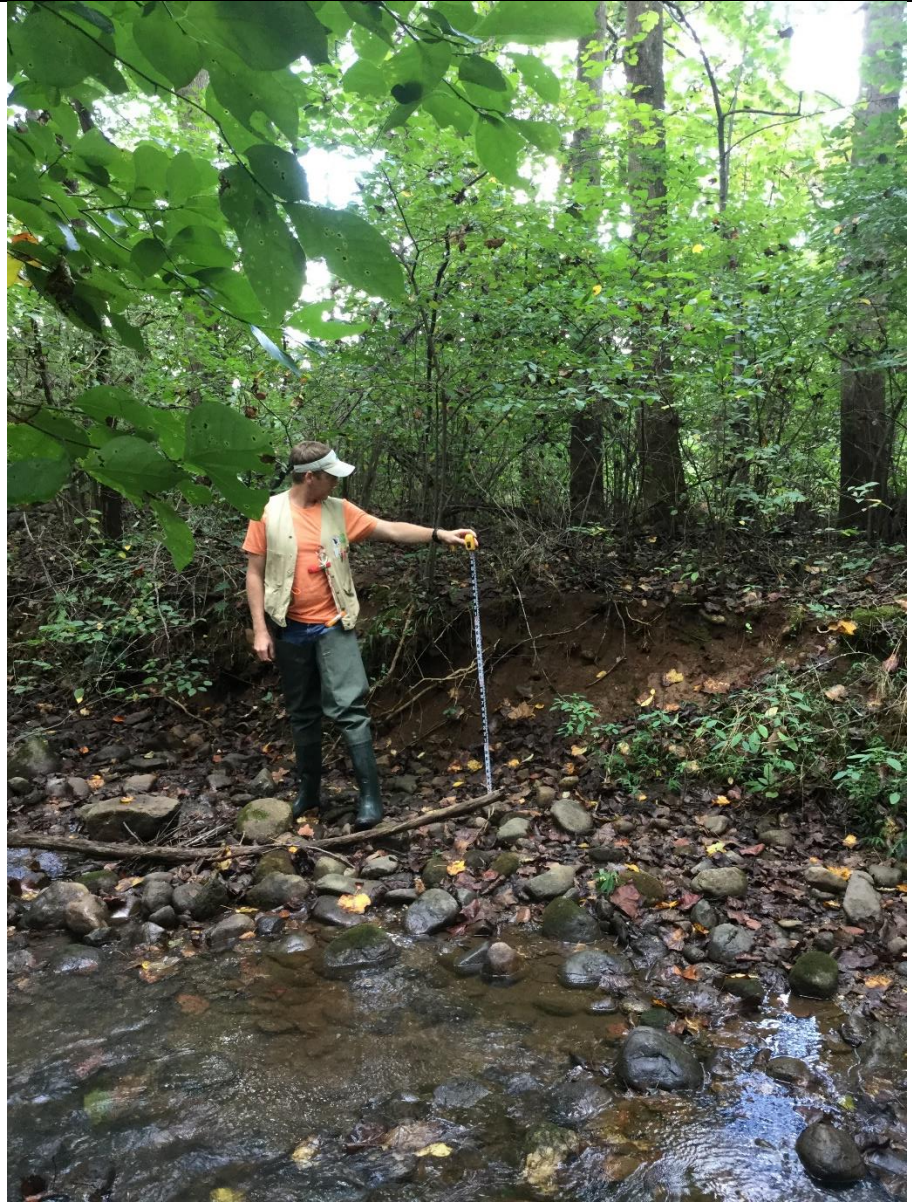
Direction: Towards right
bank

Description: View of
right bank terrace
showing cobble-sized
particles in a fine-grained
matrix at toe of bank with
fine-grained bank
material above.

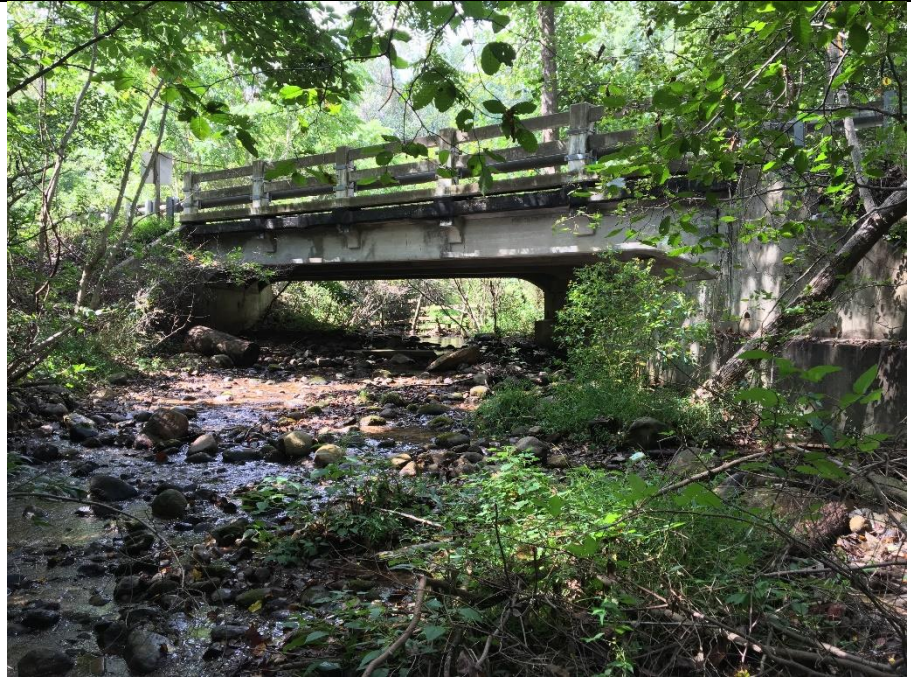
Direction: Upstream

Description: State Rd.
151 bridge located about
200 ft upstream of
crossing that provides
lateral confinement.
Clearance is about 7 ft.

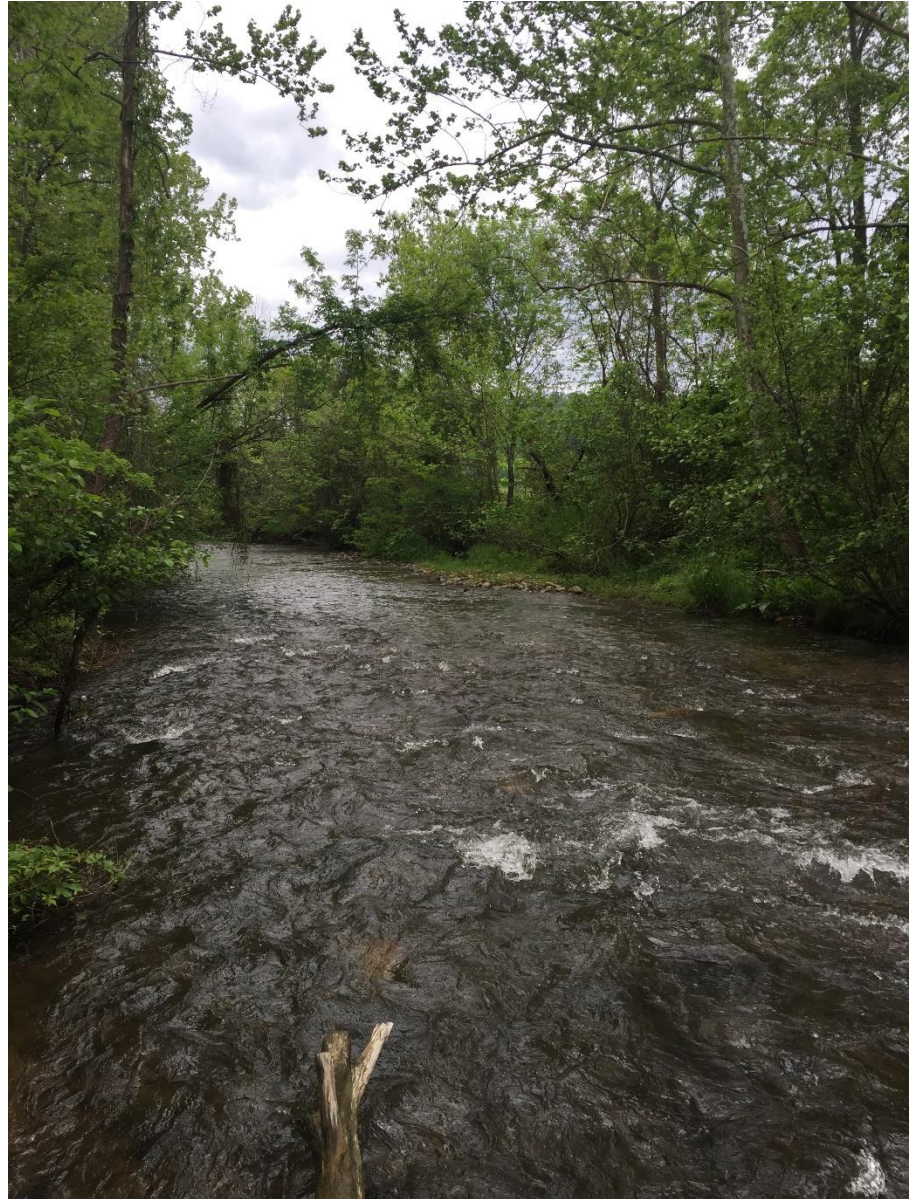
Direction: looking
downstream

Description: Riffle
section with relatively
narrow riparian buffer
and shallow right bank,
well connected
floodplain.

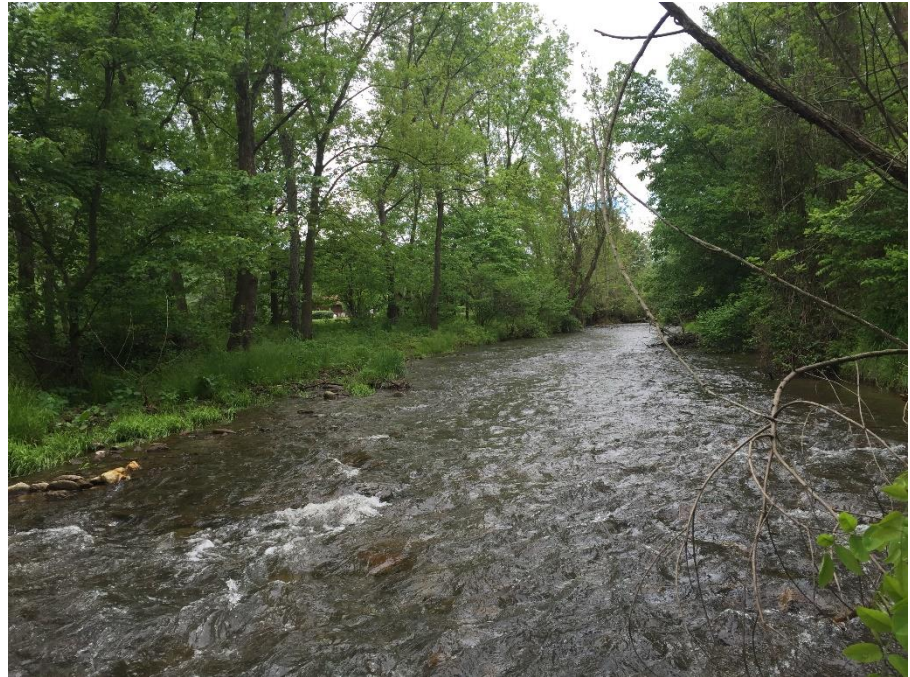
Photograph 2

Direction: looking upstream

Description: thicker riparian buffer and higher banks off left bank with upstream eroded banks visible in the distance.

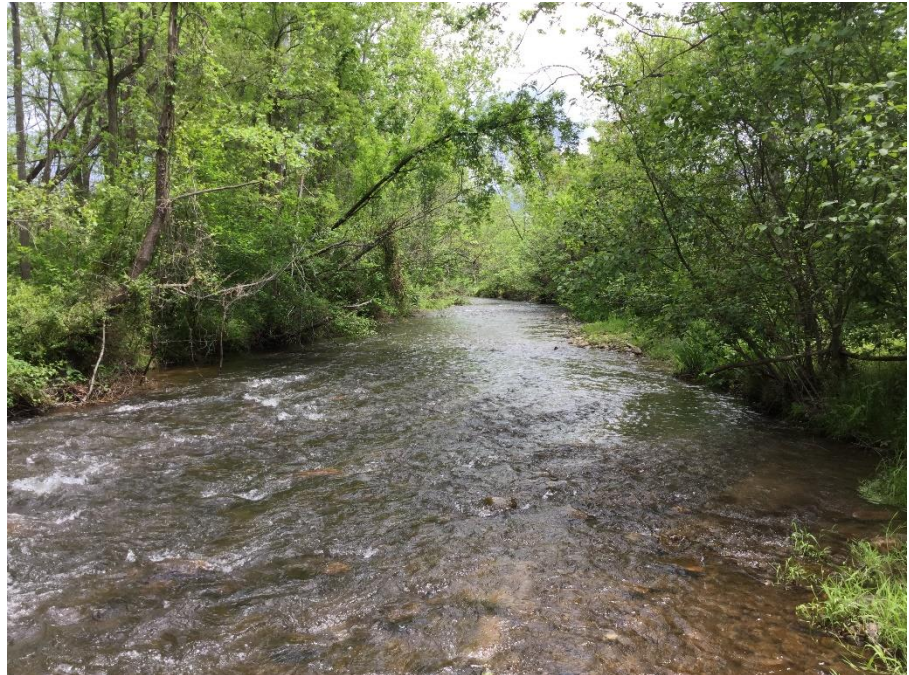
Direction: Downstream

Description: Left bank exhibits wider riparian buffer than is between 5 and 10 river widths, whereas right bank riparian buffer is only about 1 river width. Rounded to subrounded cobbles on stream bed.

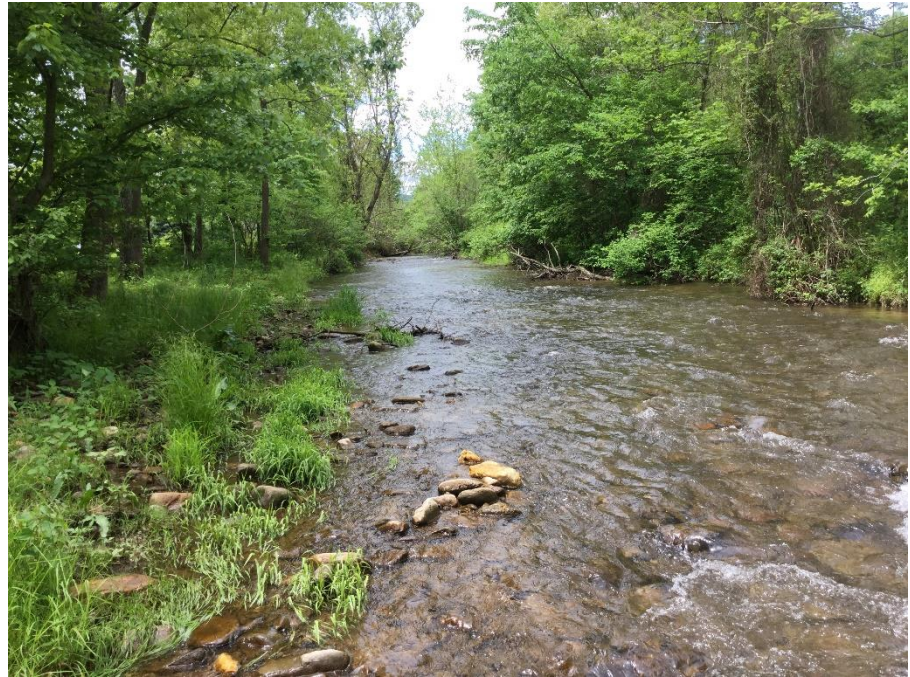
Direction: Upstream

Description: Stream well connected to flood plain with relatively low bank height (2 ft or less at full bank)

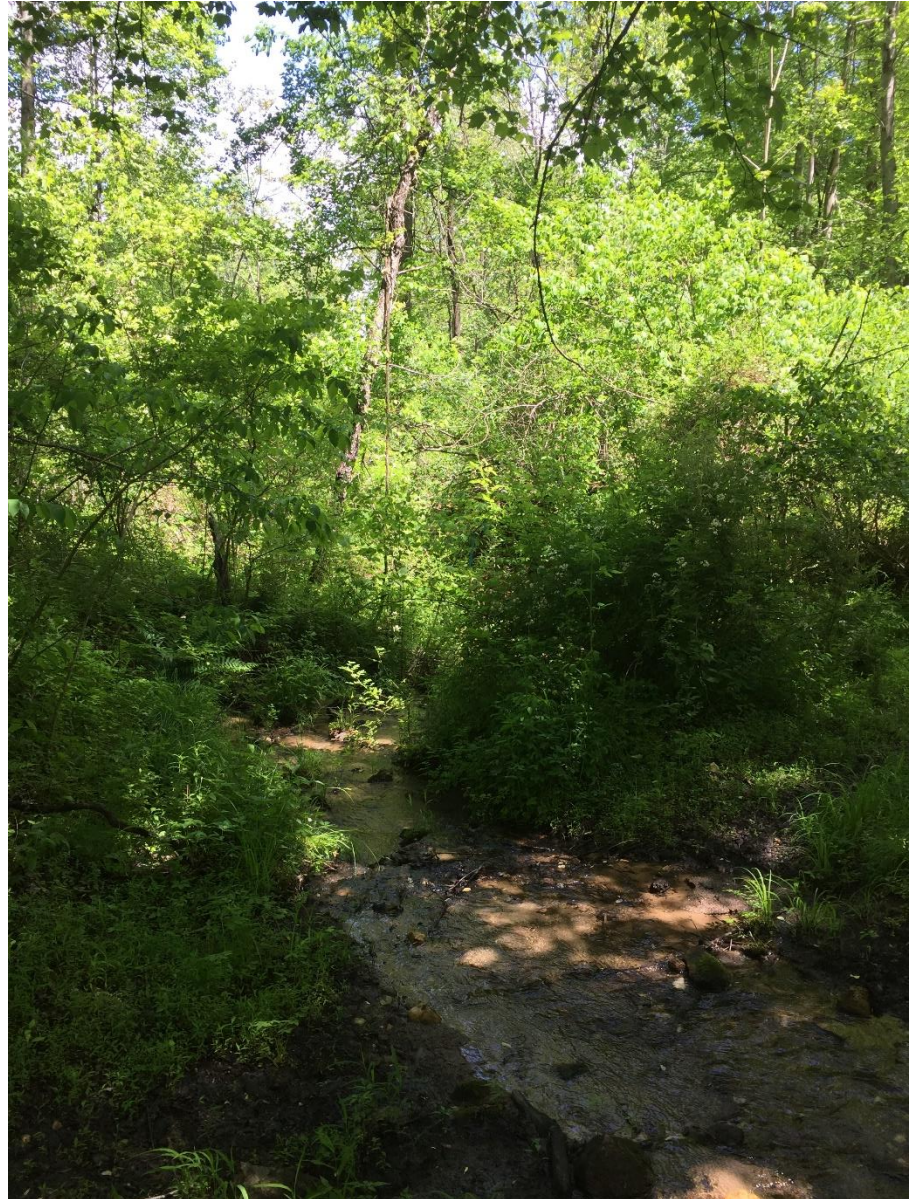
Direction: looking
downstream

Description: thick, well established riparian buffer. Photo taken from small road crossing approximately 20 yards upstream of pipeline crossing.

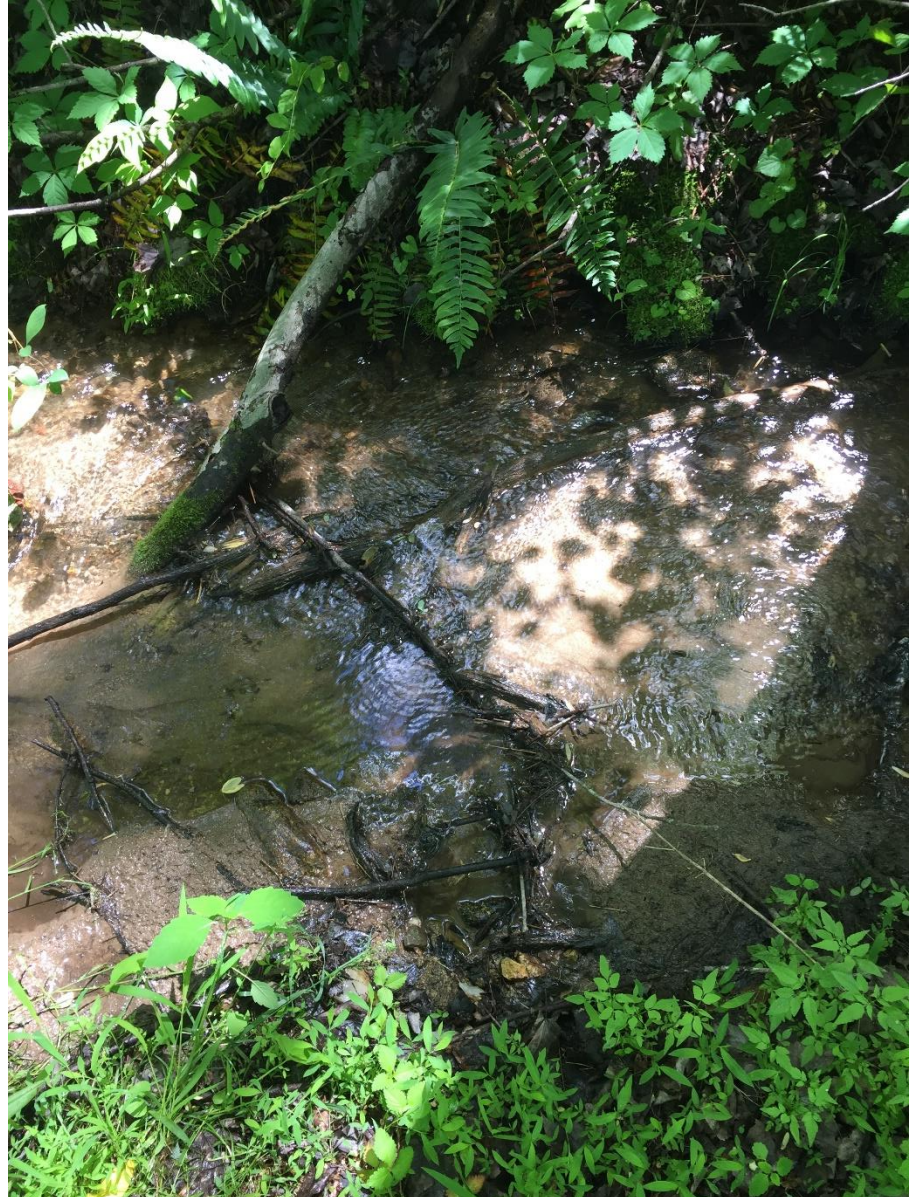
Photograph 2

Direction: looking at
across stream, flow to the
left

Description: minor debris
embedded into
predominantly sand
channel.

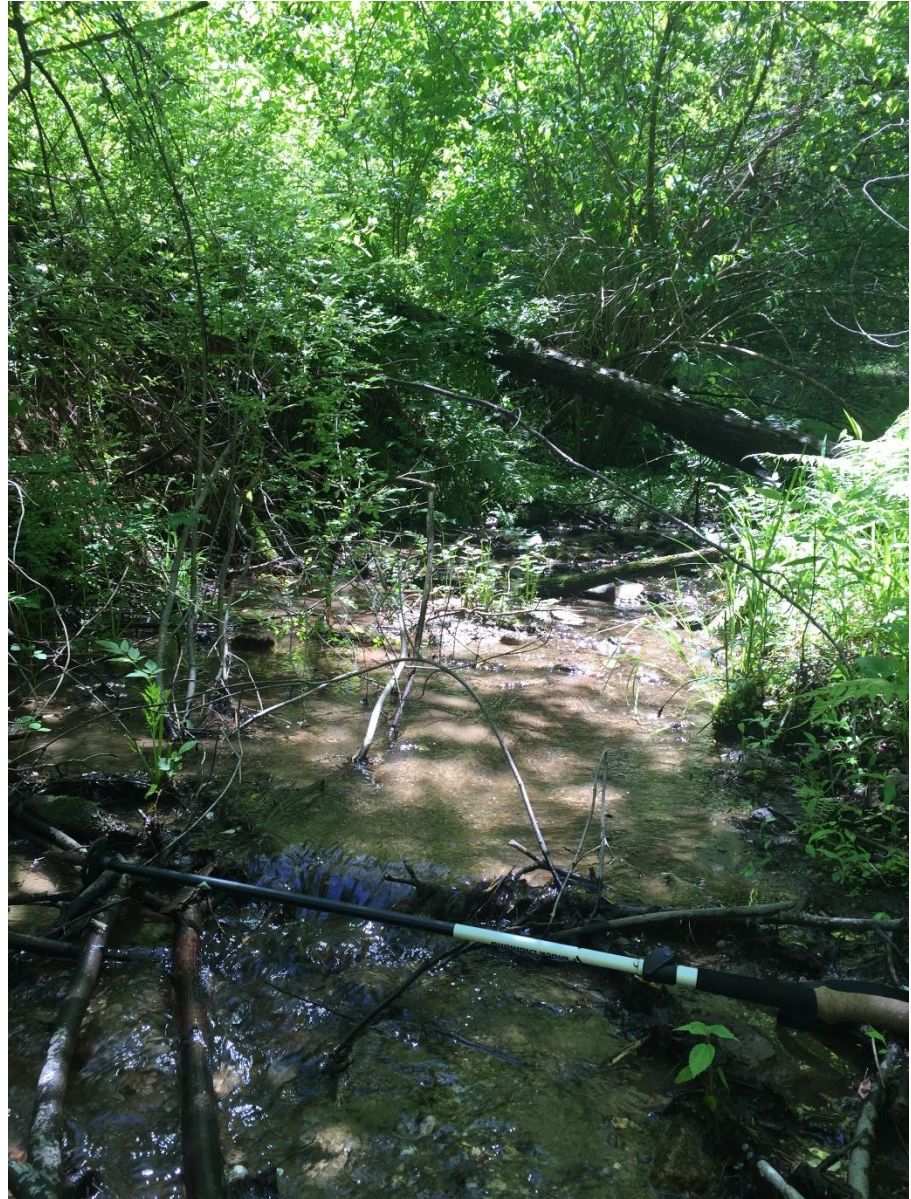
Direction: looking upstream

Description: minor debris in channel with lateral confinement provided by local topology and riparian buffer, trekking pole shown for scale.

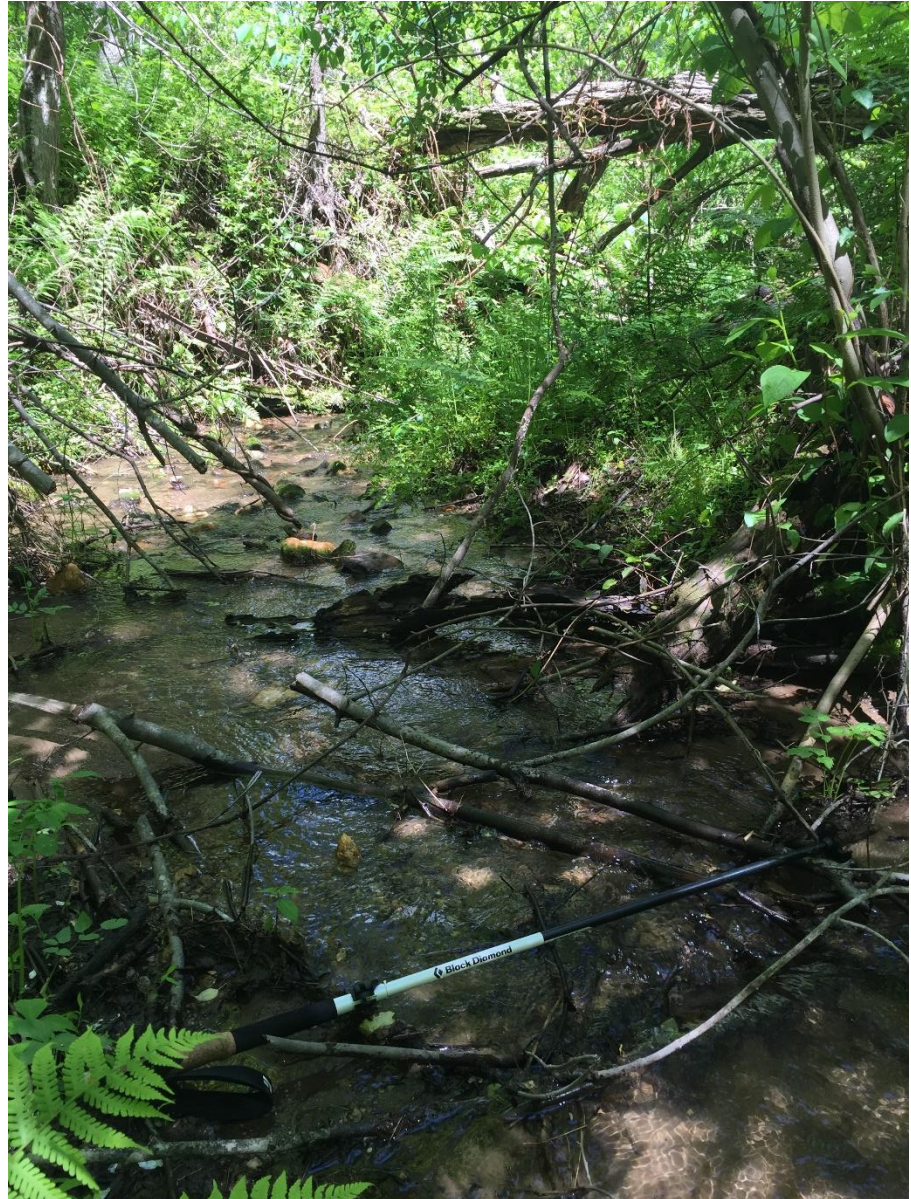
Direction: looking
downstream

Description: thick riparian buffer and local topology providing lateral confinement. Eroded banks on outside of bends, trekking pole shown for scale.

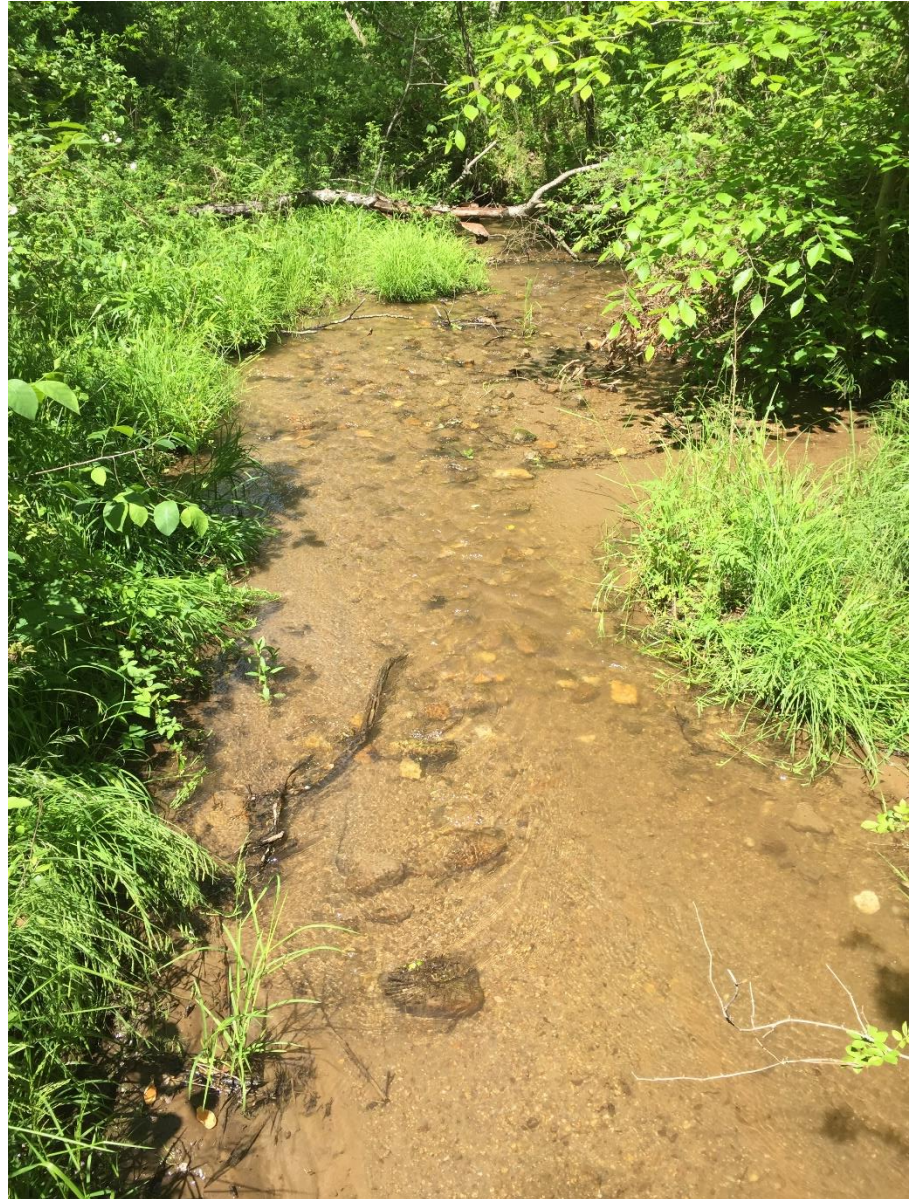
Direction: looking
downstream

Description: large fraction of sand characteristic of channel bed along with some cobbles and well established riparian buffer off both banks. Main channel of two shown. Similar channel approximately 55' off left bank. Confluence point prior to downstream culvert.

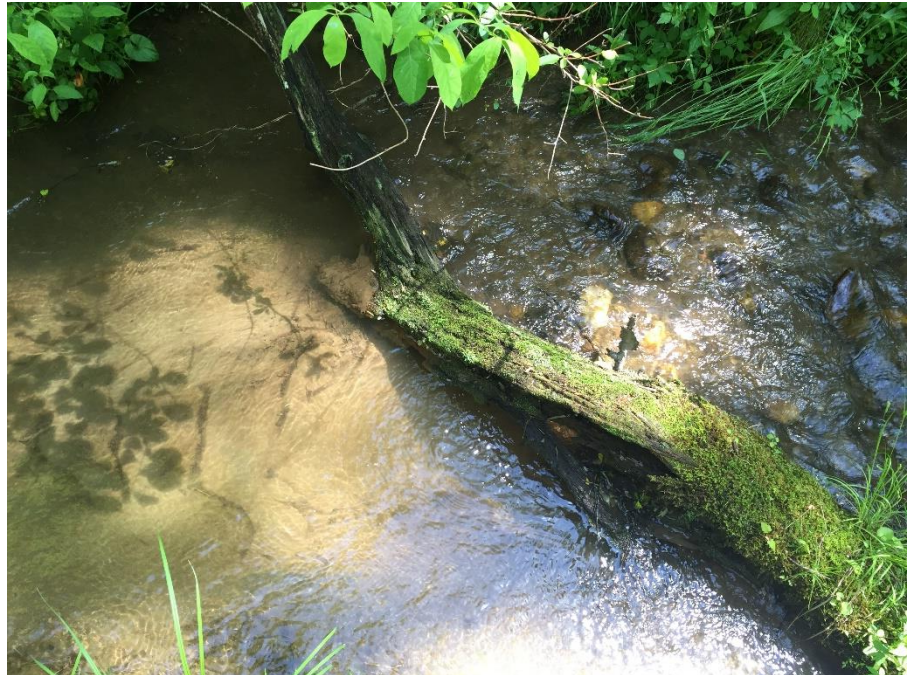
Photograph 2

Direction: looking at
across stream, flow to the
right

Description: minor debris
and change in bed slope
indicated by change in
bed materials. Upstream
of crossing.

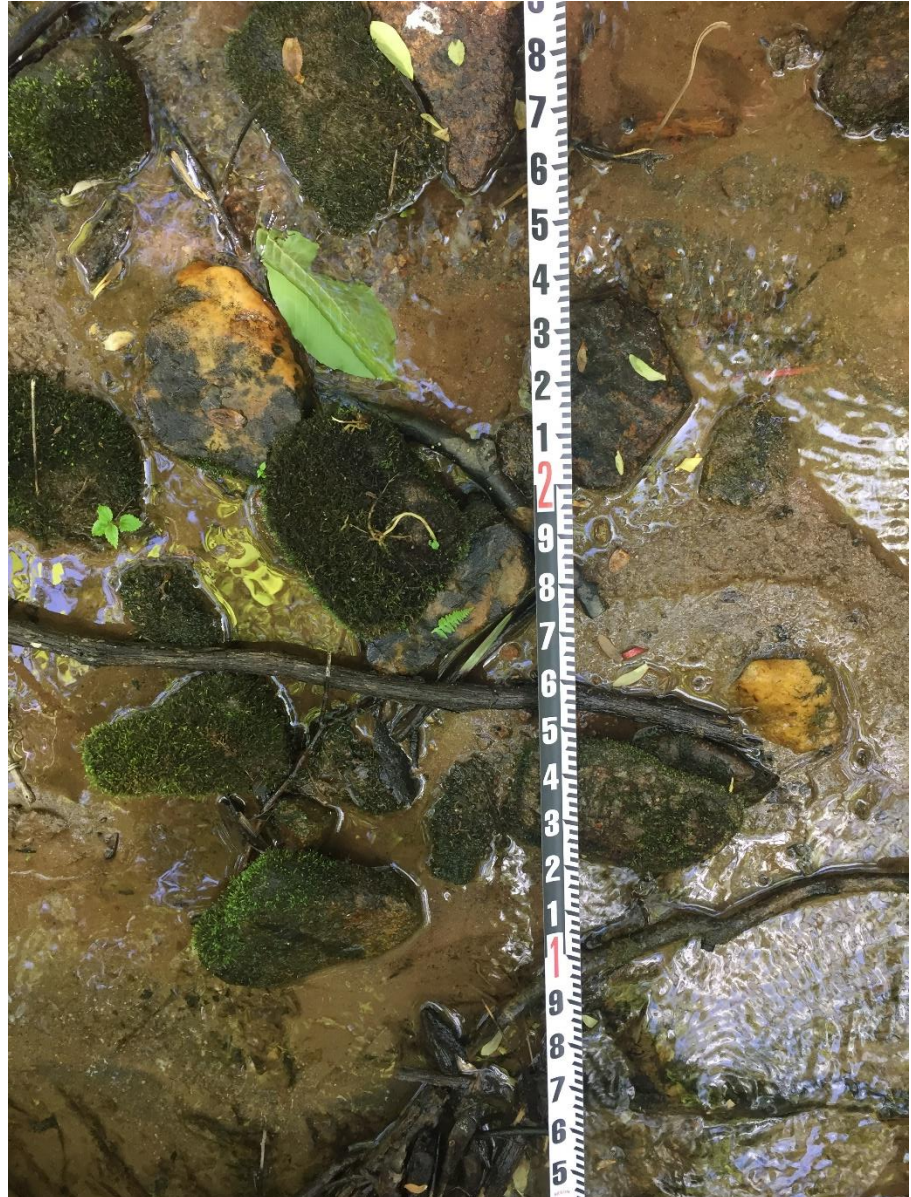
Direction: looking down
at channel bed, flow to
the right

Description: scale
showing relative size of
the larger cobbles,
embedded in sand.

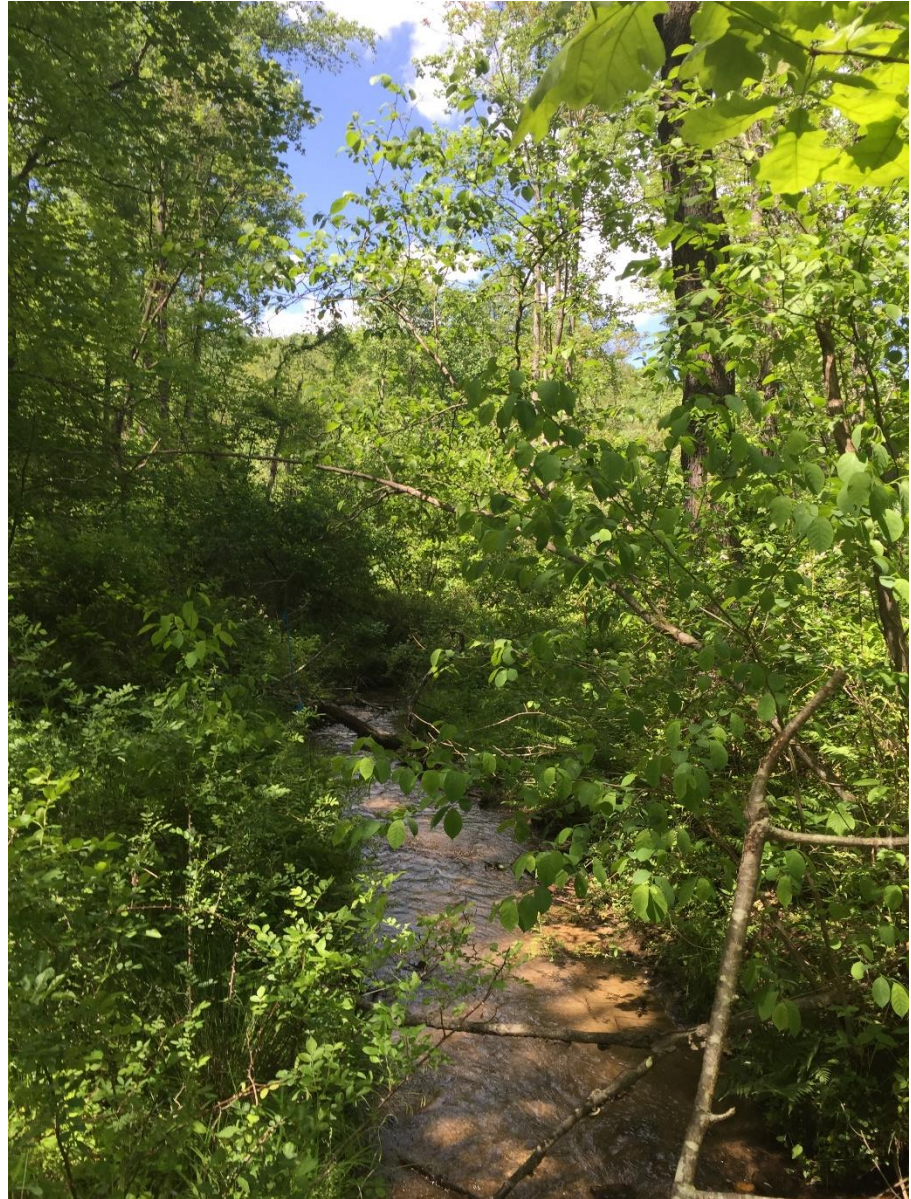
Direction: looking downstream

Description: thick riparian buffer and local topology providing lateral confinement. Multiple threads of channel present along with minor debris and fallen tree limbs.

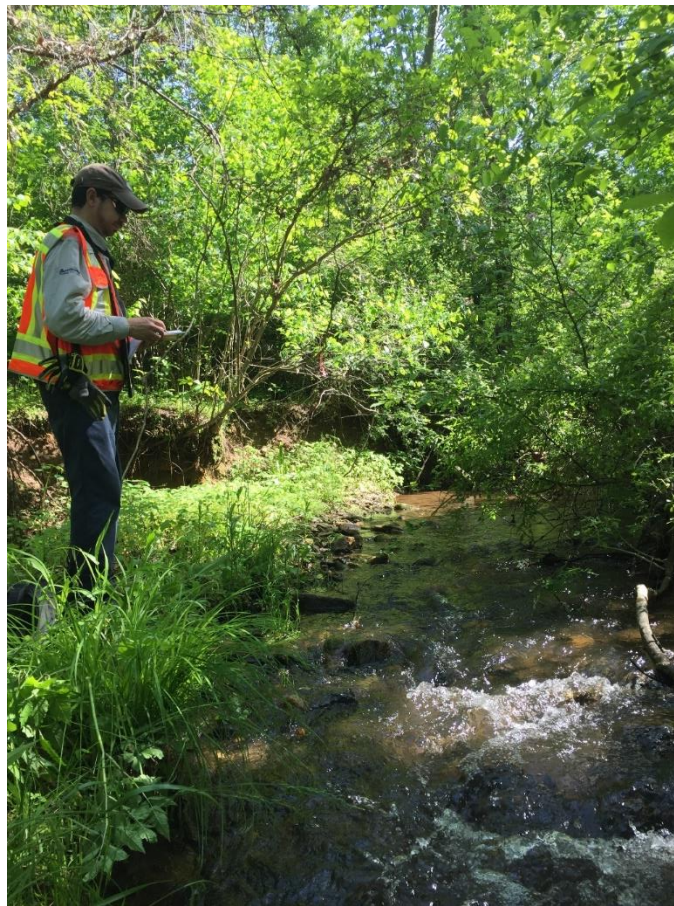
- Headcut (approximately 1.5 feet bed elevation change) observed downstream of crossing, being held from migration by tree root across channel.
- Channel bed comprised of cobbles and medium to fine gravels with sand in depositional areas.

Direction: looking upstream on SC_0462

Description: thick, well established riparian buffer. Steep eroded banks on outside of bend near steeper stream section. Crossing upstream of riffle.

Evaluate scour depth for pipeline burial depth. Given potential for debris flows, sag bends should be located at valley edges. If bedrock is encountered shallower than proposed burial depth, burial in bedrock is recommended.

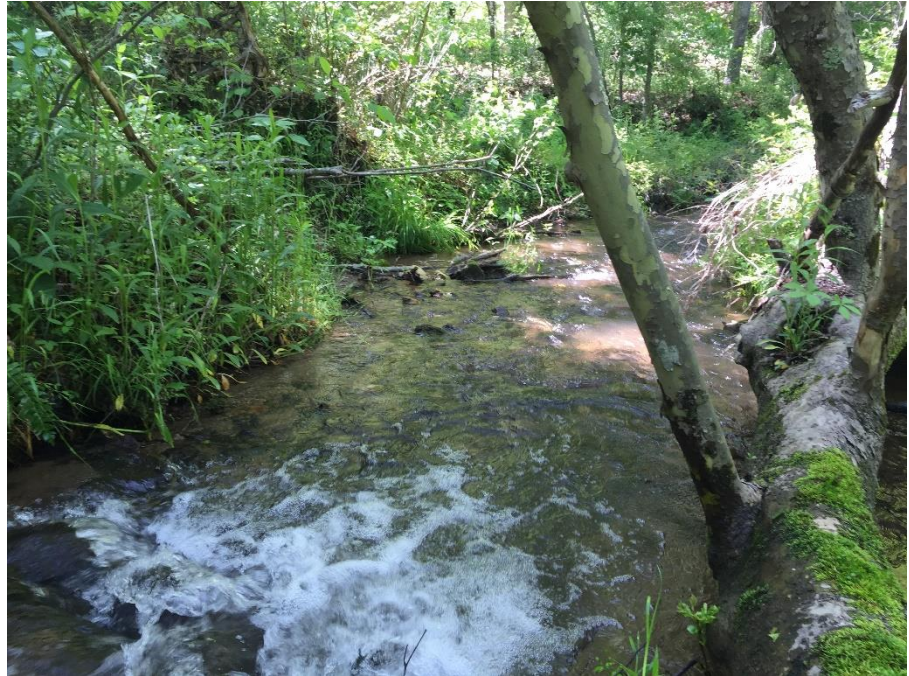
Photograph 2

Direction: looking
downstream on SC_0462

Description: head cut
being held from migrating
by riparian root growth in
channel. Tree on right of
photo with main trunk
growing horizontal and
roots into channel.

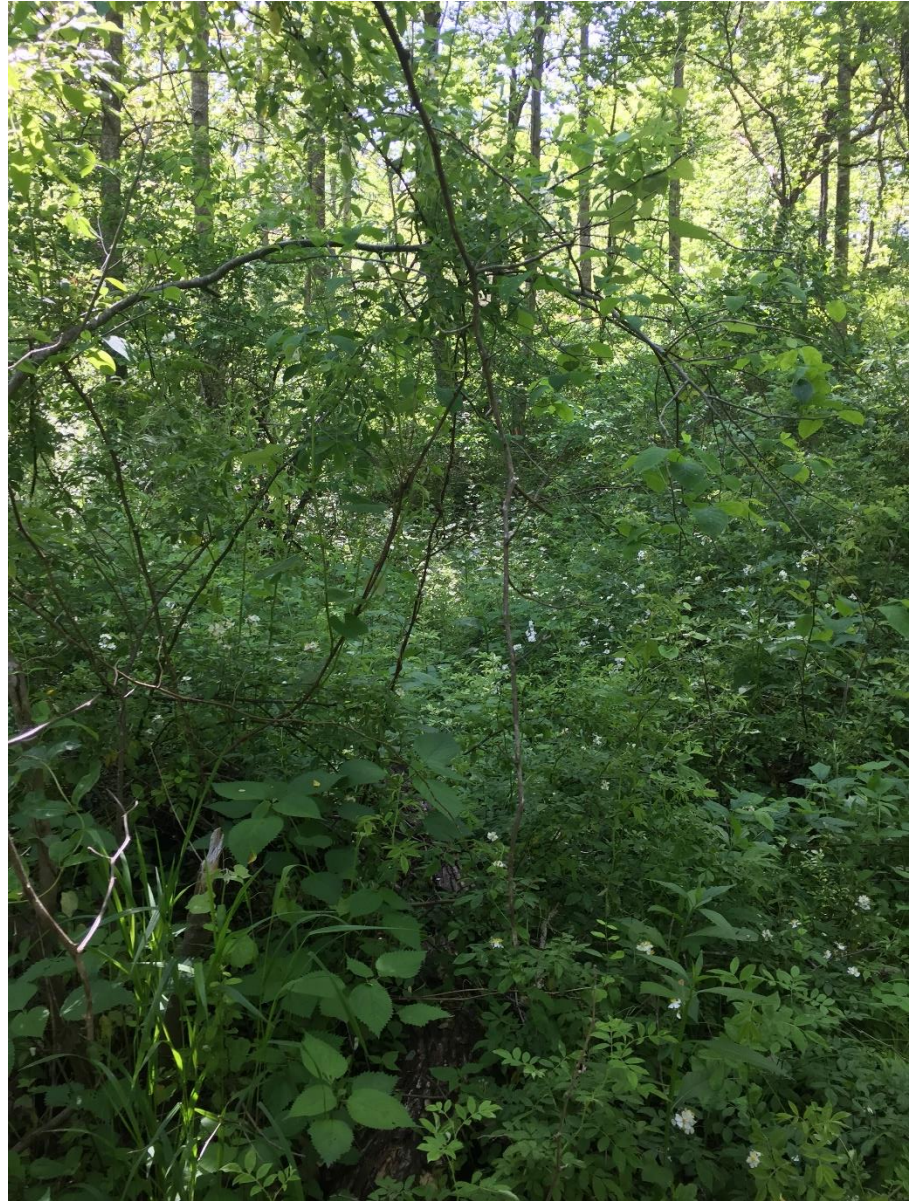
Direction: looking across
riparian buffer, stream
flow to the right

Description: thick
riparian buffer throughout
valley.
