TID	SC_0799	ACP Segment	AP-1
Stream Name	Pond Hollow	MP	158.91
Survey Date	13-May-2016	Start Time	1100 hrs

Client: Atlantic Coast Pipeline

Project Number: TXG0007

Stream Crossing Plan View and Profile

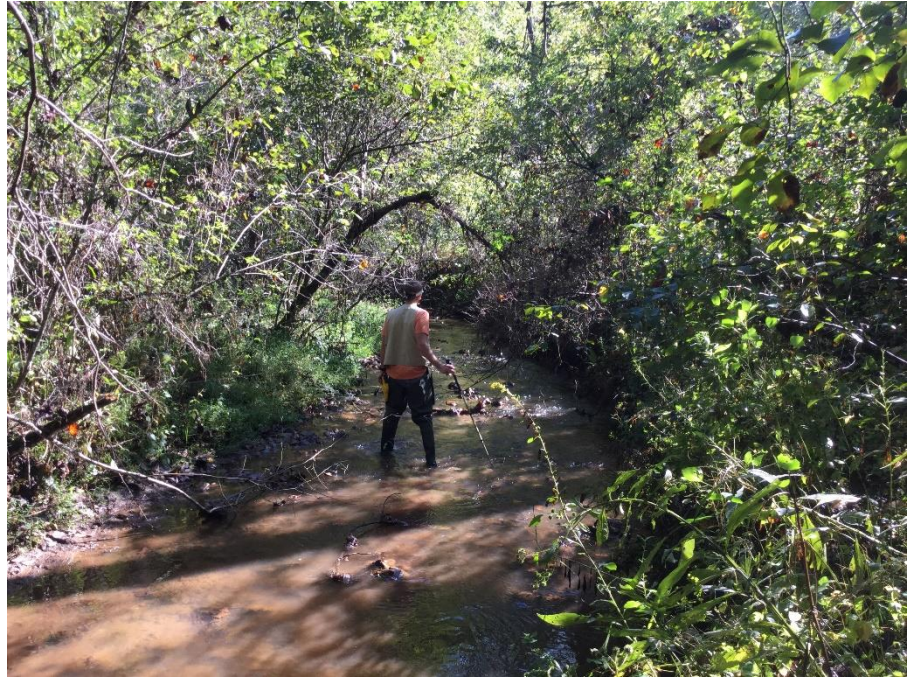
Direction: Downstream

Description: View of densely vegetated narrow riparian buffer (1 channel width on both banks) and entrenched stream at pipeline crossing. Bankfull width is 16.5 ft and depth (maximum) is 1.8 ft. Right bank terrace is 7-ft high and left bank terrace is 5-ft high.

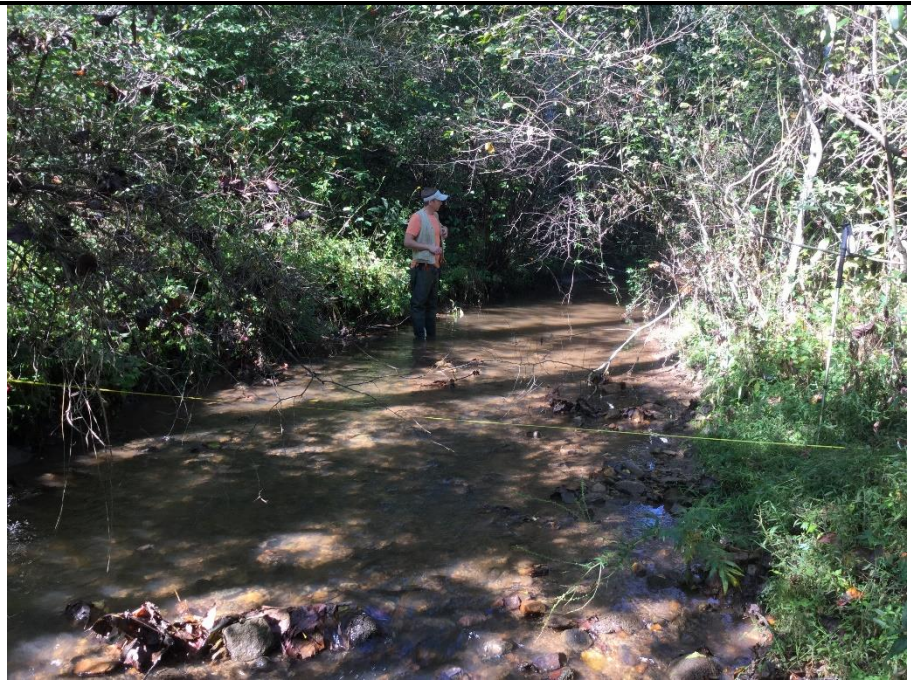
Photograph 2
(IMG_1125.JPG)

Direction: Upstream

Description: Stream bed is comprised of gravel armor and some cobble-sized particles. The water is turbid due to precipitation prior to survey.

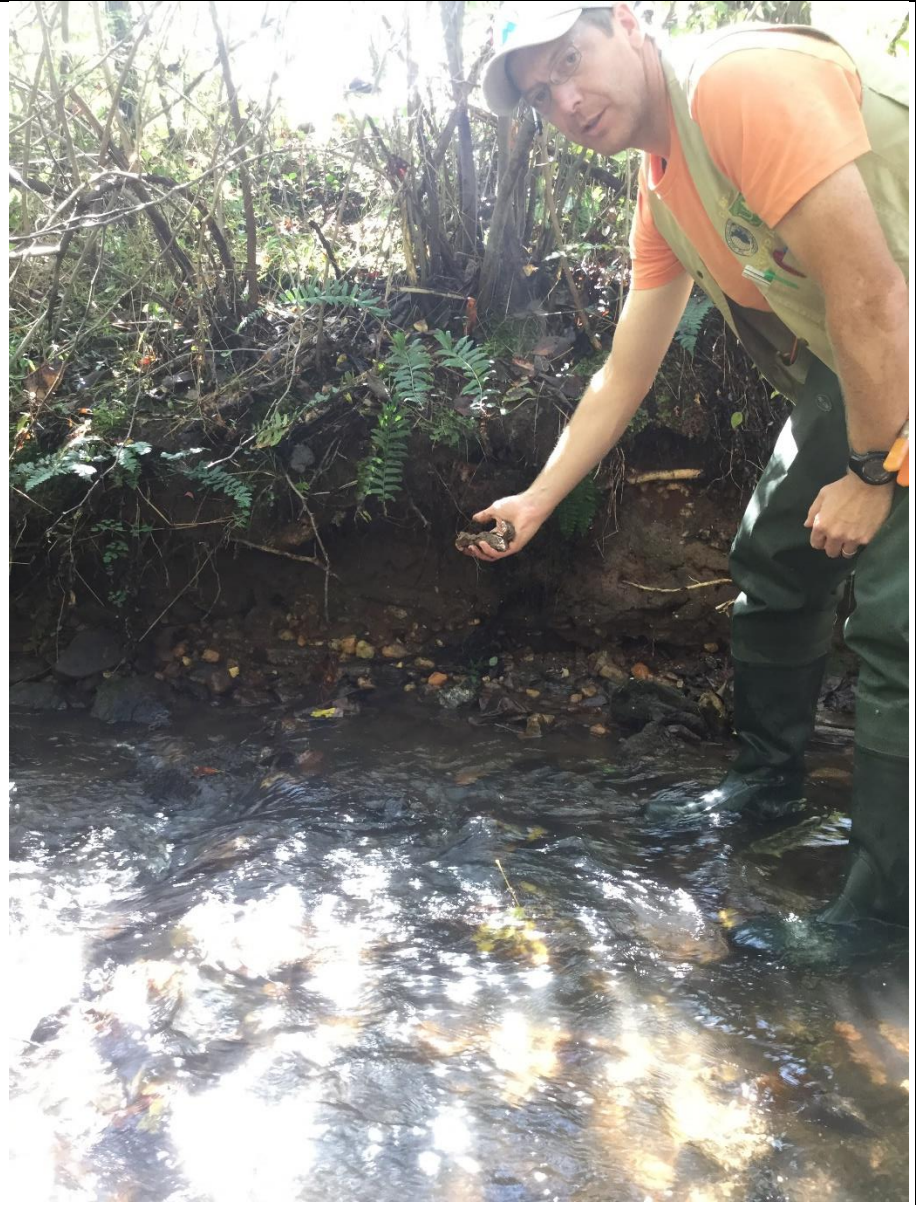
Direction: Towards right
bank

Description: Layering of coarse gravel-sized particles on right bank overlain by fine grained soils with possible outcrop of weathered bedrock (or boulder) at toe of bank below water surface.

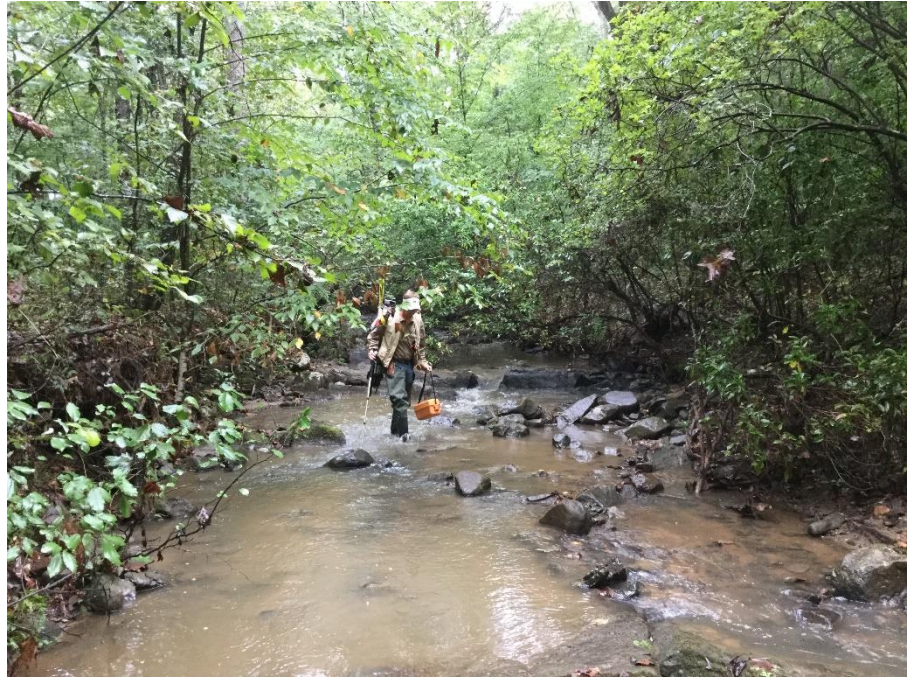
Description: View of densely vegetated riparian buffer along a straight reach at pipeline crossing. Stream comprises large cobbles and some boulders and underlain by bedrock. The water is turbid because survey was conducted in the morning following precipitation.

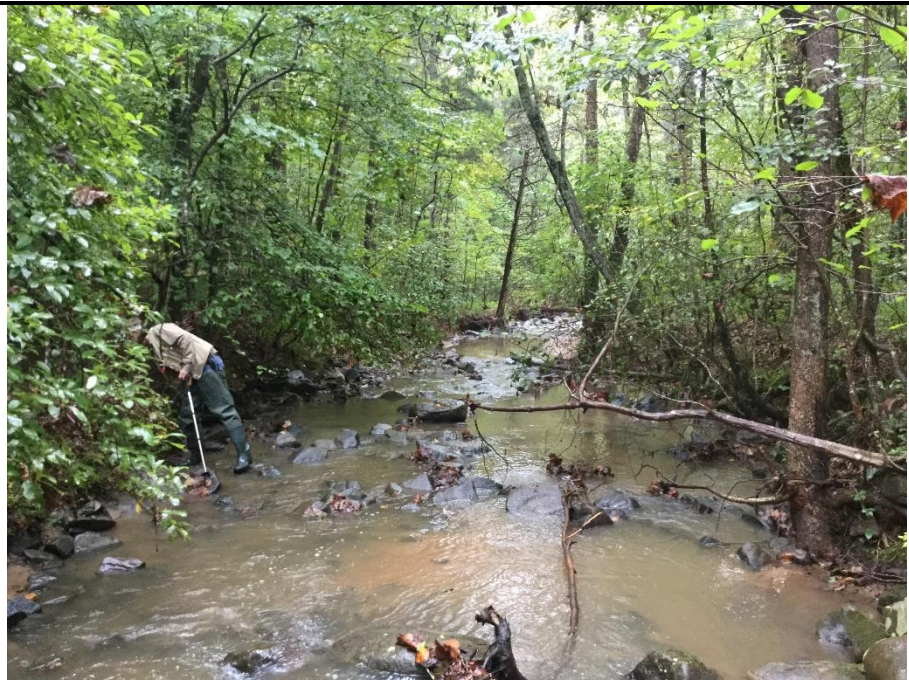
Photograph 2
(IMG_1113.JPG)

Description: Similar observations as above in this downstream view. Stream bankfull width is 19 ft and depth (maximum) is 2.1 ft. Right and left bank terraces are 3 ft above bankfull.

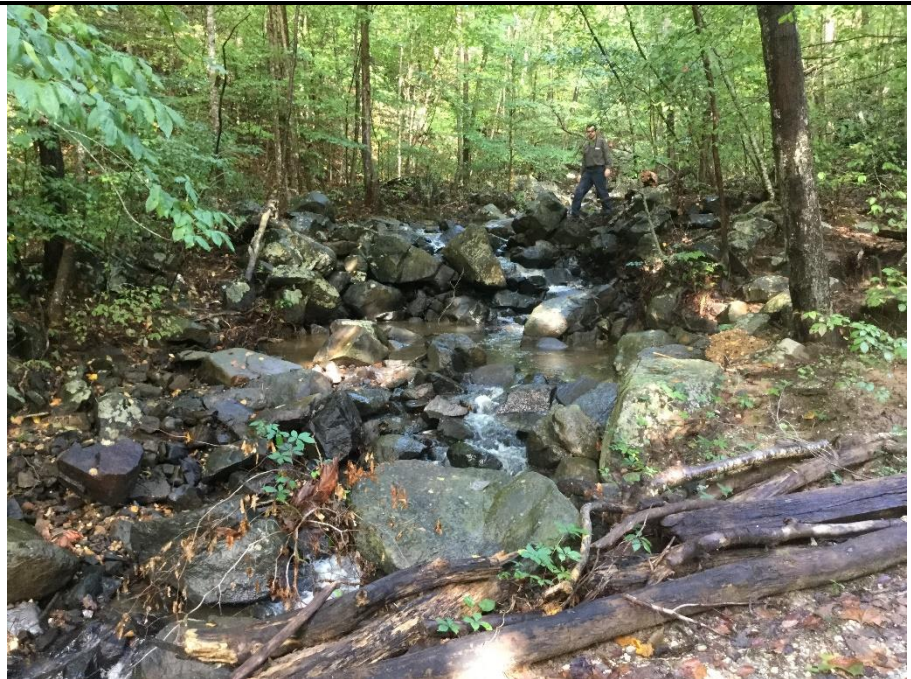
Description: View of step pool morphology with stream bed dominated by boulders at a road crossing about 0.8 miles upstream of pipeline crossing.

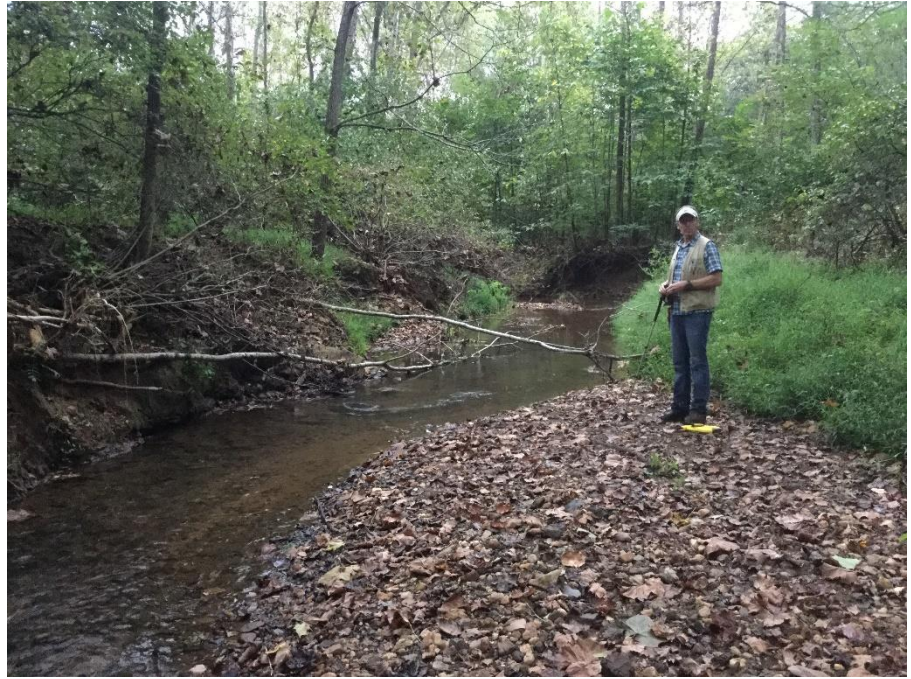
Description: View of point bar and meander at pipeline stream crossing, where stream bed comprises coarse sand and fine and coarse gravel. Stream bankfull width is 26 ft and depth (maximum) is 3.2 ft (cross-section was at a pool).

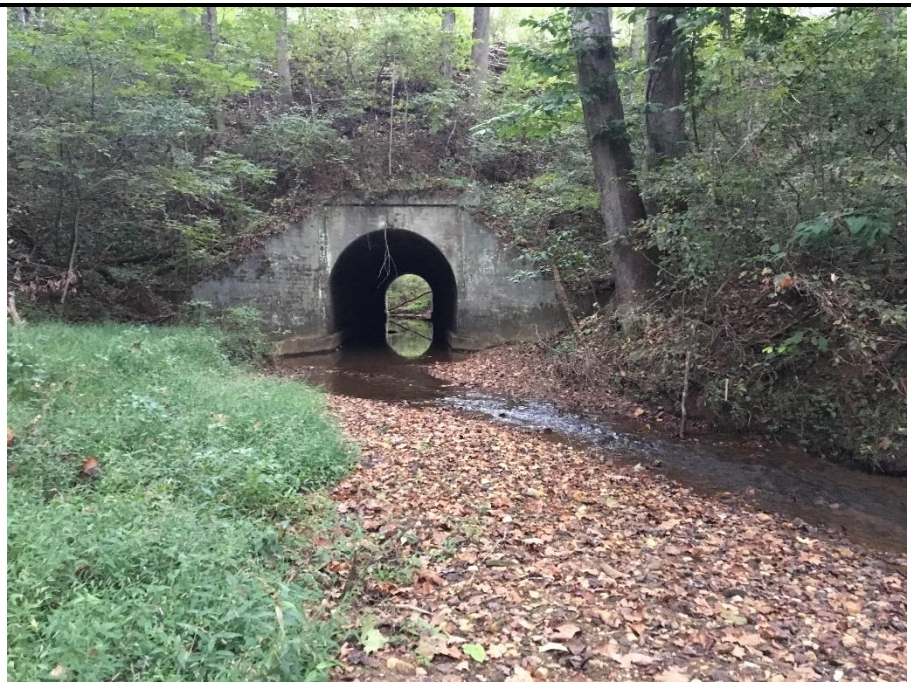
Photograph 2
(IMG_3923.JPG)

Description: 14-ft wide tunnel underneath embankment of abandoned railroad. This upstream structure provides lateral confinement.

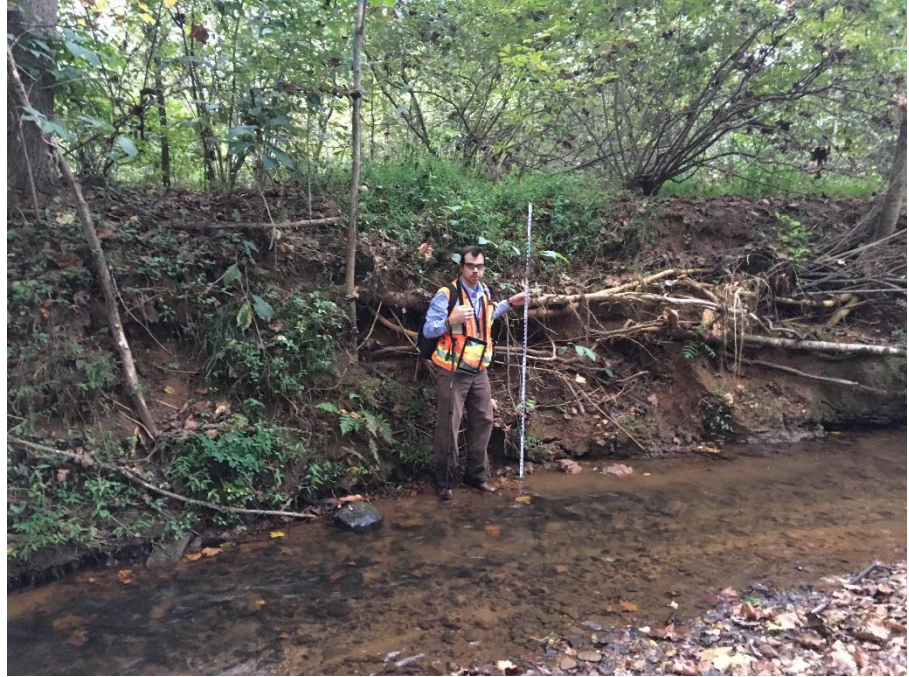
Description: View of steep 7-ft high left bank terrace at meander comprising silt and fine sand and densely vegetated riparian buffer of young and mature trees and shrubs.

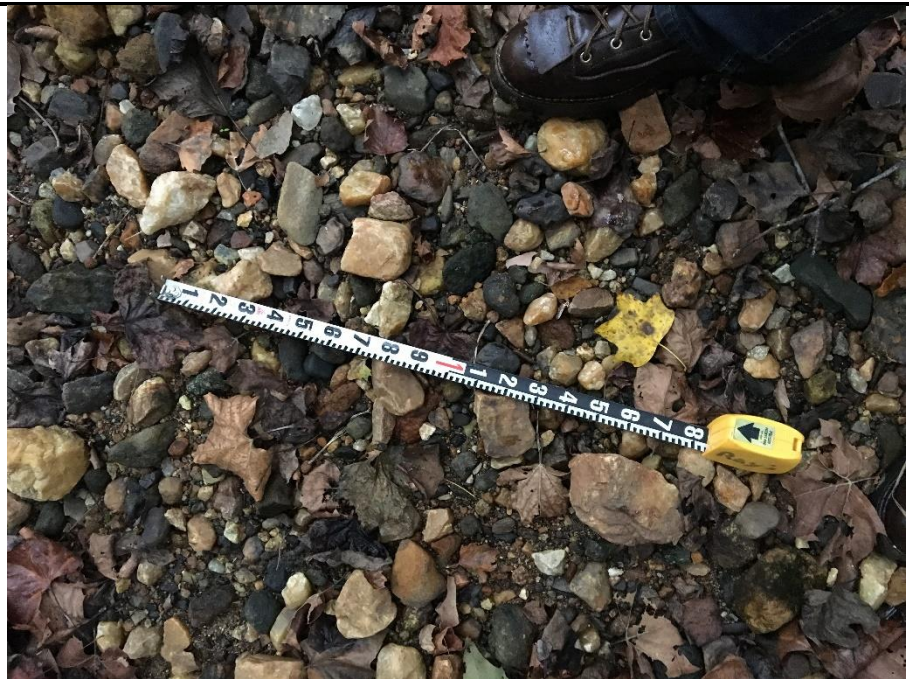
Photograph 4
(IMG_3928.JPG)

Description: View of coarse sand to coarse gravel particle sizes at point bar.

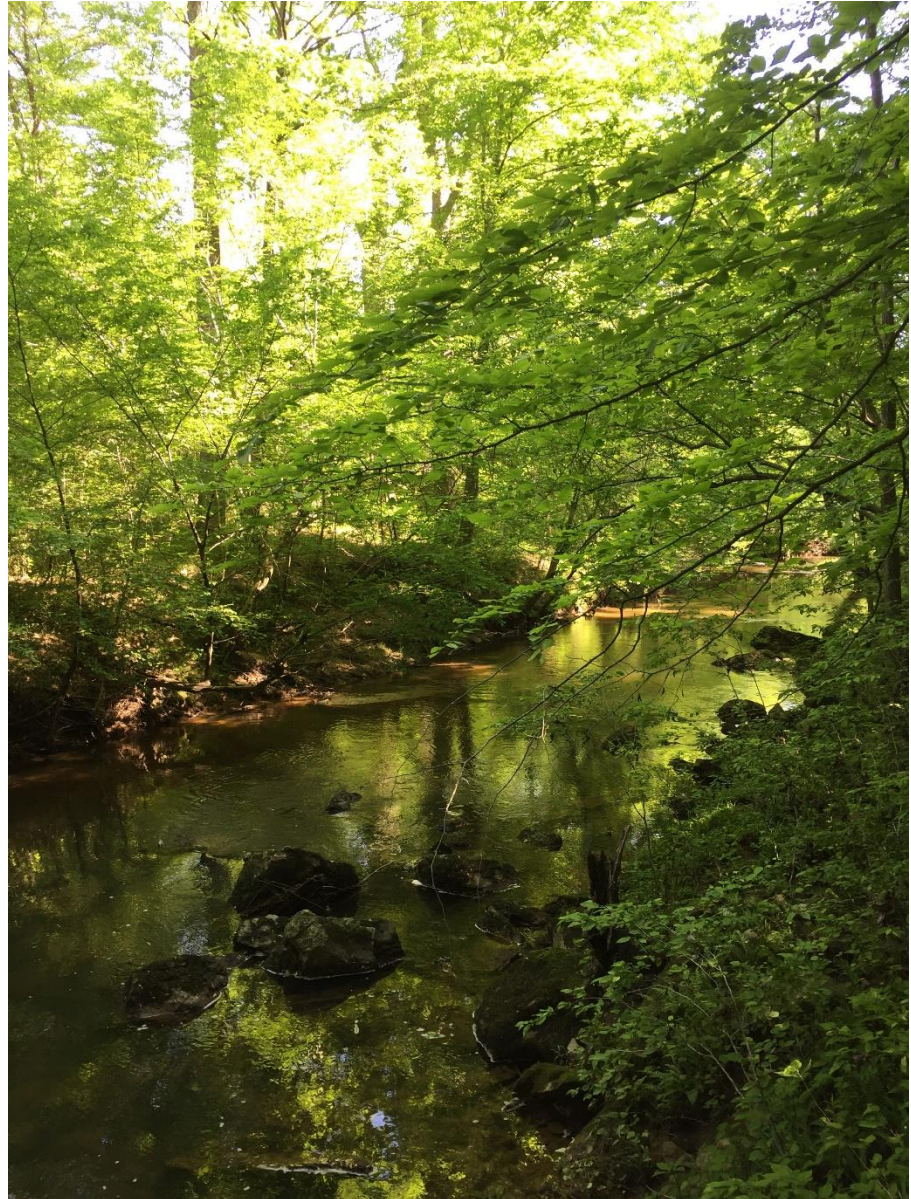
Description: thick, well established riparian buffer. Lateral confinement provided by valley walls and riparian buffer.

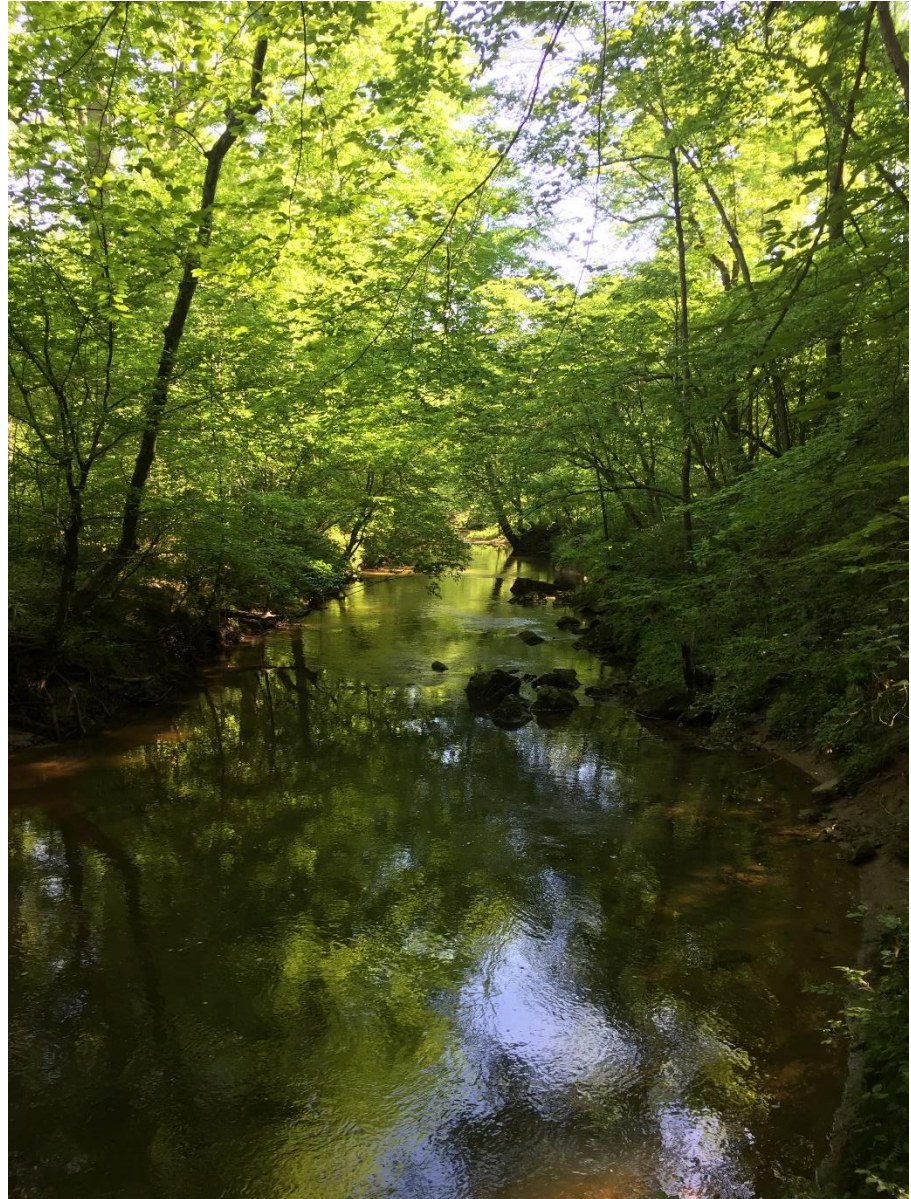
Description: relatively
steep banks in vicinity of
crossing and historical
channel incision.
Maturity of some trees
near bank indicating slow
rates of fluvial erosion.

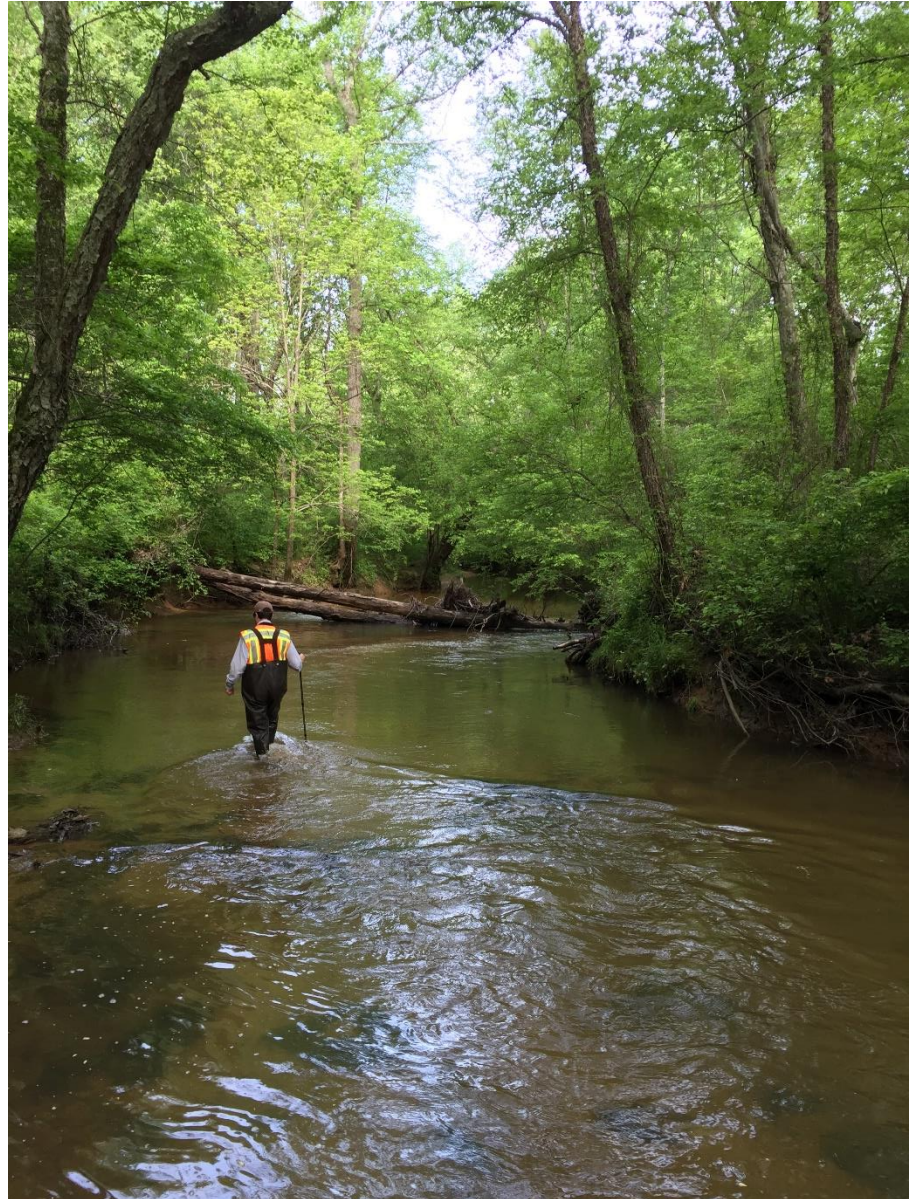
Photograph 4

Description: fallen trees and in channel debris upstream of crossing and bedrock outcropping. Scour present around structures/debris.

Evaluate scour depth for pipeline burial depth especially considering local scour potential resulting from woody debris and boulders within channel. Additionally, consider realignment of crossing approximately 120 feet downstream in a straight reach. If crossing is maintained at present location, the right bank would require significant armoring to maintain stability of the crossing. Sag bends should be located at least two channel widths outside of respective banks. If bedrock is encountered shallower than proposed burial depth, burial in bedrock is recommended.
