Stream Crossing Plan View and Profile

Stream Reconnaissance (Based on Thorne, 1998)

Client: Atlantic Coast Pipeline

Subject Site: SC_0398, McElroy Creek at MP 18.55 (TL-635)

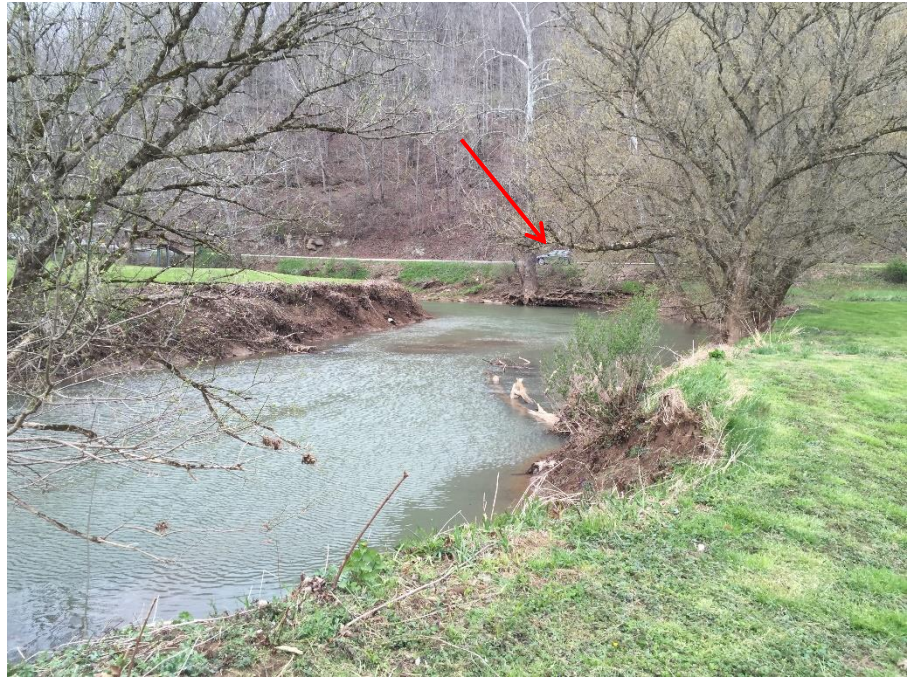
Direction: Downstream

Description: View of creek, clayey banks, and 90 degree bend against Hwy. 23 (see vehicle).

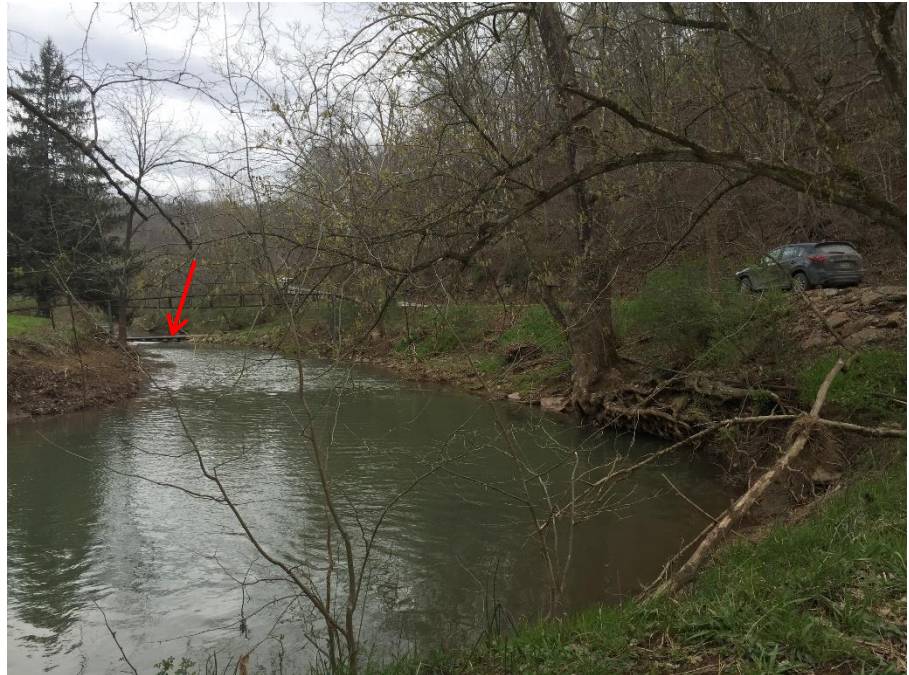
Direction: Downstream

Description: View from 90 degree bend about 30 yards downstream of crossing of elevated pedestrian crossing and culverts. Fluvial erosion undercutting mature tree on right bank is noticeable.

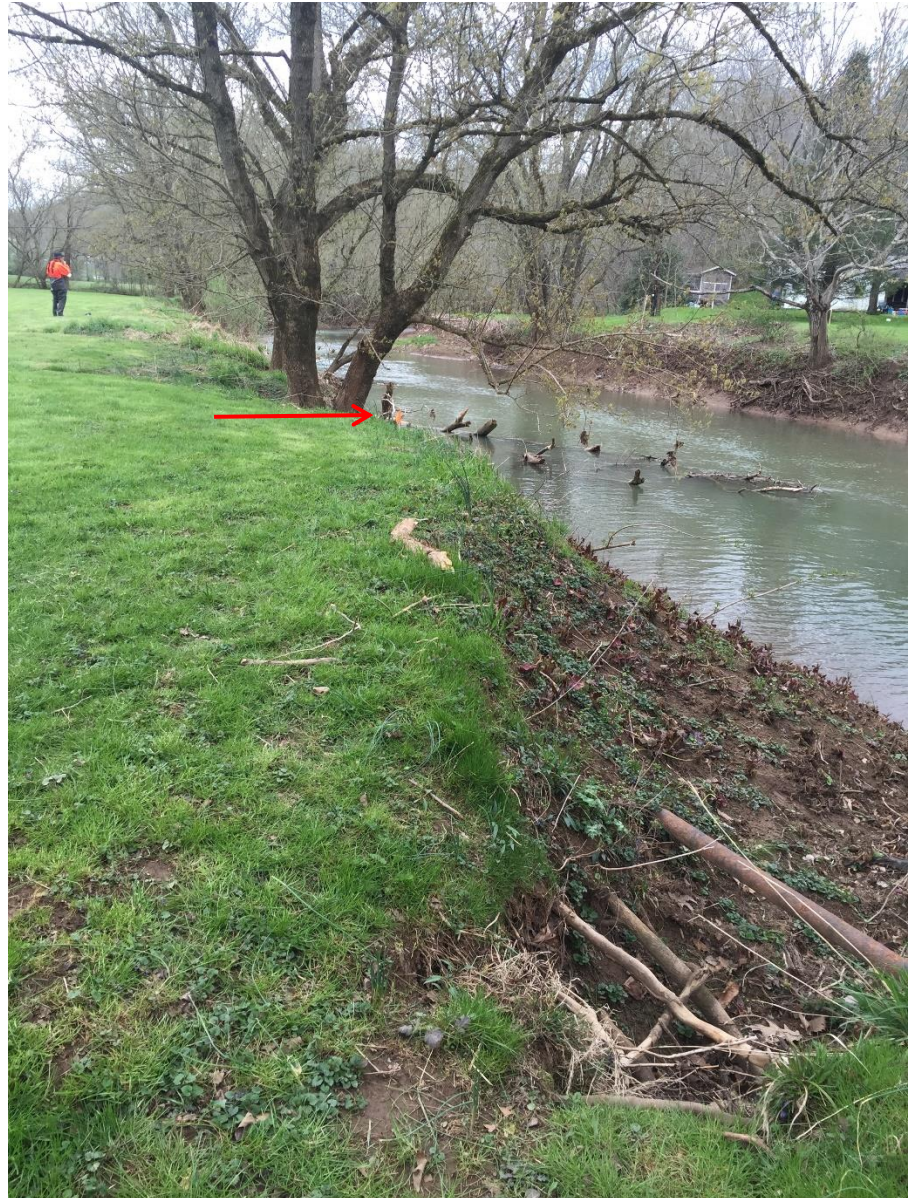
Direction: Upstream

Description: View of pipeline crossing survey marker (red arrow), sloping banks, lack of riparian buffer, and floodplain on the right bank (left side of photo).

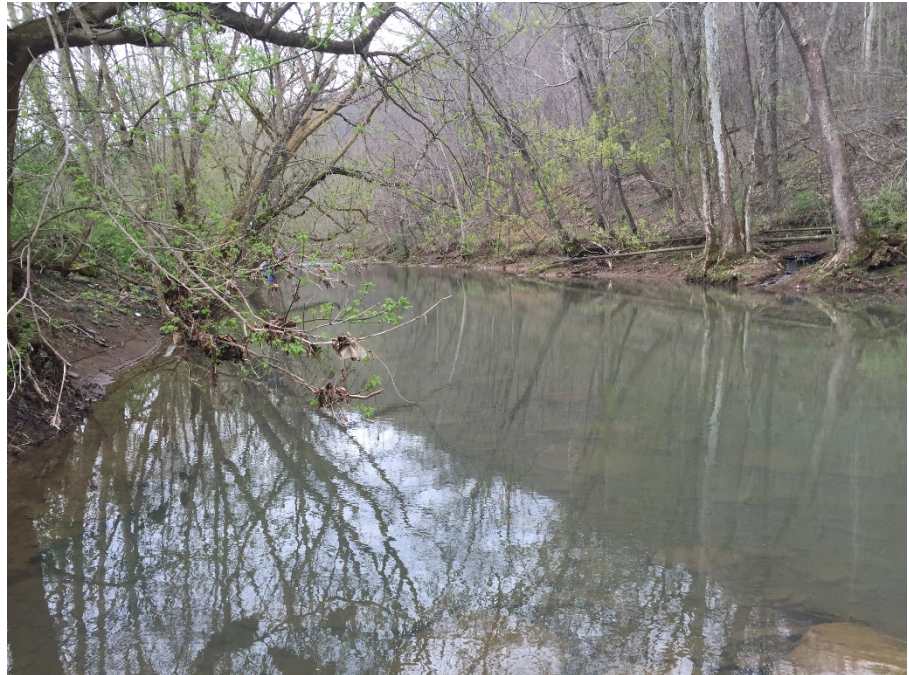
Direction: Upstream

Description: View of sloping left bank (valley wall) as well as approximately 6-ft high right bank. Falling trees noticeable as well as flood debris on.

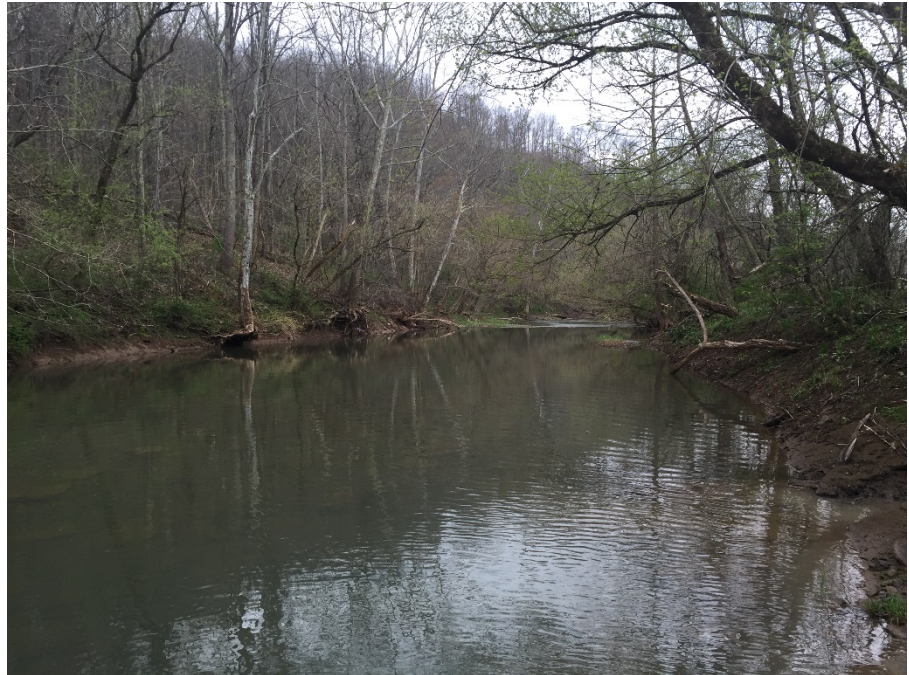
Direction: Downstream

Description: View of extensive riparian buffer on left bank (valley wall) and sloping ground providing lateral confinement.

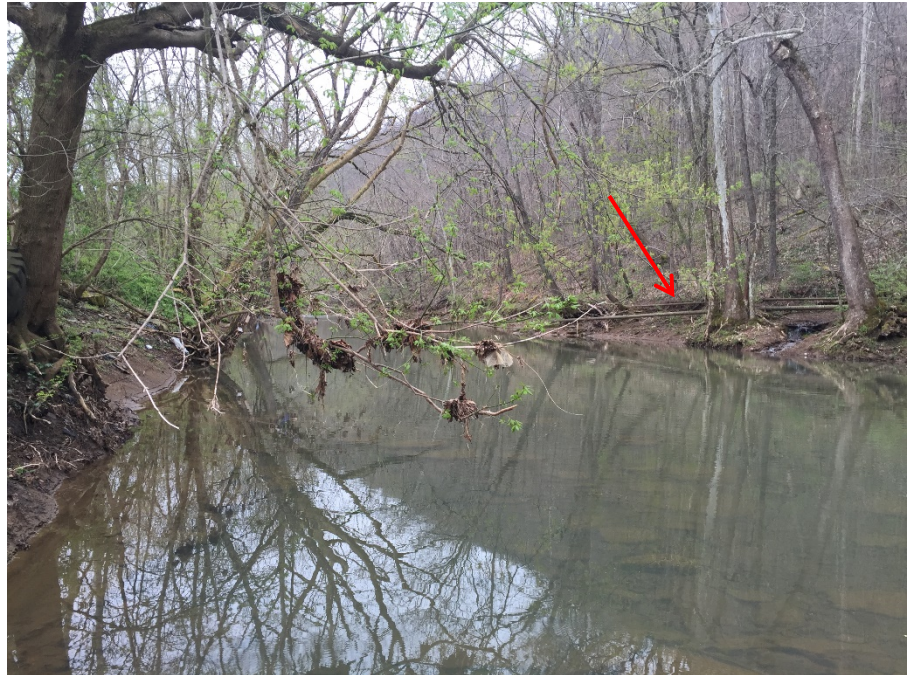
Direction: Upstream

Description: View through water of platy cobble sized particles on stream bed. Steel pipes running along left bank are also noticeable (red arrow).

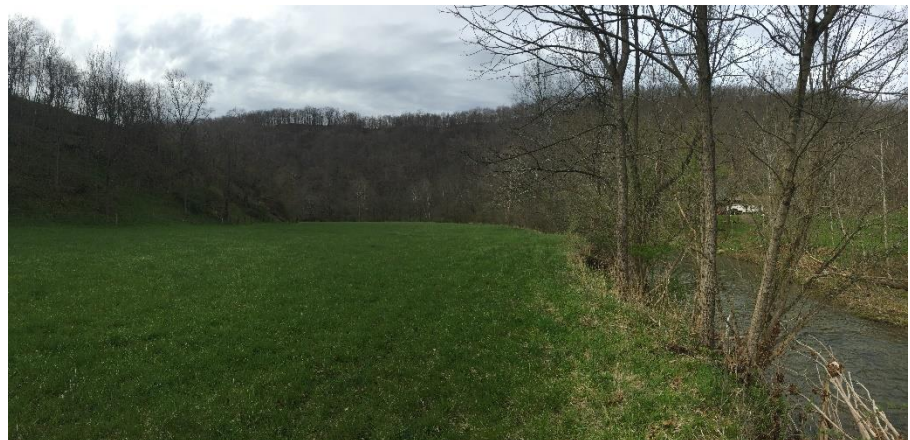
Direction: Downstream

Description: Panoramic view of floodplain on left bank and valley wall in background where stream crossing will be located. Notice very thin riparian buffer.

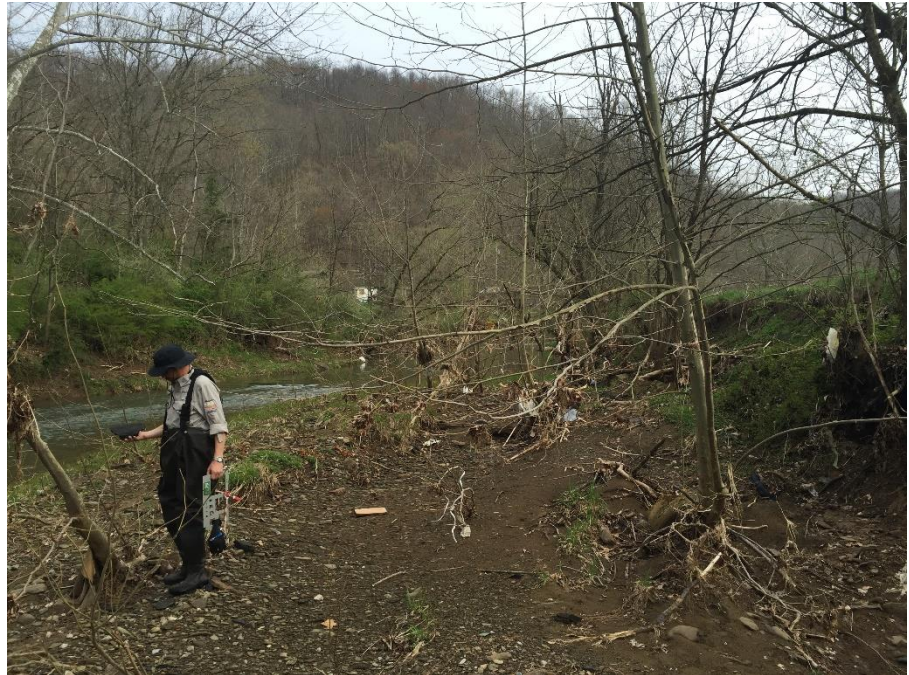
Direction: Upstream

Description: Lateral bar
upstream of 90 degree
bend. Flood debris on
branches indicates recent
high stages.

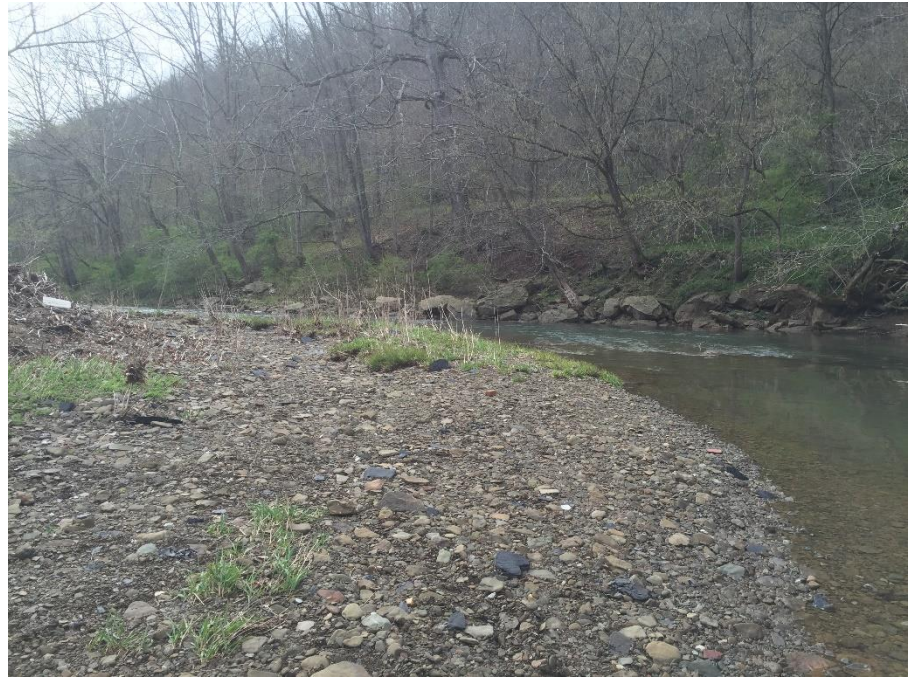
Direction: Downstream

Description: View of 90-degree bend against right valley wall at stream crossing.

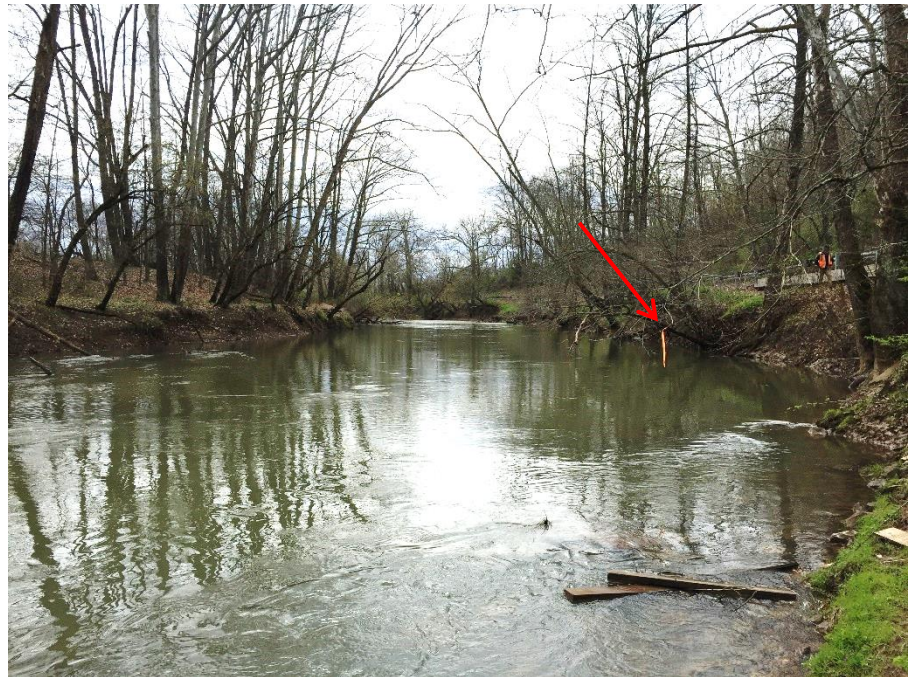
Direction: Upstream

Description: View at stream crossing (orange tape on left bank) showing falling trees and fluvial erosion along banks. Kincheloe Rd. on left bank with person in view for scale (photo brightened to improve clarity)

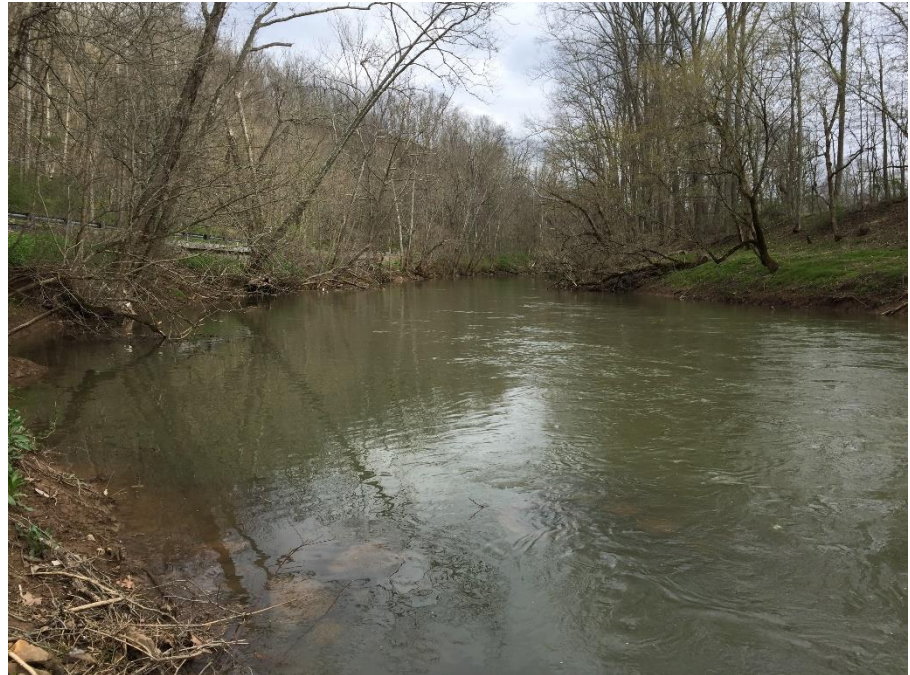
Direction: Downstream

Description: View of
fluvial erosion causing
trees to fall and terrace on
right bank

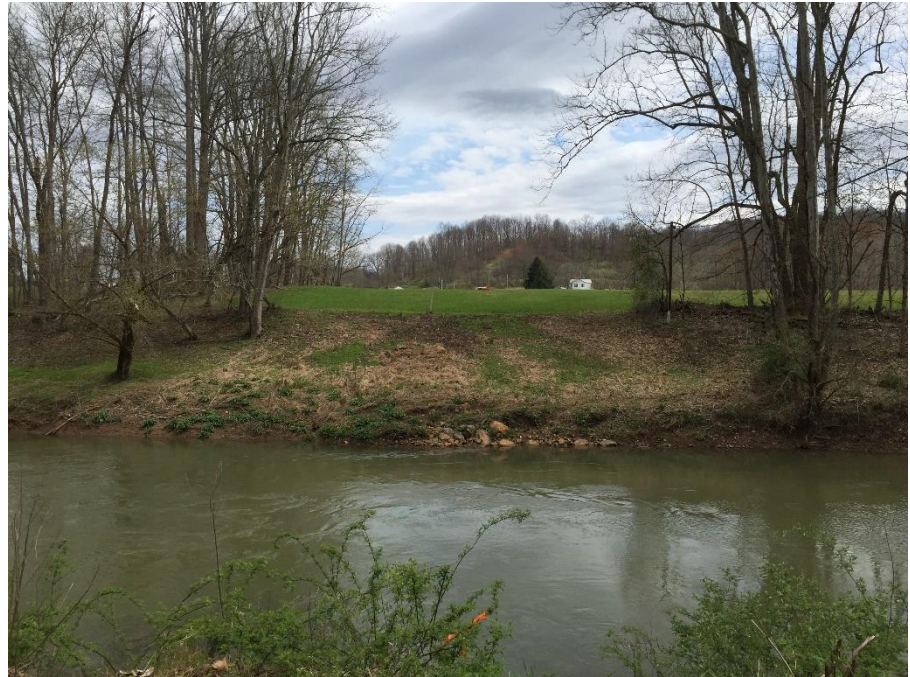
Direction: towards right bank

Description: View of gas pipeline right of way on right bank.

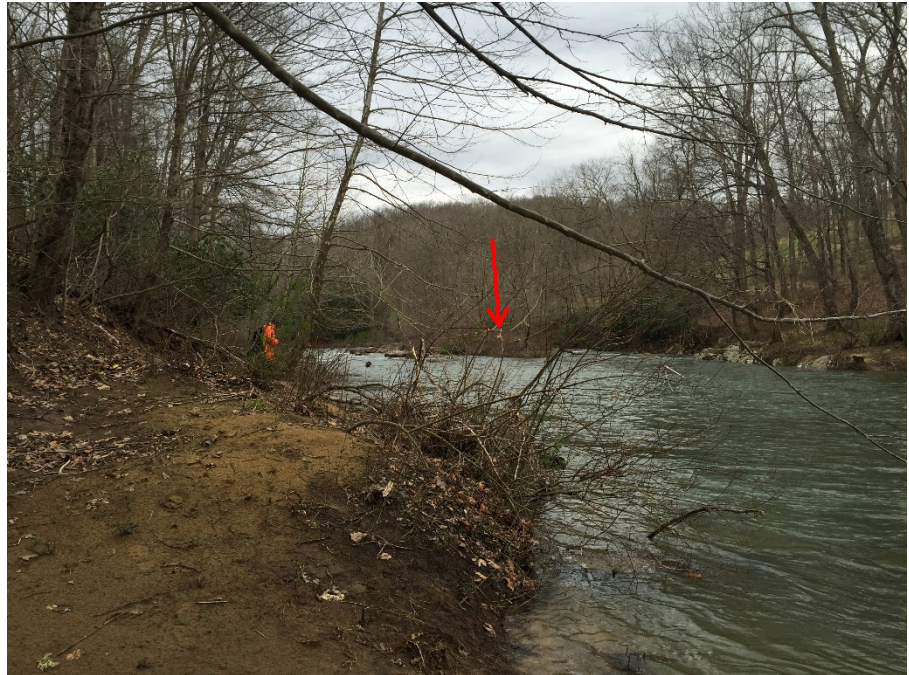
Direction: Upstream

Description: View from right bank showing mid-channel island (red arrow). Sandy bank noticeable on foreground.

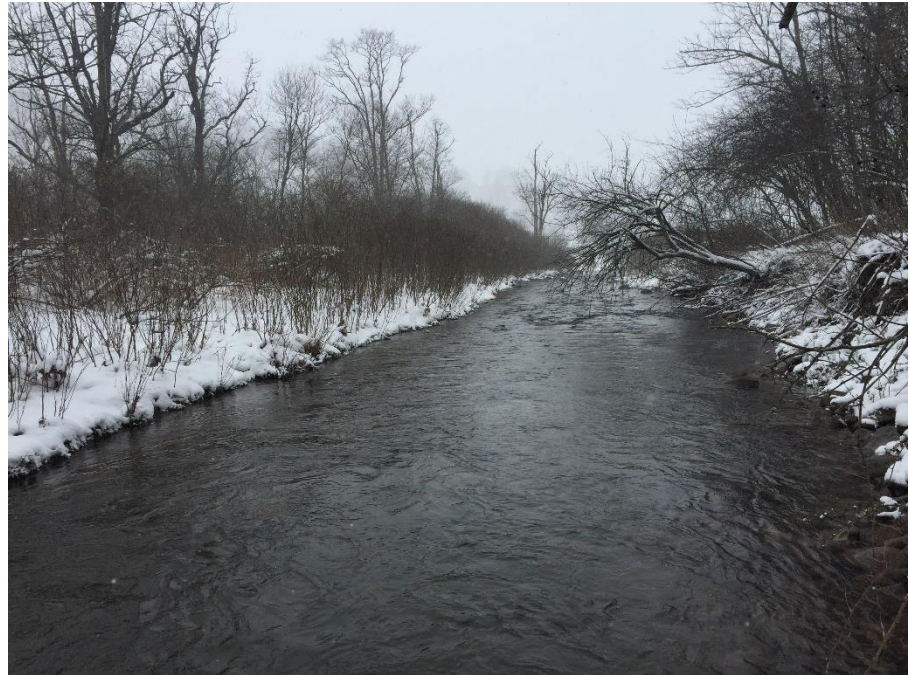
Direction: Downstream

Description: Riffle at crossing also showing shrubs and trees on left bank and falling trees on right bank.

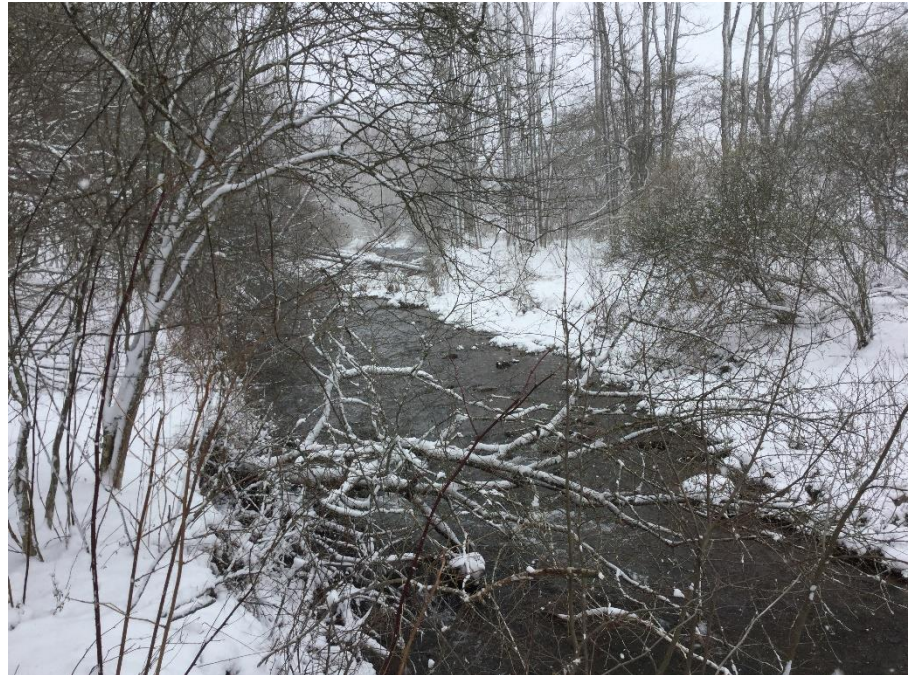
Direction: Upstream

Description: Stream bed
comprises cobbles and
boulders.
