TID	SC_0816	ACP Segment	AP-1
Stream Name	Jackson River	MP	91.47
Survey Date	12-May-2016	Start Time	1105 hrs

PHASE 2 – RAPID STREAM RECONNAISSANCE
Photographic Record

Client: Atlantic Coast Pipeline

Subject Site: SC_0816, Jackson River at MP 91.47 (AP-1)

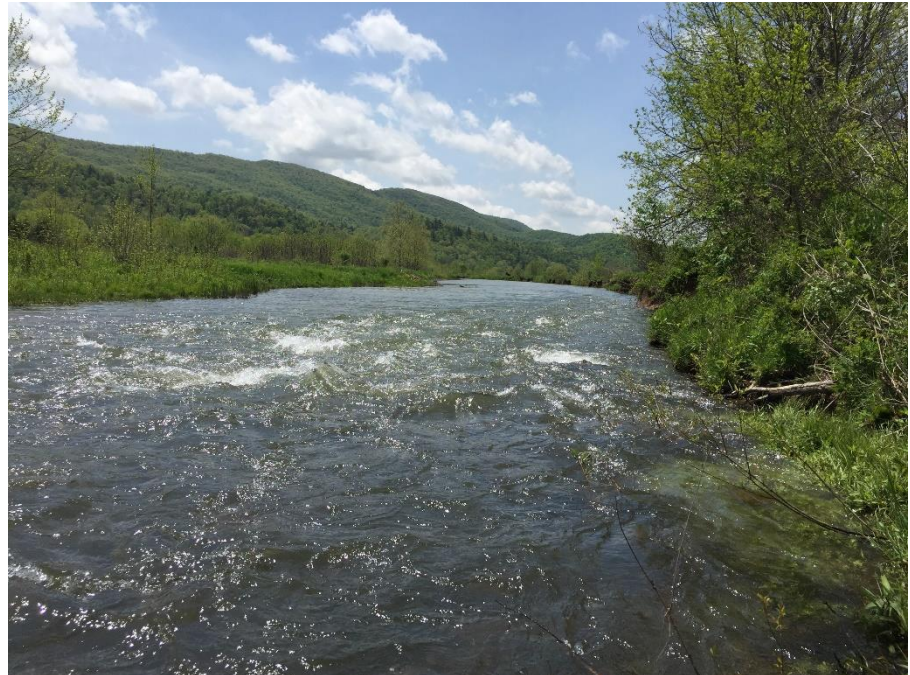
Description: Wide,
accessible floodplain off
left bank entering very
wide agricultural valley.

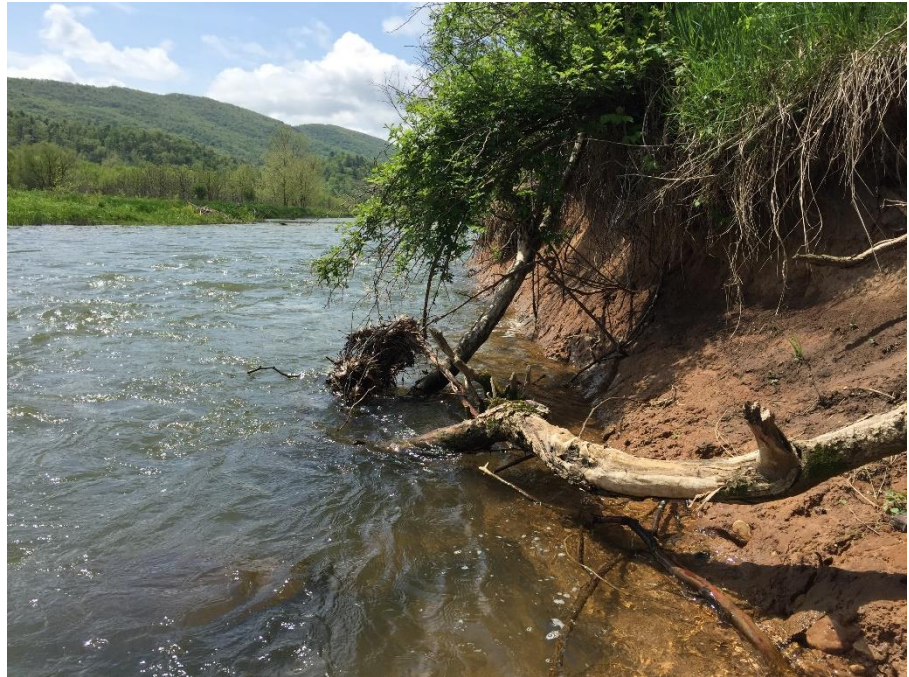
Photograph 2

Description: Steep
erodible banks on right
bank with little to no
riparian buffer.

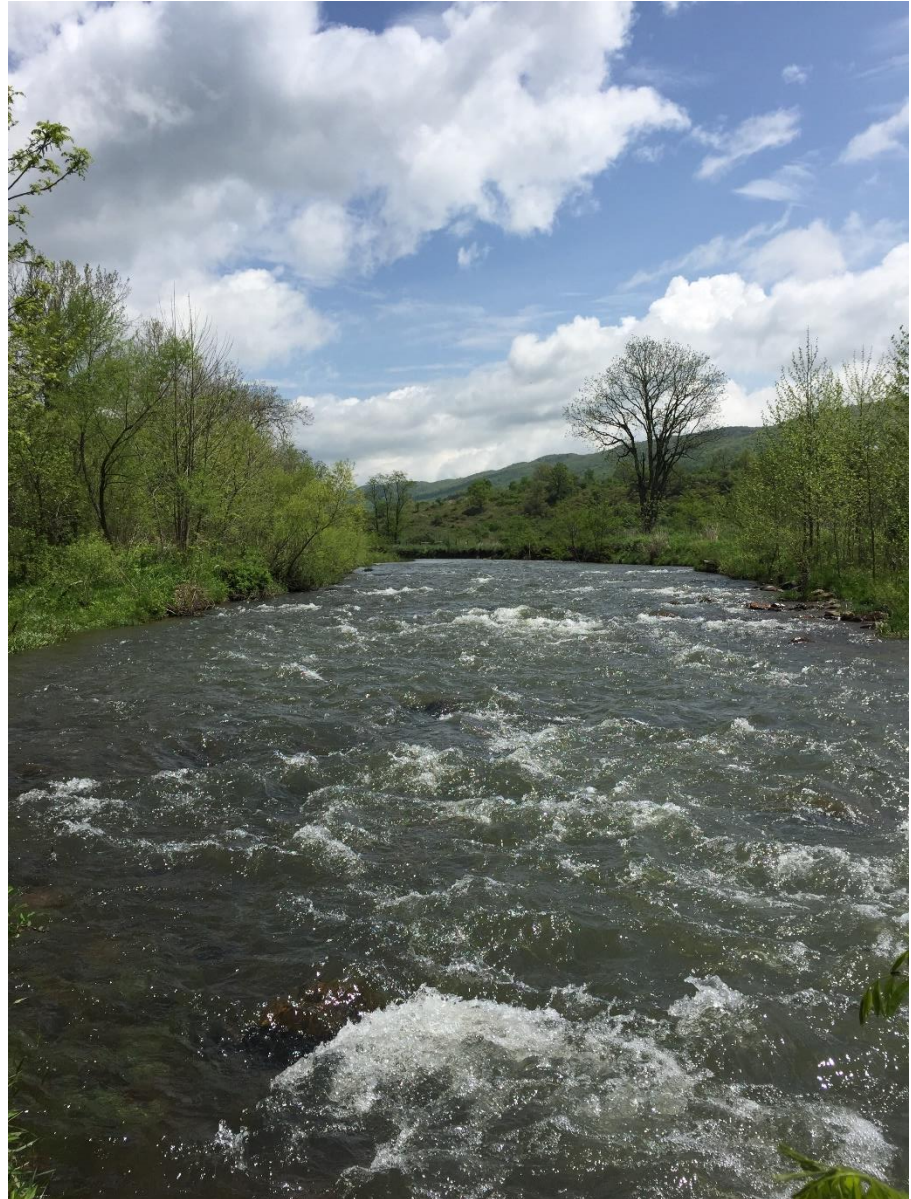
Photograph 3

Description: Riffle section with head cut and deep pool at lower end.

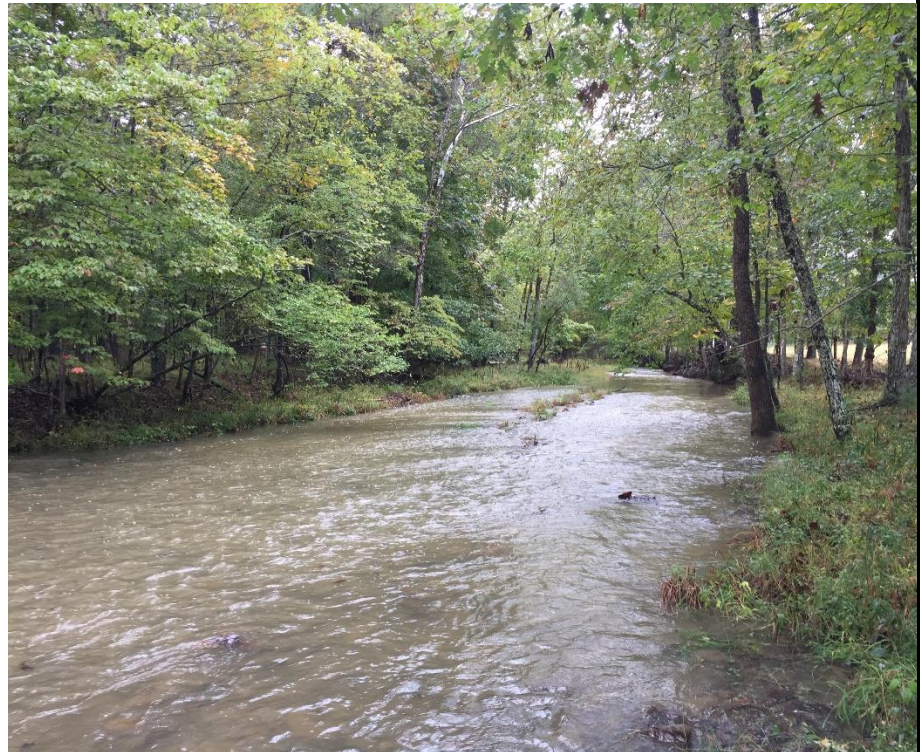
Description: shallow banks with well-connected floodplain at crossing location. Crossing at relatively straight riffle section with 0.5-ft and 1.5-ft high head cuts up and downstream, respectively.

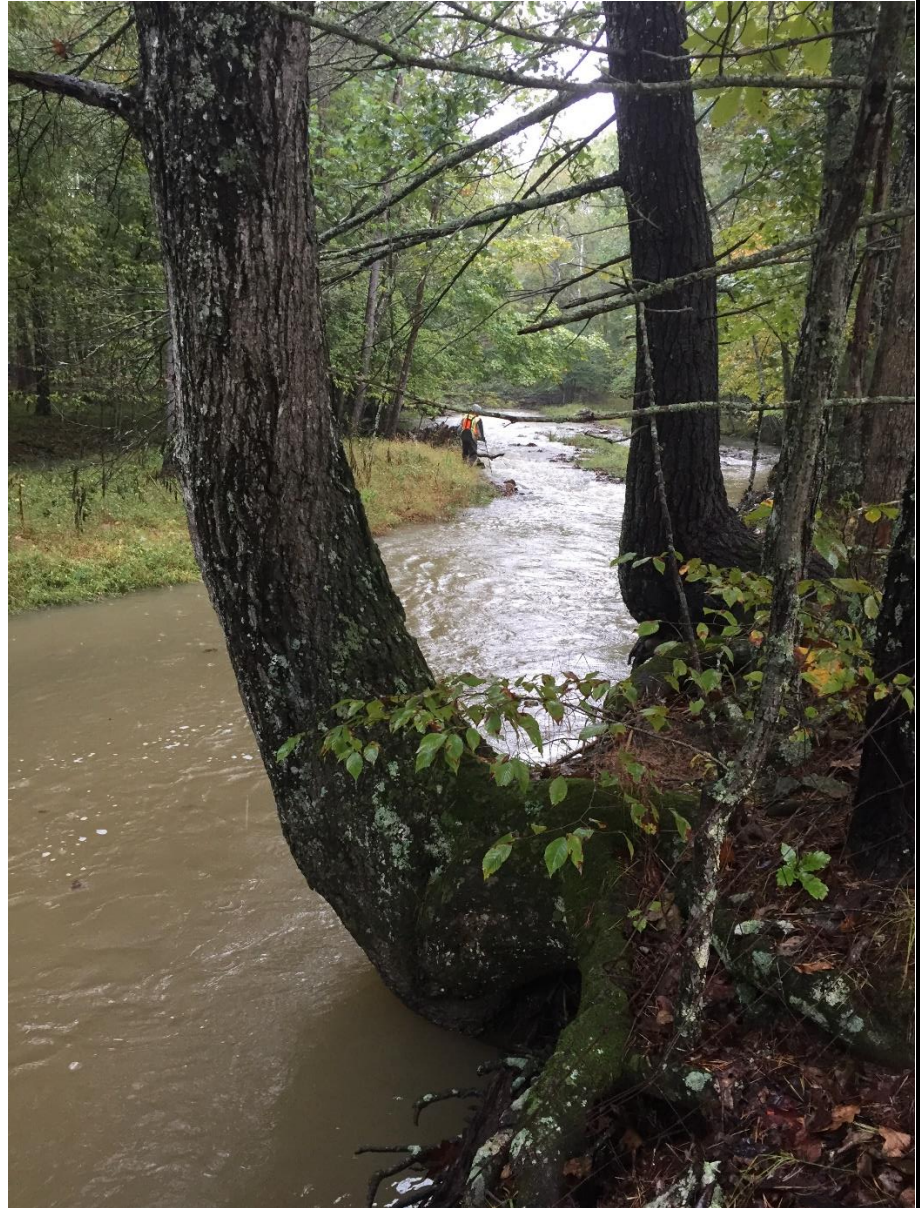
Description: steeper banks near head cuts and significant undercutting of left bank upstream of crossing. Mature tree growth indicates relatively slow rate of erosion.

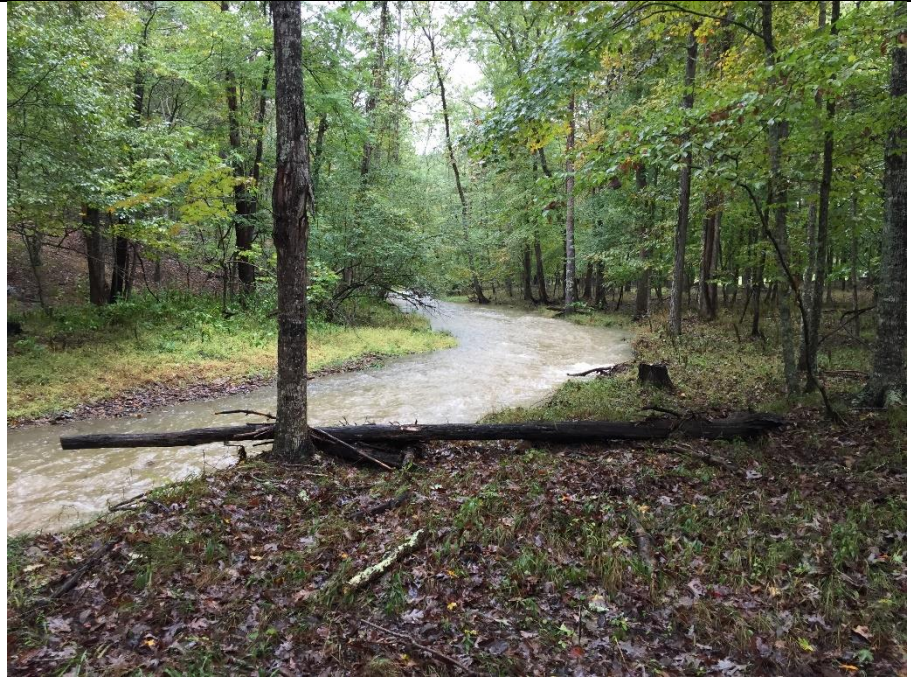
Description: View of stream following precipitation. Left bank is connected to floodplain of Stuarts Run (SC_0723). Right bank is confined.

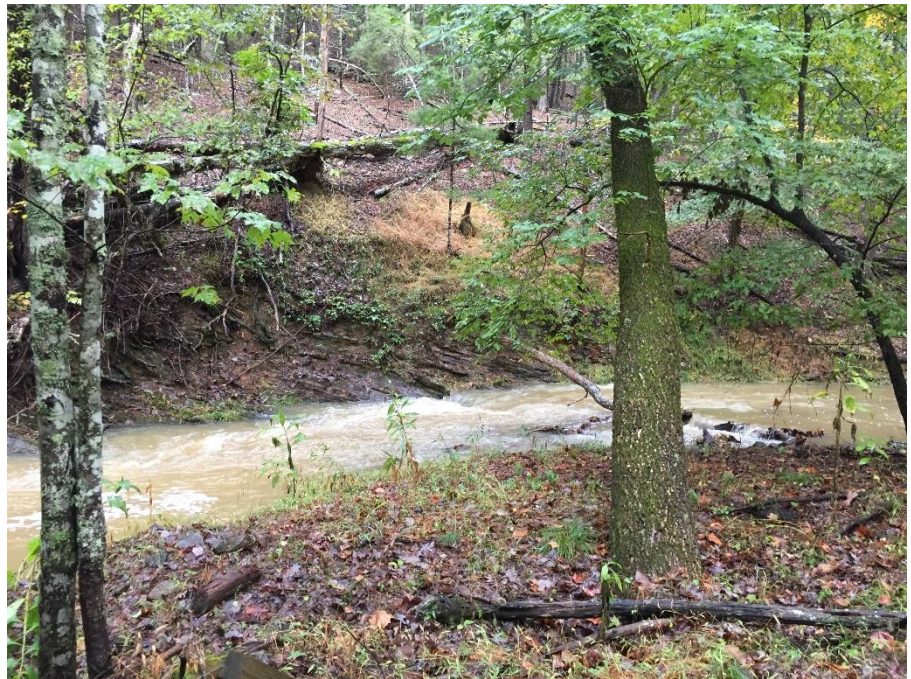
Photograph 2
(IMG_1623.jpg)

Description: Bedrock outcropping on right bank.

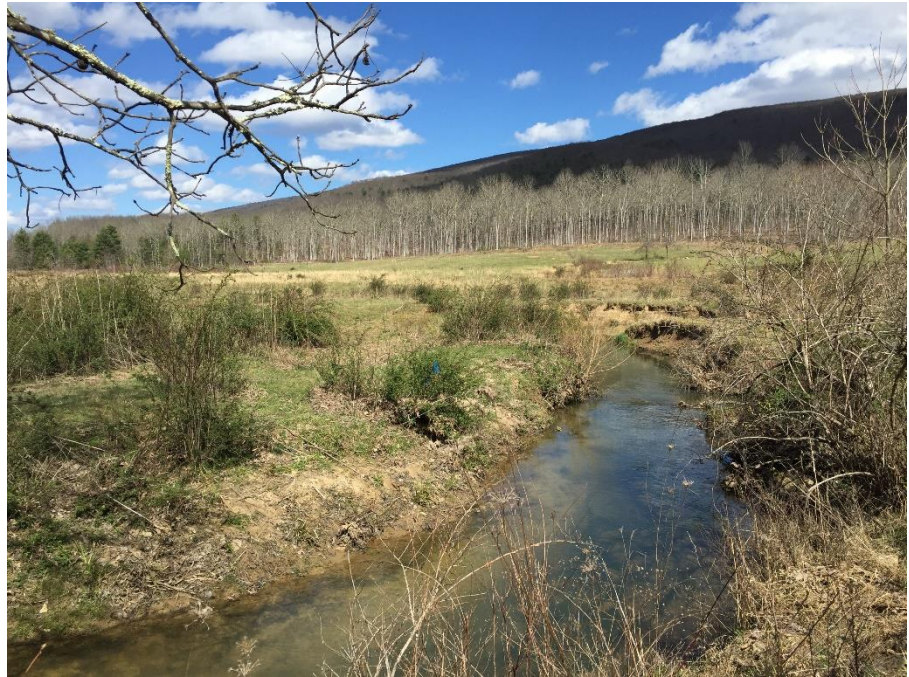
Description: View of stream from right bank showing lack of riparian buffer and wide floodplain

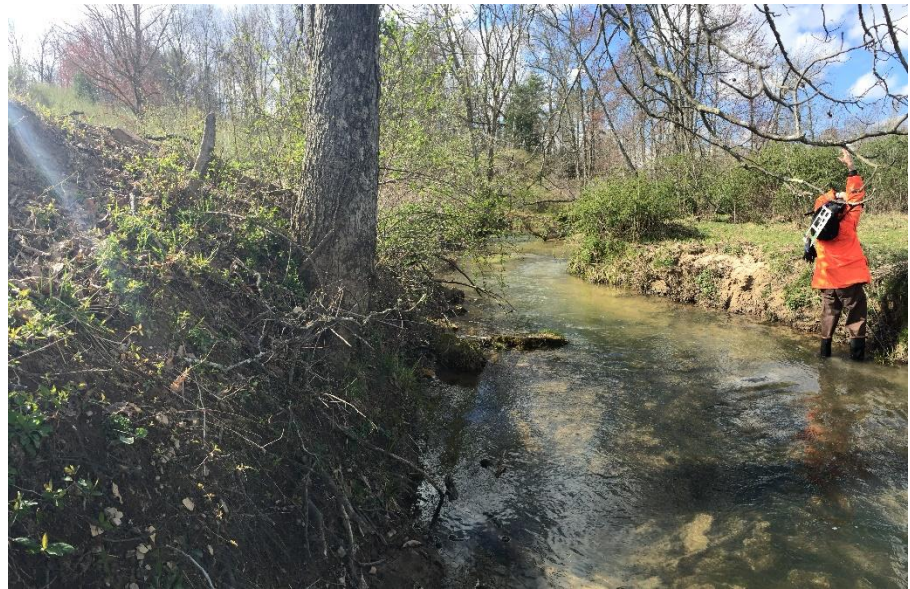
Description: View of
steep banks comprising
primarily fine grained
soils

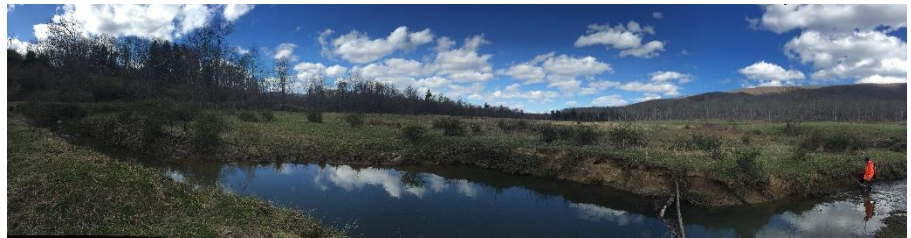
Description: Wide view of stream and floodplain showing sinuosity of stream

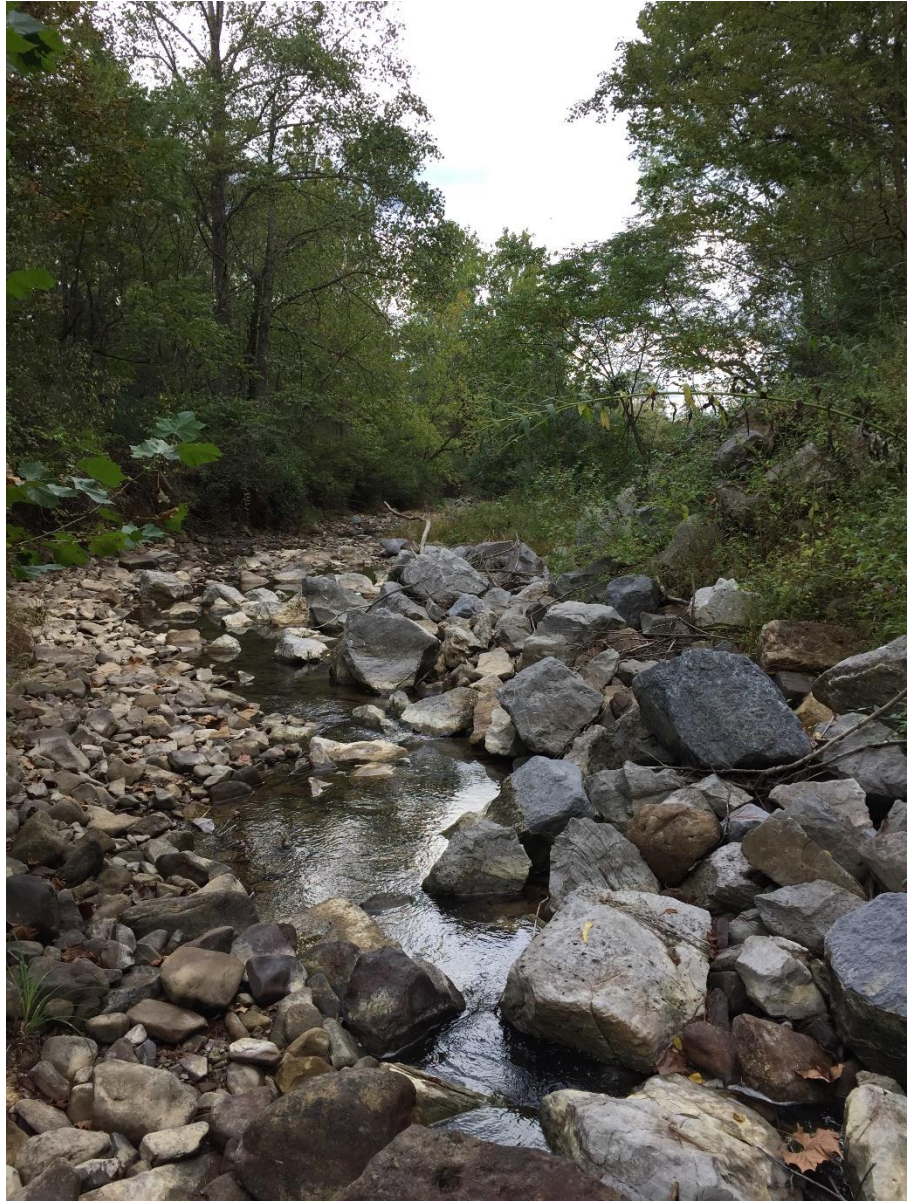
Description: Relatively confined channel with cobble bed and some boulders, right bank rip-rap visible on right of photo.

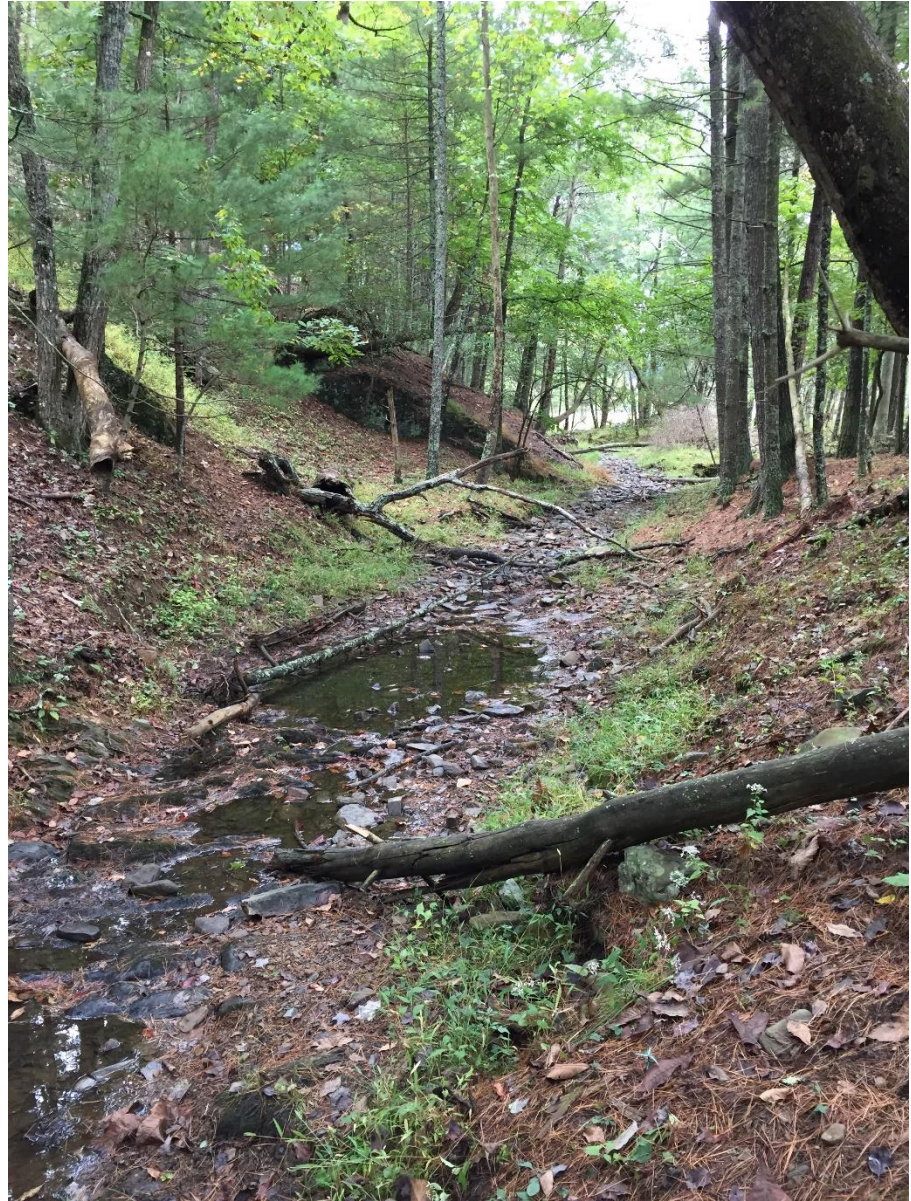
Description: Valley wall
confinement off left bank,
connected agricultural
floodplain off right bank.
Bedrock outcroppings
present on left bank in
background.

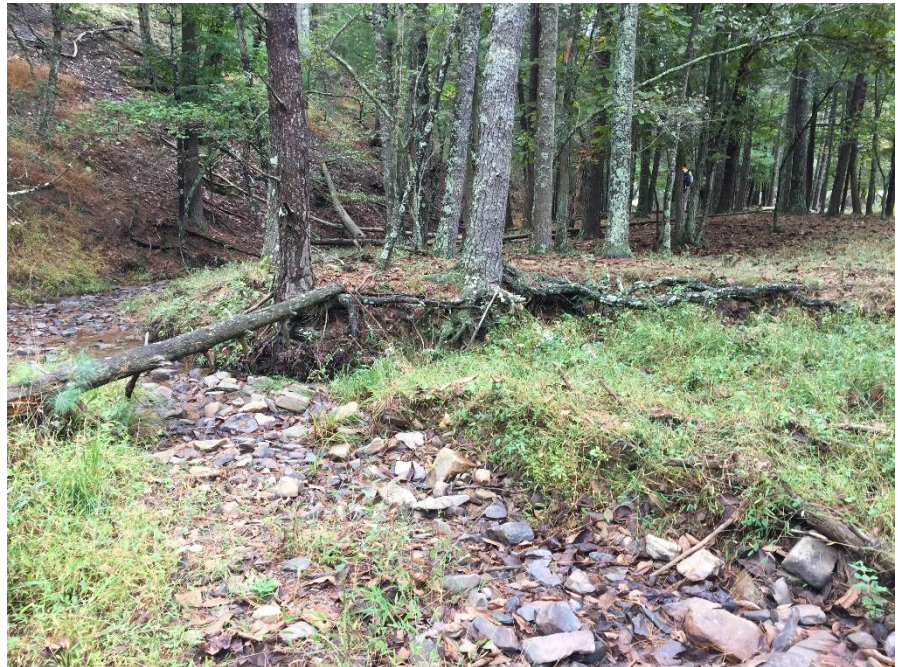
Photograph 3
(IMG_4289.JPG)

Description: Bradding of channel upstream of bedrock outcroppings with signs of right bank erosion. Stream begins to flow along left valley wall.

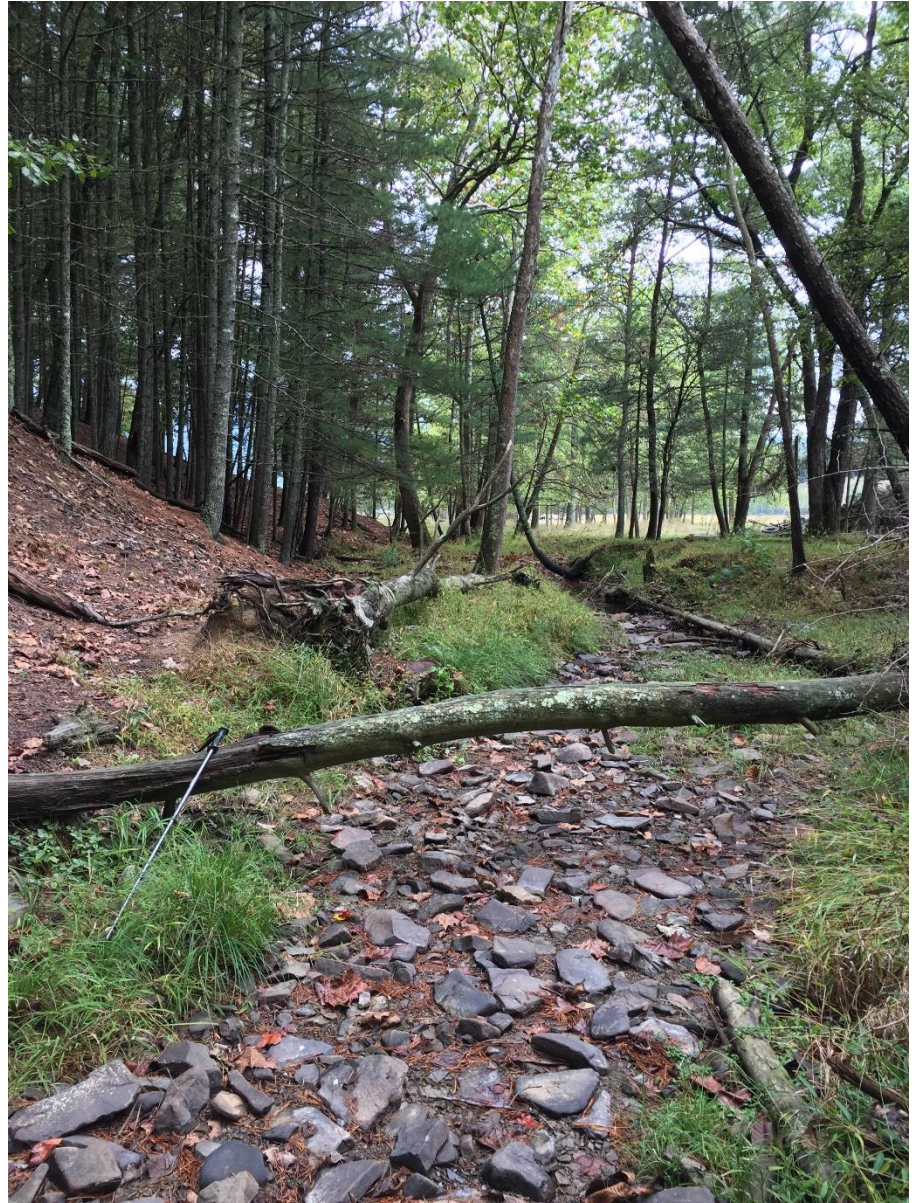
Description: Relatively stable section of stream with significant head cuts downstream. Bedrock present just upstream of visible reach.

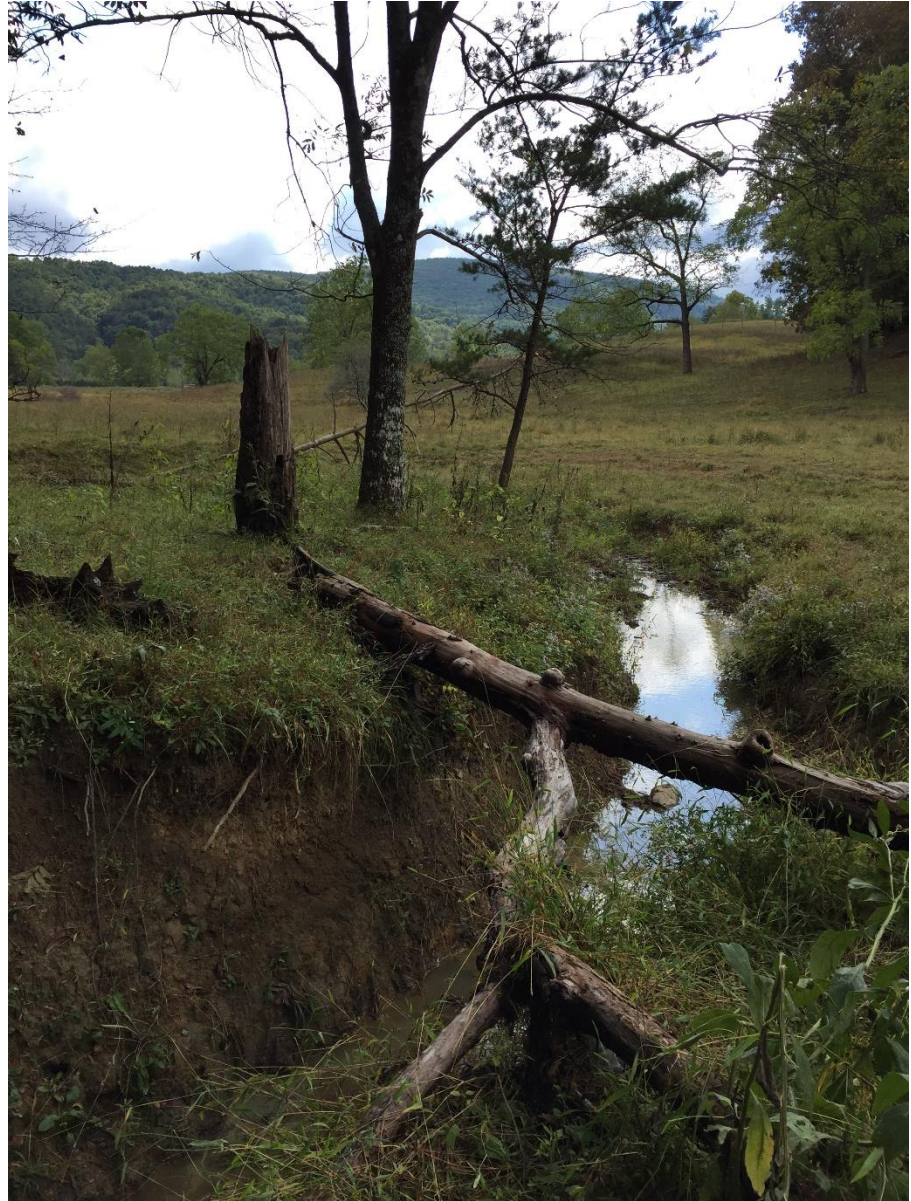
Description: Incised
channel with silty-clayey
bed and bank materials
with some gravel sized
particles.

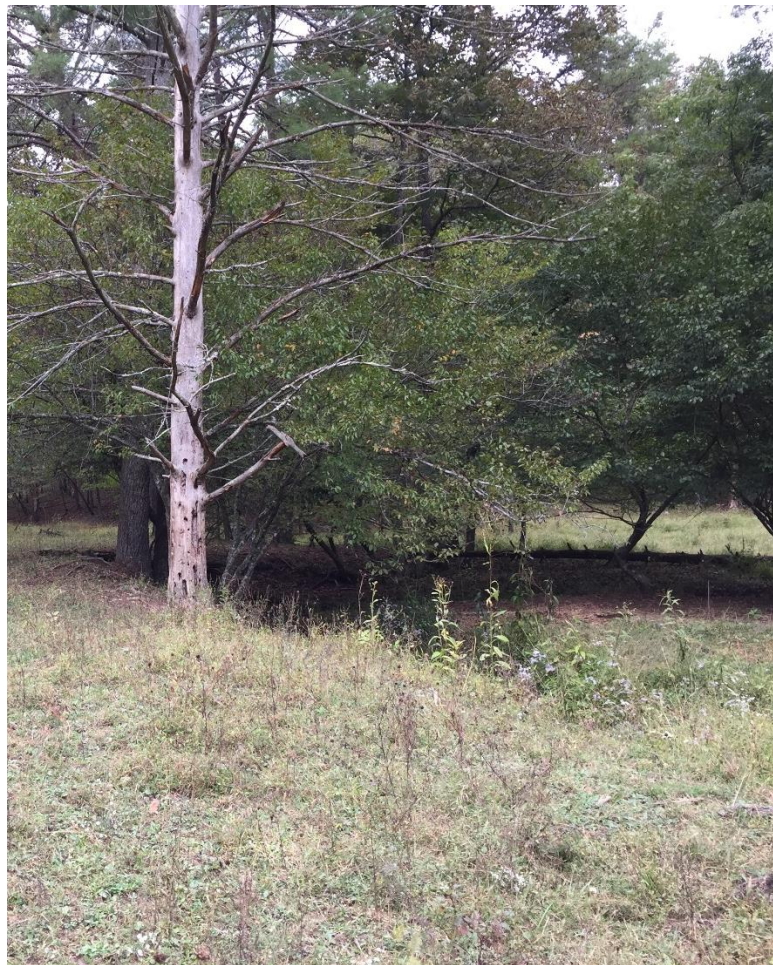
Photograph 3
(IMG_4302.jpg)

Description: Upstream of crossing, stream flows closer to the center of the local valley and is better connected to its floodplains.

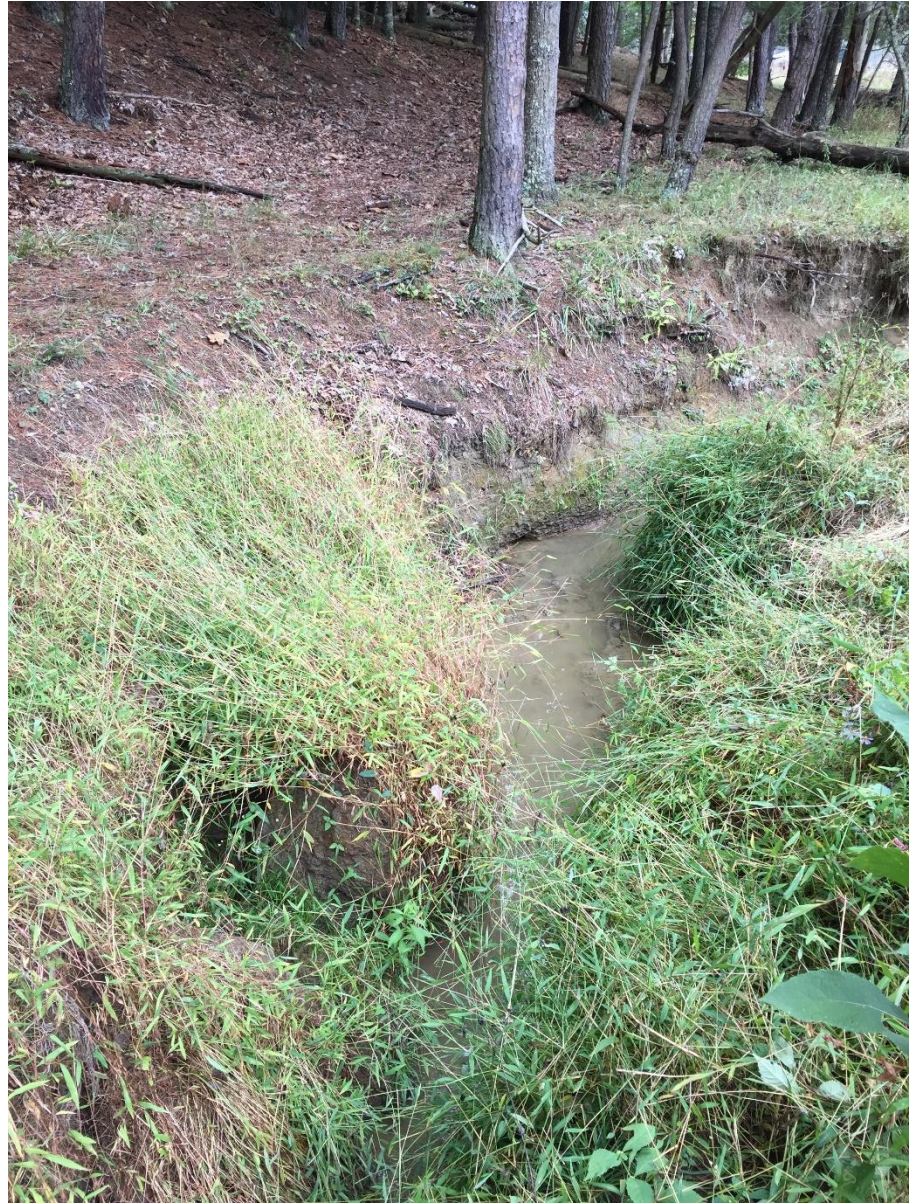
Description: Bank erosion
at meander bends. Valley
confinement off left bank

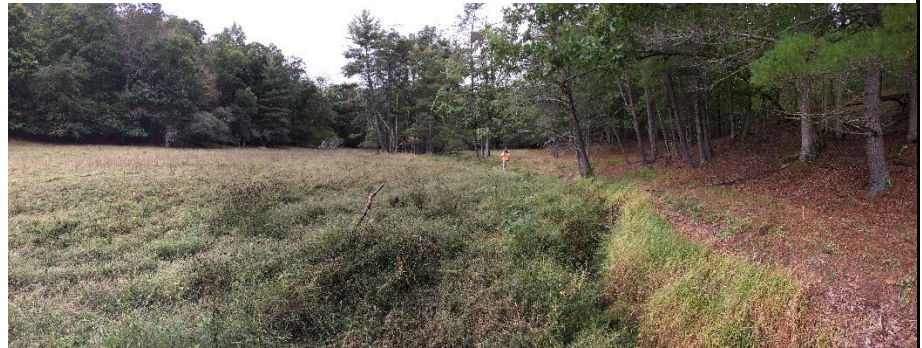
Description: Relatively flat floodplain outside of incised channel valley. Confinement off left bank at crossing. Stream flows closer to the center of the local valley upstream.

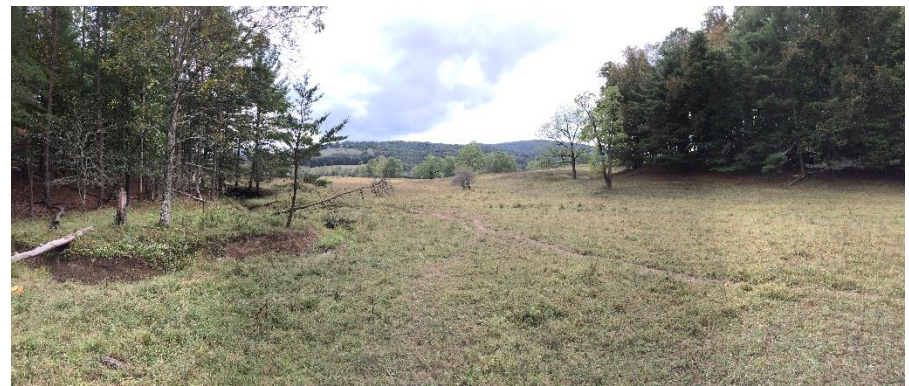
Photograph 6
(IMG_4303.jpg)

Description: Relatively flat floodplain outside of incised channel (incised banks visible on left of photo). Floodplain is better connected to the channel upstream of crossing.

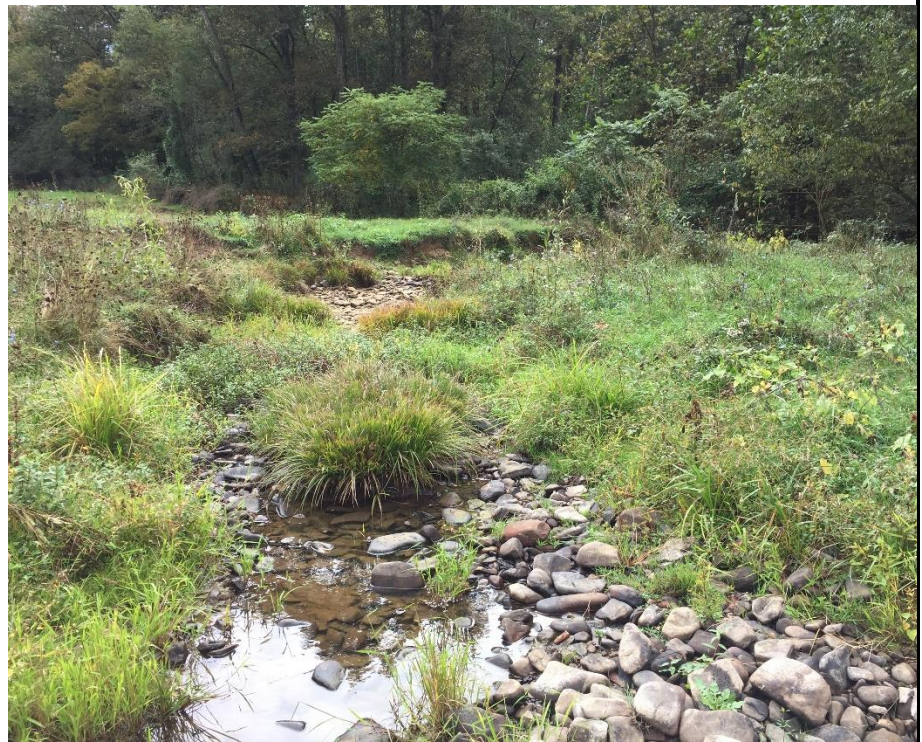
Description: small, vegetated mid-channel and point bars present within channel. Riparian corridor of Tim's Draft visible in background.

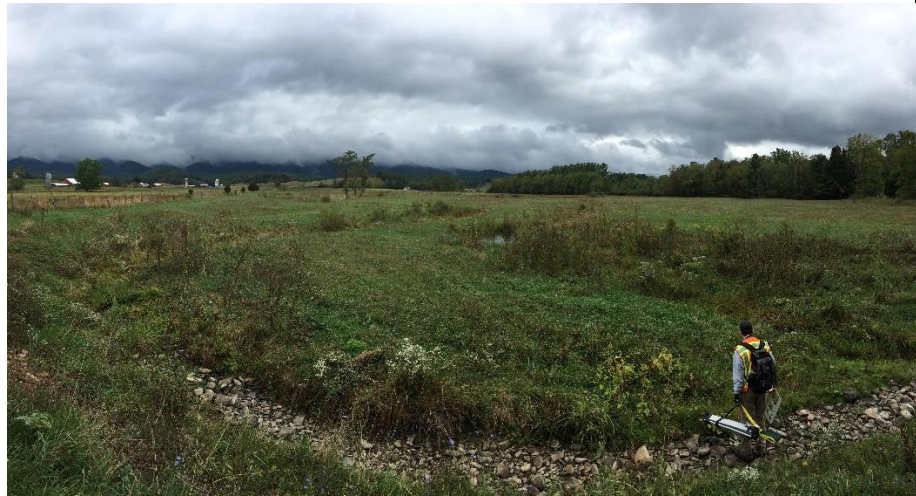
Description: Wide
agricultural floodplain off
both banks, disconnected
due to incision. Threaded
channel visible.

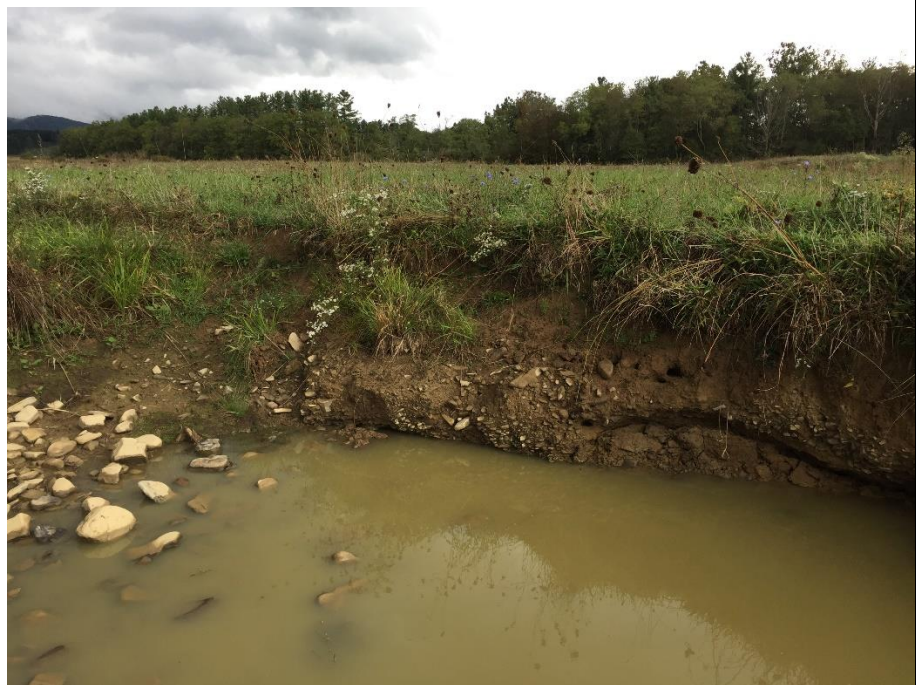
Photograph 3
(IMG_4279.jpg)

Description: Steep to
vertical banks with highly
erodible materials. Sub-
angular cobbles and fines
comprise channel bed.

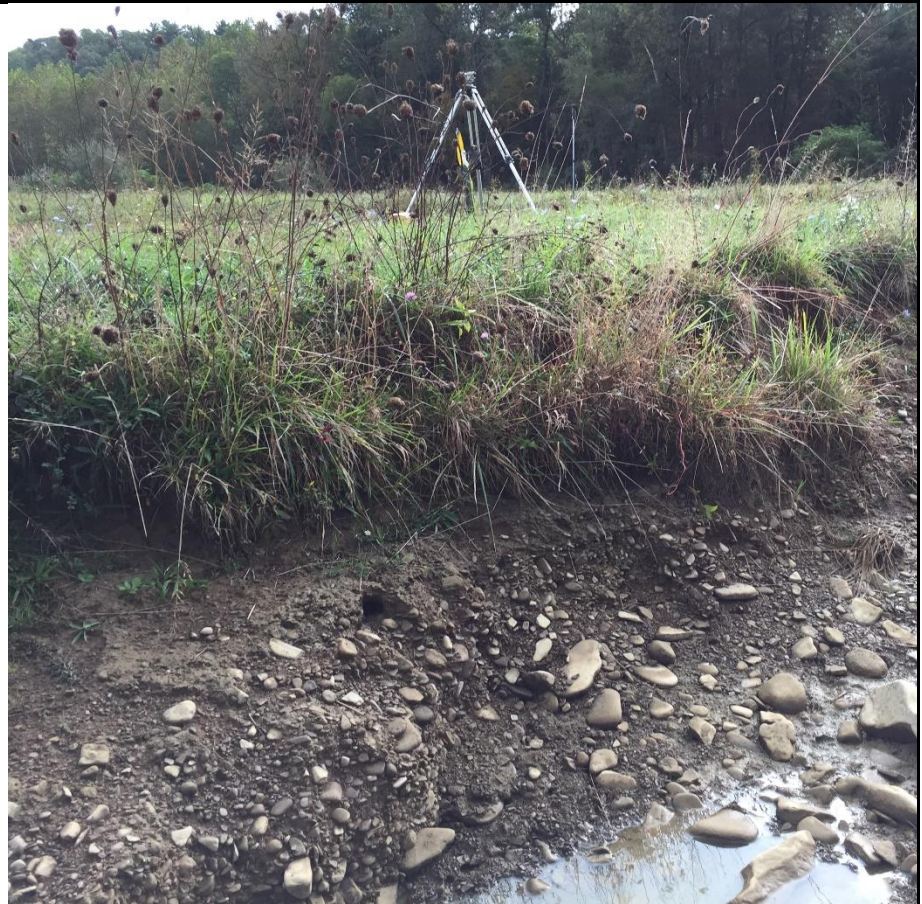
Description: Sub-angular
to rounded cobble bed
with some gravels in
moderately stratified
banks.

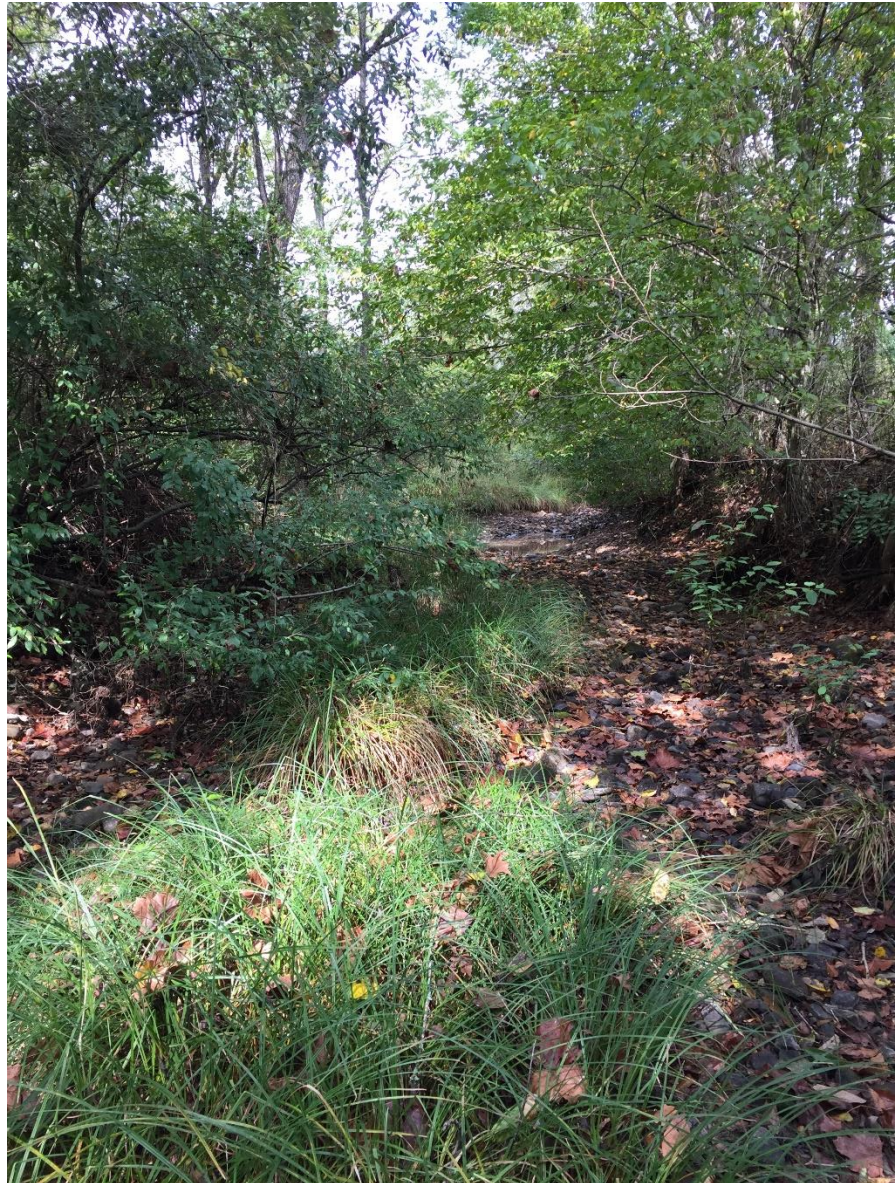
Description: Stream was dry at the time of our survey. Small, vegetated mid-channel bars present. Riparian corridor typically 1-5 channel widths. Banks comprise silty-clayey materials. Bed comprises gravel with some cobble-sized particles.

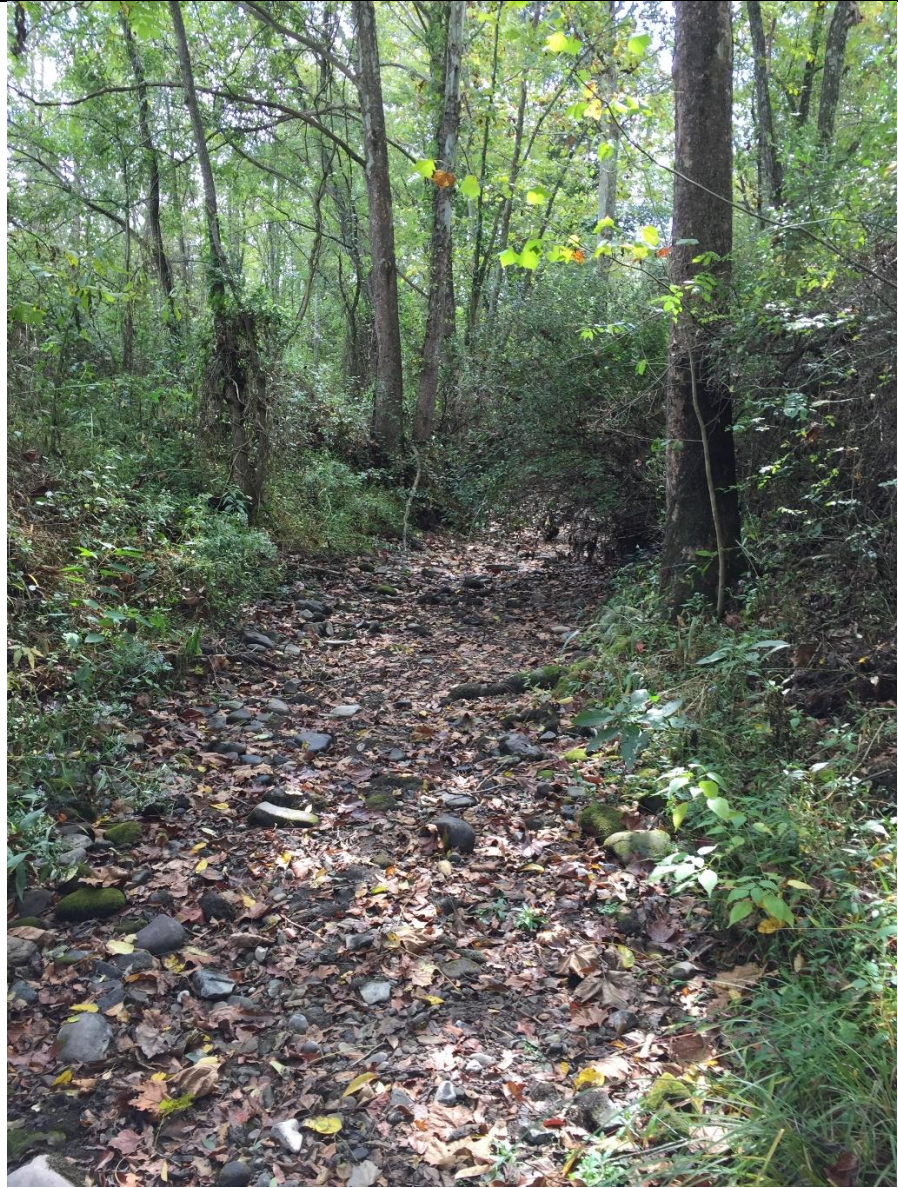
Description: relatively defined channel with moderately steep and typically vegetated banks. Highly erodible bank materials with deeper incision of channel and head cuts downstream of crossing.

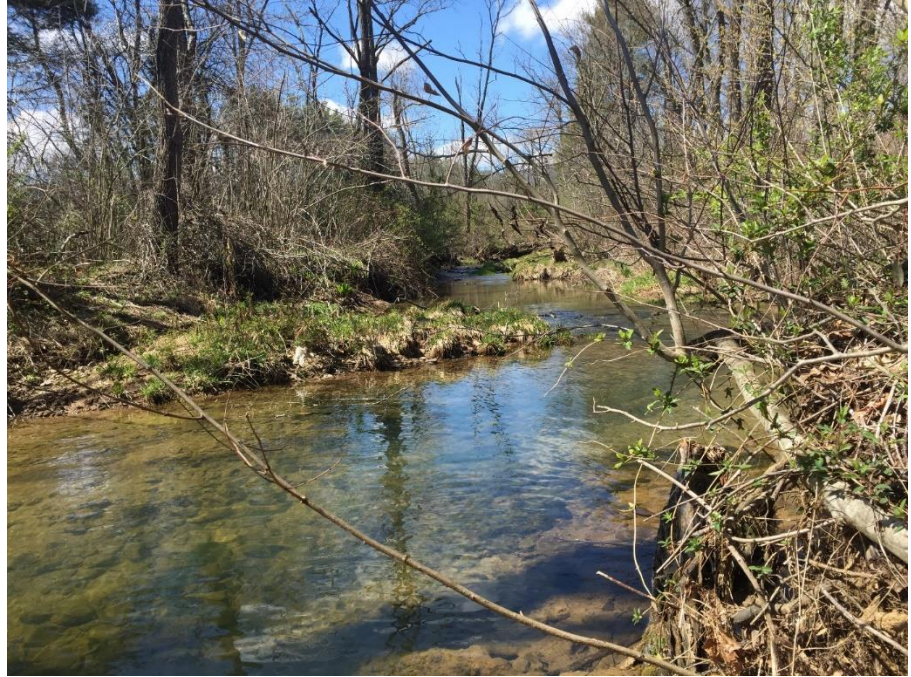
Description: Pool riffle
section with vegetated
point bars and
filamentous algal growth
in channel.

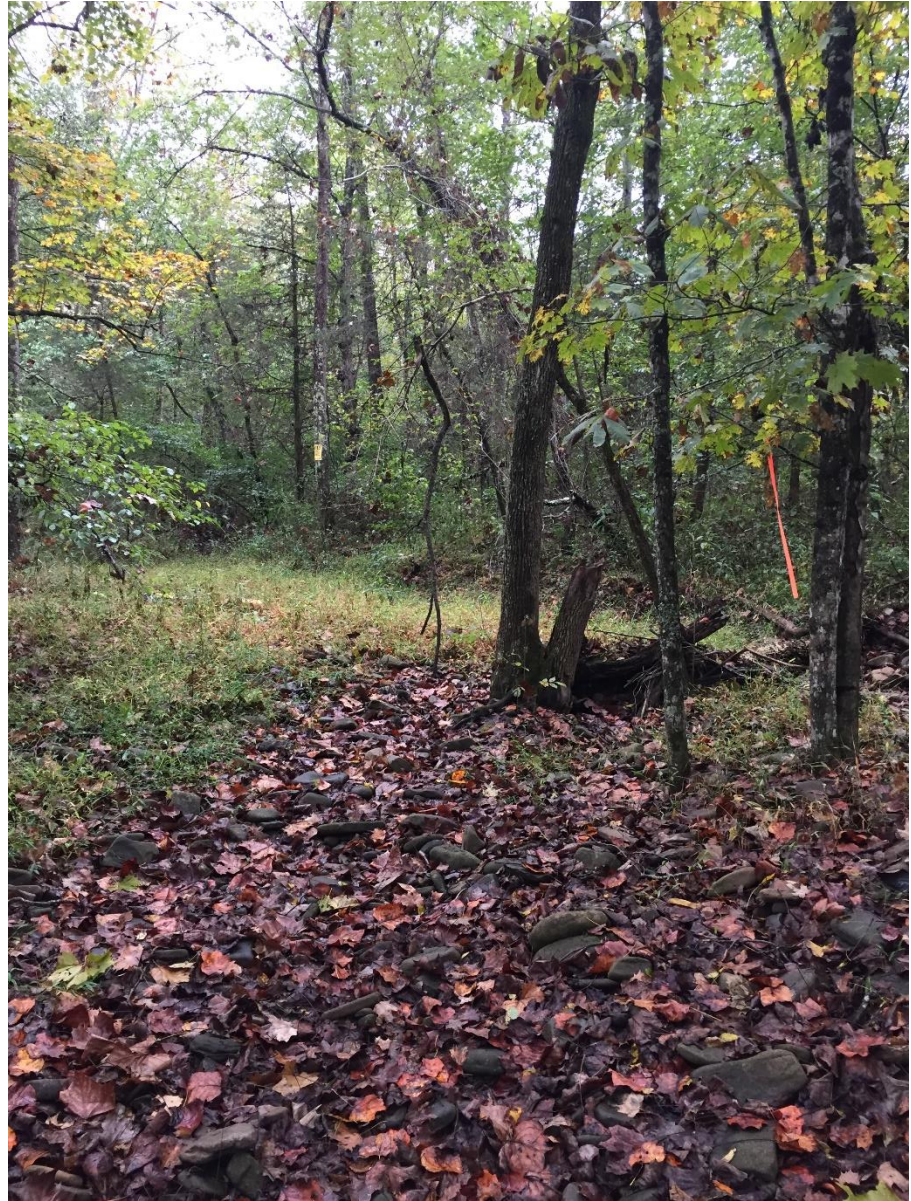
Direction: looking
upstream

Description: small islands
present within channel
with mature tree growth.
Stream was dry at the
time of reconnaissance.

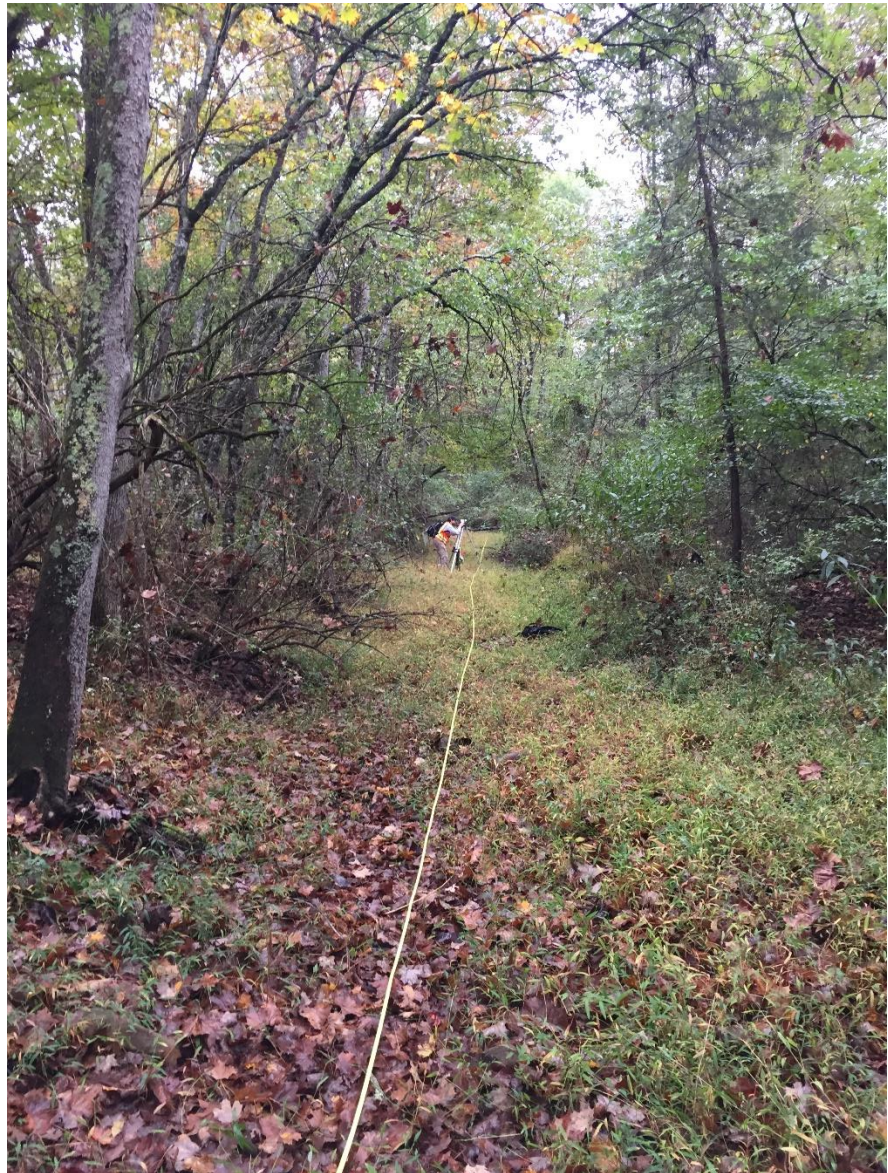
Direction: looking
downstream

Description: Relatively low gradient channel with vegetation present. Established riparian buffer, particularly off left bank.
