TID	SC_0816	ACP Segment	AP-1
Stream Name	Jackson River	MP	91.47
Survey Date	12-May-2016	Start Time	1105 hrs

PHASE 2 – RAPID STREAM RECONNAISSANCE
Photographic Record

Client: Atlantic Coast Pipeline

Subject Site: SC_0816, Jackson River at MP 91.47 (AP-1)

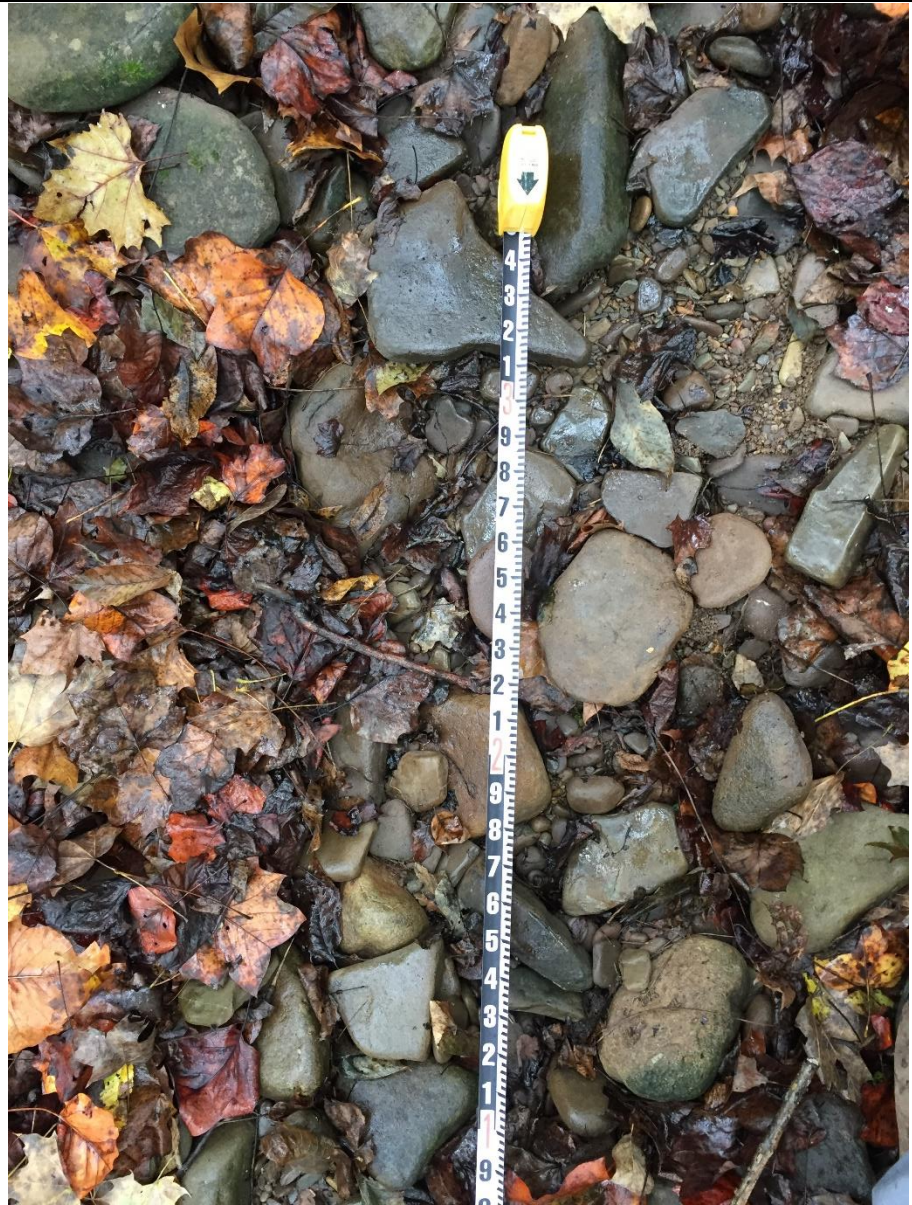
Direction: looking down
on channel bed

Description: Sub-angular
to rounded gravel and
cobble bed.

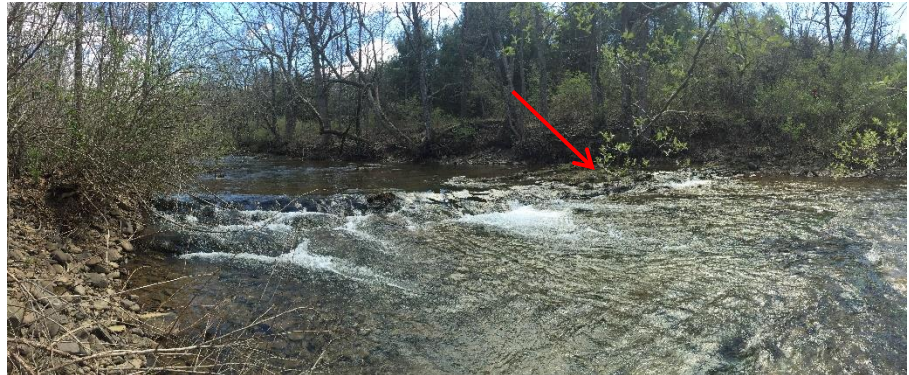
Direction: Upstream

Description: View of step at stream crossing. Rock outcrop identified on left bank (red arrow).

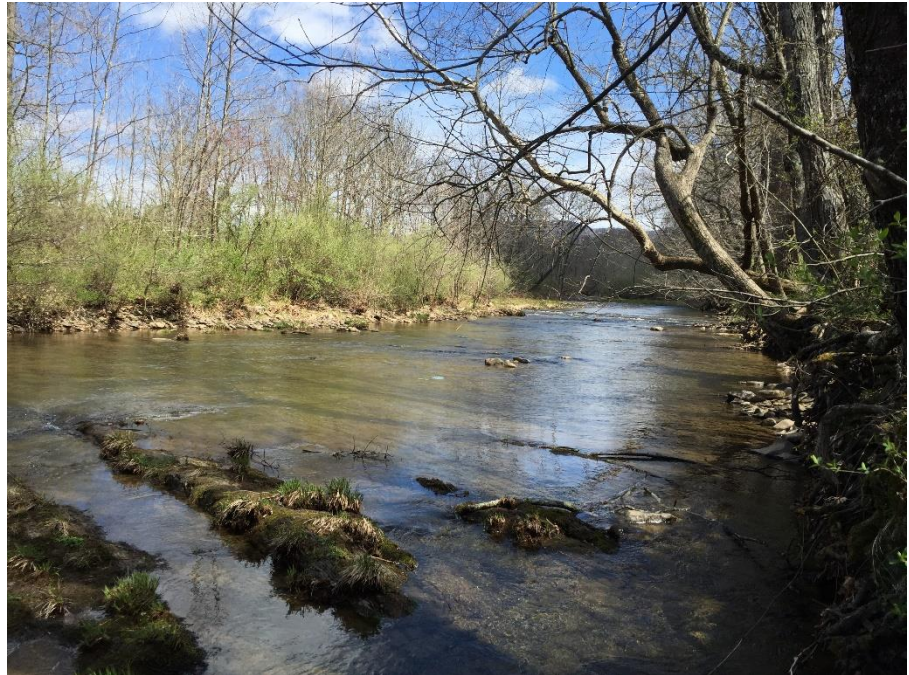
Direction: Upstream

Description: View of rock outcrop in stream on left bank as well as thin riparian buffer on right bank.

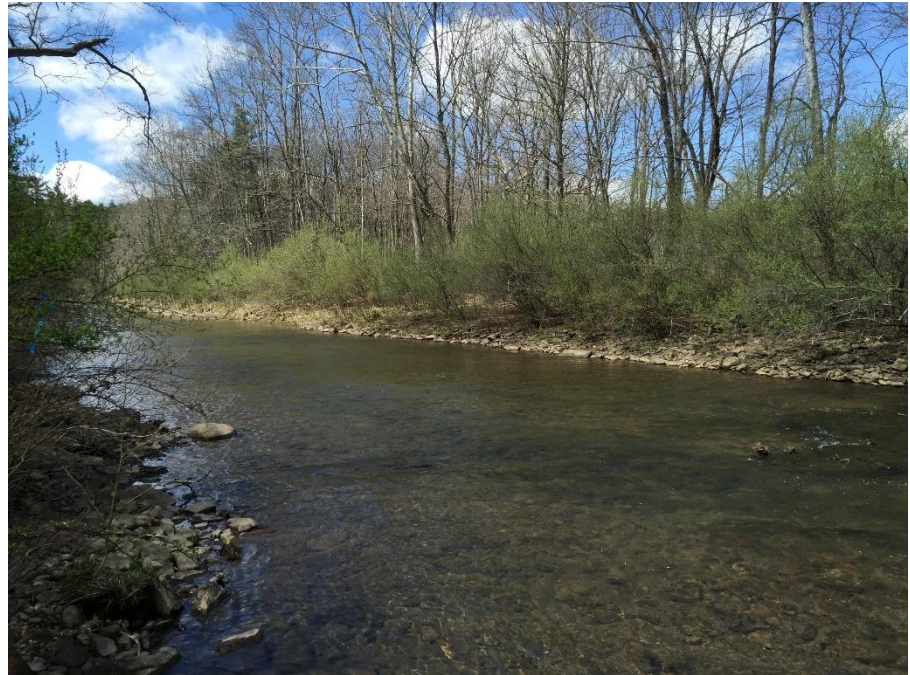
Direction: Downstream

Description: View of cobbles and occasional boulders in stream bed as well as cobbles lining right bank.
