Linear Waterbody Data Sheet

Survey Description			
Project Name: Atlantic Coast Pipeline		Waterbody Name: UNT to Slaty Fork	
Waterbody ID: spoa420		Date: 6/1/2016	
State: West Virginia	County: Pocahontas	Company: NRG/ERM	Crew Member Initials: GB, KO
Photos: 4 photos			
Tract Number(s): access road 05-001-C008.AR1		Nearest Milepost: 72.1	Associated Wetland ID(s): none
Survey Type: <i>(check one)</i> <input type="checkbox"/> Centerline <input type="checkbox"/> Re-Route <input checked="" type="checkbox"/> Access Road <input type="checkbox"/> Other:			
Physical Attributes			
Stream Classification: <i>(check one)</i> <input type="checkbox"/> Ephemeral <input checked="" type="checkbox"/> Intermittent <input type="checkbox"/> Perennial			
Waterbody Type: <i>(check one)</i> <input type="checkbox"/> River <input checked="" type="checkbox"/> Stream <input type="checkbox"/> Ditch <input type="checkbox"/> Canal <input type="checkbox"/> Other:

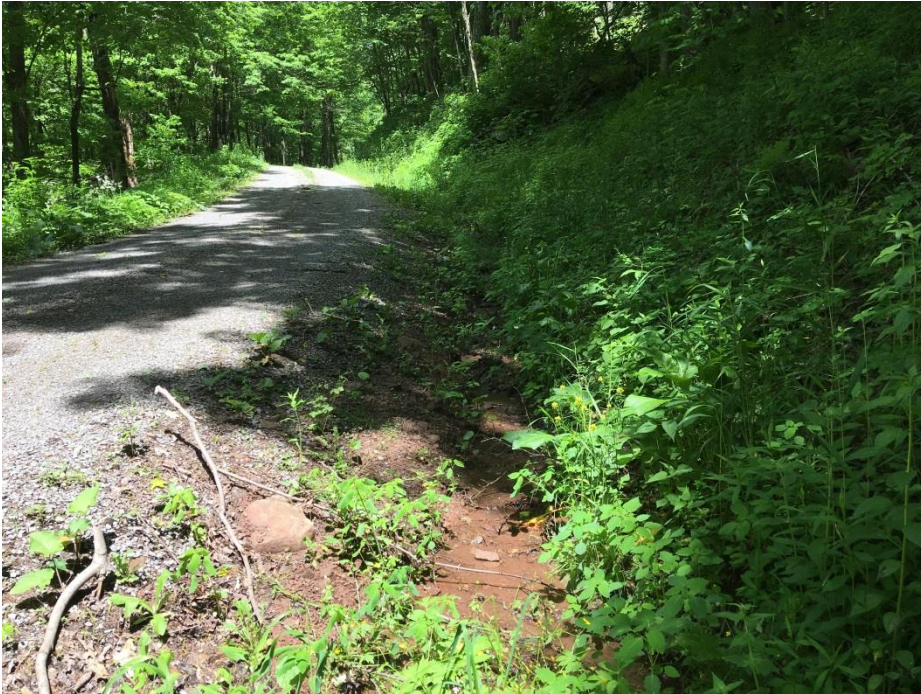
Waterbody SPOA430 facing northwest upstream

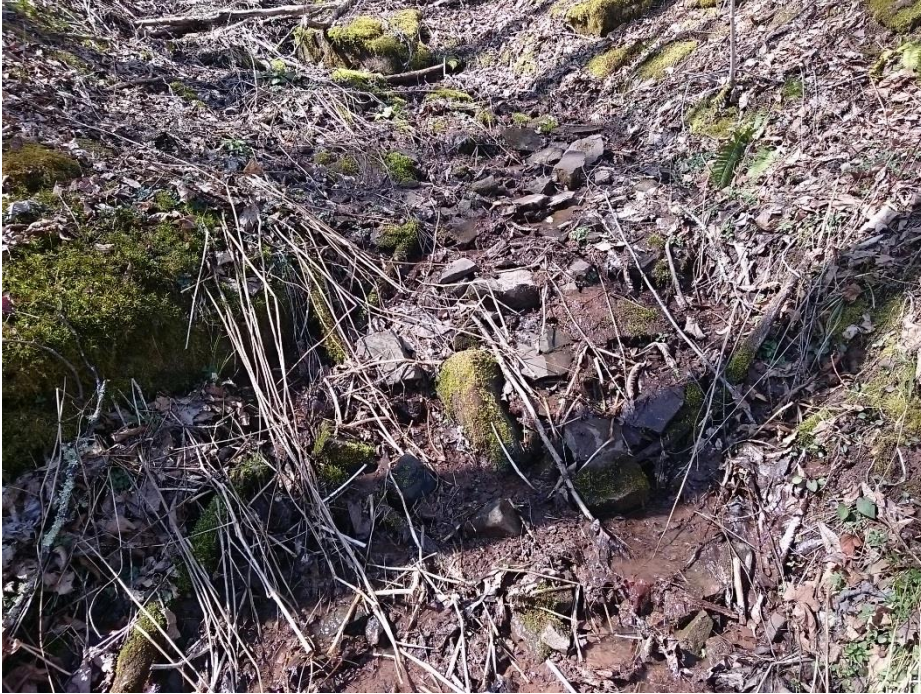
Waterbody SPOC109 facing west upstream
